# **Archeological Monitoring Report**

## **City Island Water Main Project Pelham Bay Park, Bronx County, New York**

***John Milner Associates  
Architects • Archeologists • Planners***

*March 2003*

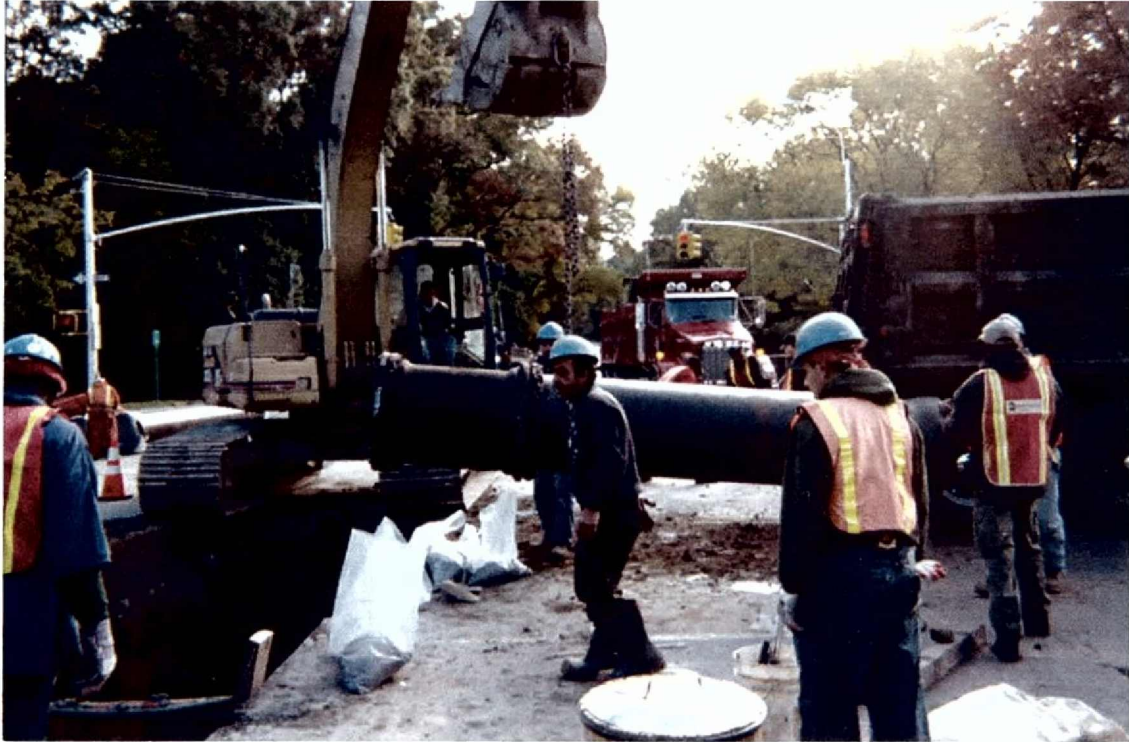
Plate 1. Installation of main at approximately Sta. 115+50; view to the east.

At 7:00 AM on October 31, 2002, construction crews began work at the intersection of City Island Road and Shore Road, at Sta. 115+00. They excavated short trenches north and south of the intersection with City Island Road within Shore Road, and then proceeded to excavate east within City Island Road. At this portion of the Project area, construction activities associated with installation of the new water main included the excavation of a trench approximately 4.5 m long, 2 m deep, and 1.8 m wide. Excavated spoil was placed directly into dump trucks. Trench walls were shored and a pipe segment was lowered into the trench; the segment was then joined to the segment laid in before it. The trench was backfilled with sand and gravel, and then covered with asphalt (Plate 1, Plate 2).

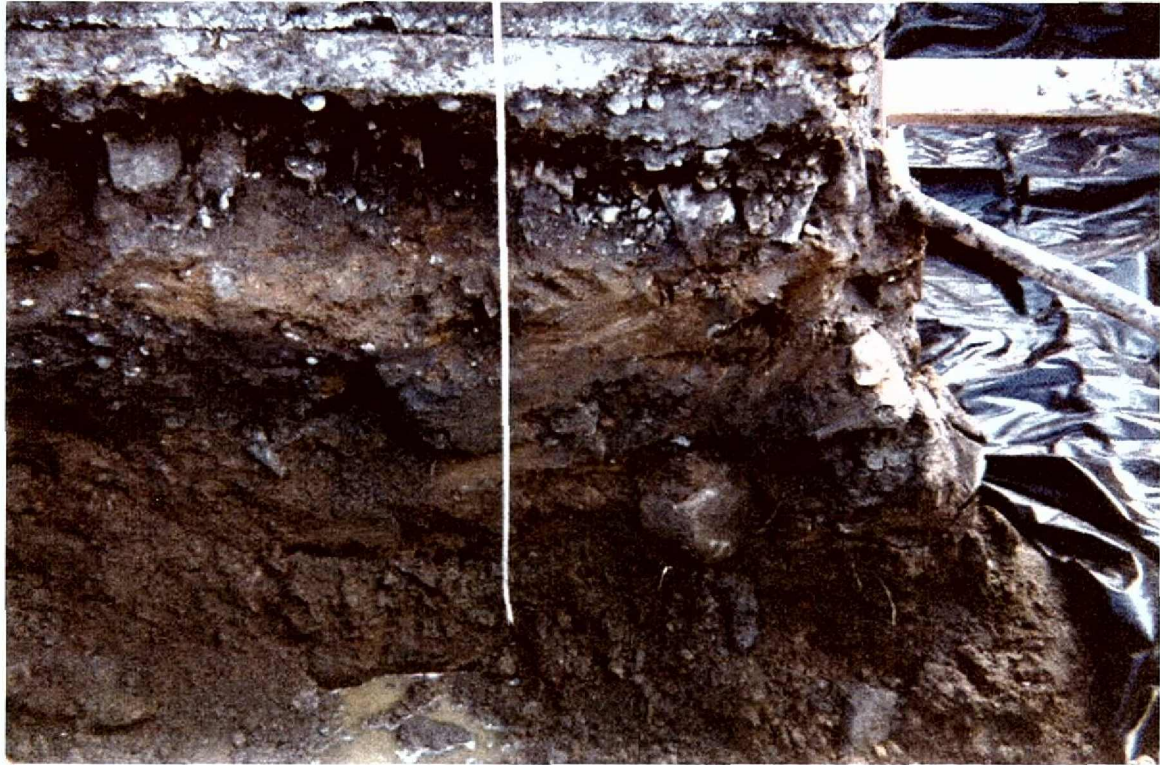
Plate 3. Stratigraphic profile of east wall of trench at intersection of City Island Road and Shore Road ( at approximately Sta. 115+00); view to the east.

The observed stratigraphic profile of the trench in the vicinity of the City Island Road/Shore Road intersection (Plate 3) can be described as follows: Stratum A (~0-25 cmbs)<sup>1</sup> consisted of the asphalt and cement road; Stratum B (~25-50 cmbs) consisted of a dark gray (10YR 4/1) gravelly silt with cobbles and rubble; and Stratum C (~50-200 cmbs) consisted of a dark yellowish brown (10YR 4/6) sandy, rocky soil with mottling of both lighter and darker soils. The homogeneity of the soil as well as the cement and rubble present throughout the profile suggests that the soil is fill probably associated with previous road construction. The streaked and mottled appearance of the lower two strata also suggests that the ground had been previously disturbed. The water table was encountered at approximately 2 m below the surface. With the exception of a feature and an anomaly in the stratigraphy, the profile within this stretch of the Project area remained consistent.

- A** modern road; asphalt 0-10 cm below surface, cement 10-25 cm below surface
- B** dark gray (10YR 4/1) gravelly silt with cobbles and rubble; 25-50 cm below surface
- C** dark yellowish brown (10YR 4/6) sand with rocks, mottled with darker and lighter soils; 50-200 cm below surface

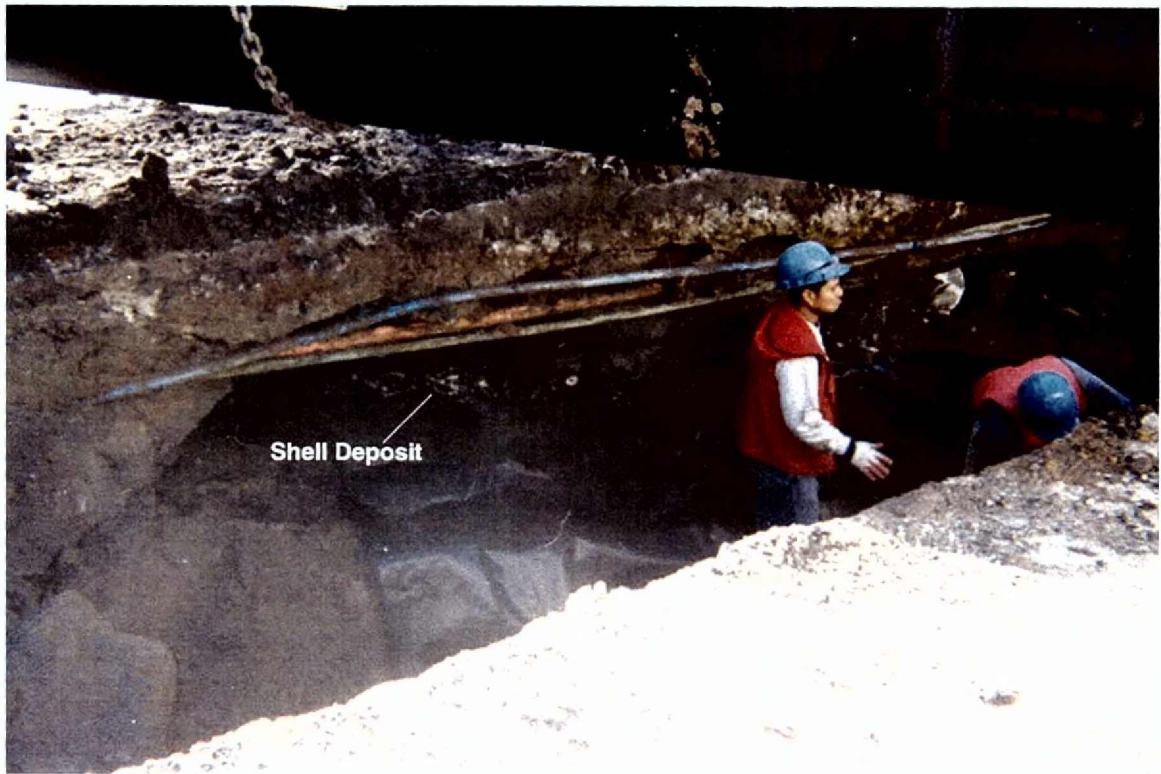
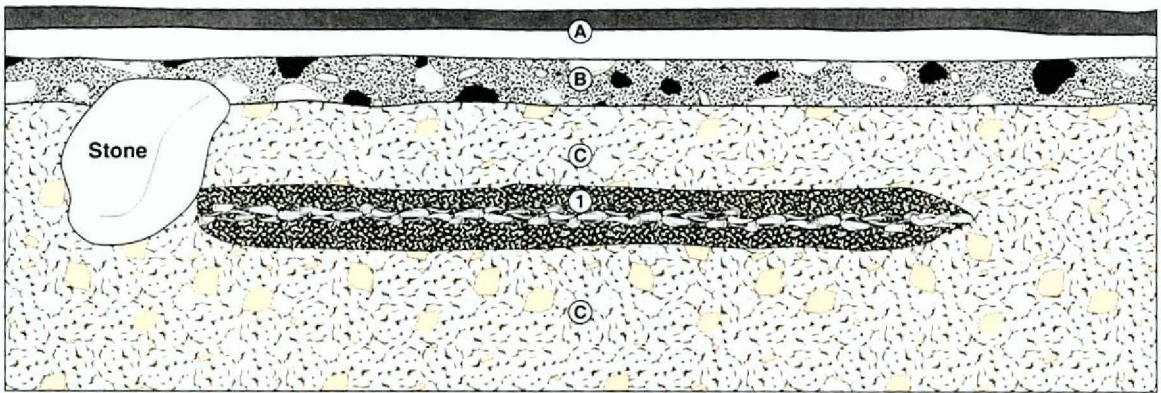
Plate 4. Feature 1 shell deposit at approximately Sta. 115+60; view to the south.

At approximately Sta. 115+60, monitors observed a 10 cm thick lens of shell and black (10YR 2/1) soil in the south wall of the trench within Stratum C at approximately 110 cmbs (Plate 4). The lens was designated Feature 1. The black soil extended 10 cm above and 10 cm below the shell, and the entire deposit was approximately 4 m long. A sample of the feature matrix was collected. A visual inspection of both the deposit while it was *in situ* and a later examination of the sample revealed no artifacts or faunal material other than the shell. The shell was predominantly oyster with a small percentage of scallop. Most of the shell was fragmentary, but some small complete valves were noted in the sample. Because the shell band did not extend any farther to the east (the direction in which construction was proceeding), and because it appeared to be located within a stratum that was probably disturbed, JMA did not recommend that work be halted for further investigation of the feature. LPC staff was contacted by phone and concurred with JMA's decision that no further work was required in regards to Feature 1.

One feature (Feature 1) was observed during the course of monitoring. It consisted of a 10 cm by 4 m band of shell (predominantly oyster shell) intermixed with a black (10YR 2/1) soil located at the approximate location of station 115+60 (Plate 4). Feature 1 was both overlain and underlain by what appeared to be a disturbed stratum of mottled soils suggesting some form of re-deposition. No artifacts or bone were found within or near Feature 1. Feature 1 may extend south from the area in the trench wall where it was observed. Any future construction to the south of the monitored trench may intersect Feature 1.

- A modern road; asphalt 0-10 cm below surface, cement 10-25 cm below surface
- B dark gray (10YR 4/1) gravelly silt with cobbles and rubble; 25-50 cm below surface
- 1 shell deposit intermixed with black (10YR 2/1) soil; 95-125 cm below surface
- C dark yellowish brown (10YR 4/6) sand with rocks, mottled with darker and

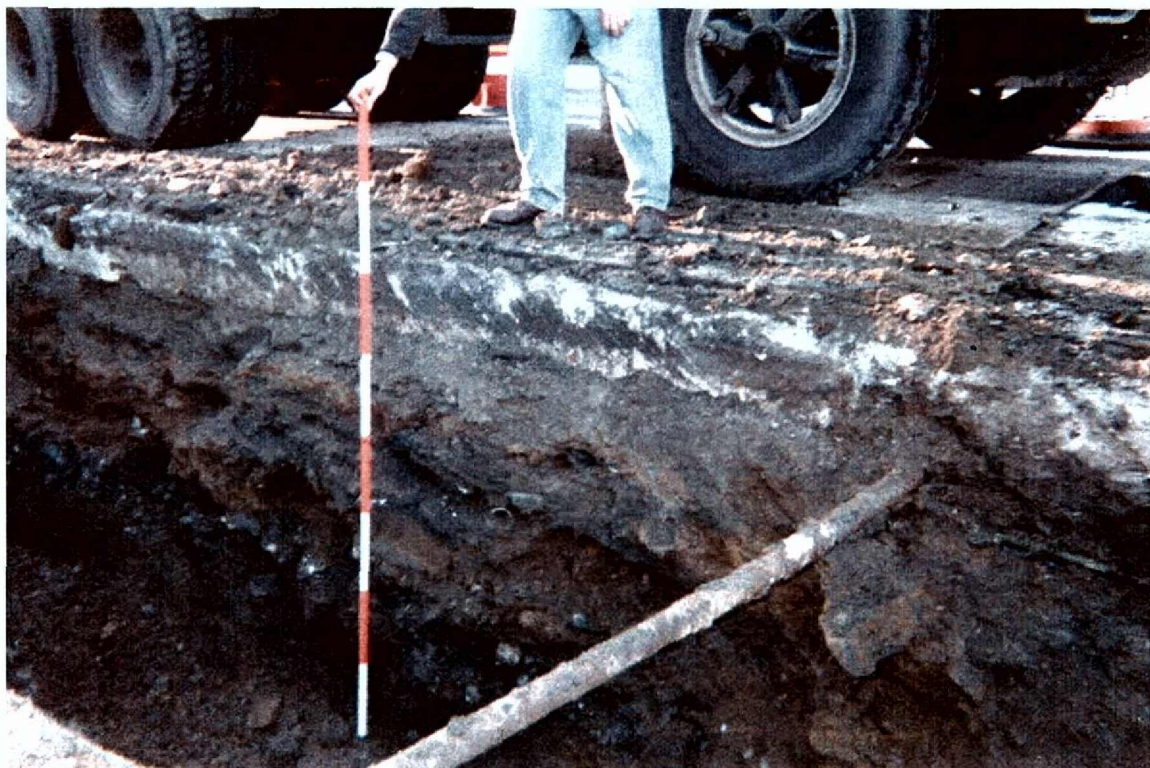
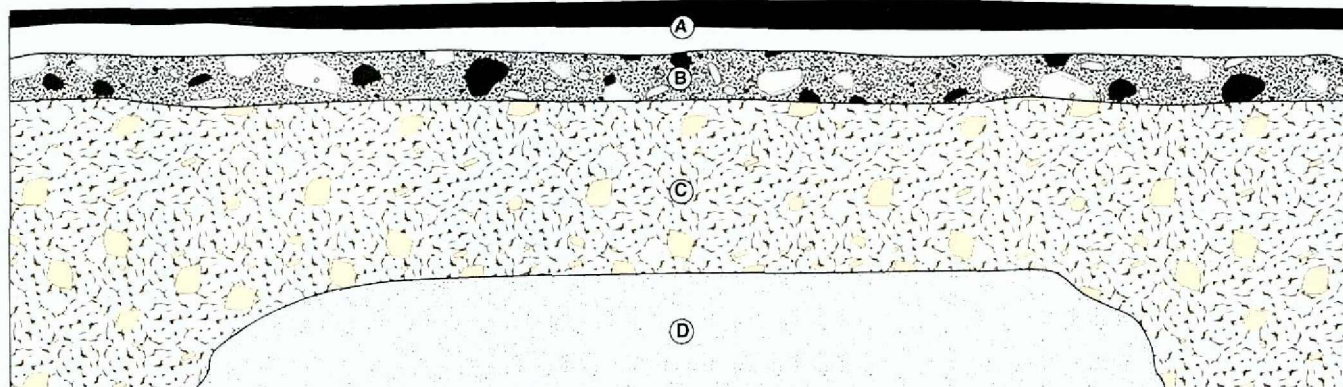
Plate 5. Stratigraphic profile at approximately Sta. 117+75; view to the south.

At approximately Sta. 117+75 (Plate 5), monitors observed a 5 m wide band of very dark gray (10YR 3/1) silty sand in the south trench wall at approximately 140-200 cmbs. The band was designated Stratum D. Monitors concluded that this lens of darker soil was most likely fill associated with prior construction. No archeological or faunal remains were observed in association with Stratum D.

- A modern road; asphalt 0-10 cm below surface, cement 10-25 cm below surface
- B dark gray (10YR 4/1) gravelly silt with cobbles and rubble; 25-50 cm below surface
- C dark yellowish brown (10YR 4/6) sand with rocks, mottled with darker and lighter soils; 50-140 cm below surface
- D very dark gray (10YR 3/1) silty sand; 140-200 cm below surface

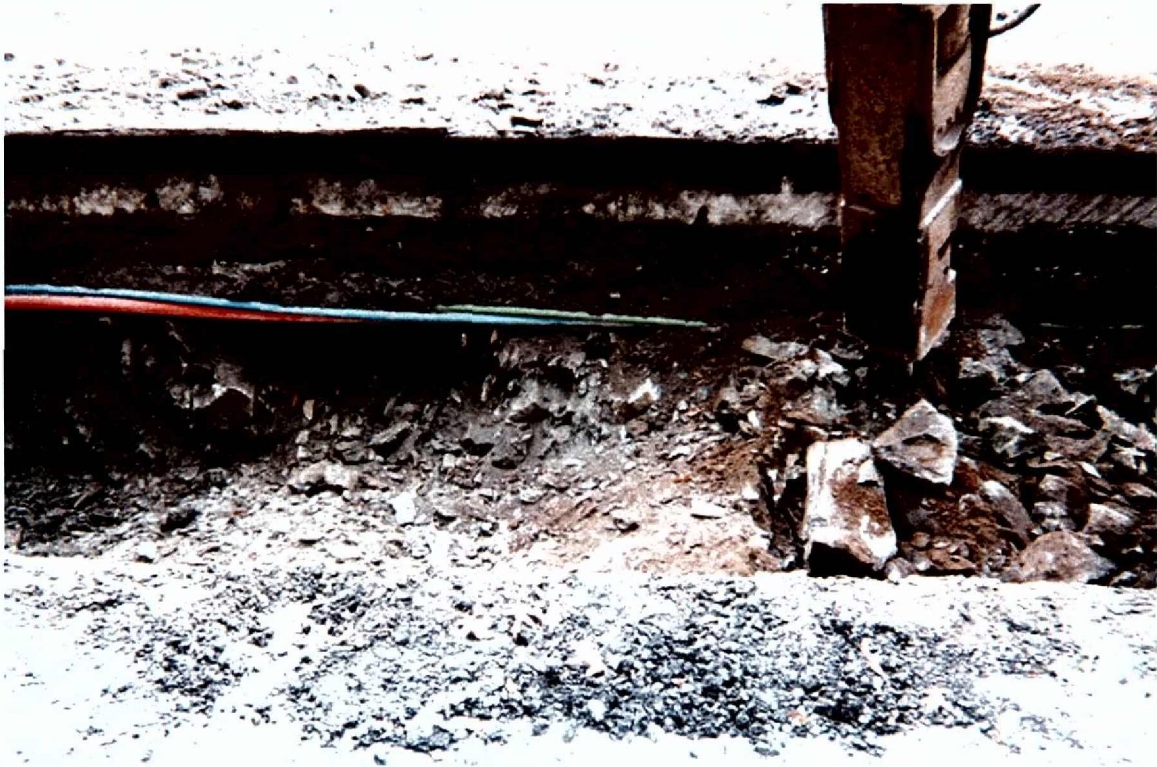
Plate 6. Stratigraphic profile of south wall of trench at approximately Sta. 118+00 showing the location of a bedrock outcrop; view to the south.

Construction trenching encountered a bedrock outcrop at approximately Sta. 118+00 (Plate 6). It significantly slowed excavation, which proceeded to approximately Sta. 118+20 by the end of the day on November 1. In summary, no archeological or faunal remains (other than the shell in Feature 1) were observed during the week ending November 1, 2002.

- A modern road; asphalt 0-10 cm below surface, cement 10-25 cm
- B dark gray (10YR 4/1) gravelly silt with cobbles and rubble; 25-50 cm
- C dark yellowish brown (10YR 4/6) sand with rocks, mottled with darker and lighter soils

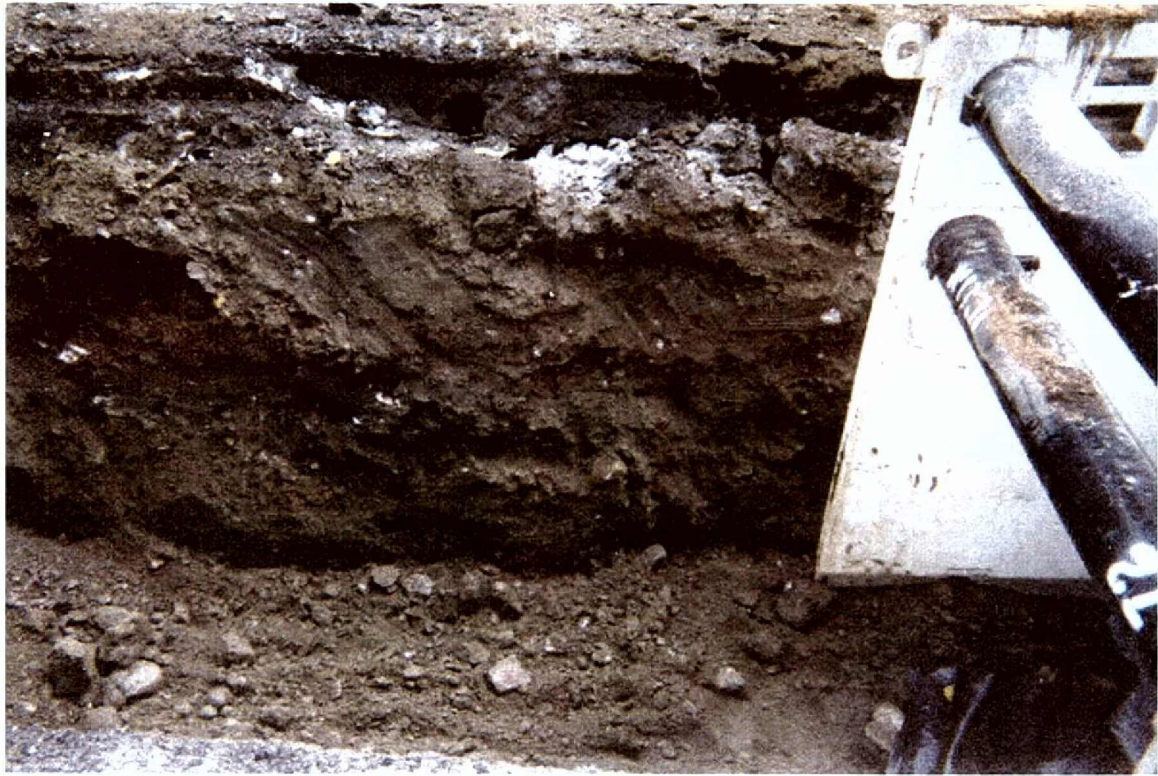
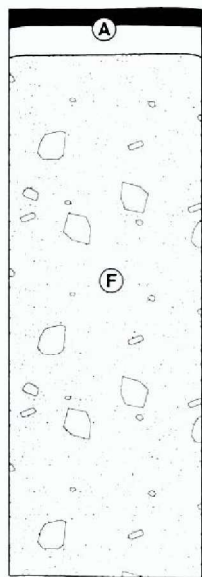
Plate 7. Stratigraphic profile of south wall of trench at approximately Sta. 125+00; view to the south.

At approximately Sta. 124+25, another bedrock outcrop was encountered. It extended for approximately 60 feet. Once the rocky area was passed, the trench was excavated to a depth of approximately 3 m below the surface. The soil underlying Stratum A (~0-25 cmbs) was designated Stratum F. Stratum F consisted of a homogenous, very dark gray (2.5Y 3/1) silty sand with rounded cobbles that extended from approximately 25 to 300 cmbs (Plate 7). Starting at Sta. 129+90, Stratum A was underlain by Stratum G, a dark olive brown (2.5Y 3/3) silty sand with rounded cobbles.

**A** modern road; asphalt 0-10 cm below surface, cement 10-25 cm below surface

**F** very dark gray (2.5Y 3/1) silty sand with rounded cobbles; 25-300 cm below surface

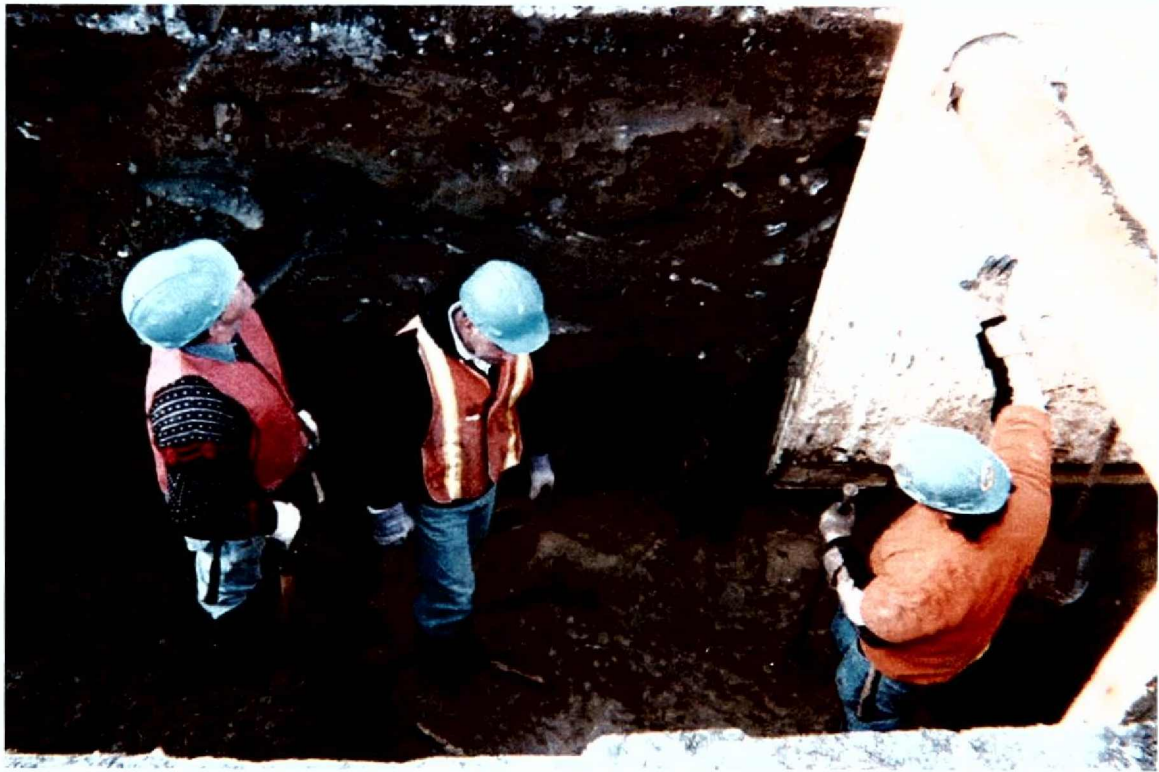
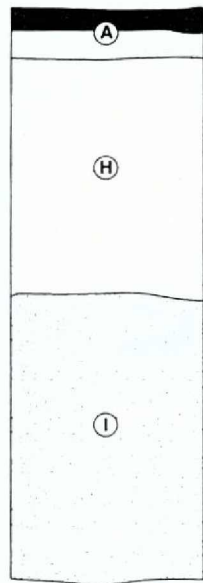
Plate 8. Stratigraphic profile of south wall of trench at approximately Sta. 137+00; view to the south.

Construction monitoring resumed on November 12. With one exception, from approximately Sta. 131+10 through Sta. 138+60, the modern road (Stratum A, ~0-25 cmbs) was underlain by Stratum G (~25-300 cmbs), a dark olive brown (2.5Y 3/3) silty sand with rounded cobbles. Between Sta. 137+00 and Sta. 137+20, Stratum A (~0-25 cmbs) was underlain by Stratum H (~25-150 cmbs), a strong brown (7.5YR 4/6) silty sand, and Stratum I (150-300 cmbs), a dark grayish brown (10YR 3/2) silty sand (Plate 8).

- A** modern road; asphalt 0-10 cm below surface, cement 10-25 cm below surface
- H** strong brown (7.5YR 4/6) silty sand; 25-150 cm below surface

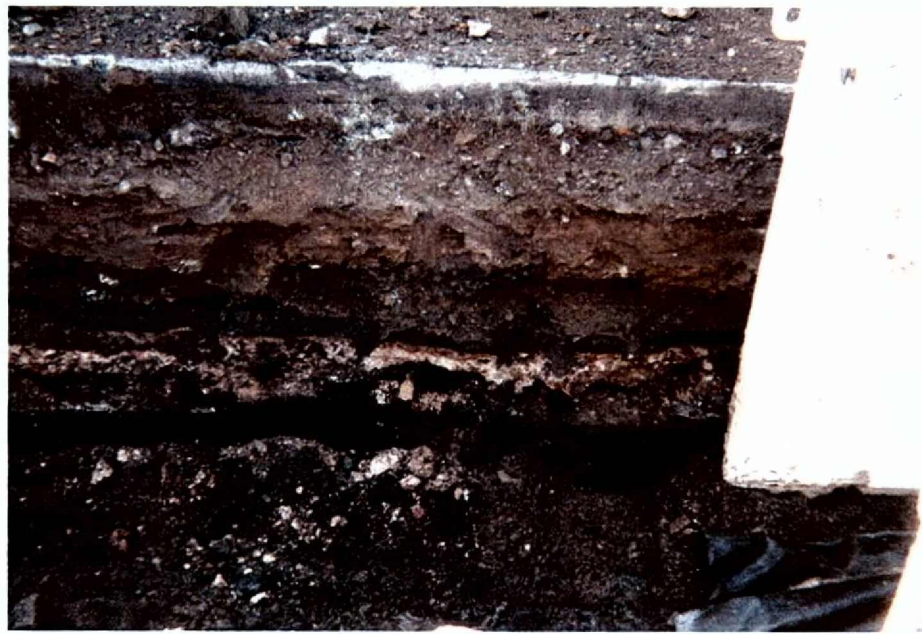
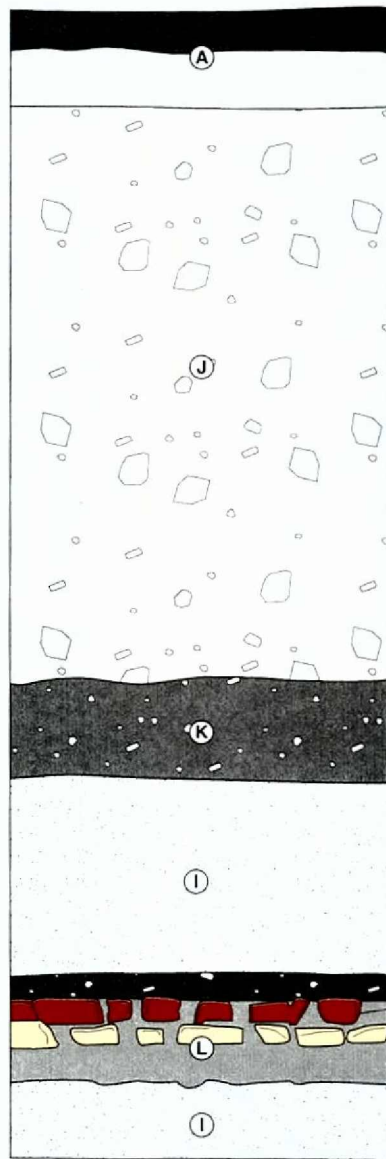
Plate 9. Stratigraphic profile of south wall of trench at approximately Sta. 143+50; view to the south.

Monitors observed a significant change in the stratigraphic profile of the trench walls from approximately Sta. 138+60 to Sta. 144+00. Within this stretch, the stratigraphy can be described as follows: Stratum A (~0-25 cmbs) was underlain by Stratum J (~25-175 cmbs), a brownish yellow (10YR 6/8) silty sand with large cobbles. Beneath Stratum J was Stratum K (~175-200 cmbs), a dark band of asphalt and gravel. This stratum was interpreted as an earlier roadbed. Below the old roadbed lay Stratum I (~200-300 cmbs), a dark grayish brown (10YR 3/2) silty sand. This dark color may be attributed to the leaching of the asphalt into the underlying stratum. In some locations during this stretch, a layer of tar, gravel, red and yellow brick fragments, and

ash designated Stratum L was observed at approximately 250-270 cmbs. Monitors interpreted Stratum L as another former roadbed (Plate 9).

- A** modern road; asphalt 0-10 cm below surface, cement 10-25 cm below surface
- J** brownish yellow (10YR 6/8) silty sand with large cobbles; 25-175 cm below surface
- K** old road bed I; asphalt and gravel; 175-200 cm below surface
- I** dark grayish brown (10YR 3/2) silty sand; 200-300 cm below surface
- L** old road bed II, occasionally visible in stratum I; 250-270 cm

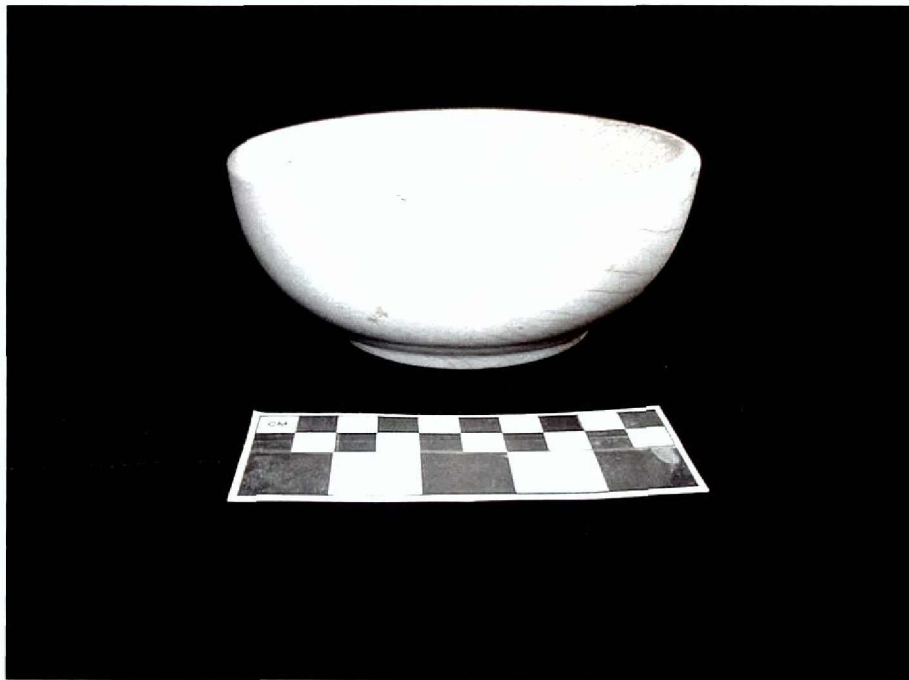
Plate 10. Ironstone bowl recovered at approximately Sta.139+40.

A complete ironstone bowl was found in excavated soil at approximately Sta.139+40 (Plate 10). This artifact was marked with the words "Edwin M. Knowles, China, 1[?]-8-2-1." The Edwin M. Knowles China Company was in operation from 1900 until 1963 (Lehner 1988:237-238). A fragment of ironstone including a portion of a footing was found in soil excavated at approximately Sta. 142+25 (Plate 11). The fragment contains a partial maker's mark reading "... Knowles . . . china . . . 8-2-1." Given the dates of operation of the Knowles pottery, it is likely that the bowl and ironstone fragment are associated with post-turn-of-the-century road fill

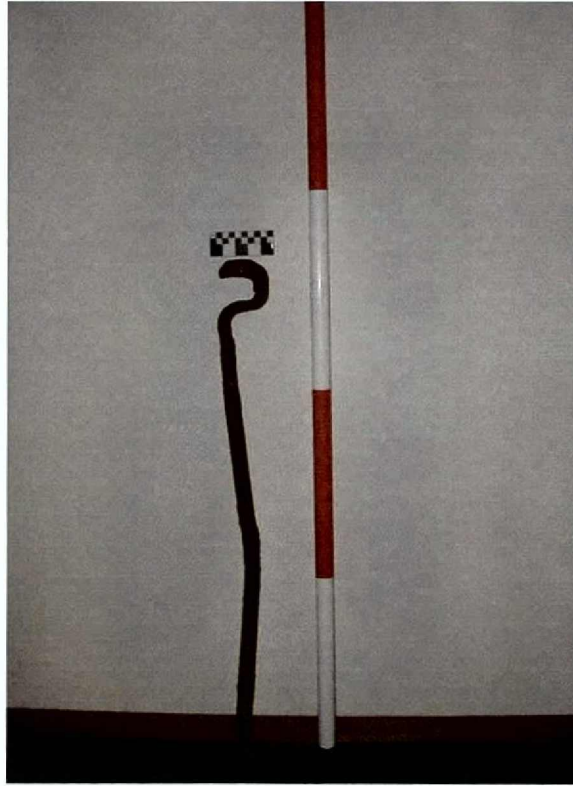
Plate 12. Iron object recovered at approximately Sta.139+60.

An iron object was found in excavated spoil at approximately Sta.139+60 (Plate 12). This object was a 33 cm long rod that curved to a hook on one end. It was 2.5 cm in diameter, and was heavily oxidized. Ironstone fragments were also found at approximately Sta. 141+90 and 142+10.

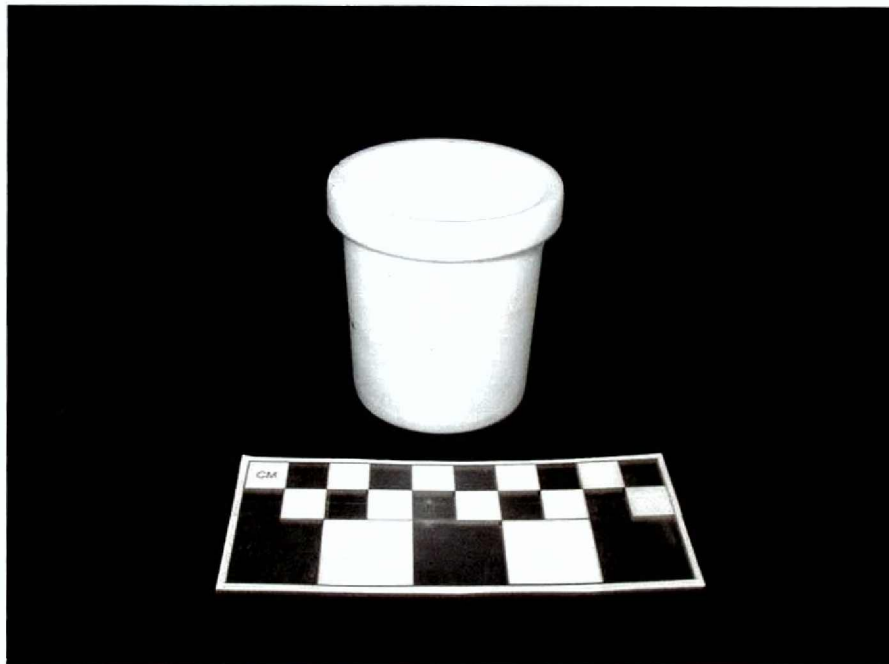
Plate 13. Soft-paste porcelain vessel recovered at approximately Sta.143+00.

Finally, a small cylindrical-shaped soft-paste porcelain container was found at approximately Sta. 143+00 (Plate 13). The base of the container is stamped with the trademark for MacLaren's Imperial Cheese. This product was marketed by Alexander Ferguson MacLaren beginning in 1892 (Johnston 1903). Its presence is therefore chronologically consistent with post-turn-of-the-century deposition with road fill.

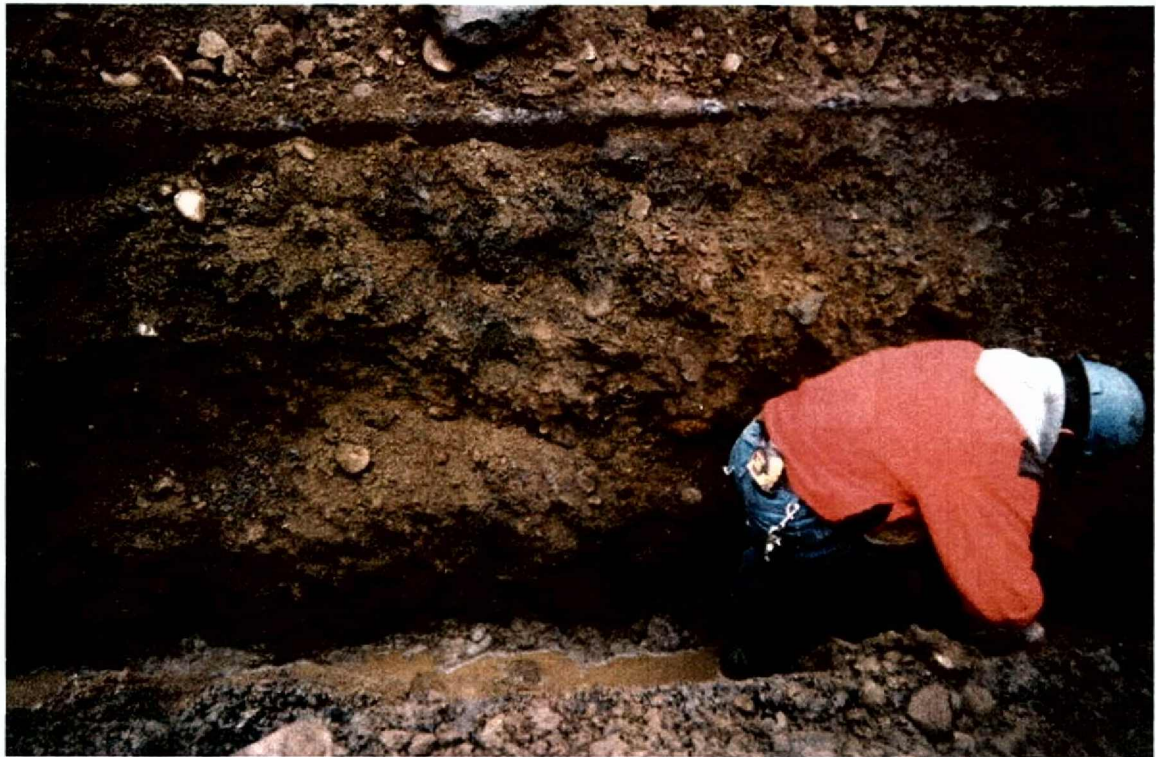
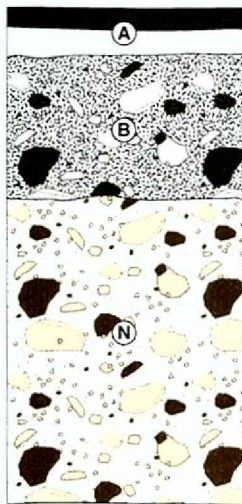
Plate 14. Stratigraphic profile of south wall of trench at approximately Sta. 243+50; view to the south.

A soil change was observed at approximately station 243+50. Beyond this point, Stratum B (~25-100 cmbs) was underlain by Stratum N (~25-250 cmbs), a 10YR 4/6 dark yellowish brown silty sand with large cobbles and rubble (Plate 14)

- A** modern road; asphalt 0-10 cm below surface, cement 10-25 cm below surface
- B** dark gray (10YR 4/1) gravelly silt with cobbles and rubble; 25-100 cm below surface
- N** dark yellowish brown (10YR 4/6) silty sand with large cobbles and rubble; 100-250 cm below surface
