**New York City  
Department of Environmental Protection  
South Richmond Drainage  
Storm Water and Sanitary Drainage Plan**

**Lemon Creek Drainage Area**

**Phase 1B Archaeological Field  
Testing and Photo documentation of  
BMP LC-3B: Kramer Avenue, BMP LC-  
12: Woodvale Avenue and BMP SP-5:  
Islington Pond  
Staten Island, New York**

**February 2006**

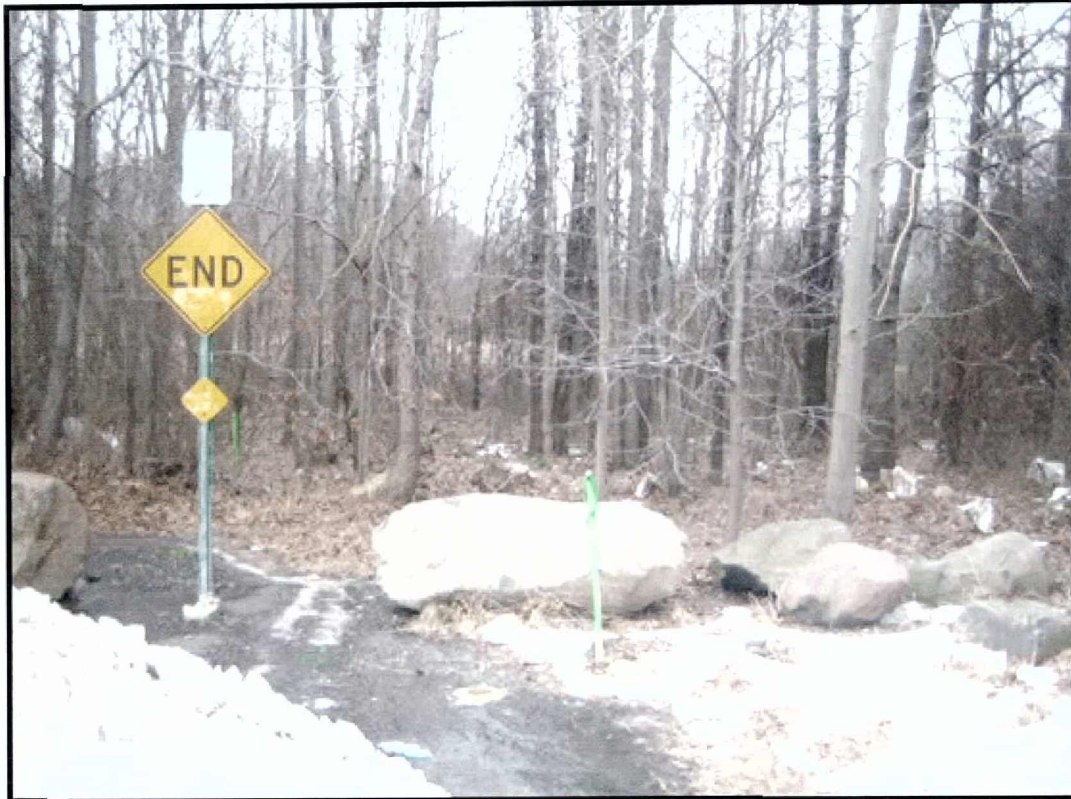
Photo 1. BMP LC-3B: Kramer Avenue looking northeast, February 18, 2006.  
Photographer: James Cox.

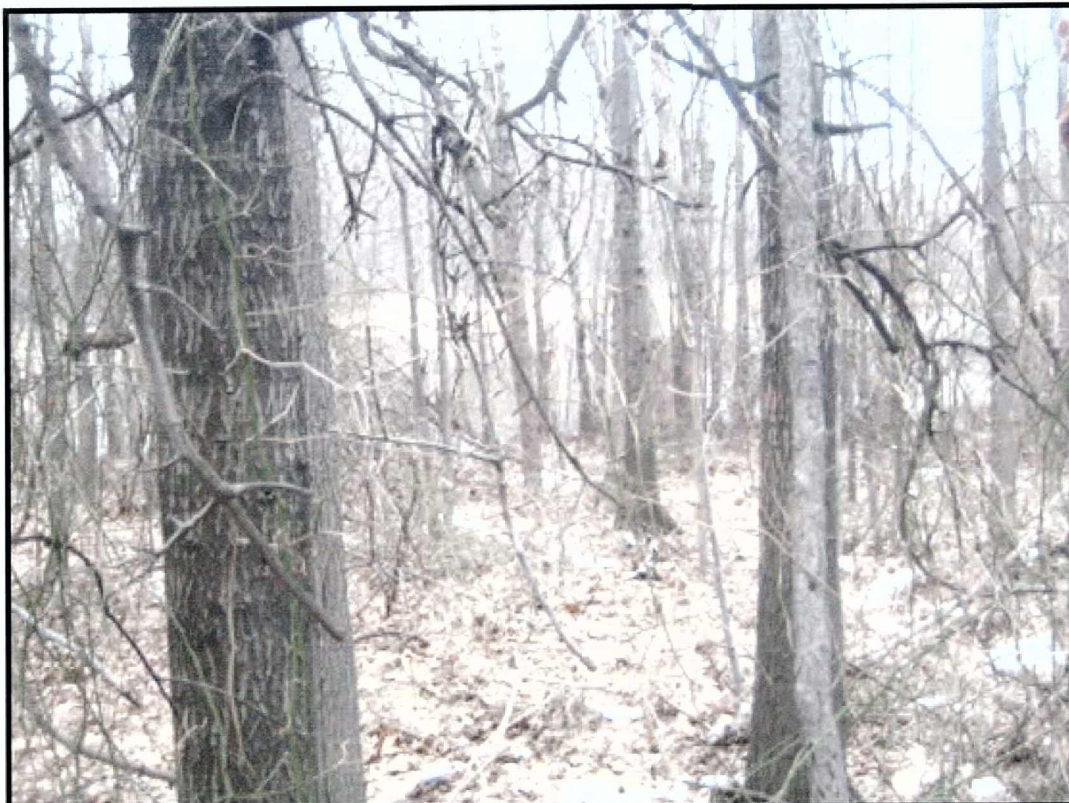
Photo 2. BMP LC-3B:Kramer Avenue looking west, February 18, 2006. Photographer: James Cox.

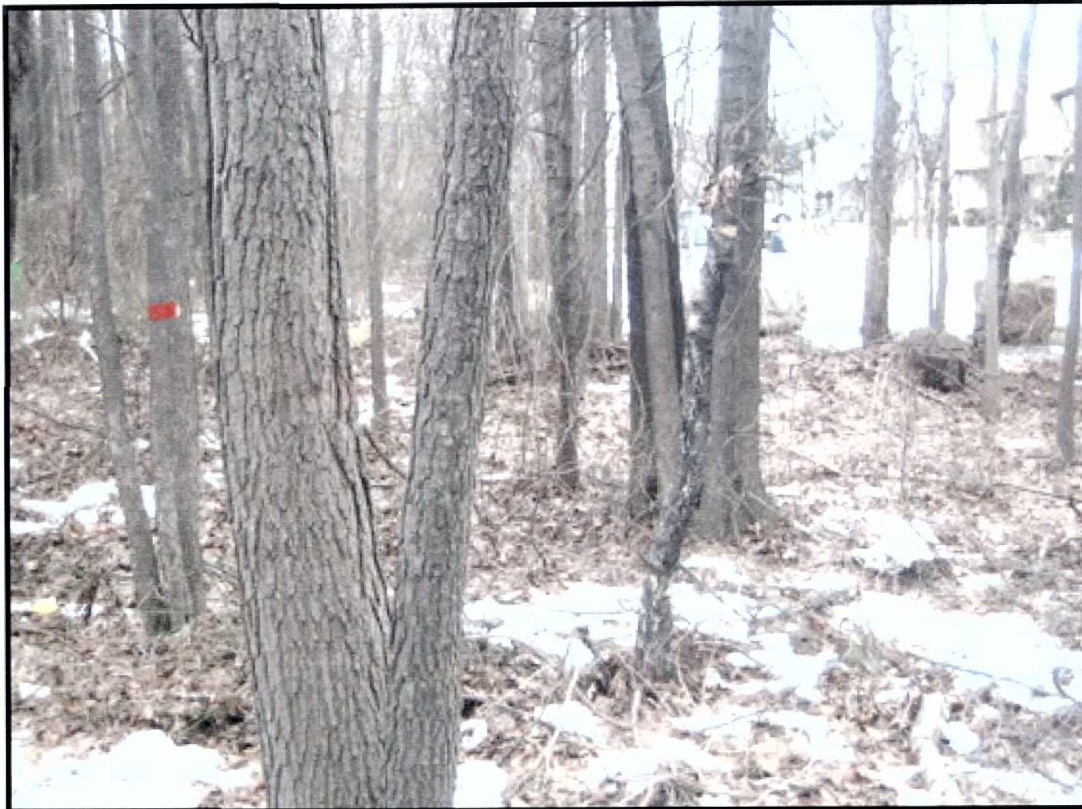
Photo 3. BMP LC-3B: Kramer Avenue looking northwest toward Kramer Avenue, February 18, 2006. Photographer: James Cox.

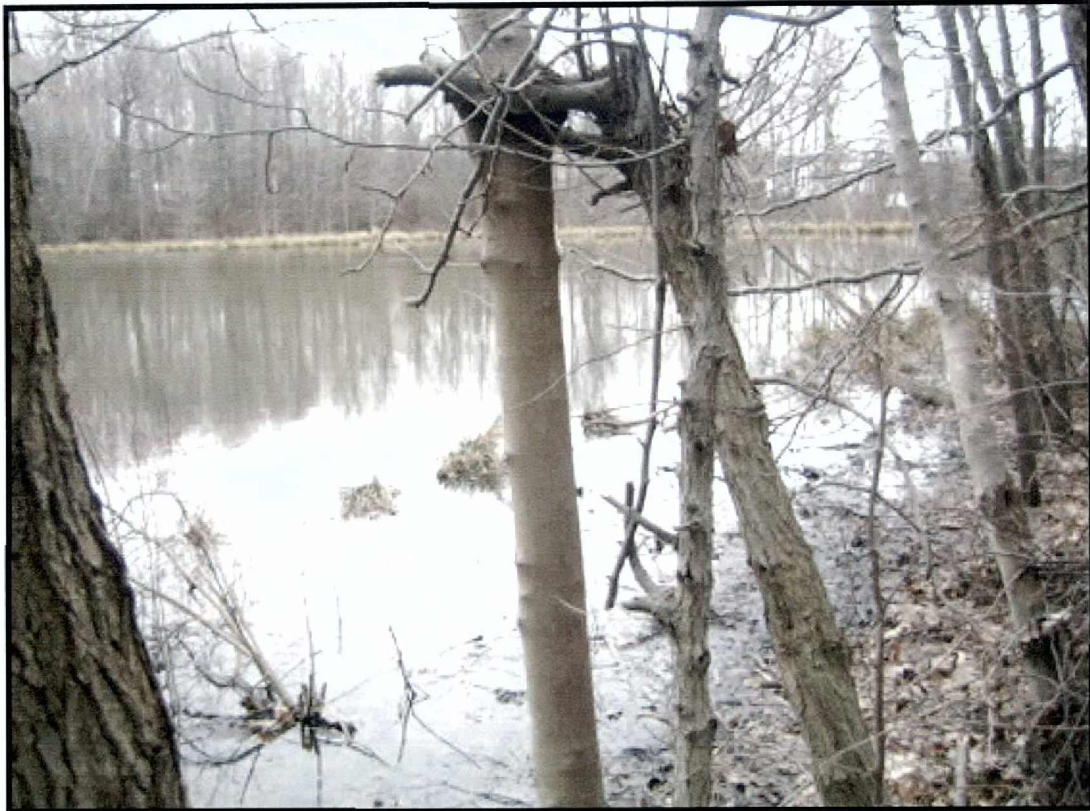
Photo 4. BMP LC-3B: Kramer Avenue looking southeast along western bank of Porzio's Pond, February 18, 2006. Photographer: James Cox.

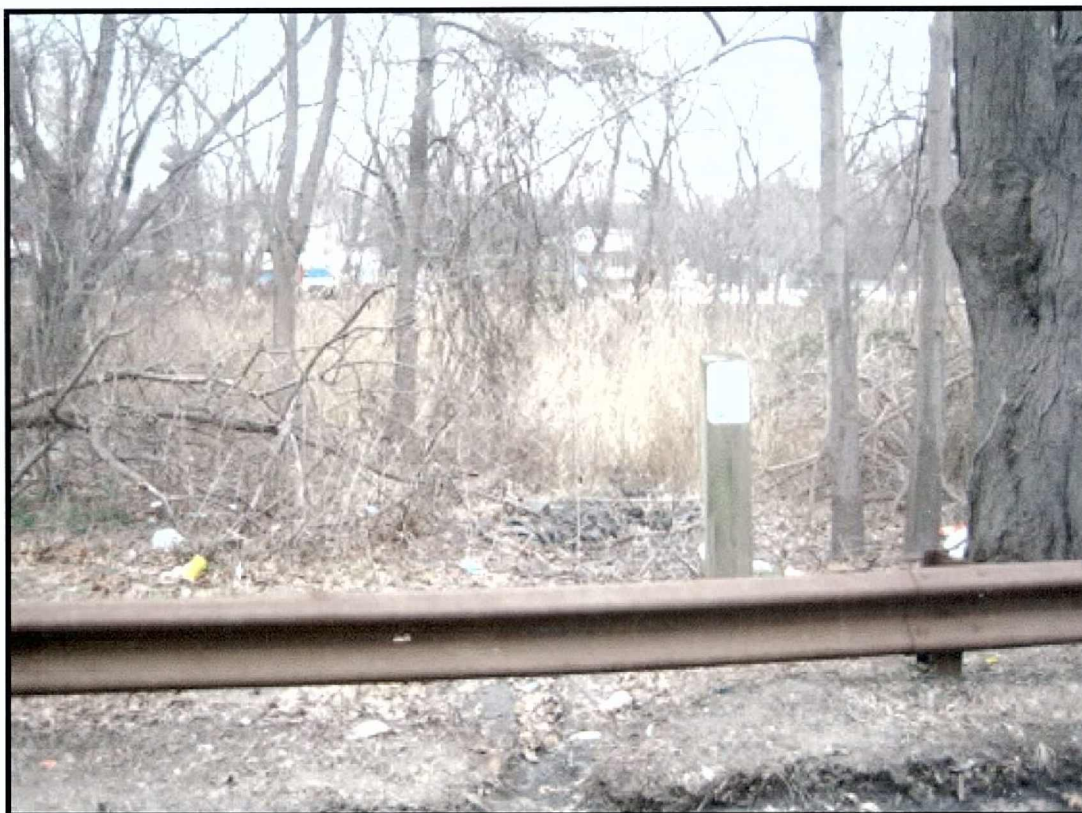
The standing water and marshy conditions of the site prohibited excavations within the APE. Instead, numerous photos were taken (see Photo 5 and 6) and a brief reconnaissance level survey conducted.

Photo 5. BMP LC-12: Woodvale Avenue looking northeast, February 18, 2006.  
Photographer: James Cox.

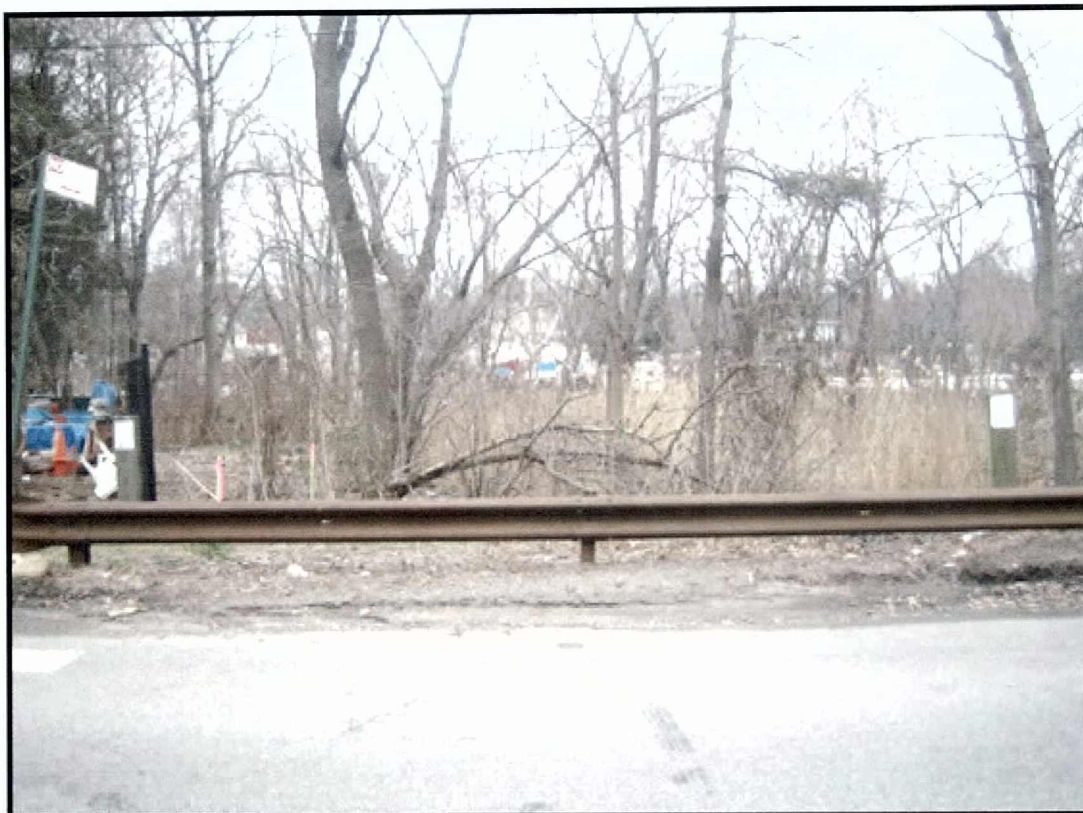
Photo 6. BMP LC-12: Woodvale Avenue looking northeast, February 18, 2006.  
Photographer: James Cox.

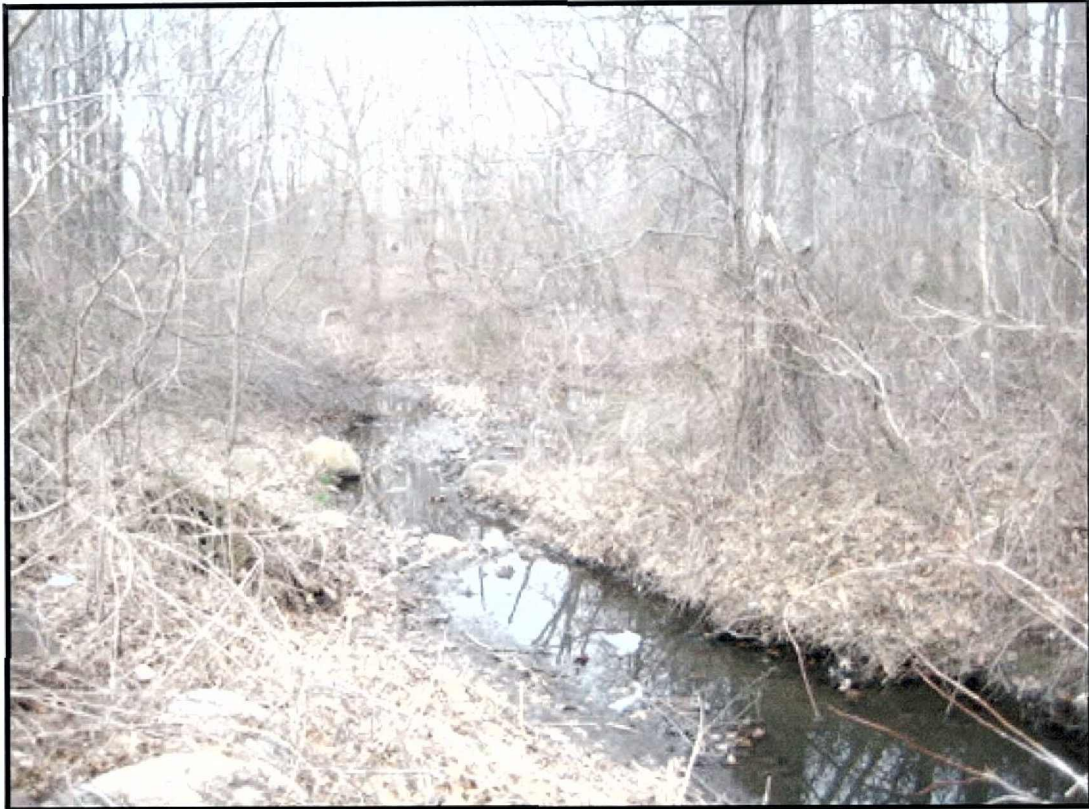
Photo 7. BMP SP-5: Islington Pond looking northwest along creek, February 18, 2006.  
Photographer: James Cox.

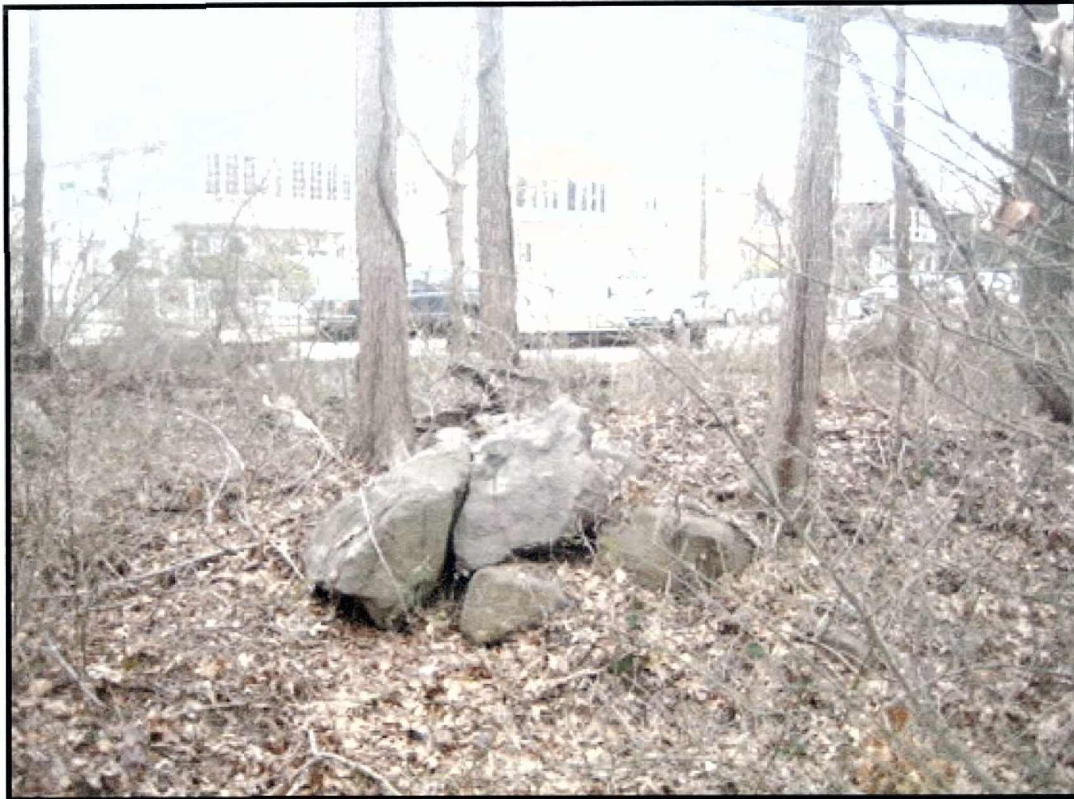
Photo 8. BMP SP-5: Islington Pond looking southwest toward Islington Street, February 18, 2006. Photographer: James Cox.

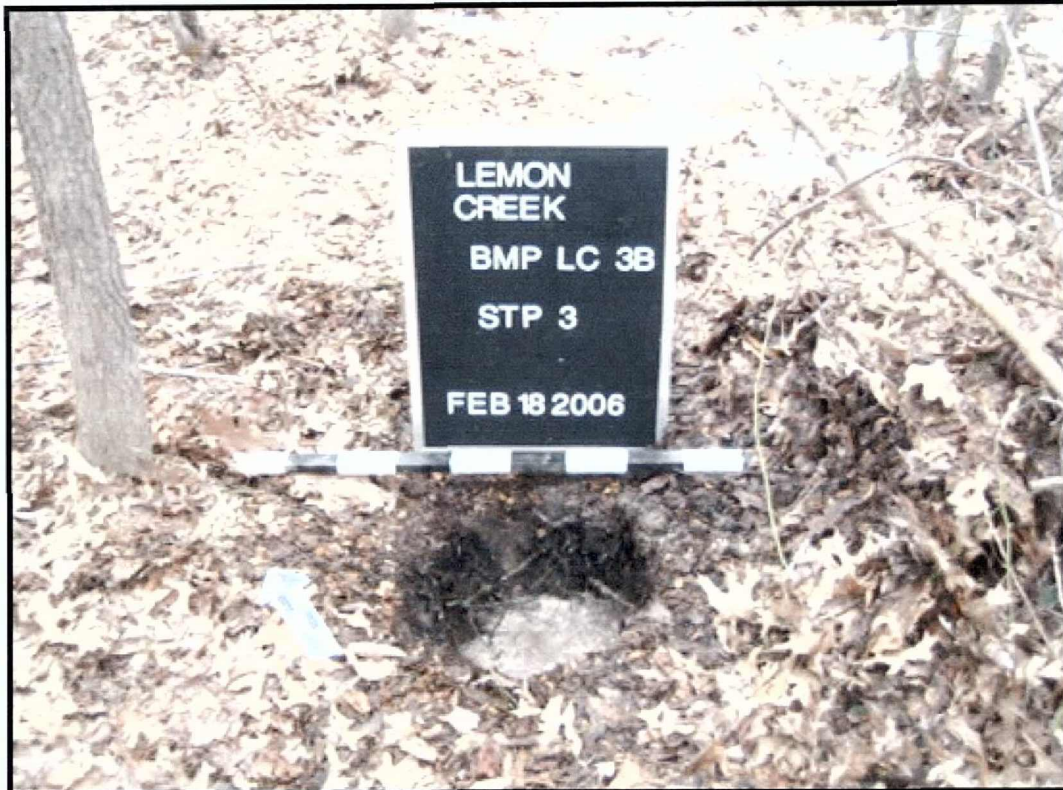
Evident from the field survey, the area is poorly drained with a very high water table approximately 25cm (9.8in) below grade. Three distinct soil horizons were identified through field-testing. Level 1 consisted of a silty sand humic deposit ranging from 10YR 2/1 (black) (STs 2-5) to 10YR 3/2 (very dark grayish brown) (ST 1). Level 2 offered the greatest variability and together with Level 3 exhibited the episodic flooding or marshy conditions of the site. ST 1, Level 2 consisted a mottled wet silty clay 7.5YR 4/6 (strong brown) with 7.5YR 5/1 (gray); ST 2, Level 2 consisted of a fine sandy silt 10YR 3/3 (dark brown); STs 3-4, Level 2 consisted of a fine sand 10YR 5/1 (gray); ST 5, Level 2 consisted of a dense fine sand 10YR 5/1 (gray). ST 1, Level 3 consisted of medium sand 7.5YR 3/3 (dark brown); ST 2, Level 3 consisted of mottled fine sandy silt 10YR 3/4 (dark yellowish brown) with 10YR 5/6 (yellowish brown); ST 3, Level 3 consisted of fine sand 10YR 5/3 (brown); STs 4 and 5, Level 3 consisted of mottled dense fine sand 10YR 5/3 (brown) with 10YR 5/6 (yellowish brown).

Photo 9. BMP LC-3B: Kramer Avenue, Shovel Test Pit 3 looking northeast, February 18, 2006. Note standing water in test pit. Photographer: James Cox.

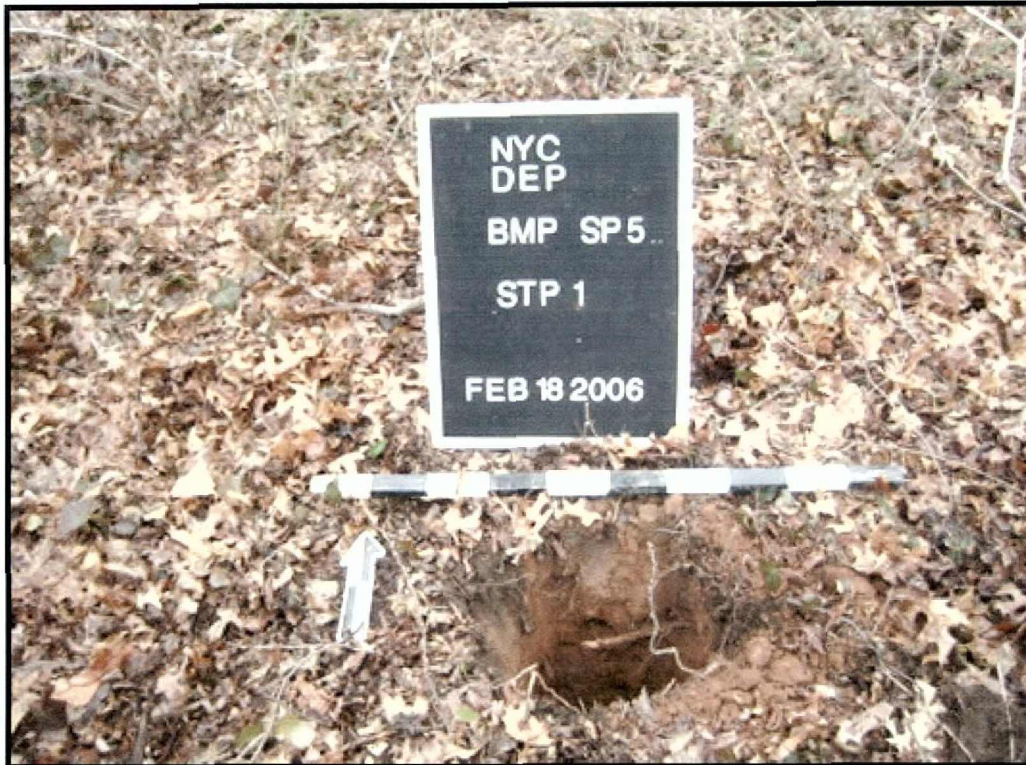
A single shovel test was placed on the highest, level ground within the APE along the eastern edge of the creek. Level 1 of the shovel test consisted of a silty sandy humic deposit 10YR 2/1 (black); Level 2 consisted of a sandy clay 2.5YR 4/6 (red); Level 3 consisted of a clay with sand inclusions and gravel 2.5YR 4/6 (red); Level 4 consisted of a rock impasse (Figure 6, Photo 10, Table 2). No cultural features, horizons or materials were identified during field-testing.

Photo 10. BMP SP-5: Islington Pond, Shovel Test Pit 1 looking north, February 18, 2006. Photographer: James Cox.
