**NEW YORK DOWNTOWN HOSPITAL  
BLOCK 100, LOT 1  
BOROUGH OF MANHATTAN, NEW YORK  
PHASE IB ARCHAEOLOGICAL FIELD TESTING REPORT**

Prepared for: Forest City Ratner  
Prepared by: Celia J. Bergoffen, Ph.D., R.P.A.  
Mara Horowitz

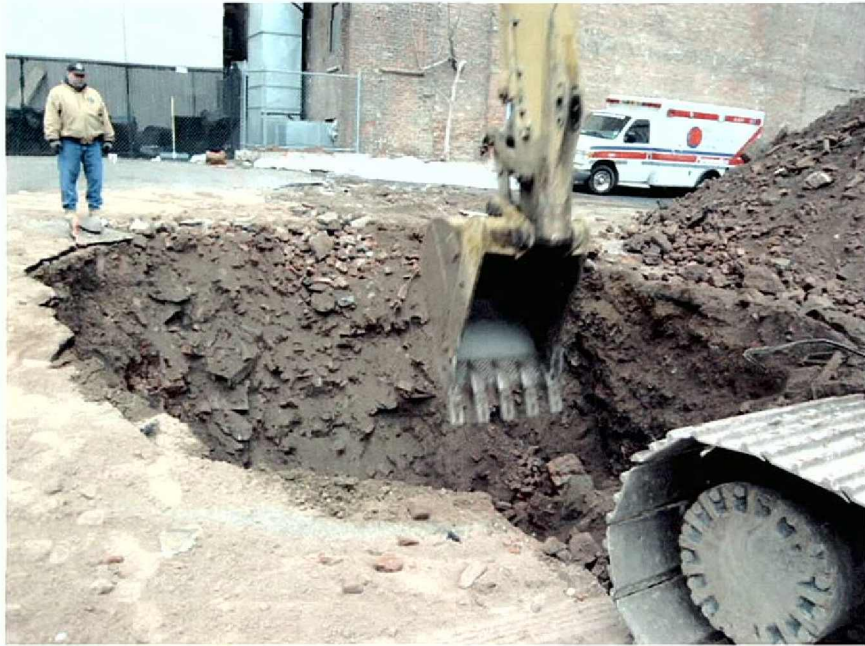
We began opening trench 1 at a distance of ten feet from the east face of 150 Nassau Street and excavated to a depth of ca. six feet below grade (Fig. 4) before reaching the top of a brick wall that we took to be the west wall of 8 Spruce Street (and later confirmed). The trench up to that point was filled with building detritus consisting of bricks and mortar, parts of concrete beams, and even the foot of a cast-iron column, dislodged finally at approximately seven feet below grade (Fig. 5). The shaftway between the houses here was too narrow and too clogged with debris to excavate successfully with the backhoe. The back wall (north) of the former building at 18 Beekman Street was found, as anticipated from the insurance maps, running 100 feet south of Spruce Street. We continued east for a distance of approximately 15 feet until we reached the east corner of the back wall of 18 Beekman Street (Fig. 6). The back wall of this building and the one opposite it fronting on Spruce Street were still continuing down, so we decided to excavate trenches 1 and 2 together south of the corner of 18 Beekman Street, taking in both the yards of 20 Beekman Street and 10 Spruce Street together (Fig. 7). This wider exposure between what were obviously the basement (and sub-basement) walls of the structures would yield an easier-to-read and more comprehensive result than leaving a baulk or unexcavated, four-foot strip between trenches 1 and 2, as originally planned. The ten foot wide backyard area of 8 Spruce Street was excavated approximately fifteen feet east / west to a depth of approximately seven feet (Fig. 8).

**Fig. 4. View of trench 1 at ca. 6 feet depth looking west.**

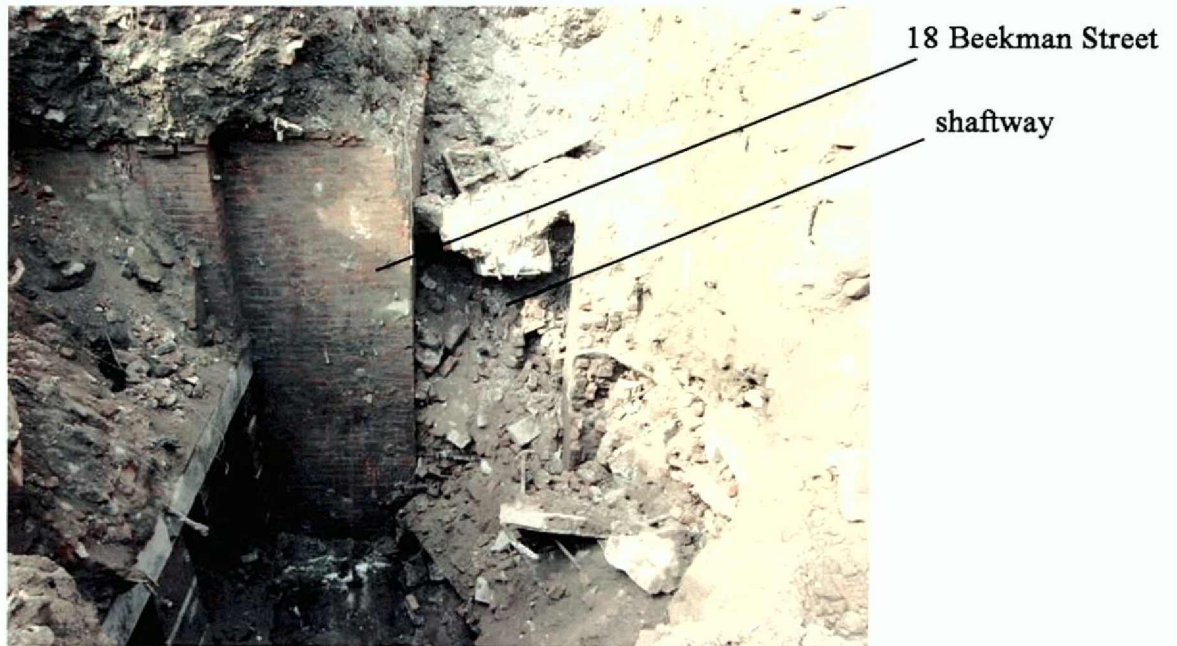
**Fig. 8.** View of trenches 1 and 2, looking at the northeast corner of 18 Beekman Street and the shaftway between it and 8 Spruce Street; the back wall of 20 Beekman Street is on the lower left.

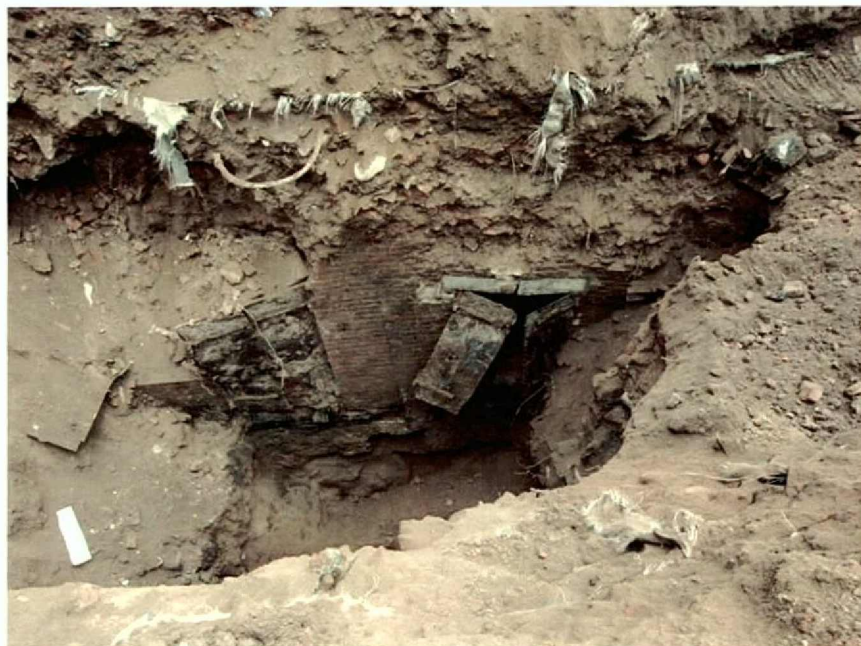
(Fig. 9). The cellar level had barred windows and a door to the shaftway between the buildings (Fig. 10). The basement and sub-basement wall of 10 Spruce Street opposite was also exposed. At approximately twenty-one feet below grade we encountered the concrete pavement of the yard of 20 Beekman Street and an adjoining slate pavement behind 10 Spruce Street (Fig. 11). We continued to excavate two to three feet below the pavement. In the last buckets, the clean, coarse, medium-brown sand brought up was found to be devoid of cultural remains. The ending depth in the trench was approximately twenty-two feet below grade (Fig. 12). According to the backhoe operator and Angelo Leone, who has worked in the area, this sandy material is a natural deposit, i.e. virgin soil. In consultation with both Amanda Sutphin and Arthur Bankoff of the LPC, it was decided that this section of the trench did not warrant further investigation, but that the next section of trenches 1 and 2 further south should be excavated the next day to check if the deposit below the shaftway's pavement(s) was the same as in the section already excavated or whether any significant cultural remains might be present.

**Fig. 10. View of the cellar door of 12 Spruce Street, looking east.**

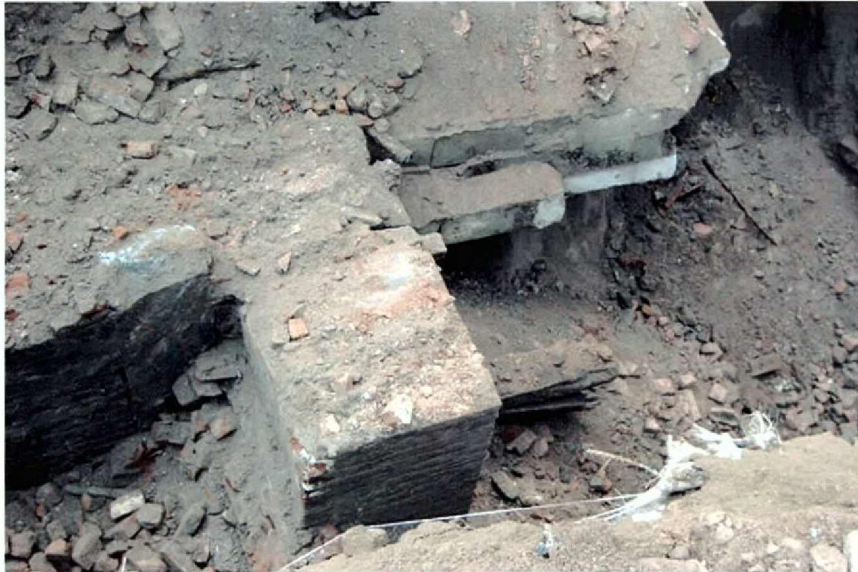
At sixty-nine feet east of the east wall of 150 Nassau Street we encountered, on the south side of the trench, the west, brick wall of 24 Beekman Street projecting north of the line of 22 Beekman Street. There was a brick column standing in the shaftway in front of the northwest corner of 24 Beekman Street (Fig. 13). We excavated approximately ten feet of the shaftway area further east, beyond this pillar (Fig. 14).

**Fig. 14. View of the brick pillar at the north corner of 24 Beekman Street, looking west (the back wall of 22 Beekman Street adjoining has collapsed).**

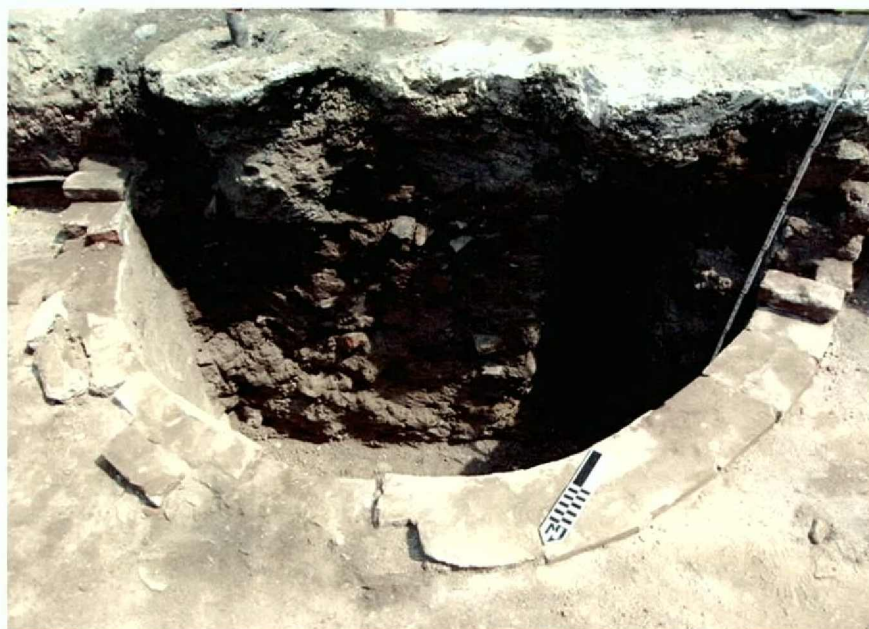
The cistern consists of a circular brick wall, two courses thick, laid header-stretcher in places. The exterior diameter was approximately eight feet. The northern half of the Cistern is in Trench A, while the southern half was located under the road. The gas pipe mentioned above also bisects the cistern, and was removed in the course of the

excavation. The inner wall of the cistern was thickly plastered with cement. The deposit inside the cistern was sectioned, with the southern quarter excavated first. We proceeded in one-foot increments, as a control for the collection of the artifacts. No change in the character of the fill was noted through five feet of depth. The remaining, northern quarter of the cistern was then excavated as a single locus. The artifacts are as follows (from the top):

**Fig. 20. View of the cistern in ATT / A, looking east, at the end of excavation.**

As for the so-called cistern in ATT / A, which is situated half in the former curb area and half in the street bed, as noted in the addendum to Bergoffen 2004 (Op. Cit.), the Common Council of the City of New York did allocate funds, in 1814, for the installation of a well and pump near the intersection of Beekman and William Streets. Quite possibly what has been designated as the cistern in the present report is that early 19<sup>th</sup> well. At that time, however, it would have been half in someone's front yard. Unfortunately, the well or cistern contained very few artifacts and the fill was homogenous throughout the five

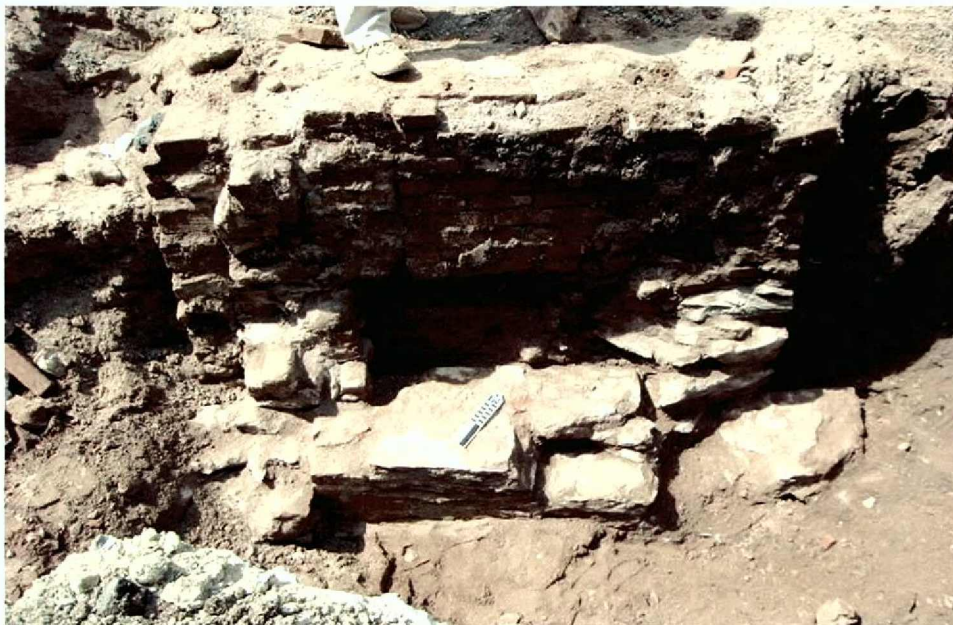
Two architectural features, walls 3 and 5, were encountered at one foot six inches below grade, both built of brick and mortar. Wall 3 was a thick block of bricks measuring seven feet long and twenty-two inches wide, located one foot eight inches south of, and running parallel to, the north wall of the trench. There may have been a spur wall running east, perpendicular to wall 3, which the bulldozer destroyed. Wall 3 had several building phases visible and appeared to have originally been only four feet three inches in length. The base of the southern part of the wall, showing the multiple phases, is three feet seven inches below grade and rests partly on piled stones from an earlier structure, wall 4.

Wall 4 follows a different orientation from wall 3 and is preserved to a height of four feet ten inches. The bottom of the wall was not found. Wall 4 was built of large irregular local fieldstones (granite/gneiss/feldspar/schist) set in mortar, with a corner built of bricks where the wall turned west. The north and south ends of wall 3 both rested on a pile of stones and bricks associated with, or salvaged from, wall 4. A cavity about one foot three inches high beneath the center of wall 3, filled with sand, had weakened the wall 3.

Fig. 23. View of walls 3 and 4 in ATT / B looking west

Stone wall 4 in in ATT / B certainly belong to an earlier building period, as indicated by its relationship with brick wall 3. Wall 3 rests partly on a column of stones on top of stone wall 4, which has a different orientation from the brick wall and begins about five feet below grade. The southern end of brick wall 3, which shows three distinct segments representing different building episodes, overlaps the southern end of stone wall 4. No foundation trench for either wall 3 or 4 could be discerned. Instead, the eastern half of the trench was composed of the usual stratigraphically undifferentiated brown sandy fill. Although there were no associated floors or deposits that could be associated with the earlier building phase evidenced by wall 4, it is very likely that this wall, the only one excavated that did not run parallel to the present-day curb, belongs to the period of occupation that preceded the erection of the five-story stores, and dates from the early 19<sup>th</sup> century, if not earlier. At its south end, it is approximately three feet west of the thirty-foot street curb line; at its northern end, two feet from the curb. If this wall traces the line of the pre-mid-19<sup>th</sup> century facades, then the street front was either quite irregular at that time, or it narrowed towards the north, something that is not indicated on the 1755 Maerschallck map however for this block.<sup>5</sup>

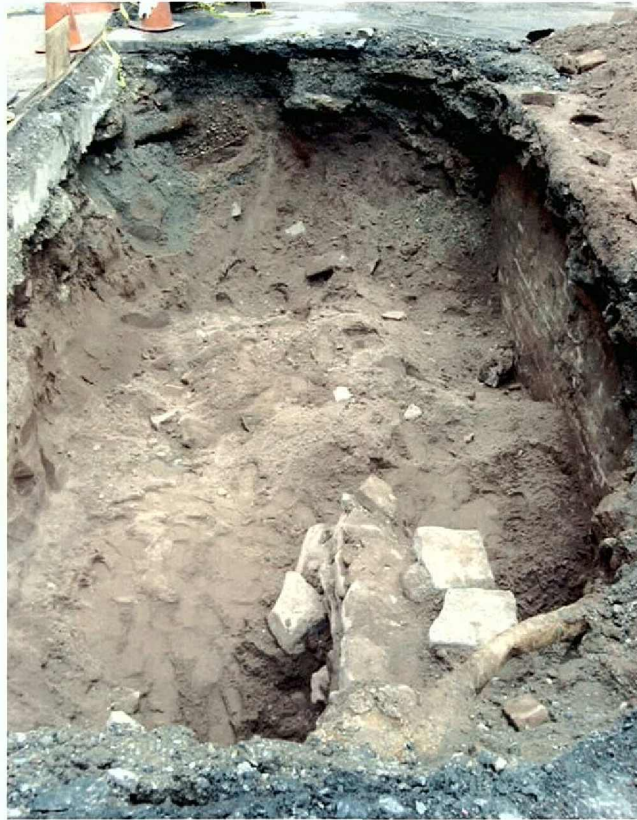
Fig. 25. View of walls 6 and 7 ATT / C, looking south.

The stone wall in ATT / C, which begins about three and a half feet below grade and whose base is at six feet below grade, is not connected to brick wall 7 of the mid-19<sup>th</sup> century, which runs parallel to it, two feet to the west, and whose base lay below the six-foot deep bottom of the trench. The base of wall 6 is six feet below grade. It was probably a foundation wall for a brick building which had only a shallow basement, not the deep basement and cellar levels noted in the excavation of trenches 1 and 2 and surmised for the mid-19<sup>th</sup> century stores on William Street as well, judging by wall 7 and the existence of basements noted on the insurance maps. Wall 6 in ATT / C clearly belongs to a different and no doubt earlier building period than the mid-19<sup>th</sup> century store represented by wall 7. It lies on the same line as brick wall 3 in ATT / B – the only two walls in the

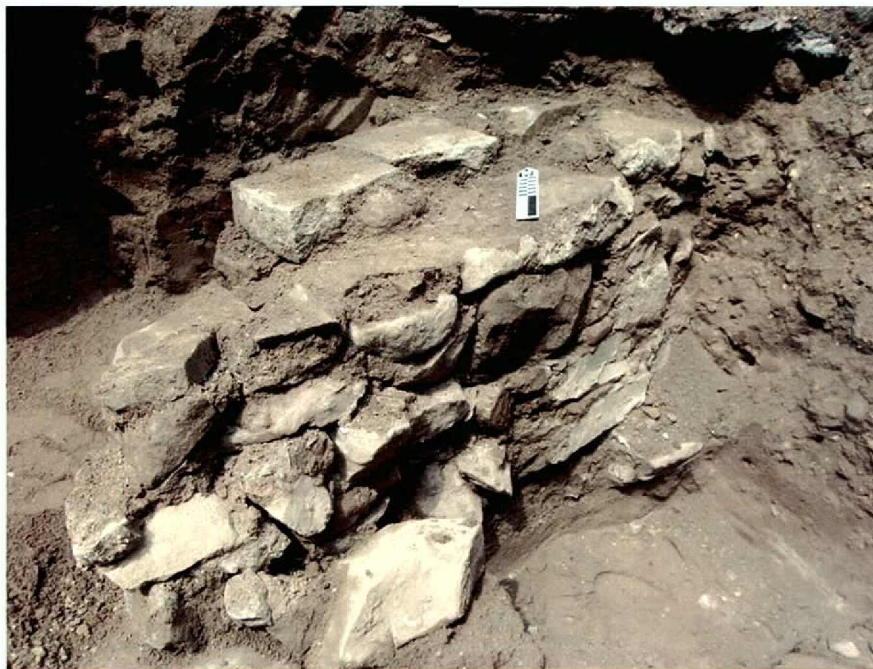
At a depth of three feet three inches the remains of a wall 6 were encountered running north-south about one foot six inches east of the trench's west edge. The uppermost preserved course was rectangular cut blocks of a sedimentary stone measuring approximately one foot to one foot five inches. Beneath these the wall was poorly made of jumbled medium and small river stones and broken bricks, apparently without any mortar. Wall 6 ran six feet south from the north baulk before dissolving into a tumble of stones. It is not clear whether this was a corner where the wall turned westward. Only clean sand was recovered on the west side of wall 6.

Fig. 26. View of wall 6, ATT / C, looking northwest.

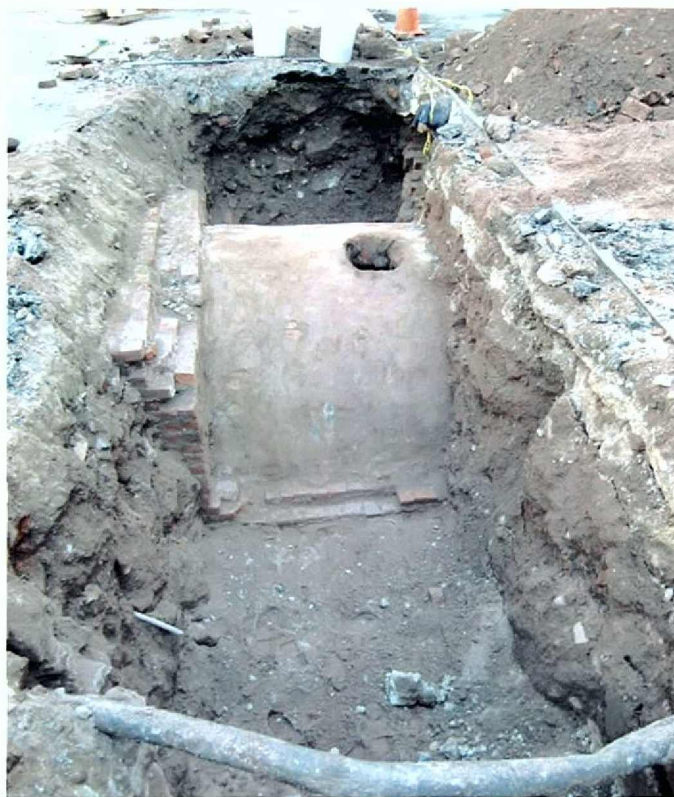
The top of a brick wall, wall 9, appeared one foot five inches below grade. It ran along the west baulk line eleven feet six inches beginning at the northwest corner of the trench. Three brick courses of wall 9 were within the trench, the rest lay outside the trench to the west. The bottom of wall 9 was not excavated, but was observed within the barrel vaulted structures (below) to continue to a depth of at least nine feet.

Fig. 28. View of wall 9 and vault 1 looking north.

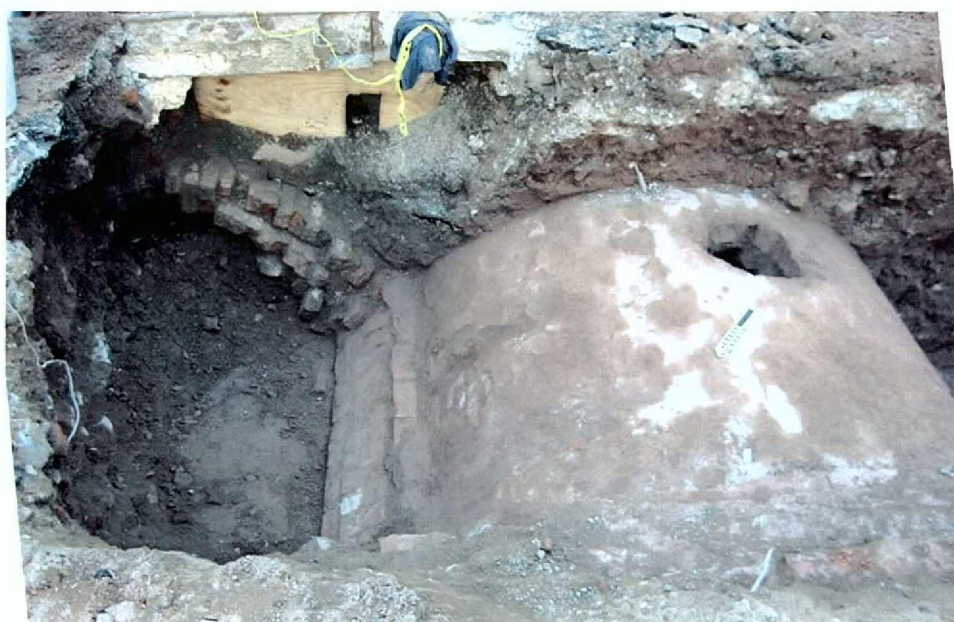
Fig. 29. View of the remains of vault 2 (left) and vault 1 (right), looking east

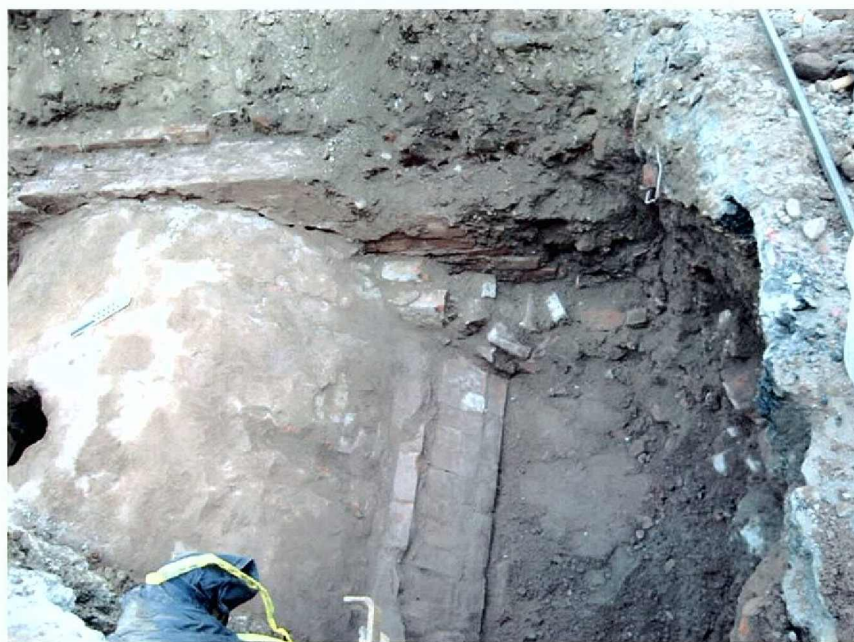
**Fig. 30.** View of vault 1 (left), and the remains of vault 2 (right), looking west.

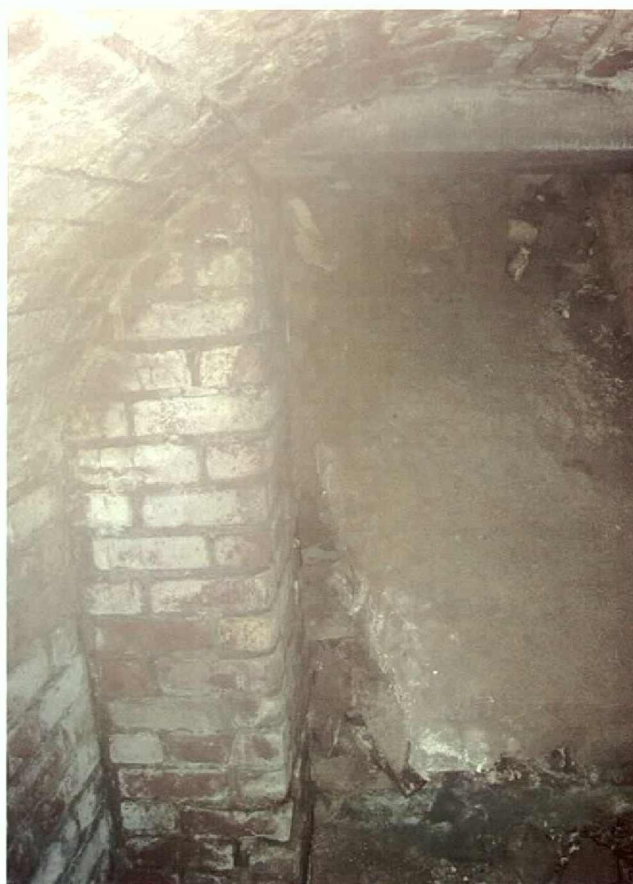
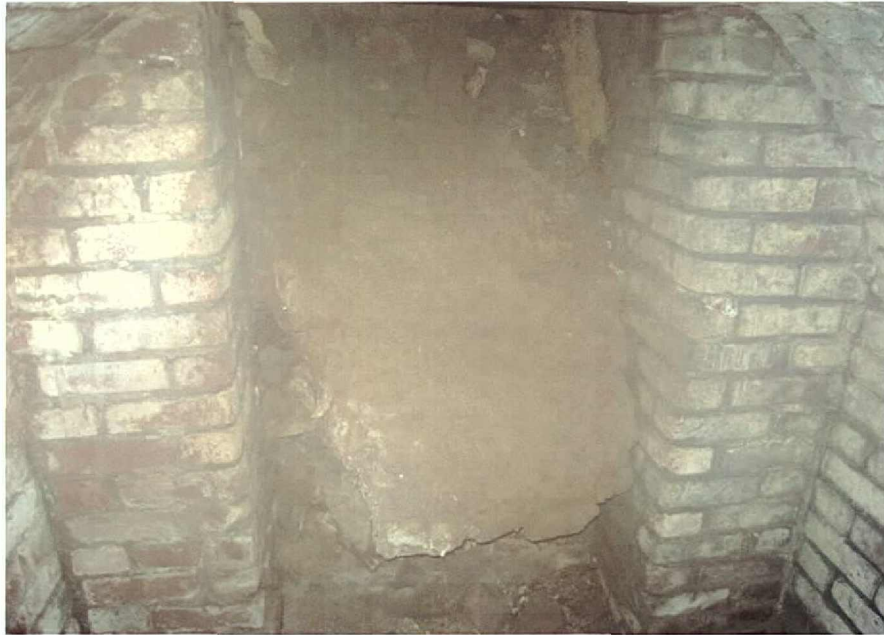
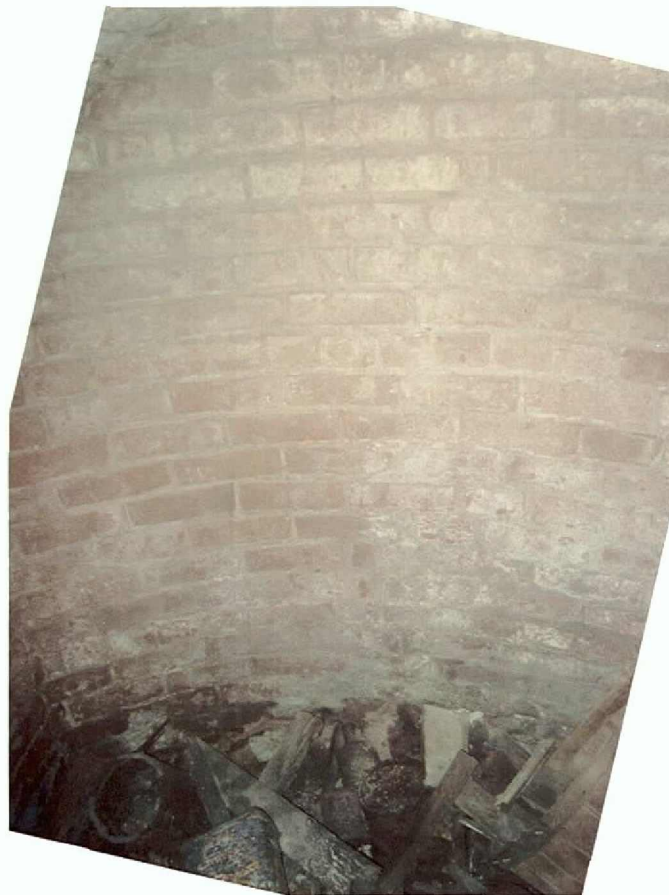
The arched brick feature observed in UTT / 1 was found to belong to a pair of barrel vaulted basement rooms whose interiors had remained largely free of debris (Figs. 31-33). The arches were built of four courses of bricks laid header-stretcher in parts, and the upper and lower surfaces were covered in cement plaster. These rooms apparently had no superstructure attached to them except for wall 9 on the west. It is suggested that they may have been built as extensions to a basement, and ran beneath the former sidewalk. The rooms had an interior area of approximately eight by eight feet and a ceiling height

The southern room was quite well preserved. An opening about two by two feet had been broken into the top of this vault and closed with a large stone block. It was possible to observe and photograph the basement room through this opening. A doorway on the west side was blocked with soil, but presumably once led into the basement of the adjoining building. The brick wall closing the east side of the chamber was segmented into three facets. A pipe one foot in diameter ran west-east along the ceiling at the highest point of the vault.

**Fig. 31.** View of the interior of vault 1, looking west.

Fig. 32. View of the interior of vault 1, looking west.

Fig. 33. View of the interior of vault 1, looking east.

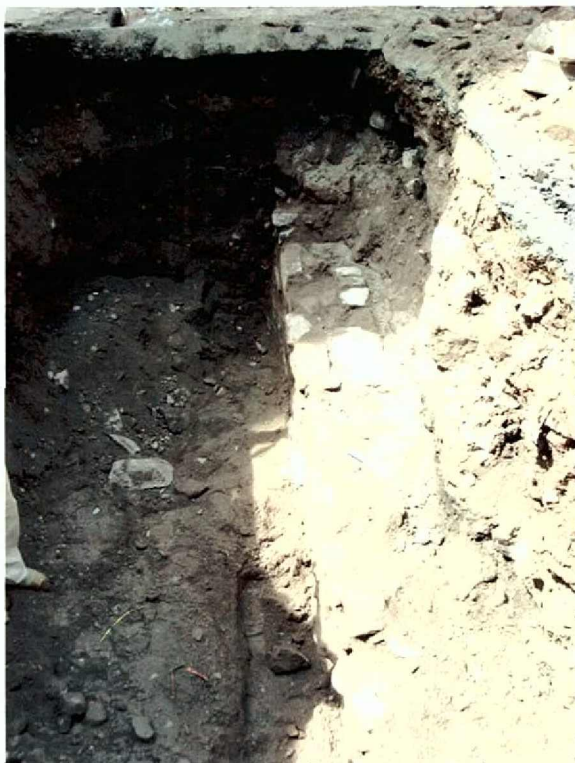
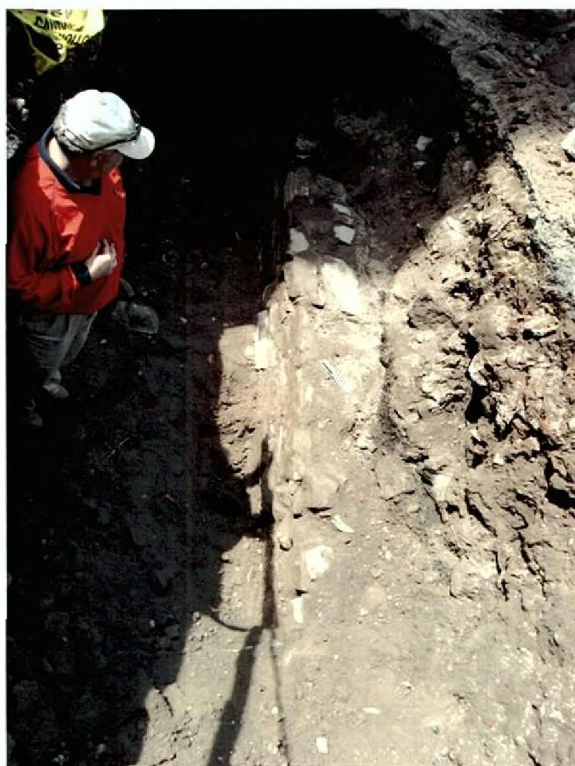
At a depth of four feet, a deposit of dense black soil (water-seeped tar or burnt material?) occurred, which overlay the remains of a fieldstone wall, wall 8. Wall 8 runs

Fig. 35. View of wall 8 in ATT / E, looking south.

Fig. 36. View of wall 8 in ATT / E, looking south.

The most substantial stone wall, wall 8 in ATT / E, does not follow the orientation of any of the other walls and was also founded at a greater depth of approximately seven feet below grade. The uppermost course of this best preserved of the three stone walls was composed of rectangular cut blocks, another feature distinguishing it. By its location and depth it would not to be related to a building period preceding the stores, but the lack of associated surfaces or connection with the stores makes it particularly difficult to phase.
