**CCNY/ASRC SCIENCE FACILITY PROJECT
CITY COLLEGE OF NEW YORK CAMPUS
MANHATTAN, NEW YORK**

**PHASE IA
CULTURAL RESOURCE
ASSESSMENT**

**The Louis Berger Group, Inc.
100 Halsted Street
East Orange, New Jersey 07018**

May 2006

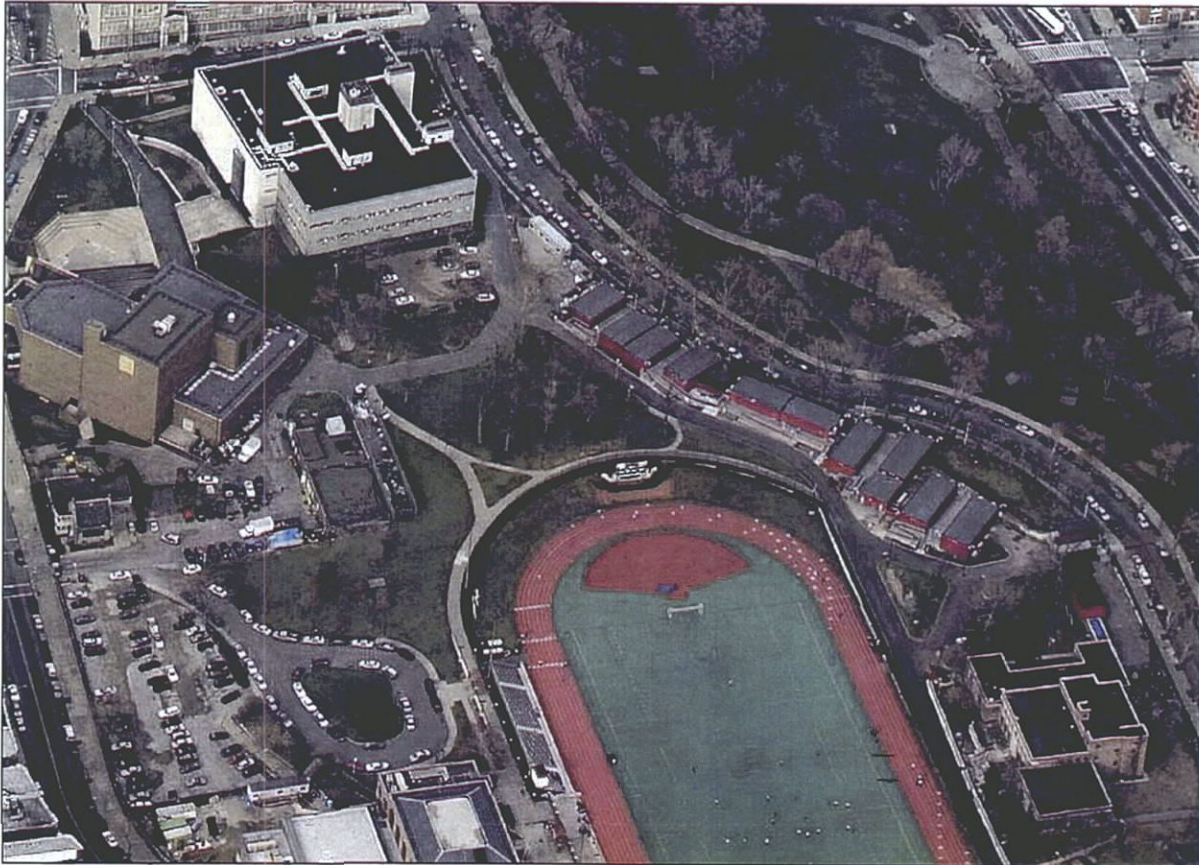
Photo 1 – Bird’s Eye View of the Project Area (Source: Windows Live Local <http://local.live.com/>, Microsoft Corp. 1988-2004; Pictometry 2005)

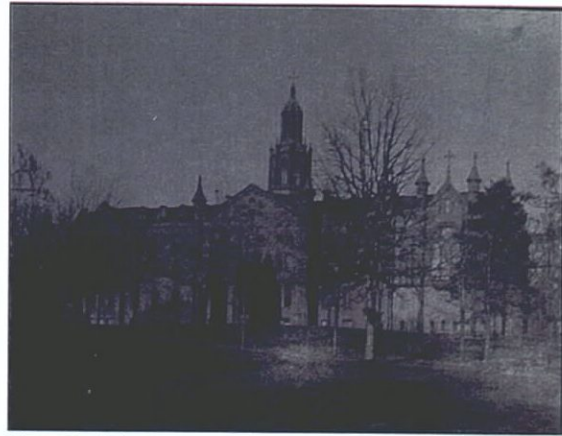
Photo 2 – Mid-nineteenth century view of the Convent of the Sacred Heart (Source: Manhattanville College Library)

building. The chapel was now located within the original building, at the southeast corner. Photo 2 provides a view of the Convent of the Sacred Heart in the mid-19th century.

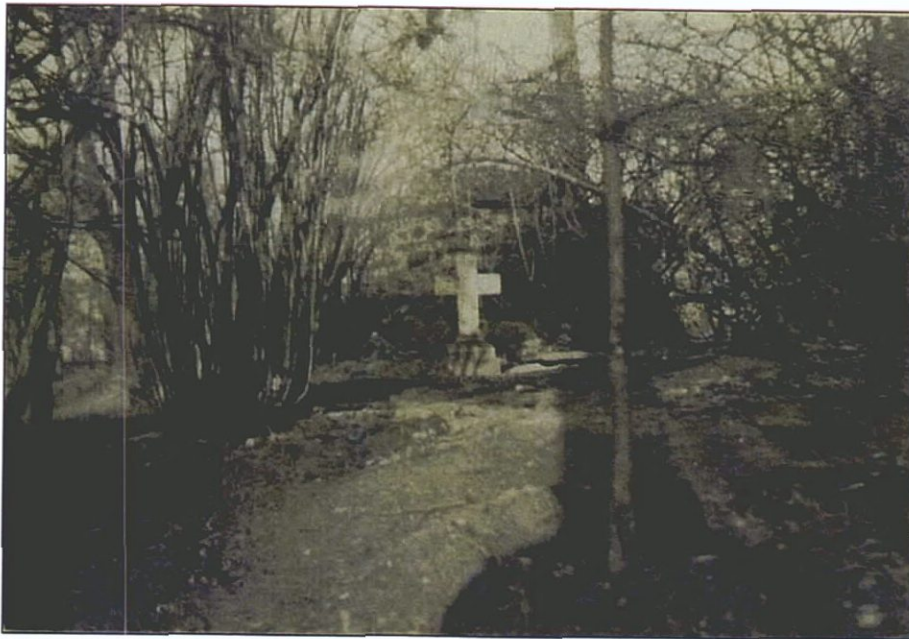
Photo 4 - Stone Cross Located over the Burial Crypt and North of the Chapel. Note the Presence of the Stone Structure behind the Cross, Possibly the Vault Structure on the Sanborn Map. View North. (Source: Manhattanville College Library).

The 1909 Sanborn map illustrates the Convent complex had expanded at the beginning of the twentieth century with the addition of a gymnasium and a Hall of Science to the west and north of the previously existing building (Figure 17). The one-story structure located to the north of the chapel is described as a "Vault." It is likely that this vault is the burial crypt described as located behind the Grotto of Our Lady of Lourdes. This grotto (Photo 3) was likely located to the north of the chapel and was built into the slight mound that is present on the site today. The vault may have been formed from a natural fissure in the bedrock here, as there are many locations today where bedrock outcrops on the surface. It is known that the crypt was located underneath a stone cross (Photo 4) that represented the location of a chapel to St. Joseph, which was destroyed some time in the 1940s. In the foreground behind the stone cross is a structure that is likely the above ground representation of the crypt or vault as shown on the Sanborn maps. This vault/crypt was used for the burial of nuns from the Convent and had previously been interred in two cemeteries within the limits of the Convent's property. The remains of the nuns were disinterred from these cemeteries and reinterred at this crypt, located behind the Grotto of Our Lady of Lourdes.

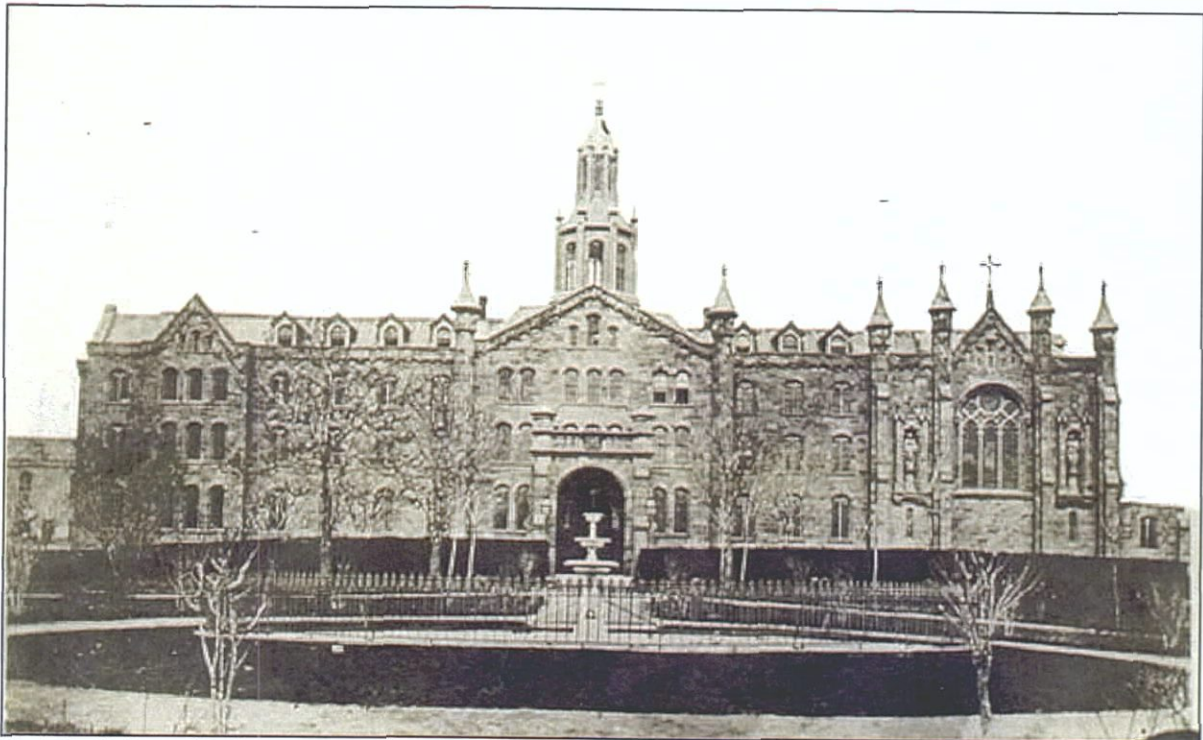
Photo 5 - College of the Sacred Heart, View from the South. (Source: Gabriel 1925-29)

The 1939 Sanborn map of the project area shows that a residence hall was constructed on the east side of the Convent, still referred to as the Convent of the Sacred Heart, but the complex was officially known as the College of the Sacred Heart as it had been chartered by the New York State Board of Regents in 1917 (Manhattanville College Library Special Collections). Outside of the residence hall, the College of the Sacred Heart would have appeared the same as it did throughout the early twentieth century as little modifications were made to the southern portion of the College in the twentieth century (Photo 5).

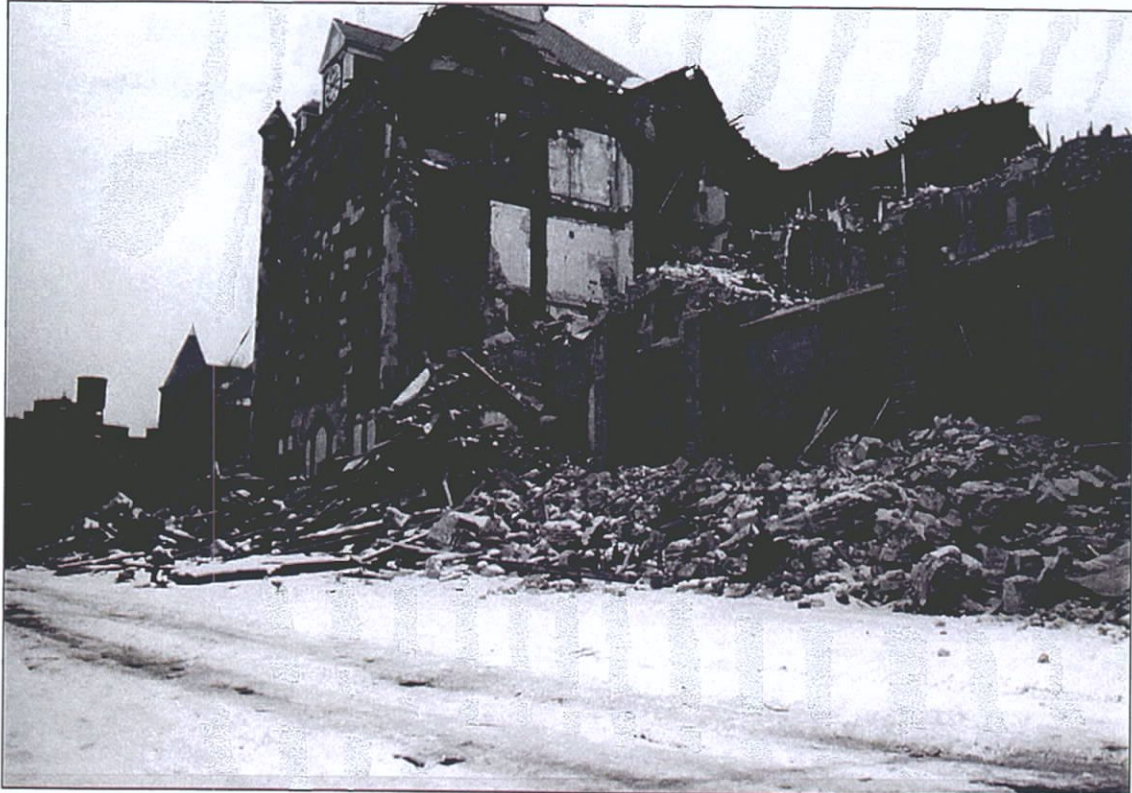
Photo 7 – Demolition of the Finley Student Center (1889 Sacred Heart Convent), in 1985. (Source CCNY Archives)

By 1986 (Figure 23), the Finley Student Center was demolished after it was realized that to repair the building would be too costly following the fire in 1969 (Photo 7). This demolition removed the oldest portions of the Sacred Heart Convent including the main building and the chapel. A second building demolished by 1986 was Klapper Hall, the former the Orphans Home of the Protestant Episcopal Church at the northern end of the APE, demolished to make way for a parking lot.

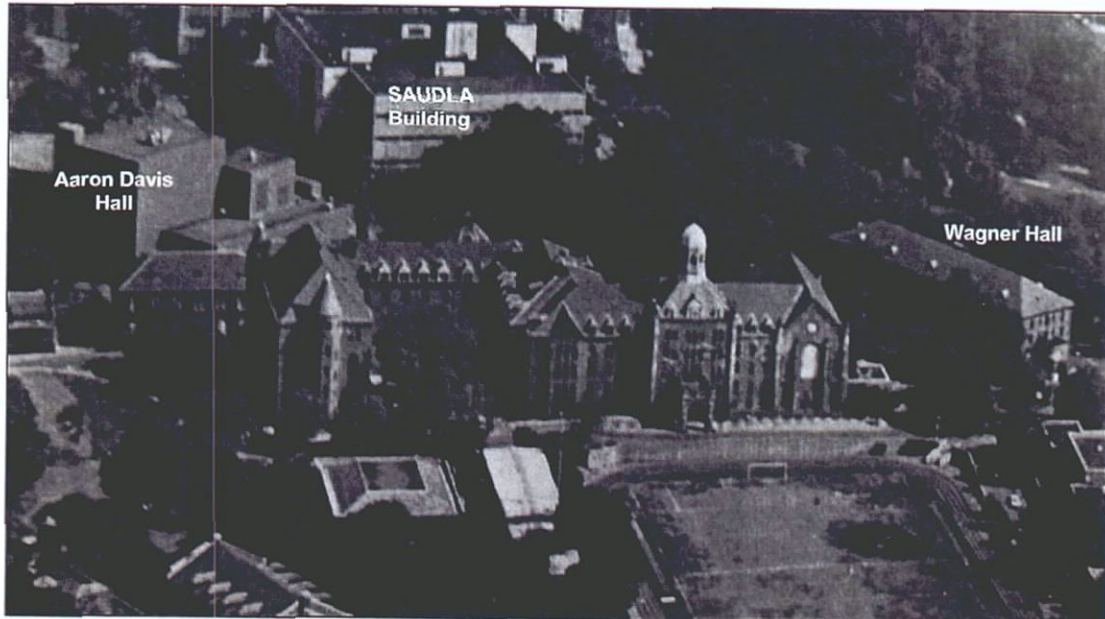
Photo 8 - 1983 Aerial View of the Finley Student Center. Compare this View to the Modern Aerial Shown in Photo 1. View North. (Source: CCNY Archives).

construction (Figure 28). The summary of building construction within and adjacent to the APE indicates a large portion of the APE has been significantly disturbed. The area of the College of the Sacred Heart has disturbed the proposed area for the CCNY building in the southwest corner of the APE and the area for the underground connector between the CCNY building and ASRC building. Additionally, the western limits of the APE for the utility installation have also been disturbed by the history of building activities. A historical aerial view of the Finley Student Center illustrates the extent of these buildings and the extent of disturbance from the construction of the athletic field in front of the Finley Student Center (Photo 8).

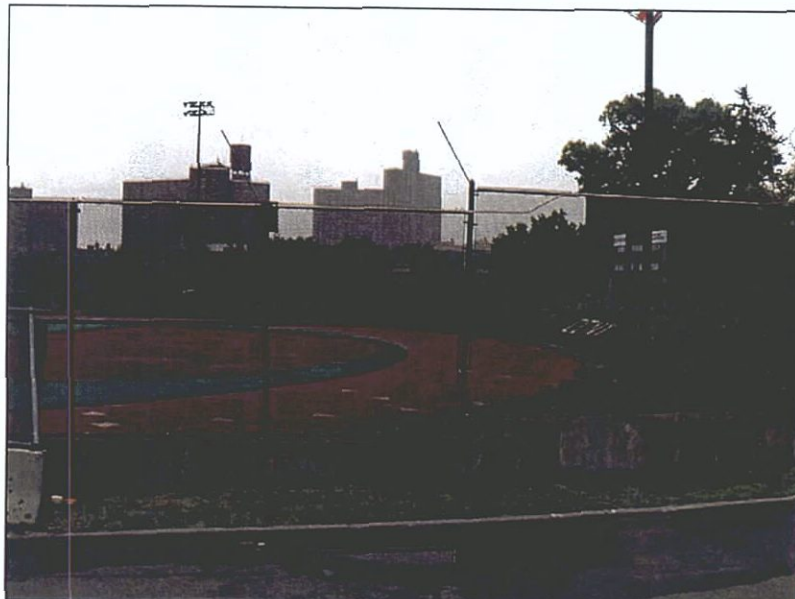
Photo 9 - View of the Northern End of the Athletic Field in the General Location of the Main Building for the Convent of the Sacred Heart. View West.

The northern end of the modern athletic field corresponds roughly with the historic location of the College of the Sacred Heart's main building. Additionally, the area surrounding the location of the athletic field's scoreboard has been extensively excavated, creating a further disturbance to the APE.

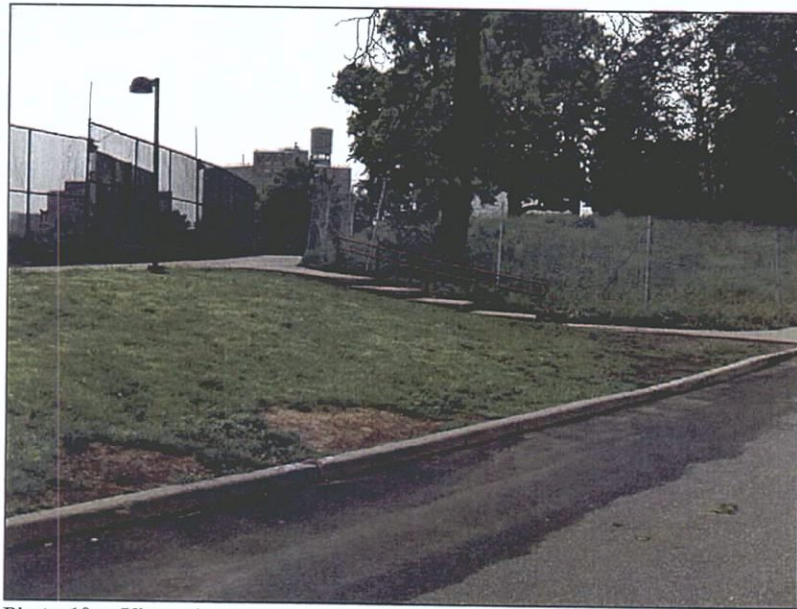
Photo 10 – View of the Grassy Mound Area North of the Athletic Field. View Northwest.

North of the modern athletic field in the portion of the APE to be disturbed by the utility trench installation is a small grassy area enclosed by a pedestrian footpath. Based upon the historic map analysis, this area appears to have been the location of the vault/crypt that appeared on the twentieth-century Sanborn maps. Outside of this vault, no other historic structures are known within this area. A site visit to the project area confirmed the lack of historic structures on the surface and the relatively undisturbed nature of this portion of the APE (Photo 10).

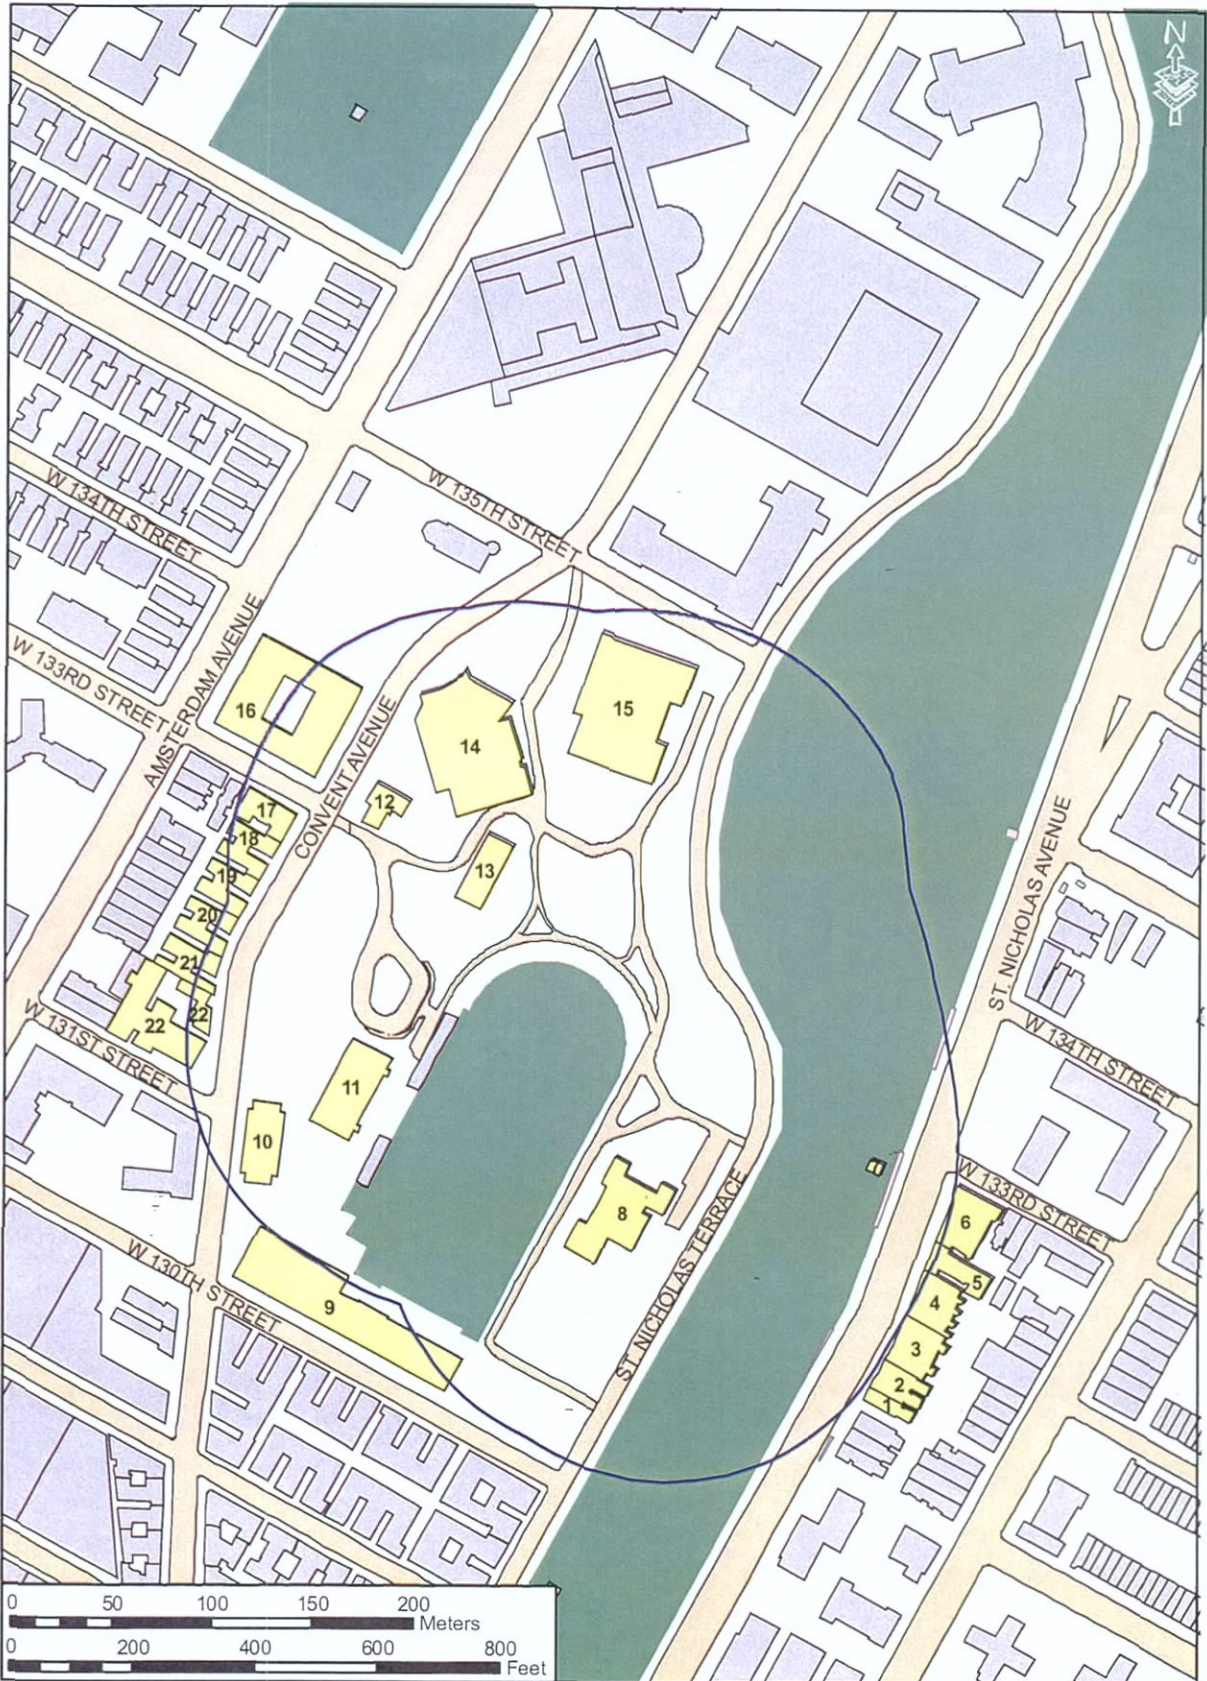
FIGURE 30: Historic Architectural Resources Surveyed for the Proposed CCNY/ASRC Project

The following historic architectural resources were documented within the historic architectural APE and appeared to be 30 years in age or greater (Figure 30; Table 3). The 22 resources described below were assessed for their potential to be listed as New York City Landmarks using the criteria outlined above.

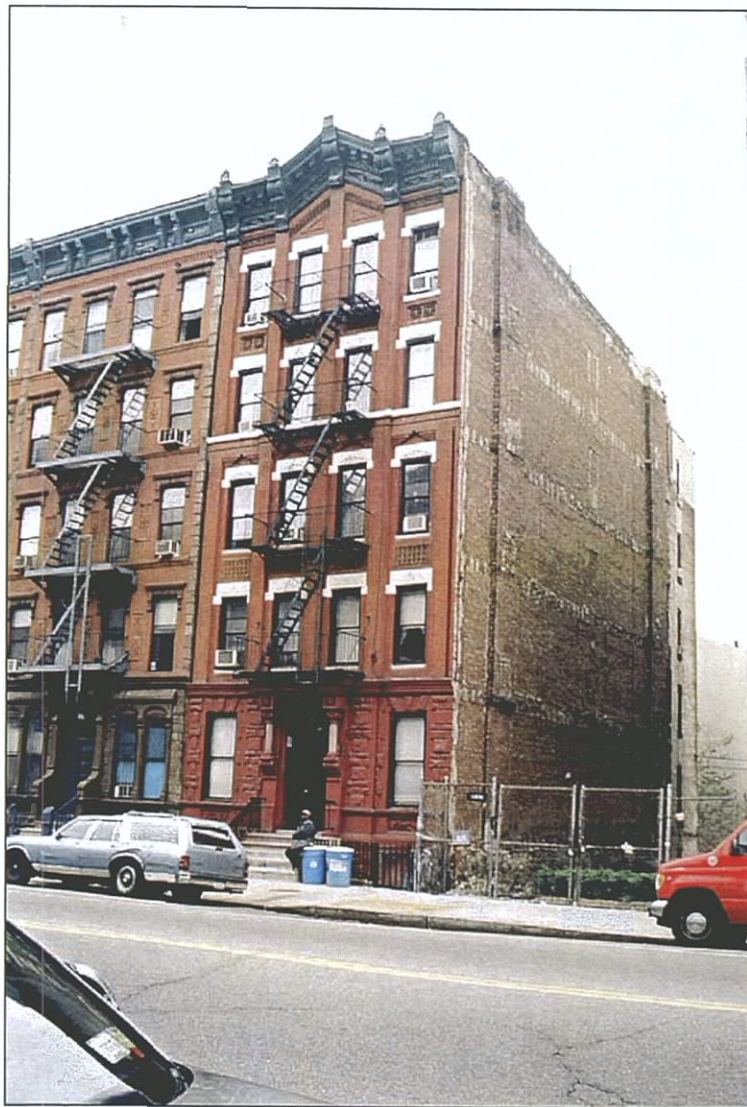
Photo 11 - 426 St. Nicholas Avenue, View East.

Although New York City tax data indicates construction of the building at 426 St. Nicholas Avenue occurred in 1901, a building of similar dimensions and footprint appears at this location on an 1890 atlas map of the area (Robinson 1890). Insurance maps indicate that a building that once stood immediately to its south comprised part of the same overall structure (Sanborn 1893). The present structure, in addition to only being half of the original structure, has had all of its original windows and its principal entrance replaced with modern units. The present building possesses poor integrity and lacks quality of style, workmanship, and materials. The building does not reflect the noteworthy characteristics of a particular architectural style, architect or designer. Research has not identified any relationships with historically significant events, persons, or patterns of activity, or with historically or culturally significant groups. The property has not yielded nor is it likely to yield important information contributing to our understanding of history. In the opinion of the surveyor, the building does not possess any special character or special historical or aesthetic interest. The building also does not possess any value as part of a development, heritage, or cultural characteristic of New York City, the State of New York, or the nation. Therefore, the building does not appear to meet New York City Landmarks eligibility criteria and is recommended as not eligible for landmark status.

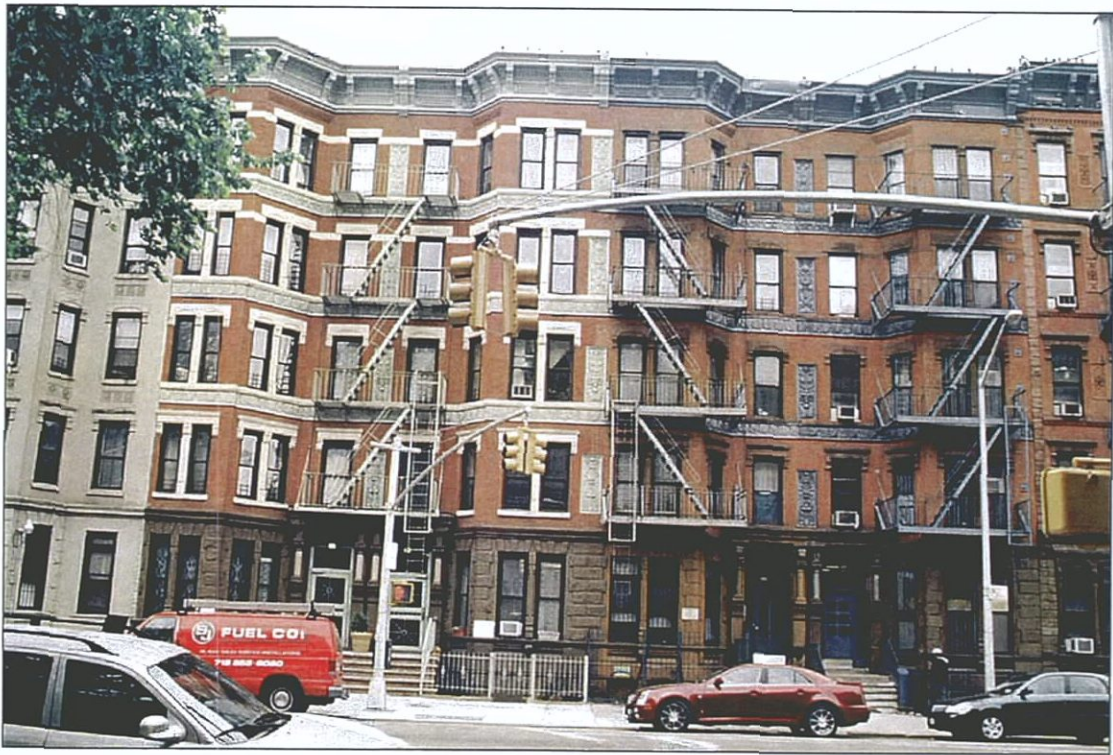
Photo 13 - 432-438 St. Nicholas Avenue, View East

The five-story, stretcher bond brick structure at 432-438 St. Nicholas Avenue consists of four three-bay wide structures sharing common exterior walling and finishes. Common features include terra cotta belt courses between each of the upper stories, brownstone lintels and sills, vertical ornamental terra cotta panels set between windows, a stone cornice band dividing the first and second stories, and a decorative metal cornice with large brackets that crowns the entire building. Set back entrances with concrete stoops in each of the four structures are joined to form central paired recessed entries with one-bay wide angled walls connecting the main facades of the buildings.

Modern replacement doors have been installed underneath original large fixed transoms. The building at 432 St. Nicholas features a wood door with six lights and a two-light sidelight, while 434 St. Nicholas possesses a metal door with two vertical wireglass lights and a single sidelight. Both doors on 436 and 438 St. Nicholas consist of decorative metal sunbursts panels over large rectangular lights. The doors are framed by stone veneer surrounds and ornate brownstone cornices supported by marble columns set atop brownstone plinths. All window openings contain one-over-one metal replacement sash in either single or paired configurations. Single windows occupy the recessed portions of each building and three of the angled walls. The fourth angled wall, on 438 St. Nicholas, possesses paired windows that extend the elevation further west slightly to take advantage of the additional land provided by St. Nicholas Avenue's angling northwestward away from the plane of the other western elevations.

New York City tax data reveals that construction of the building at 432-438 St. Nicholas Avenue occurred in 1901. However, it is likely that construction of the building occurred shortly before 1890. A building of similar dimensions and footprint appears at the location of the current structure on an 1890 atlas view of the area (Robinson 1890). Insurance maps of the period indicate that despite being built on four adjoining tax parcels, the four buildings comprised part of the same overall structure (Sanborn 1893). The present structure has had all of its original doors and windows replaced, and possesses poor integrity. The building also lacks quality of style, workmanship, and materials. The building does not reflect the noteworthy characteristics of a particular architectural style, architect or designer. Research has not identified any relationships with historically significant events, persons, or patterns of activity, or with historically or culturally significant groups. The property has not yielded nor is it likely to yield important information contributing to our understanding of history. In the opinion of the surveyor, the building does not possess any special character or special historical or aesthetic interest. The building also does not possess any value as part of a development, heritage, or cultural characteristic of New York City, the State of New York, or the nation. Therefore, the building does not appear to meet New York City Landmarks eligibility criteria and is recommended as not eligible for landmark status.

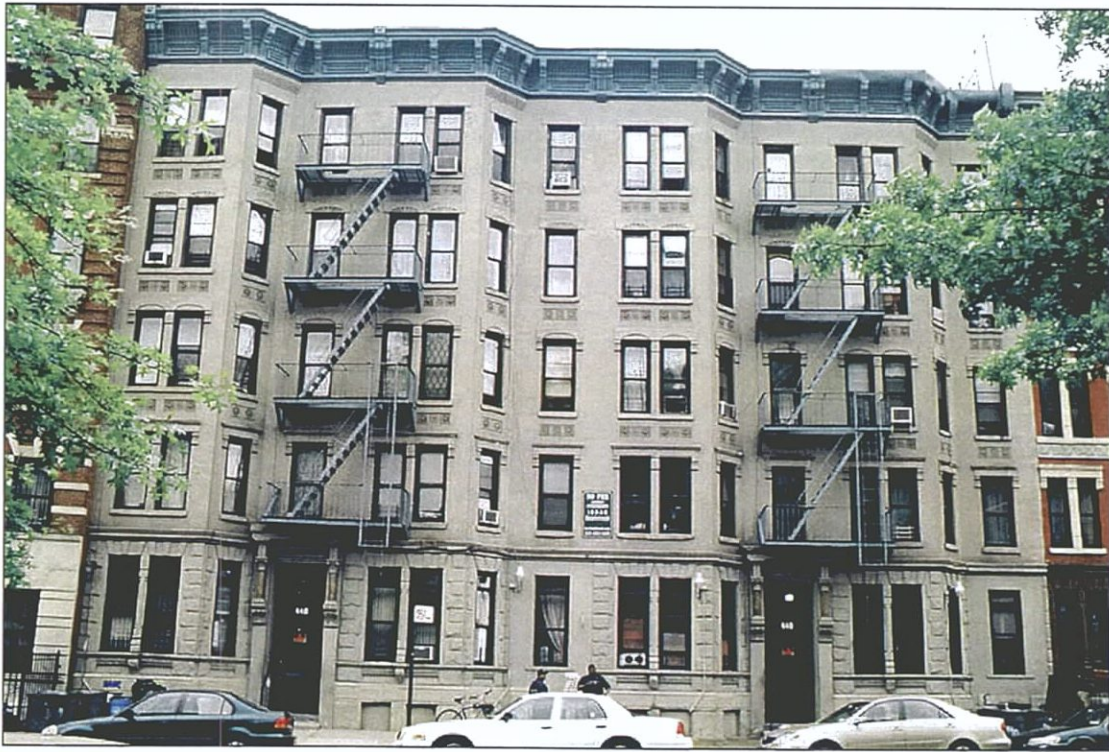
Photo 14 - 440-446 St. Nicholas Avenue, View East.

The multiple residence located at 440-446 St. Nicholas Avenue stands five stories tall with a total of 12 symmetrically spaced bays across its main western elevation facing St. Nicholas Avenue. The building consists of two brick stretcher bond structures using a repeating fenestration pattern of six bays each similar to the fenestration patterns utilized on the residential building immediately to its south, 432-438 St. Nicholas. The southern most bay of each six-bay wide grouping contains a single window, with another single window penetrating a canted wall immediately to its north. The façade then angles back to its original plane with paired windows and a single window, or door on the first story, penetrating the elevation. Another single window occupies the canted wall immediately to the door's north. The elevation then returns to its original plane, displaying a single window in its bay. This stepped fenestration pattern that effectively takes advantage of angled lot line along St. Nicholas Avenue is repeated on both portions of the building. Nearly all window openings contain one-over-one metal replacement sash. First story windows possess an additional smaller window topping typical-sized sash. Other common features include a large metal cornice, horizontal terra cotta panels below upper story windows, and ornamented stone lintels and sills. The first story possesses a stone cornice band dividing the first and second stories and stone veneer on its first story that imitates the finish treatments on the adjacent building, 432-438 St. Nicholas. The evenly spaced entrances also copy 432-438 St. Nicholas with columns stop marble columns set atop stone plinths supporting an ornamented cornice. The doorways contain metal-framed glass replacement doors with a two fixed transoms, one transom being used to fill in for the original taller door. Two first story bays without stone veneer treatment may indicate the placement of original door openings since replaced with windows.

Construction of the structure at 440-446 St. Nicholas Avenue occurred in 1901 according to New York City tax data. However, buildings of similar size, dimensions and footprint appear at the location on atlas views of the area in 1885 (Robinson 1885). Insurance maps indicate the four current buildings comprised part of the same overall structure (Sanborn 1893). The present structure has had all of its original windows and doors replaced. The building possesses poor integrity and lacks quality of style, workmanship, and materials. The building does not reflect the noteworthy characteristics of a particular architectural style, architect or designer. Research has not identified any relationships with historically significant events, persons, or patterns of activity, or with historically or culturally significant groups. The property has not yielded nor is it likely to yield important information contributing to our understanding of history. In the opinion of the surveyor, the building does not possess any special character or special historical or aesthetic interest. The building also does not possess any value as part of a development, heritage, or cultural characteristic of New York City, the State of New York, or the nation. Therefore, the building does not appear to meet New York City Landmarks eligibility criteria and is recommended as not

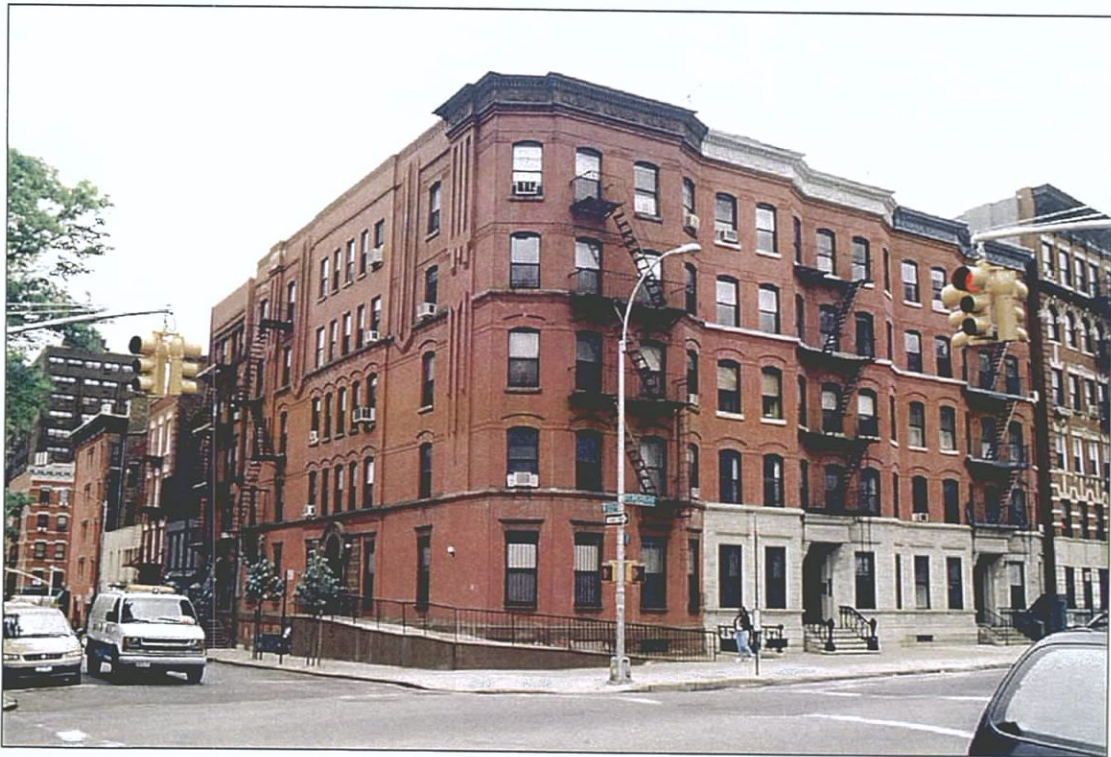
Photo 16 - 452-456 St. Nicholas Ave, View Southeast.

The multiple residence at 452-456 St. Nicholas Avenue consists of a five-story, stretcher-bond brick structure with a dentiled wood cornice standing at the southeast corner of St. Nicholas Avenue's intersection with West 133rd Street. The building extends 15 bays along St. Nicholas, possesses a canted bay at the corner of the two streets, and features eight additional bays along its northern elevation facing West 133rd. Similar to 440-446 St. Nicholas and 448-450 St. Nicholas, the building repeats a fenestration pattern across its western elevation. The southern most bay penetrates an angled wall while the next two bays occupy a wall surface parallel to the street. This fenestration pattern is repeated five times. Most windows contain stone sills supporting one-over-one replacement metal sash with arched metal headers installed below either brick segmental arch or brick jack arch lintels. Terra cotta string and belt courses separate each story. A stone belt course also divides the third and fourth stories. The western elevation's 13-bay-wide first story features stone veneer and terra cotta ornament. The elevation's two entrances possess decorative surrounds supporting small entry hoods comprised of a frieze with inset panels and a molded cornice. The southern entrance, for 452 St. Nicholas, contains a metal door with six upper lights, three-light sidelights, and fixed transoms. The frieze above features "The Raymon" in its western face. "The Lesster" occupies the western frieze panel and "429" is visible in the southern side panel of the frieze of 454 St. Nicholas. Paired wood doors and a fixed transom occupy 454 St. Nicholas's entry. Two windows flank each entrance. The northern three bays of the western elevation, all windows, comprise part of 456 St. Nicholas which also encompasses eight bays along West 133rd Street. A poured concrete ramp starting beside the St. Nicholas elevation wraps around the canted corner bay and extends along the West 133rd elevation, terminating at a doorway with a brownstone round arch lintel set atop terra cotta capitals. The northern elevation exhibits corbelled piers and terra cotta string and belt courses. Windows sash, lintel and sill treatments match the western elevation.

According to New York tax data, construction of the structure at 452-456 St. Nicholas Avenue occurred in 1901. However, buildings of similar size, dimensions and footprint appear at the location on atlas views of the area in 1890. The atlas maps also reveal that the building at 452 St. Nicholas was named the "Raymon" while the building at 454 St. Nicholas was titled the "Lesster" (Robinson 1890). Both Lesster and Raymon appear in the frieze panels of 452 and 454 respectively. Insurance maps of the era also provide earlier street addresses; the 429 street address given for the current building at 454 St. Nicholas matches the "429" in the southern panel of the building's entrance frieze (Sanborn 1893). However, the present structure has had all of its original windows and doors replaced. Due to its diminished integrity, the building lacks quality of style, workmanship, and materials. The building does not reflect the noteworthy characteristics of a particular architectural style, architect or designer. Research has not

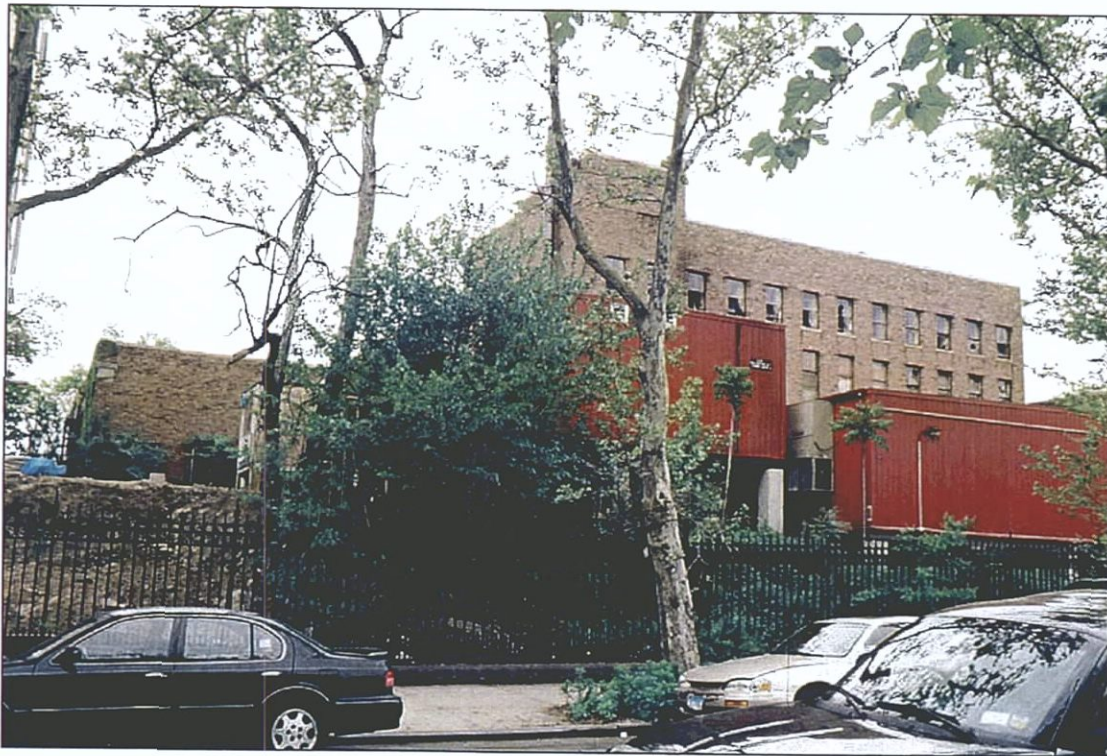
Photo 18 - Eisner Hall, View Northwest.

The building's formal entrance occupies the central bay of the main structure's western elevation, and features a cast stone surround with horizontal incised bands flanking a metal medallion above the door. The doorway features a single metal slab door set within a larger original opening filled with concrete block. Vertical incised bands ornament the cast stone belt course above the three first story window openings to either side of the door. Each window features concrete block infill set behind original metal frames for paired casement windows with upper and lower fixed-light panels. Most window glazing throughout Eisner Hall has been removed or vandalized. Large metal spandrels are installed above the western elevation's first story windows. Second story windows feature paired metal casements with lower fixed-light panels. Cast stone balustrades enclose a granite patio extending across the main structure's western elevation. The two wings display three evenly spaced bays containing two large, metal-framed awning windows with fixed-light upper and lower panels. The center bays of the wings possess three windows with cast stone spandrels below the windows and surrounds. The four bays of the Cee-shaped building's central elevation and its two northern elevation wings all contained three double metal-framed awnings with fixed upper and lower panels with cast stone spandrels below the windows and cast stone surrounds. Fenestration on the rear 12-bay wide, three-story structure consists of one-over-one and one-over-one-over-one sash.

Originally opened as the Brady Memorial Library for the Manhattanville College in 1942, City College renovated Eisner Hall in 1952 prior to its use as classrooms and offices by the College's Art Department and Architecture and Engineering unit (A&SC 2006c; Andrea 1953). The building has undergone the removal of most of its original fenestration and now possesses poor integrity and quality of style, workmanship, and materials. The building does

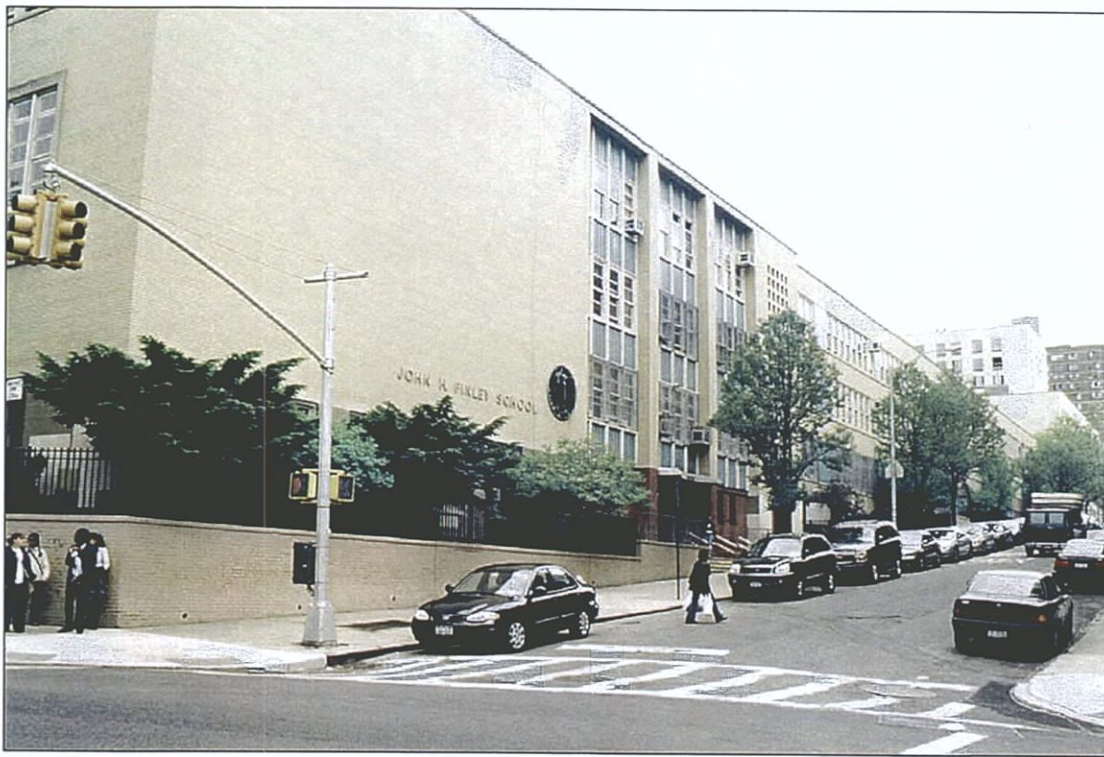
Photo 19 - P.S. 129, View Northeast.

Resource No. 9 - P.S. 129, 415-425 West 130th Street (Photo 19)

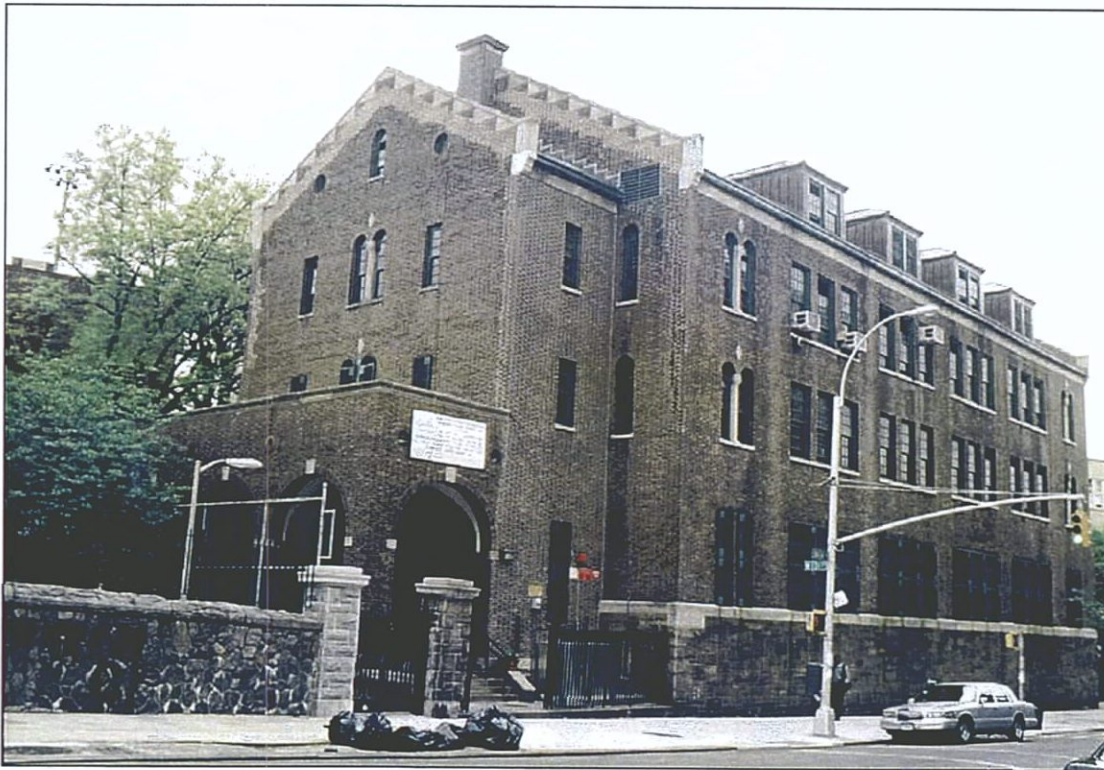
Photo 20 - Mott Hall, View Southeast.

Resource No. 10 - Mott Hall (Photo 20)

Mott Hall stands along the eastern side of Convent Avenue at its intersection with West 131st Street. The building consists of a three-and-one-half story, Flemish bond brick school with a slate-covered, parapetted gable roof. Four symmetrically spaced hipped-roof dormers with standing seam metal roofs and walls occupy each slope. Brick interior chimneys occupy both gable peaks. Three-story stair towers are appended to each gable end and feature round-arch framed porticoes that provide access to the building's entry doors. The porticoes' first stories feature

vaulted ceilings and large, paired wood slab doors. The brick gable ends of both the main structure and stair towers are ornamented with cast stone cornices. The entire building stands atop a rough-coursed ashlar raised basement topped by a cast stone coping. The main structure possesses six bays across its western and eastern elevations. The fenestration on these elevations consists mainly of triple 12-over-12 metal sash units sharing a cast stone sill in the central four bays of each floor. The remaining bays of the western elevation's second and third story contain paired three-over-three metal sash divided by cast stone engaged columns crowned by four-light fanlights and round arch lintels. The western elevation's first story features paired, rectangular four-over-four metal sash units in the two outside bays. The eastern elevation possesses single windows of the same type in its outside bays. The southern and northern elevation's of the stair towers display three evenly spaced bays occupied by single three-over-three metal sash and paired two-over-two metal sash separated by engaged columns and crowned by fanlights and round-arch lintels. Six-over-six metal sash occupy the dormer's window openings. The building's northwest corner presents a 1938 date stone in Roman numerals.

As noted by its date stone, construction of Mott Hall occurred in 1938 during the Manhattanville College's tenure of the property. The building may be the Annunciation Girls School described as part of the Manhattanville Campus in a 1939 guide to New York City (WPA 1939). An inventory of the Manhattanville College buildings in 1953 described the structure as a former elementary school. The inventory noted that City College was renovating the building's interior to provide additional classrooms and offices for the English, German, and Classical Languages departments (Andrea 1953). The structure is currently leased to the New York City Board of Education and used as a school.

Due to the remodeling of its interior and the replacement of all of its original windows and doors, Mott Hall does not reflect its historic appearance. The building possesses poor integrity and lacks quality of style, workmanship, and materials. The building does not reflect the noteworthy characteristics of a particular architectural style, architect or designer. Research has not identified any relationships with historically significant events, persons, or patterns of activity, or with historically or culturally significant groups. The property has not yielded nor is it likely to yield important information contributing to our understanding of history. In the opinion of the surveyor, the building does not possess any special character or special historical or aesthetic interest. The building also does not possess any value as part of a development, heritage, or cultural characteristic of New York City, the State of New York, or the nation. Therefore, the building does not appear to meet New York City Landmarks eligibility criteria and is recommended as not eligible for landmark status.

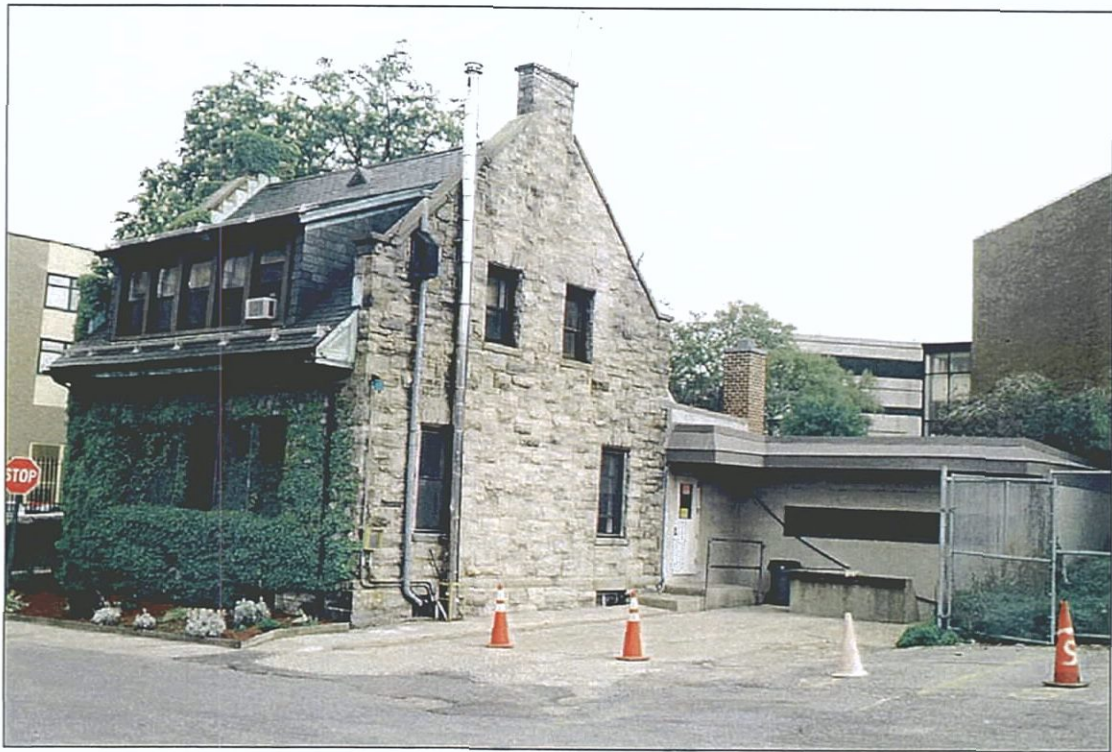
Photo 22 - Schiff House, View Nothwest.

Resource No. 12 - Shiff House (Day Care Center) (Photo 22)

The Shiff House stands at the northeast corner of West 133rd Street's intersection with Convent Avenue. The building displays at least two periods of construction comprised of a one-and-one-half story, rough-coursed stone building with a slate-sheathed gable roof, and a flat-roofed, one-story rectangular concrete block structure appended to its northern elevation forming a tee. The gable-roofed building features nearly full-width shed-roofed dormers on

both roof slopes, interior stone chimney piles at both gable peaks, and copper-clad extended eaves. Banks of five one-over-one aluminum sash occupy the southern elevation's first story and both dormers. The eastern gable end features two symmetrically spaced window openings on both stories, each containing one-over-one aluminum sash. The western elevation's original fenestration matched the eastern gable end but has been modified by the appending of a modern fire escape tower that required the enlarging of windows into doorways on both stories. The first story doorway possesses a metal slab door with a wire-glass transom. Windows throughout the stone building feature stone jack arch lintels and cast stone sills. The concrete block tee possesses roll asphalt roofing, an aluminum-cased cornice, and banks of one-over-one metal windows and awning windows. A metal slab door with large upper light penetrates the southeastern portion of the tee. Now used as a child care center, the building also possesses a fenced playground located its north side.

Due to the appending of the unsympathetic additions, the installation of the fire escape requiring the enlarging of original window openings, and the replacement of the building's remaining original windows with modern metal units, the structure possesses poor physical integrity and lacks quality of style, workmanship, and materials. The building does not reflect the noteworthy characteristics of a particular architectural style, architect or designer. Research has not identified any relationships with historically significant events, persons, or patterns of activity, or with historically or culturally significant groups. The property has not yielded nor is it likely to yield important information contributing to our understanding of history. In the opinion of the surveyor, the building does not possess any special character or special historical or aesthetic interest. The building also does not possess any value as part of a development, heritage, or cultural characteristic of New York City, the State of New York, or the nation. Therefore, the building does not appear to meet New York City Landmarks eligibility criteria and is recommended as not eligible for landmark status.

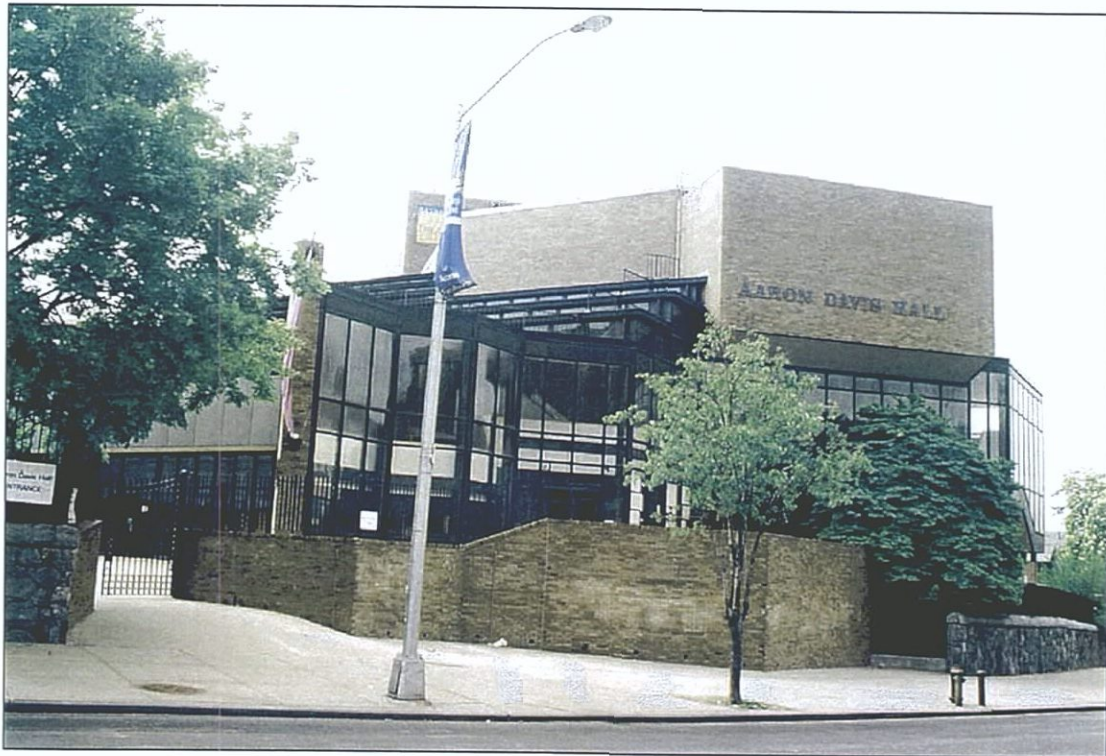
Photo 24 - Aaron Davis Hall, View Southeast

Resource No. 14 - Aaron Davis Hall (Photo 24)
