**CCNY/ASRC SCIENCE FACILITY PROJECT
CITY COLLEGE OF NEW YORK CAMPUS
MANHATTAN, NEW YORK**

**PHASE IA
CULTURAL RESOURCE
ASSESSMENT**

**The Louis Berger Group, Inc.
100 Halsted Street
East Orange, New Jersey 07018**

May 2006

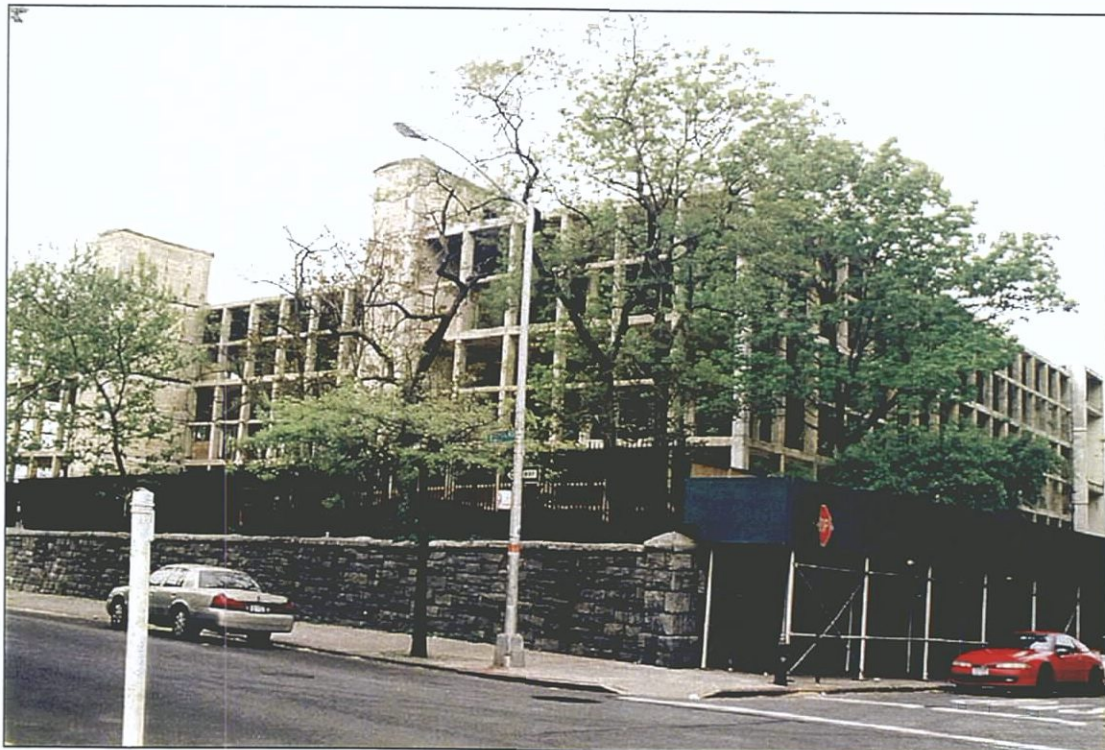
Photo 5 - SAUDLA Building, View Southeast.

In May 2006, the SAUDLA Building, located at the southwestern corner of West 135th Street and St. Nicholas Terrace, consisted of a poured concrete post-and-beam framework supporting three stories of poured concrete floor decks. Nearly all exterior and interior walling and utilities had been removed from the former library building as it underwent an extensive renovation during early 2006. A poured concrete foundation and pad supported the frame. Interior concrete columns provided support between floors. Intermediate concrete beams provided additional lateral support to the building's walls. Two fire stairs enclosed in fire-proof blocks occupied the building's eastern elevation.

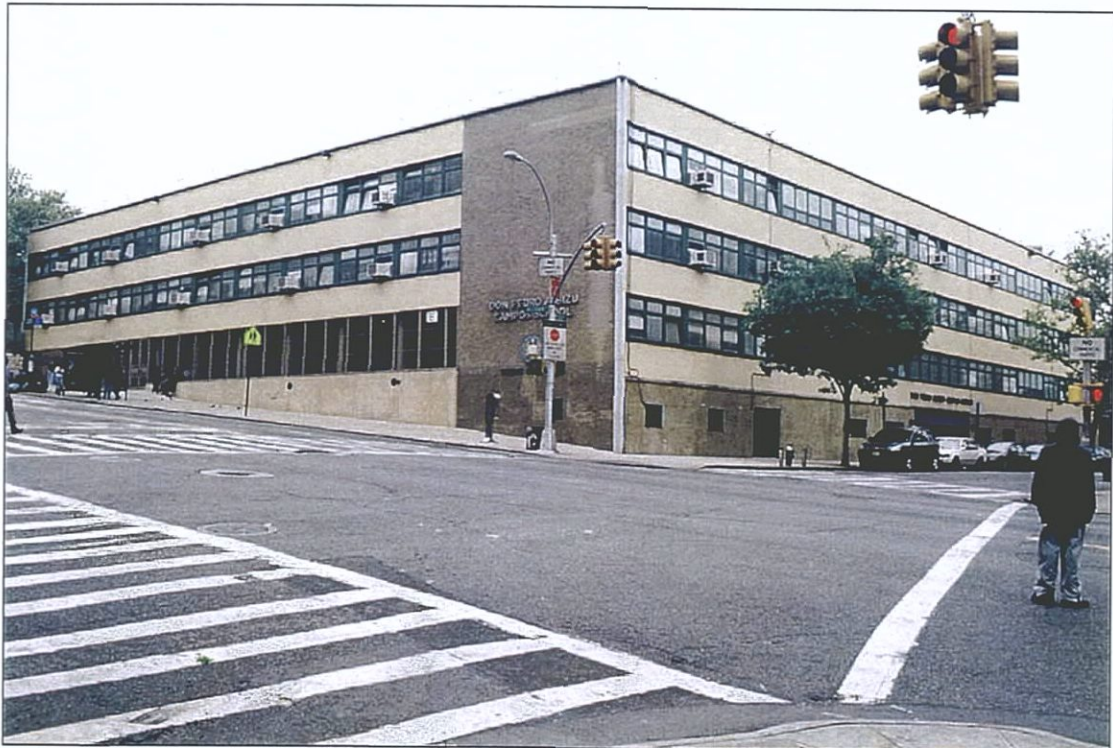
Photo 26 - P.S. 161, View Northeast.

Resource No. 16 - P.S. 161, 1481 Amsterdam Avenue (Photo 26)

The Don Pedro Abizu Campos School, P.S. 161, occupies the entire north side of West 133rd Street between Amsterdam and Convent Avenues. Forming a large rectangle, the school stands three stories tall with a raised basement along its southern elevation due to the downward slope of the grade from north to south. The building features a pre-cast concrete coping, cream-colored and brown brick stretcher bond walls, horizontal banks of windows extending the entire width of building elevations, one-over-one metal hopper windows, and recessed first stories on its western and eastern elevations hidden by protective screens. The south elevation displays 11 symmetrically spaced bays on its basement level. Paired metal slab doors with upper lights occupy the central bay and the third bay from the west and east. The remaining bays contain single or paired one-over-one hopper windows with protective screens.

New York tax data indicates construction of P.S. 161 occurred in 1962. The building's architectural style and materials are consistent with a 1962 date of construction. The present structure, however, lacks quality of style, workmanship, and materials. The building does not reflect the noteworthy characteristics of a particular

architectural style, architect or designer. Research has not identified any relationships with historically significant events, persons, or patterns of activity, or with historically or culturally significant groups. The property has not yielded nor is it likely to yield important information contributing to our understanding of history. In the opinion of the surveyor, the building does not possess any special character or special historical or aesthetic interest. The building also does not possess any value as part of a development, heritage, or cultural characteristic of New York City, the State of New York, or the nation. Therefore, the building does not appear to meet New York City Landmarks eligibility criteria and is recommended as not eligible for landmark status.

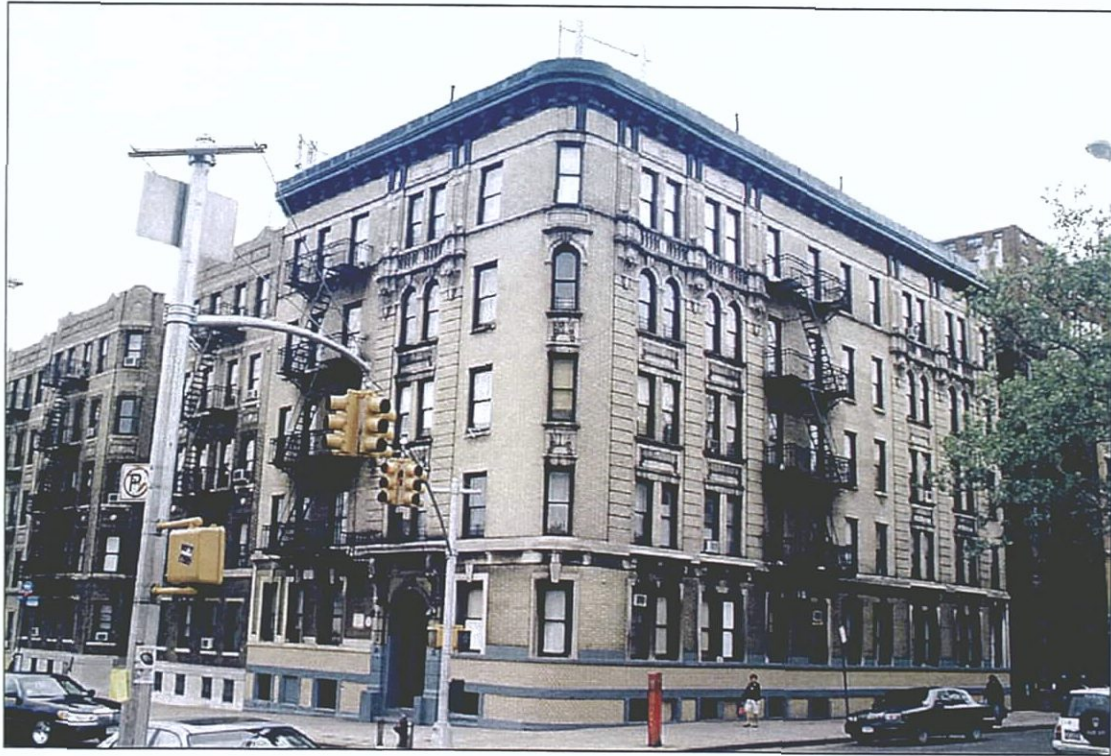
Photo 27 - 110 Convent Avenue, View Southwest.

Resource No. 17 - 110 Convent Avenue (Photo 27)

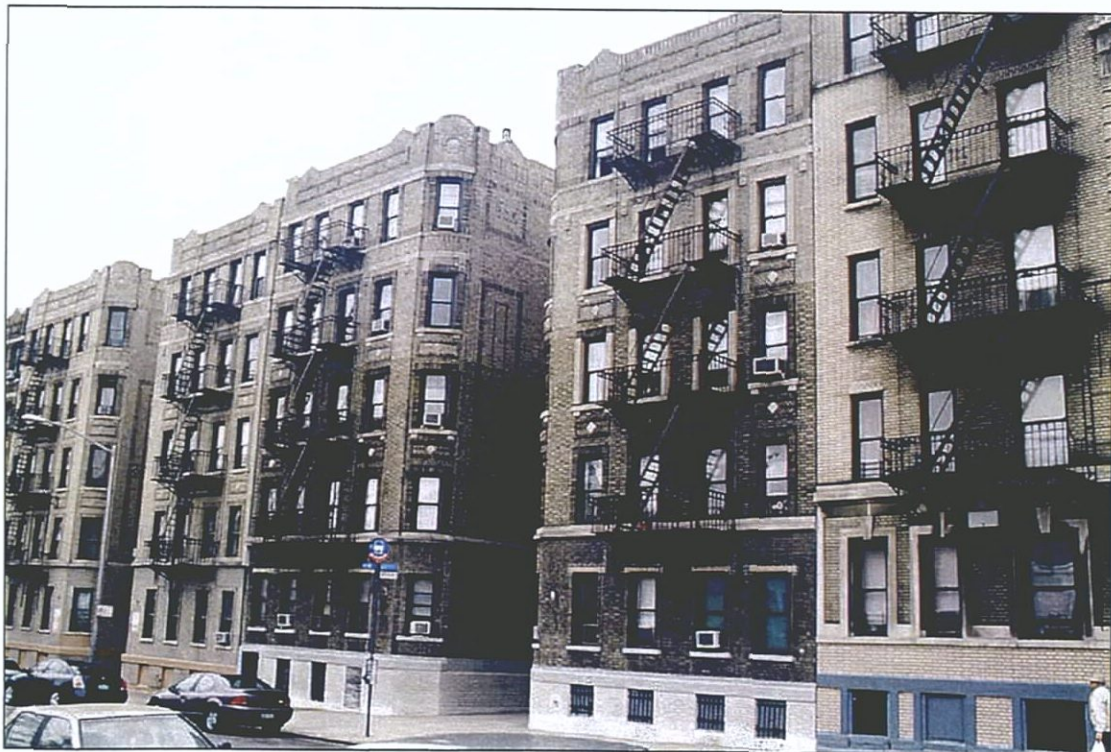
Photo 28 - 106-108 Convent Avenue, View West.

Resource No. 18 - 106-108 Convent Avenue (Photo 28)

The five-story multiple residence at 106-108 Convent Avenue features five-to-one common bond with Flemish variation brown brick construction, cast stone water table, sills and belt courses, and corbelled panels with terra cotta diamond insets. The building consists of a central recessed entry flanked by four bays on both sides. Decorative patterns have been executed in the five-bay deep side walls of the recessed entry by varying colored brick shades. The entry possesses paired metal-framed glass doors topped by a stuccoed panel. A terra cotta surround frames the door and its adjoining one-over-one metal sash window. The symmetrically spaced window openings contain one-over-one metal replacement sash with rowlock and soldier brick surrounds.

Construction of the structure at 106-108 Convent Avenue occurred in 1901 according to New York City tax data. However, a building does not appear at this location on available nineteenth century atlas maps of the area. Construction of the building probably occurred shortly after 1909 when an insurance map depicted an empty lot at the location (Sanborn 1909). The present building appears on a 1939 insurance map (Sanborn 1939). The present structure, however, has had all of its original windows and doors replaced. The building possesses poor integrity and lacks quality of style, workmanship, and materials. The building does not reflect the noteworthy characteristics of a particular architectural style, architect or designer. Research has not identified any relationships with historically significant events, persons, or patterns of activity, or with historically or culturally significant groups. The property has not yielded nor is it likely to yield important information contributing to our understanding of history. In the opinion of the surveyor, the building does not possess any special character or special historical or aesthetic interest. The building also does not possess any value as part of a development, heritage, or cultural characteristic of New York City, the State of New York, or the nation. Therefore, the building does not appear to meet New York City Landmarks eligibility criteria and is recommended as not eligible for landmark status.

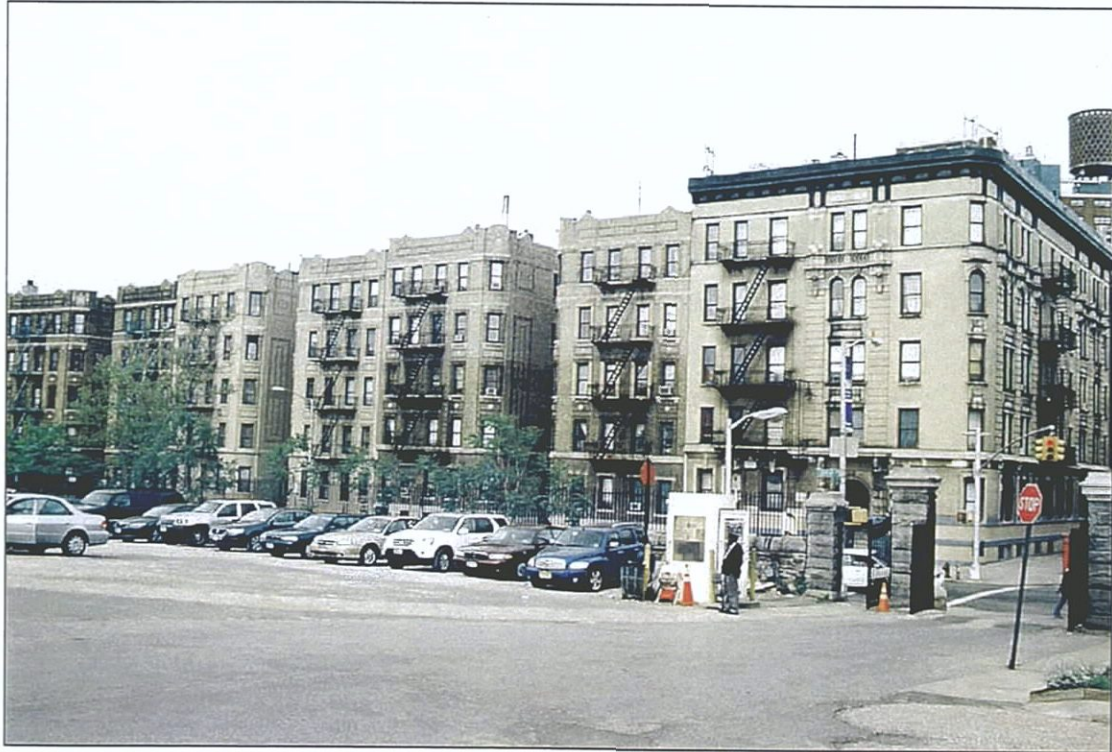
Photo 29 - West Side of Convent Avenue, Showing 96-100 Convent Avenue, 102-104 Convent Avenue, 106-108 Convent Avenue and 110 Convent Avenue from Left to Right, View West.

Resource No. 19 - 102-104 Convent Avenue (Photo 29)

Resource No. 20 - 96-100 Convent Avenue (Photo 29)

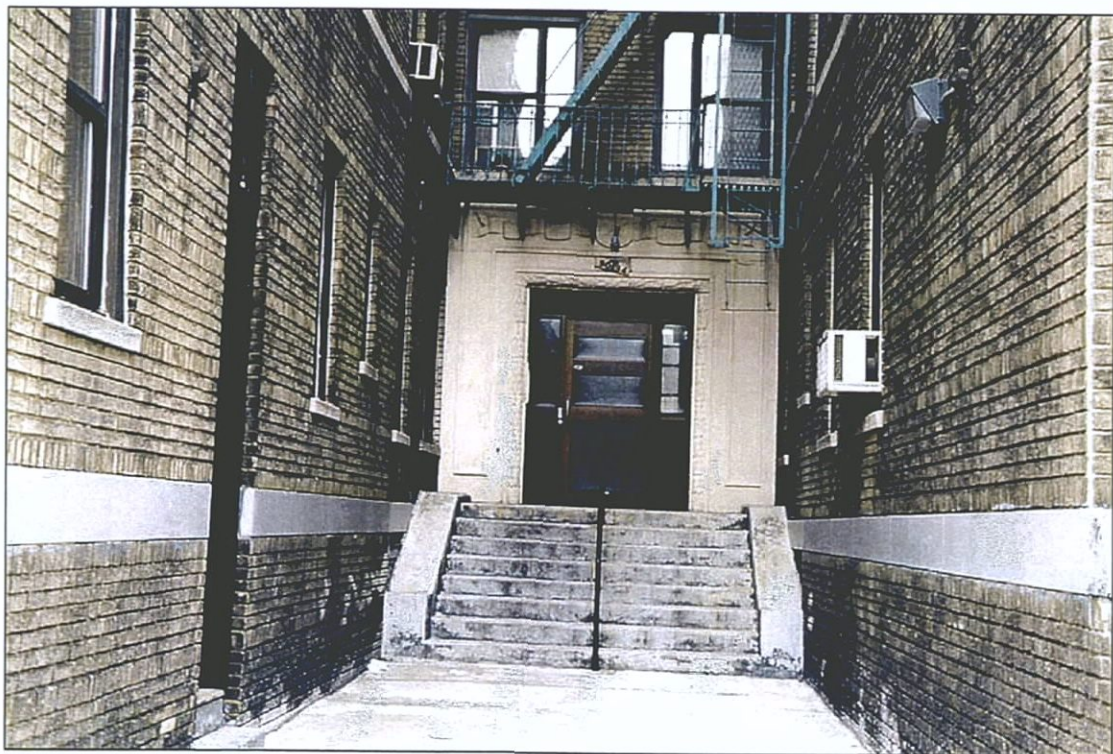
Photo 10 - Entryway to 90-94 Convent Avenue, View West.

Resource No. 21 - 90-94 Convent Avenue (Photo 30)

The multiple residence at 90-94 Convent Avenue is a near copy of the five-story buildings at 106-108, 102-104, and 96-100 Convent Avenue. The building at 90-94 Convent possesses only two bays on its eastern elevation south of its recessed entry, whereas the other three buildings contain four bays on both sides of their recessed entry. The building at 90-94 Convent features five-to-one common bond with Flemish variation brown brick construction, cast stone water table, sills and belt courses, and corbelled panels with terra cotta diamond insets. Decorative patterns have been executed in the five-bay deep side walls of the recessed entry by varying colored brick shades. The entry possesses a single metal panel door with sidelights and a panel transom. A terra cotta surround frames the door. The symmetrically spaced window openings contain one-over-one metal replacement sash with rowlock and soldier brick surrounds.

Although New York tax data indicates that construction of the structure at 90-94 Convent Avenue occurred in 1901, the building was probably not built until after 1909. A 1909 insurance map depicts an empty lot at the location (Sanborn 1909). The present building appears on a 1939 insurance map (Sanborn 1939). The present structure, however, has had all of its original windows and doors replaced. The building possesses poor integrity and lacks quality of style, workmanship, and materials. The building does not reflect the noteworthy characteristics of a particular architectural style, architect or designer. Research has not identified any relationships with historically significant events, persons, or patterns of activity, or with historically or culturally significant groups. The property has not yielded nor is it likely to yield important information contributing to our understanding of history. In the opinion of the surveyor, the building does not possess any special character or special historical or aesthetic interest. The building also does not possess any value as part of a development, heritage, or cultural characteristic of New York City, the State of New York, or the nation. Therefore, the building does not appear to meet New York City Landmarks eligibility criteria and is recommended as not eligible for landmark status.

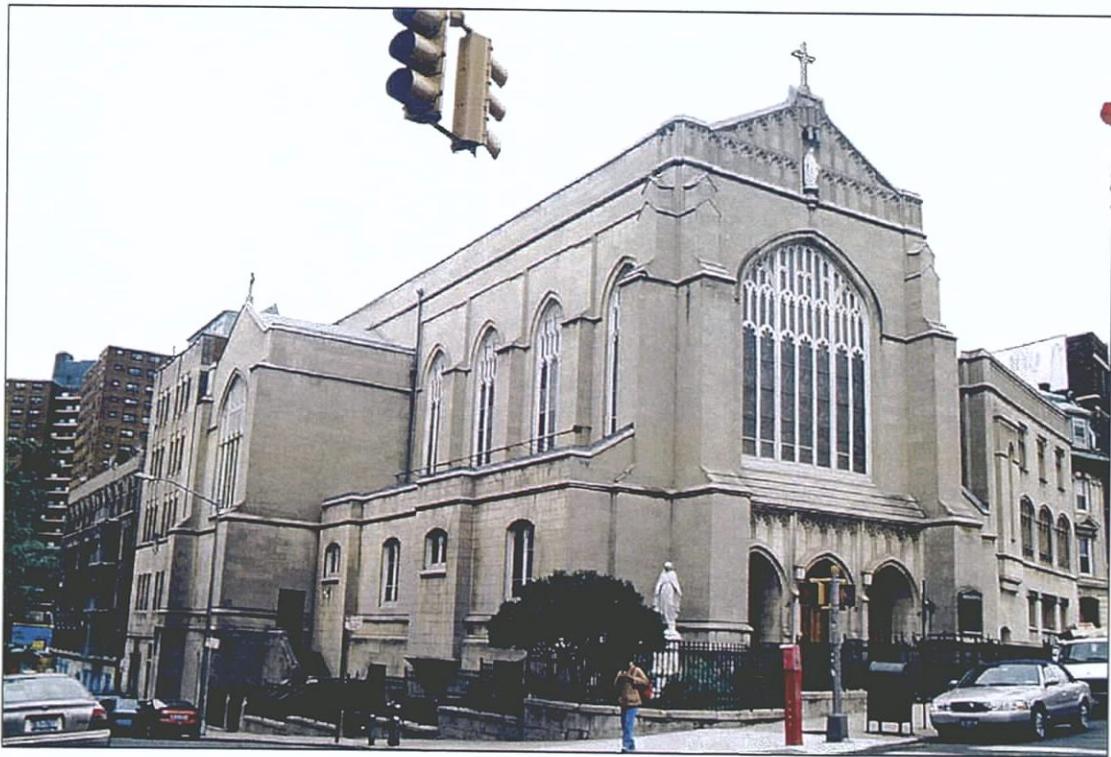
Photo 11 - Annunciation Church and Rectory and Annunciation School, View Northwest.

The five-story, light brown stretcher bond school standing at 461 West 131st Street is appended to the western gable end of the church via a one-bay wide, two-story hyphen. The two bay wide school building features cast stone molded string courses between its first, second and third stories, and cast stone lintels, sills, and door surround. The entrance possesses double-leaf metal slab doors with single upper lights. Cast stone spandrels also ornament the upper story windows. Each window bay consists of triple one-over-one wood sash; first story windows also feature transoms.

The Annunciation Church, the rectory building at 88 Convent Street, and the school building on West 131st Street were probably erected simultaneously in 1906, the year the church was erected according to its date stone. All three structures appear on a 1909 insurance map of the area (Sanborn 1909). Construction of the church's wing linking the original rectory with the church occurred between 1909 and 1939. The link appears on a 1939 insurance map. Religious properties typically do not meet significance criteria unless a noteworthy example of a particular architectural style or part of a historic district. The Annunciation Church and related buildings are common examples of religious architecture and do not reflect the noteworthy characteristics of a particular architectural style, architect or designer. Research has not identified any relationships with historically significant events, persons, or patterns of activity, or with historically or culturally significant groups. The property has not yielded nor is it likely to yield important information contributing to our understanding of history. In the opinion of the surveyor, the

buildings do not possess any special character or special historical or aesthetic interest. The buildings also do not possess any value as part of a development, heritage, or cultural characteristic of New York City, the State of New York, or the nation. Therefore, the buildings do not appear to meet New York City Landmarks eligibility criteria and are recommended as not eligible for landmark status.
