**ARCHAEOLOGICAL BORINGS AND TEST PIT MONITORING
SCHERMERHORN ROW BLOCK
BOROUGH OF MANHATTAN
CITY OF NEW YORK**

by
Arnold Pickman

**Submitted To:
THE SOUTH STREET SEAPORT MUSEUM**

January 2000

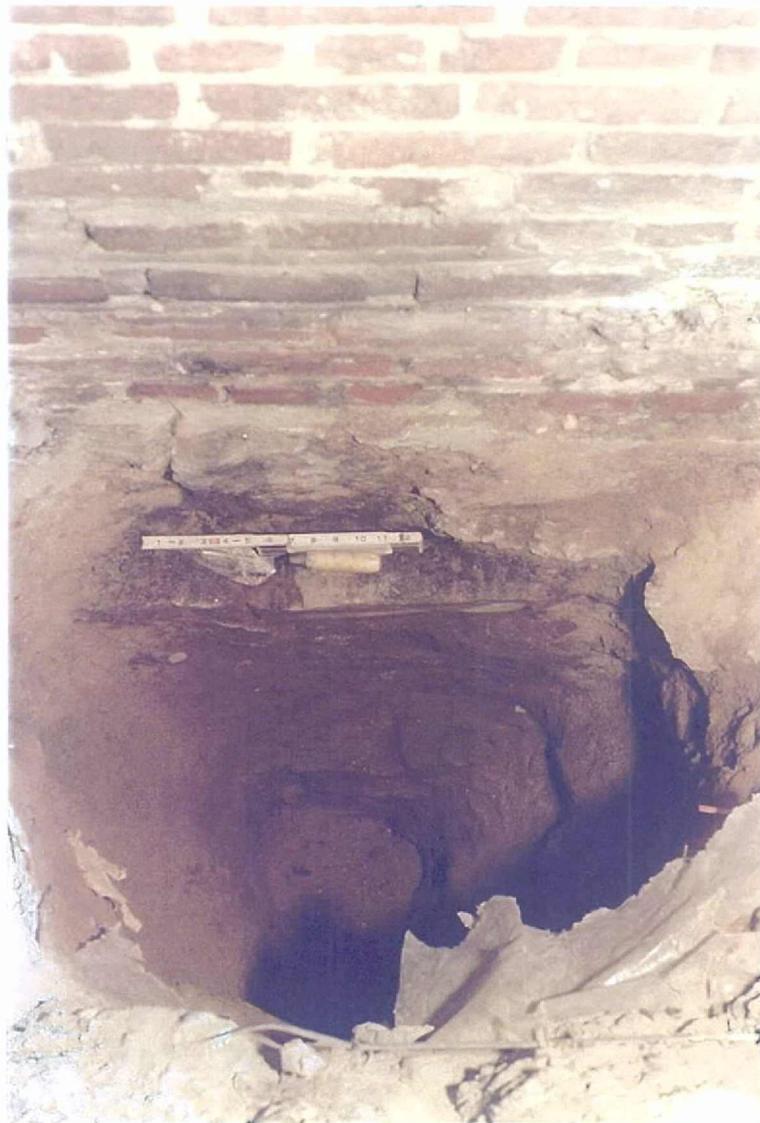
Figure 5
Test Pit 4
View Facing East

In test pit 4, all three sections of the stone foundation underlying the rear wall of 91 South Street were exposed (see Figure 5). The uppermost section, on which the brick wall rests, extends for two feet below the base of the brick superstructure wall, with the second section extending for an additional 20 inches below the uppermost section, and the third section continuing downward from this point. Test pit 4 was excavated to a depth of some five feet below the concrete floor without reaching the base of this stone wall. However, probing by the excavators encountered what appeared to be spread footer planks at a depth of approximately 6 1/2 feet, which is approximately the depth at which they were noted by Kardas and Larrabee. The uppermost portion of the stratigraphy encountered in test pit 4 consisted of approximately 20 inches of tan sand apparently

deposited in connection with the construction of the one foot thick concrete floor. The sand was underlain to the base of the test pit by a deposit of reddish brown sandy silt, which contained fragments of brick and schist of the type used for the construction of the foundation. This may have been deposited at the time the building was constructed. Pieces of shell were visible in the walls of the test pit in this stratum, but no other artifacts were noted. During the excavation of this deposit the construction workers encountered and removed a piece of wood measuring 9 x 7 x 2 inches with two corroded nails or hooks embedded in it.

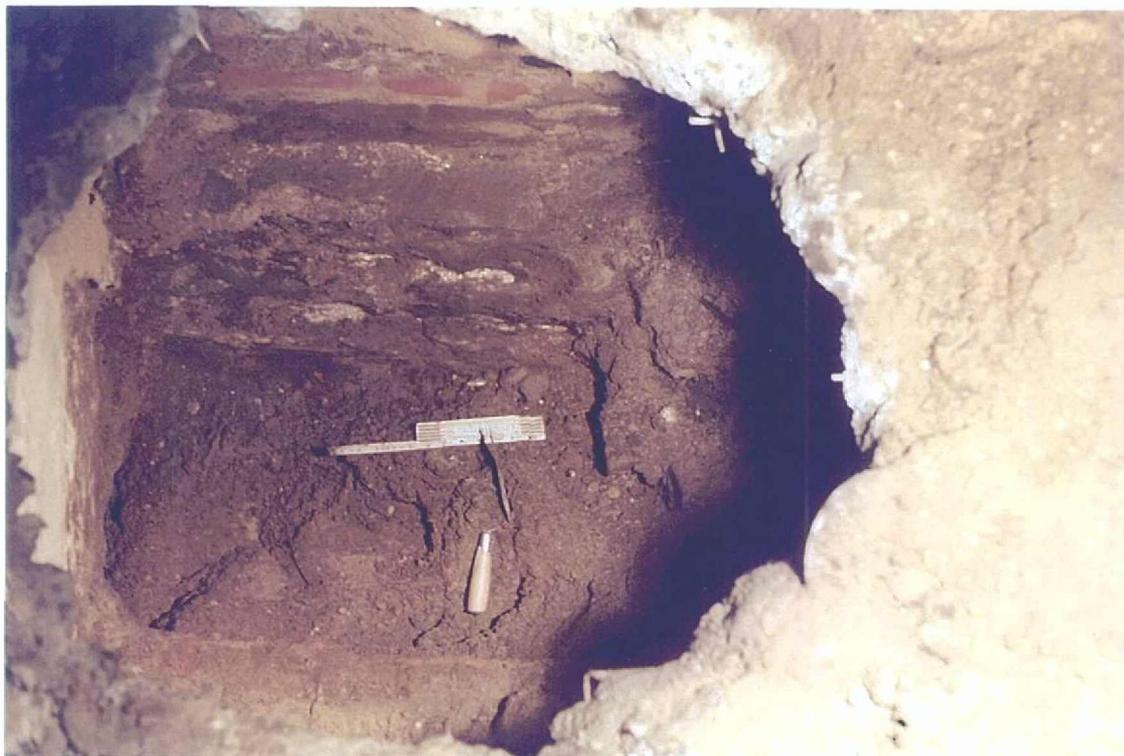
Figure 6
Test Pit 1
View Facing North

Test pit 1 exposed the upper portion of the foundation of the rear wall of 12 Fulton Street. At this location the brick superstructure wall extended to a depth of 27 inches below the existing surface. This was underlain by the uppermost section of the stone foundation, which was 12 inches high. Only the uppermost foot of the underlying second section of the foundation wall was exposed.

The southernmost portion of the test pit 1 stratigraphy had been disturbed by the installation of an iron pipe (see Figure 6). Additional disturbance to this area would have been caused by the construction of the brick "cantilever wall" on the west side of the test pit. This wall was apparently constructed during the ca. 1980 renovations and serves to support the covered passageway and the stairs noted previously. In the eastern wall of the test pit the two inch thick paving stones were underlain by an additional six inches of concrete followed by one foot of tan sand bedding material. This was underlain by eight inches of light brown sand containing pieces of mortar, followed by gray brown sand with brick and stone fragments to the base of the test. This latter deposit may represent an undisturbed portion of the upper fill deposits encountered in test pit 4. However, it should be noted that the map included in the 1991 Kardas and Larrabee report (see Figure 3) indicates that a trench had been excavated in this area during the archaeological project and the material encountered could represent soil backfilled into this trench.

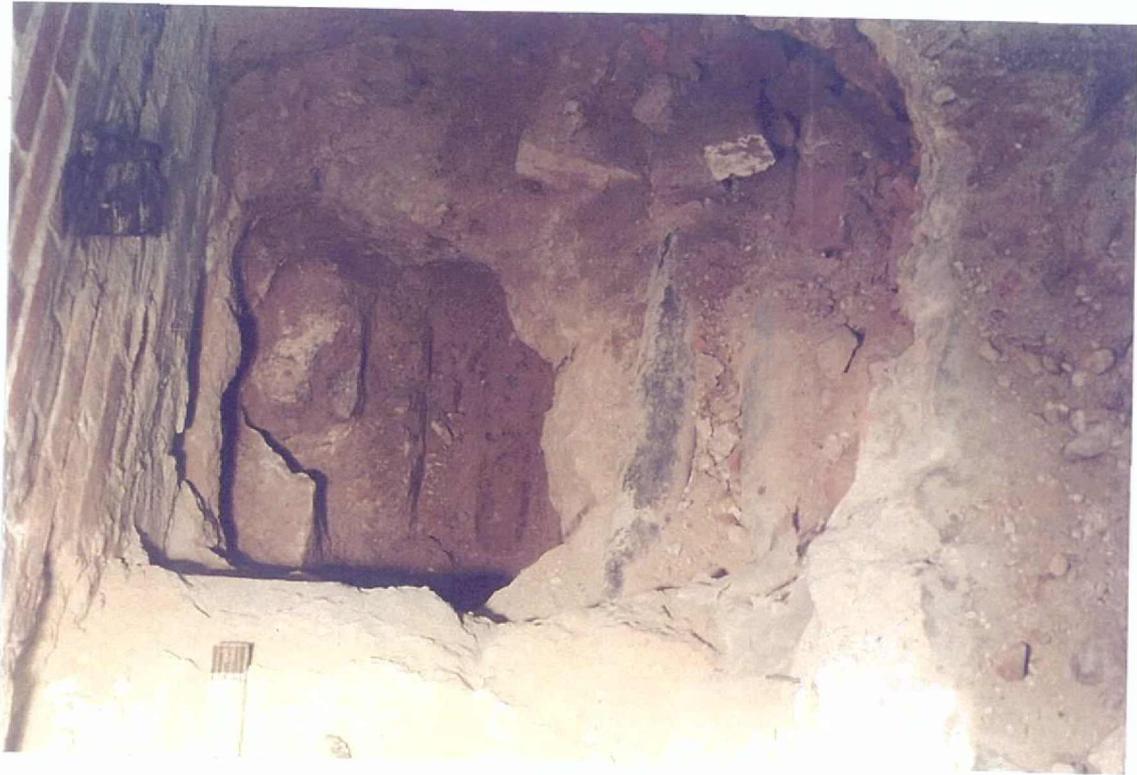
Figure 7
Test Pit 2
View Facing East

Test pit 2 exposed the upper portion of the rear wall of 10 Fulton Street. At this location the base of the brick superstructure wall was separated from the approximately six inch thick uppermost section of the foundation wall by approximately one foot of mortar. The top of the underlying second section of the foundation wall was encountered at a depth of 38 inches below the surface (see Figure 7). The location of this test had been disturbed by the installation of a pipe located some three inches south of the foundation and encountered at a depth of 38 inches below the surface. Twenty two inches south of the brick superstructure wall two additional, four inch diameter, iron pipes were encountered at 17 - 19 inches below the surface. These pipes were underlain by concrete to a depth of 34 inches below the surface.

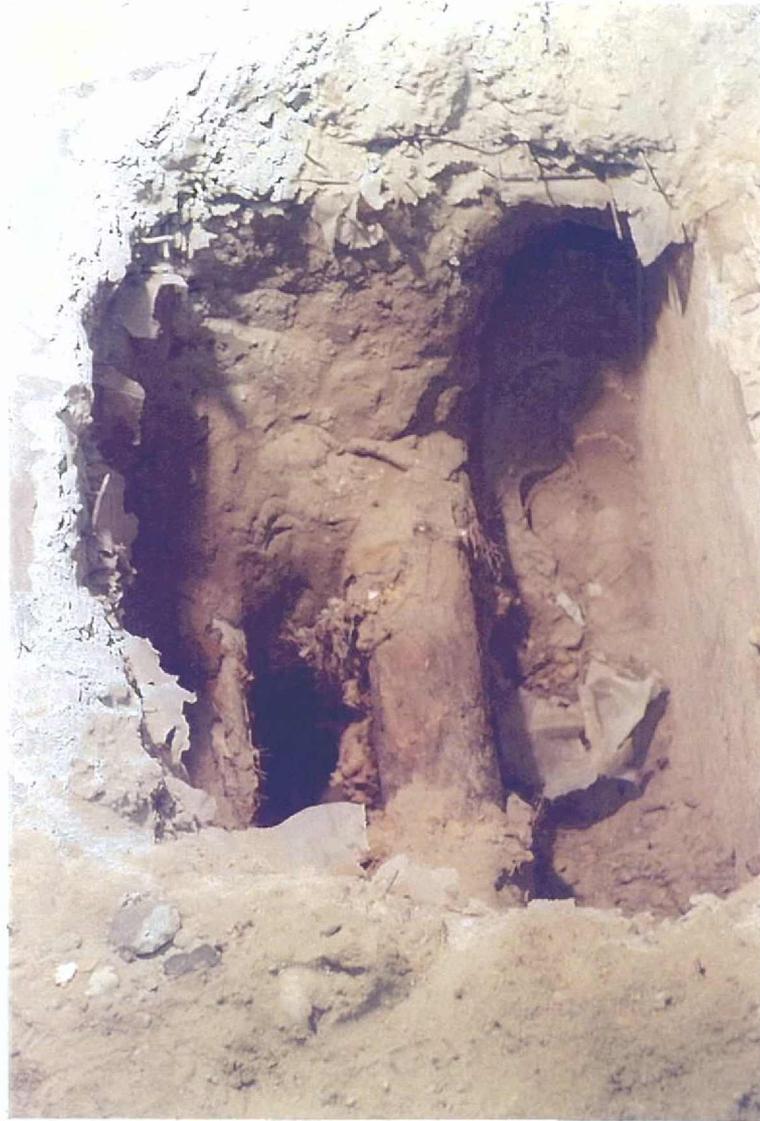
Figure 8
Test Pit 3
View Facing East

Test pit 3 was placed against the rear (south) wall of the covered corridor and exposed the concrete foundation of this wall. The entire area exposed by this test pit had been disturbed by the installation of two seven inch diameter iron pipes about two feet below the surface (see Figure 8). At a depth of approximately 50 inches, concrete was encountered extending some twenty inches outward from the concrete foundation to a

location beneath the southernmost of the two iron pipes. Probing by the excavators encountered the base of this concrete at approximately 62 inches beneath the surface. This concrete most likely represents an electrical duct. Probing by the excavators beneath the concrete floor immediately east of test pit 3 encountered what appeared to be another concrete duct extending northward from the rear wall of the corridor. What appears to be an electrical equipment room is located immediately south of the location of this test pit.
