**STAGE 1B  
ARCHAEOLOGICAL  
FIELD SURVEY**

**240-244 WEST BROADWAY  
BLOCK 190, LOT 44  
MANHATTAN, NEW YORK**

Historical Perspectives, Inc.  
P.O. Box 3037  
Westport, CT 06880

September 2007

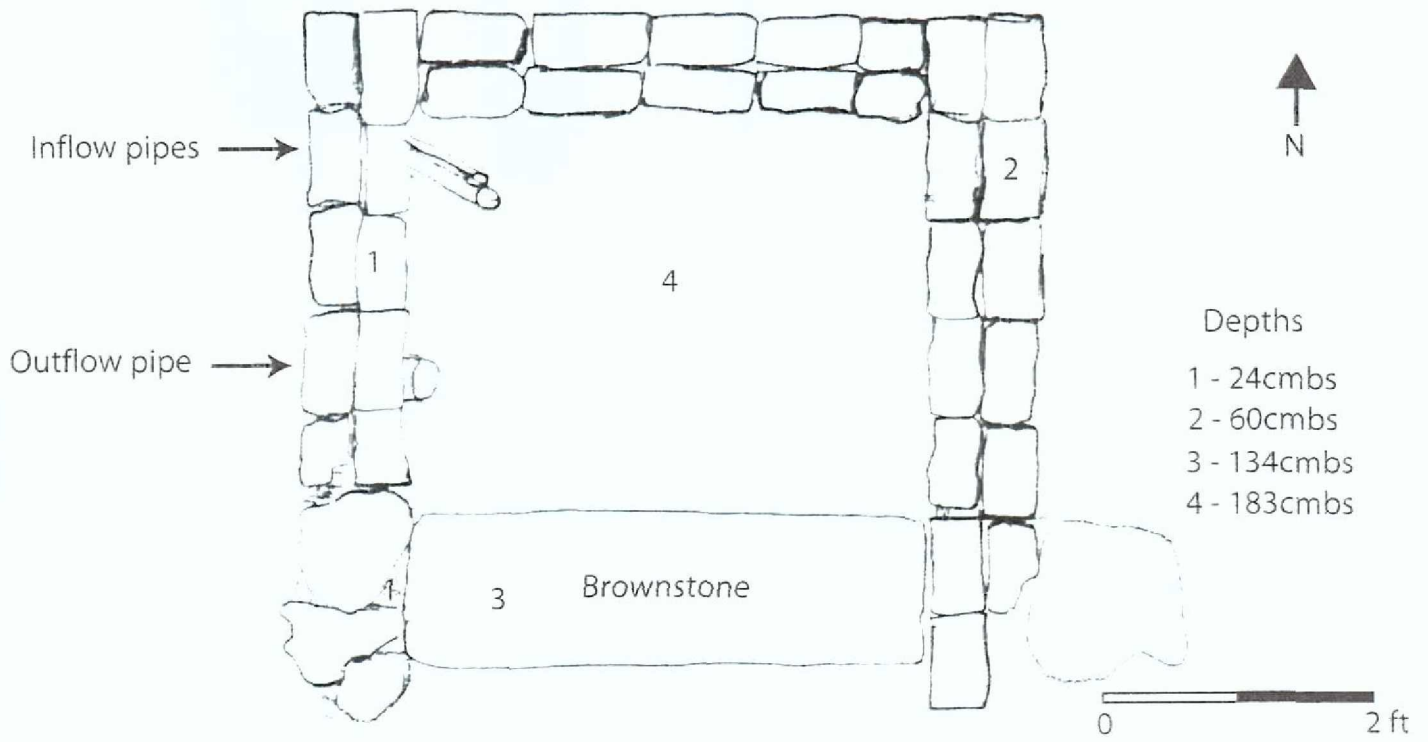
240 West Broadway Project Site

Figure 5. Plan and Profile of Feature 7.

The top of the brick feature was approximately 97 cm (just over 38 inches) wide (see Photograph I; Figure 5). The southern side of the feature was carefully removed to enable excavation of the interior. Following the removal of the fill, two lower fill strata were excavated by hand. No evidence of organics was observed during the hand excavation of the approximately 25 cm of soils, and only a handful of artifacts were recovered (see Appendix). The artifacts include window glass, ironstone vessel fragments, pieces of porcelain teawares, and a large machine-made colorless bottle base. This limited collection is difficult to date, but again appears to be from the late 19<sup>th</sup> through early 20<sup>th</sup> centuries. Only one bottle was recovered. This was a 19<sup>th</sup>-century blob top bottle that was embossed "P.CARR" "PHILADa." To date, no information on the bottle manufacturer has been found.

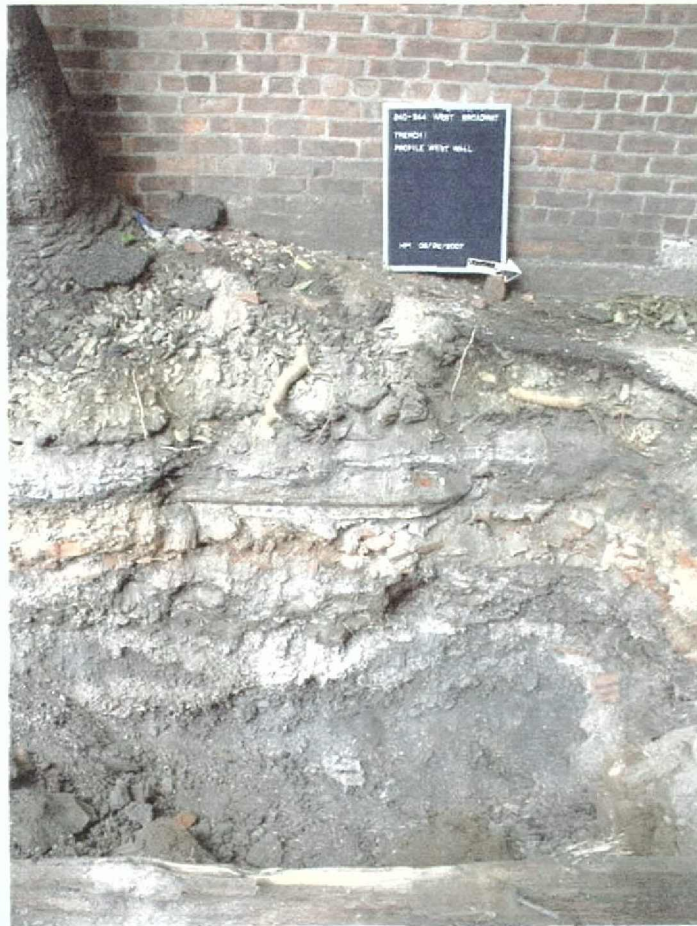
Photograph B. Photograph of the West Wall of Trench 1.

On the west side of the Trench (Lot 46), seven distinct soil strata were identified (see Stratigraphic Sequence Table below and Photograph B) during excavation. One of these layers was associated with a significant demolition/fill episode. The fill encountered appeared to be the result of 20<sup>th</sup>-century demolition activity that took place on the project site, as well as possible filling activities that were completed to create a level surface for the asphalt parking lot.

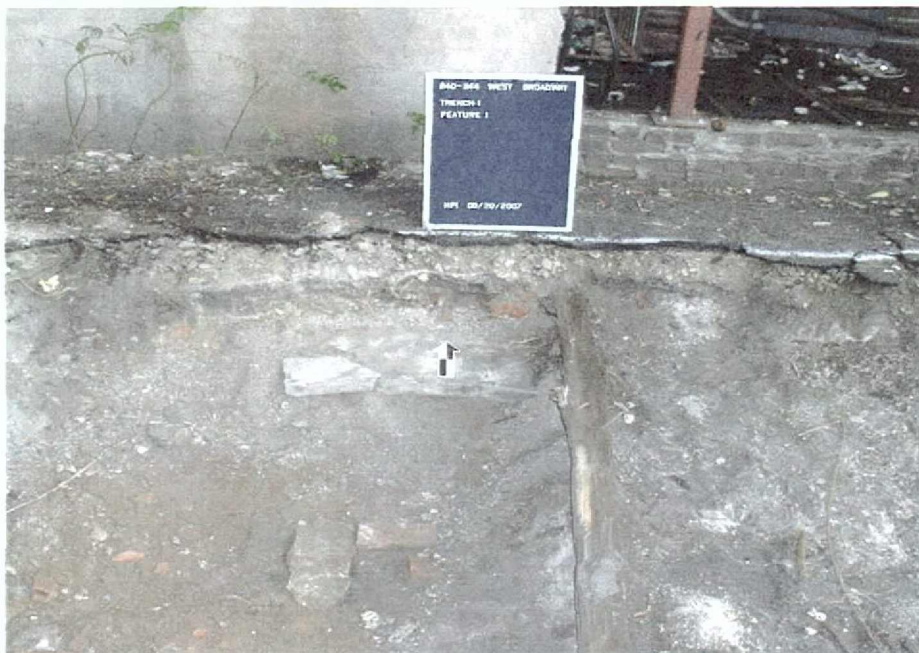
Photograph C. 240 West Broadway Project Site, Trench 1, Feature 1.

Feature 1 was the remnant of a former floor (Photograph C) located at the northern edge of the trench. The floor was clearly part of an unrecorded addition to a structure spanning Lot 46. The portion of the floor that was uncovered was comprised of a wood beam (running north-south) that had been broken at the south end, and two flagstones abutting the wood beam. Features 3 and 6 were likely associated with Feature 1 in the past (see Photographs C, D, and H). Each was located at the northern edge of the trench and were likely once parts of a larger foundation/floor for the undocumented addition (see Figure 5). Because of the extensive demolition activity within the lot, the connection between these features has been lost.

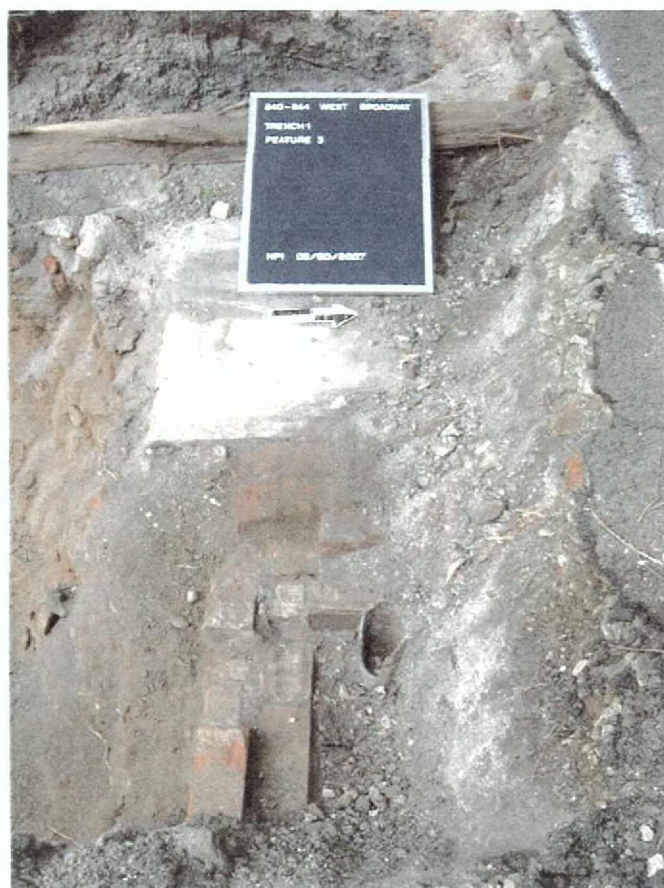
Photograph D. 240 West Broadway Project Site, Trench 1, Feature 3.

A second concentration of artifacts was recovered adjacent to Feature 3, the brick foundation wall and drain spout. This was a larger collection of artifacts that included fragments from numerous utilitarian vessels (stoneware jar, yellowware bowl, and possible chamberpot fragments), tablewares (porcelain teacup, ironstone plate rims, whiteware cups), and bottles. The bottles appear to date to the late 19<sup>th</sup> century, including one that is embossed "L. Riederer Druggist." No organic soils were associated with this concentration of materials. Instead, the surrounding context was a yellowish brown silty sand, similar to subsoil in this half of the trench. Concentration 2 appears to be a late-19<sup>th</sup>-century domestic trash deposition, possibly when the drainage spout was installed and/or the unrecorded addition was constructed.

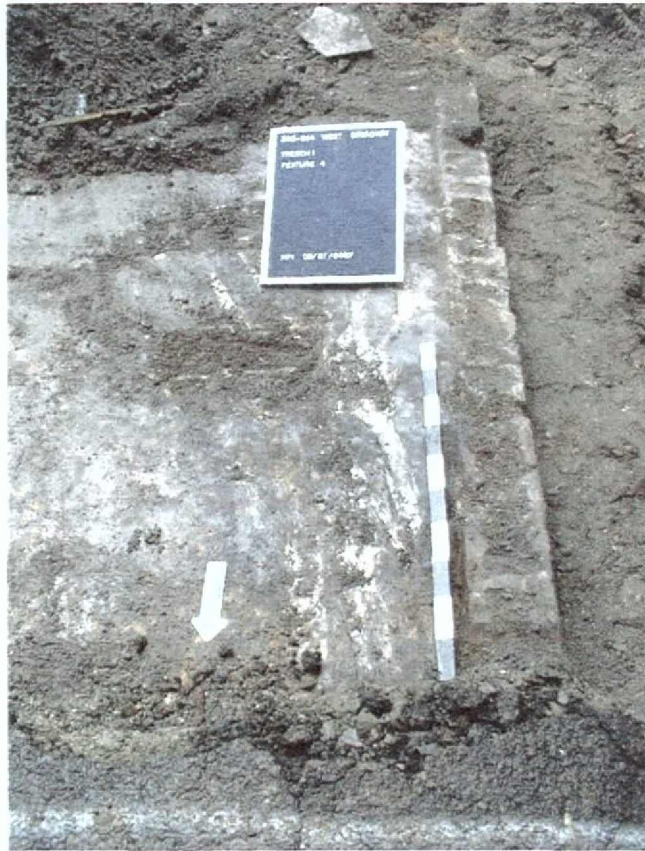
Photograph E. 240 West Broadway Project Site, Trench 1, Feature 4.

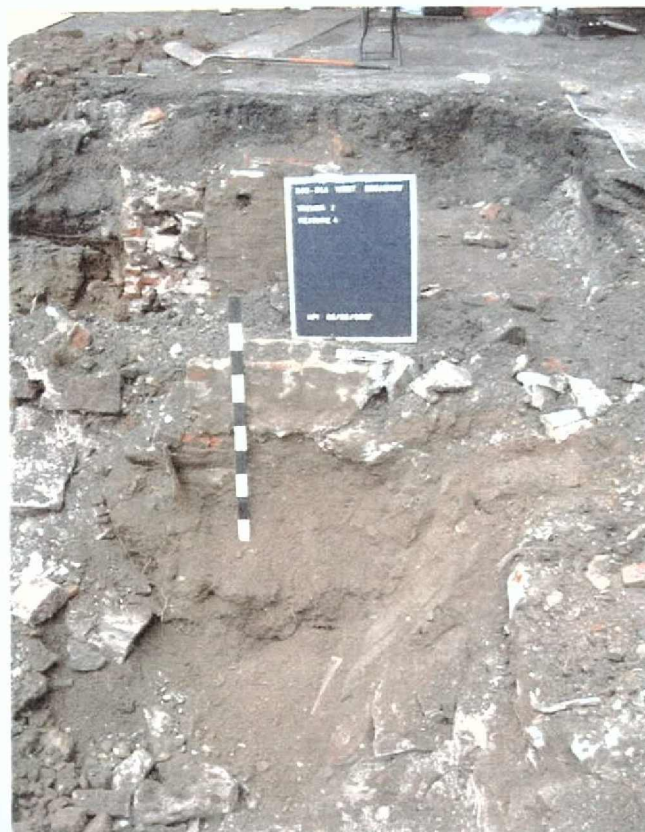
Photograph F. 240 West Broadway Project Site, Trench 2, Feature 4.

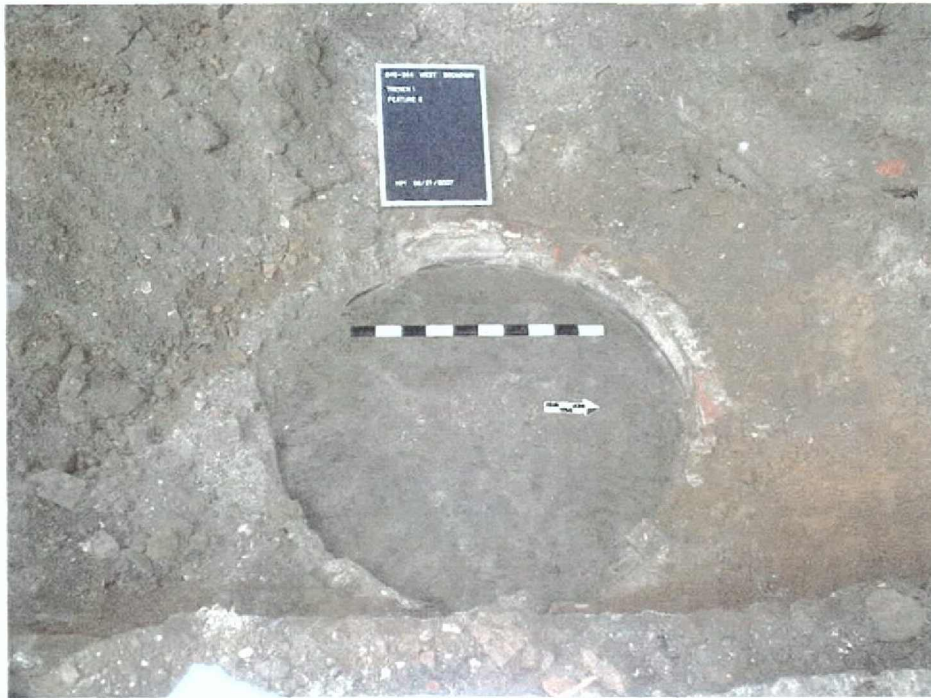
Photograph G. 240 West Broadway Project Site, Trench 1, Feature 5.

The final feature identified in Lot 46 was the base of a severely truncated cistern (Photograph G). In the center of the trench, the fill layer extended to almost 160 cmbs (centimeters below the surface). At that depth a brick-and-mortar cistern base, surrounded by subsoil, was discovered. This feature had been almost completely truncated by demolition activities that took place in this back lot.

The remaining 15 cm of fill within the interior was hand excavated and the soils screened. Only a small number of artifacts were recovered, the majority dating from the late 19<sup>th</sup> century (see Appendix). Only two truly diagnostic artifacts were recovered from the feature. They included an ironstone bowl fragment with a partial makers mark (“DWARDS”) and a trace of a registry mark used in the late-19<sup>th</sup> century, prior to 1883. The second diagnostic artifact is a complete “Knicker Bocker Soda Water” bottle. This artifact is a well-known bottle type dating to the late 19<sup>th</sup> century. It is a cobalt-blue bottle embossed with the address “164 18th Street” and an “1848” date that was identified as being manufactured by William Pond (<http://www.glswrk-auction.com/031.htm>). It is likely that this feature was constructed in the mid-19<sup>th</sup> century and may be associated with the occupation of the only long-term resident identified in the documentary analysis, Peter Frevell, who lived there from ca. 1842 through ca. 1853.

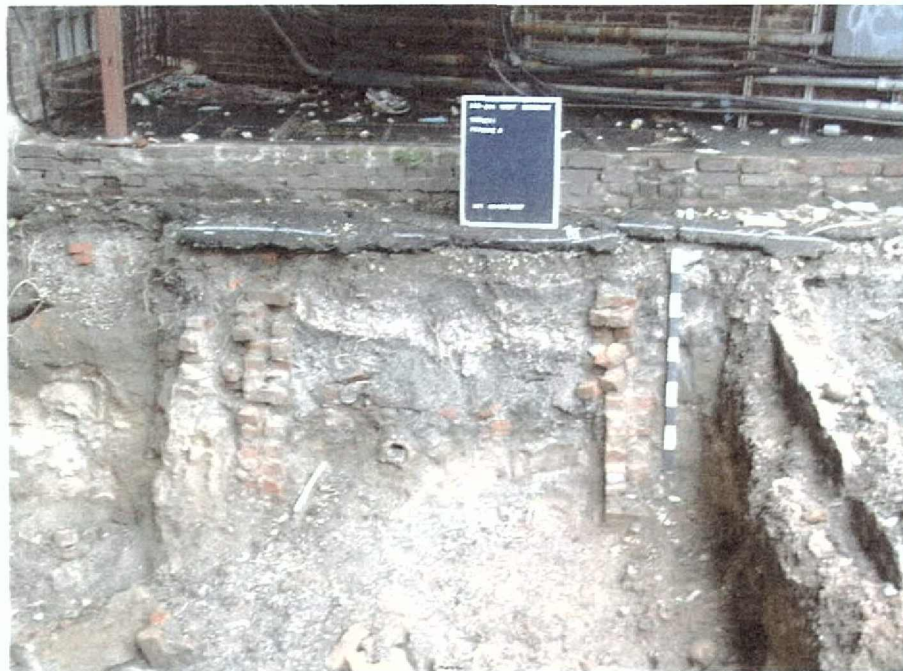
Photograph H. 240 West Broadway Project Site, Trench 1, Feature 6.

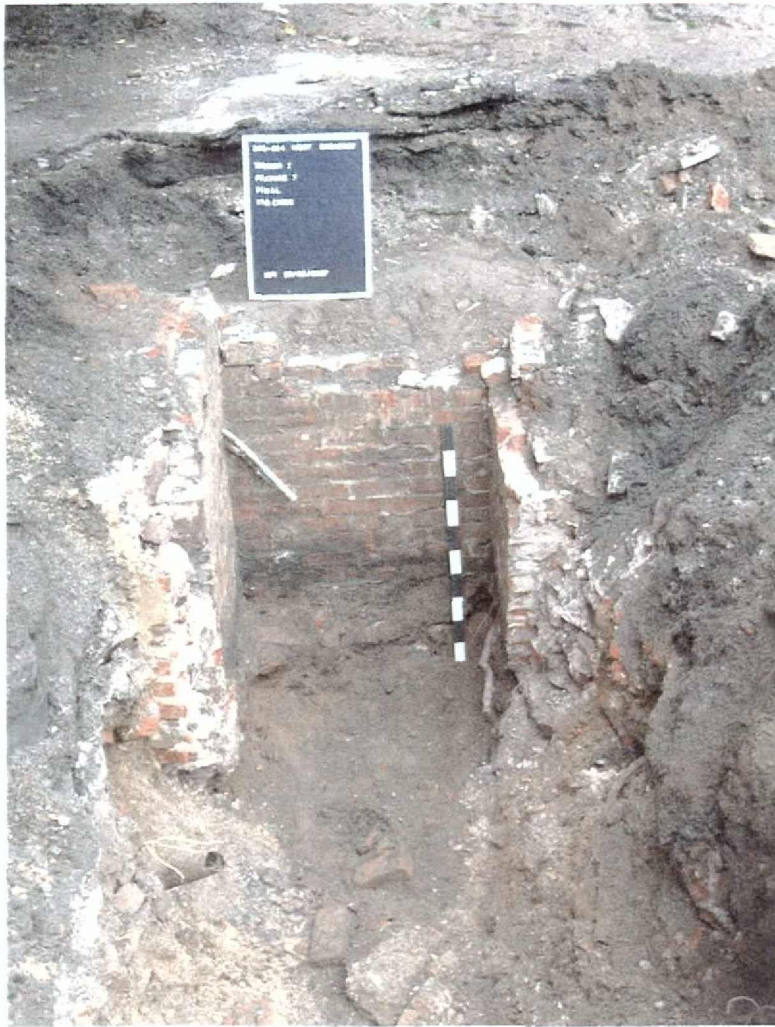
Photograph I. 240 West Broadway Project Site, Trench 2, Feature 7.

Within the rear "yard" of Lot 46, the project team encountered one feature that was attached to the basement foundation. Feature 7 was likely a brick water closet attached to the back of the main house. It does not appear to have been used as a privy, but instead may have been the location of garden sink with the broken ends of associated inflow and gray water outflow pipes still present (see Photograph I; Figure 5). If it had been used as a true water closet, the pipes could have provided water and waste outflow for a toilet. Examination revealed that the rear foundation wall had been broken to construct this feature. Cast iron pipes were present, extending out from the middle of the feature. The top of the feature had been filled with modern trash and architectural debris (bricks, cinderblocks, plaster). Approximately 20 clear and lime green bottles were noted within the fill. The clear bottles were embossed "ERCO Beverages" "Evers---Rehn Co." "419 E. 24TH St. NY." To date, no record of this manufacturer has been identified.

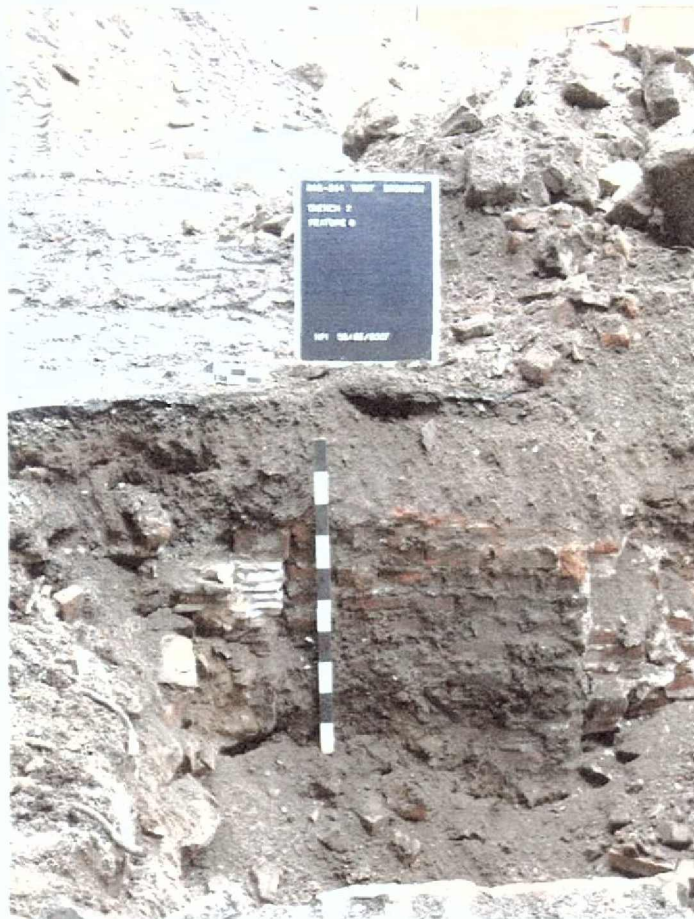
Photograph J. 240 West Broadway Project Site, Trench 2, Feature 8.

Trench 2 was located in the center of the project site. It extended across all three of the former back lots. Excavation revealed the presence of deep basements in each of the three lots (see Photographs J and K). There was no evidence of undisturbed yard areas

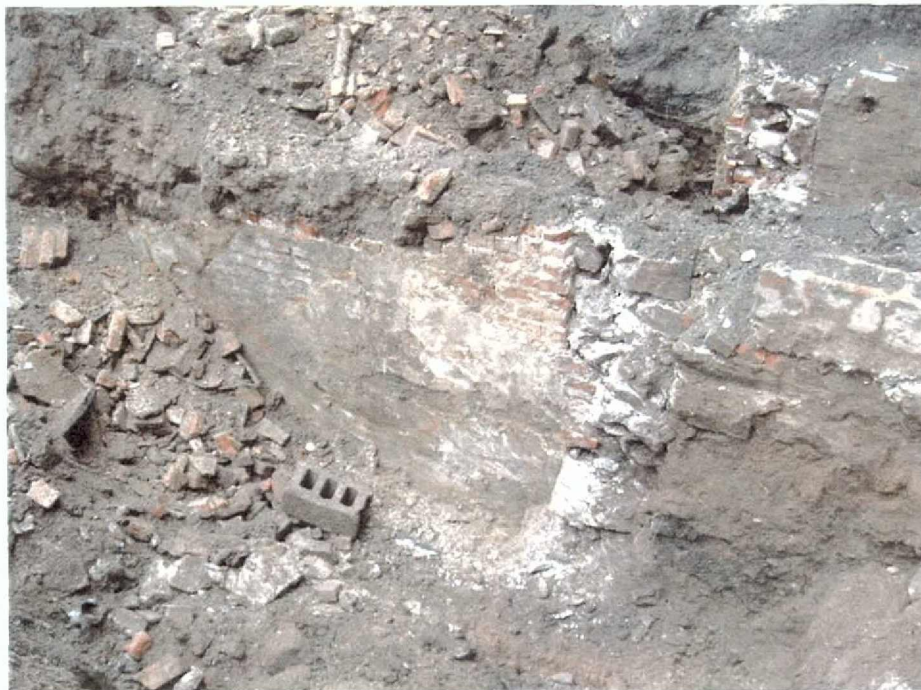
Photograph K. 240 West Broadway Project Site, Trench 2, Feature 8.
