# **STOCKHOLM STREET HISTORIC DISTRICT**

## **Designation Report**

**New York City Landmarks Preservation Commission  
November 28, 2000**

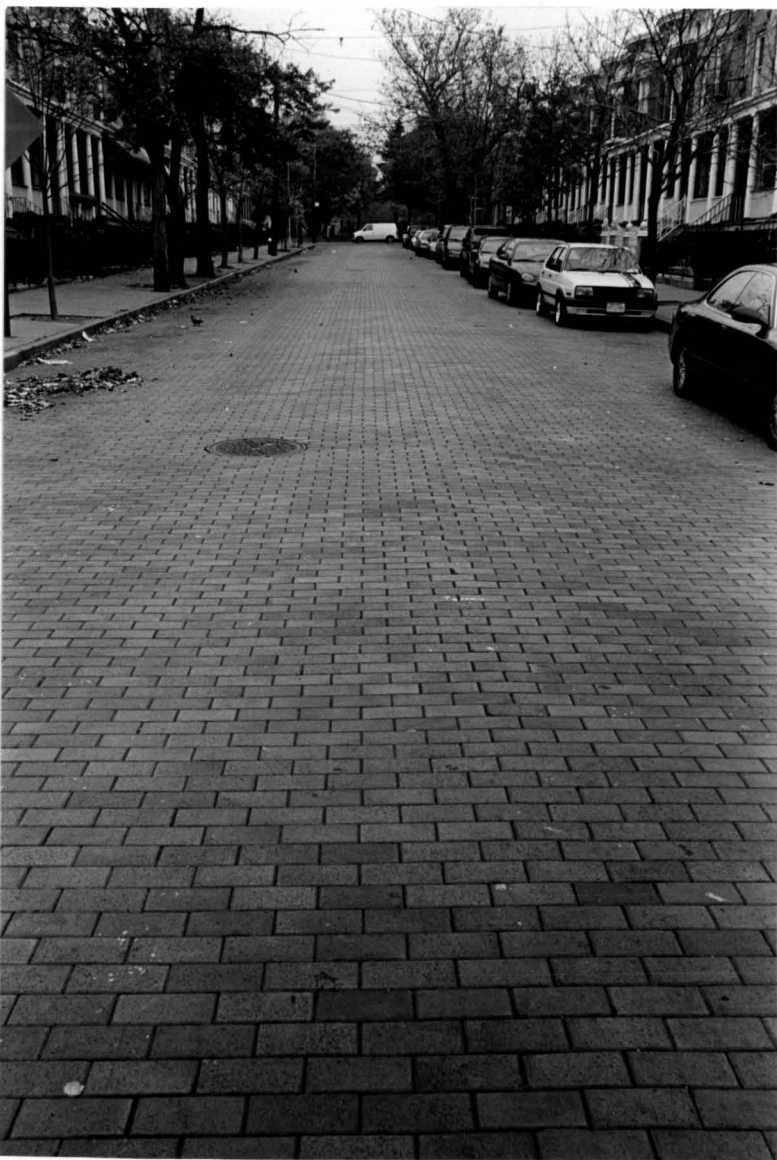
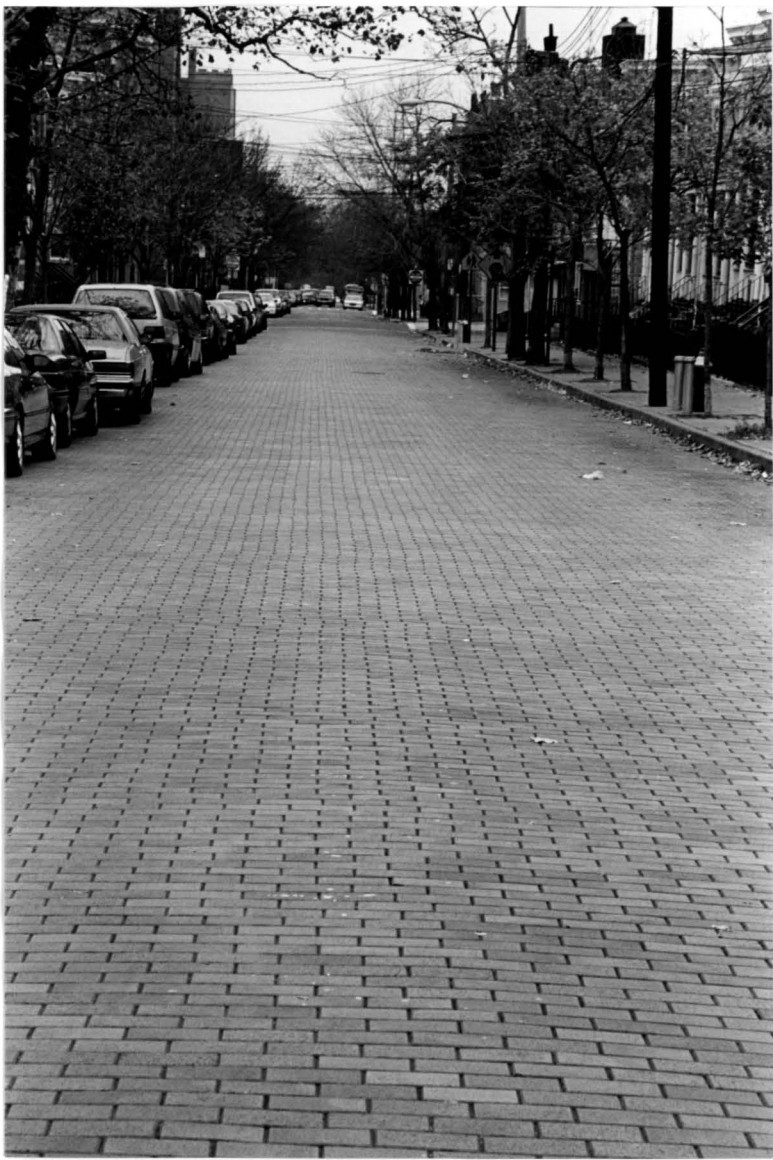
Brick Pavement, looking North  
Photo: Carl Forster, 2000

This section of Stockholm Street has the only extant brick street in Ridgewood, which was at one time extensively paved with brick. In 1907 and 1908, brick was the leading paving material for streets in the United States, and brick streets were common in many New York City neighborhoods. Most of the brick streets in the city were paved over with blacktop in the mid-twentieth century and only a few have survived. The original bricks on Stockholm Street were produced by the S.B.T. Company, a major manufacturer of clay products, located in Clearfield, Pennsylvania.

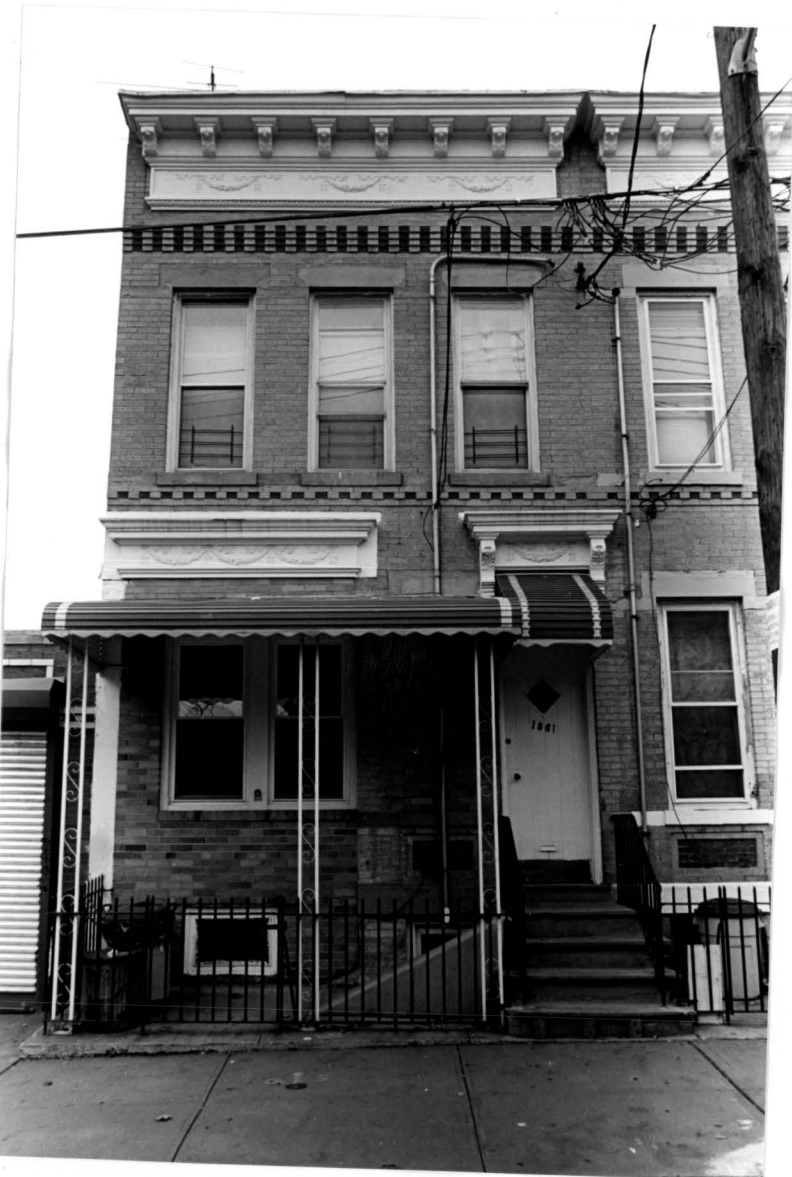
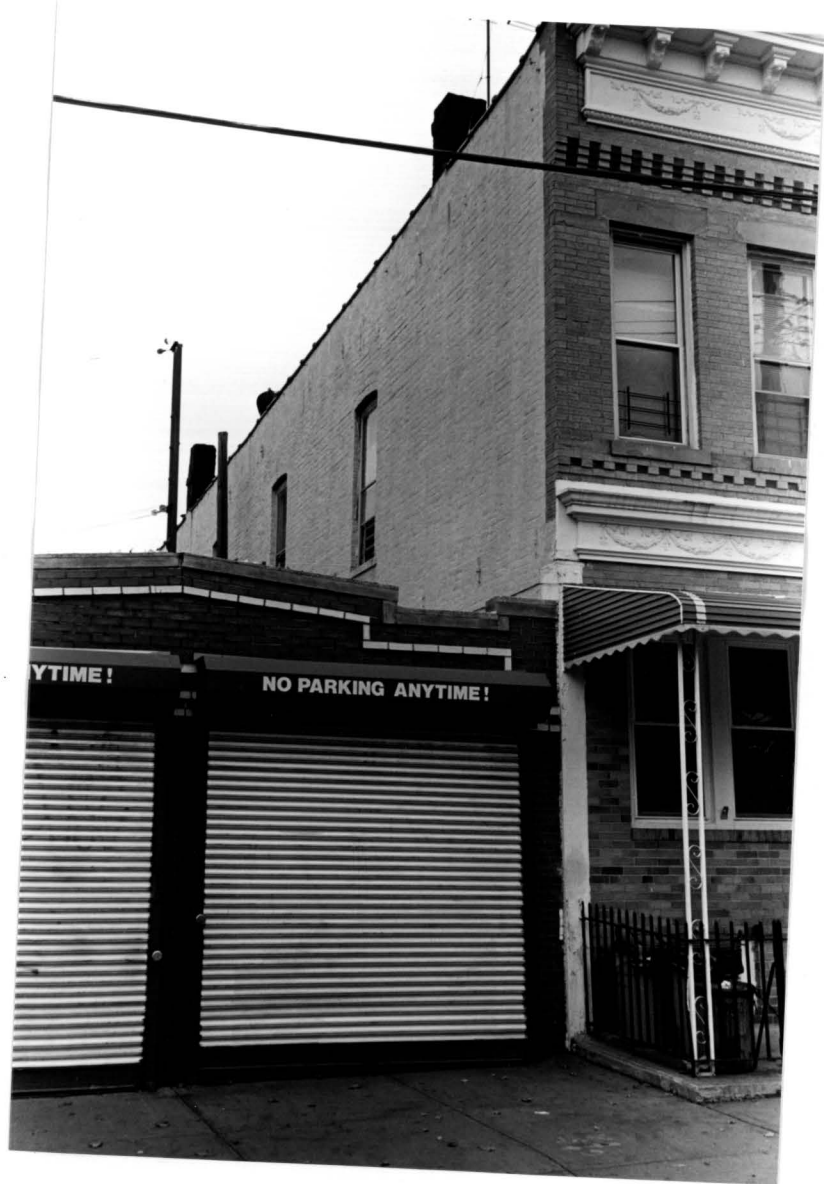
1861 Stockholm Street  
Photo: Carl Forster, 2000

**1861 Stockholm Street:** Three bays; altered stoop with non-historic wrought-iron railings; non-historic door under the stoop; non-historic wrought-iron fence at the areaway; entryway with non-historic door and pressed-metal hood featuring swags and foliated brackets; first-story window sealed with brick; brick panel below the graystone sill; limestone window lintel; original carriage entryway, topped by a bracketed and festooned hood, was enclosed with brick infill (c. 1938-1944) and contains non-historic sash at the basement and the first-story; non-historic metal awnings at the first story; upper stories feature graystone sills and lintels in continuous bands; the facade is crowned by corbeled dentilwork and a pressed metal roof cornice with swags and scrolled brackets. South elevation: Brick covered with cement stucco; non-historic sash; stucco-covered brick chimneys at the roofline.

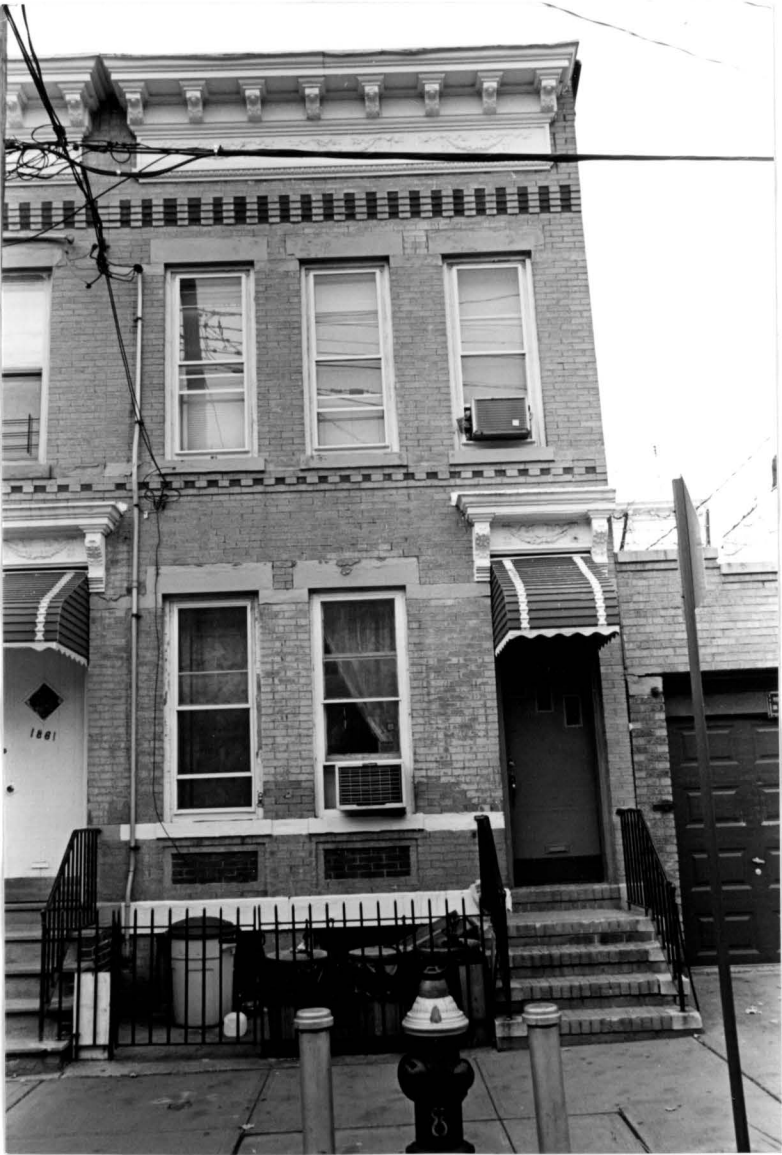
1863 Stockholm Street  
*Photo: Carl Forster, 2000*

**1863 Stockholm Street:** Three bays, non-historic brick stoop with non-historic wrought-iron railings; non-historic wrought-iron fence and bulkhead door at the areaway; entryway with non-historic door, non-historic metal awning, and pressed-metal hood featuring swags and foliate brackets; graystone water table, painted; brick panels beneath the first-story windows; historic wood sash at the first floor; window sills and lintels set in a continuous graystone band, painted; non-historic sash at the second floor; the facade is crowned by corbeled dentilwork and a pressed metal roof cornice with swags and scrolled brackets. North elevation: Brick covered with cement stucco, painted.

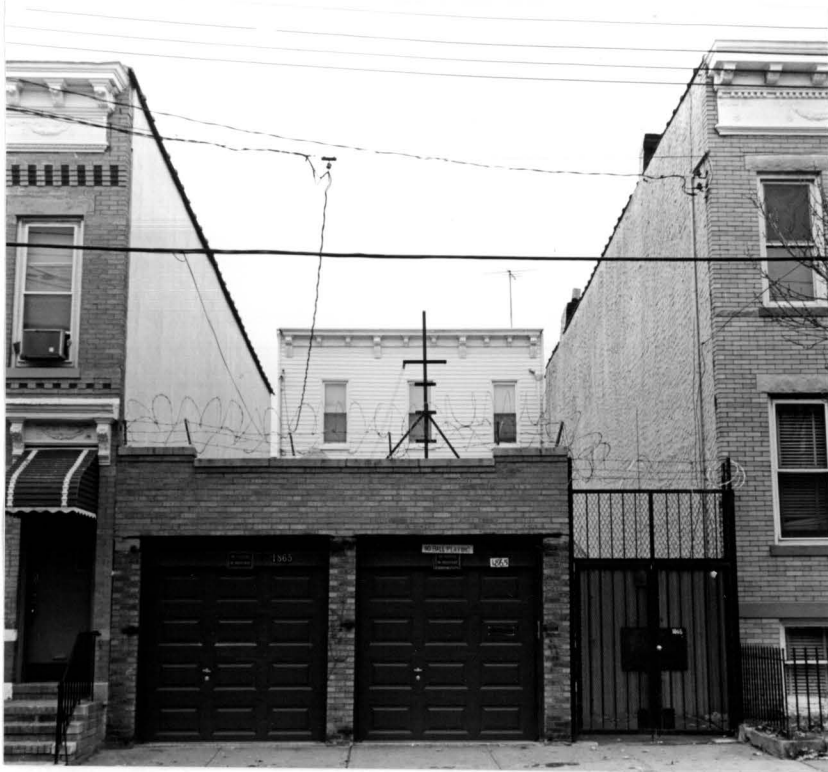
1865 Stockholm Street  
*Photo: Carl Forster, 2000*

House - Three bays, covered with synthetic siding; non-historic sash; bracketed wood cornice; one-story front extension (built c.1903-1938) covered with synthetic siding. Garage (built 1927-28): Brick columns and parapet with stone coping; non-historic doors; cement block north elevation. Site feature: Non-historic wrought-iron gate with mesh covering.

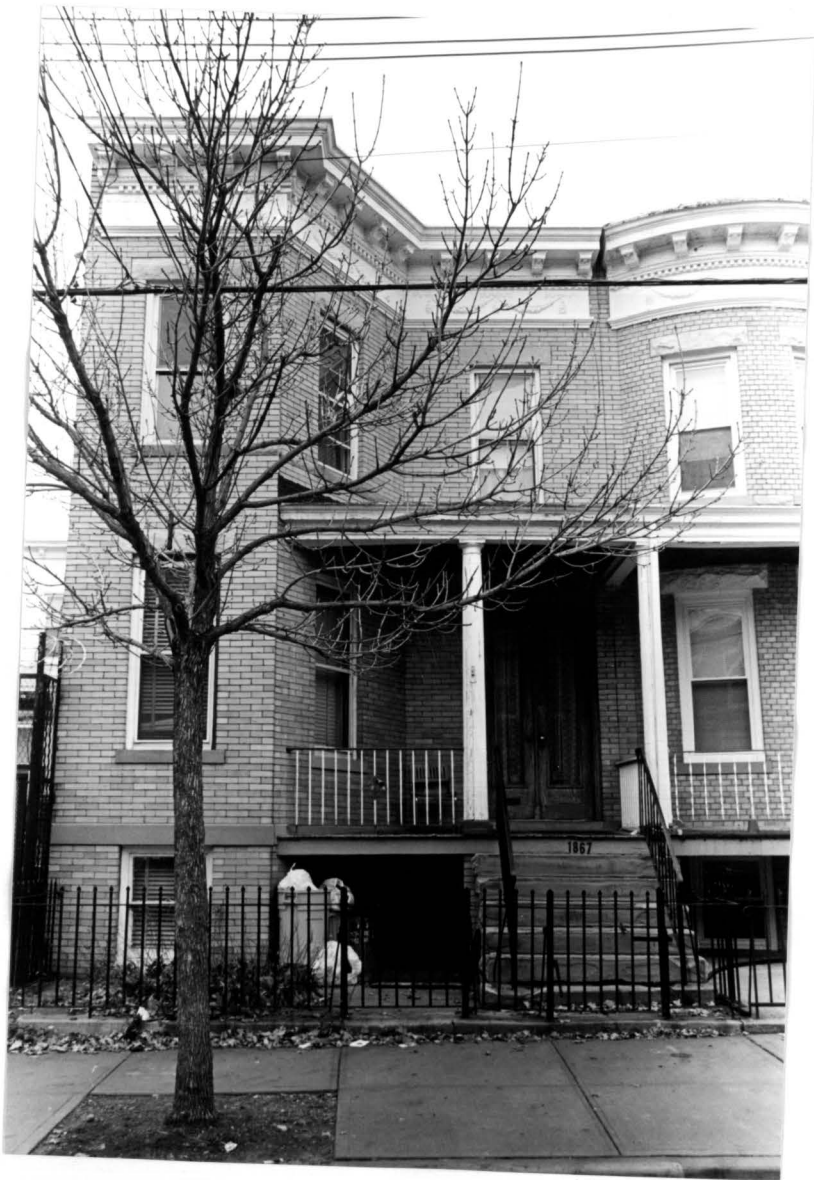
1867 Stockholm Street  
*Photo: Carl Forster, 2000*

**1867 Stockholm Street:** Three bays, angled; non-historic wrought-iron fence and gate; limestone water table, painted; graystone stoop with non-historic wrought-iron railings; non-historic door under the stoop; wood porch featuring Doric columns, non-historic wrought-iron railing, and molded cornice; historic double, wood and glass doors at the main entryway; rock-faced limestone lintels over windows; limestone window sills in a continuous rock-faced limestone band; historic wood sash at the basement and first story; non-historic sash at the second story; pressed metal cornice featuring swags, dentils, and scrolled brackets. South elevation: Brick covered with cement stucco.

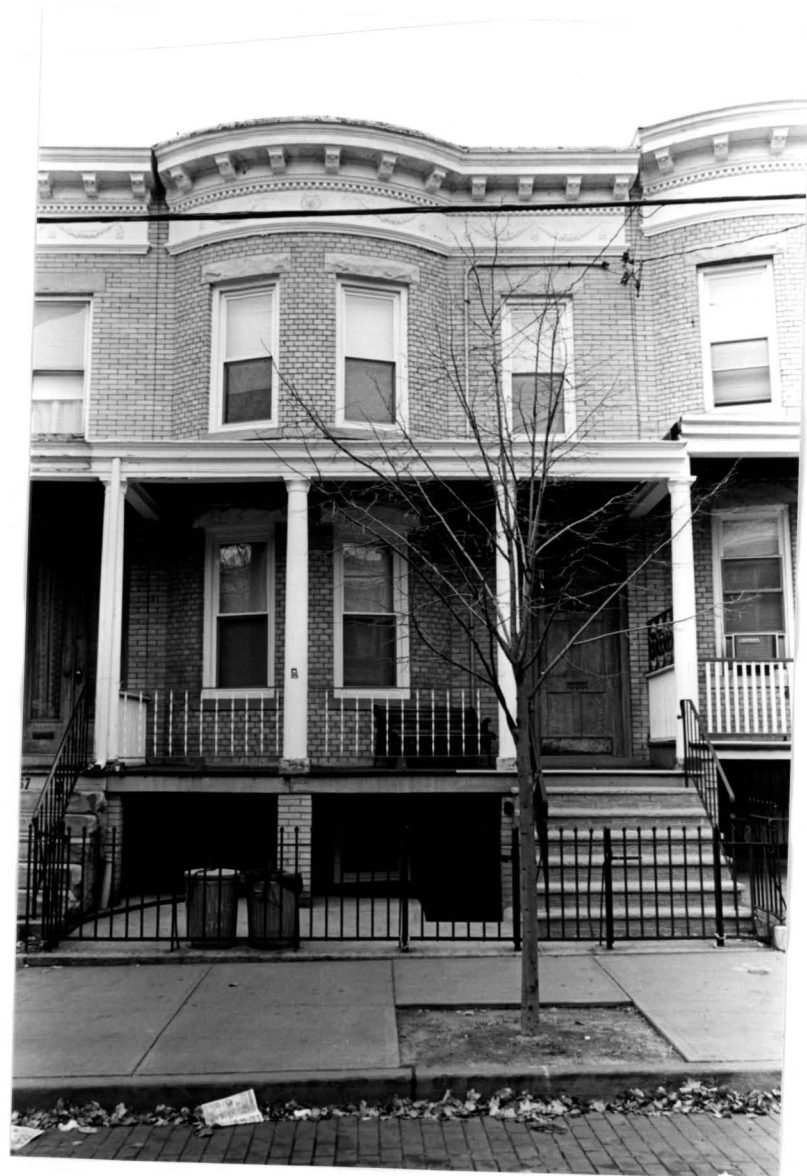
1869 Stockholm Street  
*Photo: Carl Forster, 2000*

**1869 Stockholm Street:** Three bays, curved; non-historic wrought-iron fence and gate; non-historic brick stoop with non-historic wrought-iron railings; non-historic doors under the stoop and at the main entryway; full-width wood porch featuring Doric columns, non-historic wrought-iron railings, and molded cornice; rock-faced limestone lintels over the windows; limestone window sills in a continuous rock-faced limestone band; non-historic sash; pressed metal cornice featuring swags, dentils, and scrolled brackets.

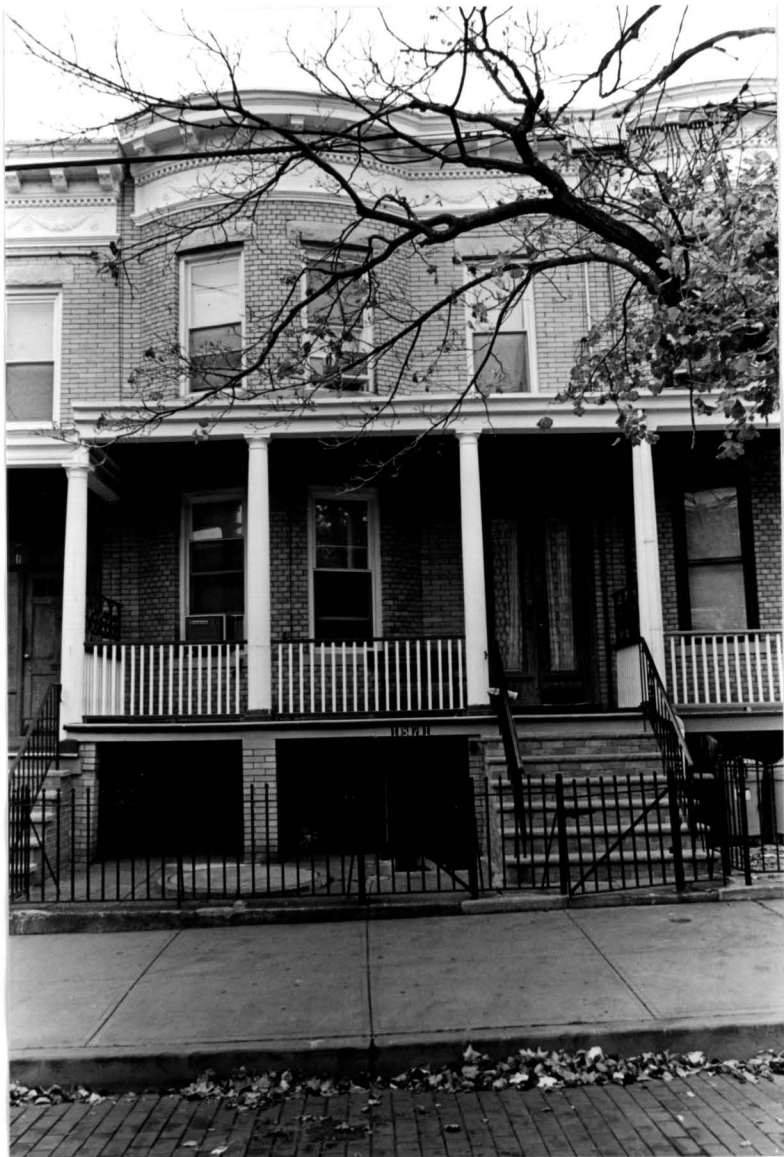
1871 Stockholm Street  
*Photo: Carl Forster, 2000*

**1871 Stockholm Street:** Three bays, curved; non-historic wrought-iron fence and gate; non-historic brick stoop with non-historic wrought-iron railings; non-historic door under the stoop; non-historic wrought-iron security grilles at the basement windows; full-width wood porch featuring Doric columns, square spindles, and molded cornice; historic double, wood doors at the main entryway; rock-faced limestone lintels over entryway and windows; limestone window sills in a continuous rock-faced limestone band; non-historic sash; pressed metal cornice featuring swags, dentils, and scrolled brackets.

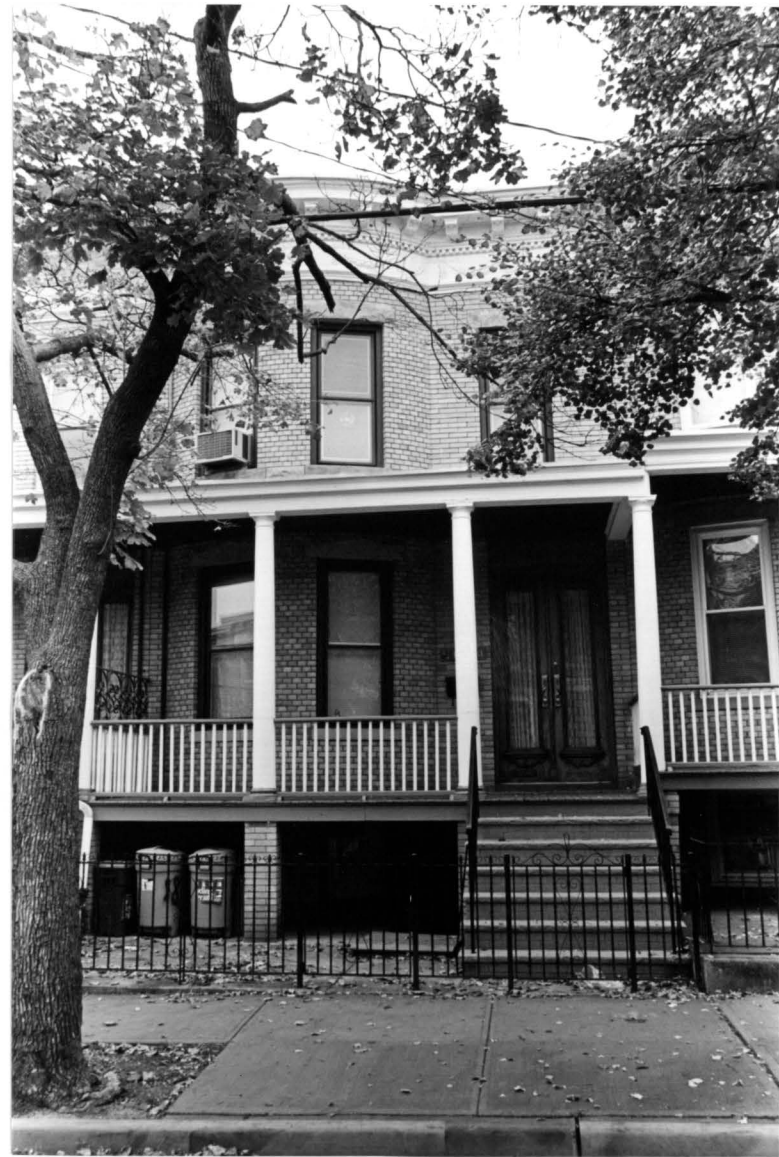
1873 Stockholm Street  
*Photo: Carl Forster, 2000*

**1873 Stockholm Street:** Three bays, curved; non-historic wrought-iron fence and gate; non-

historic brick stoop with non-historic wrought-iron railings; historic wood door under the stoop; full-width wood porch featuring Doric columns, square spindles, and molded cornice; historic double, wood and glass doors at the main entryway; non-historic mailbox affixed to the facade next to the main entryway; rock-faced limestone lintels over the windows; limestone window sills in a continuous rock-faced limestone band; non-historic sash; pressed metal cornice featuring swags, dentils, and scrolled brackets.

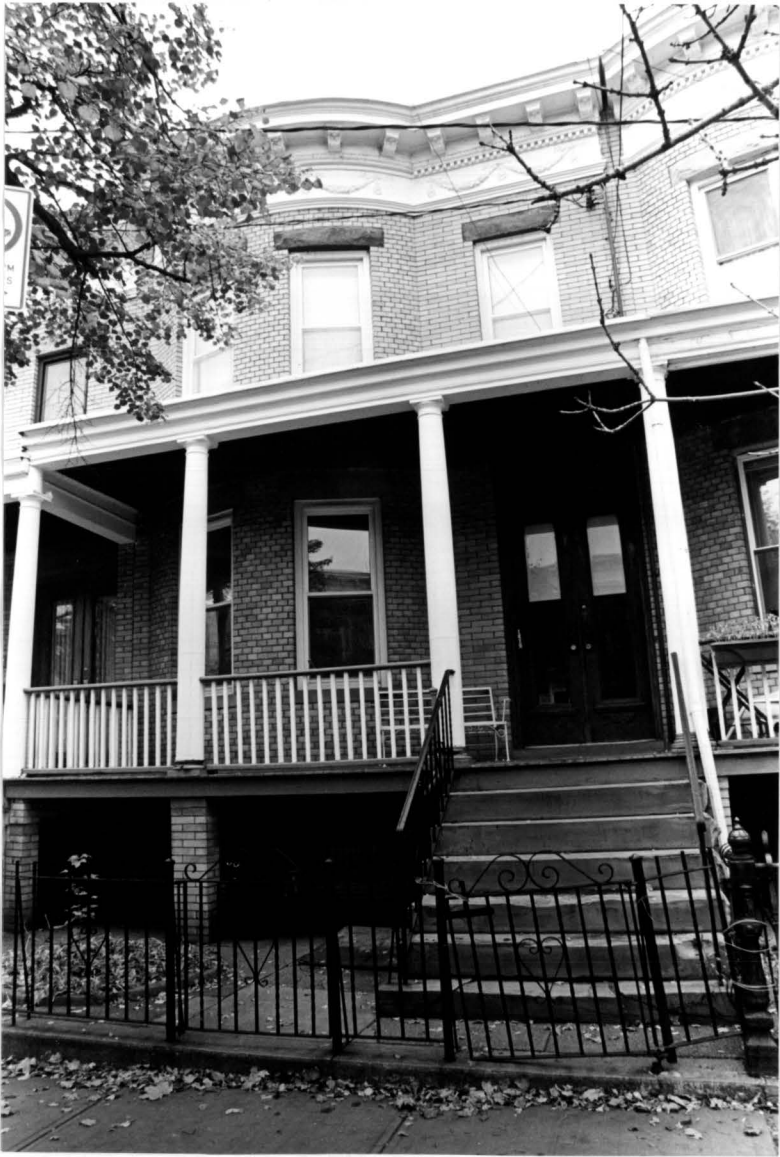
**1875 Stockholm Street**  
*Photo: Carl Forster, 2000*

**1875 Stockholm Street:** Three bays, curved; non-historic wrought-iron gate and fence; historic graystone stoop with non-historic wrought-iron railings; historic wood door under the stoop; full-width wood porch featuring Doric columns, square spindles, and molded cornice; historic double, wood and glass doors at the main entryway; rock-faced limestone lintels, painted, over the windows; limestone window sills in a continuous rock-faced limestone band; non-historic sash; pressed metal cornice featuring swags, dentils, and scrolled brackets.

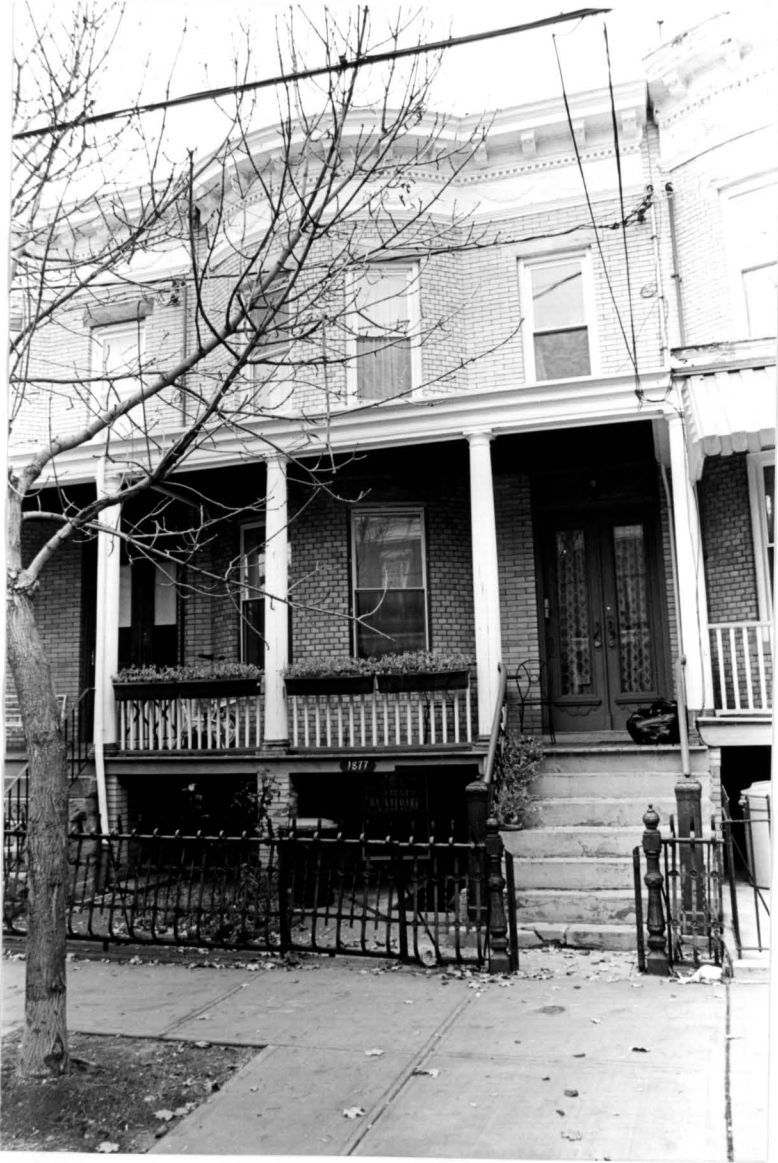
**1877 Stockholm Street**  
*Photo: Carl Forster, 2000*

**1877 Stockholm Street:** Three bays, curved; historic wrought- and cast-iron fence and gate; historic graystone stoop with historic wrought-iron railings and cast-iron newel posts; non-historic door under the stoop; full-width wood porch featuring Doric columns, square spindles, and molded cornice; historic double, wood and glass doors at the main entryway; non-historic light fixture; rock-faced limestone lintels over the windows; limestone window sills in a continuous rock-faced limestone band; non-historic sash; pressed metal cornice featuring swags, dentils, and scrolled brackets.

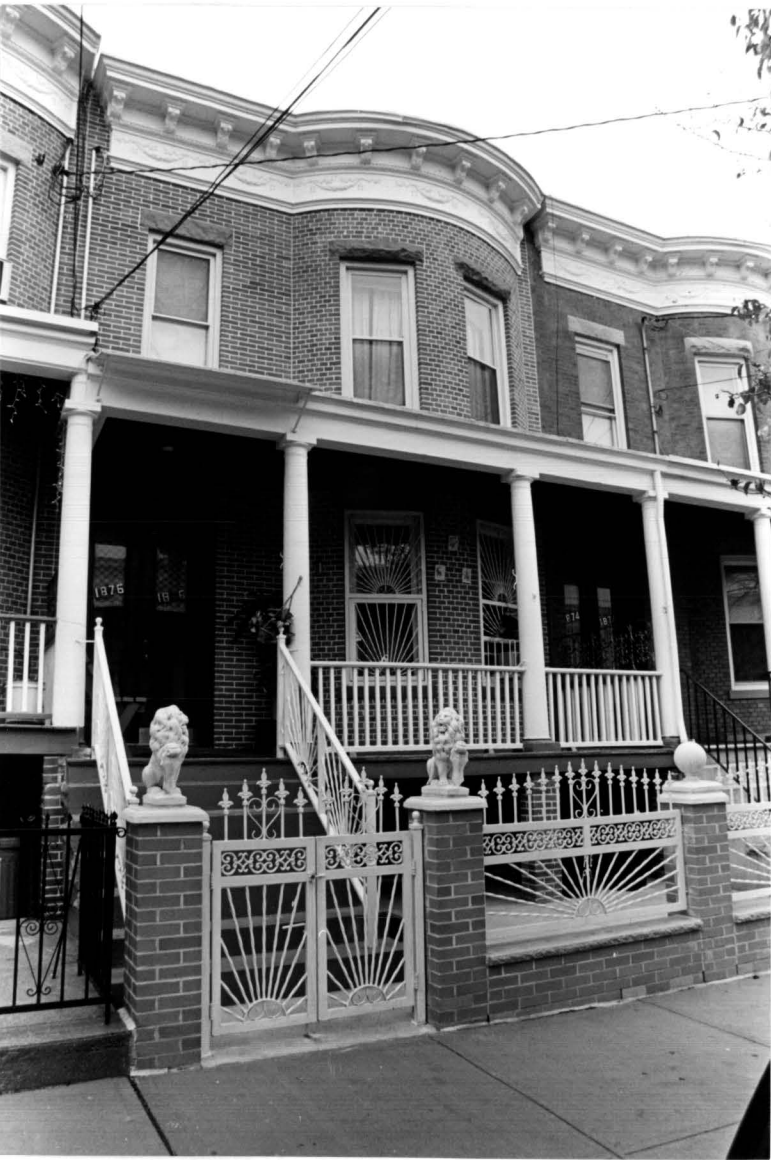
**1876 Stockholm Street**  
*Photo: Carl Forster, 2000*

**1876 Stockholm Street:** Three bays, curved; original iron fence and gate removed and replaced with brick non-historic posts with statuary and wrought-iron fence and gate; facade repointed; historic stone stoop, resurfaced and painted, with non-historic wrought-iron railings; full-width wood porch featuring Doric columns, square spindles and molded cornice; non-historic door under the stoop; historic double wood and glass doors at the main entryway; rock-faced limestone lintels over windows; non-historic wrought-iron security grilles at the basement and first-story windows; limestone window sills in a continuous rock-faced limestone band; non-historic sash; pressed metal cornice featuring swags, egg-and-dart molding, and scrolled brackets.

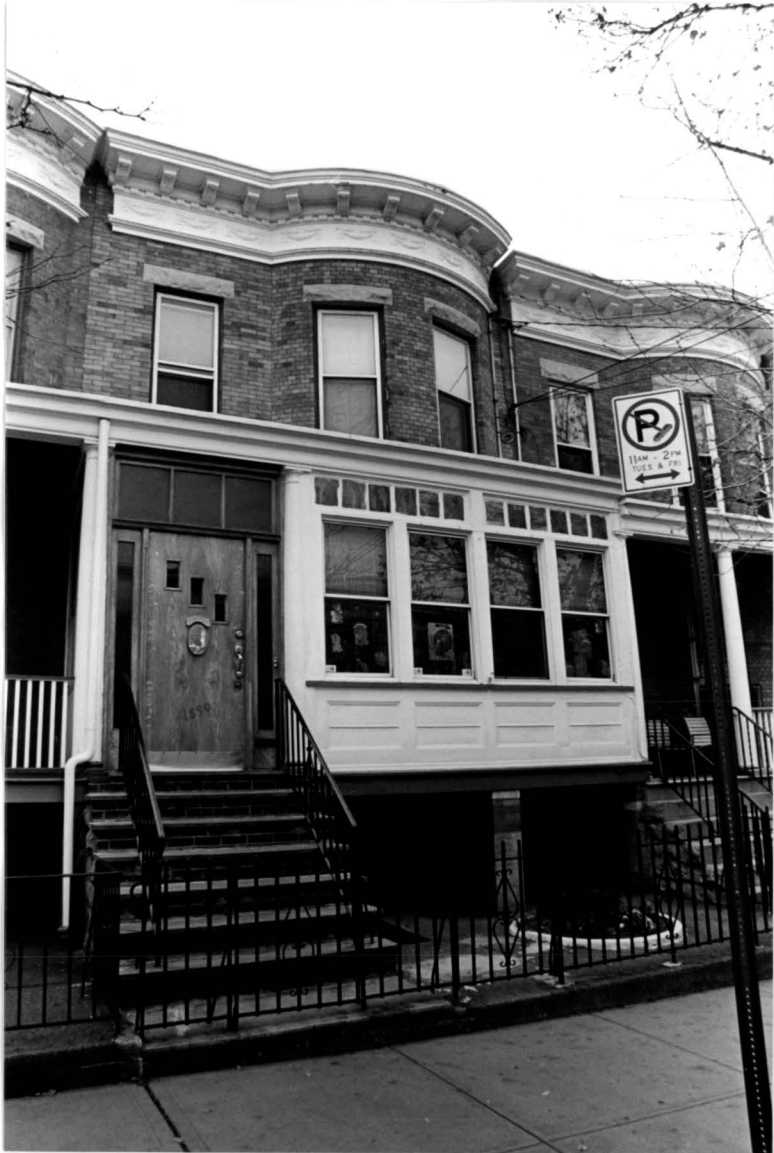
**1890 Stockholm Street**  
*Photo: Carl Forster, 2000*

**1890 Stockholm Street:** Three bays, curved; non-historic wrought-iron fence and gate; original graystone stoop altered with brick steps and non-historic wrought-iron railings; enclosed first-story porch featuring paneled base, non-historic sash, multi-light stained-glass transoms, and molded cornice; historic door under the stoop; non-historic sash and wrought-iron security grilles at the basement windows; non-historic door at the main entryway; rock-faced limestone lintels over the windows; limestone window sills in a continuous rock-faced limestone band; historic wood sash at the second story; pressed metal cornice featuring swags, dentils, and scrolled brackets.

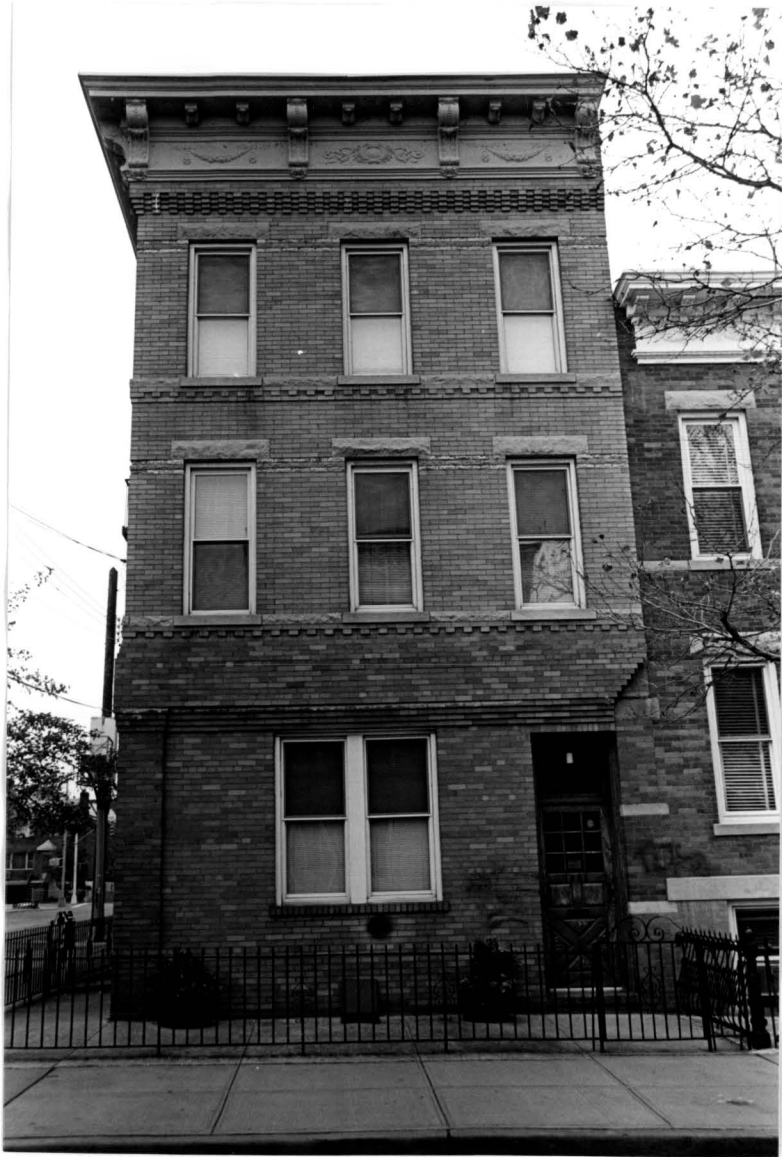
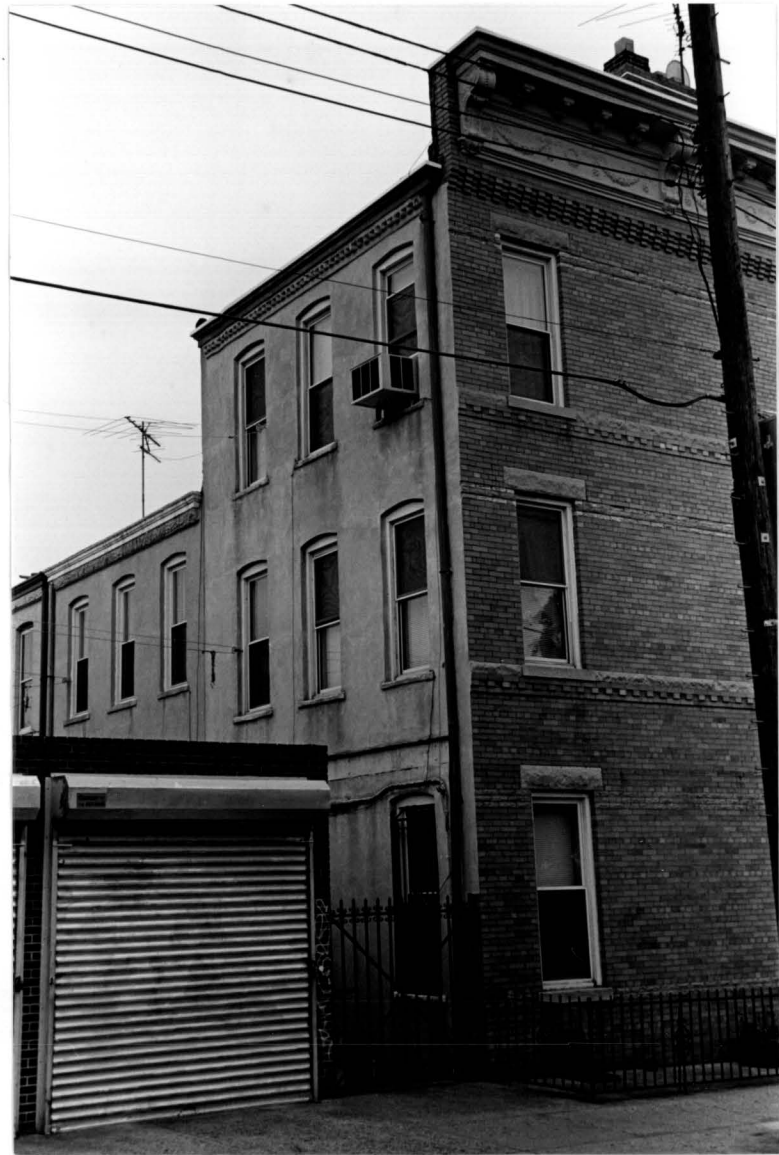
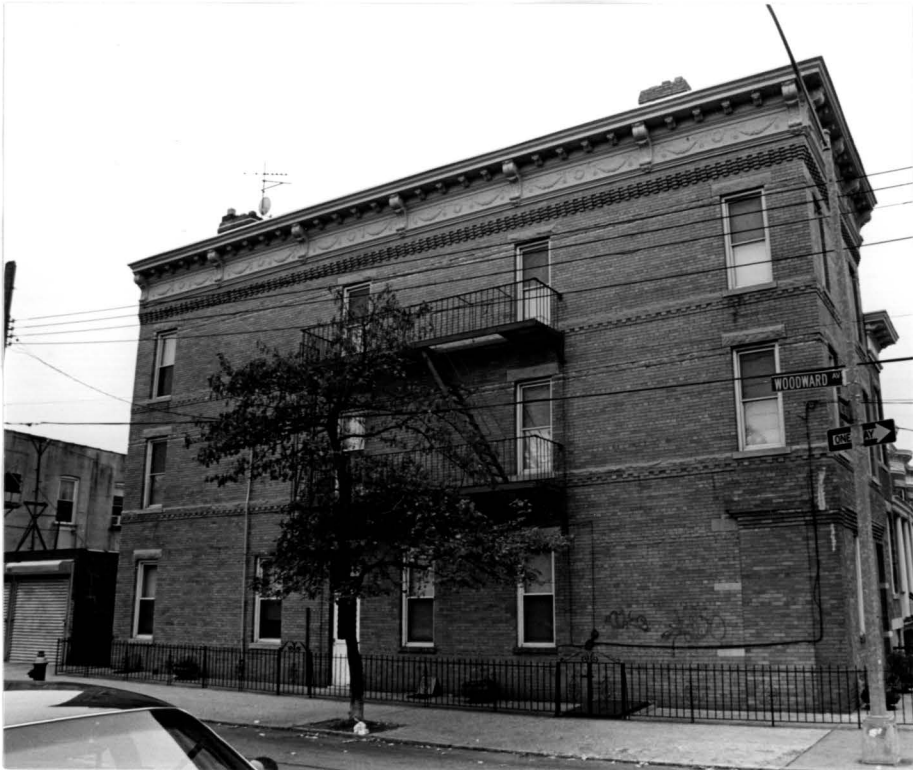
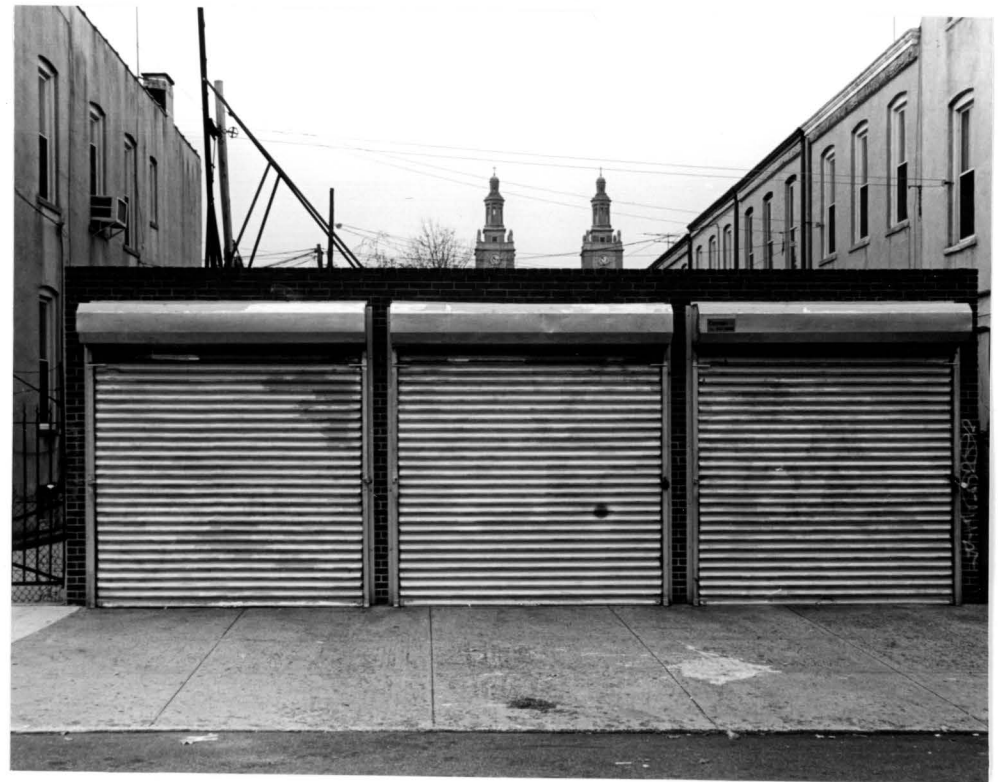
1896 Stockholm Street (Stockholm Street Facade)  
*Photo: Carl Forster, 2000*

**1896 Stockholm Street (aka 376-384 Woodward Avenue):** Stockholm Street facade - two bays at the first story, three bays above; original first-floor storefront removed and replaced with brick infill and non-historic paired sash; non-historic door at the main entryway; upper floors feature limestone sills in a continuous rock-faced band, rock-faced stone lintels, rock-faced stretcher brick bands, dentil courses, and corbel course above the third story; non-historic sash; pressed metal cornice with swags and scrolled brackets. Woodward Avenue facade - five bays at the first story, four bays above; original first-floor storefront removed and replaced with brick infill (in 1946); secondary entryway with historic door and transom; brick window sills; limestone window sills; rock-faced limestone lintels; rock faced brick band; upper stories feature limestone sills in a continuous rock-faced band, rock-faced stone lintels, rock-faced stretcher brick bands, dentil courses, and corbel course above the third story; non-historic sash; pressed metal cornice with swags and scrolled brackets; non-historic wrought-iron fire escape; brick chimneys visible on roof. East Elevation - two bays at the first story, three bays above; brick covered with cement stucco; non-historic sash; cornice with dentils. Garage (built 1925) - brick and cement block; non-historic doors. Site features - non-historic fence and gates at the areaway facing both streets and at the rear yard facing Woodward Avenue.
