May 2009

Prepared for:
MTA/NYC Transit

**Archaeological Monitoring for the
37th Street and Park Avenue
Ventilation Facility,
East Side Access Project**

URS

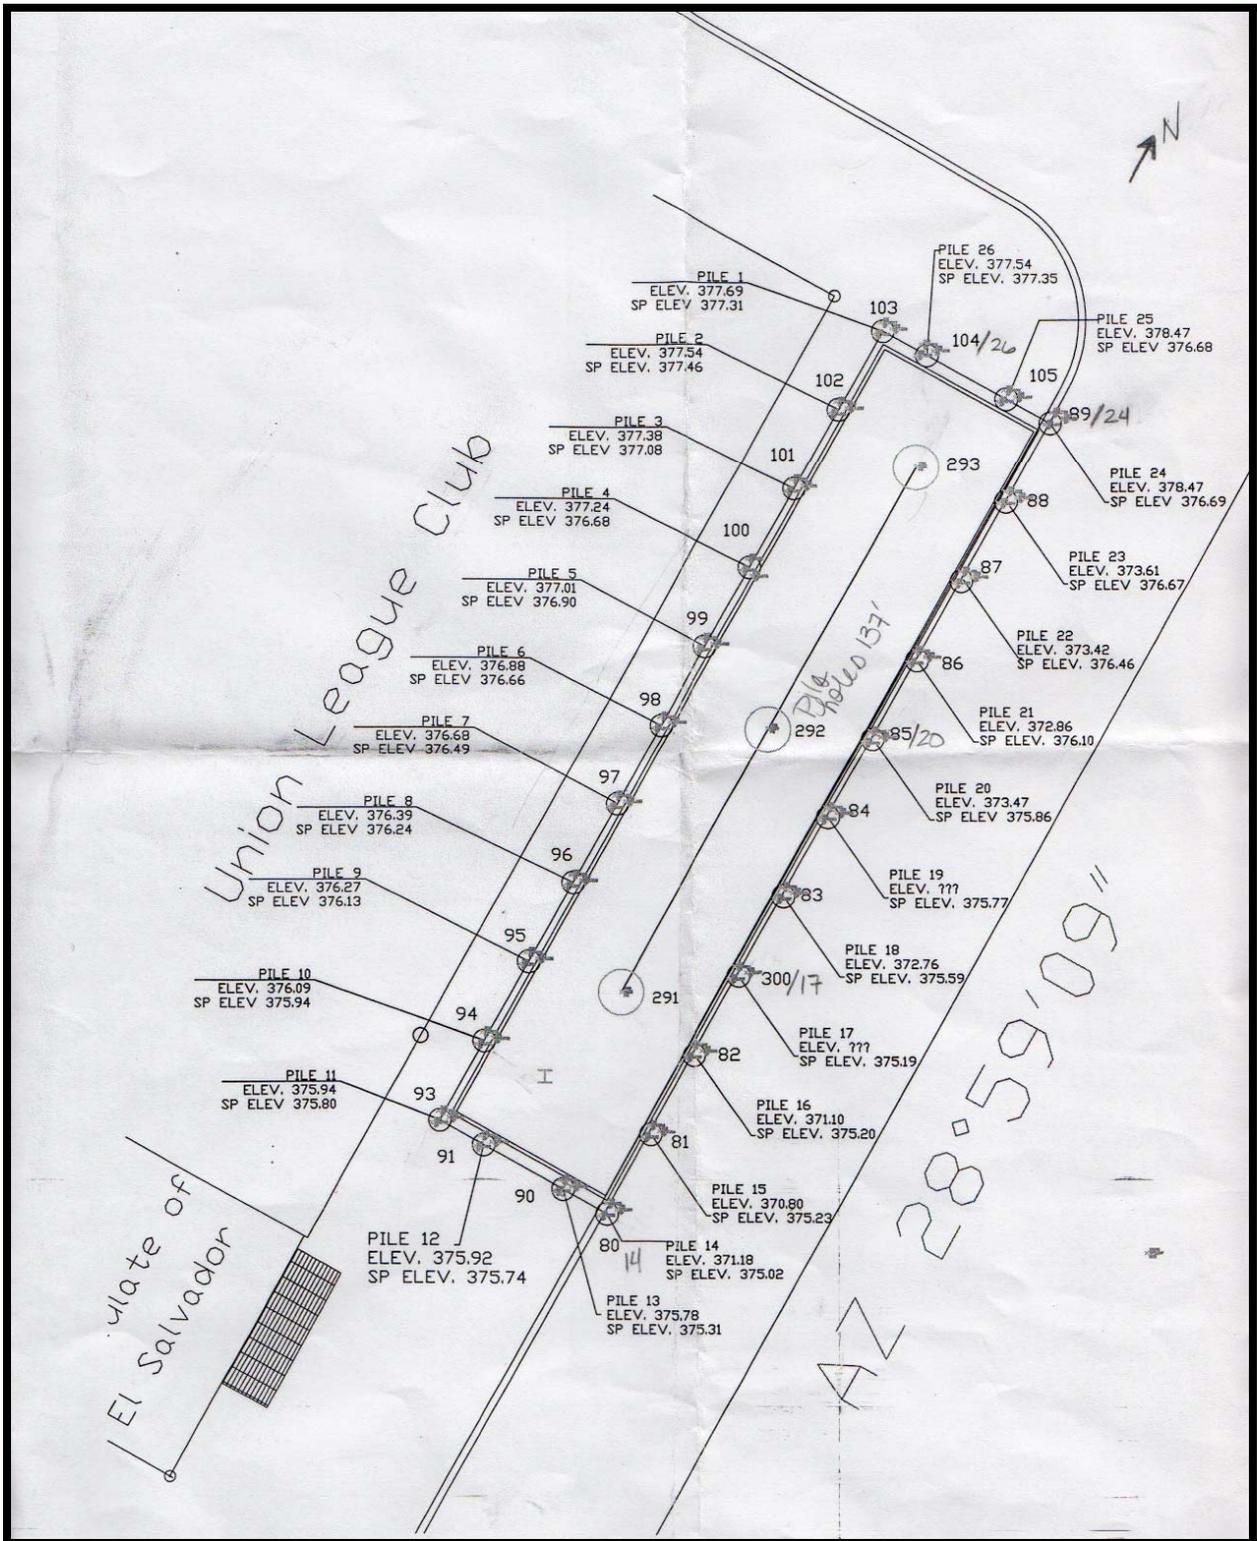
Figure 3.1 Plan map showing pile locations.

Prior to excavation, 26 piles at 8-foot intervals (Figure 3.1) were drilled to an average depth of 130 feet to allow for the installation of deck plating in order to facilitate excavation in excess of 6 feet below modern grade. This drilling indicated the shallow depth of the bedrock in this area, ranging from 6.5 to 15.5 feet below surface.

Excavation occurred in two phases: the first phase consisted of the section from the corner of 37th Street and Park Avenue to the approximate mid-point of the excavation, between Piles 1 through 6. Following the installation of deck plating, the remainder of the project area was excavated.

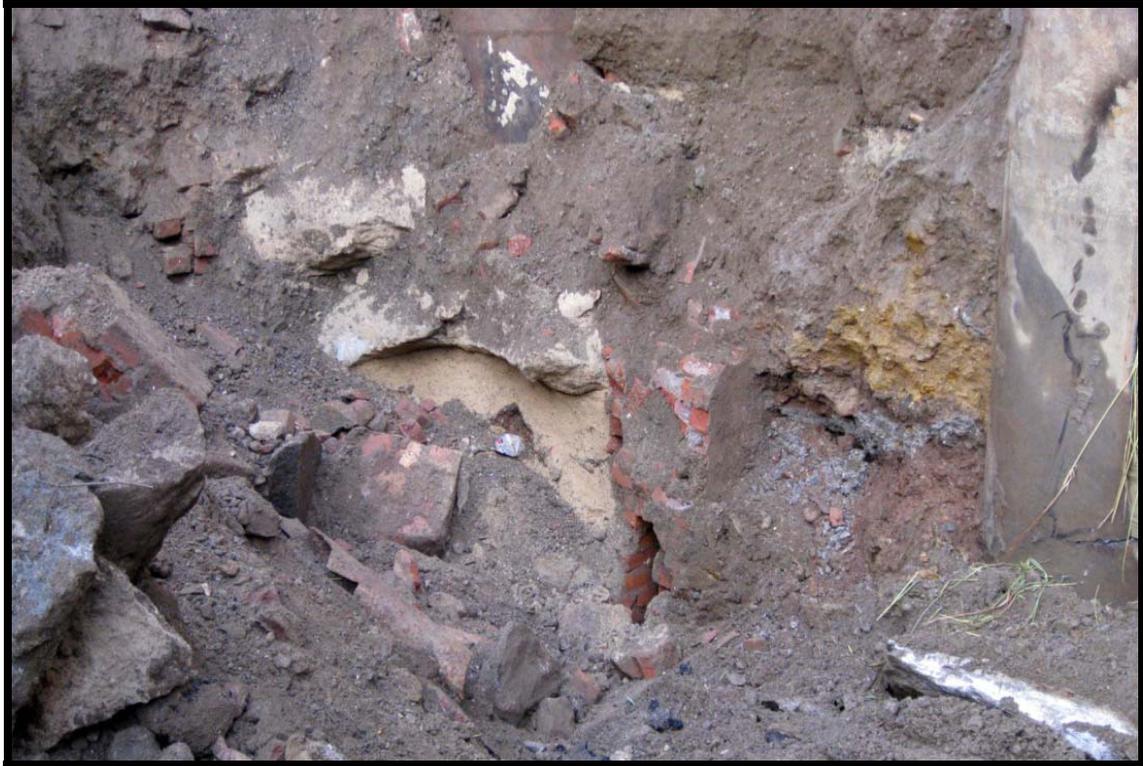
The area between Piles 4 through 6 contained the remnants of a brick vault (Photograph 3.1). The vault had been impacted by previous excavation work, as its walls were already disturbed. Large portions of disassociated brick wall were observed in the area. The areas surrounding the vault consisted of several different soil types, including clean sand and large pieces of mortar and cement.

Photograph 3.1 Initial exposure of brick vault, view looking northwest.

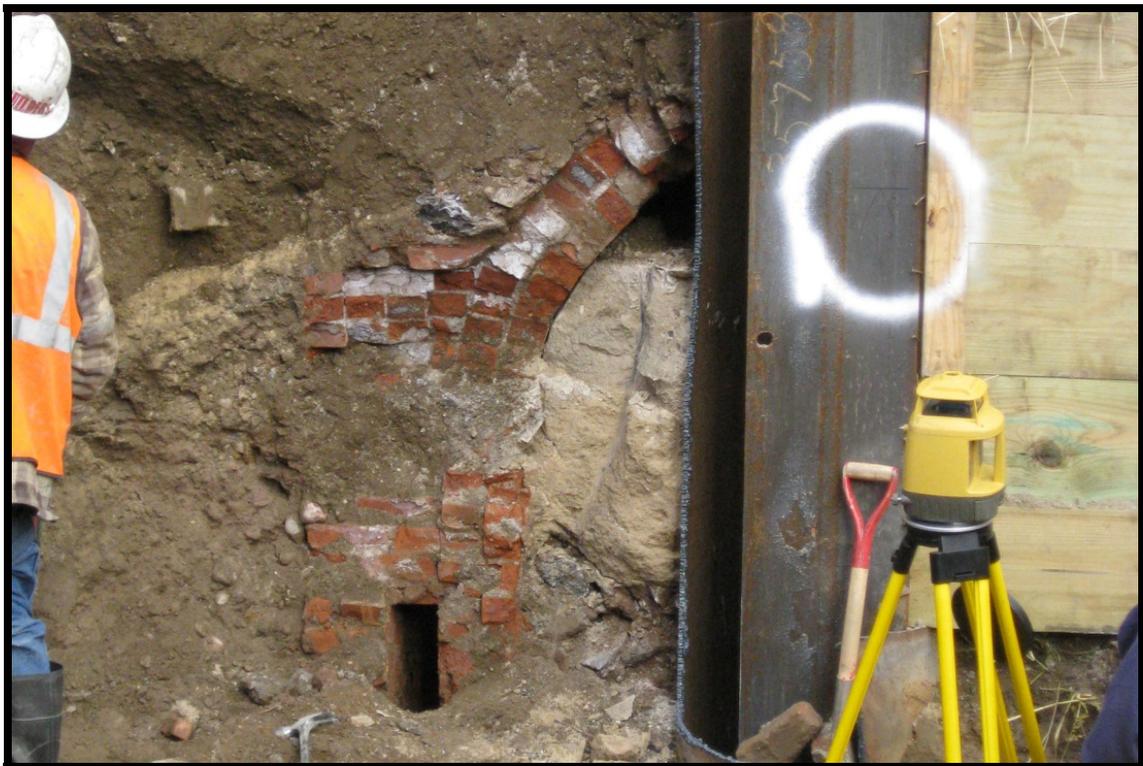
The form of the vault exposed in the profile showed it to be constructed of nineteenth-century brick; its ceiling, located 3.5 feet below surface, was two courses thick and the sidewall four courses thick (Photograph 3.2).

Photograph 3.2 Profile of Vault 1, view looking west.

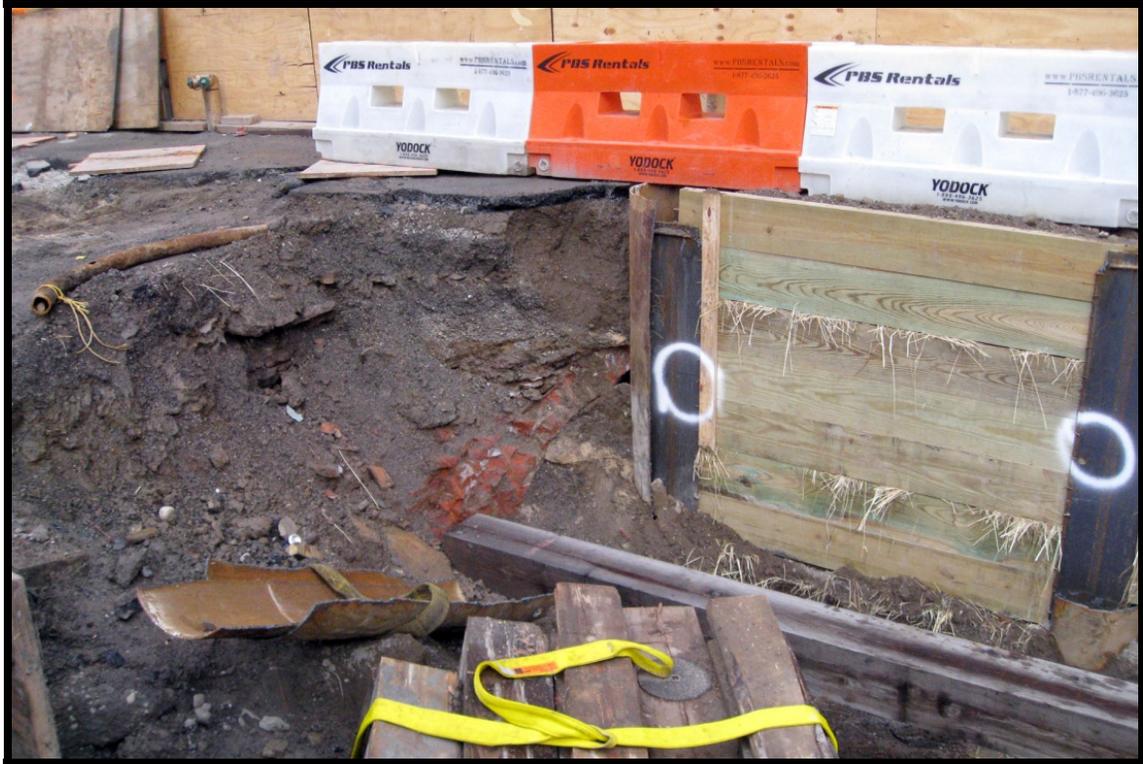
A total of two brick vaults were uncovered in this area. The second vault was in a similar state of deconstruction. Both structures were identical in shape, size, and construction material. As with the first vault, the second vault was completely disturbed.

One of the vaults was opened and it was possible to view the interior. Inside the vault were various amounts of debris, consisting of sand, ash, and blocks of cement or mortar. This fill was most likely placed there when the vaults were originally abandoned (Photographs 3.3 and 3.4).

Photograph 3.3 Profile of Vault 2, view looking southwest.

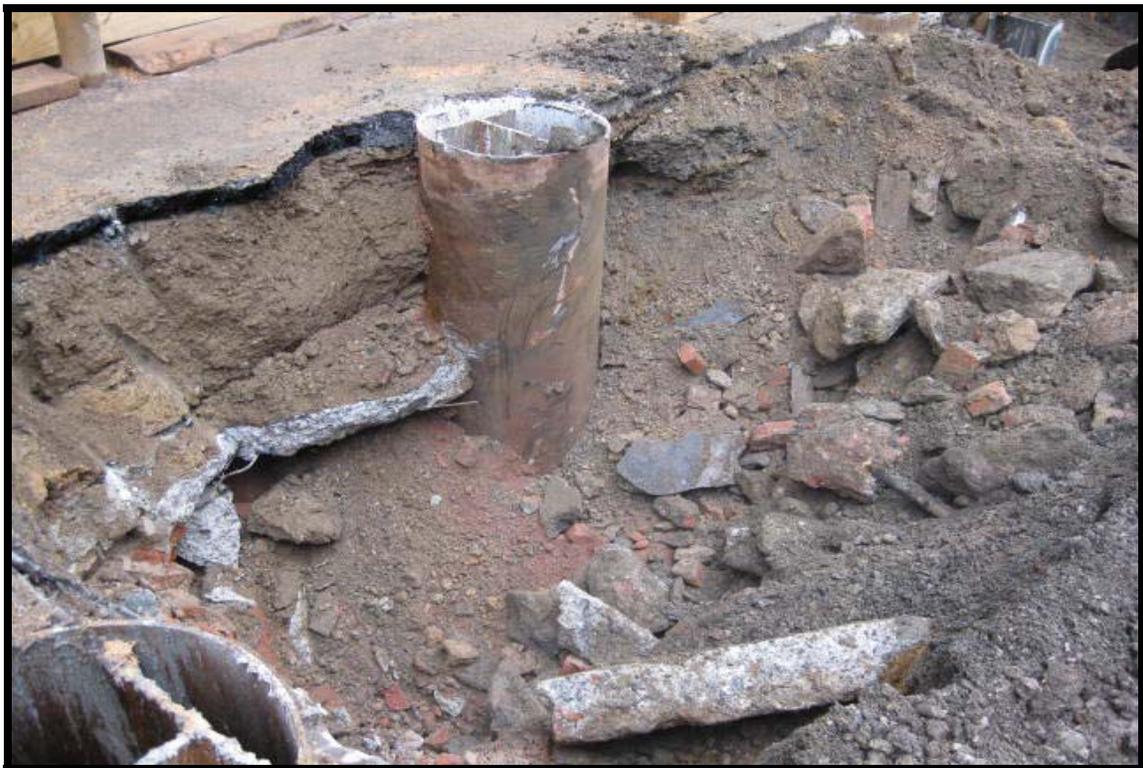
Photograph 3.4 Rubble fill within and adjacent to the two brick vaults.

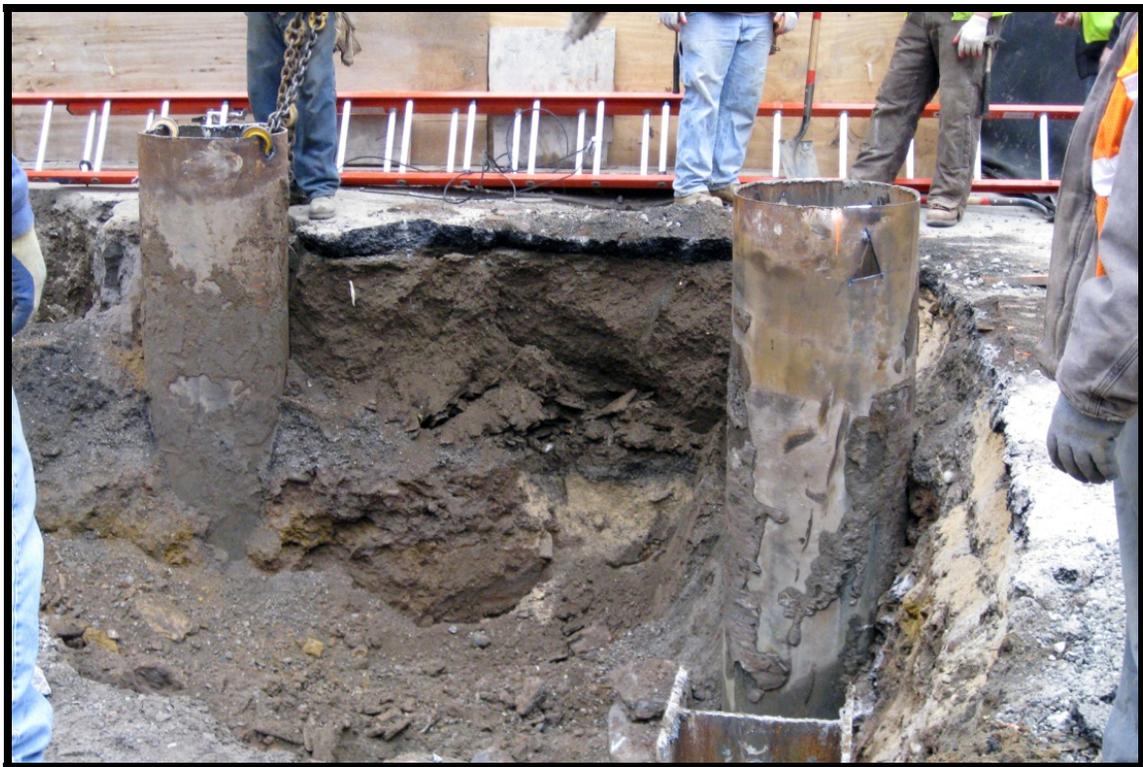
Pavement – concrete	0 – 4”
Gravel underlayment	4” – 10”
Sandy loam	10” - 28”
Sandy loam w/rubble and or large pockets of ash or sand	28” – 48”
Sandy loam	48” – 60”
Bedrock	60”+

Despite the extensive disturbance to the area, a general profile consisting of six layers was discernible (Photograph 3.5).

Photograph 3.5 Typical stratigraphic profile of excavation, view looking west.

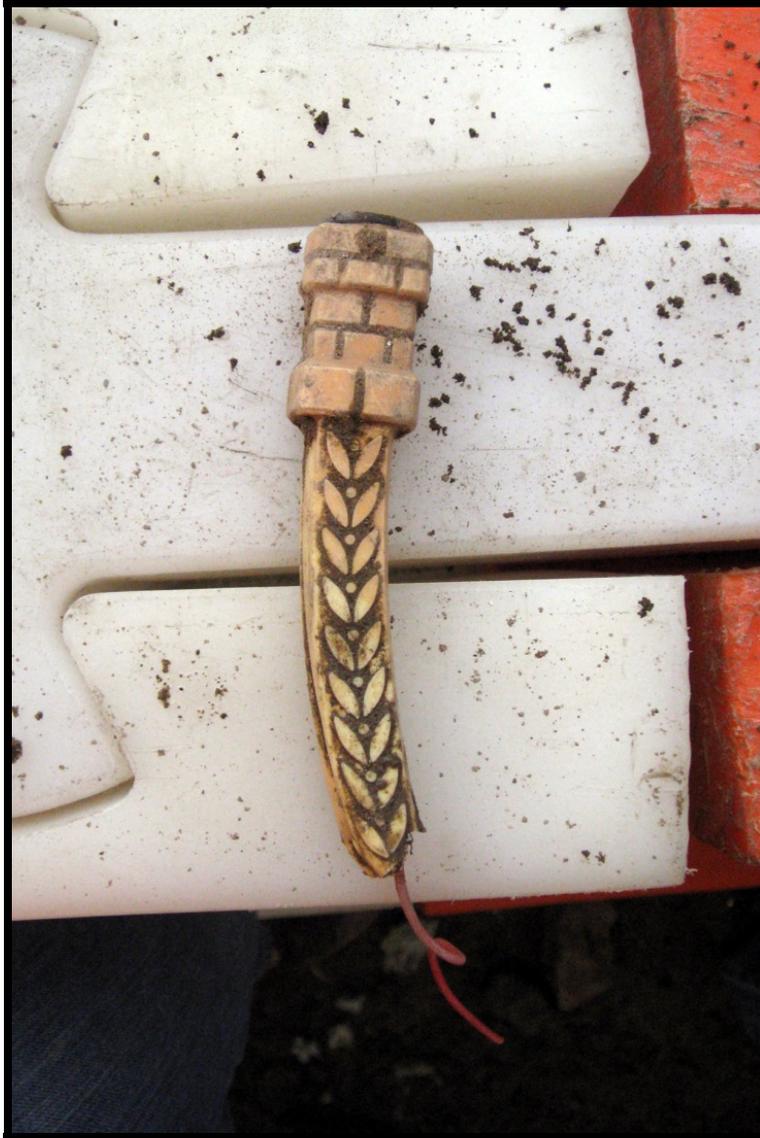
Throughout the area, there was evidence of modern deposits, including plastic beverage bottles. Only two artifacts contemporaneous to the vaults were observed: a late-nineteenth-century bottle and an ornate Bakelite electric lighting fixture (Photograph 3.6).

Photograph 3.6 Bakelite electric light fixture.
