HISTORICAL PERSPECTIVES INC.

**Memorandum: Phase IA Cultural Resources Sensitivity Evaluation Addendum and Phase IB Archaeological Investigation of BMP LC-16 and LC-17
New York City Department of Environmental Protection
South Richmond Drainage Storm Water and Sanitary Drainage Plan
Lemon Creek Drainage Area, Staten Island, New York
Knox Street, BMP LC-16, BMP LC-17, BMP LC-18, and BMP LC-19**

PHASE IA CULTURAL RESOURCES SENSITIVITY EVALUATION ADDENDUM

PHASE IB ARCHAEOLOGICAL INVESTIGATION

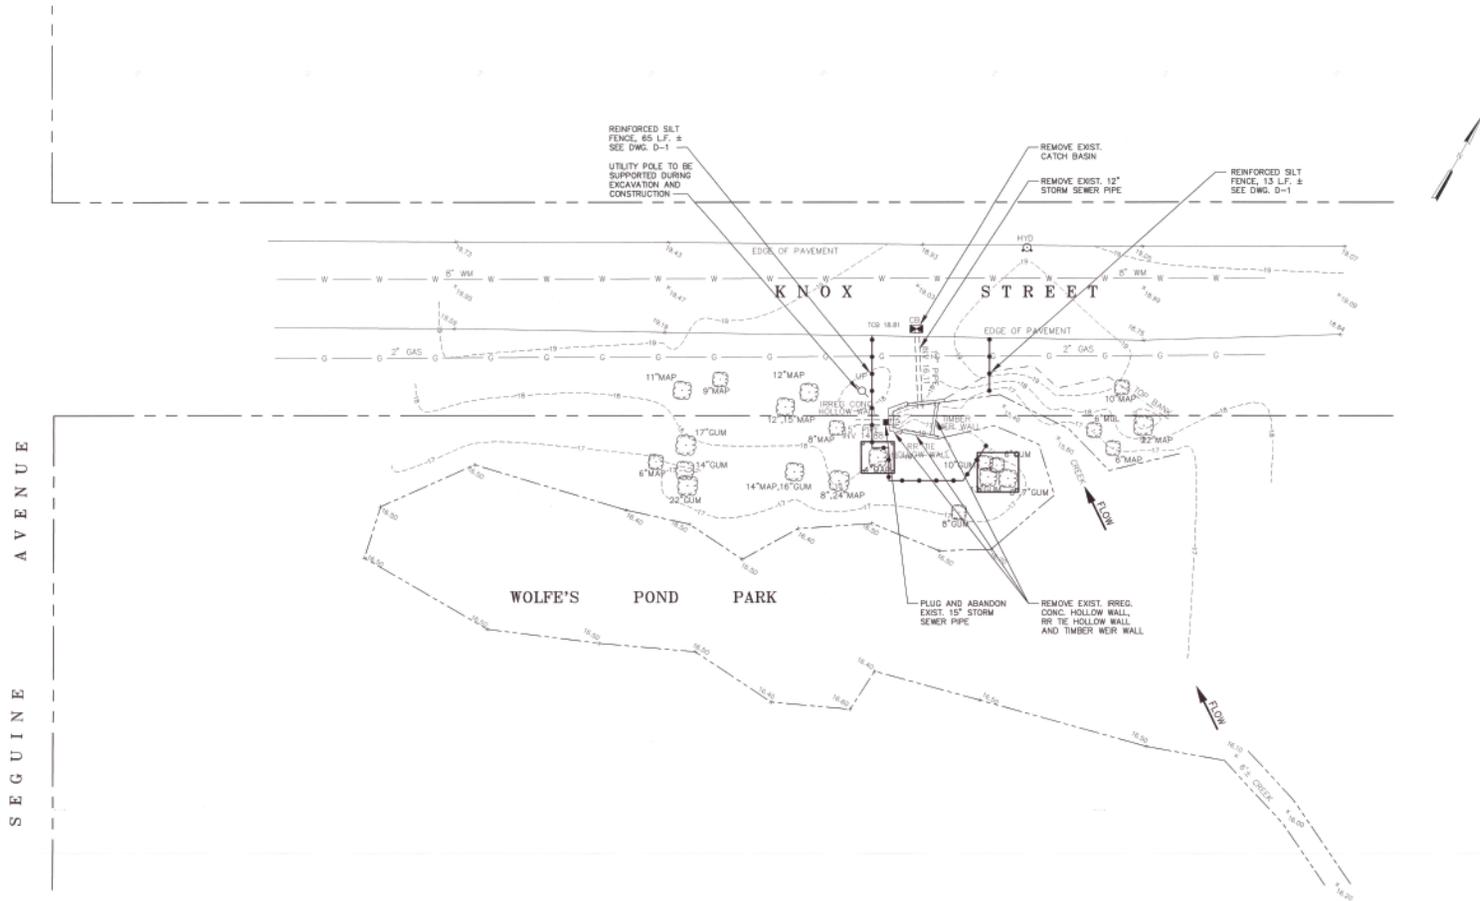
Figure 2: Knox Street APE

The APE for Knox Street is located on the south side of the street, approximate 200 feet northeast of Seguine Avenue, at the site where a small creek, which empties into Wolfe's Pond to the east, meets the road. It includes an existing 15-inch storm sewer drain, associated concrete walls and a timber weir wall, and a catch basin. The APE boundary is the area that will be enclosed by silt fencing, as shown on Figure 2.

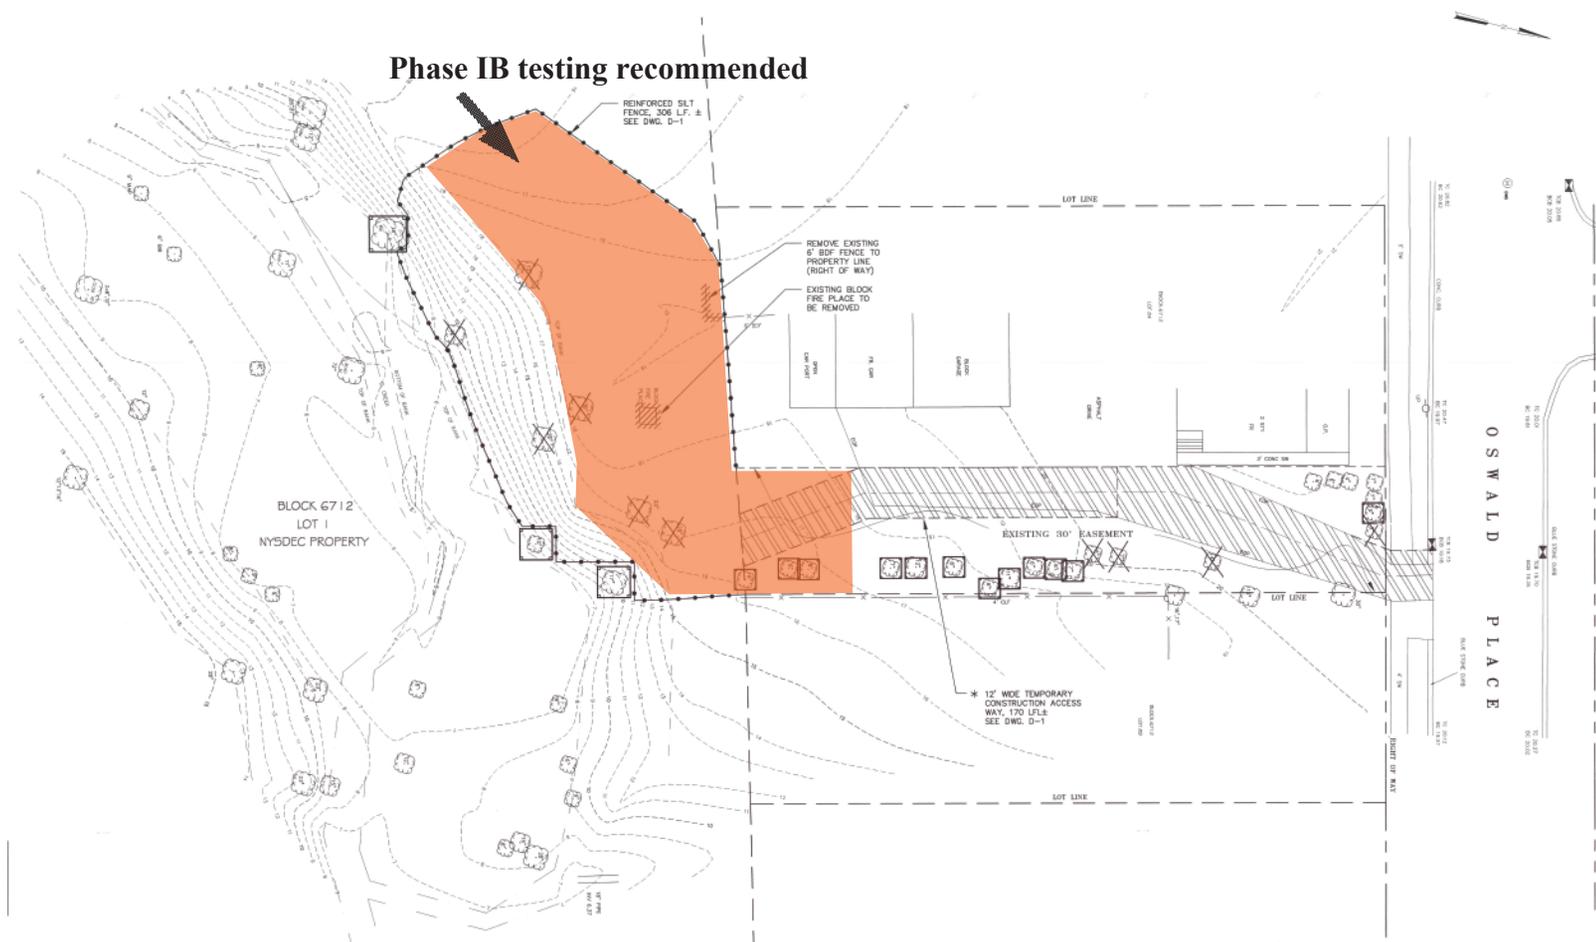
Figure 3: BMP LC-16 APE

The APE for BMP LC-16 is located on the south side of Oswald Place, opposite Elizabeth Place. A 12-foot wide temporary construction easement is located on the east side of the Block 6712, Lot 84 property. The remainder of the APE is on NYSDEC property to the south of this property, and includes a small terrace and sloped area overlooking a branch of Lemon Creek, as shown on Figure 3.

There are two areas, at BMP LC-16 and BMP LC-17, where there are level terraces overlooking the creek, and which appear to be relatively undisturbed. These two areas, shown on Figures 3 and 4, have a high precontact sensitivity.

Based on the above conclusions, HPI recommends a limited program of Phase IB archaeological testing on the terrace areas of BMP LC-16 and BMP LC-17, as shown on Figures 3 and 4. No further archaeological investigations are recommended for the Knox Street, BMP LC-18, or BMP LC-19 APEs.

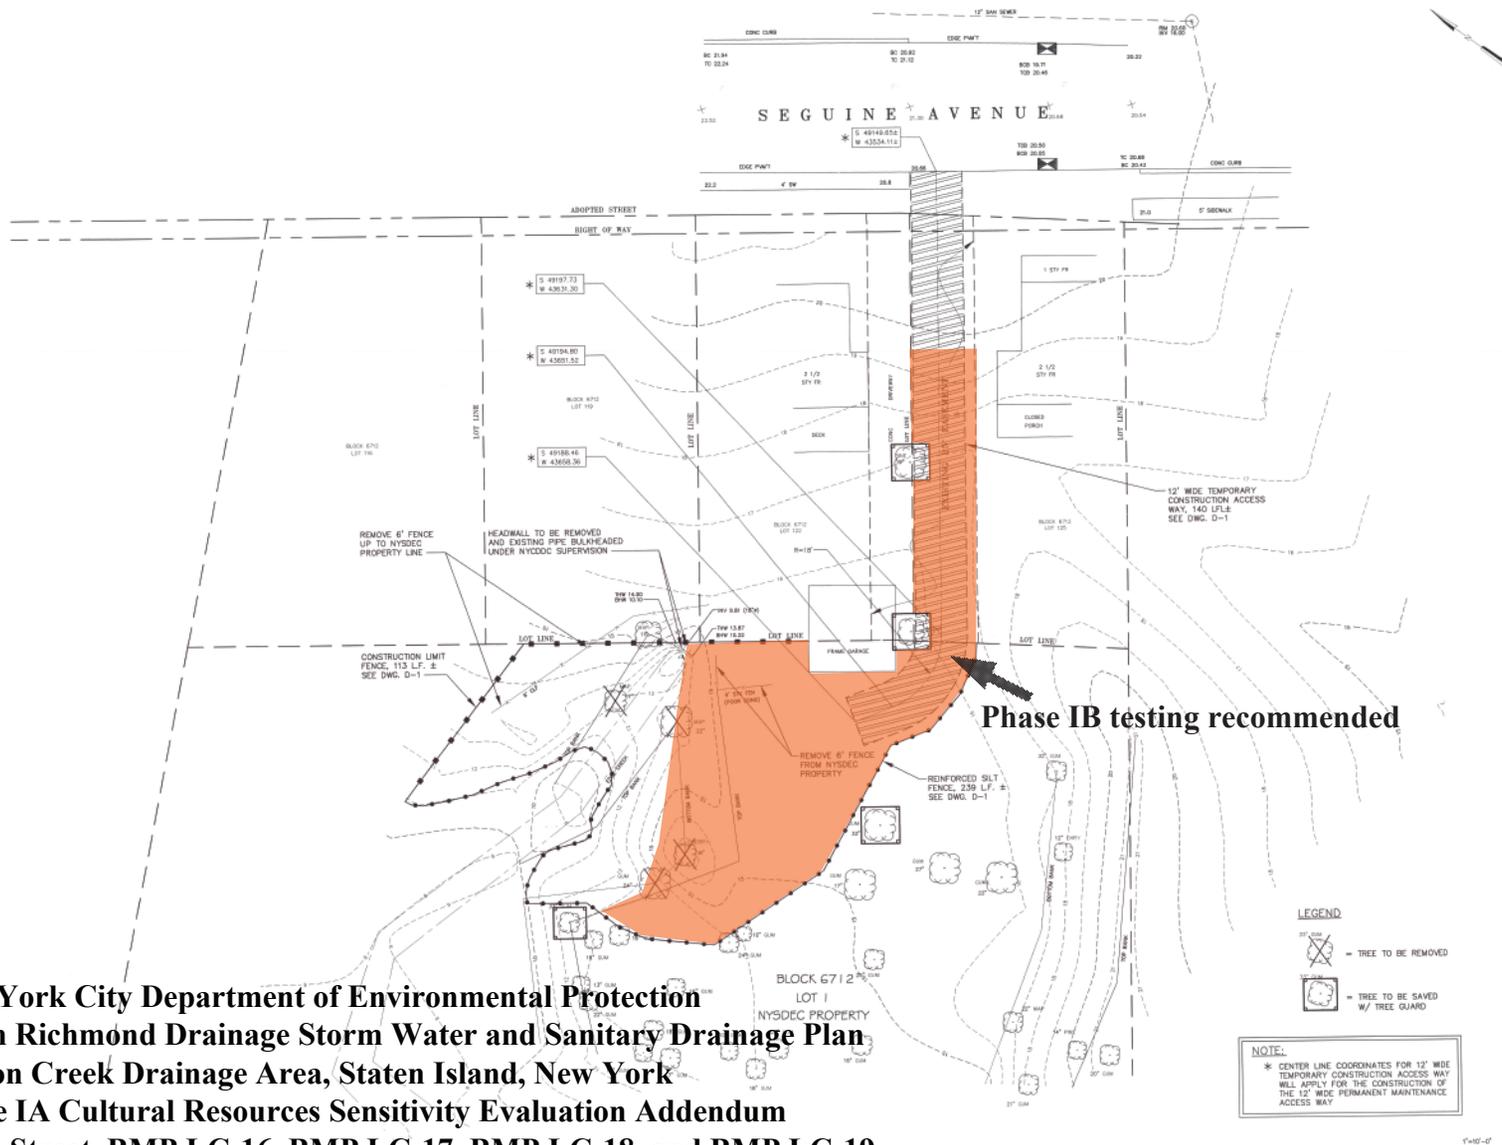
Figure 4: BMP LC-17 APE

The APE for BMP LC-17 is located on the west side of Seguine Avenue, just north of the intersection with Knox Street. A 12-foot wide temporary construction easement is located on the north side of the Block 6712, Lot 125 property. The remainder of the APE is on NYSDEC property behind the residential properties on Seguine Avenue, and includes a small terrace and sloped areas overlooking a branch of Lemon Creek. There is an existing storm sewer pipe and headwall at the end of the creek outlet. The APE is shown on Figure 4.

Phase IB testing recommended

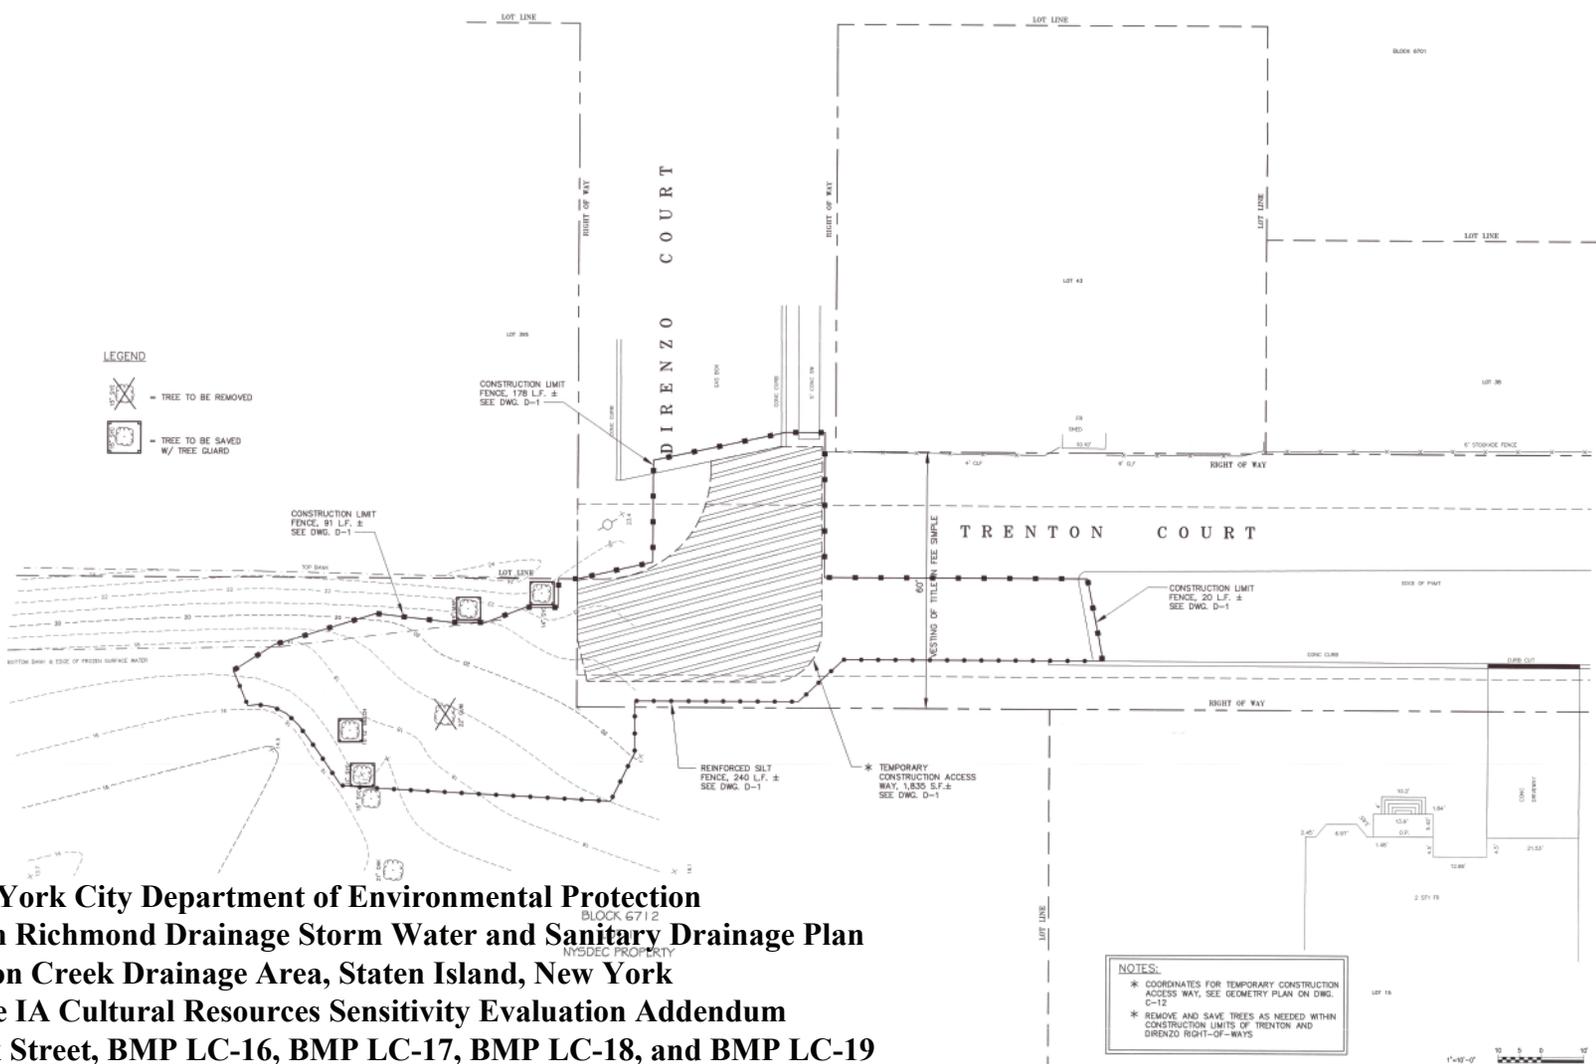
Figure 5: BMP LC-18 APE

The APE for BMP LC-18 is located at the western terminus of Drenzo Court and the northern terminus of Trenton Court. The APE extends to the northwest of this projected intersection as well, including a slightly sloped area, as shown on Figure 5.

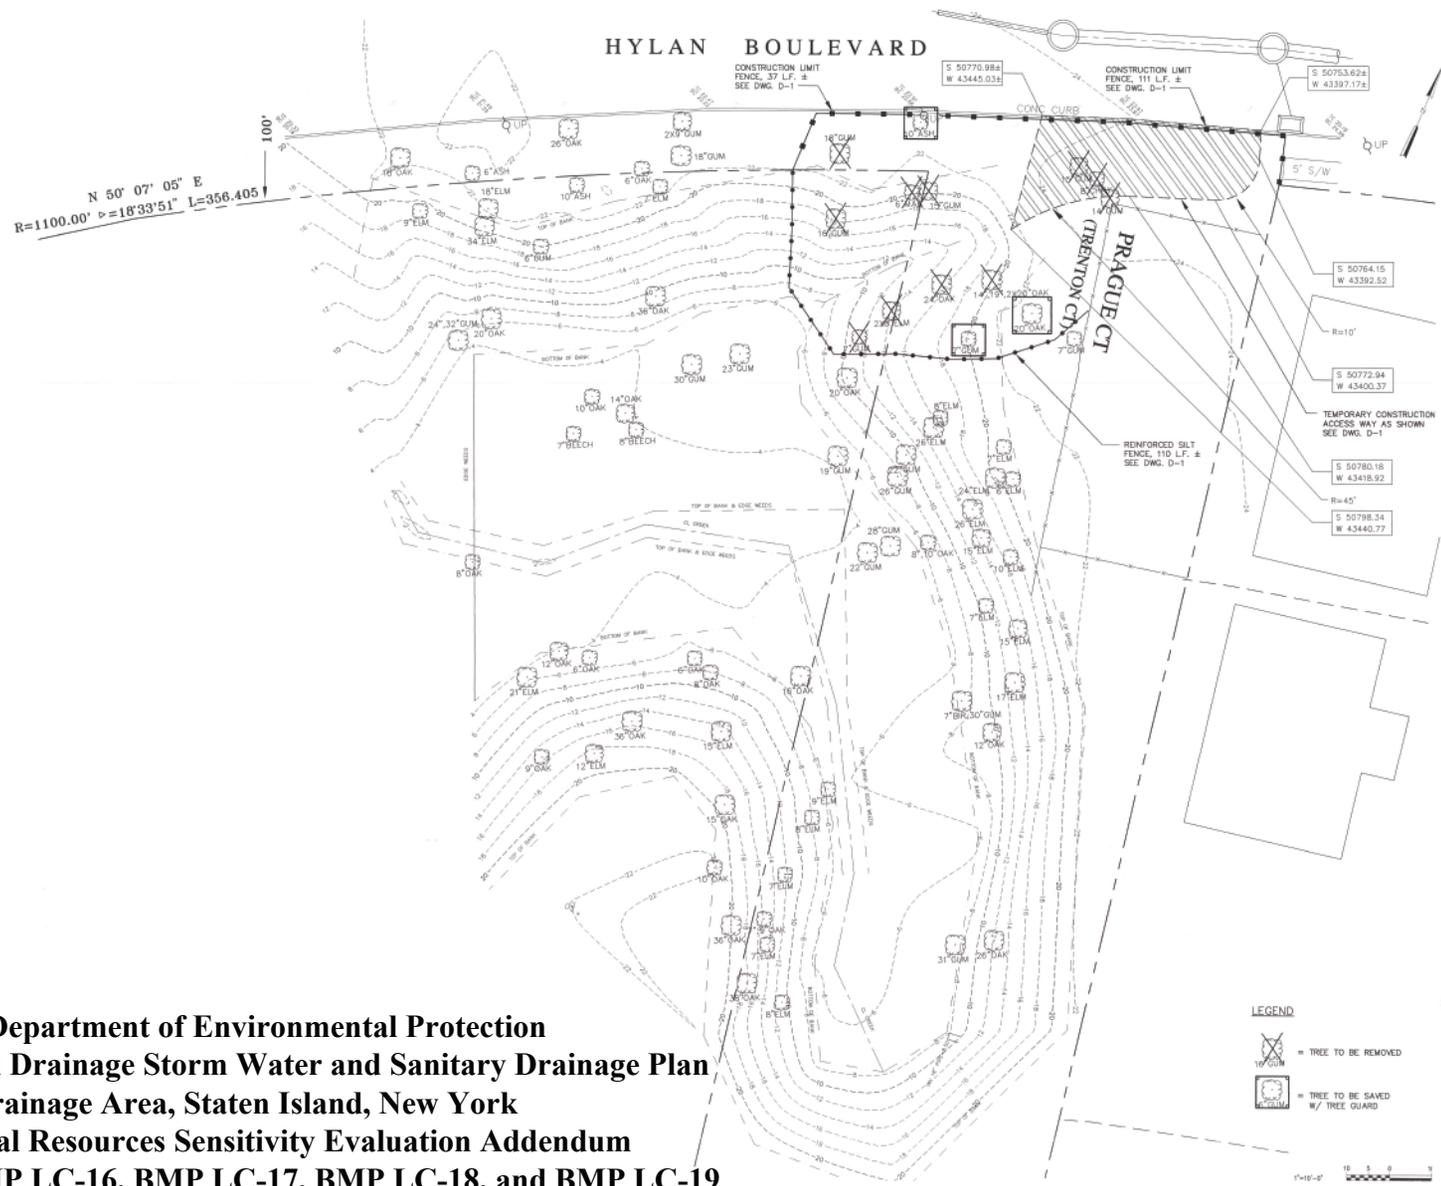
Figure 6: BMP LC-19 APE

The APE for BMP LC-19 is located on the south side of Hylan Boulevard, at the projected intersection of Trenton Court. It includes a mostly level area immediately south of Hylan Boulevard, and a heavily sloped area overlooking a creek to the southwest of the terrace, as shown on Figure 6.

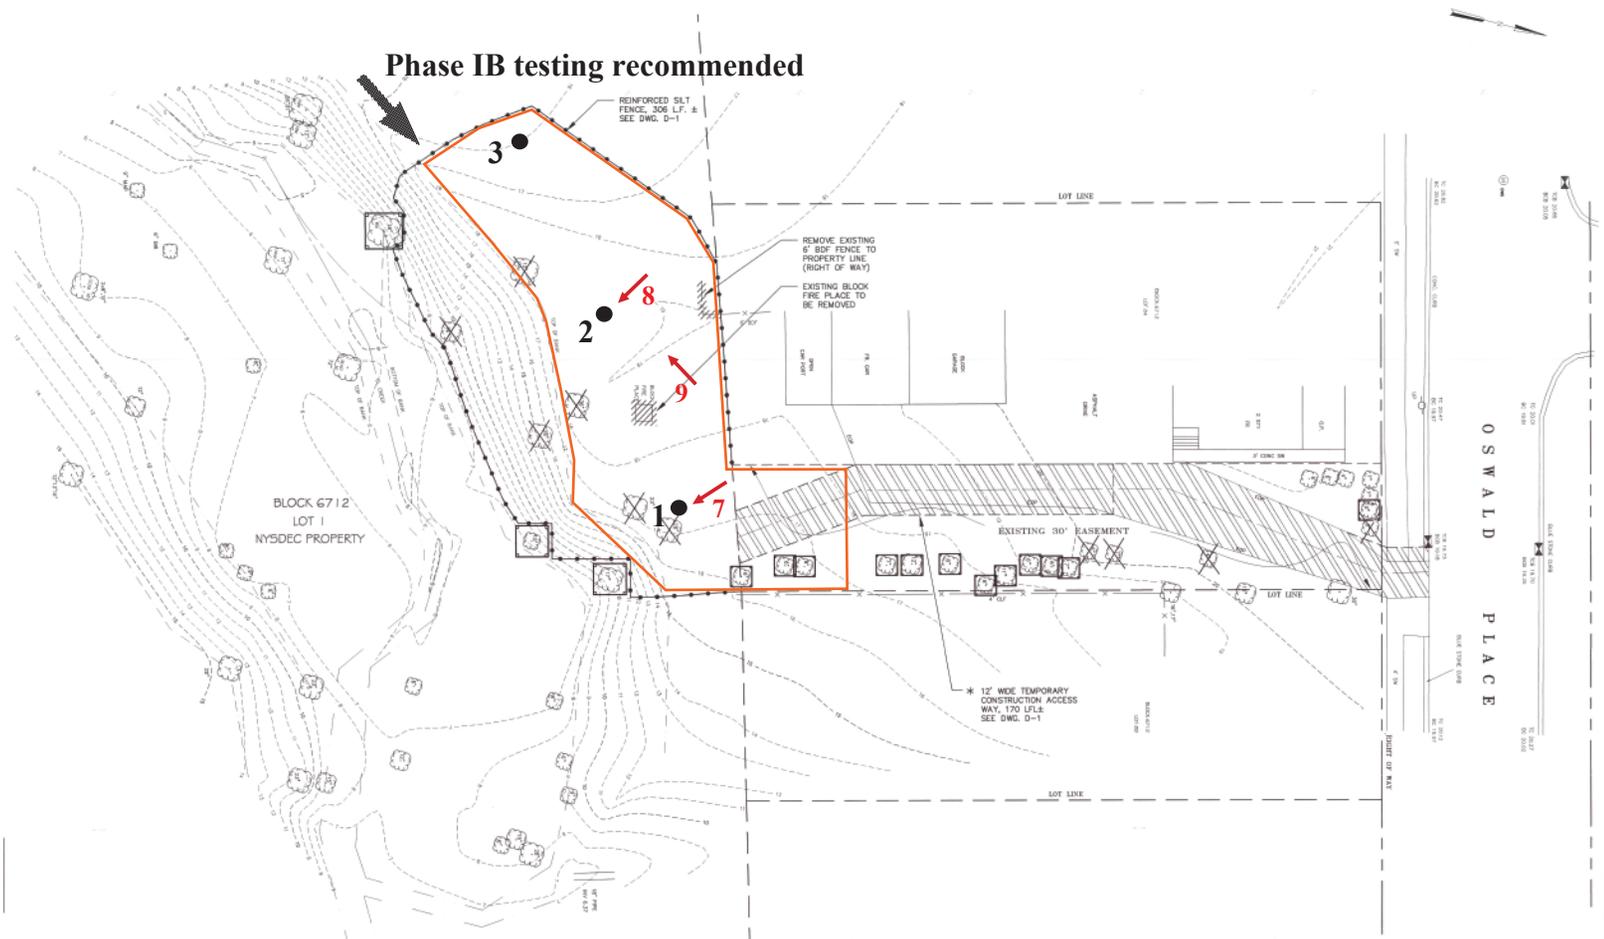
The APE for BMP LC-16 is located behind garages of the Oswald Place property. The terrace landform of the APE is about 39m (115 ft) long (east/west) by 6 (20 ft) to 14m (45 ft) wide (Figure 7). The northeast end is comprised of grassy lawn, while the remainder is covered with trees and brush. Some dumped debris is present, as is a block fireplace. Three STs were excavated at this BMP, along an approximate transect through the central axis of the terrace landform. No STs were excavated along the steep slope that comprises the remainder of the APE.

Figure 7: BMP LC-16 APE with Shovel Test and Photograph Locations

Phase IB archaeological testing has been completed at the two BMP areas previously recommended for testing, BMP LC-16 and BMP LC-17. Precontact archaeological material consisting of chert flakes, a tested jasper pebble, and a thermally altered quartzite cobble were recovered from one ST in BMP LC-16. This precontact material was found in an undisturbed context in ST 2. Therefore, additional archaeological testing is recommended. The next level of field testing should be designed to establish the age, extent, integrity, and potential National Register-eligibility of any precontact remains. The non-precontact era artifacts from this BMP are modern in nature and have no archaeological significance.

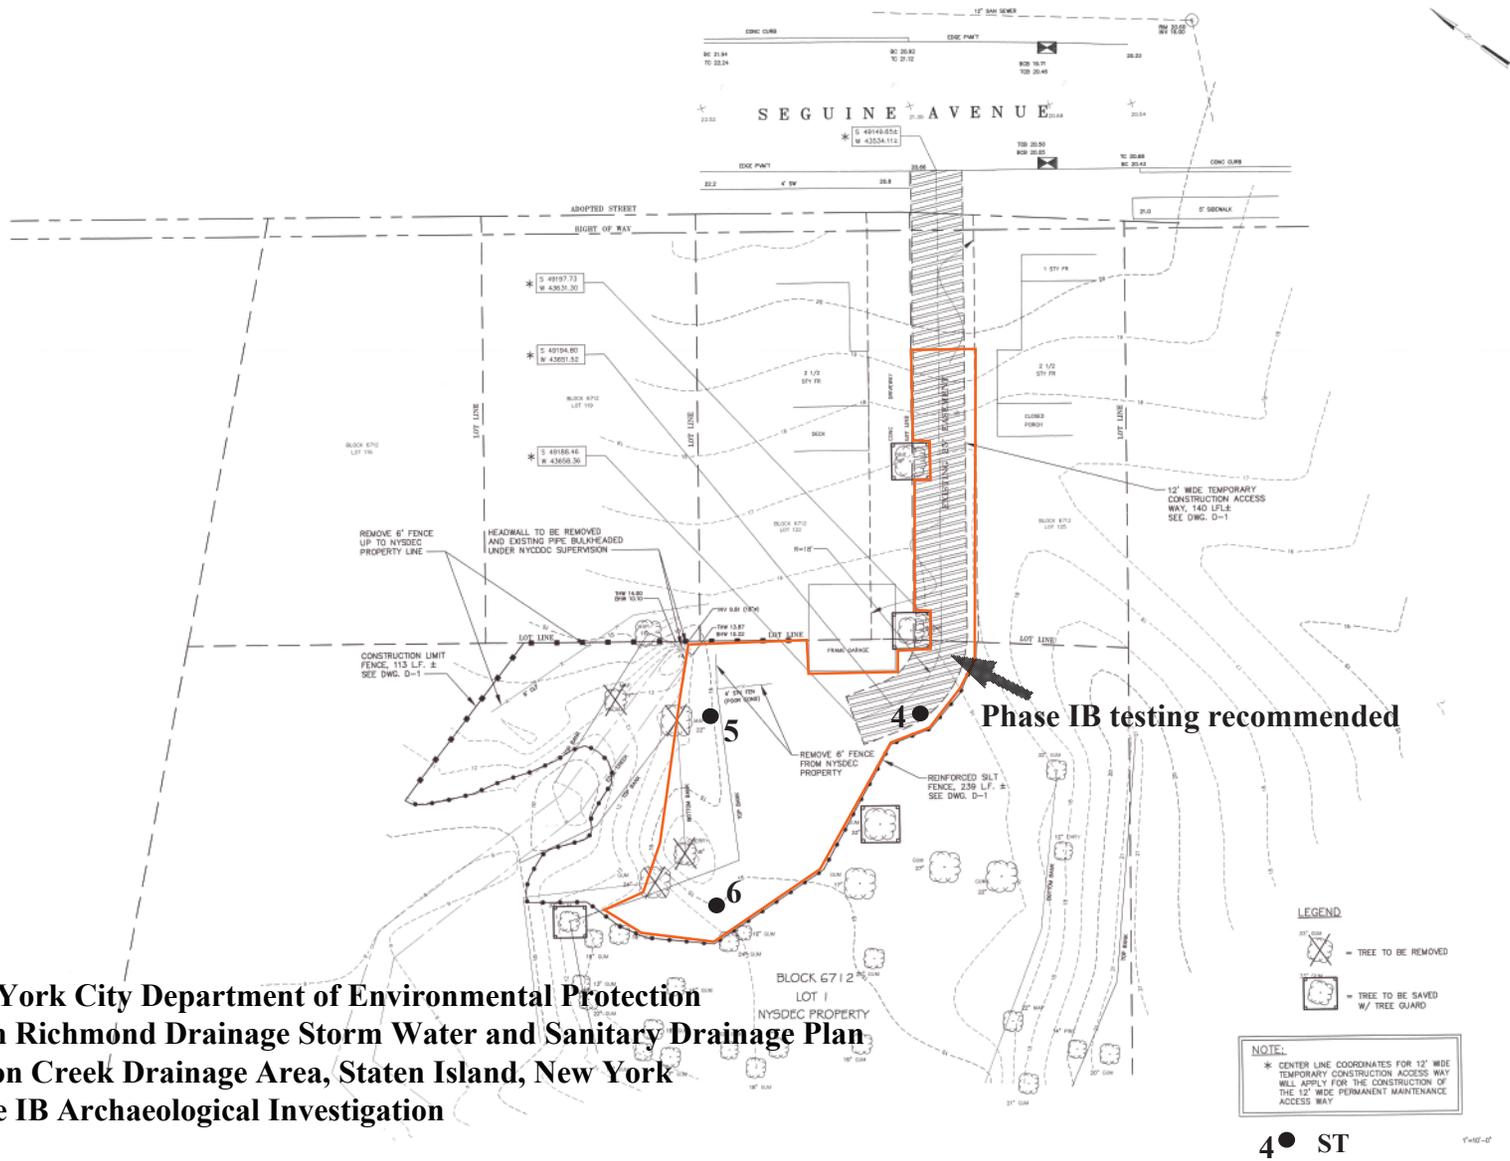
The APE for BMP LC-17 includes areas adjacent to Lemon Creek. Access from Seguire Avenue will be through an existing driveway. This drive is built of fill, and is about 0.6m (2 ft) above the adjacent driveway to the north. Because it is built of fill and will not be impacted, the driveway was not tested. Three STs were completed within the area previously recommended for testing (Figures 4 and 8). The tables, below, indicate the ST results. Each of the STs contained modern artifacts in fill layers, but none of the STs contained any precontact resources.

Figure 8: BMP LC-17 APE with Shovel Test Locations

No intact archaeological deposits were identified at the BMP LC-17 location. Much of this area has been disturbed and covered with fill. Only modern materials were found in the fill soil here. One test reached the water table. Therefore, no further archaeological investigations of BMP LC-17 are recommended.

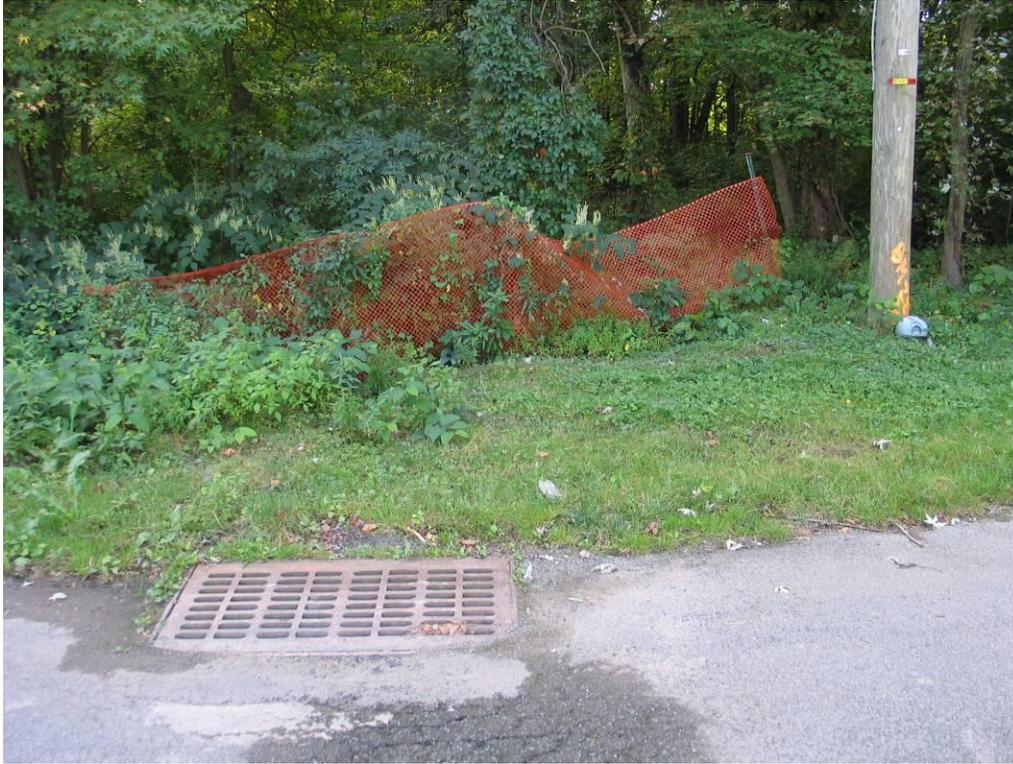
The APE for Knox Street includes a strip of land included in the roadway easement that has been disturbed from installation of utilities, including a subsurface gas line and a catch basin, and from earthmoving associated with road construction and construction of the existing storm sewer drain here (Photographs 1 and 2). To the south of the road easement is wooded land that also has been disturbed from construction of the storm sewer drain, the associated concrete walls and the timber weir wall. The APE ranges from 17-19 feet in elevation. In 1910, this area was mapped as 16 feet in elevation, suggesting there has been a slight rise in elevation here, presumably for creating Knox Street. The small creek that is located within the APE (and channeled via the storm sewer drain) discharges into Wolfe's Pond to the southeast.

Photograph 1: Knox Street APE, showing a strip of land included in the roadway easement that has been disturbed from installation of utilities, including a subsurface gas line and a catch basin. View looking southeast from Knox Street.

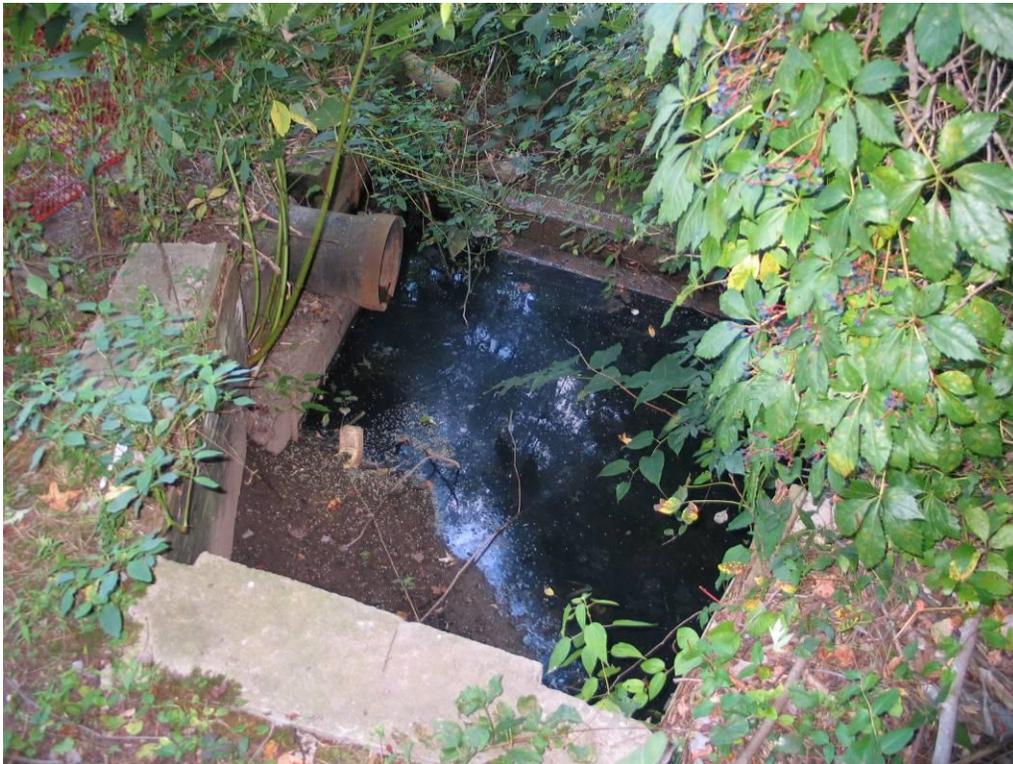
Photograph 2: Knox Street APE, showing the existing storm sewer drain, the associated concrete walls and the timber weir wall. View looking northeast.

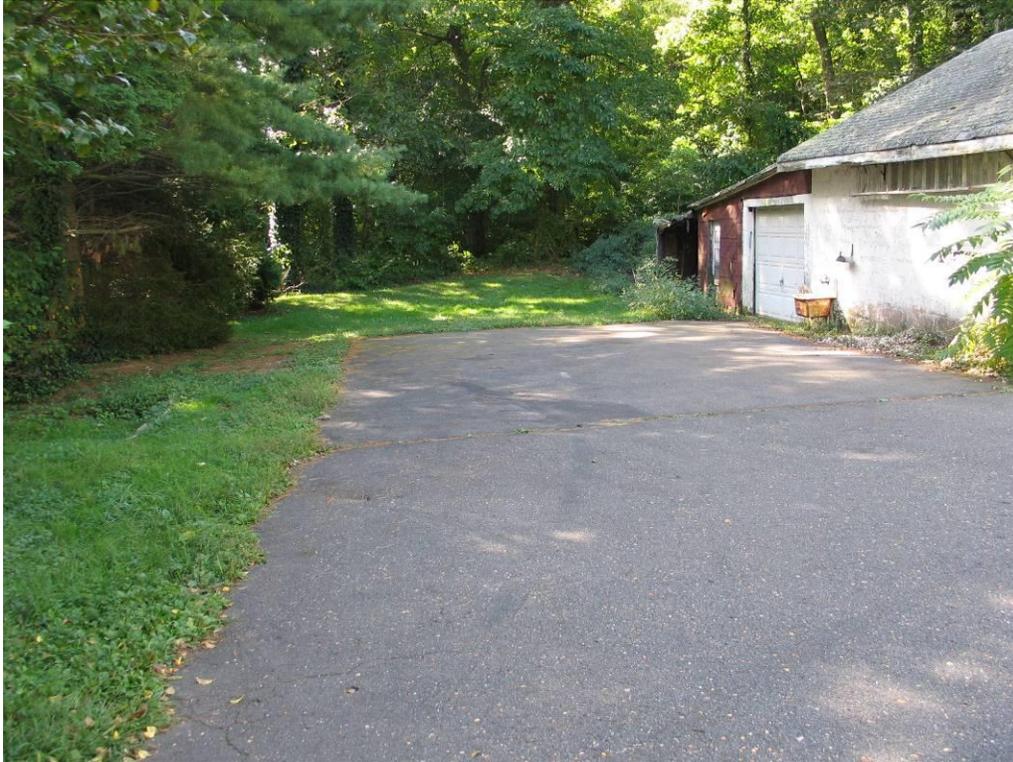
property (Photograph 3). The easement area is a generally level area covered with an asphalt driveway, and the wooded area consists of a generally level terrace behind the residence and a sloped area south of the terrace. The terrace and slope are covered with dense understory and there has been some dumping and mounding in these areas, perhaps including leaf composting. The easement and the terrace both range from 16-20 feet in elevation and the sloped area ranges from 7-18 feet in elevation. Comparison with the 1910 topographic map for this area shows little to no change in elevation over time. A branch of Lemon Creek runs just south of the APE, at the base of the sloped area.

Photograph 3: BMP LC-16 APE showing construction easement through residential driveway, with terrace in background. View looking south.

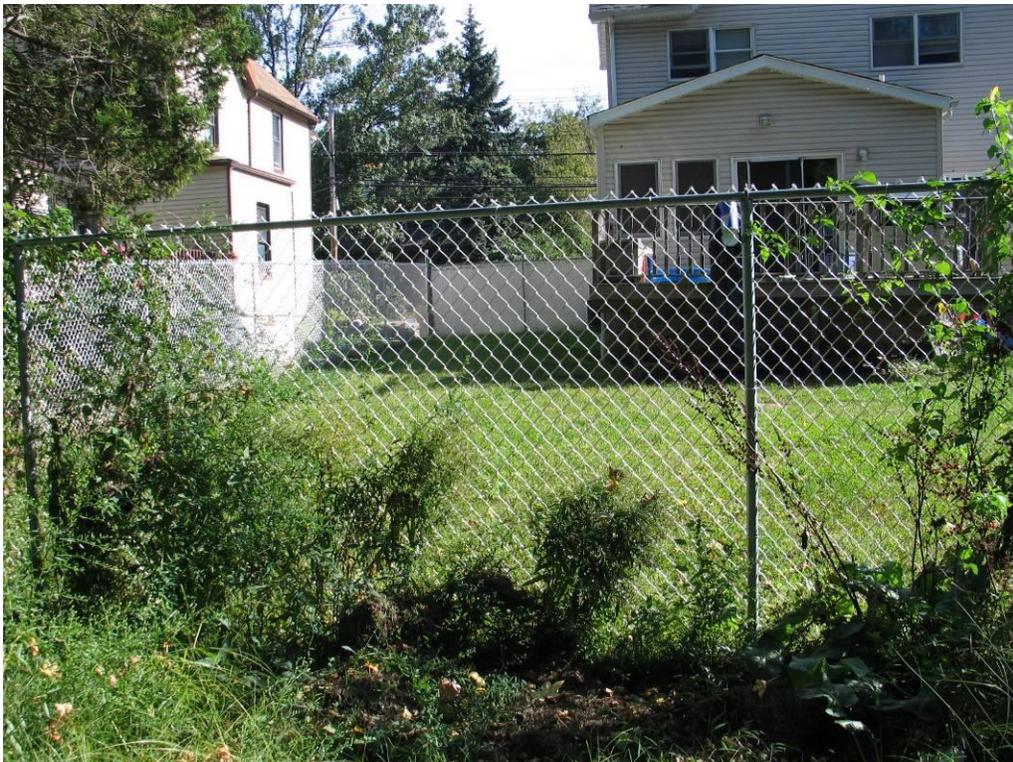
Photograph 4: BMP LC-17 APE showing construction easement through residential yard, on west side of house. View looking northeast.

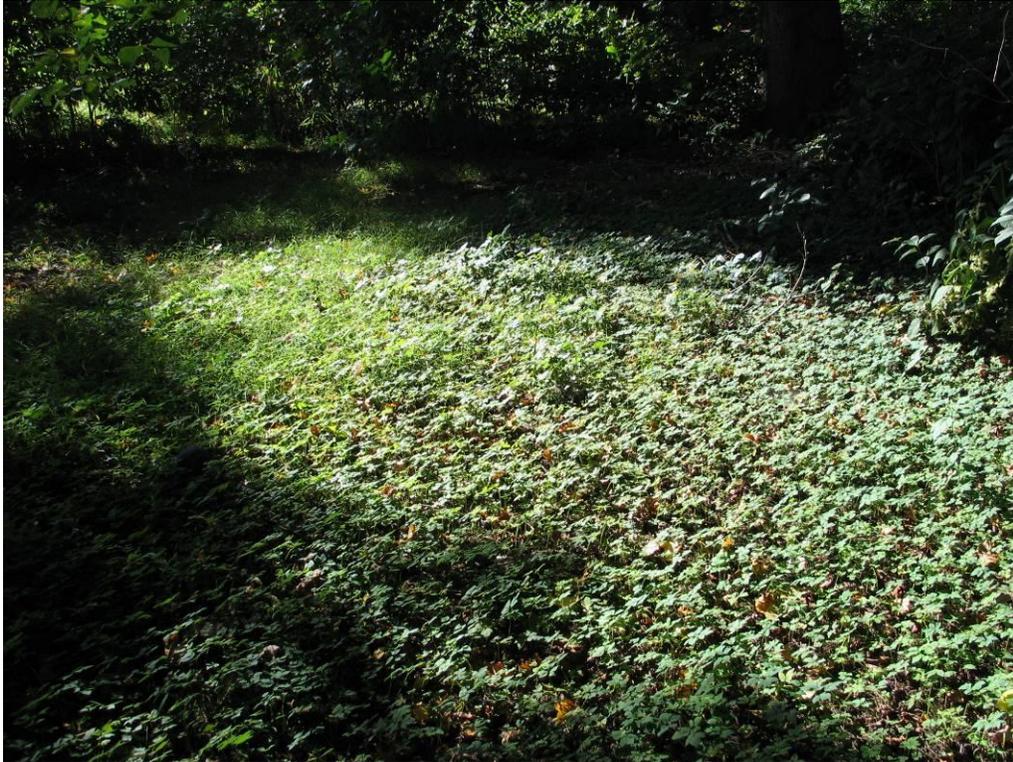
Photograph 5: BMP LC-17 APE showing level terrace. View looking southeast.

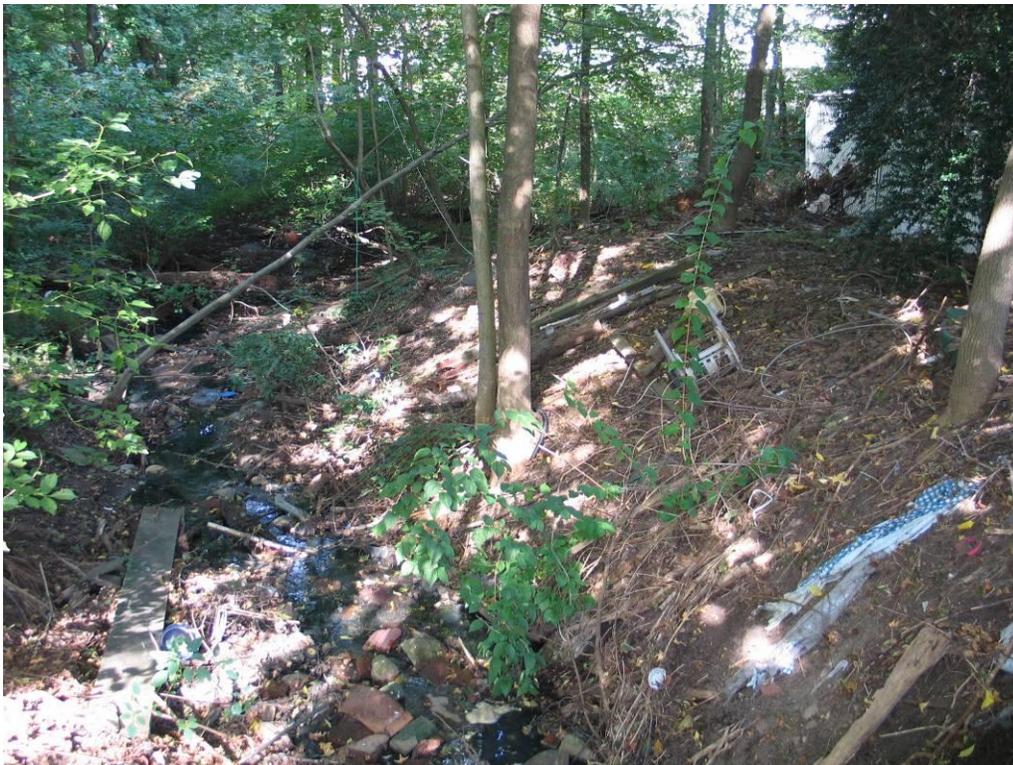
Photograph 6: BMP LC-17 APE showing sloped areas on either side of the branch of Lemon Creek that runs through the APE. View looking northwest.

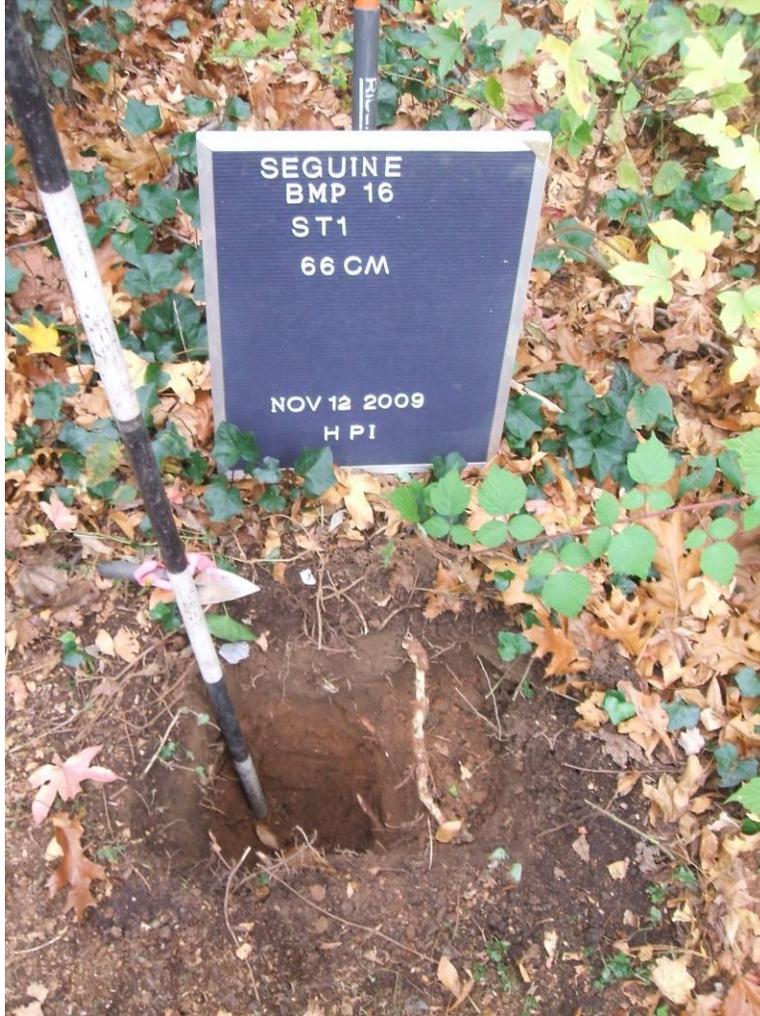
Shovel Test 1 (ST1) was located at the end of the driveway on the east end of the property (Photograph 7). The profile had a developed root mat and humus over an A Horizon that was 28cm thick. Most of the artifacts came from this level; some came from the top of Level 3. All were modern materials.

Photograph 7: View looking east at ST1 in BMP LC-16.

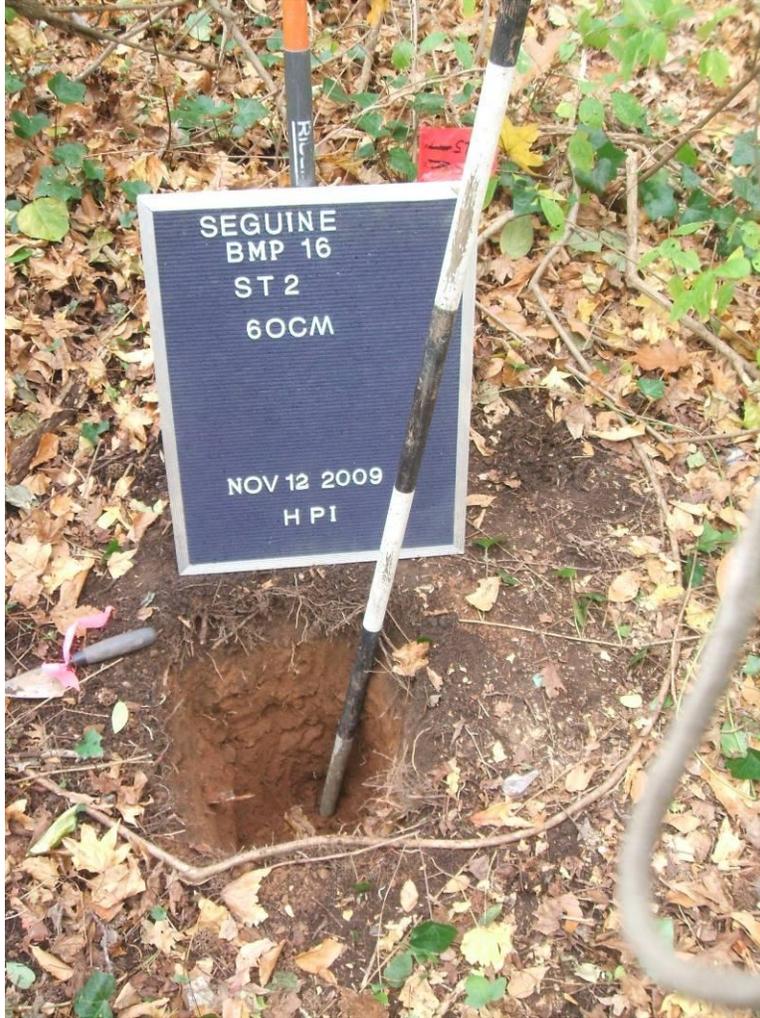
ST2 was placed in the center of the APE for BMP LC-16. The A Horizon was much thinner here, only 9cm thick. It contained glass and coal. The B Horizon was strong brown loamy sand (Figure 7, Photographs 8 and 9). It produced a tested chert pebble, 3 chert flakes, and a thermally altered cobble. The C Horizon was brown gravelly sandy clay loam and contained no artifacts.

Photograph 8: Profile photo of ST2 looking east in BMP LC-16.

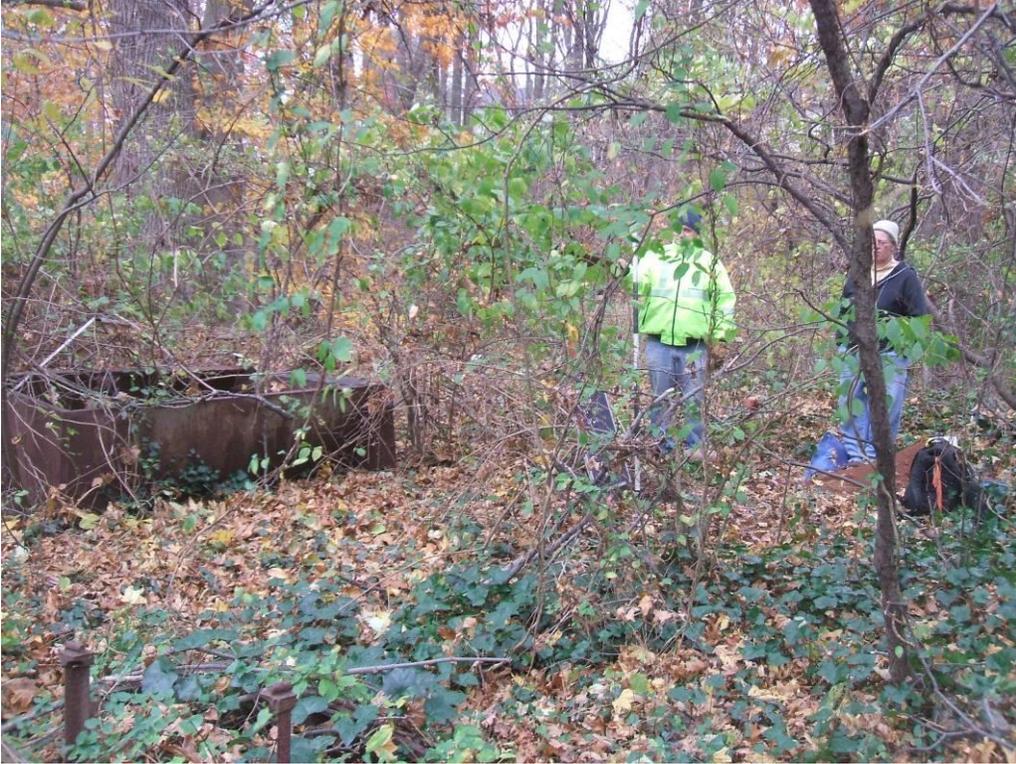
Photograph 9: View looking south at ST2 in BMP LC-16
