**U.S. Army Corps of Engineers
New York District**

**PHASE IB ARCHAEOLOGICAL
CULTURAL RESOURCES INVESTIGATION
FOR THE ADMIRAL'S ROW SECTION OF THE
FORMER BROOKLYN NAVY YARD, BROOKLYN,
KINGS COUNTY, NEW YORK**

July 2009

**PANAMERICAN CONSULTANTS, INC.
Buffalo Branch Office
2390 Clinton Street
Buffalo, New York 14227-1735**

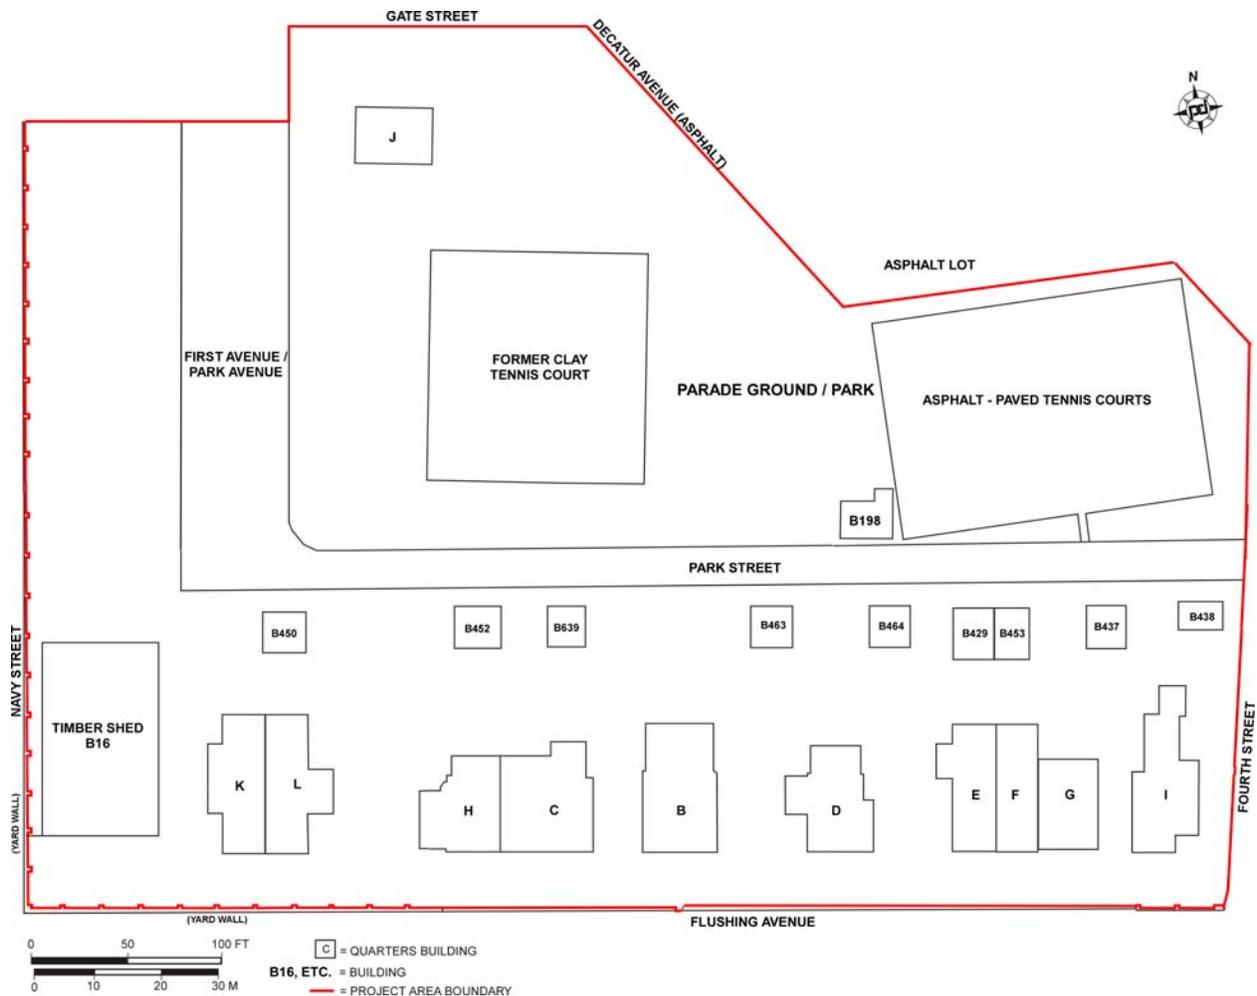
Figure 2. Layout of the project area showing buildings, roads, and other features. Brooklyn Navy Yard, Kings County, New York (PCI 2009).

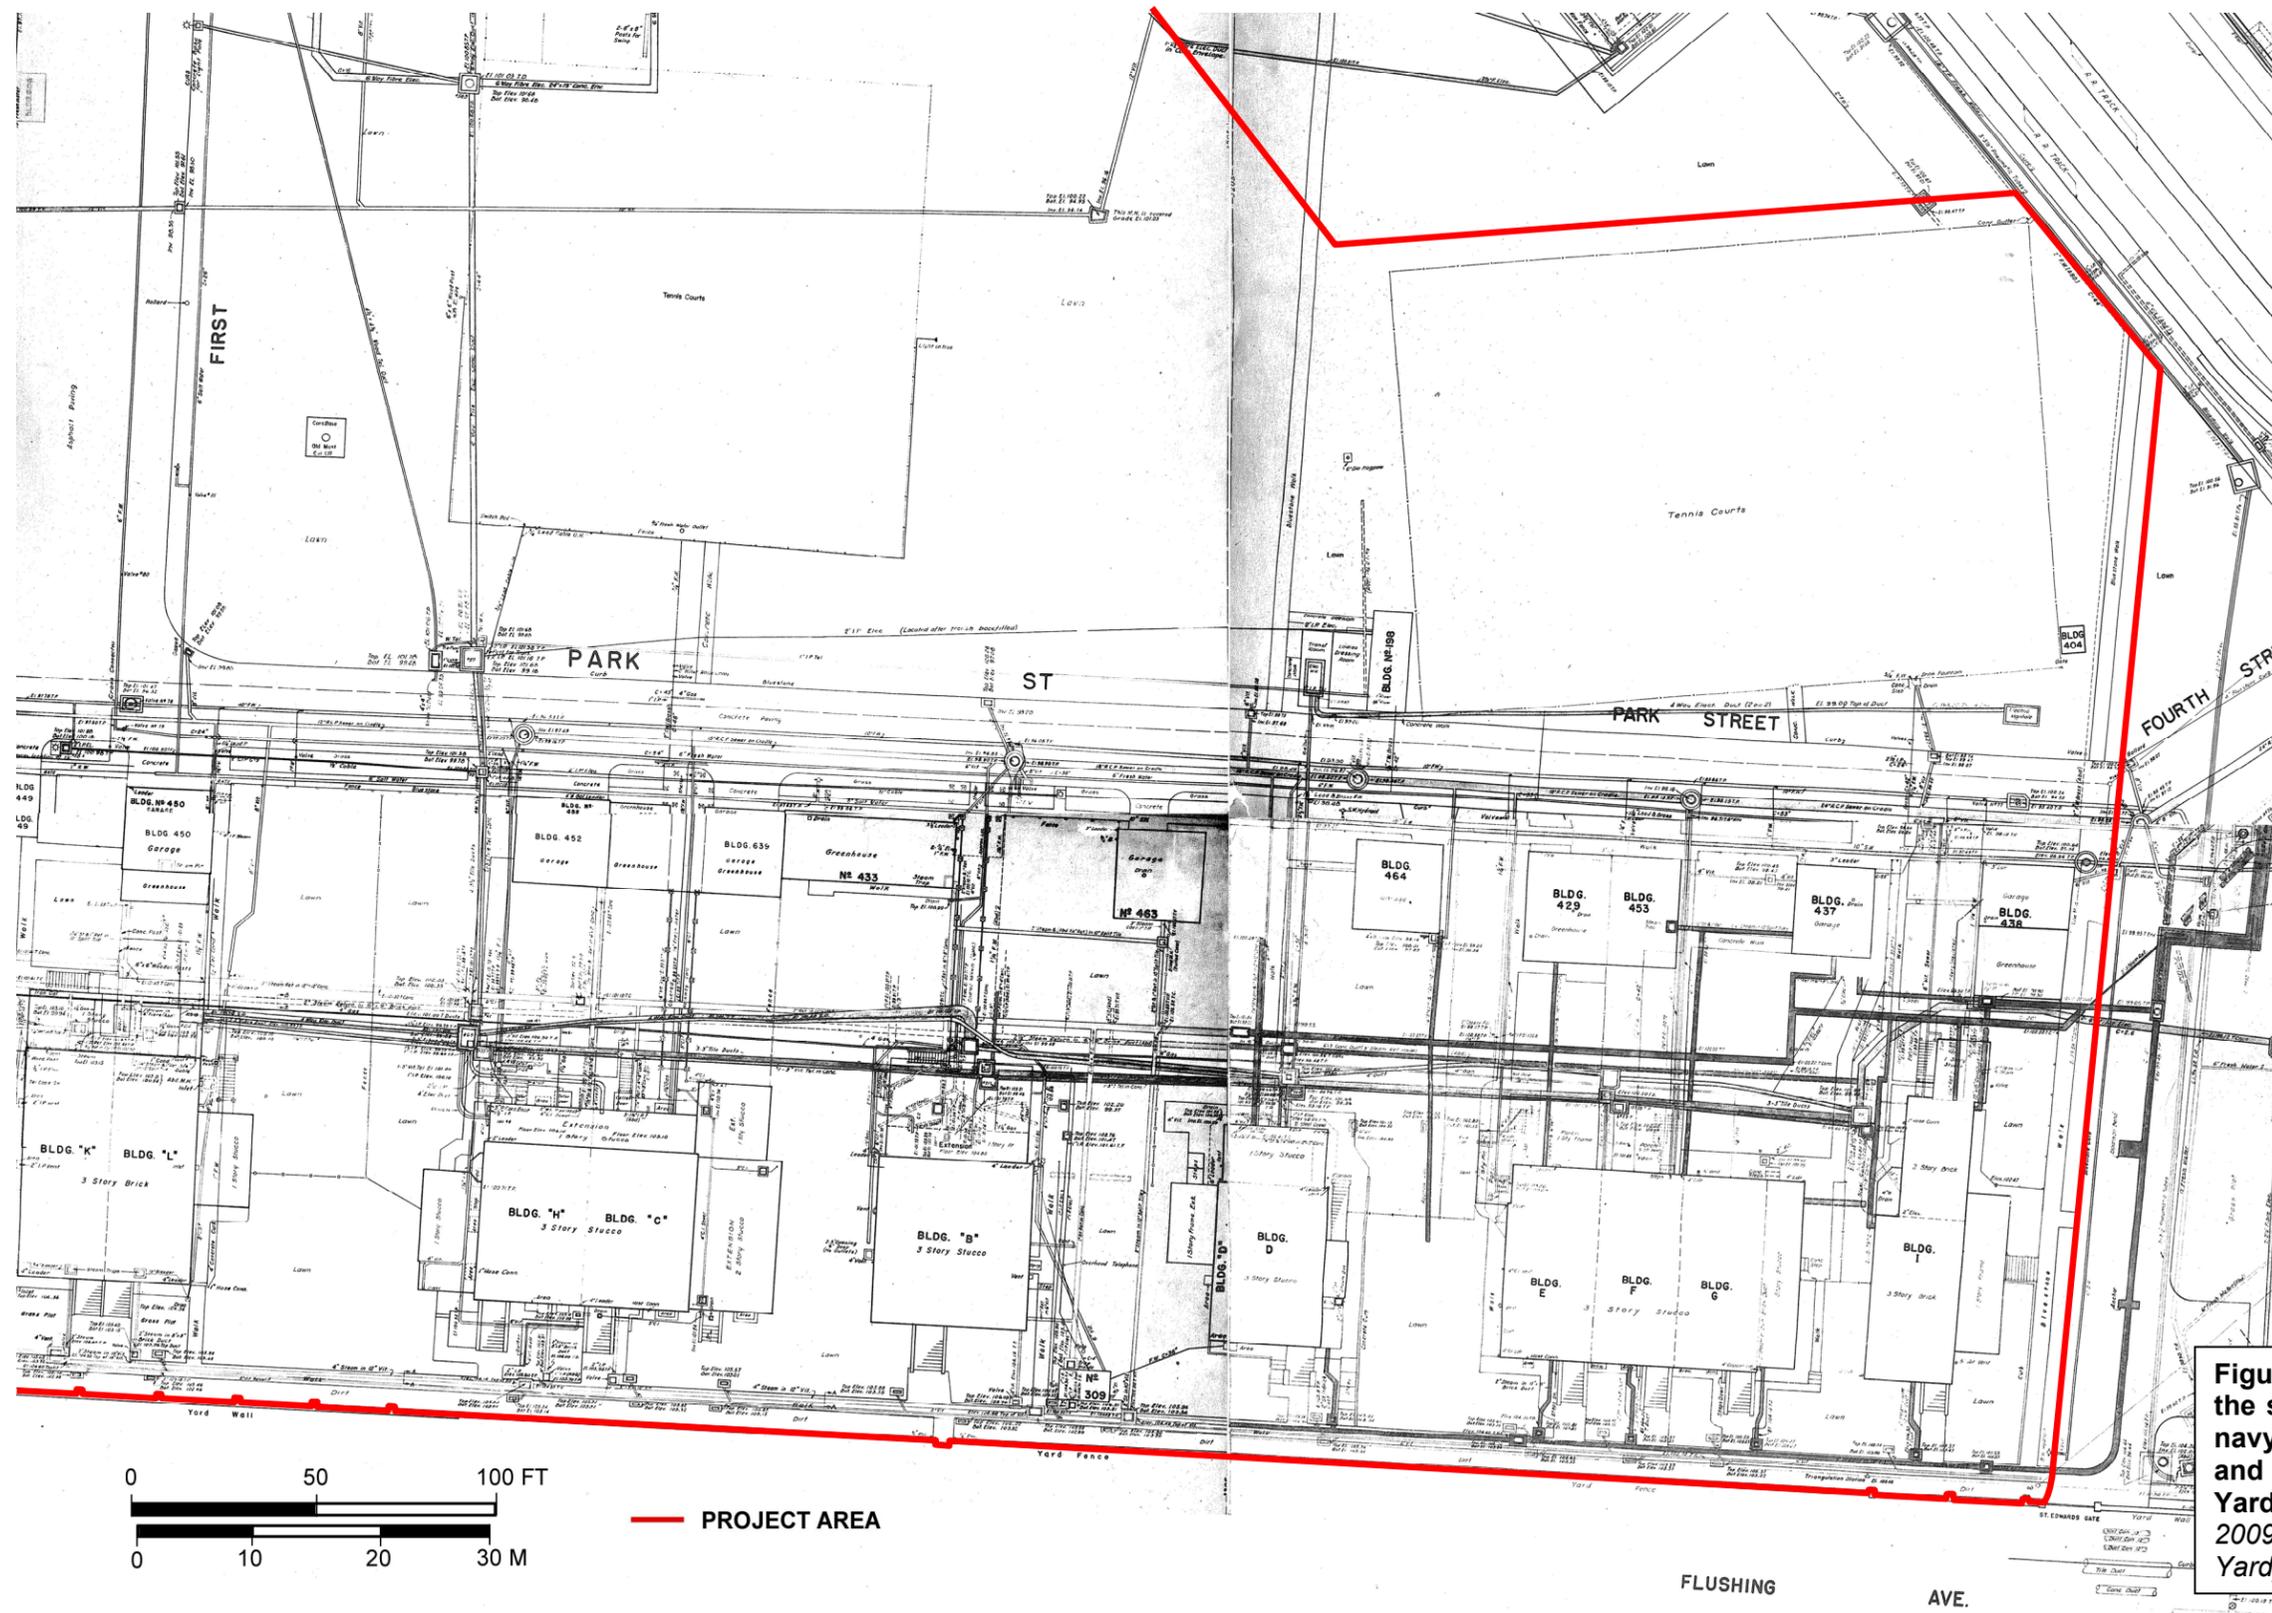
Figure 4. The southeast portion of the study area on a 1958 map of the navy yard showing utilities, fences, and other details. Brooklyn Navy Yard, Kings County, New York (PCI 2009). (map courtesy of Brooklyn Navy Yard).

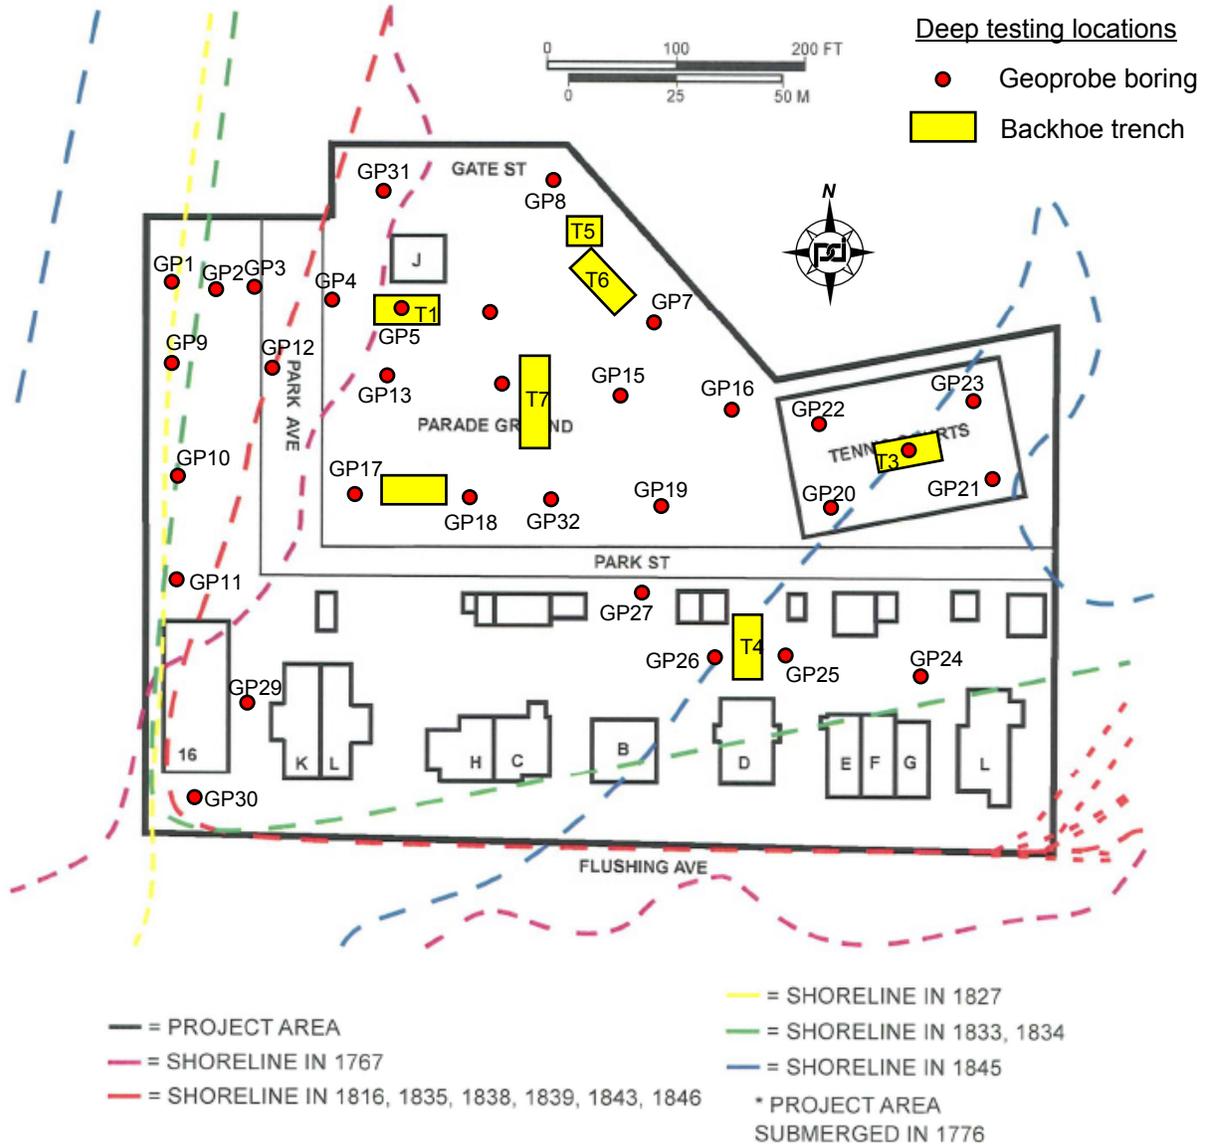
Figure 5. Location of Geoprobe borings and backhoe trenches across the project area. Brooklyn Navy Yard, Kings County, New York (PCI 2009).

Deep borings and backhoe trenching comprised the soils/geomorphological testing (Figure 5; the boring and trench logs are included in Appendix F). In consideration of the anticipated thickness and make up of the fill across the project area, a Geoprobe 6620DT recovering samples in 2-inch diameter cores and 5-foot sections was used for deep borings. Geoprobe boring was generally successful, however, there were some issues with the recovery of saturated sands and with saturated sediments flowing into the borings. The result of these problems was that in some cases the given depths from which samples were recovered may be incorrect. Backhoe trenching was similarly hampered by the relatively high water table in the project area with saturated sediments slumping and preventing trenches from being excavated deeply. Soil morphological properties including horizonation, color, texture, moist consistence, and redoximorphic features were described (Soil Survey Staff 1992; Schoeneberger et al. 1998).

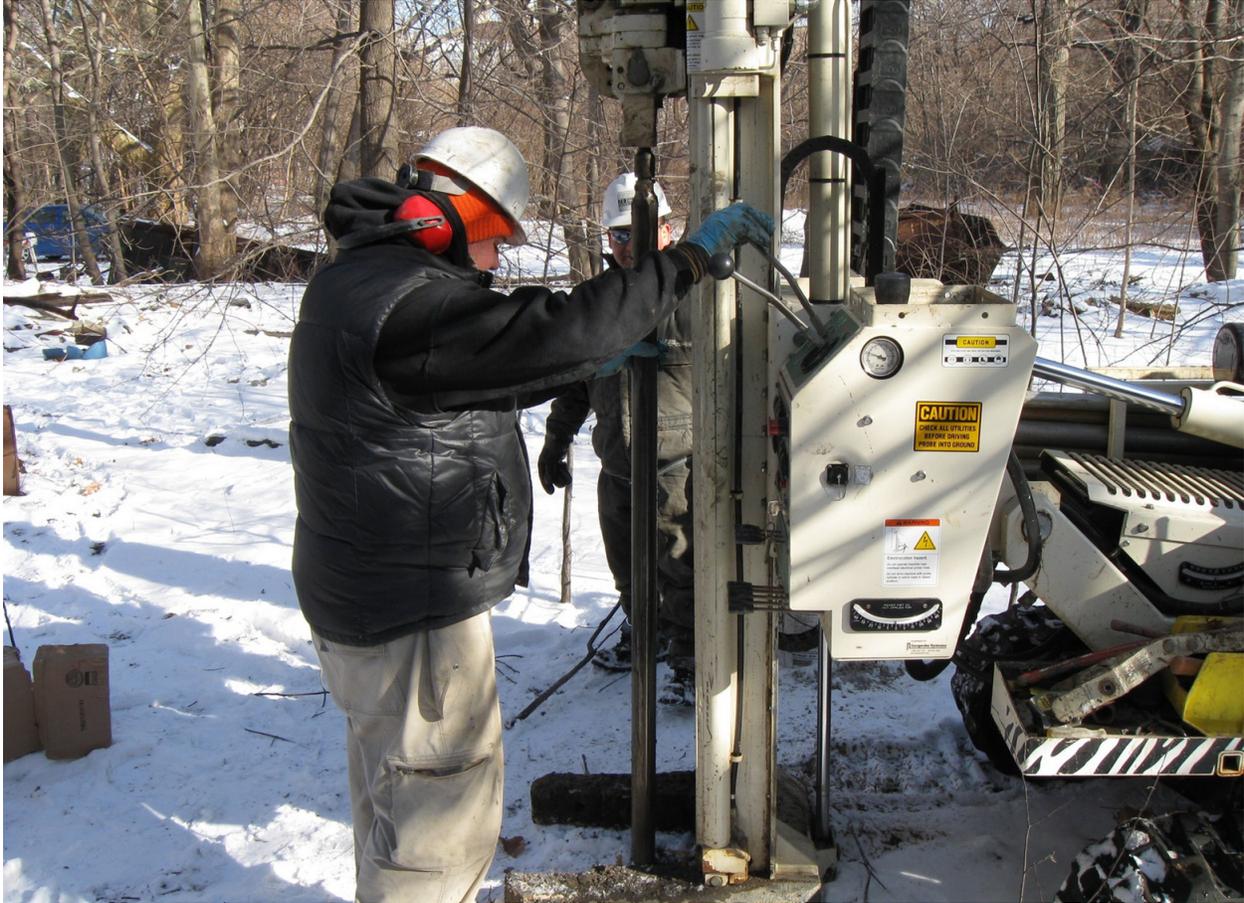
Figure 6. Acquiring a core sample with the Geoprobe machine during the geomorphological investigation. Brooklyn Navy Yard, Kings County, New York (PCI 2009).

Thirty-two deep Geoprobe observations were made across the project area (Figure 6). Maximum depth of the borings ranged from 250 cm to 571 cm. Historic fill was present in all borings. An organic soil was recovered in 26 of the 32 borings and fine lacustrine sediments were recovered in 28 of the 32 borings.

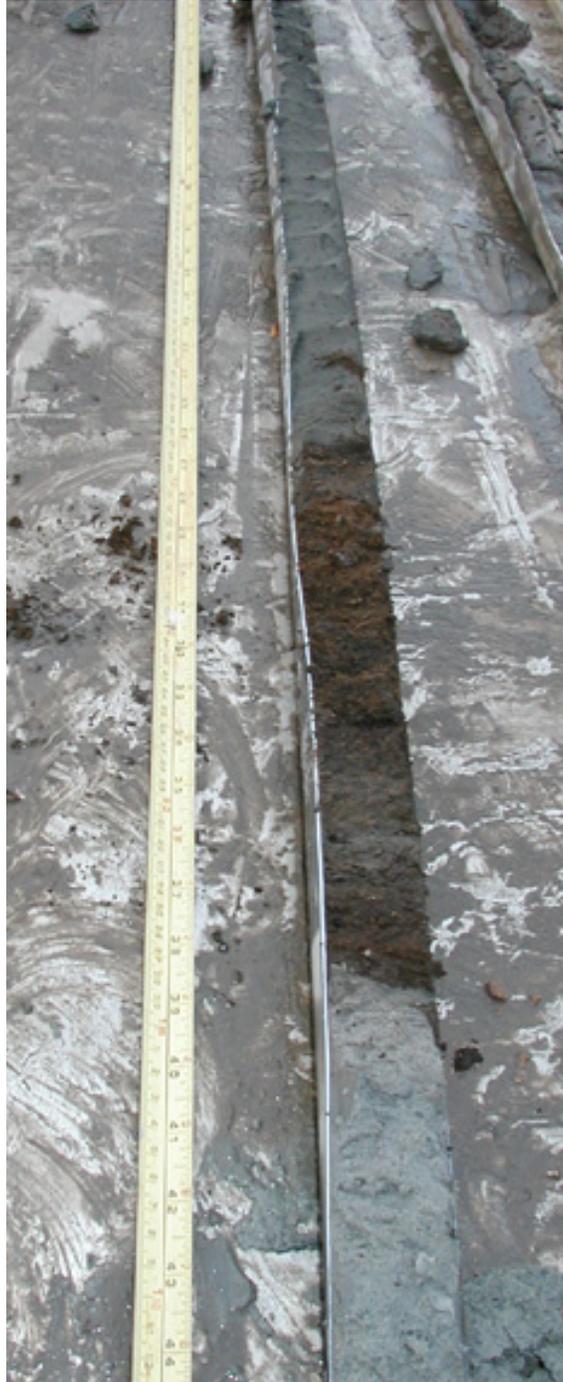
Figure 7. GP27 showing the sequence of very dark gray (N3) silty lacustrine sediments, very dark brown (7.5YR 3/3) organic tidal marsh surface, and gray (2.5Y 6/1) sandy fluvial/estuarine sediments. Note: tape shows scale not depth. Brooklyn Navy Yard, Kings County, New York (PCI 2009).

Historic fill was present in all observations. The thickness of the fill ranged from 147 cm in Geoprobe (GP) 27 to 372 cm in GP 4. In most observations fill was between 200 and 300 cm thick. Texture was predominantly sandy loam but varied widely. Coarse fragment (> 2 mm) contents ranged from zero to 55 percent. Concrete, brick, coal, ash, wood, slag, and historic ceramics were common. Color, like texture, was mixed and variable.

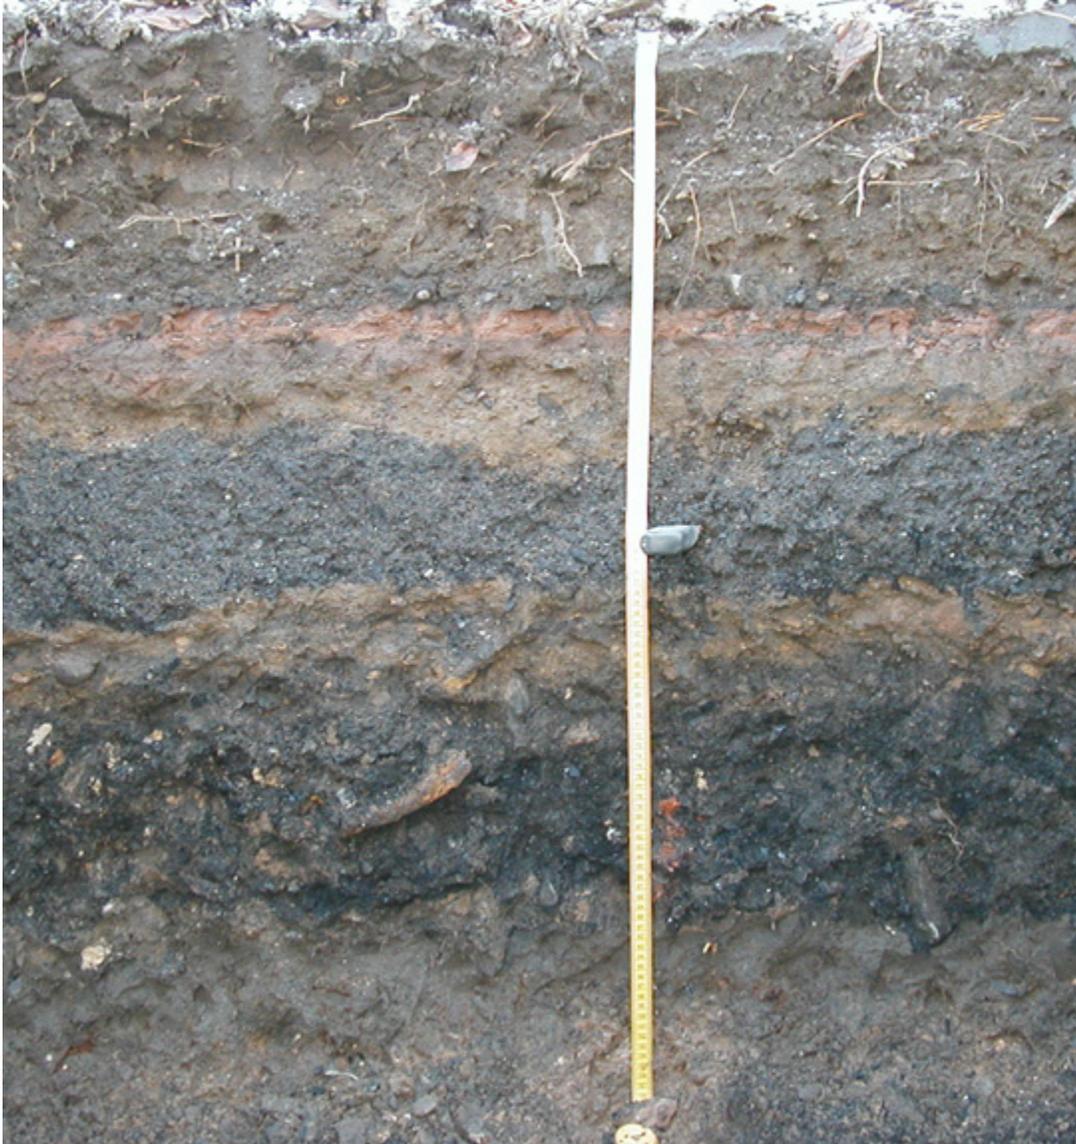
Figure 8. Profile from T7 showing stratified historic fill. Soil knife at 50 cm is in a layer of ash and slag. A second layer of ash and slag from 70 to 96 cm has brick and iron. Brooklyn Navy Yard, Kings County, New York (PCI 2009).

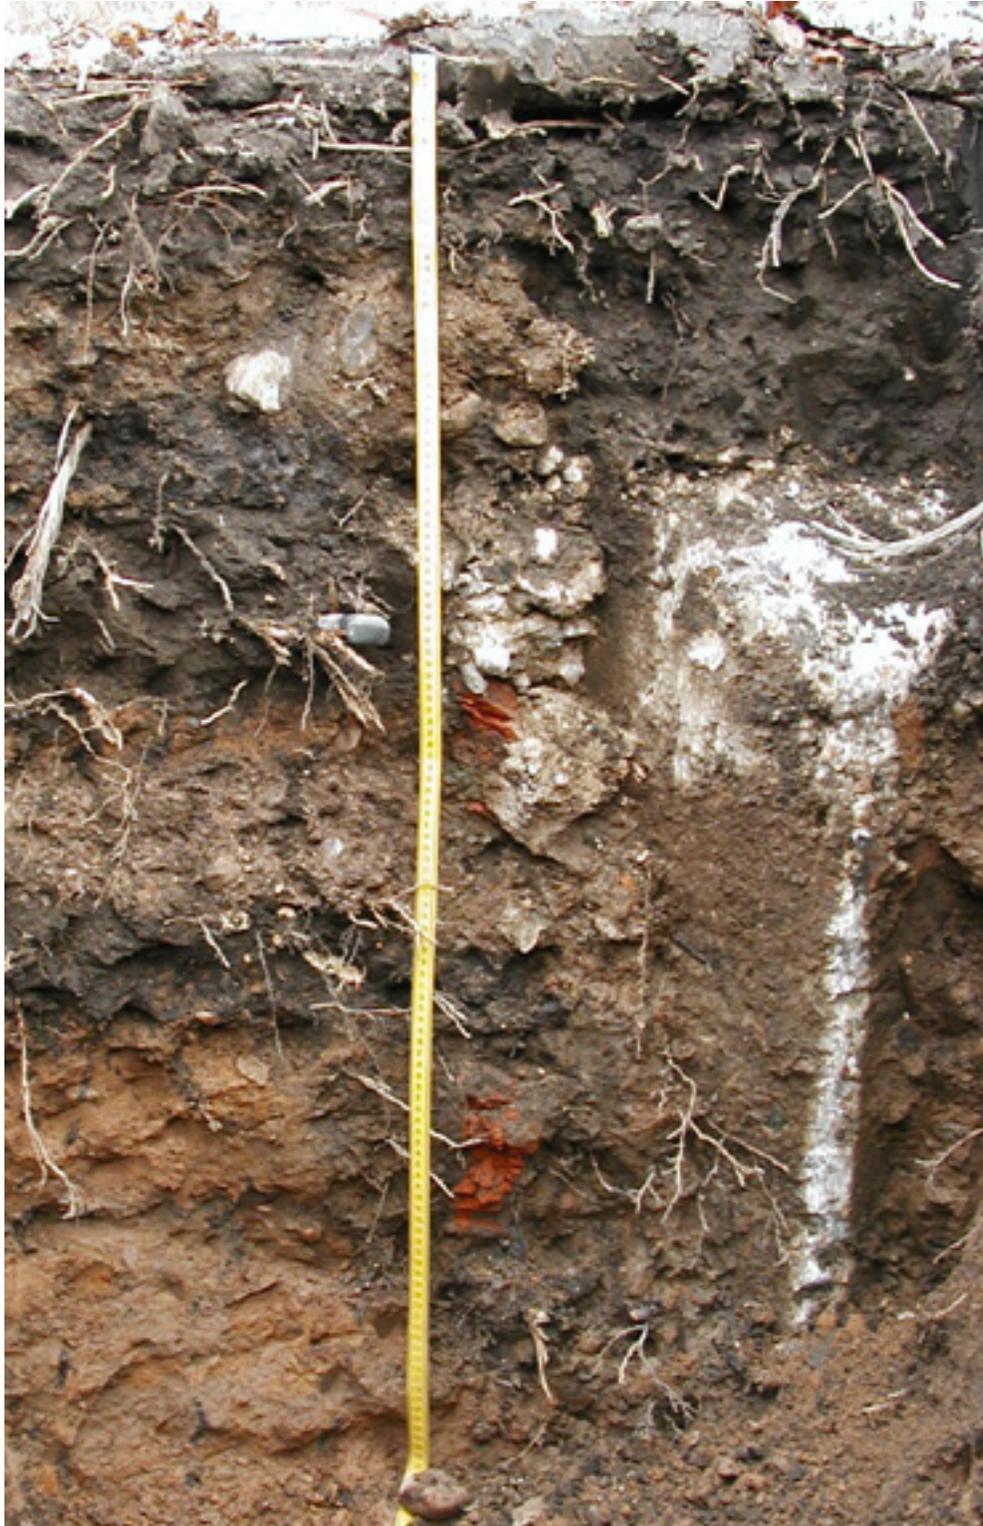
Figure 9. Profile from T2 showing stratified historic fill. A concrete pillar extending beyond the bottom of the trench is in the right side of the profile. Brooklyn Navy Yard, Kings County, New York (PCI 2009).

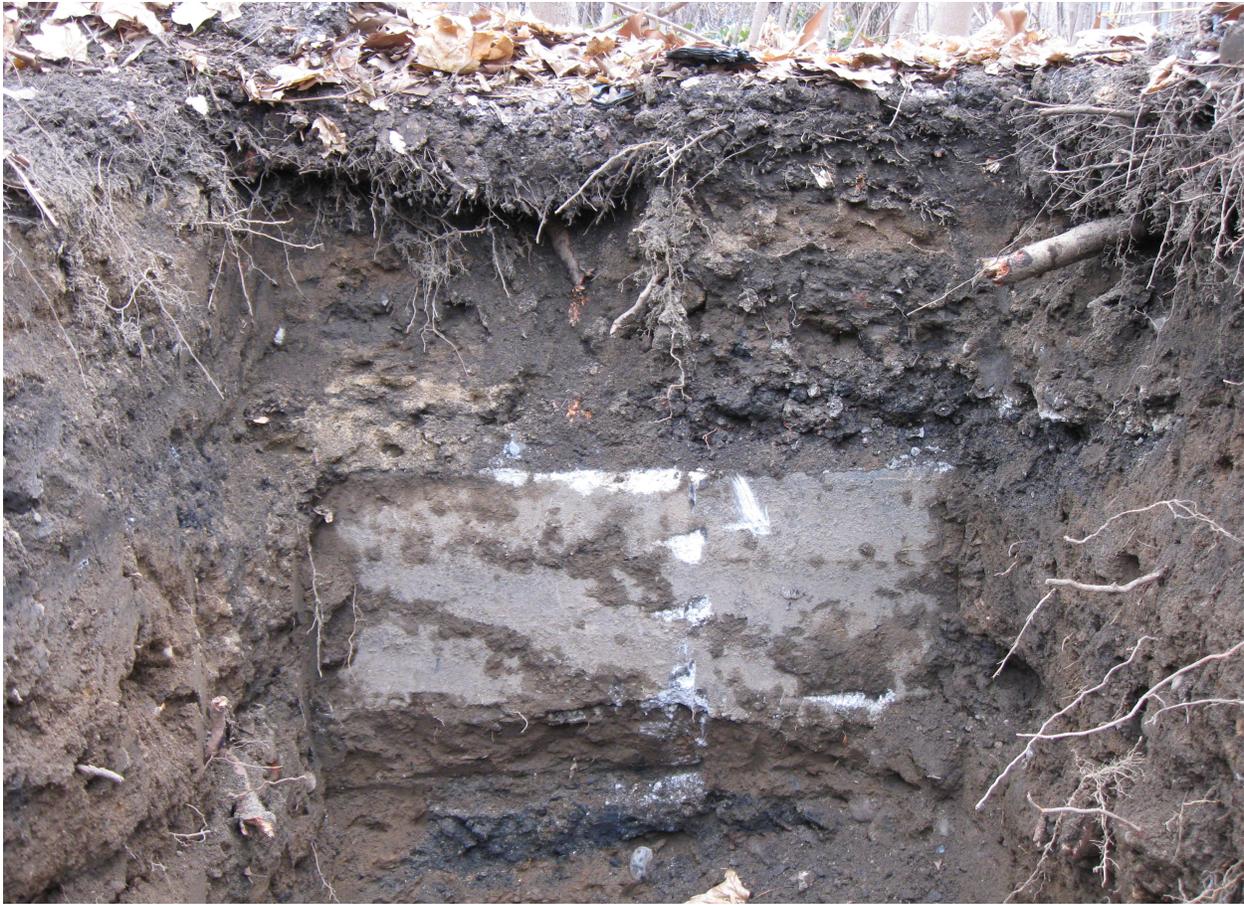
Figure 11. Poured-concrete utility casing exposed in the west end of Trench 1. Brooklyn Navy Yard, Kings County, New York (PCI 2009).

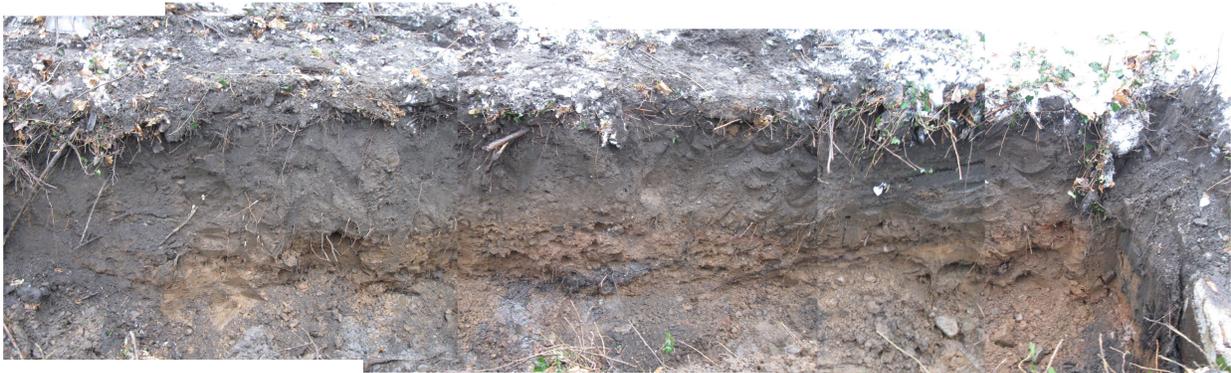
Figure 15. Trench 4 west wall. Brooklyn Navy Yard, Kings County, New York (PCI 2009).

Trench 4. Trench 4, the only trench dug in the archaeologically sensitive area around the Admiral's Row quarters, was north of Quarters D, in the southeast quadrant of the study area (see Figure 5). It totaled 5.3 m in length and 120 cm in depth and was oriented along a north-south axis (Figures 14 and 15). Four strata were identified in the trench, fewer than in any of the others dug in the project area. Stratum 1 was a layer of black and dark brown sandy loam that reached 40 to 50 cm below the surface; Stratum 2 was a 30-to-40-cm thick deposit of dark yellowish brown sandy loam; and Stratum 3 was dark yellowish brown and strong brown gravelly sandy loam that extended below an average level of about 80 cm. It contained a large, obliquely-oriented lens of black gravelly sand that had a maximum thickness of roughly 10 cm. Two concrete-encased utilities were identified; one was oriented east-west and was in the south end of the trench. The other was nearly parallel to the west side of the trench, and a 1.5-m-long portion of its lateral surface was exposed near the north end of the excavation (Figure 16).

Second, characteristics of the soil stratigraphy in Trench 4, relative to those of the strata in the other trenches, corresponds with the conditions shown in the 1857 woodcut from *Leslie's Illustrated Newspaper*, in which the area south of Park Street is depicted as land, while the site of the parade ground / park is shown as still filled with water. The stratigraphy in the trench is composed of only three soil strata, which were oriented obliquely downward towards the north. Trenches dug across the parade ground, however, cut through at least six soil strata, all of which were roughly horizontal. Also, the layer of nineteenth-century industrial, architectural, and domestic trash found in trenches across the parade ground was not noted in Trench 4. Thus the evidence implies that the Trench 4 soils were laid down with different depositional mechanisms than was the material in the parade ground. This is consistent with the hypothesis that the project area was filled during at least two episodes – one before 1853, when Quarters B, C, and D were constructed and another soon after 1857. Also, although it is problematic to interpret artistic woodcuts too literally, the 1857 image apparently shows the terrain around the quarters sloping gently towards the north, which may be reflected in the oblique orientation of the soil strata in Trench 4.

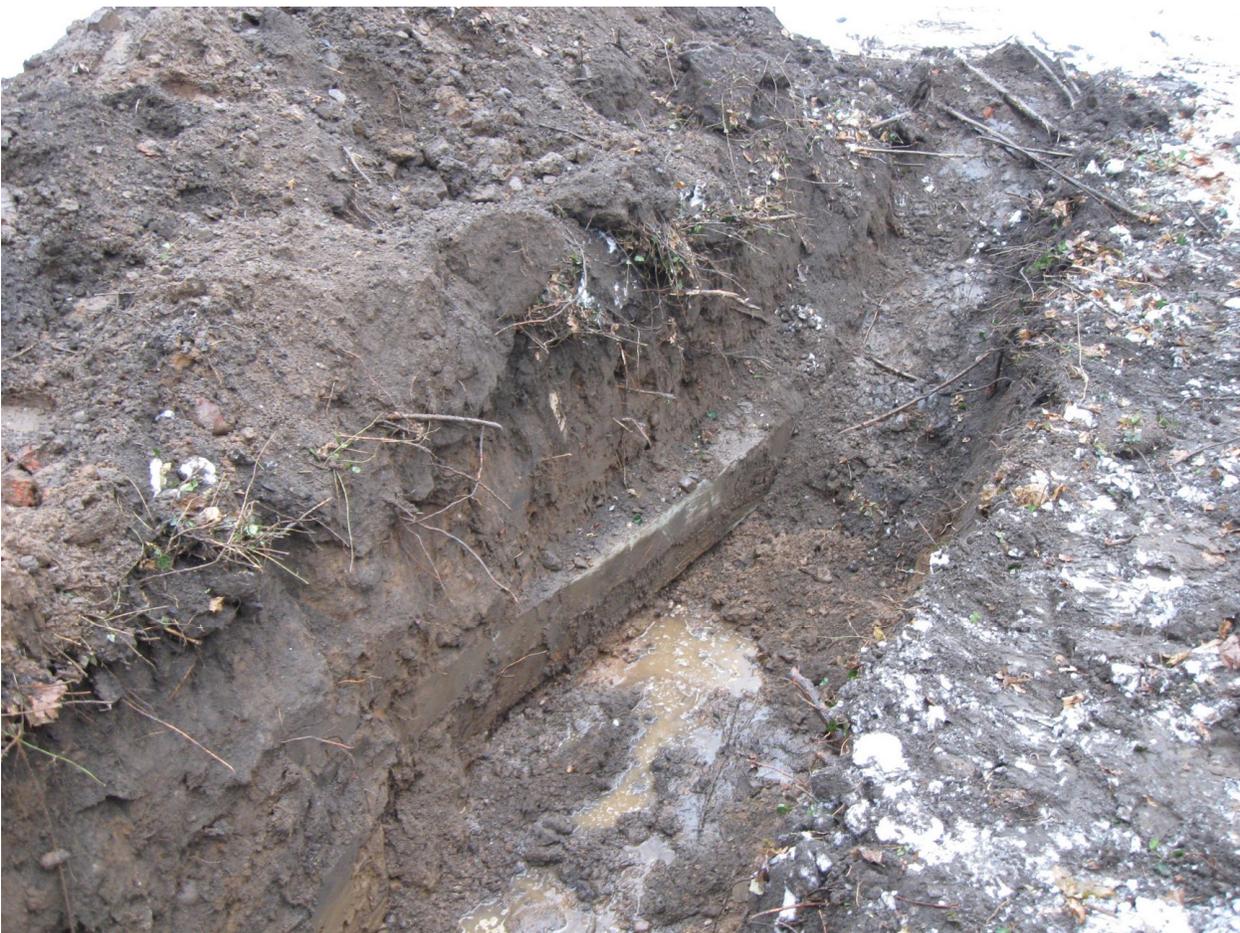
Figure 16. The southern part of the east wall of Trench 4, showing the concrete utility casing exposed along the edge of the trench. Brooklyn Navy Yard, Kings County, New York (PCI 2009).

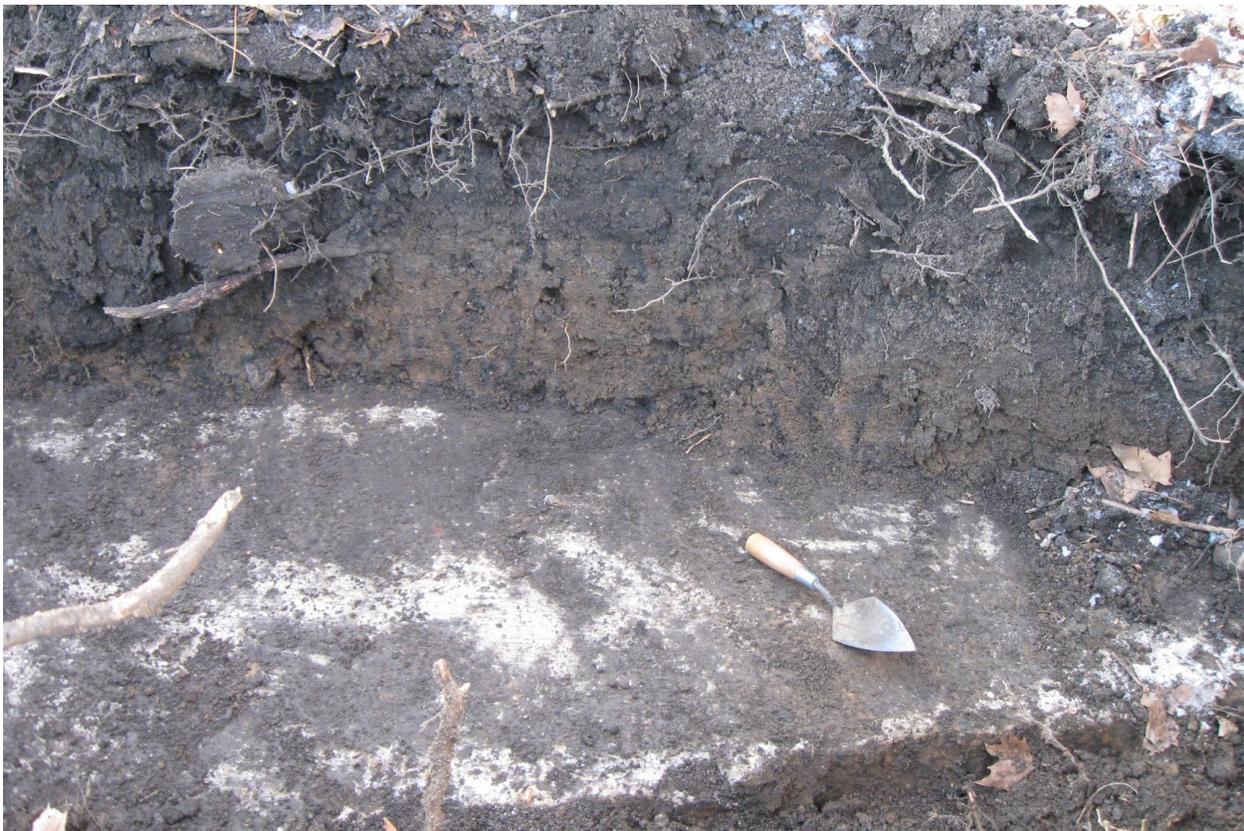
Figure 17. South wall profile of Trench 5; the trowel sits atop the concrete utility encasement inadvertently uncovered in the trench. Brooklyn Navy Yard, Kings County, New York (PCI 2009).

Two artifacts were collected from the Trench 5 back dirt: a complete brick with a maker's mark reading "SHAMROCK" and a piece of salt-glazed stoneware.

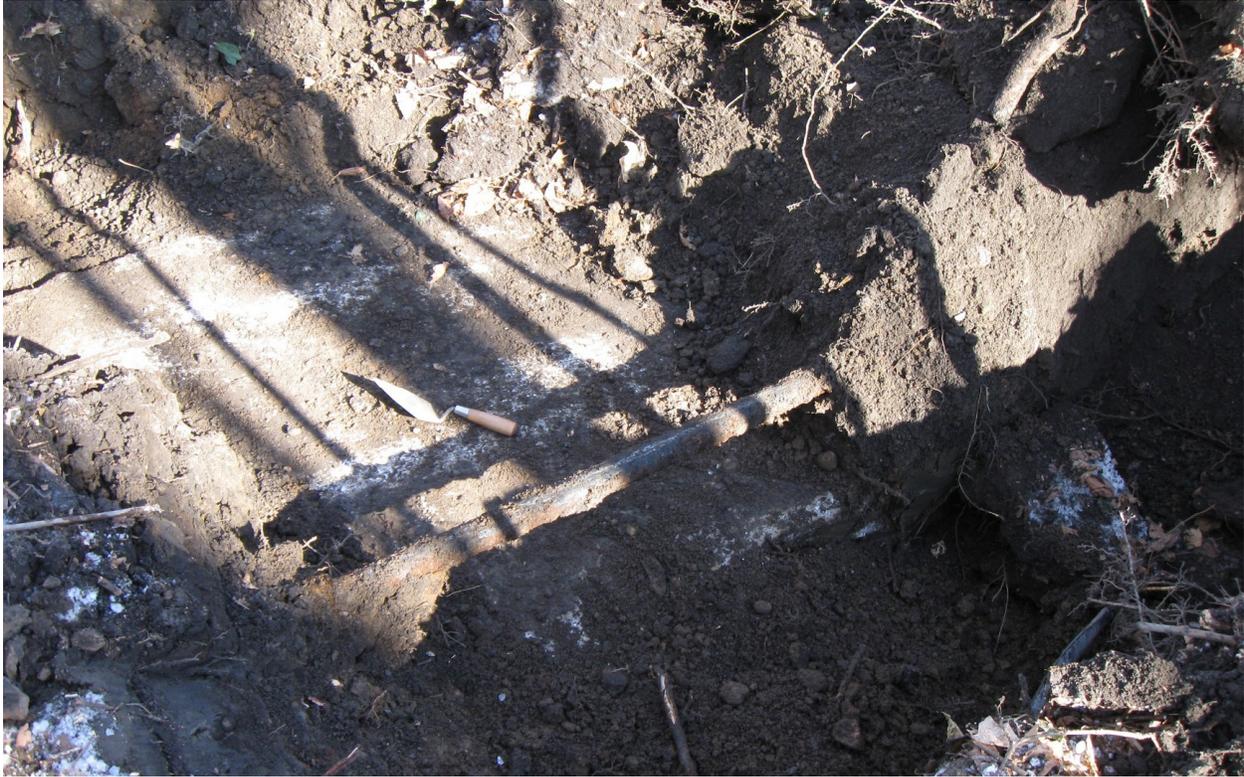
Figure 18. Concrete utility casing in Trench 5 after the trench was widened to the north. Brooklyn Navy Yard, Kings County, New York (PCI 2009).

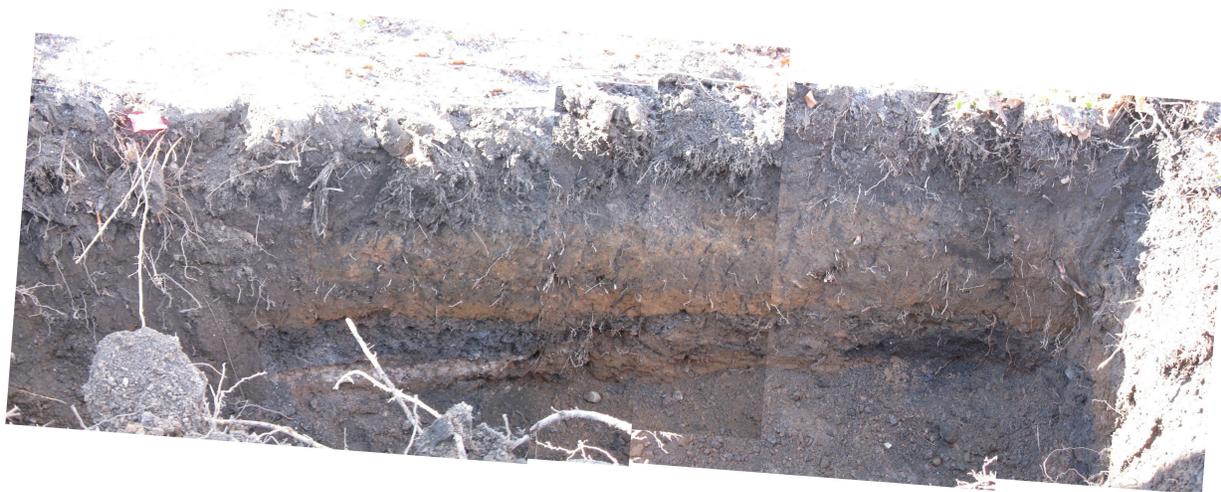
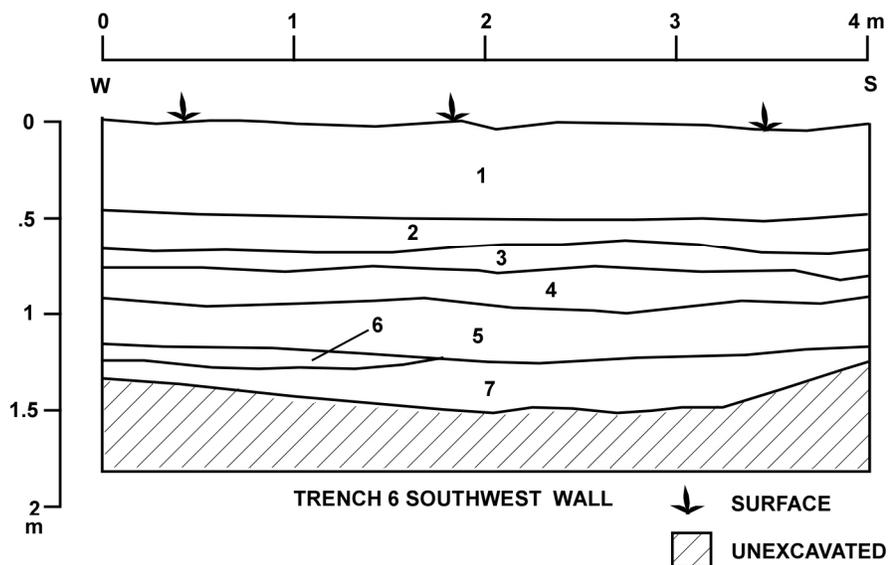
- STRATUM 1 = MIX OF DARK BROWN (10YR 3/3) AND BLACK (10YR 2/1) SANDY LOAM
- STRATUM 2 = MIX OF STRONG BROWN (7.5YR 4/6), AND DARK BROWN (10YR 3/3) GRAVELLY SANDY LOAM
- STRATUM 3 = DARK BROWN (10YR 3/3) SANDY LOAM
- STRATUM 4 = MIX OF DARK YELLOWISH BROWN (10YR 4/6) AND BLACK (10YR 2/1) SANDY LOAM
- STRATUM 5 = ASH, MORTAR, BRICK FRAGMENTS, IRON SLAG, AND COAL
- STRATUM 6 = MORTAR FRAGMENTS
- STRATUM 7 = YELLOWISH BROWN (10YR 5/6) VERY GRAVELLY SAND

Figure 19. Trench 6 southwest wall profile. Brooklyn Navy Yard, Kings County, New York (PCI 2009).

A sample of 10 historical artifacts was collected from the Trench 6 back dirt, including a piece of creamware; 2 fragments of ironstone; a thick (14 mm) piece of green plate glass; a piece of heavy-gauge copper-sheathed wire; an unidentified fragment of iron (possibly a fastener); and 4 leather shoe sole fragments. All the items were likely from Stratum 5, the deposit of coal ash, mortar, brick fragments, iron slag, and coal.

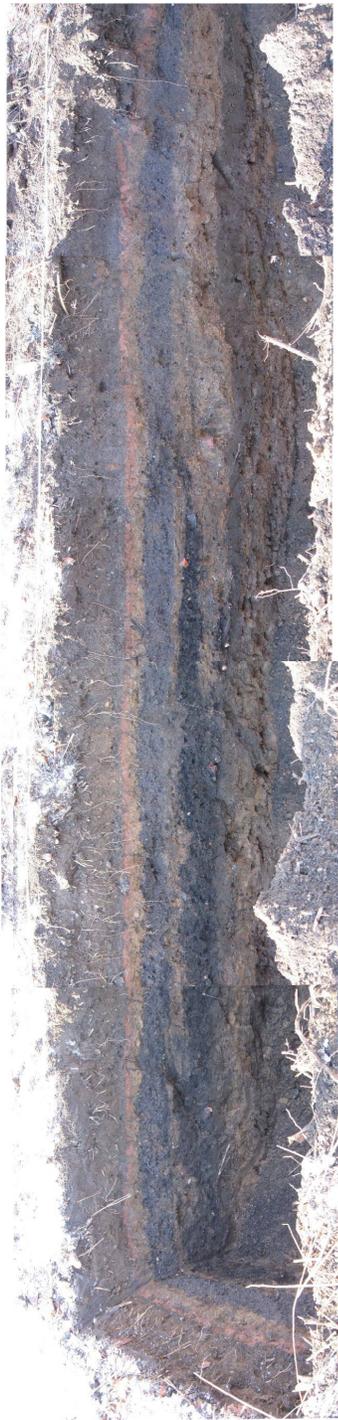
TRENCH 7 WEST WALL

- STRATUM 1 = DARK BROWN (10YR 3/2) GRAVELLY SANDY LOAM
- STRATUM 2 = DARK GRAYISH BROWN (10YR 4/2) VERY GRAVELLY SAND
- STRATUM 3 = RED (2.5YR 4/6) LOAMY SAND
- STRATUM 4 = DARK YELLOWISH BROWN (10YR 4/6) GRAVELLY LOAMY SAND
- STRATUM 5 = BLACK (10YR 2/1) COAL ASH AND IRON SLAG
- STRATUM 6 = MIX OF DARK YELLOWISH BROWN (10YR 4/6) AND BROWN (10YR 4/3) GRAVELLY SAND
- STRATUM 7 = VERY DARK BROWN (10YR 2/2) AND BLACK (10YR 2/1) COAL ASH AND IRON SLAG
- STRATUM 8 = MIX OF DARK YELLOWISH BROWN (10YR 4/6) AND BROWN (10YR 4/3) GRAVELLY SAND
- STRATUM 9 = VERY DARK GRAYISH BROWN (10YR 3/2) SAND
- STRATUM 10 = MIX OF STRONG BROWN (7.5YR 4/6) DARK GRAYISH BROWN (10YR 4/2) AND VERY DARK BROWN (10YR 2/2) GRAVELLY SAND
- STRATUM 11 = STRONG BROWN (7.5YR 4/6) SAND

Beyond this, the evidence from the trenches sheds some additional light on the mechanisms with which the study area was filled. First, a large portion of the fill material was composed of a mix of industrial, architectural, and domestic trash. Stratum 6 in Trench 1, Stratum 10 in Trench 3, Strata 5 and 6 in Trench 6, and Stratum 10 in Trench 7 all were composed almost entirely of a mix of coal, coal ash, brick fragments, and iron slag, within

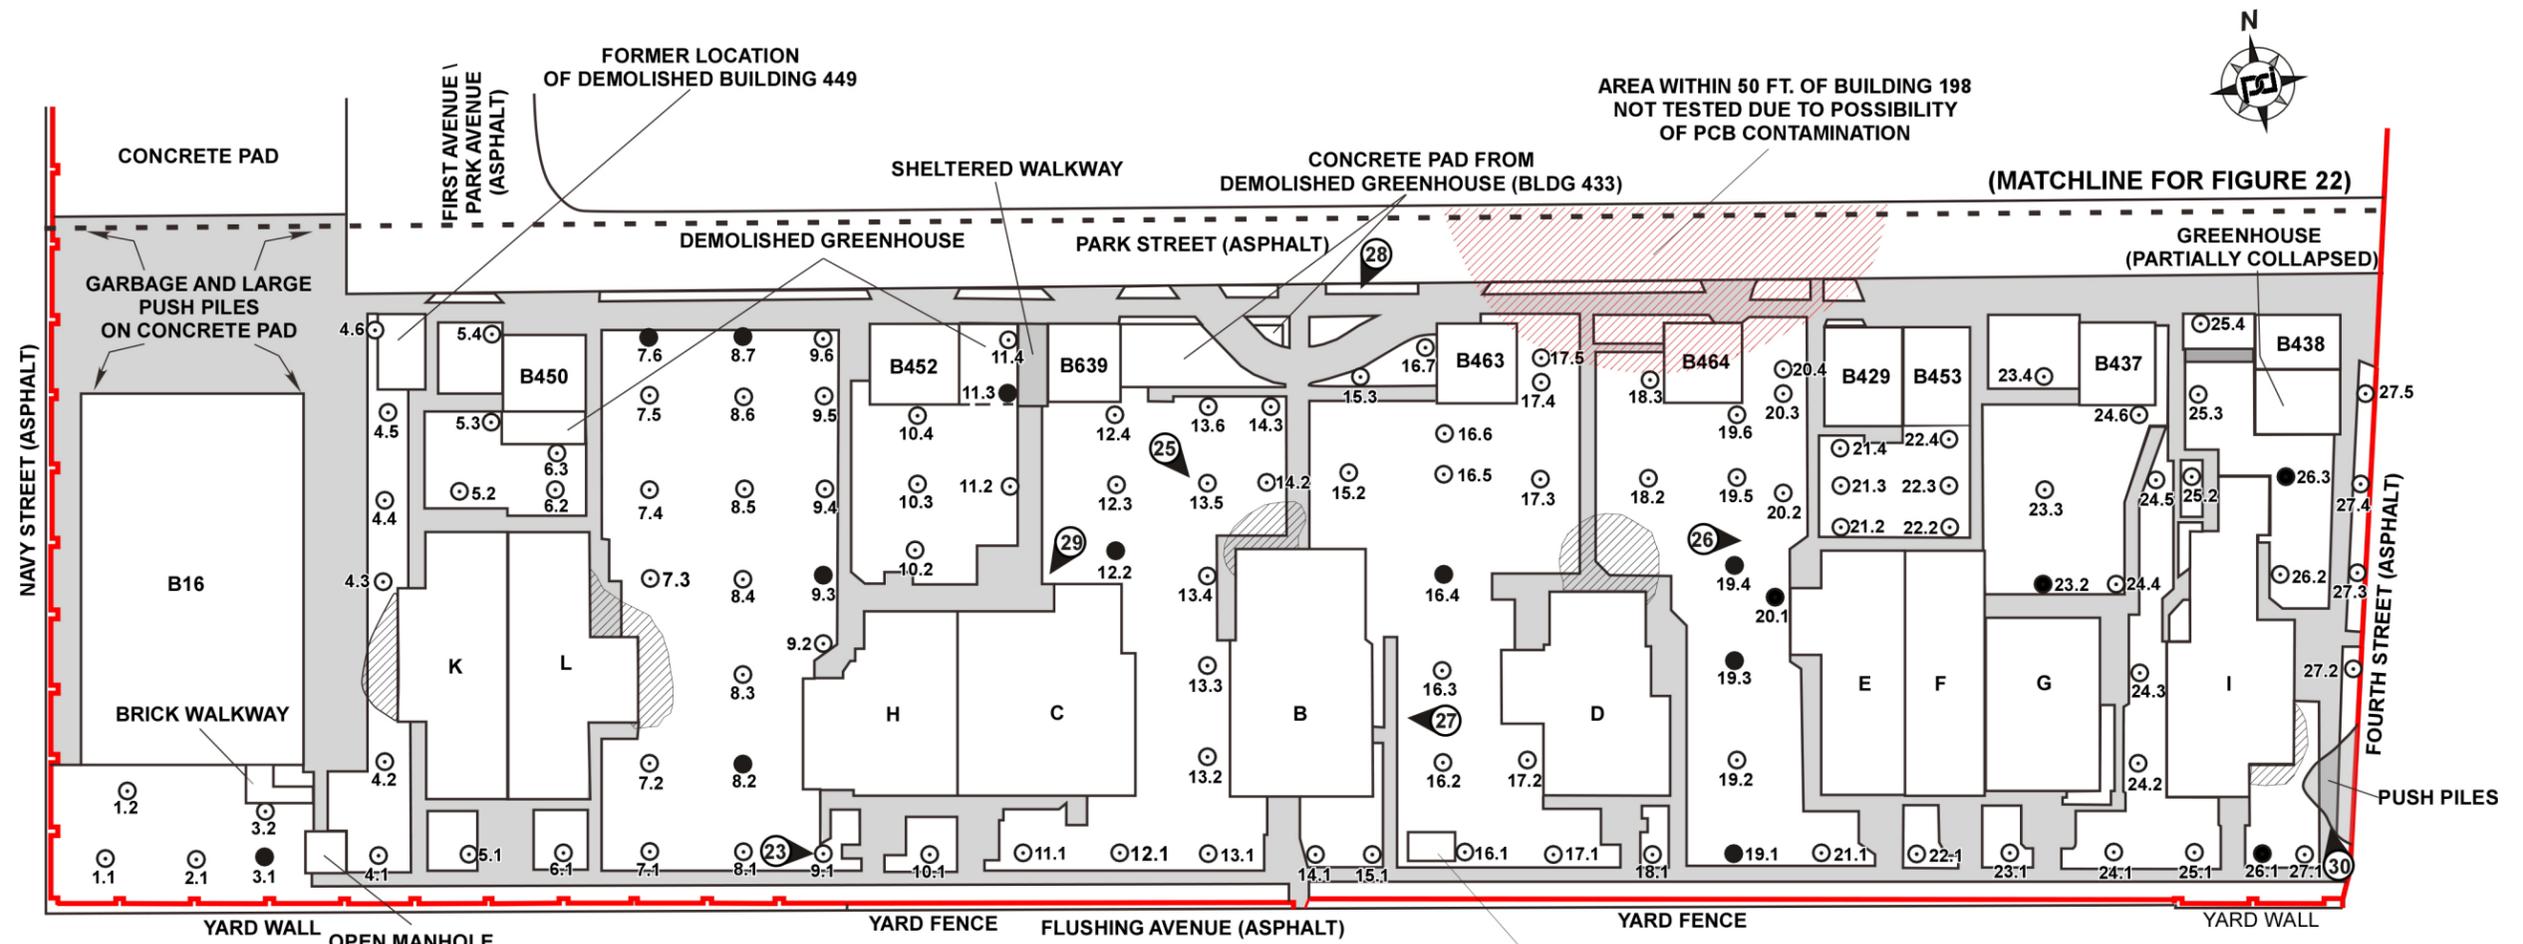
Figure 21. Project Area layout and shovel test arrangement for the area around the Admiral's Row quarters, south of Park Street, also showing photo angles. Brooklyn Navy Yard, Kings County, New York (PCI 2009).

A total of 20 domestic historical (i.e., non-modern) artifacts were found in 15 of the regular-interval tests dug around the quarters (STPs 3.1, 7.6, 8.2, 8.7, 9.3, 11.3, 12.2, 16.4, 19.1, 19.3, 19.4, 20.1, 23.2, 26.1 and 26.3). The items include: a piece of stoneware; a fragment of creamware with blue transfer-printed decoration on both sides; 3 pieces of pearlware (of which one has a flow blue design with leaves and berries; one has a blue hand-painted design and possibly comes from a tea pot or a serving vessel; and one has molded floral decoration); a small fragment of molded porcelain with a single glazed surface possibly from a doll; 3 pieces of whiteware (of which one is hand-painted, one has blue transfer print decoration, and one is undecorated); 3 fragments of undecorated semi-vitreous china; a crescent-shaped piece of medium-gauge sheet brass (possibly decorative); 6 fragments of container glass (one of which is possibly from a drinking glass or tumbler and another is from a bottle with a hexagonal cross section); and a faux-mother-of-pearl plastic button.
