**U.S. Army Corps of Engineers
New York District**

**PHASE IB ARCHAEOLOGICAL
CULTURAL RESOURCES INVESTIGATION
FOR THE ADMIRAL'S ROW SECTION OF THE
FORMER BROOKLYN NAVY YARD, BROOKLYN,
KINGS COUNTY, NEW YORK**

July 2009

**PANAMERICAN CONSULTANTS, INC.
Buffalo Branch Office
2390 Clinton Street
Buffalo, New York 14227-1735**

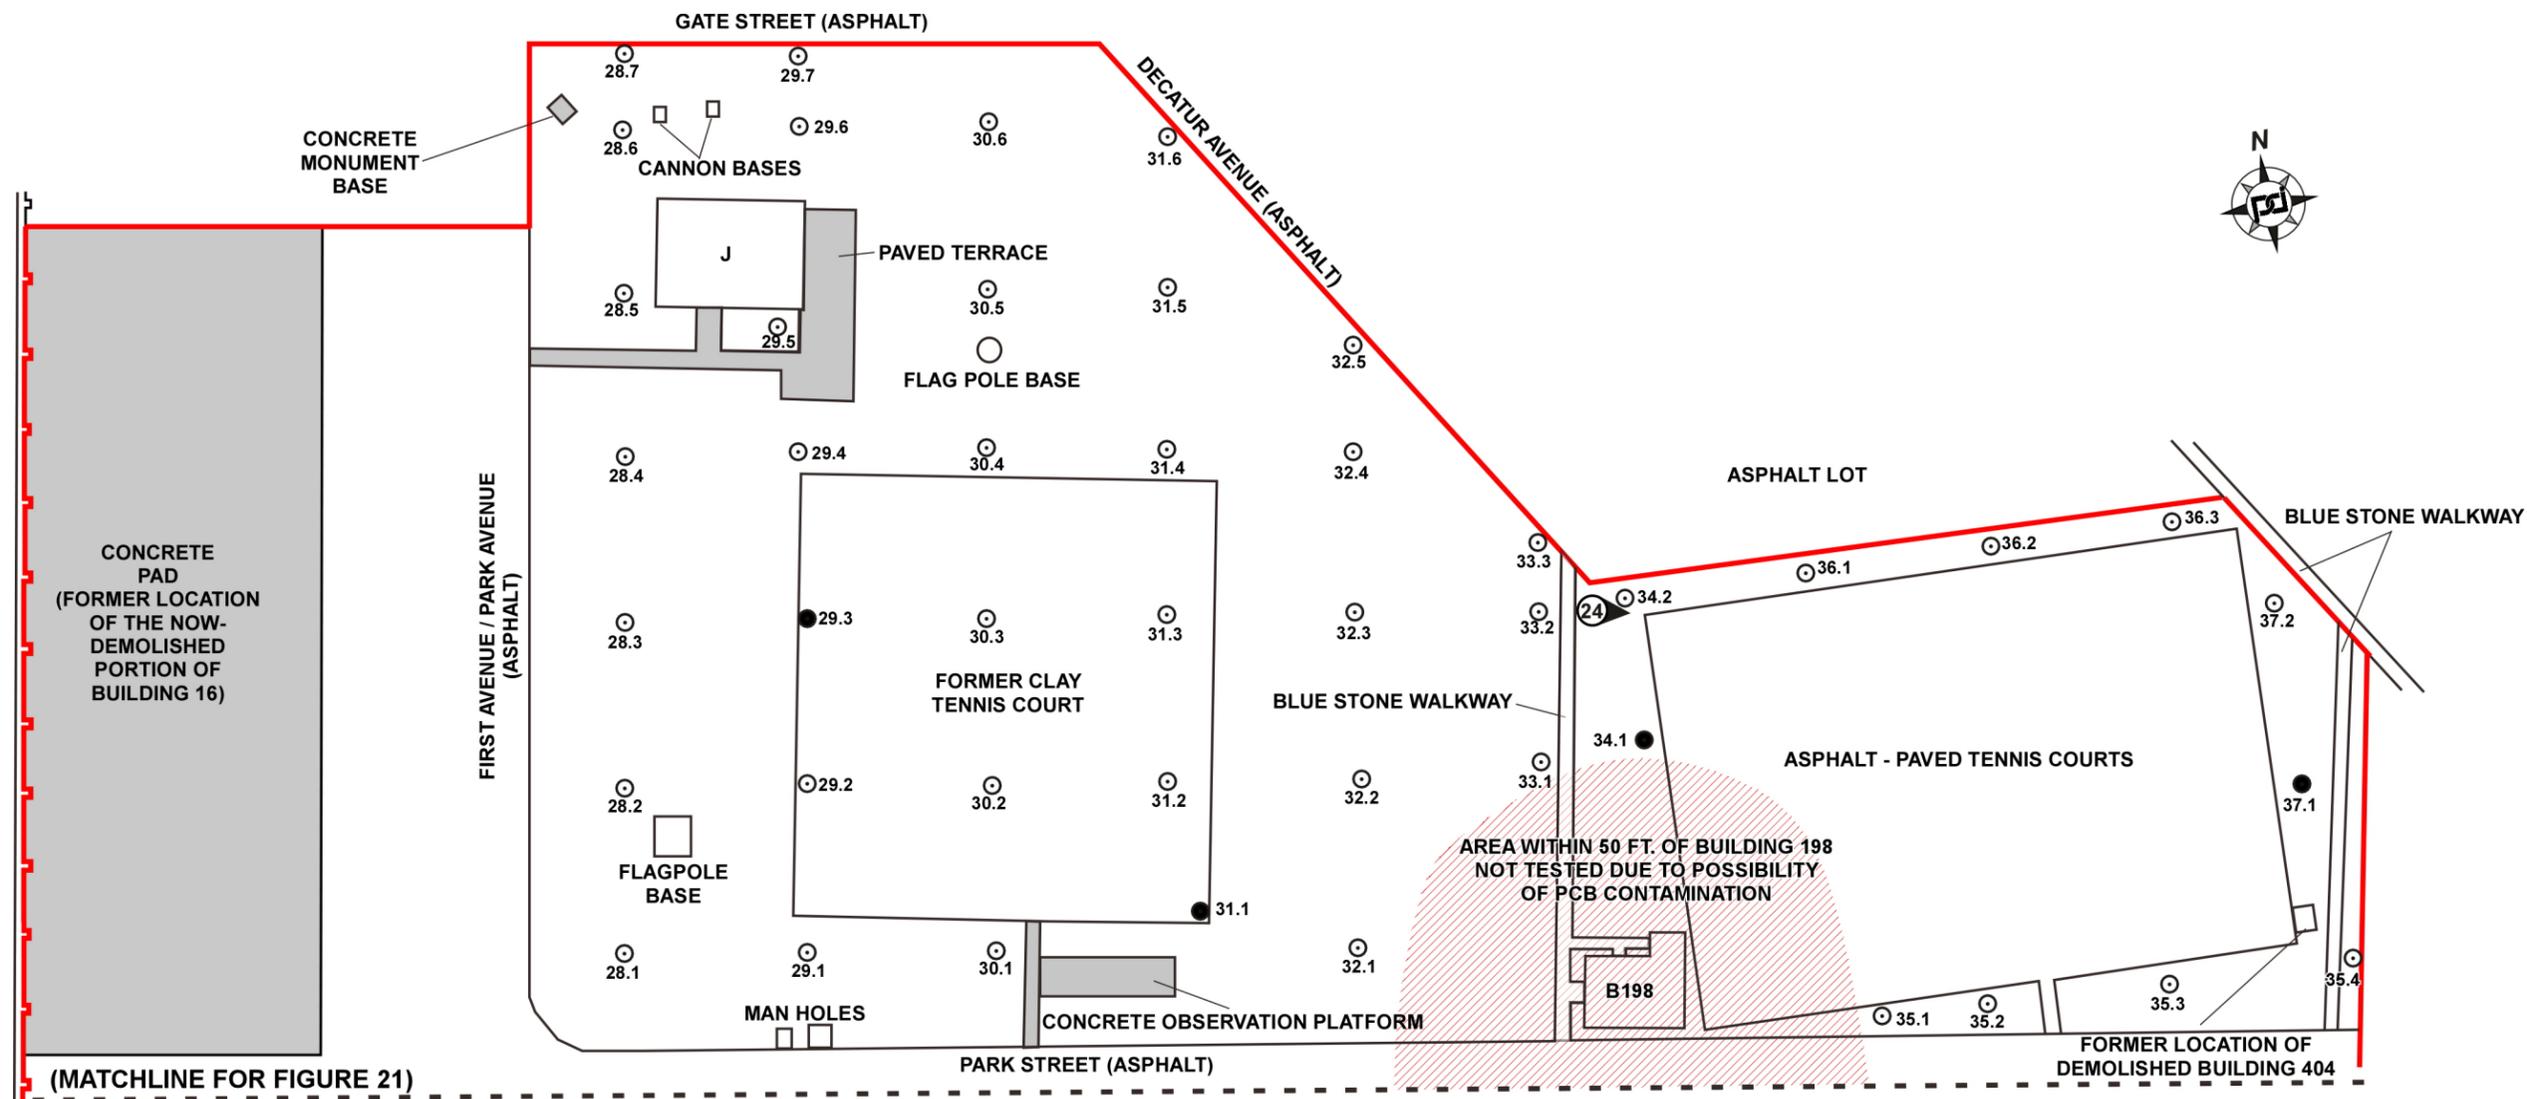
Figure 22. Project Area layout and shovel test arrangement for the zone north of Park Street, including the former parade ground / park, also showing photo angles. Brooklyn Navy Yard, Kings County, New York (PCI 2009).

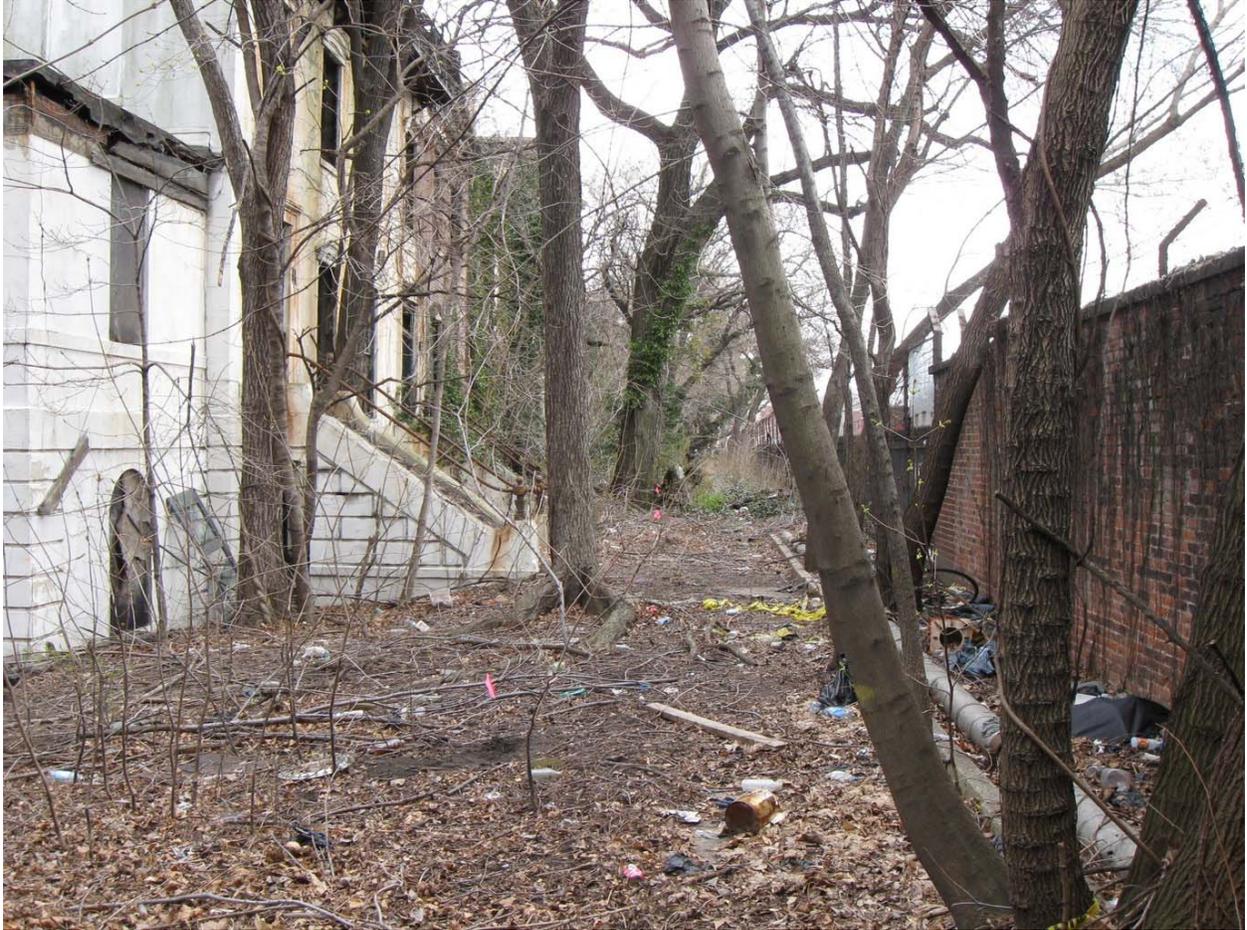
Figure 23. The front (south) yards of Quarters C and H, facing east. The yard wall is at right. An aboveground steam utility line is visible just to the left of the wall. Note the large amounts of modern refuse. Also note the density of obstructions that precluded the use of heavy machinery in this part of the study area during the geomorphological investigation. Brooklyn Navy Yard, Kings County, New York (PCI 2009).

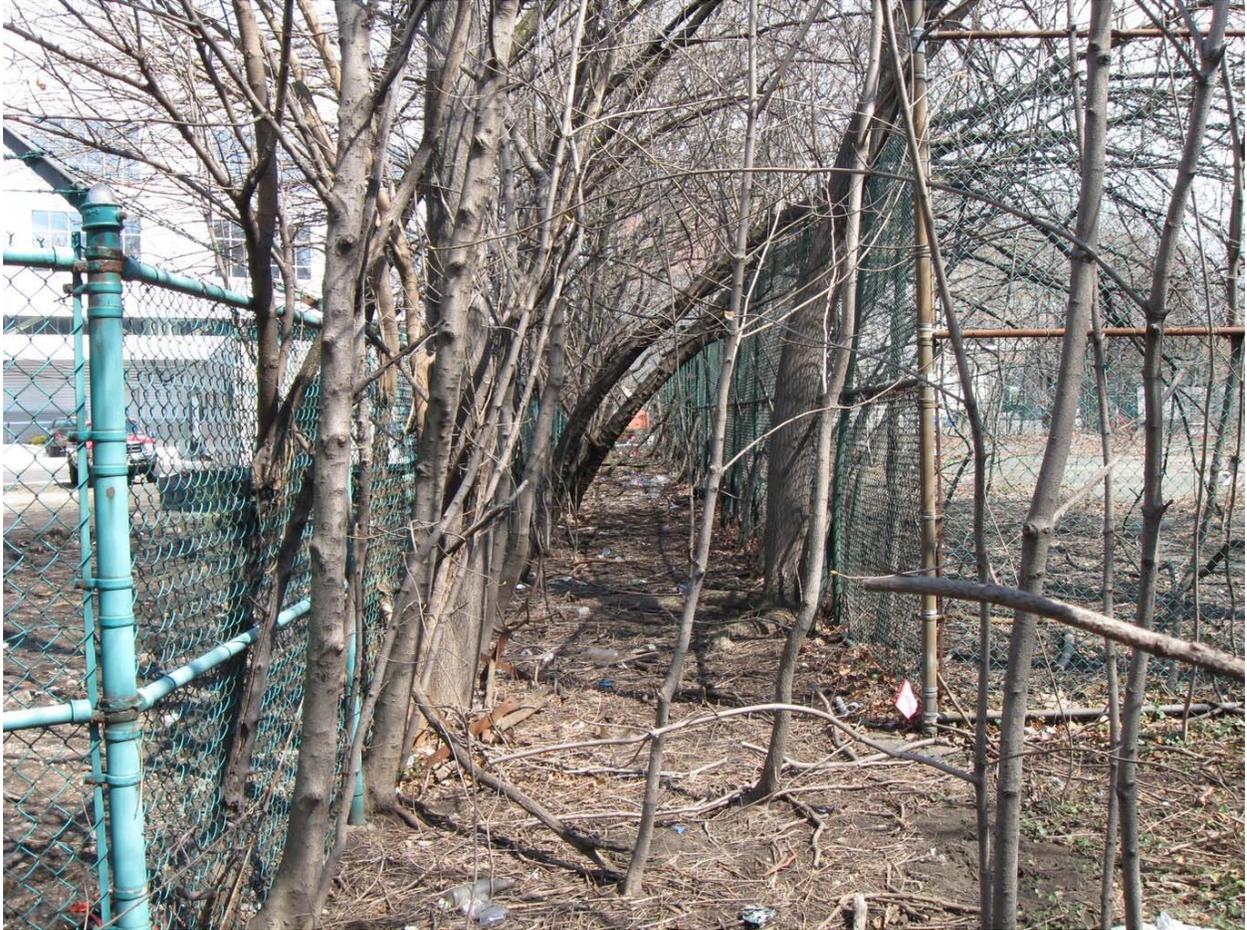
Figure 24. Site surface conditions along the north side of the asphalt-paved tennis courts in the northeastern portion of the study area, facing east. Brooklyn Navy Yard, Kings County, New York (PCI 2009).

At the time of the field investigation (Figures 21 and 22), large amounts of modern trash and historical building debris were scattered across the surface of much of the project area (Figures 23 and 24). The largest density of modern litter occurred just inside the yard wall along Flushing Avenue and Navy Street. The amount of modern items was just slightly lower along the fences adjacent to the navy yard. Typically, the volume of trash decreased with distance from the edges of the study area, although at least moderate amounts of litter were nearly ubiquitous.

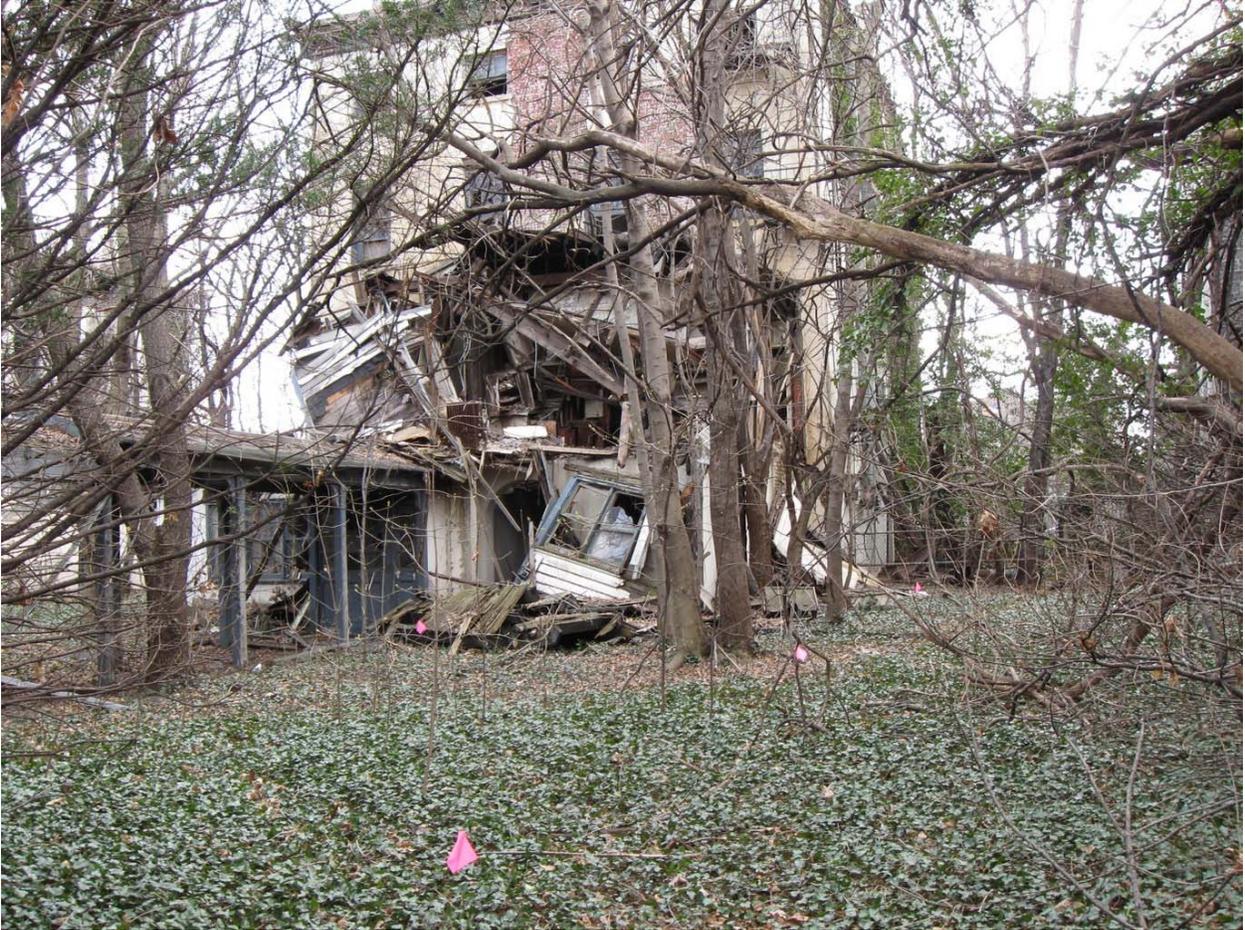
Figure 25. Partially collapsed twentieth-century extension on the north (back) side of Quarters B, facing southeast. The pink flags mark the locations of shovel tests in Transects 13 and 14. Brooklyn Navy Yard, Kings County, New York (PCI 2009).

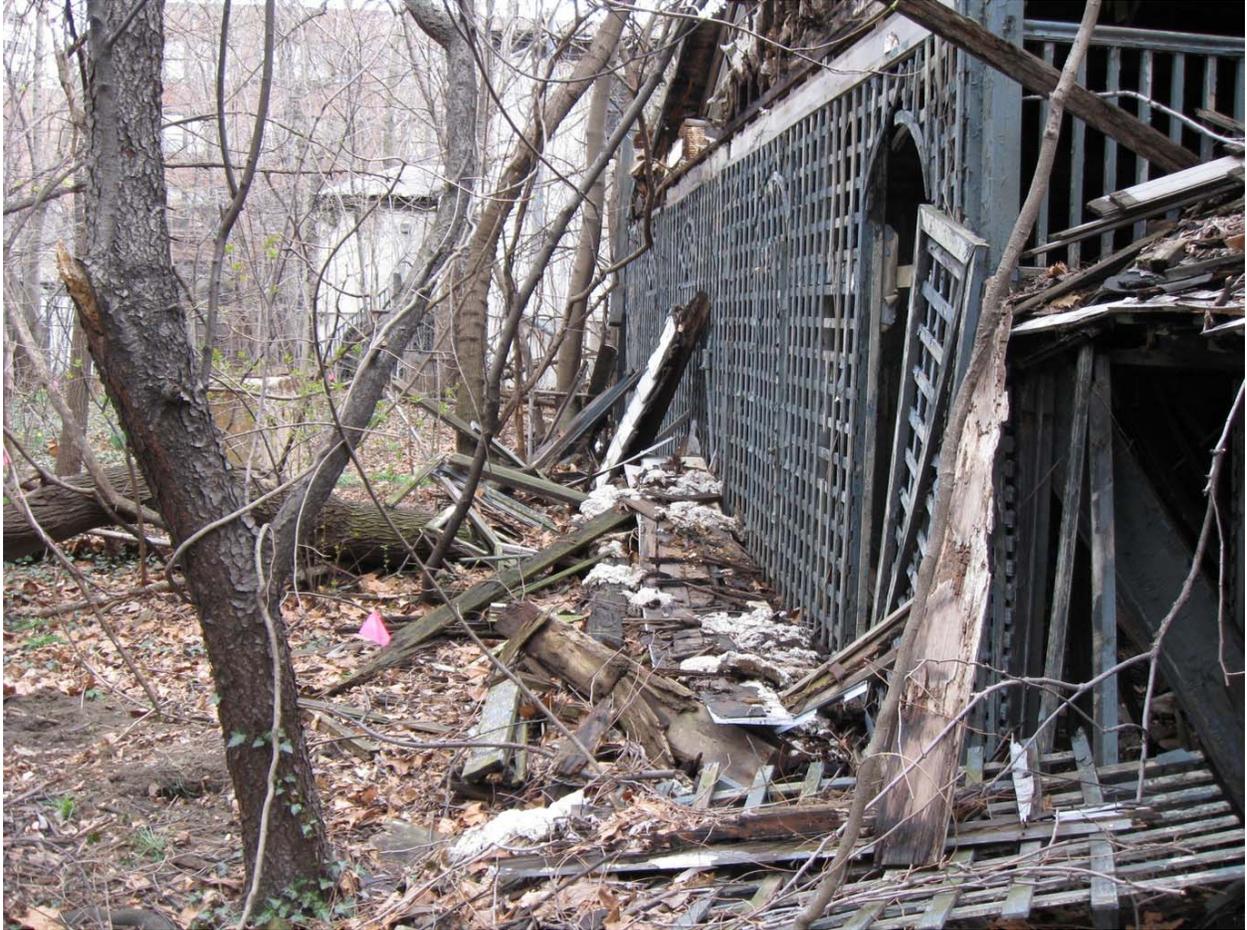
Figure 26. Debris along the north side of Quarters E/F from the partially collapsed twentieth-century extension on the north (back) side of the building, facing east. The pink flag marks the location of STP 21.2. Brooklyn Navy Yard, Kings County, New York (PCI 2009).

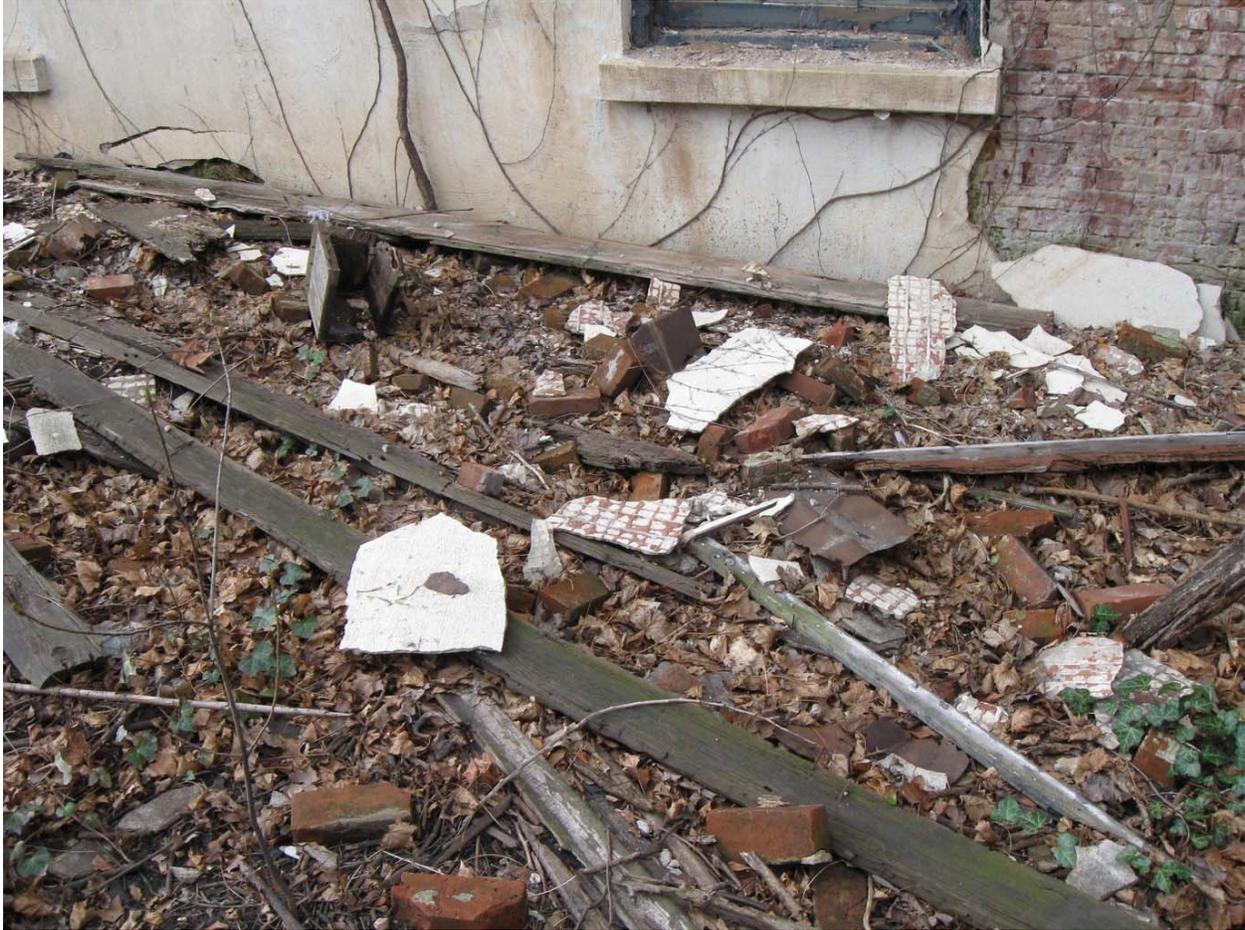
Figure 27. Architectural debris on the east side of Quarters B. This density of material is typical of that along the lateral sides and fronts (i.e., south sides) of the quarters buildings. Brooklyn Navy Yard, Kings County, New York (PCI 2009).

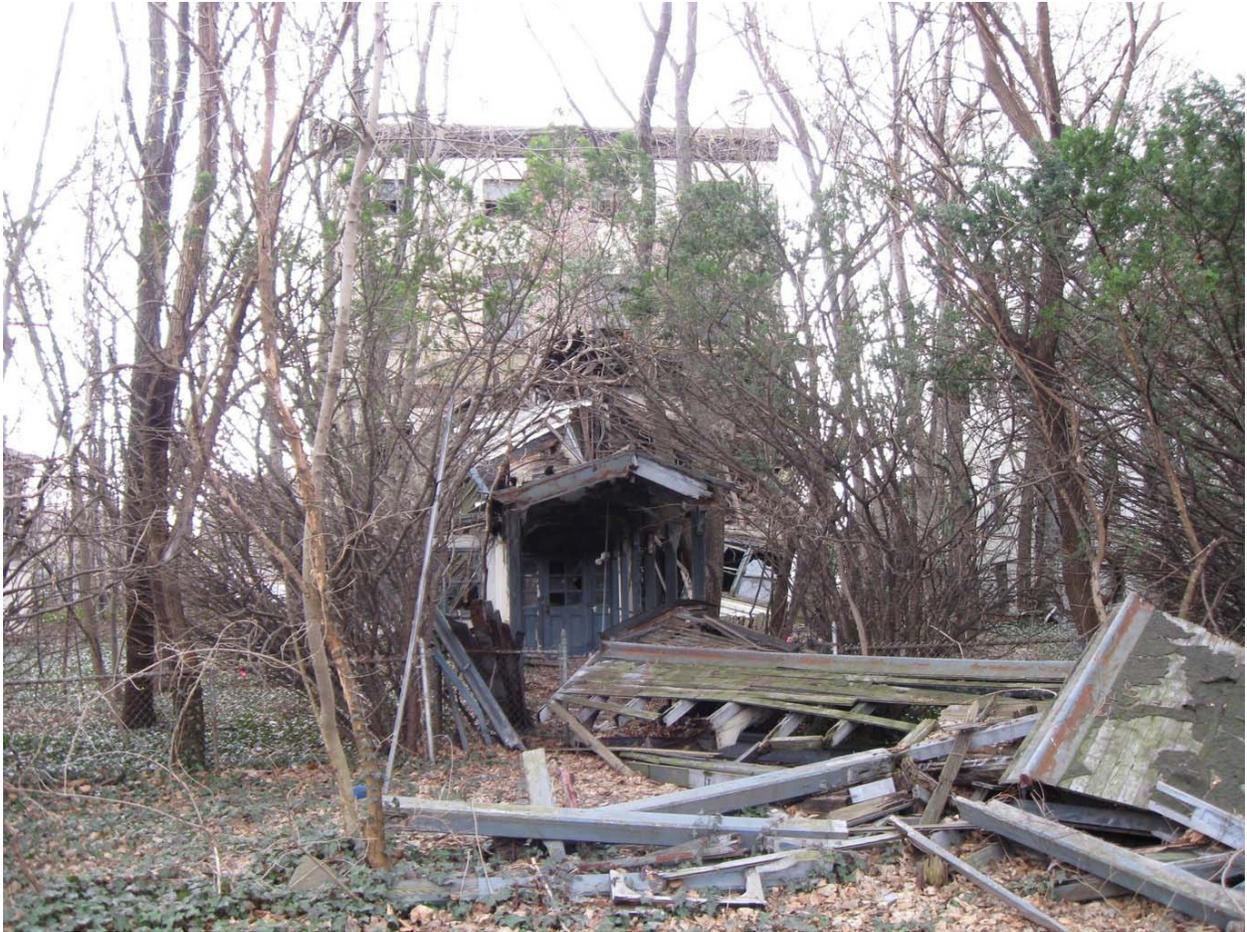
Figure 28. Collapsed portion of the superstructure for the roofed walkway that extends north from Quarters B, facing south from Park Street. Brooklyn Navy Yard, Kings County, New York (PCI 2009).

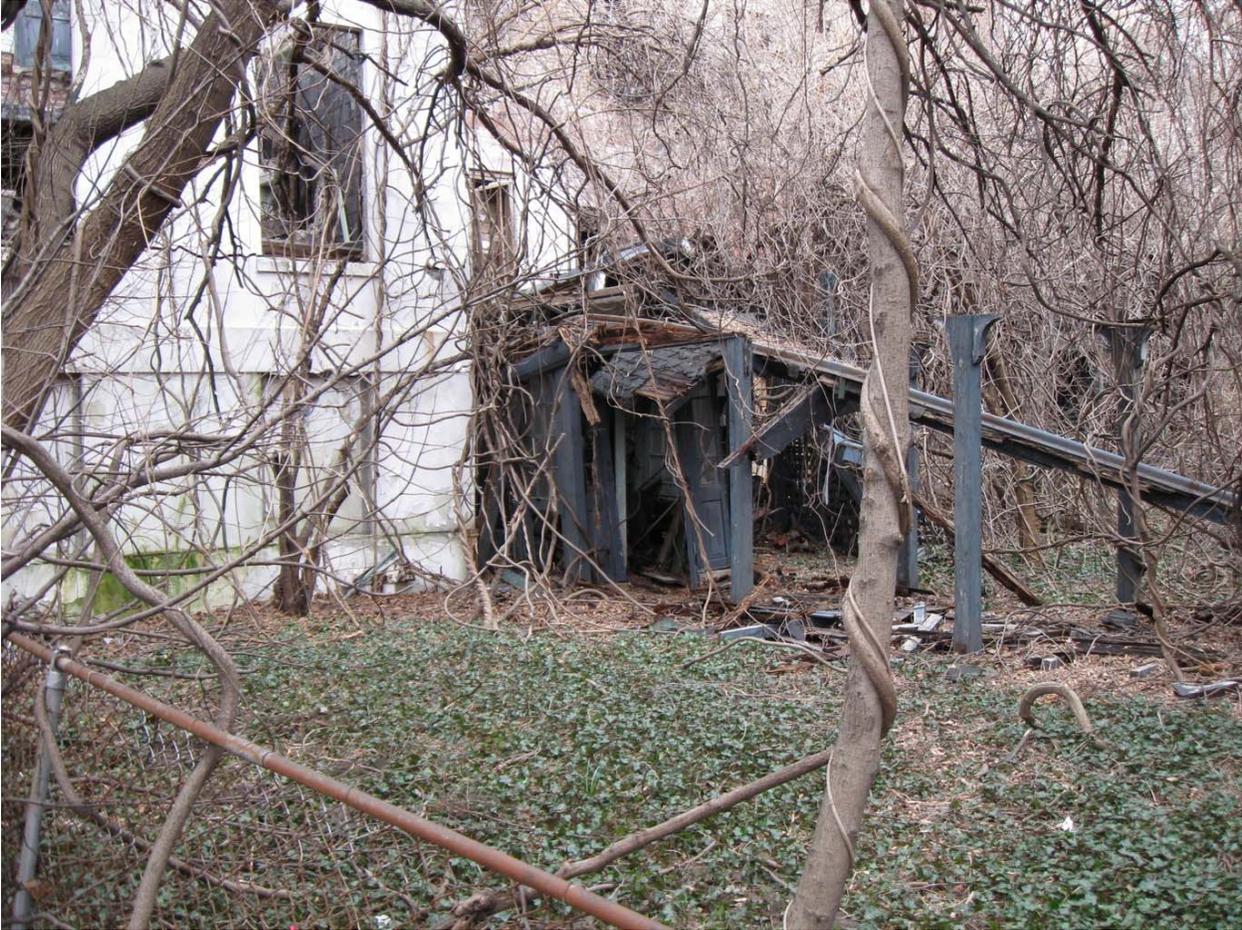
Figure 29. Collapsed portion of the superstructure for the roofed walkway that extends north from Quarters C, facing southwest. Brooklyn Navy Yard, Kings County, New York (PCI 2009).

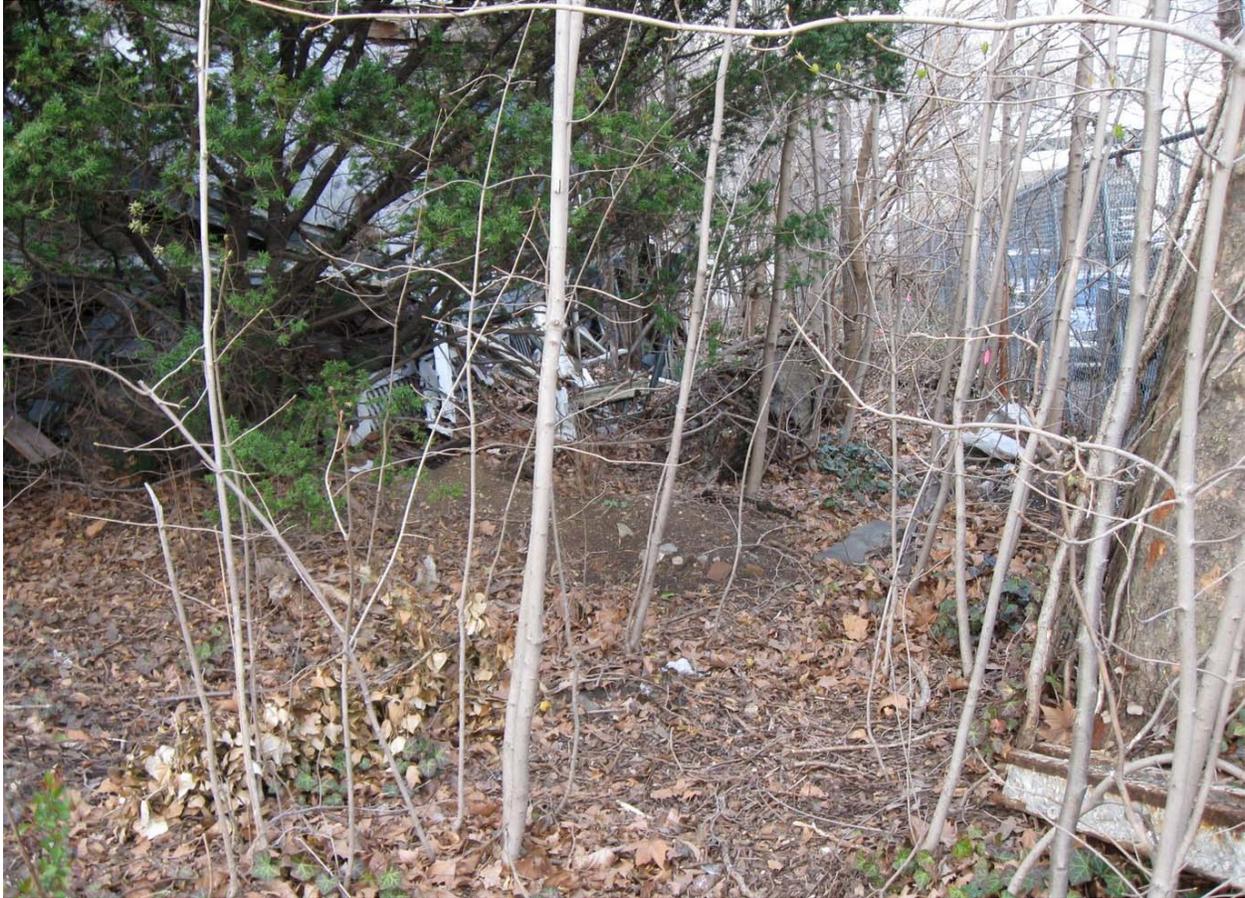
Figure 30. Push piles along the boundary of the study area southeast of Quarters I, facing north. Fourth Street is at right. Brooklyn Navy Yard, Kings County, New York (PCI 2009).

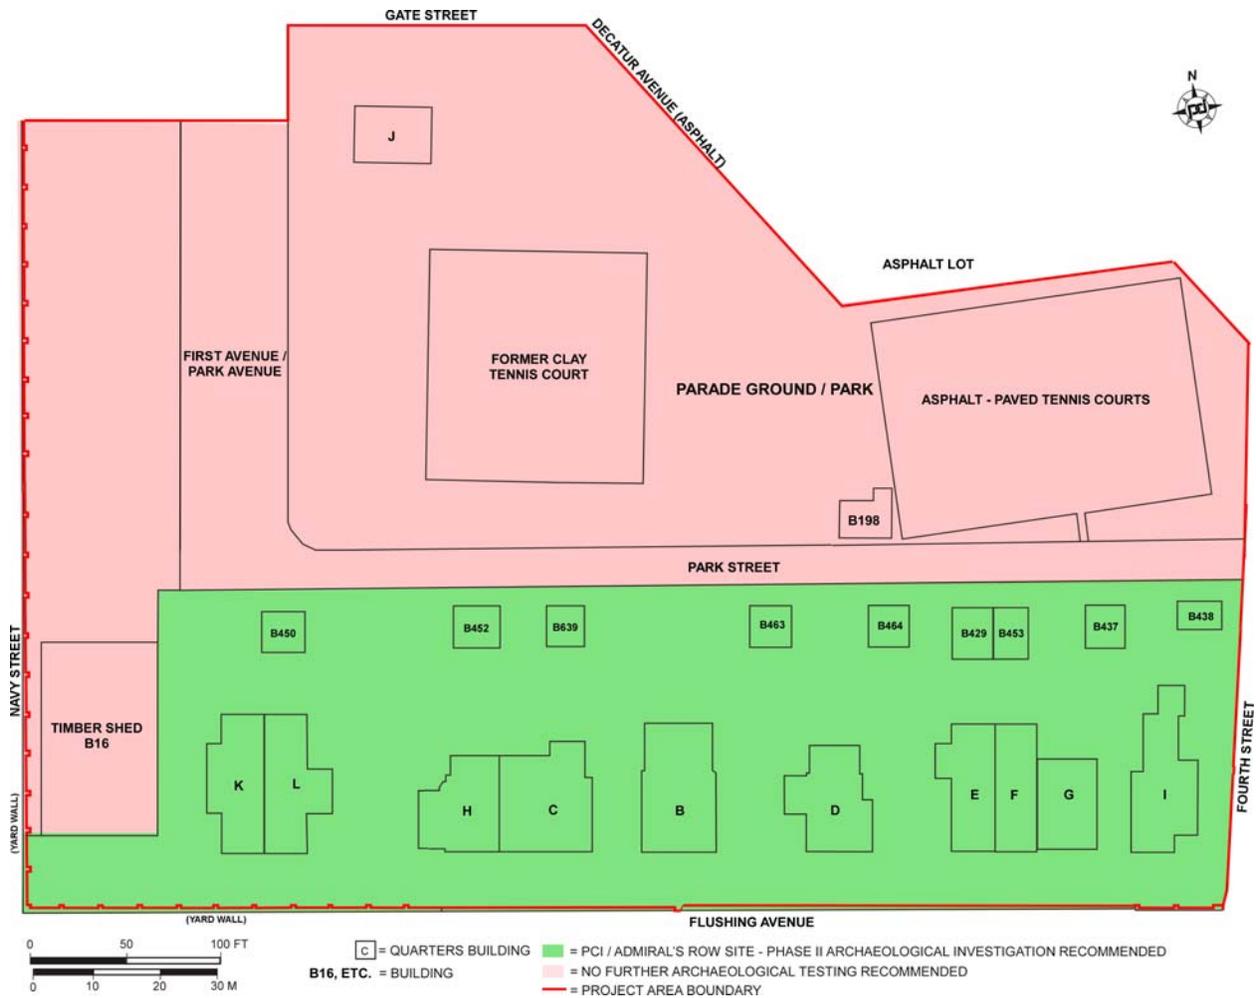
Figure 40. Summary of Phase IB recommendations.
