Phase 1B Archaeological Testing Report

44th Street and Eleventh Avenue

Block 1073, Lot 1 (Part)

Manhattan, New York County, New York

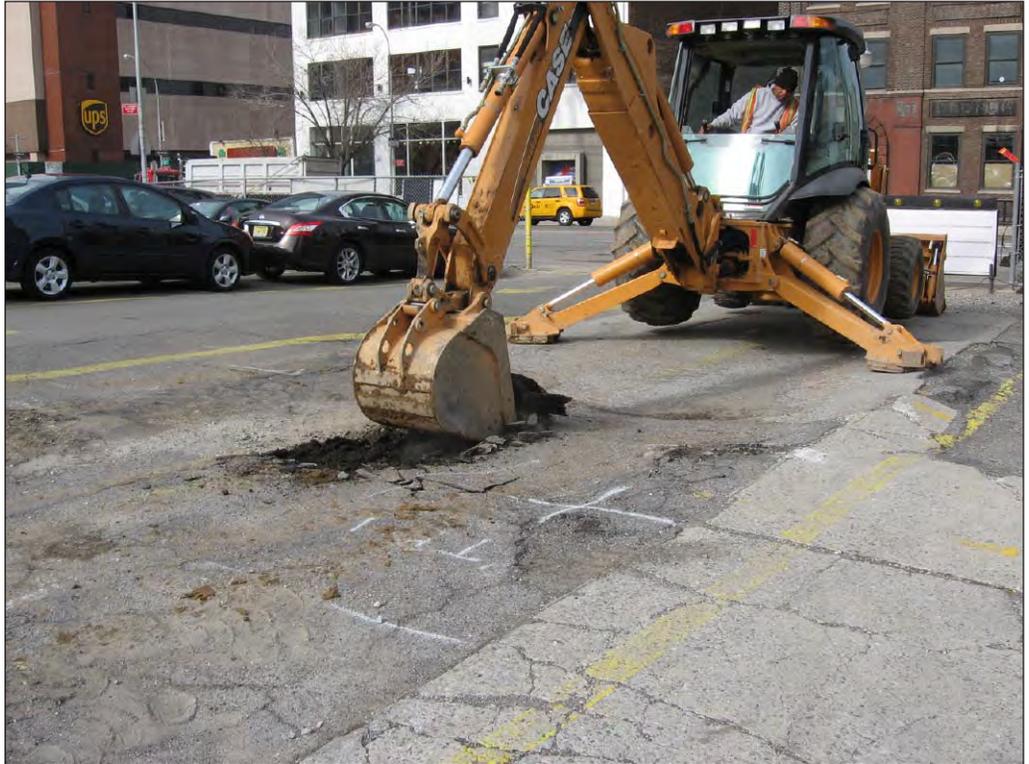
1

Facing northwest from center of parking lot toward intersection of W45th Street and 11th Avenue

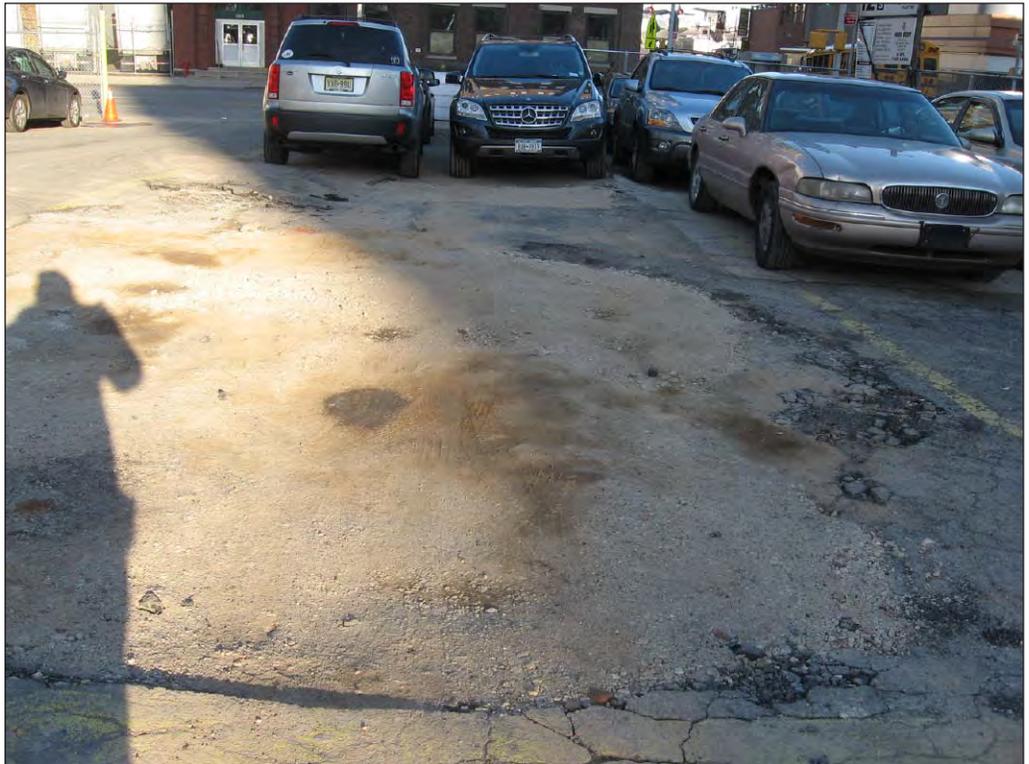
2

Facing north across Area 1 toward 45th Street

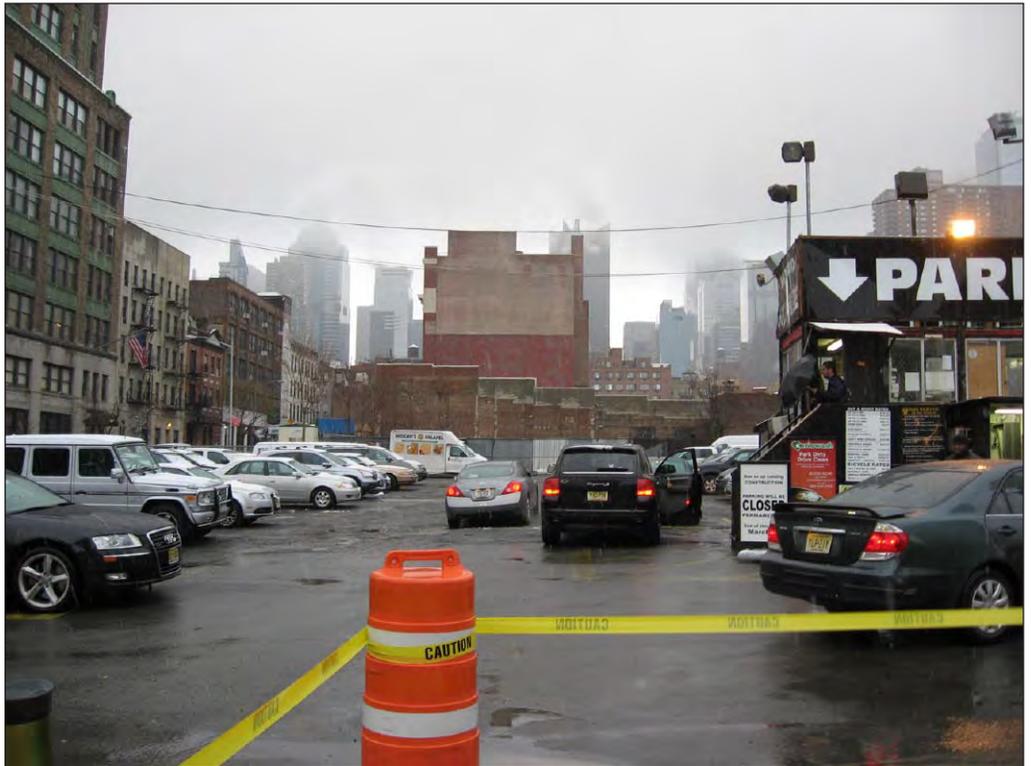
Facing east across parking lot from location of Area 2 3

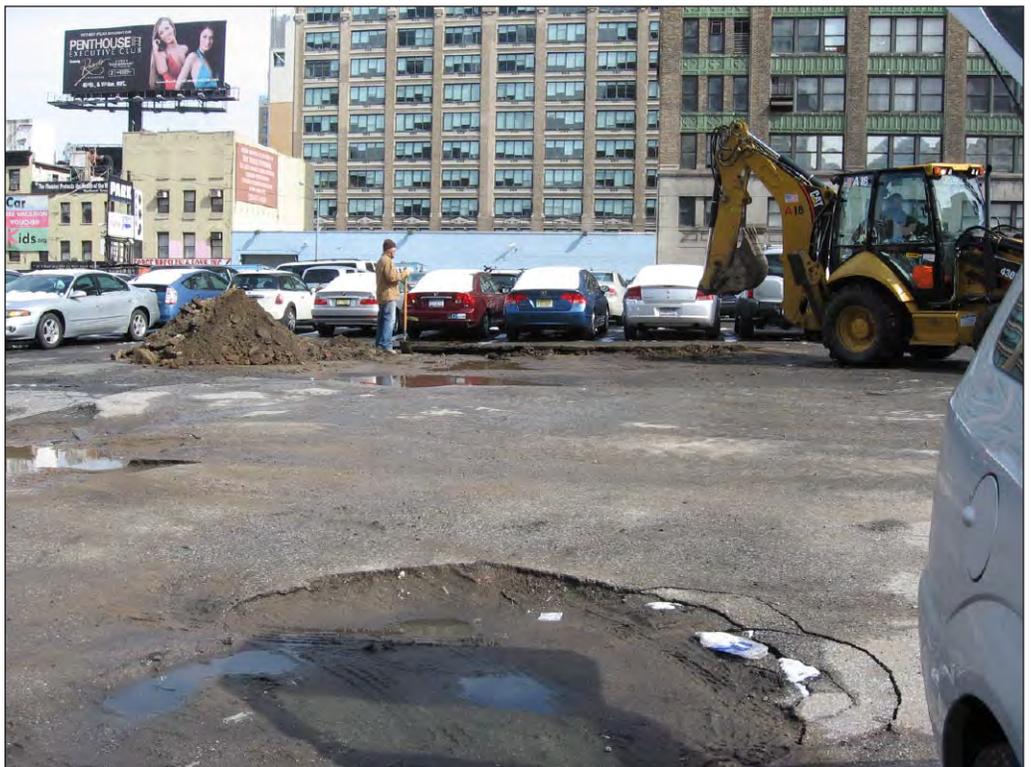
Facing north from south side of parking lot near W44th Street showing testing of Area 3 4

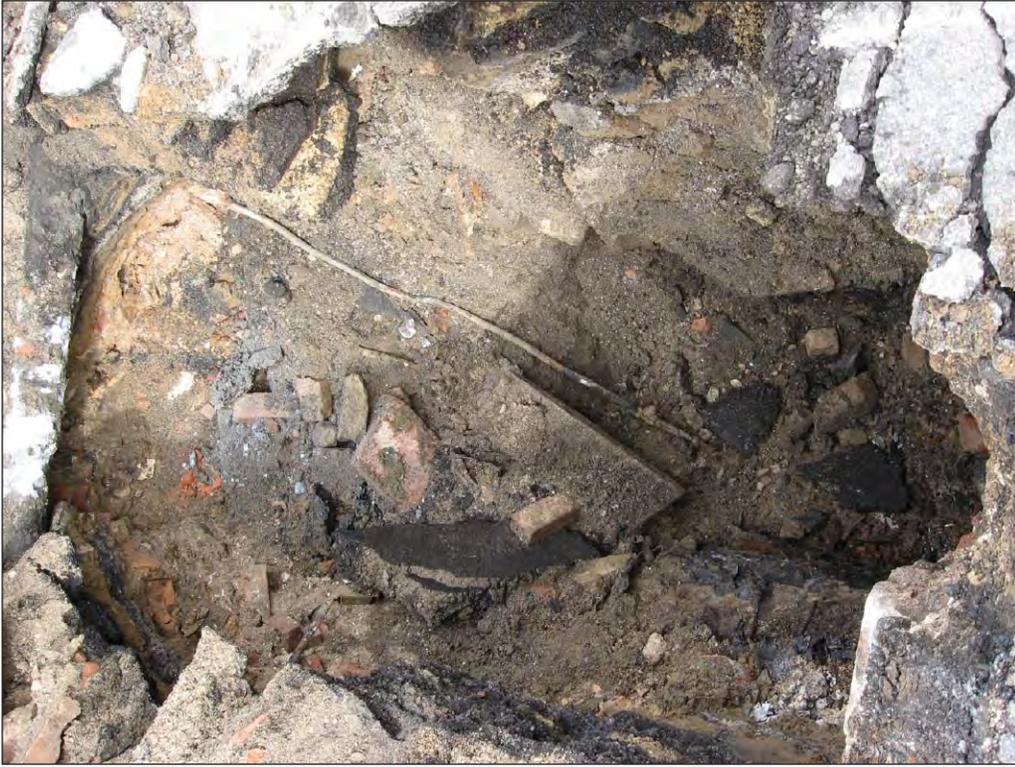
This trench was excavated on the west side of Area of Sensitivity 1 and had dimensions of approximately eight feet by eight feet. It was excavated to a depth of over six feet and contained loose demolition debris and significant quantities of brick. An intact foundation wall was observed on the east side of the trench indicating that the trench likely encountered the debris-filled basement of the former building.

Test Pit 1 showing over six feet of mixed demolition debris 5

Figure 5 provides two photographs of this trench. A small number of artifacts were collected from the soils excavated from this trench.

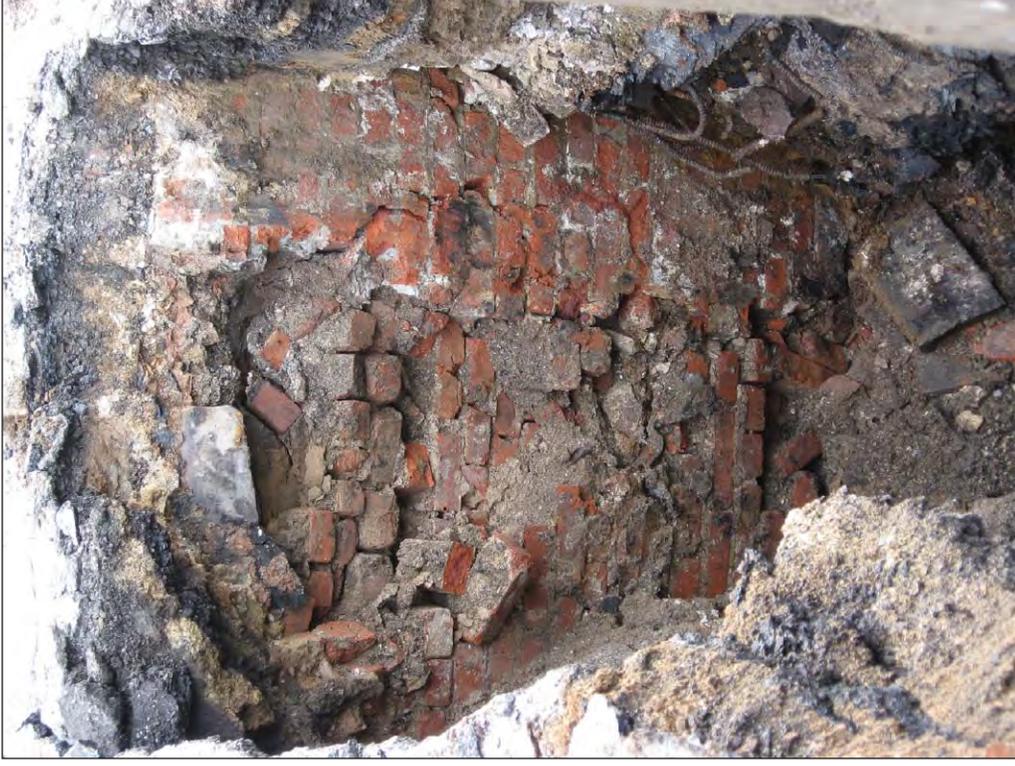
Test Pit 1 showing brick foundation wall on east wall of pit. A concrete slab was observed at the base of this wall 6

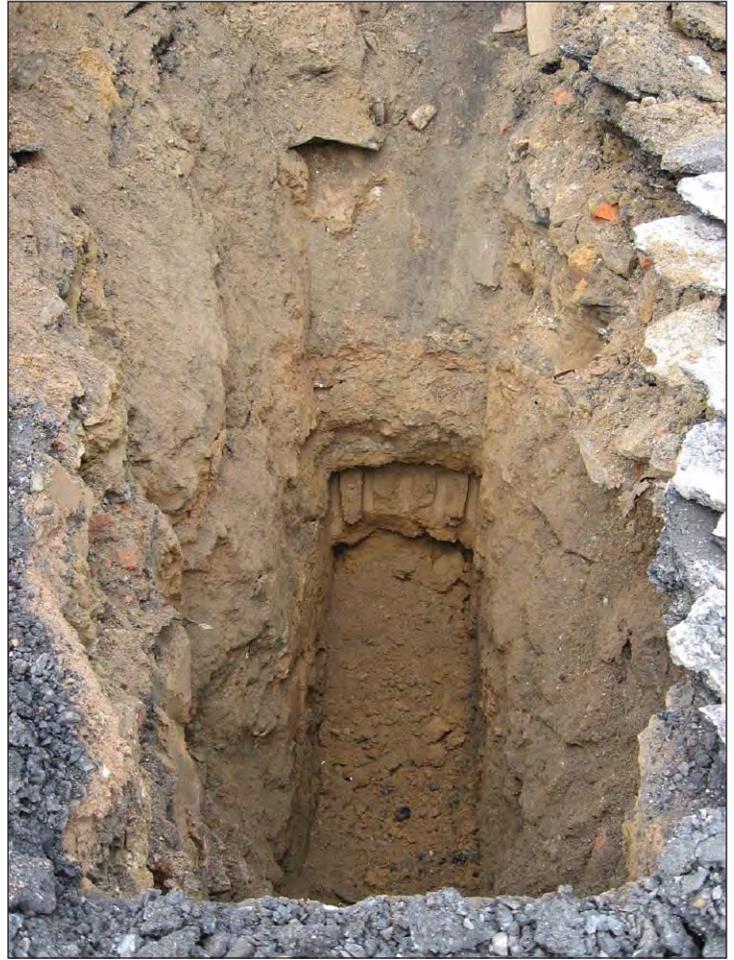
Excavated on the east side of Area of Sensitivity 1, this approximately 8 foot by 6 foot trench was shifted to the west of its original location due to the presence of a substantial concrete pad immediately beneath the asphalt paving. Once again significant quantities of demolition debris were encountered. The debris included a large quantity of brick and extended to a depth of over 10 feet below ground surface. At the bottom of the trench the soils were redder and clayey and appear to be fill. The entire area of Area of Sensitivity 1 appears to have been the location of a basement based on TP1 and TP3.

Test Pit 3 showing loose sandy fill to a depth of over six feet below pavement

Photograph 7 on Figure 6 depicts the loose debris encountered in this trench. Once again, a small number of historic artifacts were observed and collected during excavation.

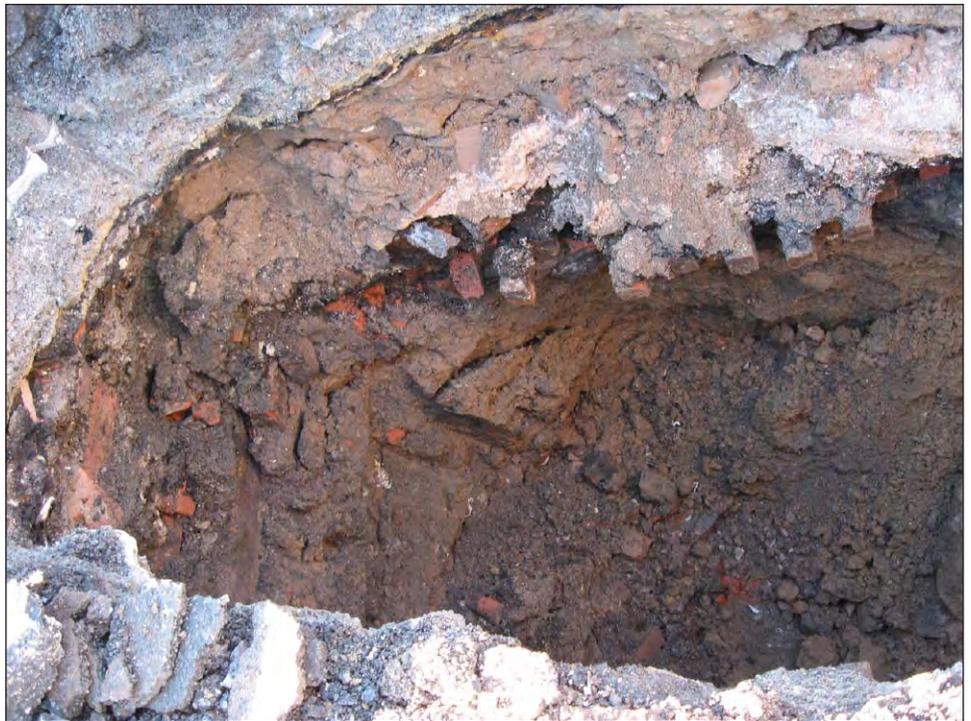
TP4 was excavated in the southeast corner of Area of Sensitivity 2 and had dimensions of approximately 8 feet by 5 feet. A four foot by eight feet concrete slab was encountered and removed directly below asphalt, followed by several feet of construction debris. At a depth of approximately three feet below pavement, the field archaeologist observed what may have been a brick floor, although several additional feet of mixed fill were encountered below it. At a depth of eight to ten feet weathered chunks of bedrock were removed.

Test Pit 4 showing loose construction debris and bricks to a depth of ten feet below pavement

Photograph 8 on Figure 6 shows the loose debris encountered in TP4. A small number of historic artifacts were observed and collected during monitoring of this trench.

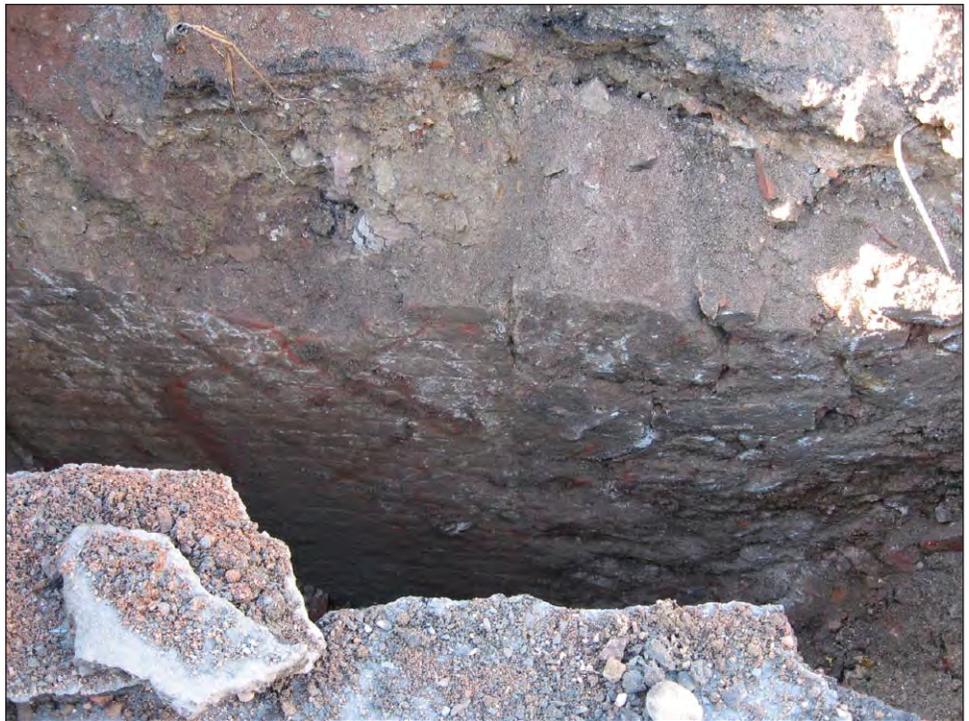
This trench was located immediately southwest of Area of Sensitivity 2 and encountered utilities and brick rubble to a depth of over six feet below ground surface. TP5 had dimensions of approximately 10 feet by 6 feet. Less brick rubble was observed. An intact foundation wall was present along the south edge of this trench (Photographs 9 and 10 on Figure 7). A toilet seat fragment was observed but not collected in TP5.

Test Pit 5 showing south wall of pit where two foundation walls meet, one brick and one, on right, larger cut stone

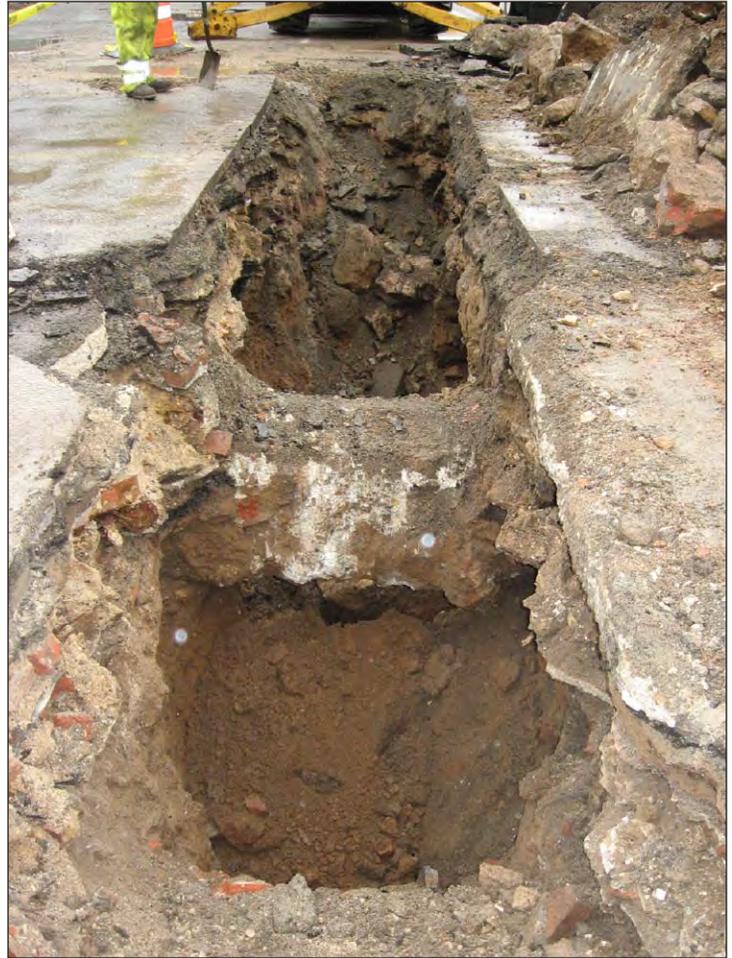
This trench had a length of approximately 30 feet and a width of approximately 4 feet and was excavated to a depth of about 5 feet on the north half and 8 feet along its southern half. The trench was oriented north-south through the center of Area of Sensitivity 2. The encountered soils consisted of a mixture of modern and historic fills and demolition debris. The remains of brick and concrete foundations were observed bisecting the trench from east to west.

Photo 11 - Trench 1 in Area 2, facing south partial foundation remains and demolition debris **11**

Photograph 11 on Figure 8 depicts the remains of a foundation wall bisecting the trench and Photograph 12 shows modern and historic fills. A larger number of artifacts were observed and collected from this trench.

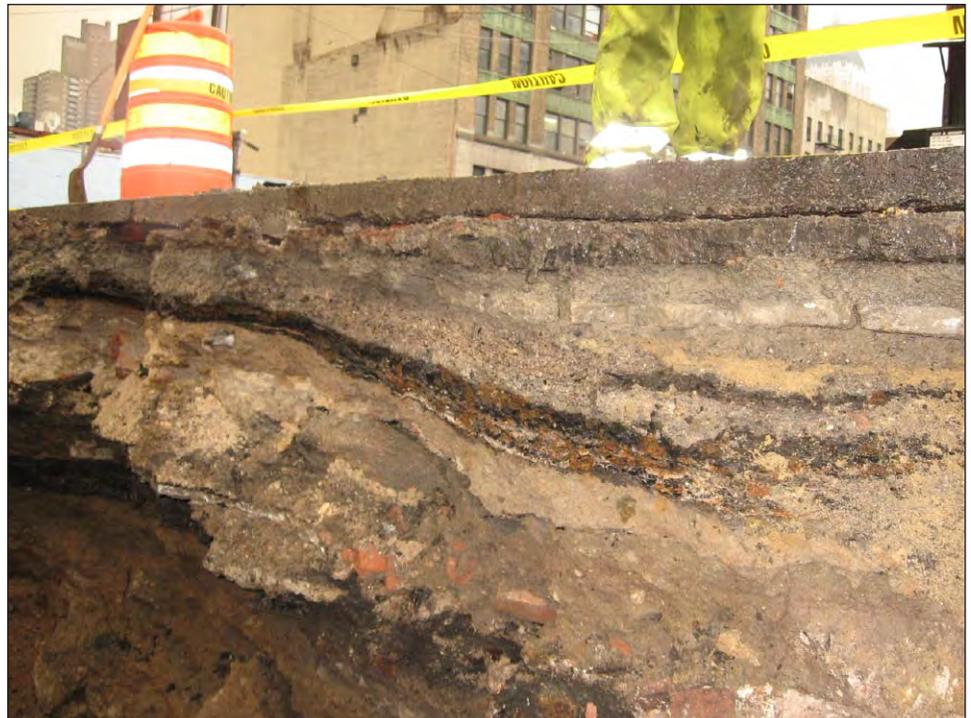
Trench 1 in Area 2 showing layers of fill and demolition debris on east side of trench **12**

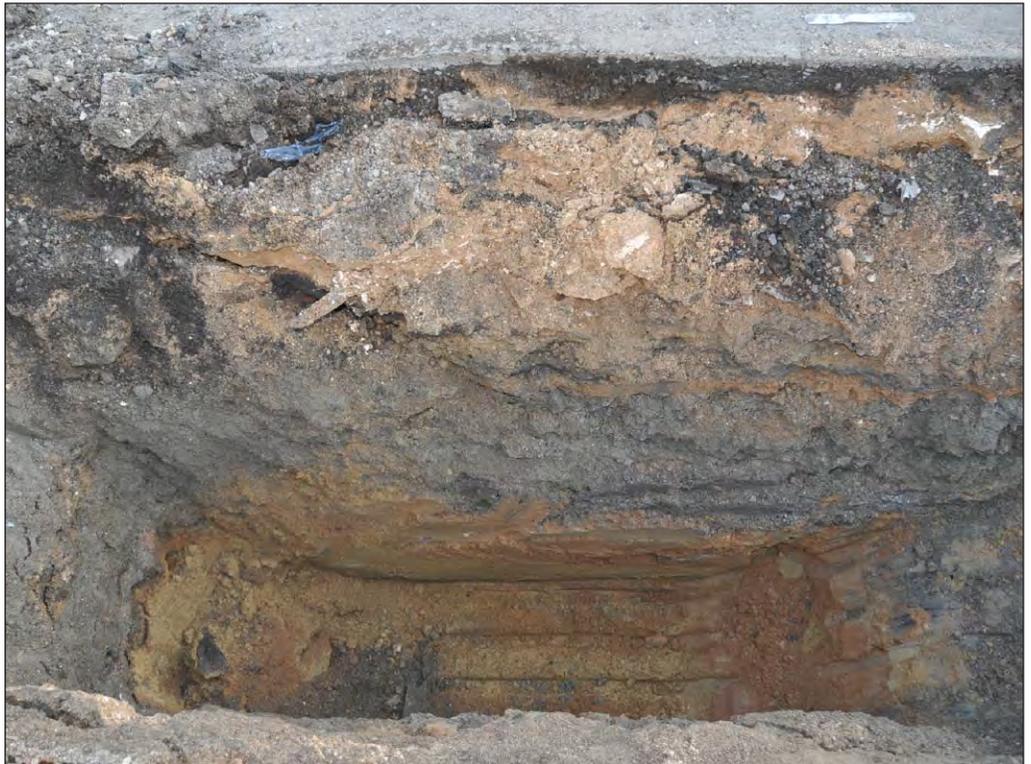
This trench had a length of almost 100 feet and extended across the length of Area of Sensitivity 3 from east to west, crossing the backyard area of several historic lots. The trench was excavated in several segments and encountered modern and historic fills, ashy layers, and demolition debris. At a depth of about four feet below the asphalt paving, the archaeologists observed a brown silty sandy subsoil (7.5 YR 4/4 to 10YR 4/6). With depth the subsoil became lighter (2.5 Y 3/4). A screen was used during excavation of several inches of the ashy deposit but no artifacts were recovered.

Trench 2 in Area 3, showing sterile light brown sandy subsoil **14**
beneath four feet of loose historic fill and demolition debris

Photographs 13 and 14 on Figure 9 depict excavation of Trench 2. A variety of artifacts were observed and collected from this trench.
