Phase IB Archaeological Monitoring – Sewer Replacement -
John Street/Burling Slip, New York, New York - Project
Number: MG41100-107MA - (NY SHPO: 07PR3695)

DRAFT REPORT – April 2011

MANAGEMENT SUMMARY TABLE

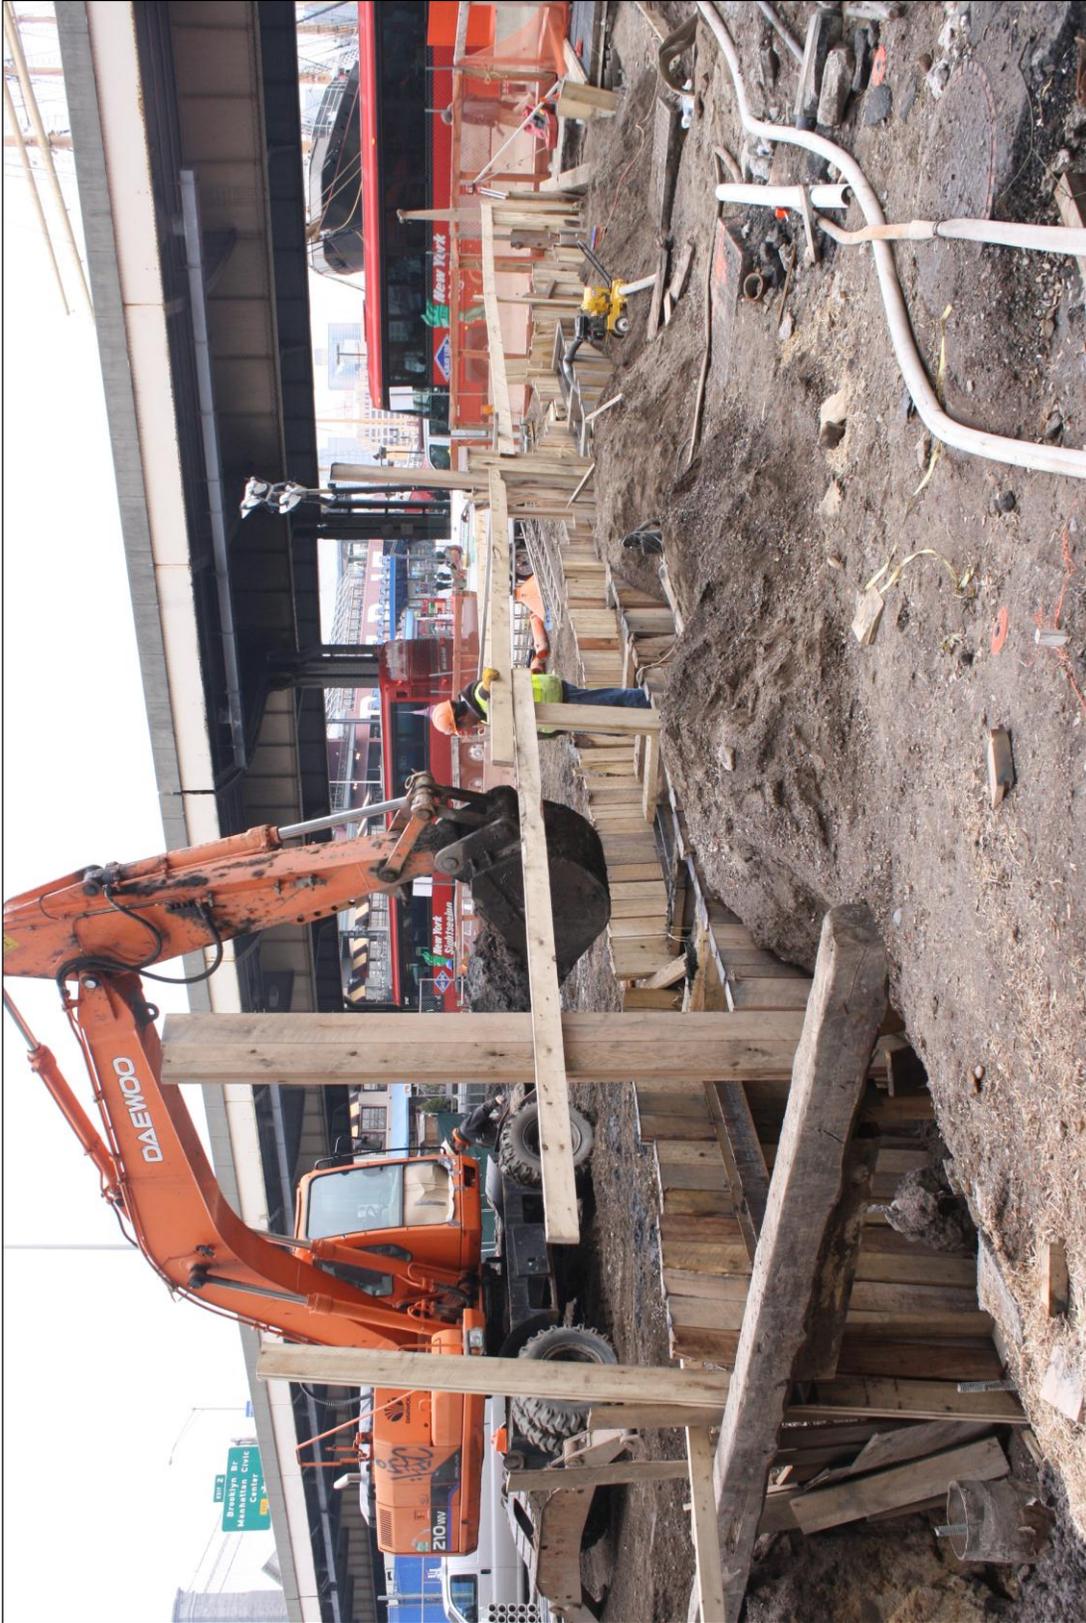
Image 01: John Street looking northeast

Chrysalis was called to the site by Trocom during the first week of December 2009. By that time, due to the previous work for Imagination Playground and the pre-excavation work started in anticipation of the sewer line excavation, the modern pavement and bedding layers had been removed (Image 01). In total, approximately eighteen to twenty-four inches (18" - 24") had been removed prior to Chrysalis being engaged for this project and significant excavation had occurred in various areas throughout the larger Imagination Playground project area. Chrysalis informed the LPC of this through email.

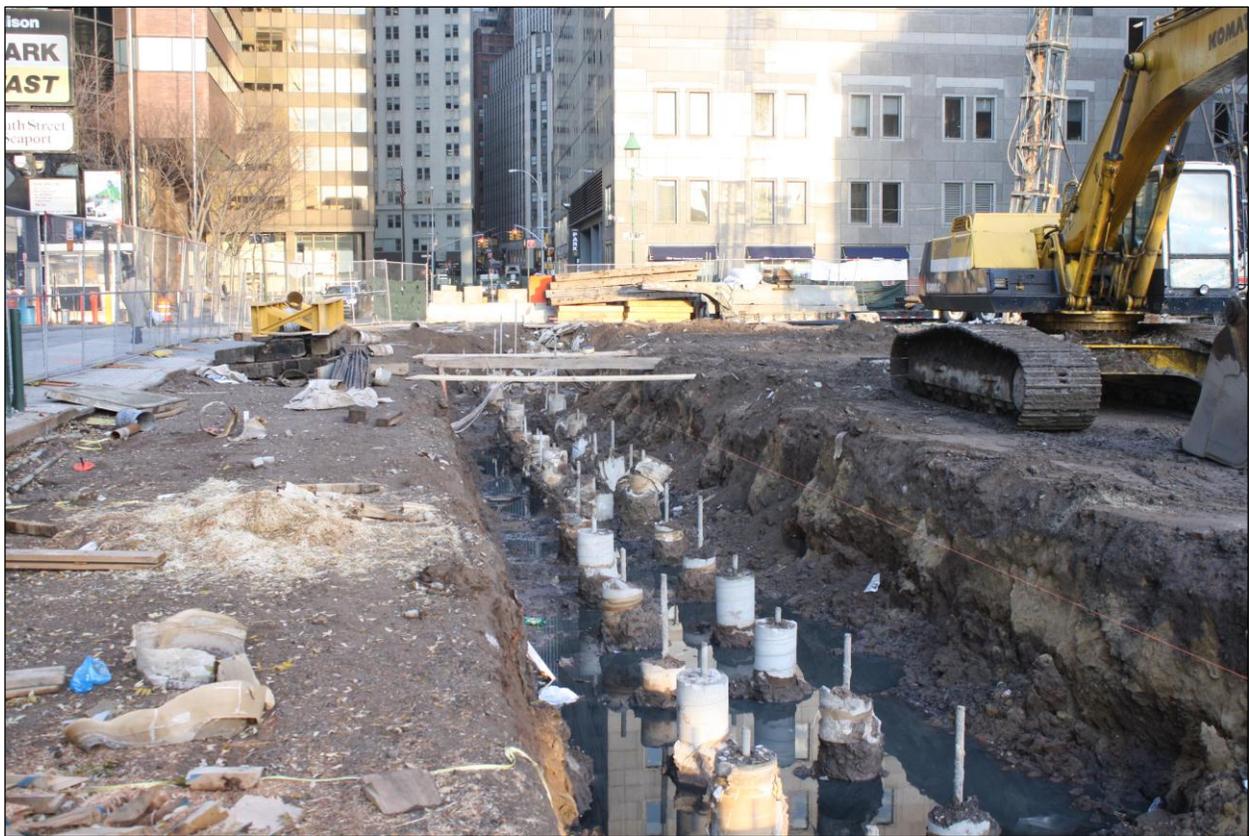
Once the trench was excavated to the above noted dimensions, concrete and rebar piles, measuring one-foot (1') in diameter, were driven into the ground in two parallel lines through the entire length of the trench. The piles were aligned in north/south pairs approximately three feet (3') apart and at five-foot (5') intervals (Image 02). Map 06 details the approximate location from where the field images were taken from.

Image 02: John Street, looking west during pile driving operation – note the ground water intrusion

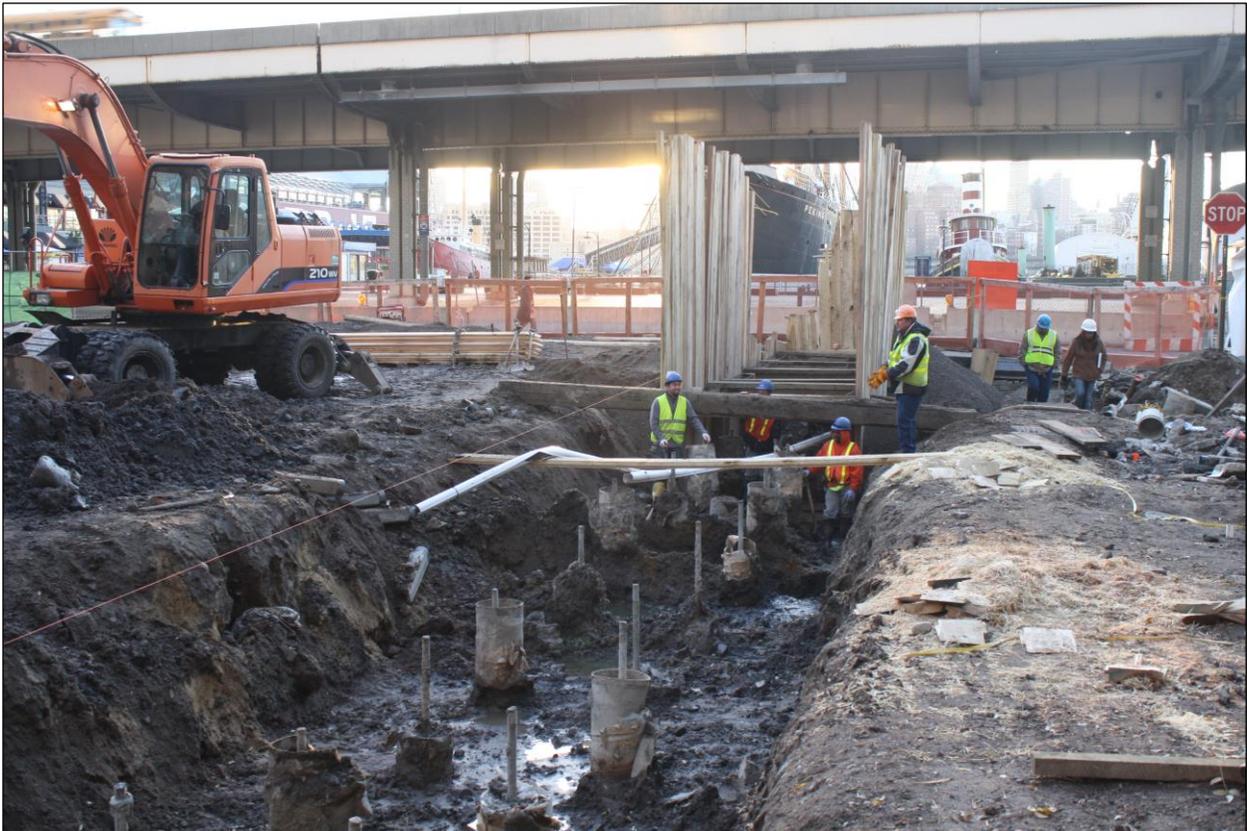
After installation of the piles was completed, sheeting was installed in twenty-foot (20') increments during the course of the excavation. Boards measuring twenty feet (20') in length were placed upright along the trench wall (Image 03) and driven into the floor by the machine then braced with steel I-beams. Once a sheeting section was installed excavation continued from east to west to an overall depth of ten to fifteen feet (10' – 15') below grade. As each section was sheeted, excavation continued. Excavation was conducted in sections based upon the sheeting installation (Map 07).

Image 03: John Street trench, looking east, showing concrete piles and twenty-foot (20') sheeting boards prior to being driven into the ground for trench shoring.

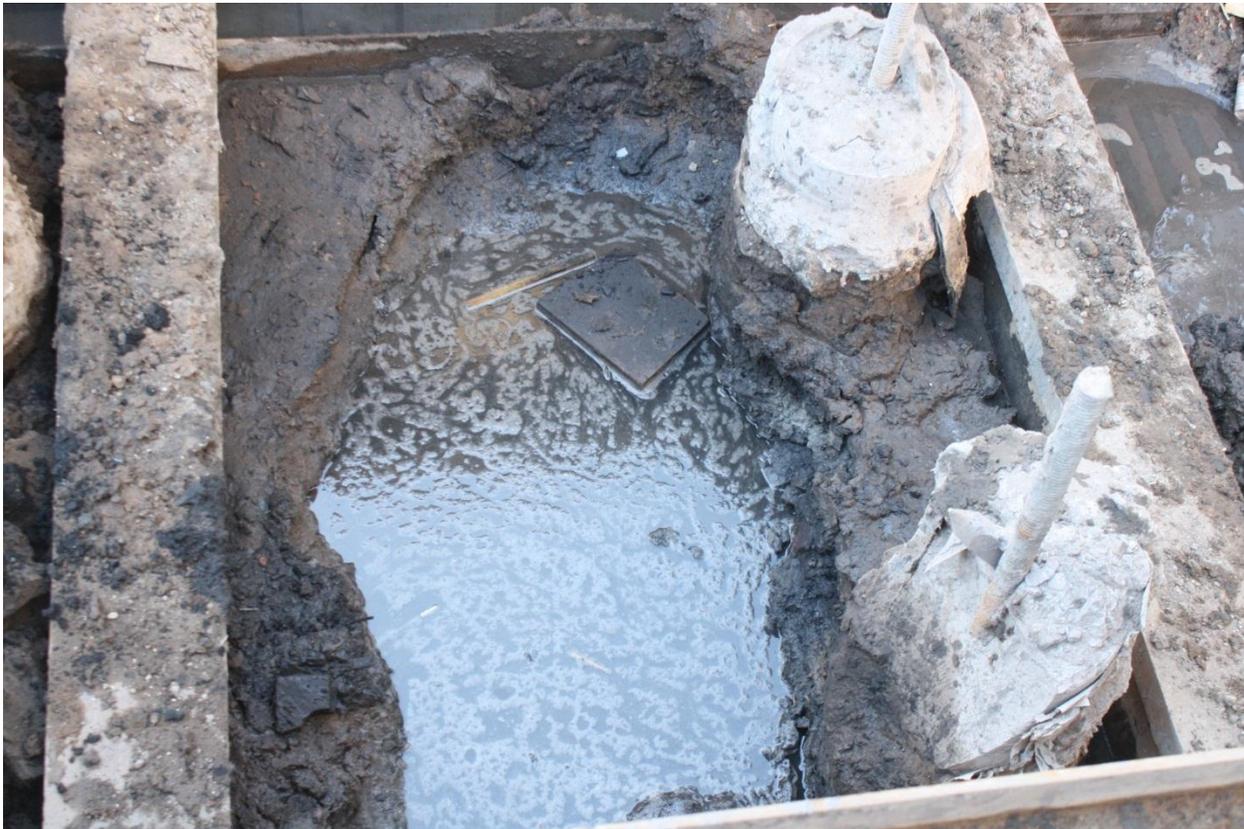
A combination of factors including the sheeting being driven into and down along the trench walls and the constant presence of standing water severely impeded observation during portions of the excavation. Sheeting was required per OSHA regulations to prevent the collapse of the trench walls. The un-solidified nature of the soils within the project area necessitated the sheeting method utilized. However, much of the excavation occurred manually and it was possible to examine soils as the construction crew excavated them. Water was a significant impediment to archaeological monitoring throughout the entirety of the excavation below five feet (5') (Image 04). The water table for the area is at approximately six feet (6') below street grade but water began pooling within the trench at approximately five feet (5') below the street surface. This water was dark, muddy and often opaque, obscuring all visibility. Pumps were brought in and operated continuously. This lowered the water level in the trench by several feet but only did so for short periods of time. Despite constant dewatering, between one to three feet (1' - 3') of standing water remained at all times throughout the excavation (Image 05).

Image 04: Water continually filled the excavation trench

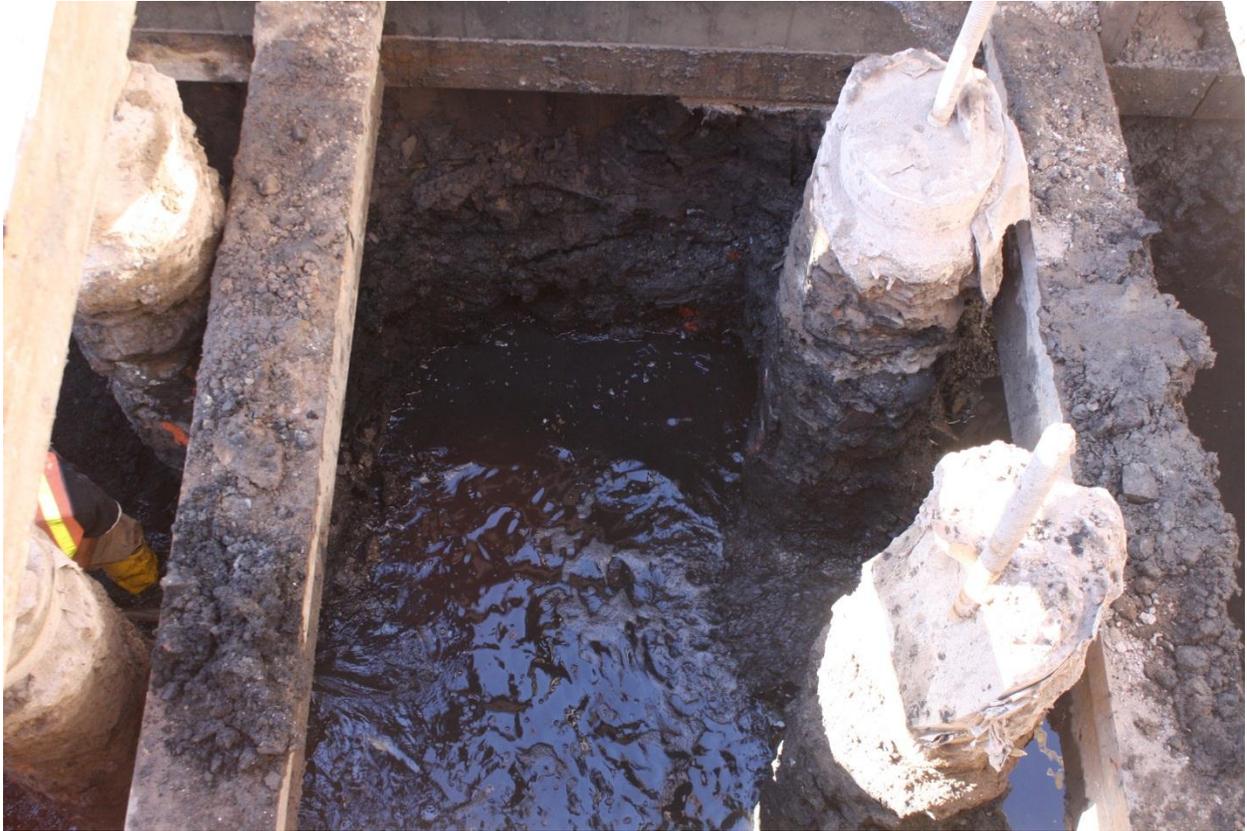
Image 05: Standing water in trench

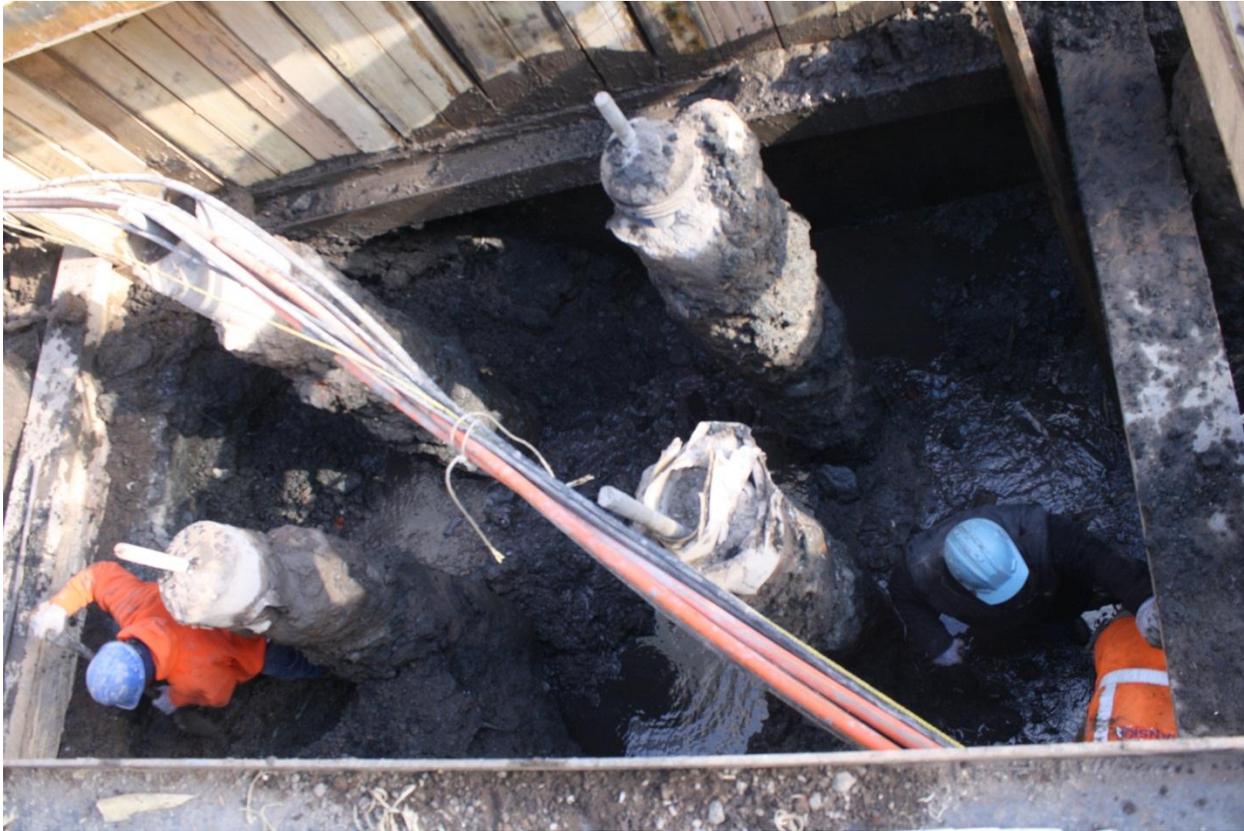
Installation of the vertical sheeting prior to excavation past five feet (5') also impeded archaeological observation. As a result no profiles were drawn below five feet (5'). Due to the high water content, soils quickly mixed within the trench further obscuring stratigraphic observation (Image 06). Soil type was monitored within the trench to the extent possible, during excavation and within the backhoe bucket and the back dirt pile, precise stratigraphic divisions were not always possible to identify. The following is a general stratigraphic profile based on available observations.

Image 06: Soil conditions during active de-watering

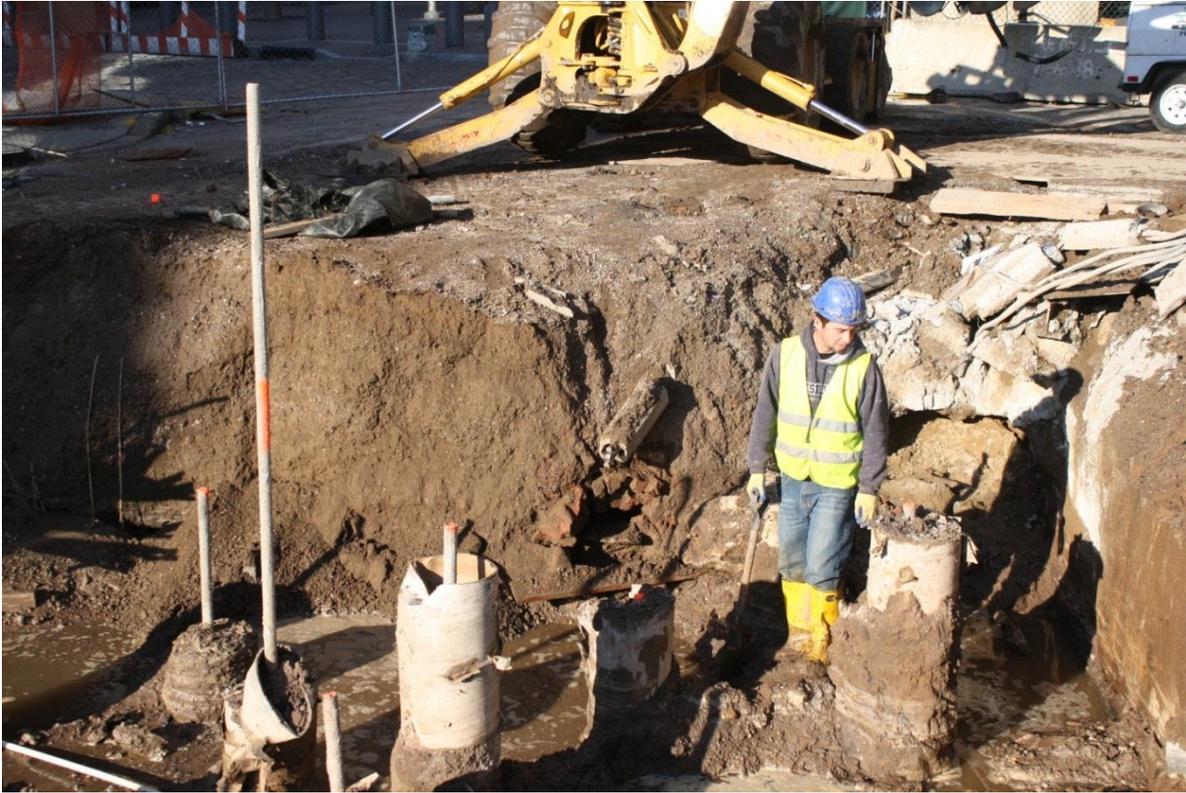
Surface layers of asphalt and concrete and sub-surface measuring twelve to eighteen inches (12” – 18”) covered the entire excavation area prior to the start of the Imagination Playground Project. Beneath the pavement to approximately five to six feet (5’ - 6’) below grade the matrix consisted of re-deposited fill soils. These were either a medium-brown or orange-brown sandy loam with pebble, gravel and small to medium rock inclusions, or one of several shades of clean sand. Below six to seven feet (6’ - 7’) and extending to approximately 10’ below grade, strata became darker and included some cultural materials. Slight variations at this depth in density and type of inclusions were noted between the east and west ends of the trench. Strata in both areas had a base matrix of a medium brown sandy loam. The eastern end contained some pockets of clay (Image 07). The matrix at the west end contained some coal in addition to plaster, brick, shell, mortar and slate, and rocks and pebbles. In some areas lower portions of the west end of the trench contained malodorous, dark gray/black sludge. Gray-brown waterlogged silt was the deepest stratum identified throughout the trench (Image 08).

Image 07: General stratigraphic image

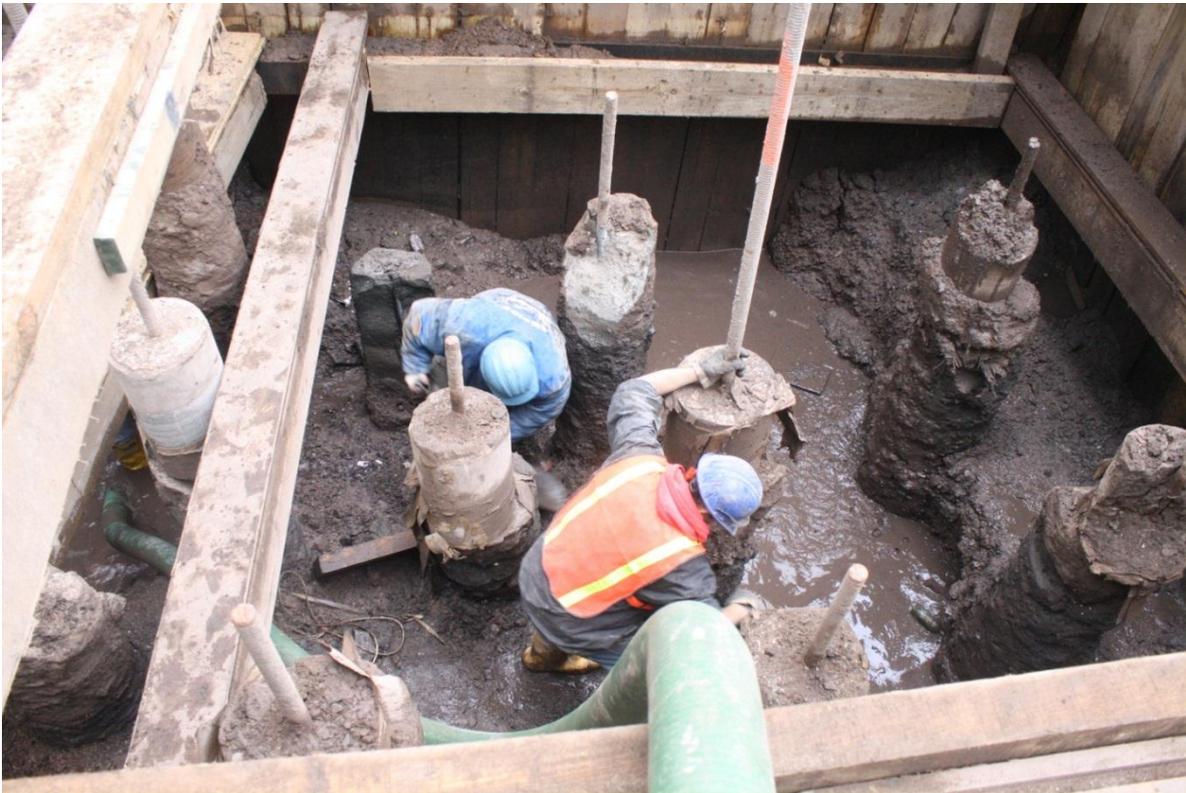
Image 08: Gray-brown, water-logged soil

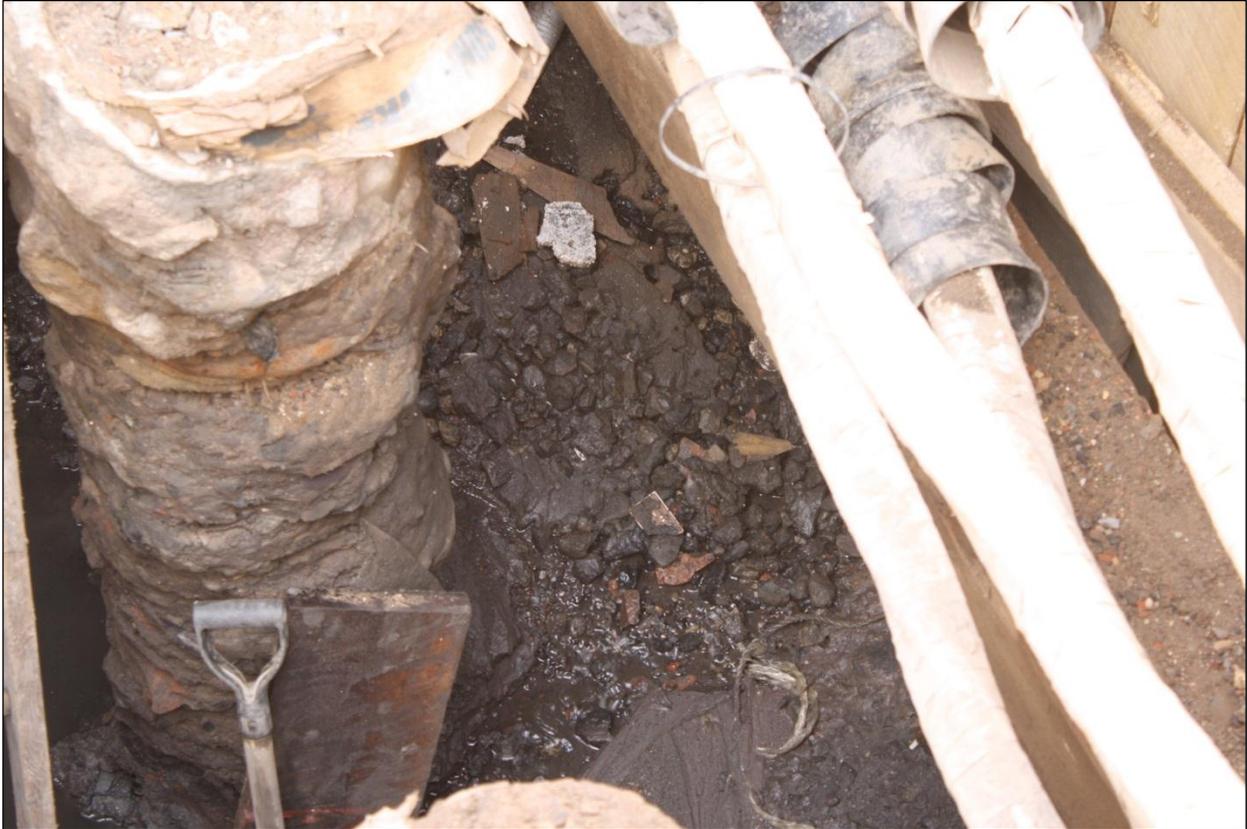
There were several existing utilities present within the trench. The south wall matrix was intersected by two sand pockets associated with utilities, both within twenty-five feet (25') of the west end of the trench. The north wall matrix was interrupted by one sand pocket matching that in the south wall twenty-five feet (25') east of the west end. Most utilities were between two and four feet (2' - 4') below grade (Image 09).

Image 09: Representative image of utility intrusions throughout the trench.

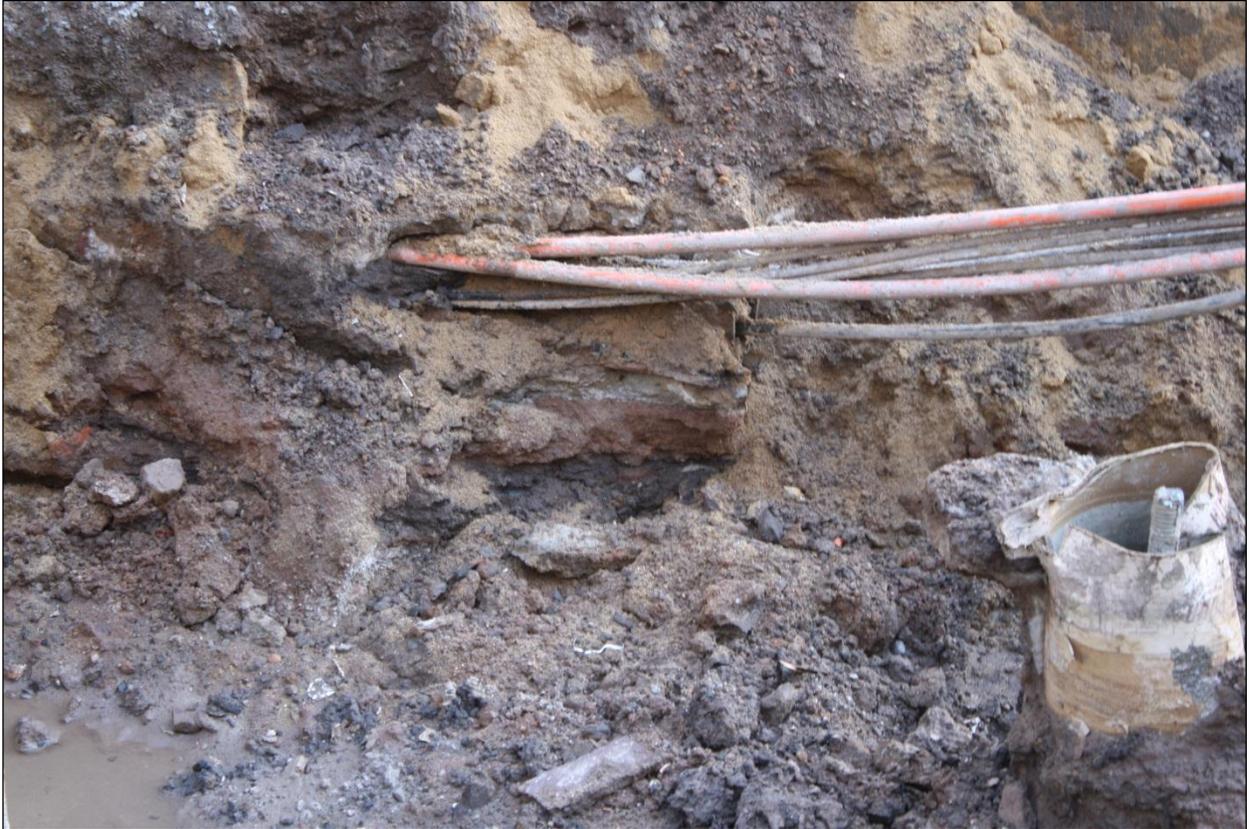
The western end of the trench contained a large duct bank in the southwest corner as well as several two to four inch (2" to 4") iron pipes, ranging from eighteen inches to five feet (18" to 5') below grade. Several square concrete ducts and a concrete manhole box that extended to more than eight feet (8') below grade were located in the western half of the trench. Two ductile iron pipes were located in the eastern end of the trench, one at eighteen (18") and one at two feet (2') below grade. Both were perpendicular to the trench. A bank of four or five PVC ducts with the same north/south alignment was located at three feet (3') below grade in this area. Electrical cables encased in square concrete ducts and a telephone duct bank were also observed within the trench. The electrical cables crossed the trench on a southeast to northwest orientation from twenty-five to sixty feet (25' - 60') west of the eastern end of the trench. The telephone ducts were on the same orientation located at approximately one hundred eighty to two hundred ten feet (180' - 210') east to west.⁷ Both were between two to four feet (2' - 4') below grade. A water main, running east to west was partially exposed in the south wall of the trench at approximately three and one half feet (3 ½') below grade (Image 10).

Image 10: Representative image of utility intrusions throughout the trench

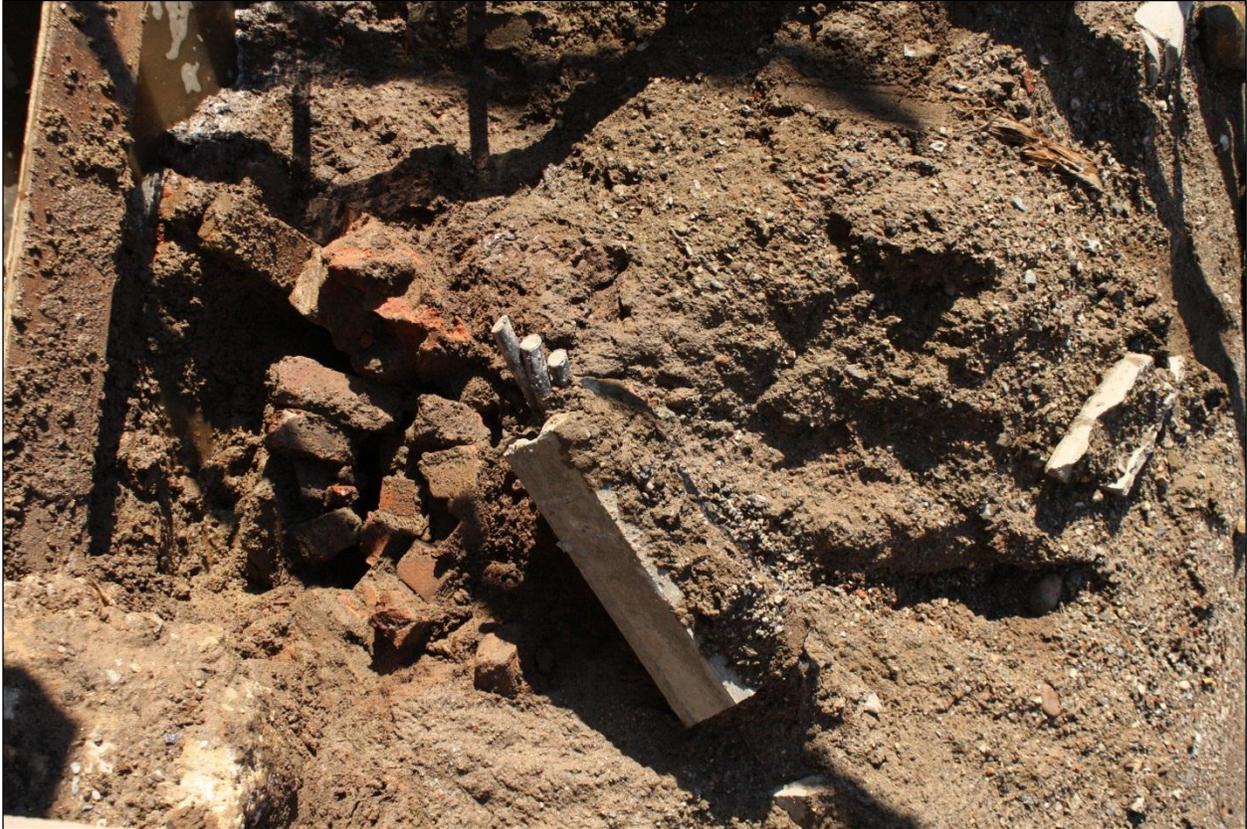
In the western end of the trench, in the southwest wall of the wedge-shaped extension a possible circular brick sewer was exposed at four feet (4') below grade. This collapsed brick feature measured twenty-eight inches (28") wide and eighteen inches (18") high and had been previously disturbed. The bricks measured eight by three and one half by two and one half inches (8" x 3 1/2" x 2 1/2") and had no stamps or other visible markings. They appear to date to the late nineteenth century. No artifacts were found within the area of the possible sewer (Image 11).

Image 11: Previously disturbed remains of a possible brick sewer

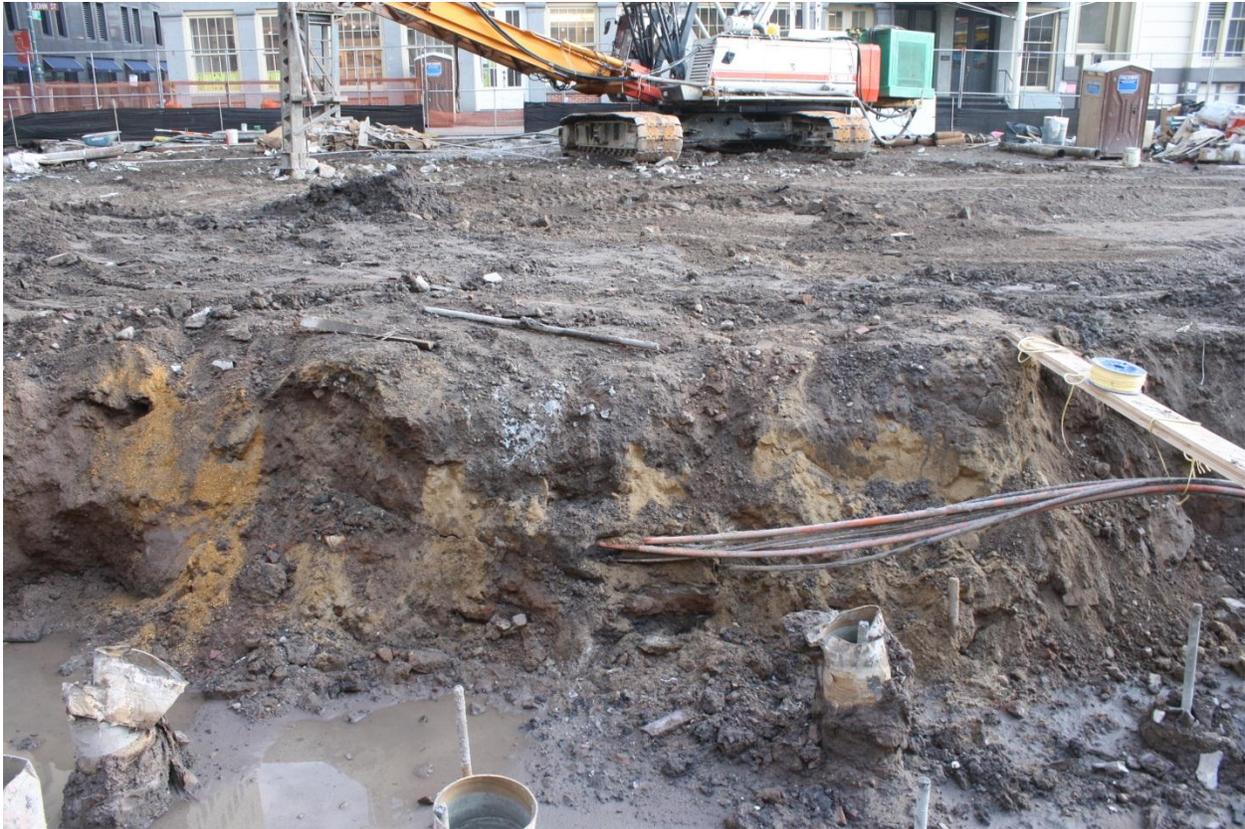
Image 12: Unit 1 general area excavated

The first stratum of Unit 1, beginning at five feet (5') below grade was a dark brown sandy loam containing a substantial amount of rubble/debris, including brick, coal, clinker, plaster, wood fragments, charcoal, slate and mortar (Image 12). A large amount of small pebble and smooth and angular rock inclusions, similar to pea gravel was also present. This stratum extended to ten feet (10') below grade exposing a gray brown waterlogged silty sludge mixed with small to medium rocks. Pockets of black or gray natural clay were arbitrarily present within this lower stratum. Soil at the lower two to three feet (2' - 3') was malodorous, likely containing a substantial amount of organic material. Unit 1 was excavated to a final depth of twelve feet (12').

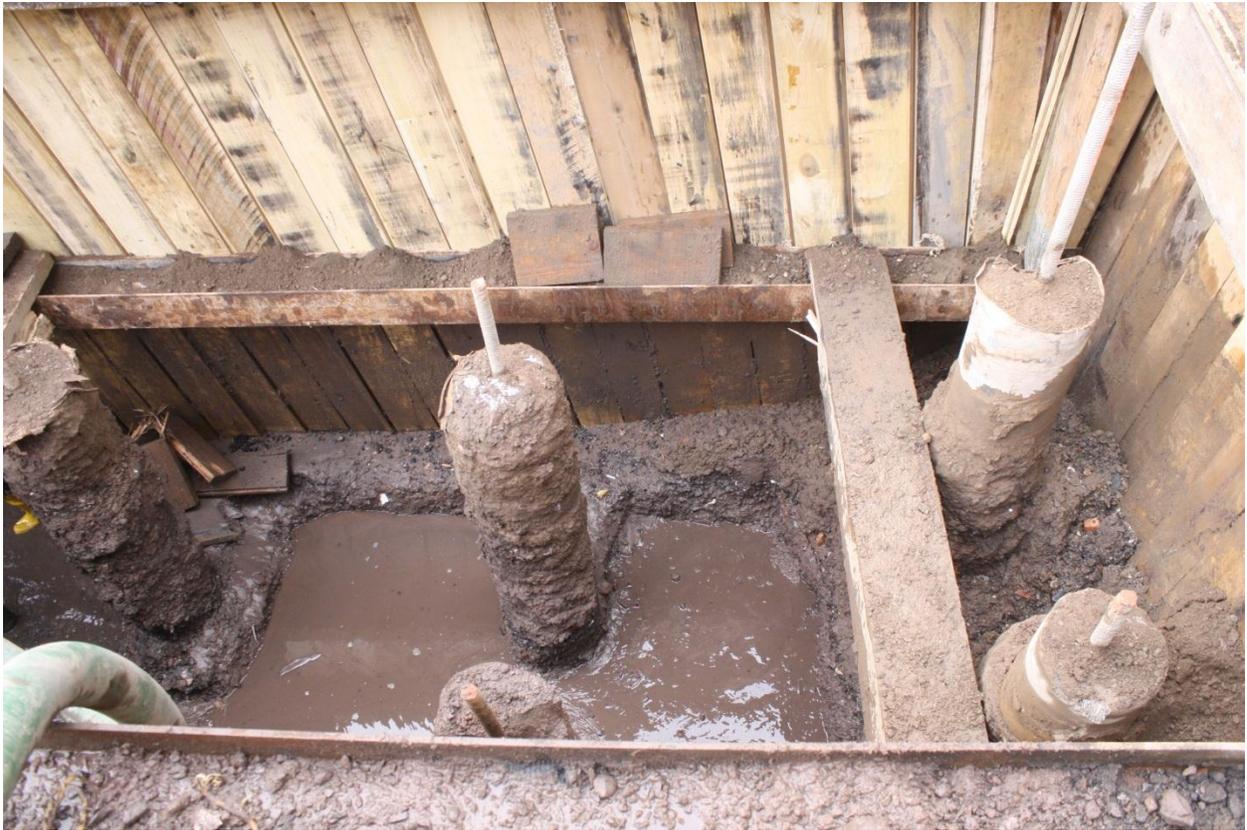
Unit 2 extended across three shoring segments from sixty to one hundred twenty feet (60' – 120') (Map 05). Stratigraphy was consistent with that observed in Unit 1, although a larger amount of clean sandy fill was noted in this area. Water continued to impede excavation during monitoring from five (5') to the final excavation depth of twelve feet (12'). In this area water began to more rapidly seep through the trench walls. Despite having sump pumps running continuously the trench remained filled with approximately three and one half feet (3 ½') of opaque standing water. Excavation was monitored and every third backhoe bucket was sampled for closer inspection due to the limited visibility (Image 14).

Image 14: Example of water-logged site conditions

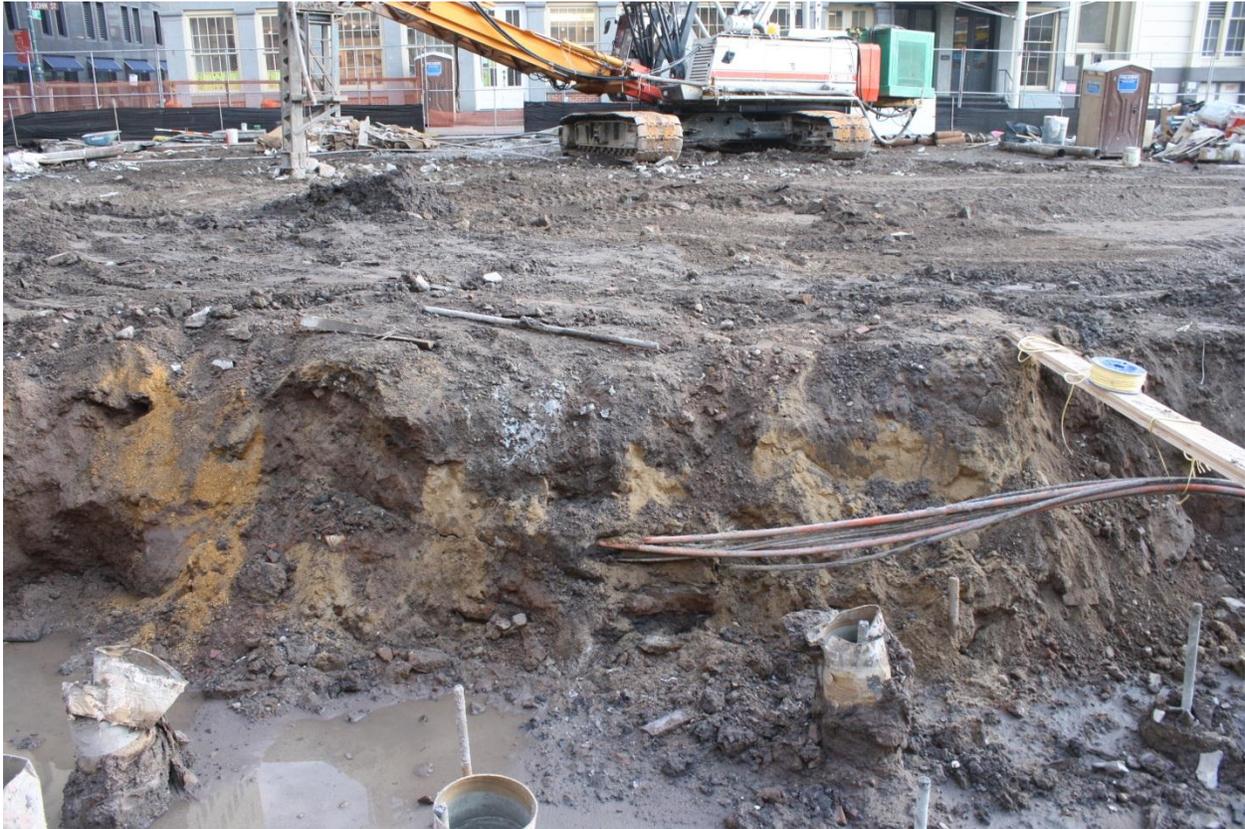
Image 15: General area of Unit 3 – initial excavation

The area from one hundred twenty to one hundred forty-four feet (120' to 144') exhibited stratigraphic consistent with the previously excavated areas (Map 08). Materials similar to those from Units 1 and 2 were also observed in this area (Image 15).

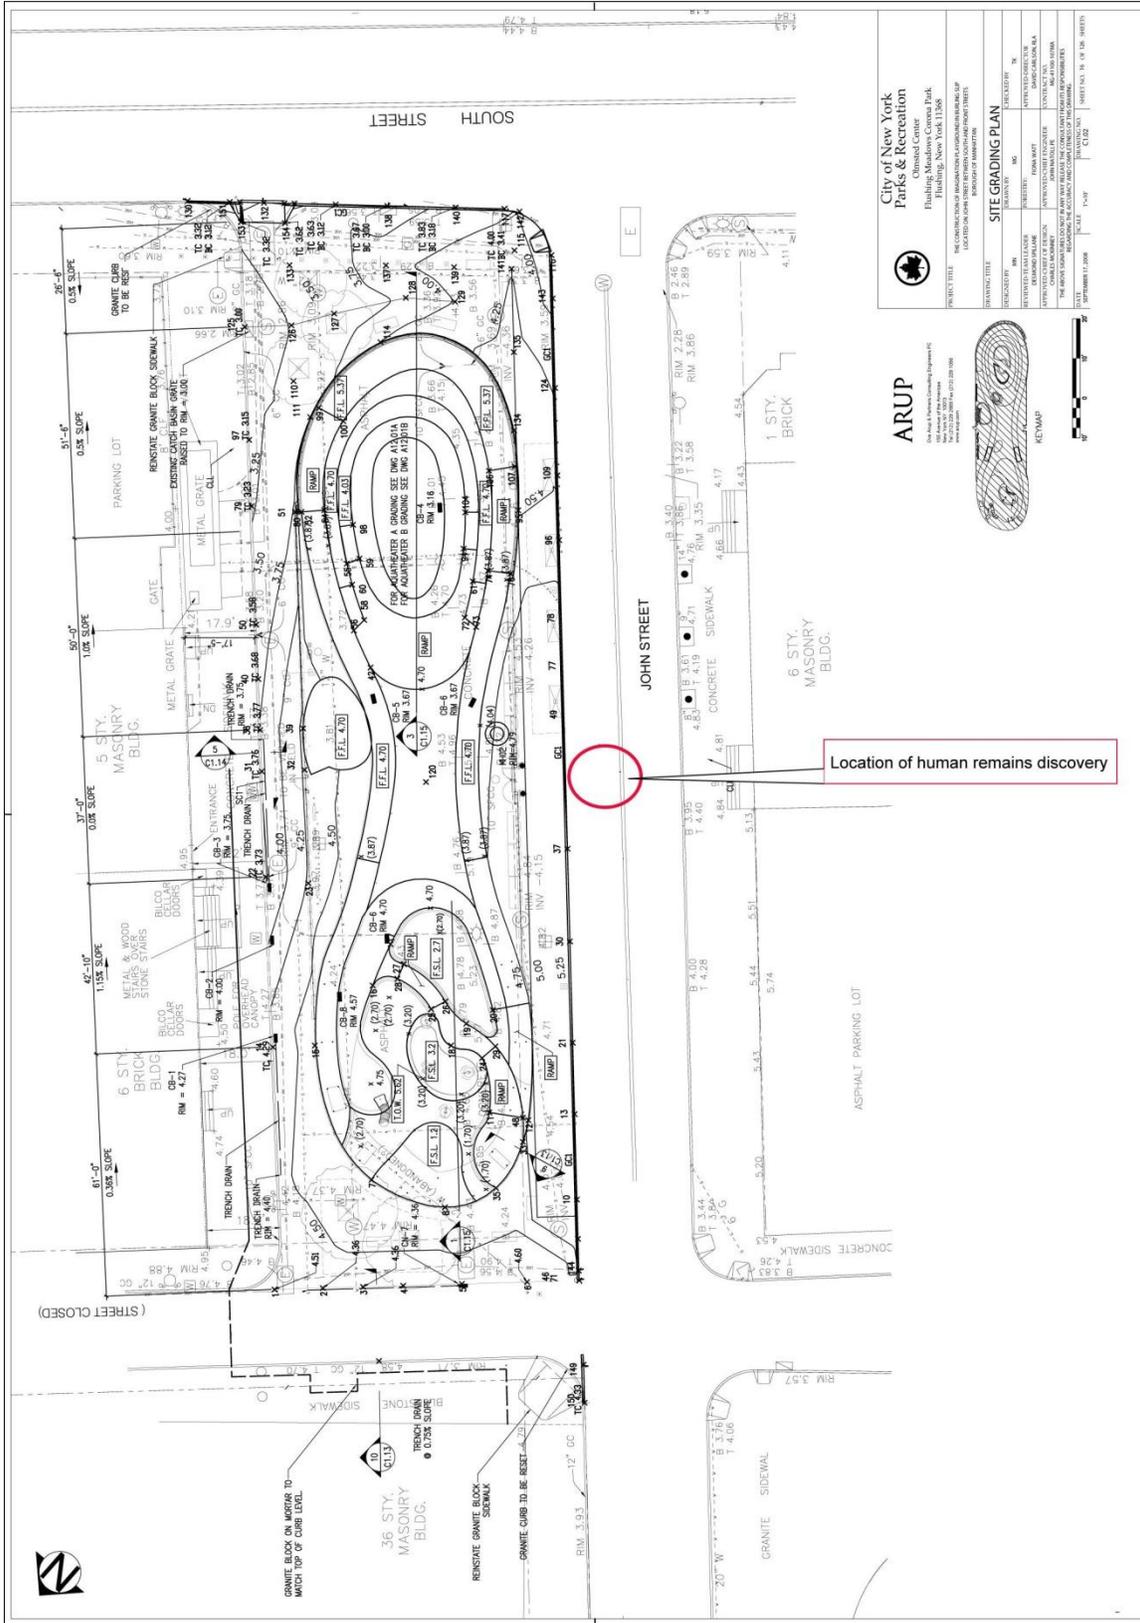
Map 08: Map detailing the approximate location of human remains

The archaeologist entered the water-logged trench in the area where the femur was recovered and examined the area to determine if additional remains were present. At one hundred forty-four feet (144'), near the southwest corner of the sheeted area, two additional human skeletal elements were found at approximately twelve feet (12') below grade. The project notified all relevant parties including, NY SHPO, LPC, Parks and the City of New York – Office of the Medical Examiner (OME).

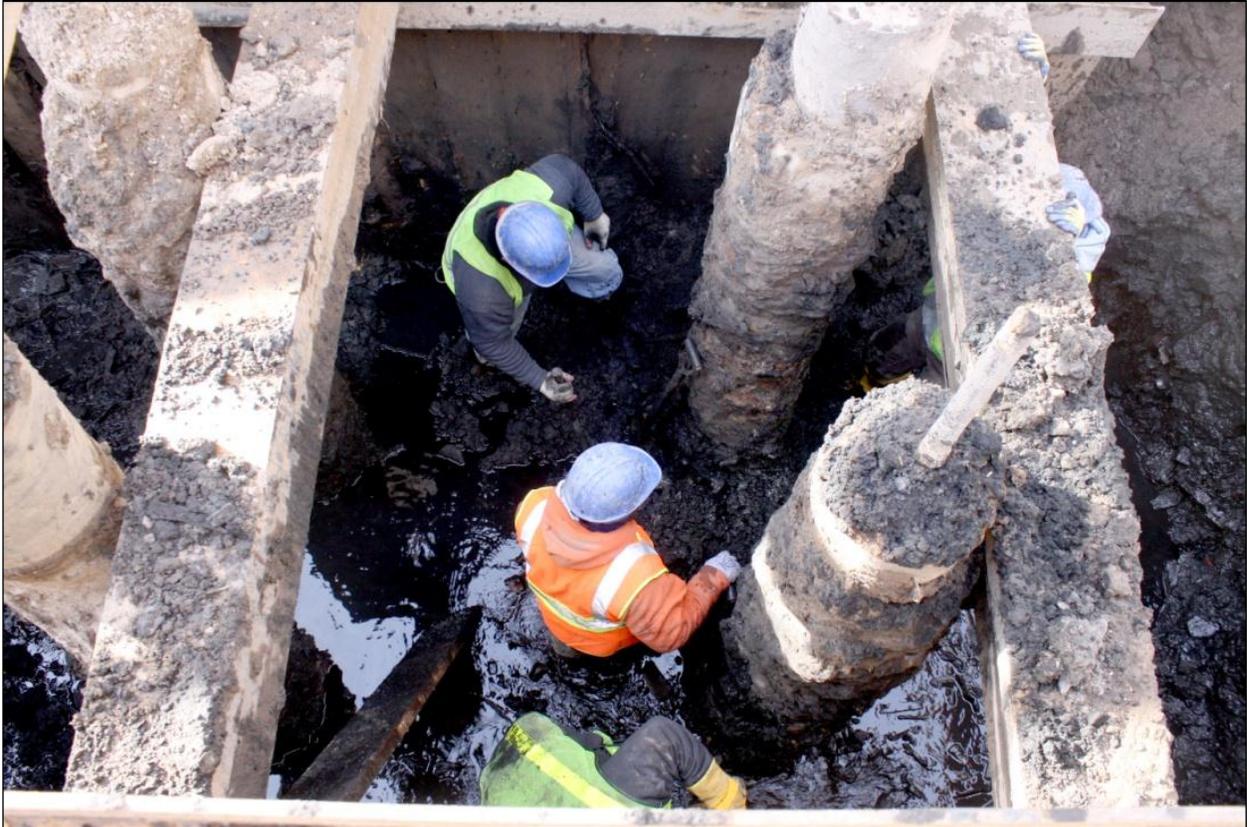
On December 30, 2009, an anomaly was exposed. At approximately one hundred forty feet (140') west, at ten feet (10') below grade, a human femur was removed from the trench (Map 06). The bone had been dislodged by the excavation and recovered by the construction crew (Image 16). The archaeologist halted all excavation within this area and the protocols laid out in the Unanticipated Discoveries Plan, including Human Remains (Appendix B) were put into effect.

Image 16: Looking east beneath the bracing at the trench segment where the human remains were recovered

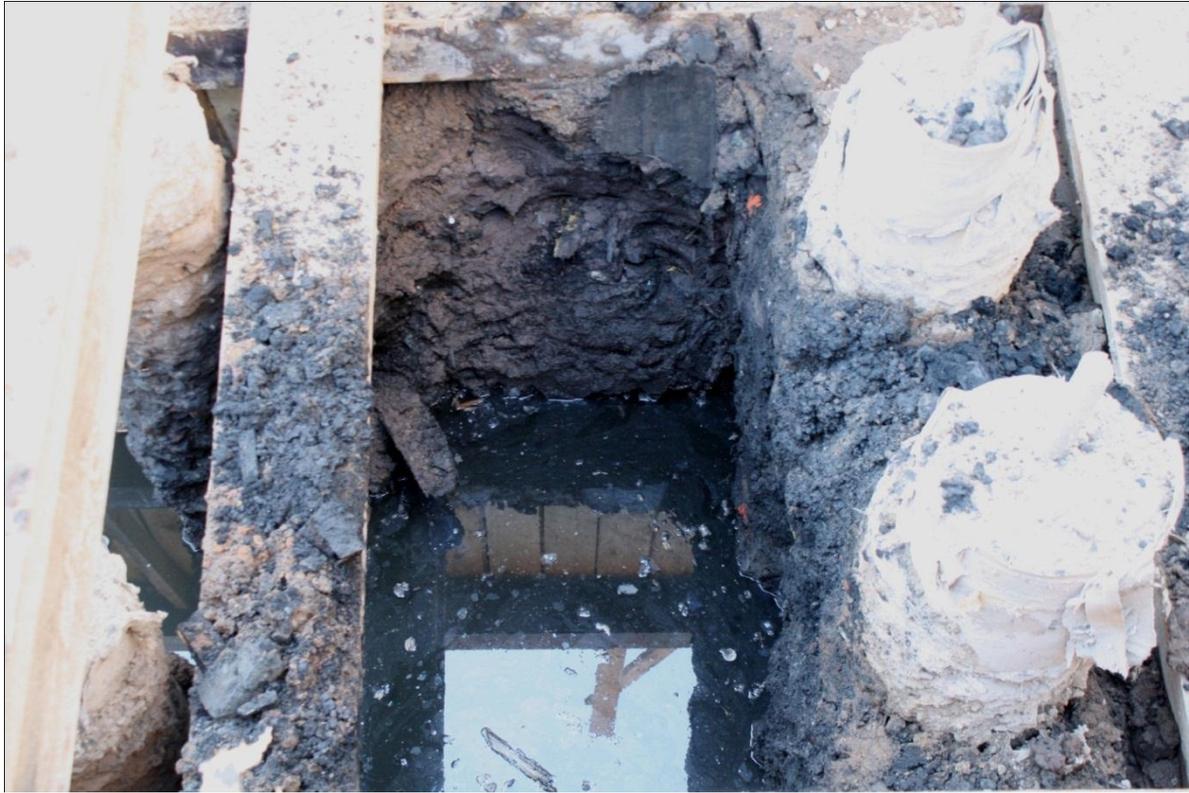
Image 18: General excavation area

Unit 4 of the trench was a twelve-foot (12') section from one hundred forty-four to one hundred fifty-six feet (144' and 156') (Map 05). Stratigraphy remained consistent throughout and was similar to the previously excavated units. Small pieces of fragmented brick, wood and fragmented oyster and clam shells were observed throughout the excavation unit (Image 18).
