Phase IB Archaeological Monitoring – Sewer Replacement -
John Street/Burling Slip, New York, New York - Project
Number: MG41100-107MA - (NY SHPO: 07PR3695)

DRAFT REPORT – April 2011

MANAGEMENT SUMMARY TABLE

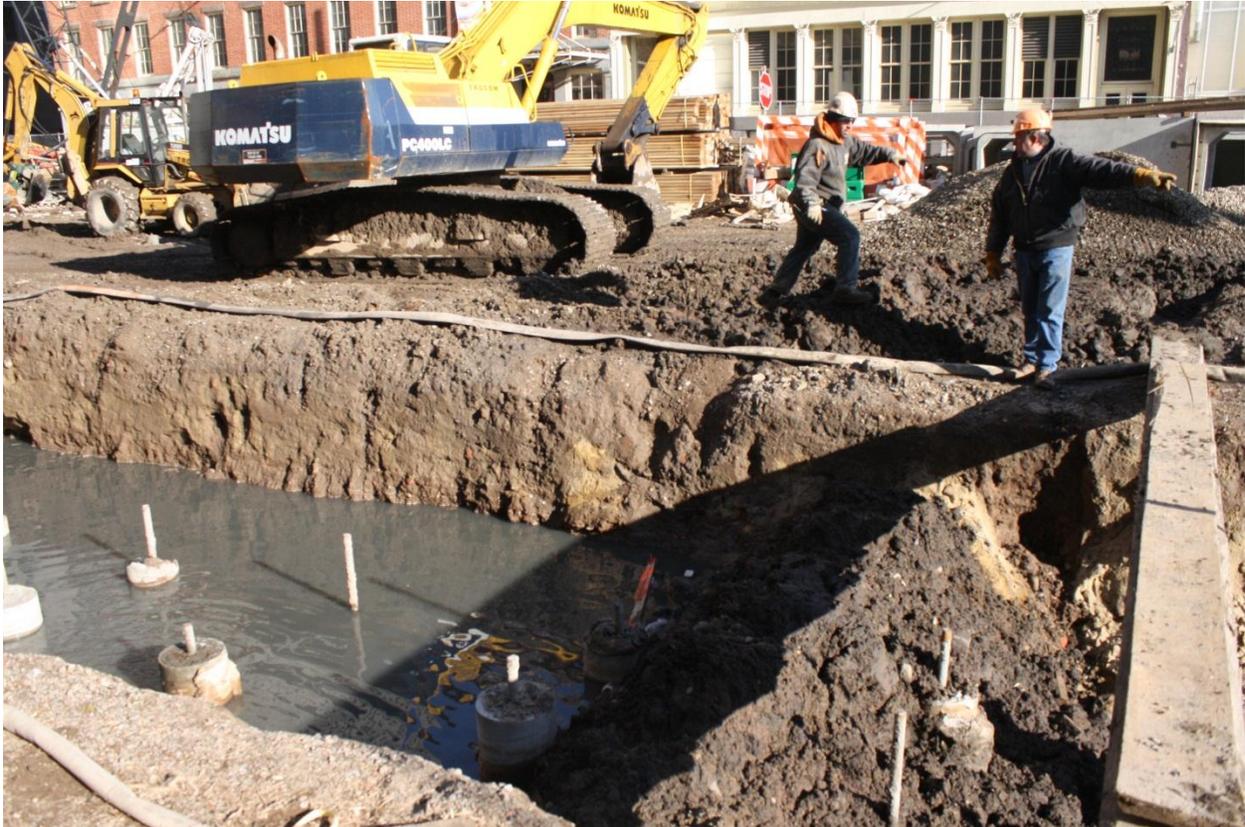
Image 20: Area of excavation Unit 5

Unit 5 was a twenty-four foot (24') segment located between one hundred fifty-six and one hundred eighty feet (156' - 180') (Map 05). At seven feet (7') below grade, the soil morphed into a dark black sludge that was extremely malodorous. No clear soil division was evident to define this dark black sludge and it appeared as though some substance had leached into the soil in this area or it represents some other disturbance. At approximately ten feet (10') below grade the gray brown silty loam seen elsewhere was evident (Image 20).

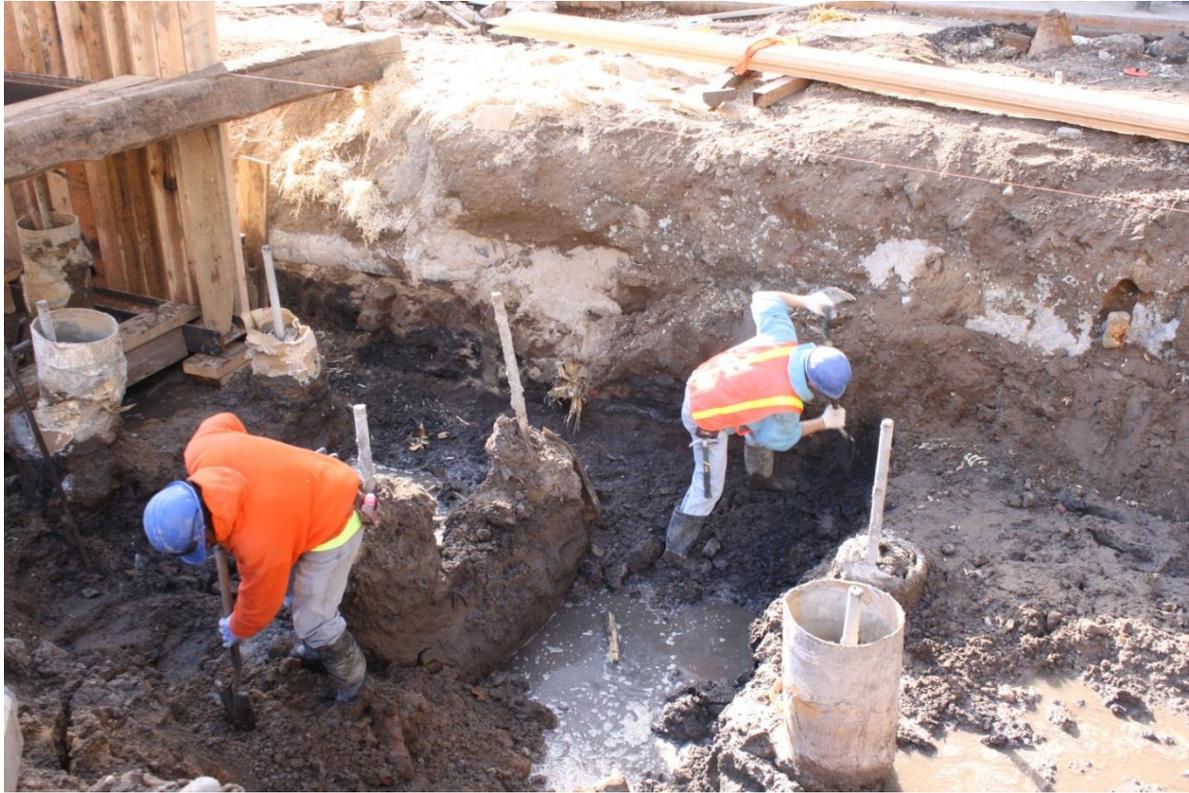
This unit consisted of the twenty-foot (20') section between one hundred eighty and two hundred feet (180' to 200') (Map 04). The matrix was slightly lighter in color and less fetid than the prior section but was consistent in composition (Image 22).

Image 21: Excavation area – prior to water infiltration

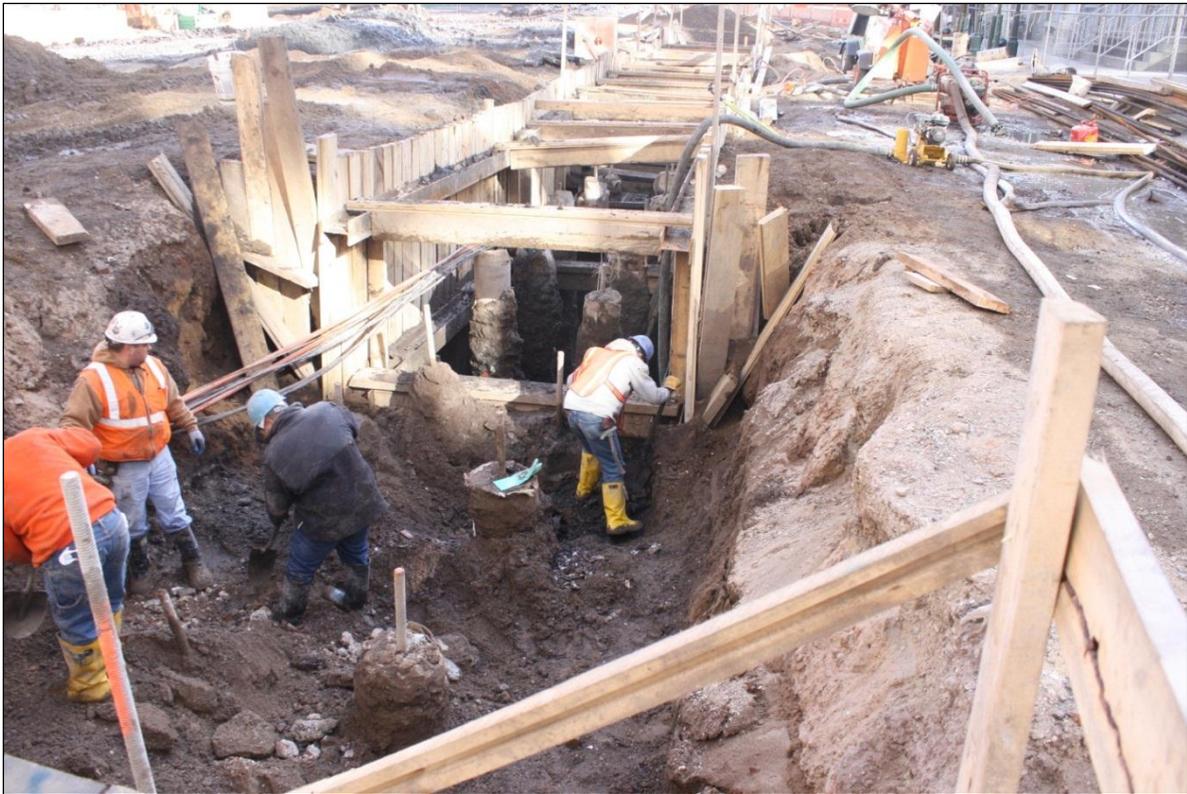
Between seven and nine feet (7' - 9') below grade, the matrix became much coarser and contained coal, charcoal, bits of brick, mortar, shell, rough irregular pebbles, slate and some medium to medium-large rock inclusions. The soil was wet but not as waterlogged as elsewhere due to the large amount of gravel and rock. At nine (9') below grade, the matrix became a darker gray-brown with some ash and charcoal and containing fragmented oyster, a few pieces of clam shell. A gray brown sludge was present at the base of this unit (Image 24).

Image 24: Excavation Unit 7 – showing area of wall collapse

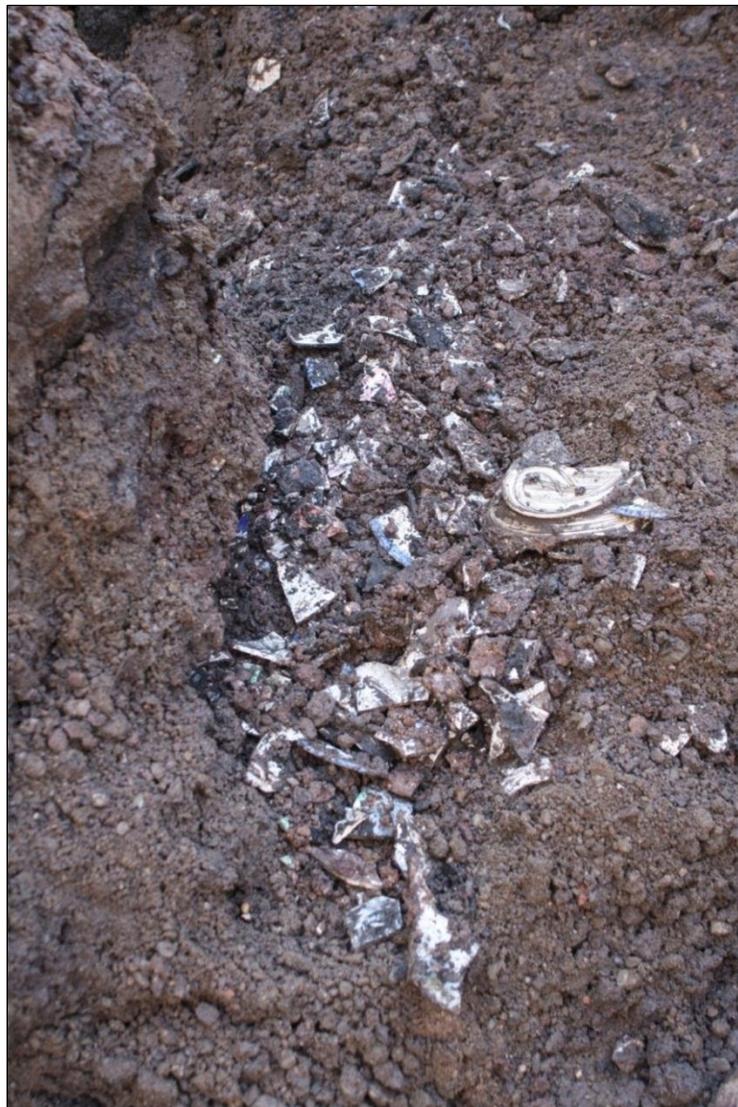
Image 25: Artifact “sheet deposit”

Prior to installation of the sheeting in Unit 7, a partial wall collapse exposed a ceramic sheet deposit at approximately four feet (4') below grade and approximately two hundred five feet (205') west was uncovered. The deposit was offset from the trench wall and would not have been exposed had the wall not collapsed (Image 25).

Work was halted in this area and the deposit was excavated archaeologically. The feature was approximately two feet (2') from the *formal* southern trench wall and measured approximately three feet by four feet (3' – 4') and was six inches (6") thick. A larger four by five foot (4' x 5') area was excavated to ensure the entire deposit was recovered. The boundaries of the deposit were defined by an absence of cultural material and slight soil differentiation suggesting it was part of a re-deposition of soils from another area. Further supporting this are two pieces of PVC recovered at the edge of, but within, the deposit.

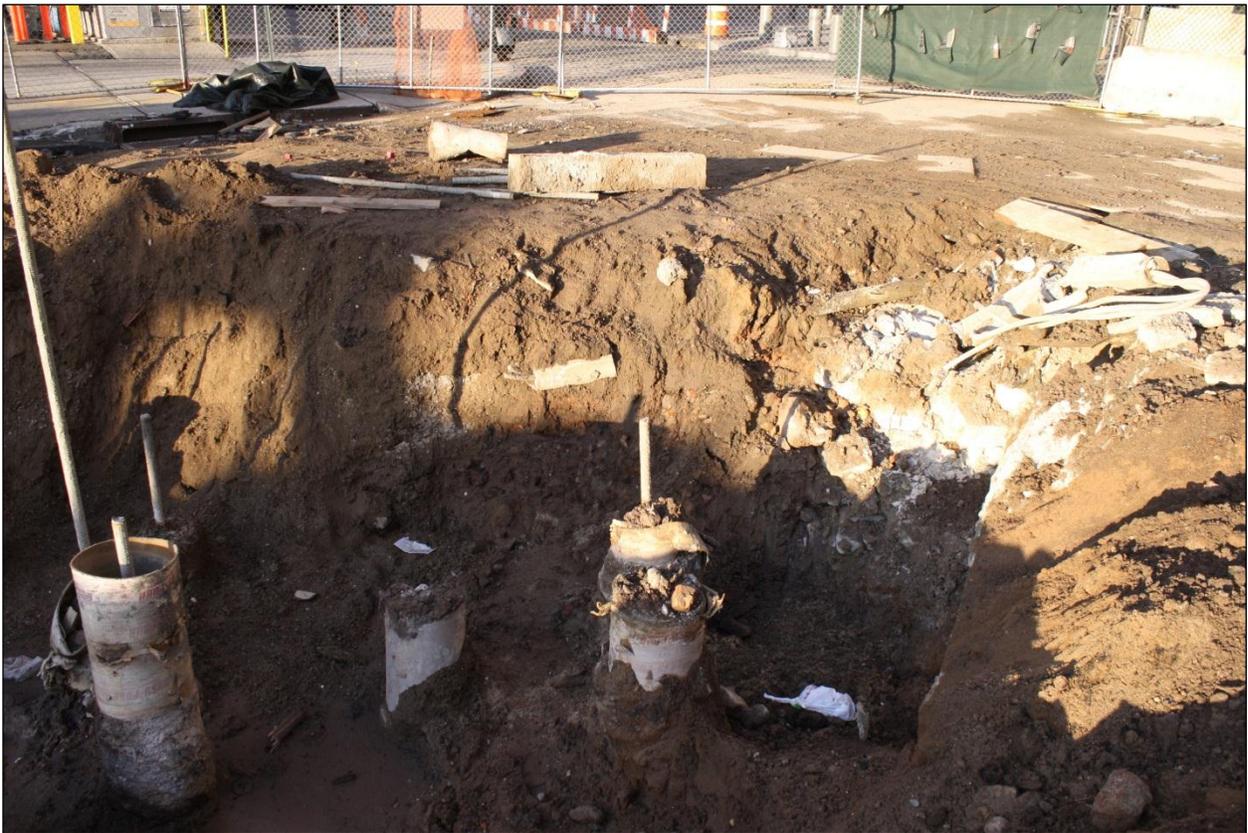
Image 28: Western Area Extension

This area was excavated to a depth of twelve feet (12') after which the western wall shoring was removed to extend the unit eight feet (8') in a wedge-shaped area. This allowed for an unobstructed view of the stratigraphy. The profile was consistent throughout the entire depth consisting of a medium brown coarse sandy loam heavily included with small pieces of coal, pebbles and small to medium sized river and angular rocks (Image 28).

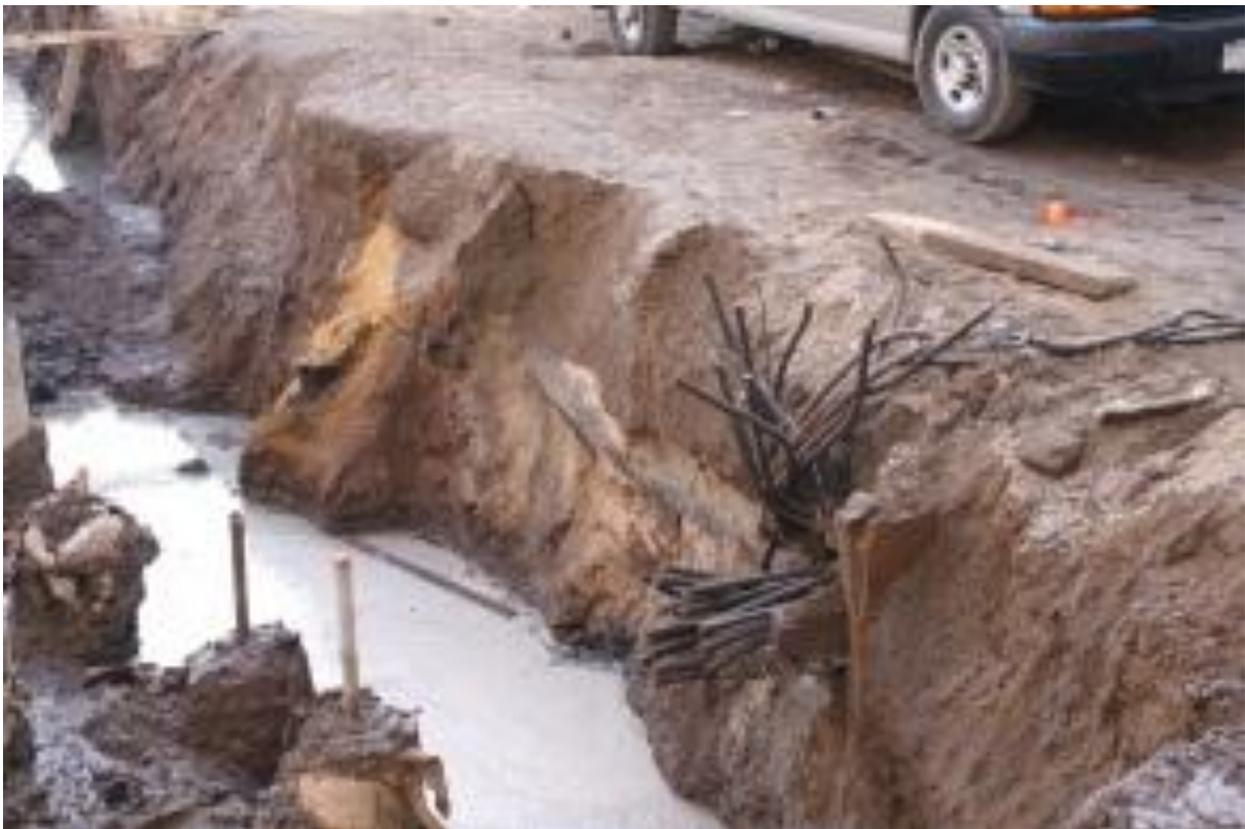
Within the overall Burling Slip/John Street project area, the consistent presence of a significant amount of standing water, from the East River, reminds one that the project area lie within the East River until the second quarter of the nineteenth century (Image 29). Several of the images throughout this report document the extremity of the water influx in several sections of the overall trench. Only by constant pumping was the water temporarily lowered enough to undertake the required construction tasks (Image 30).

Image 29: Ground water intrusion, coupled with previous utilities were a constant throughout the site

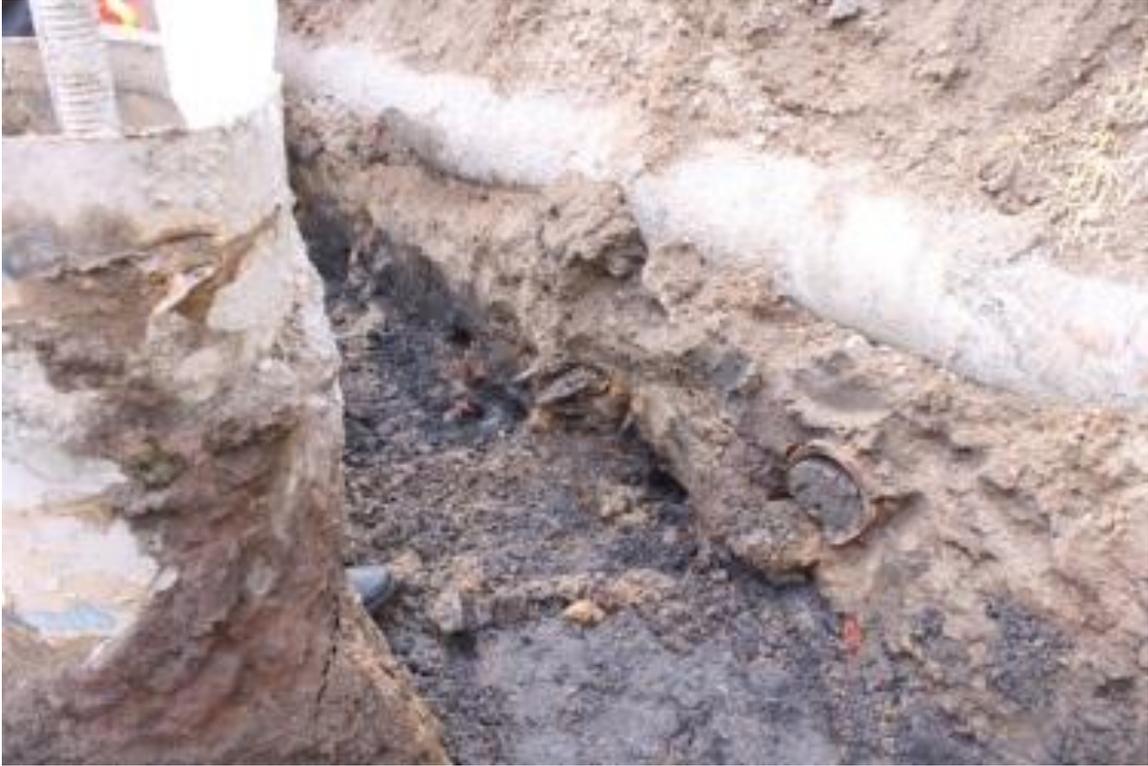
Existing utilities were present throughout the project area from surface to five and a half feet (0' – 5 1/2') below grade (Image 31). These installations impacted the area disturbing and/or destroying potential *in situ* cultural resource deposits to a depth of five and a half feet (5 1/2'). In some areas modern utility disturbance extended to ten or twelve feet (10' – 12') due to sewers, manhole and catch basin installations (Image 32)⁸. In the vicinity of these previous manhole installations, modern twentieth century artifacts were recovered, or noted, in association with nineteenth century artifacts.

Image 31: note the existing water line intrusion and brown silted water

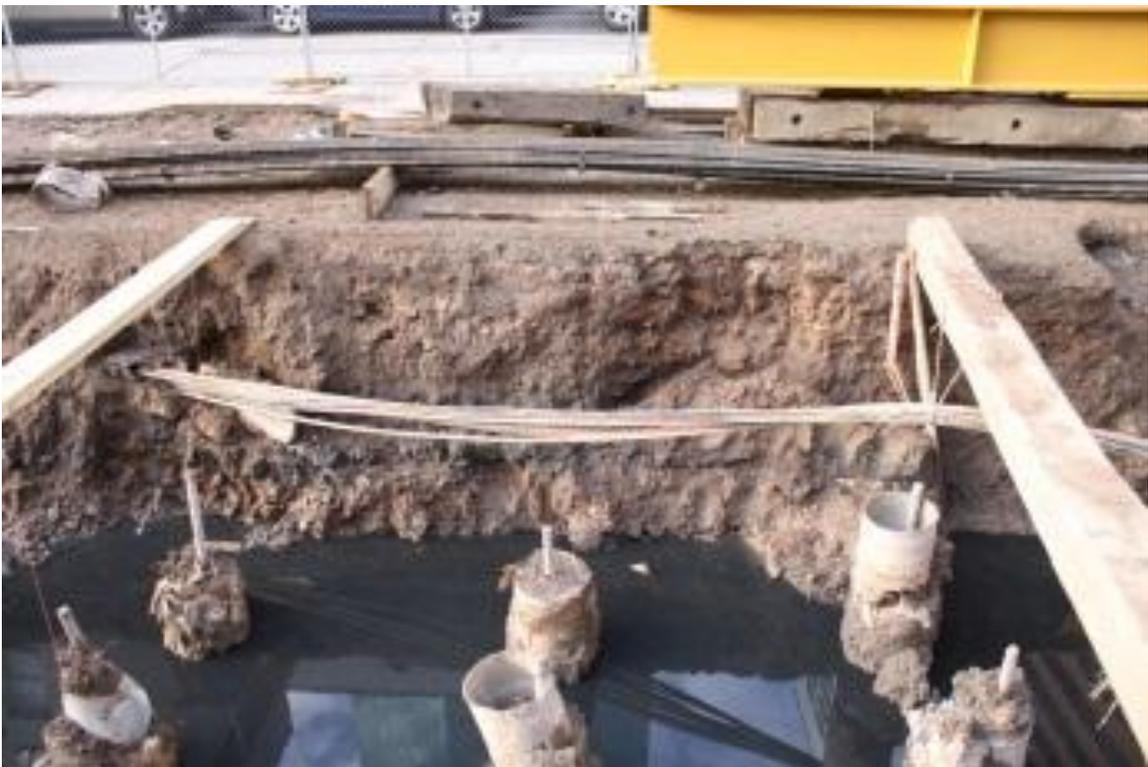
Image 32: Both utility lines and water intrusion in the trench

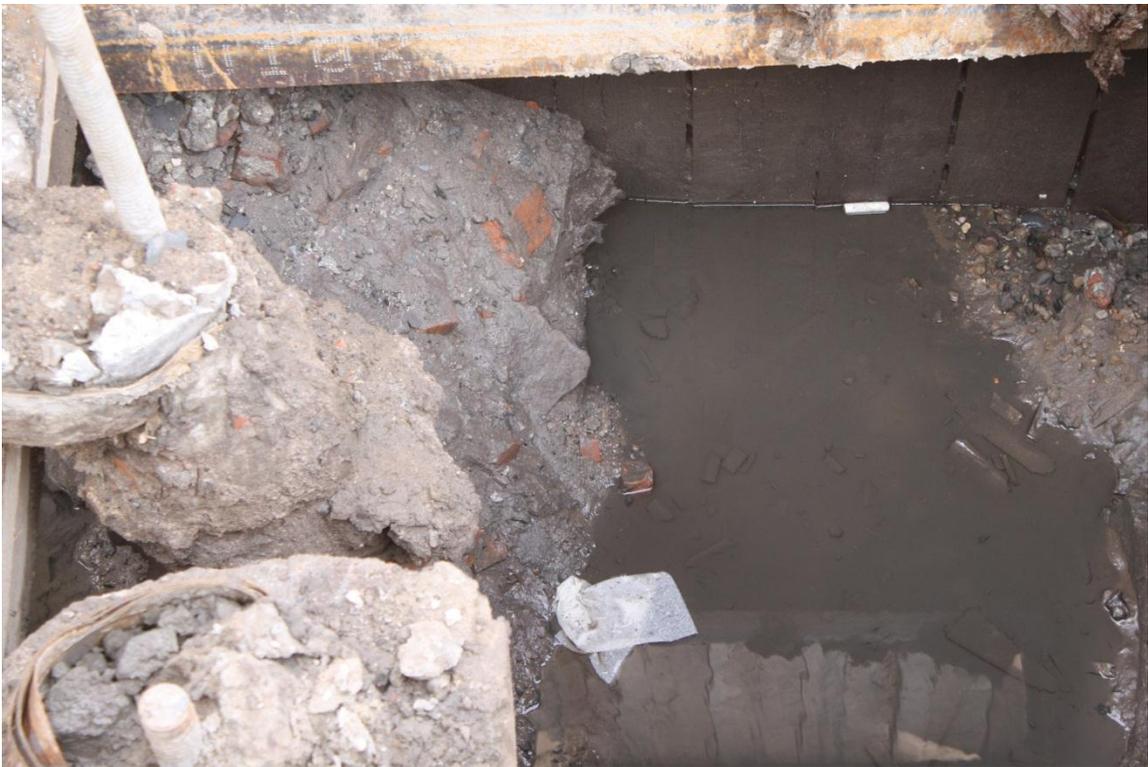
Image 46: general example of ground water intrusion

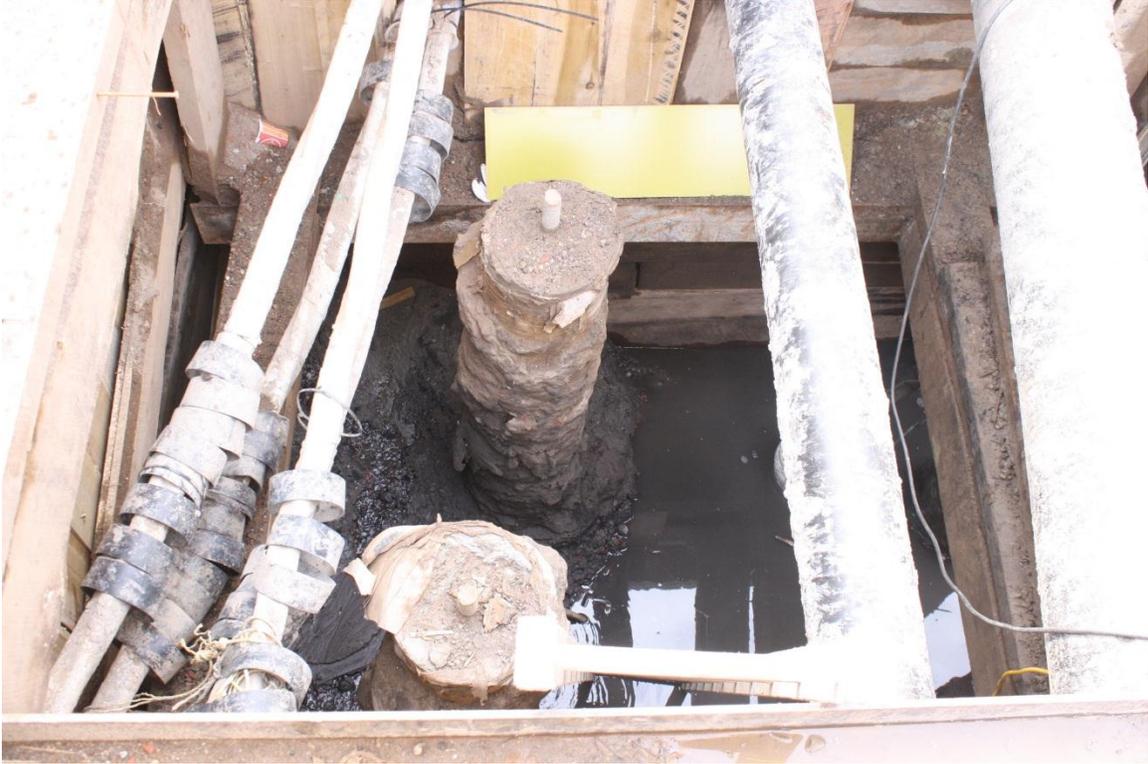
Image 47: general example of ground water intrusion and modern utility

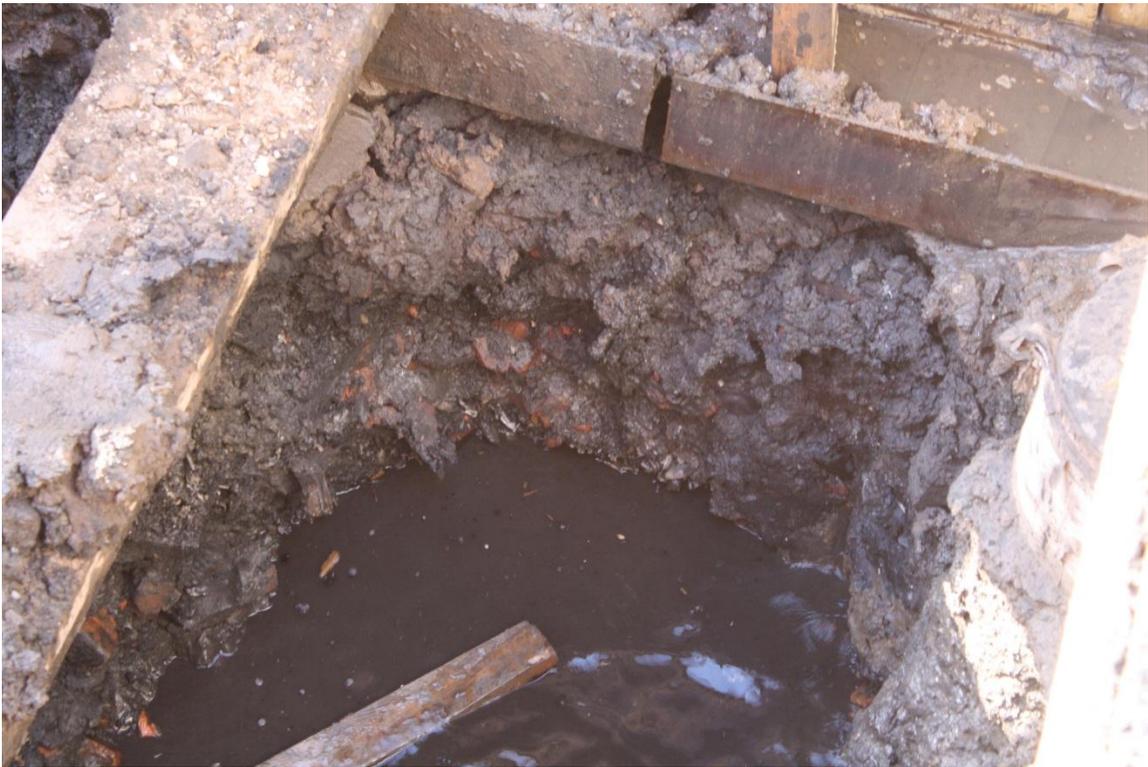
Image 50: remains of possible brick sewer

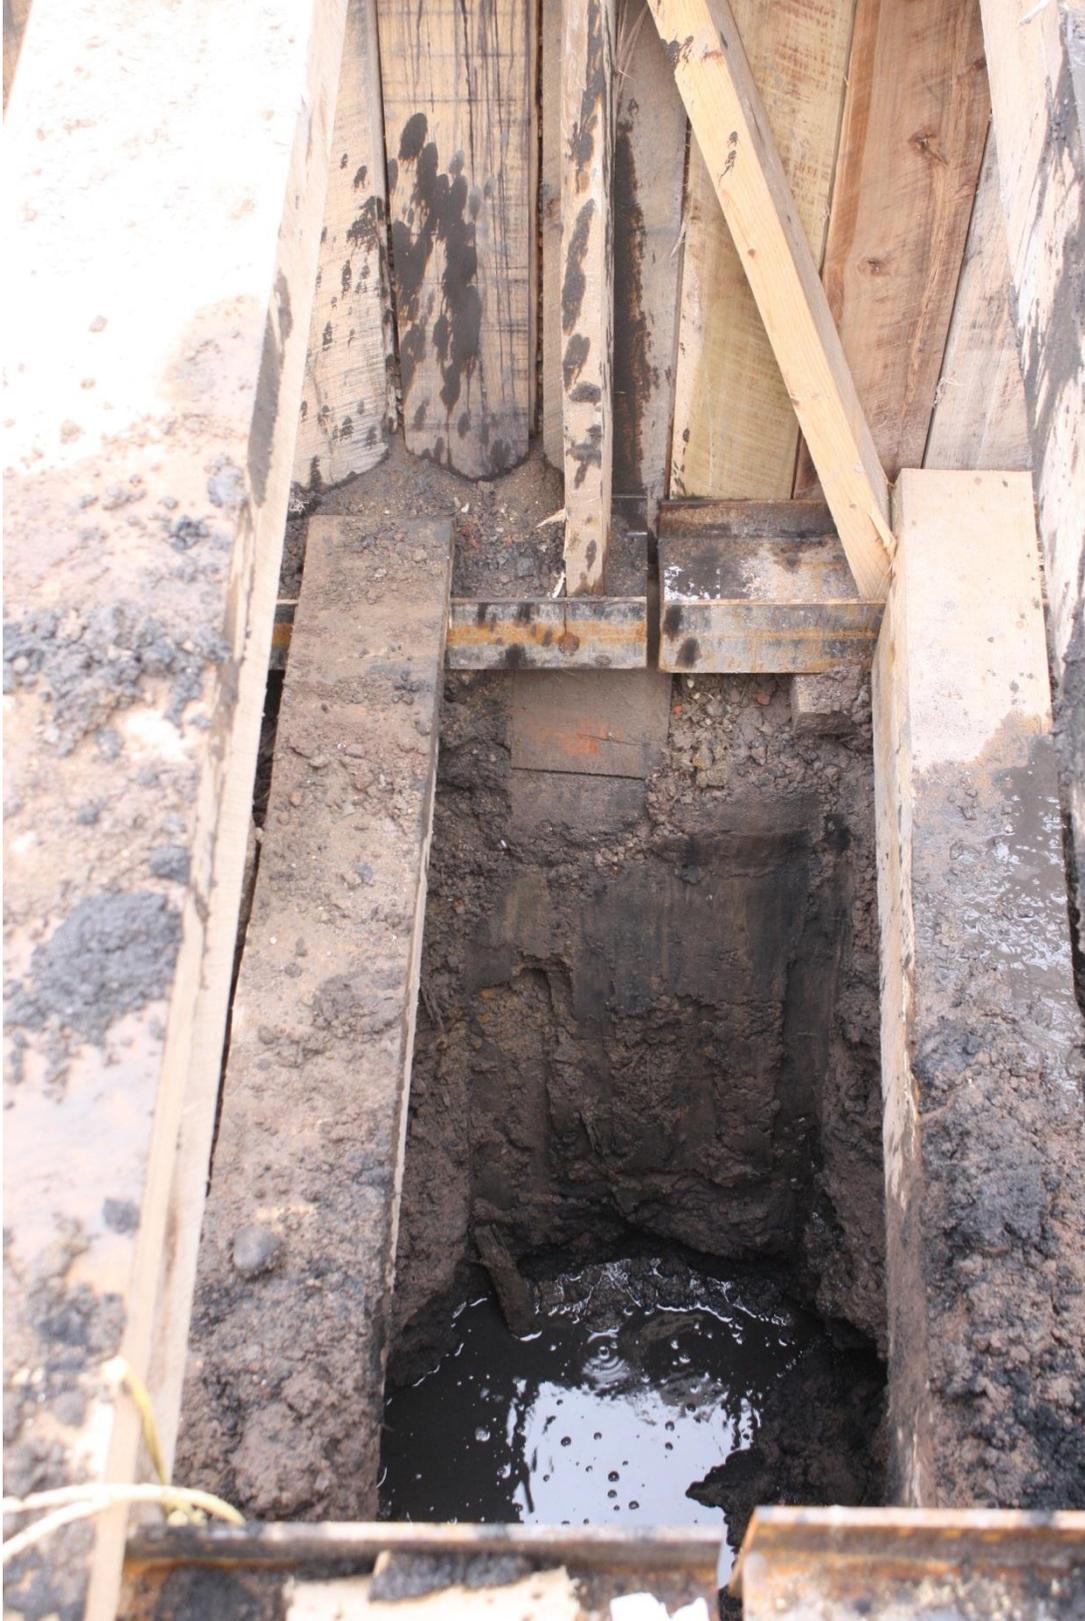
Image 52: muck and mud at the bottom of the trench

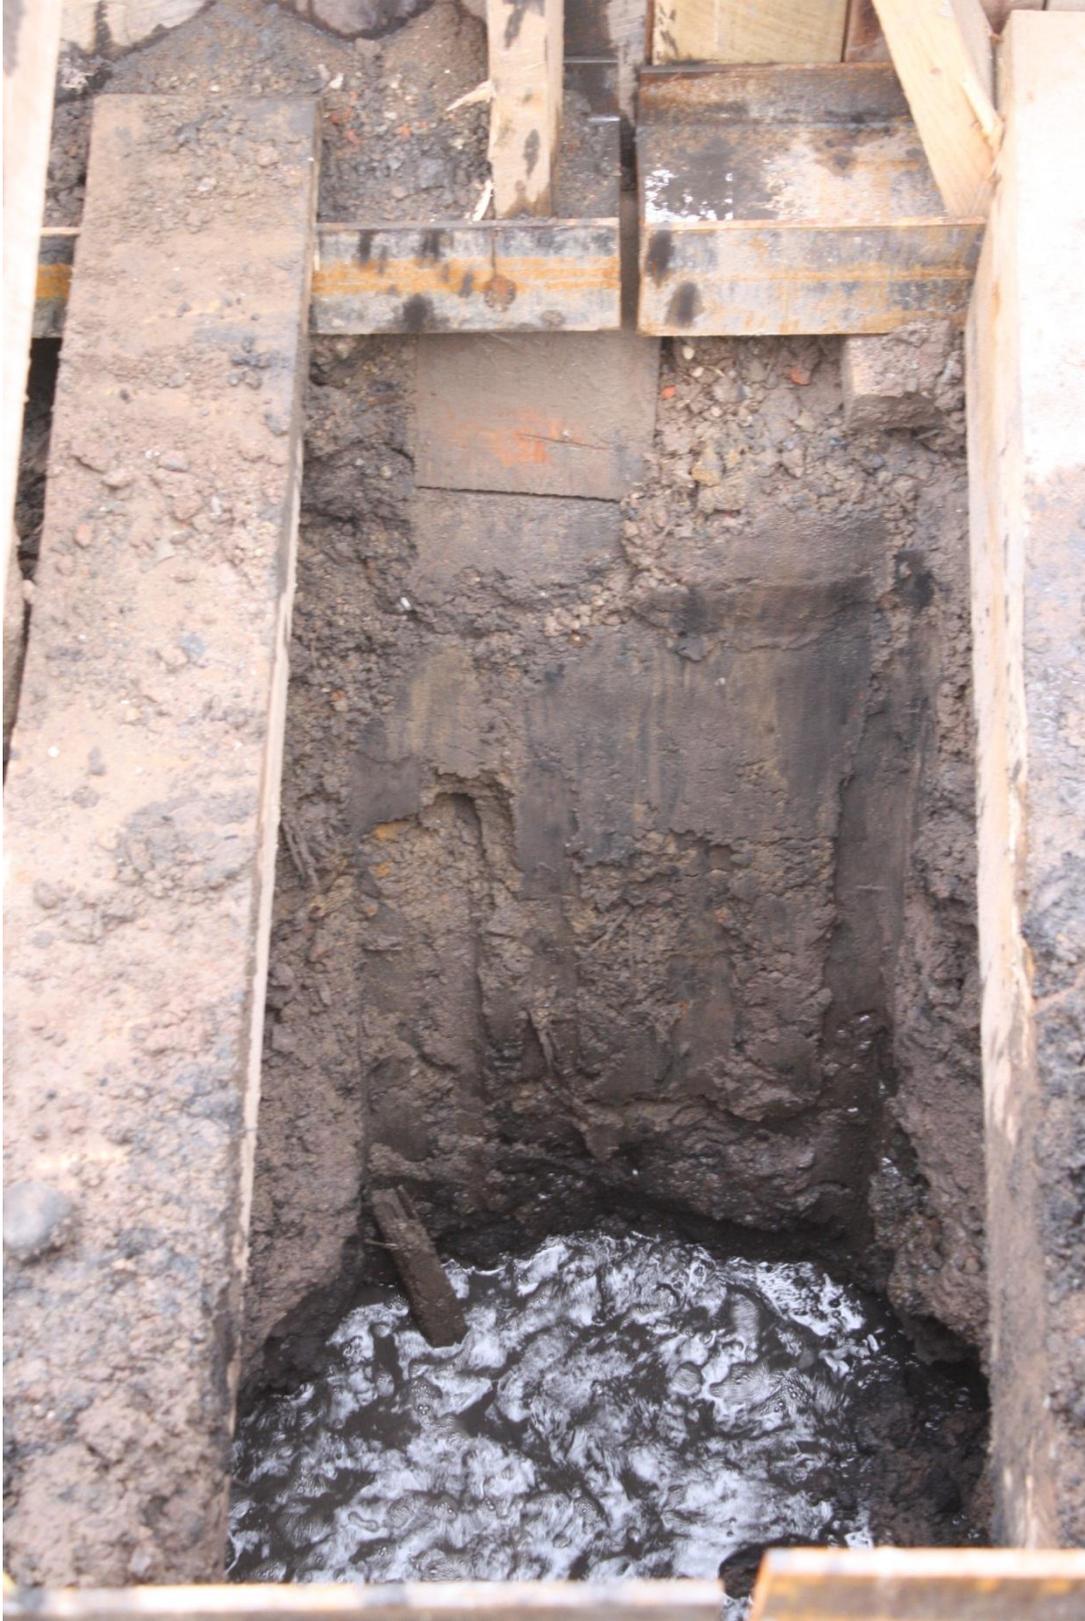
Image 53: ground water intrusion

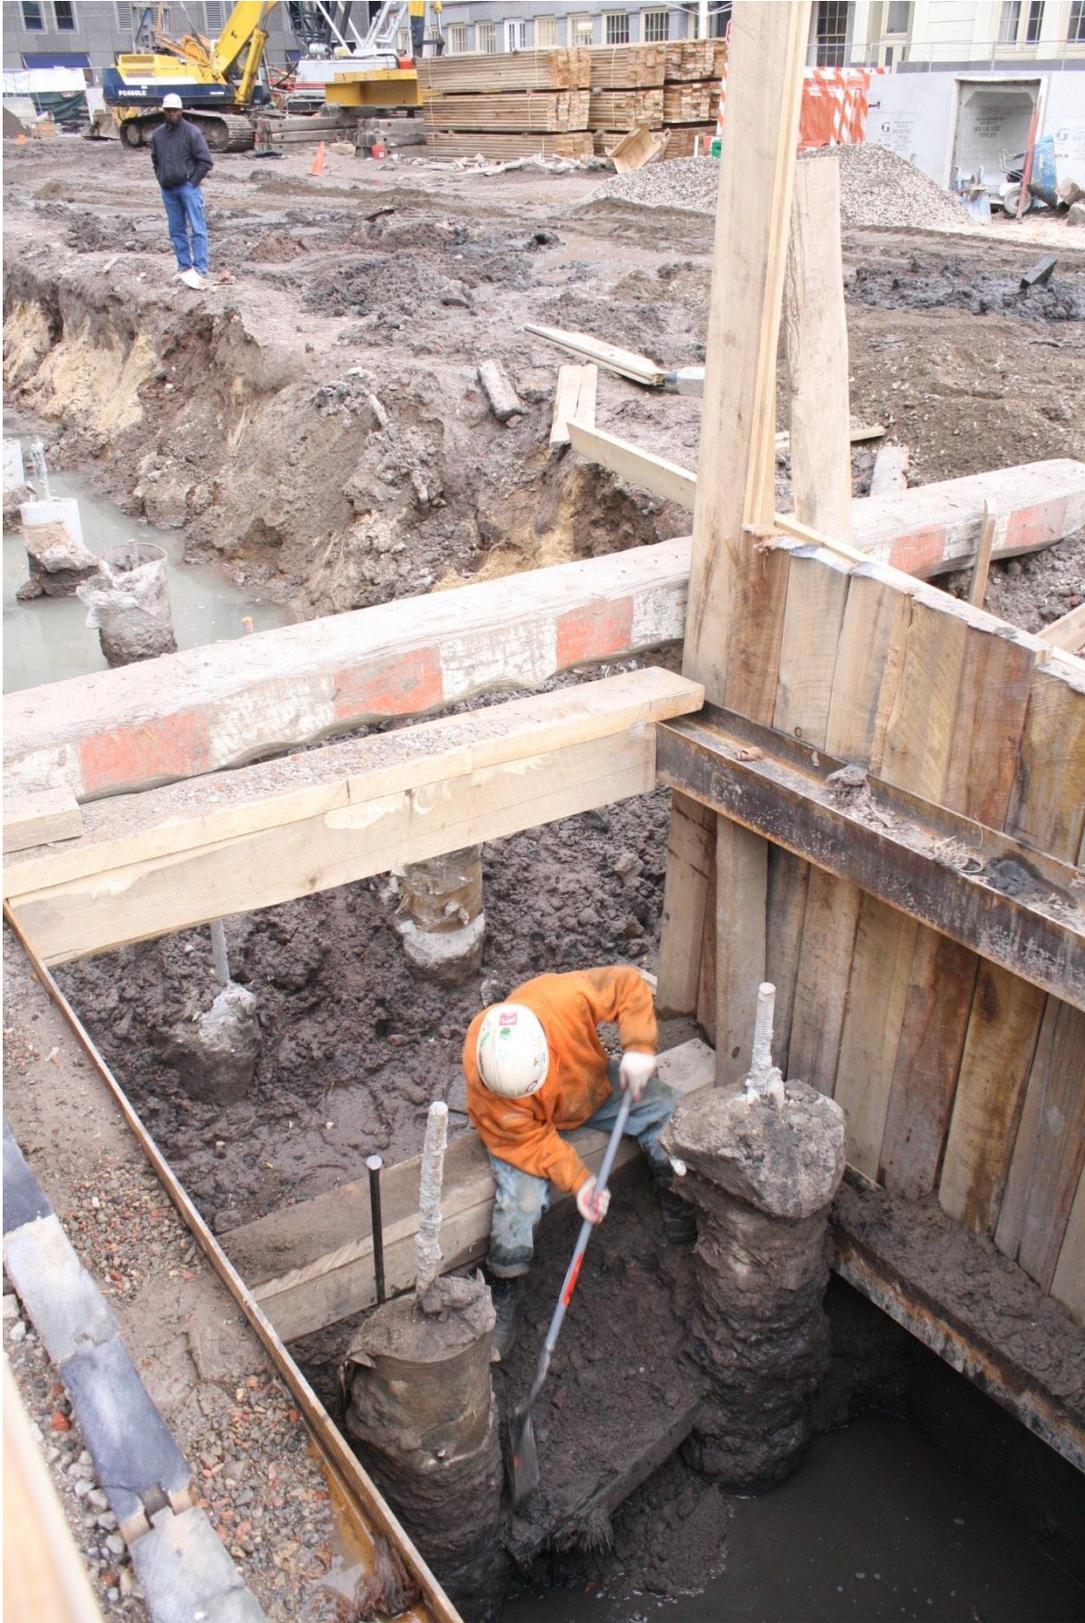
Image 54: clearing away the concrete column support

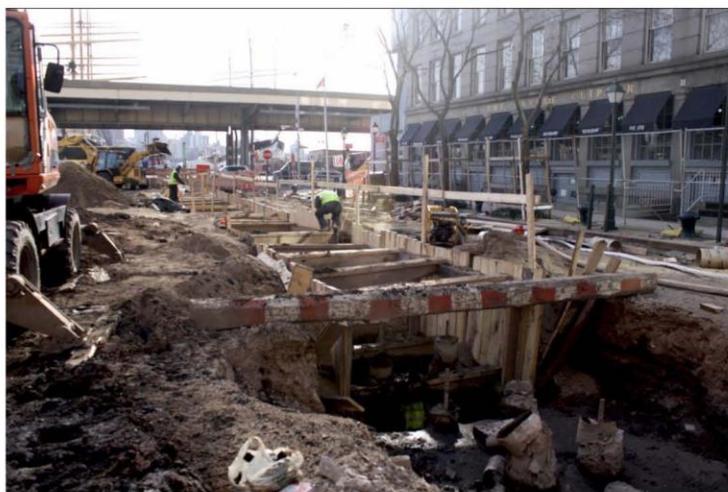
Image01: Looking southeast. The human remains were recovered from the western end of the sheeted area (in the center of the photo).

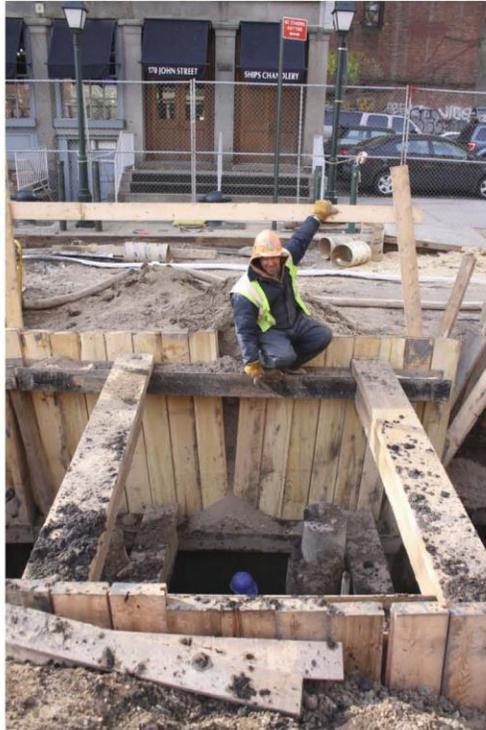
Image 02: Looking south at the segment of trench from which the human remains were recovered

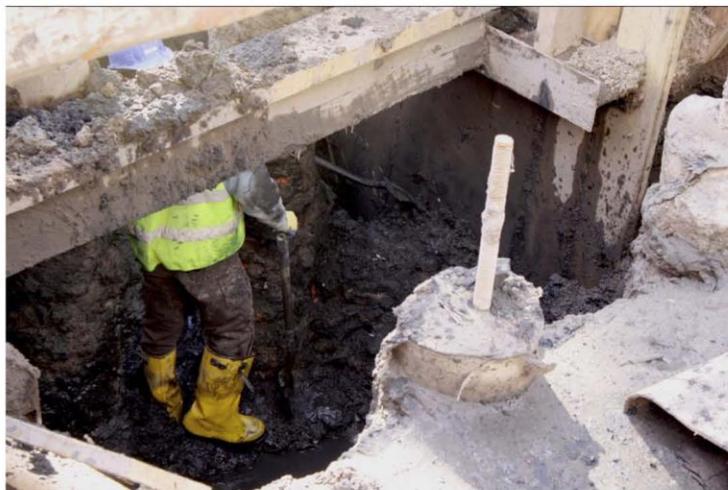
Image 03: looking into the trench segment from where the human remains were recovered

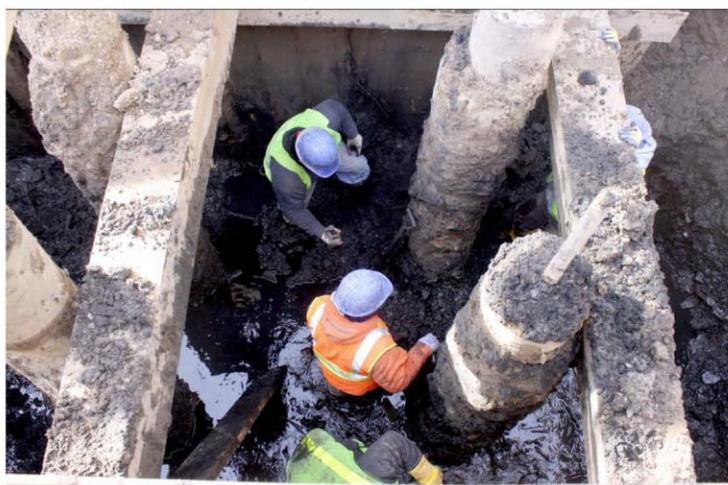
Image 04: looking east under brace into the trench segment from where the human remains were recovered
