**PHASE IB ARCHAEOLOGICAL
FIELD INVESTIGATION**

TRIANGLE PLAZA HUB

BLOCK 2294, LOT 60

**ARCHAEOLOGICAL FIELD INVESTIGATION
TRIANGLE PLAZA HUB
BLOCK 2294, LOT 60
459 EAST 149th STREET
BRONX, NEW YORK**

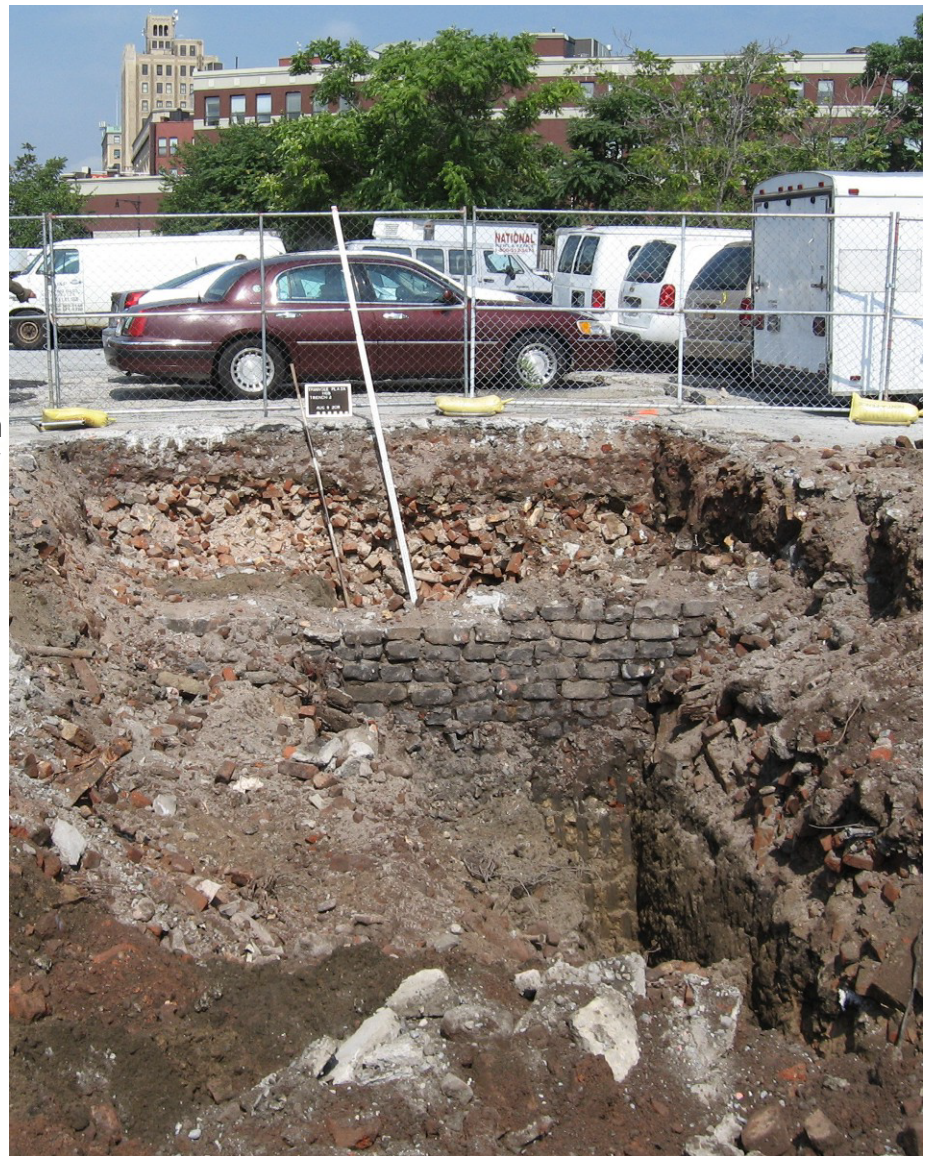
FIGURE 5: Soil profile, Test Trench 2, West Wall.

Test Trench 2 West Wall

Six distinct strata were encountered near the center of the Trench 2 (Table 1; Figure 5).

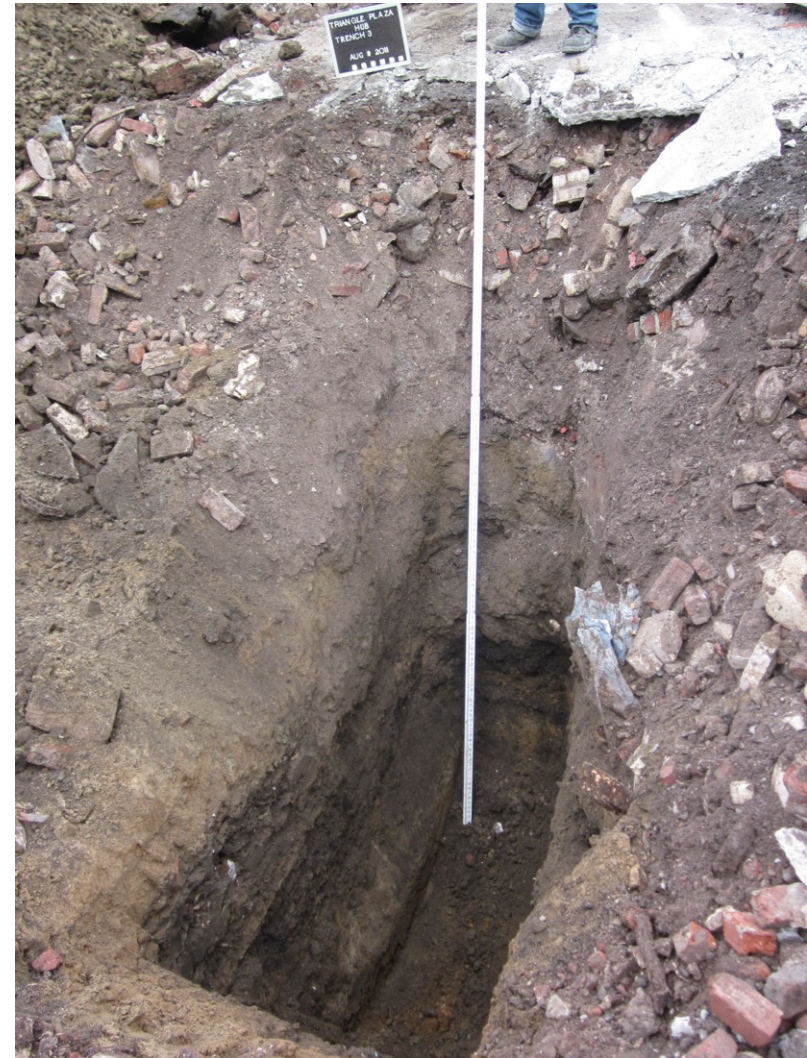
FIGURE 6: Soil profile, Test Trench 3, North Wall.

Test Trench 3 North Wall

western side of the trench at four feet and continue excavation within the remaining eastern portion section (ca. 10 x 10 ft) of the trench. Fill strata were discovered to be present to a depth of greater than ten feet, the depth at which the protocol called for the hand excavation of shovel tests. A concentration of early twentieth century artifacts, including several complete bottles was noted at a depth beginning at 130 cmbs (4.2 ft). The artifacts were collected and are included in Appendix A. Eight distinct strata were encountered during testing (Table 4; Figure 6).

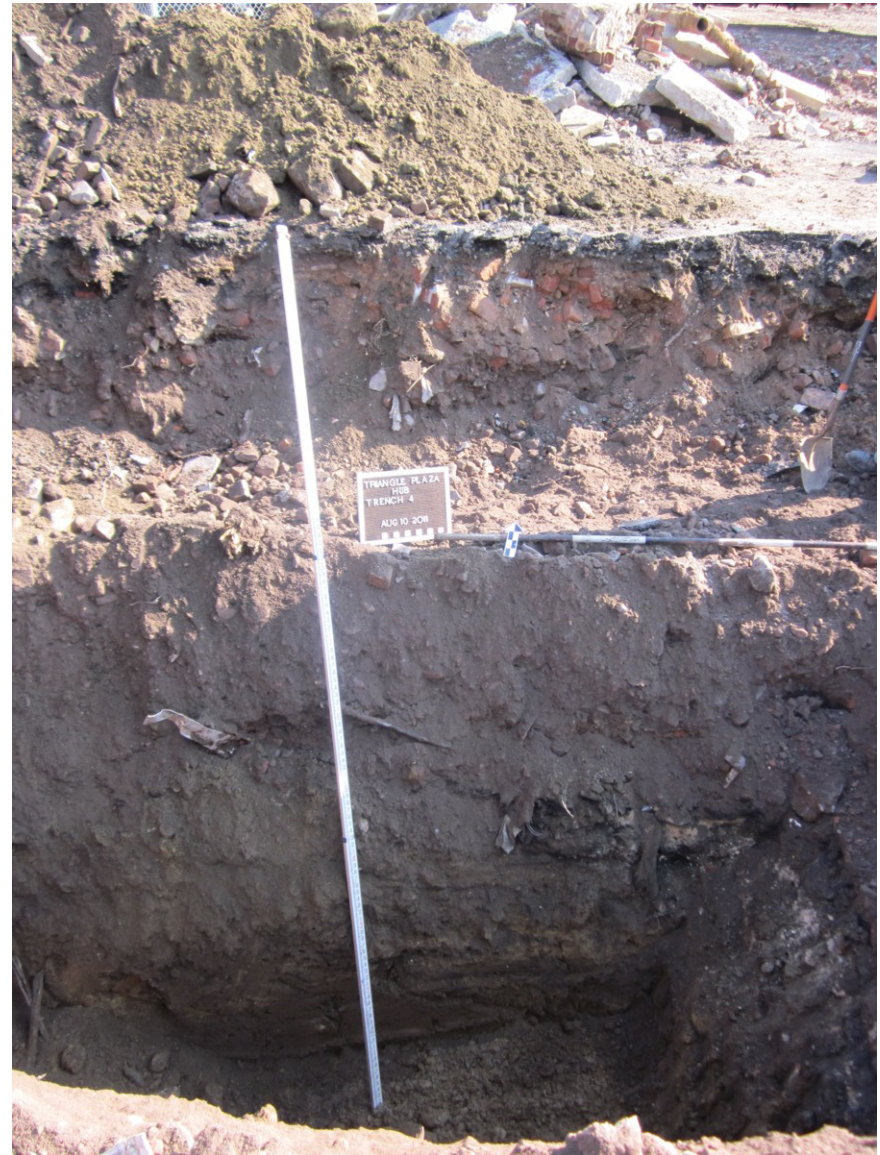
FIGURE 7: Soil profile, Test Trench 4, North Wall.

Test Trench 4 North Wall

The majority of the area where Trenches 4-6 were located was covered with asphalt and thin concrete (Photograph 6). Trench 4 was 4.27 x 4.25 meters (ca. 14 x 14 ft) in size (Figure 3). Following the removal of the asphalt surface layer, the backhoe continued the excavation of the fill strata, under the supervision of the HPI archaeologists. HPI archaeologists instructed the operator to bench the northern side of the trench at four feet and continue excavation within the southern section (ca. 10 feet wide) of the trench. The fill strata were discovered to be present to a depth of greater than ten feet, the depth at which the protocol called for the hand excavation of shovel tests. As with the previous trenches examined, neither a buried A or B horizon was discovered and the field team recommended that mechanical excavation continue. Eight distinct strata were encountered in the northern portion of Trench 4 (Table 5; Figure 7).

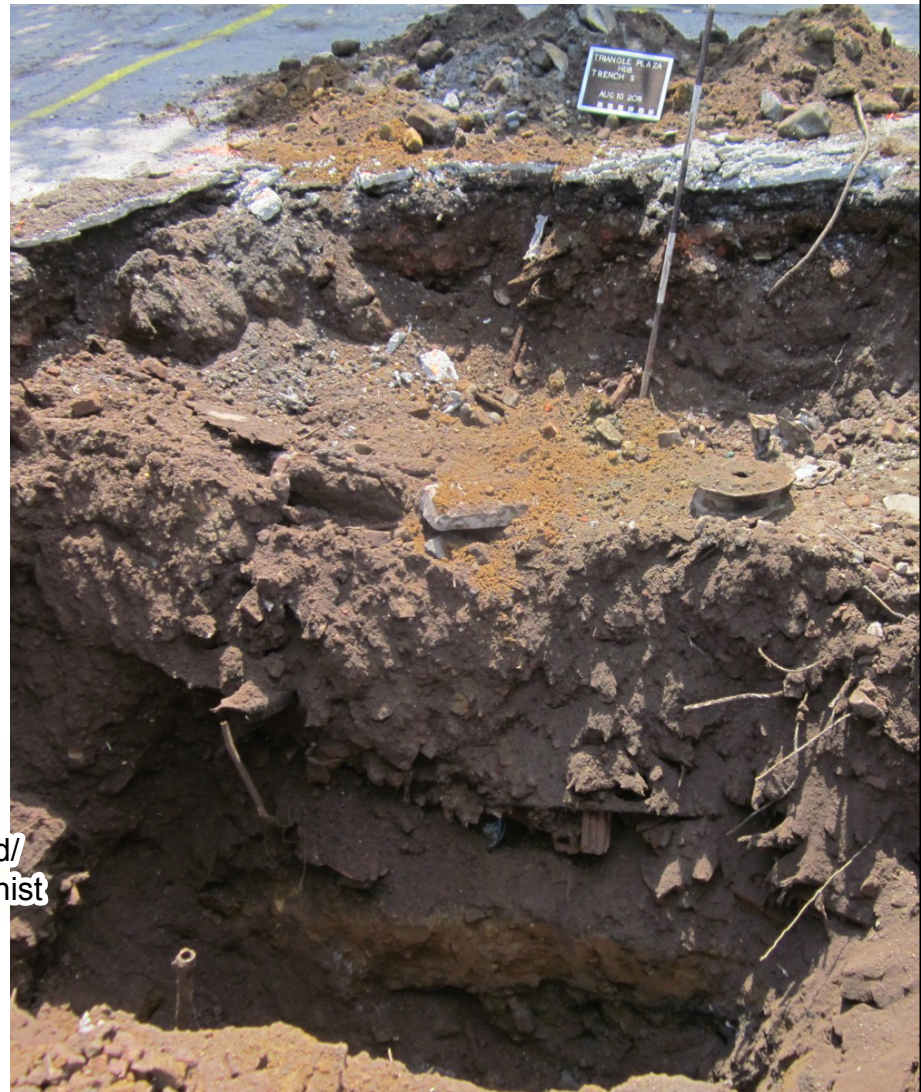
FIGURE 8: Soil profile, Test Trench 5, North Wall.

Test Trench 5 North Wall

tests. Eight distinct strata were encountered in the central portion of Trench 5 (Table 6; Figure 8).

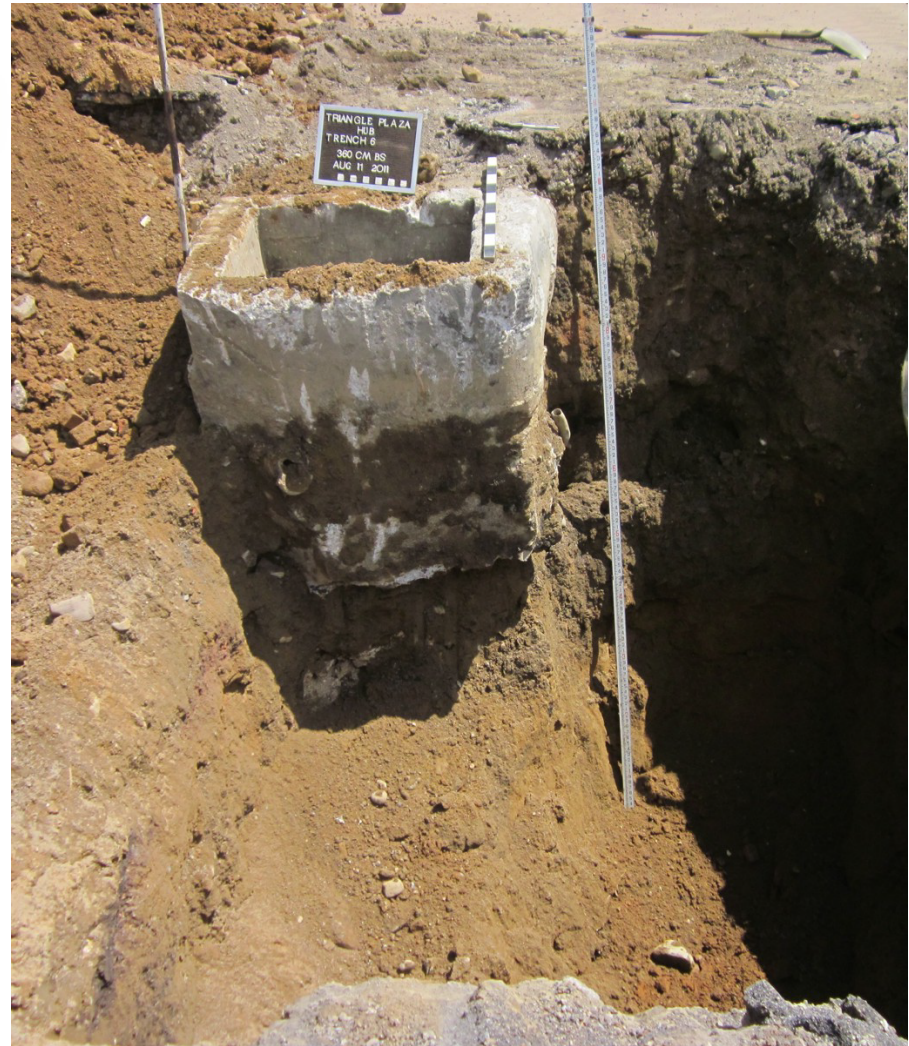
FIGURE 9: Soil profile, Test Trench 6, West Wall.

Test Trench 6 West Wall

As excavation continued in the remainder of the trench, HPI archaeologists instructed the operator to bench the southern end of the trench at a depth of four feet. The fill strata were discovered to be present to a depth of greater than ten feet in the majority of the trench. Eight distinct strata and one lens were encountered in the northern portion of Trench 6 (Table 7; Figure 9).

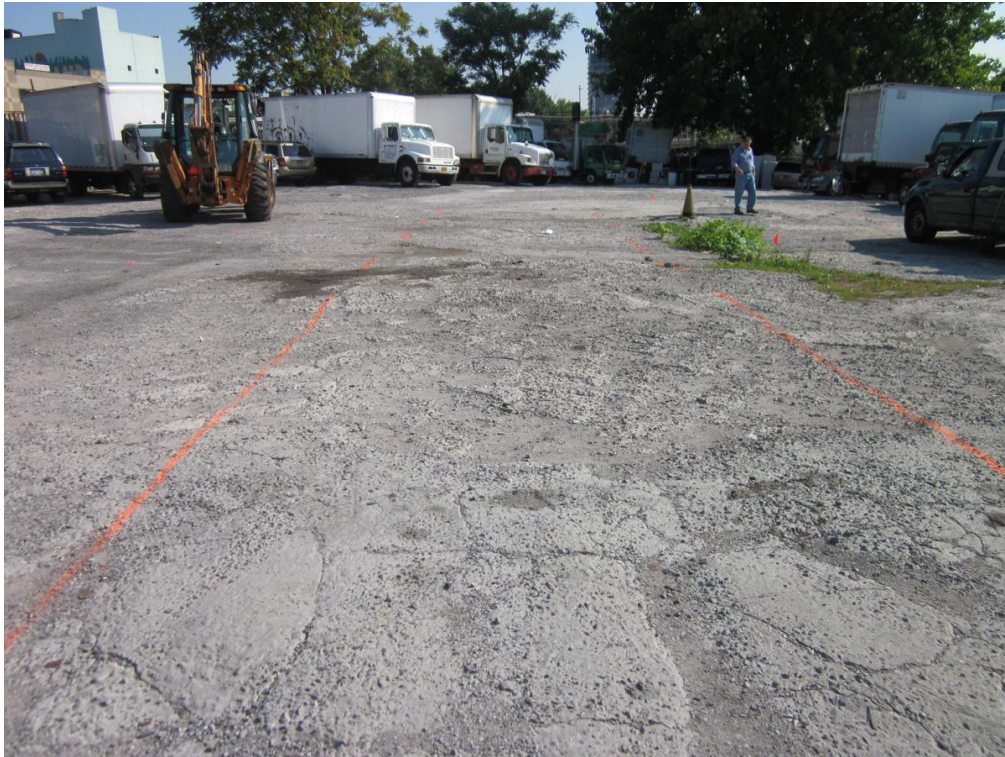
Photograph 1. Project Site. Location of Trench 1, Facing North.

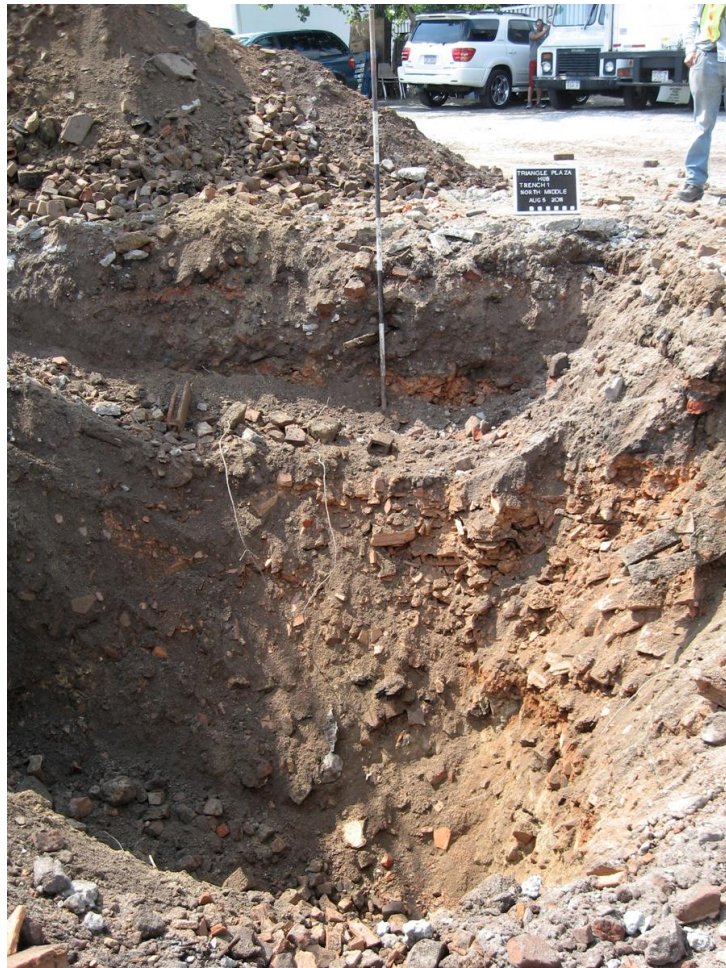
Photograph 2. Profile of West Wall at the North End of Trench 1.

Trench 1 was 23.4 x 4.5 meters (ca. 77 x 14.76 ft) in size, running north-south (Figure 3; Photograph 1). The trench was examined in ca. 4.9-meter (16-foot) sections to ensure proper control of the removed soils and the safety of the field personnel. Following the removal of the concrete surface layer, excavation of the fill strata began, utilizing the backhoe under the supervision of the HPI archaeologists in the northernmost section of the trench. HPI archaeologists instructed the operator to bench the eastern and western sides of the trench at four feet and continue excavation within the central section of the trench (ca. 8 feet wide). The fill strata were discovered to be present to a depth of greater than ten feet, the depth at which the protocol called for the hand excavation of shovel tests. Because neither a buried A or B horizon was discovered, the field team recommended that mechanical excavation continue. This alteration of the protocol was conveyed to LPC, who agreed with this approach (LPC communication 8/5/11). In the northern portion of the Trench 1 in Area C five distinct strata were encountered (Table 1; Figure 4; Photograph 2).

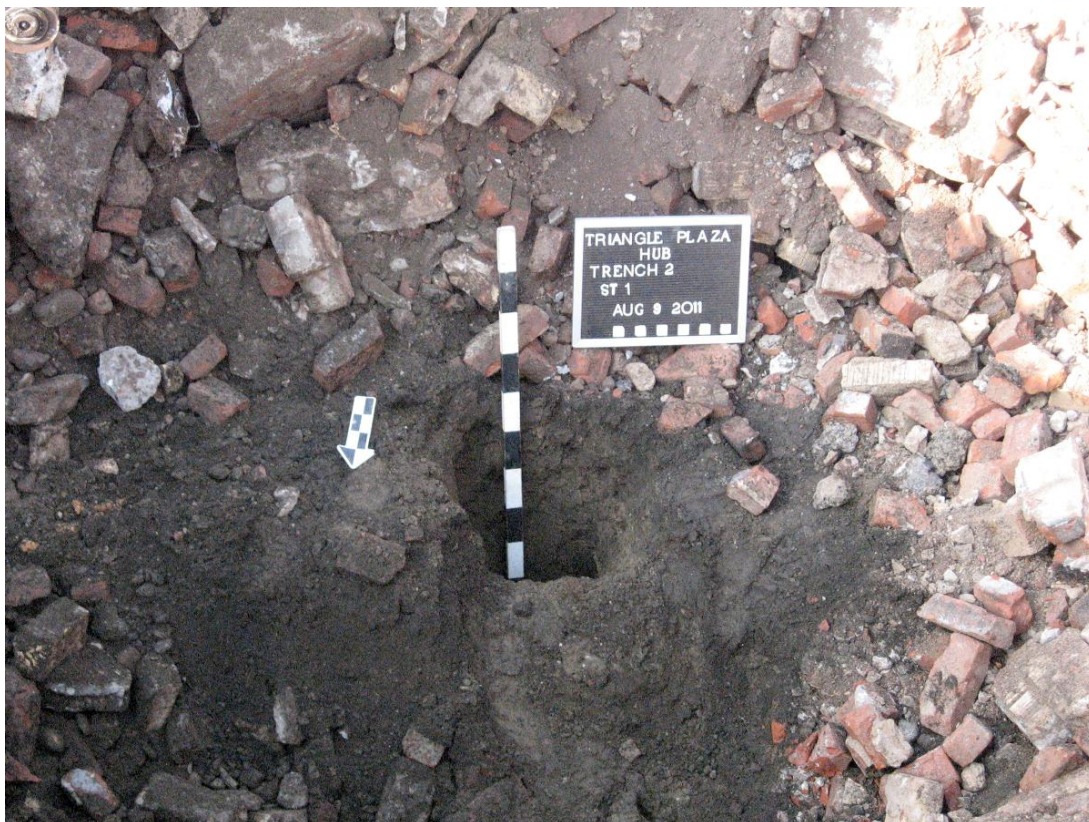
Photograph 4. Trench 2, Shovel Test 1.

dept of 250 cmbs (Photograph 4). Architectural debris was found throughout the shovel test unit and it was determined that it was still a mixed fill stratum. Because neither a buried A or B horizon was discovered, the field team recommended that mechanical excavation continue and fill was exposed to depths between 350 and 375 cmbs.

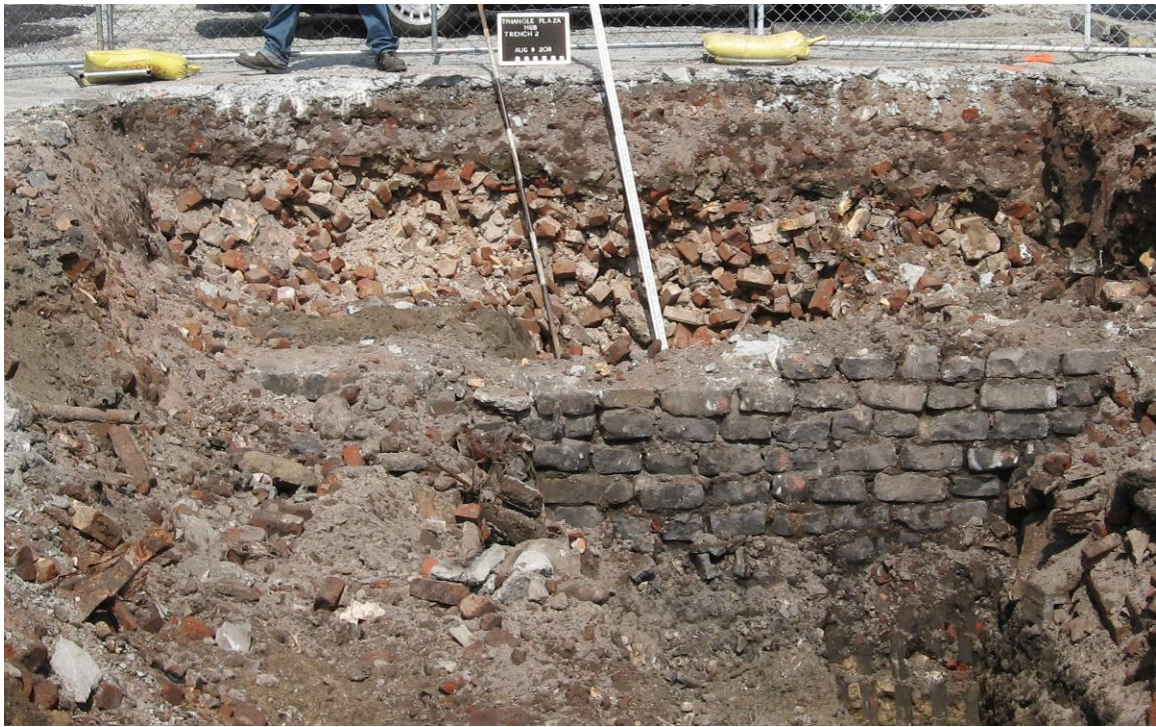
Photograph 5. Stone Foundation Wall Noted in Trench 2.

The team exposed a stone wall (Photograph 5) near the center of the trench. The remaining wall was eight courses in height and one course wide with the base being 325 cmbs (10.6 ft). The average stone was ca. 16 to 18 cm (6 to 7 in) in size. The wall might have been associated with an unrecorded addition to a building or outbuilding in this lot. No early historical or precontact features or concentrations were noted throughout the trench.

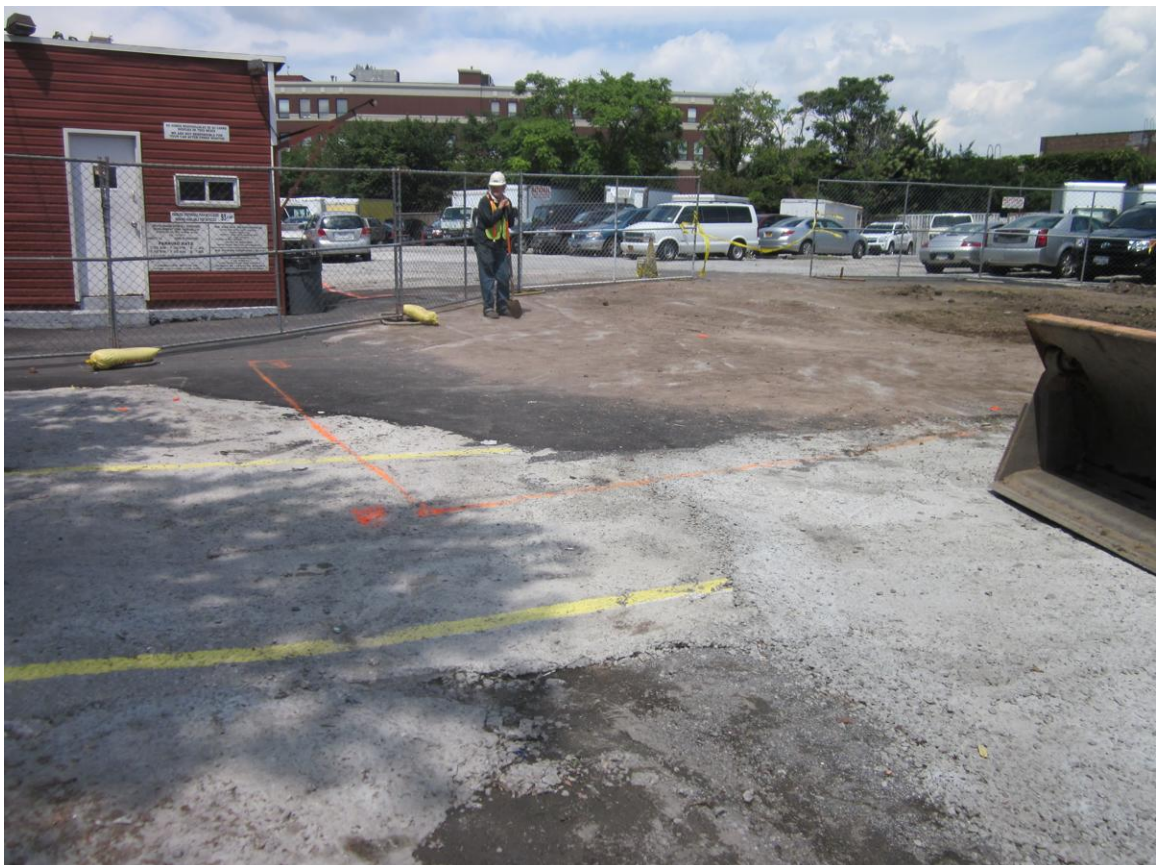
Photograph 6. Location of Trenches 4-6 and Attendants' Shed Prior to Excavation.

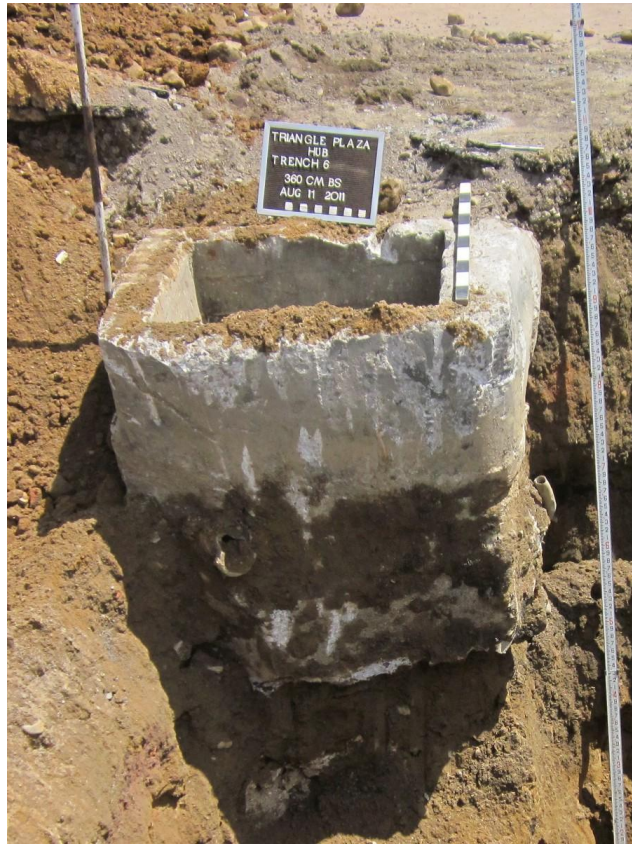
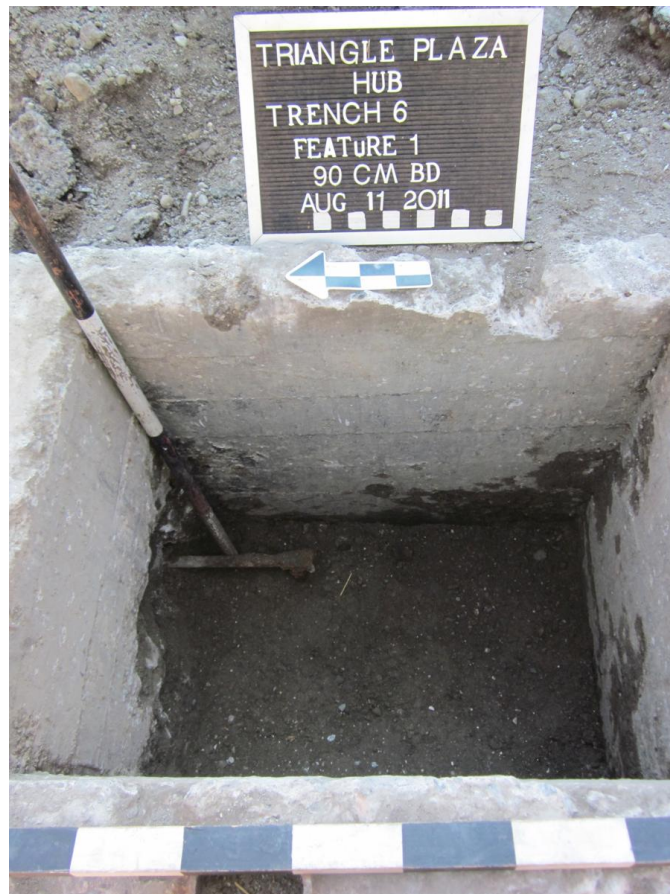
Photograph 7: Feature 1, Concrete Water Management Feature in Trench 6.

Photograph 8: Feature 1, Concrete Water Management Feature in Trench 6.

Near the northeast corner of the trench, a rectangular concrete water management feature was encountered at a depth of 15 cmbs (ca. 0.5 ft) (Photographs 7 and 8). The HPI team hand excavated approximately 65 percent of the feature in arbitrary 30 cm levels and it was found to contain a single mixed fill stratum with 20th century domestic trash and architectural fragments (e.g., window glass, nails). The domestic materials were primarily ceramic (whiteware) and bottle glass (various colors). A fragment of a bisque dolls head, a shell button, and a small flashlight-size light bulb were also present.

Three iron pipes were found extending from the exterior to the interior of the feature. The team noted that the interior had been created using wood forms and the exterior appeared to have been set into the surrounding sand. No cap was present and the base of the feature was determined to be 140 cmbs (ca. 4.6 feet). It is likely that the feature was utilized as a water tank – either a cistern or dry well.

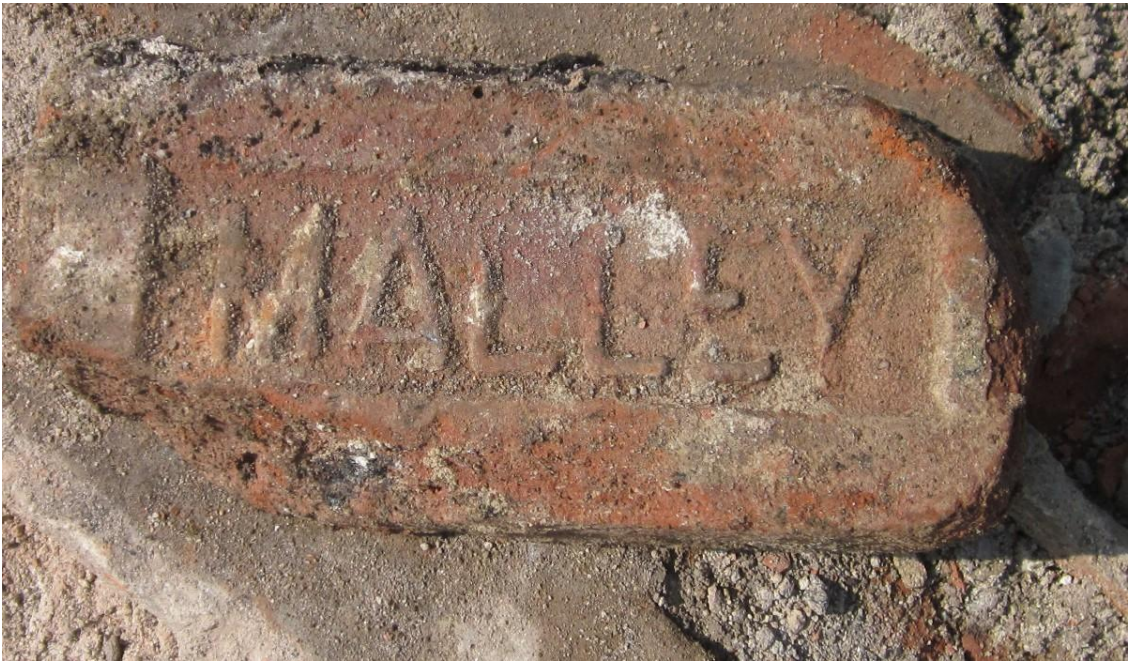
Photograph 9: Brick sample (Malley), Triangle Plaza Hub Site.

Often called the brickmaking capital of the world, the Hudson River Valley furnished many of the raw construction materials needed for the construction of the buildings in New York City during the late 19th and early 20th century. The expanding construction in the City, along with the influx of large numbers of working immigrants encouraged the rapid growth of the industry during those decades. As would be expected in landfill of demolition debris from this era, the excavation of the six trenches at the Triangle Plaza Hub site recovered numerous bricks with identifiable brick maker marks (Photographs 9 and 10). A sampling of these bricks is included in Table 8.

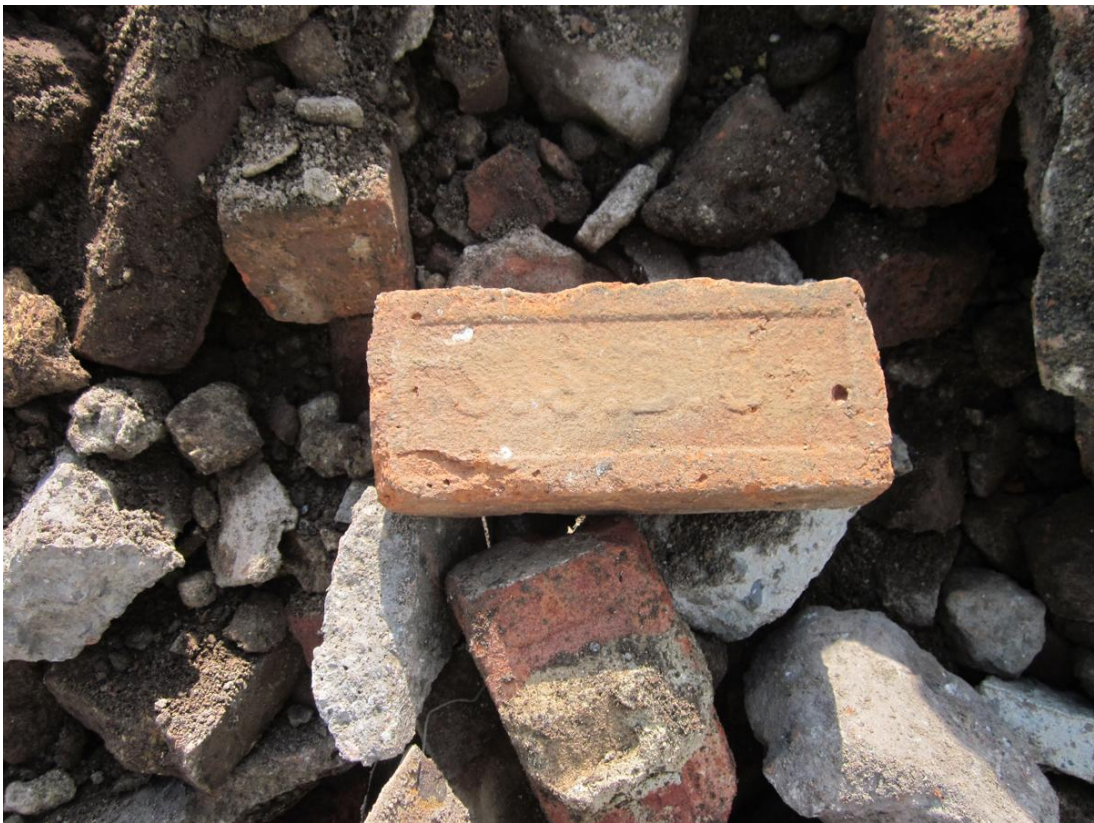
Photograph 10: Brick sample (S.S. B. Co), Triangle Plaza Hub Site.
