**FINAL REPORT:
PHASE 1B ARCHAEOLOGICAL ASSESSMENT FOR THE PROPOSED
WATERFRONT PATHWAY PROJECT, RANDALL'S ISLAND, MANHATTAN,
NEW YORK**

New York City Economic Development Corporation
110 William Street
New York, NY 10038

**Geoarcheology Research Associates
92 Main Street, Suite 207
Yonkers, NY 10701**

October 13, 2011

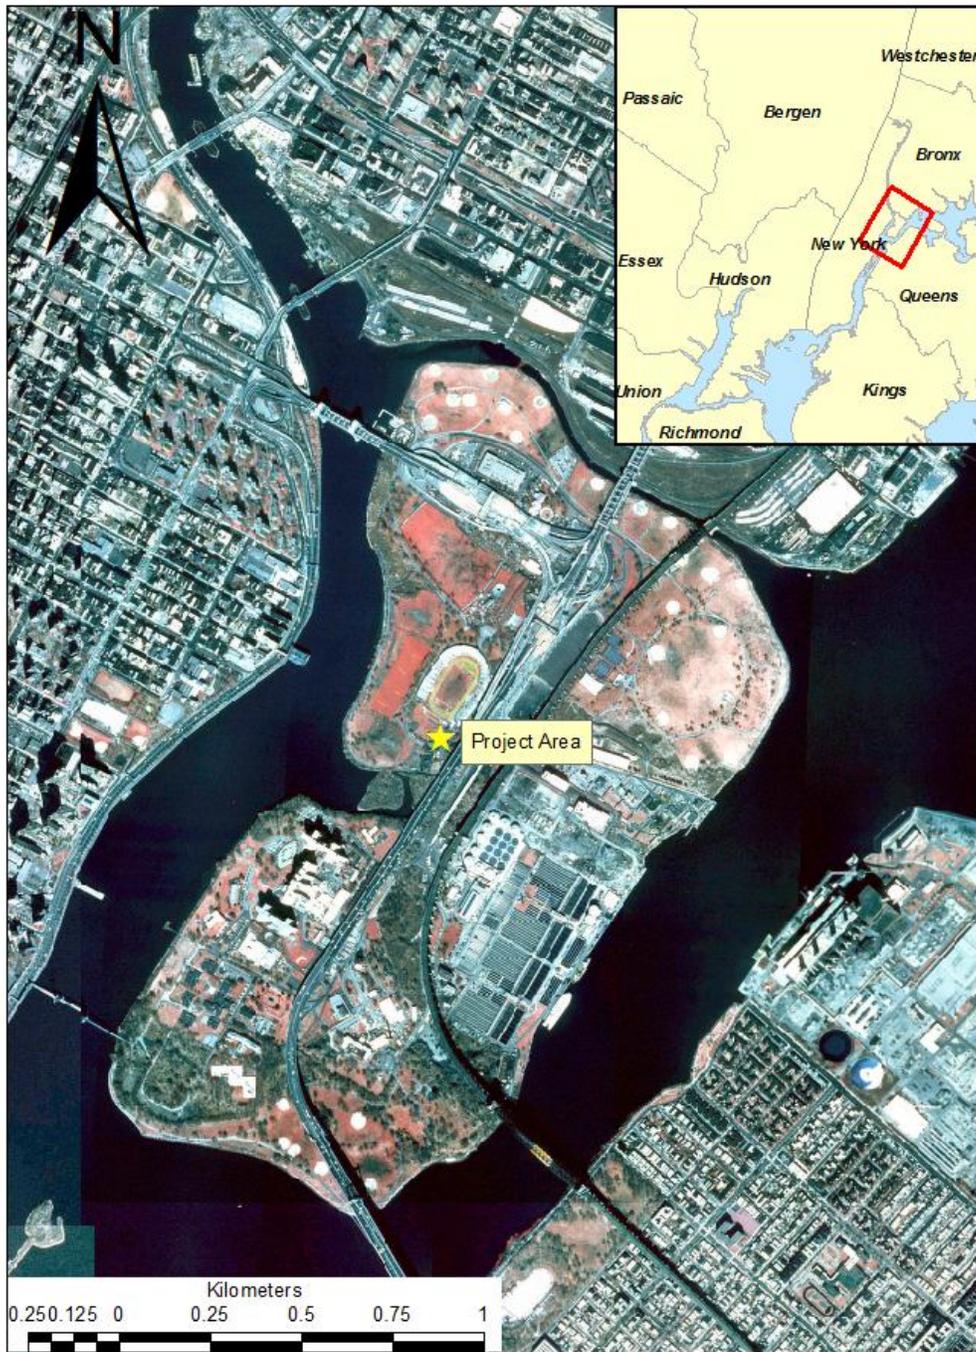
Figure 1: Aerial photo (late 1990's) showing location of Randall's Island, New York City. The Waterfront Pathway project is shown south of Icahn Stadium.

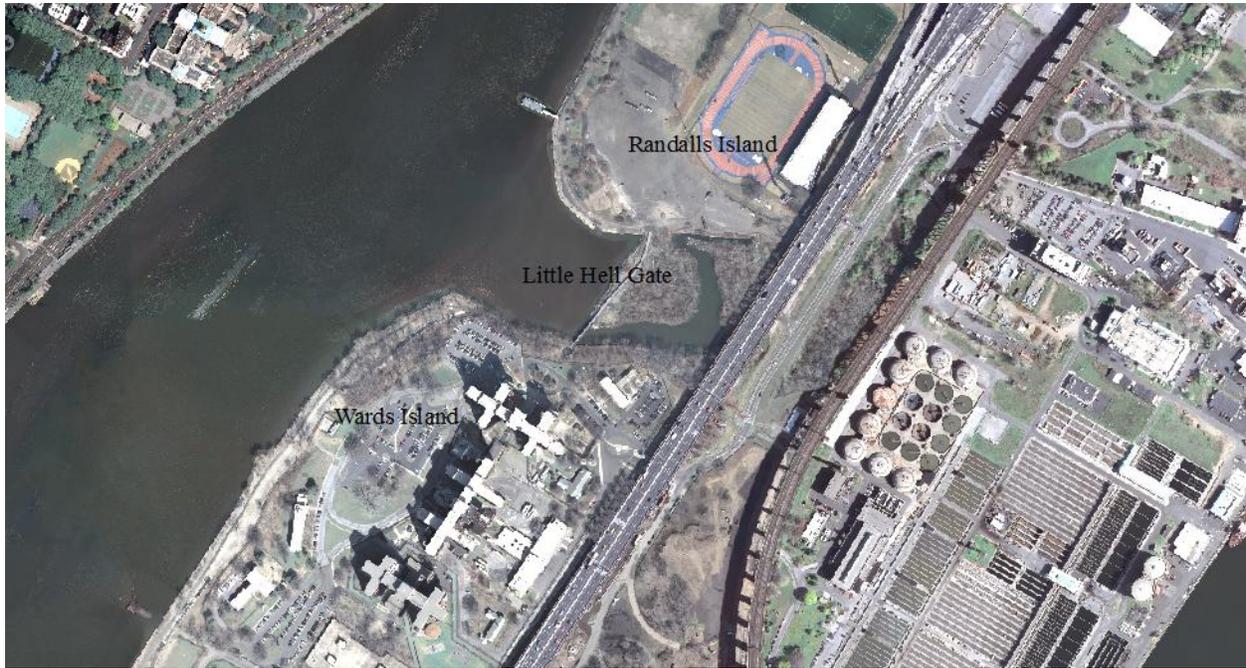
Figure 3: Overview of Randall's Island, Little Hell Gate and Wards Island

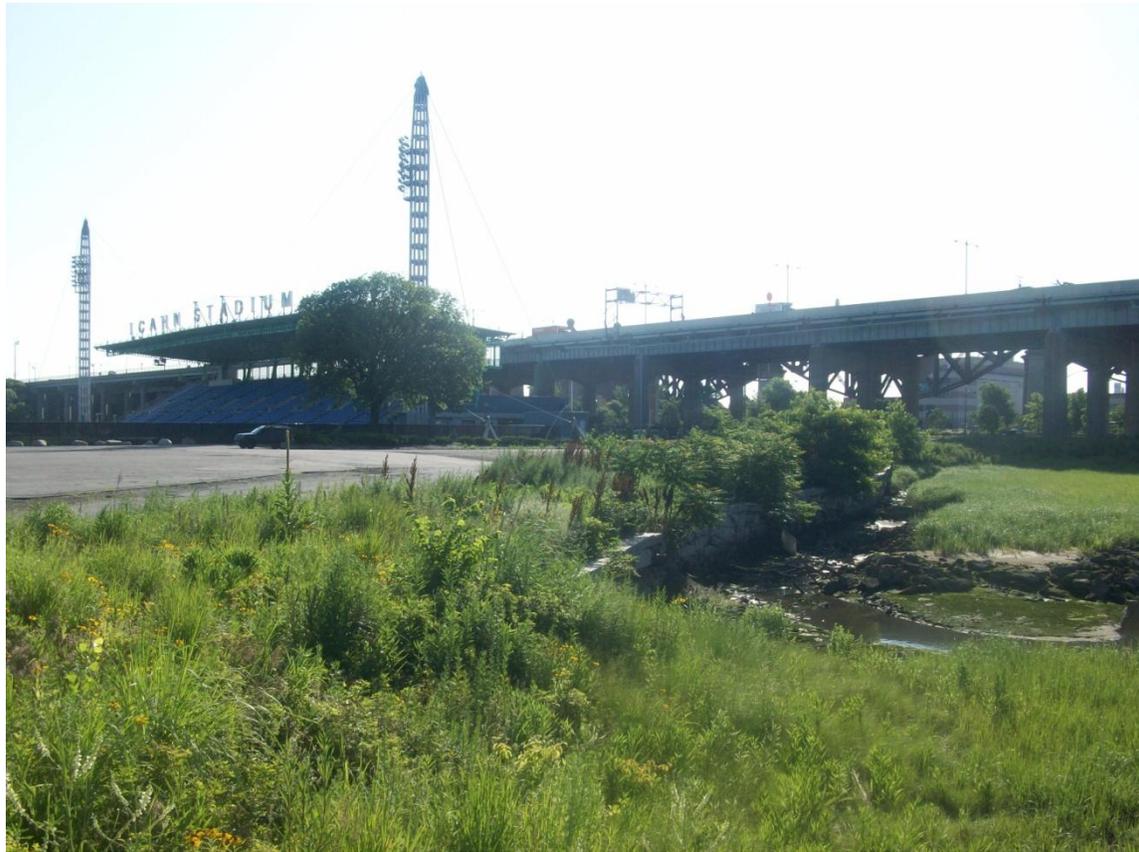
Figure 4: Field view of the remains of Little Hell Gate at the southwestern section of the project impact area.

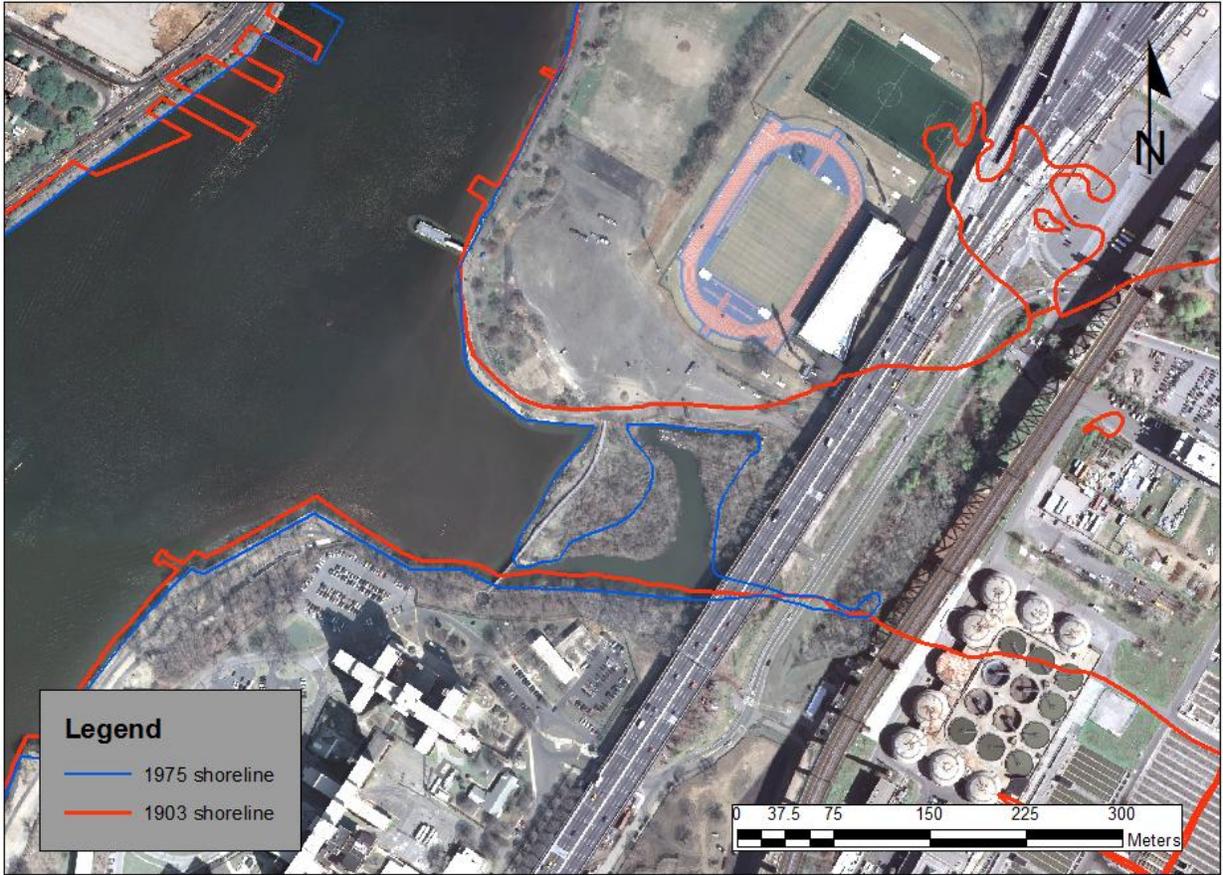
Figure 5: Sequential shoreline modifications, 20th century

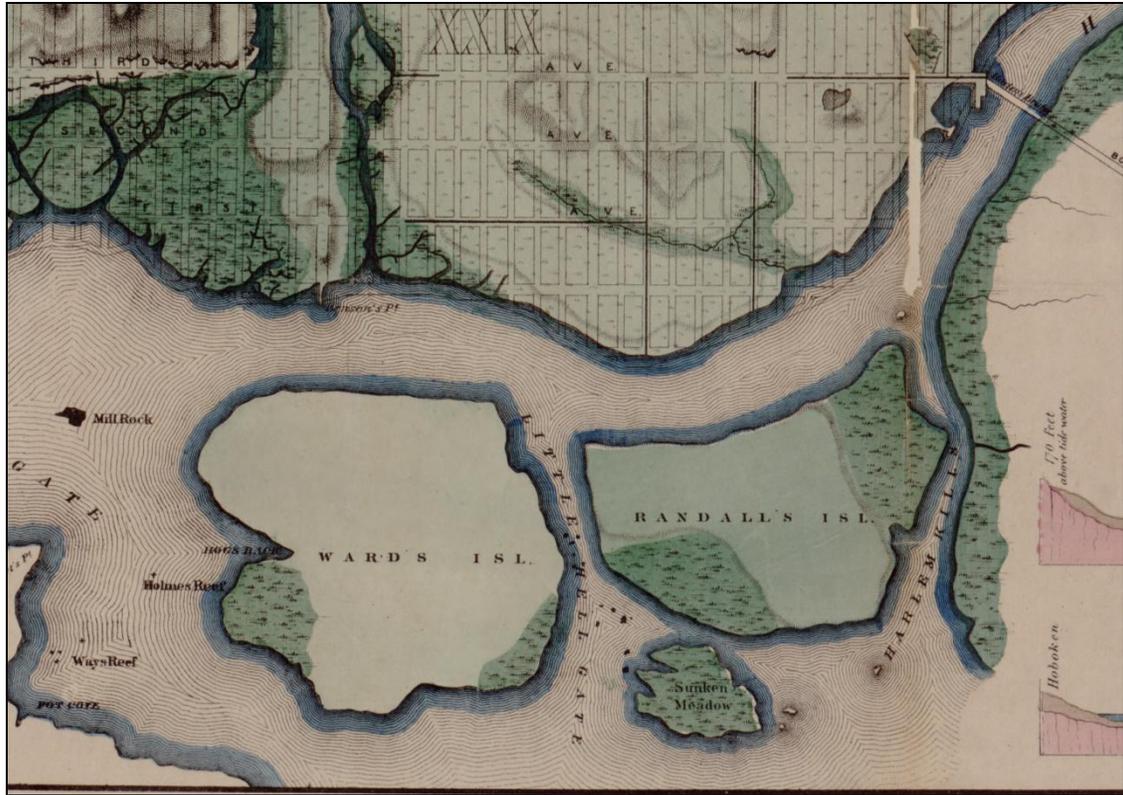
Map 1. Viele, 1874. Map depicting original geography of New York with overlay of contemporary street grid.

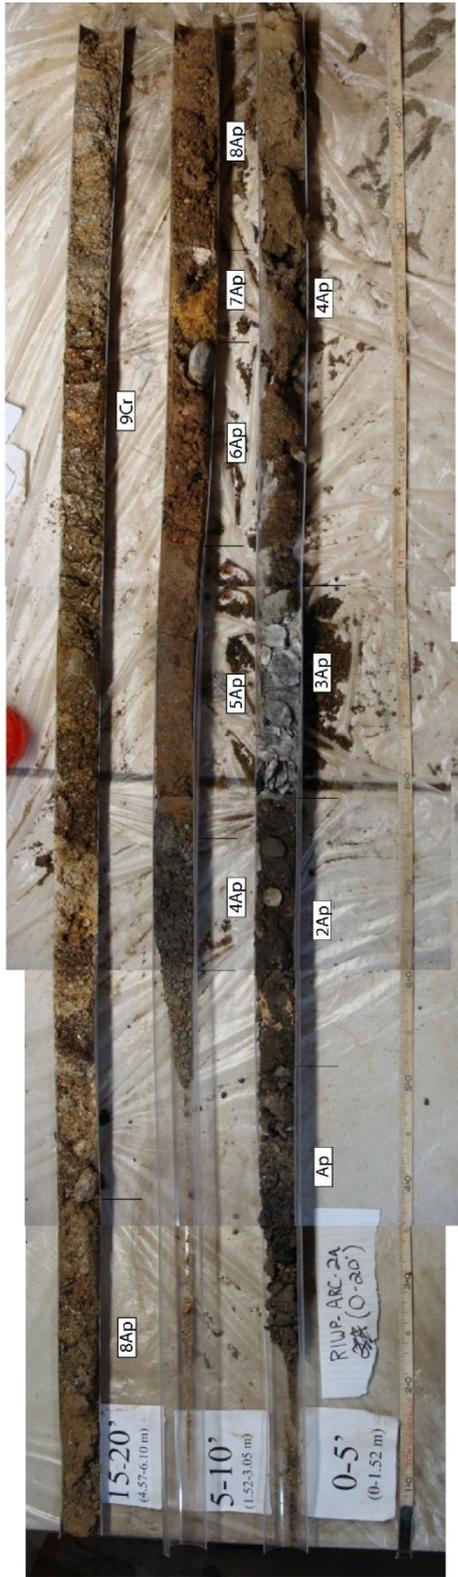
RIWP-ARC-2A									
Unit	Depth (cm)	Thickness (cm)	Soil Horizon	Munsell Color	Texture	Structure	Consistence	Boundary	Comments
Fill	0-50	50	Ap	10YR 2/1	VGS	dist	l	c	Asphalt
Fill	50-79	29	2Ap	10YR 2/1	SiL	dist	fi	c	V. few subrounded rock frags.
Fill	79-97	18	3Ap	See Comments	VGS	dist	l	c	Broken schist in 4 cm round plates; white rind w/ dark gray middle; no matrix.
Fill	97-225	128	4Ap	2.5Y 4/3	GSiL	dist	fi	c	None
Fill	225-251	26	5Ap	2.5Y 4/3	SiL	dist	fi	c	None
Fill	251-269	18	6Ap	10YR 3/6	SiCL	dist	fi-slfi	c	Mod-poorly sorted; 1 large (4 cm) flat rock at base.
Fill	269-274	5	7Ap	10YR 6/8	VGS	dist	l	c	Crushed rock; well sorted.
Fill	274-340	26	8Ap	2.5Y 4/3	SiL	dist	fi	c	None
Bedrock	340-450	60	8Cr	10YR 5/8	GSCL	gr	fri	n/a	10YR 3/3 - Fe stain; at 422 cm rock fabric is arranged in a horizontal fashion, everything else remains the same.
Texture:	Si=silt; L=loam; C=clay; S=sand; F=fine; V=very; G=gravel; O=organic

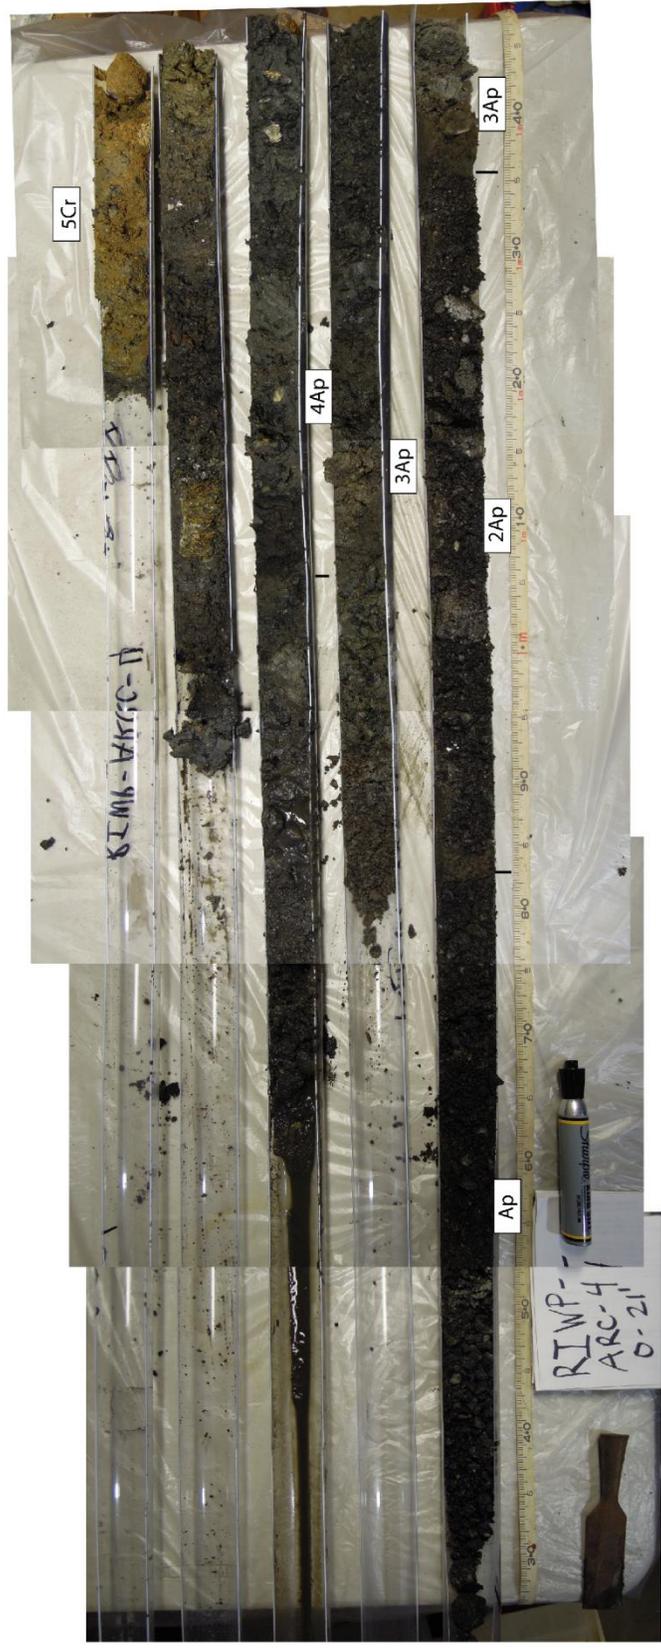
RIWP-ARC-4									
Unit	Depth (cm)	Thickness (cm)	Soil Horizon	Munsell Color	Texture	Structure	Consistence	Boundary	Comments
Fill	0-46	46	Ap	10YR 3/1	VGS	dist		c	Asphalt
Fill	46-128	82	2Ap	10YR 2/1	GSiL	dist	l	c	Cinders; bone frags.
Fill	128-396	268	3Ap	10YR3/1	GSiL	dist	ss	c	Common cinders; glass frags - green clear, amber; wood frags; f. fine brick frags; f. fine shells.
Estuary/Fill	396-594	198	4Ap	10YR 4/1	GSiL-CL	dist	ss	c	few ceramic; v.f. shell frags; possibly dist. Estuary deposits.
Bedrock	594-630	46	4Cr	10YR5/6	GSCL	gr	fri	n/a	Weathered schist.
Texture: Si=silt; L=loam; C=clay; S=sand; F=fine; V=very; G=gravel; O=organic									
Structure: 1=weak; 2= moderate; 3=strong; f=fine; m=medium; c=coarse gr=granular; mass=massive; strat=stratified; sbk=subangular blocky; ab=angular blocky; pr=prismatic pl=platy; dist=disturbed/no structure									
Consistence: fri=friable; sl=slightly; v=very; l=loose; fi=firm; h=hard; st=sticky; ss=strongly sticky
