PHASE 1B ARCHAEOLOGICAL TESTING REPORT

Macedonia Plaza Development

**Block 4978, Lot 25 (Part)
Flushing, Queens County, New York**

November 2011

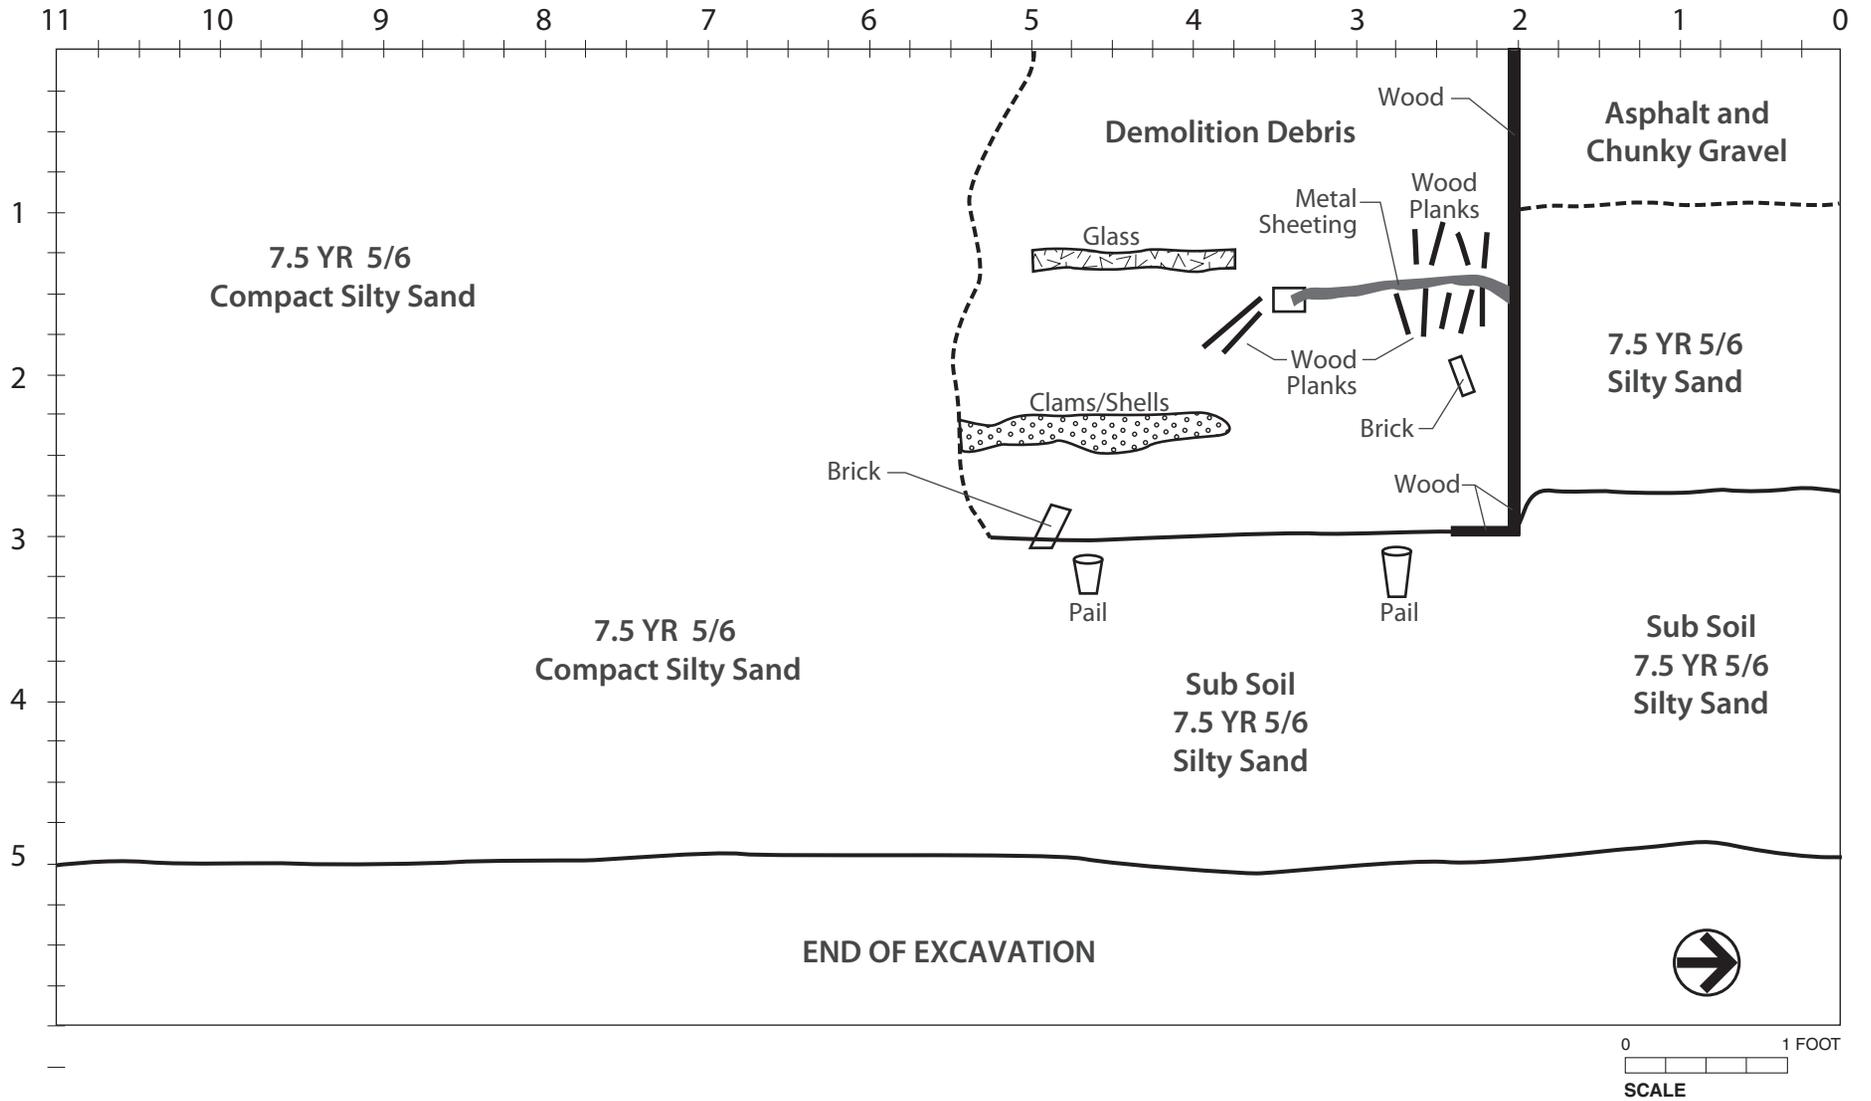
**Trench 1: North Wall Profile
with Bisected Brick Shaft Feature**
Figure 7

21 inches and was composed of highly compacted fine brown silt with some gravel and inclusions (10YR 5/4) (see **Figure 7**). The builder's trench for the privy was three feet wide and composed of strong brown coarse sand with fine gravels (7.5 YR 4/6). The builder's trench disappeared at about 6 feet below ground surface.

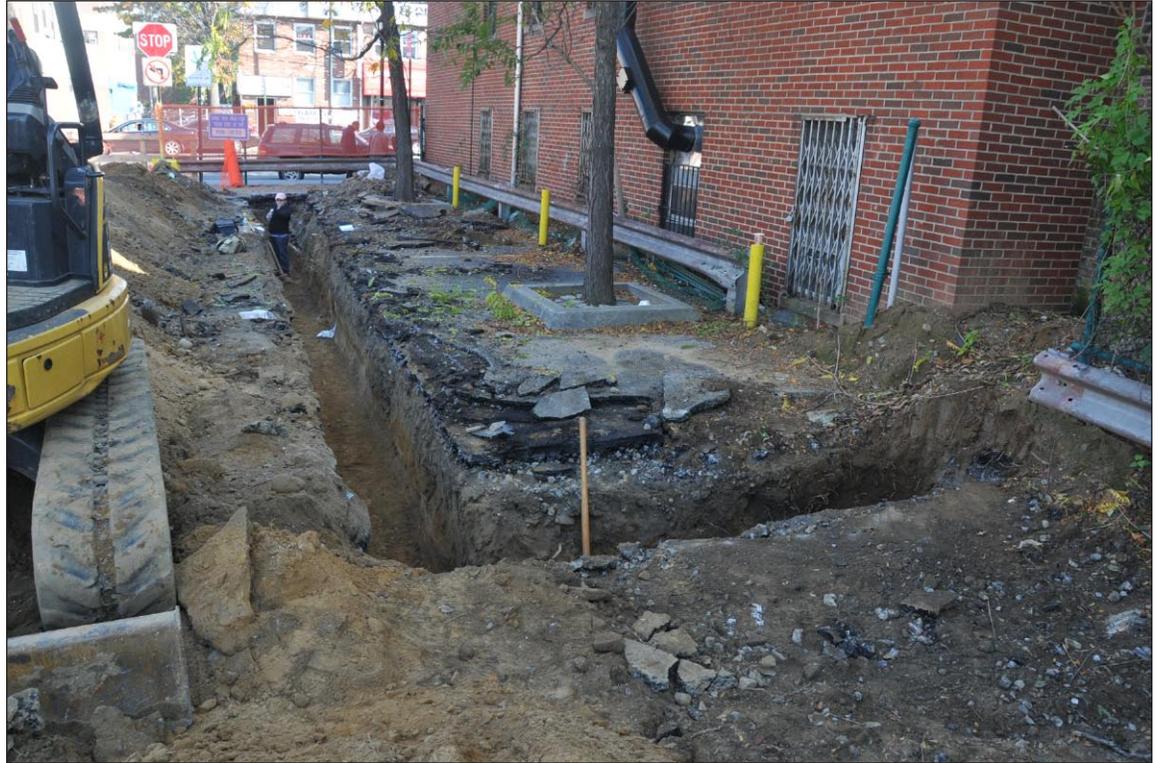
Trench 1 behind the church and facing east towards Union Street. This photo shows the original 58.5' x 3.5' dimensions, and a 6' x 3' (later widened to 6') extension to the south

Trench 1: The archaeologists excavated a single, approximately 60-foot-long east-west oriented trench in the Buffer Zone Area behind the church. The trench was approximately 3.5 feet wide and was excavated to a depth of approximately 4 feet below ground surface, except in the location of a brick privy (discussed below) where excavation extended to a depth of 8 feet below pavement. Trench 1 also included a 6 foot by 6 foot extension that extended southward, toward the church structure, creating an L-shape (**see Photograph 1 for original shape of the trench**). The walls and floor of the trench were shovel skimmed and scraped with trowels. The archaeologists found no burial shafts or human remains in Trench 1.

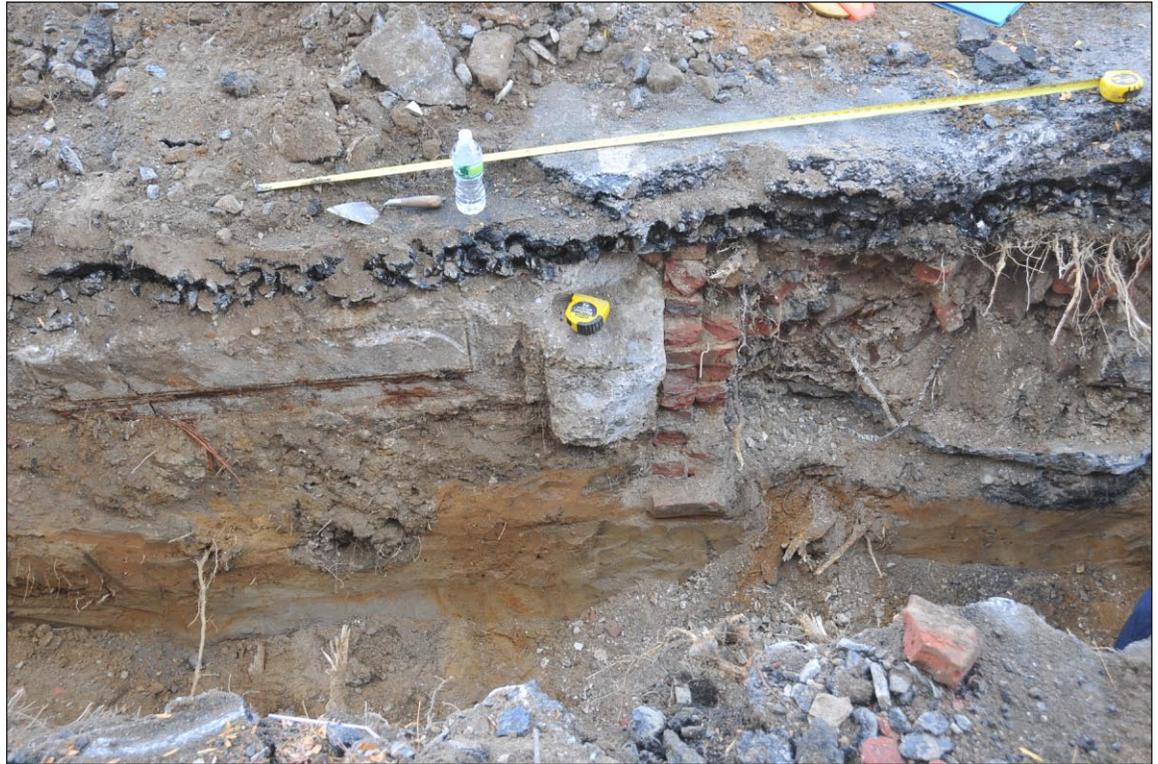
Concrete and brick foundation in the north wall of Trench 1, located approximately 14'-9" west of the fence at Union Street **2A**

Brick and concrete foundation remains were observed directly to the east of the privy (see **Photo 2A**). It is possible these were associated with a building or buildings on Lot 41 where there was once a 3-story dwelling and for a brief time, a single-story store with no basement (See **HPI 1988 and 2006 and Figure 4**). These were likely demolished to make way for the parking lot.

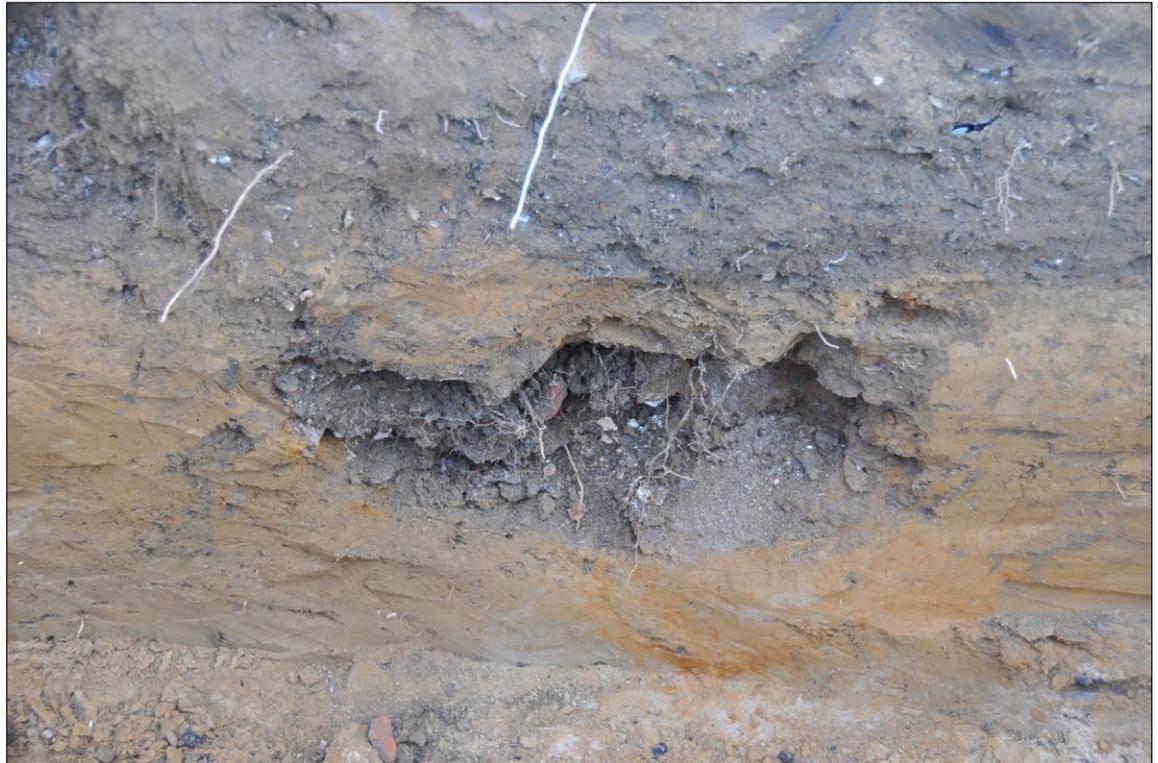
Small feature in Trench 1, approximately 16" wide **2B**

A small, approximately 16" wide shallow "pit," irregularly shaped and about 3 feet below the asphalt, was found intruding into the south wall of Trench 1 (see **Photo 2B**). This shallow

feature was more like a “gouge” in the earth that had been hastily filled in than an actual feature. The bottom of the feature was filled with jumbled fill-type soils (10 YR 4/3, loose Sandy Silt), which differentiated it from the soils in Trench 1. The small feature contained bits of shoe leather, shell, brick, and corroded metal fragments. No evidence of human remains, burial shafts, coffin hardware or coffin wood was recovered.

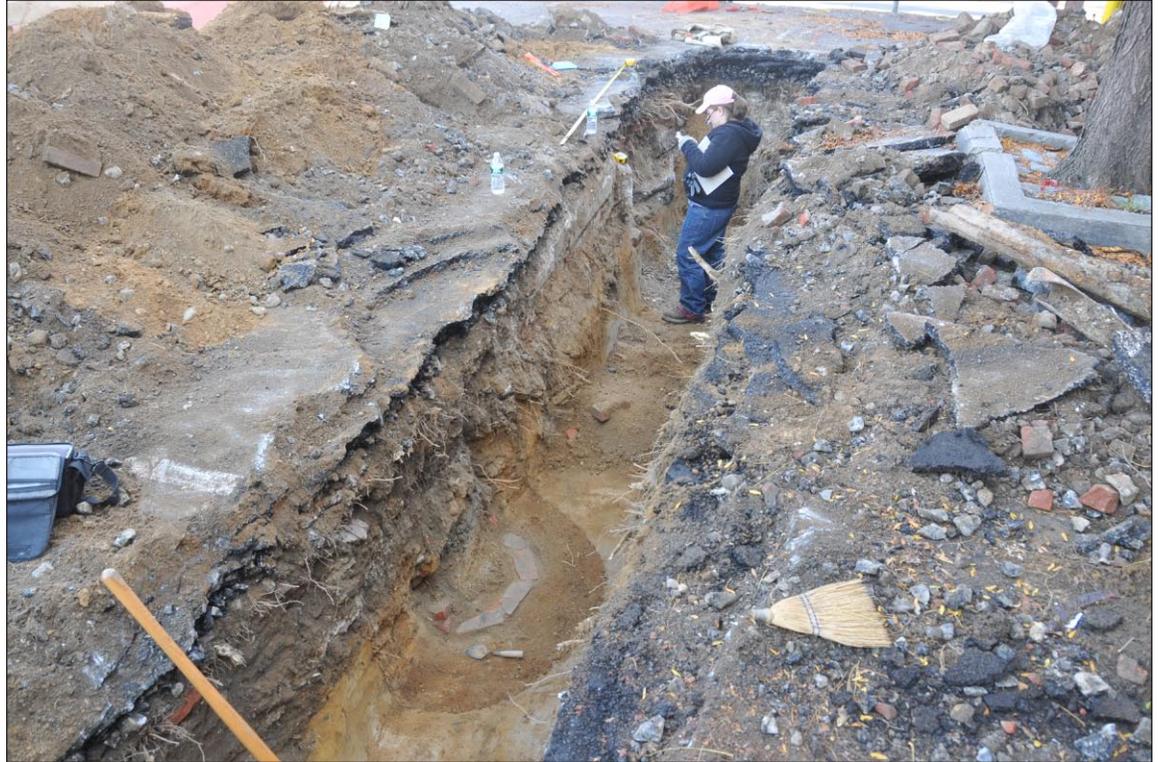
A circular brick shaft feature, probably a privy, and its builder's trench, located in Trench 1. The bricks were dry-laid. No mortar was present **3A**

The archaeologists did discover a 2-foot-diameter, dry-laid brick privy in the north wall of Trench 1 which was also the northern border of the Buffer Zone. The trench was expanded to the north an additional 6 feet beyond the buffer zone, and east and west in order to fully expose the brick feature (**see Photographs 3A, 3B, 4A, 4B and 5**). The interior of the privy measured about

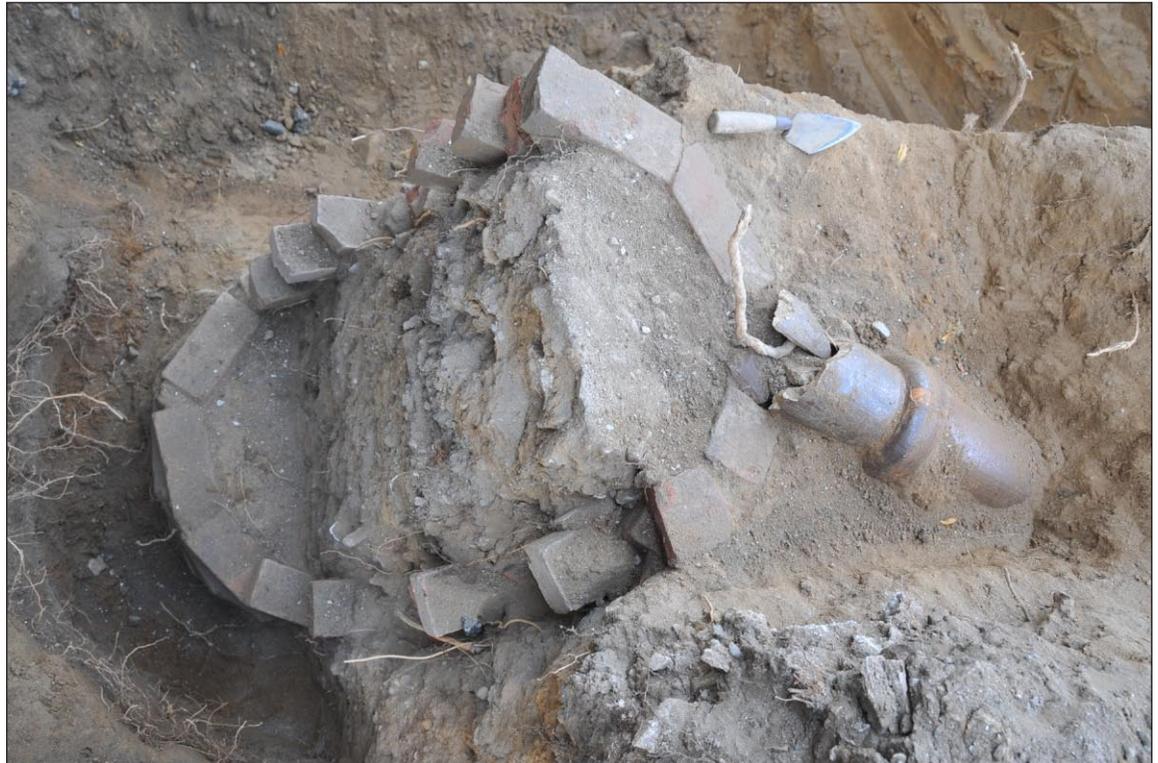
Drain pipe at the top of the bisected shaft feature. Most bricks had clipped edges in order to create the circular shape of the privy. Hard compacted soil and fill was inside the privy **3B**

The privy was constructed of standard bricks, approximately 8"X 4" X 2" inches in size. Many of the bricks were missing one corner. This was probably done deliberately by the mason to create the rounded shape of the privy. It is also possible the mason reused old bricks that were already broken. None of the bricks had indentations called "frogs" and none was marked with the name of the company. Branding began in the 1850s but not every yard branded their products and although frogs begin as early as 1880, it is possible that flat faced bricks were produced after that date. Therefore, it is not reliable to rely on the bricks to date the privy (Alan Gilbert, personal communication, 11/15/11).

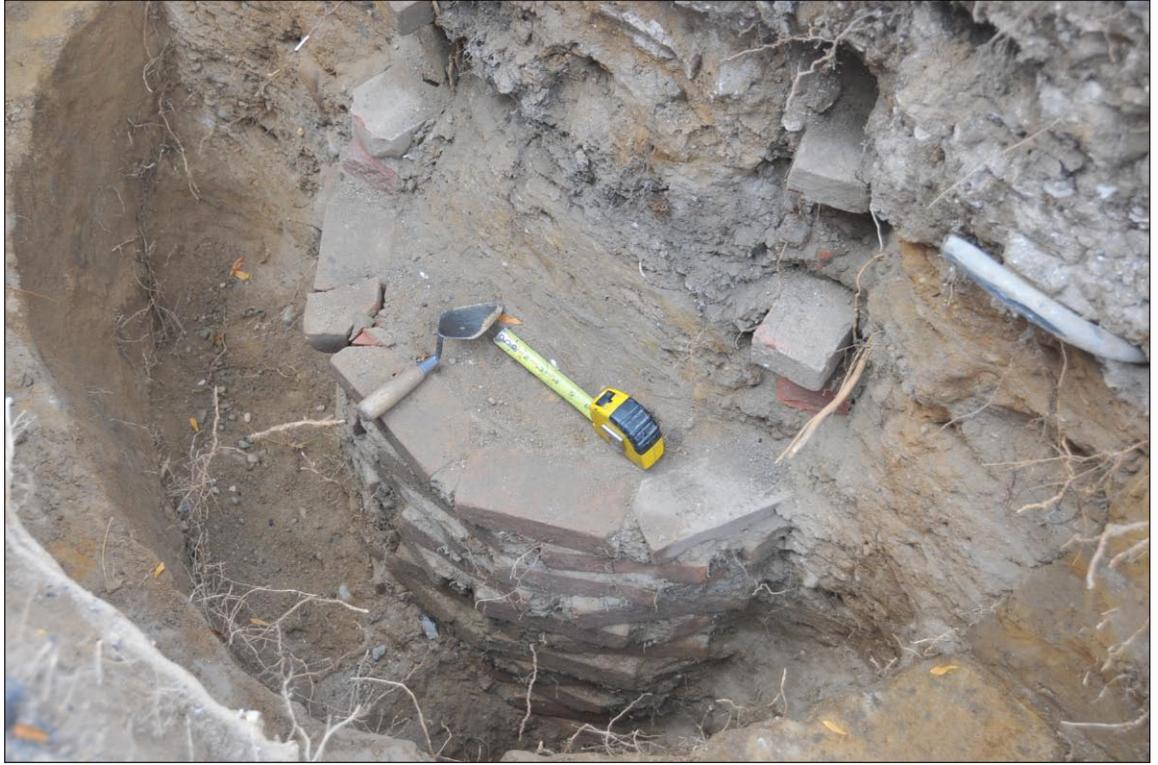
East side of the circular brick feature (privy) **4A**

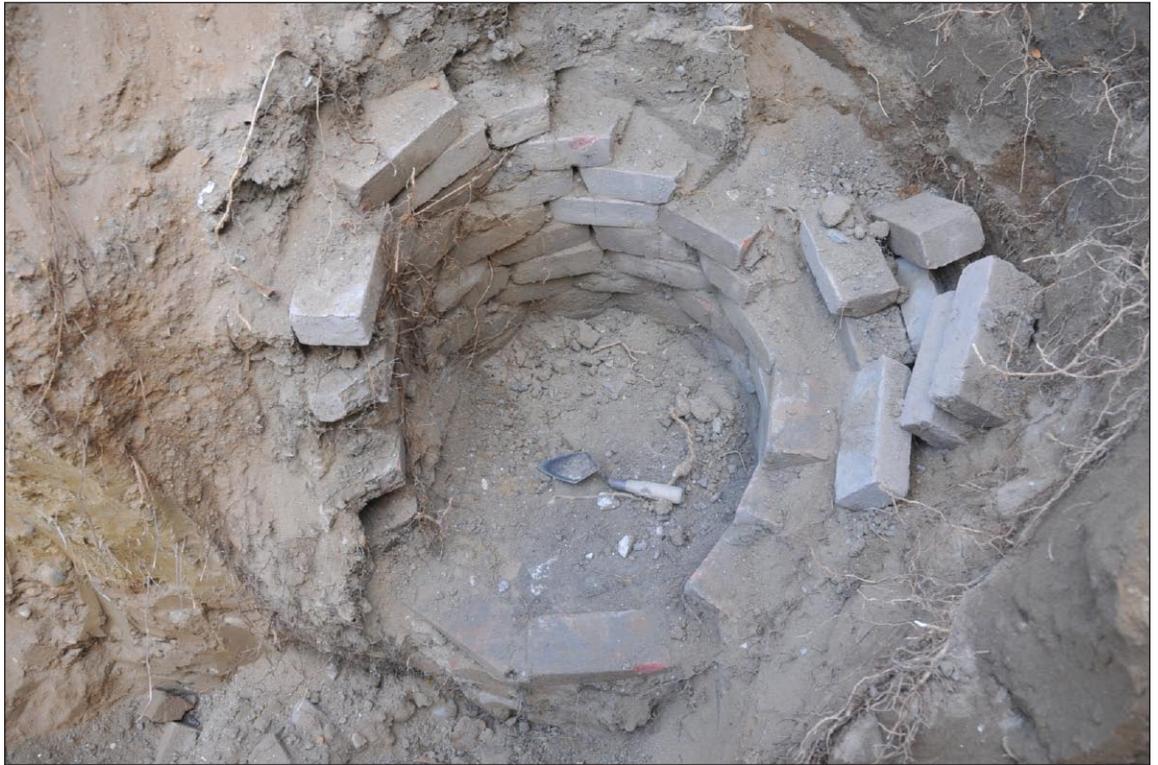
Bottom of the shaft feature **4B**

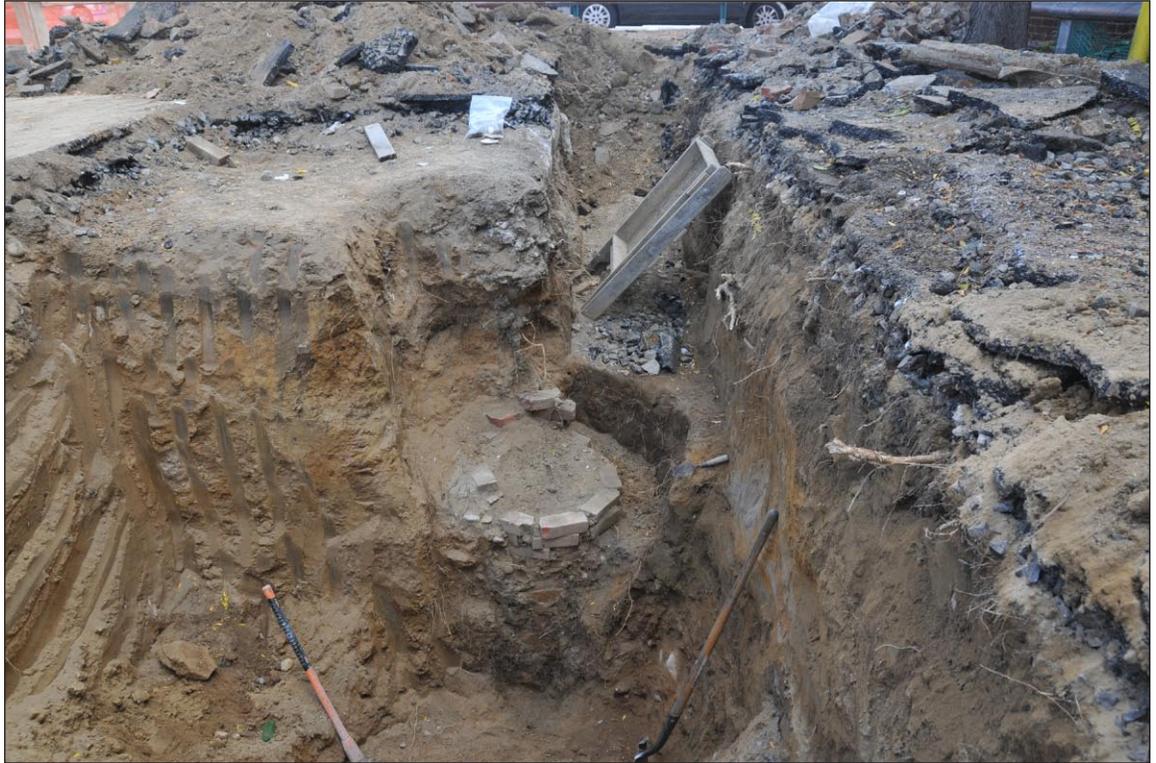
Trench 1 expansion exposes more of the privy and the buffer zone **5**

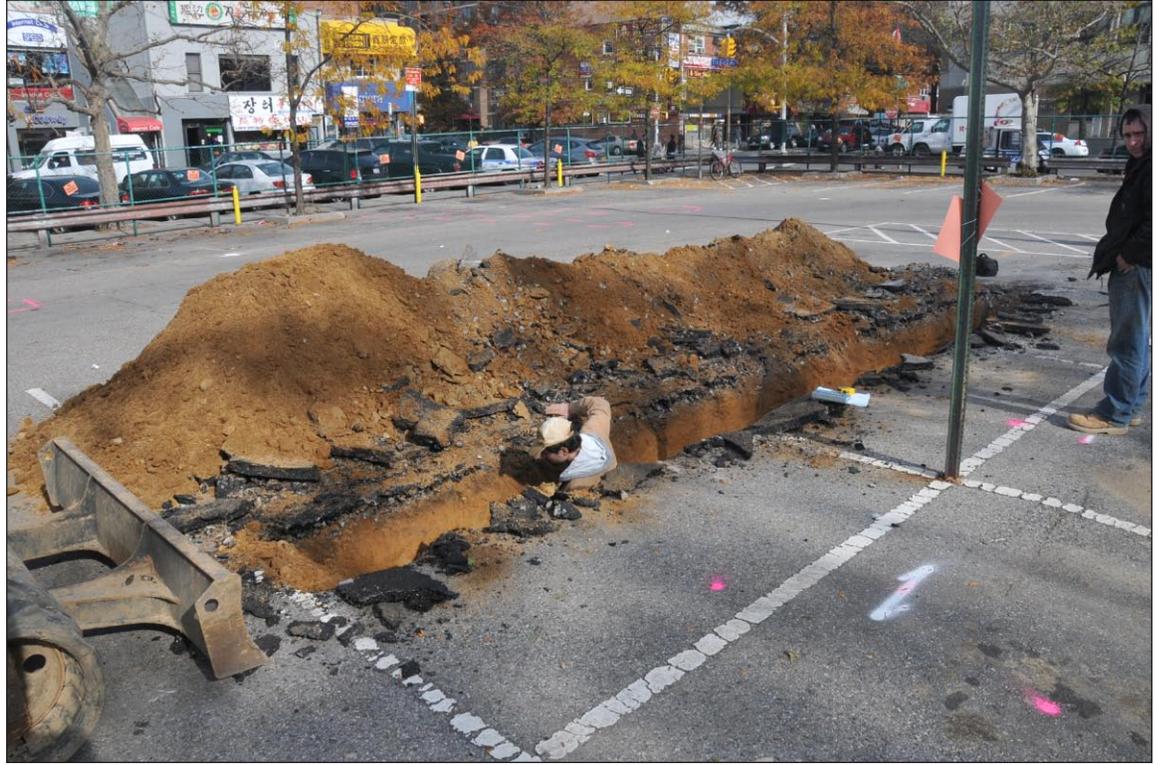
Trench 2 in the Homelots Area, facing NE toward 37th Ave. and Union Street **6A**

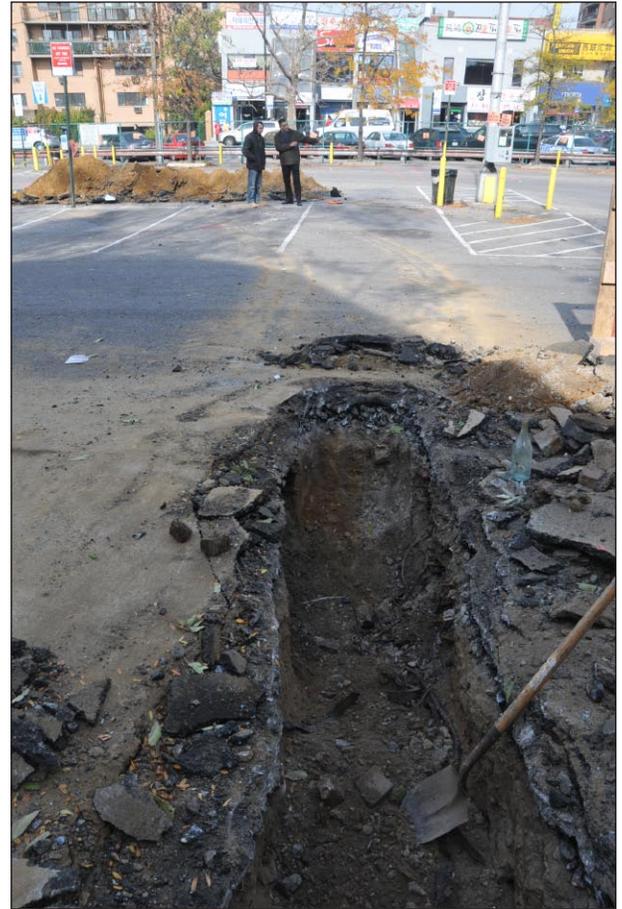
Trench 3 facing north toward 37th Ave.
Trench 2 can be seen in the background **7A**

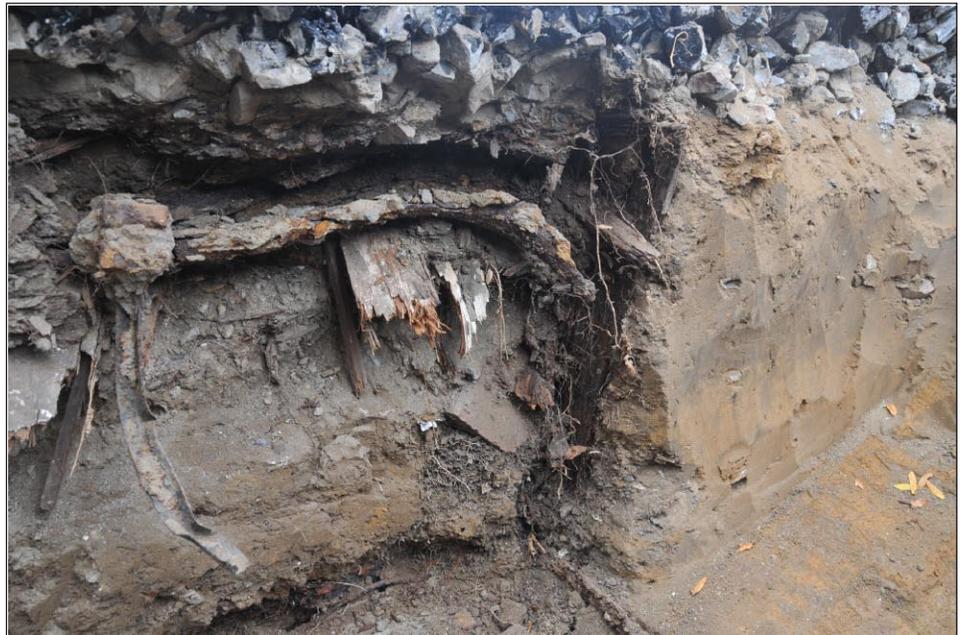
Trench 3 was excavated as a GPR anomaly. It consisted of a dense deposit of artifacts and demolition debris. Metal sheeting and wood appear to line the deposit. **7B**
The original subsoil can be seen to the right

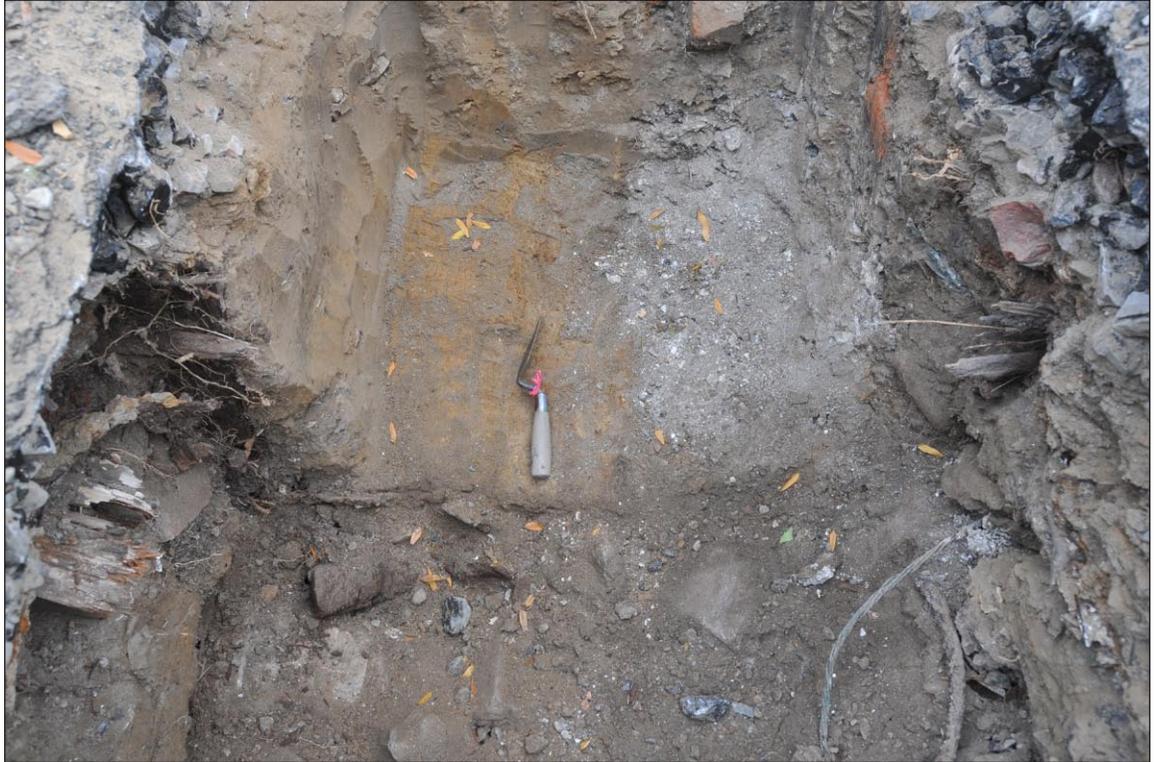
Ash deposit approximately 2' deep in the north wall of Trench 3. **8A**
This deposit also extended into the east wall of the Trench

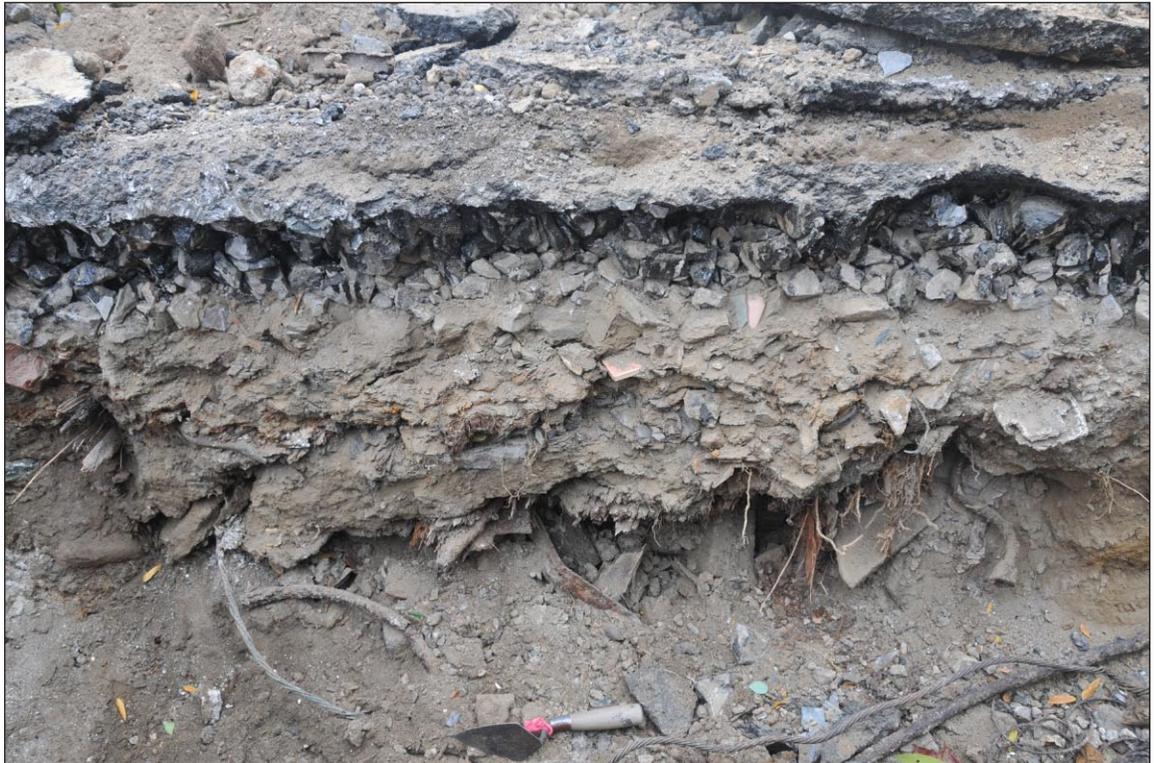
East Wall profile of Trench 3. Note the salmon colored bathroom tile below the asphalt and gravel **8B**
