Phase IA Archaeological Documentary Study

**Randall's Island Living Shoreline Recreation Area
Part of Block 1819, Lot 203
Randall's Island, New York County, New York**

**City of New York, Parks and Recreation Project M104-110M
LPC # NYC DPR / Pre-CEQR-M**

February 2012

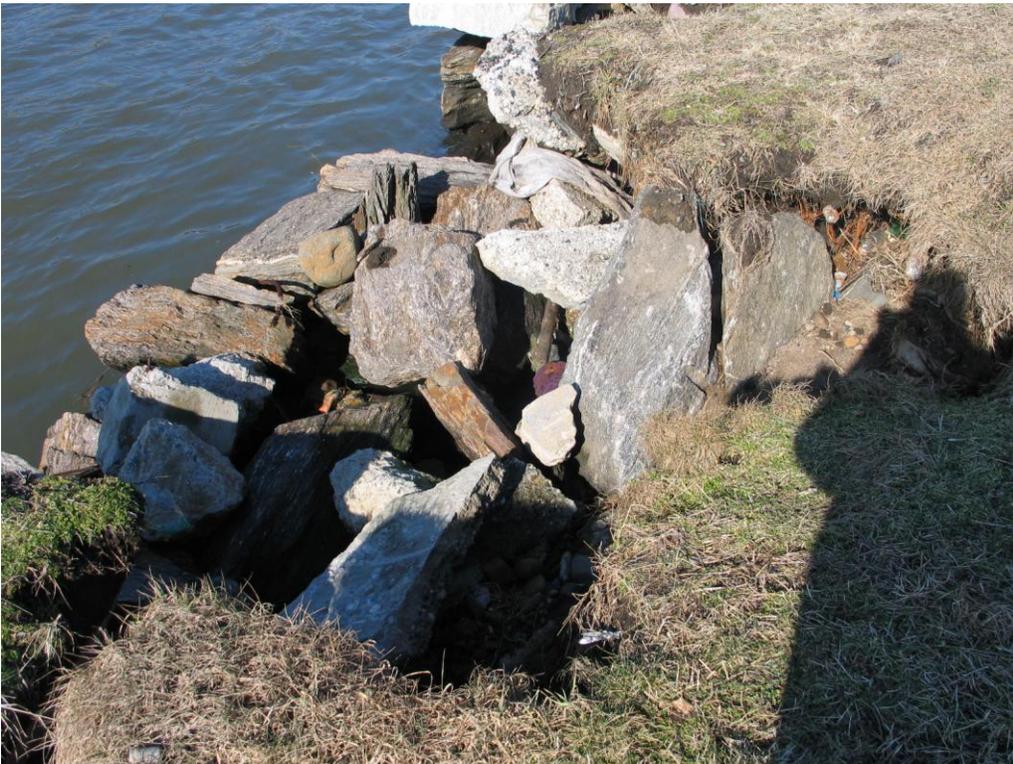
Photograph 10: Project site showing typical rubble fill behind deteriorating seawall. View looking north.

The waterline is marked by a stone seawall, which varies in condition depending on location. The seawall along the northernmost portion of the APE is relatively intact, but portions moving south along the waterfront are in poor condition, with stones along the upper reaches missing or displaced (see Photographs 1 and 2). Additional stones are located inland of the seawall and serve as jumbled rubble fill (Photograph 10). A concrete jersey barrier is located in one particularly bad breach (Photograph 11). Photographs 23-27, taken in 1941, show that only one section of the seawall along the northern end was intact at that time, whereas the remaining section of the seawall within the APE was in significant disrepair. The seawall was reconstructed along this stretch of waterfront after 1941. Today, lighter colored dressed capstones (contrasting with the darker and cruder cut lower stones) attest to perhaps an additional episode of seawall reconstruction or repair (Photograph 12).

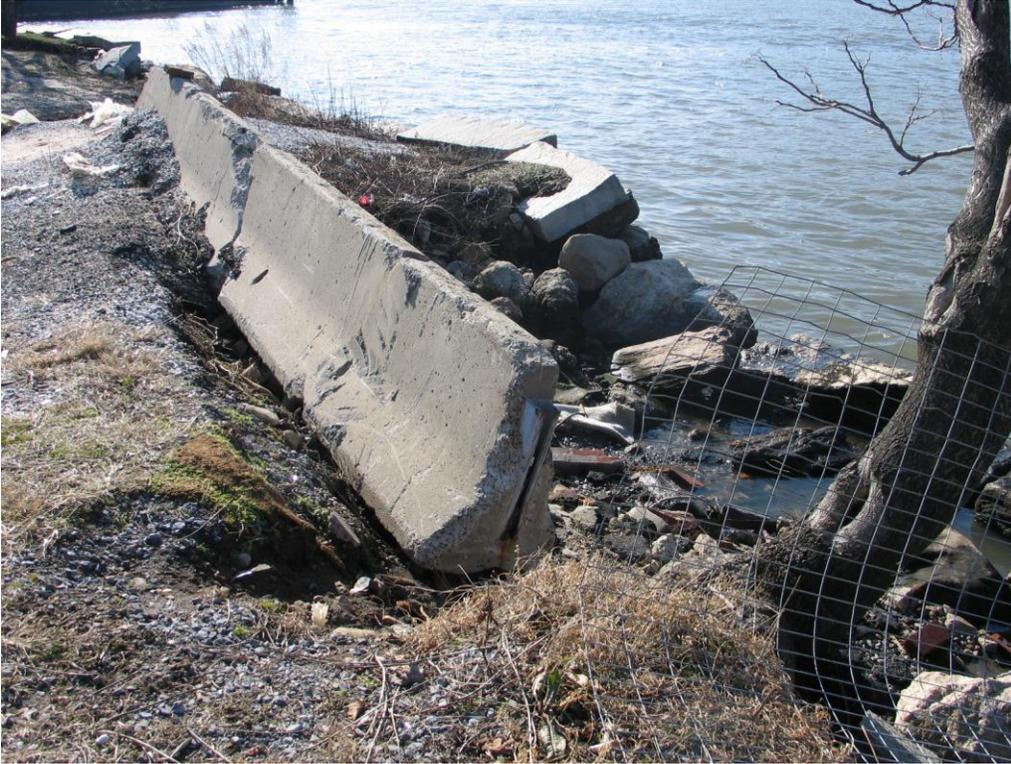
Photograph 11: Project site showing concrete jersey barrier along breach of seawall. View looking southwest.

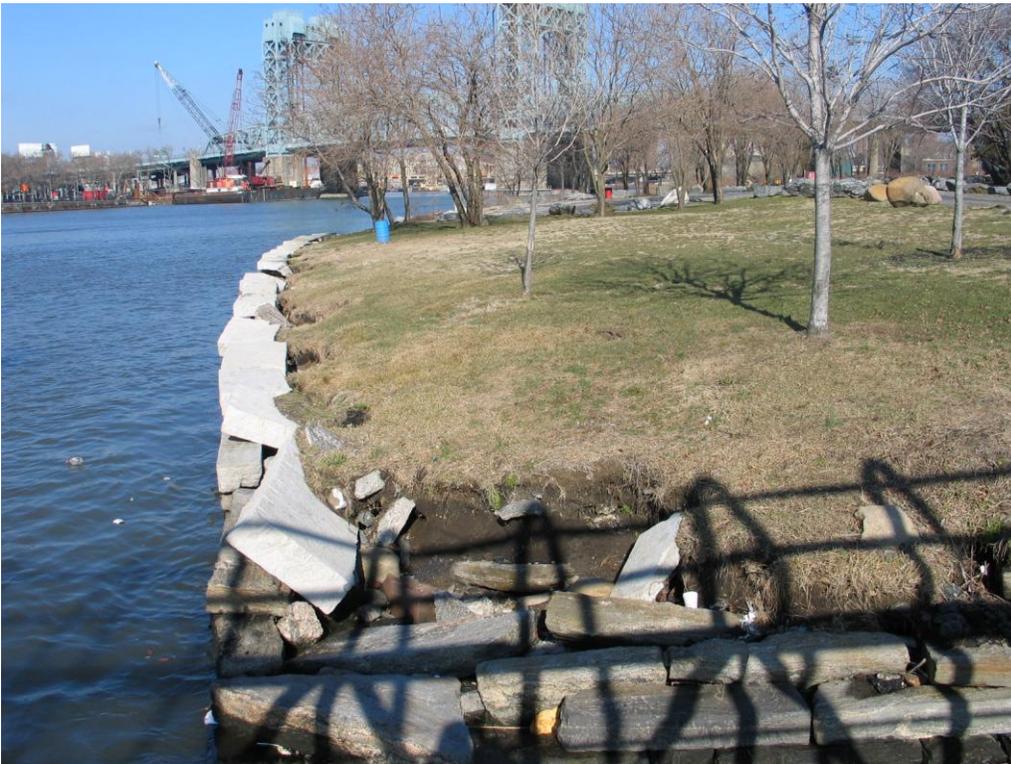
Photograph 12: Project site showing example of lighter colored capstones atop seawall. View looking northwest.

Since the 1940s, the APE has been further bolstered as parkland by planting additional grass and trees, backfilling behind the seawall and repairing and/or replacing some portions of the seawall, as evidenced by the lighter colored capstones atop the wall along stretches of the wall within the APE. Aerial views including the Randall's Island and the project site, online at historicaerials.com, show little change to the APE from the mid-1950s through 1980. By at least the turn of the 21st century, however, additional plantings had occurred on the APE, and aerial views show the present trees within the property. For a time the area under the Triborough Bridge (soon to be renamed the RFK Bridge) was used as an asphalt covered staging area, with vehicles and trailers clearly shown occupying the area. This portion of the APE at the northern end still shows evidence of this use, with degrading pavement, several trailers still in place, and debris littering the shoreline. The water taxi stand abutting the southern end of the APE is a relatively new addition to the park, erected between 2004-2006.

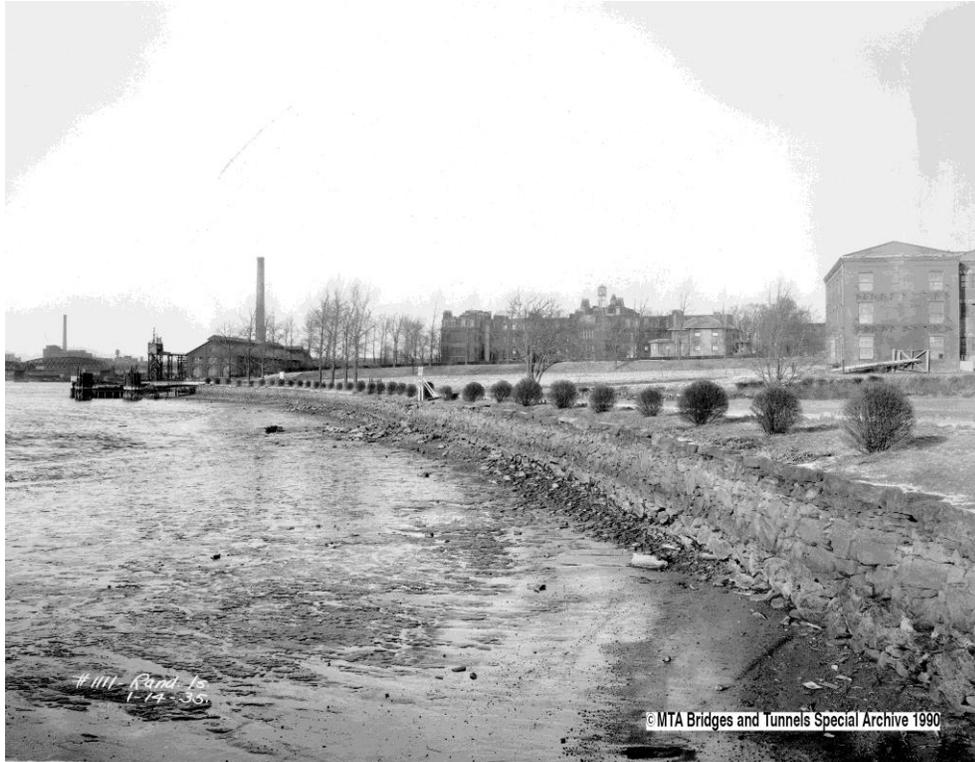
Photograph 15: “Randall’s Is./Sea wall north of old dock, off northern end of “House of Refuge.” View N. from point on northern side of old dock.” Image 1111, contract 31-A, courtesy MTA Bridges and Tunnels Special Archive. 1-14-35. Project site is in left background, beyond pier.

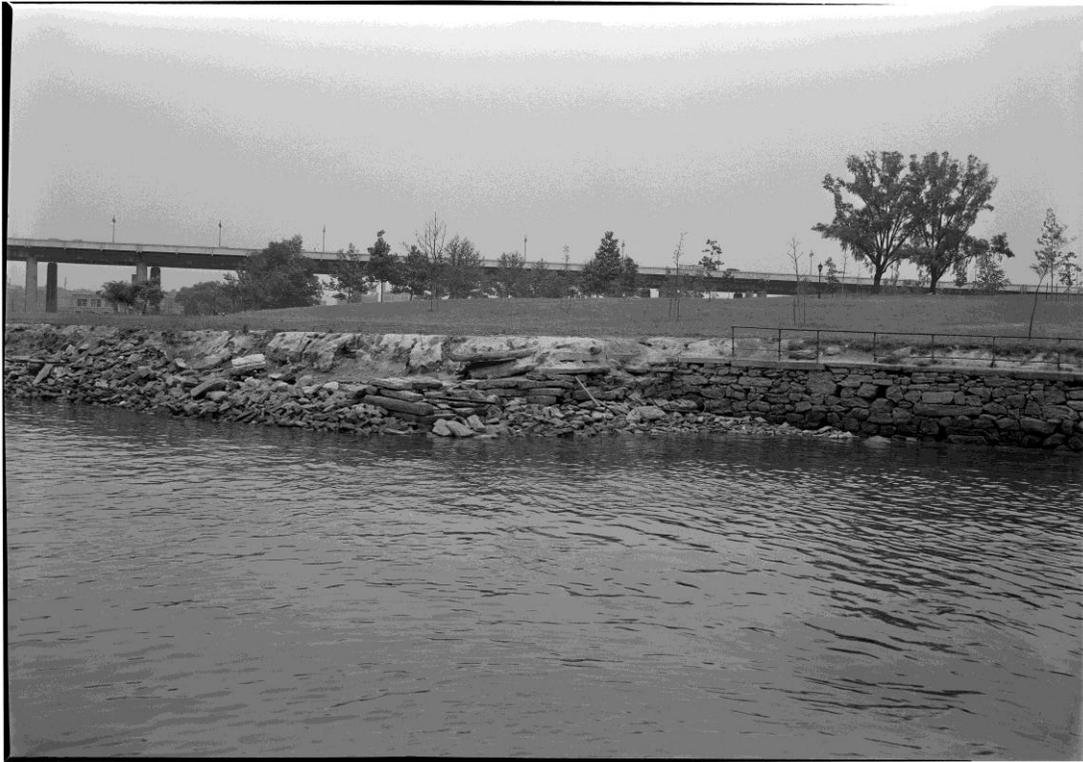
Photograph 23: Southern end of project site showing seawall. View looking northeast. 6-3-41. Courtesy DPR.

project site in 1941 (Photographs 23-27) documenting the condition of the seawall, show a completely vacant landscape, indicating that the power house and its associated structures had been razed by this time and the ground restored to grassland. So, too, had the piers shown in 1936 (one pier was still depicted in 1939) been removed, although Photographs 24-26 do show remnants of one pier complex along the central shoreline of the APE in the form of several remaining pilings atop a scoured landform, and Photograph 23 may show remnants of a wood foundation that could represent one of the former 19th century buildings along the waterfront at the southern end of the APE.

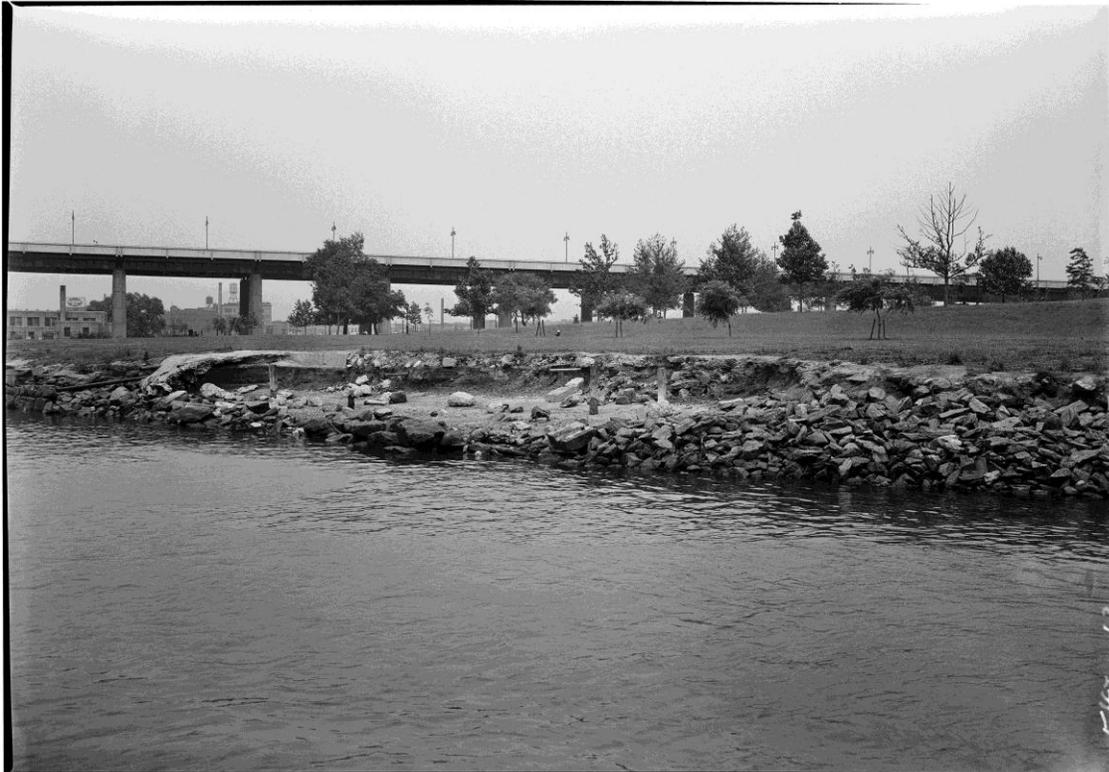
Photograph 24: Southern and central portion of project site showing seawall. View looking northeast. 6-3-41. Courtesy DPR.

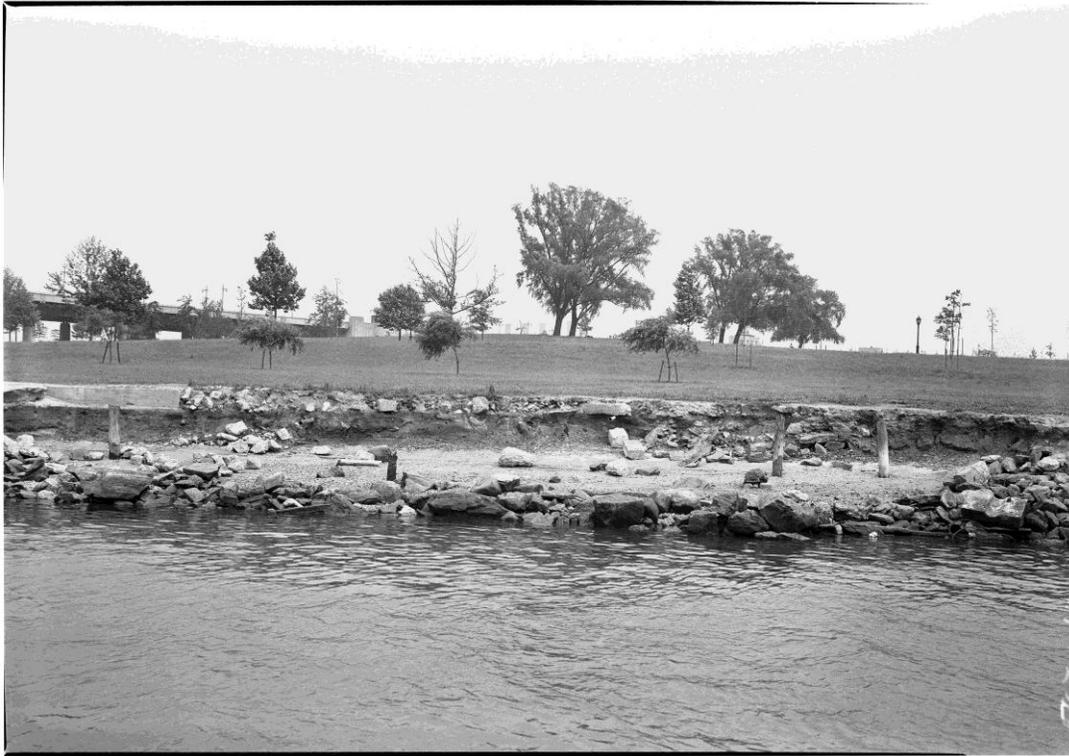
Photograph 25: Central portion of project site showing seawall. View looking east. 6-3-41. Courtesy DPR.

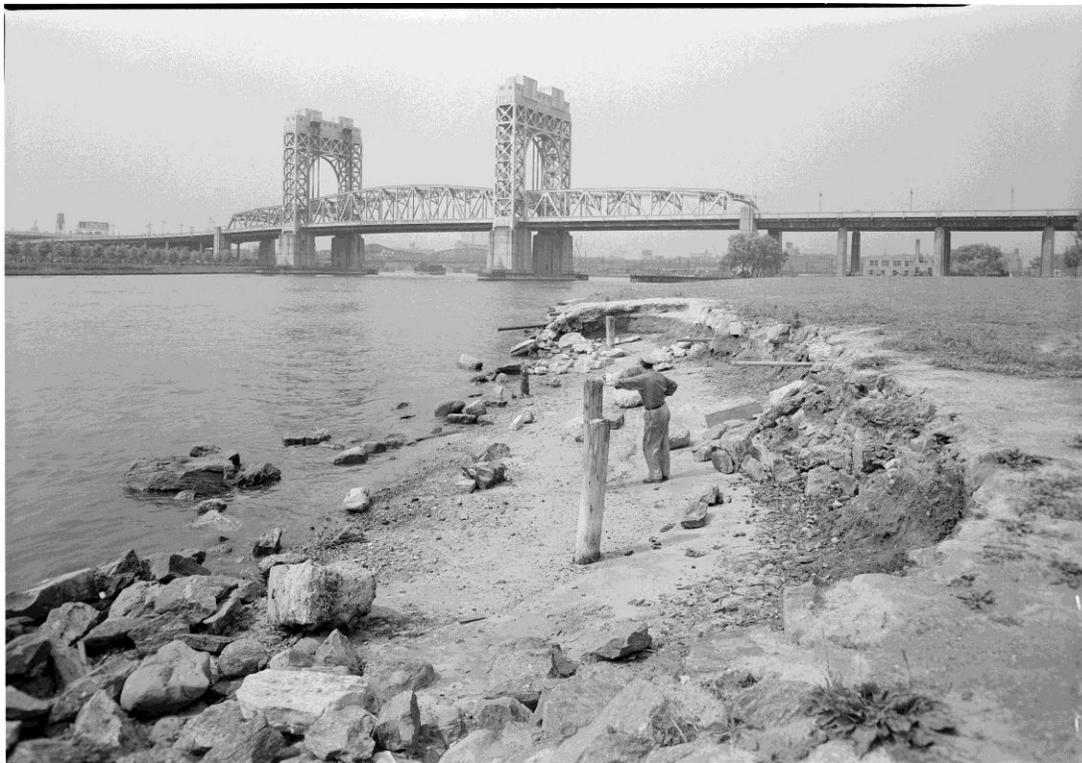
Photograph 26: Central portion of project site showing seawall. View looking north. 6-3-41. Courtesy DPR.

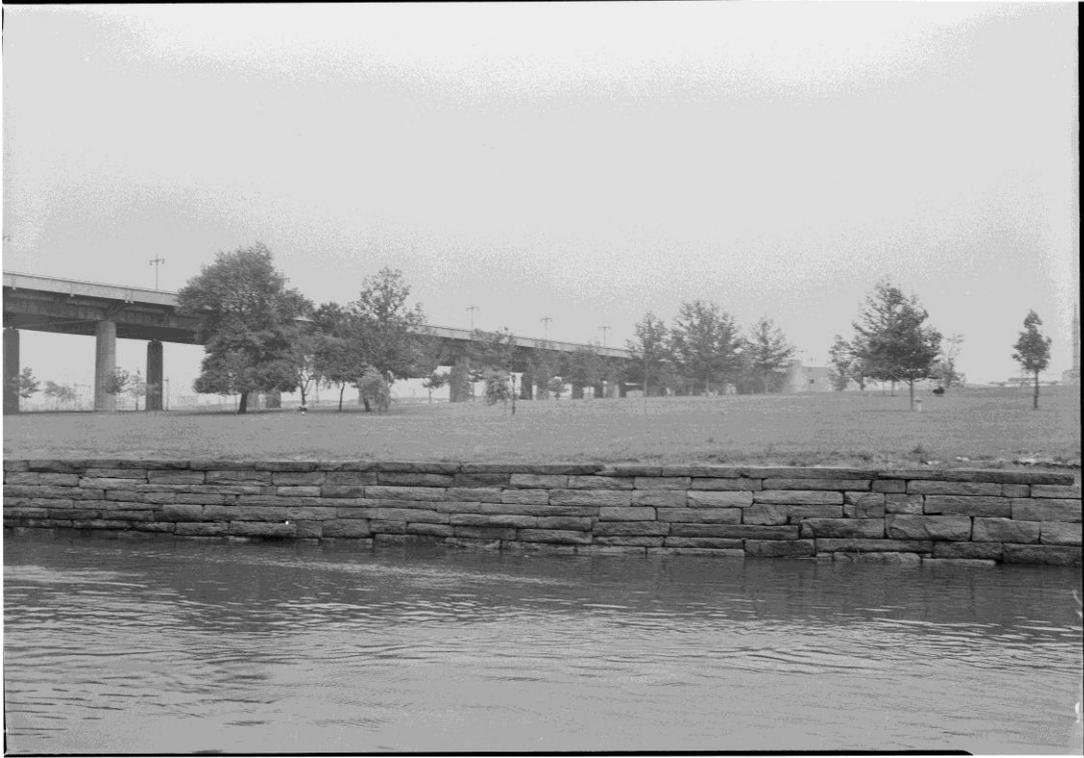
Photograph 27: Northern end of project site showing seawall. View looking northeast. 6-3-41. Courtesy DPR.
