REPORT ON
ARCHAEOLOGICAL WORK RELATED TO
GRADING EXCAVATIONS TO CREATE
PLAY FIELDS AT THE SOUTHERN END
OF THE PARADE GROUND
ON GOVERNORS ISLAND
NEW YORK, NEW YORK

Prepared for: West 8
333 Hudson Street, Suite 905
New York, New York 10013

Submitted by: Linda Stone, MA, RPA
249 East 48th Street, #12B
New York, New York 10017

June 18, 2012

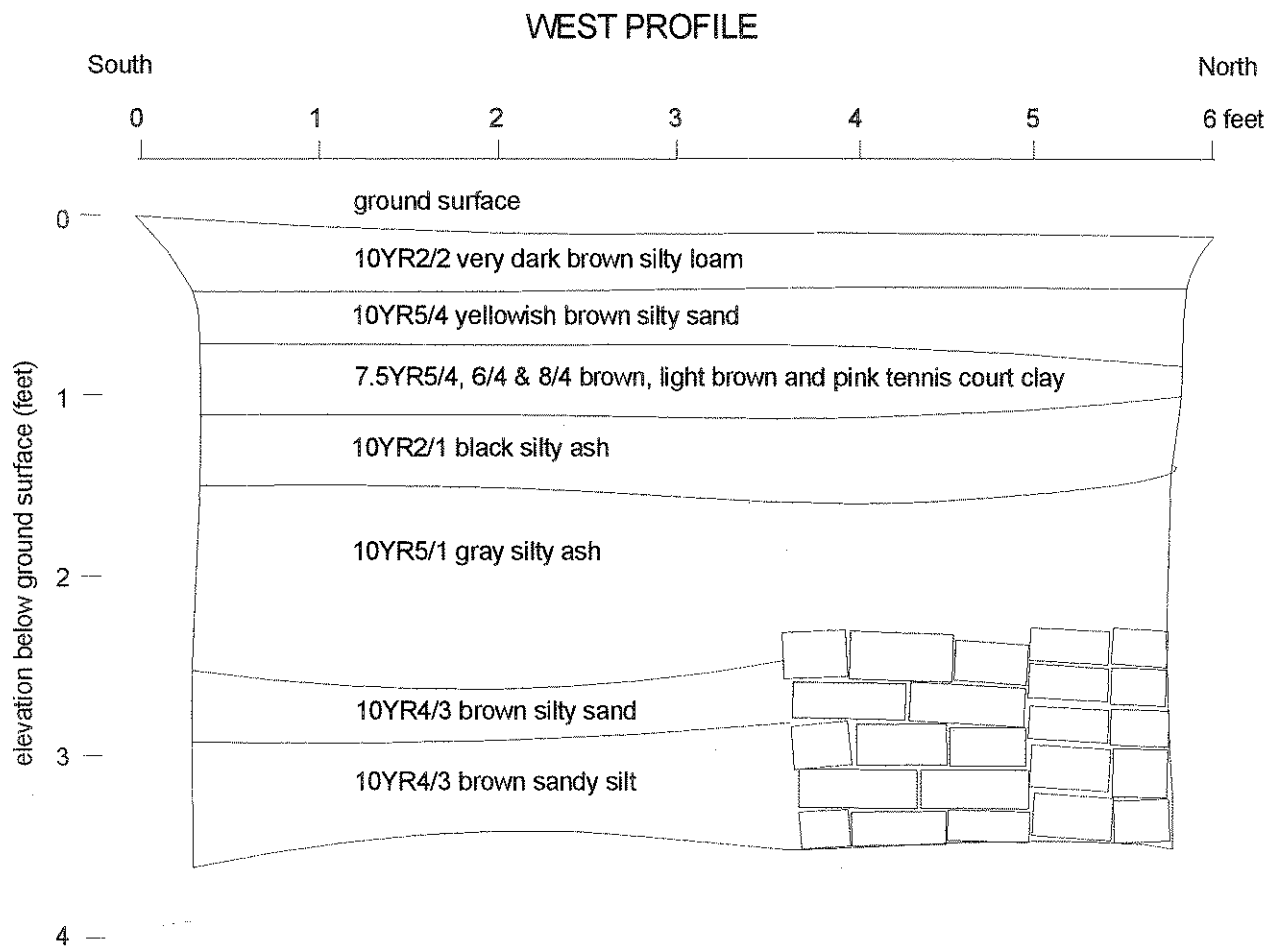
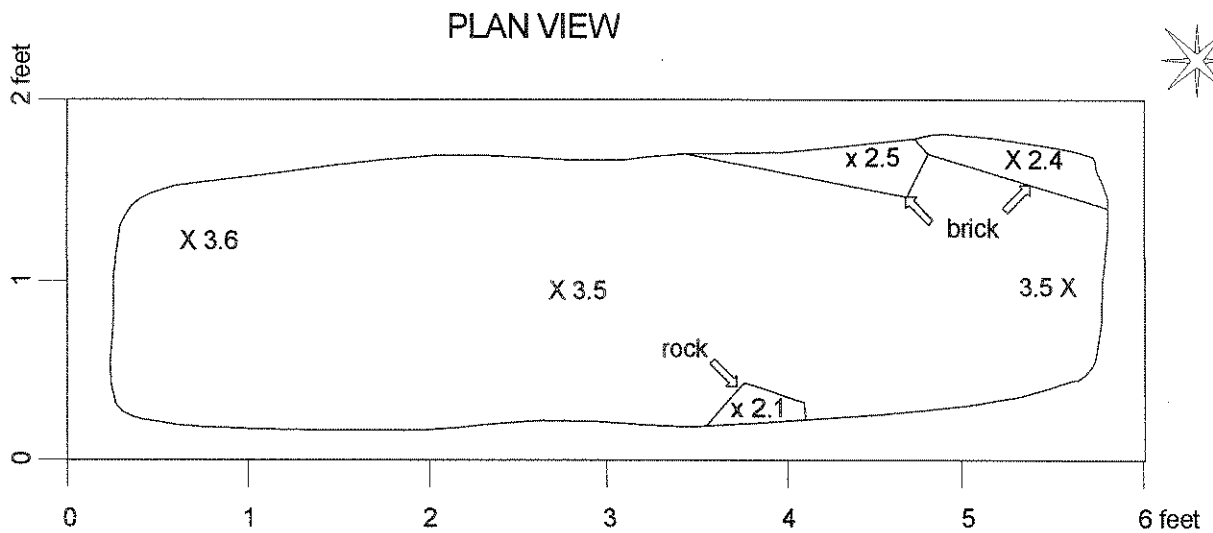
Figure 2 Results of probing to re-establish locations and depths of previously identified archaeological features.

One hundred twenty-seven (127) probes were placed in a circular area where a concentration of debris was documented during archaeological monitoring of a previous project. The debris was originally found when the former golf course was graded. It was buried just beneath the top soil in an area measuring approximately 12 x 8.5 feet (3.6 x 2.5 m) across (Stone 2008a: 4). Once grading excavations were completed, the debris was covered and reburied.

Forty-eight (48) probes were placed in a rectangular area where a brick feature was identified during archaeological testing for a previous project. The portion of the feature exposed during that testing measured approximately 1.5 feet (46 cm) square and was found buried at 0.8 feet (24 cm) below ground surface. The brick feature was reburied upon completion of testing (Stone 2007: 5). However, subsequent work to level out the golf course may have altered the depth below ground surface at which the brick feature may now rest. The current grading plan for the area of the brick feature will involve cutting the grade down by approximately 0.8 feet (24 cm) or less.

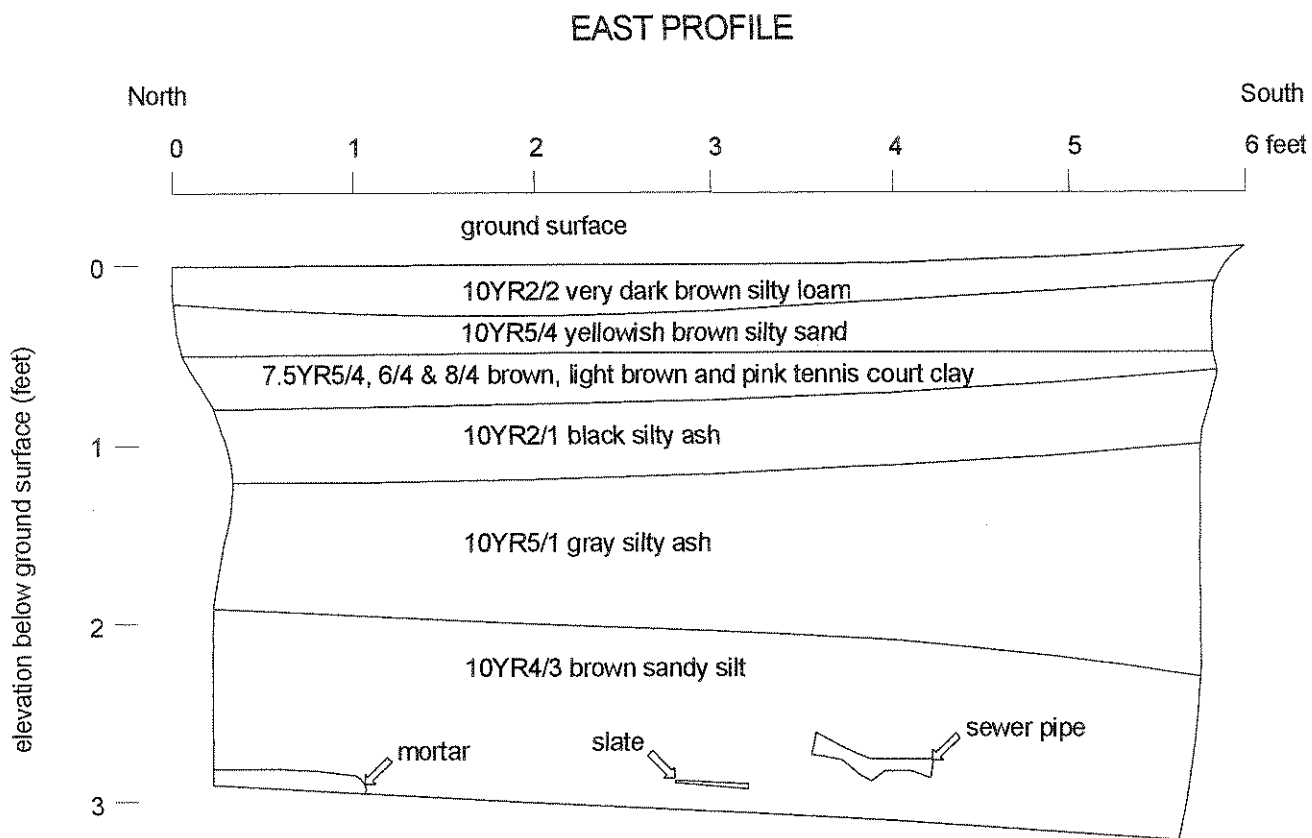
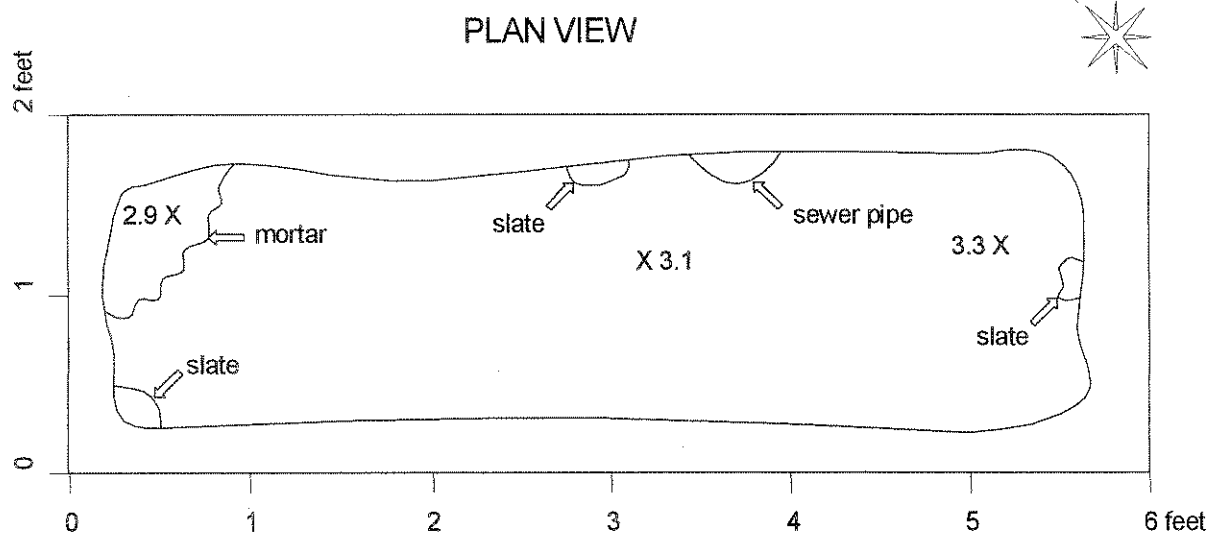
Figure 3 Trench 2 plan and profile.

Trench 2 (T2) was placed to identify possible remains of the southern side of the first St. Cornelius Chapel, built in 1847 and demolished when a new edifice was erected across the street in 1905, as well as to determine if the debris field found during previous archaeological work extended that far south. Possible foundation remains of the Chapel were identified, but the debris field found further to the north was not encountered.

The clay tennis court was on top of a thick coal ash layer; Stratum 6. The upper level was darker, which could have been a result of depositional conditions. In any case, the two levels were screened separately for artifact recovery. The *tpq*² is the 1870s based on a glass bottle neck and finish. Other artifacts of interest include a piece of lead paint with chromium yellow (Context T2.6.1) and a number of shoe part fragments (Context T2.6.2). Besides a profusion of coal, cinder and slag, large brick fragments and stone were also present, becoming denser with depth. Stratum 7 was the stratum where the possible brick foundation remains of St. Cornelius Chapel were identified in the northwestern corner of the unit. It was approximately 2.5 feet (76 cm) below ground surface. The dense concentration of brick and stone

By the time the base of excavation was reached, the possible brick foundation was exposed to its maximum extent within the excavation and project vertical APE (see Photo 2). The brick feature represents either a corner or a jog in a brick wall that could have been part of the foundation. Historic maps depict the former chapel with a "+" shaped footprint that was expanded over time and by 1879 had additions on the eastern and western sides of the structure (see Cover Photo which depicts the addition on the western side and Appendix A: Figure 5). Although the thickness of the wall was not exposed in T2, the vertical dimension and configuration of the bricks is clear. Five courses of bricks were present, although it is likely the wall extends deeper with more courses. Figure 3 contains a profile drawing which more clearly represents the configuration of the bricks. The southern part of the wall was laid in alternating rows, one all stretchers and one with every other a stretcher or header. The stretcher only course contains two bricks within the excavation and the stretcher/header rows contain three. The

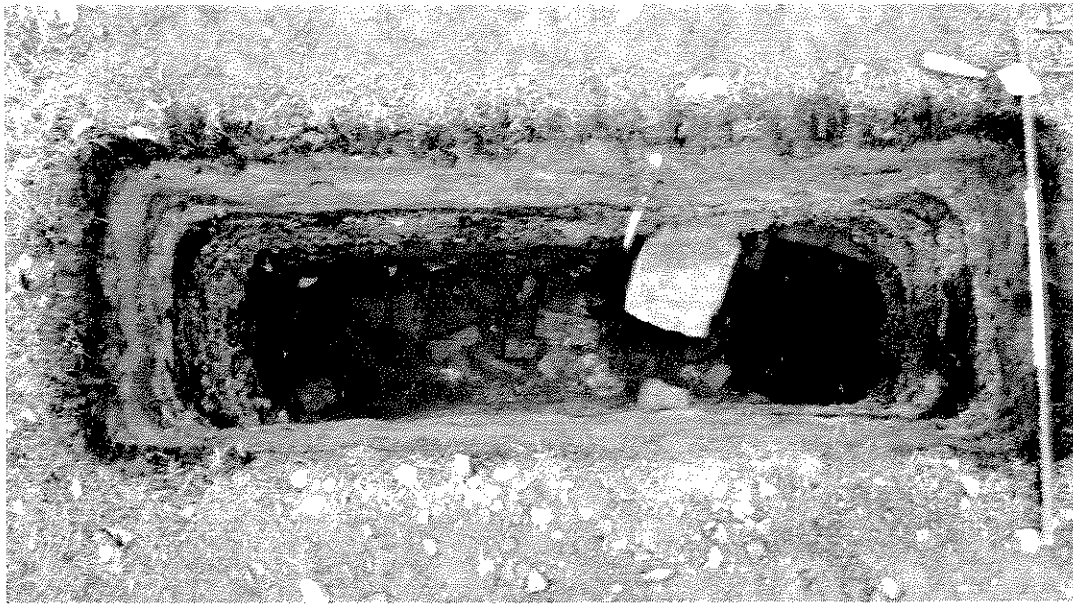
Figure 4 Trench 3 plan and profile.

Although evidence of the former chapel was documented in T2 and seems likely to exist buried between T2 and T3, no structural remains were found during excavation of T3. The deposits excavated in T3 were similar to those in T2 (see Figure 4). The former clay tennis court was found underlain with two levels of coal ash in T3, as in T2. However the coal ash was found directly on top of the truncated brick structure in T2, but not in T3. It is possible T3 was not positioned in the precise location to identify another wall or it is equally possible a wall is present in that location, but more deeply buried, beneath the planned Play Field depth of impact (3.1 feet or 94 cm). Artifacts recovered from the basal stratum of T3 are not very telling regarding deposition date because of the large range of manufacture dates. The *tpq* of the stratum is the early-19th century based on a whiteware ceramic sherd.

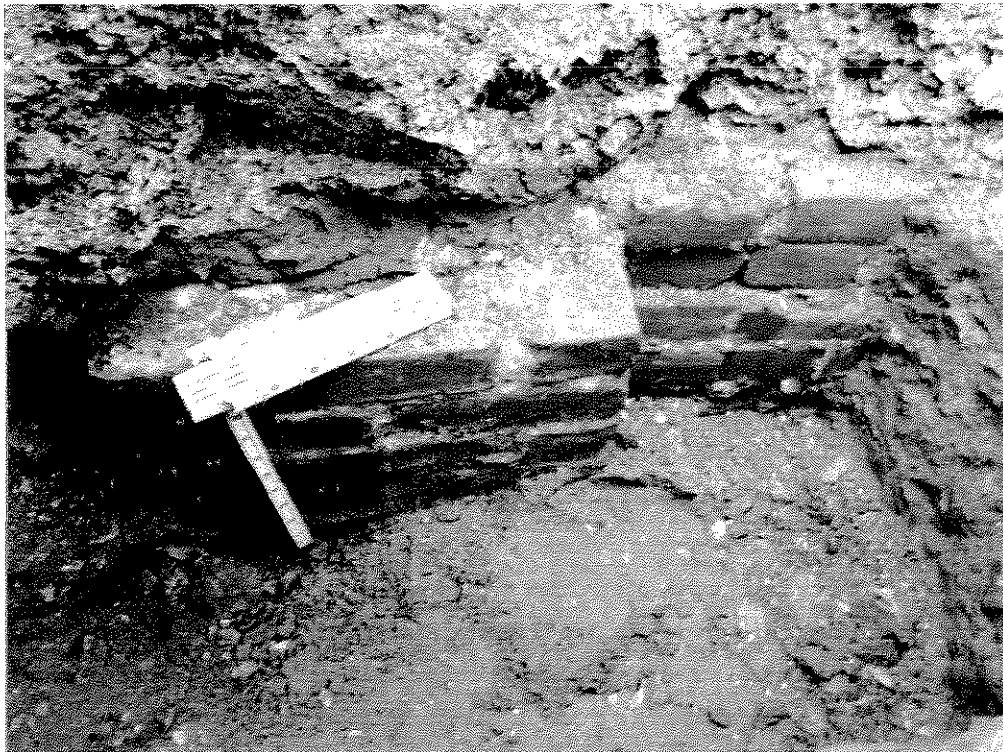
Photo 2 Brick feature in T2 upon completion of excavation, facing west (January 25, 2012).
