**Replacement of Willis Avenue Bridge over the Harlem River**  
**BIN No. 2-24005-9/A/B Total Design; Contract No. HBM 1124**  
**New York and Bronx Counties, NY**  
**Manhattan Approach**  
*NYS OPRHP No. 03PR00939*  
*LPC No. DOT/LA-CEQR-X*

**Final Summary of Archaeological Monitoring**  
**Manhattan Approach**  
**January 2009 through April 2012**

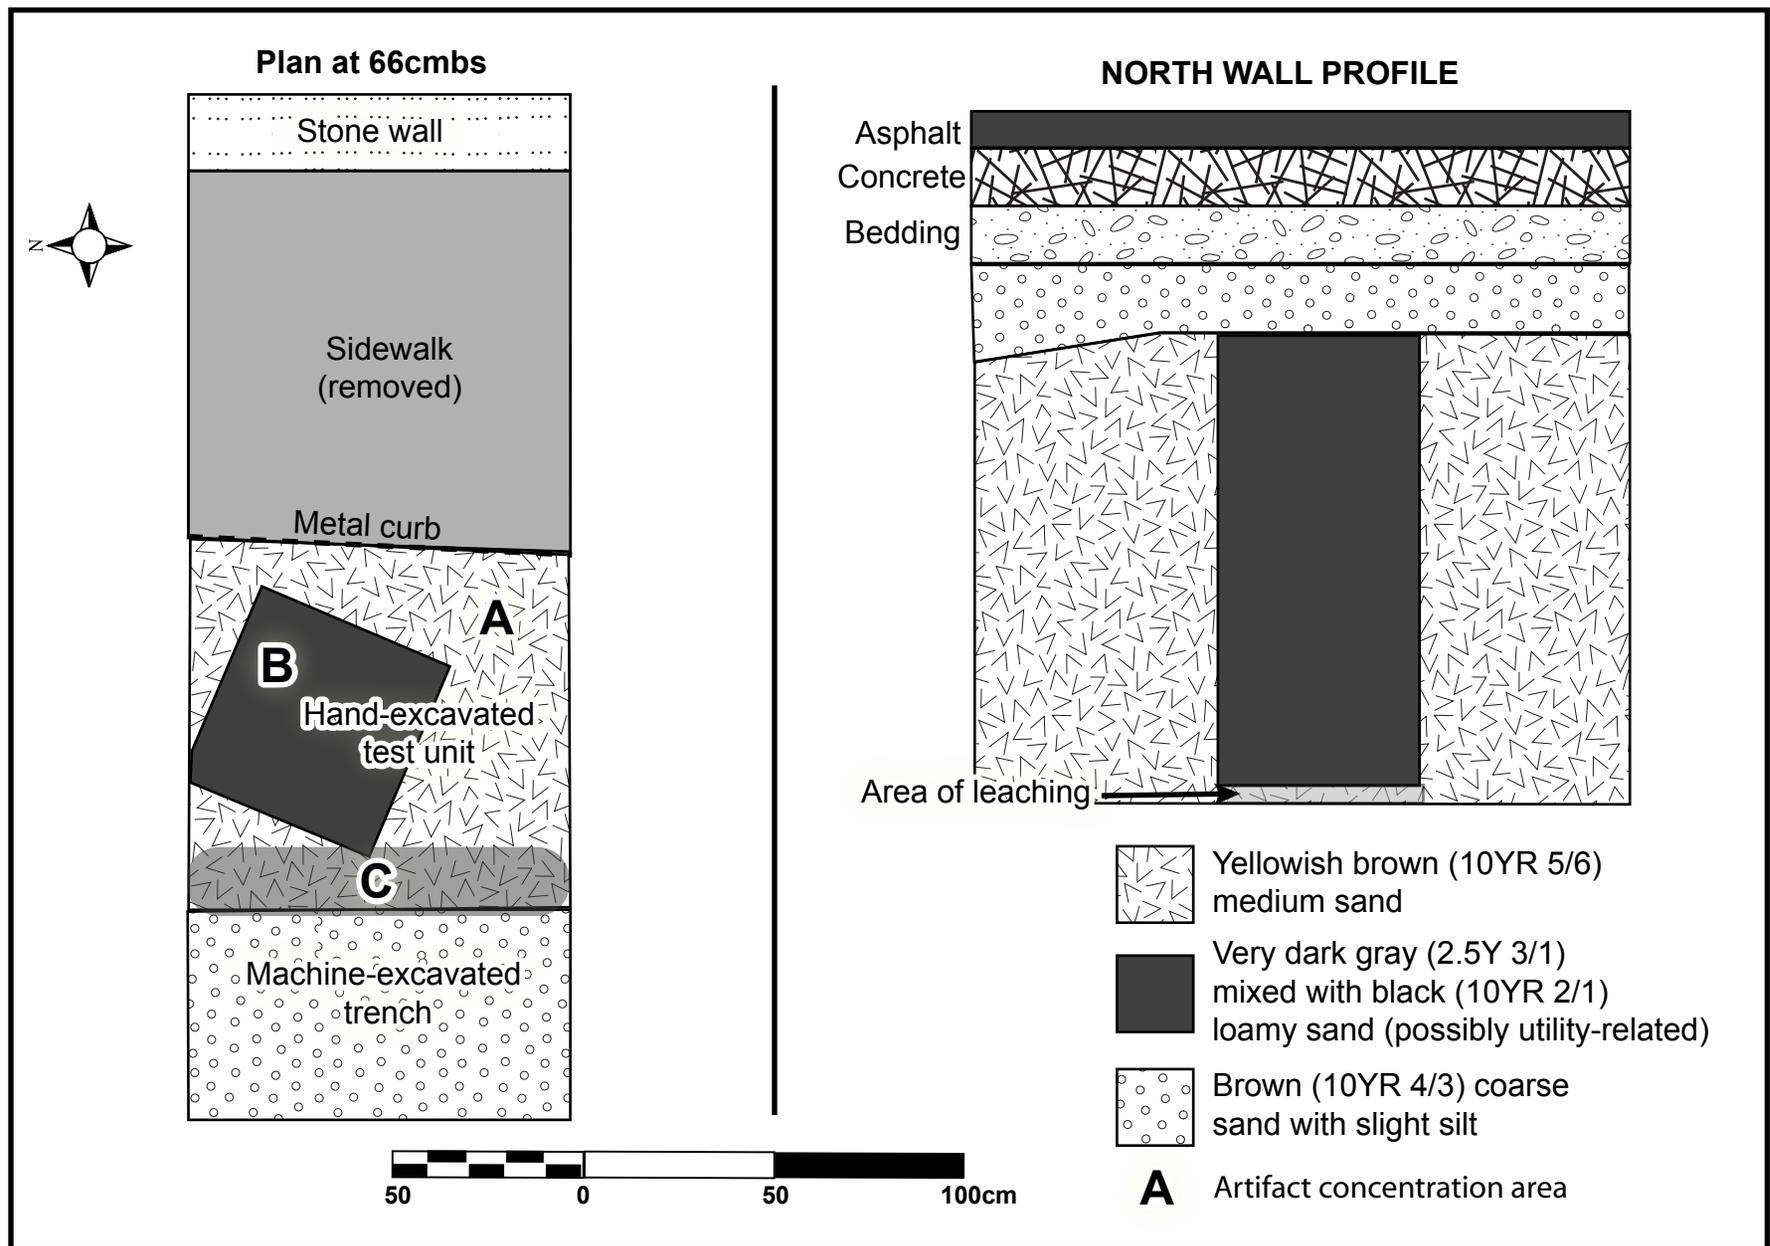
Figure 5. First Avenue, Trench 1 plan (left) and profile of north wall (right).

The remains were identified just below a mixed fill level containing fragments of asphalt, sewer pipe, and unidentified plastic (not collected). At the top of the domestic trash deposit and within the same soil matrix (identified visually and by texture and Munsell chart), the Kiewit/Weeks excavator revealed bone fragments, identified as Area A of Trench 1. As per protocol, Tom Amorosi, PhD, the on-call forensic archaeologist was called to the site. The investigation of the domestic deposition found that the main pocket was less than 15 cm by 20 cm in size and was adjacent to a utility trench containing asphalt fragments and a single fragment of unidentified shell (not collected). Adjacent to the pocket were several soil lenses, also containing a handful of artifacts (identified as Areas B-D) (Figure 5). The mixing and folding of strata is not unusual in street beds or locations where construction (associated with the abutment wall and sidewalk) and utility installation has occurred. Dr. Amorosi confirmed the bone recovered as food/animal remains that were consistent with domestic refuse and the deposit has been identified as domestic fill of unknown origin (Photographs 1 and 2). The WAB Zone collection of recoveries is temporarily housed in the Historical Perspectives archives unit, an environmentally controlled facility. The collection is stored in a discrete file container, labeled WAB/ManhattanMonitoring/1.09. The following list details the materials found in the fill from Trench 1.

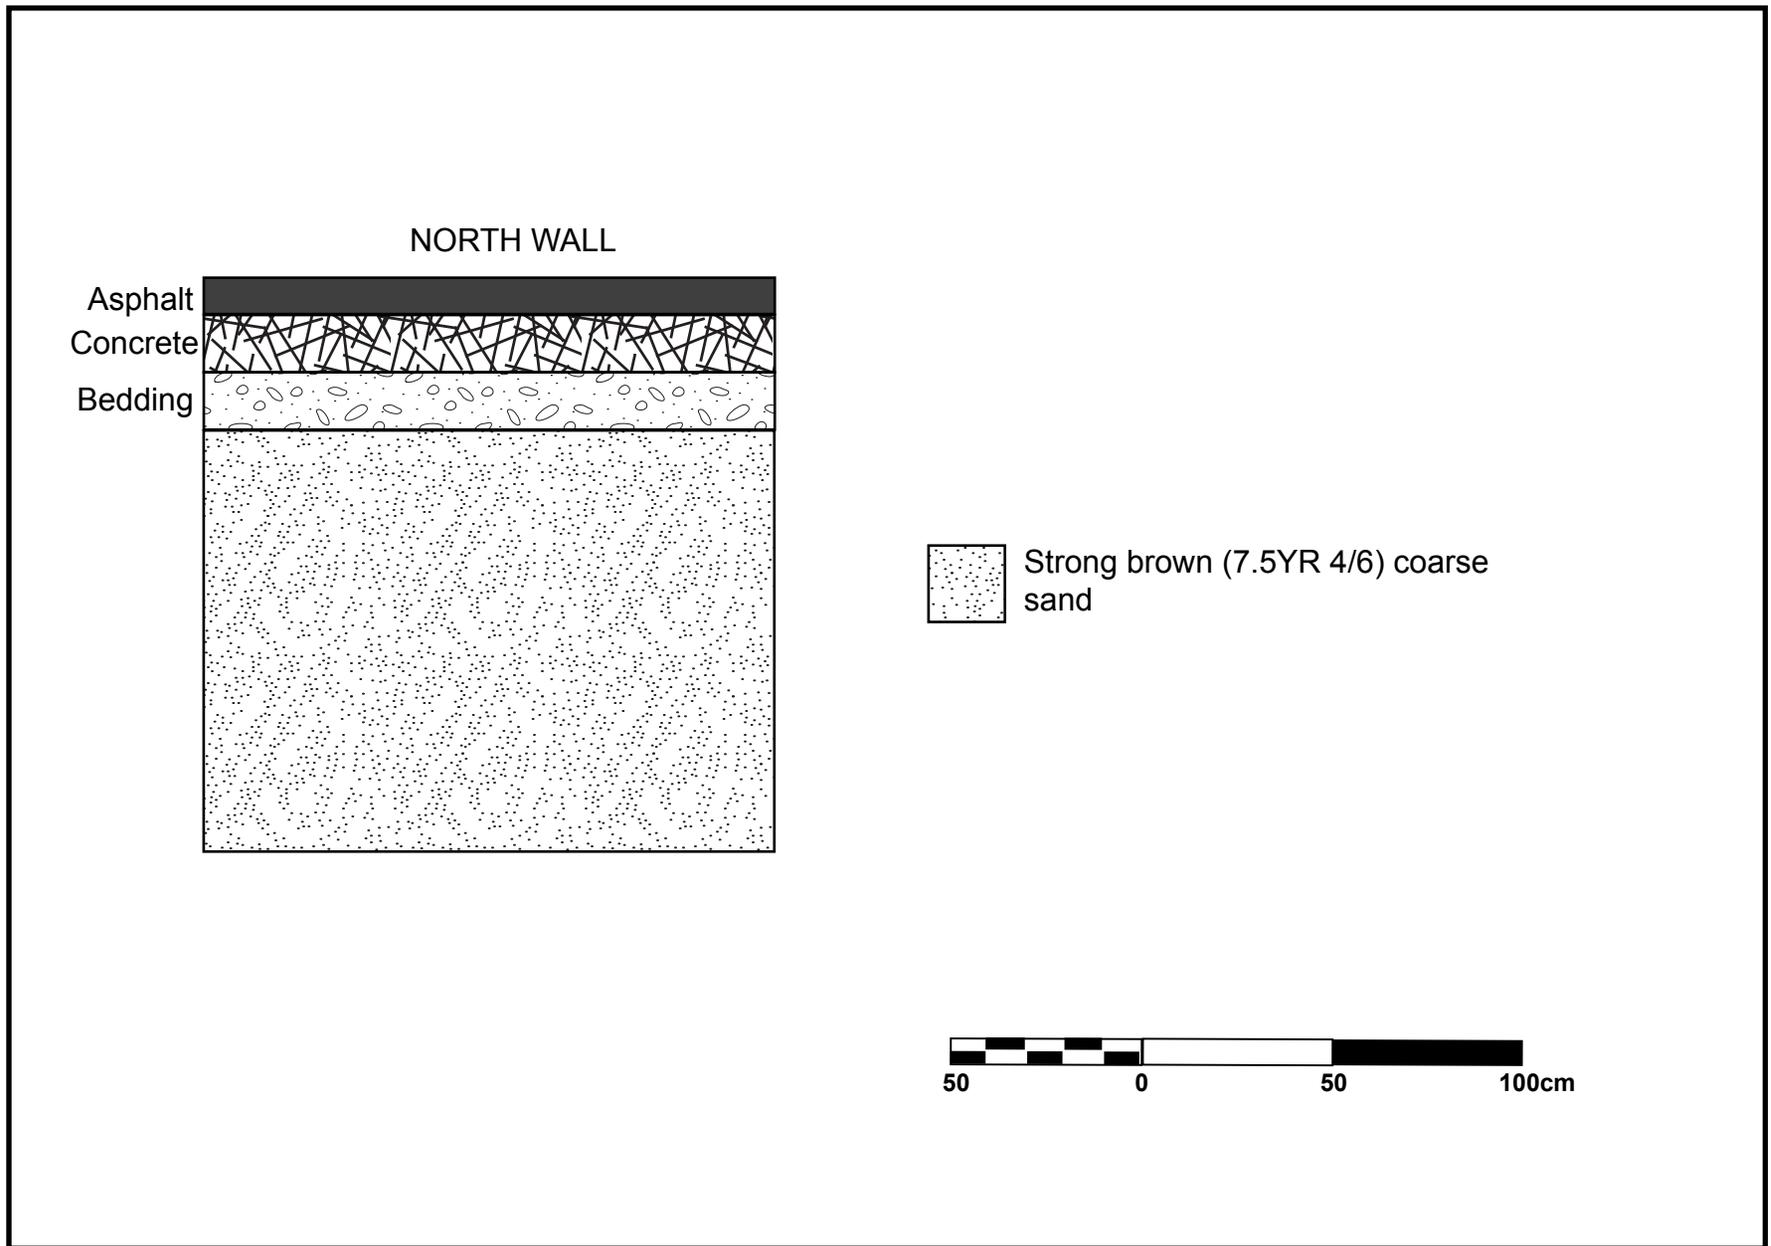
Figure 6. First Avenue, Profile of Trench 2, north wall.

The archaeology team also observed the excavation of a second trench within the monitoring zone, Trench 2 (Figure 6; Photograph 3). Clean fill was observed beneath the modern bedding in Trench 2. No cultural resources were present in Trench 2. The Trench 2 fill was likely associated with a deep utility installation which was later observed in the opened Trench 3, just south and outside of the monitoring zone. Although Trench 3 was outside of the monitoring zone, a photograph was taken for illustrative purposes (Photograph 4).

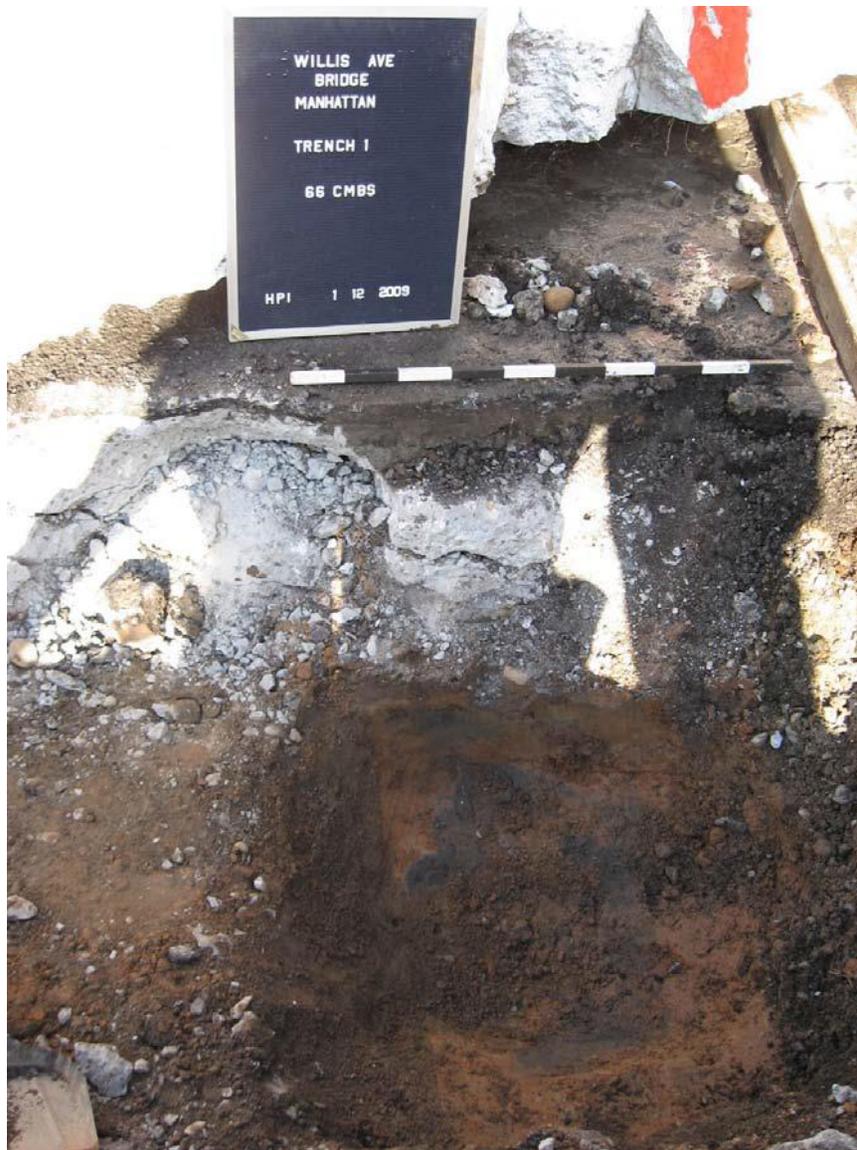
Photograph 1: (8/6/09 memo) First Avenue, hand-excavated portion of Trench 1 at 66 cmbs, looking north.

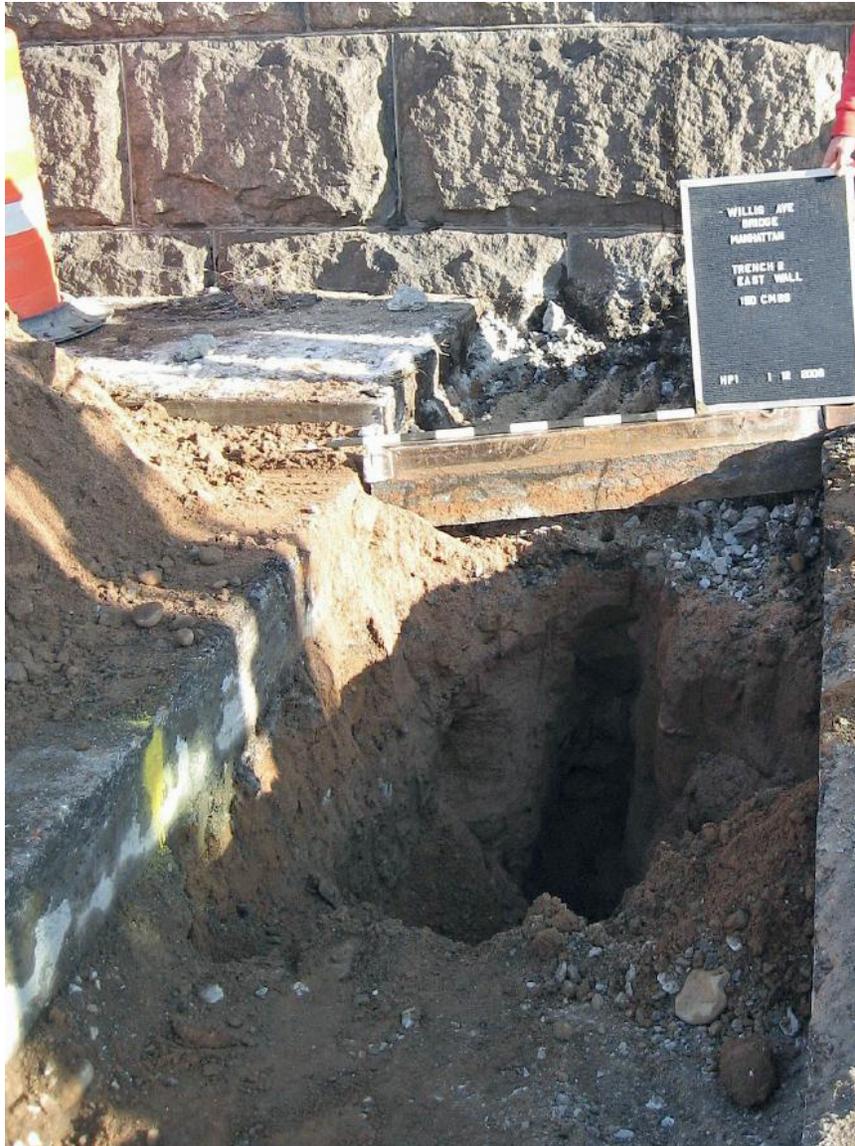
Photograph 3: (8/6/09 memo) First Avenue, Trench 2 after machine excavation, looking east.

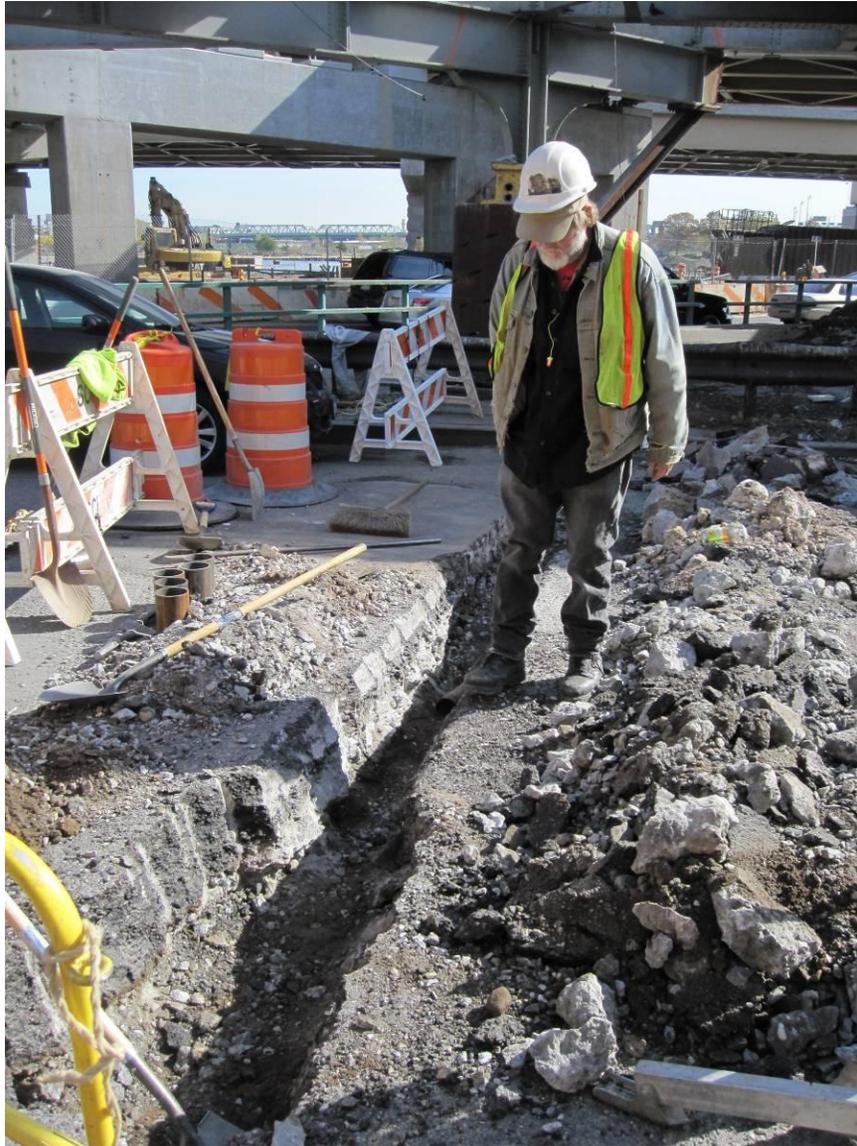
Photograph 4: (8/6/09 memo) First Avenue, Trench 3 (outside monitoring zone) after machine excavation, looking east.

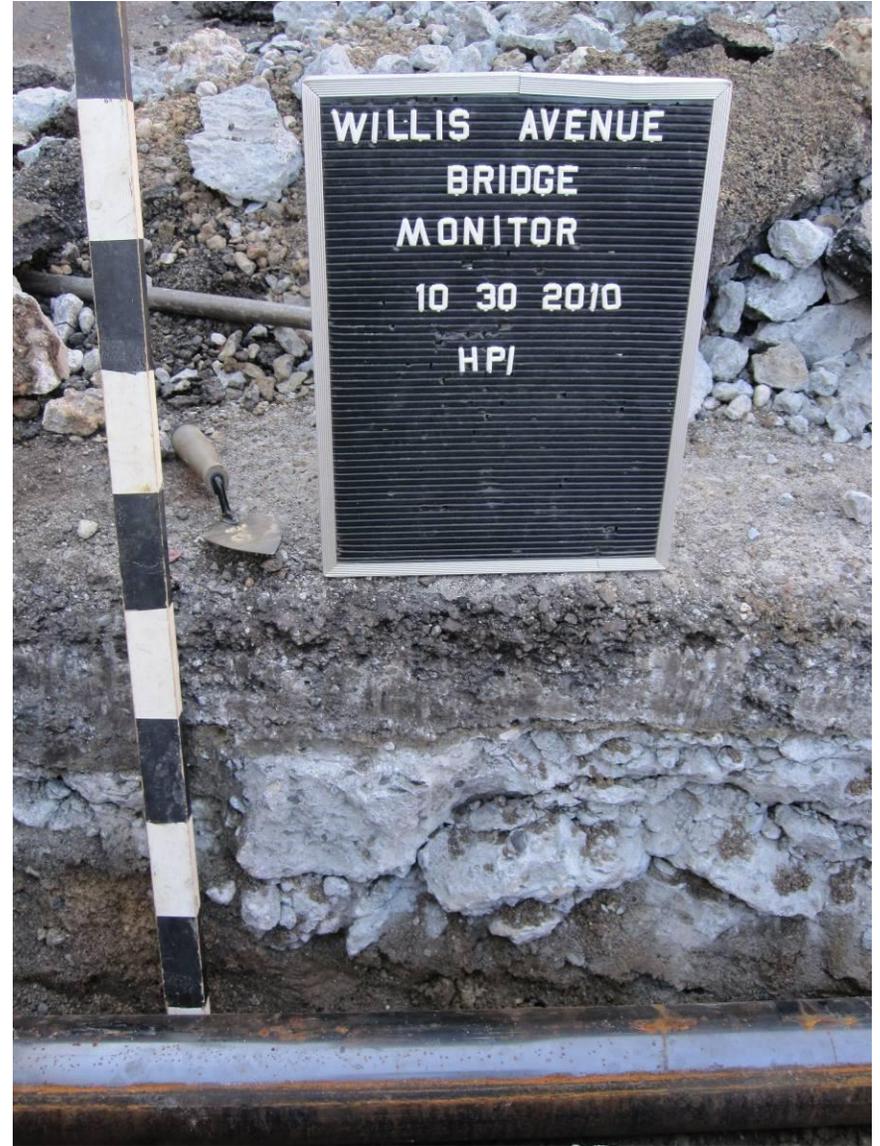
Photograph 6: (11/1/10 memo) First Avenue, south profile of hand-excavated utility trench. Note the multiple levels of blacktop and concrete above ash fill, and final installation of 4" iron utility pipe.

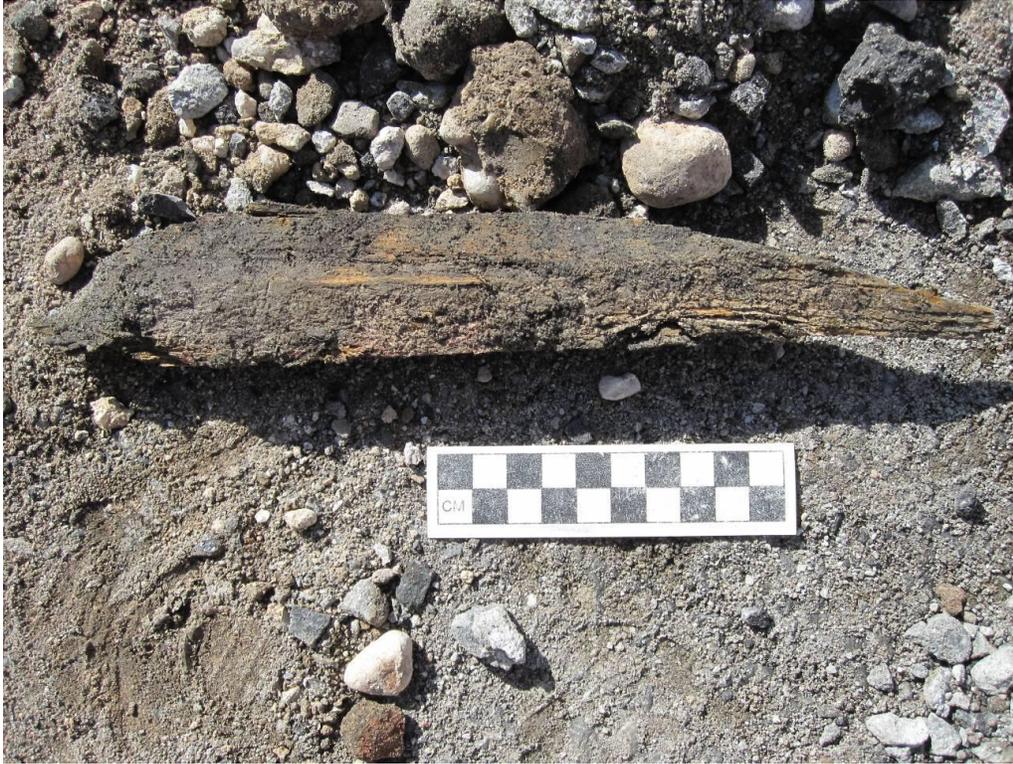
No historical artifacts or osteological material was observed in the trench excavation. Only sand, ash, and gravel bedding for the original road surface was removed from beneath the lowest level of concrete. Artifacts within this fill level were extremely minimal, and were confined to several small brick fragments, and a few small pieces of coal and slag. Two small pieces of oyster shell were also encountered, as were several small roots. Immediately adjacent to the westernmost manhole were several small pieces of wood staking of modern origin (Photograph 7).

Photograph 7: (11/1/10 memo) First Avenue, close up of wood stake fragment recovered from western end of trench immediately adjacent to existing manhole.

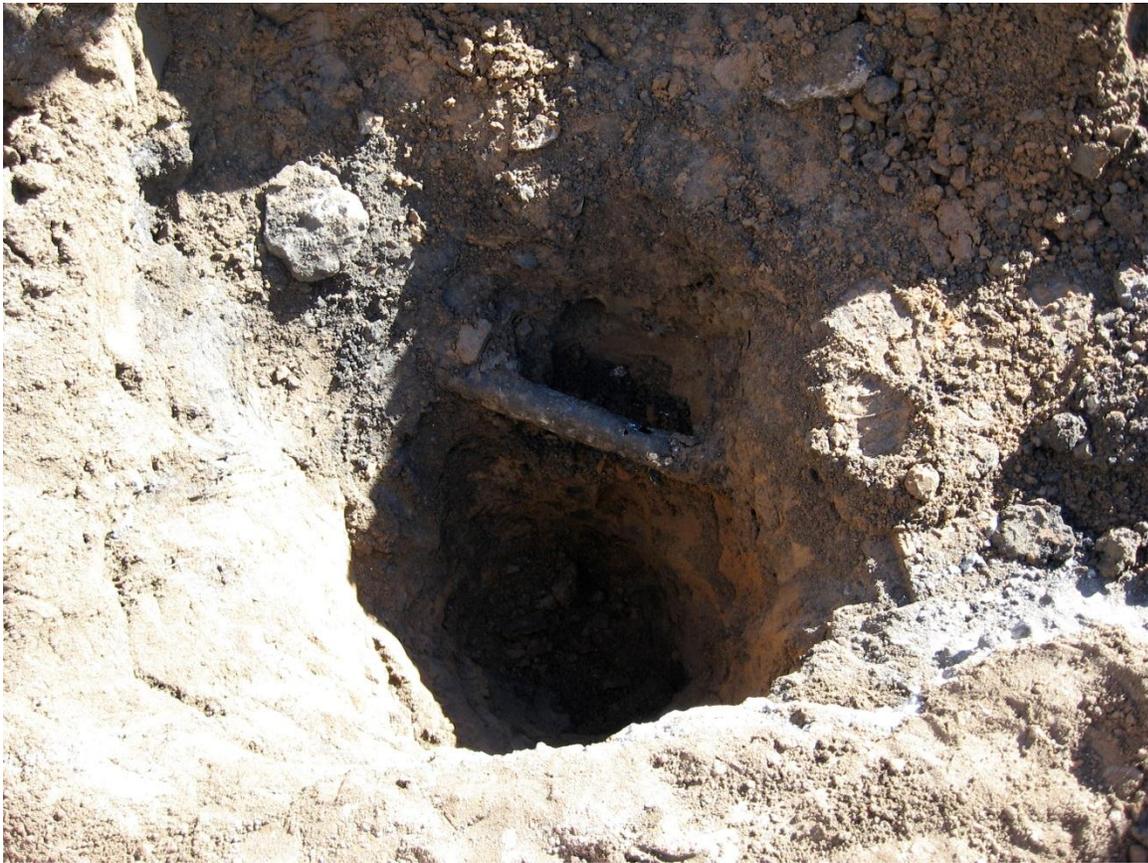
Photograph 8: (12/1/10 memo) First Avenue, Sono tube excavation.

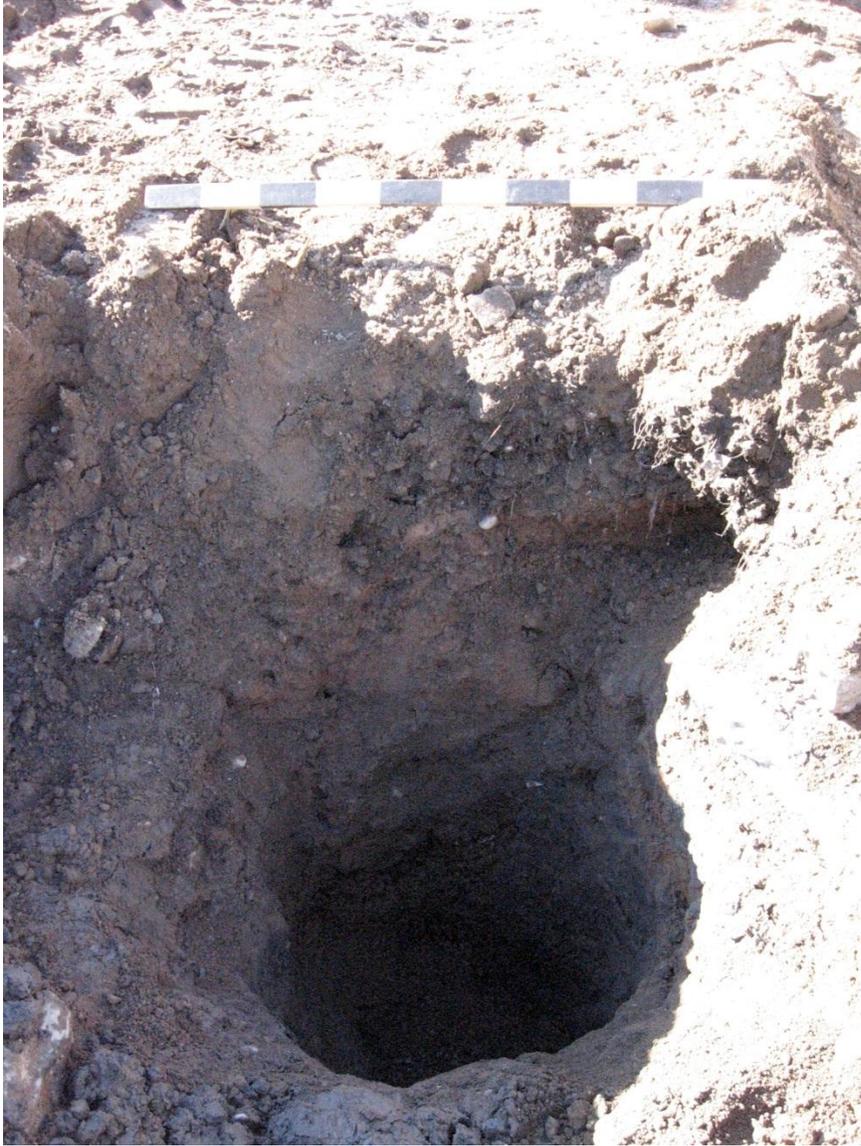
Photograph 11: (12/15/10 memo) First Avenue, Test Unit 1 profile.

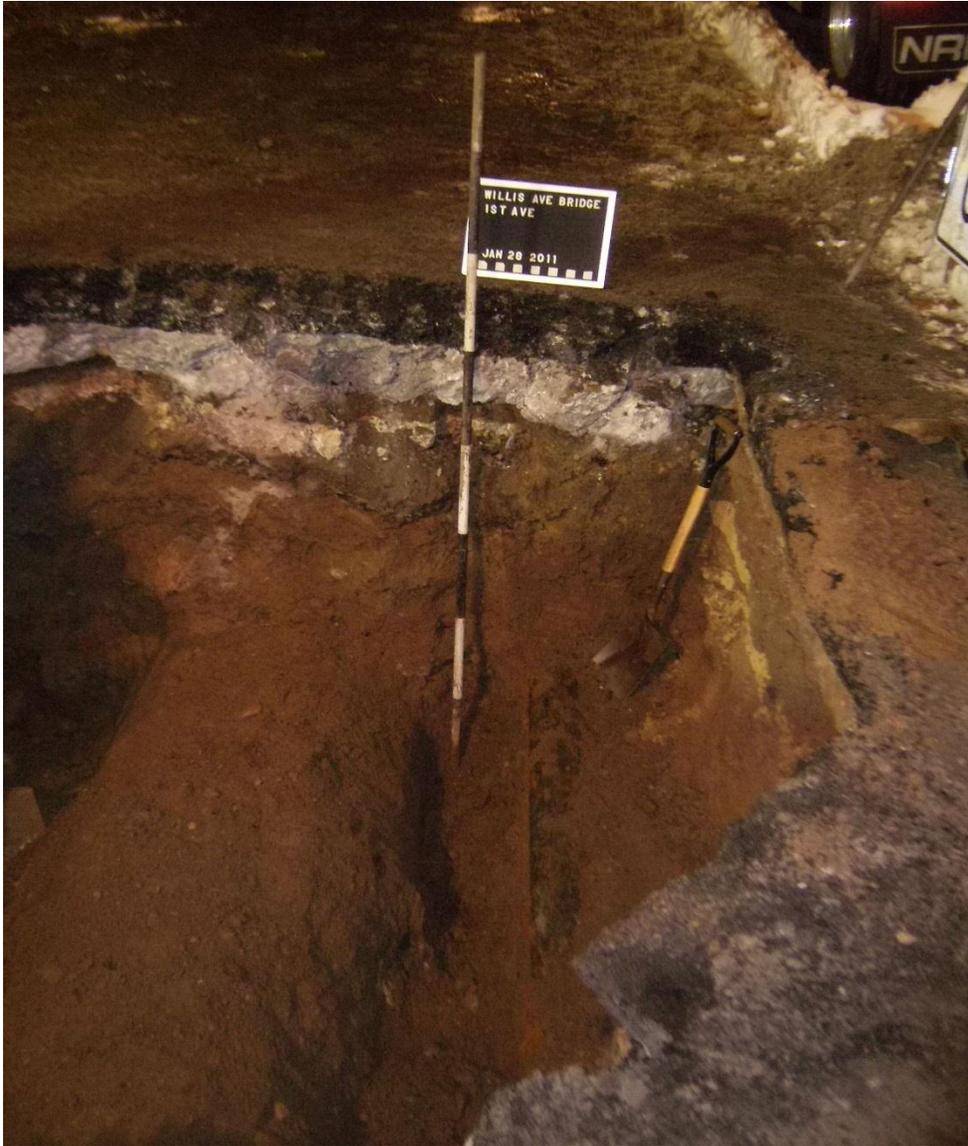
Photograph 12: (12/15/10 memo) First Avenue, Test Unit 2 profile.

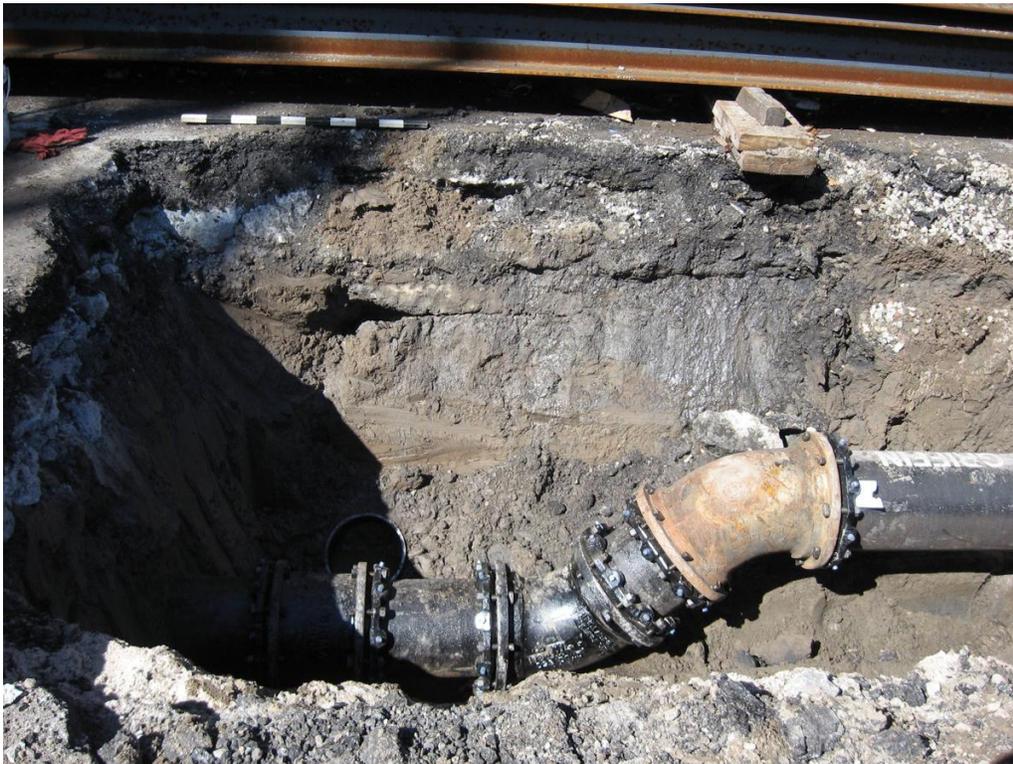
Photograph 16: (4/22/11 memo) First Avenue, Test Trench 3, looking north.

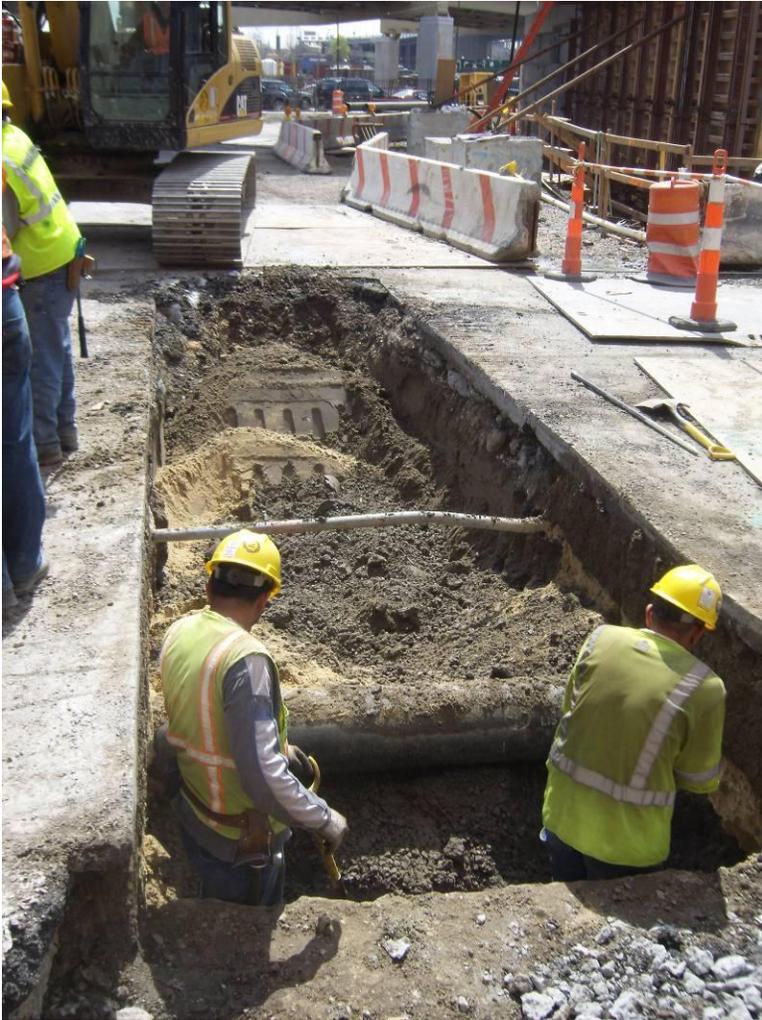
Photograph 18: (9/8/11 memo) First Avenue, Utility Trench 2/2 – 2/3 facing east. Water main in foreground and telephone conduit at center of photograph.

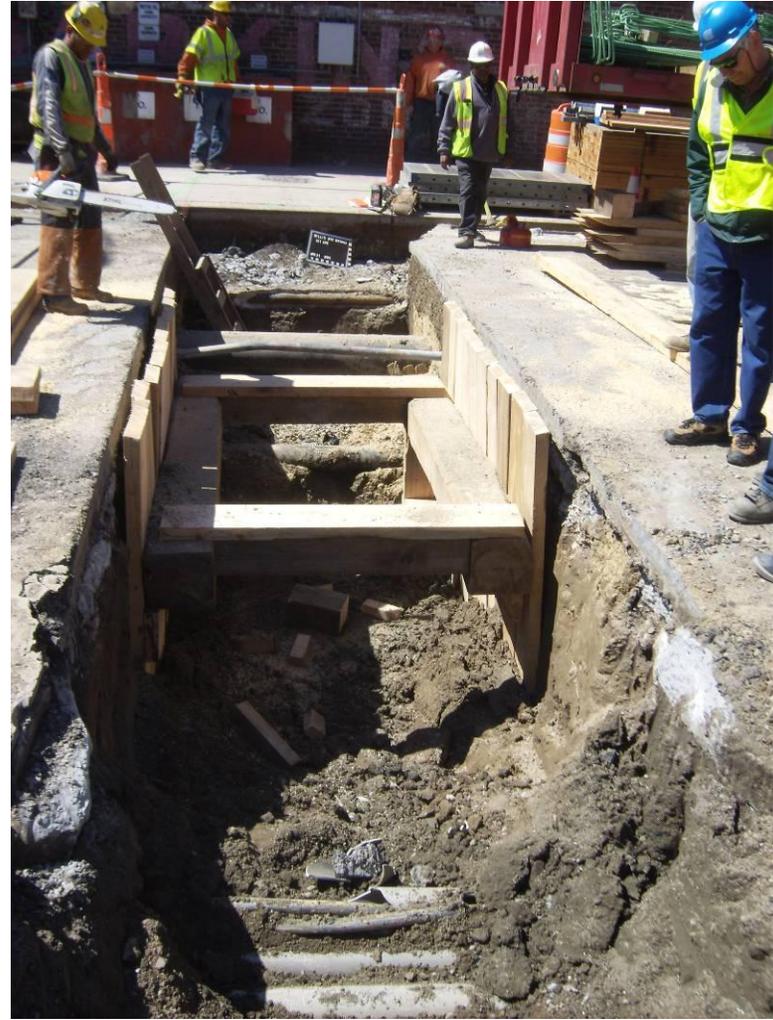
Photograph 19: (9/8/11 memo) First Avenue, Utility Trench 2/2 – 2/3 facing west. Utility lines are visible in foreground and at center of photograph. Shoring walls is in progress.

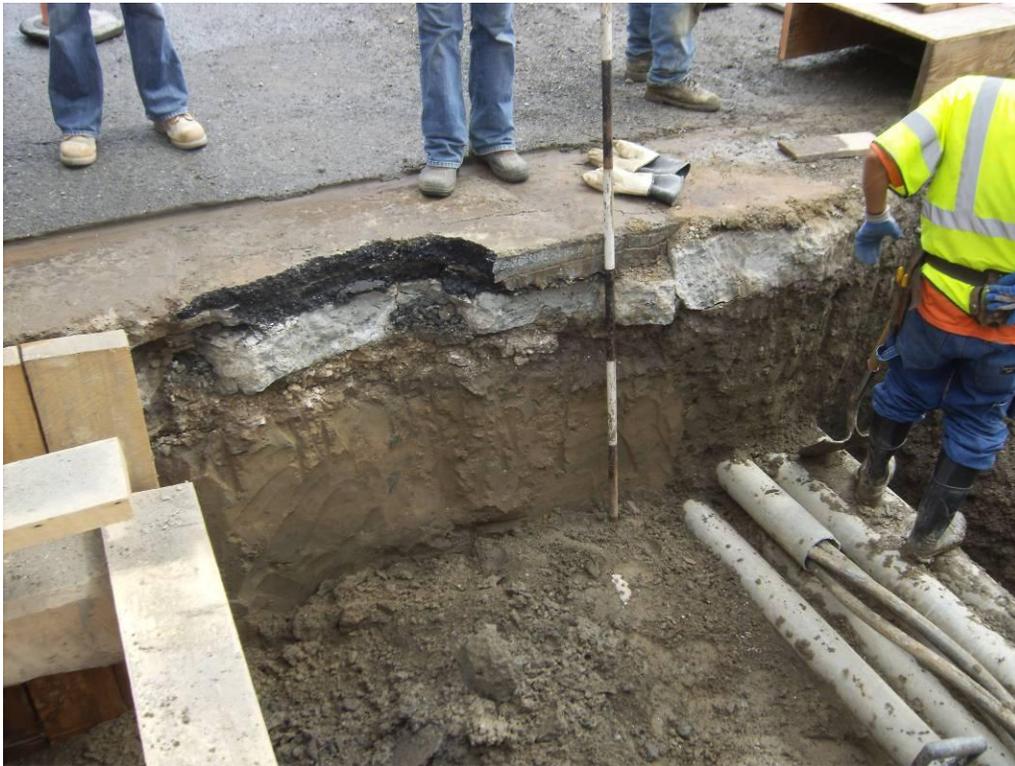
Photograph 20: (9/8/11 memo) First Avenue, Utility Trench 2/2 – 2/3, facing northeast to north wall. Note electrical lines at .7m below grade at right.

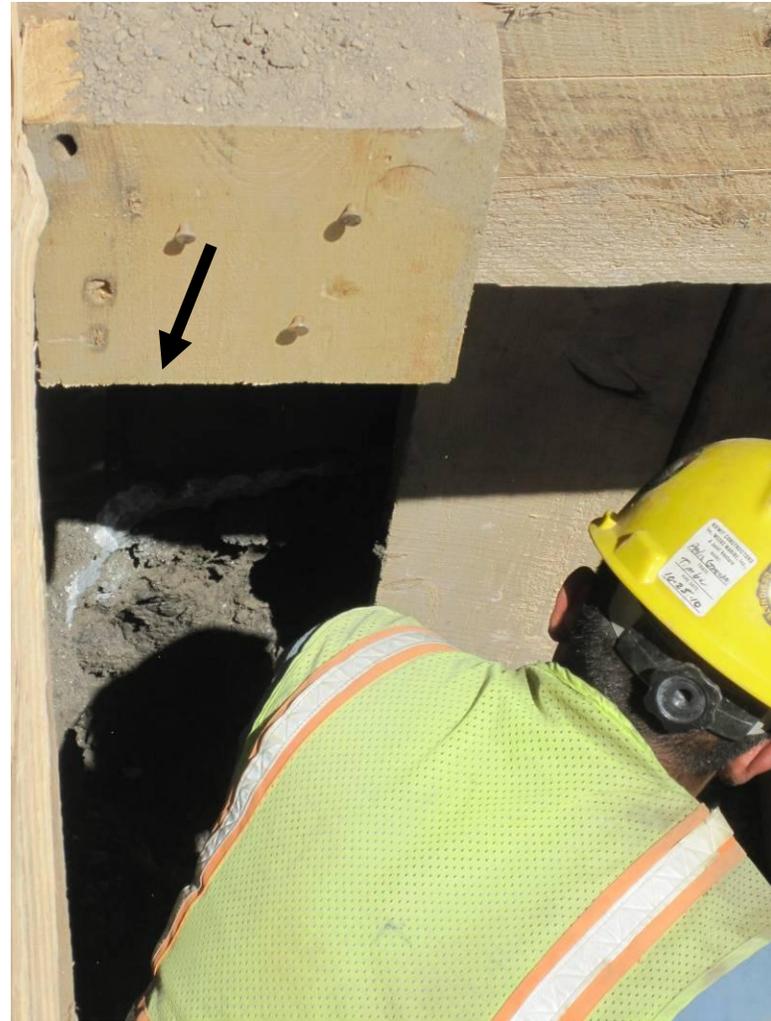
was found protruding from the south wall at 1.8m (6 ft) below grade. The board was removed with a chain saw, and appeared to be modern with wire nails protruding from it. Two layers of concrete were encountered in the northwest corner of the trench at 1.4m (4.5 ft) below grade (Photograph 22), and in the southwest corner of the trench at about 1.8m (6 ft) below grade. These appeared to be concrete supports for the manhole, and cement protruding from the manhole was chipped off to allow for shoring.

Photograph 22: (9/8/11 memo) First Avenue, Utility Trench 2/2 – 2/3 facing north. Note the freshly broken cement at the northwesternmost corner of the trench demarcated by the arrow.

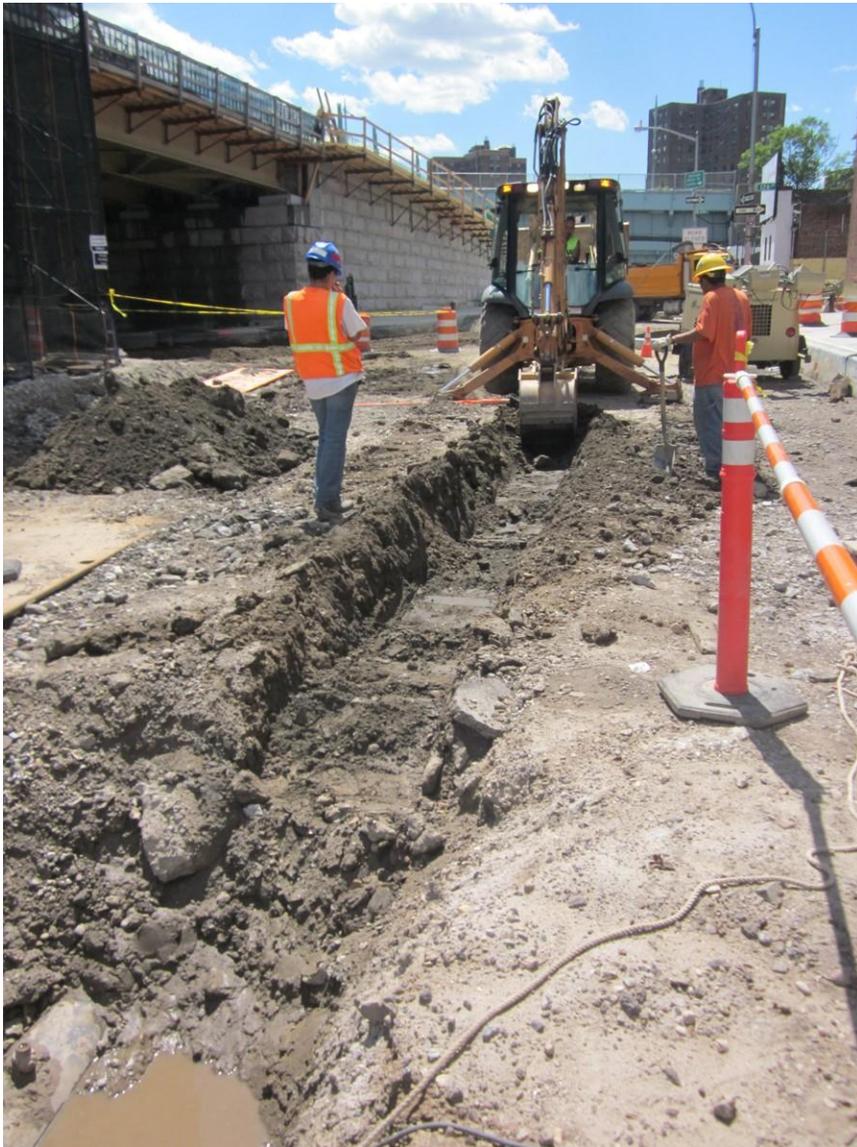
Prior to the replacement of the roadway, HPI monitored the excavation of a trench for an electric line in the north end of the west lane of First Avenue on August 15 and 16, 2011 (Photograph 23). The profile consisted of up to 1.0m (3.3 ft) of mixed fill.

Photograph 23: (9/30/11 memo) First Avenue, between East 126<sup>th</sup> and 127<sup>th</sup> Streets, looking south.

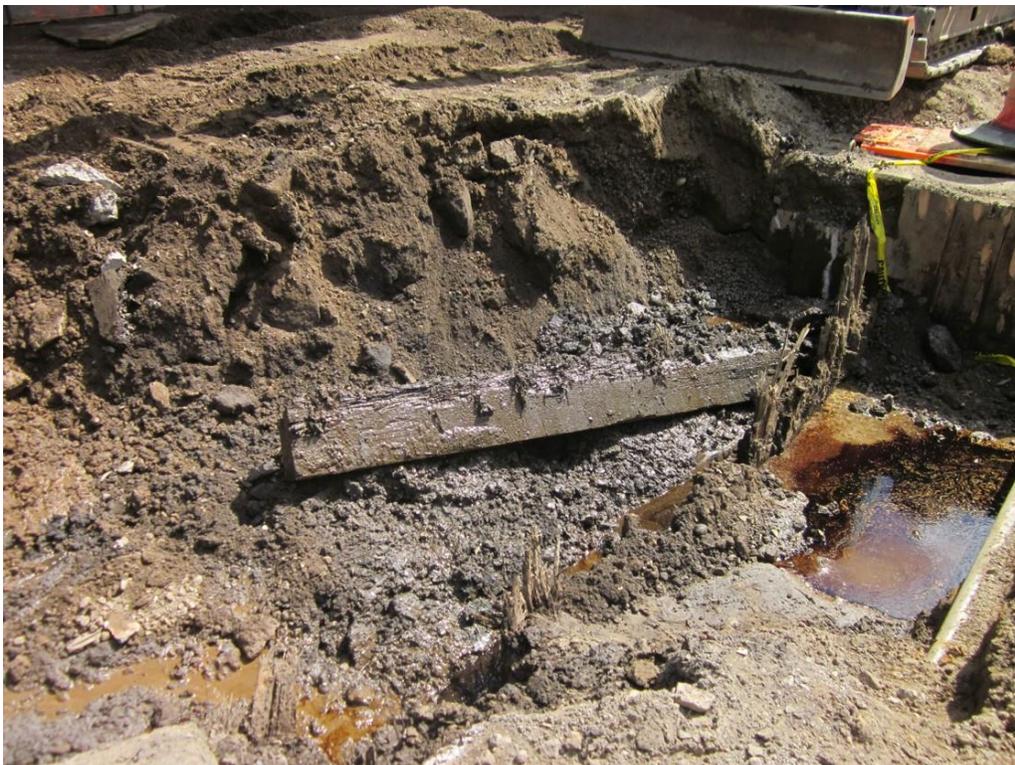
When the vertical boards were removed from the trench, a long horizontal timber was found to be abutting them, some form of lagging or brace serving as a reinforcing timber for the bulkhead or wall. The horizontal timber was 3.24m (10.6 ft) long and 30 x 17 cm (12 x 7 inches) wide. One end was broken, and the other end had a 5cm (2 inches) wide hole at 11 cm (4 inches) from the cut edge of the timber. The vertical timbers had tongue and groove construction on the long edges, and were beveled on the bottom (Photograph 26). Three timbers were examined; all were 30 cm (12 inches) wide, but none were intact lengthwise. Their lengths were 1.63m (5.3 ft), 1.8m (5.9 ft), and 2.1m (6.9 ft). Two were 8 cm (3.1 inches) thick and one was 6 cm (2.4 inches) thick, and one had an embedded iron nail.

Photograph 25: (9/30/11 memo) Remains of former bulkhead at intersection of First Avenue and access road, looking north. Tops of upright planks have been sheared off. Oily water can be seen at right.

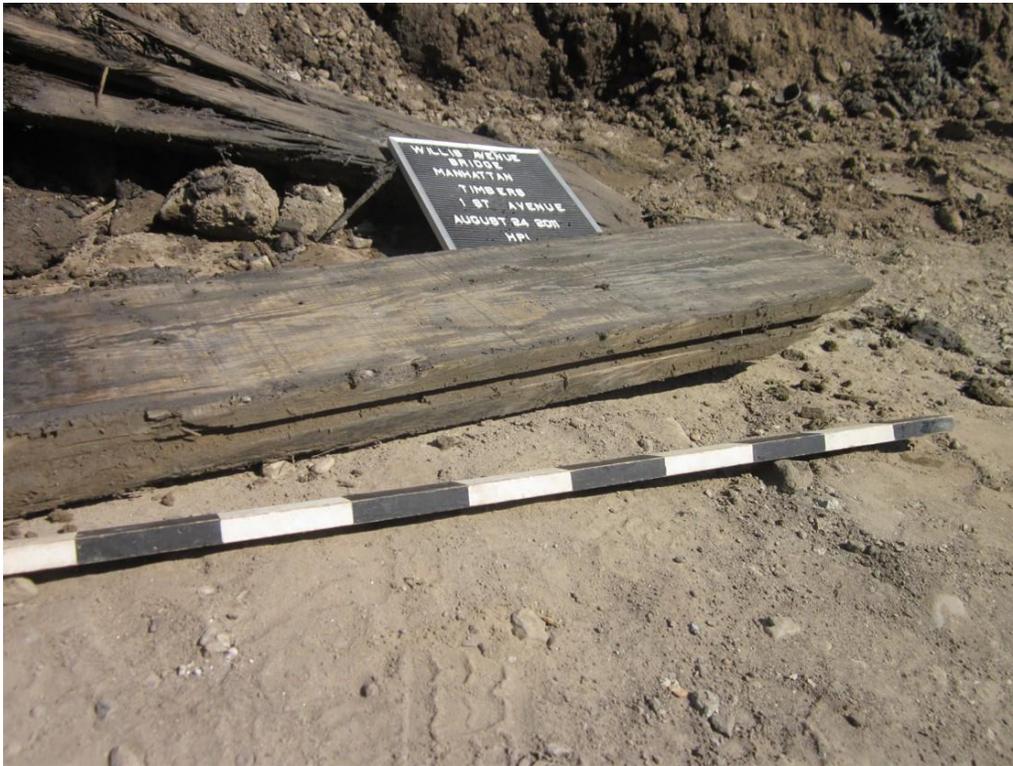
Photograph 26: (9/30/11 memo) First Avenue, one of the upright planks from the bulkhead. Note tongue and groove construction and beveled base.

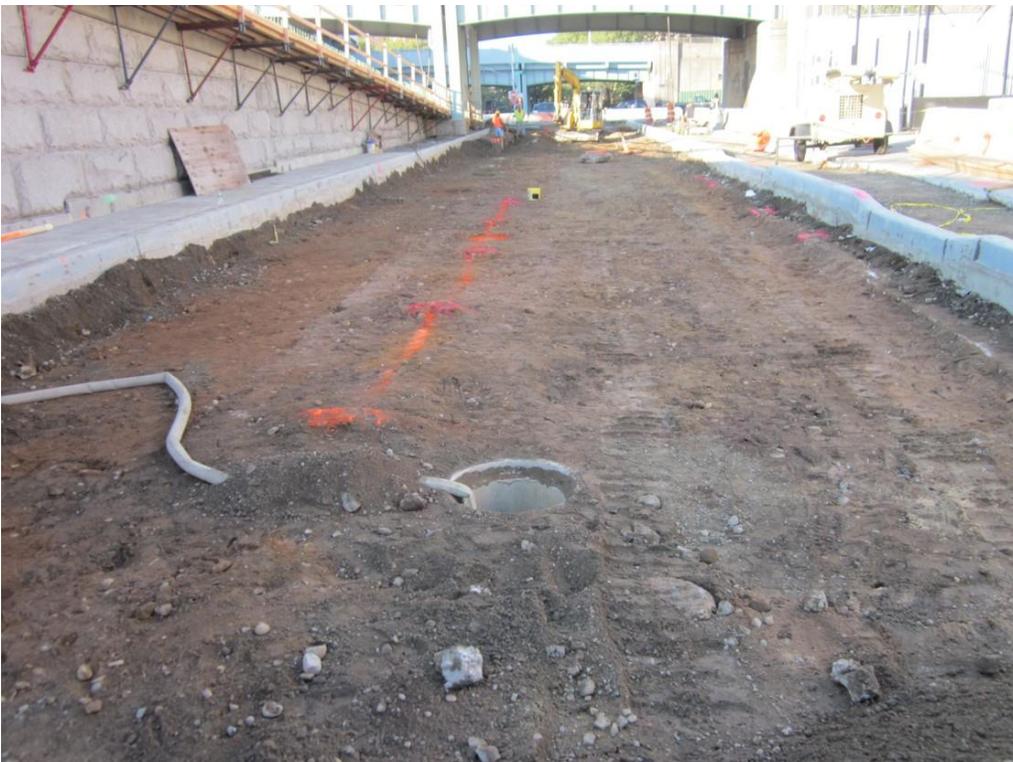
Photograph 29: (9/30/11 memo) First Avenue looking south, from intersection at East 126<sup>th</sup> Street. Orange paint shows location of large gas main.

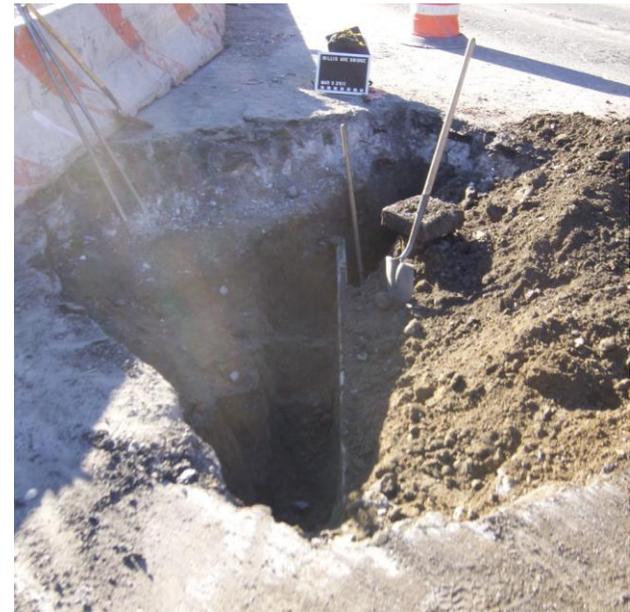
TT2 was located within East 127<sup>th</sup> Street at the end of the Marginal Street ramp (Figure 4a). TT2 was approximately 3m (10 ft) by 3m (10 ft) in size. The excavation of this trench exposed a deep fill horizon and both a water main and a cable line (Photograph 31). Below is the stratigraphy noted in TT2.

Photograph 31: (4/22/11 memo) East 127<sup>th</sup> Street, Test Trench 2, looking southeast.

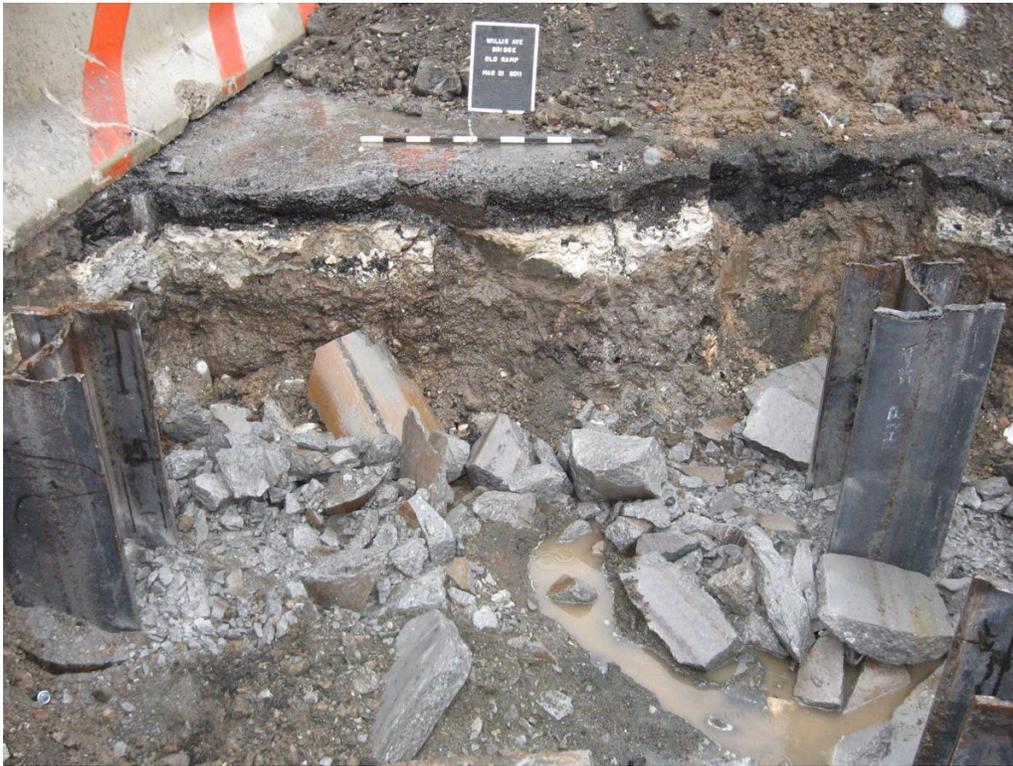
TT4 and TT5 were small trenches excavated in the East 127<sup>th</sup> Street roadbed (Figure 4a). Four metal I-beams used to support the former ramp, were exposed in Trench 4 (Photograph 32). Excavation halted at approximately 140cmbs. No features, concentrations of artifacts, or potential shafts were found.

Photograph 32: (4/22/11 memo) East 127<sup>th</sup> Street, Test Trench 4, looking west.
