**Replacement of Willis Avenue Bridge over the Harlem River**  
**BIN No. 2-24005-9/A/B Total Design; Contract No. HBM 1124**  
**New York and Bronx Counties, NY**  
**Manhattan Approach**  
*NYS OPRHP No. 03PR00939*  
*LPC No. DOT/LA-CEQR-X*

**Final Summary of Archaeological Monitoring**  
**Manhattan Approach**  
**January 2009 through April 2012**

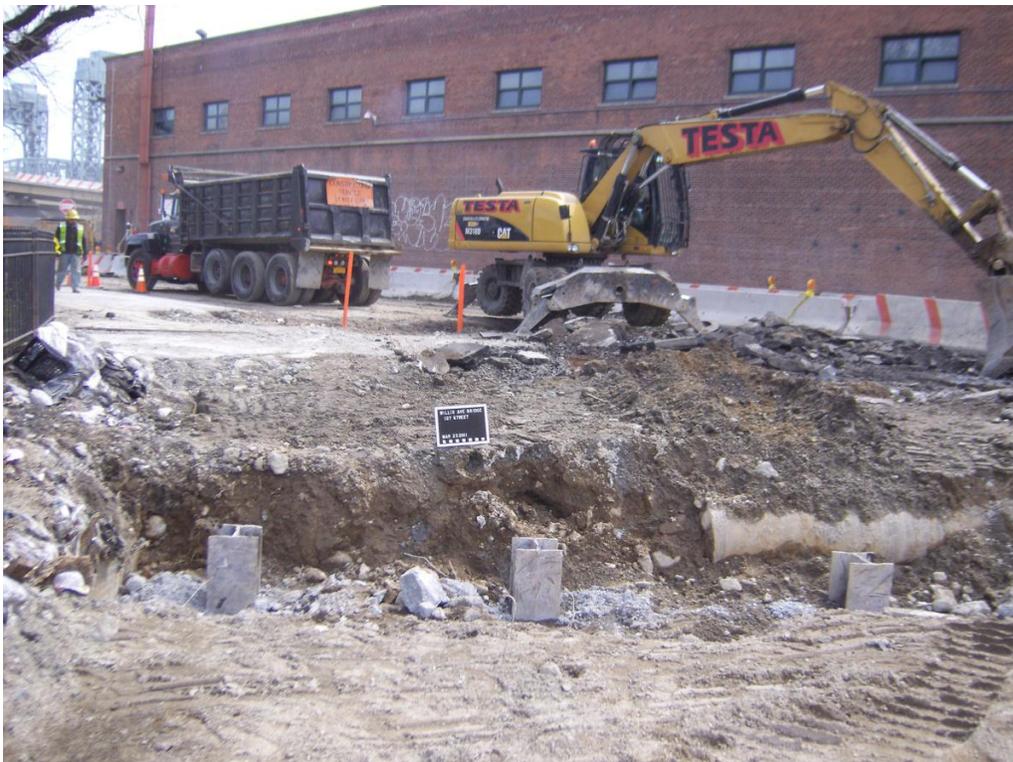
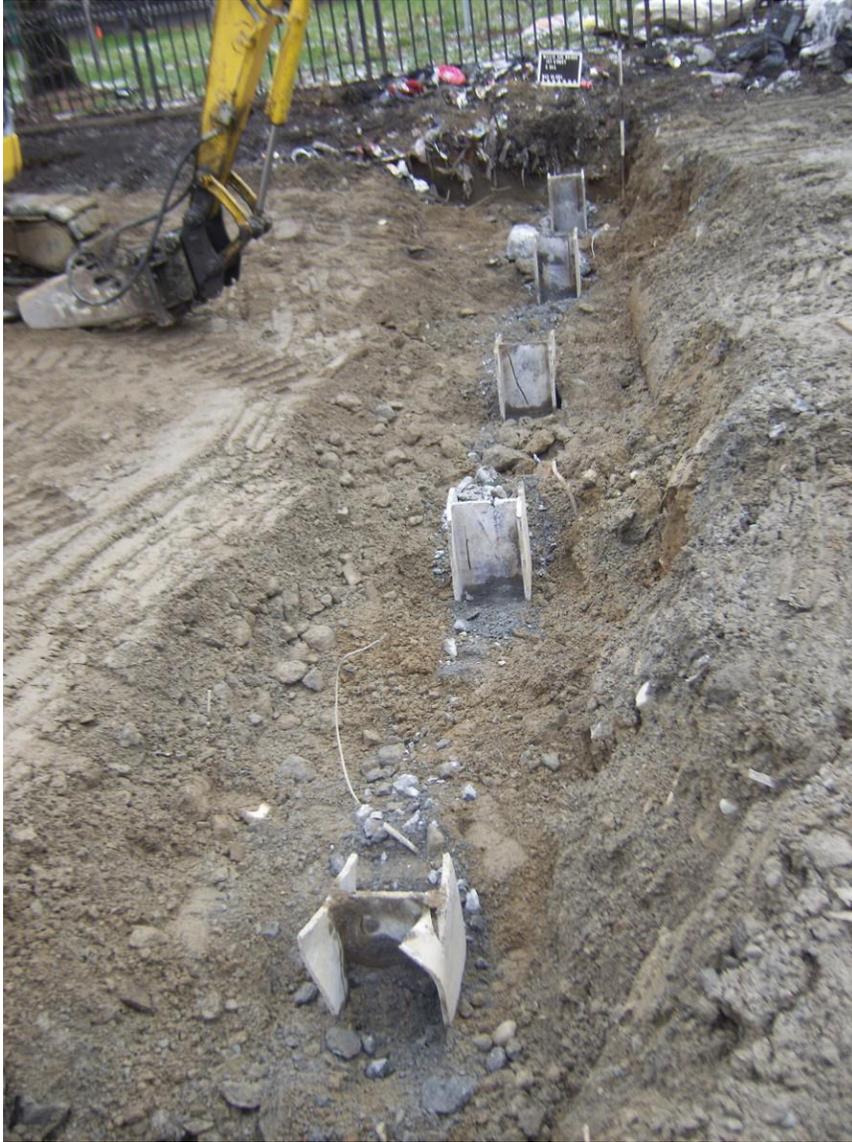
TT8 was excavated within the roadbed of East 127<sup>th</sup> Street and the Marginal Street access ramp in order to expose pilings that formerly supported a ramp structure (Figure 4a, Photographs 33 and 34). They were exposed and truncated, and the new road built over the truncated *in situ* pilings. All the soil was disturbed fill. The southwest portion of the trench falls in the Zone. Excavation was 9 m (29.7 ft) by 3m (6.6 ft) by 1.5m (5 ft) deep. No features, concentrations of artifacts, or potential shafts were found.

Photograph 33: (4/22/11 memo) East 127<sup>th</sup> Street, Test Trench 8, looking southeast.

Photograph 34: (4/22/11 memo) East 127<sup>th</sup> Street, Test Trench 8, looking north showing truncated pilings.

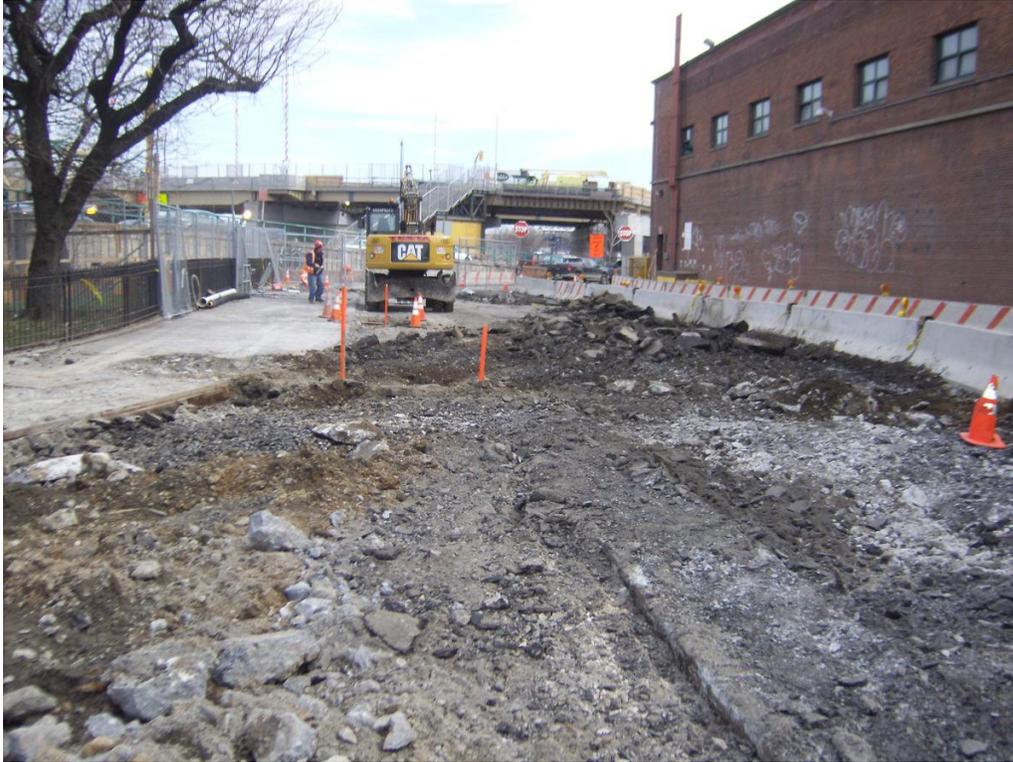
The construction team initially removed the surface asphalt for recycling, followed by the concrete road base (Photograph 37). They also removed the concrete sidewalk, which was immediately north of the Zone. Numerous utilities, both active and defunct, were encountered during the excavation of the streetbed (e.g., drains, electric lines). HPI monitors noted that a one-meter wide concrete protective cover was located above the six (three over three) PVC conduits for electric lines running the length of East 127<sup>th</sup> Street (Photograph 38). During excavation, unanticipated concrete-encased electric lines were also encountered (Photograph 39), which slowed the progress of the project.

Photograph 37: (5/24/11 memo) East 127<sup>th</sup> Street removal of asphalt, looking east.

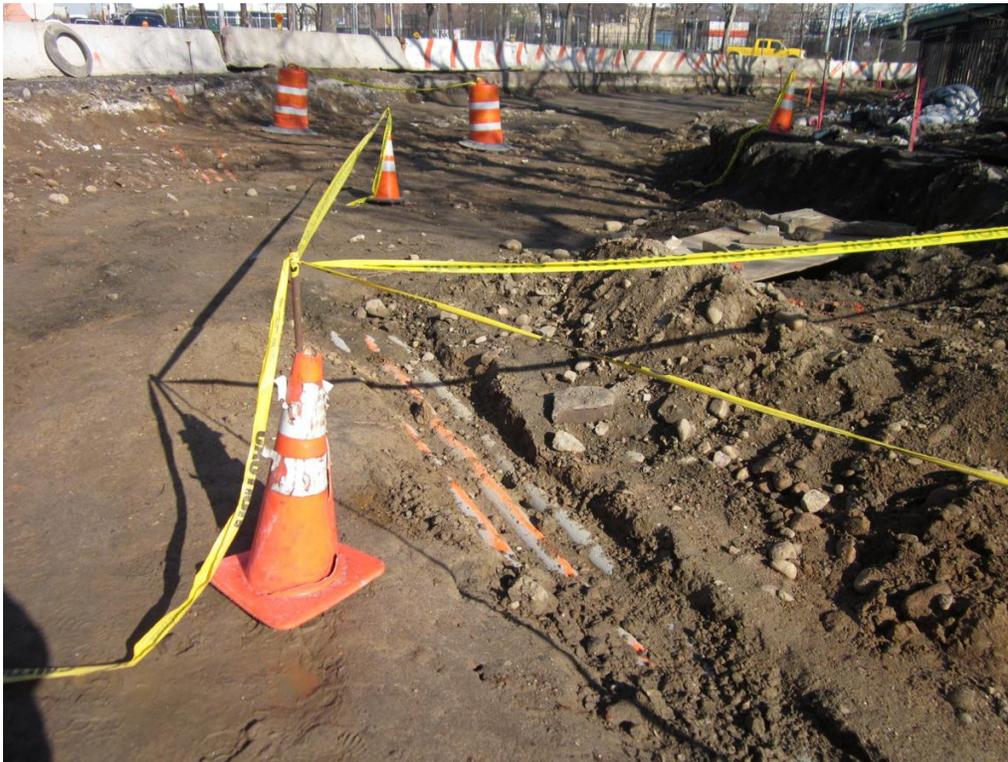
Photograph 38: (5/24/11 memo) East 127<sup>th</sup> Street, utility pipes running east-west, looking northwest.

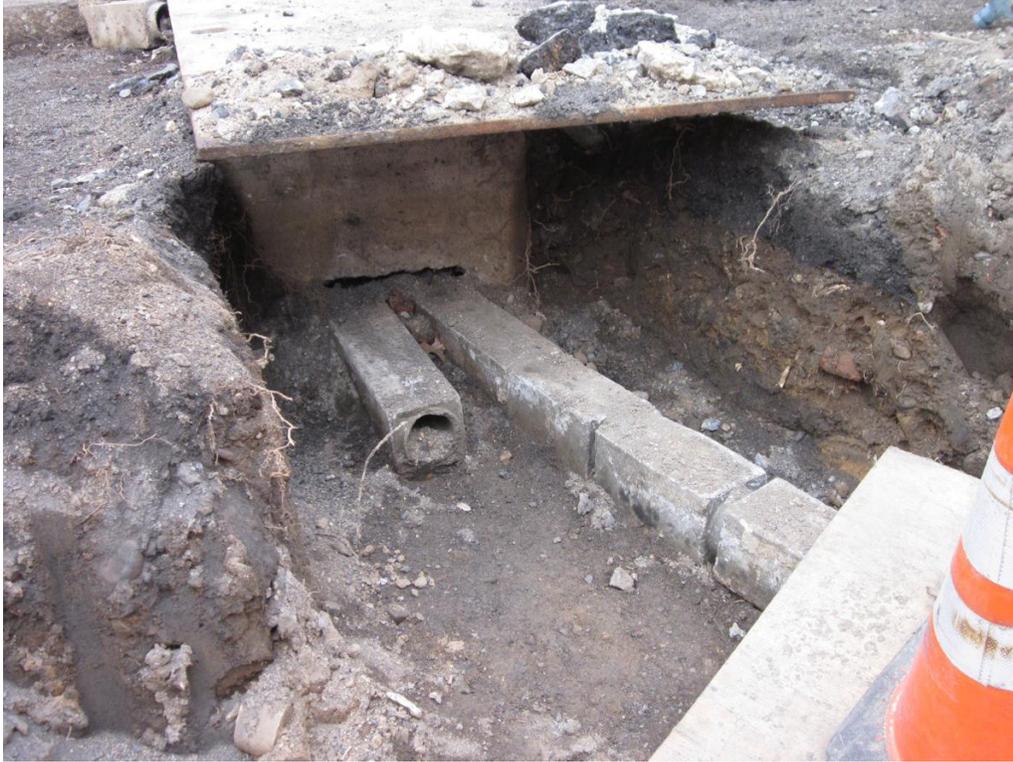
Photograph 39: (5/24/11 memo) East 127<sup>th</sup> Street, electrical conduits, looking north.

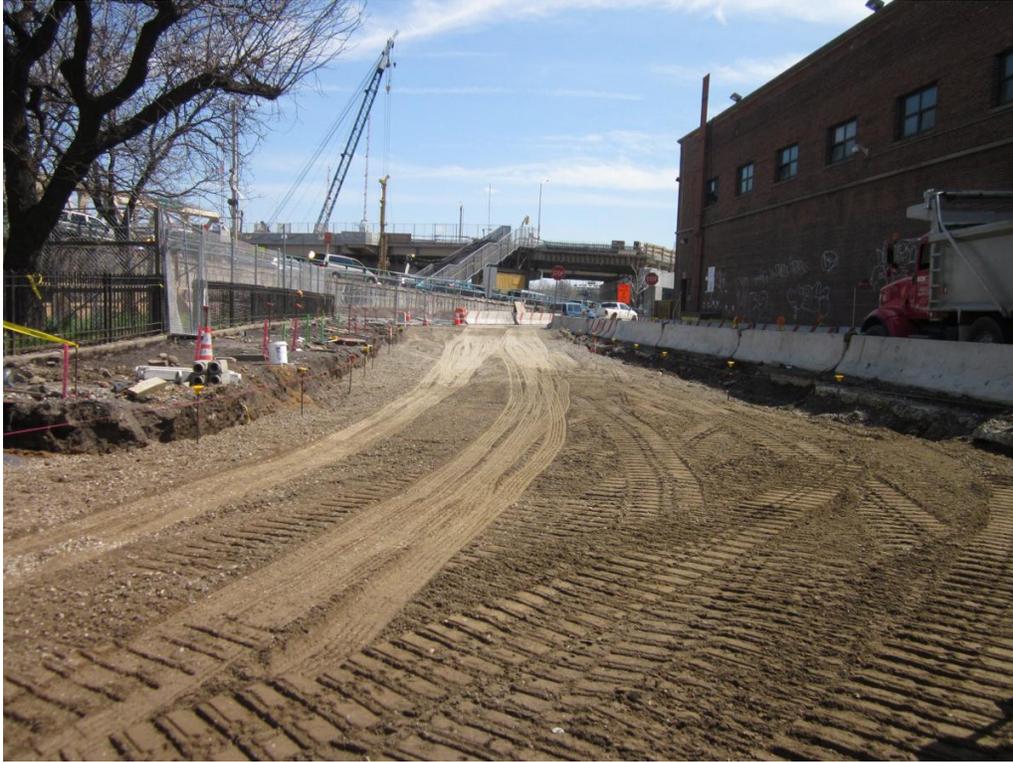
Following the clearing of the roadbed, steel plates were used to cover the utilities and clean fill was introduced into the roadbed (Photographs 40 and 41).

Photograph 40: (5/24/11 memo) East 127<sup>th</sup> Street, utility pipes covered by steel plates, looking east.

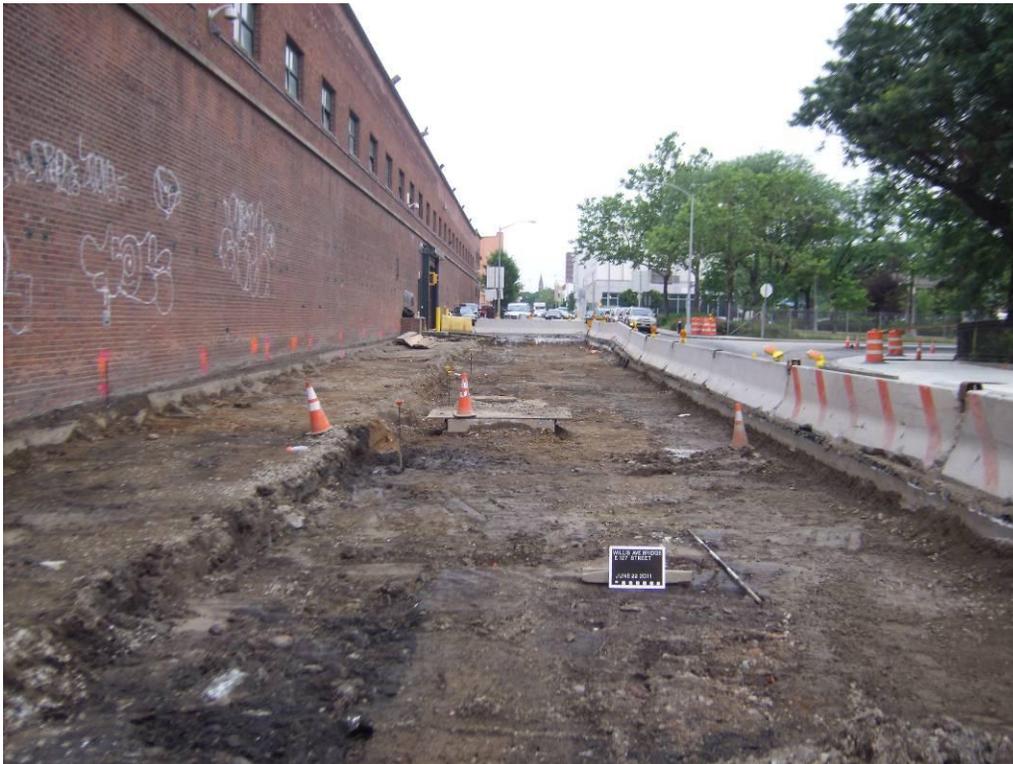
In addition to the curbing and sidewalk, the south (eastbound) lane of East 127<sup>th</sup> Street removal and replacement was monitored between mid-June and early July, 2011 (Figure 4b, Photograph 42). The first excavations involved testing to identify the location of utilities. Most of these test excavations were relatively shallow, up to 1.1m (3.6 ft) deep. This western segment of East 127<sup>th</sup> Street was about 97m (320 ft) long by 7.5m (25 ft) wide. Almost all of the test excavations had profiles consisting entirely of mixed fill with artifacts dating to the late nineteenth century. At a depth of about 0.9m (3 ft) below current street level, two tan glaze stoneware bottles were found. One bottle, impressed "J. AXTMANN" was from the Hoboken, New Jersey bar of John Axtmann. He produced weiss beer (a German wheat beer) from 1875 until 1895 (Hoboken Historical Museum n.d.). The other bottle was impressed "TAUNUS BRUNNEN/BY APPOINTMENT" and "J. FRIEDRICH/GROSSKARBEN/B(/)FRANKFURT A(/)M". This appears to be a wine or gin bottle dated to the late nineteenth-early twentieth century.

Photograph 42: (9/8/11 memo) East 127<sup>th</sup> Street, view looking west following the removal of the southern sidewalk, curb, and south lane roadbed.

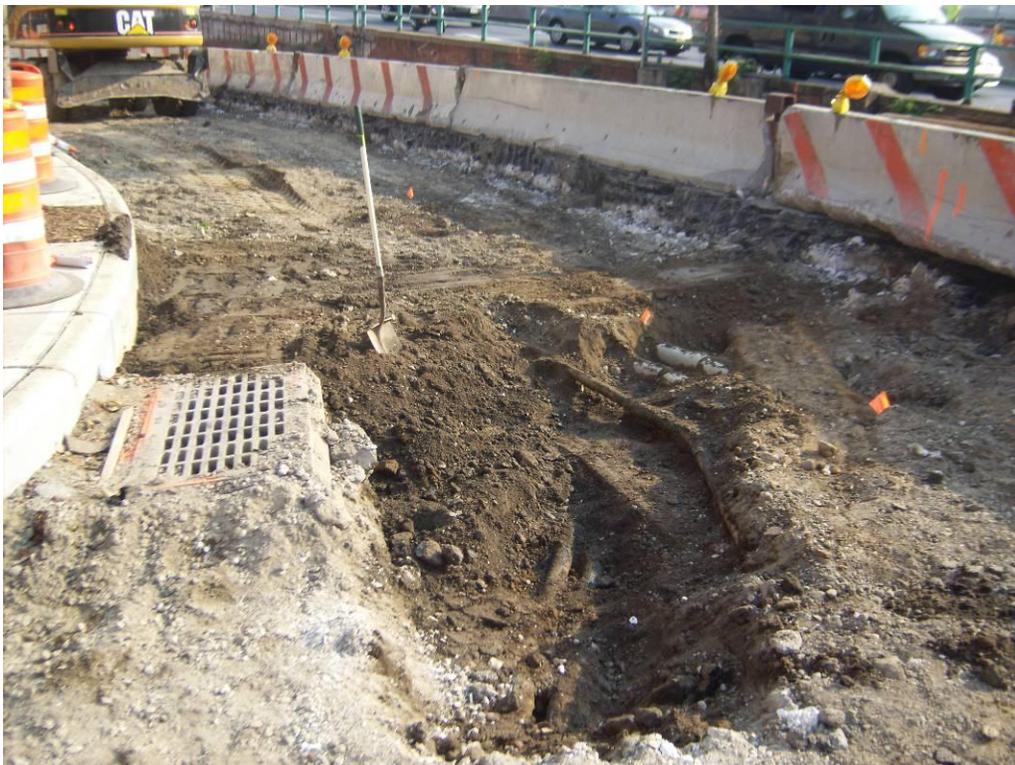
On the west side of the road trench, a small area adjacent to a utility line was the only place that excavations extended below the proposed roadway subgrade (Photograph 43).

Photograph 43: (9/8/11 memo) East 127<sup>th</sup> Street, view looking southeast at deep test at the west side of the south lane.

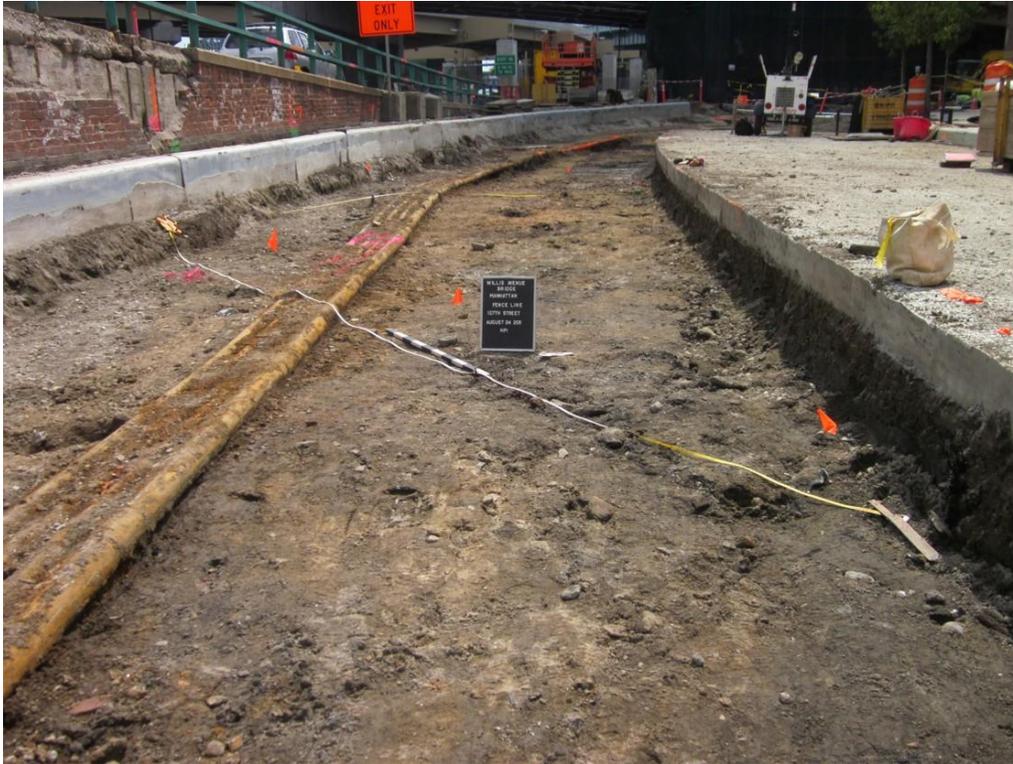
On the east end of the excavations, a cluster of no fewer than 14 utility lines, colloquially known as the "rats' nest" was exposed. Some of these lines were unexpectedly shallow, one being immediately below the concrete road base (Photograph 44). A variety of ceramic and glass artifacts were collected from the fill on East 127<sup>th</sup> Street in this area. They include ceramics from the era 1886 – 1910, and a bottle stopper of similar vintage. These and the few pieces of faunal material recovered (e.g., cut cow bone) may have originated from Sulzer's Harlem River Park and Casino that served as a beer garden and was on City Block 1803 at the turn of the twentieth century. A few vertical posts or logs were noted in an approximate line on East 127<sup>th</sup> Street, turning to the south at First Avenue. These may be the remnants of an early twentieth century fence line. Overall, it was obvious that the East 127<sup>th</sup> Street roadbed immediately below the concrete and pavement contained ash and cinder fill. Where utility lines were installed, trench lines were backfilled with a lighter color soil that bisected the cinder fill.

Photograph 44: (9/8/11 memo) East 127<sup>th</sup> Street, view looking northwest at some of the many utilities at intersection of the north end of First Avenue.

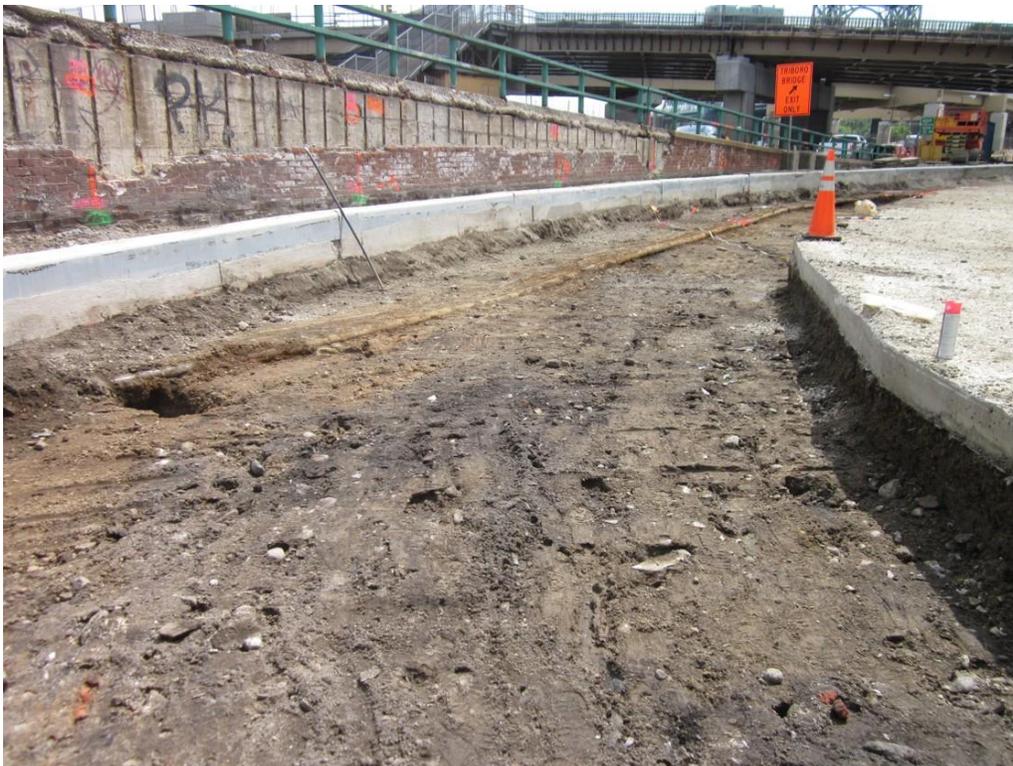
Photograph 46: (9/30/11 memo) East 127<sup>th</sup> Street, view of the dark ashy soil present in the roadbed, looking east. Note the disturbance caused by the installation of utility lines at left.

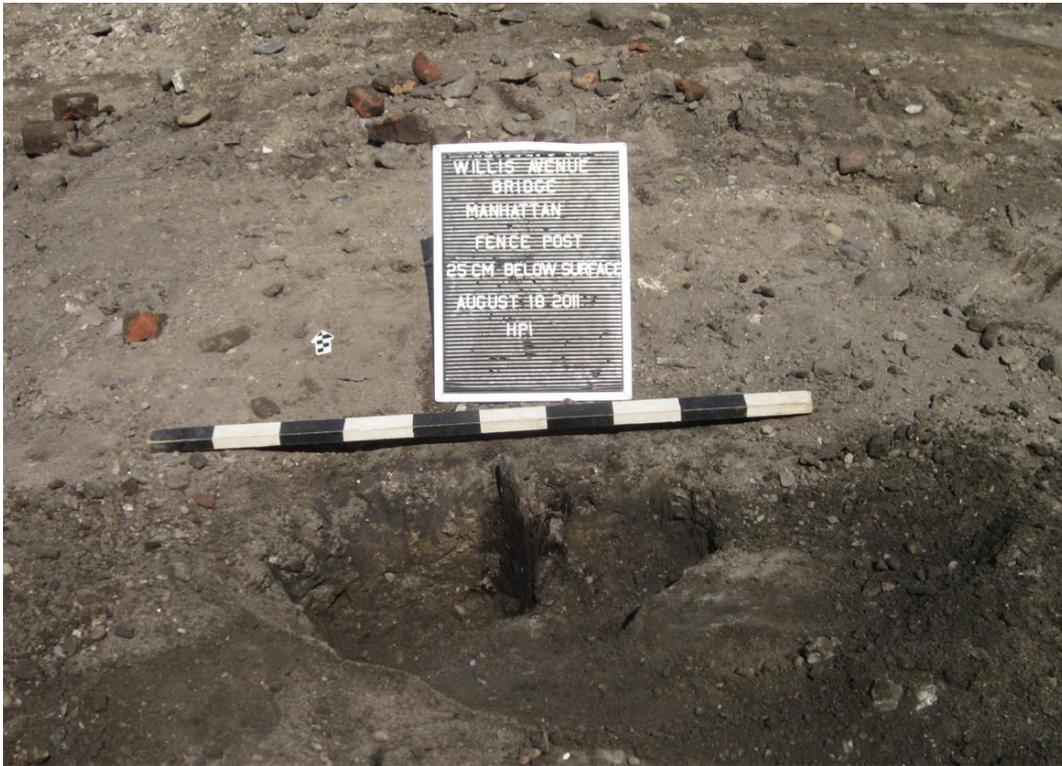
Photograph 47: (9/30/11 memo) East 127<sup>th</sup> Street, excavation of post hole in north lane roadbed, looking north. Truncated post is still present.

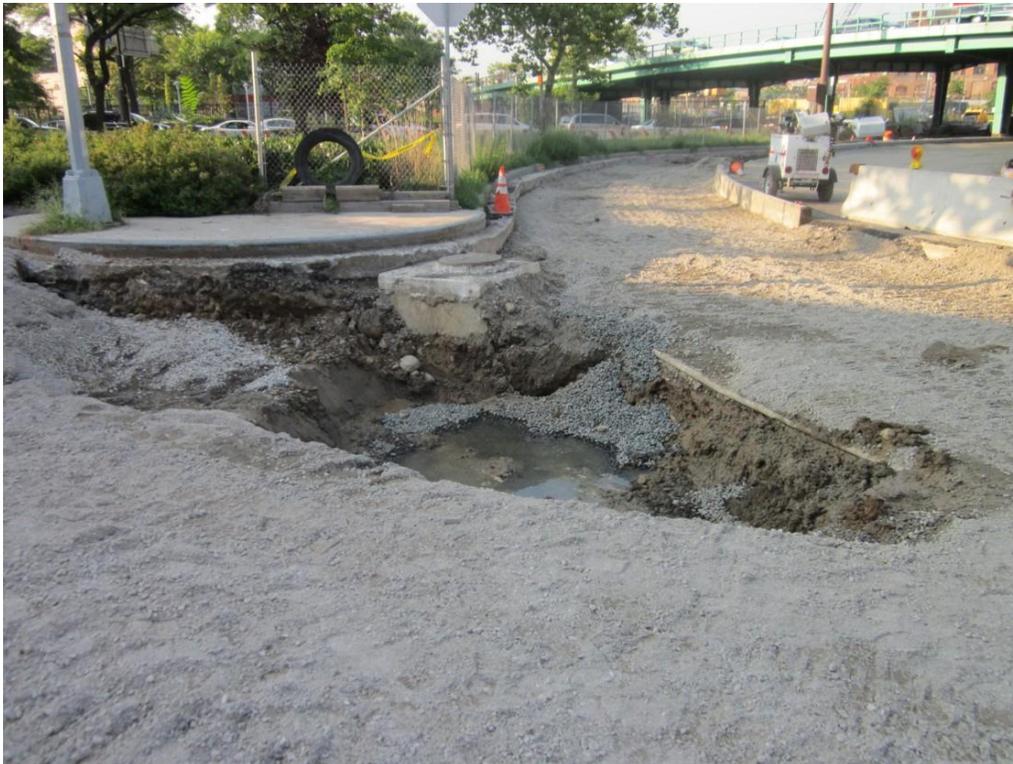
One post hole was excavated to attempt to date the construction of the fence (Photograph 47). The artifacts found within the post hole appear to date to the late nineteenth century and early twentieth century, and include similar cultural material to that found elsewhere within the roadbed.

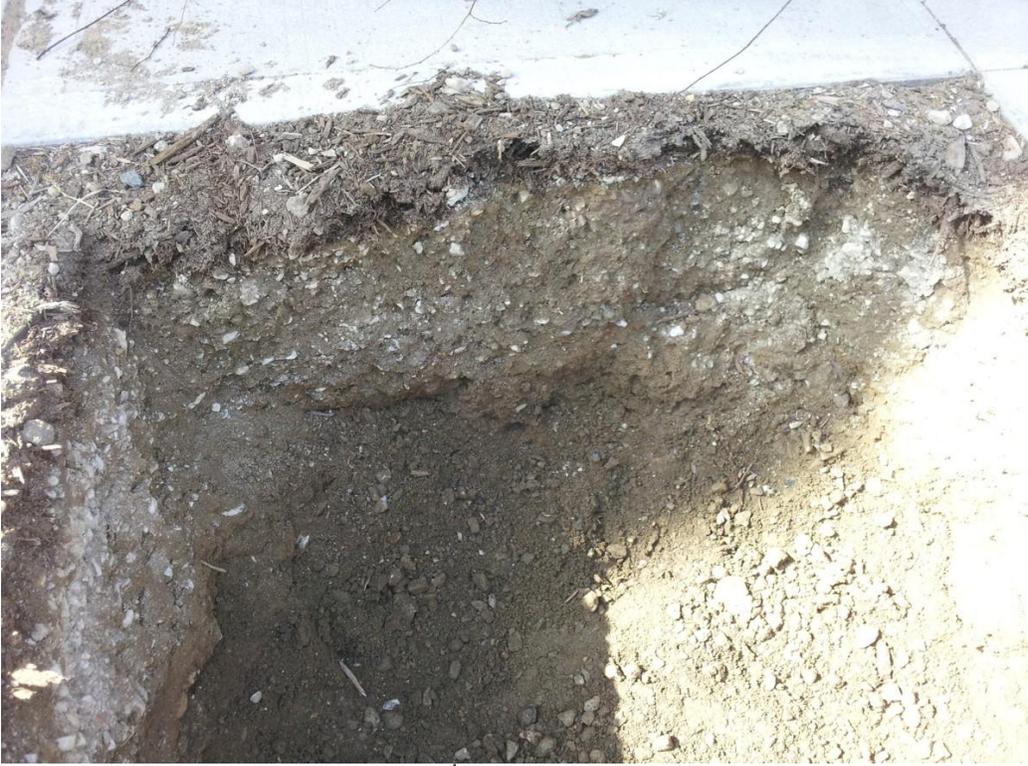
Photograph 50: (4/12/12 memo) East 127<sup>th</sup> Street, south side, Pit 1, looking east, showing gravel and road sub-base throughout pit.

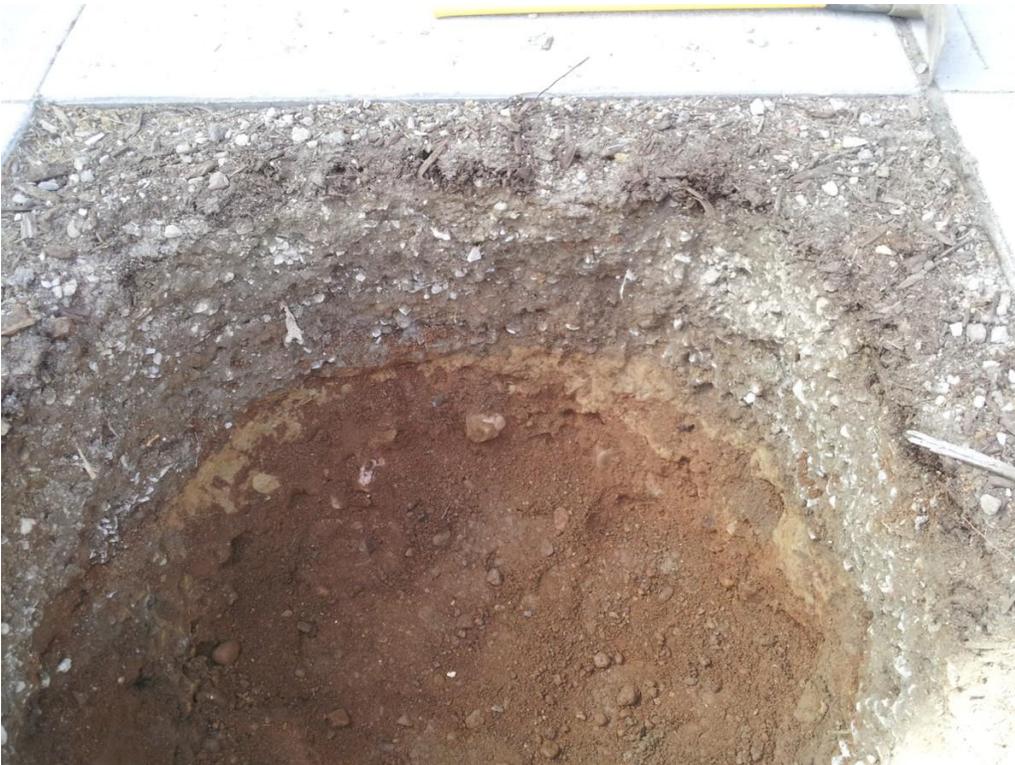
Photograph 51: (4/12/12 memo) East 127<sup>th</sup> Street, south side, Pit 4, looking south, showing sub base over a layer of dark yellowish brown fine sandy fill over a brown fine sandy fill level.

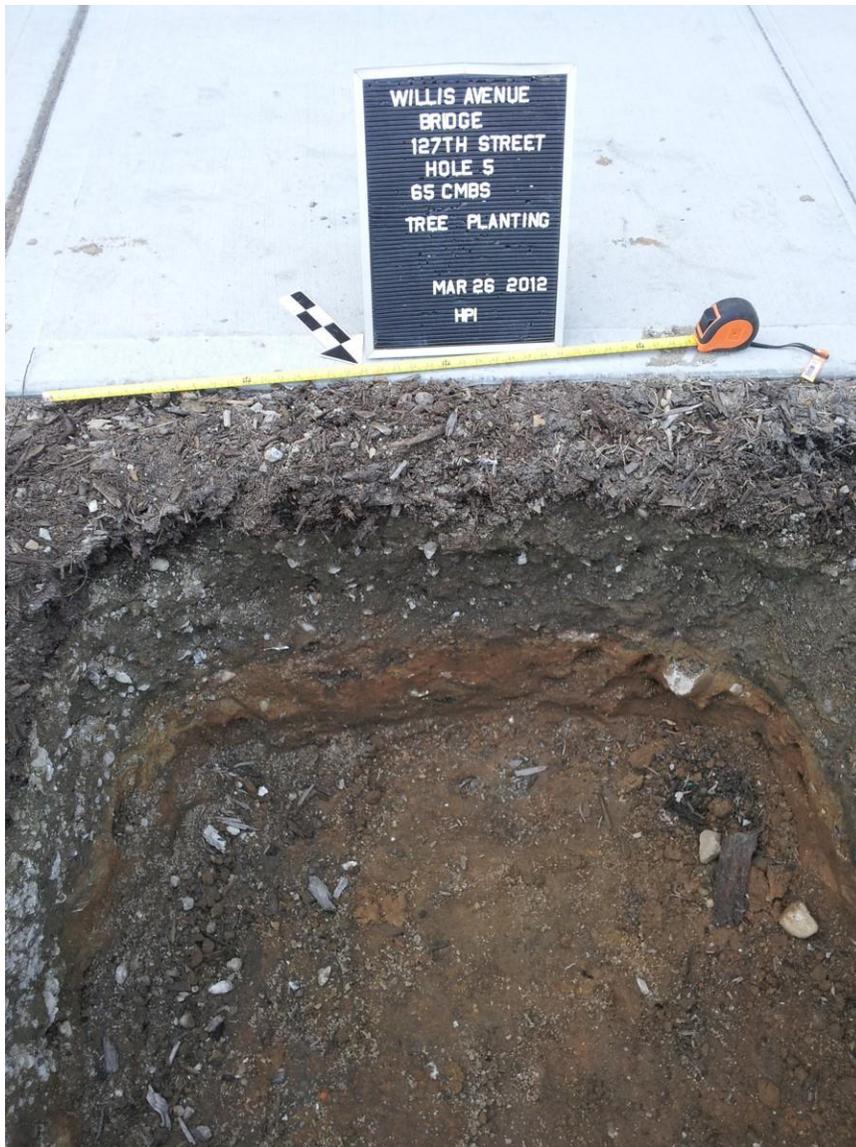
Photograph 52: (4/12/12 memo) East 127<sup>th</sup> Street, south side, Pit 5, looking south, showing sidewalk sub base over brown silty sandy fill. The measuring tape is set at one meter (3.3ft) in length.
