**PHASE IA ARCHEOLOGICAL SENSITIVITY
ASSESSMENT**

Bloomington Road Reconstruction Project

Borough of Staten Island
Richmond County, New York

HAA # 4437-11

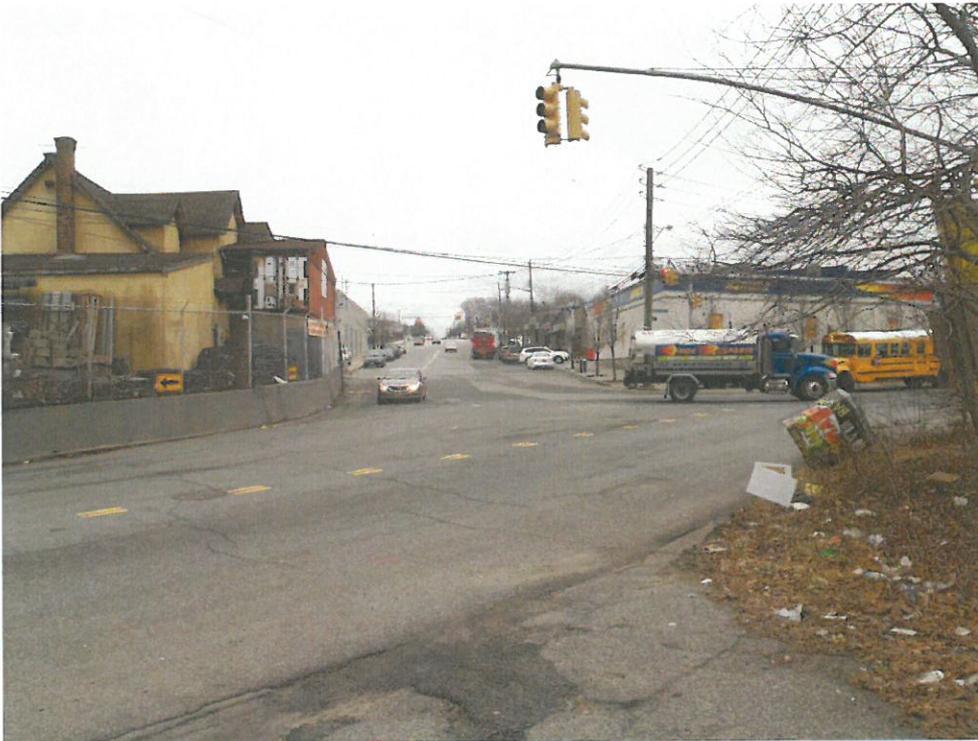
Photograph 1. View to the south of the northern terminus of the project area at the intersection of Bloomingdale Road and Arthur Kill Road. This area has been heavily developed over time, although the north side of the Arthur Kill Road intersection is now covered in tree and brush growth.

This section of Bloomingdale Road is one of the most commercial/industrialized portions of the project area (Photos 1 and 2). Just to the north beyond the Project Area lies a former chemical facility (Photo 3). The property was once part of the Oakland Chemical Company that produced hydrogen peroxide through the late 19th century and early 20th century. The site was sold in 1955 and much of the buildings demolished by 1968. The NYS Correctional Department built on a portion of the site in 1969.

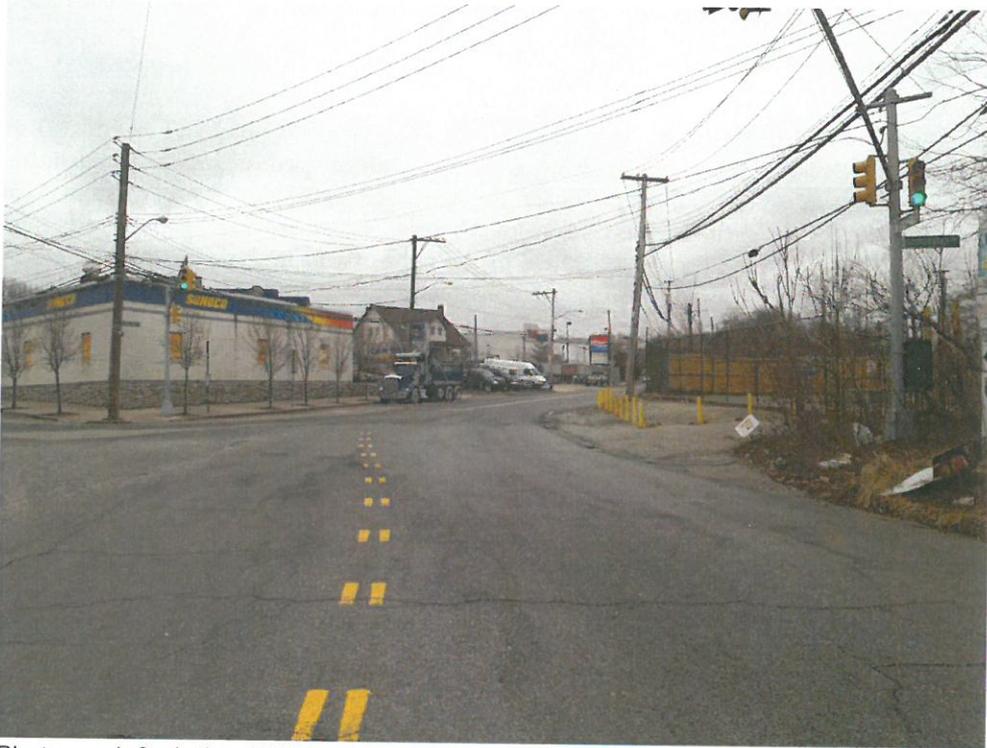
Photograph 2. Arthur Kill Road viewed west from the intersection of Bloomingdale Road.

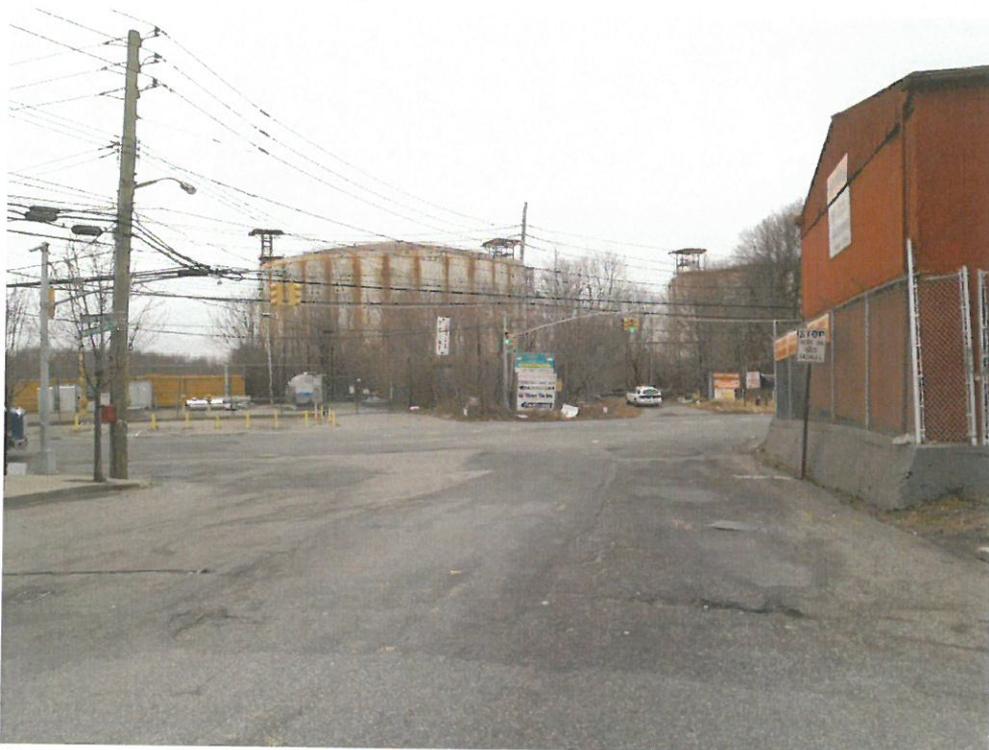
Photograph 3. Bloomingdale Road and Arthur Kill Road to the north. Note the former chemical facility in the background. Within Perry's Brickyard to the right is an 18th-century structure. Due to building and driveways this area is not accessible for shovel testing.

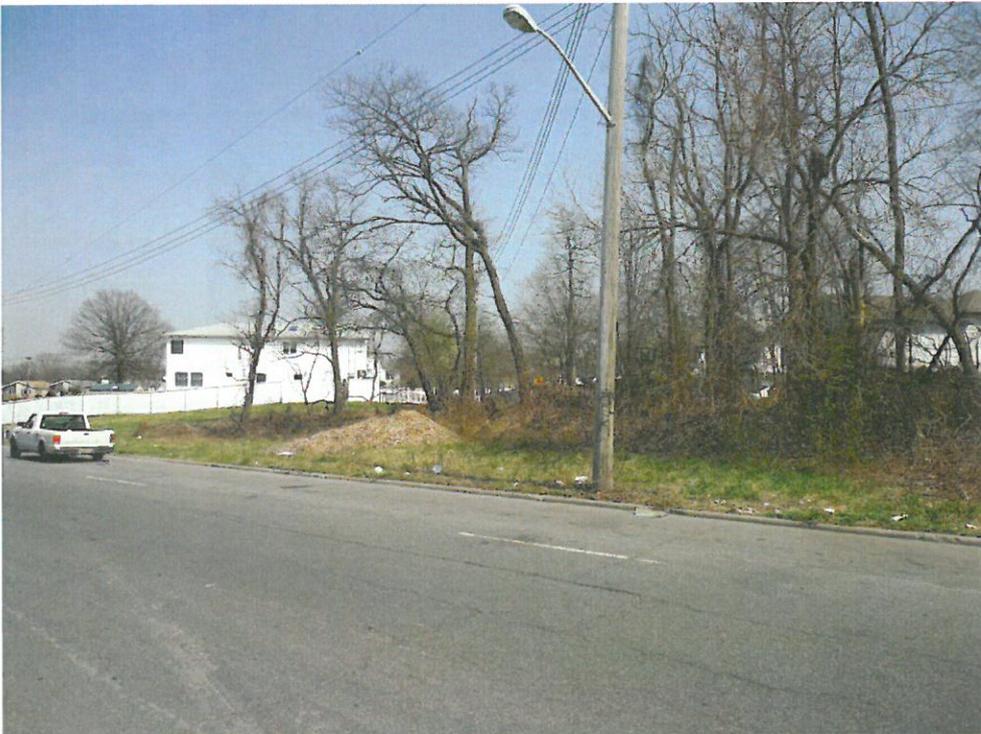
Photograph 4. A "paper street" where Charleston Avenue is inaccessible from along Veterans Road East. Much of the east side of Veterans Road East is undeveloped, but likely disturbed from highway construction.

The segment is approximately 1,000 feet (305 m) long and starts at Bloomingdale Road and extends to the intersection of Winant Avenue. This section of roadway is largely undeveloped as most of the nearby residences front along Charleston, Westfield, and Winant Avenues to the east. Both Westfield and Charleston Avenues terminate before their intersections with Veterans Road, leaving "paper roads" and undevelopable space along the service road (Photo 4). Much of the right-of-way in this area appears to have been disturbed by nearby road building activities and house construction, despite the fact that much of the ROW is undeveloped and left as open space. Limited shovel testing is recommended in this section to document the previous disturbance.

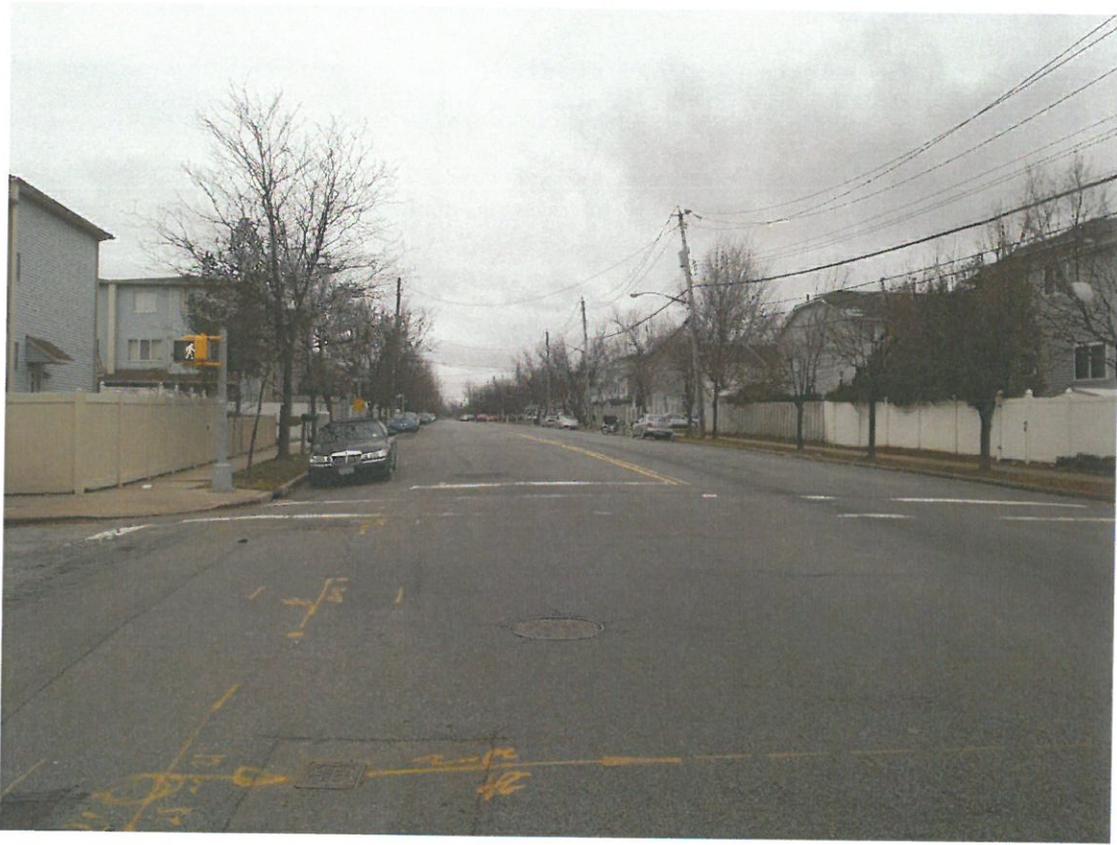
Photograph 5. Bloomingdale Road as viewed to the south from the intersection of Wirt Avenue. This stretch of the project area is heavily developed with recent multi-unit residential structures.

This section of Bloomingdale Road is largely developed with multi-unit structures built in the 1980s and 1990s (Photo 5). The ROW largely includes the existing sidewalks on both sides of the road and a narrow strip of grass and trees. Cross-streets through this section include Lucille, Wirt, Candon, Malvine, Correll, Sheil, and Radigan Avenues and Prince Lane. The cross-streets only extend along the east side of Bloomingdale. On the west side the former paper streets have been developed with residential units. Only Radigan Avenue remains underdeveloped along the west side of Bloomingdale Road, as discussed below.

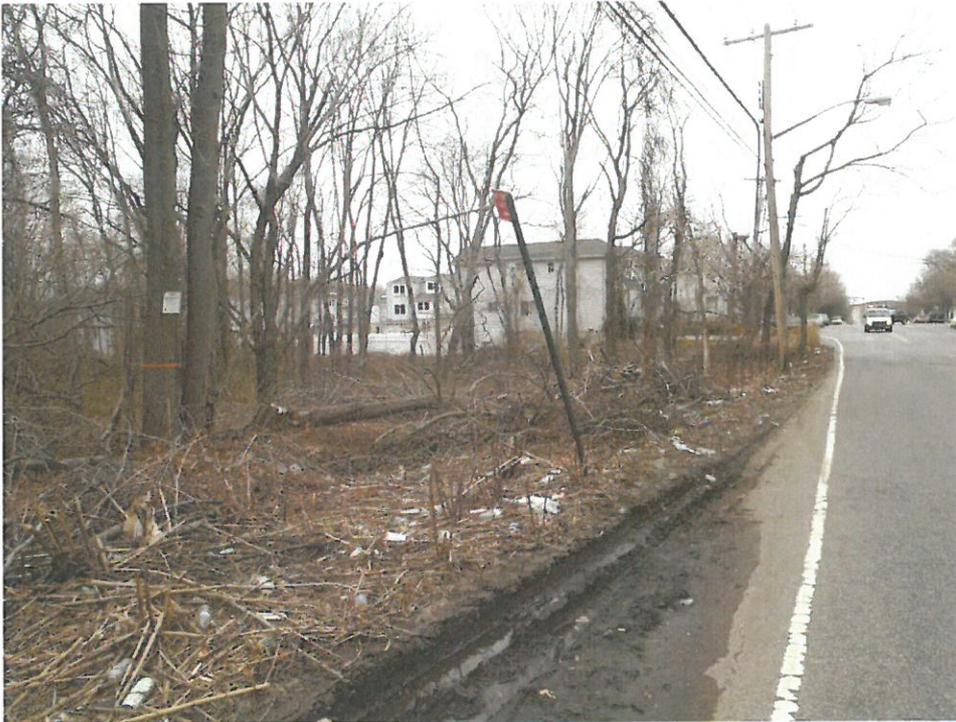
Photograph 6. A view of the empty lot on the west side of Bloomingdale Road (a paper street of Radigan Avenue). This area is wooded and covered with garbage and piles of fill and debris. Shovel testing is recommended within the road ROW.

This portion of the project area is expected to be impacted by the installation of new drainage features. Most of this work is expected within the existing roadway. Candon Avenue is developed with multi-unit structures with off-street parking located in the front of the lots. There is no open space for archeological testing in this area. Sheil Avenue connects with Bloomingdale Avenue, while Radigan does not. At the west end of Radigan is an empty lot that appears to have been a dumping ground for a number of years. Shovel testing is recommended for the portion of Radigan Street that fronts along Bloomingdale Avenue. Similarly, there is an empty lot along the west side of Bloomingdale Road (also a paper street for Radigan Avenue and now part of the Clay Pit Ponds State Park) (Photo 6). This wooded lot is covered with garbage, piles of fill, and debris. This lot is part of the Clay Pits Pond State Park Preserve. Testing conducted in this area by Schuyler (1974) and Yamin and Pickman (1986a, b) identified historic features associated with the Sandy Ground community. The Sandy Ground NR inventory form on file at the OPRHP references a cemetery west of Bloomingdale Road and north of Harris Lane. The cemetery was established by the Mount Zion A.M. Church formed in 1875 from congregants of the AME Zion Church. A disagreement with the regional conference led to a split. The cemetery is described in 1982 as heavily overgrown (Florance 1982). Historical maps from 1887 (Beers 1887) and 1898 (Robinson 1898) show the property (two small lots) associated with the Mt. Zion Church in this vicinity. Askins identified Features 48 A, B C and D in this location but did not mention a cemetery, nor does the report of archeological investigations conducted for the Clay Pits Pond State Park Preserve (Yamin and Pickman 1986a, b). Shovel testing is recommended along the road within the ROW.

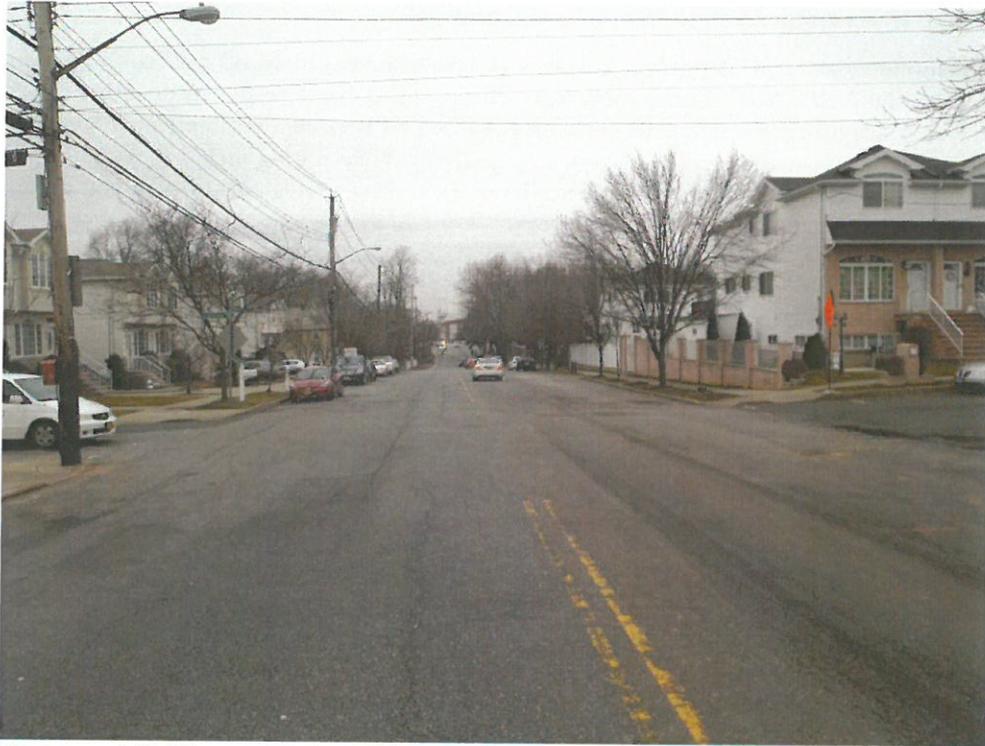
Photograph 7. View north along Bloomingdale Road from its intersection with Crabtree Avenue (left) and McBaine Avenue (right).

This section of Bloomingdale Road is also heavily developed with multi-unit residential structures (Photo 7). One of the last remaining empty lots along this portion of the project area is now being developed as Public School 62, along the west side of road opposite Woodrow Road (Photo 8). The lot being developed for the school was surveyed by AKRF (2009, 2011, 2012). They investigated and mitigated historic features initially identified by Schuyler including a brick feature just 25 west of Bloomingdale Road.

Much of the ROW consists of existing sidewalks, driveways, and several narrow strips of grass and planted trees. No archeological testing is recommended in this section of roadway.

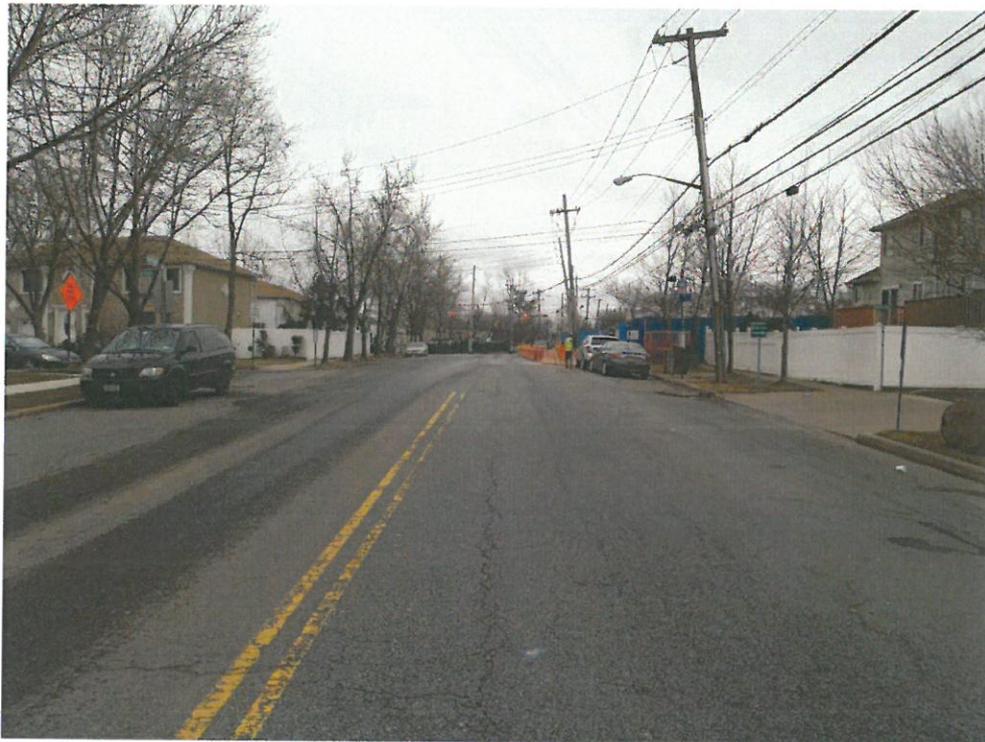
Photograph 8. View south towards the intersection of Woodrow Road. Note the construction of PS 62 on the right as indicated by the blue construction fencing.

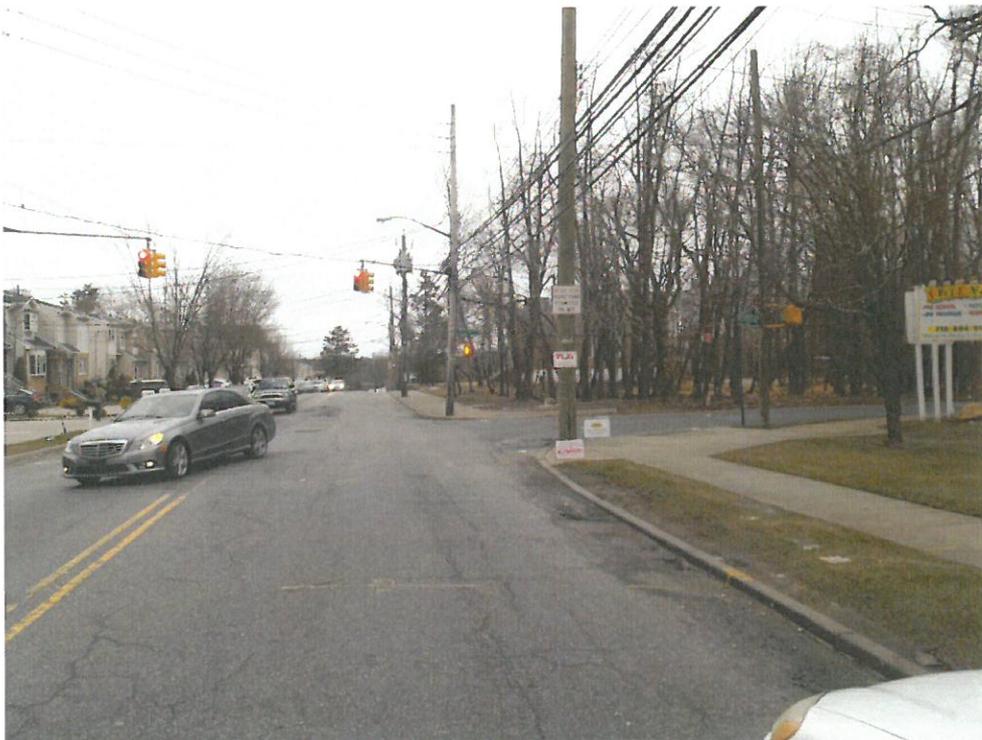
Photograph 9. View south along Bloomingdale Road toward its intersection with Clay Pit Road. The Rossville AME Zion Church lies in the center of the block between Clay Pit and Sharrotts Roads.

The intersection of Bloomingdale and Woodrow Roads was the relative center of the Sandy Ground community with the Rossville AME Zion Church at its core (Photos 9 and 10). Vacant lots on either side of the church were archeologically investigated in 2007 for a proposed senior housing development (Photos 10). The testing focused on historic features identified by Askins in 1980. While testing included Phase IB and Phase II shovel tests, units and trenches, the OPRHP considered the testing strategy insufficient and did not concur with the survey's recommendation for no further work.

Archeological testing can be conducted south of Clay Pit Road and along the front of the AME Zion Church, built in 1897 (NYC Landmark --this is the second location of the church, the original structure was on Clay Pit Road). An empty lot on the west side of Bloomingdale Road south of the church (Block 7267) can be tested as well, despite the surface disturbance noted near the roadway, as the ROW extends over 25 feet into the property.

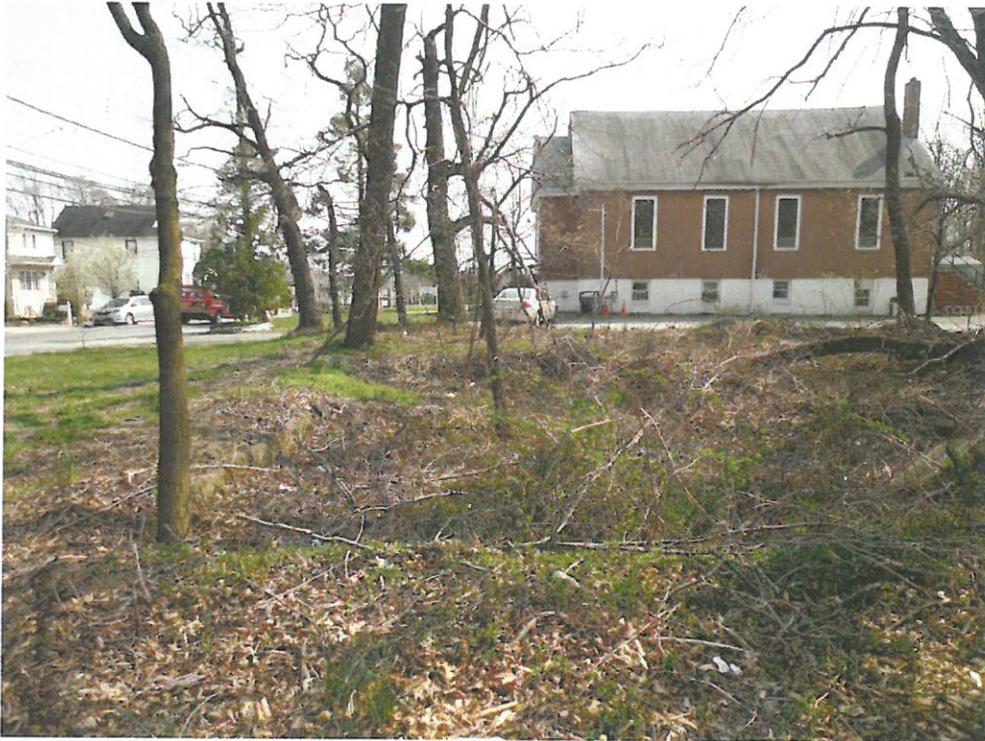
Photograph 10. A view to the south of the empty lot to the north of the AME Zion church near Clay Pit Road. Note the relationship of the church to Bloomingdale Road in the background.

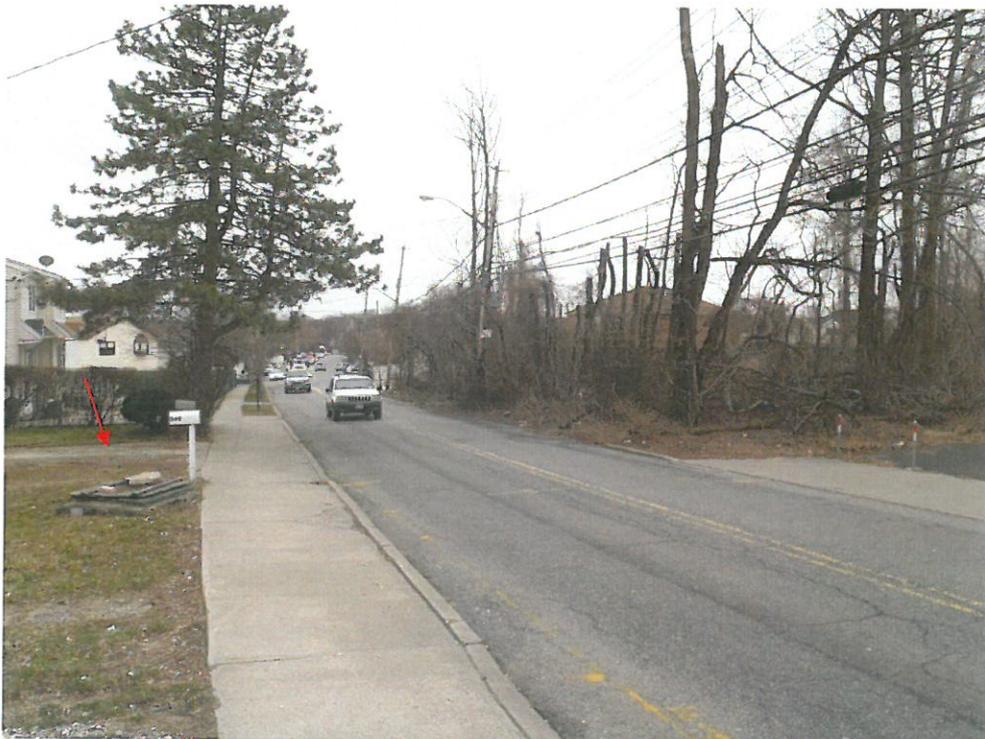
Photograph 11. A view to the southwest of an empty lot opposite the oystermen cottages along Bloomingdale Road. The frontages of 565 and 569 are to the left. A small concrete feature is located in front of 569 (as indicated by the arrow).

Two late 19th- to early 20th-century cottages associated with African-American oystermen (NYC Landmarks) are located nearly across from the AME Zion church on the east side of Bloomingdale Road (Photos 11 and 12). Since these structures are set back from the roadway, the ROW within this area can be archeological tested. Of note is a small concrete foundation near the road. Askins does not mention this foundation in his report (Askins 1980a). Its function is uncertain, but it will be further documented as part of the field reconnaissance work (Photo 11).

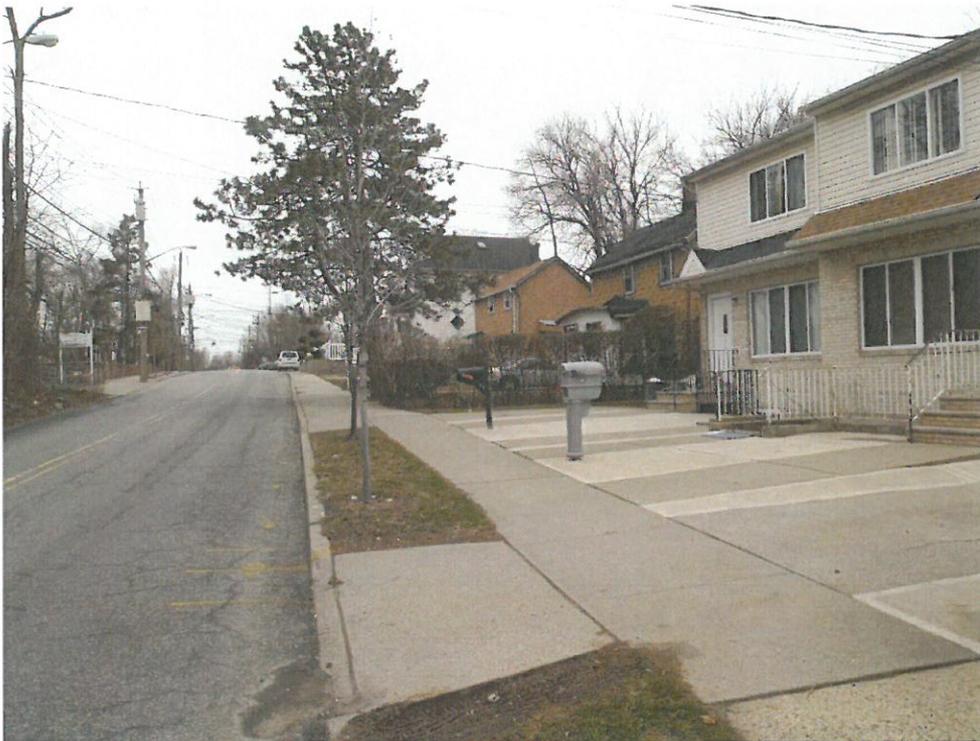
Photograph 12. A view to the northeast of the cottages at 565 and 569 Bloomingdale Road.

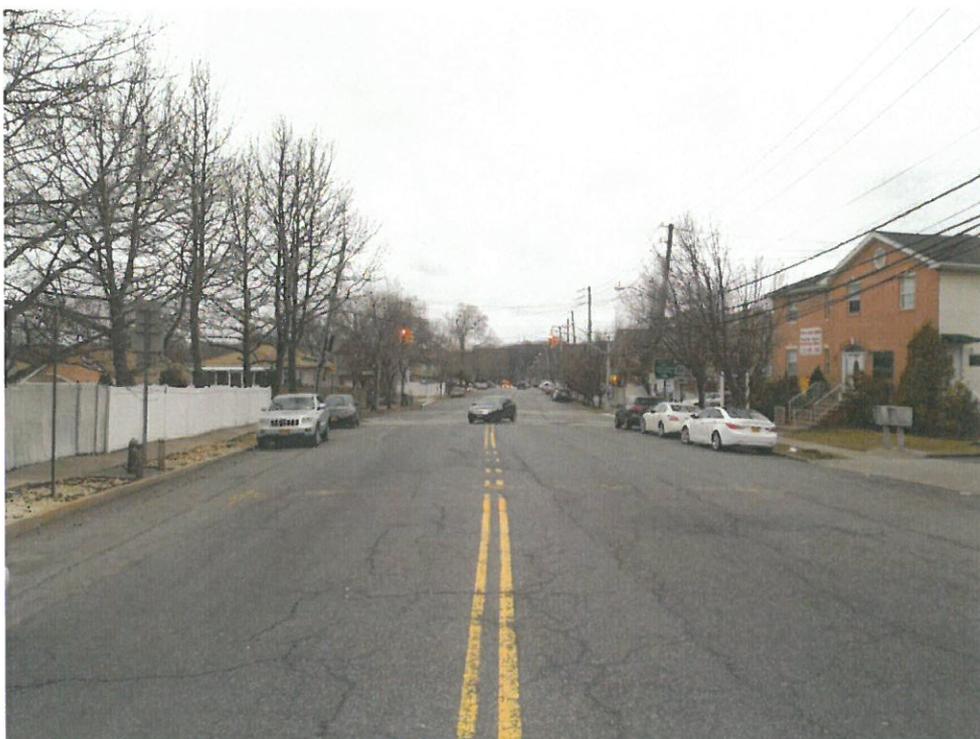
Photograph 13. Bloomingdale Road as viewed to the south towards the intersection with Sharrotts Road, as indicated by the stop lights in the background.

Much of the remainder of Bloomingdale Road to Ramona Avenue has been disturbed by recent residential construction and there is little opportunity for archeological testing (Photos 13 and 14).

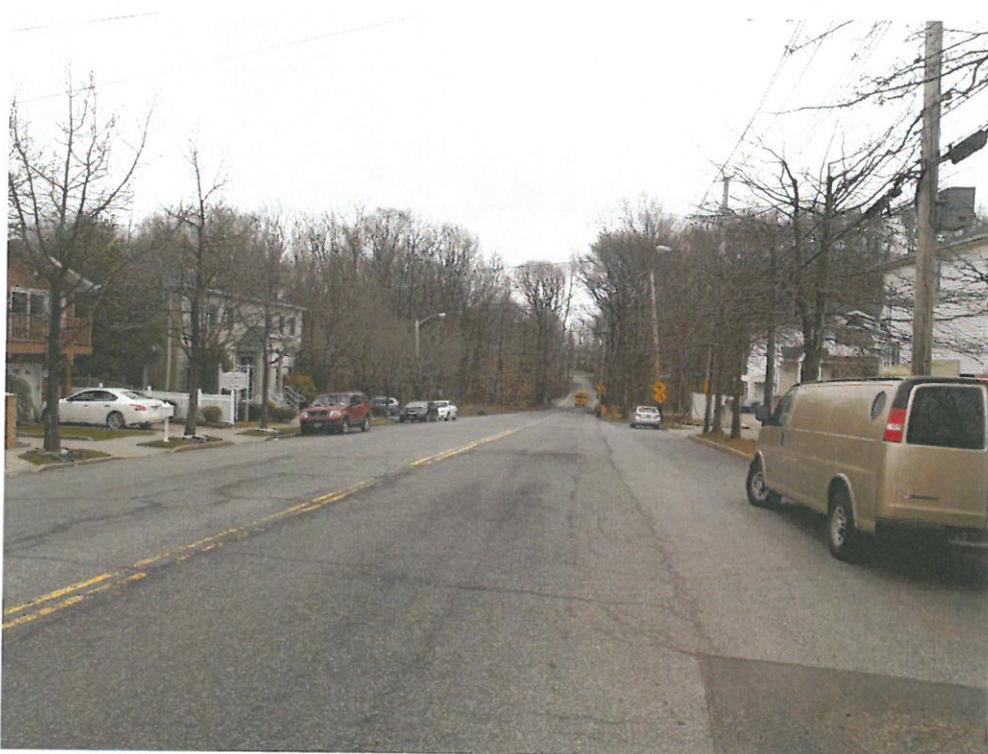
Photograph 14. Looking south along Bloomingdale Road towards Bloomingdale Park in the background.

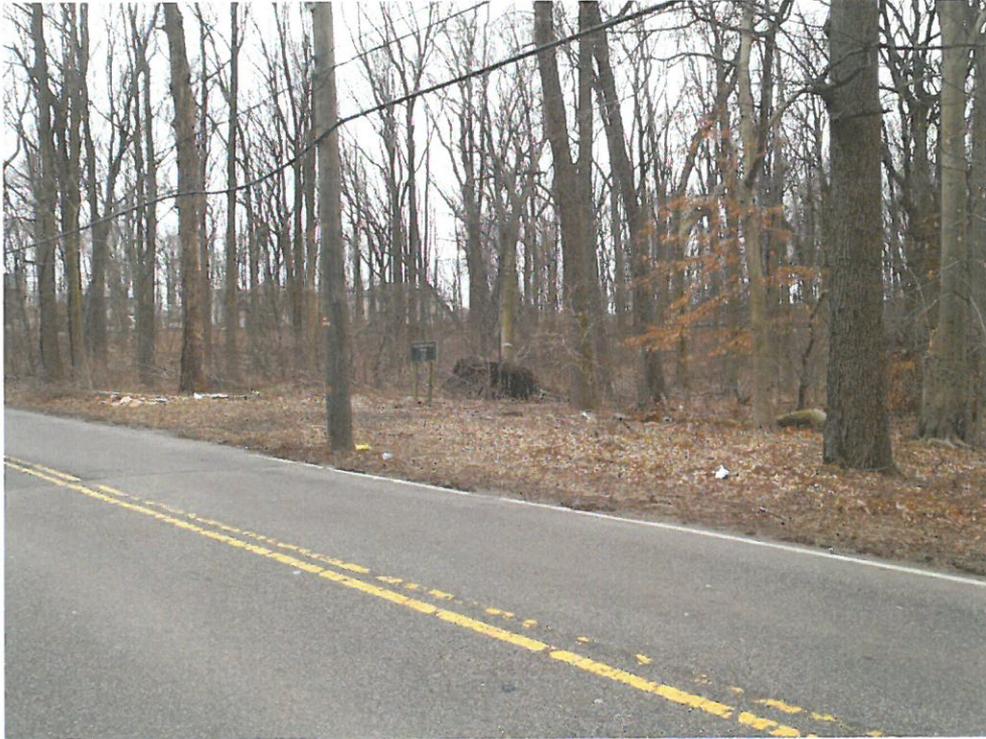
Photograph 15. Bloomingdale Road in relation to Bloomingdale Park situated on its west side. The ROW extends over 25 feet from the edge of pavement and there is no indication of existing utilities on this side.

Testing is recommended for all of the parkland on both sides of the road.

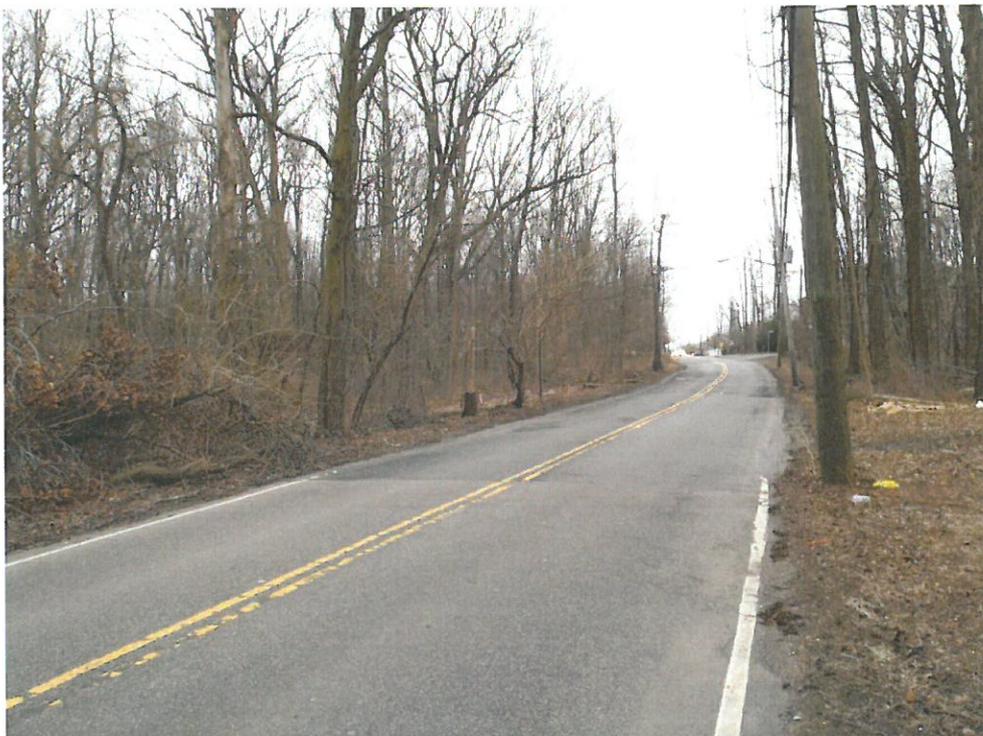
Photograph 16. A view to the south of Bloomingdale Road as it passes through Bloomingdale Park.

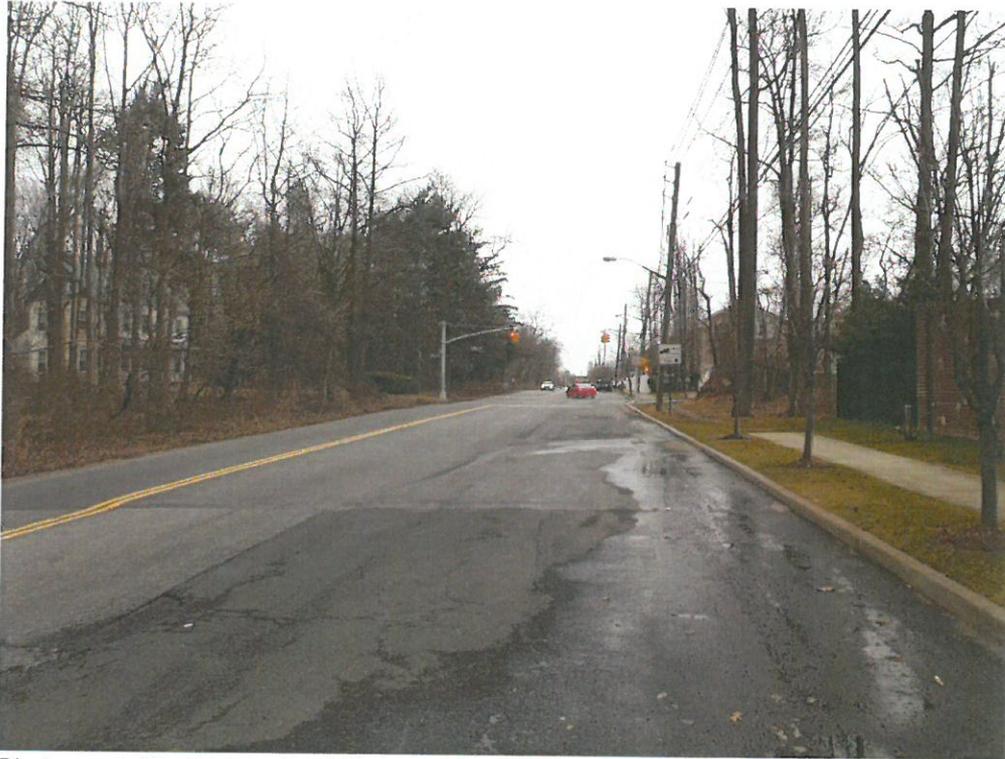
Photograph 17. Just south of Bloomingdale Park, the west side of Bloomingdale Park is heavily developed. A single remaining farmhouse stands at 299 Bloomingdale Road to the left (east side), which is relatively undeveloped and within the Bloomingdale Park boundaries.

Relatively recent residential structures line the west side of Bloomingdale Road south of Hargold Avenue. This area has been disturbed from construction and sidewalk installation. No testing is recommended along the west side of the road from Hargold Avenue to the Richmond Parkway.

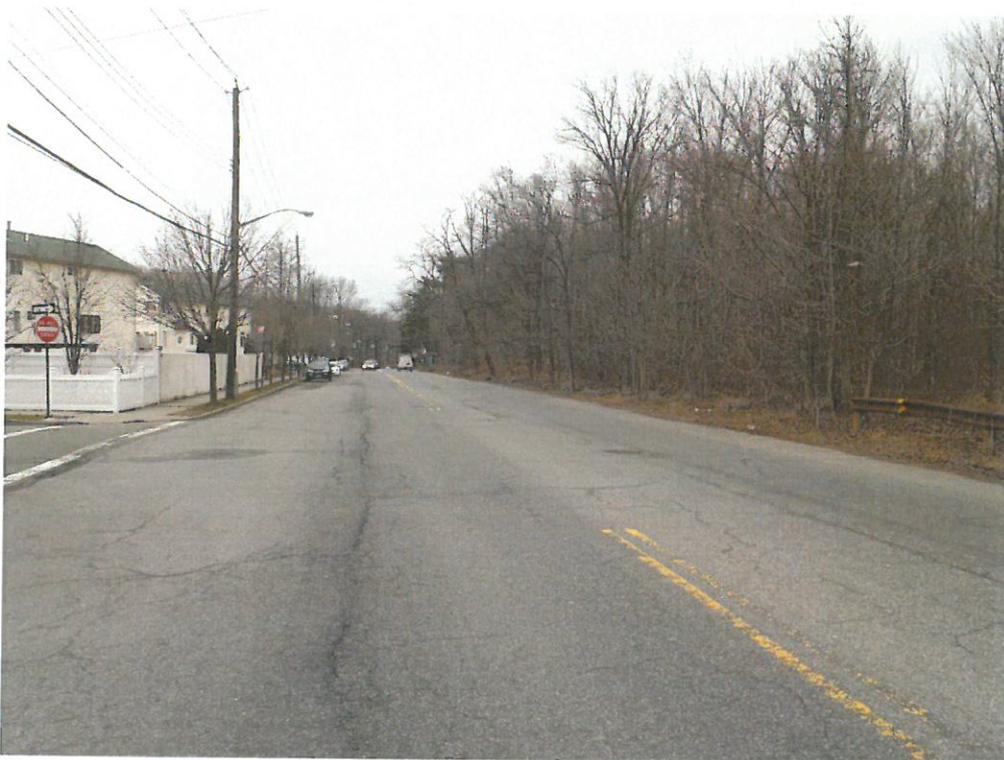
Photograph 18. View north along Bloomingdale Avenue from its intersection with Pitney Avenue. The east side of the road is undeveloped in this section to Drumgoole Road.

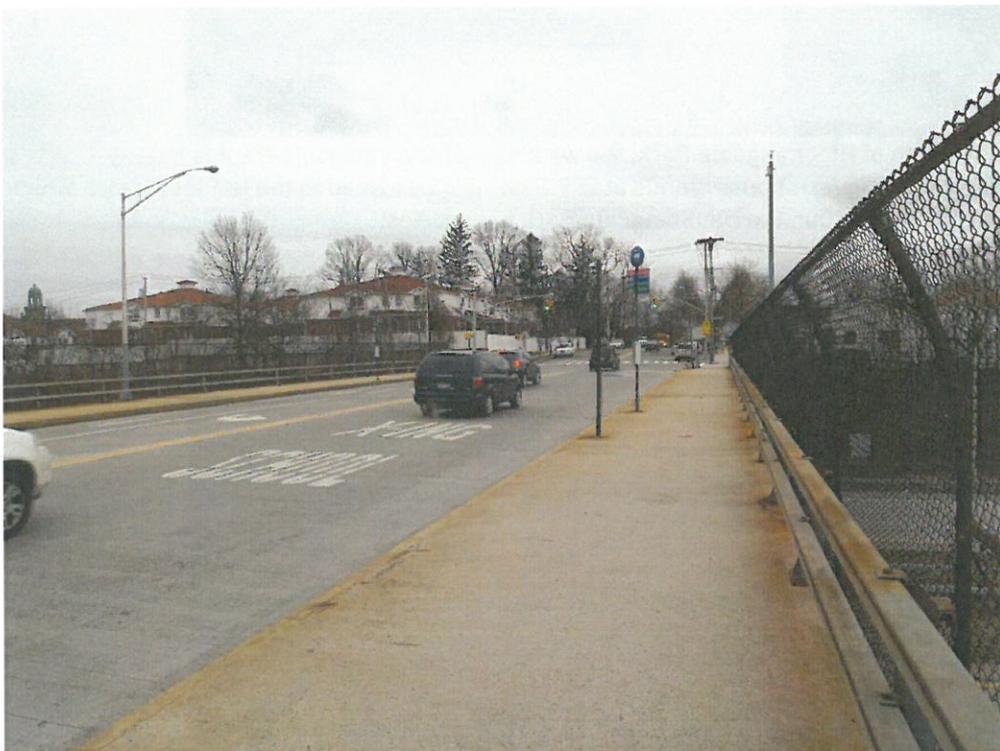
Photograph 19. Bloomingdale Road over the Richmond Parkway which was excavated well below the natural grade in this area.

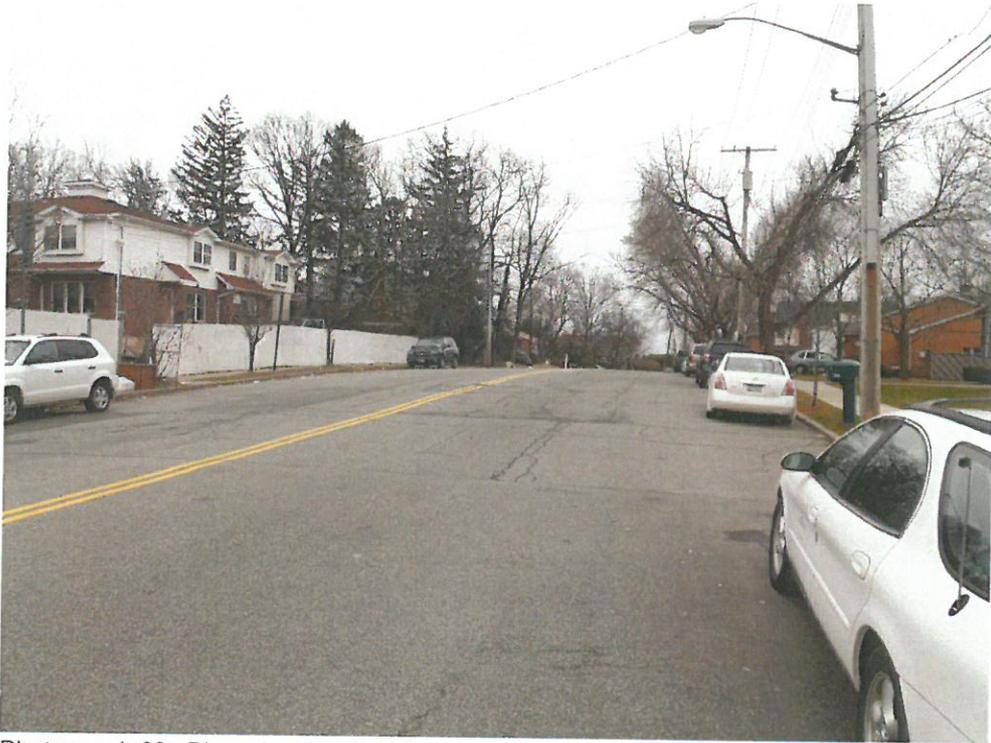
Photograph 20. Bloomingdale Road as viewed to the south from near Drumgoole Road. This is heavily developed with residential structures, most of more recent origin.

No testing is recommended along the heavily developed portion of the project area that includes Amboy Road.

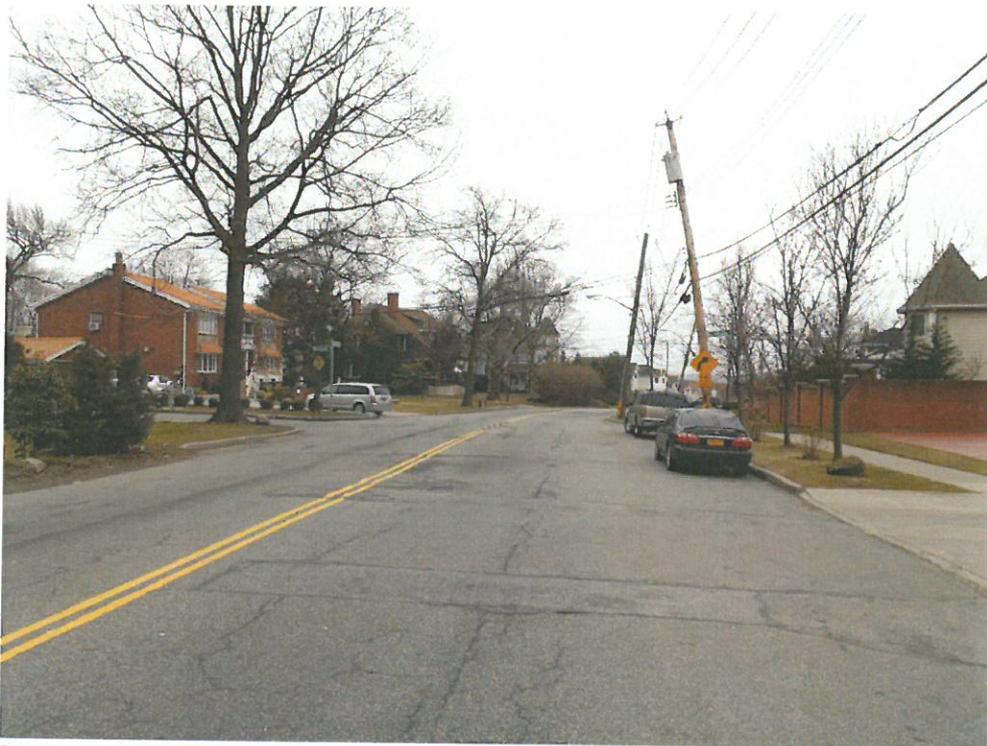
Photograph 21. Bloomingdale Road as seen to the south near Maretzek Court.

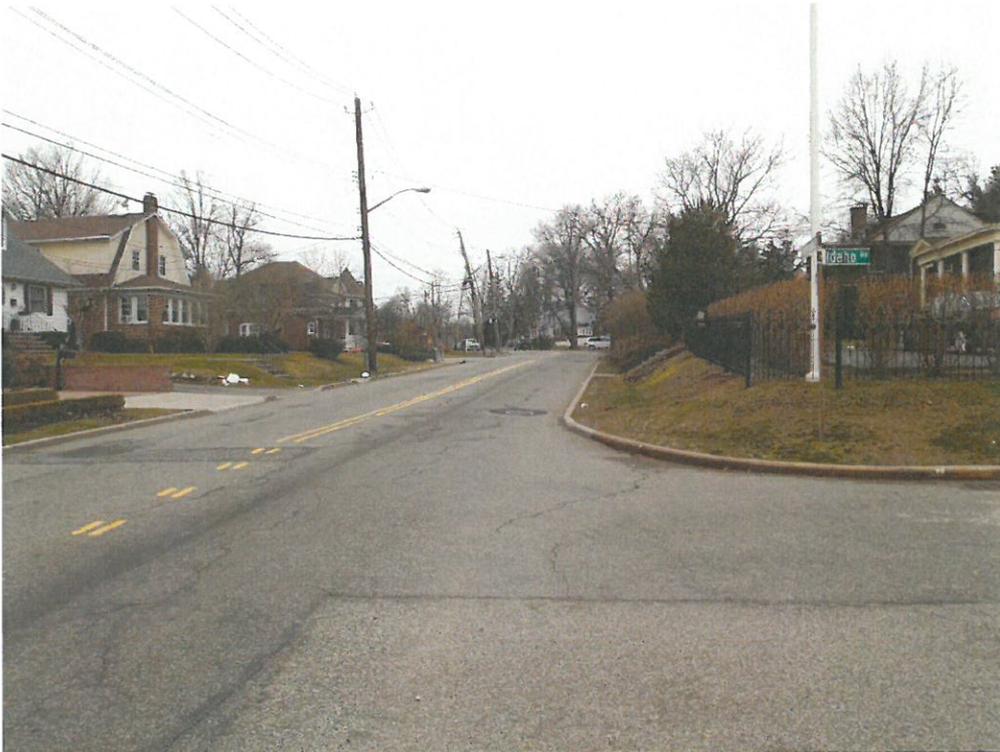
Photograph 22. Bloomingdale Road seen north from Idaho Road, a late 19th-century residence is to the right.

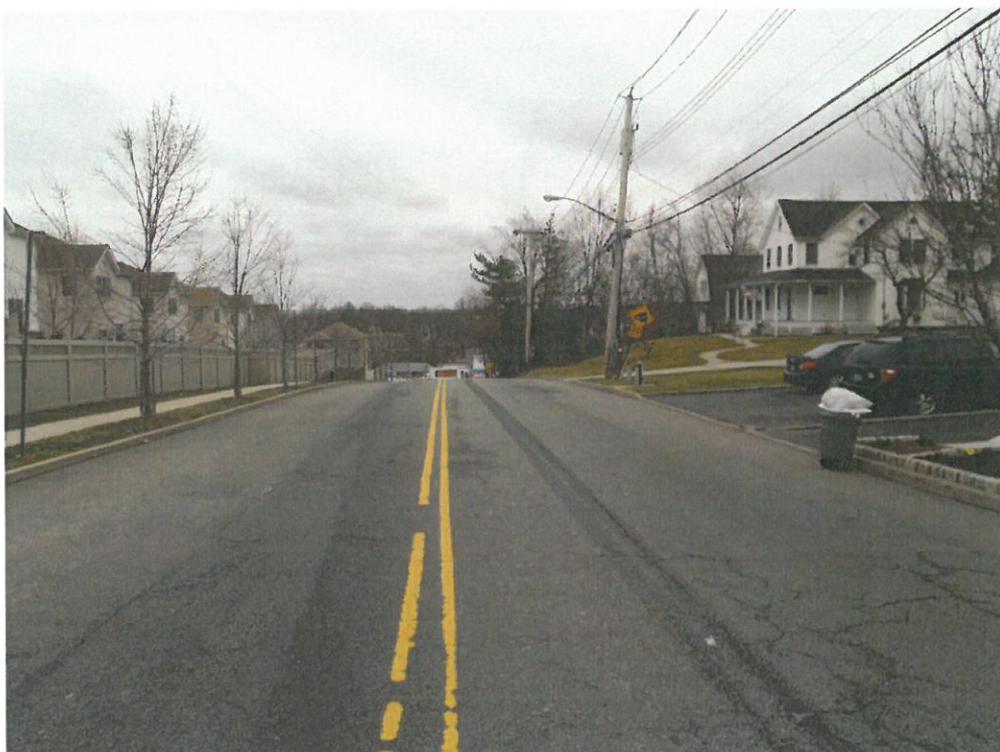
Photograph 23. A row of new residential homes (left) was recently completed on the east side of Bloomingdale Road, south of Idaho Road, as seen to the south. The west side of the street contains older 20th century homes.

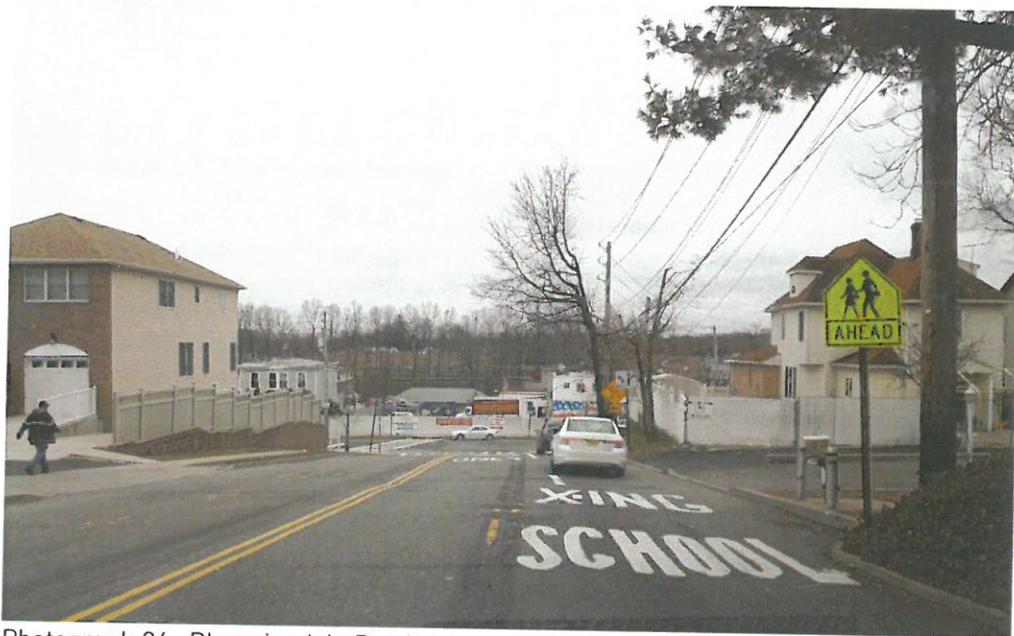
Photograph 24. Bloomingdale Road seen to the terminus of the project area along Amboy Road.

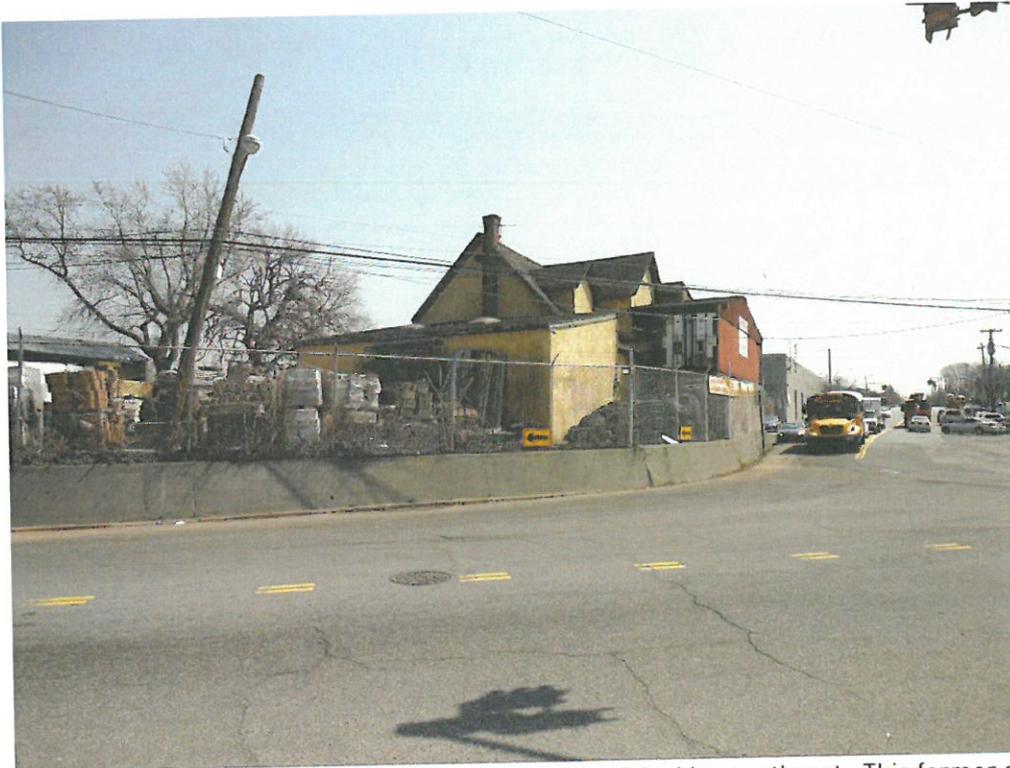
Photograph 25. Structure 1, 961a Bloomingdale Road, looking southeast. This former dwelling may date to the 18th or early 19th century, and was occupied by members of the Marshall family.

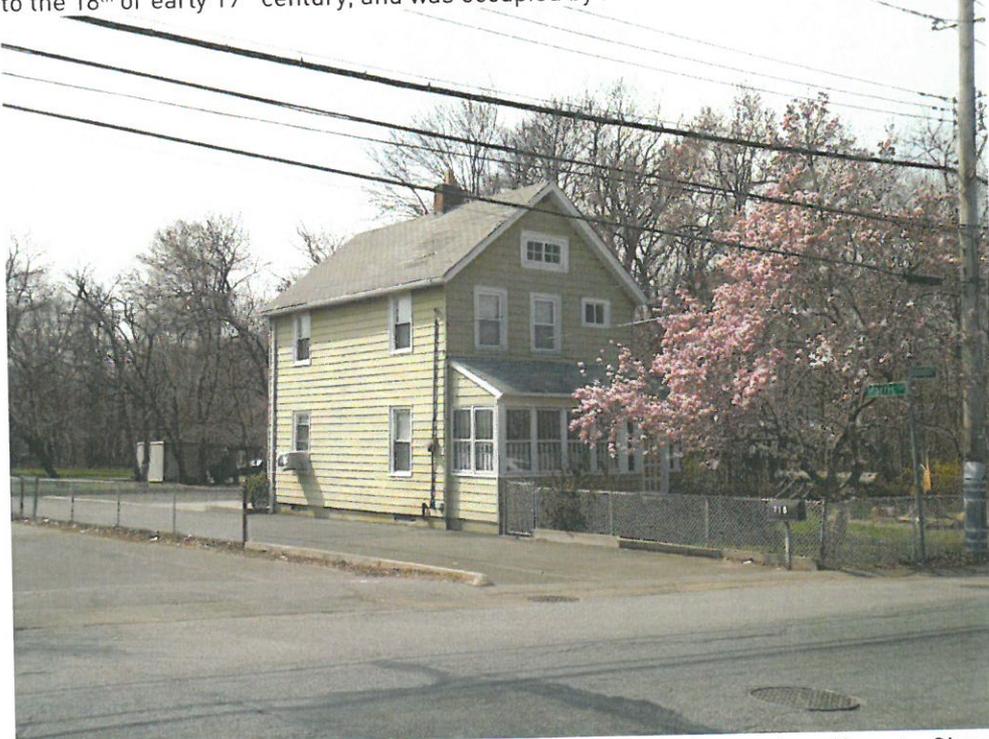
Photograph 26. Structure 38, 718 Bloomingdale Road, looking west-northwest. Changes to fenestration and exterior sheathing make this dwelling ineligible for listing on the National Register.
