**PHASE IA ARCHEOLOGICAL SENSITIVITY
ASSESSMENT**

Bloomington Road Reconstruction Project

Borough of Staten Island
Richmond County, New York

HAA # 4437-11

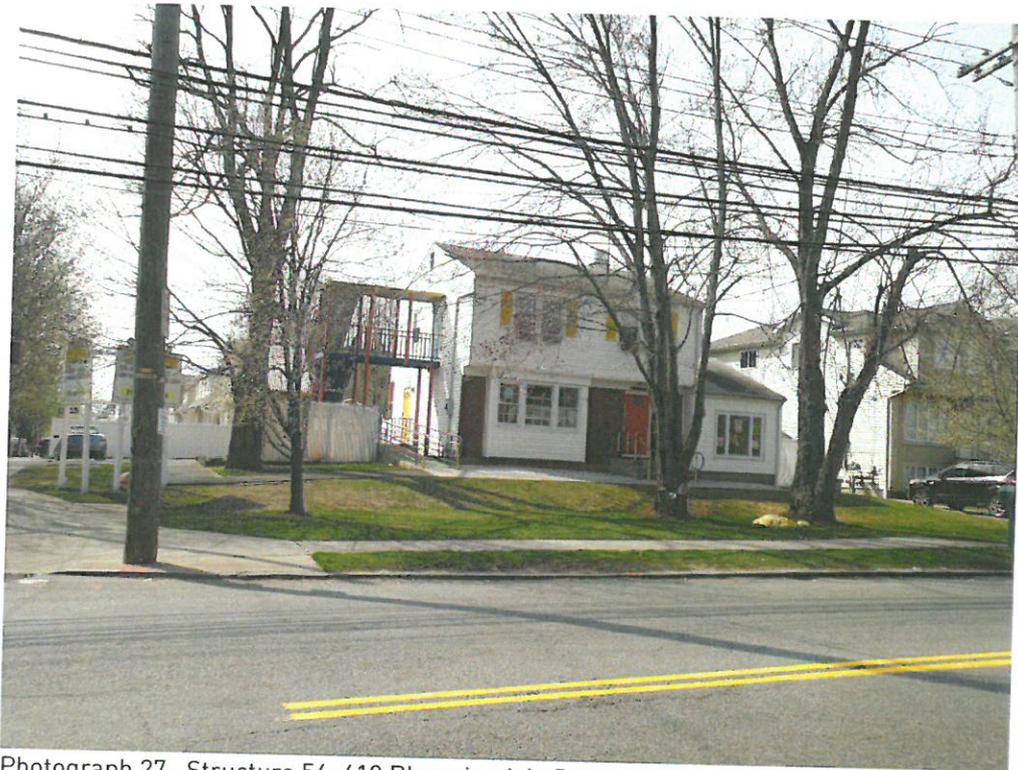
Photograph 27. Structure 56, 610 Bloomingdale Road, looking west. This altered dwelling is not eligible for listing on the National Register.

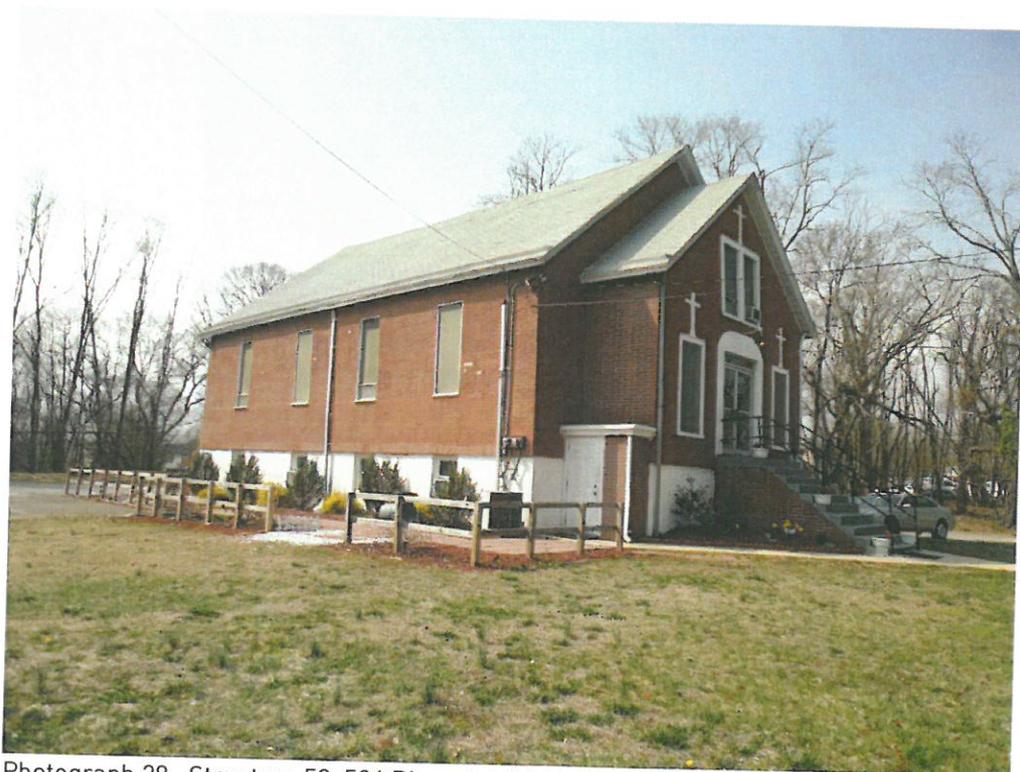
Photograph 28. Structure 58, 584 Bloomingdale Road, the Rossville AME Church, looking northwest. This structure is a designated NYC Landmark.

Seven structures are recommended for listing on the National Register. These include 565, 569 and 584 Bloomingdale Road (already listed as NYC Landmarks); and 69, 77, 81 and 390 Bloomingdale Road.

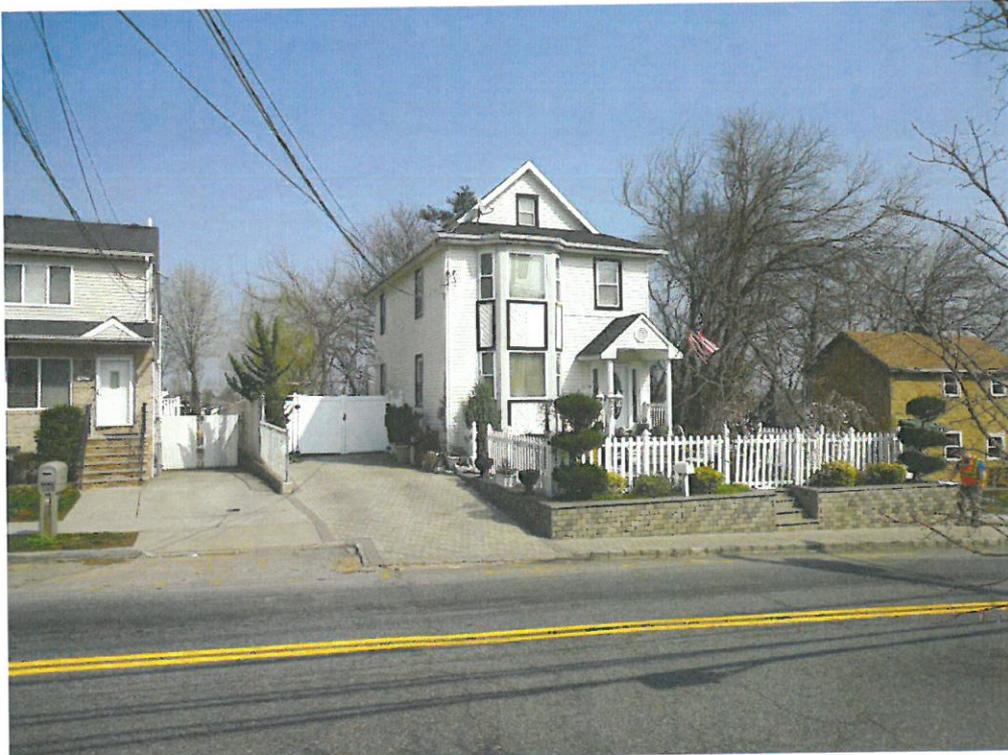
Photograph 29. Structure 59, 575 Bloomingdale Road, looking east-southeast. Extensive alterations to this late-19th or early 20th century dwelling render it ineligible for listing on the National Register.

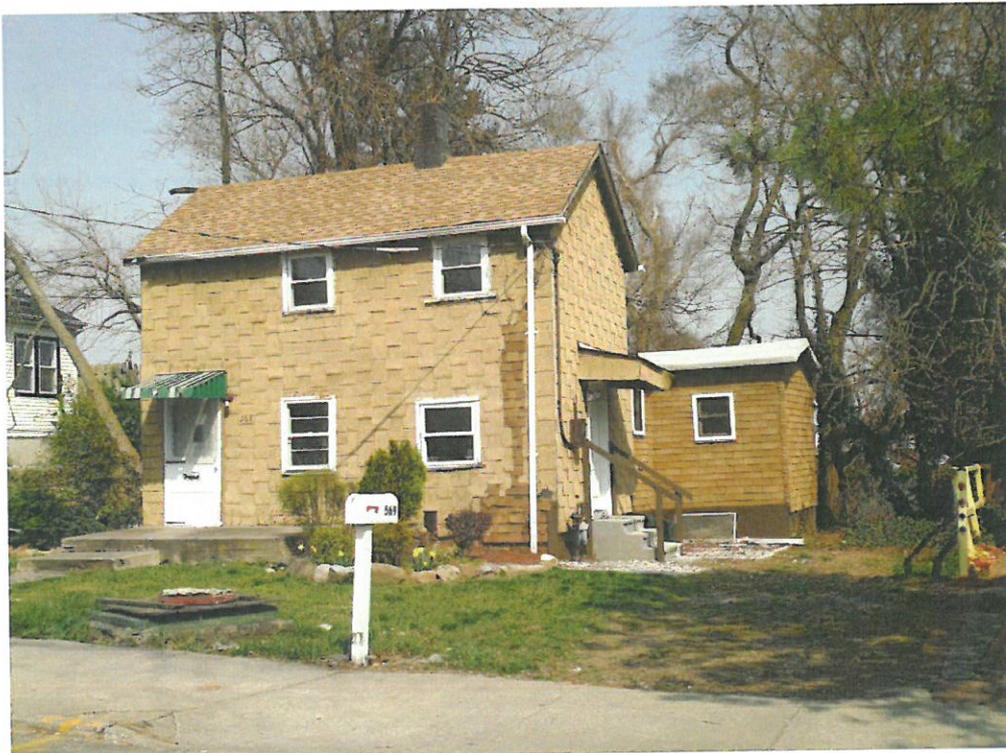
Photograph 30. Structure 61, 569 Bloomingdale Road, looking east-northeast. This dwelling, constructed as a tenant house during the last quarter of the 19th century, is a designated NYC Landmark.

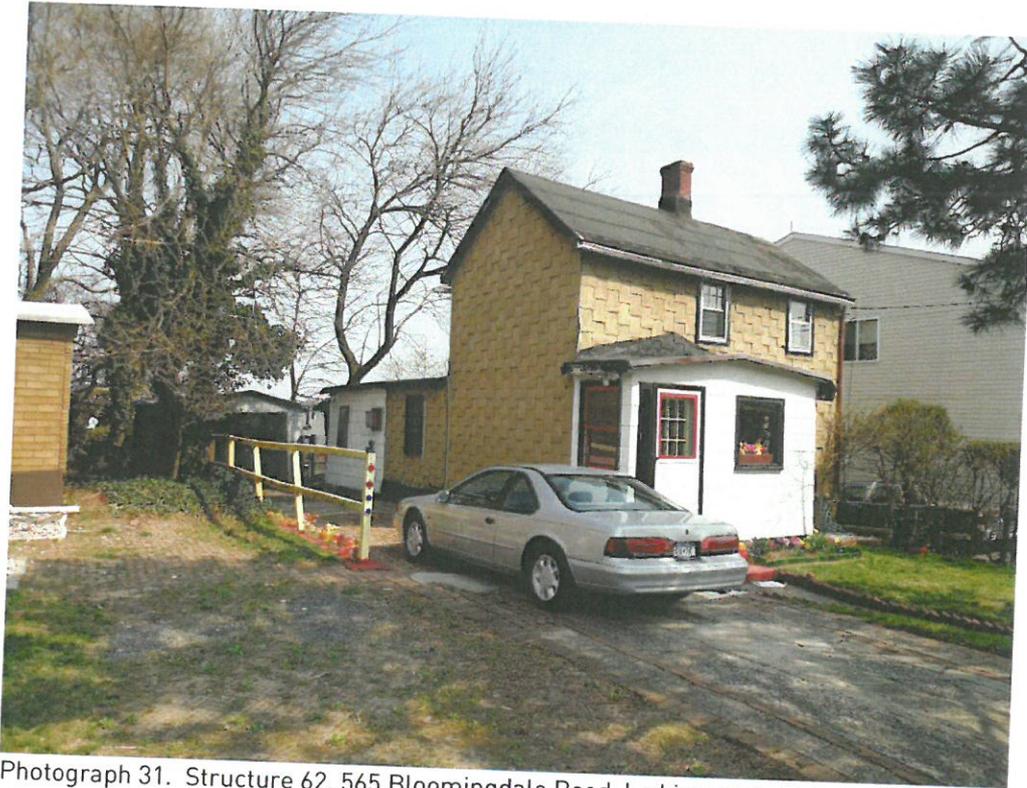
Photograph 31. Structure 62, 565 Bloomingdale Road, looking east. This dwelling, constructed as a tenant house during the last quarter of the 19th century, is a designated NYC Landmark.

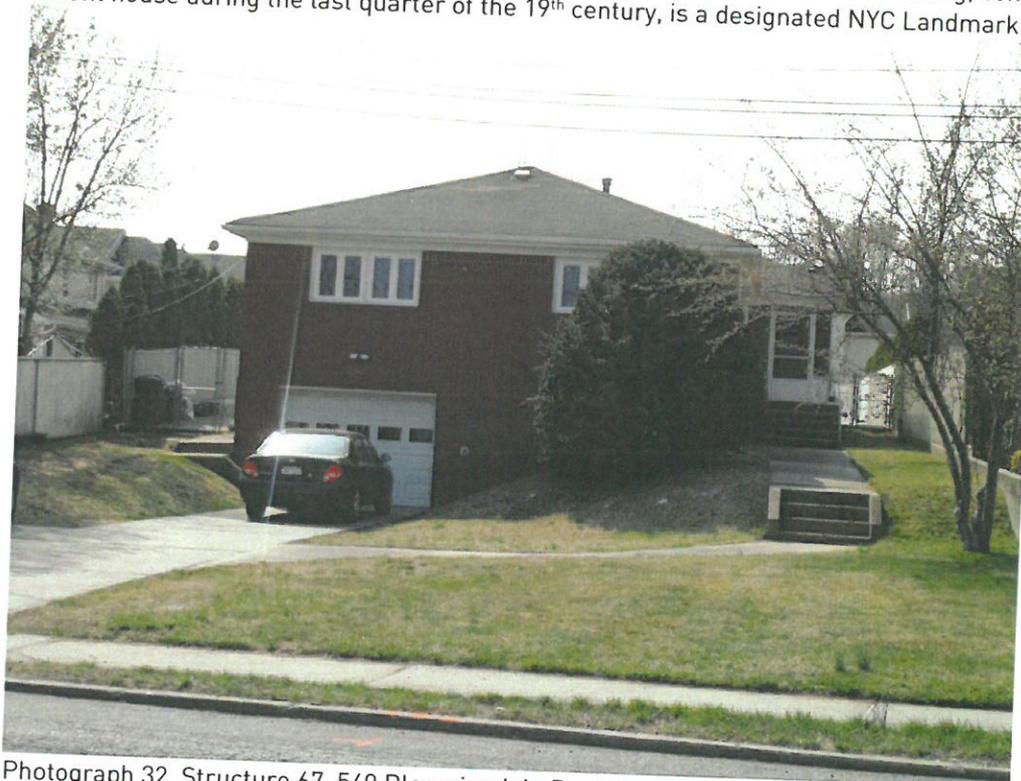
Photograph 32, Structure 67, 540 Bloomingdale Road, looking west-southwest. This mid-20th century house lacks distinguishing features and is ineligible for listing on the National Register.

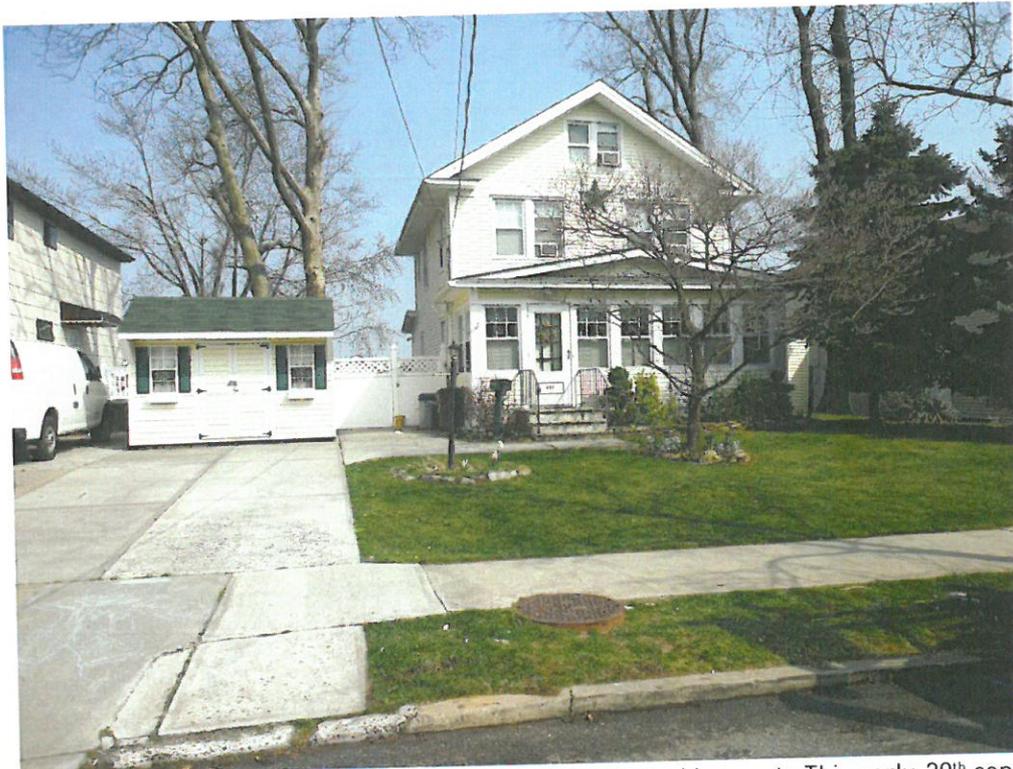
Photograph 33. Structure 85, 455 Bloomingdale Road, looking east. This early-20th century dwelling has been altered and is not eligible for listing on the National Register.

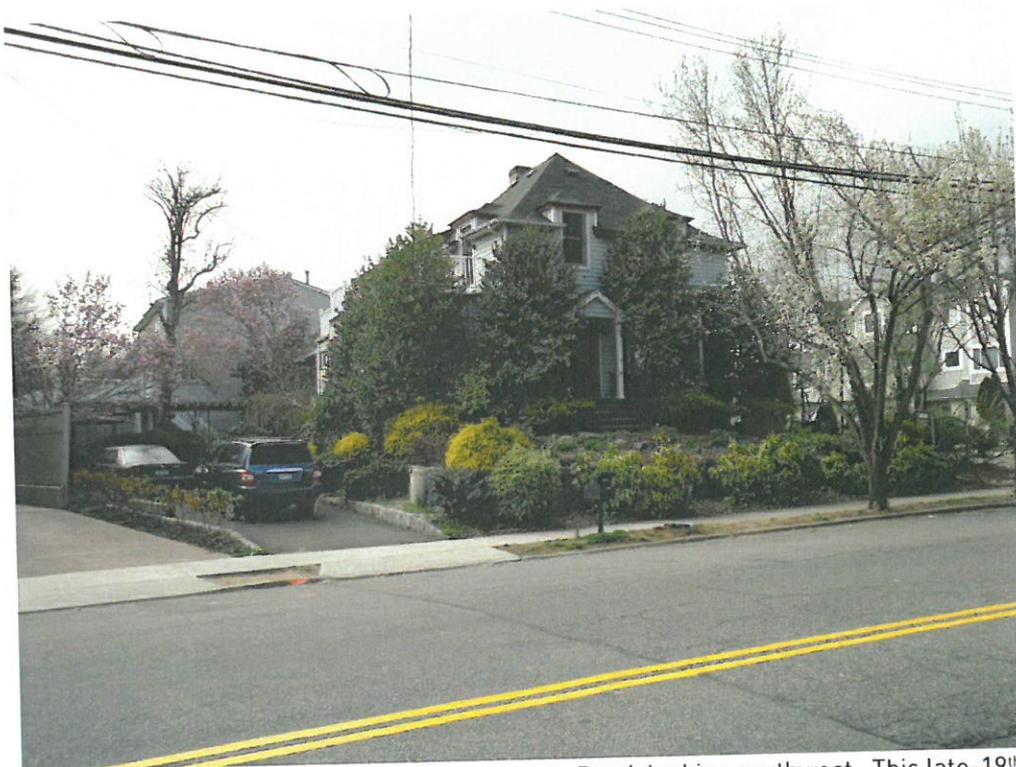
Photograph 34. Structure 91, 444 Bloomingdale Road, looking northwest. This late-19th century house has had extensive alterations and is not eligible for listing on the National Register.

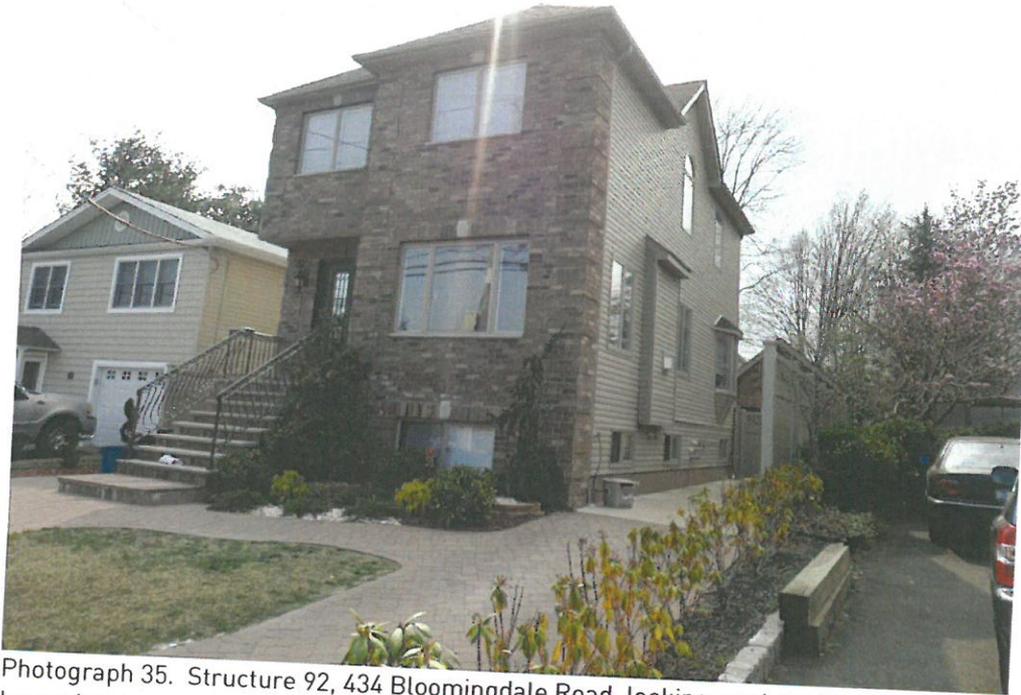
Photograph 35. Structure 92, 434 Bloomingdale Road, looking west-southwest. This late-19th century house has been extensively altered and is not eligible for listing on the National Register.

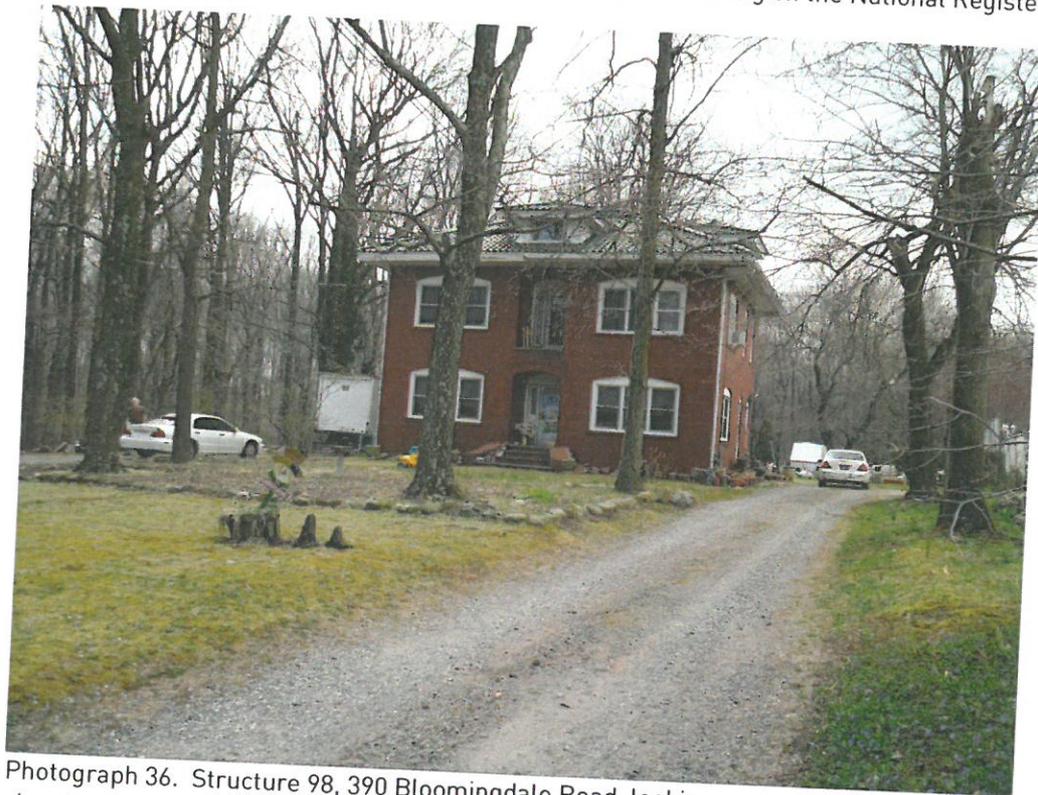
Photograph 36. Structure 98, 390 Bloomingdale Road, looking west-southwest. This c.1910 house with clay tile roof is considered eligible to be listed on the National Register.

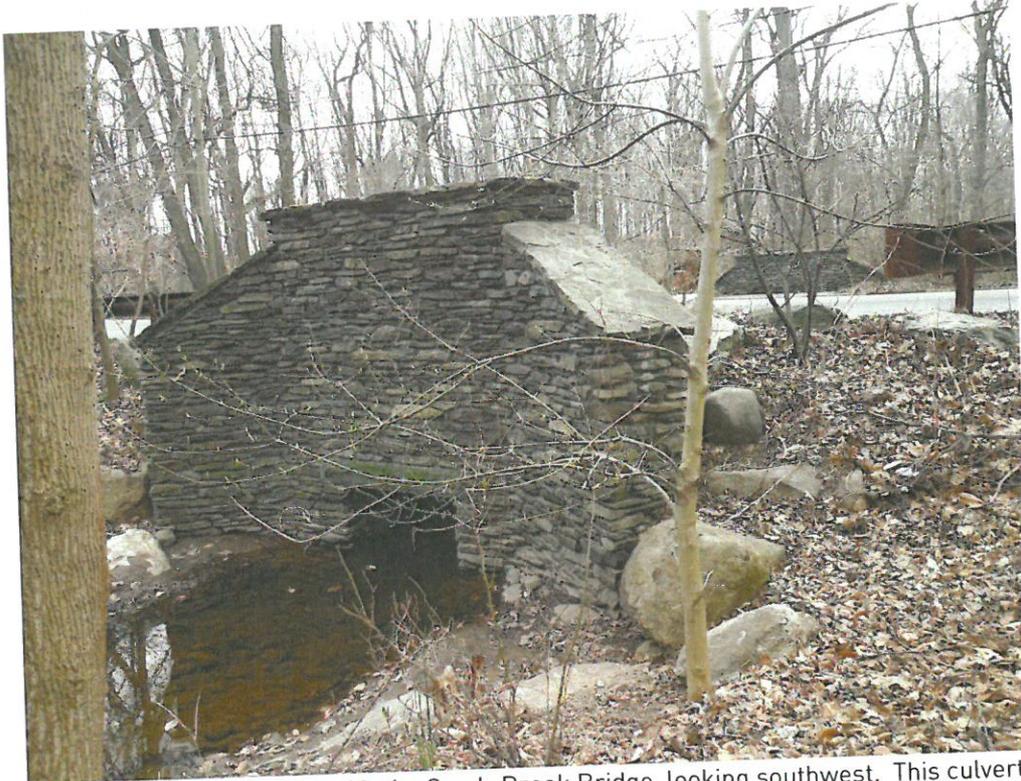
Photograph 37. Structure 102, the Sandy Brook Bridge, looking southwest. This culvert with fieldstone end walls lacks distinguishing characteristics and is not eligible for listing on the National Register.

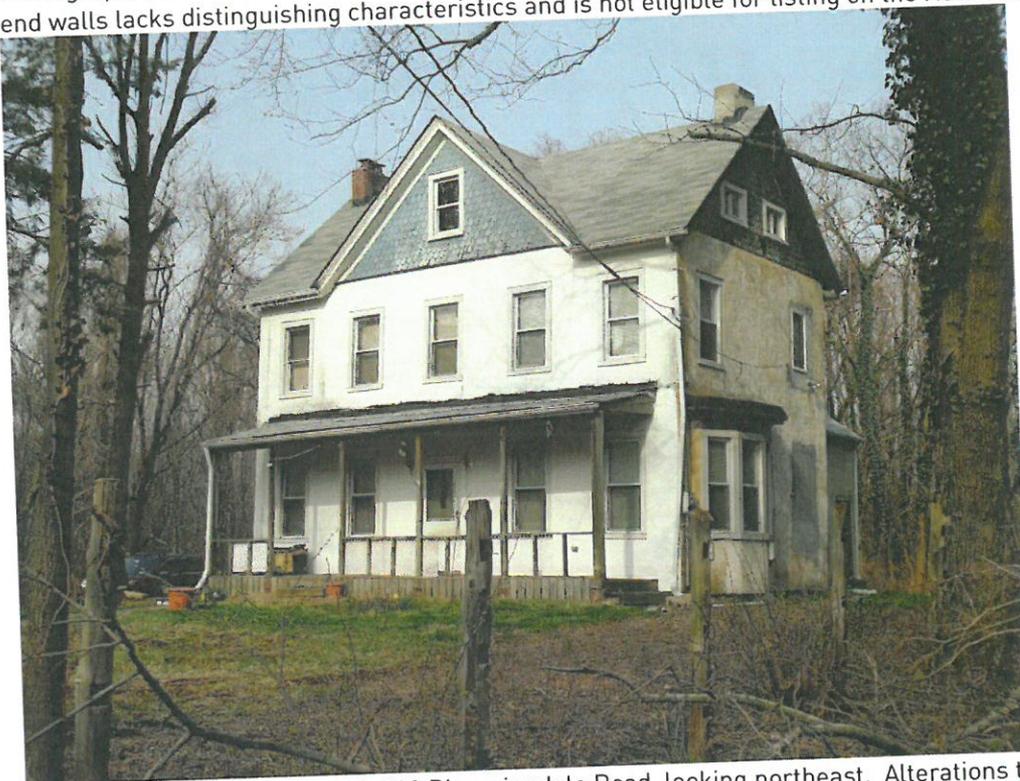
Photograph 38. Structure 104, 299 Bloomingdale Road, looking northeast. Alterations to the original fenestration pattern and porch have compromised the integrity of this dwelling; it is not eligible for listing on the National Register.

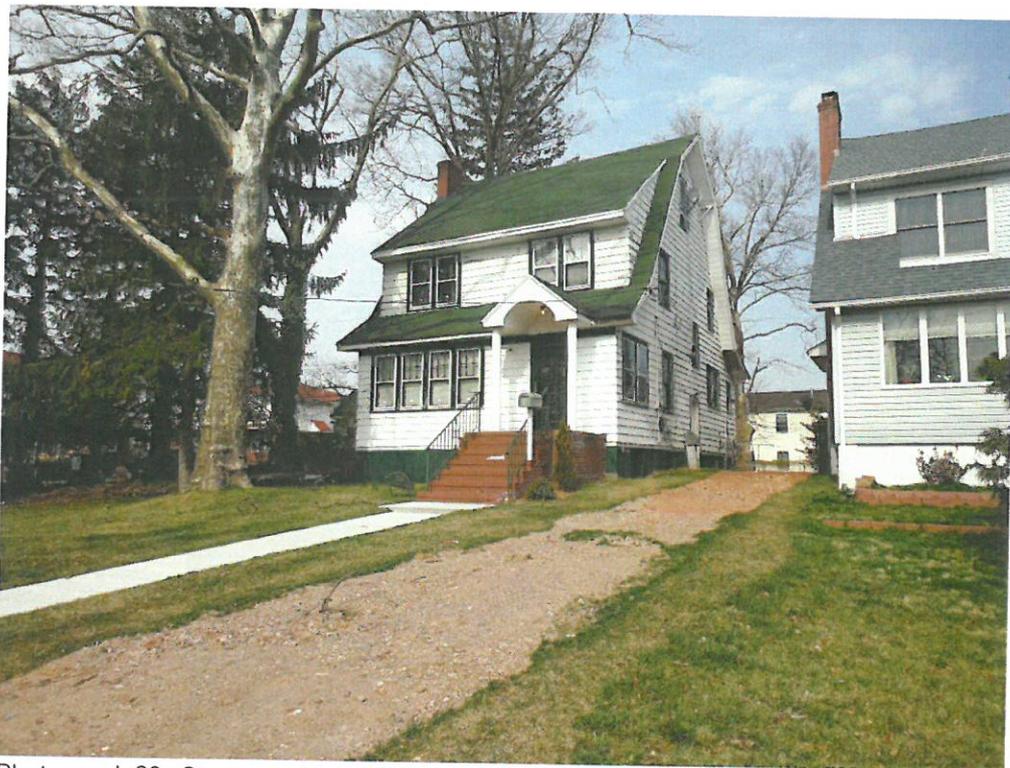
Photograph 39. Structure 122, 119 Bloomingdale Road, looking northeast. Although largely intact to its period of construction, this dwelling lacks distinguishing characteristics, and is not eligible for listing on the National Register.

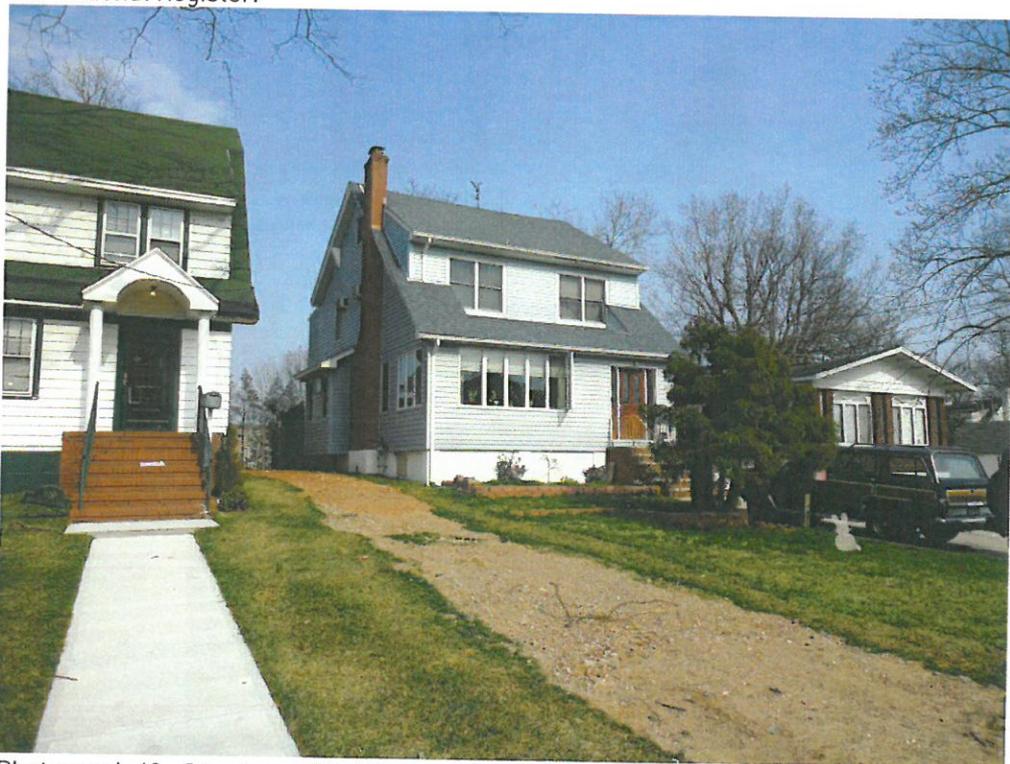
Photograph 40. Structure 123, 117 Bloomingdale Road, looking east. Alterations to the fenestration and exterior sheathing of this dwelling have destroyed its integrity; it is not eligible for listing on the National Register.

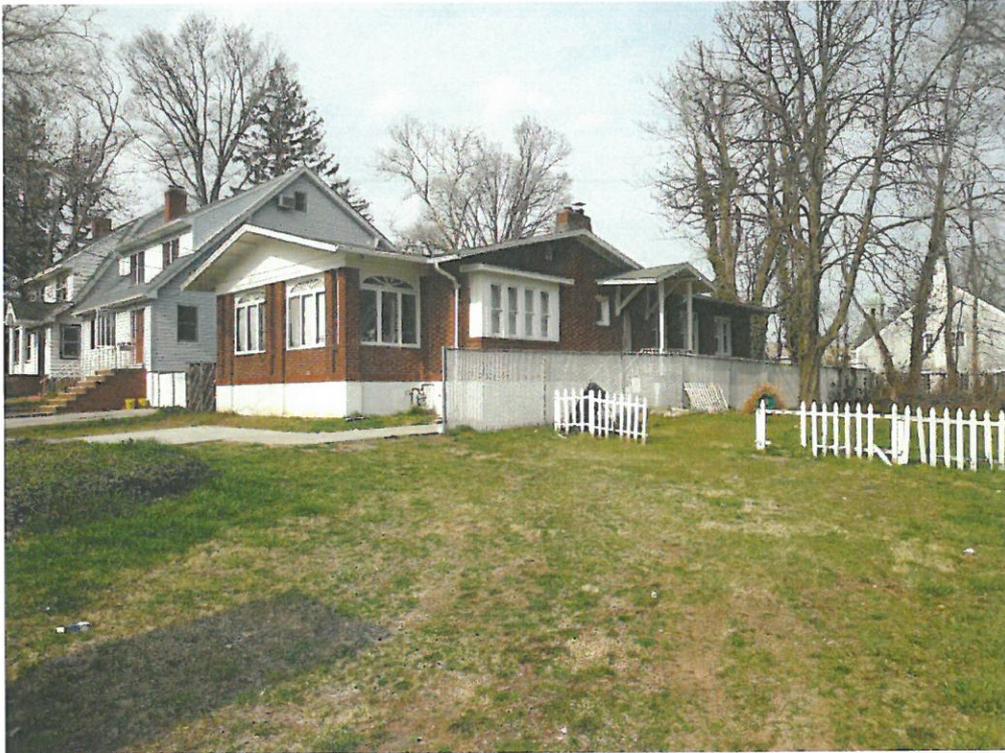
Photograph 41. Structure 124, 115 Bloomingdale Road, looking northeast. Most of the original fenestration has been replaced with vinyl windows. This house is not eligible for listing on the National Register.

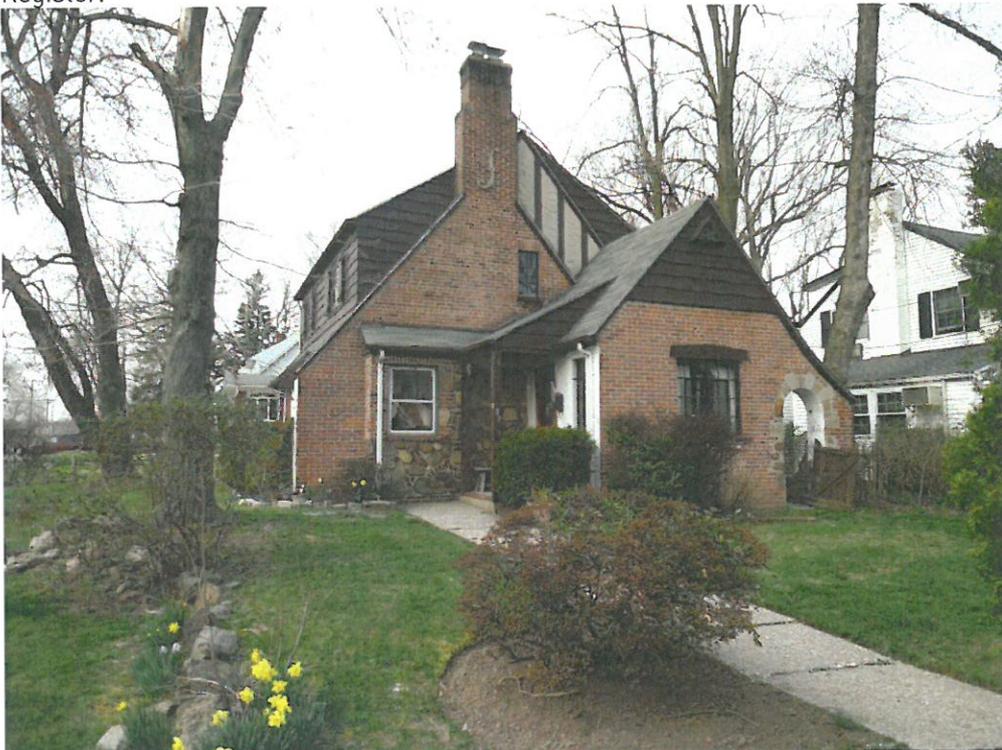
Photograph 42. Structure 125, 81 Bloomingdale Road, looking north. This c.1930 Tudor Revival house retains all of its details including some landscape features; it is considered eligible for listing on the National Register.

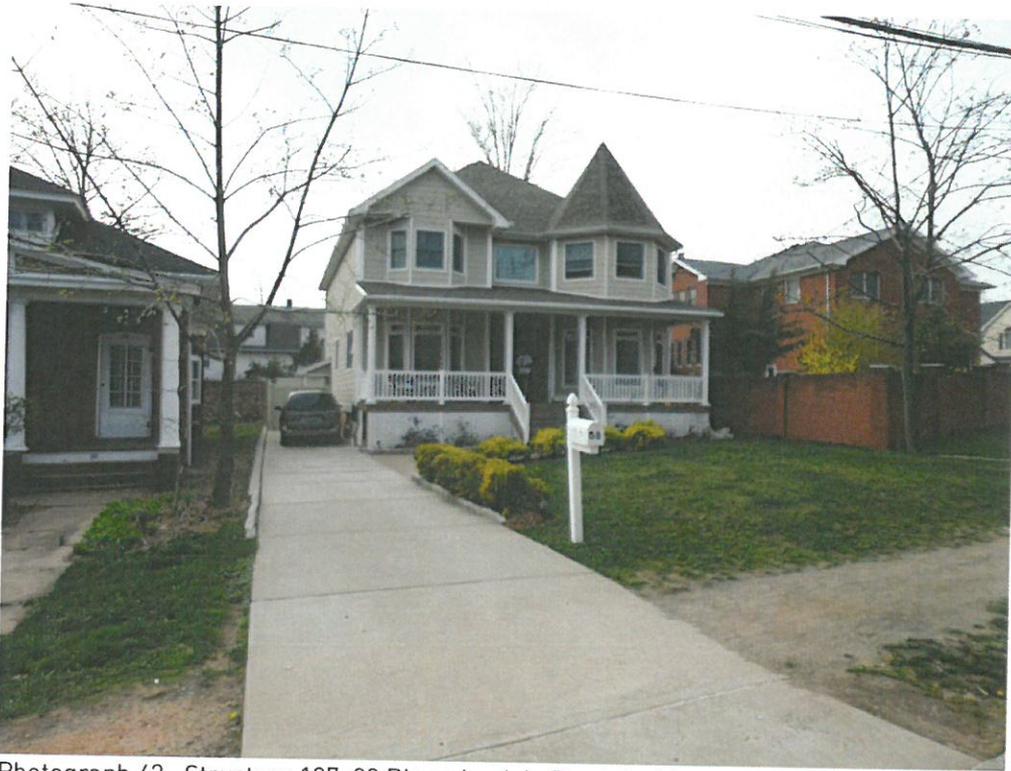
Photograph 43. Structure 127, 88 Bloomingdale Road, looking west. The windows in this house have been altered and reduced in size; its porch has been modernized. These alterations have destroyed the integrity of the building; it is not eligible for listing on the National Register.

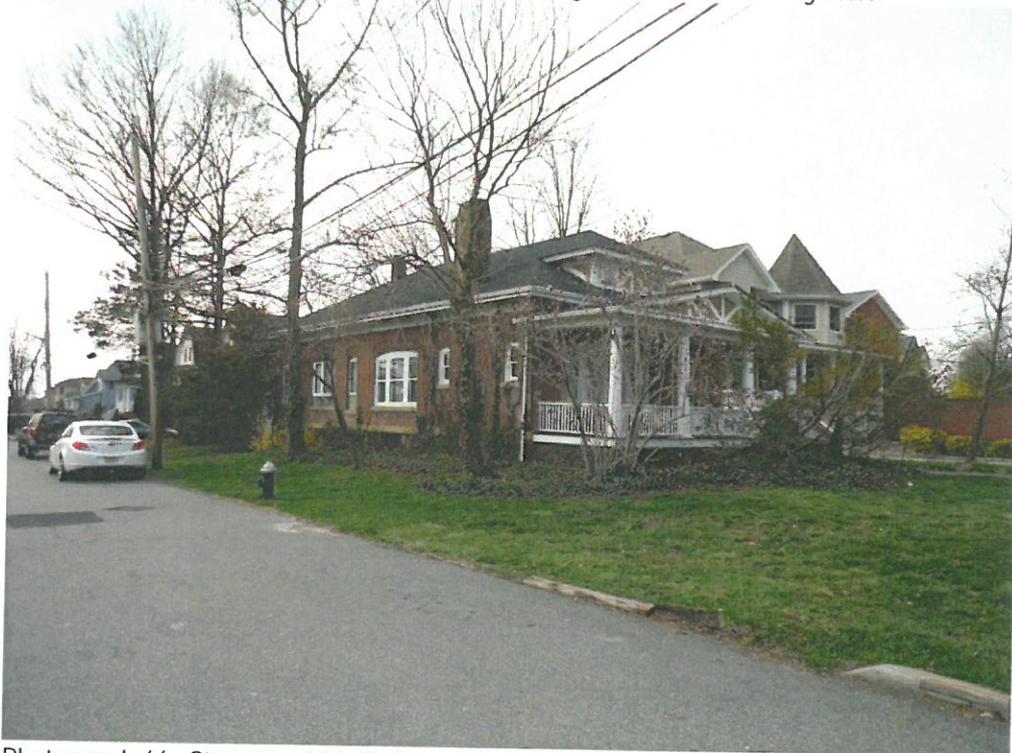
Photograph 44. Structure 128, 80 Bloomingdale Road, looking northwest. Replacement of original fenestration with vinyl windows has rendered this dwelling ineligible for listing on the National Register.

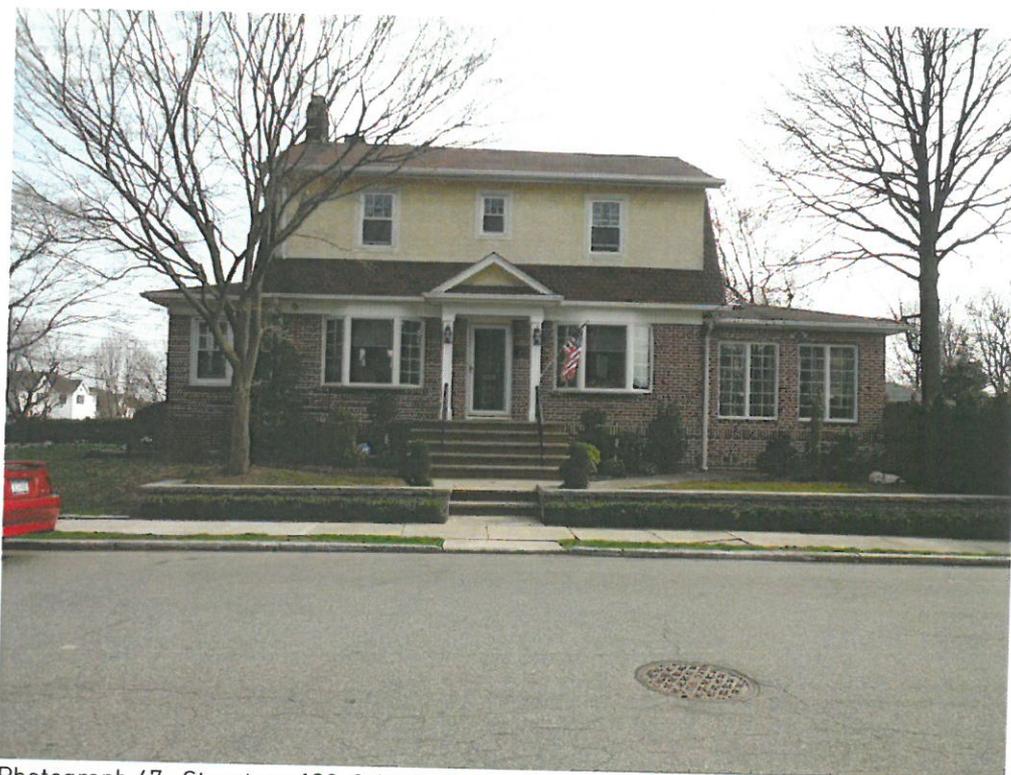
Photograph 47. Structure 132, 2 Outer Bridge Avenue, looking south. Original windows have been replaced and their forms altered, making this dwelling ineligible for listing on the National Register.

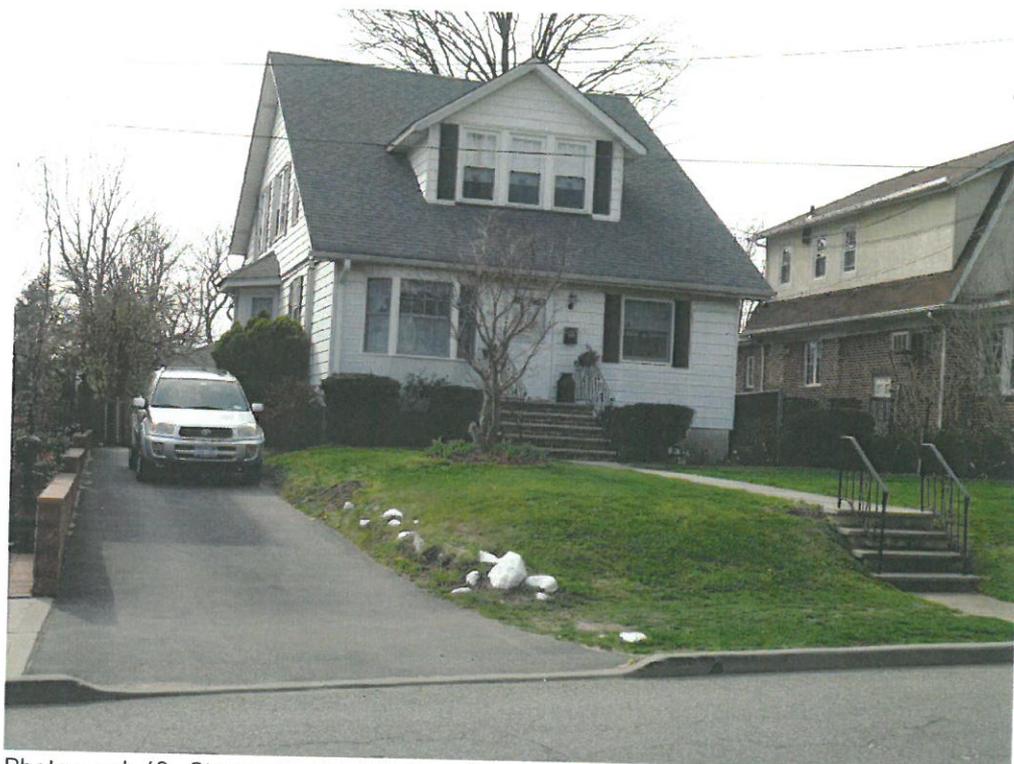
Photograph 48. Structure 133, 64 Bloomingdale Road, looking west. Exterior sheathing and fenestration have been replaced. This house is not eligible for listing on the National Register.

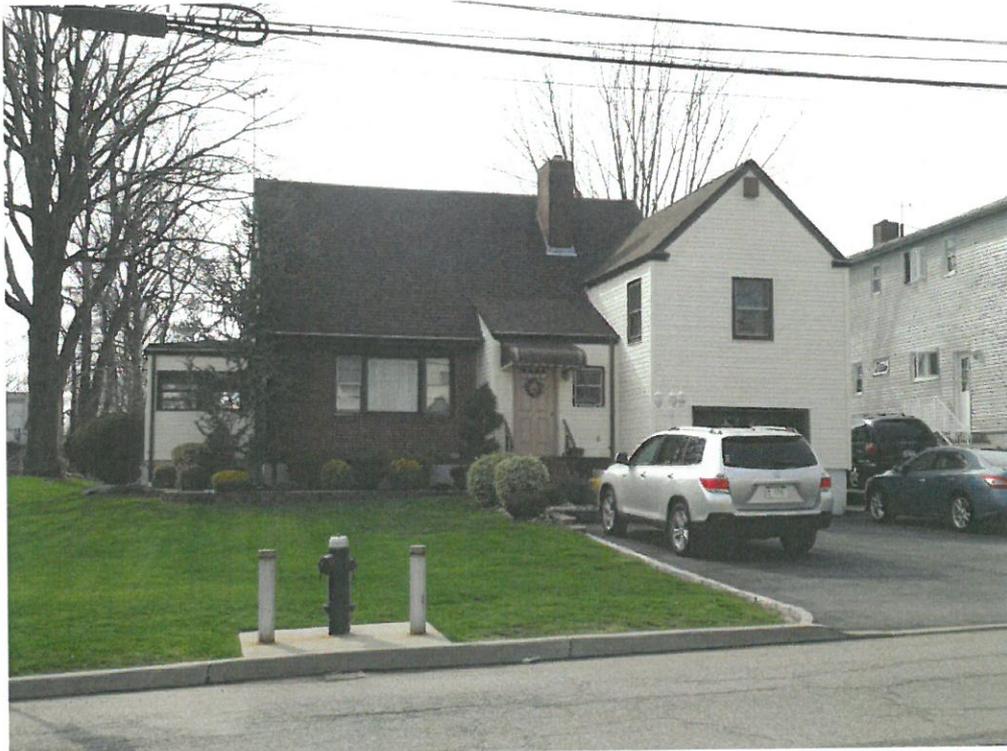
Photograph 49. Structure 136, 40 Bloomingdale Road, looking west-northwest. This mid-20th century dwelling has poor integrity and is not eligible for listing on the National Register.

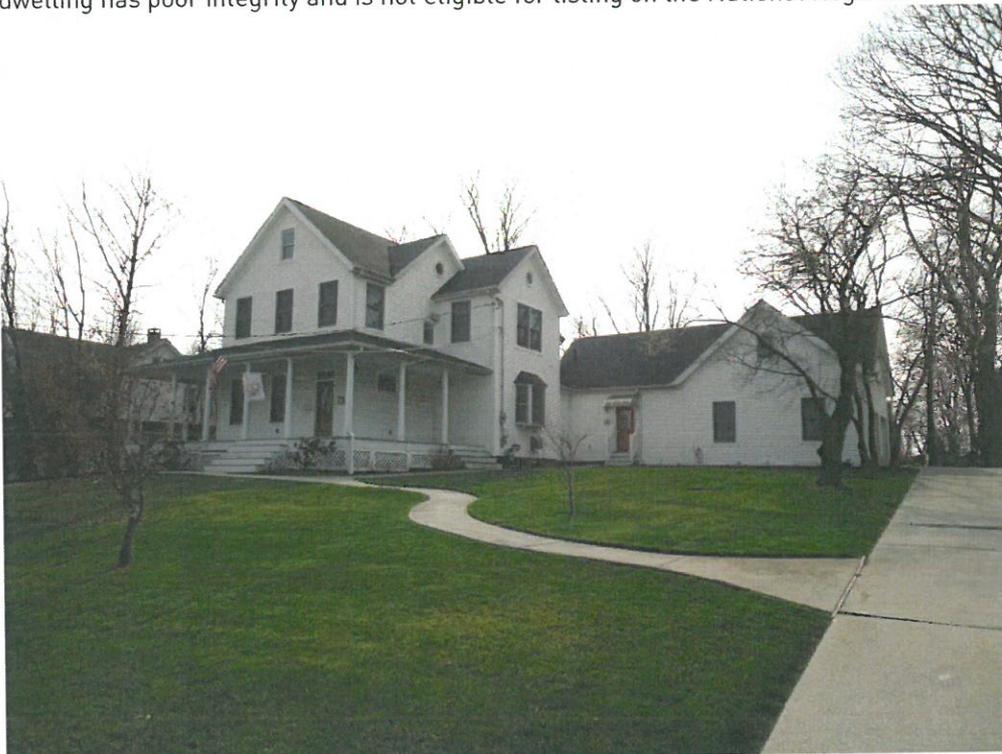
Photograph 50. Structure 137, 34 Bloomingdale Road, looking southwest. Alterations to windows, removal of exterior details and installation of vinyl siding have destroyed the integrity of this structure, making it ineligible for listing on the National Register.

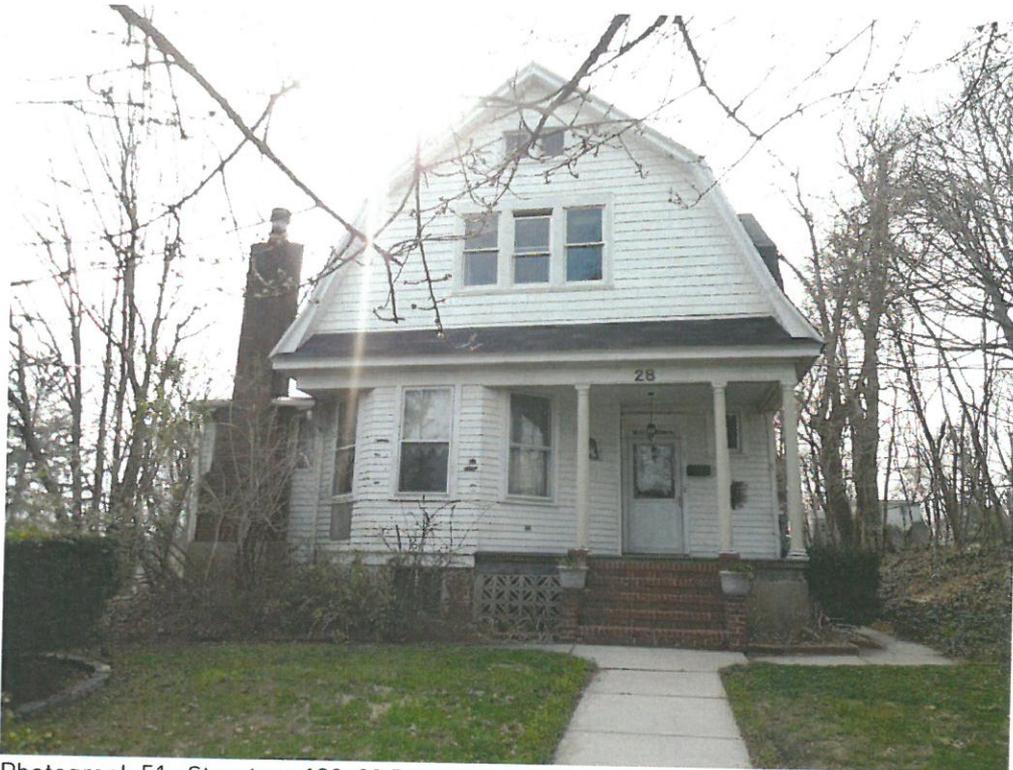
Photograph 51. Structure 138, 28 Bloomingdale Road, looking west-southwest. Alterations to fenestration and removal of exterior details make this dwelling ineligible for listing on the National Register.

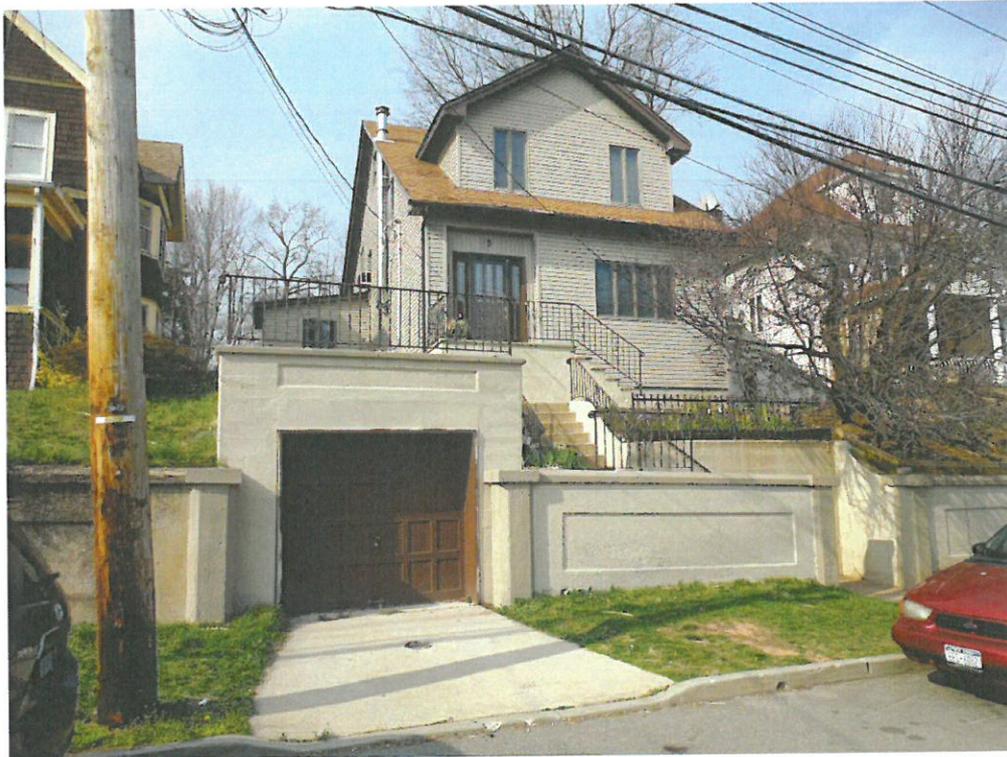
Photograph 53. Structure 149, 5 Pleasant Planes Avenue, looking north-northeast. Substantial alterations make this house ineligible for listing on the National Register.

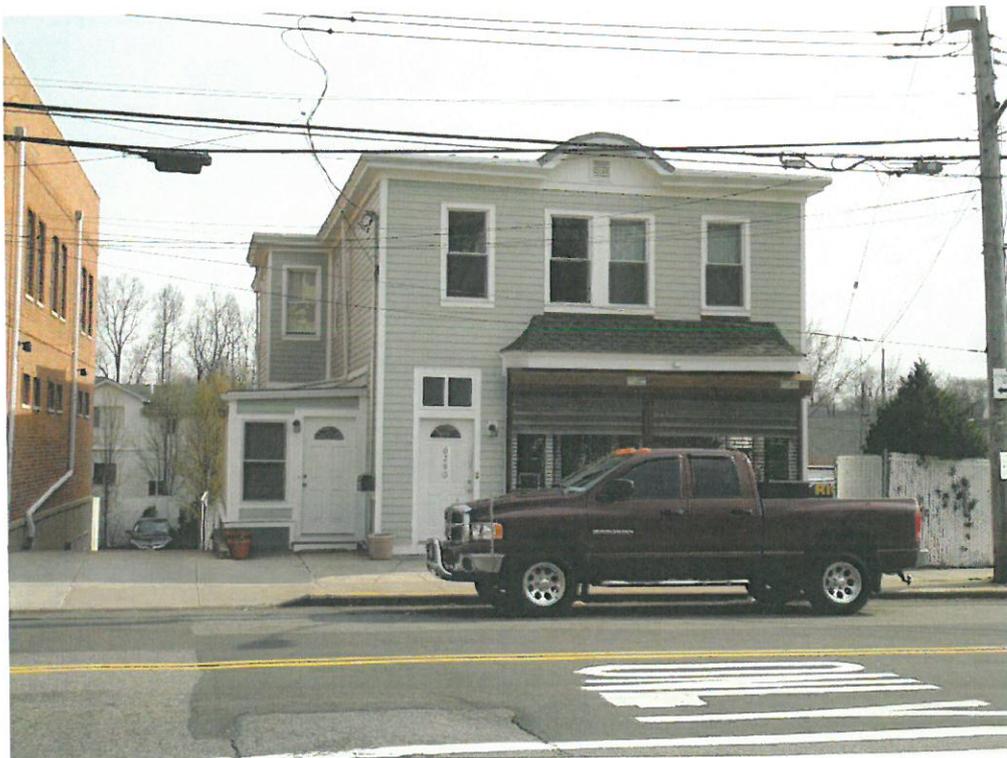
Photograph 54. Structure 150, 6280 Amboy Road, looking south-southwest. Loss of original storefront, fenestration and doors have compromised the integrity of this structure, which is not eligible for listing on the National Register.

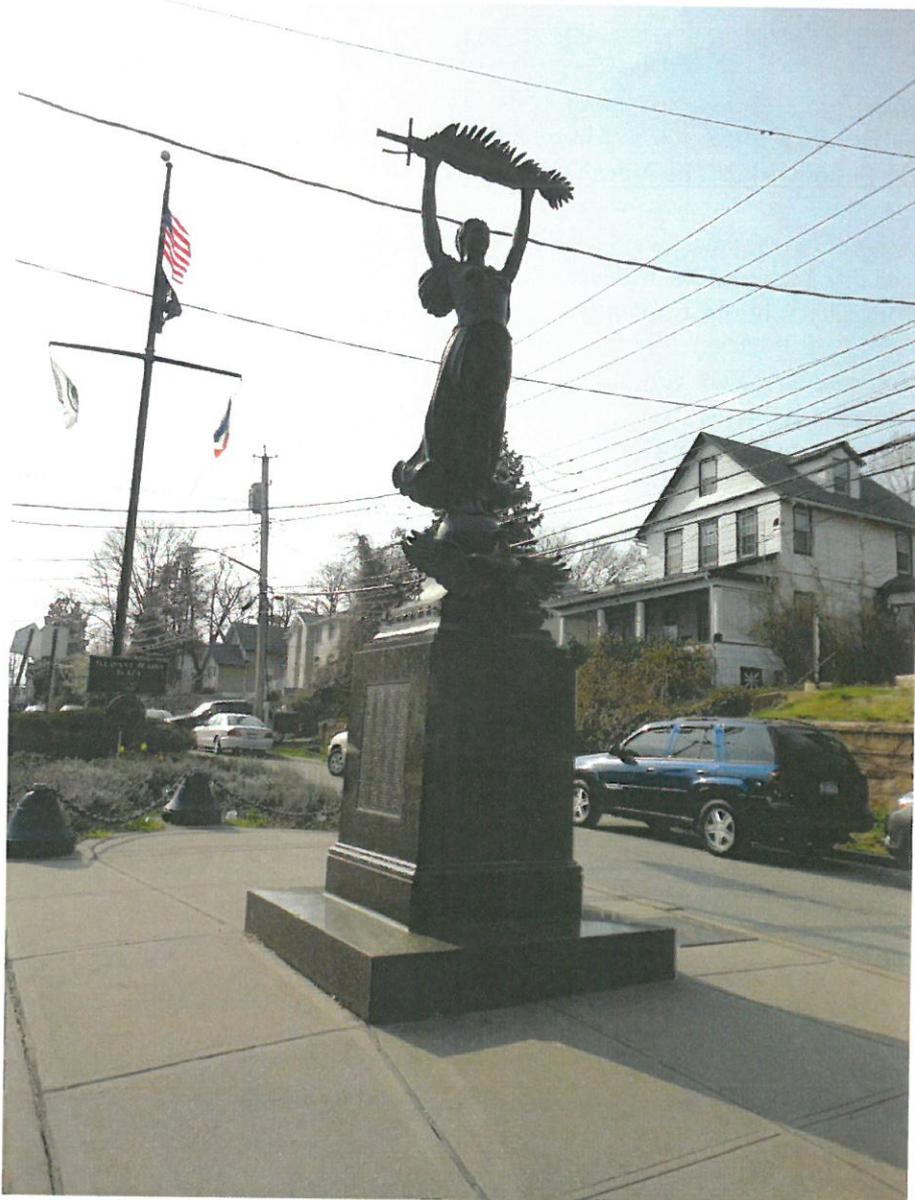
Photograph 55. Structure 151, Pleasant Plains Memorial Park monument, looking west-northwest. It incorporates portions of the original monument, dating to 1923. The present monument is, in part, a reconstruction dating to 1996 and is thus not eligible for listing on the National Register.
