Fuel Cell Installation Project –  
City Hall Park, New York, New York –  
Phase IB Archaeological Monitoring Project

FINAL REPORT – October 2013

## MANAGEMENT SUMMARY TABLE

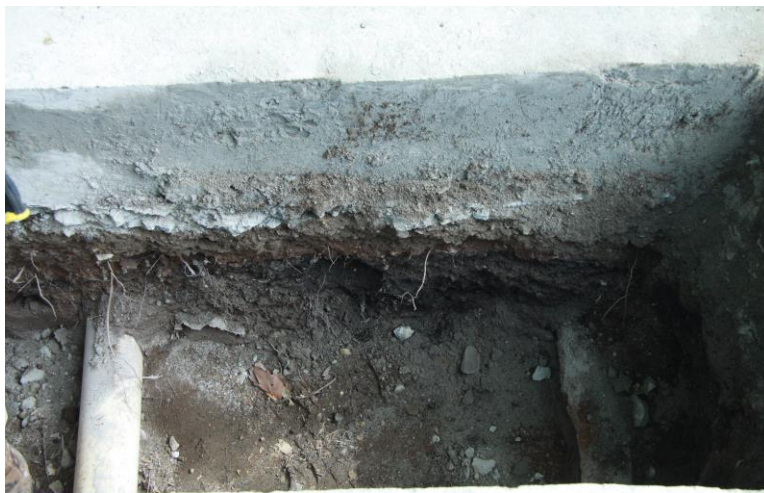
Image 02: Gas line work

Excavation for the gas line occurred from the Centre Street/Park Row entry gate proceeding west to the East Path where the trench turned north proceeding alongside the east entryway ramp. It culminated adjacent to the northeast corner of City Hall before proceeding into the previously excavated Northeast Vault area where the fuel cell will be situated (Map 02). The path of the gas line was located to deliberately avoid a nineteenth century cistern that had been identified and partially exposed during the 1999 excavation project undertaken by Parsons Environmental Sciences (PES) (see Bankoff and Loorya 2008) (Image 02).

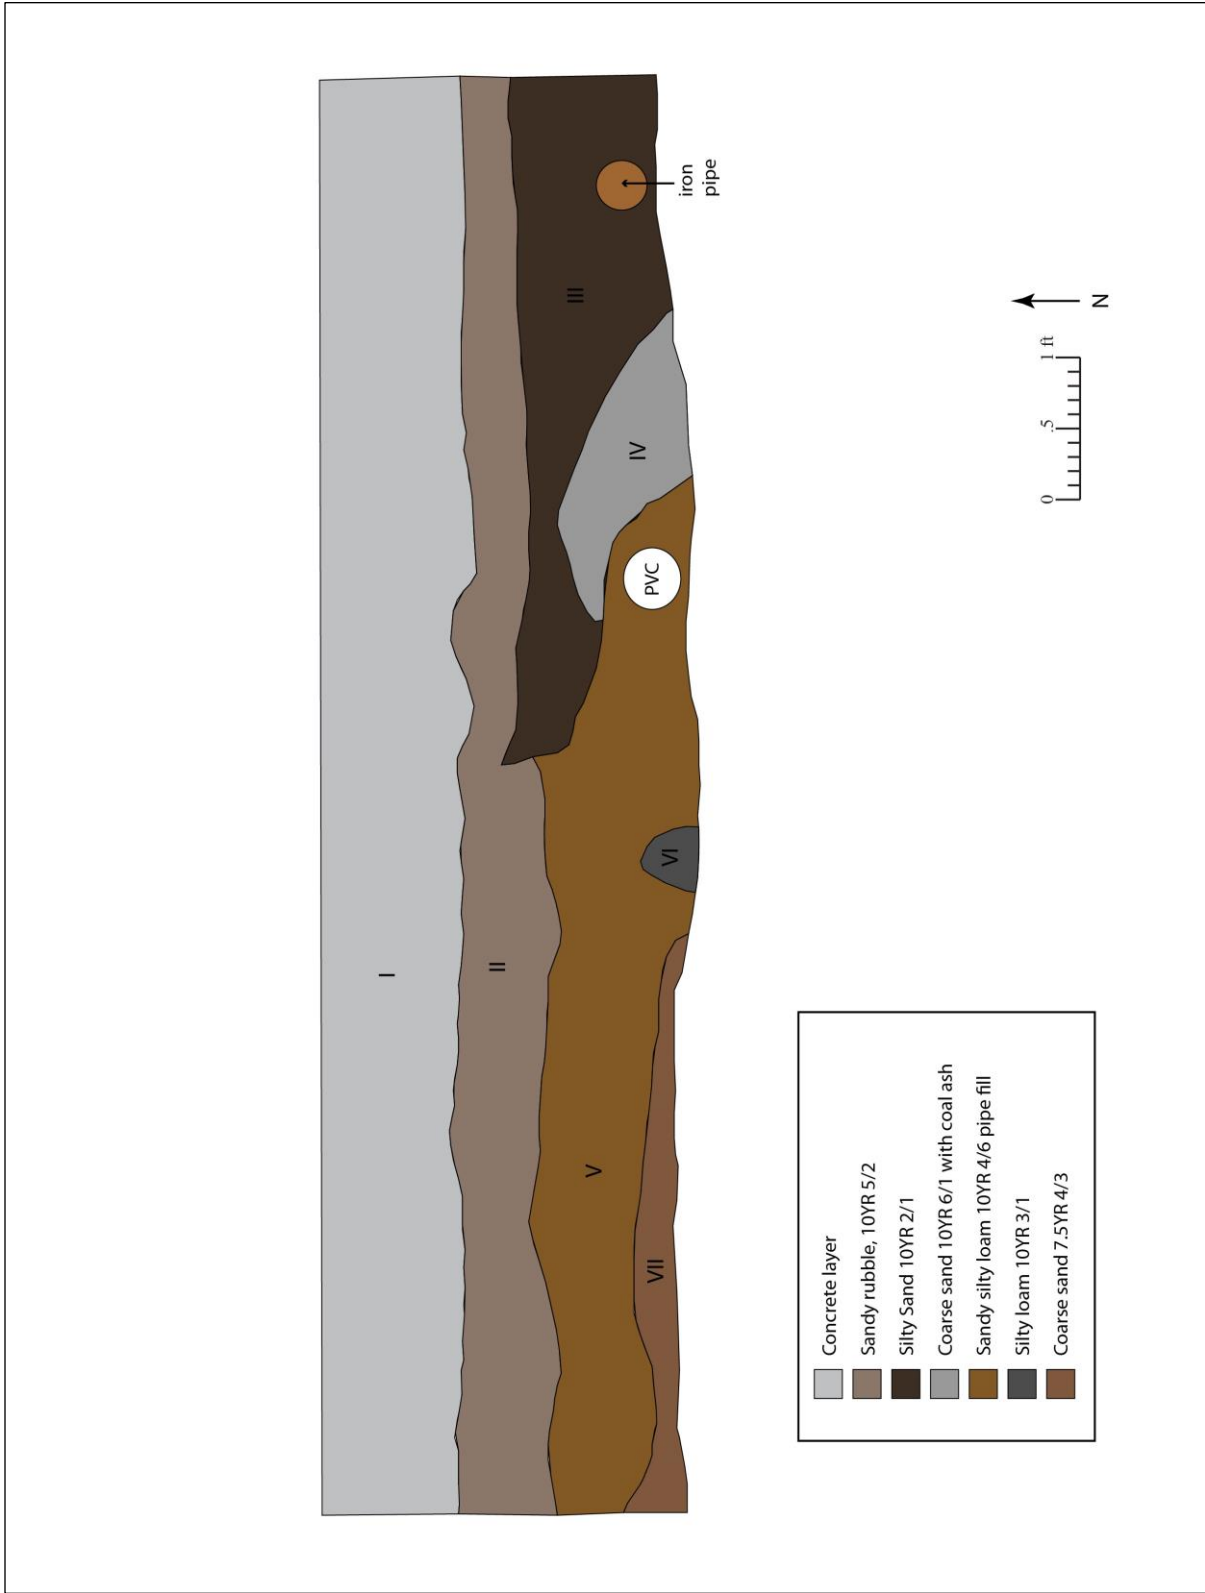
Map 03: North profile of a segment of the Centre Street Park Row excavation trench.

The gas line excavation occurred in two segments, along the Centre Street/Park Row path and along the East Path (Map 02). The Centre Street/Park Row portion of the gas line trench measured approximately 88' long by approximately 2.5' wide and was excavated to a depth of 3.5' below surface (bs). This trench segment exhibited some degree of disturbance from various utility installations and landscaping within the last half of the nineteenth through the twentieth century (Image 03). Maps 03 and 04 and Table 01 provides a representative stratigraphic profile of this area.

STRATUM	DEPTH	DESCRIPTION
I	0 – 1'	Concrete
II	1' – 1.6'	10YR 5/2 sandy rubble, loamy sand with concrete and stone inclusions
III	1.45' – 2.4'	10YR 2/1 fill horizon, silty sand fill with coal ash
IV	1.5' – 3.3'	10YR 6/1 coarse sand with coal ash
V	1.6' – 3.5'	10YR 4/6 sandy silty loam coal ash and brick inclusions
VI	2.25' – 2.7'	10YR 3/1 silty loam pocket of fill
VII	2.2' – 3.5'	7.5YR 4/3 coarse sand with iron inclusions

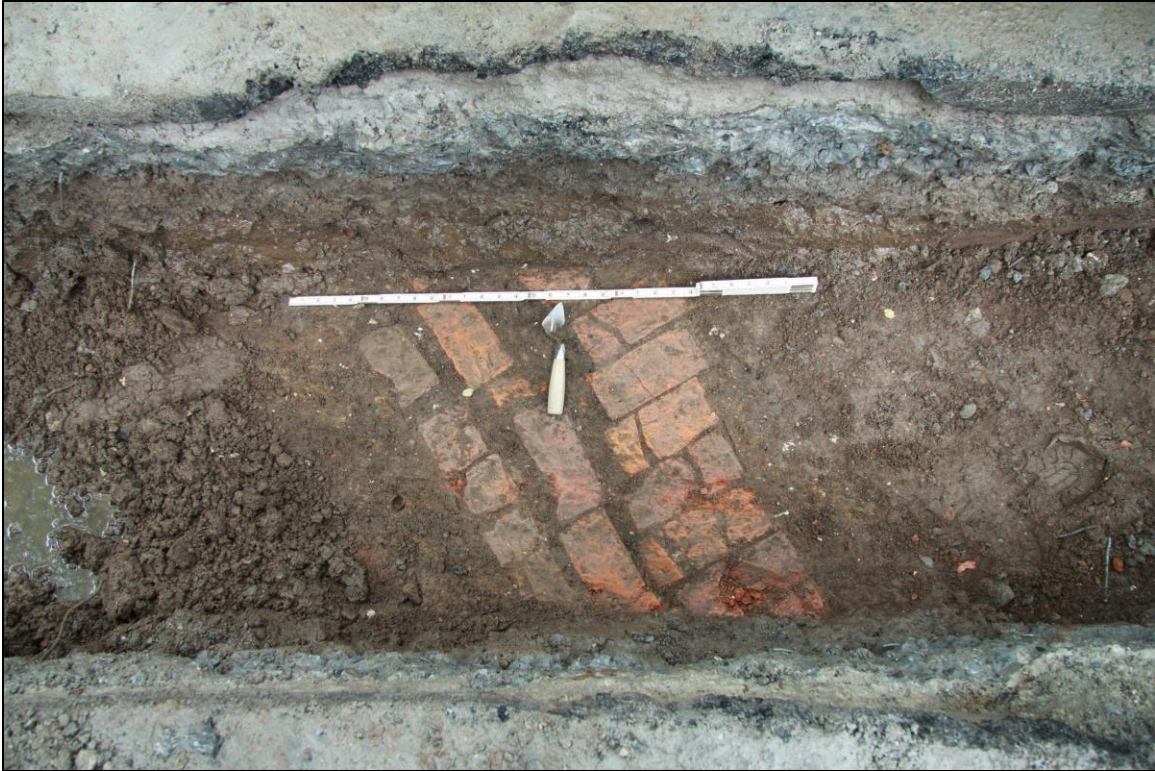
Image 04: Feature 45, brick path.

The next area of note encountered was a brick path that had been noted (as Feature 56) but not documented during the 1999 project. For the purposes of consistency with the current Chrysalis/URS project's record keeping it has been (re-)labeled as Feature 45.

Feature 45 consisted of two courses of dry-laid brick on a stone slab. The brick was exposed at 2' bs and the stone slab was located at 2.5' bs. The fill soil surrounding the bricks consisted of 10YR 4/2 silty sand and 10YR 5/6 coarse sand with brick and pebble inclusions. It was located approximately 32' west of the entry gate on Park Row (Map 02).

No artifacts were identified in association with the path. The bricks are late nineteenth century machine made brick. The depth of the path at 2' below surface provides additional information regarding the increase in elevation of the landscape surrounding City Hall as discussed in the 2010-2011 report. Analysis identified the landscape surrounding City Hall to have been 3' lower than the present grade when City Hall was constructed, 1803–1811. The elevation of this path suggests that there was a 1' variation in grade from this area to the location to City Hall or that the landscape had been raised by 1' between the construction of City Hall and installation of this path (Image 04 and 05). The latter is the most likely scenario as the elevation of the island begins to decrease toward the east from Broadway, which is the high point along this lateral of Manhattan Island.

Feature 45 was disassembled and removed to facilitate the construction.

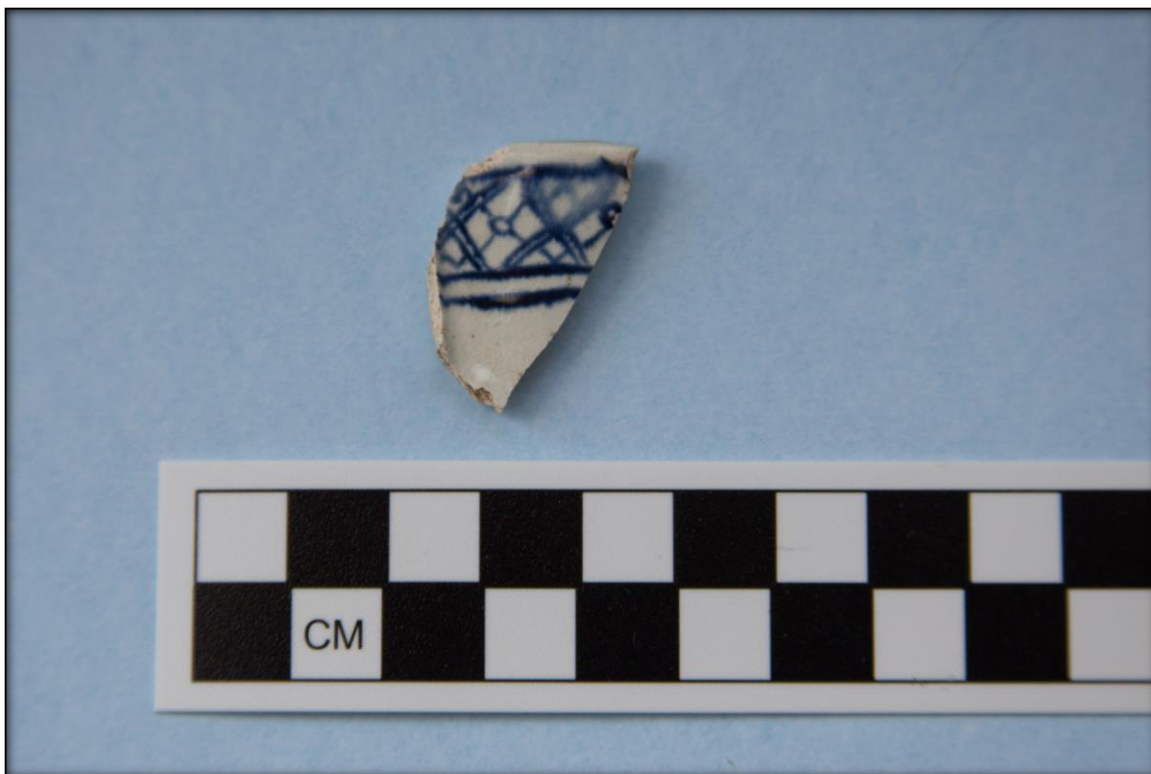
A total of 31 creamware sherds (1762–1820) were recovered. Only one of the creamware sherd exhibits any decoration, a green painted lid fragment with an indeterminate pattern (1790–1820). Of the 8 Pearlware sherds (1775–1840) recovered; 3 exhibited blue painted decoration. One of these is a Chinese landscape decoration with a 1775–1810 date range (Miller et.al. 2000), another has a trellis decoration and the third is indeterminate (Image 06). Two of the 3 Porcelain sherds recovered are Chinese import porcelain and the third is English soft-paste porcelain decorated with red painted bands. The English soft-paste porcelain sherd dates 1745–1795 (Miller et.al. 2000).

Image 06: Blue painted pearlware sherd with trellis decoration.

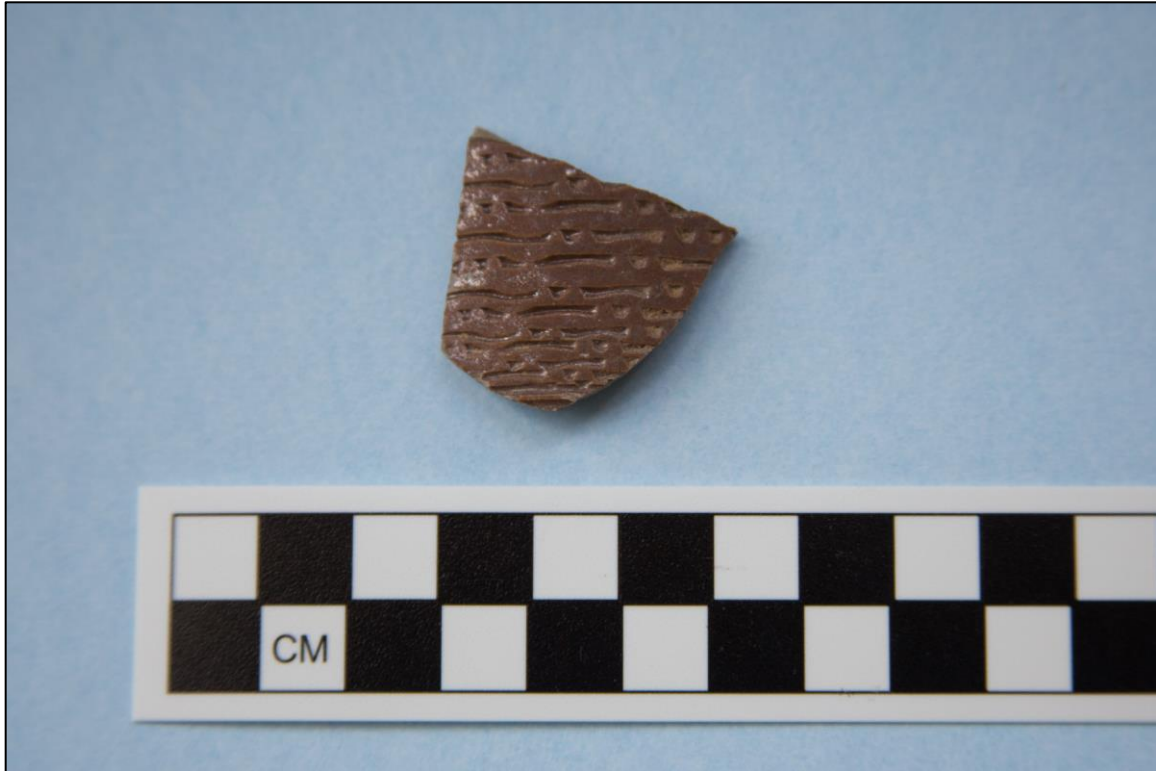
Of the 6 Stoneware sherds recovered all but one are salt-glazed. The remaining sherd is engine-turned with a reddish body and a geometric pattern. This sherd dates 1763–1820 (Azizi et.al. 1999). The ceramic assemblage is rounded out by 2 white salt-glazed sherds; one an undecorated teaware sherd (1720–1790) and the other with a molded pattern (1740–1765) and 3 tin-glazed sherds (1640–1800) (Miller et.al. 2000) (Image 07).

Image 07: Stoneware sherd with impressed geometric pattern.

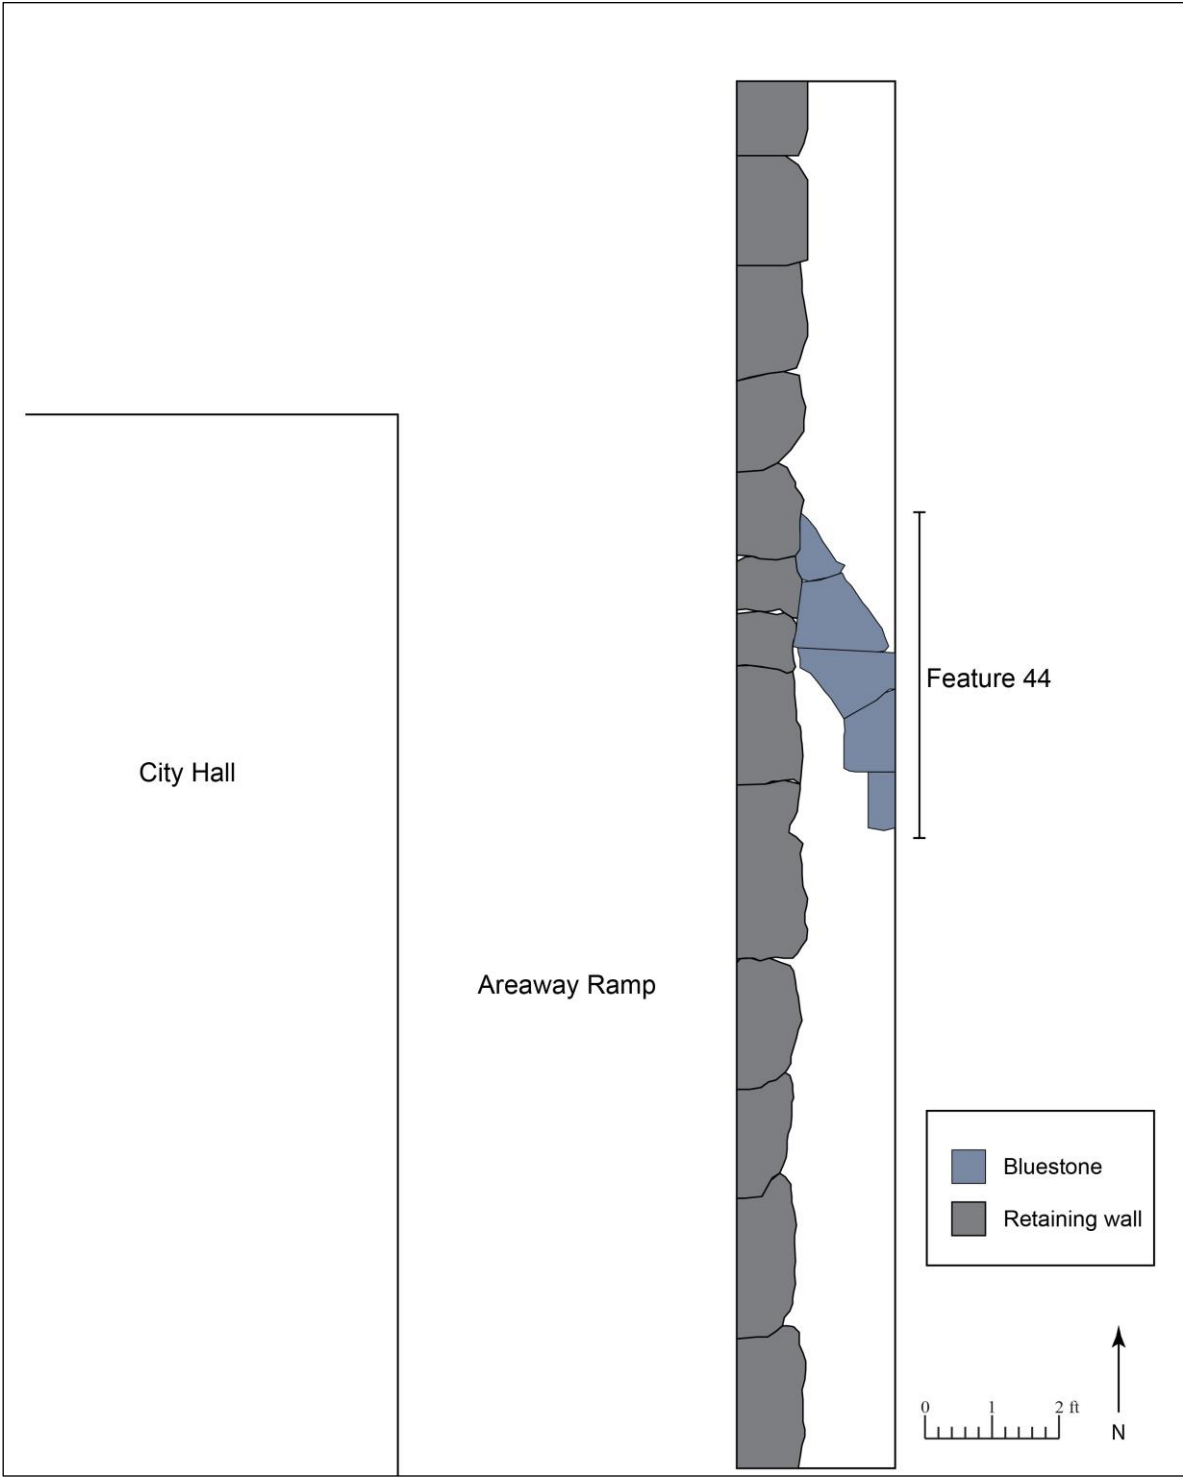
Map 05: Plan view of East Path excavation trench.

Excavation along the east path extended north alongside the ramp entry retaining wall. Several segments of this had been previously excavated during excavations in 2010 (Map 02). Current excavations exposed the retaining wall as previously documented (Map 05). The stratigraphy was consistent with that observed during the 2010 excavations (Table 03).

Toward the northern end of the trench a small segment of the nineteenth century drain line, exposed and documented throughout the northeast area in 2010, was exposed. Labeled as Feature 44 this segment extended from beneath the stone retaining wall and curved toward the southeast. The stone and brick materials of the drain were consistent with those documented in 2010. The feature was surrounded by 7.5YR 4/3 sand fill. No artifacts were observed in association with this feature. Feature 45 was disassembled and removed to facilitate the construction.

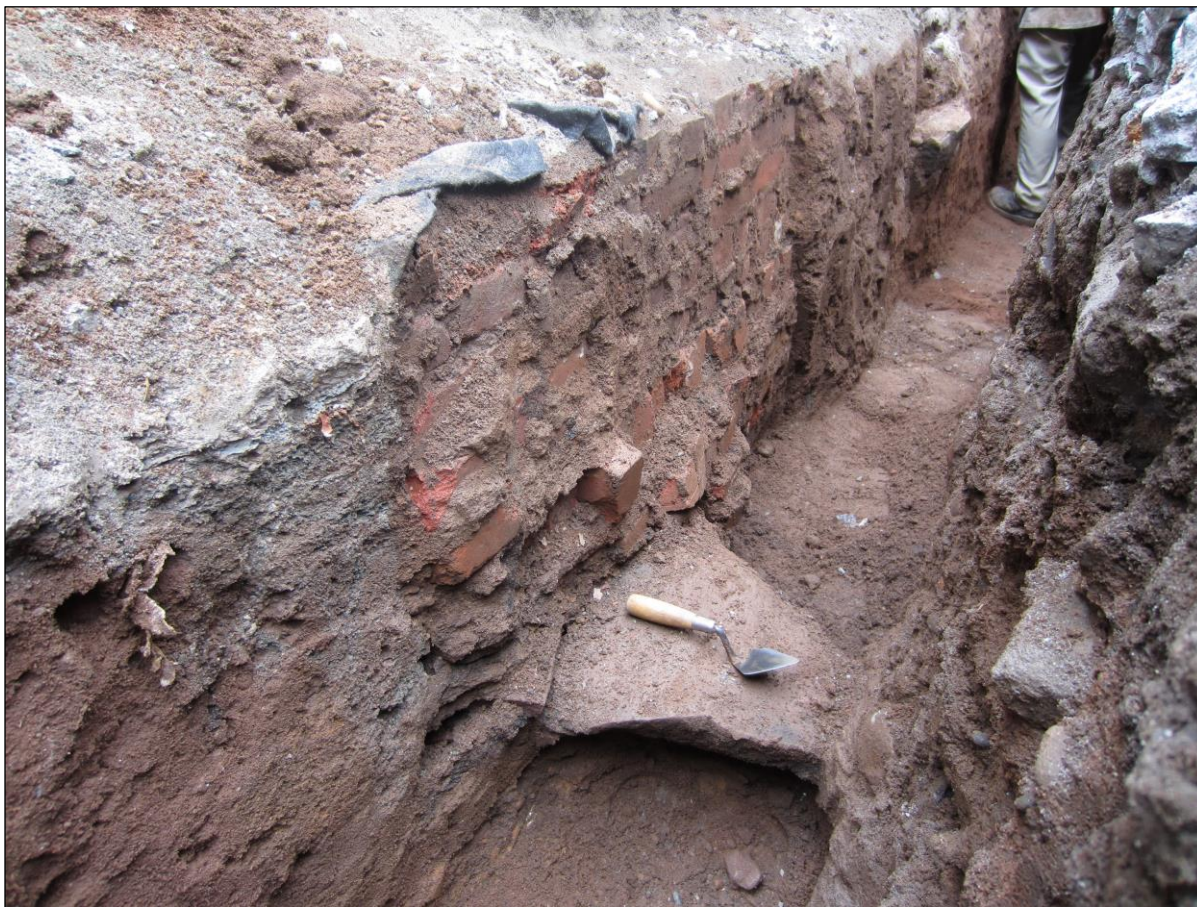
Excavation for the water line occurred in two stages within the northeast vault area. The first was the excavation of a 4' by 4' area to locate the top of an existing utility tunnel installed in the 1980s (Map 02). Excavation of this area was uneventful exposing fill soils and eventually the top of the tunnel. The second stage of the excavation was a trench that extended east to west along the northern edge of a brick feature (Feature 4) exposed during excavations in 2010. The trench excavation measured approximately 39' in length by approximately 2.5' wide and extended to a depth of 3.5' (Image 08).

Image 08: Excavation the northern edge of Feature 4 as part of the water line excavation trench.

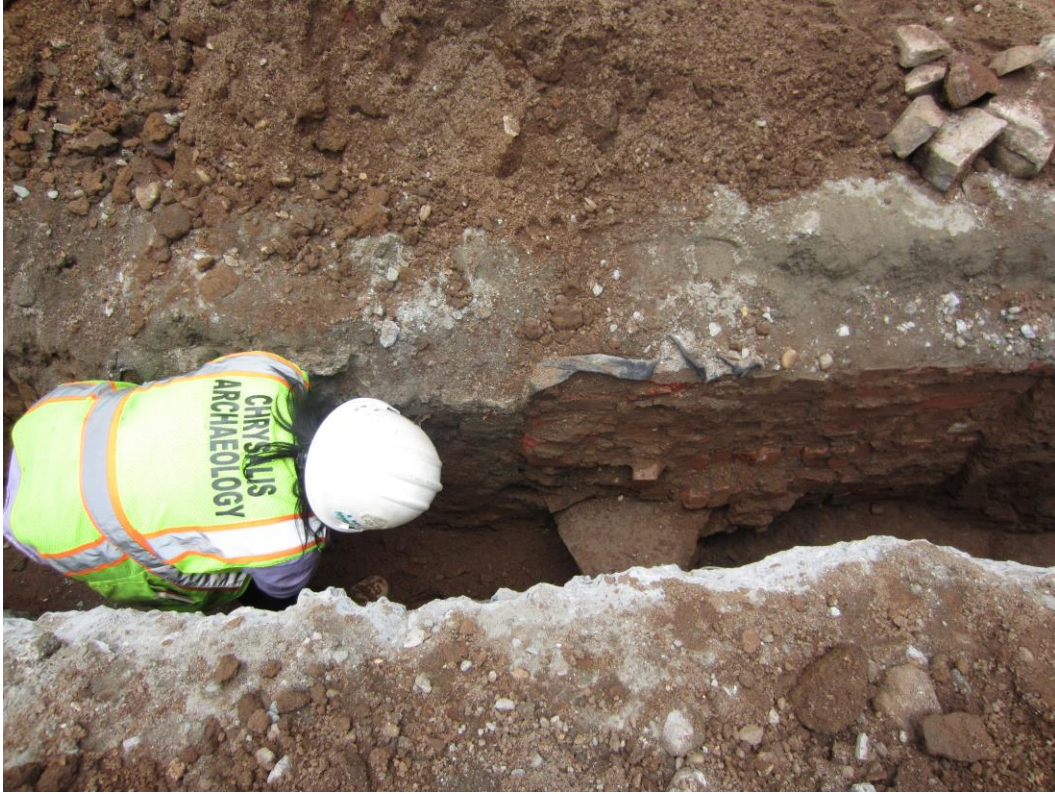
Image 09: Excavation the Water Line area

Feature 4 was a 16.8' by 8.4' nineteenth century brick structure that was associated with the early period of City Hall. Historically it was located outside a door that led to the basement kitchen of City Hall. The original function of Feature 4 remains undetermined. See Loorya et.al 2013 for further detail (Image 09).

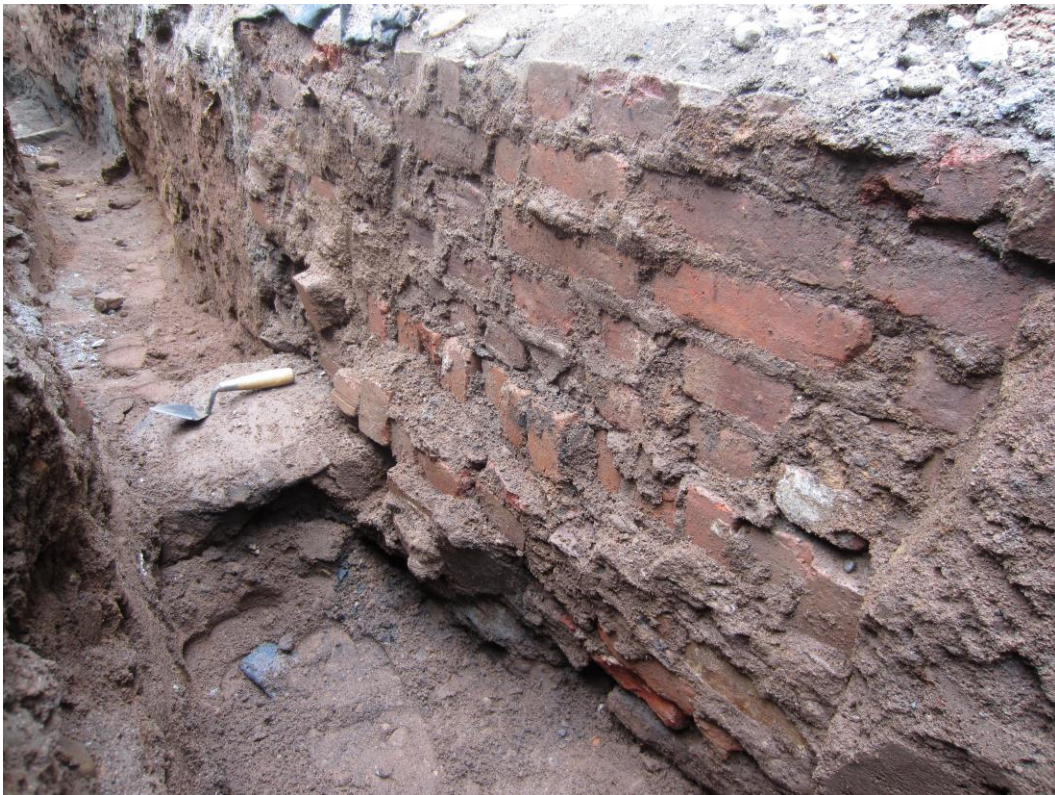
Image 10: Feature 04.

No artifacts were observed in association with this excavation. An approximate 4' section of the exterior north wall of Feature 4 was exposed and documented. The soils from this trench consisted of 10YR 5/4 sand (Image 10).
