PHASE IA ARCHAEOLOGICAL DOCUMENTARY STUDY  
50 OLD FULTON STREET  
BLOCK 202, LOTS 14, 18, P/O 12  
KINGS COUNTY, NEW YORK  
19DCP009K

Prepared by:  
Greenhouse Consultants Inc.  
386 Broadway, Ground Floor  
Bayonne, NJ 07002

June 2018 (Revised October 2018)

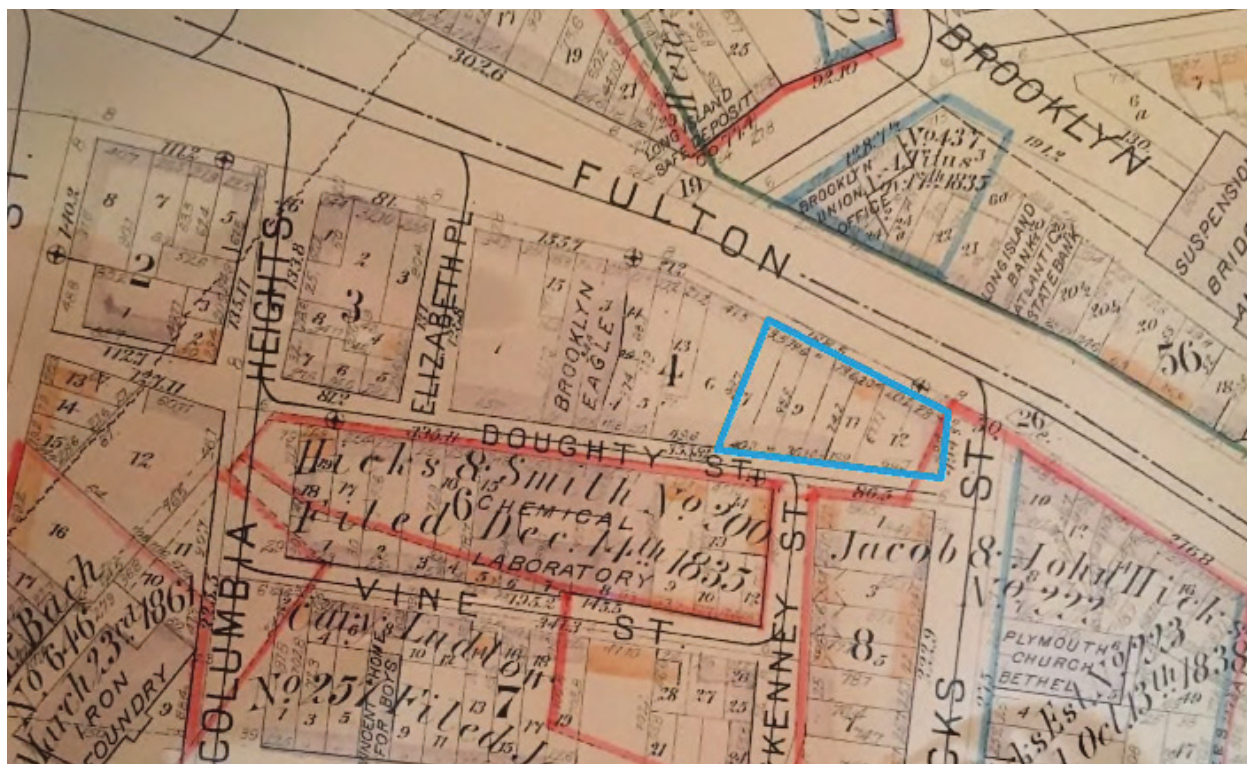
Figure 15. Detail of the 1880 Sanborn map with Lots 14 and 18 outlined (BHS).

Water pipes are first depicted on Fulton Street in the 1880 Sanborn map as 8-inch underground lines with hydrants (Figure 15). A 6-foot sewer was installed under Fulton Street in 1850, but it was a storm sewer and not connected to the houses. Solecki reminds that backyard cesspools would have been the primary recipients of wastewater and that flush toilets were particularly slow to replace outhouses in Brooklyn (Solecki 1981:378). Sanborn maps in the late 1880s and early 20<sup>th</sup> century show yards and one privy in the rear of Lot 18, on the Doughty Street side (Sanborn 1886 and 1887). This yard area has been a parking lot since the mid-20<sup>th</sup> century. A modern sewer was installed in Old Fulton Street in the late 1970s (Solecki 1981).

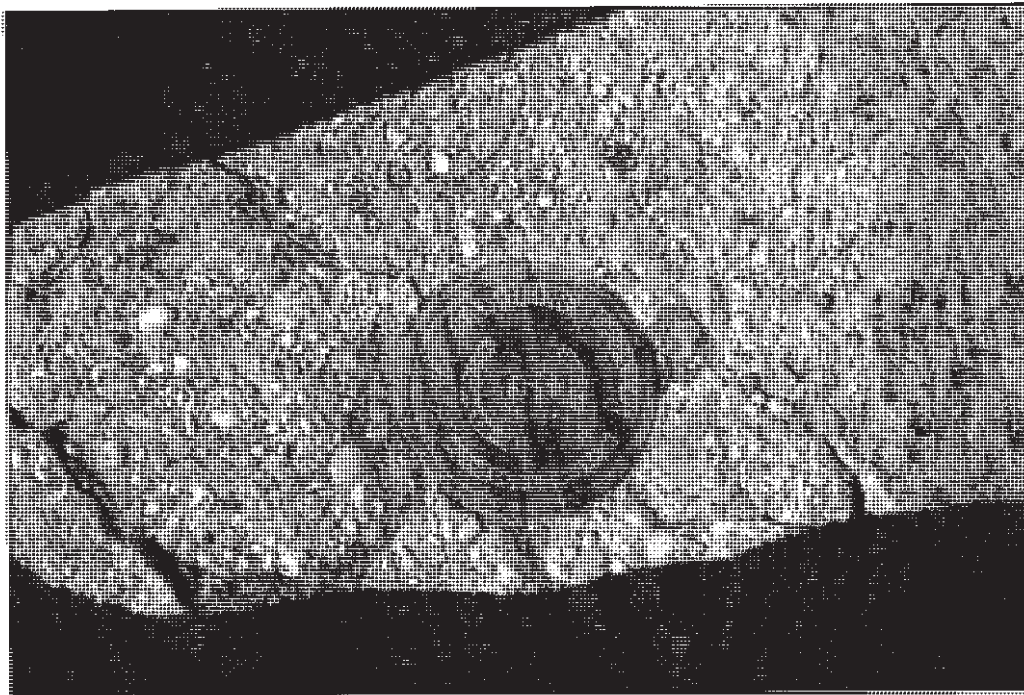
Gasoline UST Fill Pipe
