STAGE 1B ARCHAEOLOGICAL SURVEY OF THE 26TH WARD
WATER POLLUTION CONTROL PLANT EXPANSION PROJECT
BOROUGH OF BROOKLYN, NEW YORK CITY
KINGS COUNTY, NEW YORK

Prepared by:
William I. Roberts IV and
Jesse Ponz
Greenhouse Consultants Inc.
54 Stone Street, 7th Floor
New York, New York 10004

June 1990

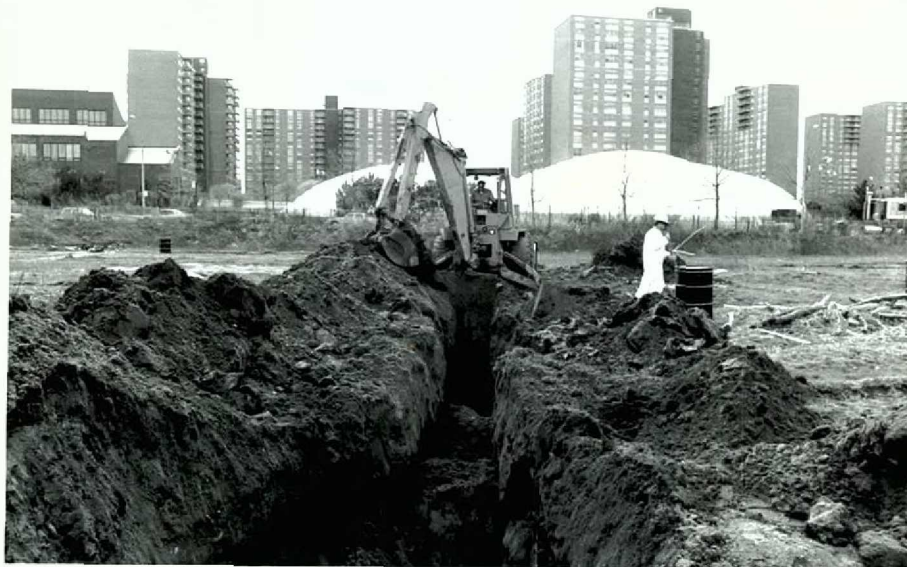
PLATE 1: View of backhoe trenching in operation.

The use of mechanical means of excavation expedites the removal of large quantities of fill. See Plate 1 for a view of backhoe trenching operation. A total of approximately 12,100 cubic feet of soil were removed from the trenches, the dimensions of which varied from 30 feet to 60 feet long, 3 feet to 5 feet wide, and 7 feet to 8 feet deep. Despite the excavation of the trenches being impeded by the seepage of ground water into the units, and the collapse of unit sides, probable original

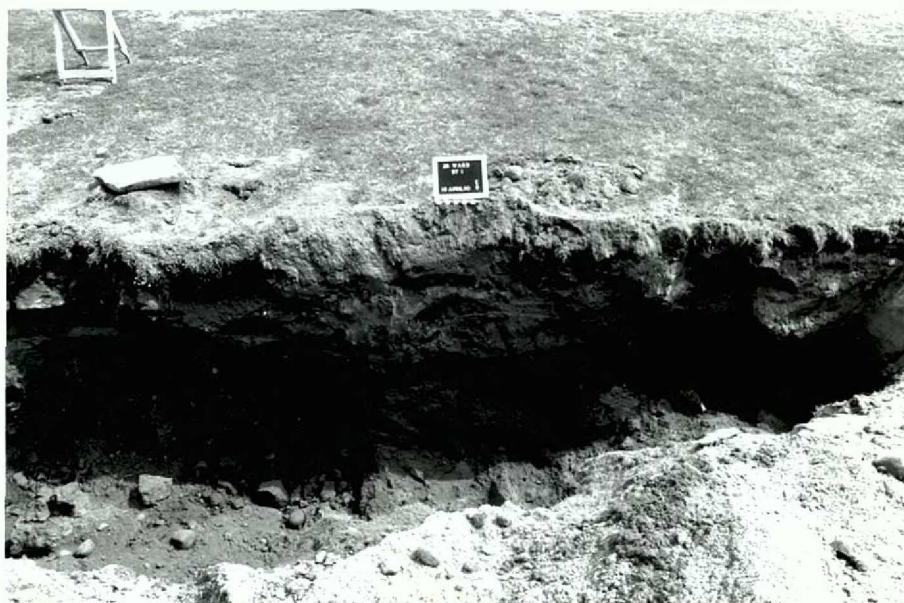
PLATE 2: View of Backhoe Trench 1, facing east.

The bottom layers of fill, approximately 4.9-5.0 feet thick, were yellow brown or dark yellow brown sand or sandy silt, with inclusions of red bricks, mortar, and small fragments of glass and ceramics. In the northern section of backhoe trench 1, a layer of dark gray brown silt was encountered adjacent to the dark yellow brown sand. In backhoe trench 2, there was a layer of black sandy silt that began between the top and bottom layers of fill, and continued down to the bottom of the trench adjacent to the yellow silty sand. The black color of the soil in this level may be the result of the leaching of a petroleum product into the soil before or after its redeposition. Large planks of creosoted wood were recovered from this stratum. The natural soils of the area, yellow brown or pale yellow brown clean sand were reached at depths of 7.0 feet to 8.0 feet. No cultural materials were recovered from this layer. In backhoe trench 2, ground water entered the unit at a depth of approximately 8.0 feet. See Plates 2 and 3 for views of Backhoe Trenches 1 and 2.

Backhoe Trench 1, located in the area proposed for new aeration tanks, was excavated to depths of 7.0 feet to 8.0 feet. Though the collapse of the sides of the unit during excavation precluded excavation in some parts of the trench to the projected depth of impact (eight feet), natural subsoil, a yellow brown sand, was encountered at a depth of approximately 7.0 feet and was devoid of cultural material. Cultural material recovered from upper layers consisted primarily of discarded building materials (e.g., bricks, window glass) and housewares used as part of the landfill during the mid-twentieth century.

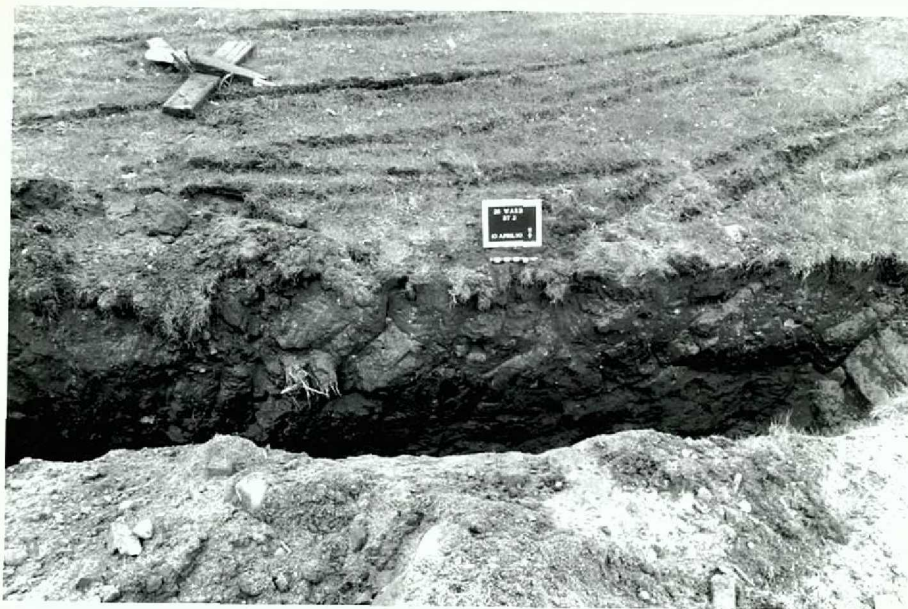
PLATE 3: View of Backhoe Trench 2, facing north.

Backhoe Trench 2, located in the area of the proposed new settling tanks was excavated to depths below eight feet, the depth of projected impact. The natural subsoil, a pale yellow brown clean sand, was encountered at approximately 8.0 feet and was devoid of artifacts. The artifacts recovered from the upper layers, comprised of mid-twentieth century landfill, consisted largely of discarded building materials, such as bricks, mortar, window glass and planks of creosoted wood.

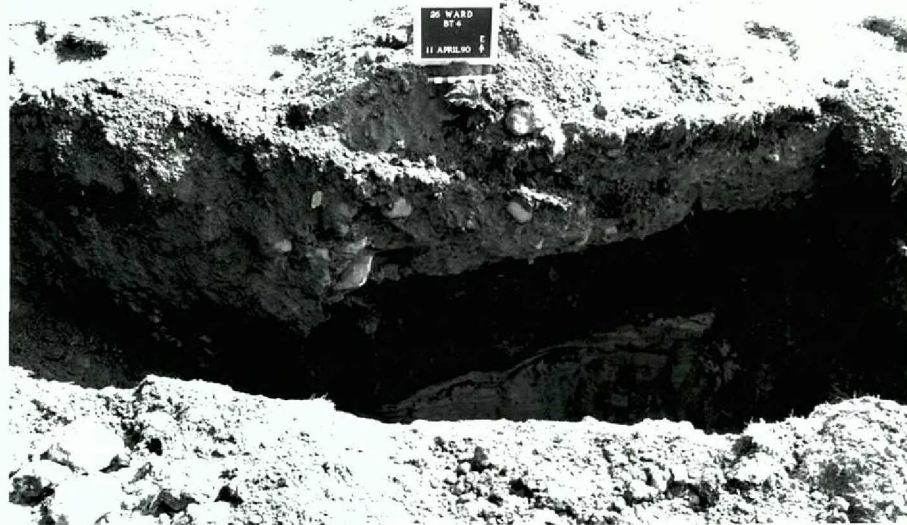
Backhoe Trench 4, located along the proposed sludge feed/return pipe was excavated to 7.5 feet, at which point ground water seeped into the bottom of the unit precluding further excavation. A buried sludge bed was encountered at a depth of 2.5 to 4.5 feet below which was a layer of dark gray sand with chunks of clay and peat probably representing redeposited marsh soils.

PLATE 5: View of Backhoe Trench 4, facing east. The bottom layer, just above the water table, consists of dark gray clay with inclusions of peat.

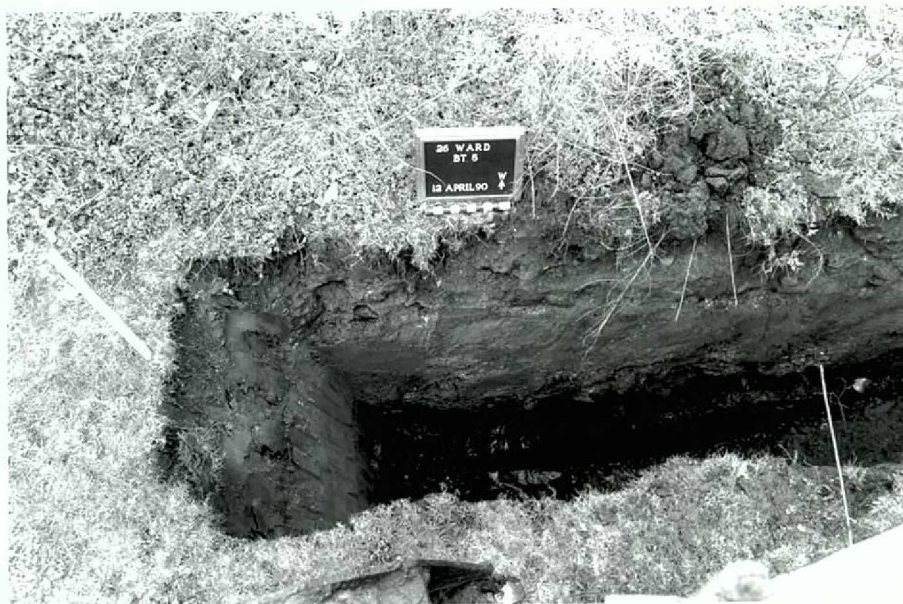
4/4), approximately 3.3 feet thick, yielded more than twenty whole bottles of mid-twentieth century origin. The bottom layer of fill was similar to that encountered in trenches 3 and 4, a very dark gray clay (10 YR 3/1) with organic inclusions of a peaty substance containing reedgrass. Ground water was encountered at a depth of 8.0 feet. The bottom layer, just above the water table, can be seen in the view of Backhoe Trench 5 provided in Plate 6.

Backhoe Trench 5, located along the proposed new electrical conduit, was excavated to a depth of eight feet at which point ground water seeped into the trench. The lowest layer, a very dark gray clay mixed with peaty organic soil encountered at a depth of approximately 5.3 feet indicates that the area of projected impact (8.0 feet below grade) is contained within landfill. Intermediate layers of landfill included a stratum consisting predominately of ash, and another of silt with a strong ash component. The ash layers, encountered at 3.0 feet below surface and continuing down for approximately 1.3 feet consisted of what appears to have been the contents of a primary or secondary waste disposal area as reflected by the concentration of mid-twentieth century artifacts, including more than twenty whole bottles (from which samples were recovered), ceramic fragments, a Christmas decorative light bulb and a radio (or television) tube.

PLATE 6: View of Backhoe Trench 5, facing west. The bottom layer, just above the water table, consists of very dark gray clay with organic inclusions.

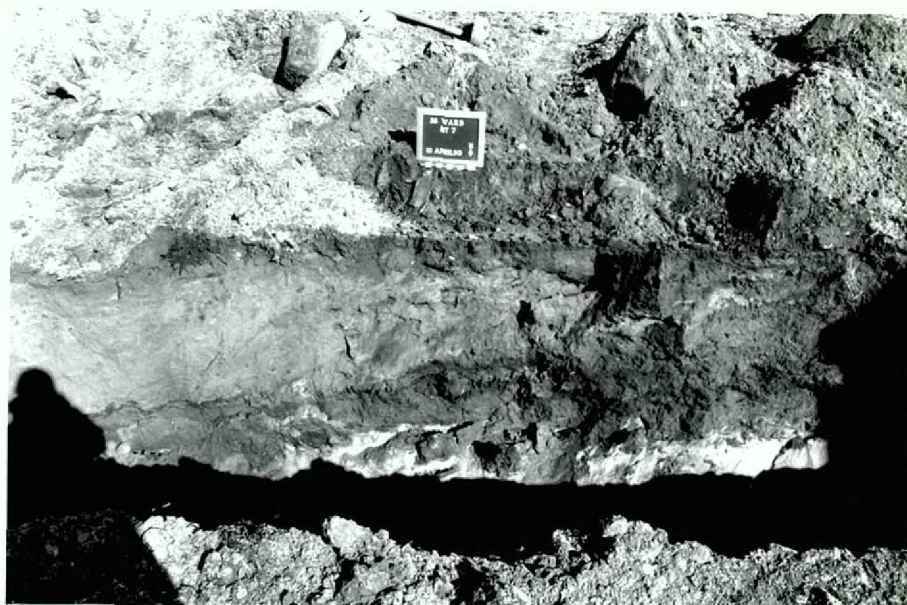
PLATE 8: View of Backhoe Trench 7, facing north.

Backhoe trenches 6 and 7 were located outside the present Water Pollution Control Plant facility in an area which though strewn with debris, had been cleared in certain areas for garden plots. The topsoil, approximately 1.0 feet in depth, was a dark yellow brown (10 YR 3/4) or very dark brown (10 YR 2/2) sandy loam. The top layer of fill, approximately 1.0 feet to 1.6 feet, was a yellowish brown (10 YR 3/4) silty sand or medium sand, devoid of cultural material. The next stratum of fill, approximately 0.6 feet to 1.0 feet in depth, was a black (10 YR 2/1) silty clay also devoid of cultural material. This layer was followed by a layer of yellowish brown (10 YR 4/6) coarse sand, approximately 1.7 feet to 2.2 feet thick. This stratum yielded fragments of bottle glass. Toward the bottom of both trenches, there were layers of fill consisting of gray (10 YR 5/1) and very dark gray (10 YR 3/1) sand with silty or coarse sand, with inclusions of the type of peat encountered in the other trenches. Approximately 2.3 feet of this layer were exposed in backhoe trench 6 before excavation was impeded by the intrusion of ground water into the unit at a depth of 7.0 feet. In backhoe trench 7, however, another stratum of fill was encountered beyond the 2.1 feet of gray coarse sand. This bottommost layer of fill, beginning at a depth of approximately 7.5 feet, was a black clayey silt with inclusions of peat and reedgrass. Cultural material from this layer included scraps of plastic, and rubber bands. Plates 7 and 8 provide views of Backhoe Trenches 6 and 7.

Backhoe Trench 7, located in the area of the proposed fire pump house, was excavated to depths of 7.0 to 8.0 feet. The lowest layers of the trench, a clayey silt with peaty inclusions, interpreted as redeposited marsh soils, contained evidence of modern cultural material, including a rubber band and fragments of a plastic bag. This evidence indicates that the depth of the proposed construction impact, here, four and a half feet, would not adversely affect any significant cultural resources.
