# Trinity Church Archaeological Oversight

## Phase 1 Construction

75 Broadway (Lot 1 Block 49) Manhattan

Prepared for Trinity Wall Street  
Through Murphy Burnham & Buttrick Architects  
and Trinity Wall Street  
Prepared by Joan H. Geismar, Ph.D., LLC  
July 2020

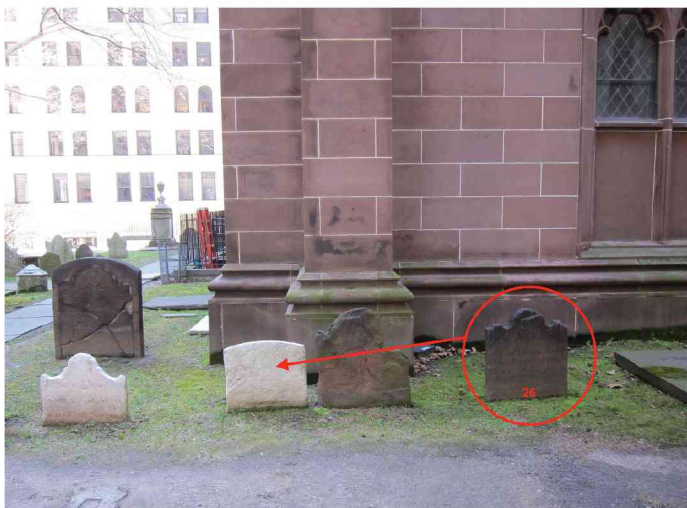
**Photo 3.** The four tombstones in the foreground, originally situated within the 1963 Manning Wing construction zone, were removed and then replaced, but not in their pre-construction order. For example, "No. 26" was originally to the left (Trinity Sketch, ND; not illustrated). (J. Geismar 4/18/18)

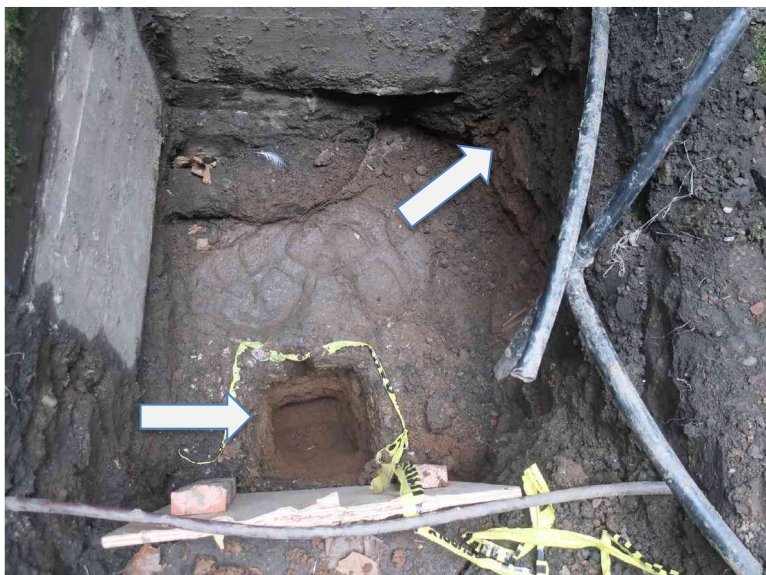
To limit excavation in a densely populated burial ground where burial sites are an unknown and where the goal was to identify a site for a 0.2 ft. (0.01 m) diameter soil boring, the project bioarchaeologist excavated a ca. 1.8 by 1.8-ft. (0.6 by 0.6-m) shovel test below the burial level (Photo 8). This determined that clean soil, which later proved to be natural, had been encountered under fill. Three days later, the site was cleared for the boring when drillers, using a posthole digger and then a hand auger, extended the initial shovel test to 8.5 ft. (2.6 m) BGS without encountering a burial or human remains and confirmed that natural soil had been reached.

**Photo 8.** Shovel test in TP LB-1 (left arrow). The view is north. The right arrow indicates where the *in situ* remains of an infant had been excavated (J. Geismar 9/7/18)

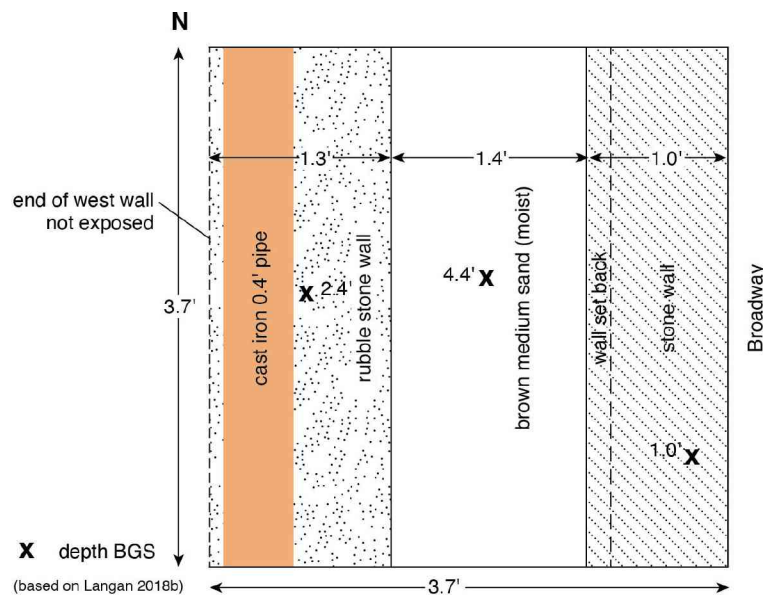
**Figure 9.** TP 1 Schematic Plan

**Description:** A slag layer under concrete paving was the same found elsewhere. Bird bones were found at the soil/slag interface; no human remains. A poorly made stone wall with cast-iron pipe above was exposed 1.4 ft. (0.4 m) W of the Broadway wall and was taken to depth of c.1.3 ft. (0.4 m) BGS]. Fill documented throughout.

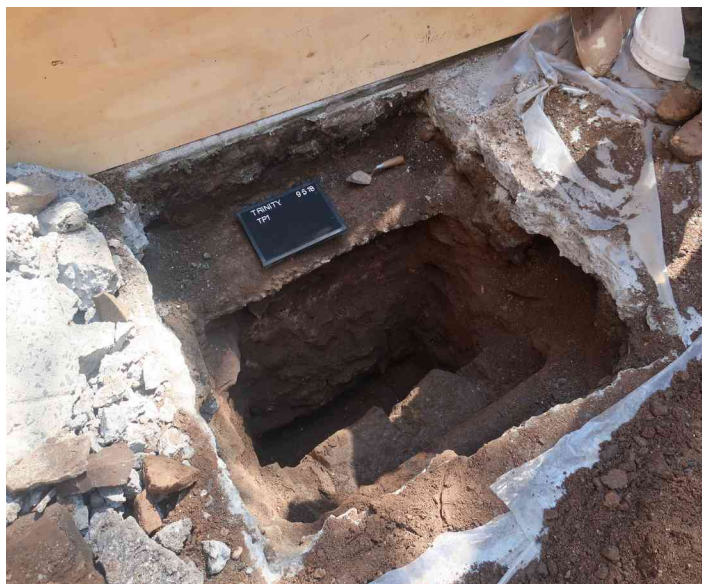
**Photo 9.** TP 1 after excavation. The view is east with the Broadway wall behind the protective plywood seen in the upper left corner of the photo. (J. Geismar 9/5/18)

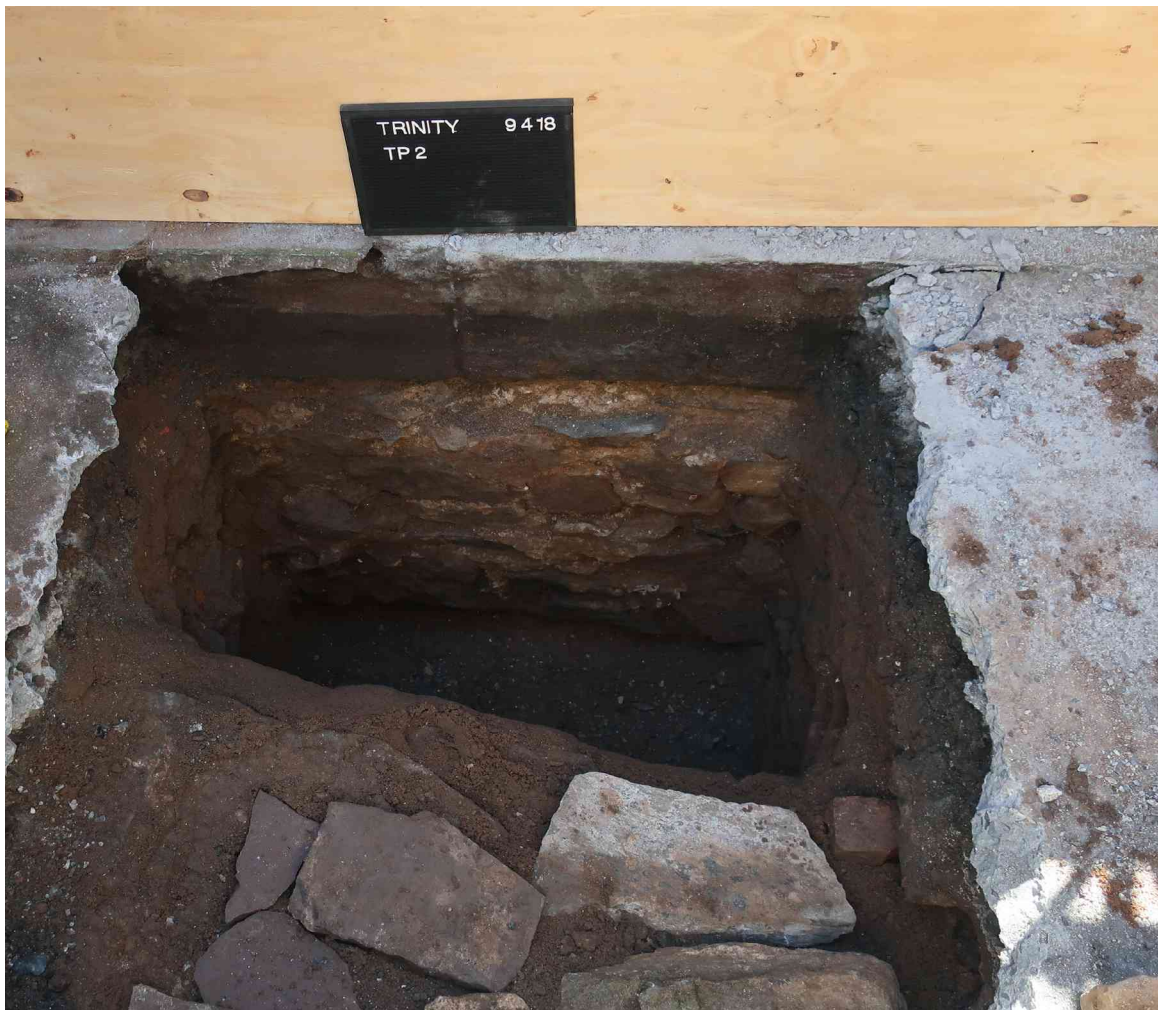
**Description:** Very dark fill soils c 0.5 ft. (0.2 m), glass frags. Brown/grey soils (10YR 3/2) under top layer. Some slag. Brick frag at c 2.0 ft. (0.6 m) in front of W wall. A distance of 4.0 ft. (1.2 m) from top of the wall to footing was exposed. Dressed stone debris, running E/W, in N corner of pit c 1.0 ft. BGS (0.3 m) topped by iron with cement dripped over the stone (?). Fill; includes some brick, shell and animal bone frags; teeth frags from a large mammal; no human remains. Fill throughout.

**Photo 10.** TP 2 located north of the church entrance. The view is east toward Broadway. The protective plywood in the upper background sits on the stone wall that serves as a base for the iron fence on Broadway (J. Geismar 9/4/18)

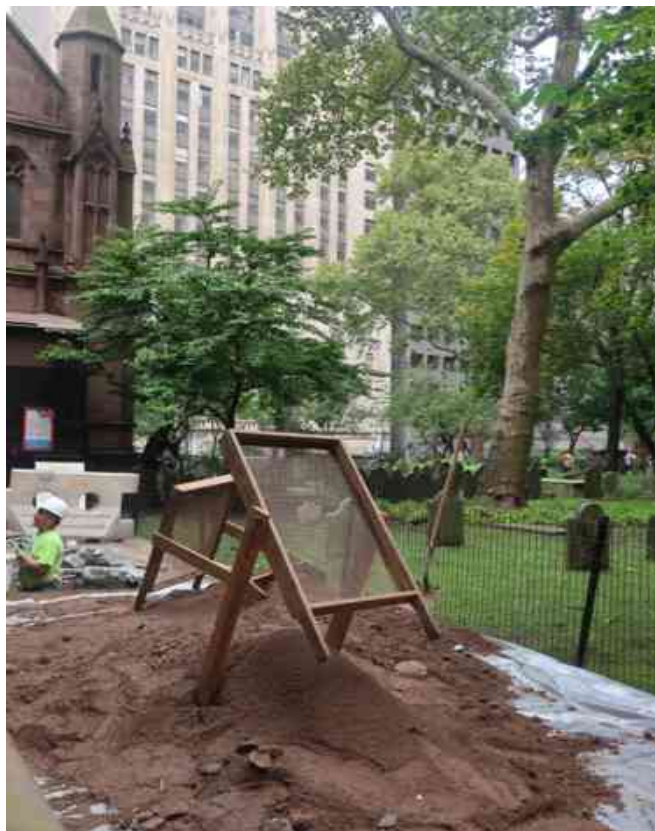
**Description:** First 0.25 ft. (0.08 m) was concrete paving over 1.25 ft. (0.4 m) of typical ash fill containing brick, shell, animal bones and corroded nails. At 1.5 ft. (0.5 m) BGS, it changed to sandy soil, still some brick frags c 2.3 ft. (0.7 m) in NW corner. Human bone frags along with clamshell, small ceramic frags, mortar, brick, terra-cotta pipe frags, unburned coal and slag, highly corroded nail, charcoal. Isolated human ulna and mandible at c 2.75 ft. (0.8 m) BGS. Bottle glass frags c 3 ft. (0.9 m). Cast -iron drain pipe exposed at 3 ft. (0.9 m) running N/S across pit 1.4 ft. (0.4 m) from W side of pit. Extended pit to determine configuration 2.7 ft. (0.8 m) to S. Human mandible in ash fill at c 3.2 ft. (1.0 m) BGS in center of extension. Much human bone at c 3.3 ft. (1.0 m) in SW half of extension; also animal bone (*rattus rattus*) and shell frags. Human remains possibly reflect disturbance from walkway and/or other construction episodes. Iron drain system is 0.66 ft. (0.2 m) diameter, upper pipe 3.7 ft. (1.1 m) BGS; top of lower pipe 5.0 ft. (1.5 m) BGS. Entire excavation in fill.

**Photo 11.** Screens at rest in the vicinity of TP 3. Screened soil from TP 3 lies under and around the screens. The view is northwest with Trinity Place in the background. (J. Geismar 9/13/18)

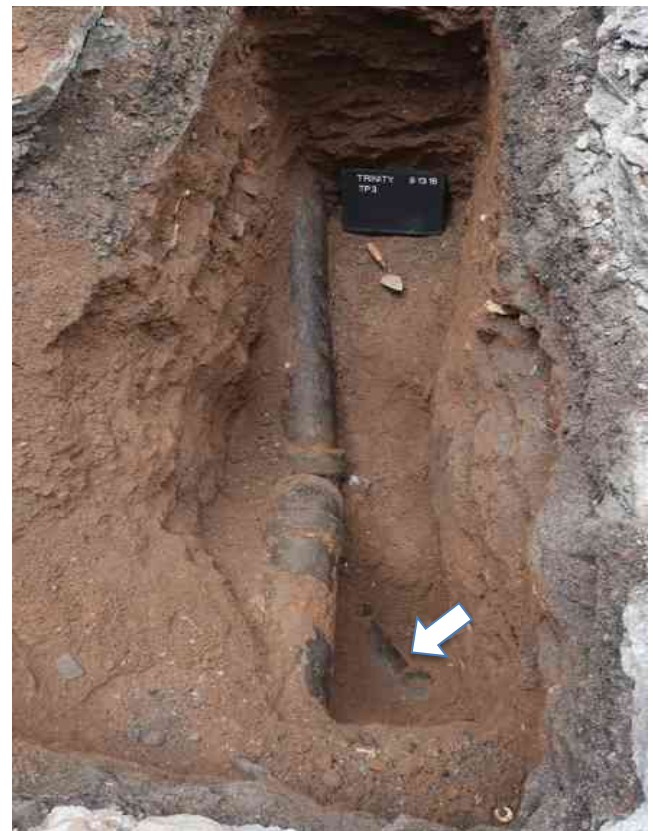
**Photo 12.** A network of relatively recent drain pipes, the sought after utilities, exposed in TP 3 on the south side of the church. Note a partially exposed deep pipe segment (arrow) to the right (J. Geismar 9/13/18)

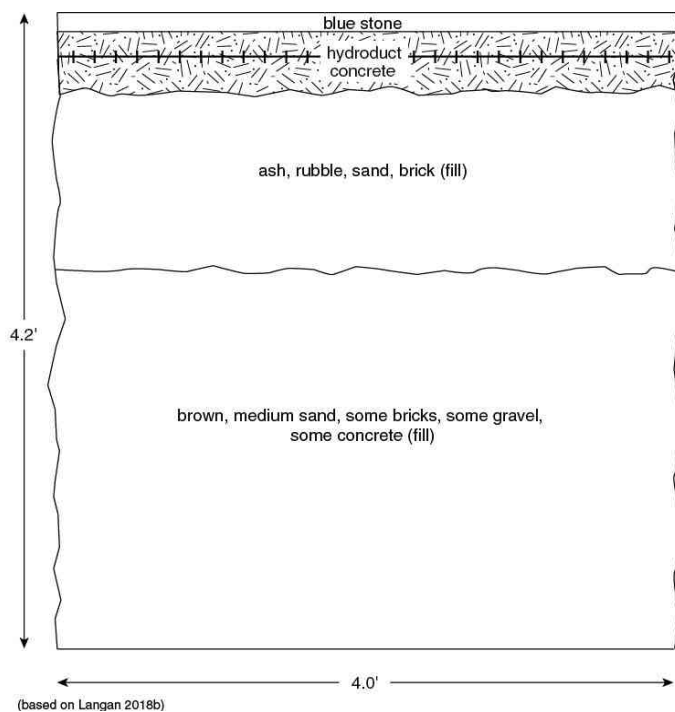
**Figure 10.** TP 4 Schematic East Wall Profile

**Description:** Paving stone removed. Excavation to 4.2 ft. (1.3 m) indicated fill throughout. Brick and terra-cotta frags, corroded nails, oyster shell. No vault was encountered.

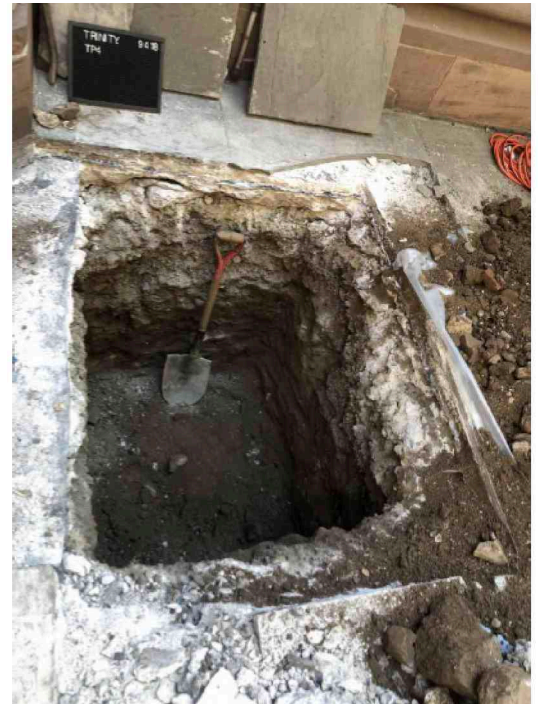
**Photo 13.** TP 4 looking east toward the back wall of Trinity Church. Soils comprised fill throughout the 4.0-foot (1.2-m) deep excavation where there was no evidence of a vault or vault access. (Langan 2018b). (J. Geismar 8/31/18)

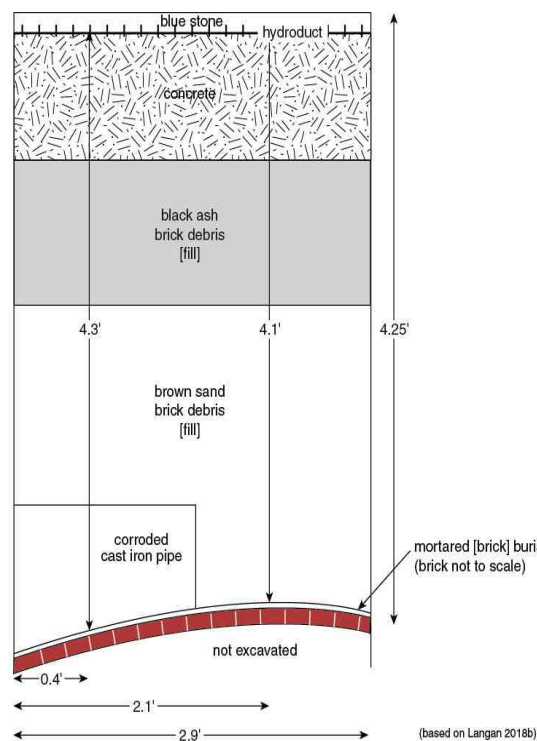
**Figure 11.** TP 5 Schematic East Wall Profile

**Description:** A blue stone walk and waterproofing was removed with a Jackhammer exposing an ashy fill followed by very compacted ashy fill soil (7.5 YR 3/4 dark brown) that contained slag, terra-cotta frags, a possible stone vault cover frag (no inscription), and one possible human bone frag. Also a great deal of oyster shell and small glass, brick, mortar, and ceramic frags, corroded metal (nail?). A human finger digit at 3.8 ft. (1.2 m) BGS in fill. A corroded cast-iron pipe extended across the top of the arched brick vault 4.0 ft. (1.2 m) BGS while a larger (0.6 ft. [0.2 m] diameter) pipe was exposed in the pit's NW corner ca. 3.ft. (1.1 m) BGS.

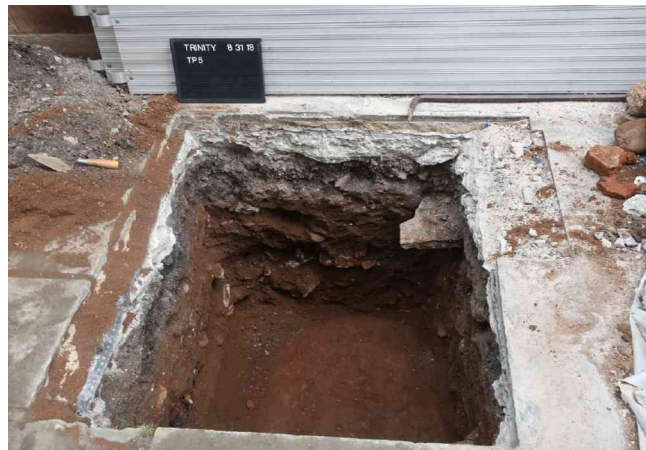
**Photo 14.** Top of a brick burial vault exposed in TP 5. The view is east looking toward the exterior rear wall of the church. Corroded cast-iron pipes were also exposed (see below). (J. Geismar 8/31/18)

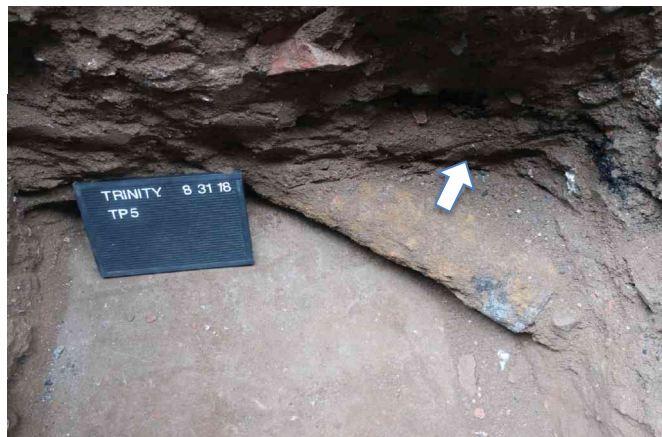
**Photo 15.** A corroded cast-iron pipe lays across the top of the exposed brick burial vault in TP 5. Another pipe (arrow) is visible in the west wall (J. Geismar 8/31/18)

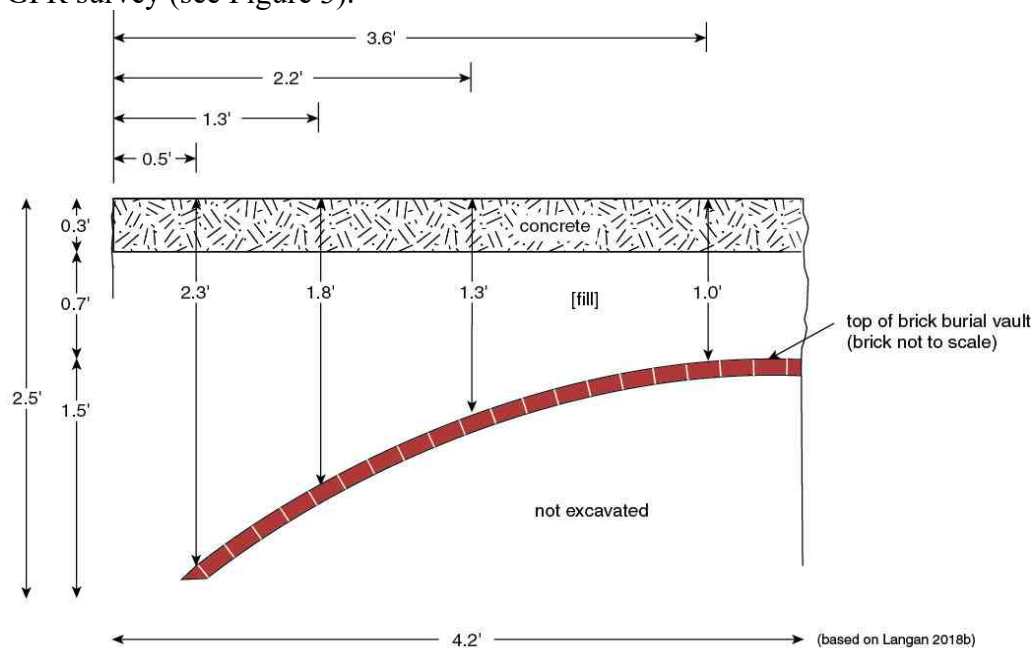
**Figure 12.** TP 6 East Wall Schematic Profile

**Description:** Surface stone paving removed followed by 0.9 ft. (0.3 m) to 1.1 ft. (0.3 m) of slag, then dark yellow brown soils. Bone frags in NW corner collected for ID. Many corroded nails in upper level of brown mix. Mortar, stone, brick frags, and unidentified bone (latter collected). The burial vault, at 1.1 ft. (0.3 m) BGS, is considerably vault was shallower than indicated by the GPR survey (see Figure 3).

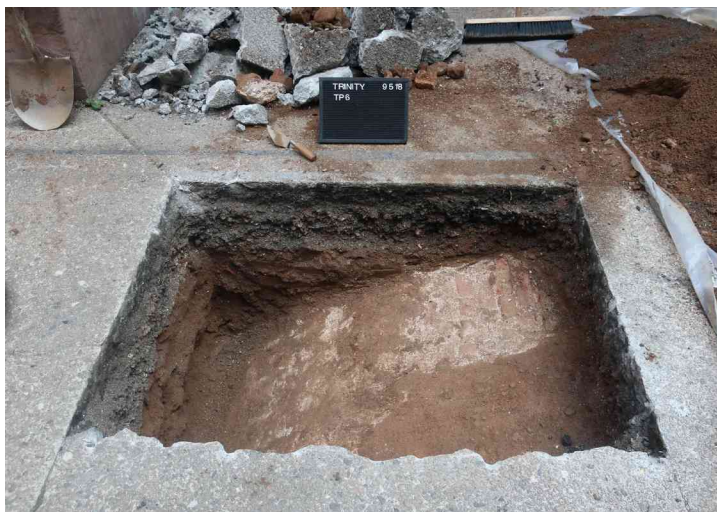
**Photo 16.** Top of brick vault in TP 6 looking east toward the exterior rear wall of Trinity Church. The GPR survey indicated the vault was 3.0 ft. (0.9 m) BGS (see Figure 3). However, it proved to be only c. 1.0 ft. BGS (0.3 m) BGS. (J. Geismar 9/5/18)

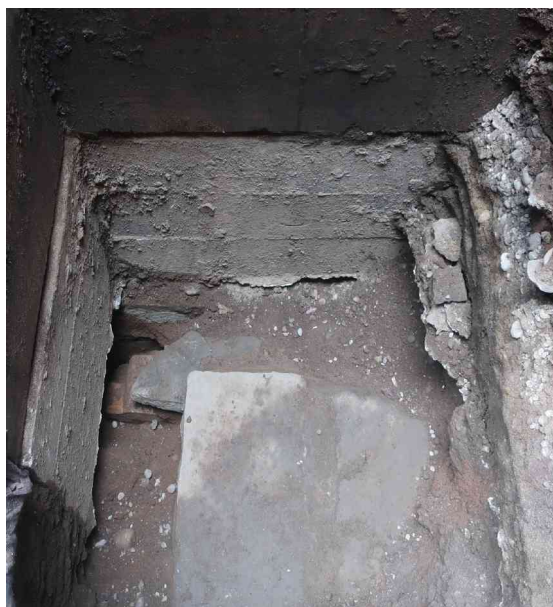
**Description:** Stony dense fill throughout. Brick and plastic frags and one plastic coffee cup lid 1.7 ft. (0.5 m) BGS and another at 2.5 ft. (0.8 m) BGS. Fill material at 2.0 ft. (0.6 m) BGS includes a shell, unburned coal, and a penny but no identifiable bone to this depth that included lumps of densely packed stony soil. Stone slab in NW corner at 3.3 ft. (1.0 m) BGS. Slab is 3.0 ft. (0.9 m) x 3.3 ft. (1.1 m). TP 7 excavation completed on 9/7/18 (see Photos 17 and 18)

**Photo 17.**  
(left) View of  
exposed west  
wall of TP 7.  
(J. Geismar  
9/7/18)

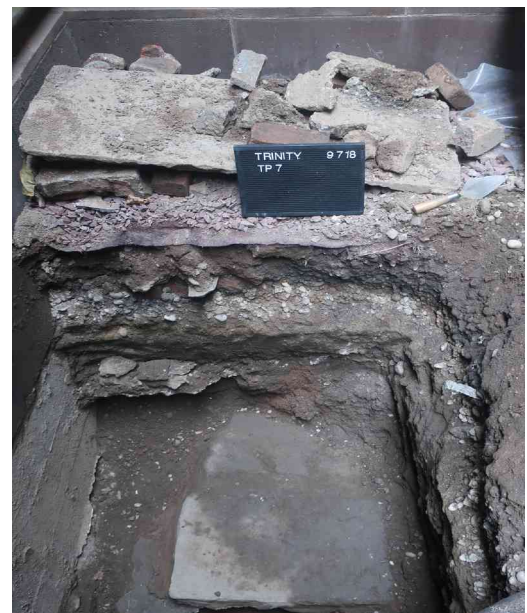
**Photo 18.**  
(right) View of  
the exposed  
east TP 7 wall.  
(J. Geismar  
9/7/18)

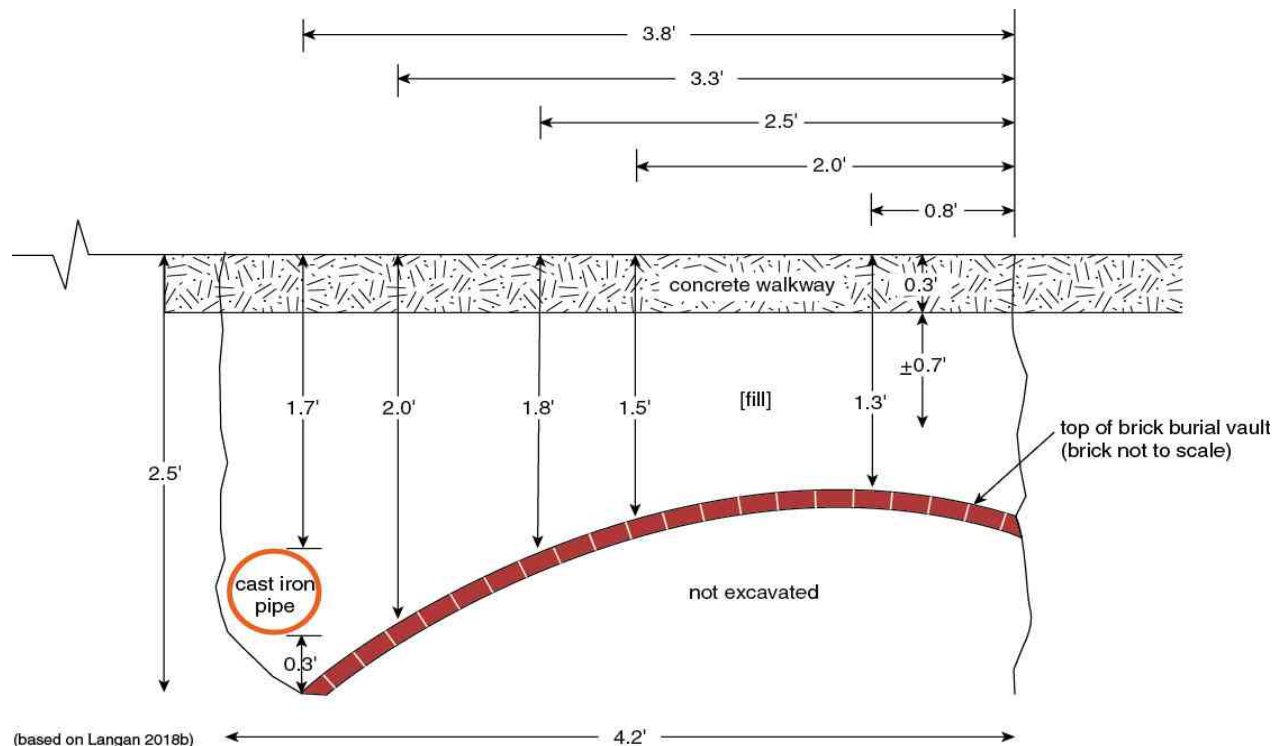
**Figure 15.** TP 8 East Wall Schematic Profile

**Description:** Ash and slag to 1.5 ft. (0.5 m). Fill included shell, brick, and stones. Drain pipe (cast-iron) along west edge of pit and vault. Vault reached at 1.9 ft. (0.6 m) BGS, but highest point (apex) actually 1.4 ft. (0.4 m) BGS, shallower than indicated by GPR. No bone material noted. Soil brown (10YR 3/3).

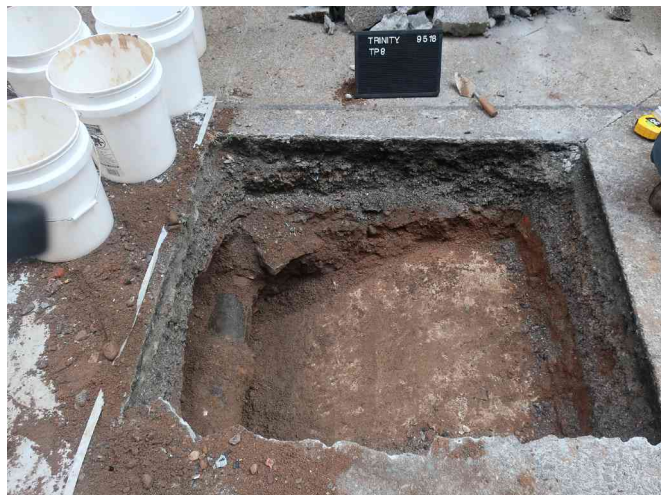
**Photo 19.** TP 8 view north toward the exterior south wall of the church. The exposed vault was considerably shallower than anticipated based on the GPR survey (see Figure 3): 2.5 (0.8 m) BGS on the survey while actually c.1.4 ft. (0.4 m) BGS, slightly higher than highest measurement indicated on the schematic profile. (J. Geismar 9/5/18),

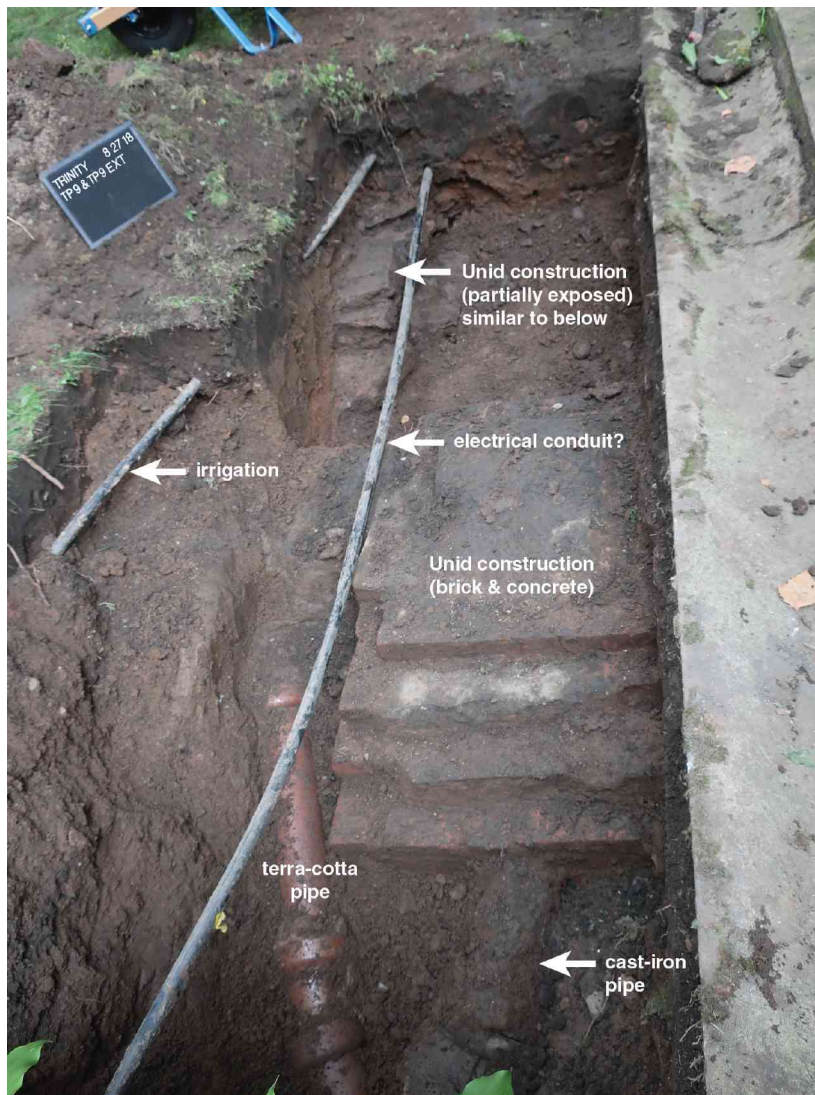
**Description: 8/27/18** Top soil followed by redeposited fill (glass, corroded metals, clinkers, coal, butchered animal bone, etc.) Irrigation pipe in NE corner of pit c 0.5 ft. (0.2 m) BGS. Soil change c 1.0 ft. (0.3 m) BGS, with metal pipe (electrical conduit) and gutter in center of the pit. Brick/concrete stepped construction [initially incorrectly thought to be vault related] encountered near S wall [ultimately assumed drainage related]. An associated terra-cotta pipe found W of the brick/stone feature c 2.0 ft. (0.6 m) BGS. TP 9 was extended E (TP 9 EXT) to expedite deeper excavation. Two (2) bone frags recovered. A comparable feature in the NE corner of the extended pit with the terra-cotta pipe running along the N side. The pipe extended south to the feature encountered in the original part of the TP. Excavation again terminated at 2.0 ft. (0.6 m) BGS. Cultural material in the extended TP included a slate pencil frag, a crown cap, assorted nails, a kaolin pipe stem frag, a 22. shell casing, a Blue Transfer Print frag (willowware?), a 1978 penny, and a HUTTER bottle closure [patented 1877] “A. KRU...KER/ 512 W. 166/ 8 ST NY/ PATENT K. HUTTER”].

**\*Note:** TP 9 was ultimately in three parts. Initially near the SW corner of the churchyard, it was extended east after a brick feature and associated terra-cotta pipes, apparently related to drainage, and electrical conduits and irrigation pipes were encountered; excavation terminated at c. 2.0 ft. (0.6 m) BGS. After components of the drainage feature were found in an extension of TP 9 (TP 9 EXT), TP 9 was relocated 8 ft. (2.4 m) further E and was successfully was taken to a depth of 11.9 ft. (3.6 m) BGS with shoring/lagging.

**Photo 20.** TP 9 and TP 9 EXT looking east. Two similar drainage features are exposed: the step-like brick construction to the right (adjacent to the Rector Street wall) with an associated cast-iron pipe and a terra-cotta pipe (left foreground) associated with a similar brick construction (only partially exposed) in the upper left corner of the pit. An irrigation pipe (far left) and a probable electrical conduit (center) complete the picture. (J. Geismar 8/27/18)

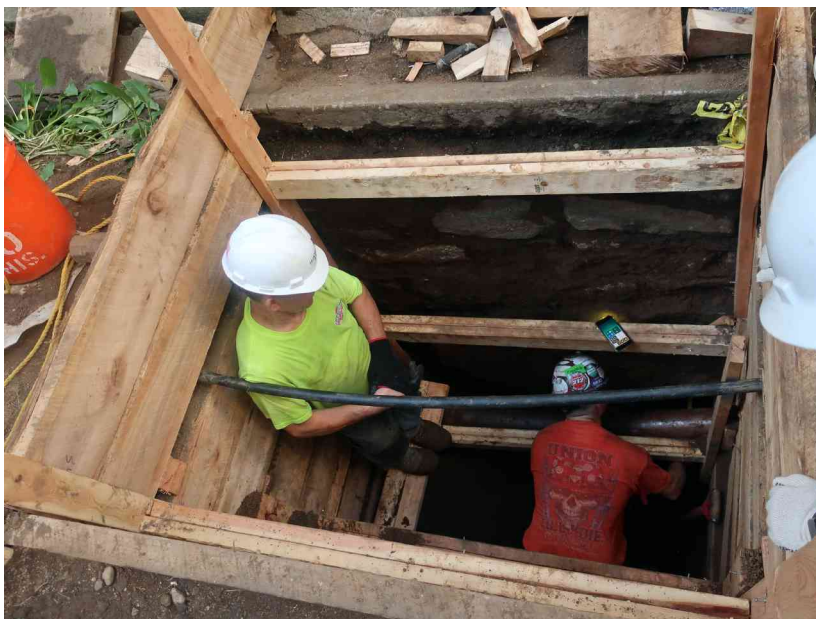
**8/30/18** The introduction of lagging continued with depth. Soils adjacent to the S wall were moist, sandy, and coarse (10YR 3/4 brown). A terra-cotta pipe was exposed adjacent to the wall in a setback for the wall footing. The top of the pipe was confirmed at 5.5 ft. (1.7 m) and the top of the footing setback at 8 ft. (2.4 m) BGS. A 2.5 ft. (0.8 m) poorly made stone “pier,” rather than a footing, extended above the set back. The pier was excavated under the wall to 11.0 ft. (3.4 m) BGS. The stone pier was associated with an inner wall while the wider exterior wall continued down.

**8/31/18** Excavation around stone pier of the inner wall ended at c 11.9 ft. (3.6 m). A small kaolin pipe stem frag at 11.2 ft. (3.4 m) BGS was the only artifact noted below 5.0 ft. (1.5 m) BGS.

Therefore, a basically clean but stony fill was found from 5.0 ft. (1.5 m) to 11.9 ft. (3.6 m) BGS where the excavation terminated. Screening was continuous throughout the 5 day excavation.

**Photo 21.** TP 9A, located adjacent to the Rector Street exterior wall and east of TP TP 9 and TP 9 EXT, near the end of excavation by LIC personnel. Lagging was introduced sequentially to shore the test Pit that ultimately extended down 11.9 ft. (3.6 m) BGS to expose the exterior wall footing and a pier-like inner wall. Scattered human remains were recovered from fill between 2.0 to 4.0 ft (0.6 to 1.2 m) BGS. (J. Geismar 8/31/18)

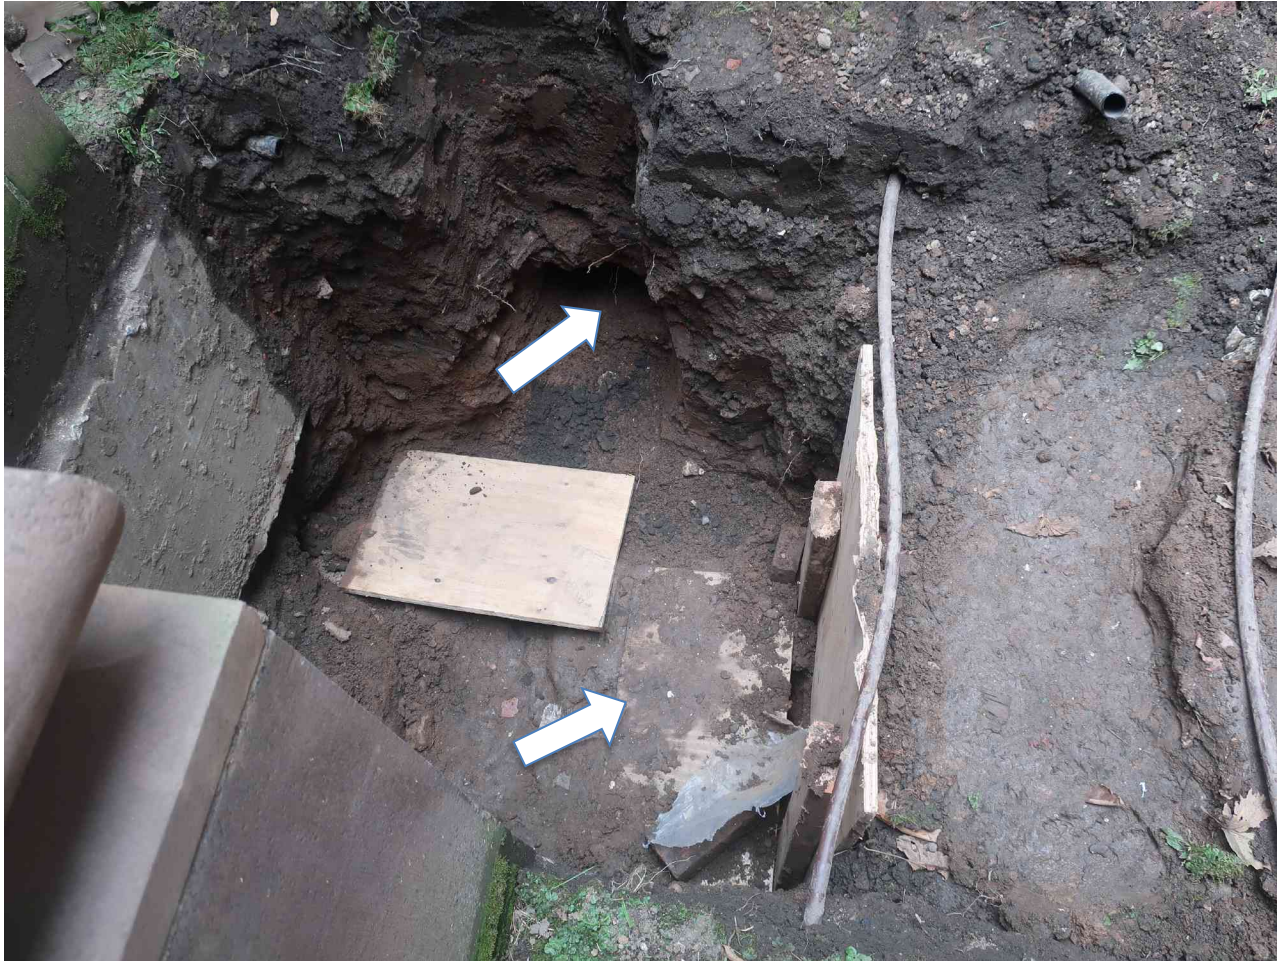
**Description:** 9/6/18 Located at the SE the corner of the building, dense wet soils with stones was encountered. Fill material included oyster shell, corroded nails, glass, ceramic, and plastic frags, animal bone, and terra-cotta pipe frags. Irrigation hoses (2) were exposed, one along the W edge of the TP, the other in the E part, both in the upper 0.5 ft. (0.2 m). Soil (5YR 2.5/black) to c. 2.3 ft. (0.7 m) BGS was stony/dense. An animal bone frag and footing stones associated with the Manning Wing encountered below this level. Soil density required troweling through the wire mesh and revealed a concentration of mainly upper body, juvenile human bones and bone fragments from the E part of TP. Included were mandible frags with teeth and sundry teeth, ribs, arm, and vertebrae. The contractor halted excavation with archaeological excavation to continue the next day.

9/7/18 The E part of the TP was photographed at 2.8 ft. (0.9 m) BGS and W part at 2.9 ft. (0.9 m) BGS prior to archaeological removal of human skeletal material (authorized by the Church prior to a proper burial after ton-site study). Bricks stabilized the plywood sheathing during excavation of the remaining bones. Matt Brown, the project bioarchaeologist, assisted by Cory Look, conducted the excavation. Possible coffin nails, heavily corroded, noted perpendicular to the left and right femurs with no evidence of a coffin or burial shaft. The radii, ulna, lumbar, and metatarsals were removed to access tibia, fibula, tarsals, and metatarsals noted under the TP's south wall. The burial was in fill that terminated immediately under the *in situ* remains (small brick fragments and an oyster shell found under the vertebrae). While apparently was *in situ*, the burial seems not in its original burial site (perhaps removed intact during the 1960s construction of the Manning Wing and then reburied?). Following excavation of the burial, and to identify a location for the soil boring, a shovel test (ST) (1.0 ft. x 1.0 ft. [0.3 m x 0.3 m]) was archaeologically excavated in the SW corner of the TP from c. 3.0 ft. (0.9 m) BGS to a depth believed to be 6.0 ft. (1.8 m) BGS (see Photo 7). There was no evidence of human remains in the screened ST soil. Photos were taken and the TP protected with plywood in anticipation of using a posthole digger the next day to take the ST to 10.0 ft. (3.0 m) BGS (Photo 21). While the ST soil below the burial level differed from soil in the burial area (7.5YR 4/4 brown), it too was dense. Small shell and brick frags in the upper part of the ST indicated fill. Soil was somewhat redder and sandier with depth (5YR 4/6 yellowish red) but remained very dense.

9/10/18 Raining. Difficult conditions. Drillers used a posthole digger and then a hand auger to take the ST from 5.2 ft. (1.6 m) to 8.5 ft. (2.6 m) BGS where a large rock/boulder was encountered. Dense soil made screening impossible so soil was troweled through. While there was no discernible soil change in what appeared to be clean soil, a decayed oyster shell frag was noted c 7.5 ft. (2.3 m) BGS. The soil remained consistent – sand, gravel, stones and some rocks (10YR 3/5 dark yellow brown) from 7.5 ft. (2.3 m) to 8.5 ft. (2.6 m) BGS. The deepest sample (8.0 to 8.5 ft. [2.4 m to 2.6 m]) BGS included two degraded oyster shells, seemingly of great age. A mystery. However, rather than fill artifacts, these shells and the one above apparently were associated with glacial kames (natural soil hills) once located near the Hudson River shore (Schuldenrein 2019:personal communication). This was prior to land reclamation that extended the shoreline to Washington Street in the late 18th century (see Viele 1865; Figure 16). In the 20th century, to create Battery Park City, additional land reclamation extended the shoreline further west.

**Photo 22.** TP LB-1 after excavation and removal of the *in situ* remains of the infant burial during Stage 1. The remains were removed by extending the excavation into the east wall of the pit (upper arrow). The shovel test shown in Photo 8 (see text) is covered by a muddied piece of plywood (lower arrow). The exposed plywood in the center was introduced to stabilize the saturated soil as was the “shoring” to the right (under an irrigation line). The exterior southeast corner of the Manning Wing is in the lower left corner of the photo. (J. Geismar 9/7/18)

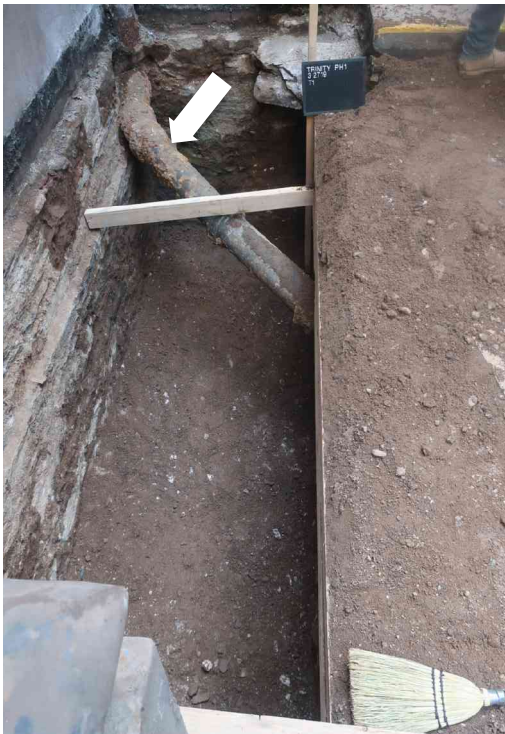
**Description:** TP 1, one of the site's unpaired TPs, was the largest planned test pit and the location of two pile sites. While test pits were basically 4 ft. (1.2 m) square, TP 1 was 8 ft. (2.5 m) E to W by 4 ft. (1.2 m) N to S. An initial ash layer (c. 1.0 to 1.5 ft. [0.3 to 0.5 m] thick), was typical of what was found under the paved walkway). What appeared to be a brick over stone "wall" that defined the pit's S edge (Photo 24) subsequently proved to extend as far as TP 8N. Speculatively a remnant of the demolished 1836 church, the second church on the site, it instead was a N line of burial vaults located beneath the existing paved walkway as documented on a 1925 map (see Figure 18).<sup>10</sup> A cast-iron drain pipe was exposed in the NE part of the TP. Pile sites 15 and 17 were located in TP 1 (Photos 25 and 26).

**Photo 24.** TP 1 in the easternmost alcove. A Cast-iron drain pipe (arrow) is exposed in the east end of the TP. (J. Geismar 3/27/19)

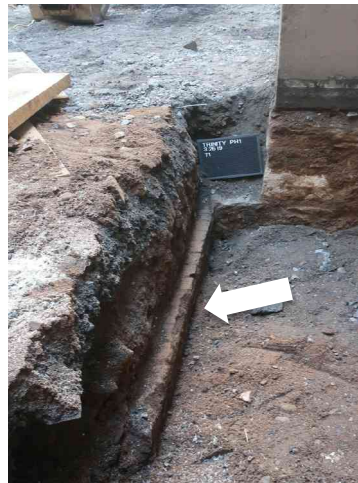
**Photo 25.** Top of brick vault "wall" (arrow) exposed on the south side of the TP. (J. Geismar 3/26/19)

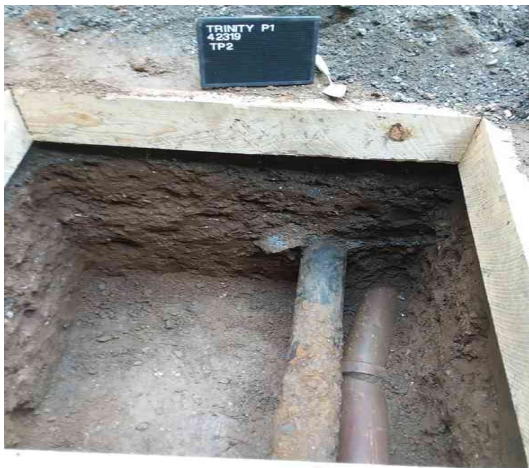
**Description:** TP 2 was one of the of six unpaired TPs in the sample. Drainage pipes were exposed in the W part of the TP c. 3.5 ft. (1.1 m) below the surface (Photo 27) and a brick construction that proved to be the W wall of a burial vault was noted in the E wall c. 2 ft. (0.61 m) BGS. Several months after the initial 4-ft. (1.2-m) deep excavation, an additional 6 ft. (1.8 m) were excavated with archaeological oversight to fulfill a Building Department requirement (Photo 28). Fill was documented throughout and the vault wall continued down beyond the monitored depth (excavation continued another 15 ft. [4.6 m] BGS without archaeological oversight). A bone cache, with a fragment of butchered animal bone, was encountered at 7 ft. (2.1 m) BGS during the introduction of S wall lagging. Dr. Allan Gilbert, a brick specialist, kindly examined a large fragment of mortared brick recovered from the TP fill c. 9.0 ft. (2.7 m) BGS. Based on its composition, condition, and mortar, he determined it could be a remnant of a colonial-era brick (Gilbert 2019:Personal Communication; Appendix C). Pile 16 subsequently was introduced into the excavated TP without additional oversight. Shallow cross beam trenches later formed a “Y” that connected Pile 16 in TP 2 and Piles 15 and 17 in TP 1.

**Photo 27.** TP 2 with cast-iron (left) and terra-cotta (right) pipes exposed on the west side of the TP. The view is south. (S. Spritzer 4/23/19)

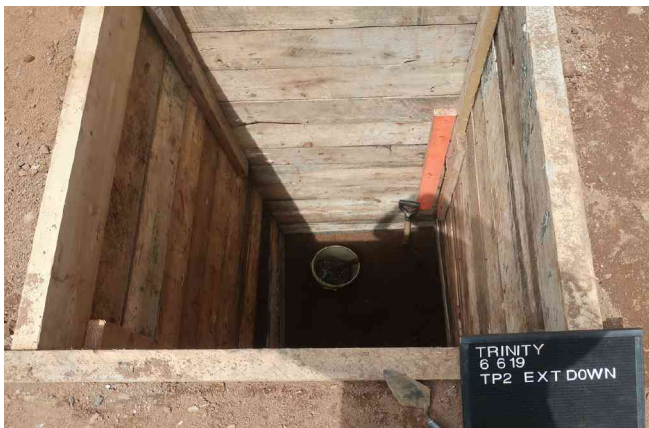
**Photo 28.** TP 2 after extension from its original 4 ft. (1.3 m) depth to 10 ft. (3.1 m) BGS with archaeological oversight (J. Geismar 6/6/19). An additional 15 ft. (4.6 m) were added without oversight to fulfill a Building Department requirement. Lagging covers the vault wall exposed on the east side (right) of the TP. Note the bucket (arrow) in the northwest corner of the TP.

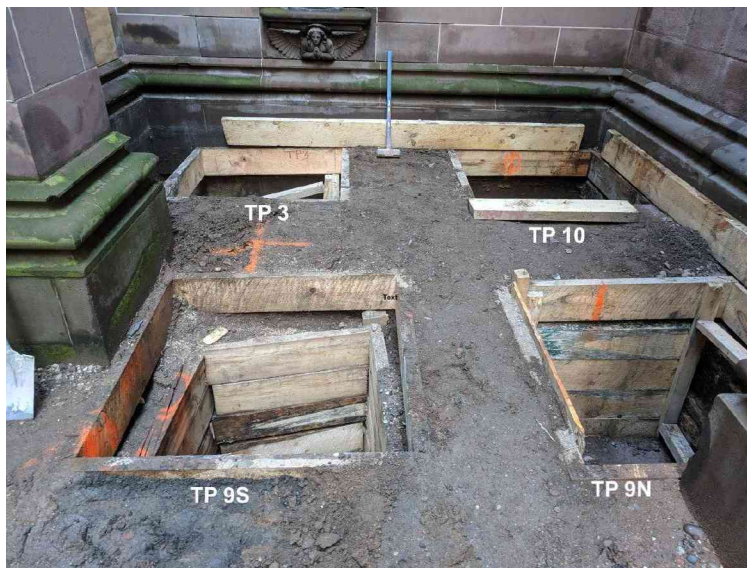
**Description** TP 3, one of the 4 unpaired TPs in Stage 2, was located at the W end of the S row of test pits, close to TP 9S and adjacent to and partly overlapping TP 7 excavated during Stage 1 oversight . The proximity of the four TPs in this area (TP 9N, TP 9S, TP 10 and TP 3; Photo 29), and a vault and vault access adjacent to the E wall of the Manning Wing, necessitated repositioning TP 3 and adding an exploratory extension (TP 3 EXT). The extension connected TP 3 and TP 9S. A concrete slab was exposed at 3 ft. (0.91 m) BGS (Photo 30) as were a building footer (Photo 31) and the vault. Mixed fill, including a Wrigley's gum wrapper at 4 ft. (1.2 m) BGS, was found throughout. Fill also included animal and human bone and a human tooth.

**Photo 29.** TP cluster (TP 3, TP 10, TP 9N, TP 9S) adjacent to the Manning Wing to the left and rear. The view is west. (D. George 5/31/19)

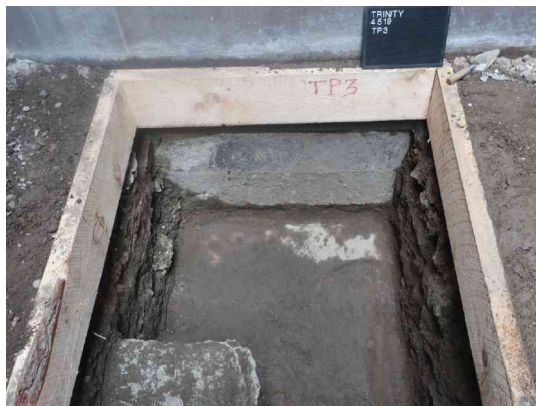
**Photo 30.** TP 3. A concrete slab in the lower left corner originally was exposed in TP 7 during Stage 1 Oversight. In the background is the east wall of the Manning Wing (D. George 6/24/19)

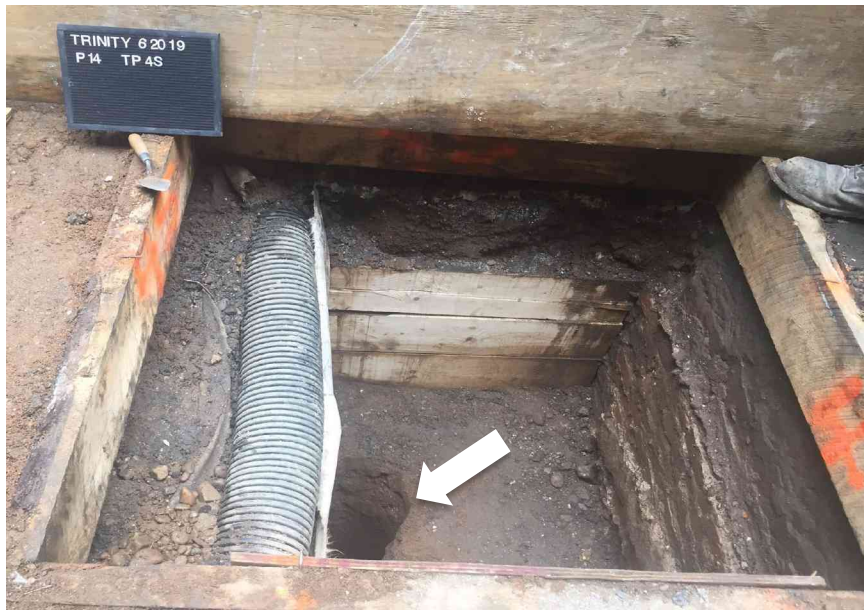
**Description:** W wall of the TP and E wall of a brick vault (?). PVC drain pipe parallels E pit wall (Photo 33). Relatively clean fill with no artifactual material noted below 4.0 ft. (1.2 m) during subsequent pile excavation although the brick wall indicated a fill situation. Excavation with a post hole digger reached a depth of 8.2 ft. (2.5 m) BGS during pile site excavation oversight. (Note: this was the initial pile site excavation. Rather than using a post hole digger, subsequent pile sites were hand excavated within each TP to attain the desired oversight depth).

**Photo 33.** TP 4S after pile site excavation with a post hole digger. The PVC pipe on the east side of the TP was exposed during the earlier TP excavation and was left in place. What appears to be a vault wall is to the right. The view is south. (J. Geismar 6/20/19)

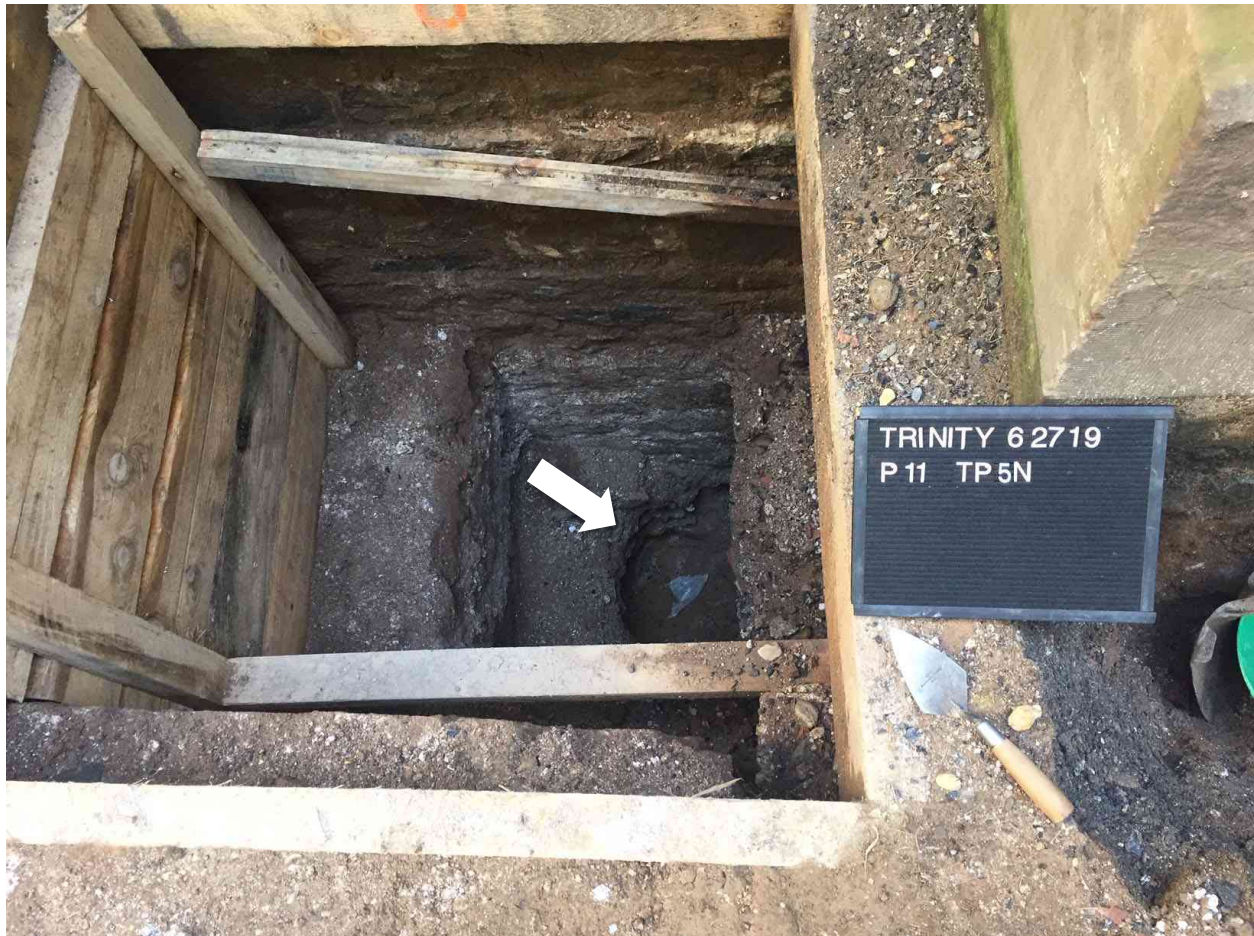
**Description:** Typical fill (some shell, corroded nails, ceramic frags). Brick and stone wall first observed on S side of TP 1 continues W. Possible animal bone frag. at 4.0 ft (1.2 m) BGS. Fill mixed with slag. Long bone frag. (animal?) in pile site excavation at 6 ft. (1.8 m) BGS. (Photo 34).

**Photo 34.** TP 5N after excavation to test for Pile 11. While there was no archaeological oversight beyond 6 ft. (1.8 m) BGS, the photo, taken 6/27/19, suggests the test was at least 9 ft. (c 2.7 m) BGS. (J. Geismar 6/27/19)

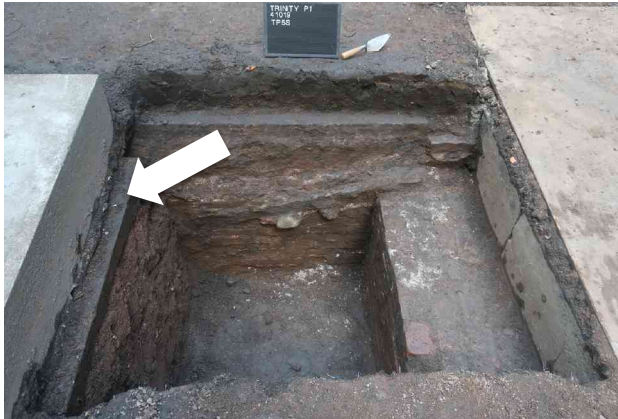
**Description:** Evidence of a shallow brick construction and stone "slabs" (edging?) along the N edge and stone slabs to the S necessitated expanding the TP to S and W (Photo 35) and were possible evidence of vault access in the TP's W wall. N wall of the TP was extended somewhat to assess brick wall. Worked stones are probably a walkway edging. Examination of the backdirt suggested that testing of Pile Site 12 reached natural soil, but at what depth was not determined.

**Photo 35.** TP 5S looking west. Excavation exposed a brick construction to the north (right), a possible brick burial vault in the west wall (rear) and the edging of a vault access to the left (arrow). (J. Geismar 4/10/19)

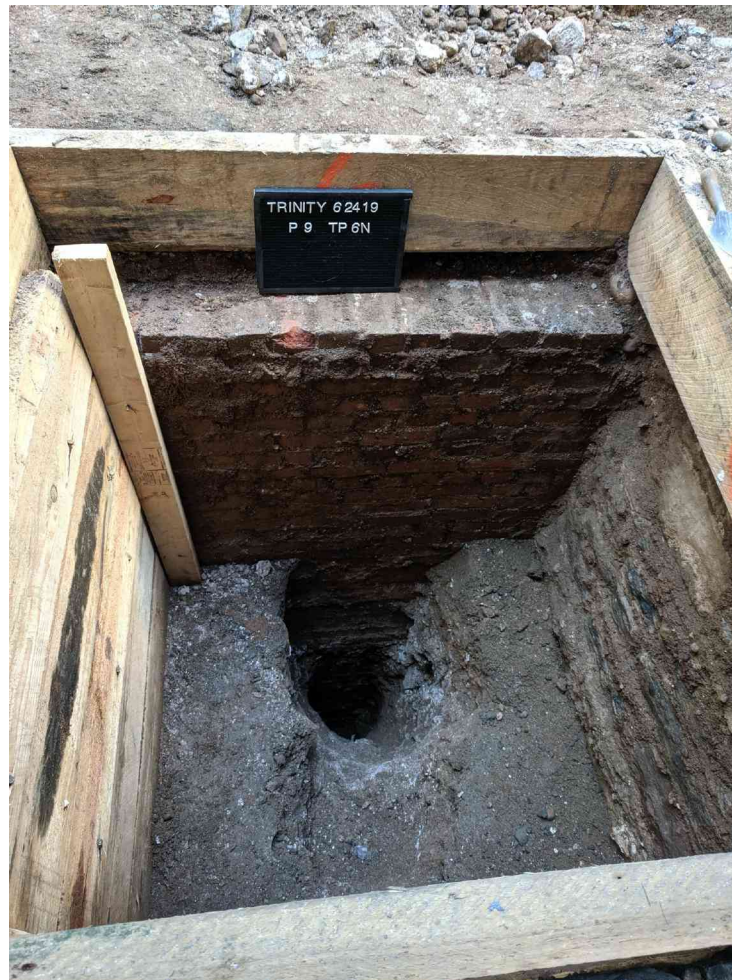
**Description:** South TP wall is again is defined by the line of brick vaults (Photo 37). Typical fill (e.g., charcoal, burned shell, corroded nails, ceramic frags., vertebrate frag) from 2.75 ft. to 4 ft. (0.8 to 1.2 m) BGS of the TP excavation beneath deep ash layer (the ash layer was troweled through rather than screened). Fill, albeit mainly brick and mortar frags, extended into the deeper pile excavation, including the last ft. of excavation. Soil more saturated with depth.

**Photo 37.** TP 6N and the site for Pile 9 excavated to 9.8 ft. (3.0 m) BGS. The view is south. The pile site is adjacent to the brick vault wall first noted in TP1. Fill included whiteware frags and a corroded nail. Construction to the right, which defines the west TP wall, was unidentified. (D. George 6/24/19)
