# Trinity Church Archaeological Oversight

## Phase 1 Construction

75 Broadway (Lot 1 Block 49) Manhattan

Prepared for Trinity Wall Street  
Through Murphy Burnham & Buttrick Architects  
and Trinity Wall Street  
Prepared by Joan H. Geismar, Ph.D., LLC  
July 2020

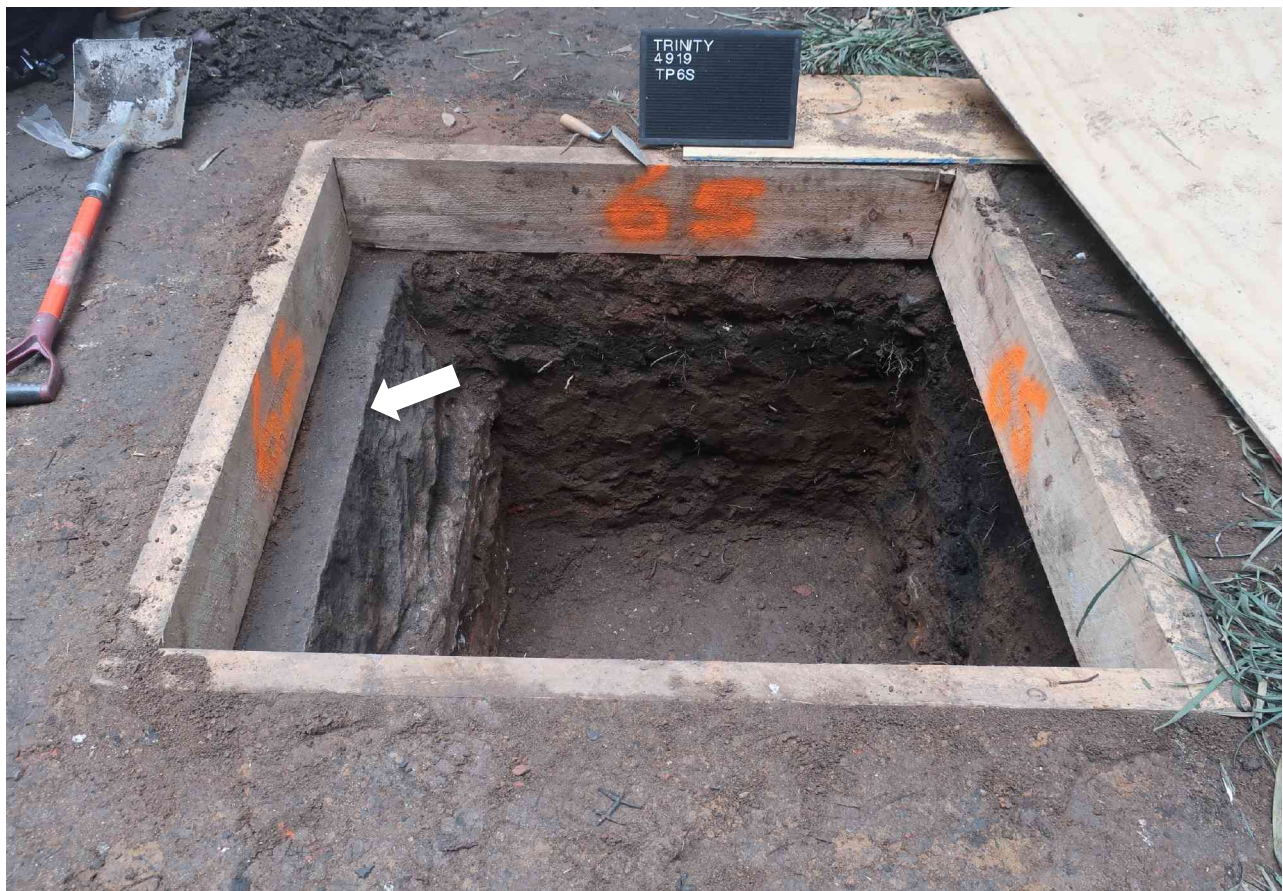
**Description:** Very rich soil in upper level. Headstone removed by others exposed Bluestone edging? on E side of the TP. Probable vault access at c. 0.7 ft. (0.21 m) BGS (Photo 38). Terminates 4.1 ft. (1.3 m) S of N end of TP. Typical mixed fill (e.g., brick, oyster, and clam shell frags, bottle and window glass, animal long bone, nails, etc). 1987 penny c. 3 ft. (0.9 m) BGS. Lighter soil with fewer artifacts in bottom half of TP but bone c. 3.75 ft. (1.1 m) BGS. Pile excavation into mixed fill continued with depth. Thin rubber (balloon?) frag. at c. 7 ft. (2.1 m) BGS. Cellophane? wrapper and machine-made bottle base frag. Brick and mortar frags (small) c. 9.0 ft. (2.7 m) BGS. Pile site successfully cleared, but with no photo documentation.

**Photo 38.** TP 6S looking south after excavation. Note the blue-stone edging on the east side of the TP (arrow) that proved to be a vault access. (J. Geismar 4/9/19)

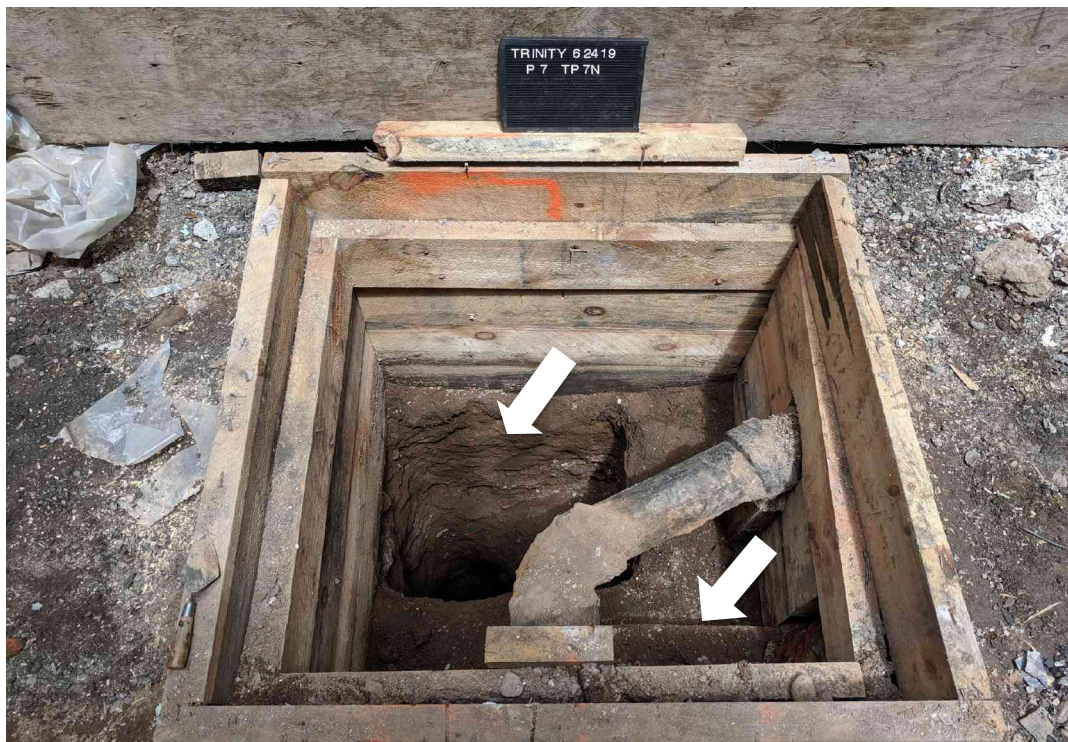
**Description:** TP for early pile and grade beam tests. Drainage pipe in SE part of TP at 1.5 ft. (0.5 m) BGS. Pile site was cleared in the NW corner of the TP (Photo 39). South church foundation exposed on N side of TP and Brick vault line in other N TPs in S TP wall. Brick feature in the SE corner of the TP at 2.5 ft. (0.8 m) BGS similar to the brick drainage feature documented in TP 9 during Stage 1 Oversight (see Photo 20). Brick vault line found in other TPs continues along S TP wall.

**Photo 39.** TP 7N after testing the site for Pile 7 in the NW corner of the TP (upper arrow). The view is north with the south wall of the church in the upper background. A brick construction barely visible under the drainage pipe in the southeastern part of the TP (bottom arrow) is similar to the brick feature documented in TP 9A during Stage 1 Oversight. (D. George 6/24/19)

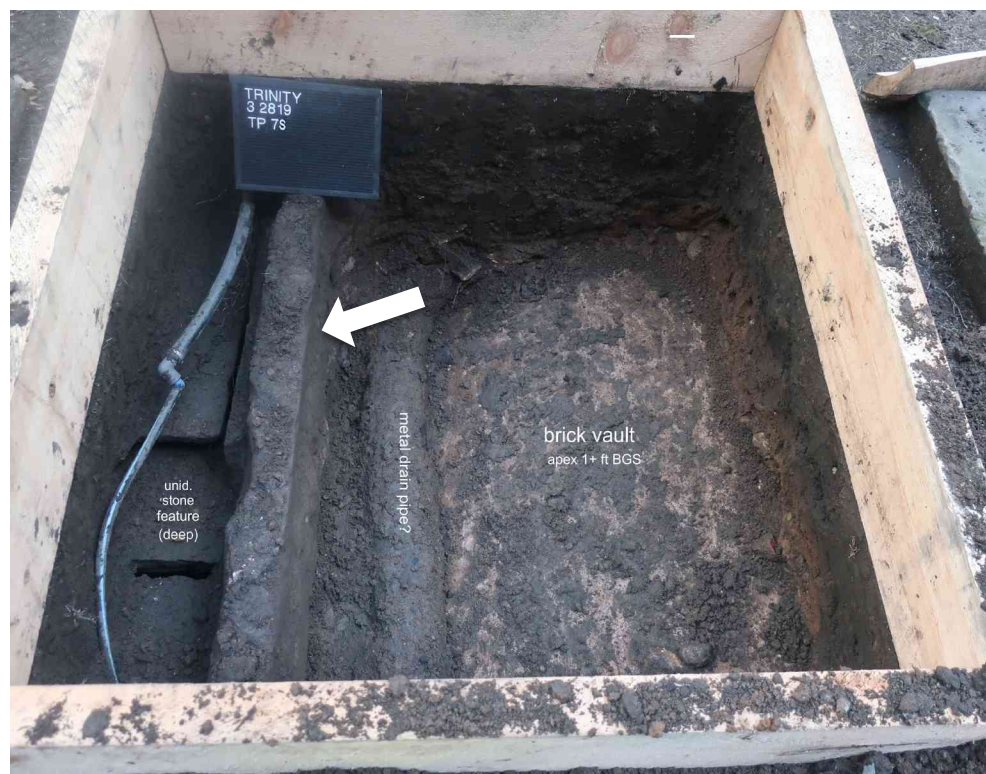
**Description:** Brick construction, apparently a burial vault, on W side of TP; cast-iron drainpipe, 1.8 ft. (0.6 m) BGS, runs N-S across the vault just off-center of the TP (apparently a continuation of drain in TP 7N). Stone edging (?) c. 0.5 ft. [0.2 m] wide with evidence of overlapping stone slabs exposed on E side of the TP (vault access). A densely constructed TP with typical fill (Photo 40). Revisited 4/22/19. Extended pit to the E and uncovered the overlapping stone slabs first seen on the E side of TP 7S. The four slabs were 1.2 ft. (0.3 m) to 1.95 ft. (0.6 m) BGS N to S (Figure 19). Holes were noted on the edge of the stones. A vault access was confirmed and, with the church's permission, the site for Pile 8 was relocated to the vault access and excavated by 6/24/19 without archaeological oversight. Any stockpiled soil above the slabs was screened.

**Photo 40.** Annotated view of TP 7S after excavation exposed a burial vault, a cast-iron drain pipe, what proved to be the stone edging (arrow) of vault access, and overlapping stone slabs (the view is south). (J. Geismar 3/28/19). The slabs were fully uncovered (see Figure 19) and, with the church's consent, the site for Pile 8 was relocated to the access to avoid disturbance to the burial vault.

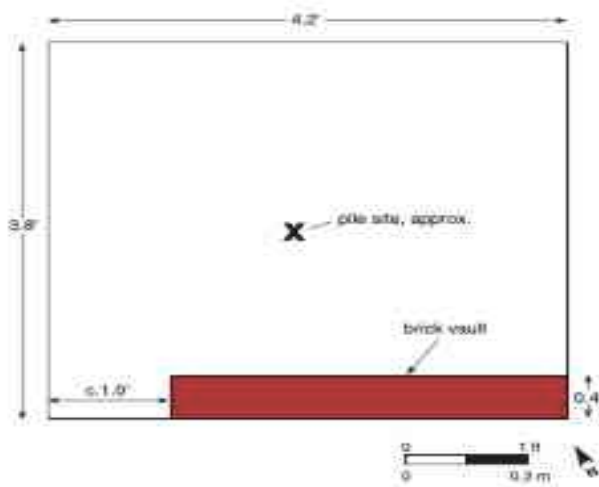
**Figure 20a.** TP 8N with Pile Site 5 Profile

**Description:** What appeared to be a virtually continuous N line of vaults first observed in TP 1 ended with an arched vault wall along the TP's S wall c. 1.0 ft. (0.3 m) from the W side of TP 8 (see schematic plan and profile Figures 20a 20b; Photos 41 and 42). Typical TP fill throughout. Pile excavation encountered thin pockets of ash below 4.0 ft. (1.2 m) in silty sand with cobbles and small pebbles. Two bricks in pile fill 7.0 to 7.5 ft. (2.1 to 2.3 m) BGS. Mortar and some brick frags noted throughout the pile excavation as well as coal, a nail, a salt-glazed stoneware sherd, and scallop, clam, and oyster shell frags.

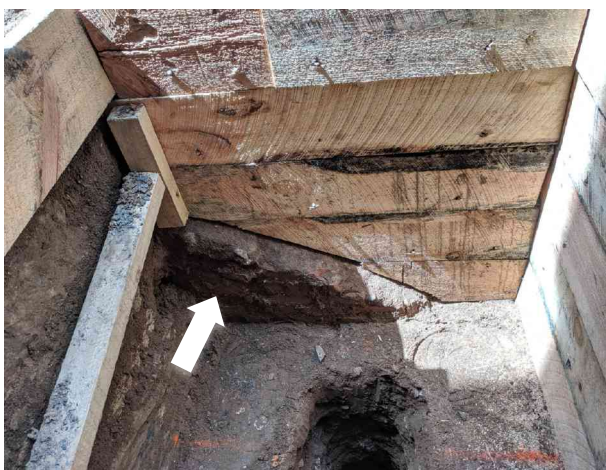
**Photo 41.** TP 8N looking S. The arched brick feature (arrow) is the most W evidence of the line of brick vaults exposed in TPs to the E. (D. George 6/20/19)

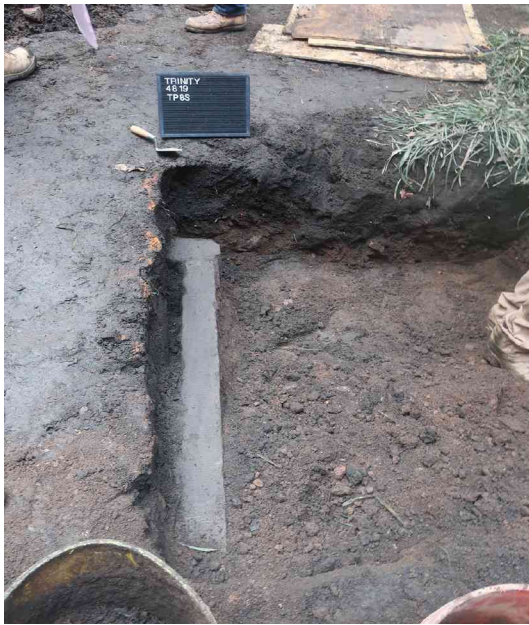
**Description:** Stone edging for vault access? (arrow) on E edge of the TP (Photo 43). Brick vault in W part less than 1.0 ft. (0.3 m) (BGS), ends 6.5 ft. (2.0 m) BGS. Slanted stone slab exposed in S and E TP wall 4.1 ft. (1.2 m) BGS proved c. 1.0 ft. (0.3 m) thick and unstable (collapsed with pressure). Pile excavation, in a reduced area, was in typical fill. The pile site (Pile 6), initially 8.6 ft. (2.6 m) BGS, was revisited and a post hole digger used to reach a depth of 9.8 ft. (3.0 m) BGS (Photo 44).

**Photo 43.** TP 8S looking S with stone edging on the E side. (J. Geismar 4/8/19).

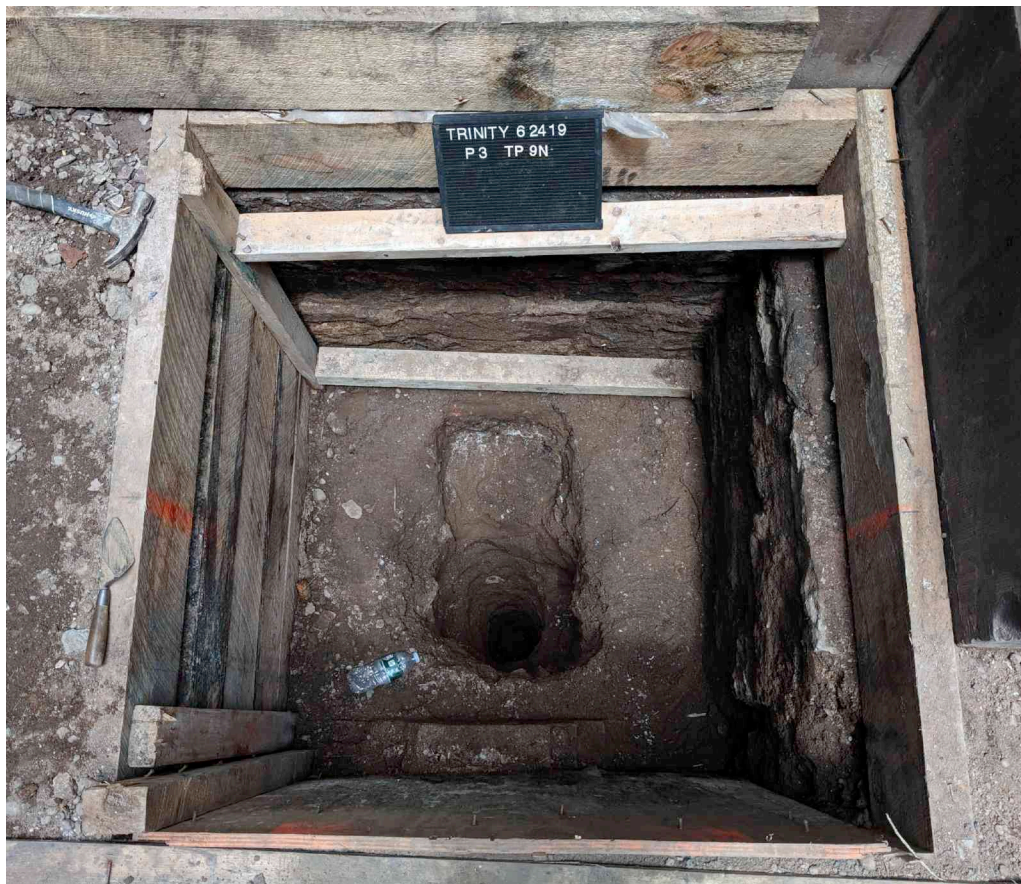
**Description:** TP 9N was among those in the aforementioned TP cluster associated with TP 3 (see Photo 29). Uppermost 1.5 ft. (0.5 m) were ash. Typical fill (oyster and clam shell frags, brick frags, small frags unburned coal). Soil saturation made screening difficult. Second day, 3 possible human bone frags mixed with ceramic and oyster shell frags, nails, and kaolin pipe stem frags mostly from stockpiled soil recovered between 2.0 and 4.0 ft. (0.6 and 1.2 m) BGS. Many rocks to 7 ft. (2.0 m) BGS with mortar and brick chunks, smaller frags, and some oyster shell as well as what appeared to be burned coal at 9.0 ft. (2.7 m) BGS (Photo 45).

**Photo 45.** TP 9N after excavation to test Pile Site 3. The view is north. (D. George 6/24/19)

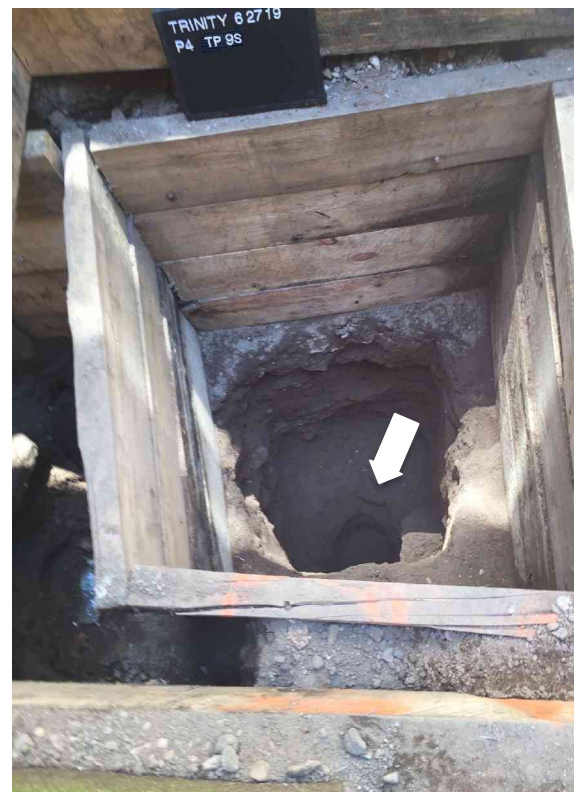
Photo 46. TP 9S after excavation of Pile Site 4 (arrow) to approximately 10 ft. (3.0 m) BGS. (D. George 6/27/19)

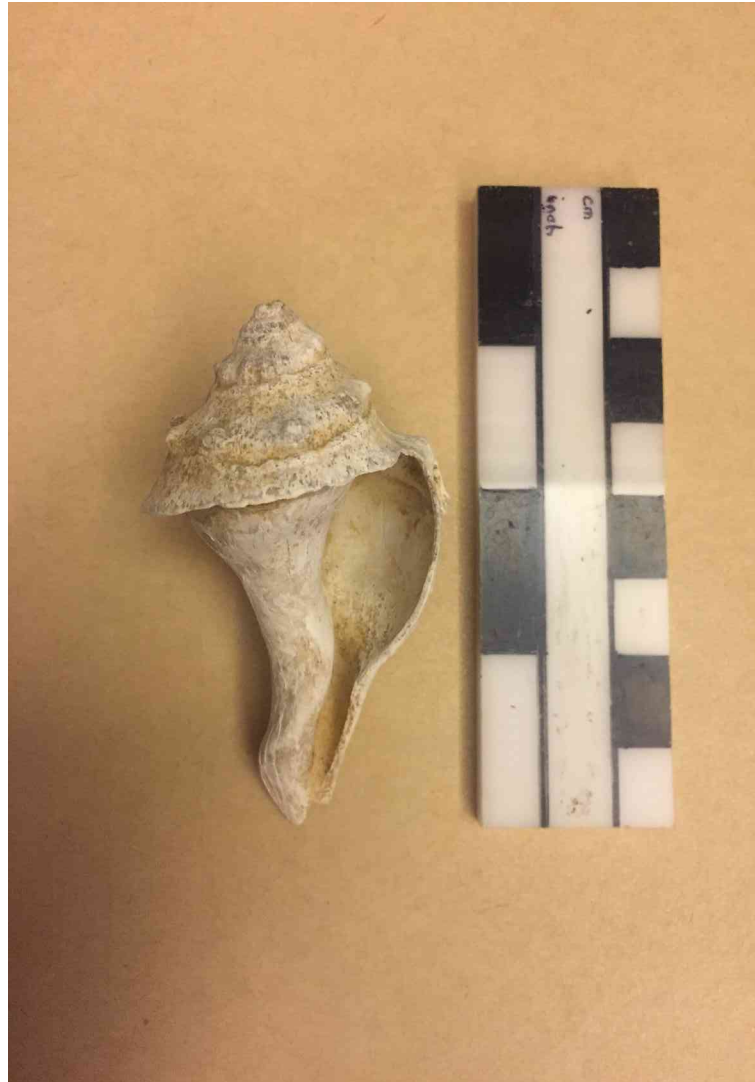
**Photo 47.** Almost whole knobby whelk shell (*Busycon carica*) recovered from natural soil in TP 9S during testing the site of Pile 4 in the S line of test pits. Identified as a “juvenile of indeterminate sex” that “currently largely inhabit tidal estuaries along the Atlantic coast” (Fisher 2020:personal communication), C-14 dating determined it could be as much as 1,000 years old (see Appendix D) and predates historic-era use of the site. Deposited prior to early-18<sup>th</sup>-C. land reclamation that altered the Hudson River shoreline, it may relate to the site’s natural history or to Native-American use of the site. Unfortunately, the shell was destroyed during radio carbon dating and this is the sole image. (Photo: J. Geismar)

Screening followed removal of 3 layers of waterproof fabric associated with the paved walkway adjacent to the church's S wall. A corrugated plastic leaching pipe exposed on E side of the TP below the 3rd layer of waterproof fabric. TP fill included 2 small human skull frags. Diagonal brick wall below stone in TP's W wall (Figure 21). During pile site excavation, brick/mortar frags 5 ft. (1.5 m) BGS with larger fragments and stones with depth. Natural soil at 7.0 ft. (2.1 m) BGS. An almost whole whelk shell (Photo 47) was recovered from natural soil at c. 7.5 ft. (2.3m) BGS (approximately the same depth as degraded oyster shells noted in nearby TP LB-1 in Stage 1). Subsequent C-14 analysis provided a date of 980-1260 AD, or 970-690 years BP for the shell (Beta Analytic 2019; see Appendix D for details) that was identified as a knobby whelk (*Busycon cariacae*) "juvenile of indeterminate sex" that "currently largely inhabit[s] tidal estuaries along the Atlantic coast" (Fisher 2020:personal communication;<sup>12</sup> Fisher and Rudders 2017).

During both oversight stages, test pits typically were 4 ft. (1.2 m) deep, but some were ultimately deeper. The soil matrix throughout the planned test pits was a redeposited fill. However, in TP LB-1 (Stage 1), only the first 3.2 ft. [0.98 m] BGS, that ended with the disturbed infant burial, were identified as such. Following removal of the burial, testing the soil boring site entailed hand excavation then a post hole digger and then a hand auger to c. 8.0 ft. BGS with oversight. Degraded oyster shells were collected, one at 7.5 and the other 8.0 ft. (2.3 and 2.4 m) BGS, both undoubtedly remnants the site's pre-historic-era. With confirmation that undisturbed natural soil was reached, the soil boring was drilled (see Appendix B for the TP LB-1 Soil Boring Log)]. During Stage 2 oversight, testing for Pile 4 in TP 9S reached natural soil at c. 7.0 ft. (2.1 m) BGS and an almost whole knobby whelk shell was recovered at 7.5 ft. (2.3 m) BGS (see Photo 47), that is, at about the same depth as the degraded oyster shells from TP LB-1 in Stage 1. The depth of these finds, and their proximity, is of interest as it relates to the natural history of the Trinity Church site. Radiocarbon (C-14) dating of the whelk shell suggests it could be almost 1,000 years old (See Appendix D). It

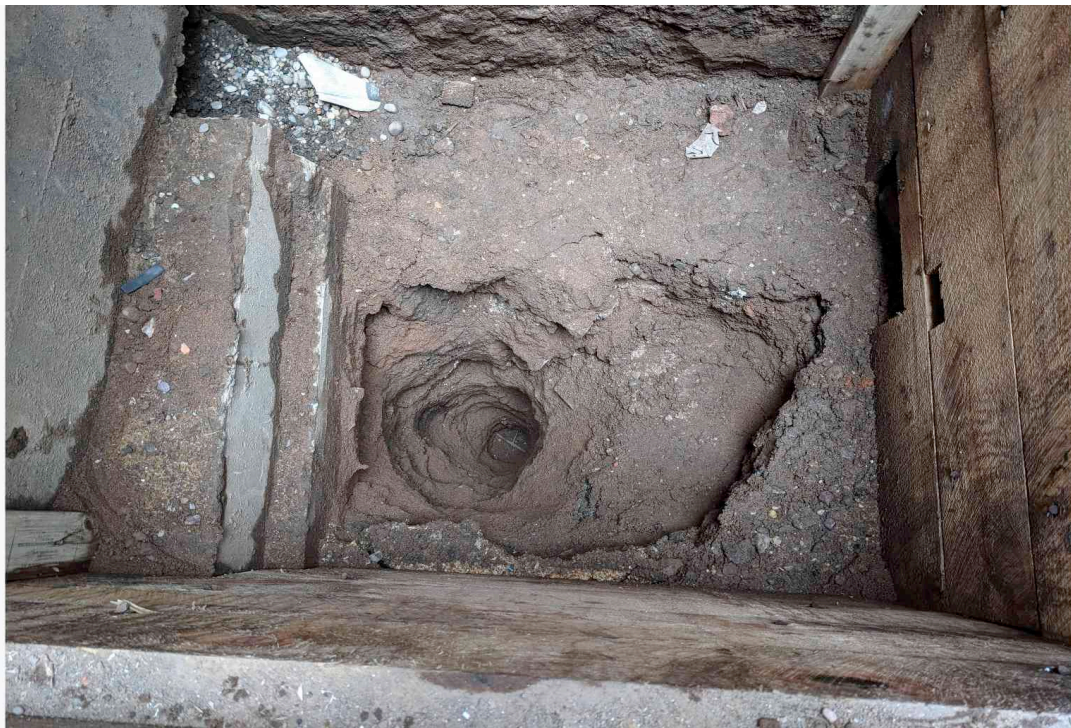
**Photo 48.** Completed excavation to 9.8 ft. (3.0 m) BGS of test for Pile Site 1 in TP 10 is a good visual example of a pile test excavation. (D. George 6/24/19)

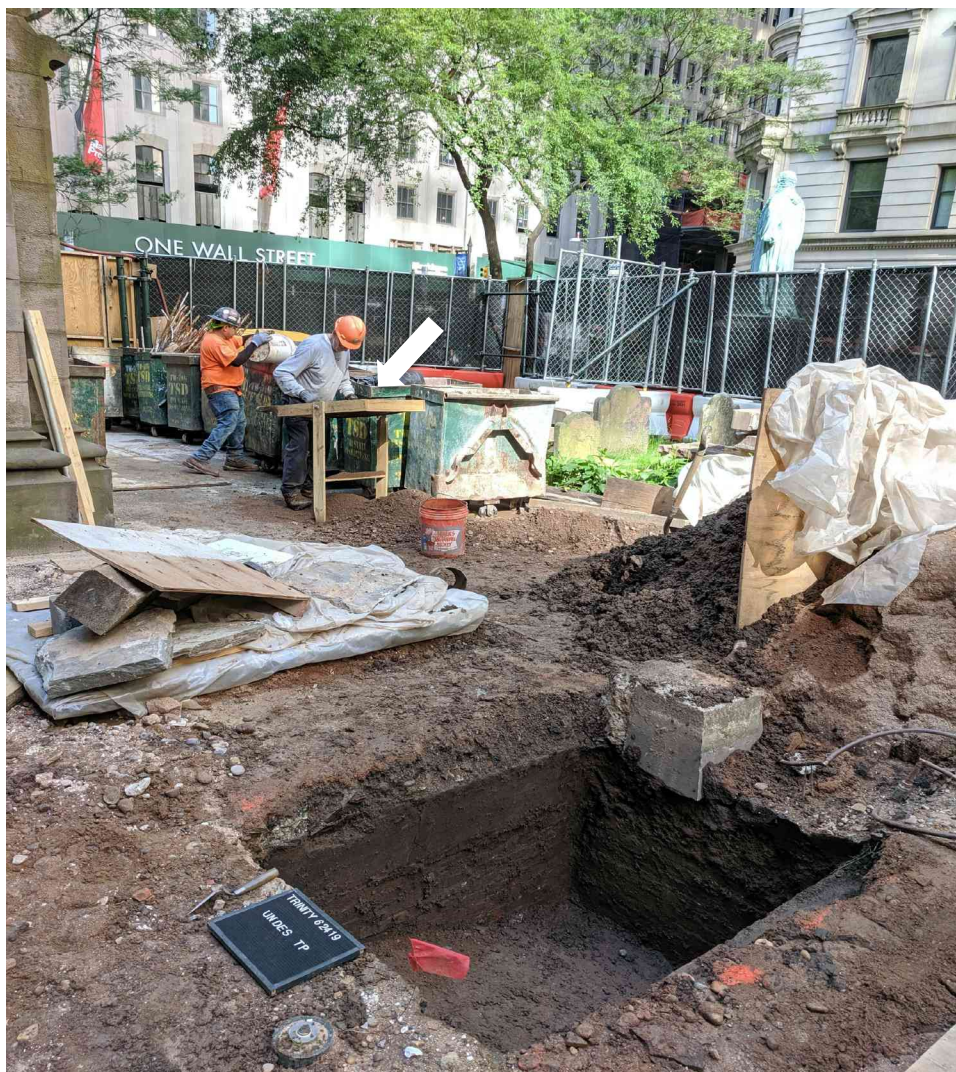
**Photo 49.** Undesignated TP in context after it had been terminated. A brick burial vault fills the excavated TP located E of TP 2 (to the left under plastic and plywood). The view is SE with the corner of Broadway and Rector Street behind the chain-link fence. Stockpiled soil from the TP is being screened (arrow). (D. George 6/27/19)

The aforementioned “Undesignated” TP was opened W of and parallel to TP 2 (see Figure 18 for location). Excavation was without archaeological oversight on an unidentified date. The goal was to locate additional pile sites that, with Pile 16 in TP 2, would create a row of three piles for a pile test. However, a brick vault was exposed at 1.9 ft. (0.6 m) BGS in the N end of the TP and 3.6 ft. (1.1 m) BGS in the S end, a feature that filled the TP (Photo 49). Bluestone steps ?? were also exposed. The TP, its excavated dimensions 3.6 ft. (1.1 m) E to W and 4.6 ft. (1.4 m) N to S, was terminated. Stockpiled soil was screened on 6/24/19 and, on 6/26/19, excavation of two additional but contiguous TPs was begun S of TP 2 to locate the sought after pile sites (see (TP 18/TP19)).

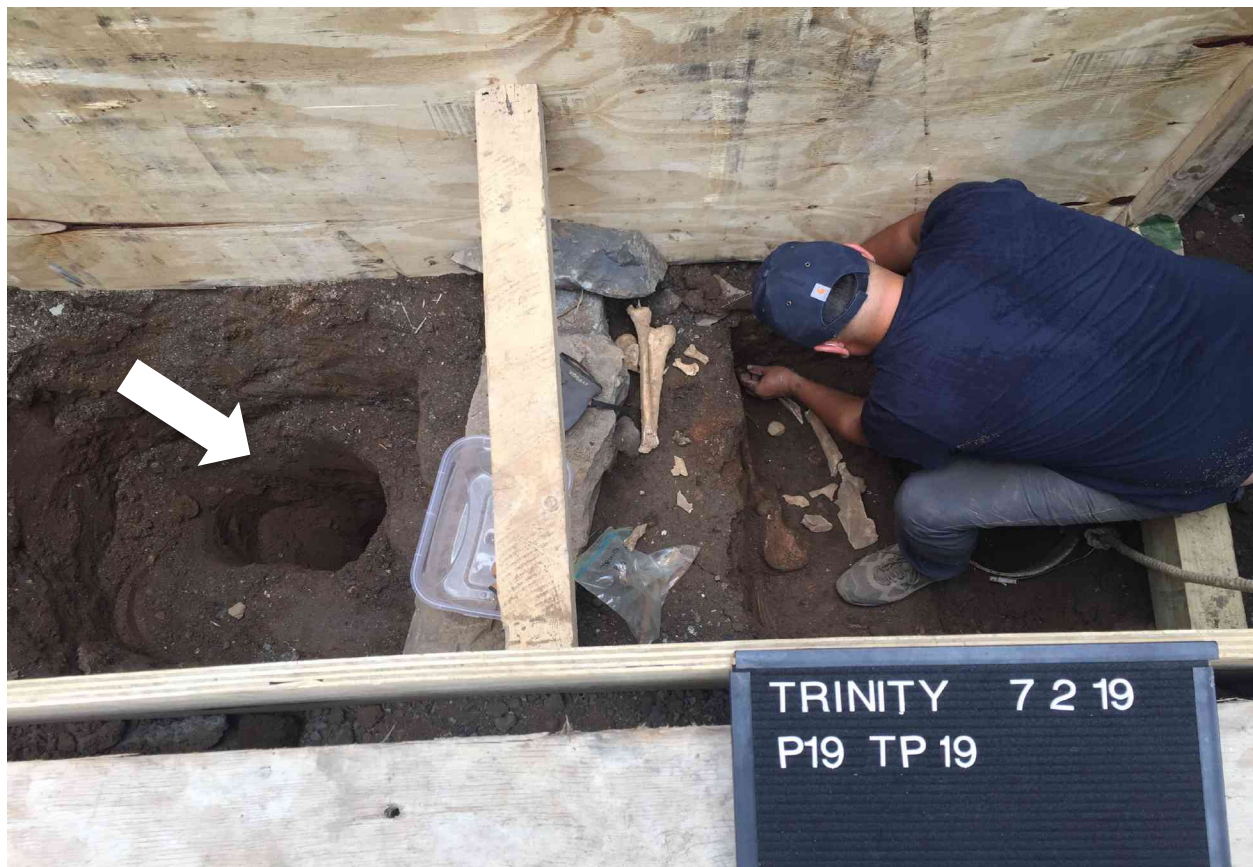
**Photo 50.** Cory Look reconstructing the placement of human bones recovered from TP 19 to determine if they represent an intact burial. Although several bones were from a single individual (see those near Cory's feet), they and others were a jumble of highly disturbed burials. At the church's discretion, the bones were left *in situ* and Reverend B. Jenner conducted a burial service (see Photo 51). Pile Site 18 (arrow) in TP 18, is to the left. A pile site in TP19 was cleared where Cory is perched. (J. Geismar 7/2/19). These piles were not among 17 initially planned but were added for a pile test

**Description:** This double TP was added to locate two sites needed to facilitate a pile pull test. Sand was documented to c. 5.6 ft. (1.7 m) BGS in both TPs followed by stone/rocks and a typical mixed fill that included slag and some animal and human bone. Excavation of TP 18 halted at 6.0 ft. (1.8 m) BGS when a cache of fragmentary bones was encountered in the NE corner, and in TP 19 at c. 5.8 ft. (1.8 m) BGS with discovery of what appeared to be a possible *in situ* burial. Further exploration indicated the bones in TP 18 would not be disturbed by excavation for the pull test and those in TP 19 comprised a thin concentration of highly disturbed and mixed human remains (MNI 2; Photo 50). After a conferring with the church, the skeletal material in TP 19 was left *in situ* to avoid disturbing any unknown burials and the church conducted a religious ceremony (Photo 51). Two locations devoid of human remains were identified for the pile test.

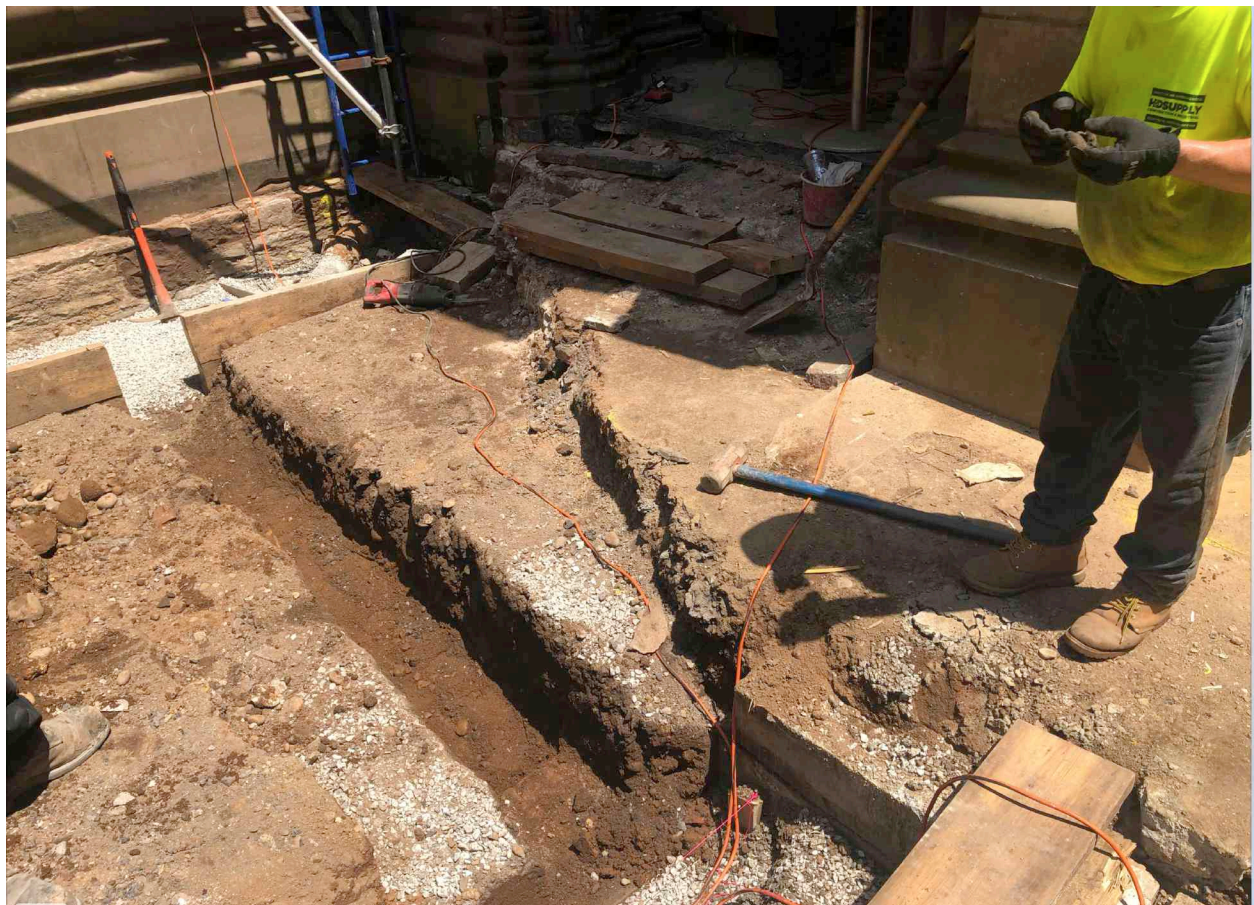
**Photo 52.** Typical shallow trench excavation on the South Terrace. (M. Kajano 8/28/19)

Beginning on 7/17/19, ten shallow cross trenches (c. 1.0 to 1.5 ft. [0.3 to 0.5 m] BGS) were excavated between pile sites on the south side of the church to accommodate grade beam supports for the new covered walkway (see Figure 18). After paving that ran along the south side of the church had been removed, any soil that remained beneath a slag and/or ash layer was to be screened. However, as it turned out, a number of grade beam sites and other shallow trenches had been previously excavated and the soil screened. The few shallow deposits of unexcavated soil that remained were easily troweled through. No bone material was recovered or noted. (see Photo 52 for typical shallow trench excavation).

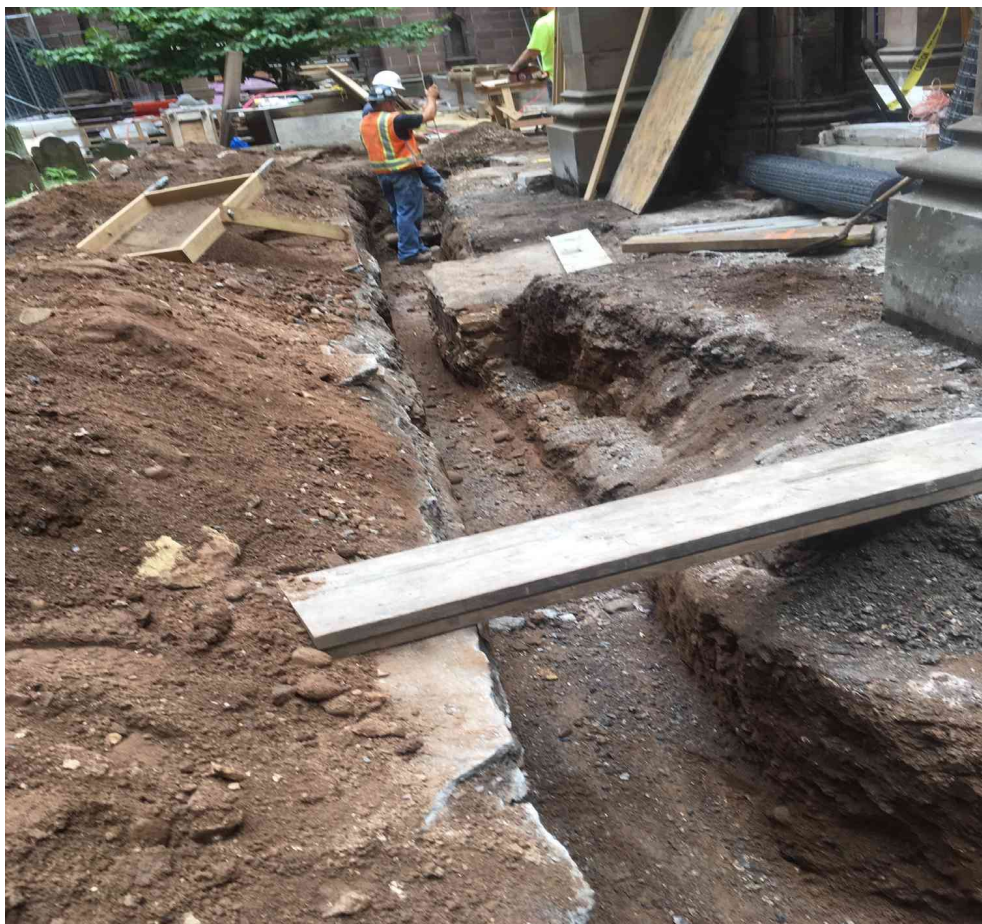
**Photo 53.** Excavation of the south drainage trench was underway on 8/28/19. The view is west on the South Terrace. (J. Geismar 8/28/19)

An approximately 200-ft. (55.0 m) long and 2 ft. to 3 ft. (0.6 to 0.9 m) deep basically L-shaped drainage trench was excavated at the close of Stage 2 archaeological oversight. On 8/28/19, excavation began at the E end of the church's 4<sup>th</sup> alcove where an existing rain drain was located next to the footprint of the planned covered walkway and proceeded east (Photo 53 and Figure 22). Just beyond the SE corner of the church, a large burial vault (c. 9.5 ft. [2.9 m] N to S) was exposed on the S side of the trench (Photo 54). A somewhat smaller vault was exposed on the N side with the two vaults defining a narrow but adequate passage for the drainage trench to continue E. Map data identifies the vault owner of the larger of the two vaults as Wynant Van Zandt, a prominent late-18<sup>th</sup>-century New York City merchant. The owner of the adjacent but slightly smaller vault was David Coutant about whom little is known (see Figure 22). Excavation continued E before turning N and terminating just beyond the church's Broadway entrance on September 30, 2019 (Photos 56-57). Recovered bone material mainly comprised animal bone fragments.

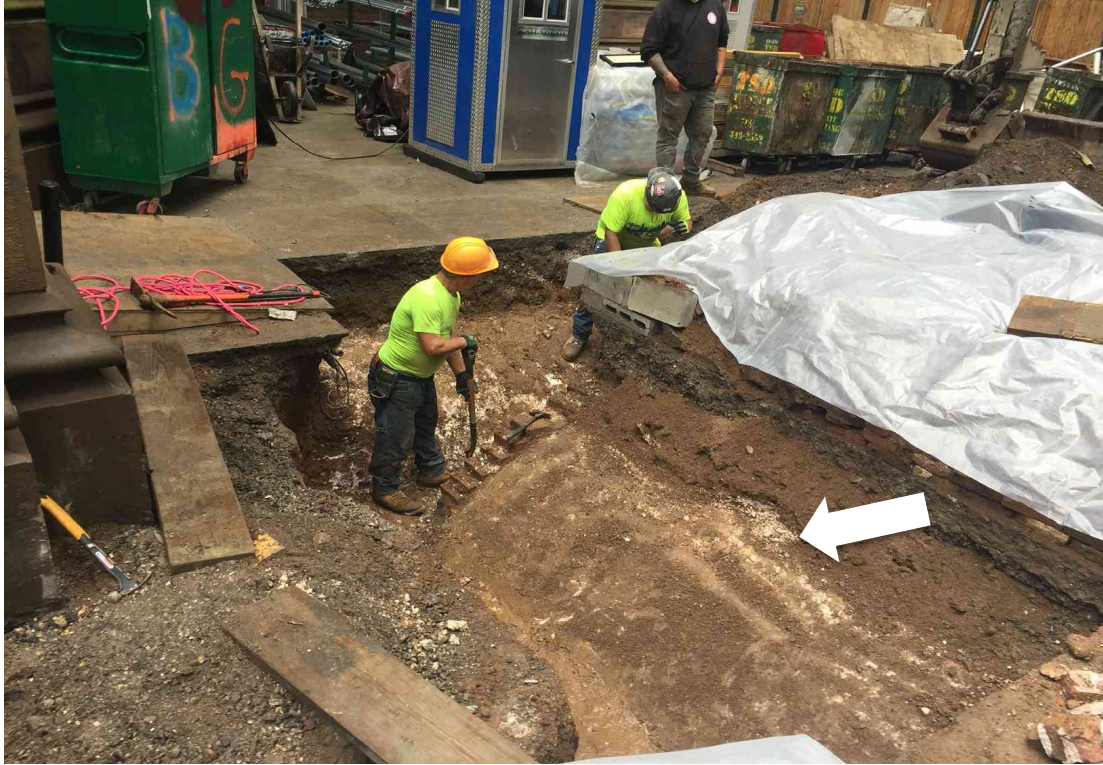
**Photo 54.** Drainage trench excavation in the vicinity of Wynant Van Zandt's large brick burial vault (arrow). Soil and cinder block were introduced above the vault. (J. Geismar 8/28/19).

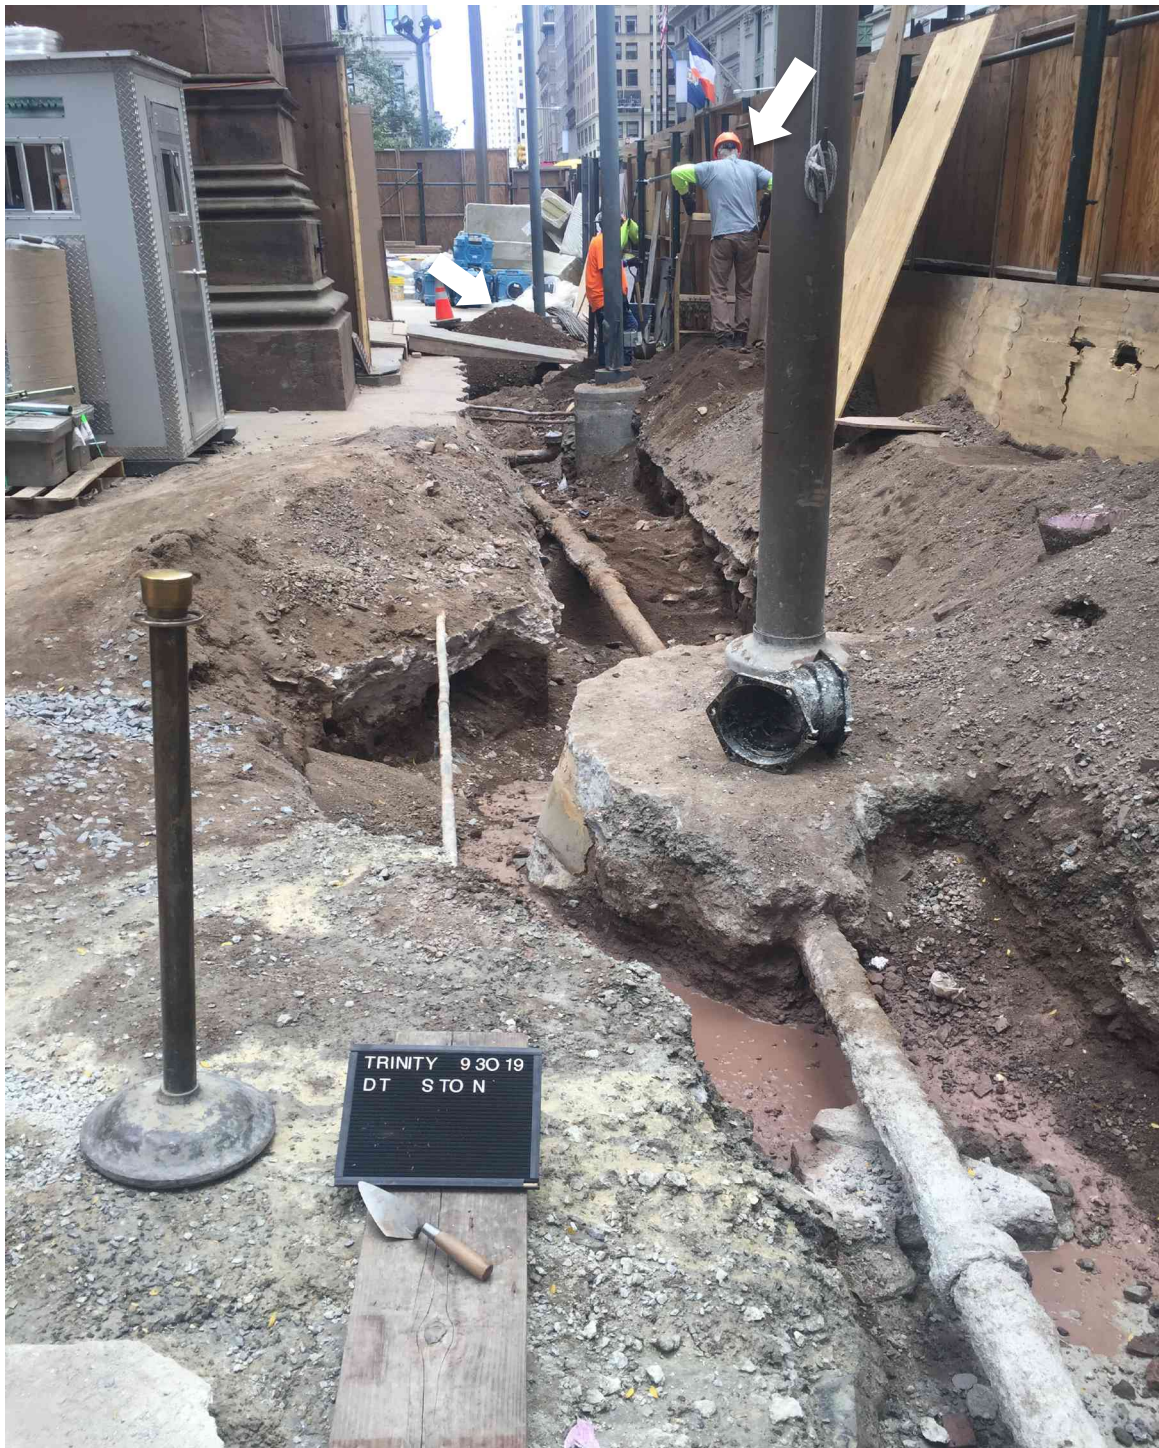
**Photo 56.** The north-south leg of the drainage trench looking north. A cast-iron pipe is exposed in the trench and Broadway is to the right beyond the plywood and chain-link fence. The excavated soil is being screened in the very limited space between the trench and the fence (right arrow). Excavation terminated to the north, just beyond the church's Broadway entrance where some screened soil temporarily is stockpiled (left arrow). (J. Geismar 9/30/19)

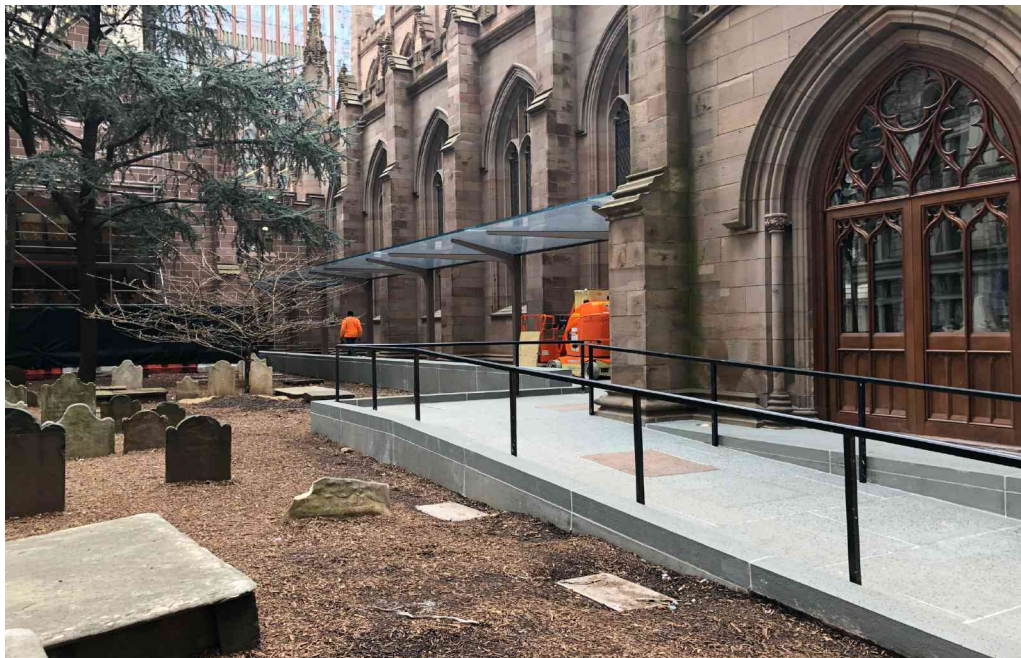
Following completion of the excavations, the ADA compliant canopy covered walkway was installed on the South Terrace adjacent to the church (Photo 57).

**Photo 57.** ADA compliant access and covered walkway newly constructed on Trinity's South Terrace. The view is northwest. (J. Geismar 3/10/20)

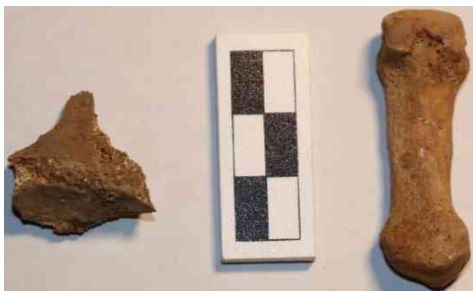
These remains consist of the complete left metacarpal 1 (see Figure 1) and a single bone fragment of an adult individual (see Table 2). The material was found in fill at a depth of 3.8 and 4 feet BGS in Test Pit 5. No grave or grave outline was identified. Age determination was based on overall size and fusion. Sex determination, ancestry and stature estimates were not possible.

Figure 1 - TP5 - MC1 and Bone Fragment

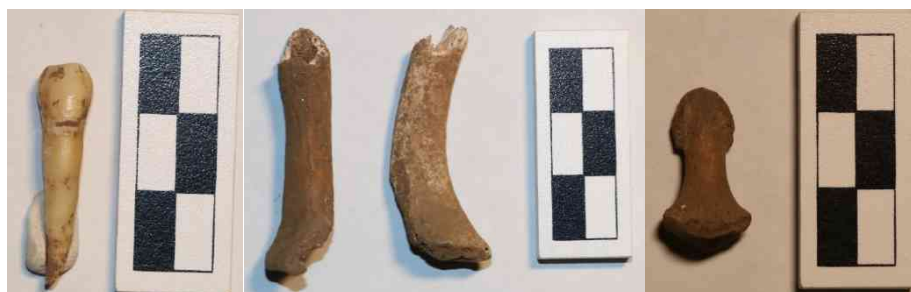
The skeletal remains from TP4 consist of three bones and two teeth constituting a MNI of two, one child (TC-2) and one adult (TC-3). All material is from fill. No grave or grave outline was identified. TC-2 (TC-18-TP4-1) is represented by a single deciduous incisor (T64-see figure 2 and Table 3). Age determination for TC-2 was based on dental eruption, and crown/root formation of tooth 64 giving an estimated age of 2-3 years old. Minimal dental attrition present. The remainder of the skeletal material from TP4 consisted of bone fragments and single tooth from at least one adult individual (see Tables 4-5 and Figure 3). No abnormalities were observed affecting the bone material. The tooth exhibited evidence of calculus affecting multiple surfaces as well as at least one hypoplasia. Age determination for the adult was based on overall size and fusion. Estimates of ancestry, stature and sex were not possible.

Figure 3 (TC-3) From left to right: T11; Metacarpal/Rib; Distal Hand Phalange

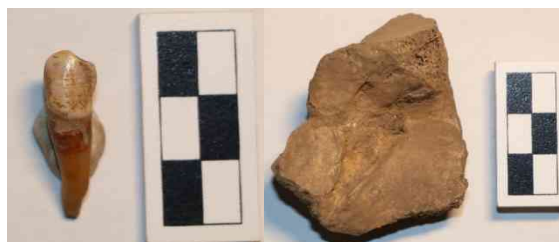
These remains consist of a single canine and a partial right calcaneus (see Figure 4 and Tables 6-7) from an adult individual excavated from the upper fill of TP-LB1 between 1.5 and 2 feet BGS. Evidence of dental pathology (hypoplasia and calculus present). No bone pathology. Age determination is based on the overall size of the bone and the amount of dental attrition. Sex determination, ancestry assessment and stature reconstruction were not possible.

Figure 4 – Canine; Calcaneus

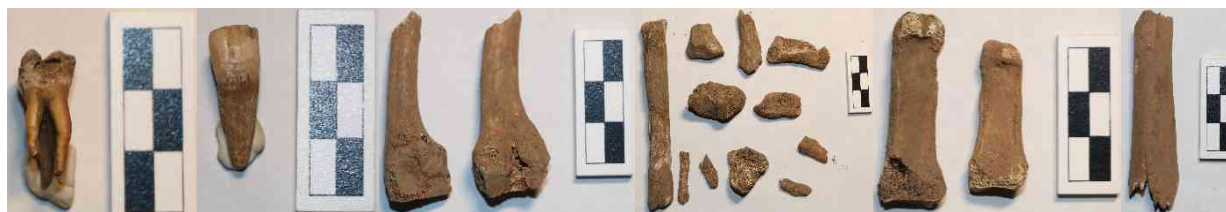
Dental material consisted of two adult teeth (T9 and T14). Both teeth exhibited pathology. Hypoplastic defects (x2) were observed on the labial surface of T9 (see Figure 5) indicating that this individual suffered at least two extended periods of stress during the development of the enamel for this tooth. In addition, ante-mortem chipping was observed. The lingual surface of T9, displayed possible shoveling morphology. T14 showed evidence for a cavity on the occlusal surface in addition to calculus and possible amelogenesis imperfecta in the form of extreme enamel pitting and lack of formation (see Figure 5).

Figure 5 – Dental and Bone Fragments from TP9

Left to right: Molar (T14); Incisor (T9); MT 2-3 (R); Bone fragments; Proximal hand phalanges; Femur (Child)

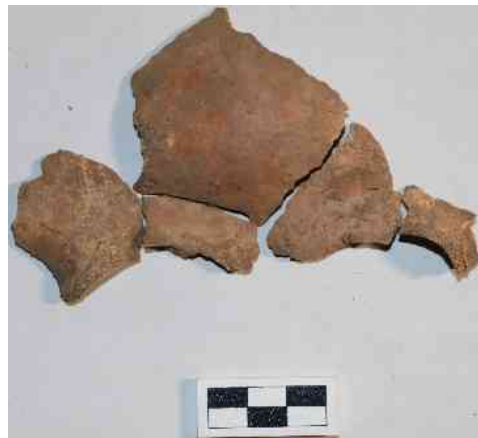
The skull was highly fragmented due to the overall fragility of and thinness of bones (see Figure 7) in addition to post-depositional damage (compression). Seven of the 28 bones of the skull were recovered (see table 11). In addition to the identified bones, there were 16 cranial fragments not identifiable to a specific skull bone. No evidence abnormalities or pathology.

Figure 7 – Frontal Bone

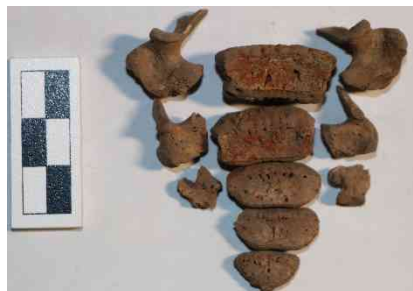
Of the 33 vertebra comprising the spinal column, 16 identifiable bones were recovered (see Table 12). Post-mortem damage mainly affected the cervical and thoracic vertebra sparing the lumbar and sacral vertebra (see figure 8). All elements exhibited a partial to complete lack of fusion. Age based on fusion rates for the vertebra suggest that this child was less than 2 years old. No abnormalities were detected.

Figure 8 - Unfused sacrum

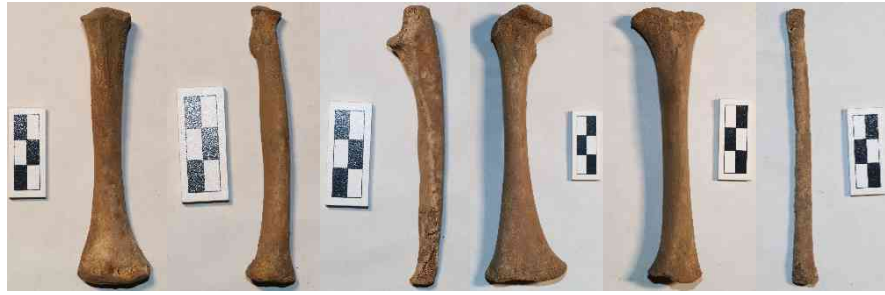
All the bones of the upper and lower limbs (n=10) and pectoral girdle (n=4) were recovered (see Table 13) and with the exception of the scapula were found in good condition (see Figure 9). Epiphyseal fusion was completely lacking for all limb bones and the pectoral girdle. Maximum length measurements were taken of the limb bones that were complete and used to assess age for this individual (see Table 13 and the section on age determination). No pathological conditions were identified.

Figure 9 – Upper and Lower Limb Bones  
Left to Right : Humerus; Radius; Ulna; Femur; Tibia; Fibula

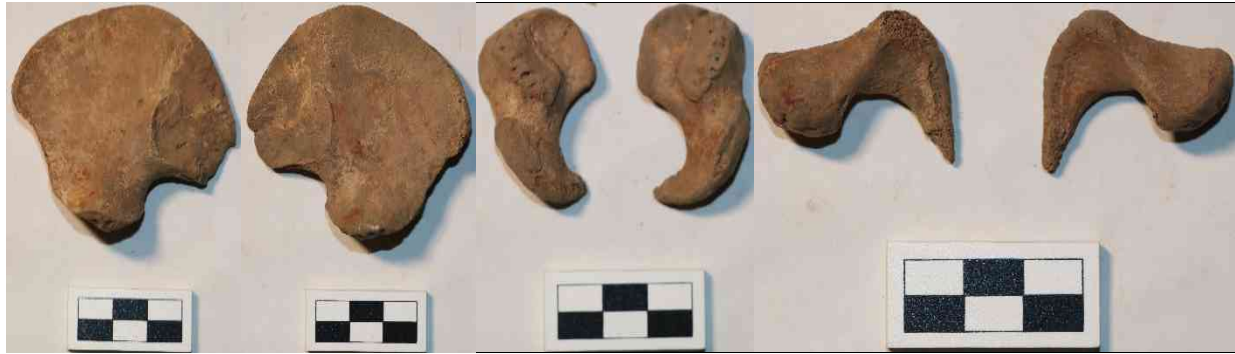
The left and right ilium, ischium and pubis (see Figure 10) were found to be complete and in good condition with minimal PMD (see Table 14). All three bones (left and right side) were completely unfused. No evidence of pathology was observed. Age determination based on size indicated that these bones were from an individual between 1 and 2 years old.

Figure 10 – Pelvis  
Left to Right: Ilium; Ischium; Pubis

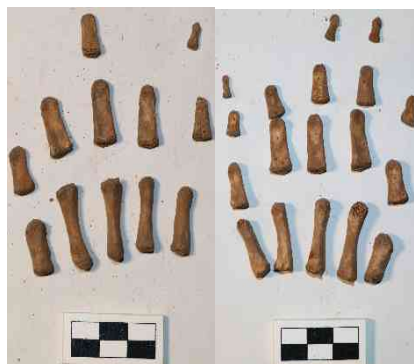
Bones of the hand and foot (see Figure 11) constituted the largest percent of bones recovered for TC-7 at 52% or 49/94 (see Table 15-16). Of the 49 hand and foot bones, 43 (20 Metacarpals; 21 Phalanges; 2 Carpals) were from the hand and wrist (see Figure 11) with the remaining bones being from the ankle (6 tarsals). Overall, the majority of bones were found to be complete and in good condition with minimal PMD. Epiphyseal fusion was lacking for all bones which is expected for an individual this young. No pathological conditions were detected.

Figure 11 – Left and right hand

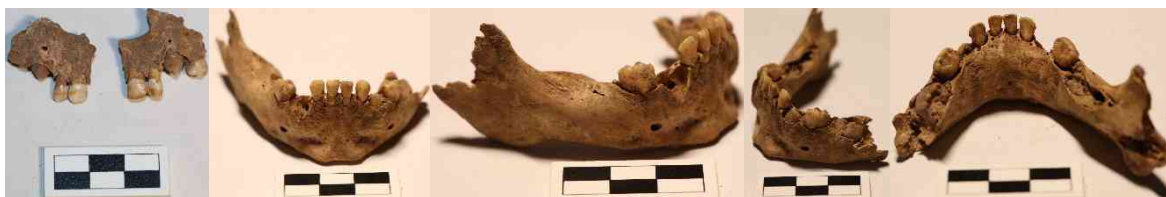
TC-7 retained a mixture of deciduous and permanent teeth from both the maxilla and mandible (see Figure 12 and Table 17). All of the teeth from this individual were found to be in good condition. Of the 20 deciduous teeth expected to be present in an individual of this age, 18 were recovered. The remaining two deciduous teeth (T52 and 68) were lost post-mortem. In addition to the deciduous teeth, three permanent teeth were recovered. These teeth showed incomplete crown and root formation, consistent with an individual of this age. Crown and root formation and dental eruption was used to help determine the age of TC-7. Based on these methods, TC-7 was approximately 1.5 years old. No dental pathology was observed, with the exception of a few deciduous teeth showing possible cavities and or hypoplastic defects (see Table 17).

Figure 12 – Dentition

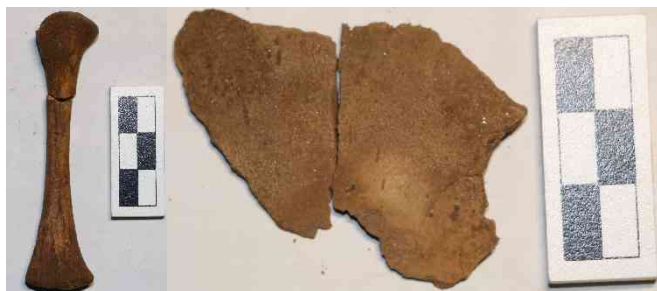
These remains consist (TC-8) of the complete left fetal femur, aged to be 38 week in utero, and 2 cranial fragments (See Figure 13 and Table 19) representing at least one individual. There is no direct connection between these remains, they were linked solely on the thinness of the cranial bones and the fetal age of the femur. No pathology was observed.

Figure 13 – Left Femur and cranial fragments

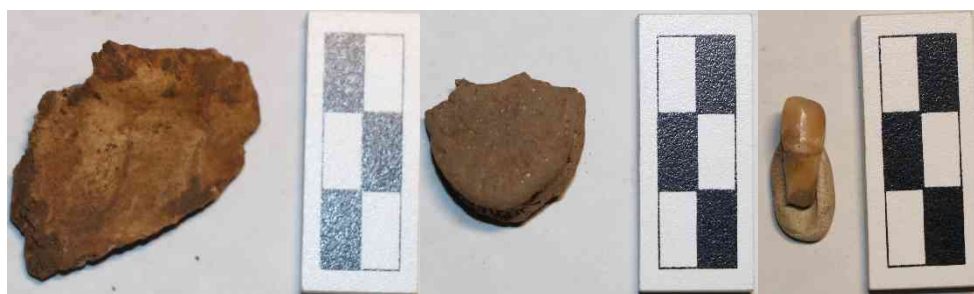
These remains consist of two bones and one tooth all from in child aged to be approximately 2.5-3 years old (see Figure 14 and Tables 20-21). Age determination was based solely on the complete eruption of T54 and the overall size of the bones. Sex determination was not possible due to the age status of the individual. No bone or dental pathology was detected.

Figure 14 – Child remains
