# Trinity Church Archaeological Oversight

## Phase 1 Construction

75 Broadway (Lot 1 Block 49) Manhattan

Prepared for Trinity Wall Street  
Through Murphy Burnham & Buttrick Architects  
and Trinity Wall Street  
Prepared by Joan H. Geismar, Ph.D., LLC  
July 2020

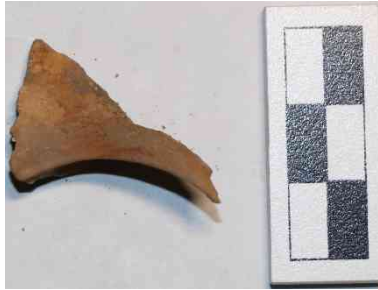
These remains consist of a fragment of the orbital region of a child's frontal bone (see Figure 15 and Table 22). Age determination was based solely on the size and thickness of the bone. Morphological sex determination was not possible due to the young age of this individual. No pathological conditions were observed.

Figure 15 – Frontal Bone (Orbit)

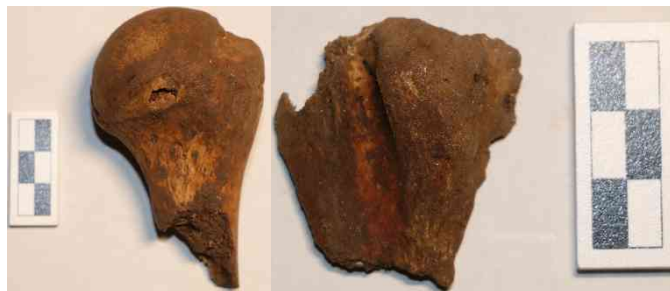
These remains consist of the very fragmented left and right humeri (see Figure 16 and Table 23). The right humerus contains the proximal end, including the head allowing of a maximum diameter of measurement (used for sex determination). Based on this measurement (47.9mm) it was determined that the right humerus was likely from a male individual. All that remains of the left humerus is the lesser tubercle and was matched to the right based on size and coloration. Age determination was based on fusion which suggested that TC-11 was over 22 years old. Stature reconstruction was not possible due to incompleteness of the bones and lack of comparative material. No pathology was detected.

Figure 16 – Right and Left Humerus

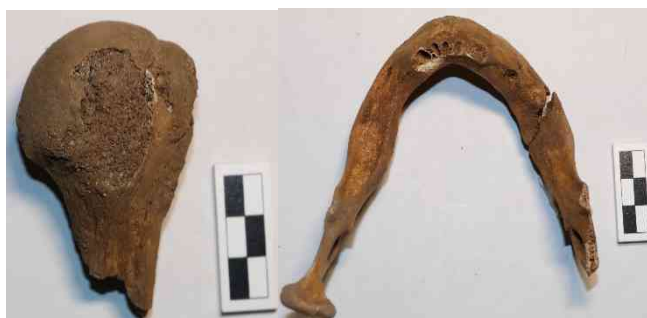
These remains consist of the proximal end of the left humerus and the complete mandible of an adult female individual (see Figure 17 and Table 24). The left humerus is missing the entire bone post the humeral neck. The mandible was found to be in good complete and in good condition but was broken post-mortem. No teeth were recovered. Extensive resorption of the alveolar sockets (post-T22 and T27) was identified with 11 of the 16 sockets sealed ante-mortem. The presence of the head allows for sex determination using the maximum diameter. This method yielded a MxD of 42.5mm suggesting that this humerus was from a female individual. The morphology of the mandible showed characteristics of associated with a female, specifically the regions of the mental eminence (chin) and the gonial angle. Age determination was based on the fusion of the proximal end of the humerus and the resorption of the alveolar sockets. Using these factors for age assessment, it was determined that TC-12 was older than 22. A specific numeric age, however, could not be obtained. Reconstruction of stature and ancestry were not possible due to the fragmentary nature of the material and a lack of comparative material. Other than a bone abscess associated with T27, no bone pathology was detected.

Figure 17 – Humerus and Mandible

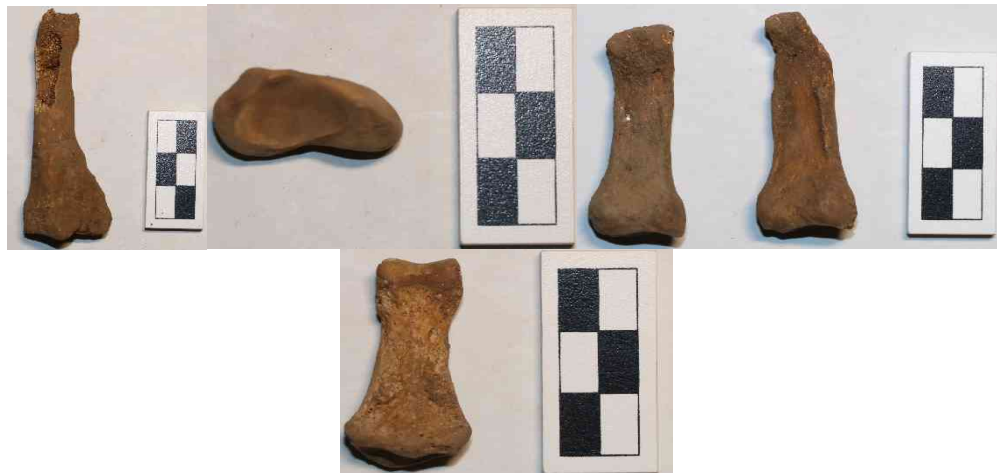
Figure 21 – Hand and Foot Bones

BONE	SIDE	COMP	PATH	CNT	COMMENTS
MC5	Right	3	NO	1	Bone in poor condition missing the proximal epiphysis and 1/2 of the distal epiphysis PM.
MT2	Right	2	NO	1	Bone in fair condition missing the distal epiphysis PM. 6650-6651
SAC	Right	1	NO	1	Bone complete in good condition. 6648.
PHP-ND	Left	1	NO	1	Bone in good condition missing small fragment from distal end (#2-4). Does not affect measurement 43.38. (6646) might go with other PHP in 6646.
PHP-ND	SND	4	NO	1	Bone in poor condition missing all except for the proximal epiphysis. 6624 Not 1 or 5.
PHP-ND	Right	1	NO	1	Bone complete in good condition (41.56) (6646) might go with other PHP in 6646.
PHI-ND	SND	1	NO	1	Bone complete in good condition 34.11 (6647) might go with 6646. #3-4
PHI-ND	Right	1	NO	1	Bone complete in good condition 28.18 (6617) might go with 6646;6647. #3-4
PFP-ND	Right	1	NO	1	Bone complete and in good condition. 29.13. (6616) Might go with other phalanges from TP3.

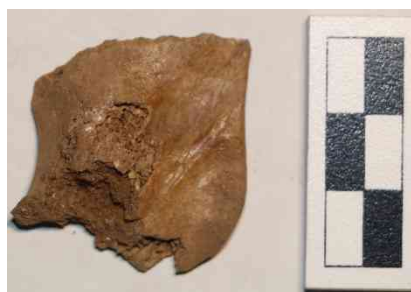
Figure 23 – Right Mandible

These skeletal remains associated with TC-14 consist of right partial mandible (see Figure 23 and Table 30) of a non-child/non-adult (possible adolescent). Age determination was based on the overall size and the possible lack of eruption or partial eruption of T32. Sex determination and ancestry assessment were not attempted due to the fragmentary nature of the mandible. No pathology was observed.

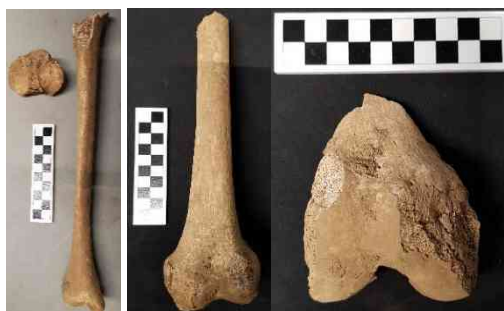
Figure 25: Tibia (R), Femur (L&R)

These remains comprise 6 bones: the partial left and right femur, the mostly complete right tibia (see Figure 25), and vertebra sacral fragment, and a pubis fragment (see Table 32) excavated from Pile 19 on June 26<sup>th</sup> 2019. In addition to the six identifiable bones, three long bone fragments were also recovered. All material is from an adult over the age of 22 years of age based on fusion rates. Sex determination was not possible but based on the overall small size of the bones it is suggest that they are more likely from a female. No pathological conditions were observed. Maximum length measurements were not possible due to post-mortem damage and a lack of comparative material. The material from TC-16 was originally mixed with the infant from TC-15. The MNI for TC-16 is one.

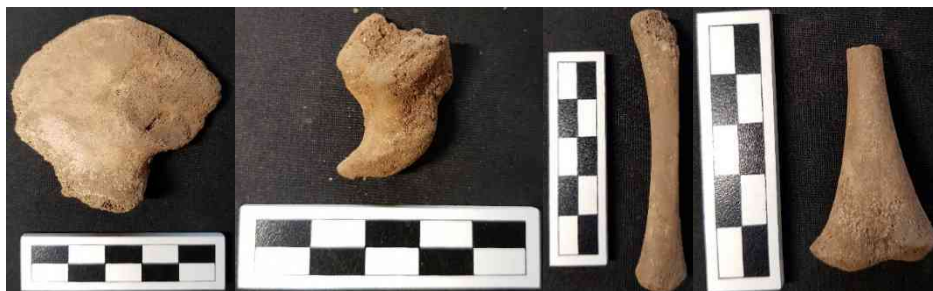
Figure 26 – Right Ilium; Right Ischium; Left Tibia; Left Femur

These remains consist of a mostly complete tibia, the distal 1/2 of a femur and the complete ilium and ischium (see Figure 26 and Table 33) of a neonate approximately one month old excavated from Drainage Trench 18-19 on June 26<sup>th</sup> 2019. Age determination was based solely on the maximum length of the tibia. No comparative material was used. Sex determination was not possible. The remains were originally mixed with TC-18 from the same unit. No pathological conditions were identified. The MNI for TC-17 is one.

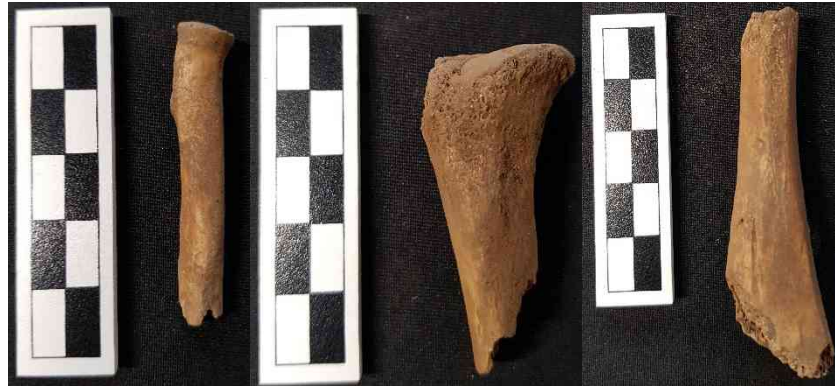
Figure 27 – Right radius; Left Tibia; Left Femur

These remains consist of four bones from a child approximately 2 years of age in fair to poor condition. All that remains of this child are the partial remains of a femur, radius and the left and right tibia (see Figure 27 and table 34) excavated from Drainage Trench 18-19 on June 26<sup>th</sup> 2019. This material was originally mixed with TC-17 from the same unit. Age determination was based on the overall size of the bones compared to material in the lab. Sex determination was not possible. No pathology was observed. The MNI for TC-18 is one.

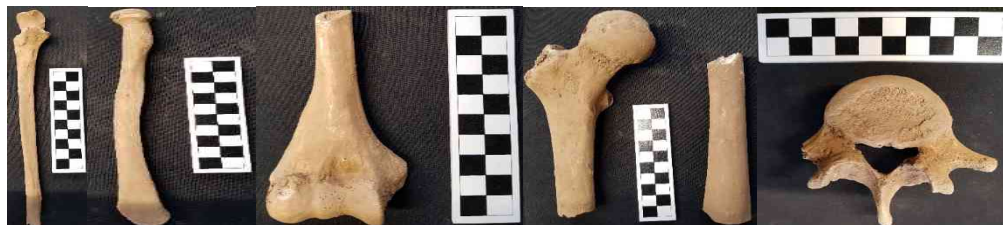
Figure 28 – Right Radius; Right Ulna; Right Humerus; Right Femur; Lumbar 5

These remains consist of post-cranial bones (see Figure 28 and Table 35) of an adult of indeterminate sex excavated from Pile 18 on 6-26-2019. Bones are in good to poor condition with most suffering from some post-mortem damage. Age determination was based on the complete fusion of all bones present suggesting that this individual was an adult. Sex determination is based on the maximum diameter of the head of the femur. These remains were originally mixed with TC-20 a child/infant from the same unit. No pathological conditions were observed. Bones present include lumbar and sacral vertebra, long bones and pelvis fragments. The MNI for T-19 is one.

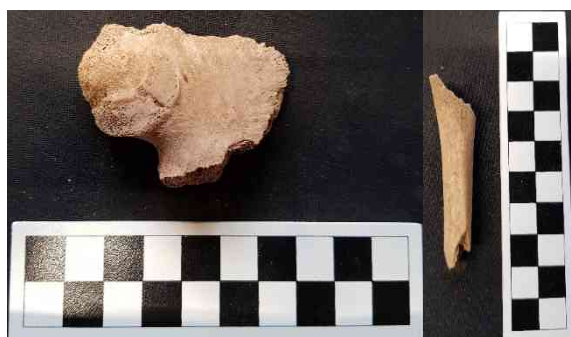
Figure 29 – Left Ilium; Tibia SND

These remains consist of one ilium one long bone (see Figure 29) and seven ribs (see Table 36), in fair to poor condition from a young child excavated from Pile 18 on June 26<sup>th</sup> 2019. Age determination is based solely on photo comparison to laboratory material. Sex determination was not possible. These remains were originally mixed with TC-19 from the same unit. No pathology was observed. The MNI for T-20 is one.

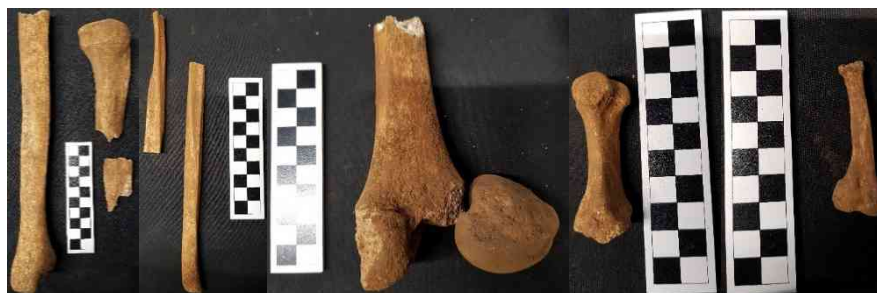
Figure 30 – Right Tibia; Fibula SND; Left Femur; Left MT1; Left MT3

These remains comprise seven post-cranial bones (see Figure 30 and Table 37) of a young adult between 20 and 25 years of age excavated from Test Pit 2-Extension at a depth of 7-8 feet BGS on June 5<sup>th</sup> and 6<sup>th</sup> 2019. The bones from TP2-EXT were in fair to poor condition with elements showing some post-mortem damage. Age determination was based on incomplete fusion of the tibia. Sex determination was not possible. No pathology was observed. The MNI for TC-21 is one.

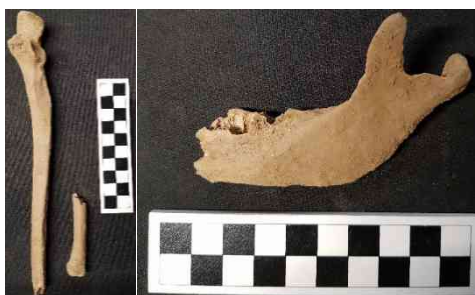
Figure 31 – Left Ulna and Right Mandible

These remains consist of the fragmented cranial and post-cranial remains (see Figure 31 and Table 38) of a young adult-adult individual of indeterminate sex excavated from TR1 on March 27<sup>th</sup> 2019. Bones were found to be in fair to poor condition with all material suffering from post-mortem damage. Sex determination was based solely on the gonial angle of the mandible which exhibited female type morphology. No pathology was observed. The MNI for T-22 is one.

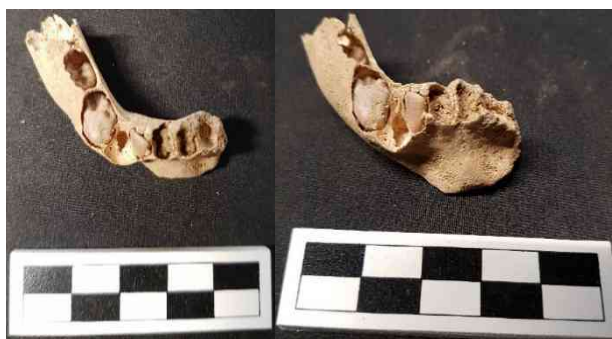
Figure 32 – Partial Mandible

These remains consist of the partial mandible (see Figure 32 and Table 39) of an infant between nine months and one year of age excavated from TP4N on March 29<sup>th</sup> 2019. The mandible is in poor condition missing the entire left side and the bone post T70. Three teeth are in situ and have not erupted (see Table 40). Age determination was based on dental eruption patterns. Sex determination was not possible. These remains were originally mixed with T-24 from the same unit. No bone or dental pathology was observed. Dental pathology assessment was only possible for T67 and T69 and was only assessed for hypoplasia. The MNI for T-23 is one.

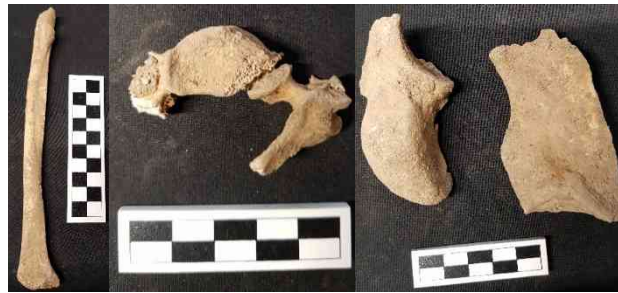
Figure 33 – Right Radius; Cervical Vertebra; Left Ilium and Ischium

These remains consists six post-cranial bone fragments (see Figure 33 and Table 41) excavated from at least one non-child/adolescent excavated from TP4N on March 29<sup>th</sup> 2019. Age is based solely on fusion suggesting an age greater than 16 years old. Bones are in poor condition with all material suffering post-mortem damage. Sex determination was not possible. These bones were originally mixed with the infant remains from T-23. No pathology was observed. The MNI for T-24 is one.

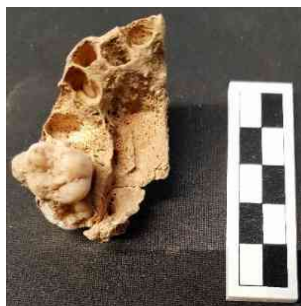
Figure 35 – Maxilla with three teeth *in situ*

These remains consist two bones, the right maxilla and palatine (see Figure 35 and Table 43) from a child approximately 11 years old excavated from TP8 on April 2<sup>nd</sup> 2019 from a depth of 30 inches BGS. The maxilla retains three teeth (see Table 44) all of which are in situ with only one that is fully erupted. Age determination is based on dental eruption patterns. Sex determination was not possible. The maxilla exhibited pathological conditions in the form of an abscess associated with T4/5. In addition, T6 is impacted with the deciduous canine abnormally retained. The MNI for TC-26 is one.

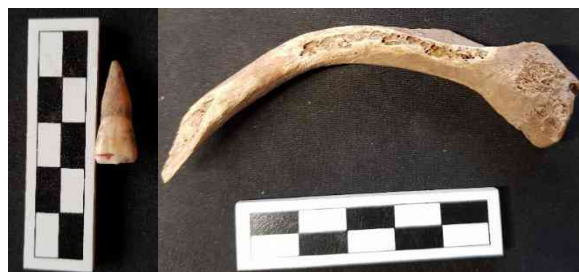
Figure 36 – Tooth 9; Rib 2-12

These remains consist of a single central incisor and one rib (see Figure 36 and Tables 45-46) of an adult between the age of 24 and 30 excavated from TP3 on April 4<sup>th</sup> 2019. Age determination is based solely on the moderate dental wear found on the incisor. Sex determination was not possible. The tooth shows clear evidence for hypoplasia formation and pre-mortem chipping. No bone pathology. The MNI for TC-27 is one.

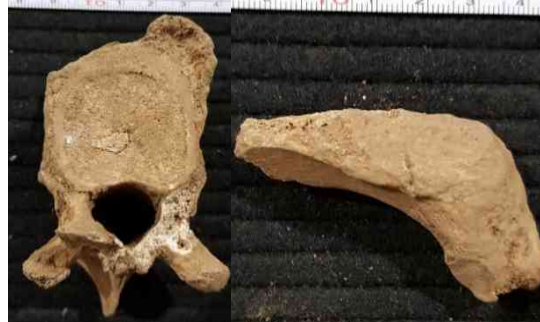
Figure 43 – Thoracic 11; Left Scapula

These remains, comprising nine cranial and post-cranial bones (see Table 54), are from an adult excavated from the South Terrace Drainage Trench between August 27<sup>th</sup> and August 29<sup>th</sup> 2019. Age determination is based on the complete fusion of bones and the degenerative (arthritic) changes seen at some of the joints. Sex determination was not possible. Pathological changes were observed affecting two bones. Thoracic vertebra 11 (see Figure 43), exhibited abnormal bone growth consistent with osteoarthritis affecting multiple joints. In addition, the acromioclavicular joint exhibited marginal lipping (see Figure 43) also consistent with osteoarthritis. This material was originally mixed with TC-33, 34 and 36. The MNI for TC-35 is one.

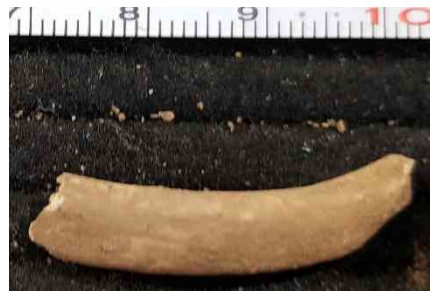
Figure 45 - Rib Fragment

These remains consist of a single rib (see Figure 45 and Table 57) fragment from a child excavated from the Southside of Church Drainage Trench East End on August 28<sup>th</sup> 2019. Age determination is based solely on the overall size of the bone. Sex determination was not possible. No pathological conditions were observed. This material was originally mixed with adult material from TC-38. The MNI for TC-37 is one.

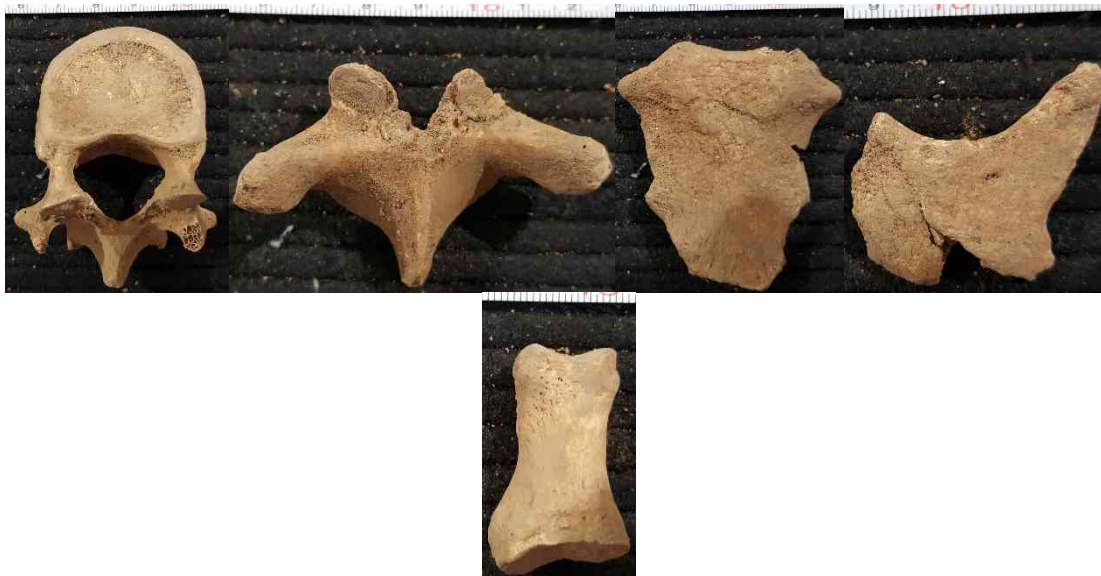
Figure 48 – Thoracic Vertebra 12; Thoracic Vertebra; Manubrium; Left Zygomatic; Proximal Foot Phalange 1

These remains consist of cranial and post-cranial bones (see Figure 47 and Table 57) of an adult excavated from the Southside of Church Drainage Trench East End on August 28<sup>th</sup> 2019. Age determination was based on the complete fusion and the overall size of the bones. Sex determination was not possible. Pathological changes in the form of abnormal porosity were observed on the manubrium at the articular surface for the clavicles. These bones were originally mixed with the child from TC-37. The MNI for TC-38 is one.
