**Phase IB Archaeological Monitoring as part of the
Reconstruction of Peck Slip, Between Water Street and
South Street, Manhattan, New York County, New York
(Contract No. M167-119M).**

Prepared for
JCC Construction Corp

Prepared by
Alyssa Loorya, Ph.D., R.P.A.
Elissa Rutigliano
Chrysalis Archaeological Consultants

August 2020

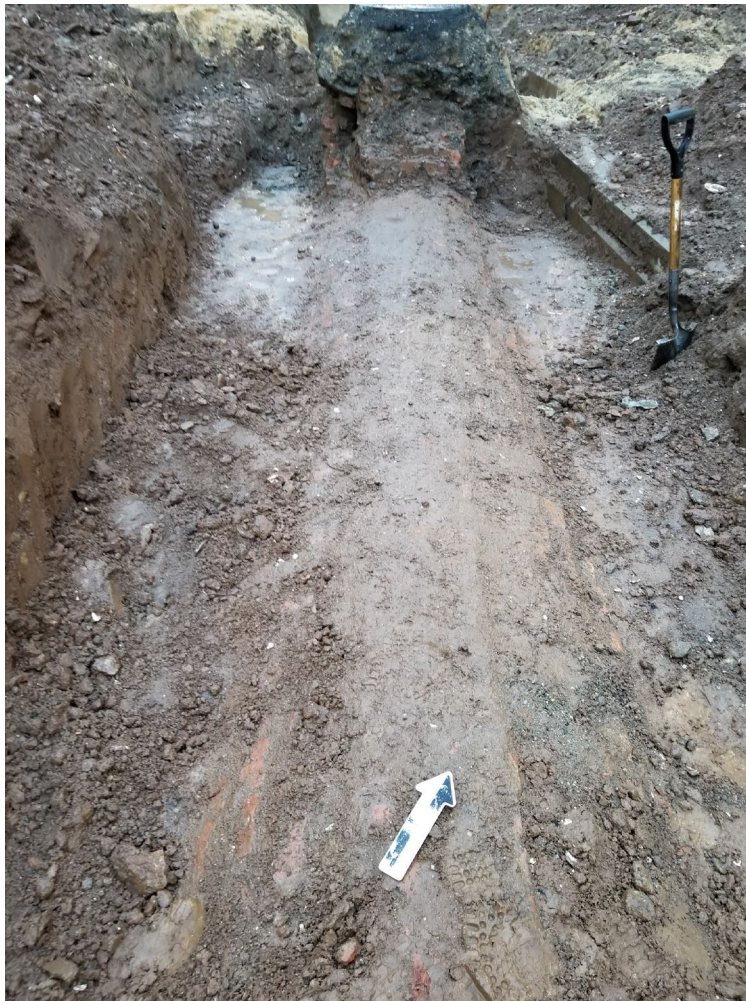
Image 01: Trench 1 with active nineteenth-century sewer in plan view, facing northwest.

Trench 1 was excavated in the Peck Slip plaza immediately south of Water Street, in Section 1 between 'Point A' and 'Point B' (Map 08). The trench measured 9' east-west and 74' north-south, with its north wall situated 12' south of the Water Street south curb-line and its west wall located 8' east of the concrete slab that borders the western property line. The trench was opened to expose the active nineteenth-century 4' by 5' combined sewer that runs north-south throughout the entirety

of the project area (Map 06). This sewer was encountered within the trench beginning at 3.4' bgs. Disarticulated brick and oyster shell likely disturbed and redeposited during the original installation of the sewer were present throughout the trench. Excavation reached a max depth of 4' bgs (Image 01) (Table 01).

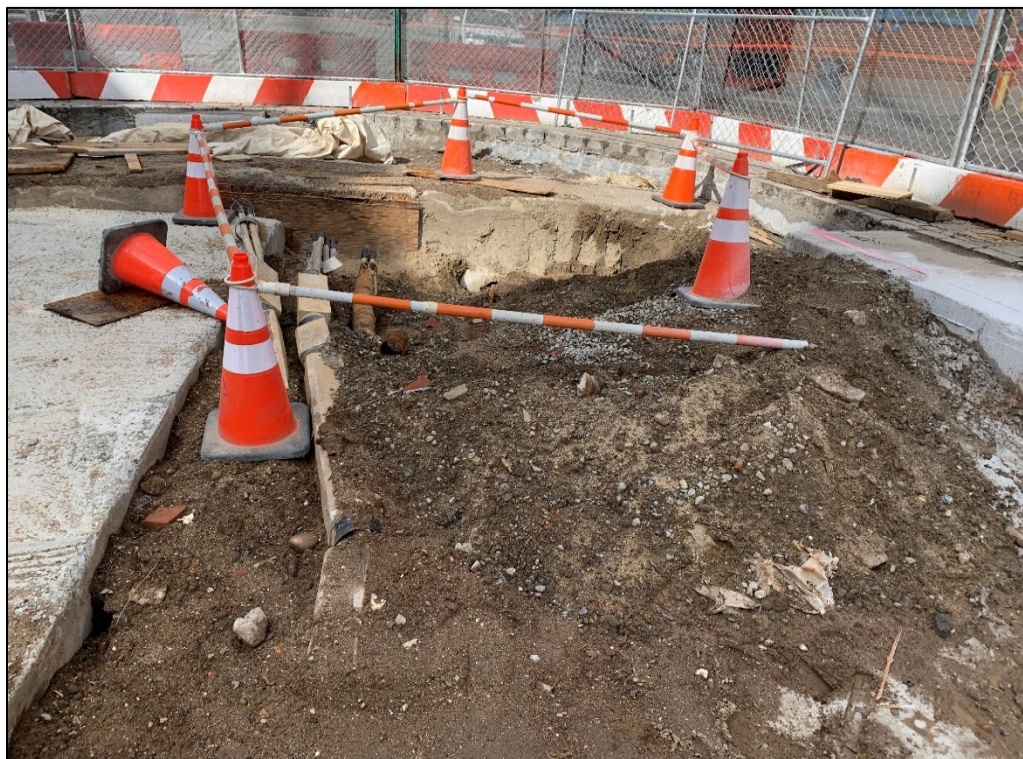
Image 02: Trench 2, general view of trench and utilities, facing north.

Trench 2 was excavated along Peck Slip, south of Water Street, in the eastern half of Section 1 (Map 08). The trench measured 10' east-west and 8' north-south. Its north wall abutted an east-west-oriented concrete encasement for a 24" steam utility, its west wall abutted the active nineteenth-century 4' by 5' combined brick sewer that runs north-south throughout the entirety of the project site (Map 06), and its east wall abutted the concrete slab that bordered the eastern property line. Two sets of north-south-oriented electric ducts were encountered in the western half of the trench at 2.5' bgs. A north-south-oriented 16" diameter high pressure water or other utility (HPW) line was encountered in the eastern half of the trench at 2.5' bgs. The northern half of the trench was excavated to a max depth of 3.24' bgs. The southern half of the trench was excavated to a max depth of 1.4' bgs. All soils exposed were fills surrounding utilities, and no intact historic soils or archaeological materials were uncovered in Trench 2 (Image 02) (Table 02).

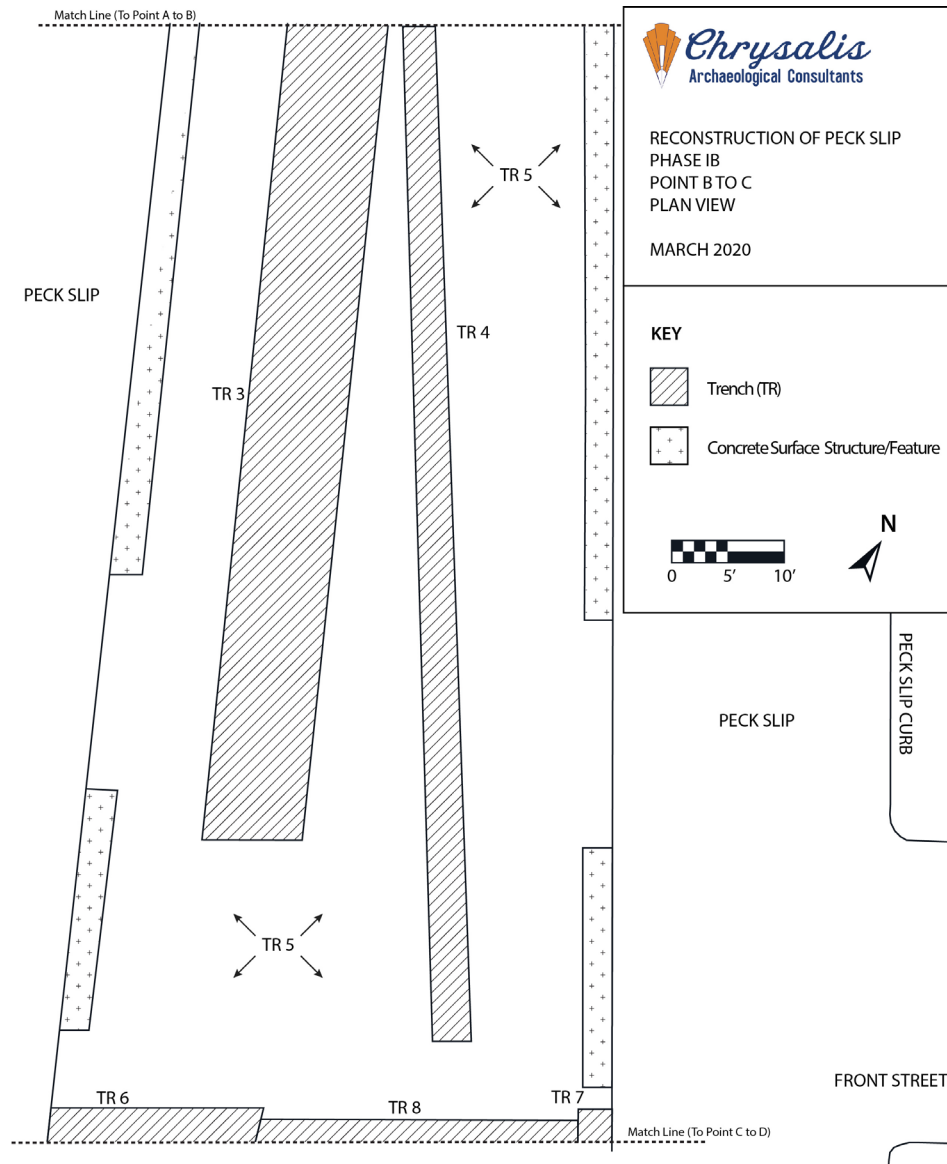
Map 09: Section 2 field results plan view.

Section 2 was the 100' segment east of Section 1 between points B and C and included Trenches 3, 4, and 5 (Map 09). No archaeological materials or intact soil strata were encountered in Section 2.

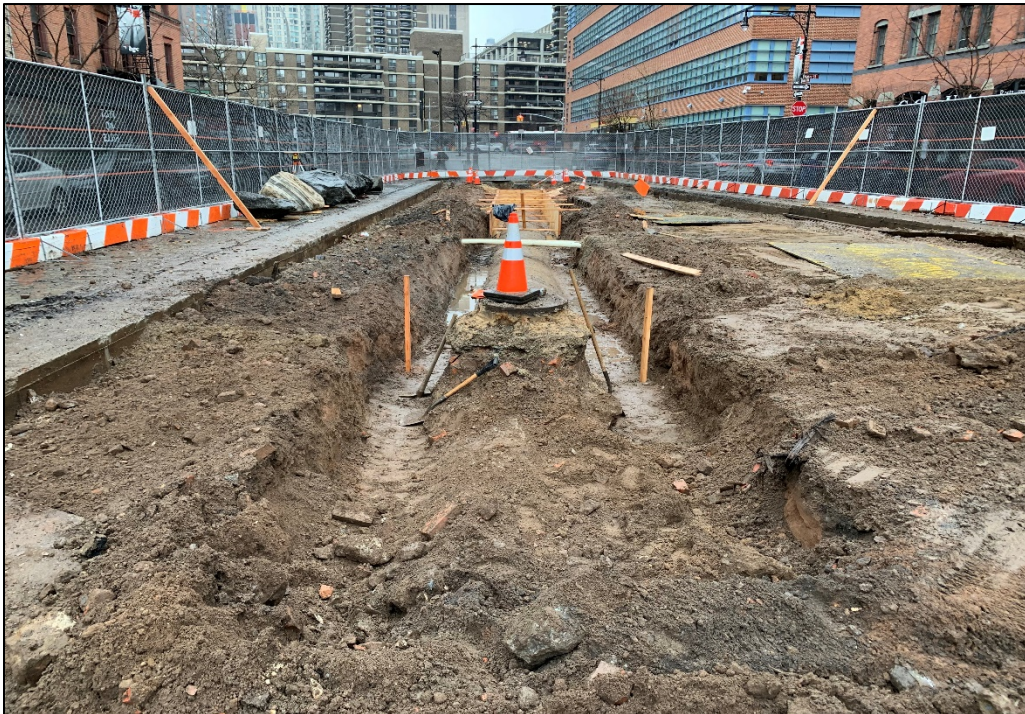
Image 03: Trench 3, plan view of trench and active nineteenth-century 4' by 5' sewer with manhole, facing north.

Trench 3 was excavated along the Peck Slip plaza in the western half of Section 2 (Map 09). This trench was aligned with Trench 1 and measured 10' east-west and 87' north-south, with its west wall located 8' east of the concrete slab that borders the western property line. The trench was opened to expose the active nineteenth-century 4' by 5' combined sewer that runs north-south throughout the entirety of the project area (Map 06) and was encountered within the trench at 3' bgs. Disarticulated brick and oyster shell redeposited during the original installation of the sewer were present throughout the trench. Excavation reached a max depth of 4' bgs (Image 03) (Table 03).

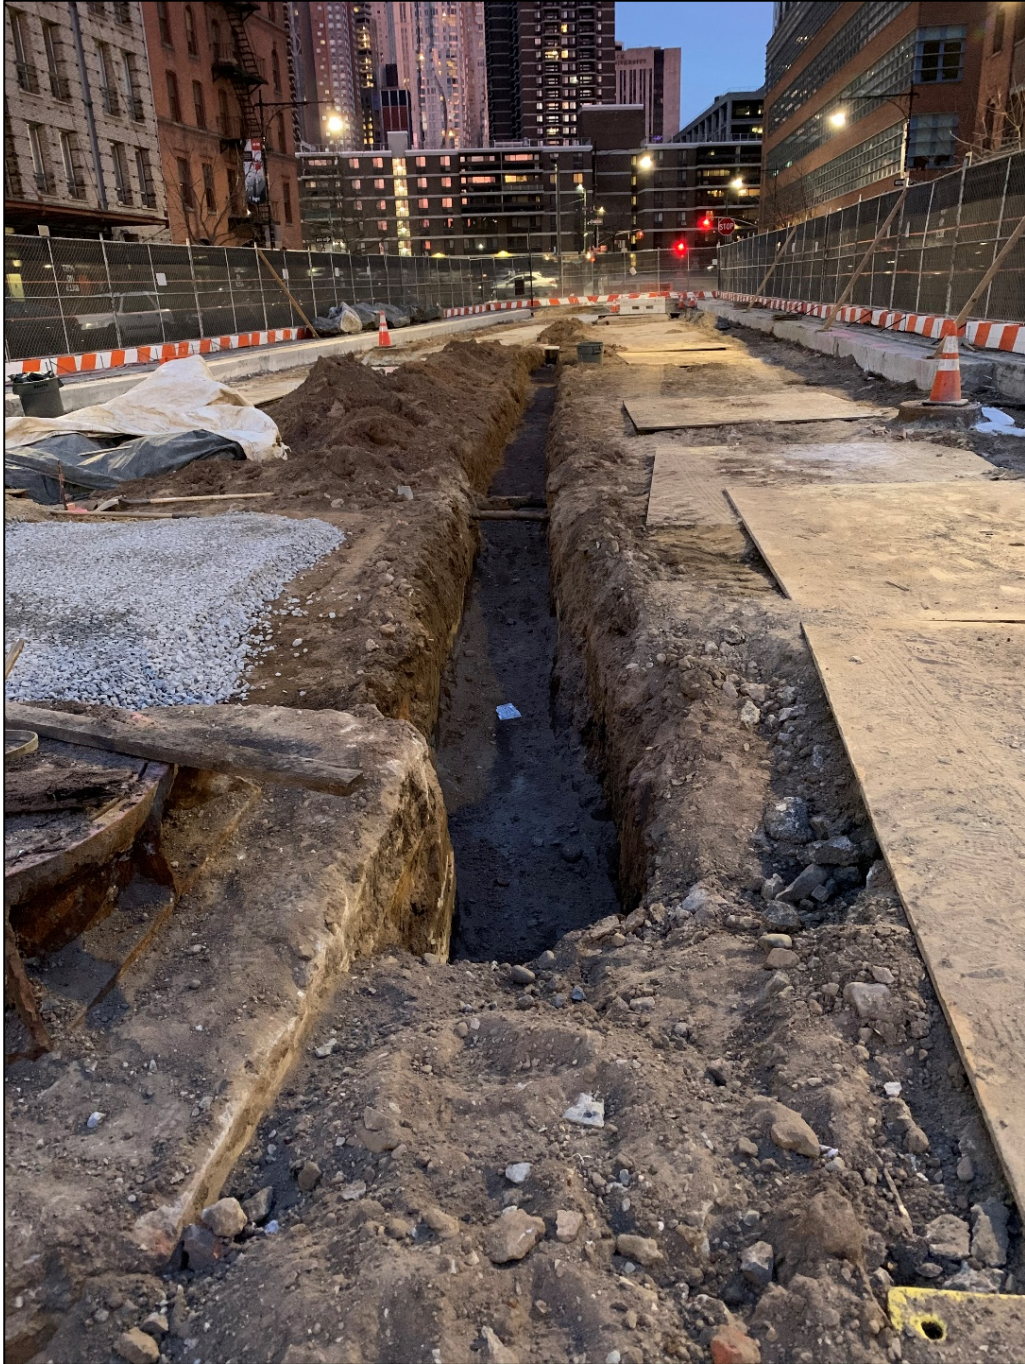
Image 04: Trench 4, plan view of trench and utilities, overview facing north.

Trench 4 was excavated in the eastern half of Section 2 (Map 09). The trench measured 3.3' east-west and 91' north-south, ending with its south wall located 9' north of the Front Street southern curb-line and its east wall located 18' west of the eastern property line. Two east-west-oriented PVC telecom ducts were encountered in the northern half of the trench at 2' bgs. Two east-west-oriented metal pipes were encountered in the southern half of the trench at 2.5' bgs. These pipes' function could not be determined based on their level of expose, and they did not reappear in subsequent excavation trenches further south. Map 06 suggests they represent electric lines, likely also exposed in Trench 02 (Map 06). The trench was excavated to a maximum depth of 4.5' bgs (Images 04-05) (Table 04). Trace amounts of disarticulated brick were seen throughout the west profile. No cultural material or intact stratigraphy was encountered.

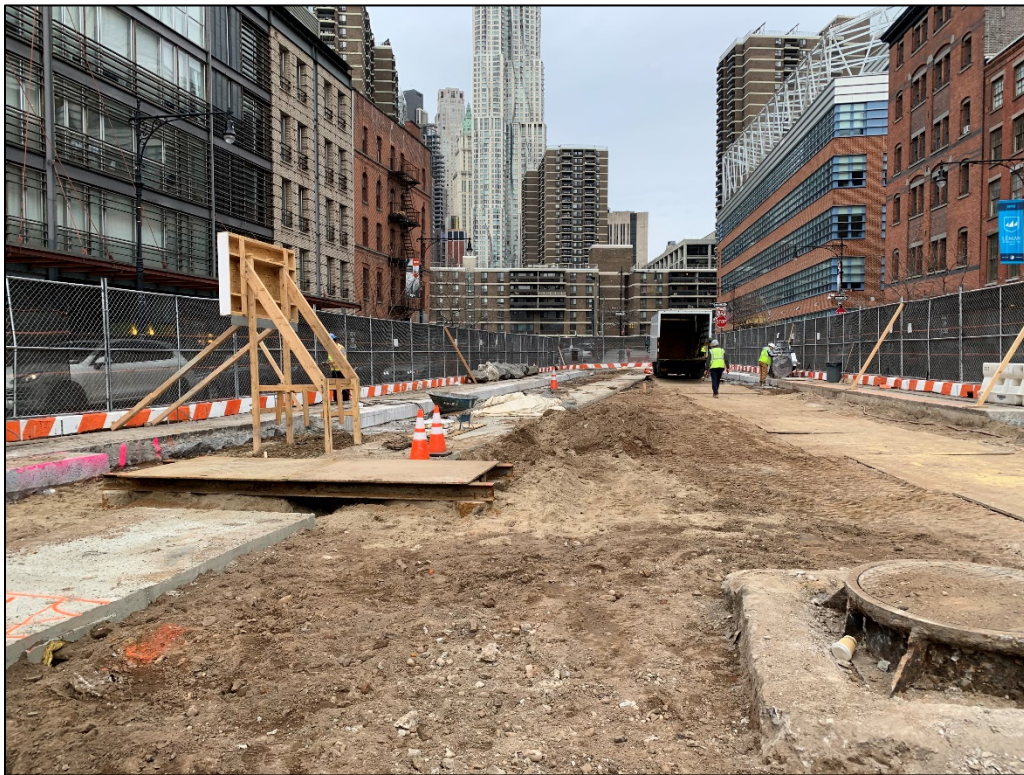
Image 06: View of the project area from ‘Point A’ to ‘Point C,’ facing north.

Trench 5 represented the remaining project area between ‘Point A’ to ‘Point C’ in Sections 1-2 (Map 09) lying outside the bounds of Trenches 1 through 4. Trench 5 was stripped to a max depth of 1.6’ bgs (Image 06) (Table 05). No cultural material or intact stratigraphy was encountered.

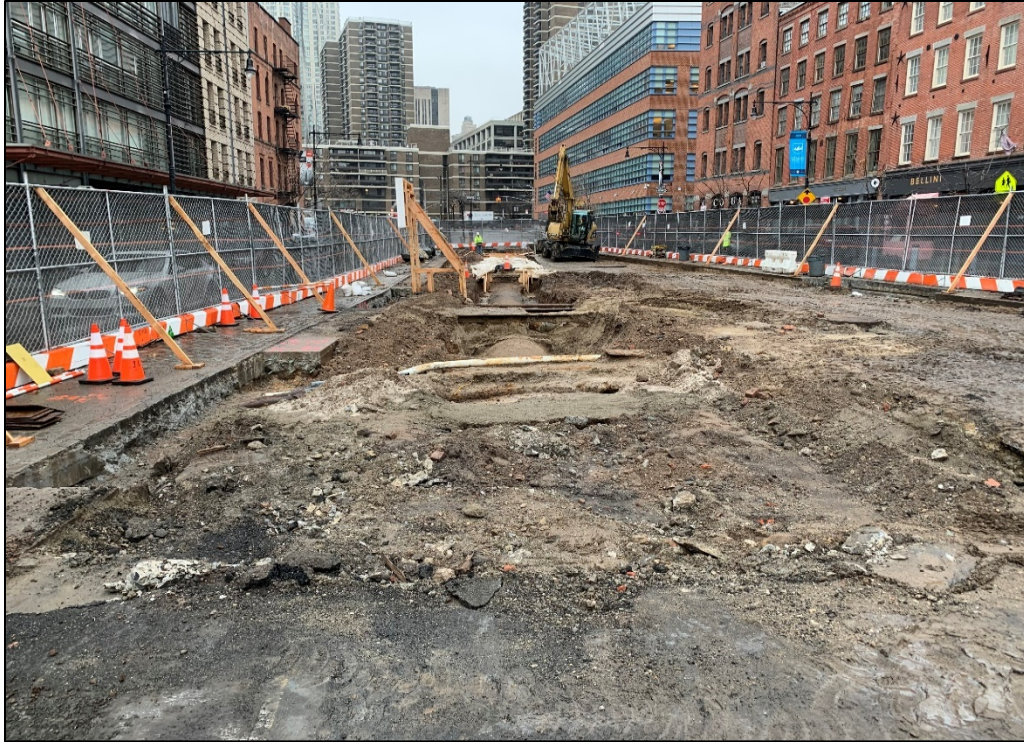
Image 07: Trench 6, plan view of trench and utilities, facing north.

Trench 6 was excavated immediately south of Front Street, in the western half of the project area. The trench measured 19' east-west and 43' north-south, with its west wall abutting the concrete slab bordering the western property line and its north wall aligning to the Front Street southern curb-line, or 'Point C' (Map 10). The trench was opened to expose the active nineteenth-century 4' by 5' combined sewer that runs north-south throughout the entirety of the project area (Map 06). The combined sewer was encountered within the eastern half of the trench at 1.96' bgs. An 11.4' east-west section of the trench surrounding the sewer utility was excavated to a maximum depth of 2.6' bgs. Several disarticulated bricks and oyster shells redeposited from the original sewer installation or its maintenance were present throughout this section (Image 07) (Table 06).

The remaining 7.6' comprising the western half of the trench was excavated to a max depth of 1.36' bgs. Excavation exposed numerous east-west-oriented utilities in the northern half of the trench (partially overlapping with the Front Street intersection, which was not monitored). These utilities included PVC, concrete-encased, and metal electric and telephone ducts encountered between 1.36' and 1.48' bgs as well as a concrete-encased metal 16" diameter HPW utility, encountered at 1' bgs (Table 07).

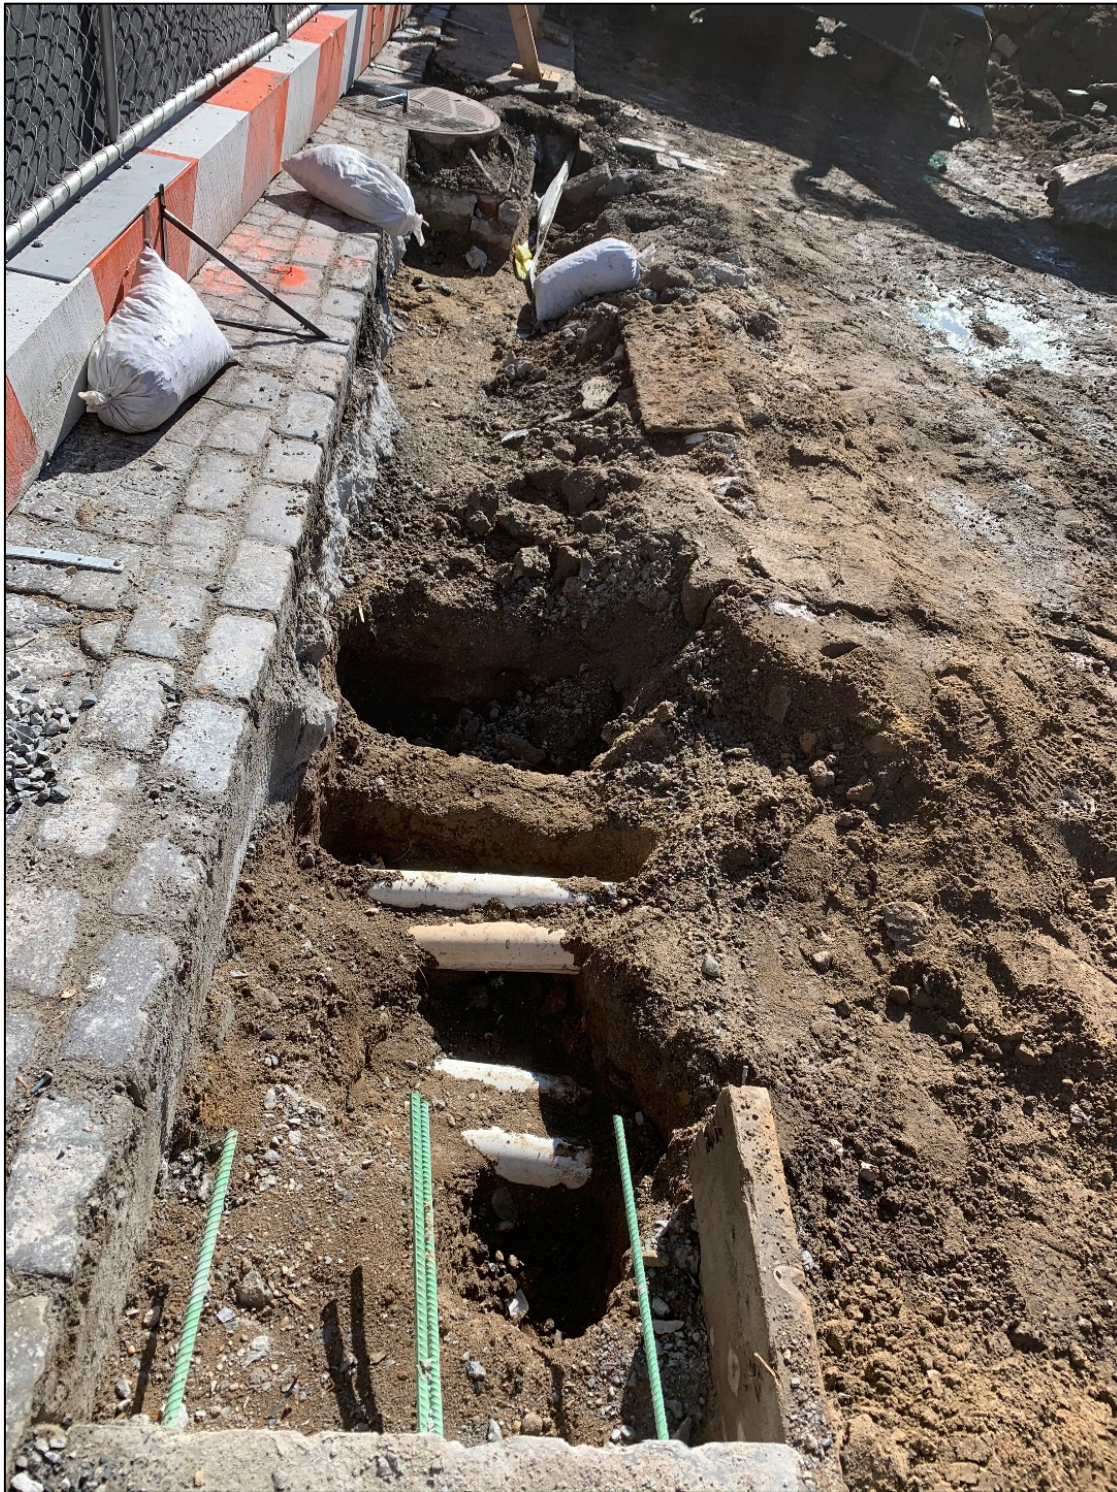
Image 08: Trench 7, plan view of trench and utilities, overview facing south.

Trench 7 was excavated immediately south of Front Street, in the eastern half of the project area. The trench measured 3.36' east-west and 16.2' north-south, with its east wall abutting the eastern property line and its north wall aligning to the Front Street southern curb-line, or 'Point C' (Map 10). The trench was opened to expose three east-west-oriented PVC and concrete-encased telephone and electric ducts seen in the northern half of Trench 6. Each of the three ducts were 9.6" wide and spaced 7" apart from each other. Two were encountered within the trench at 2' bgs, and the third was encountered within the trench at 2.36' bgs. The northern half of the trench, comprising the northernmost 7', was excavated to a max depth of 2.96' bgs. The southern half of the trench, comprising the remaining 9.24', was excavated to a max depth of 1.6' bgs (Images 08-09) (Table 08). No cultural material or intact stratigraphy was encountered.

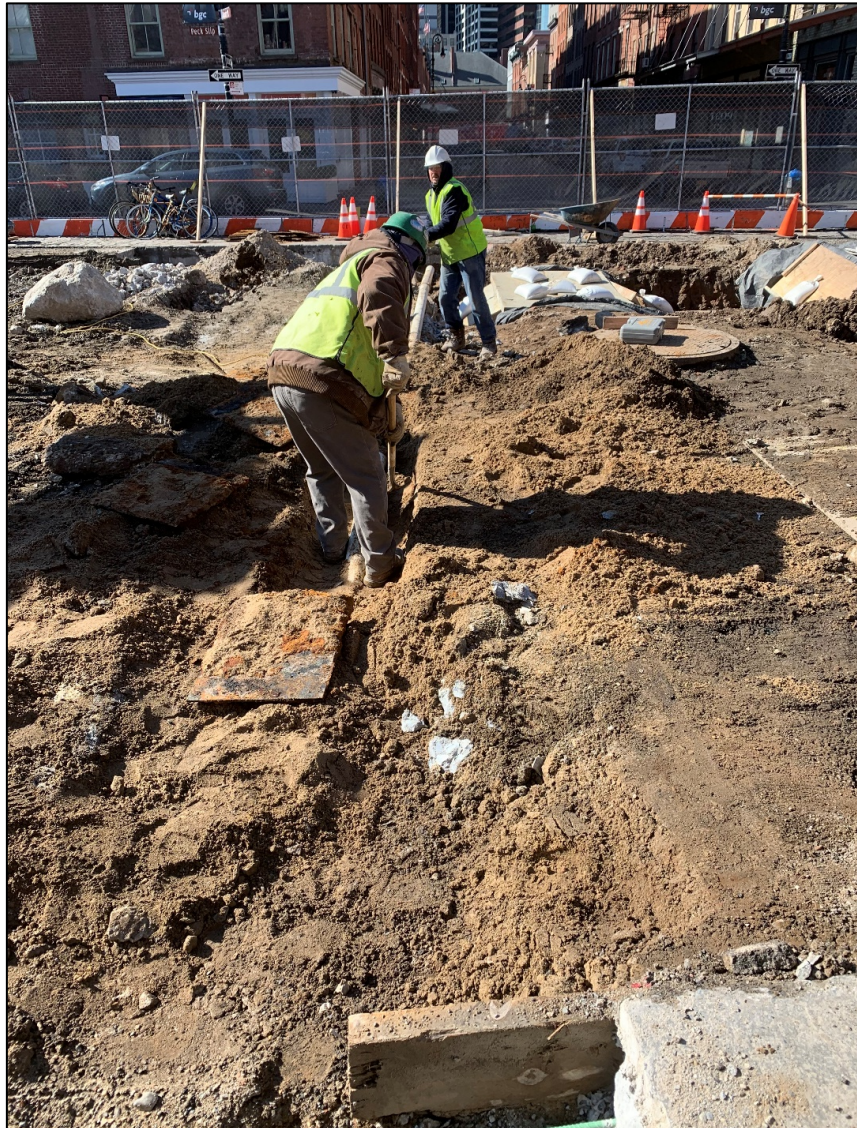
Image 10: Trench 8, Excavation in progress, facing west.

Trench 8 was excavated immediately south of Front Street. It was an east-west-oriented trench that ran between Trench 6 and Trench 7. The trench measured 36.4' east-west and 7.6' north-south, with its west wall abutting Trench 6, its east wall abutting Trench 7, and its north wall aligning to the Front Street southern curb-line, or 'Point C' (Map 10). The trench was opened to expose three east-west-oriented electric and telephone ducts seen in the northern half of both Trench 6 and Trench 7. Excavation reached a max depth of 1' bgs (Image 10) (Table 09). No cultural material or intact stratigraphy was encountered.

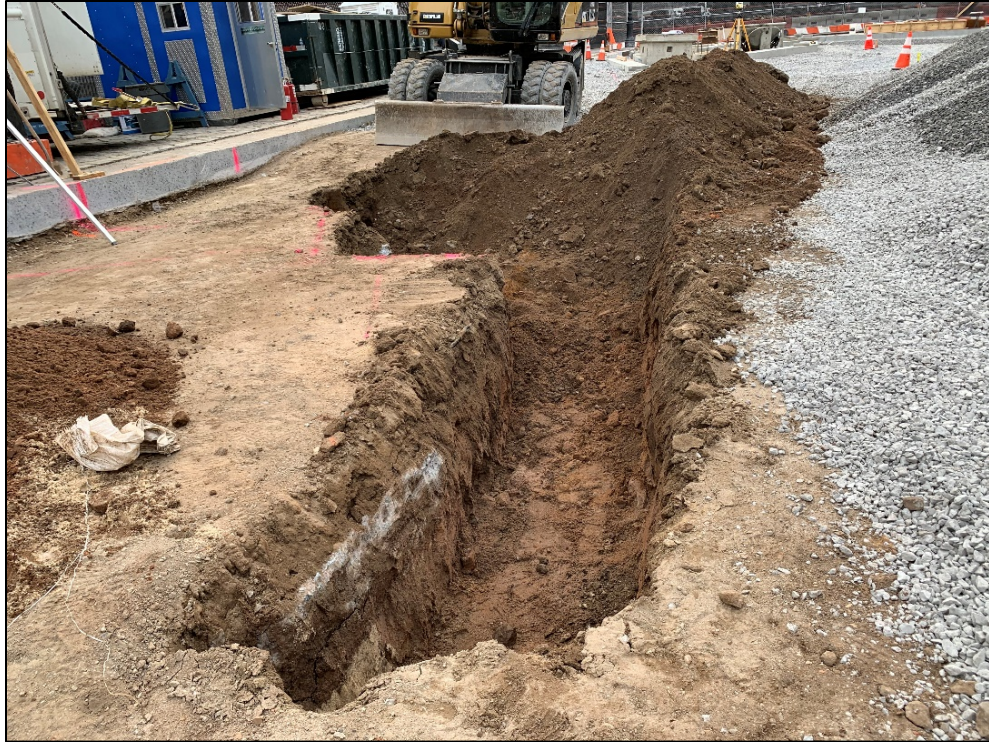
Image 11: Trench 9, plan view, facing south.

Trench 9 was excavated in the eastern half of Section 4 (Map 10). The L-shaped trench measured 23' north-south, with its north wall located 8' south of the Front Street southern curb-line. The northern portion of the trench measured 4.3' east-west, with its east wall located 15.5' west of the eastern property line. The southern portion of the trench measured 11' east-west, with its east wall located 5.5' west of the eastern property line. A north-south-oriented 12" diameter HPW utility was encountered in the southern portion of the trench at 3.8' bgs. The trench was excavated to a maximum depth of 4.9' bgs (Images 11-14) (Table 10). Oyster shell was found within the trench, and disarticulated brick was seen throughout the west profile (Table 11). Both occurred in disturbed, mixed fill soils. No cultural material or intact stratigraphy was encountered.

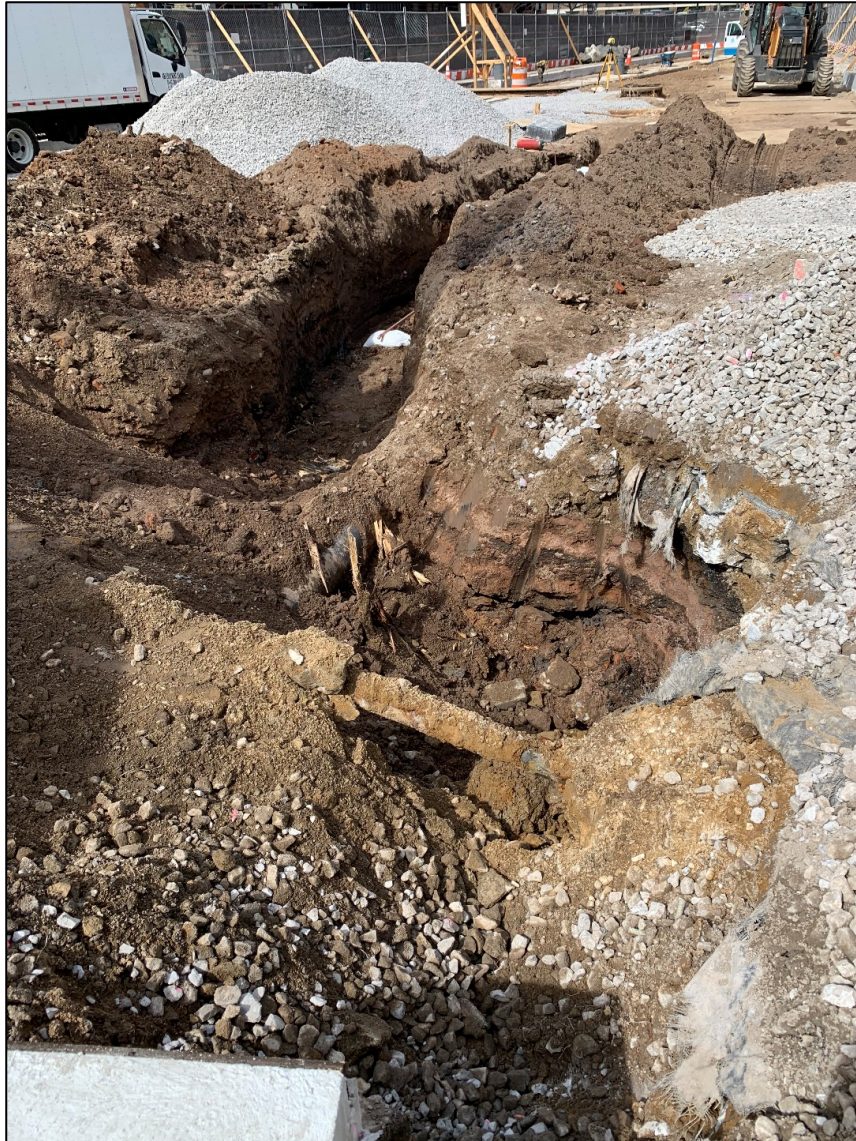
Image 15: Trench 10, plan view, overview facing northwest.

Trench 10 was excavated in the eastern half of Section 3 (Map 10). The L-shaped trench was opened south of and connecting to Trench 9 (Image 15). It measured 40' north-south, with its west wall aligned to the west wall of Trench 9. The northern portion of the trench measured 4' east-west, with the east wall located 12.3' west of the eastern property line. The southern portion of the trench measured 13.2' east-west, with the east wall located 3.3' west of the eastern property line. The north-south-oriented 12" diameter HPW utility, previously seen in Trench 9, was encountered within the trench at 3.7' bgs. The trench was excavated to a maximum depth of 5' bgs (Image 16). Disarticulated brick was seen distributed throughout the strata visible in the west profile, and the top of a stratum with increased disarticulated, crushed brick fragments was seen in the west profile at 5' bgs (Tables 12-13). No intact or articulated bricks were evident across the trench.

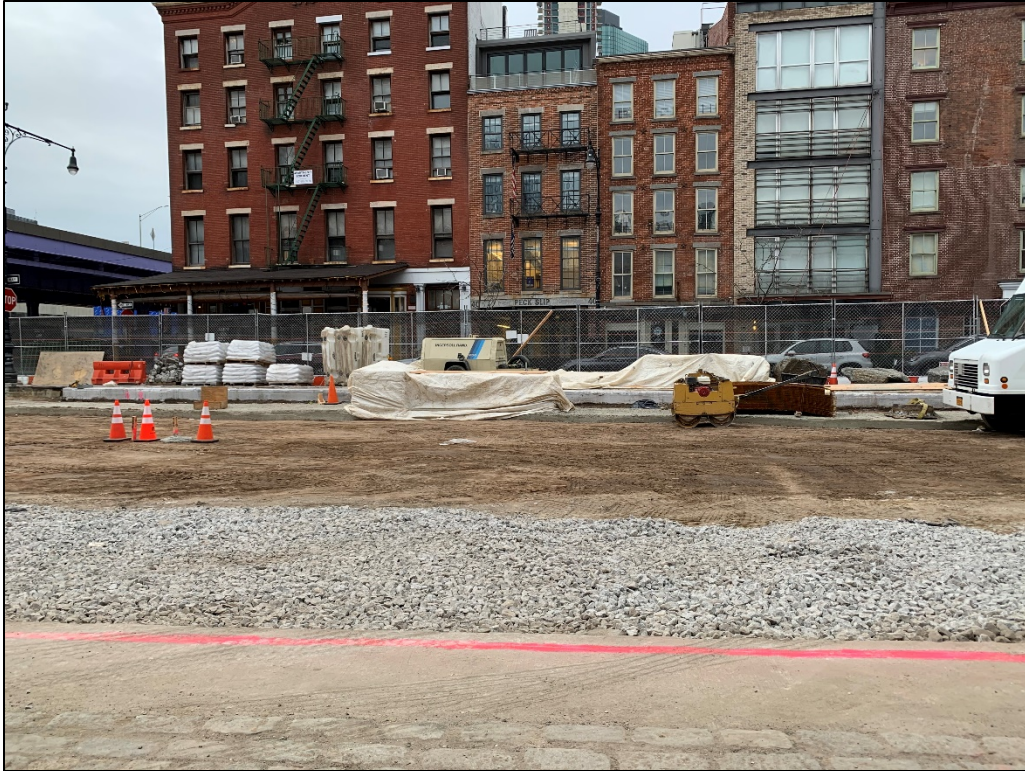
Image 17: Trench 11, overview of Section 3, facing west.

Trench 11 represented the remaining project area in Section 3 lying outside the bounds of Trenches 6 through 10 (Map 10). Trench 11 was stripped to a max depth of 1.6' bgs in anticipation of laying a gravel foundation at a later date. No cultural material or intact stratigraphy was encountered (Image 17) (Table 14).

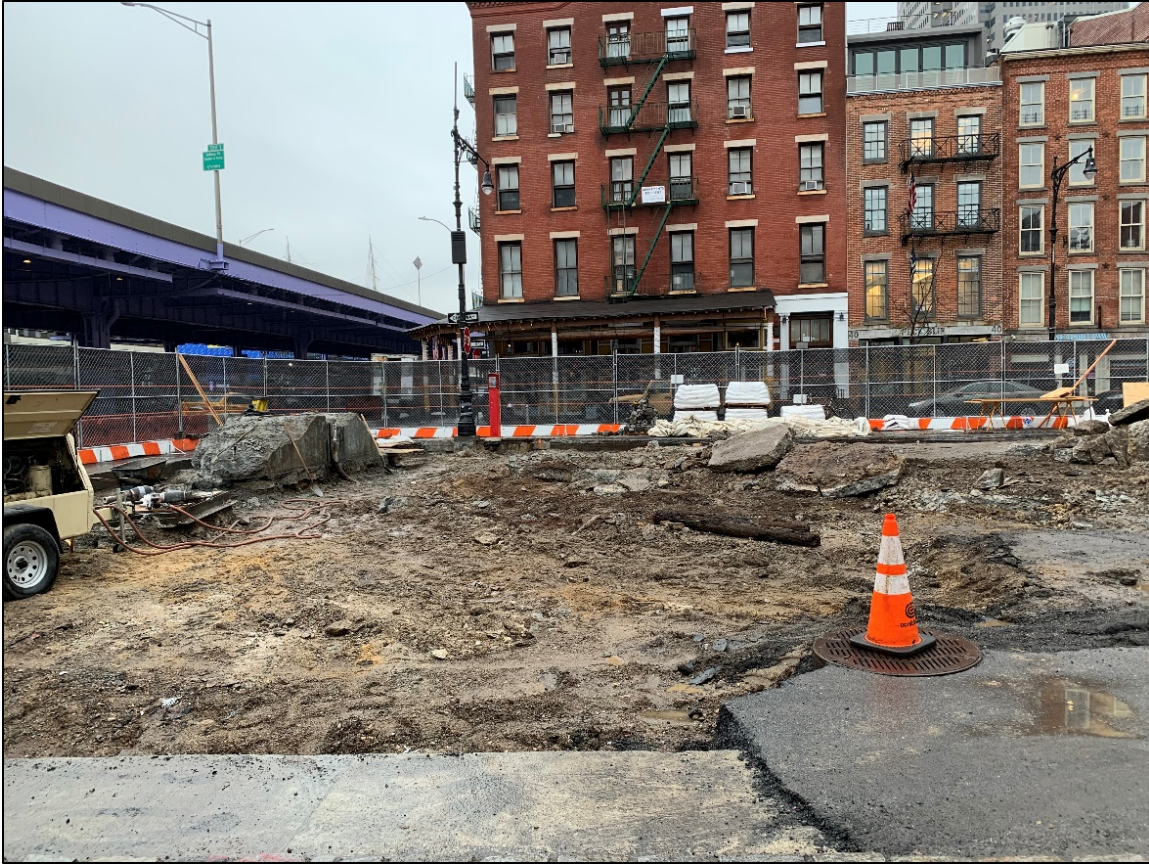
Image 18: Trench 12, plan view of trench, facing west.

Trench 12 was excavated between Front Street and South Street. The trench had a north-south measurement of 124.5', encompassing a portion of Section 3 and all of Section 4 (Map 11). The southern wall of the trench abutted the property line at South Street. The east-west measurement of the trench encompassed the entire width of the project area, with the east and west walls abutting the concrete slabs that bordered the eastern and western property lines (Image 18) (Table 15). The

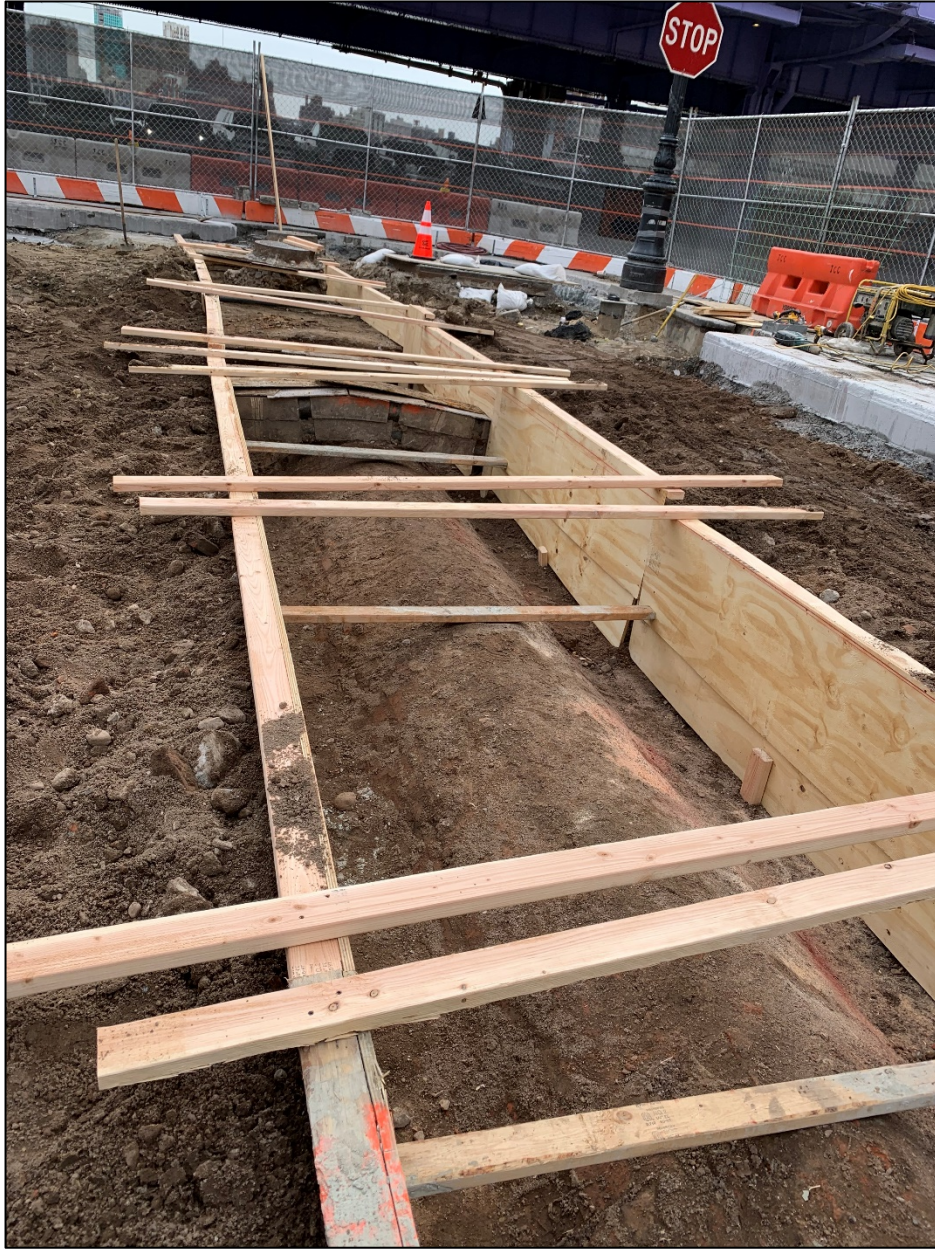
Image 19: Trench 12, active nineteenth-century 4' by 5' combined sewer , facing southwest.

westernmost 8' east-west of the trench was excavated to a max depth of 2' bgs to expose the active nineteenth-century 4' by 5' combined sewer that runs north-south throughout the entirety of the project site (Map 06) (Image 19) (Table 16). The remaining trench portion was stripped to a max depth of 1.6' bgs in anticipation of laying a gravel foundation at a later date. No cultural material or intact stratigraphy was encountered.
