Re: Archaeological Monitoring Report  
Seneca Village Sign Installation, Central Park, New York

**ARCHAEOLOGICAL MONITORING: SENECA VILLAGE SIGN INSTALLATION, CENTRAL PARK, NEW YORK**

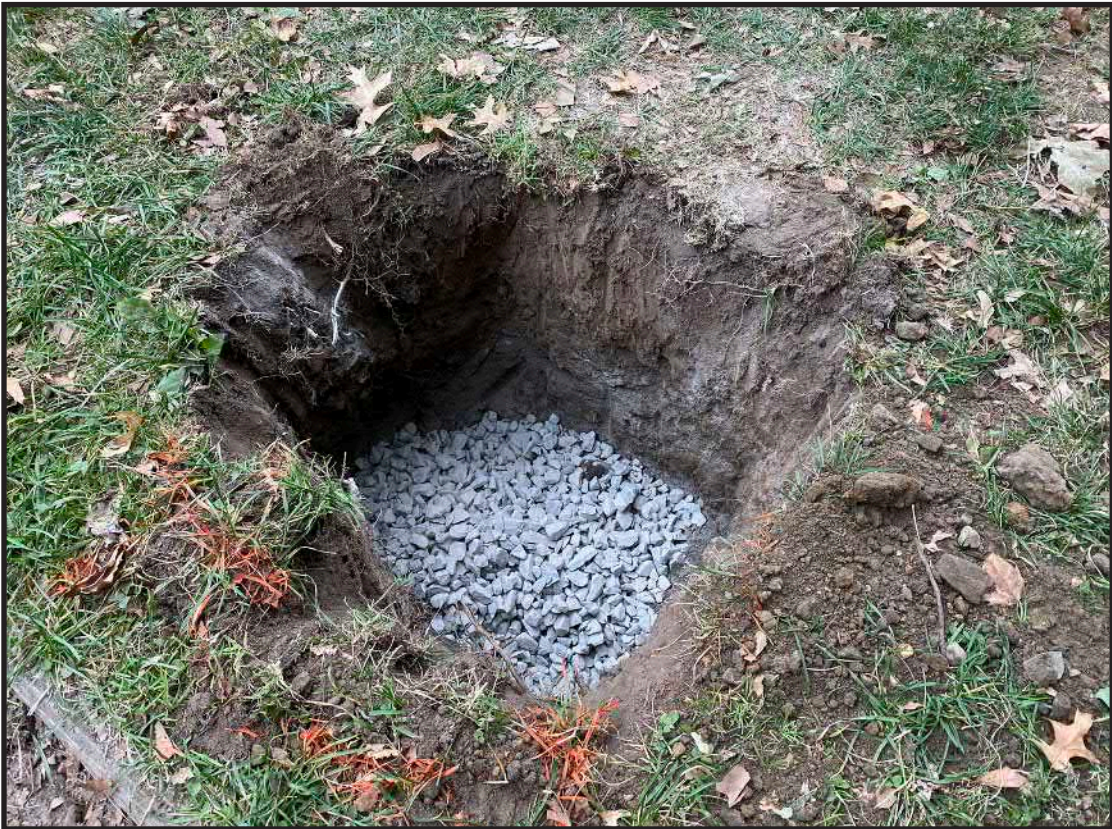
Photograph B.1. View facing northeast showing the completed excavation for Sign 13 (Photographer: James Lee, October 2019 [HRI Neg.#19070/D1:022]).

pearlware and whiteware ceramic sherds were recovered that may date to the period of occupation of Seneca Village, the lack of recognizable, intact archaeological contexts makes any direct association difficult to prove. In most excavations a dark silty loam topsoil overlay a sandy silty loam (Photographs B.1 and B.2). Bedrock was encountered in four locations, at Signs 7, 8, 9 and 11 (Figure A.2) (Photographs B.3 and B.4). At Signs 5 and 13, no second context was encountered with topsoil extending to depths of 53 and 49 cm, respectively. A modern electrical conduit was encountered in the excavation for Sign 12 (Photograph B.5). The edge of a utility vault was encountered in Sign 15, accounting for an anomalous lens of clean sand (Photograph B.6).

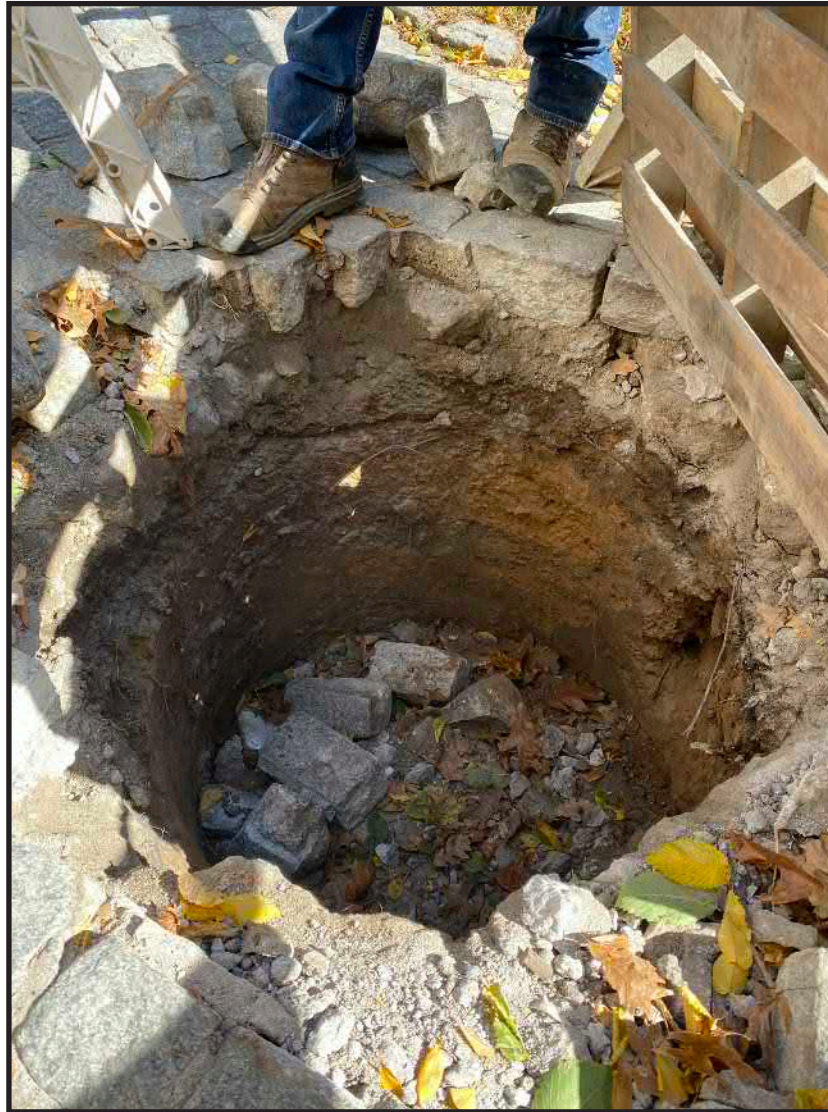
Photograph B.2. View facing northeast showing the excavation for the kiosk (Photographer: James Lee, October 2019 [HRI Neg.#19070/D1:084]).

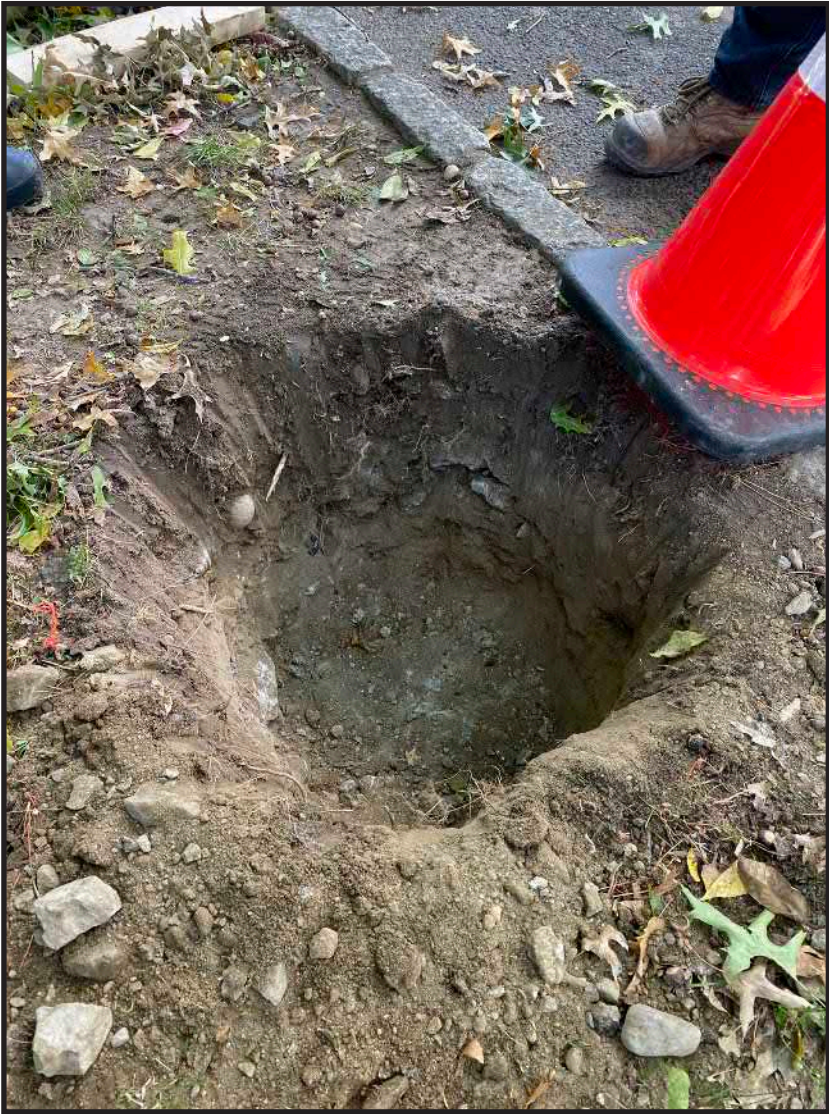
Photograph B.3. View facing northeast showing the excavation for Sign 7. Bedrock was encountered at the base of the excavation (Photographer: James Lee, October 2019 [HRI Neg.#19070/D1:082]).

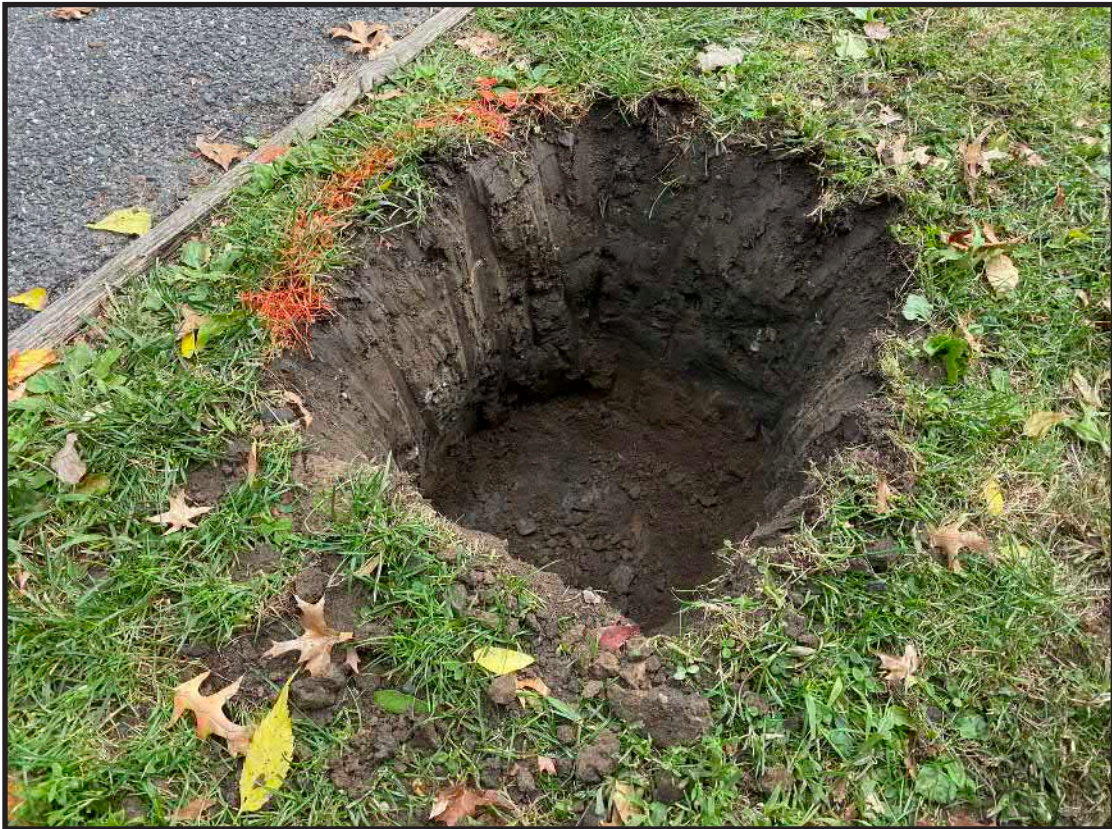
Photograph B.4. View facing northeast showing the excavation for Sign 8. Bedrock was encountered at the base of the excavation (Photographer: James Lee, October 2019 [HRI Neg.#19070/D1:077]).

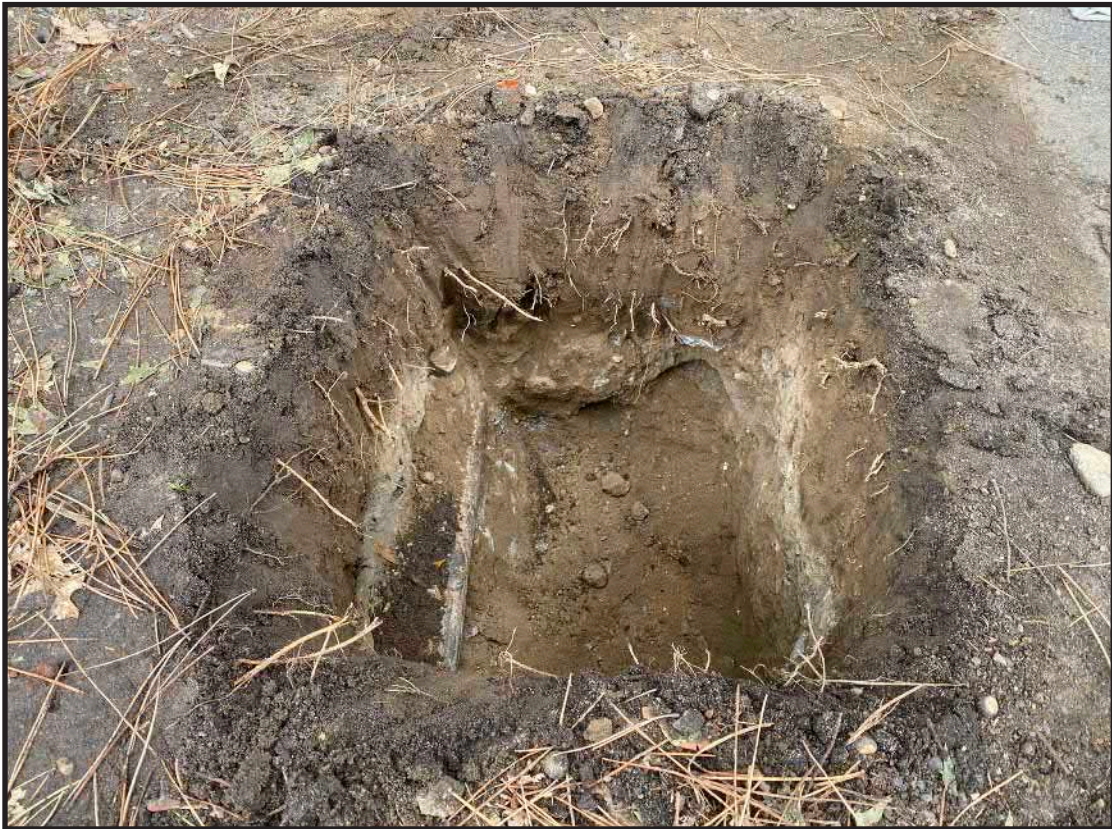
Photograph B.5. View facing northwest showing the excavation for Sign 12. Note the electrical conduit running along the southwestern edge of the excavation (Photographer: James Lee, October 2019 [HRI Neg.#19070/D1:032]).

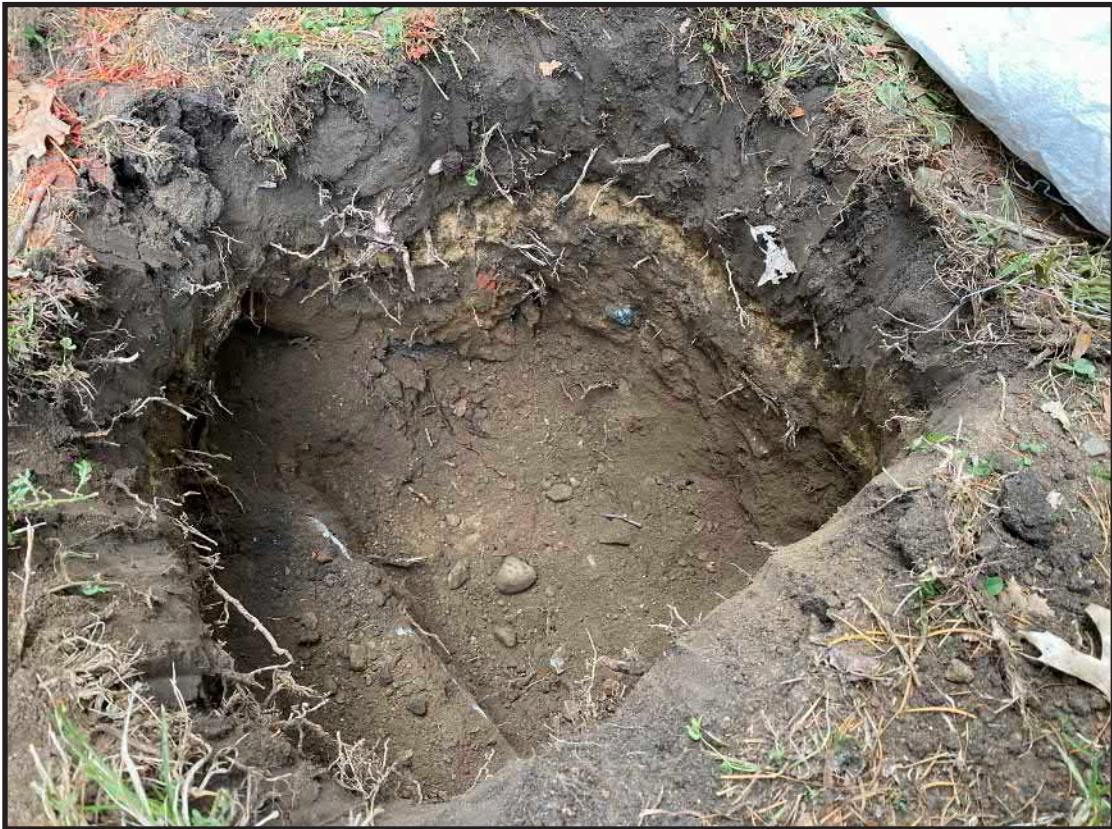
Photograph B.6. Plan view showing the excavation for Sign 15. Note the layer of sand and the edge of a utility vault (Photographer: James Lee, October 2019 [HRI Neg.#19070/D1:016]).

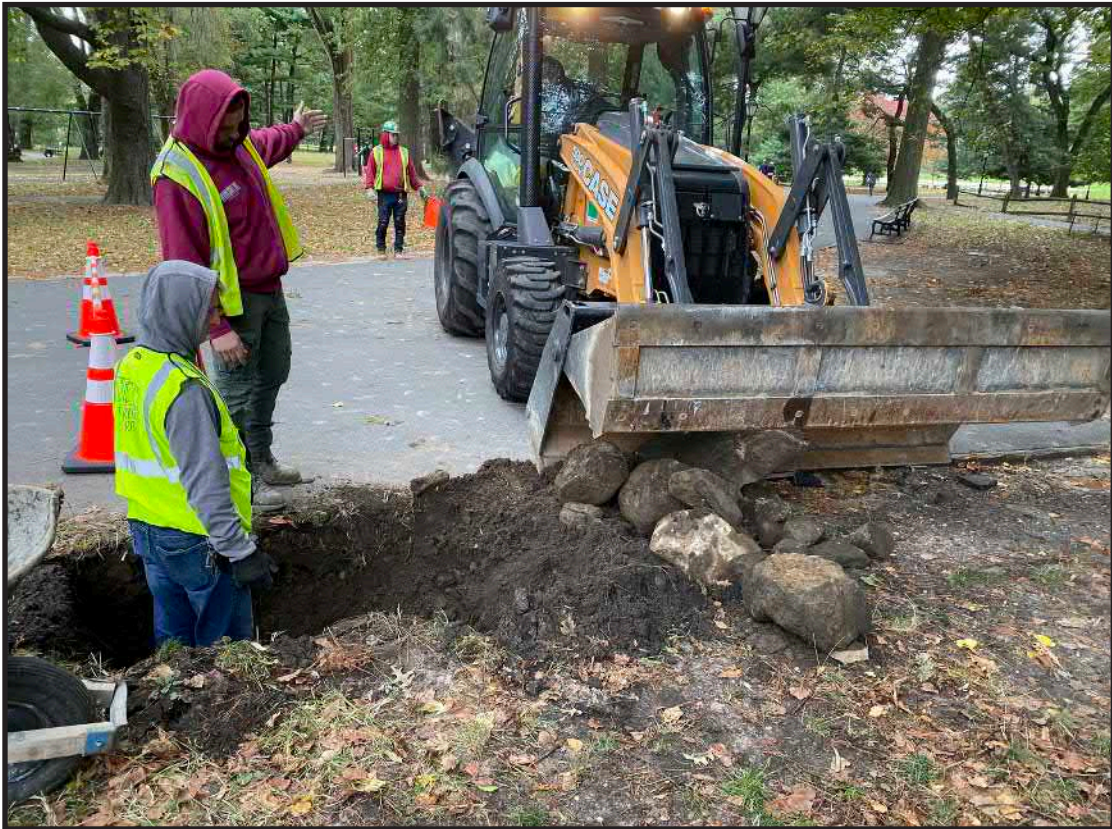
Photograph B.7. View facing east showing the stones recovered from the excavation of the eastern introduction sign (Photographer: James Lee, October 2019 [HRI Neg.#19070/D1:038]).

The excavation of greatest interest was that conducted for the eastern Introductory Sign 3 (Figure A.2). After removal of the topsoil, a context of large stones was encountered at 30 cm below the ground surface that extended beyond the limit of excavation at 79 cm (Photographs B.7, B.8 and B.9). No artifacts were associated with these stones and they were not mortared or cut in a manner that would indicate their use as a foundation wall. This sign location, according to the georeferenced Gardner and Sage maps, is within the rear yards of a stable and barn complex owned by the City of New York and apparently related to the reservoir keeper's house located a little further to the northeast (Figure A.3). The stones were most likely put in this location as part of park landscaping fill. It is possible that they were taken from the rubble core of the reservoir walls when this feature, which was located roughly 140 feet to the east, was drained and dismantled and the area re-landscaped starting in 1929.

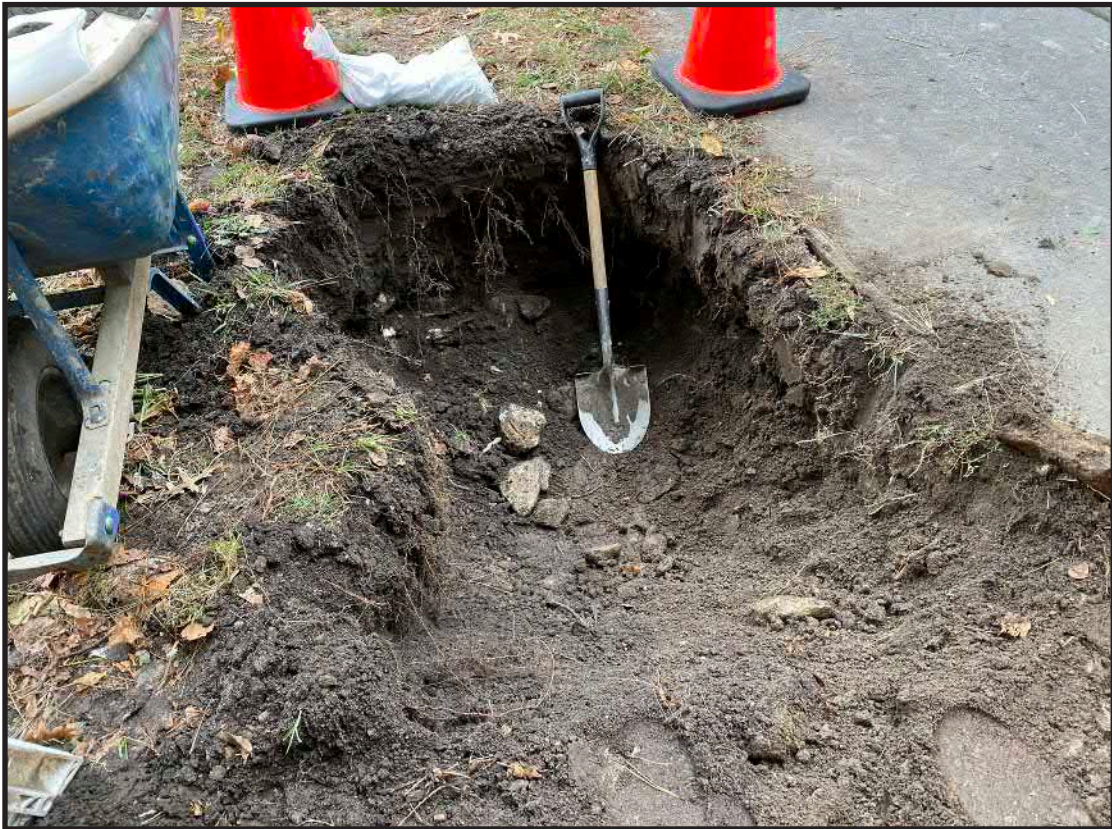
Photograph B.8. View facing north showing the large excavation necessary for the eastern introductory sign. Note the rocky context present below the topsoil (Photographer: James Lee, October 2019 [HRI Neg.#19070/D1:039]).

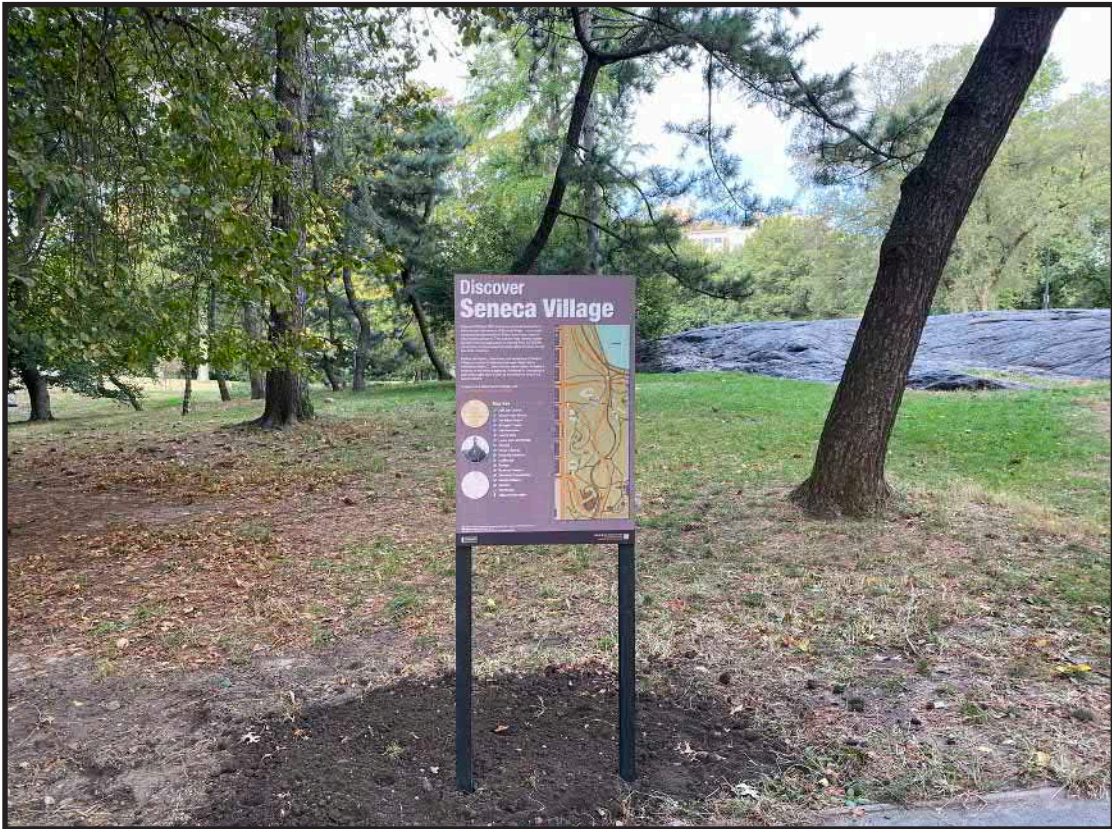
Photograph B.9. View facing west showing the installed eastern introductory sign (Photographer: James Lee, October 2019 [HRI Neg.#19070/D1:075]).
