Stage 2  
ARCHAEOLOGICAL SURVEY

The Archaeology and History of the  
Empire Stores, 2-14 Main Street, Brooklyn

CONTRACT 1A  
RED HOOK WATER POLLUTION CONTROL PROJECT  
BROOKLYN, NEW YORK

OWNER-CITY OF NEW YORK  
DEPARTMENT OF ENVIRONMENTAL PROTECTION

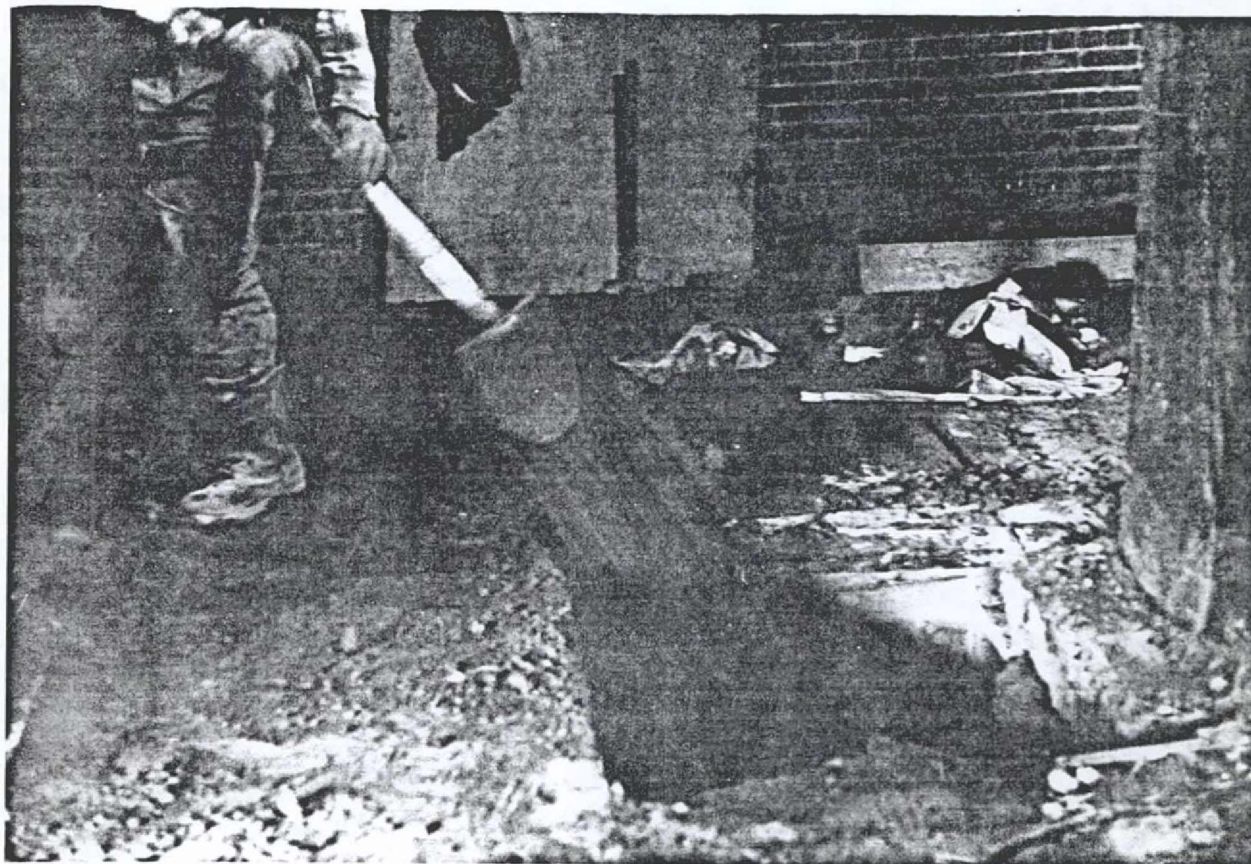
Plate 17

Trench 1 - measuring approximately 5.5 feet (N-S) and 4 feet (E-W), was located adjacent to the east side of the pier in the south east quarter of the building. Removal of the floorboards and excavation in the trench revealed the support structure of the pier, which consisted of a 2.8 foot square granite footing just over 1 foot deep below the floor boards. Beginning about 3.8 feet above sea level (all elevations were taken from "0" datum at approximate sea level), or 1.3 feet below the present floor level, were the remains of a brick structure in the east section of the trench, which formed a wall and an arch. The arch was filled with ash and could be the remains of a stove or oven, or possibly belongs to an earlier building, which was destroyed by fire. There were no indications of another arching structure to the north at a depth of about + 2 feet, but was not explored further because the excavations were halted ( Fig.20, Plate 17).

of the piers were explored. The distance between them was 8.8 feet. Sterile wet "clayey sand" was reached between 3.7 and 4.3 feet below floor level or + 1.0 to +1.6 feet depth. At + 3.7 or 1.6 feet below floor level a barrel rim was identified in the west face of the trench(Plate 17).

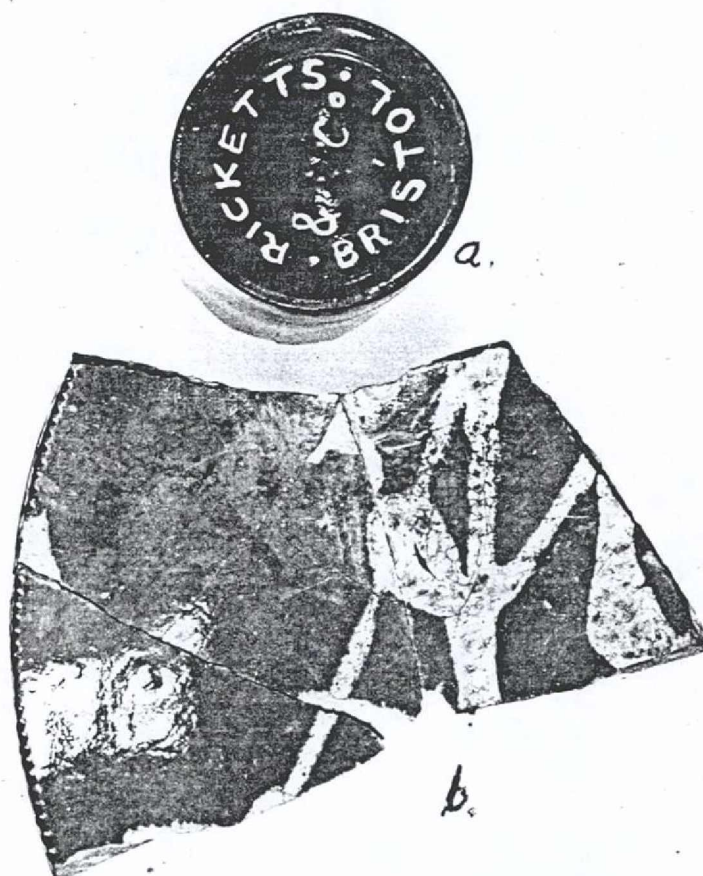
- Plate 29 a: (E.S. Pit 25-108-1) unidentified fragment, grey-blue glazed exterior with white cherubim relief, blue puddling on relief glaze, bluish tint on white exterior glaze, whiteware, ca. 1840's.

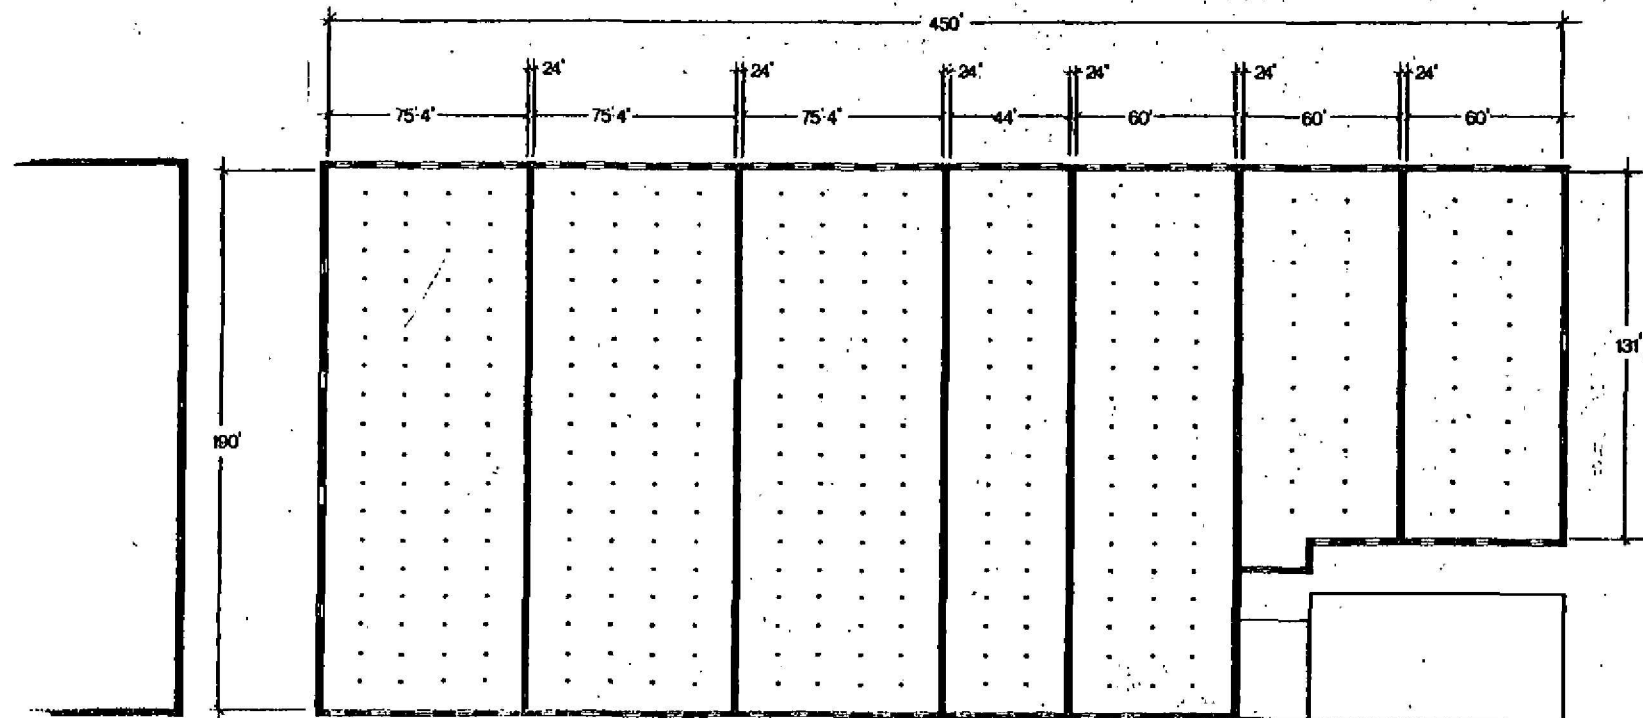
Fig. 7

Dimensional plan of a typical floor in the main building of Empire Stores shows simplicity of arrangement and adequacy of existing spaces.

According to a floor plan of the east building of the Empire Stores facing on Main Street (Fig. 8), the building width on this street measures 130 feet. The interior width is 53 feet, with exterior brick walls which measured 28 inches thick on the north side. It should be noted that the original design of the building called for a wall 32 inches thick on the river front side, and 28 inches on the Main Street side. Supporting the first floor are two rows of wood columns the length (north-south) of the room space, at a distance of 17.5 feet apart, each containing 10 columns (total 20) measuring 14 by 16 inches. These columns are 11.5 feet from center to center in each row. These columns (called piers in the original specifications) had been planned to be between 12 to 16 inches thick. The floor beams are spliced on the columns with 14 by 16 inches girders, supporting joists measuring 4 inches by 14 inches. This matches the original specifications quite well. The joists are 12 inches on centers. The flooring, in fair condition, measures 5/4 inches thick. The building is five stories high, has a height of 62 feet. The roof is flat with 5/4 inches sheathing with a paper build up surfaced with gravel. The north, south and east walls of the building are of brick on the first floor. The west wall is of stone. The wood columns decrease in size on the upper floors.

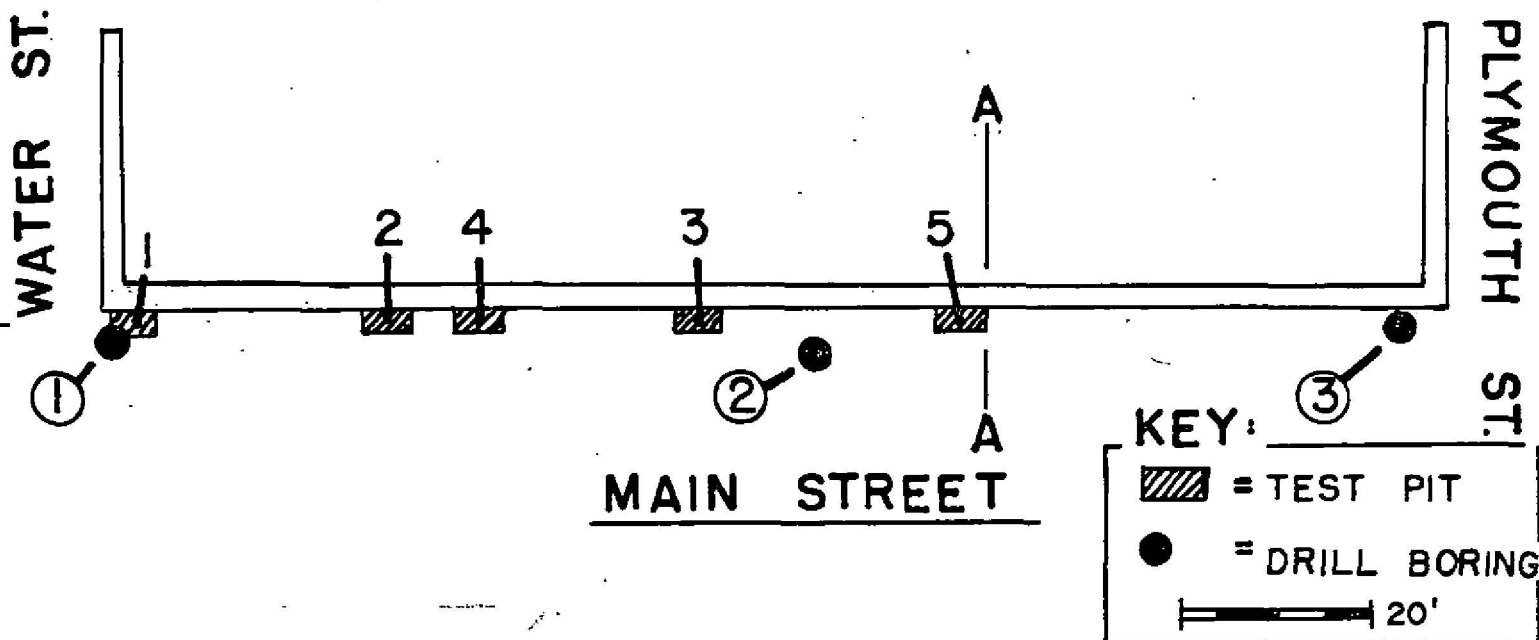
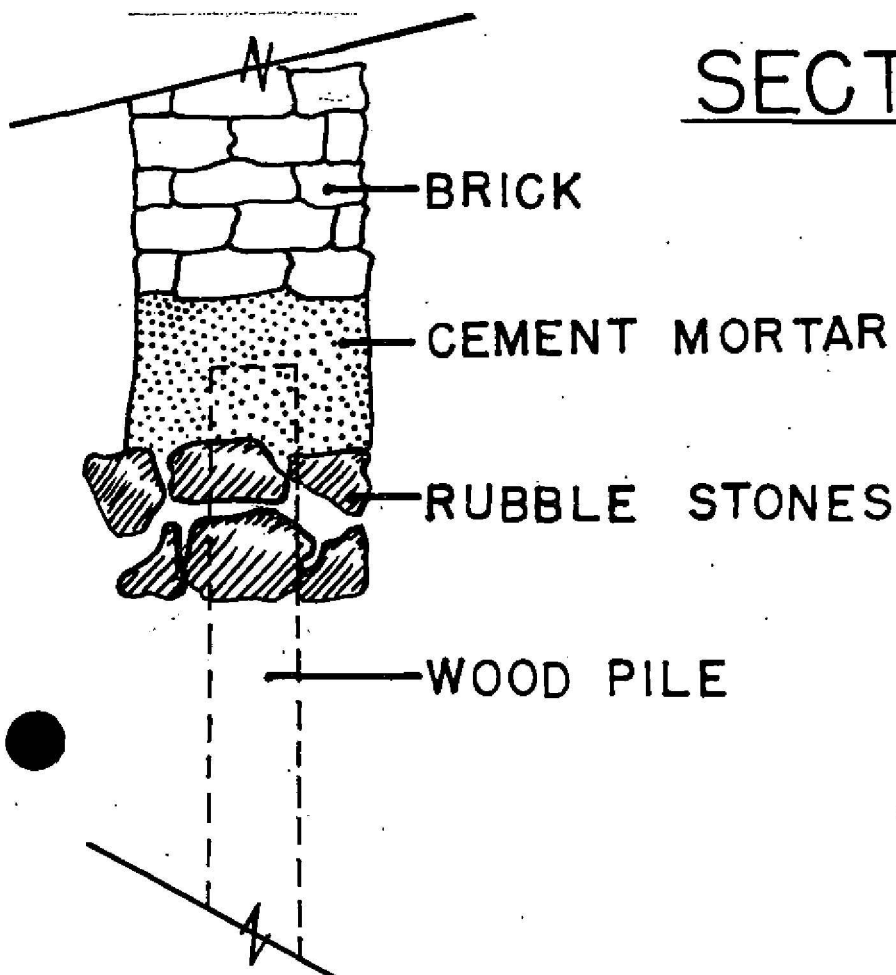
Fig. 13

# EMPIRE STORES

PLAN

## SECTION WALL A - A

On July 13th, the Underpinning and Foundation Constructors addressed a report to the Red Hook Constructors regarding their investigations at the Coffee Warehouse. The report covers their findings in the sinking of five test pits identified as Pits Nos. 1-5, and three soil borings (Fig. 11). Their findings indicated that the untreated timber piles which were the original supports of the Main Street wall of the building had disintegrated completely, and were no longer doing their intended job. As a consequence, the building was gradually transferring its weight into the layer of fill beneath the pile cap. It was this load transfer which was causing the walls of the building to crack, and this condition would continue until the "fill material is incapable of sustaining the load without excessive settlement," and the structure would collapse. The deepest pit, No. 3, was 4.6 feet deep. The front of the building was a 28 inch

thick brick wall resting on a one foot thickness of mortar and stone foundation, which in turn rested on a 1.6 foot thickness of cement and mortar capping on the wood piles. There was a 1.6 foot thickness of rubble and stones around the piles as a kind of collar. The tests were located in the eastern three quarters of the building toward Water Street. There was no test near the river side of the building.

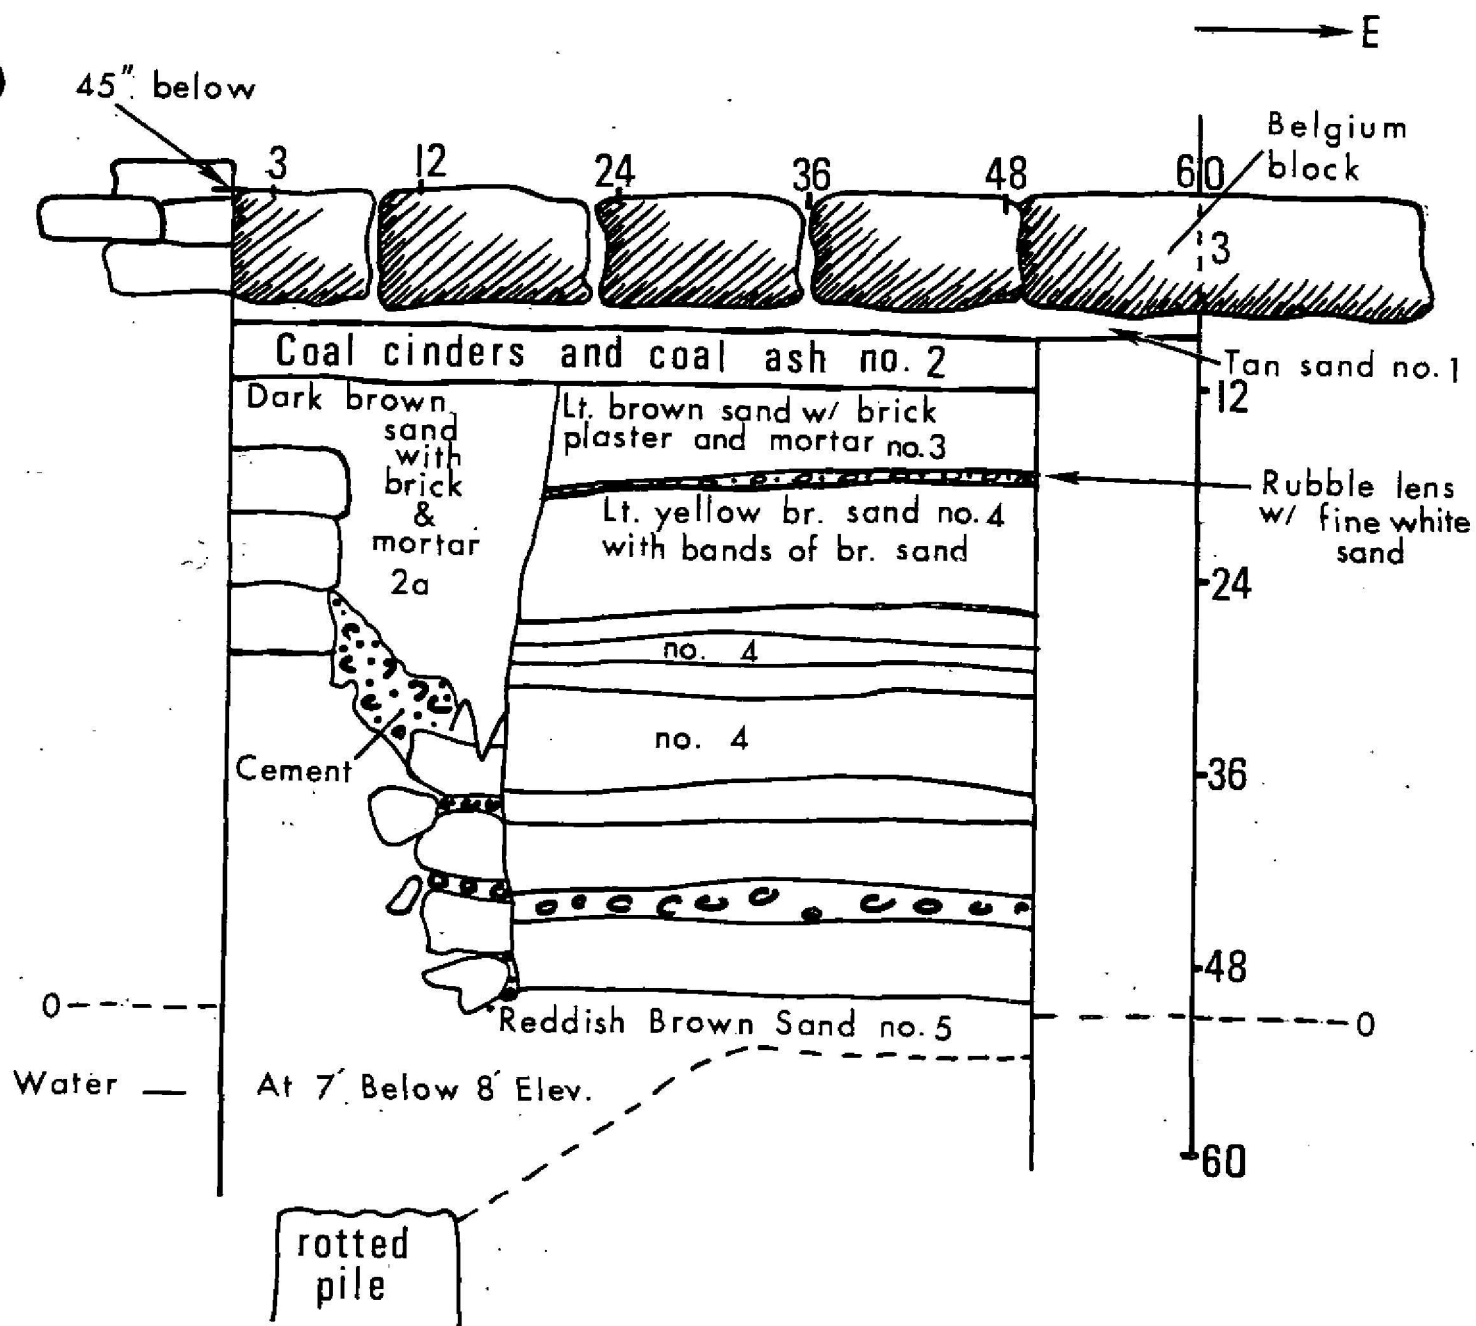
Fig. 17

## TEST PIT No. 2

EAST WALL

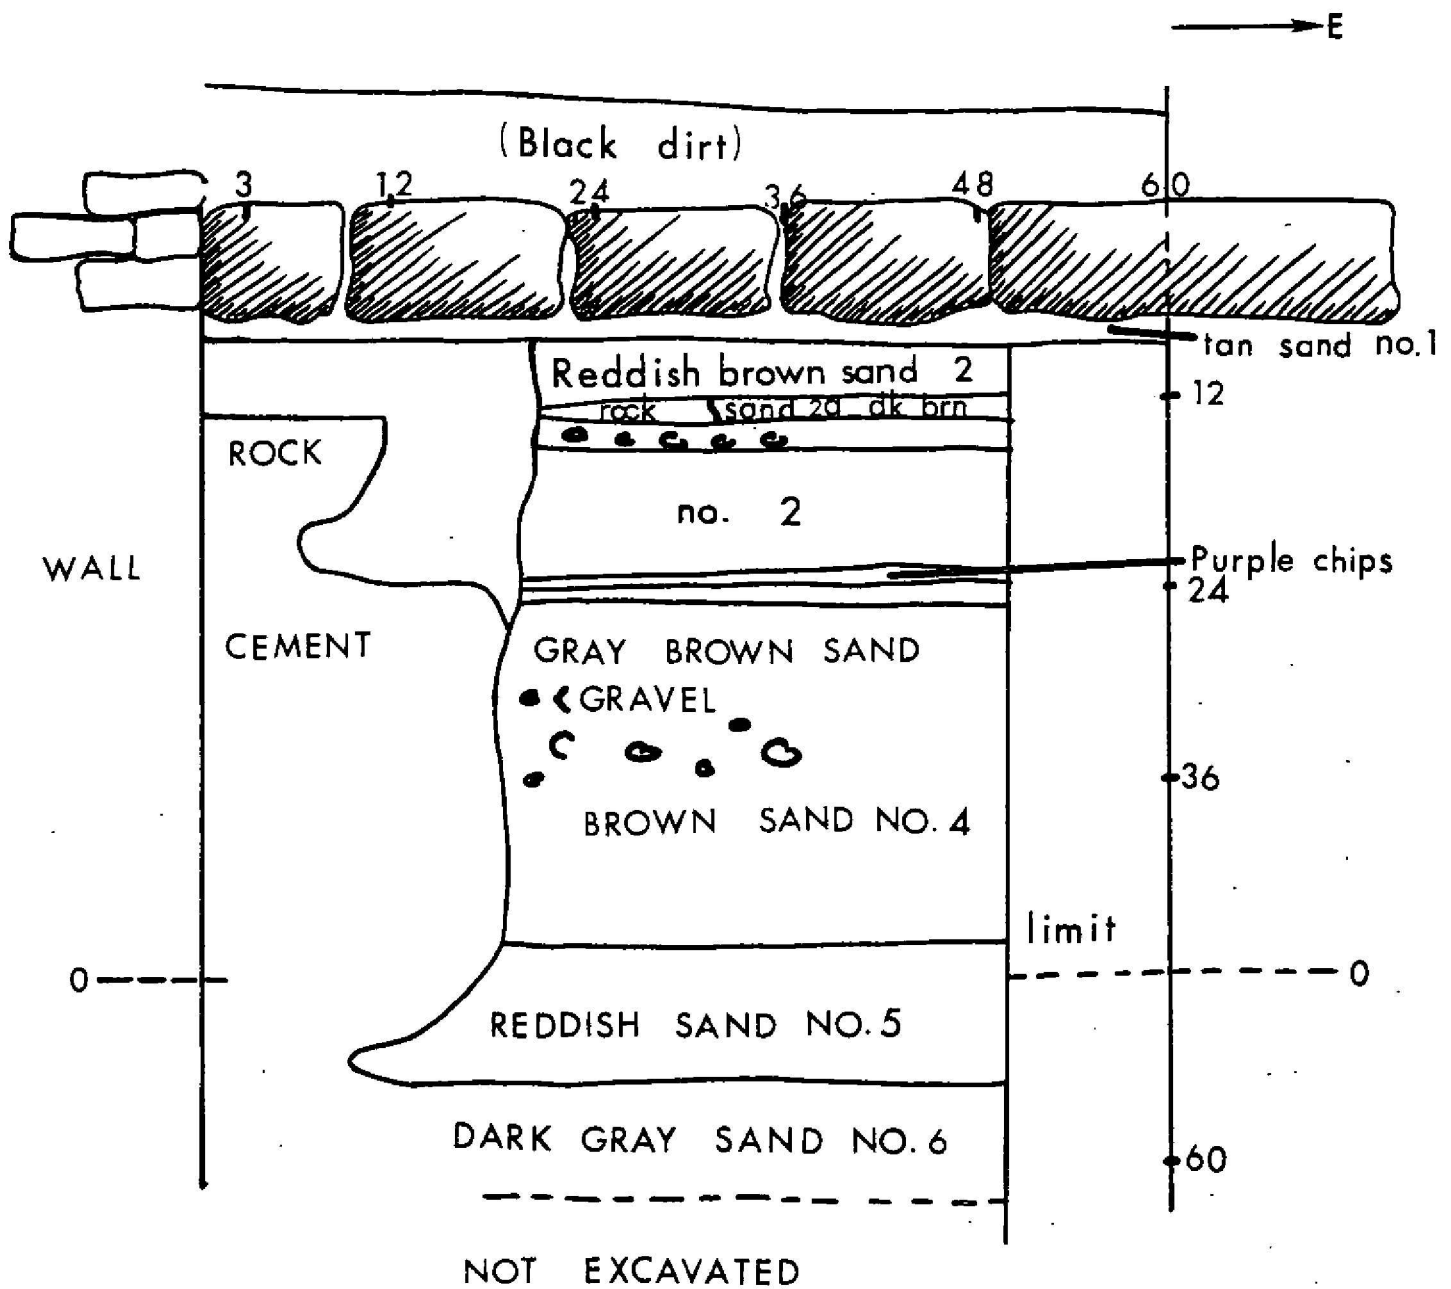
# TEST PIT No.3

EAST WALL
