Archaeological Investigation of Site 1 of the Washington Street Urban Renewal Area, New York City

Prepared By:
**The Cultural Resource Group
Louis Berger & Associates, Inc.**

September 1987

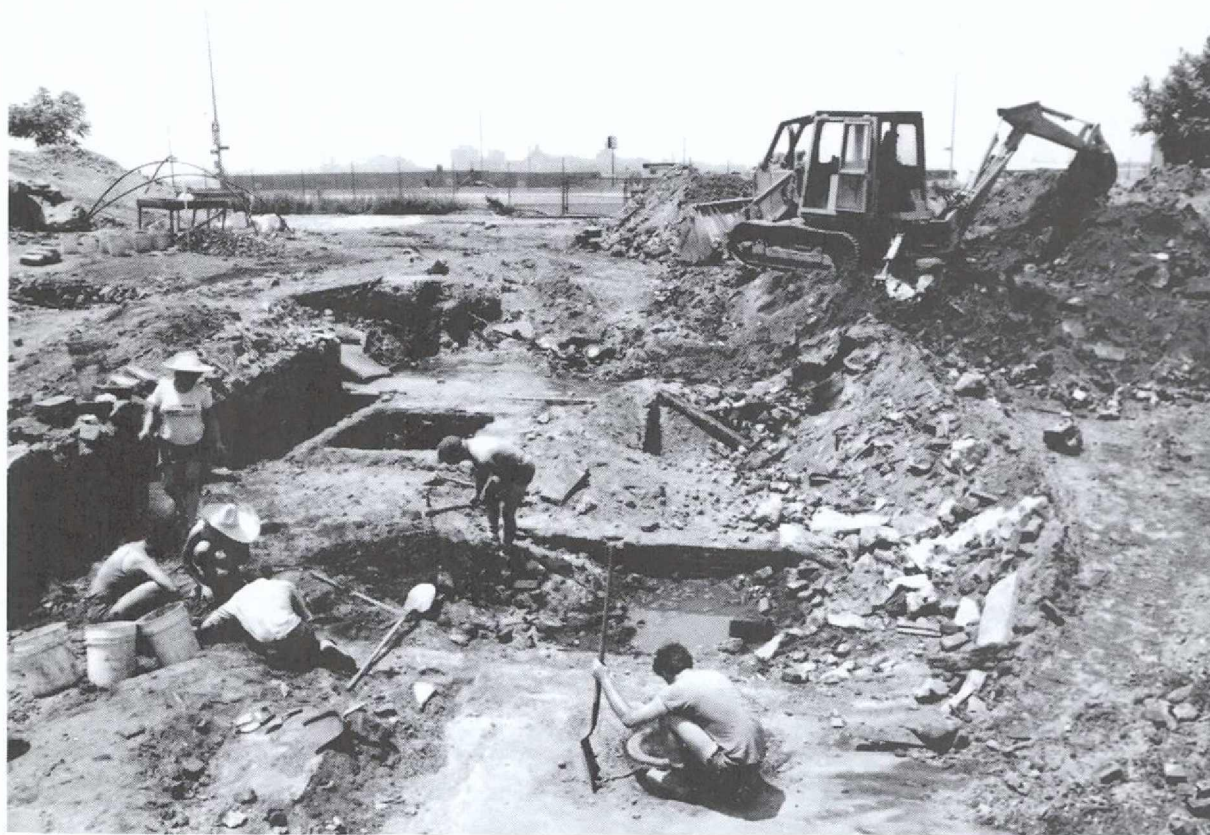
PLATE 9:
 A GENERAL VIEW LOOKING WEST ACROSS LOT 15, AREA B, WHERE THE WEST POINT
 FOUNDRY YARD WAS LOCATED DURING THE FIRST HALF OF THE 19th CENTURY. IN
 ADDITION TO EXCAVATORS, BACKHOE IS CLEARING TO ALLOW FURTHER TESTING.
 NOTE SCREENING AREA IN UPPER LEFT CORNER OF PHOTO AND WEST ST. AND
 NEW JERSEY SHORELINE IN REAR. (T. Masso 6/84).

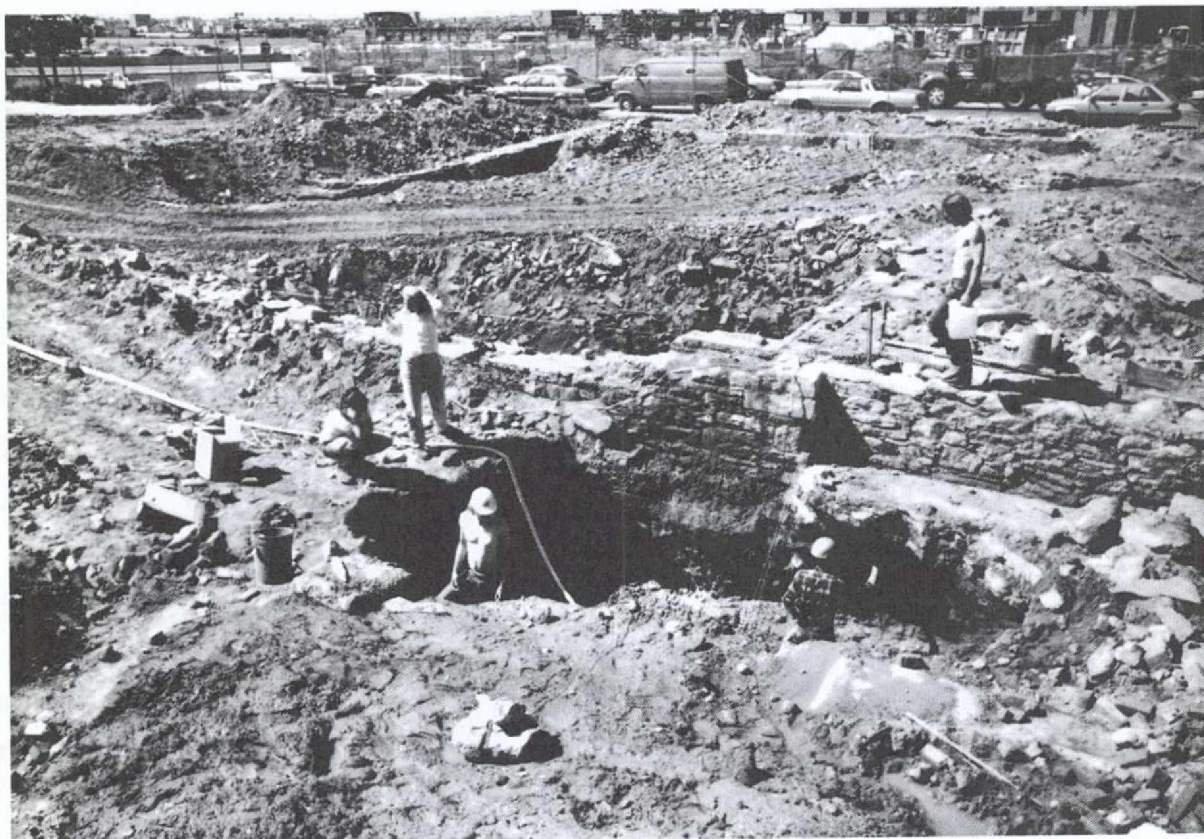
PLATE 10:
VIEW LOOKING NORTHWEST ACROSS AREA B AND DT3 DURING PROFILING OF EASTERN
HALF IN MAY 1984. NOTE CONSTRUCTION EQUIPMENT STORAGE YARD IN REAR OF
PHOTO ACROSS BEACH ST. (AREA C). (T. Masso 5/84).

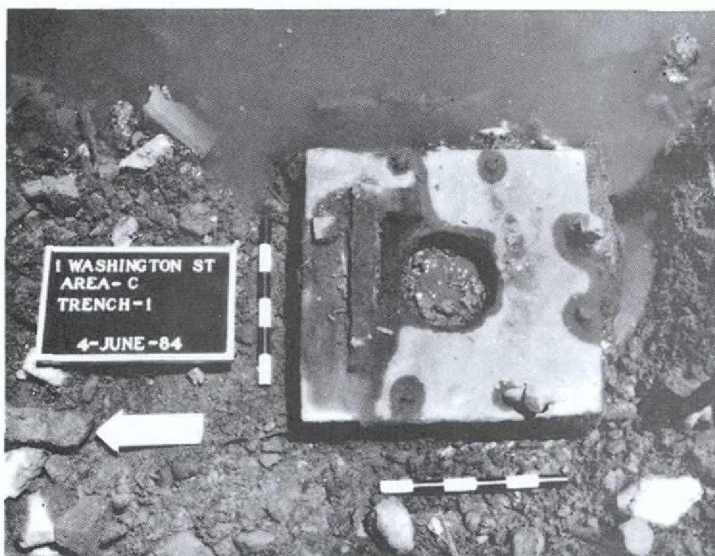
PLATE 13:

METAL COLUMN SUPPORT
IN TR. C1(C1W). (T. Masso 6/84)

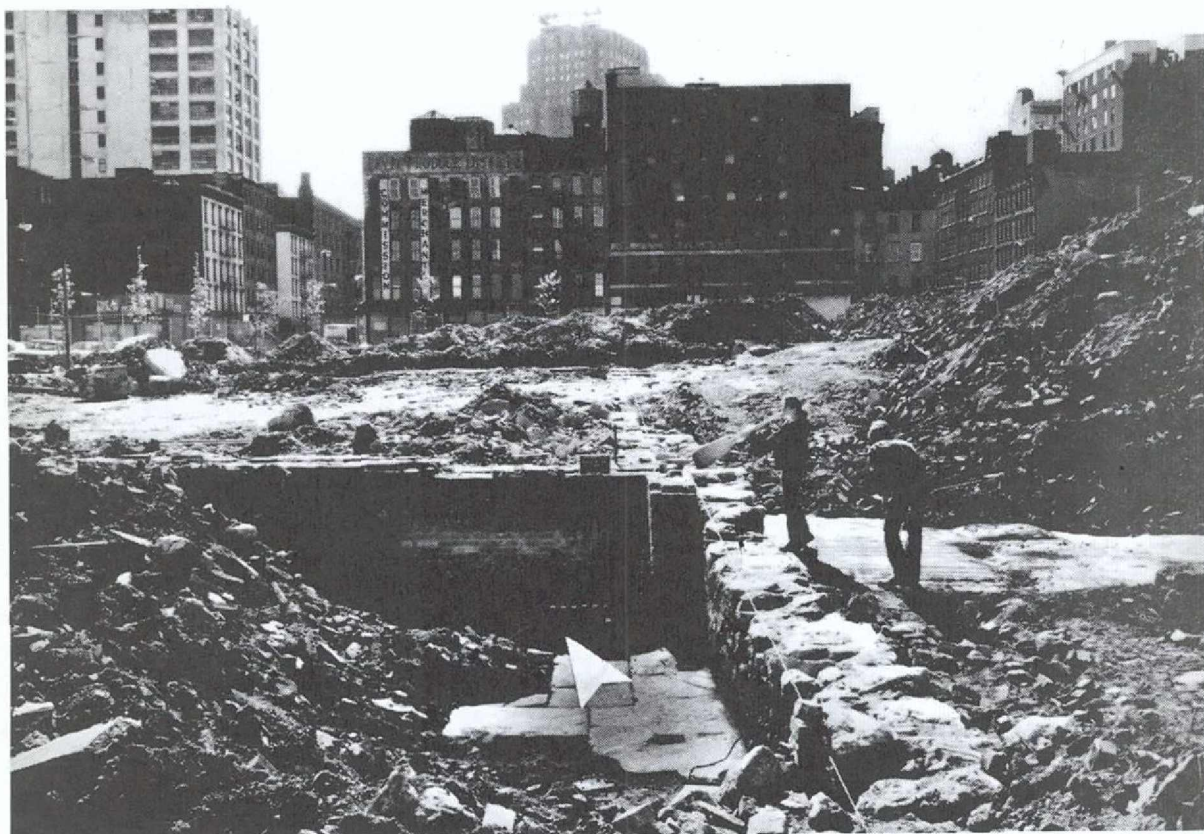
PLATE 14:
LOT 15 DURING CLEARING, LOOKING EAST (GREENWICH ST. BUILDINGS IN REAR). NOTE
CORNER FLAGSTONE WITH CENTRAL HOLE (ARROW). HOLE IN FOREGROUND TO RIGHT OF
ARROW IS A SOIL BORING LOCATION (T. Masso 5/84).

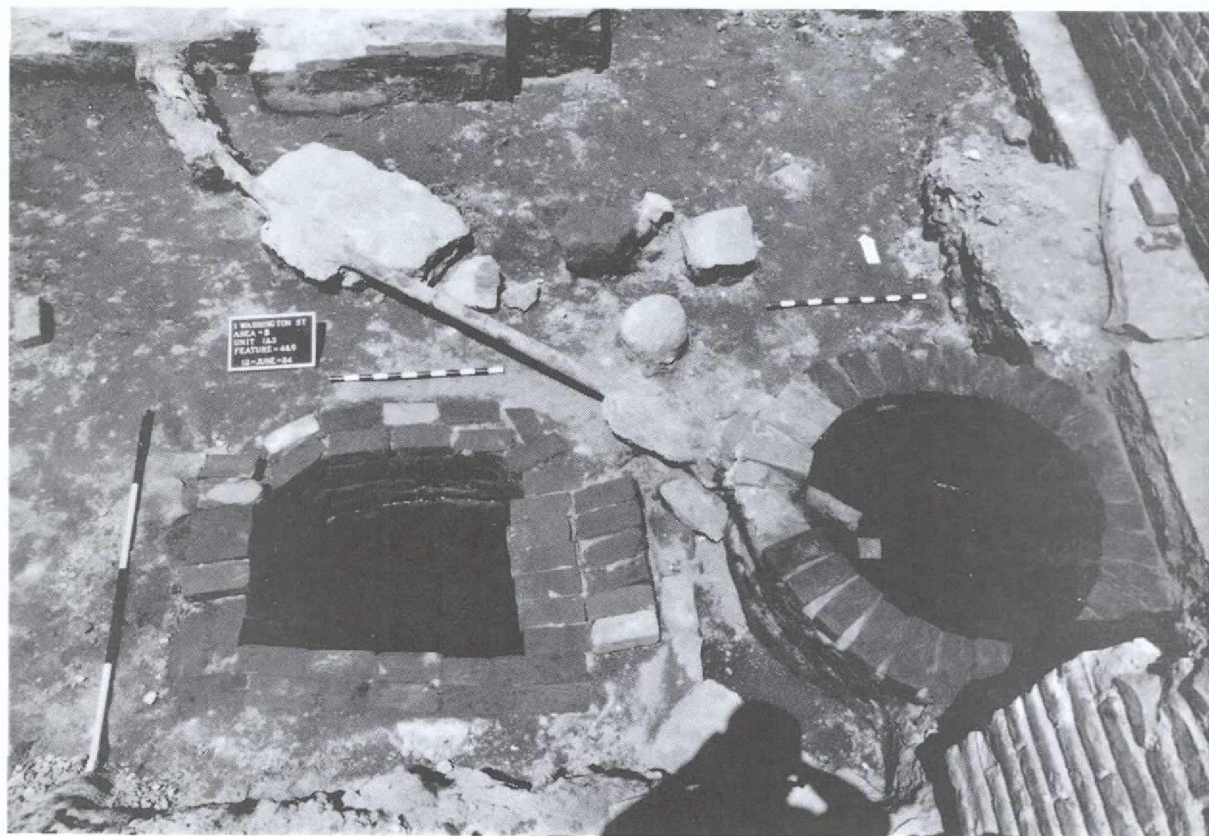
PLATE 15:
OVERVIEW OF BRICK DRY-WELL (F4) IN SOUTHEAST CORNER OF LOT 15 AND BRICK
FEATURE (F5) JUST TO LEFT (WEST). NOTE DRAINPIPE TO DRY-WELL HAS DAMAGED
NORTHEASTERN CORNER OF F5. (T. Masso, 6/84).

An extension of EU1 (EU1, ext.) exposed the eastern portion of another dry-laid brick feature (F5) that at first appeared to be rectangular or square. However, further excavation (EU3) revealed that only its southeast corner formed a right angle and that part of it had a semi-circular shape (see Figure 9 and Plate 15). Constructed directly on the landfill, ash and sand comprised its sole deposit. Since installation of the pipe to the dry-well damaged its northeast corner, this unidentified feature apparently was built first, an assessment verified by ceramic dates from the feature's undisturbed strata (Chapter V and Table 7). In addition, variation in the number of remaining brick courses could suggest it had been leveled, perhaps to create the apartment house backyard. However, it may have been built as found, a possibility also suggested by oxidation in the upper levels of the feature fill as well as in surrounding yard deposits.

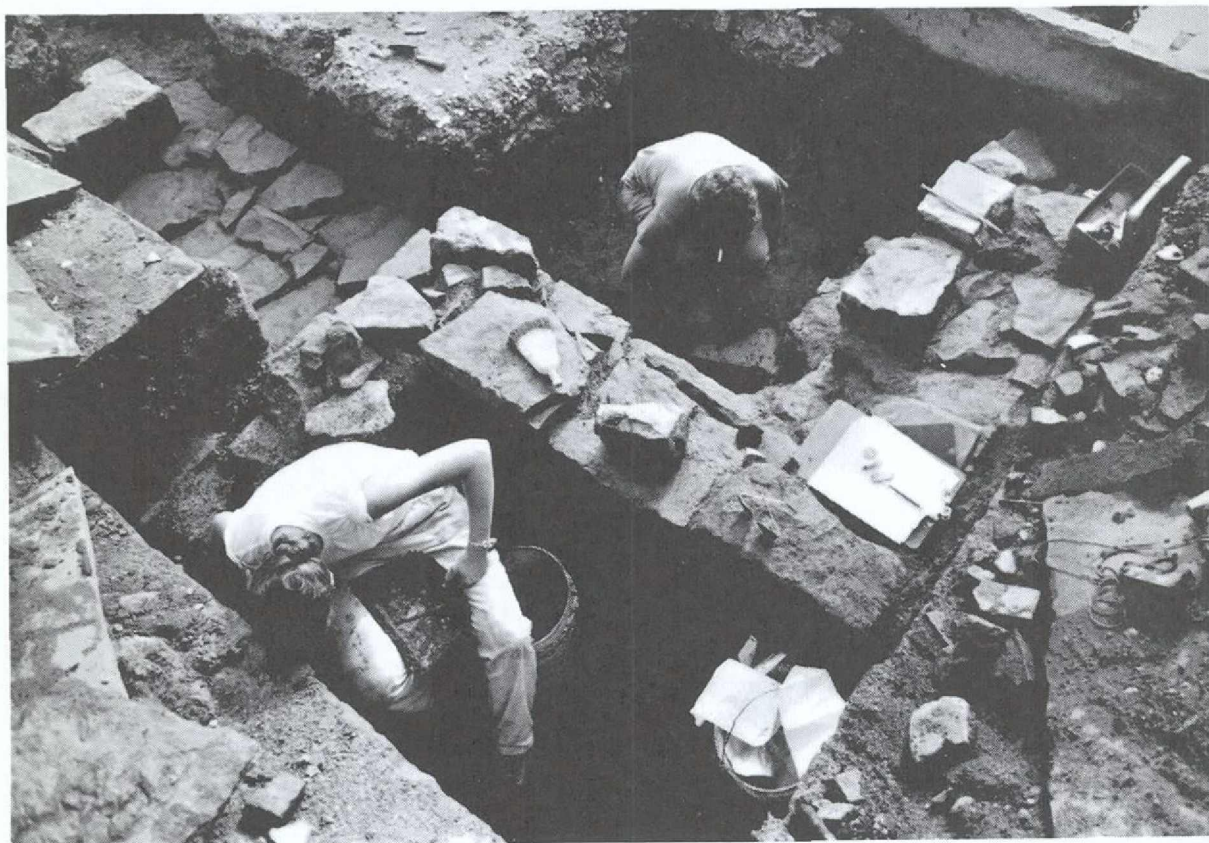
PLATE 18:
EXCAVATION IN EU 8 (JUST WEST OF SLATE SILL) AND TR.D IN LOT 15 WITH CORNER OF
OLD STONE WALL (F11) COMPLETELY EXPOSED (T. Masso 6/84)

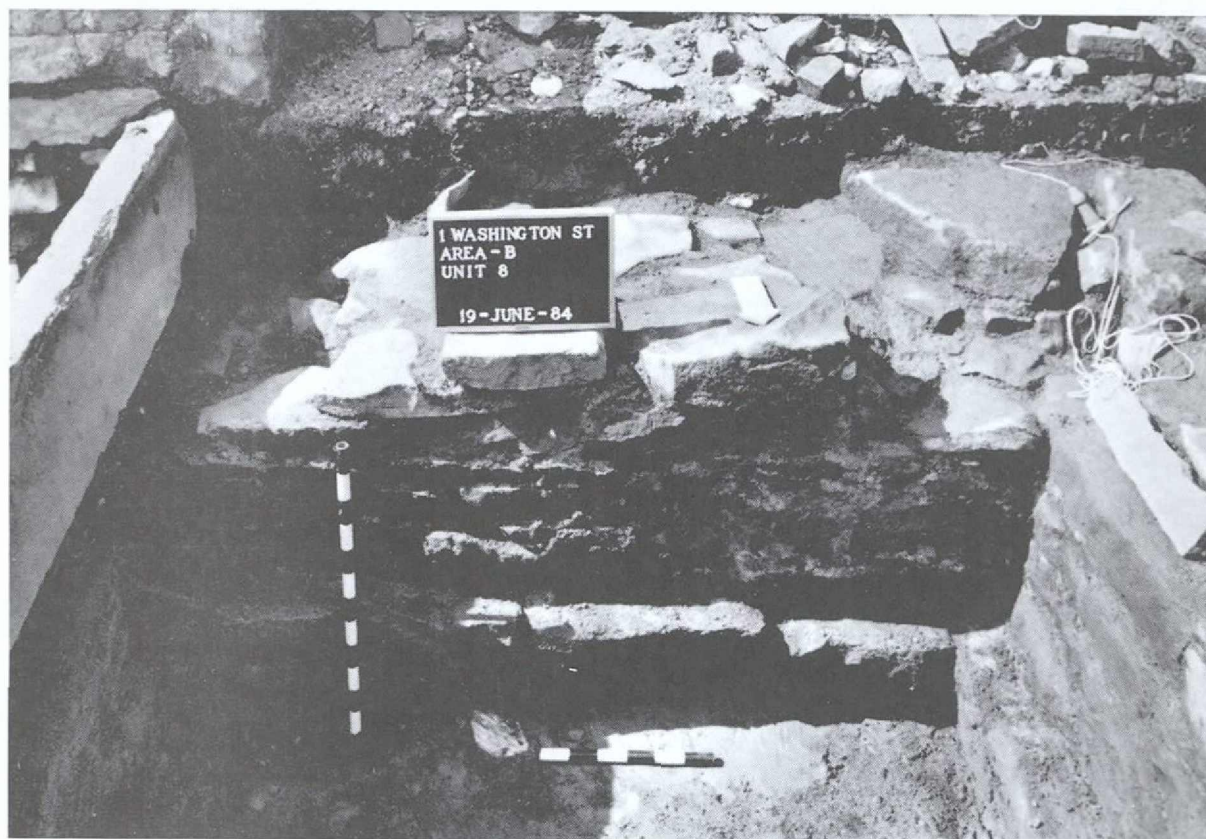
PLATE 19:
STONE WALL (F11) AND FOOTING STONES IN EU 8 LOOKING SOUTH. NOTE SLATE SILL
TO LEFT (EAST). (T. Masso 6/84).

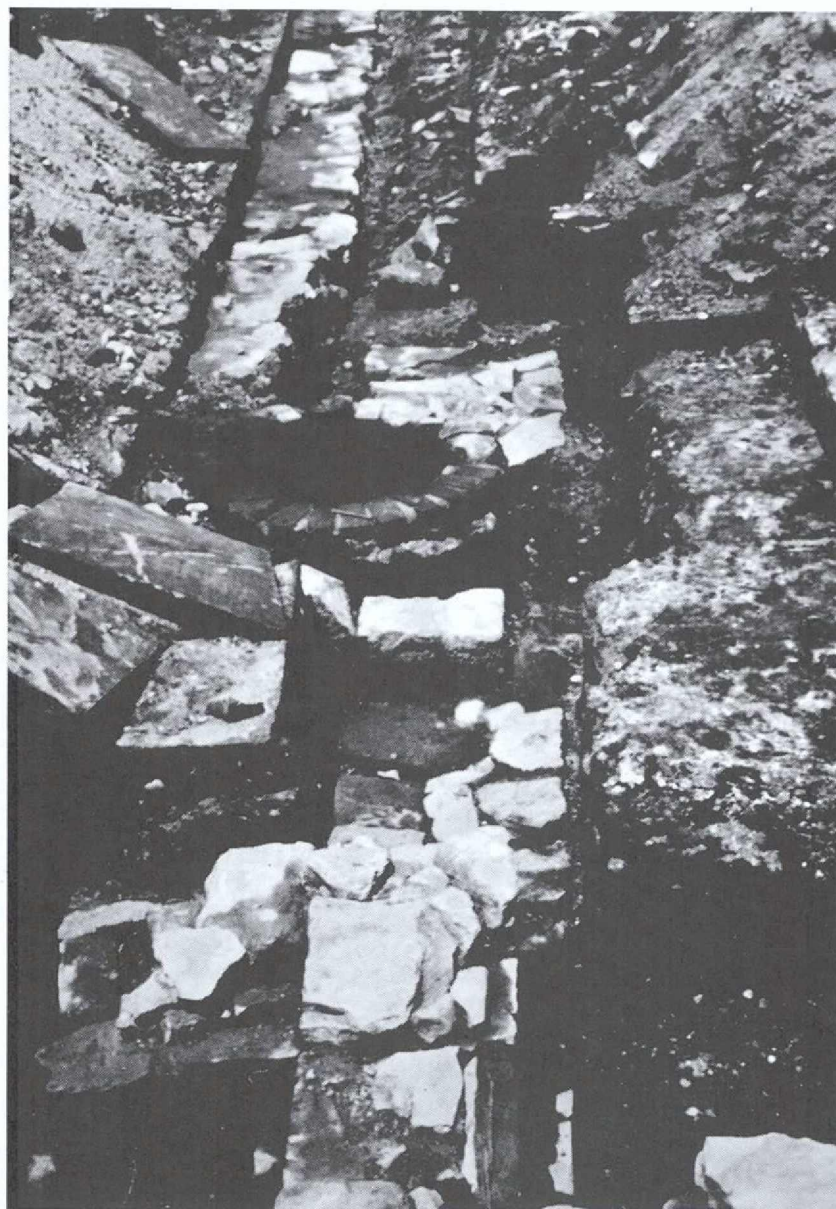
PLATE 20:
LOOKING NORTH ALONG THE WESTERN LIMIT OF LOT 15, LAST
DAY OF FIELD TESTING. NOTE STONE WALL (F11) TRUNCATED
BY DRY-WELL (F12) TO REAR. FLAGSTONES REMOVED FROM
THE YARD ARE FOUND TO THE LEFT OF THE PICTURE
(J. Geismar 6/84).

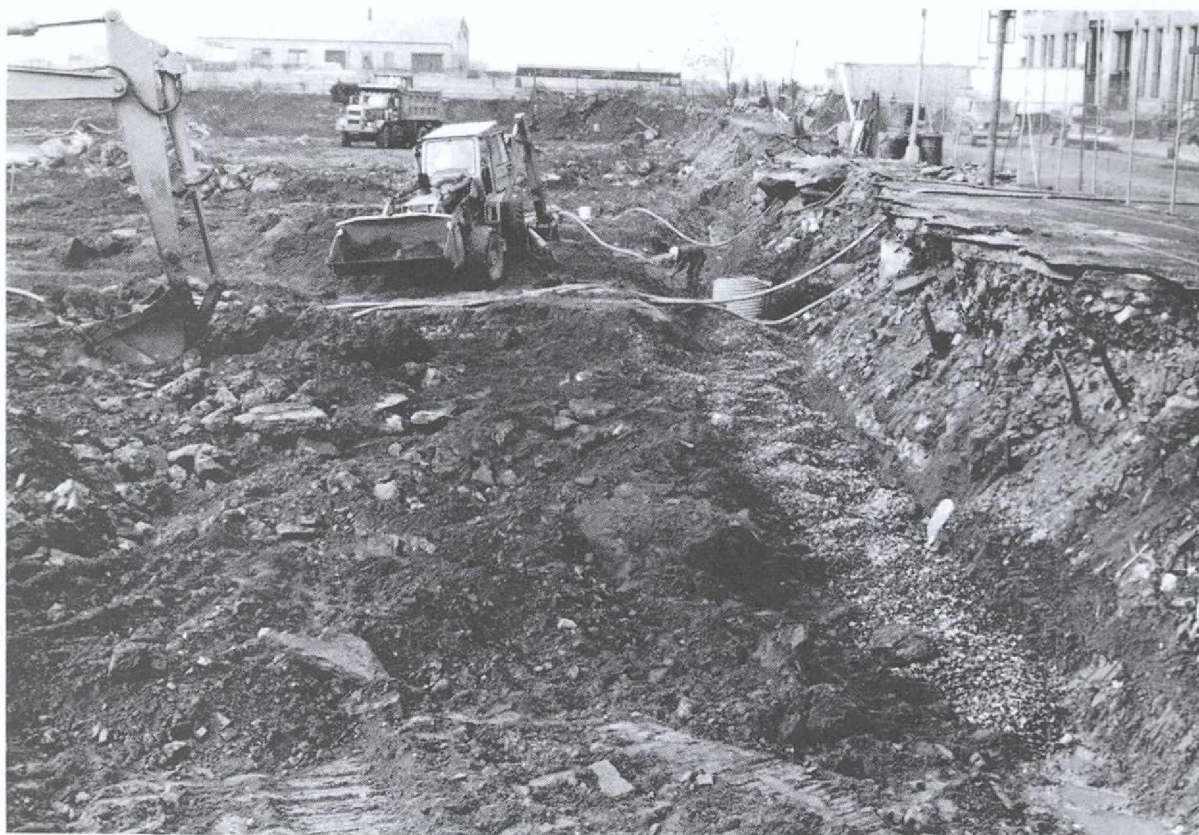
PLATE 24: GRADING AND SUMPHOLE EXCAVATIONS (LOOKING TOWARD THE
JUNCTION OF WEST STREET AND HUBERT STREET) (L. Shmookler 12/84)

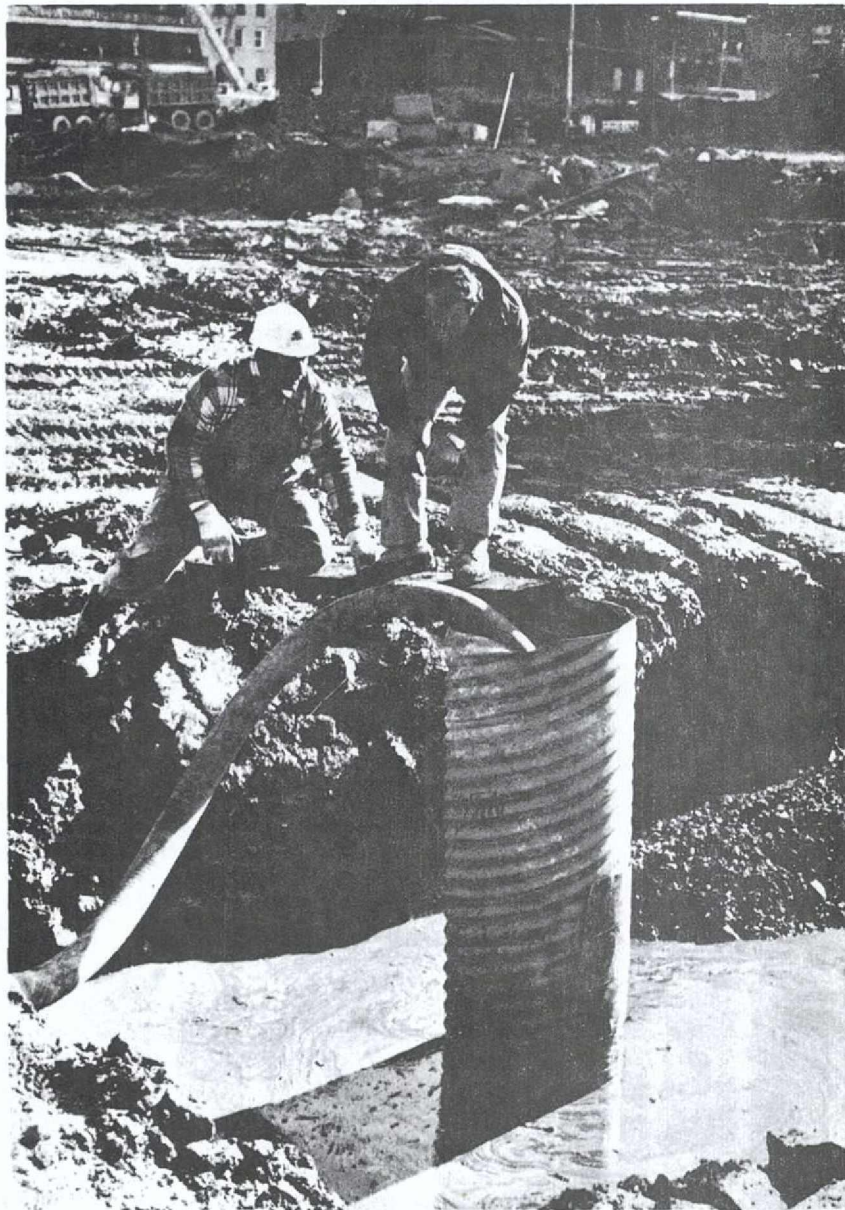
PLATE 25: PUMPING IN SUMPHOLE D

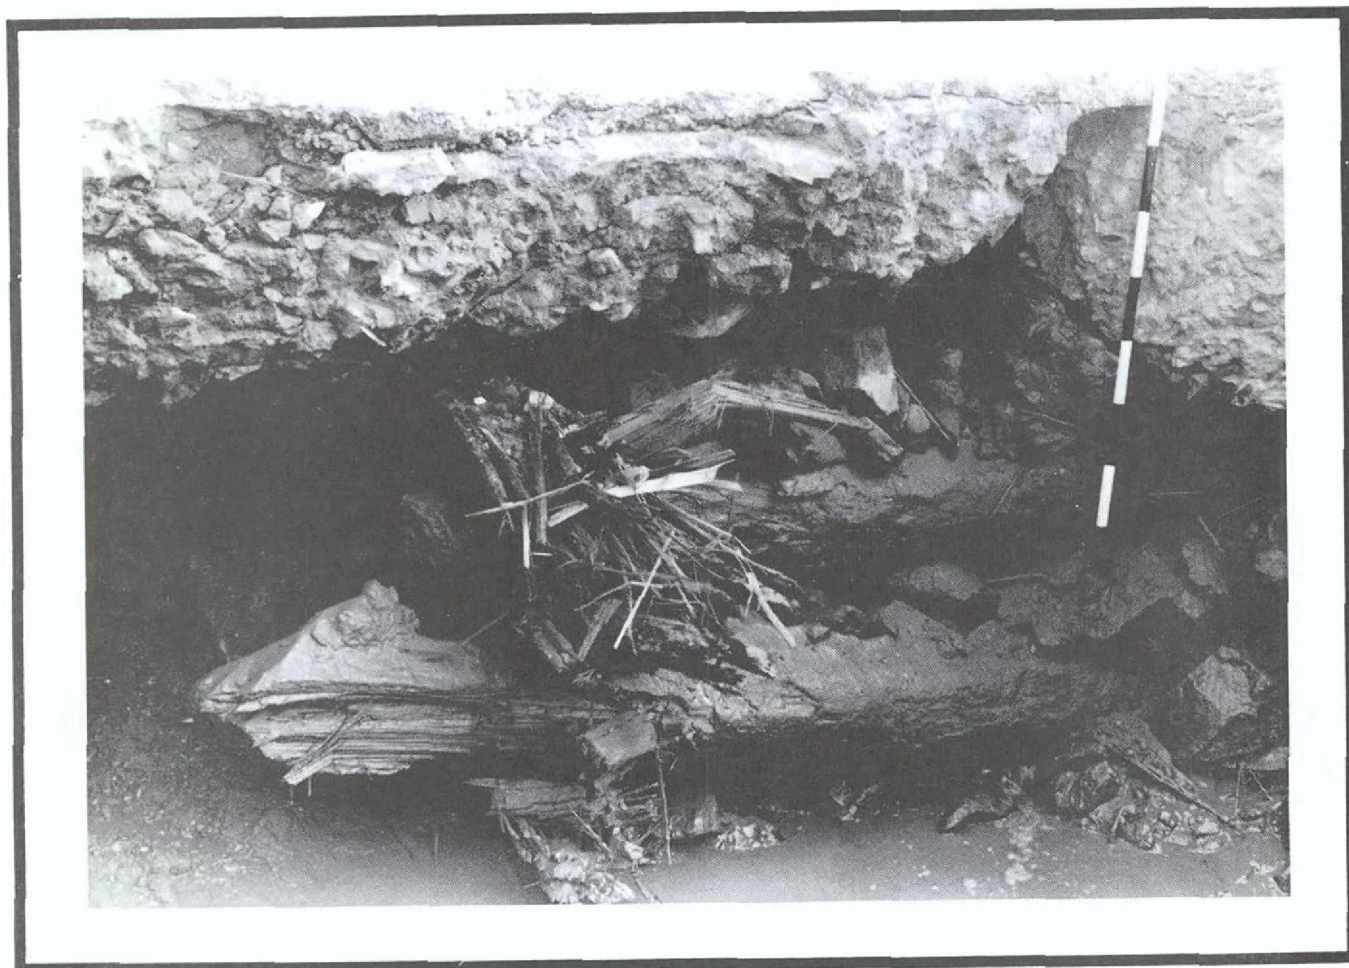
PLATE 27: NORTH EDGE OF COBB WHARF IN PILE CAP HOLE B5/6

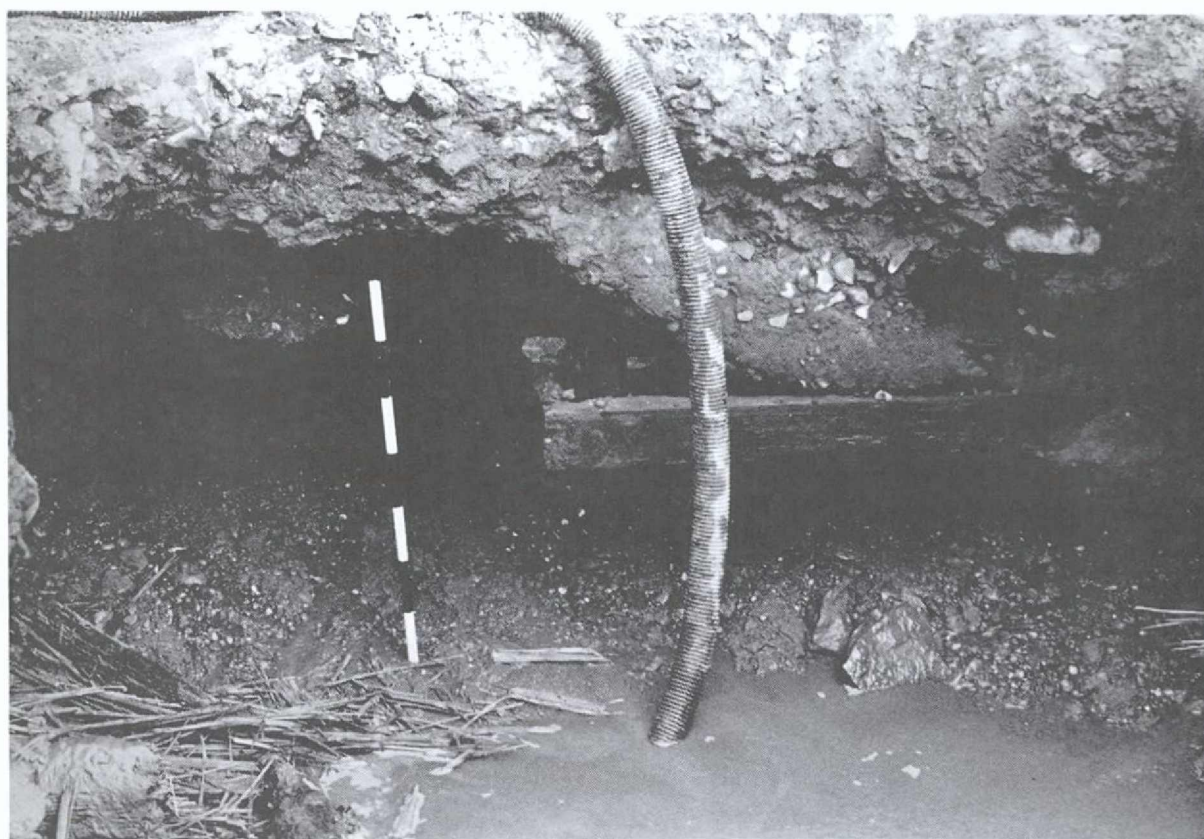
PLATE 28: CORNER OF WOODEN BOX NORTH OF COBB WHARF IN
PILE CAP HOLE B5/6 (L. Shmookler 2/85)

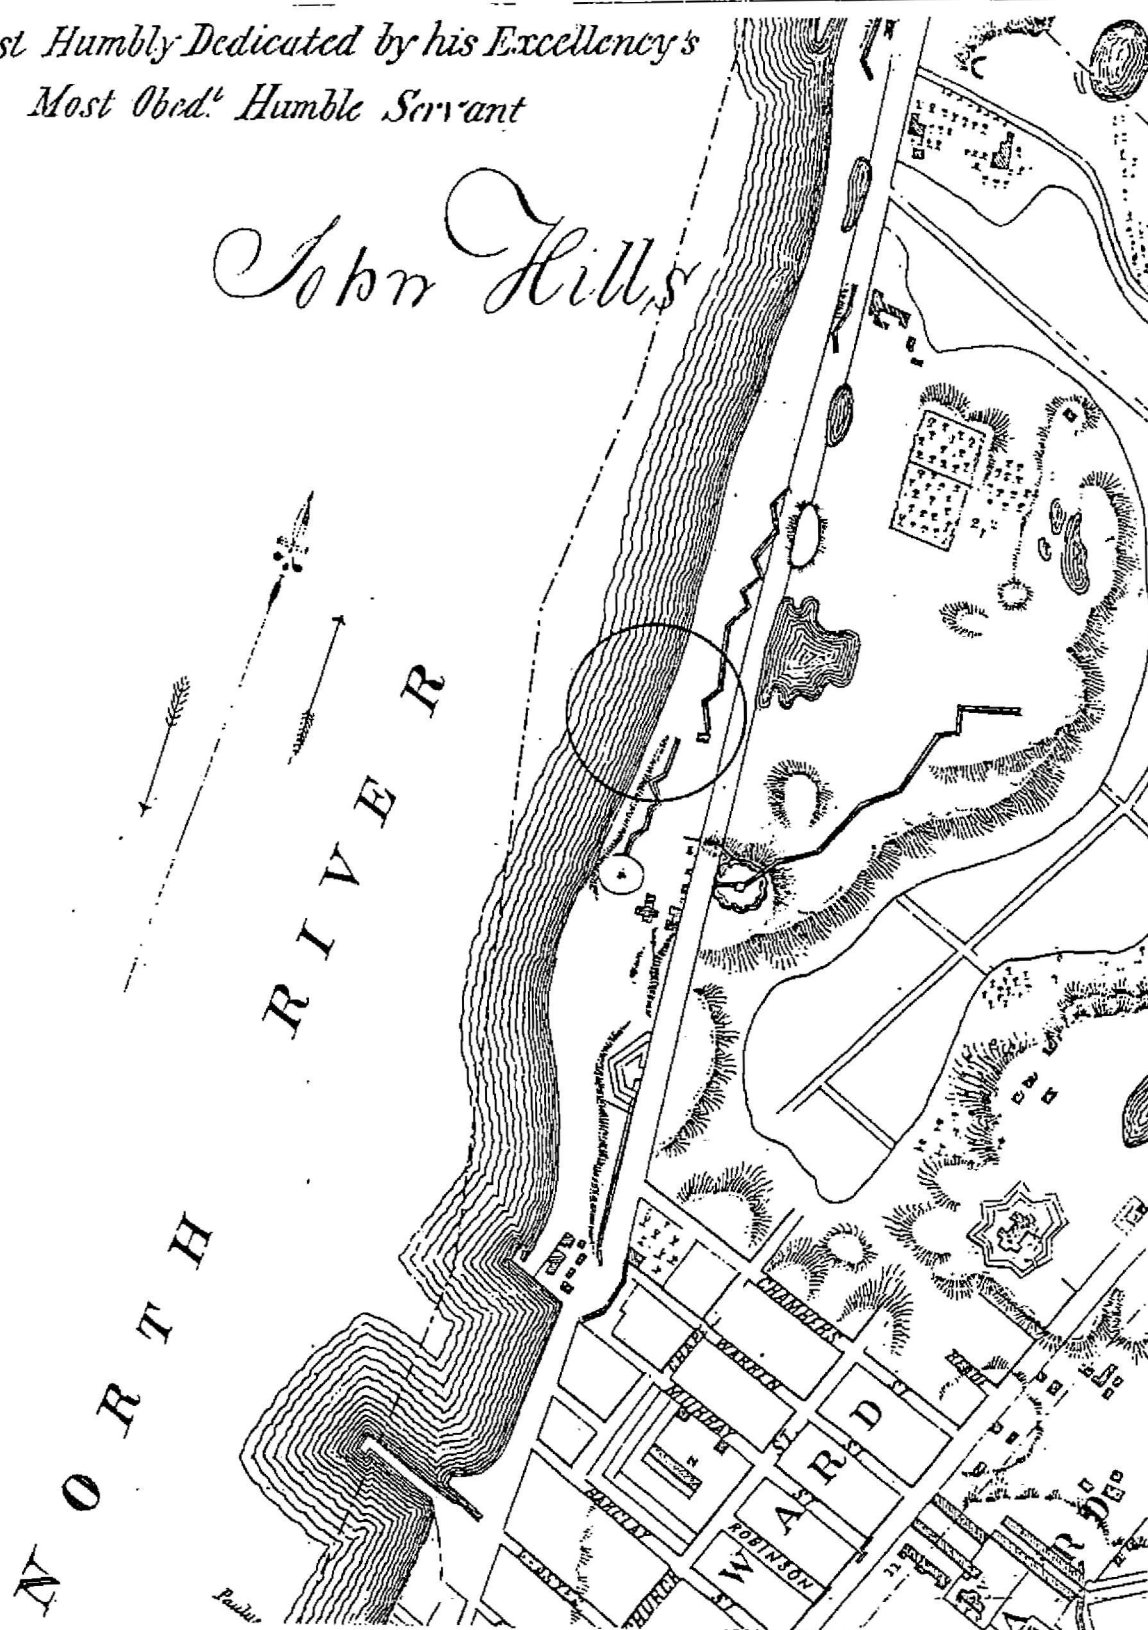
FIGURE 29: Site 1, Washington St. Urban Renewal Area.
Detail of 1782 plan of New York City (Hills 1783). Approximate site area is circled.
Note ridge indicated in area of North Moore to Hubert Streets in what would become
the vicinity of Washington Street (Valentine's Manual 1857). NOTE: No scale given.

Faunal and floral material from these tests support the hypothesis that the fill matrix on both blocks did not represent household discard. Floral analysis indicated that the fill matrix represents a meadow-type deposit rather than domestic rubbish--which would have produced seeds and pits of common edible nuts, fruits, and vegetables (see Flotation Analysis, Appendix D, this report; the general artifact catalogue lists only one unidentified nut shell from the fill [Unit ClW Level 2]). In addition, two argillite flakes of Native American manufacture (Area C, DT 3, levels 2 and 5) suggest that at least some fill may have come from land leveling, perhaps from grading a ridge that apparently once stood in the vicinity of Washington Street in the site area (Hills 1782; Figure 29 this report).
