ARCHAEOLOGICAL INVESTIGATIONS
FOUNDATION WATERPROOFING PROJECT
MORRIS-JUMEL MANSION

BY
ARNOLD PICKMAN

1994

Conducted for the New York City Department of Parks,
Recreation and Historic Preservation

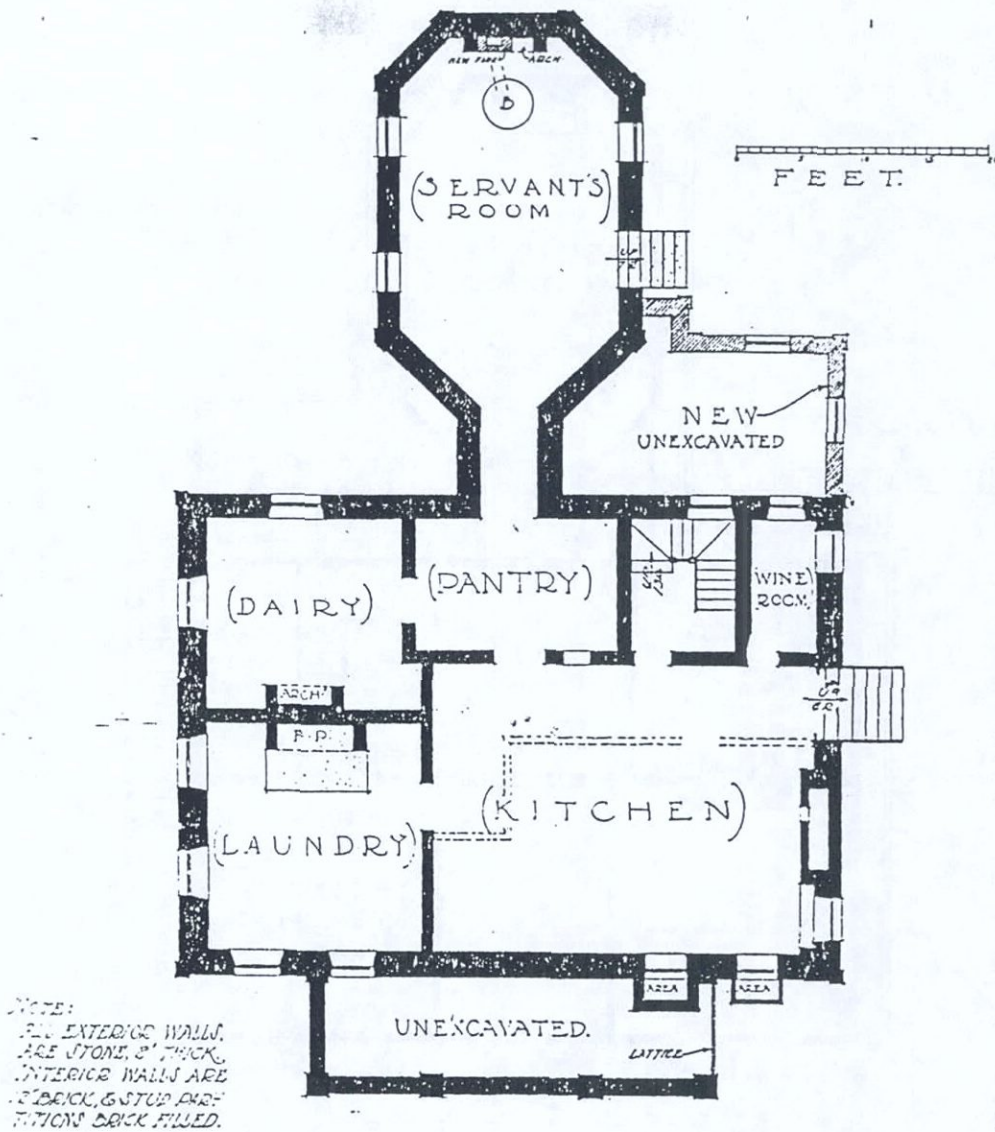
Figure 28a
 Source: Haddon (1917)

PLAN OF CELLAR—THE ROGER MORRIS
 HOUSE, OR JUMEL MANSION, NEW YORK CITY.

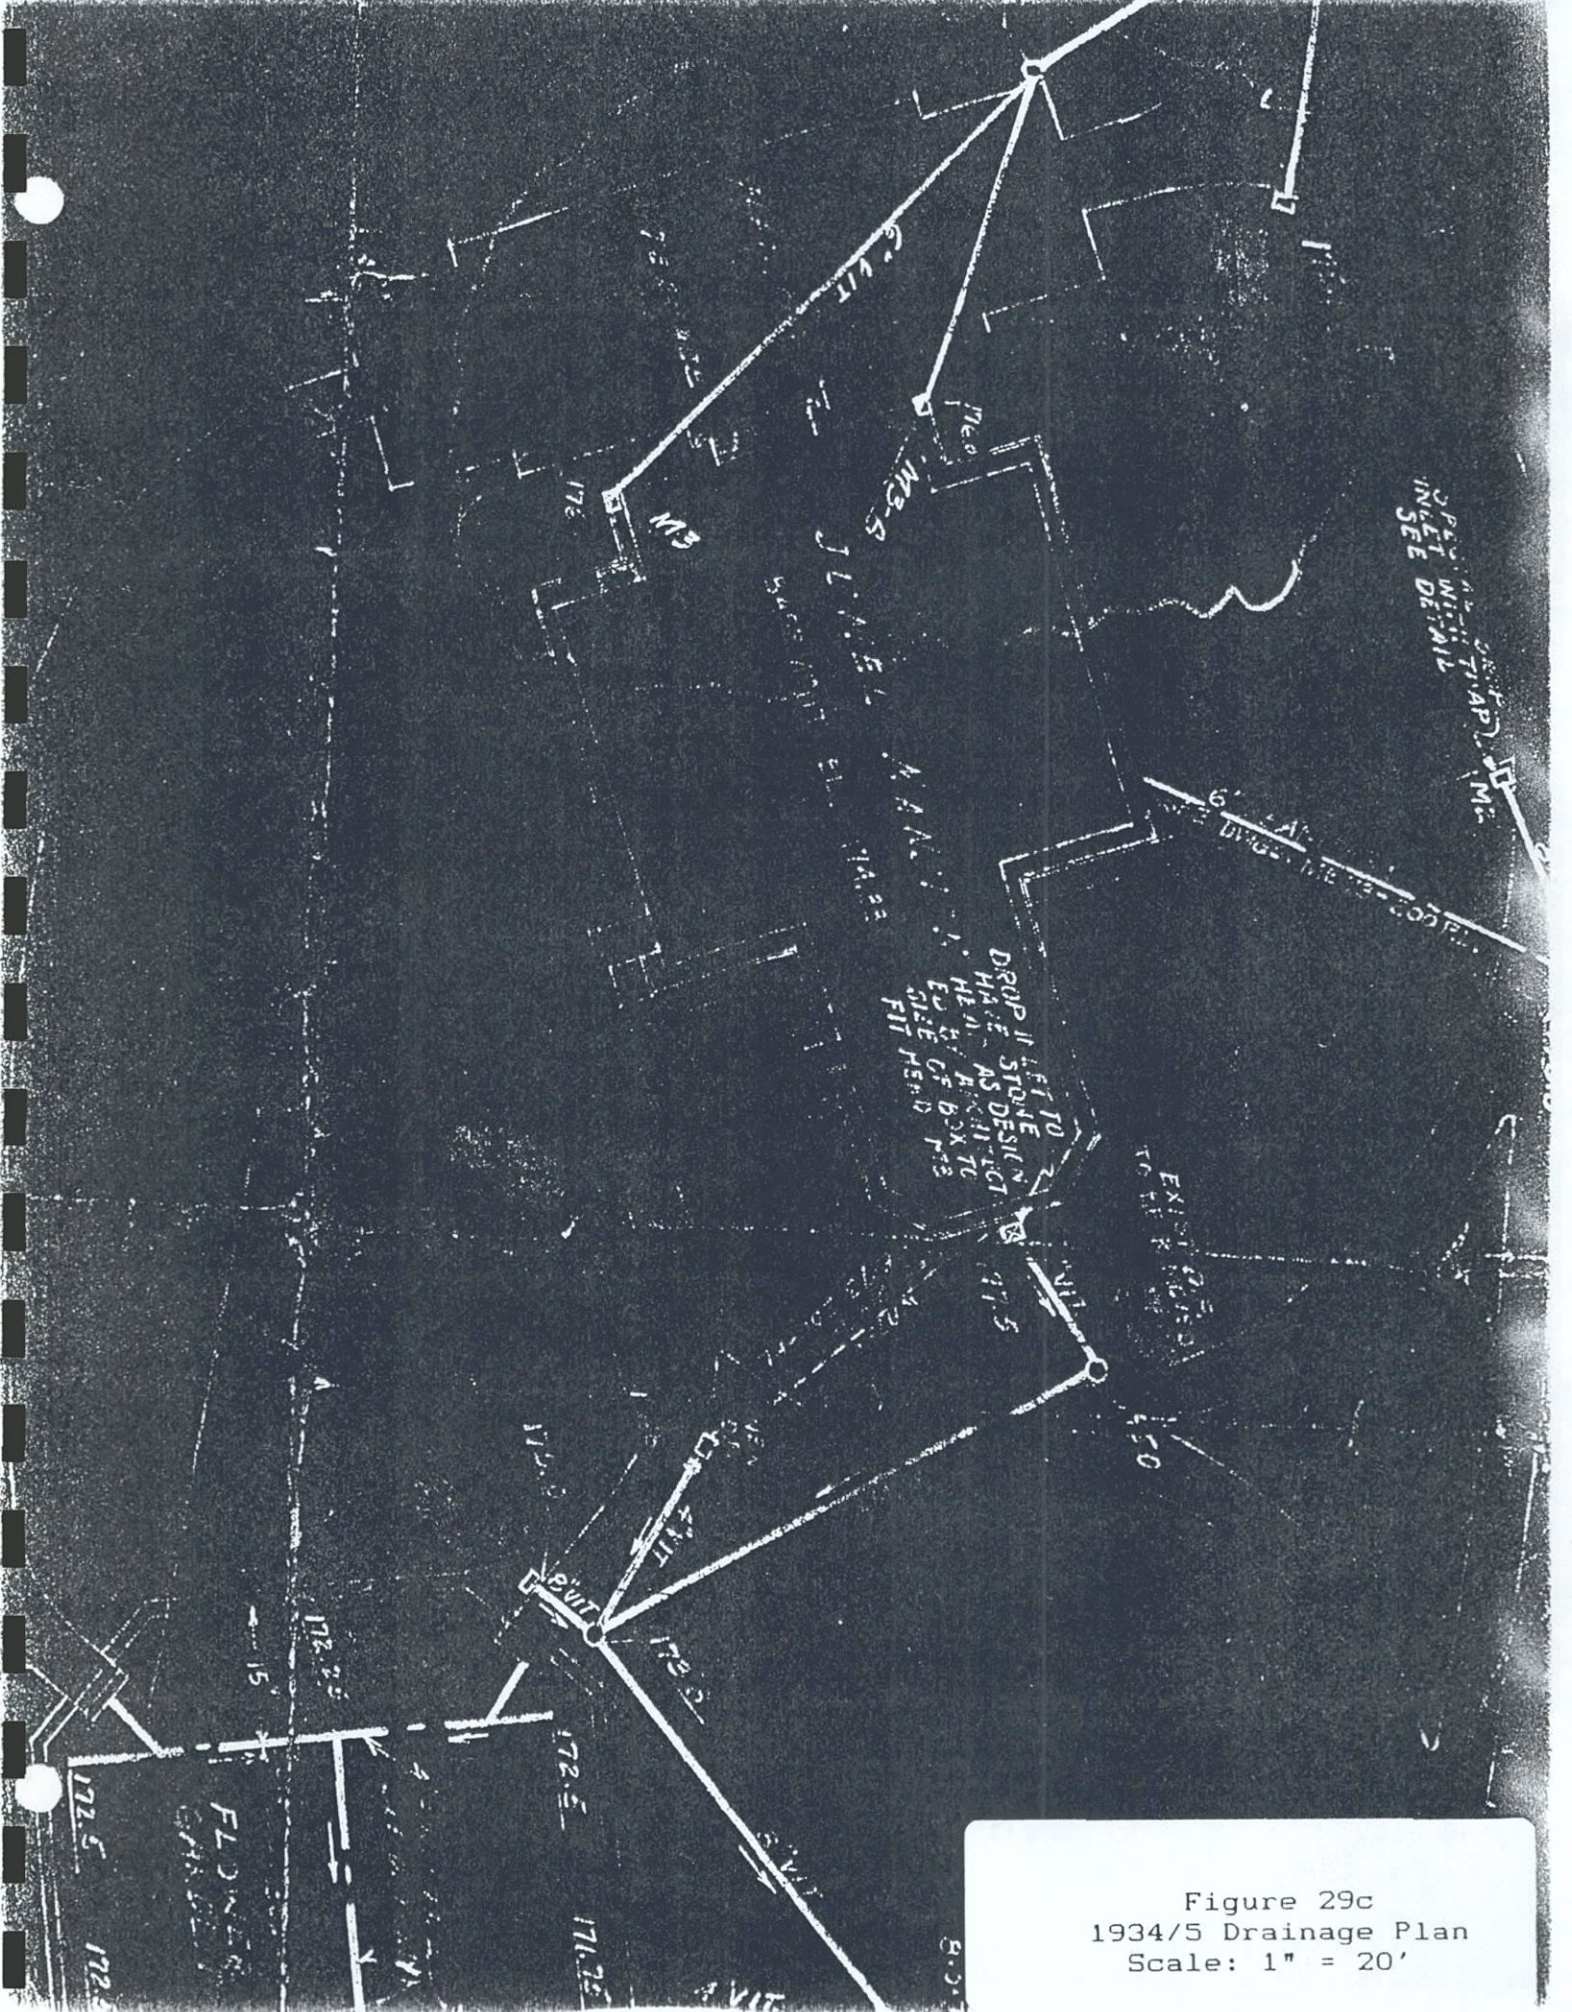
Figure 29c
 1934/5 Drainage Plan
 Scale: 1" = 20'

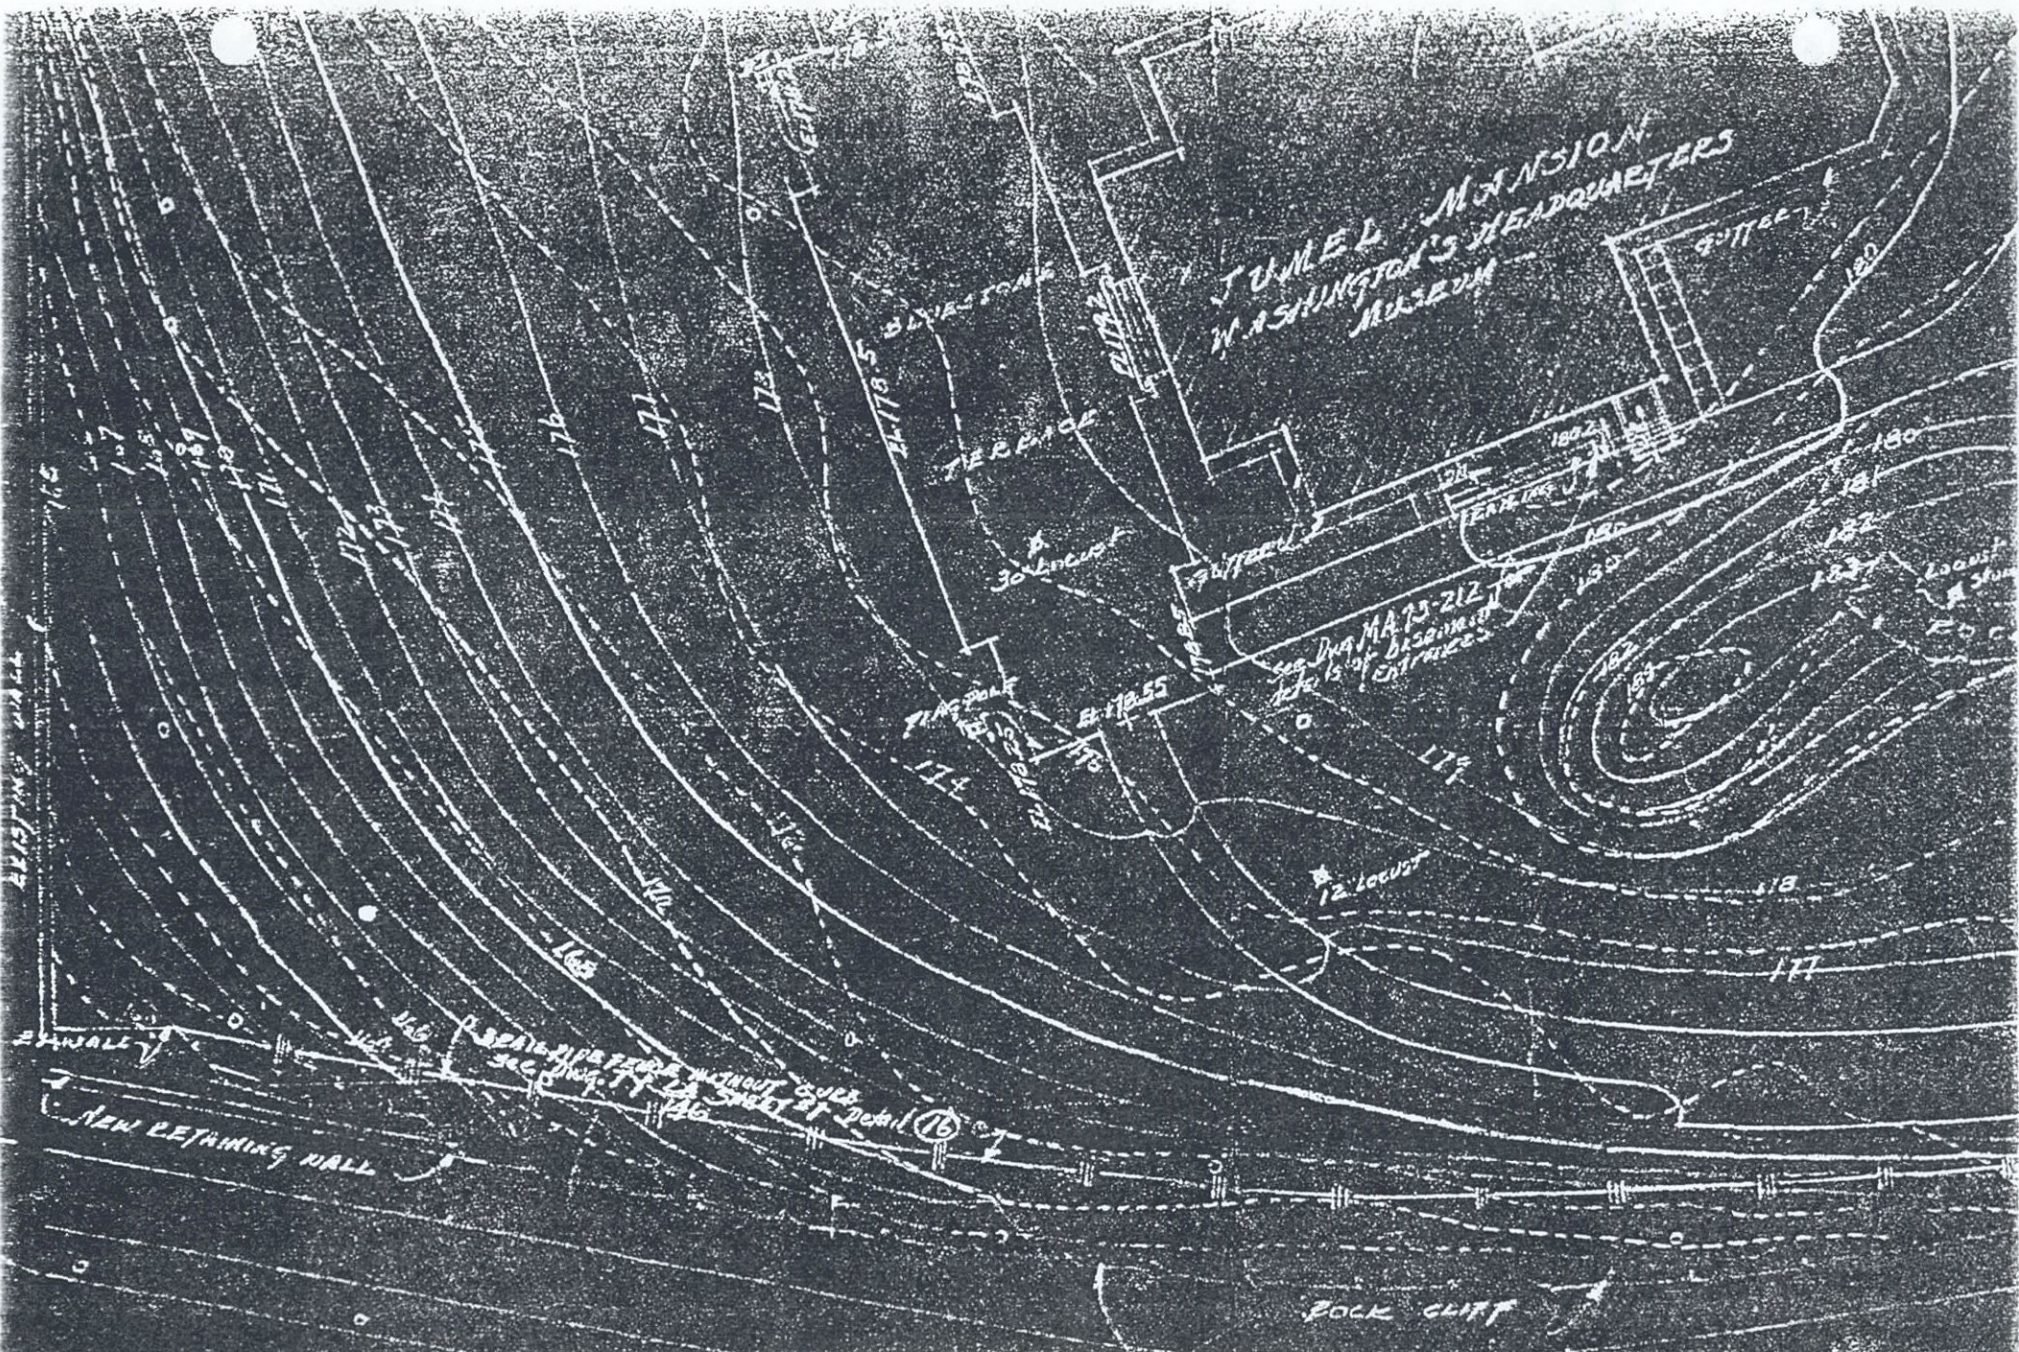
Figure 29e
Ca. 1934/5 Grading Plan
Scale: 1" = 20'

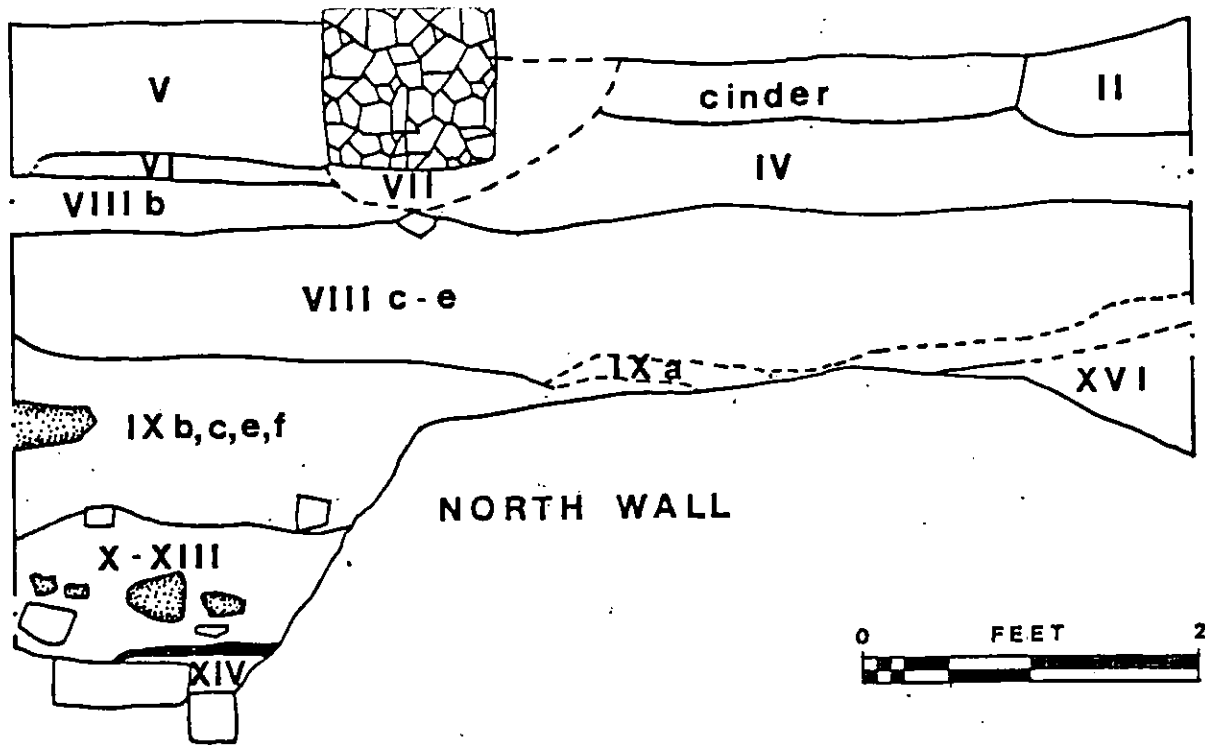
Figure 33
 North and South Wall Profiles
 1984 Test Cut 1
 Source: Dublin and Rothschild (1984:10-11)

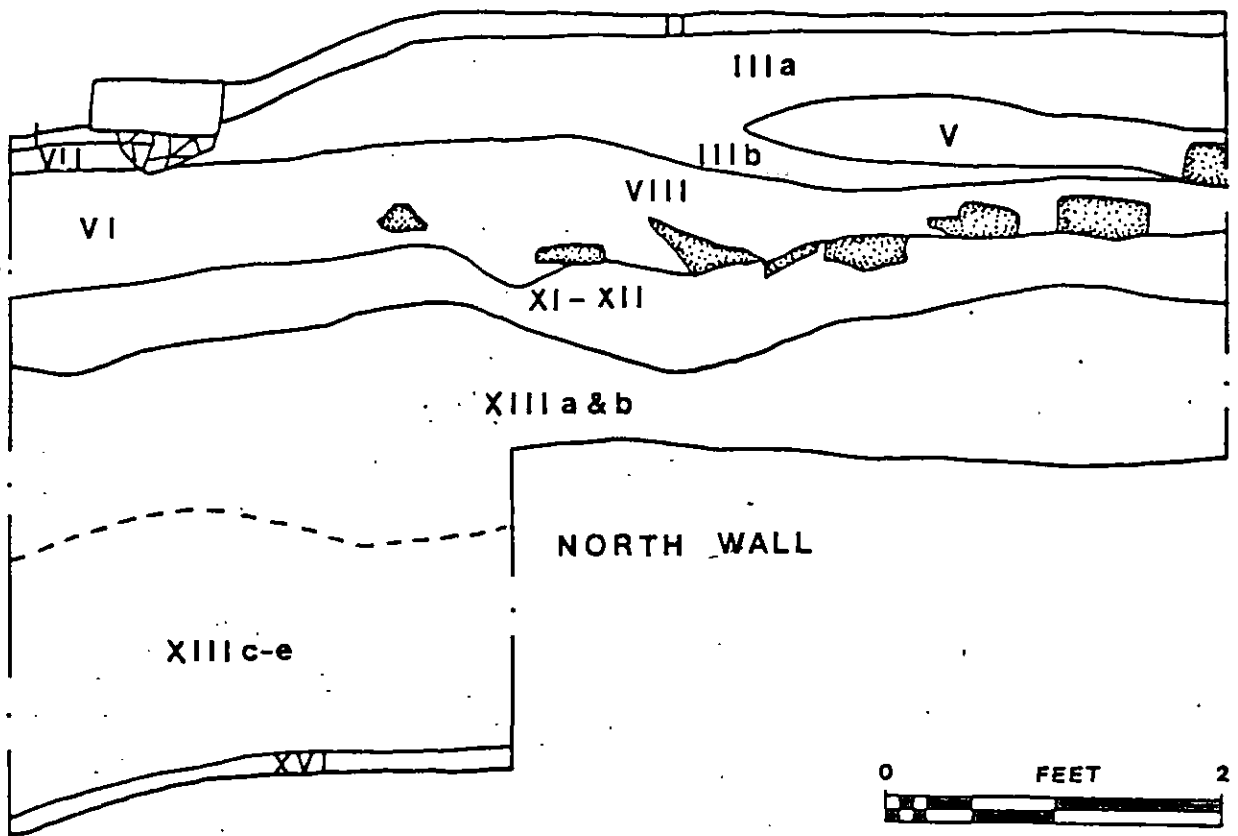
Figure 34
 North and South Wall Profiles
 1984 Test Cut 2
 Source: Dublin and Rothschild (1984:24;26)

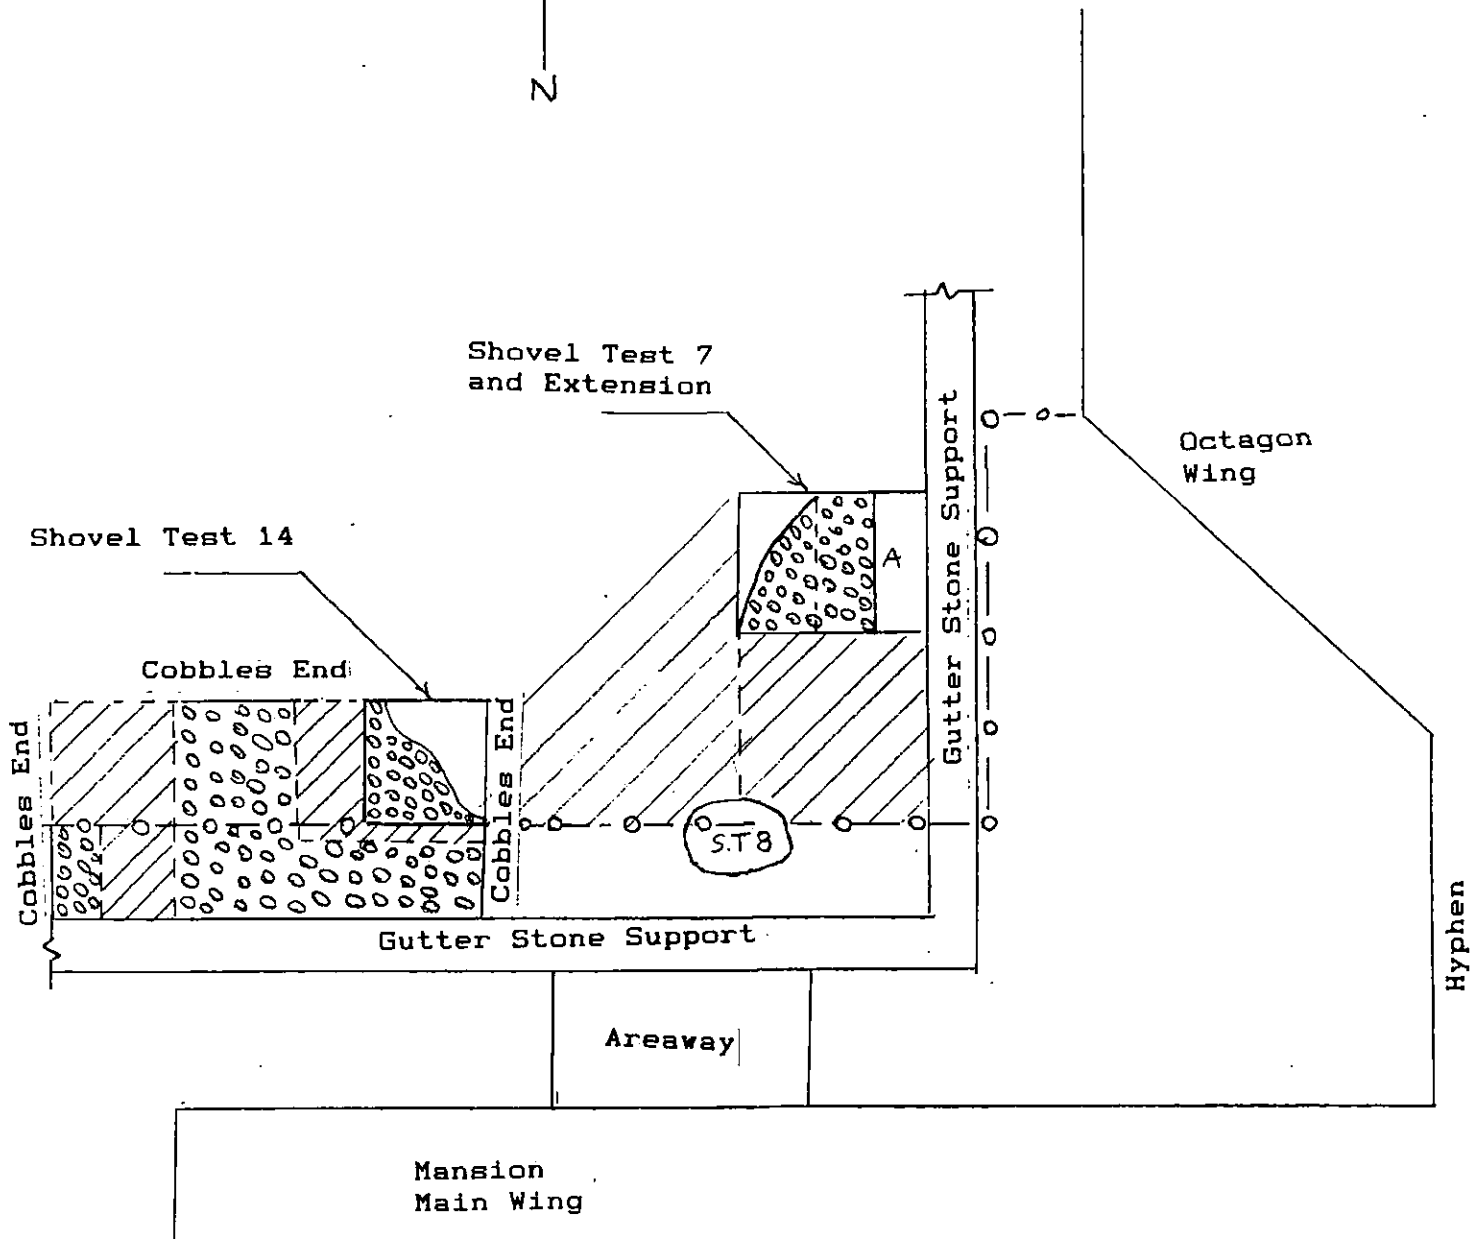
Figure 40
Plan View
Cobble Feature West Side of Mansion
Scale: 1" = 3'

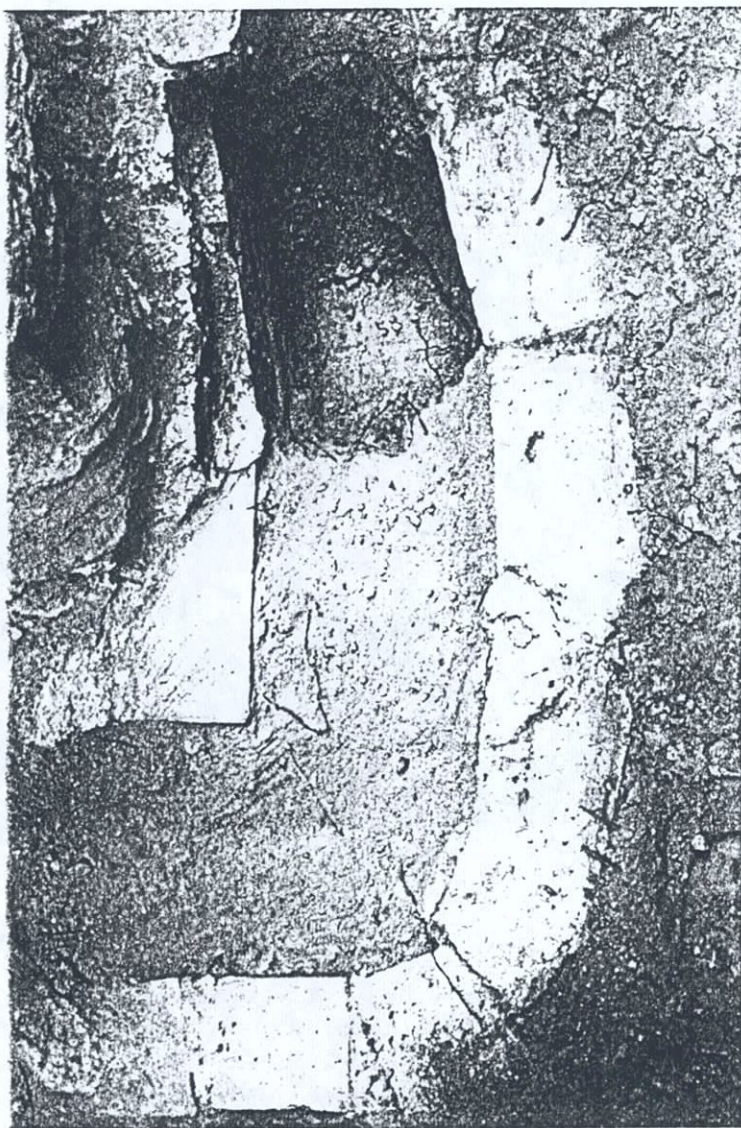
Plate 33
Detail of Brick "Drain" Feature at
Base of Foundation Wall at Southeast Corner of Mansion
View North

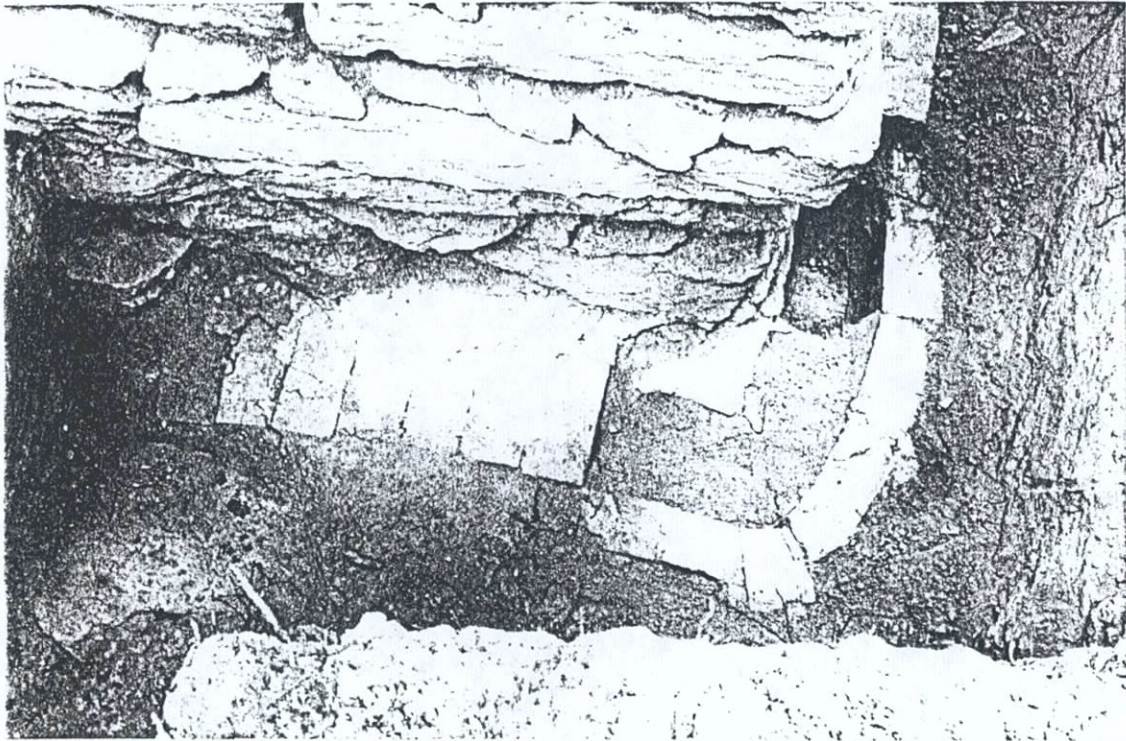
Plate 32
East Side of Mansion
Brick "Drain" Feature at Base of South Foundation Wall
Southeast Corner of Mansion at Right
Areaway at Extreme Left of Photo
View North

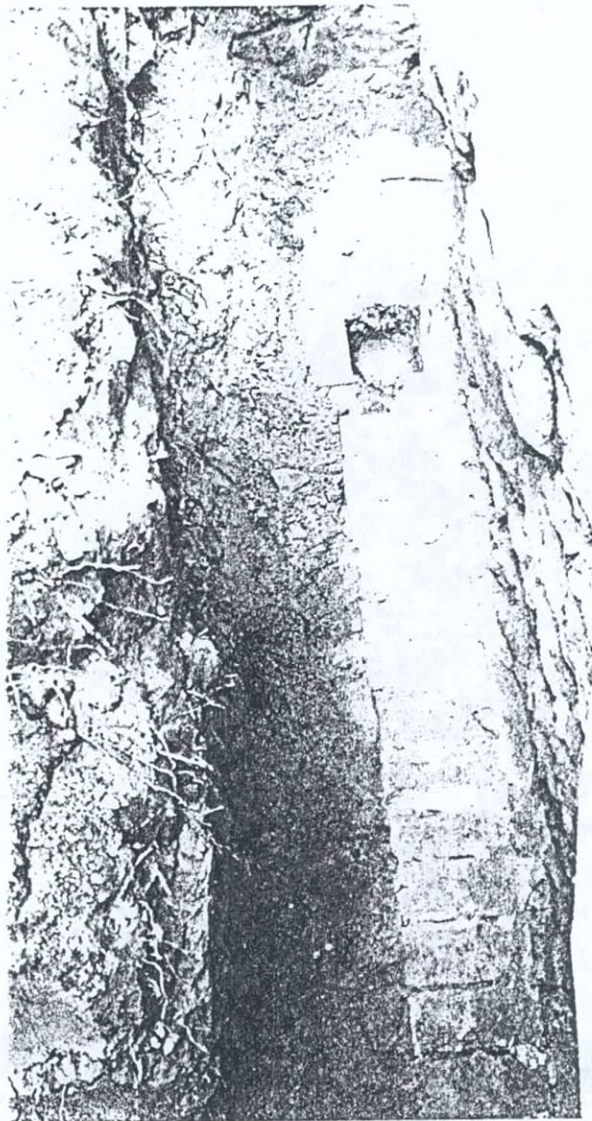
Plate 31
East Side of Mansion
Brick "Drain" Feature at Base of Foundation
Southeast Corner of Mansion at Top of Photo
View South

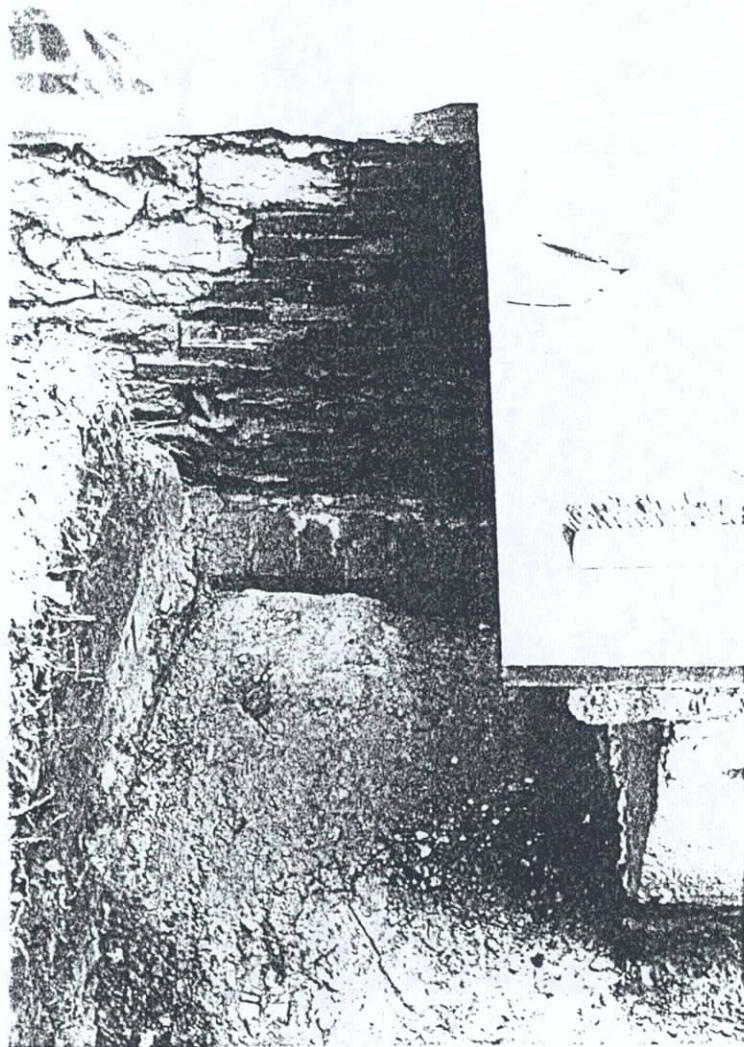
Plate 30
East Side of Mansion
Northern End of Brick "Drain" Feature at Base of Foundation
Basement Stairwell at Right, Bedrock in Foreground
View West

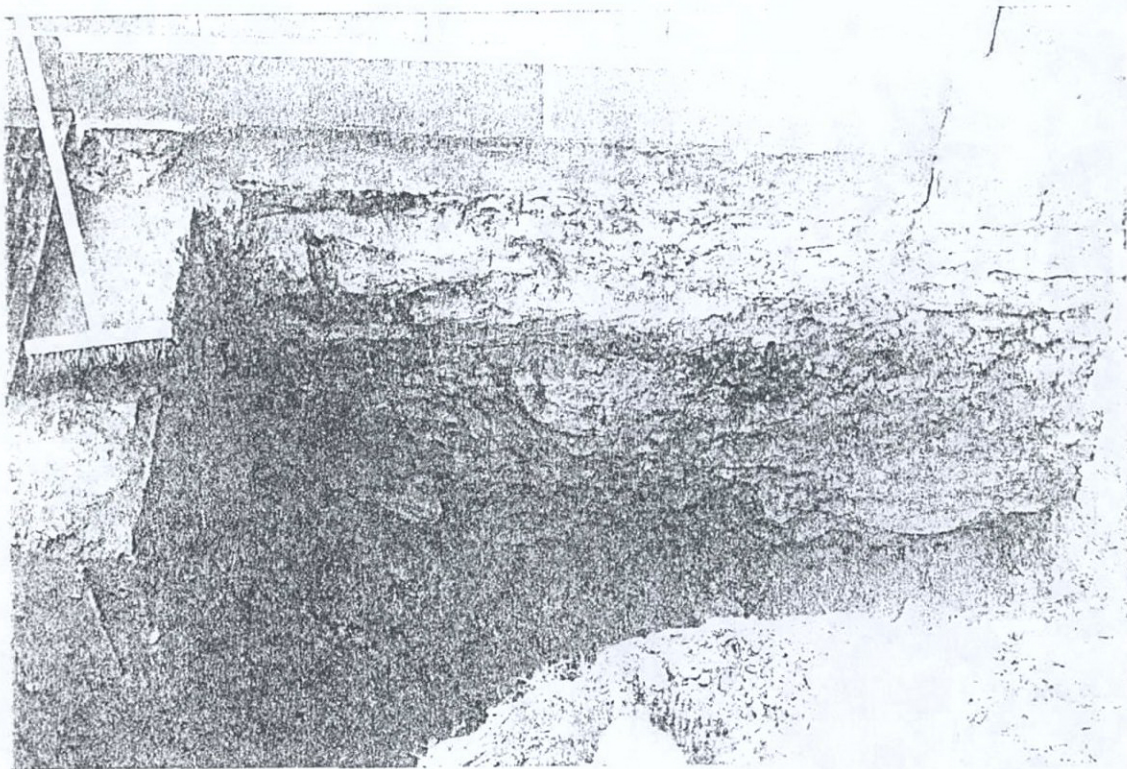
Plate 29
West Side of Mansion
Base of Foundation Wall At Southwest Corner of Mansion
Southernmost Areaway at Left
View East

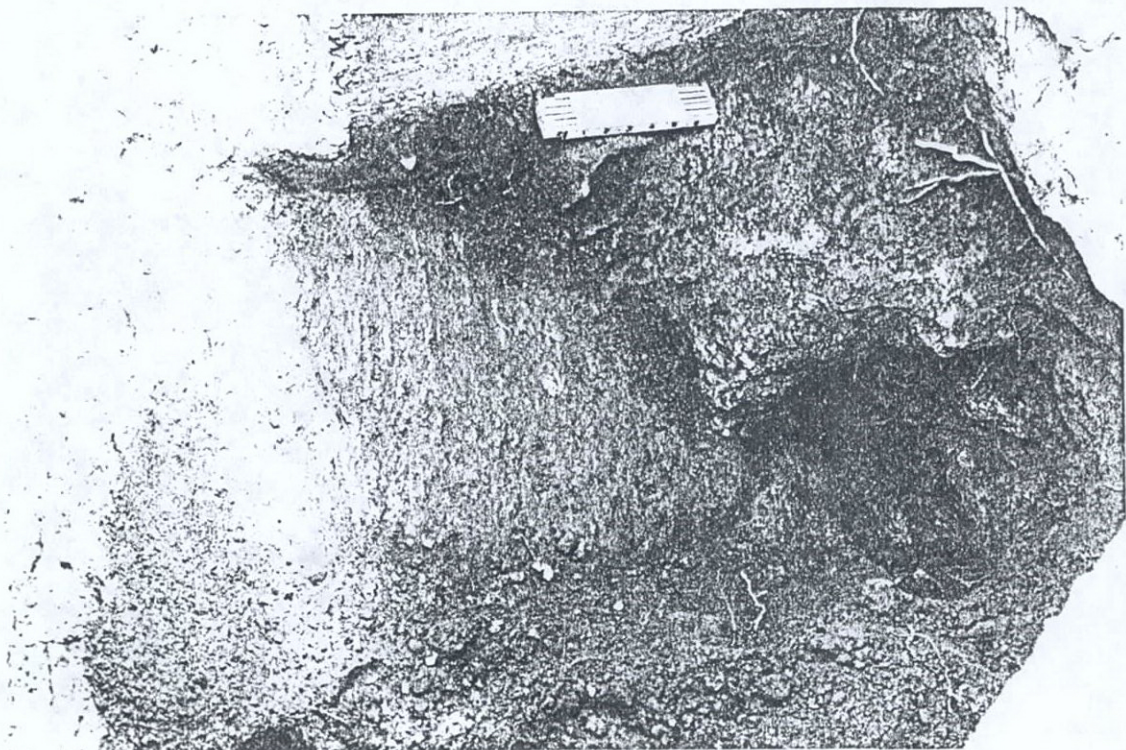
Plate 28
West Side of Mansion
Base of Foundation Wall Between Two Southernmost Areaways
Bedrock at Left, Areaway Wall at Top of Photo
View North

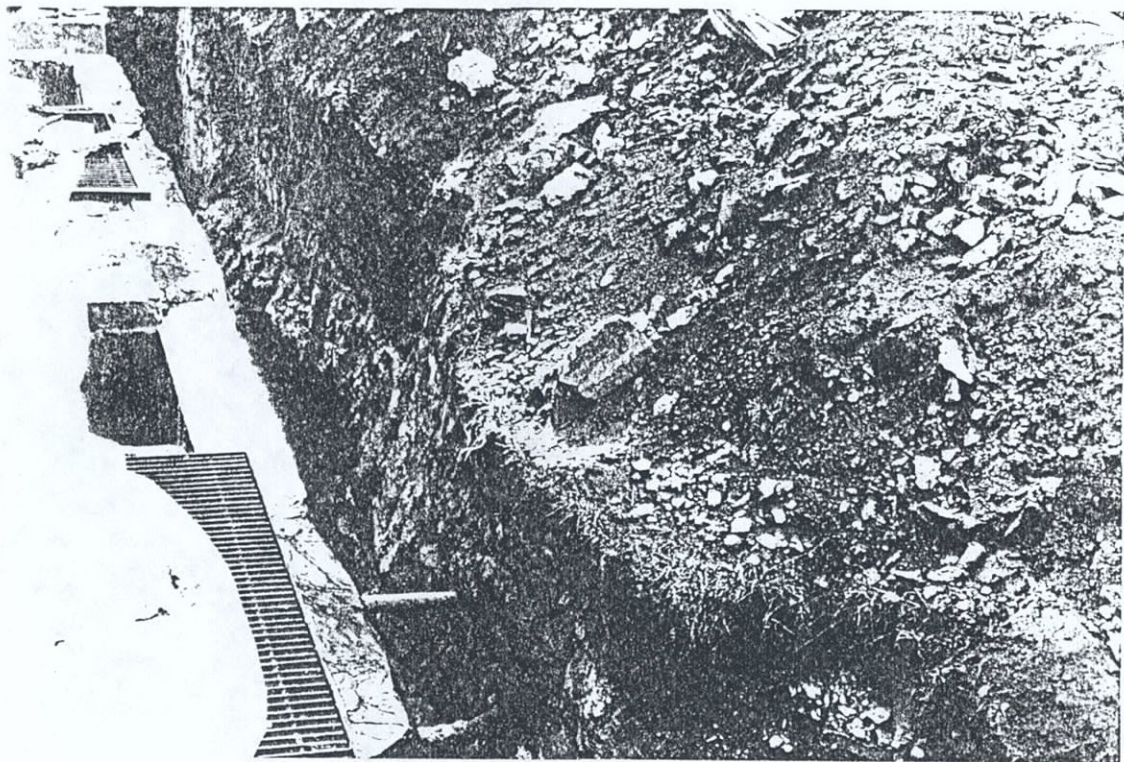
Plate 27
West Side of Mansion
Profile of Waterproofing Trench
Showing Downward Slope of Bedrock Surface
View Southwest

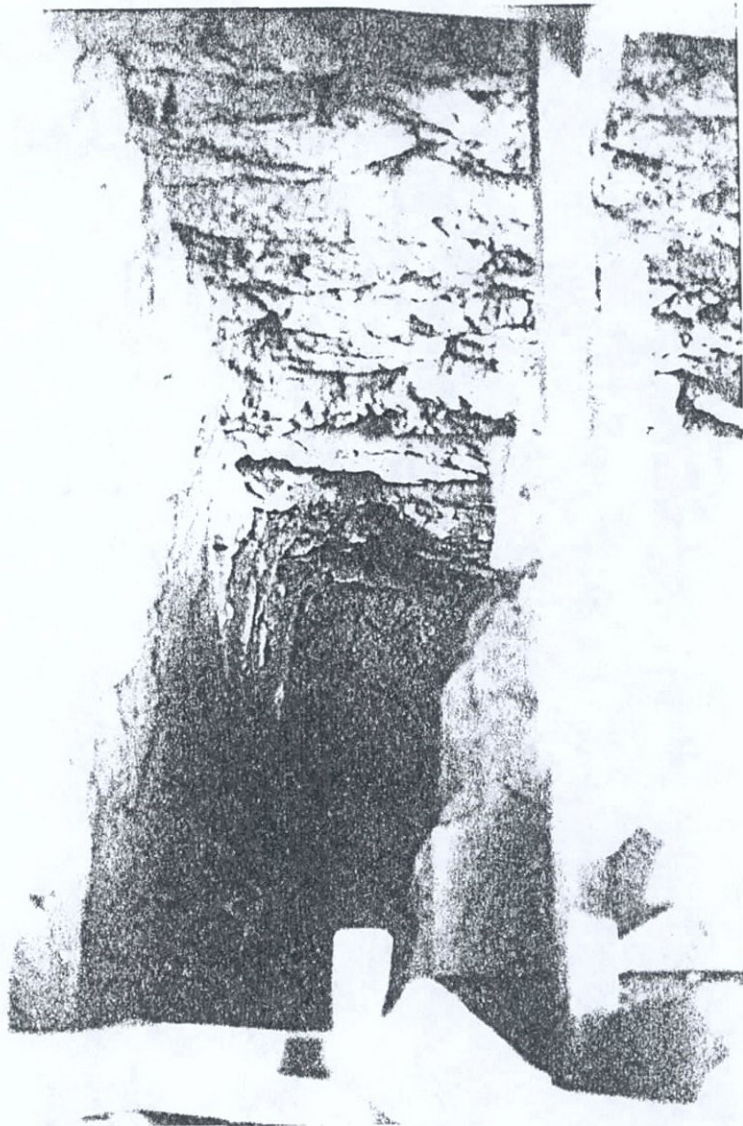
Plate 26
Intersection of Northeast Foundation Wall of Main Wing
and East Foundation Wall of Hyphen
View South Looking Downward From Hyphen Porch

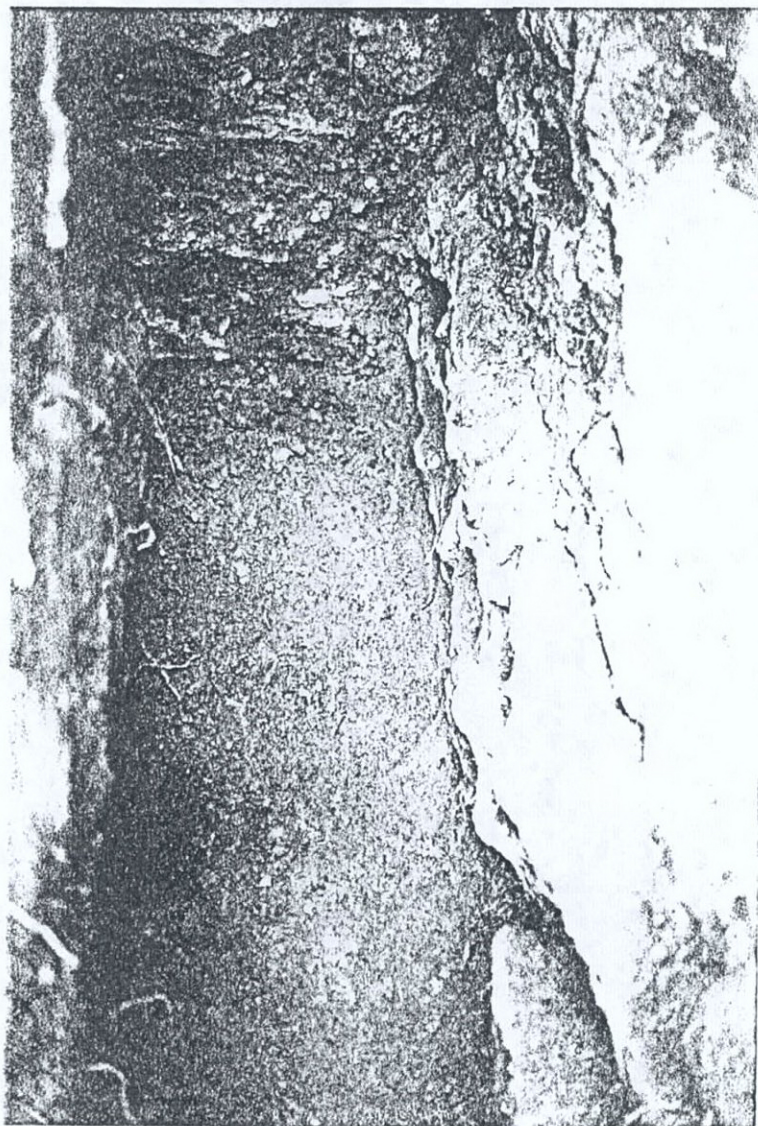
Plate 25
Eastern Portion of Northeast Foundation Wall
and East Foundation Wall of Hyphen
Note Mansion Foundation Wall Resting on Bedrock in Foreground and
Subsoil in Background

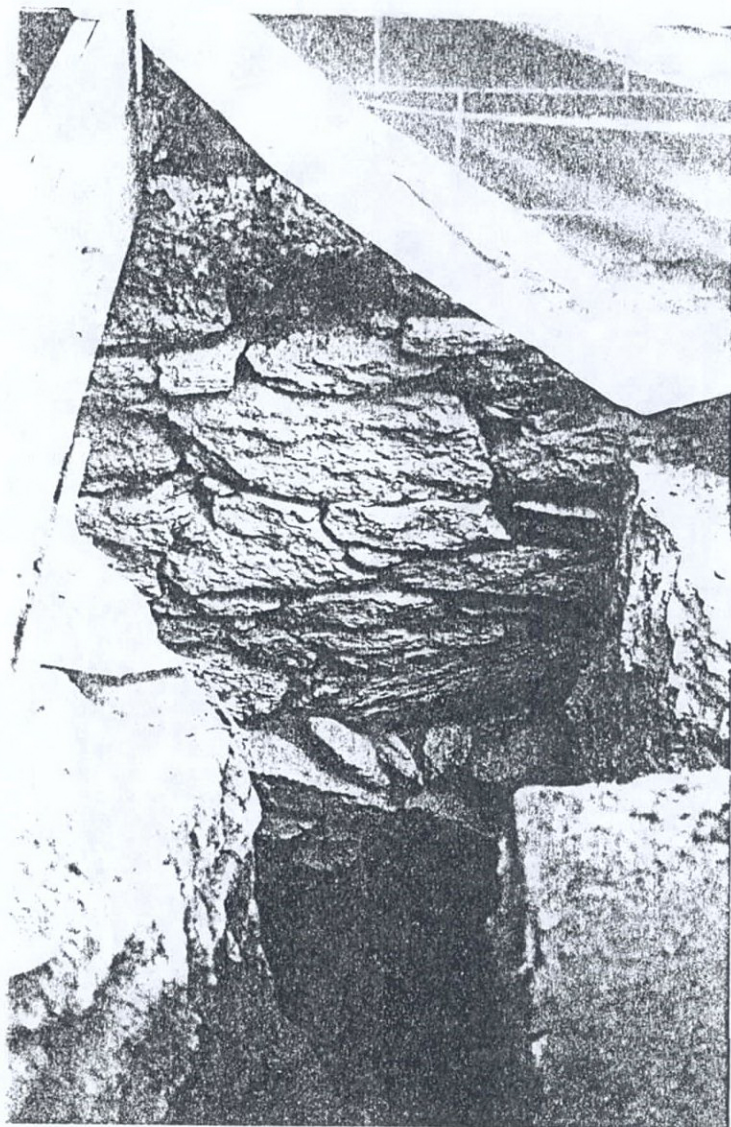
Plate 24
Northwest Mansion Foundation Wall
Portion Immediately East of Areaway
View North

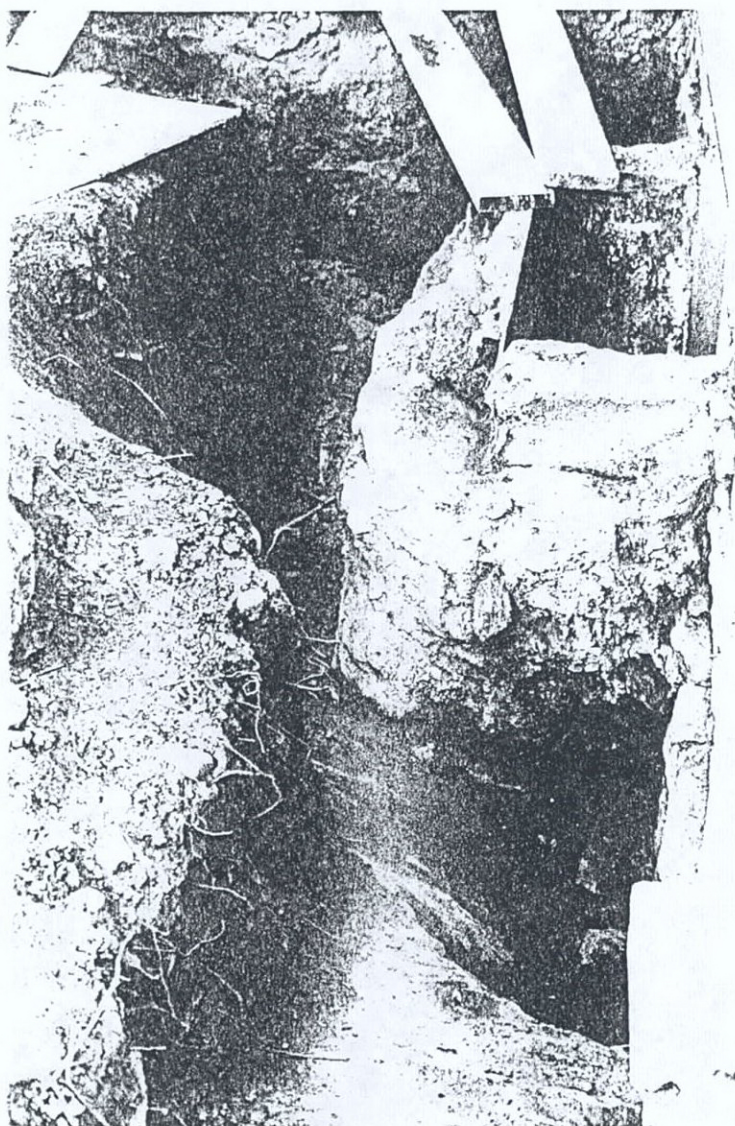
Plate 23
Downward Sloping Bedrock Surface
Along Northeast Wall of Mansion Showing Construction of Areaway
View East

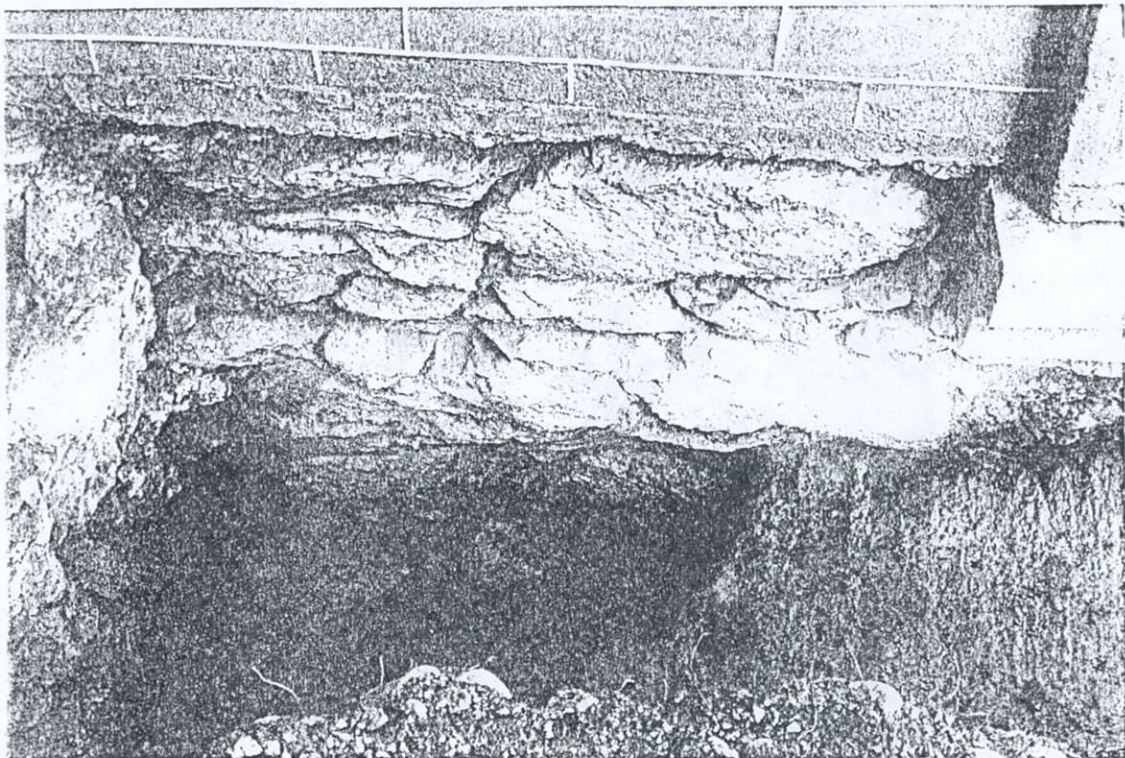
Plate 22
Foundation Wall East of Northwest Corner of Mansion
Showing Cut Out Bedrock and Foundation Wall Base
View North

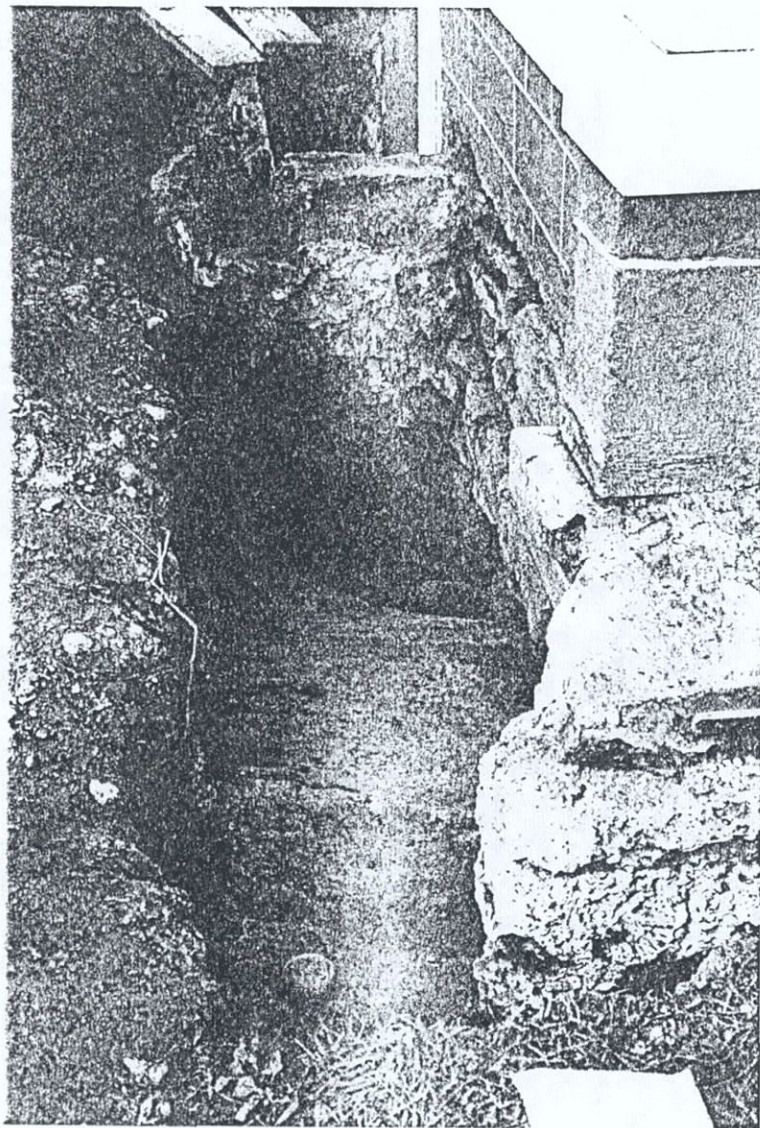
Plate 21
Northwest Corner of Mansion Foundation Wall Resting on Bedrock Slab
View East

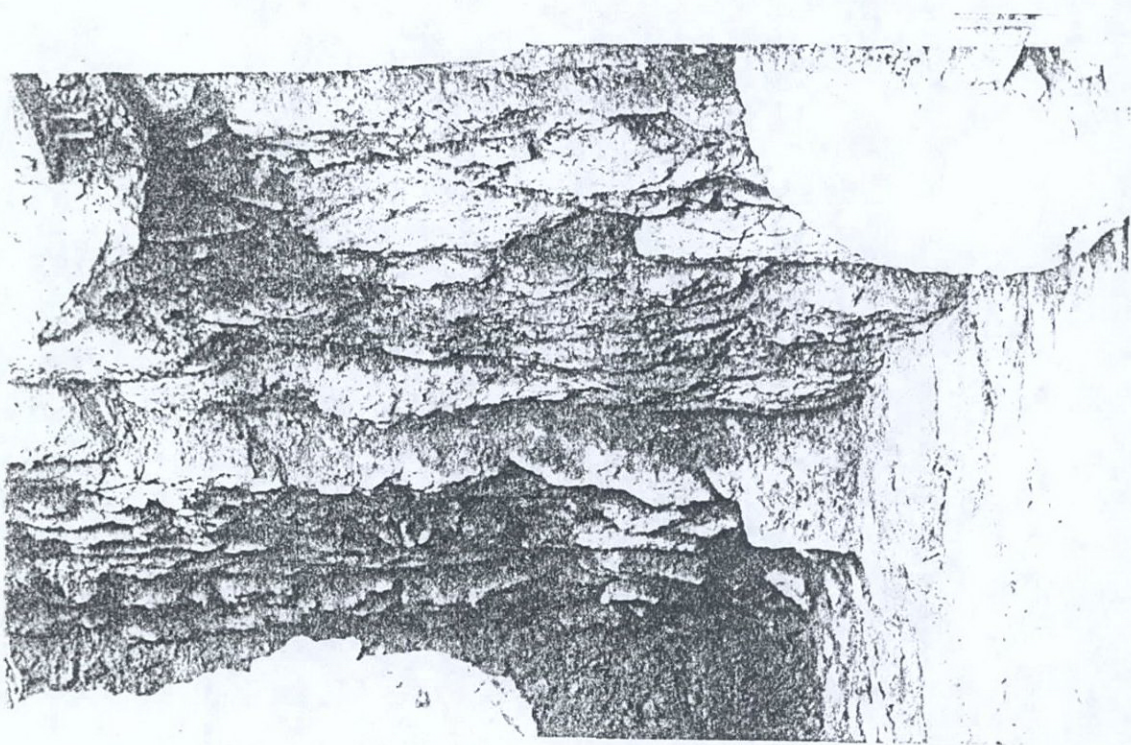
Plate 20
Intersection of North Foundation Wall of Mansion and East
Foundation Wall of Hyphen
View North Looking Downward from Hyphen Porch
