ARCHAEOLOGICAL INVESTIGATIONS
FOUNDATION WATERPROOFING PROJECT
MORRIS-JUMEL MANSION

BY
ARNOLD PICKMAN

1994

Conducted for the New York City Department of Parks,
Recreation and Historic Preservation

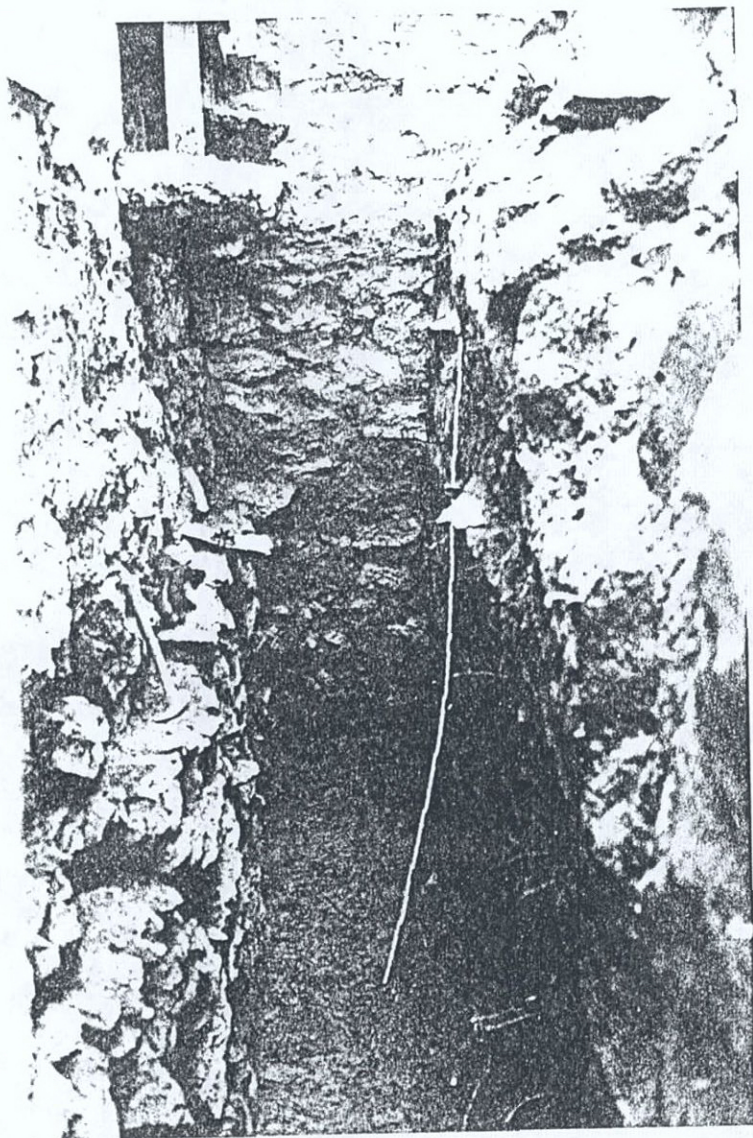
Plate 19
North Foundation Wall of Mansion and East Foundation Wall of Hyphen
View West

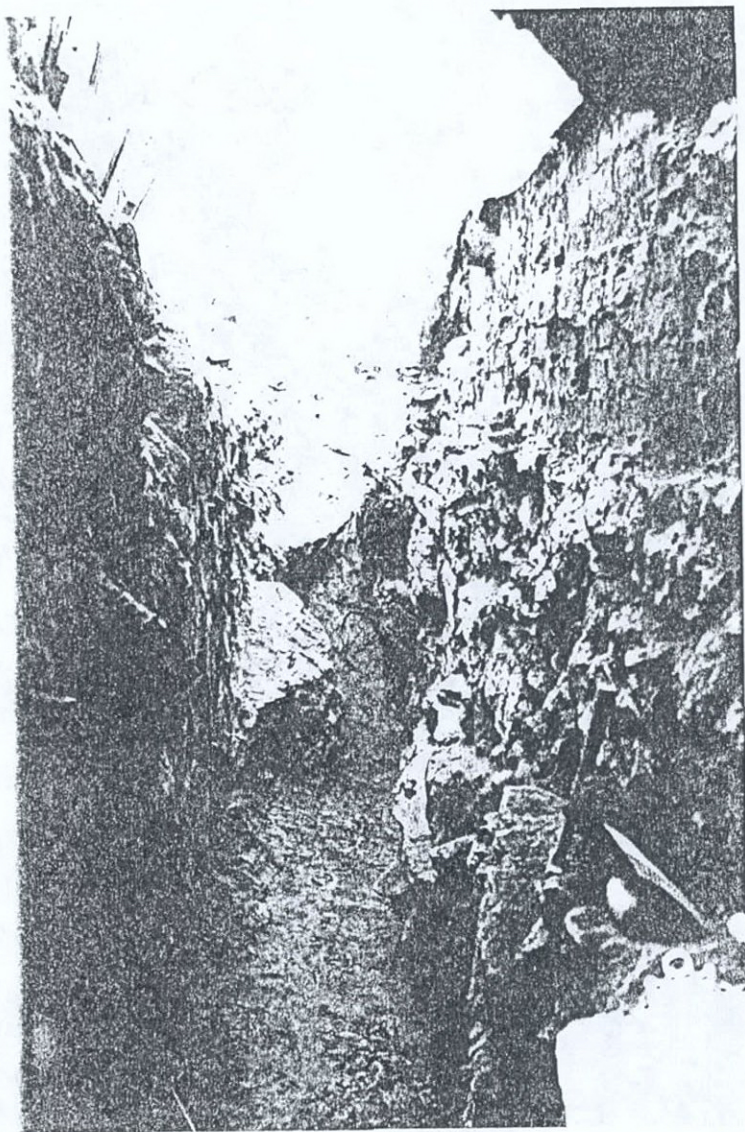
Plate 13
North Foundation Wall of Mansion Exposed East of Hyphen
Note Blue Material on Wall Applied During Waterproofing
View East

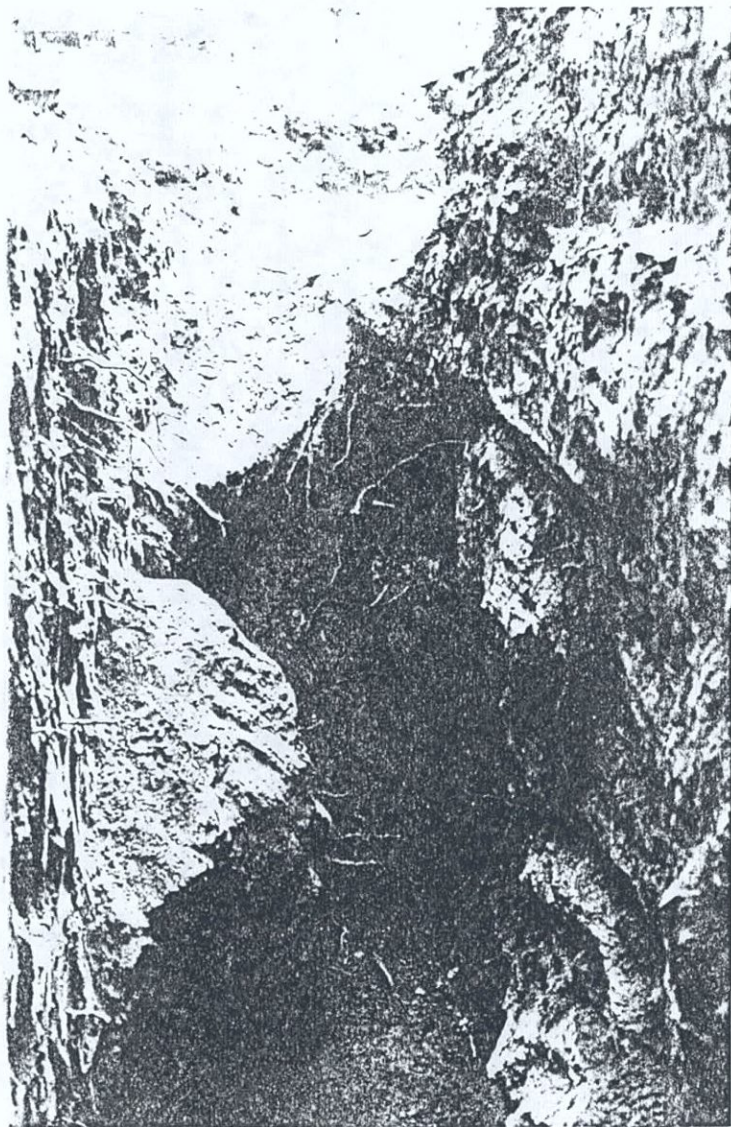
Plate 17
Waterproofing Trench Northeast Corner of Mansion
Showing Drop-off in Bedrock Surface Near Northeast Corner of Building
View East

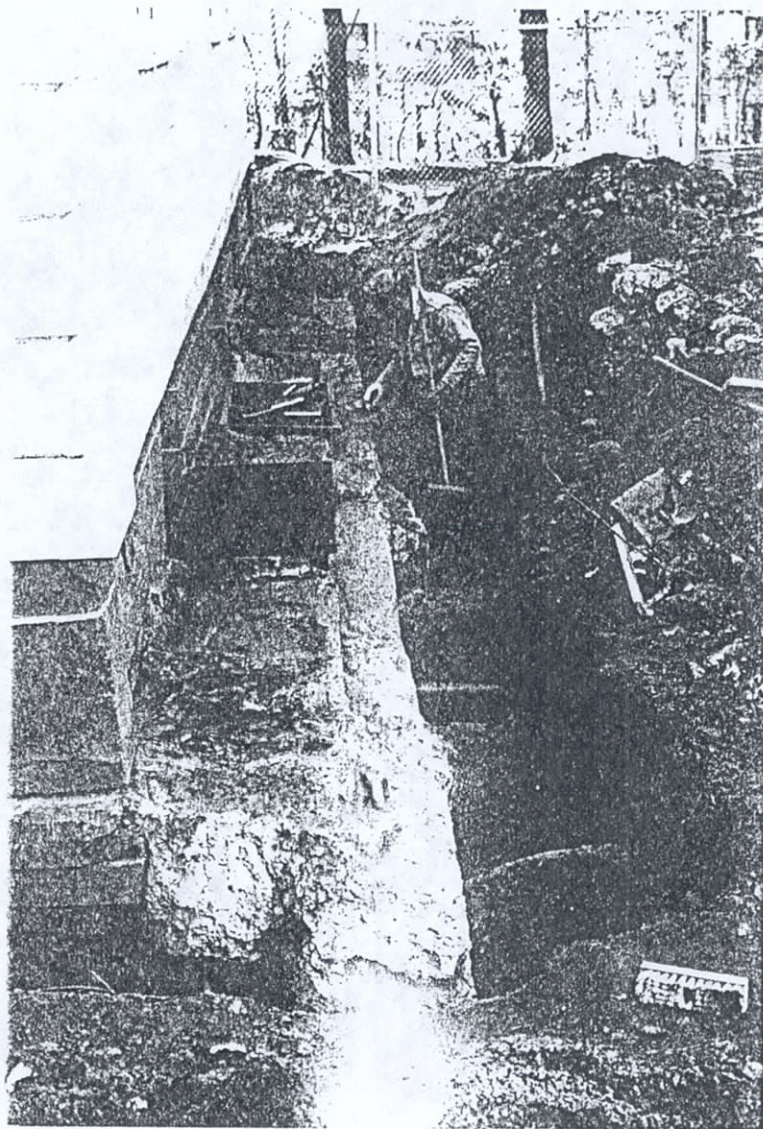
Plate 16
West Side of Mansion Showing Area Next To Foundation
Disturbed by Areaways, Concrete Slabs and Pipe Trenches
View South

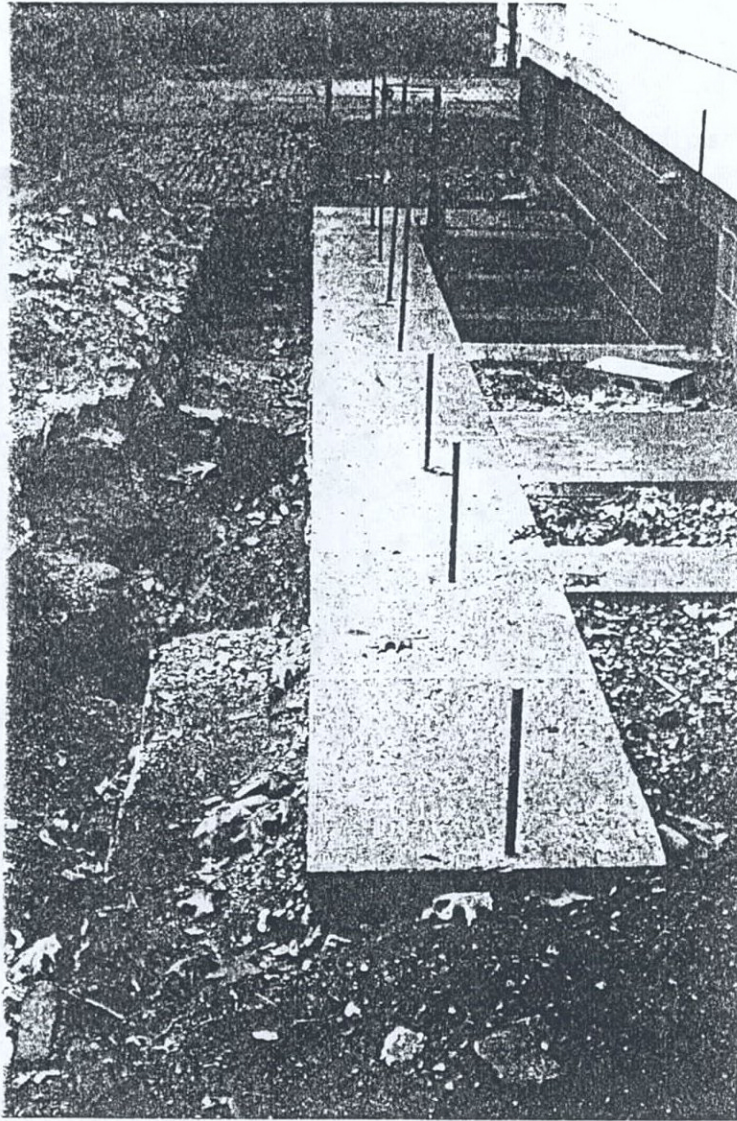
Plate 15
East Side of Mansion Showing Area Next To Foundation
Disturbed by Existing and Filled-In Basement Stairwells
View South

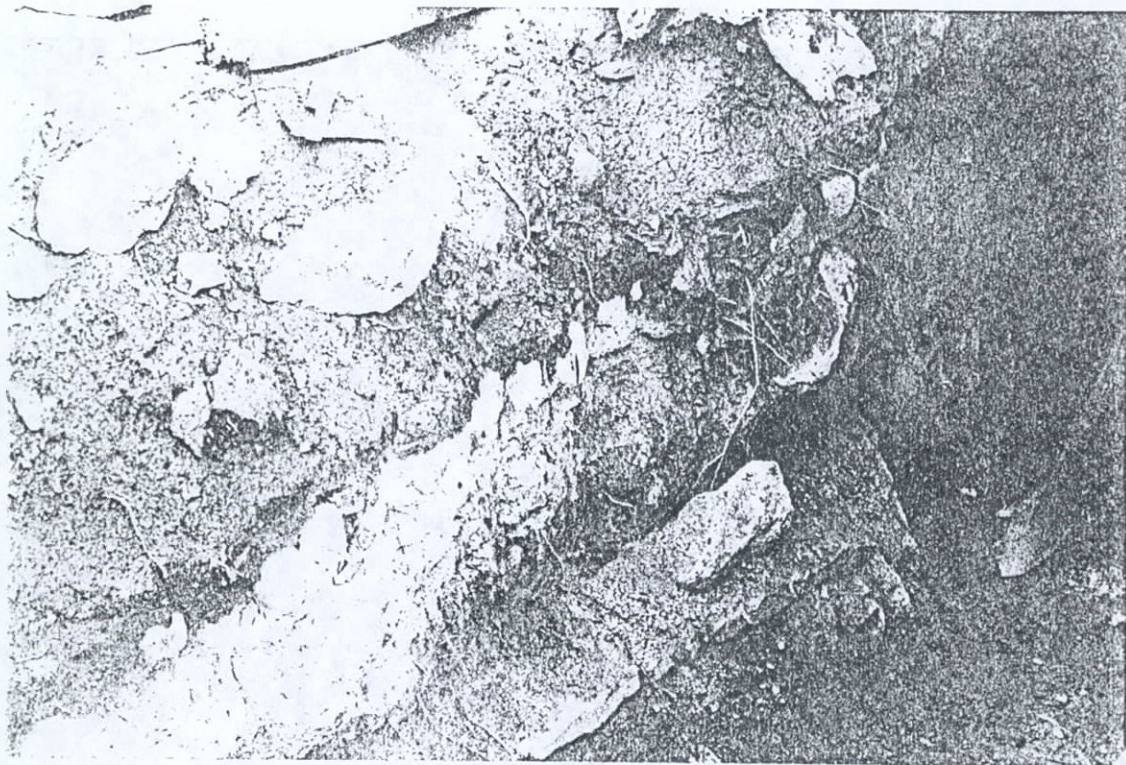
Plate 14
Cobble Feature Exposed in Wall of Waterproofing Trench
West of Location of Shovel Test 14
View Northeast

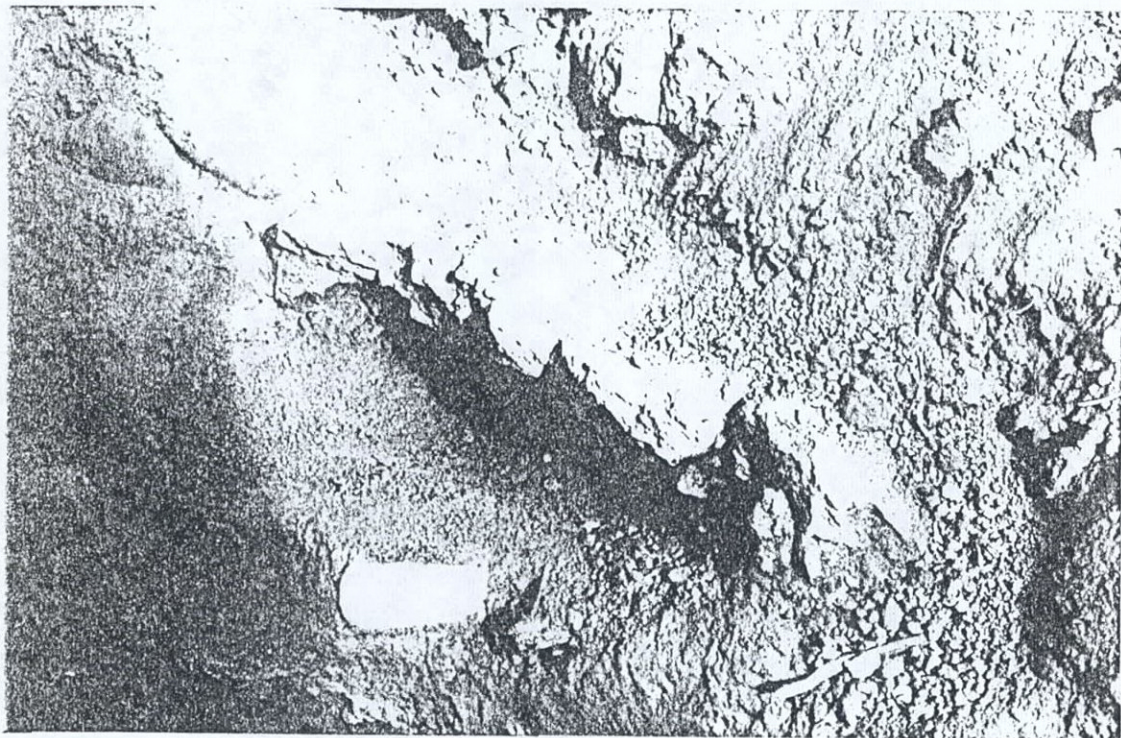
Plate 11
East Foundation Wall of Earle Kitchen
Exposed in Wall of Waterproofing Trench
View Northwest

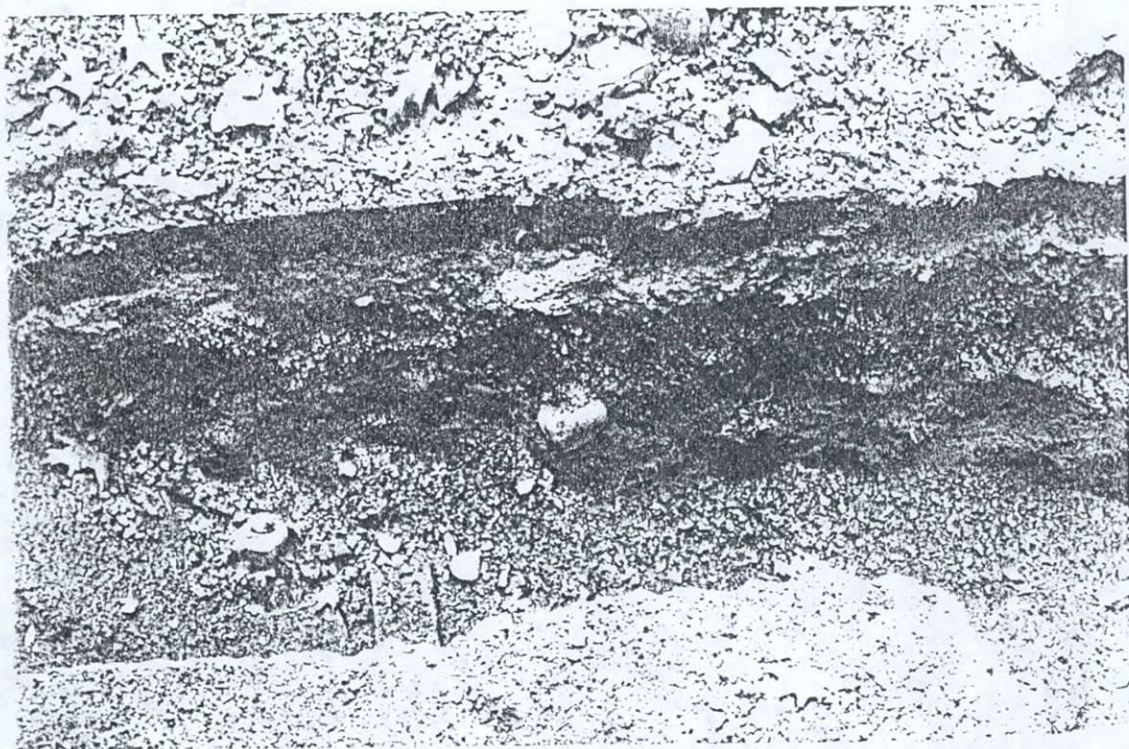
Plate 10
Cobble Feature Exposed in Wall of Waterproofing Trench
North End of Trench East of Main Mansion Wing
View East
