ARCHAEOLOGICAL FIELD TESTING
SOBEL COURT PARK
BLOCK 2877, LOTS 18 AND 105
BOROUGH OF RICHMOND
CEQR No. 95-DCP-015R

by
ARNOLD PICKMAN

Submitted To
New York City Department of Parks and Recreation

November 1995

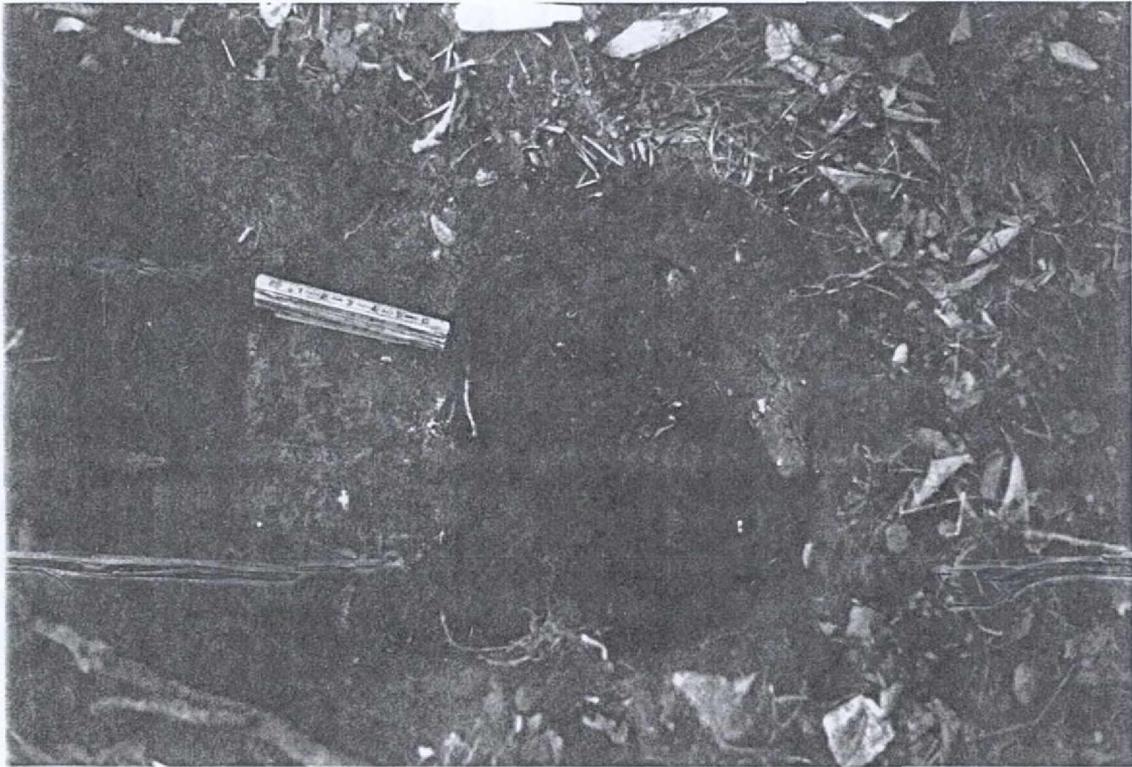
Plate 1
Shovel Test 26 and Top of Brick Wall
View West

At a depth of 10 inches below the existing surface, beneath the overlying fill (Strata I and II); shovel test 27 encountered the top of an eight inch wide brick wall (see Plate 1). The orientation of this wall is parallel to the northern property boundary line and to the side of the house as shown on the 1907 map.

Comparison of the 1907 topographic map with the 1917 Sanborn map (Figure 4) suggests that between these two years an extension was added south of the house. The location of S.T. 27 suggests that the brick wall encountered in this test represents the western wall of this extension.

Shovel test 27 was continued downward along the eastern side of the brick wall. The outline of a disturbed area immediately adjacent to the wall, apparently associated with its construction, was noted in the test profile. At the top of the

brick wall this disturbed area extended outward some 6 inches, sloping inward toward the wall with depth. The presence of this "trench" disturbance suggests that the adjacent strata were deposited prior to the construction of the extension wall. No attempt was made to excavate the deposits within the disturbed area separately from the adjacent strata. The light gray silty clay encountered at the base of S.T. 27, at a depth of 32 inches below the surface appeared to represent the subsoil at this location. The brick wall and the adjacent disturbed area extend downward below this depth.

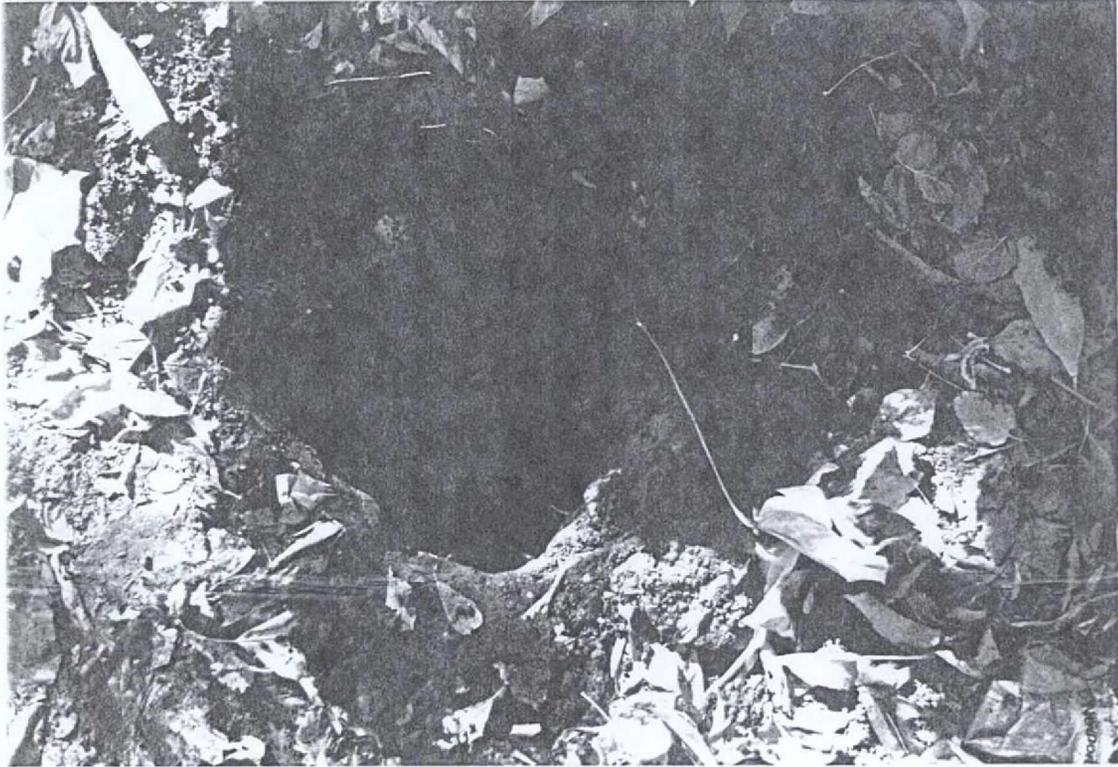
Plate 2
Shovel Test 28
Showing Brick at Base of Test
View North

Subsequent to the excavation of shovel test 27, S.T. 28 was placed approximately 12 feet east and six feet north of the wall exposed in the former test. At a depth of 13 inches, this test encountered brick (see Plate 2) which appeared to be "in situ." The test was abandoned at this point. The brick could be a portion of the rear wall of the extension. If so, however, this wall would be only some three inches (the width of one brick) wide. It is possible that this is, in fact, a loose brick contained within a fill deposit and not part of an in situ wall.

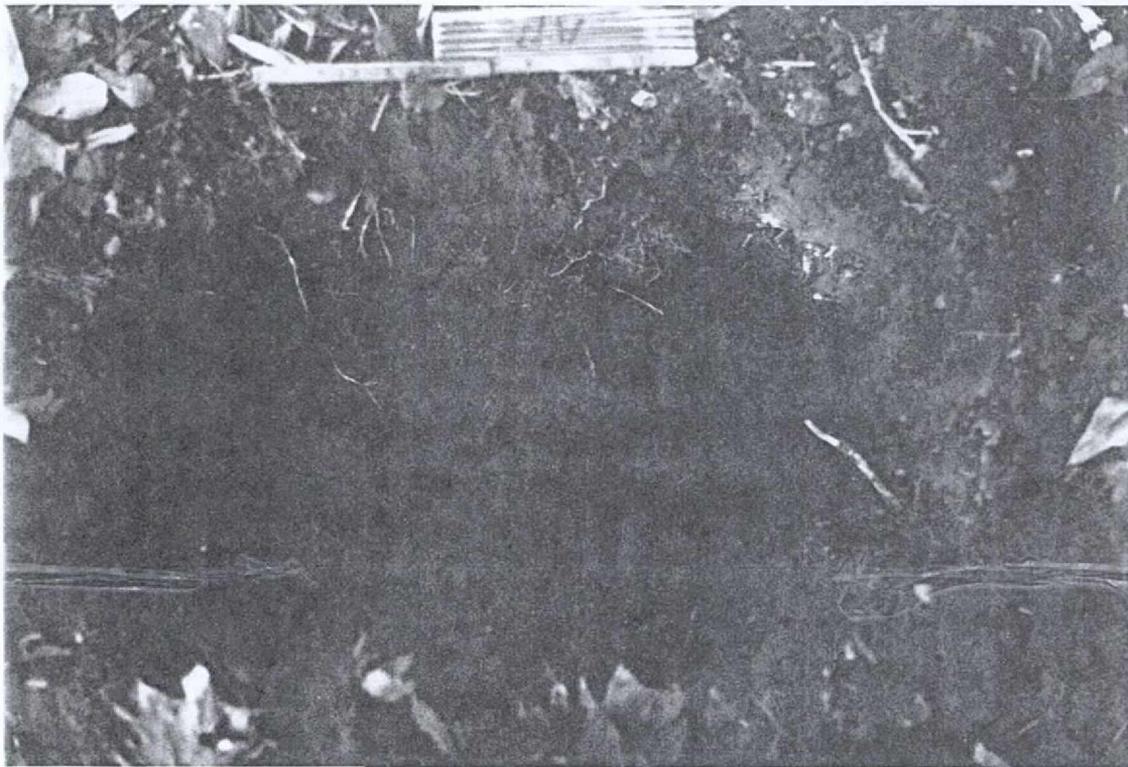
Plate 4
Shovel Test 26
Upper Portion of Stone Walls
View North

At a depth of 10 - 15 inches below the surface, shovel test 26 encountered two large stones which underlay the uppermost fill deposit. Examination of the small portion exposed in the shovel test suggested that these stones represent the basal portions of two "walls" oriented at right angles to each other (see Plate 4). The base of these "walls" was noted at a depth of 24 inches below the surface. The 1907 map (see Figure 3) shows two "pillar"-like constructions at the northeast and southeast corners of the house. The stones encountered in S.T. 26 could represent the northernmost of these constructions. However, although only portions of these stones were exposed, it appeared that their orientation would place them at an angle of some 35 degrees with the walls of the house.

Examination of the profiles of S.T. 26 indicated the presence of a disturbed area adjacent to both of the stone "walls" exposed in this test which apparently represents a portion of a trench excavated to install this stone feature. This "trench" extended outward for a distance of nine inches at the top of the stones, sloping inward to meet their bases of the stones.

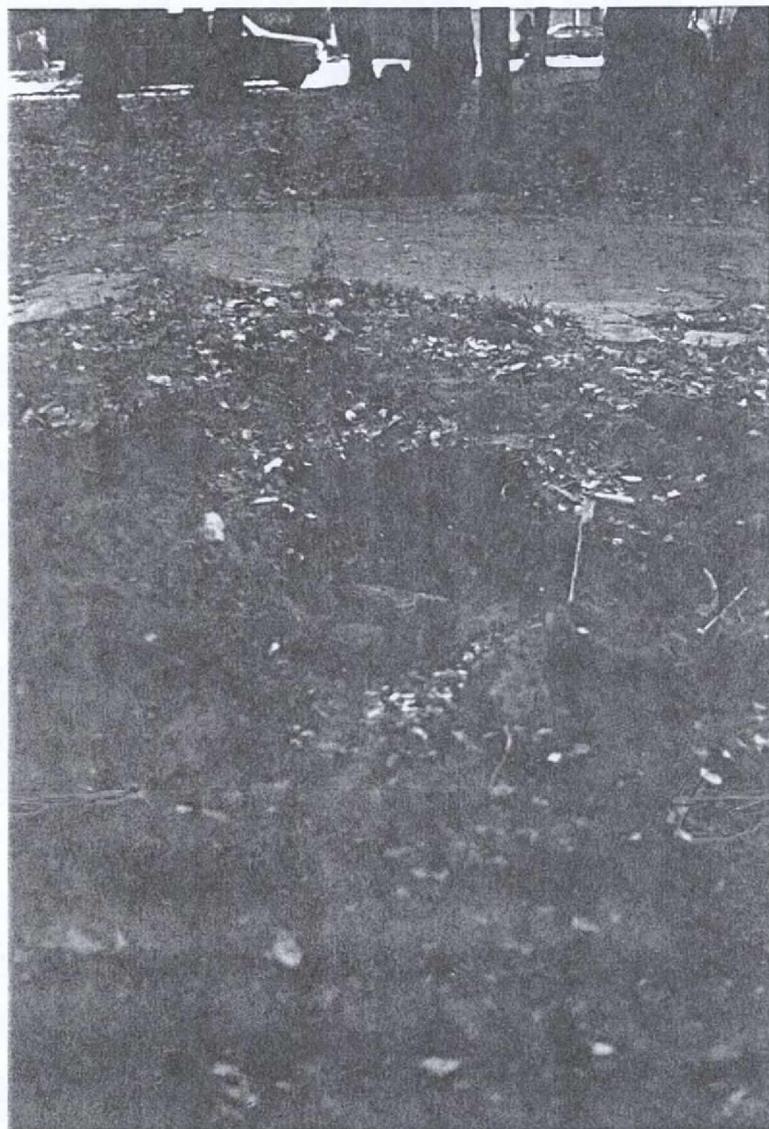
Plate 5
Stone Wall (Outbuilding #1) and Shovel Test 15
Showing Relationship to Concrete Slab
View East

Shovel test 15 was placed west of the existing concrete slab which appears to represent the floor of outbuilding #1, indicated as a 1 1/2 story frame structure on the 1907 map (Figure 3). The shovel test encountered the basal portion of a dry laid stone wall at a depth of 4 1/2 - 10 inches below the surface. The location of outbuilding #1 as shown on the map indicates that this represents the western foundation wall of this structure. The wall, which is approximately three feet in width, is shown on Plates 5 and 6. A few stones were removed during the excavation of S.T. 15, resulting in the depression in the central portion of the wall as shown on Plate 6.

The wall was overlain by the humus and fill deposits which constitute the uppermost portion of the stratigraphic sequence throughout the site as discussed above. Its eastern portion was immediately overlain by a deposit of gray brown sandy silt mixed with orange clayey silt and cinder/ash (stratum III). Shovel test 15 was extended east of the wall and continued downward adjacent to it. Stratum III continued next to the wall to a depth of some

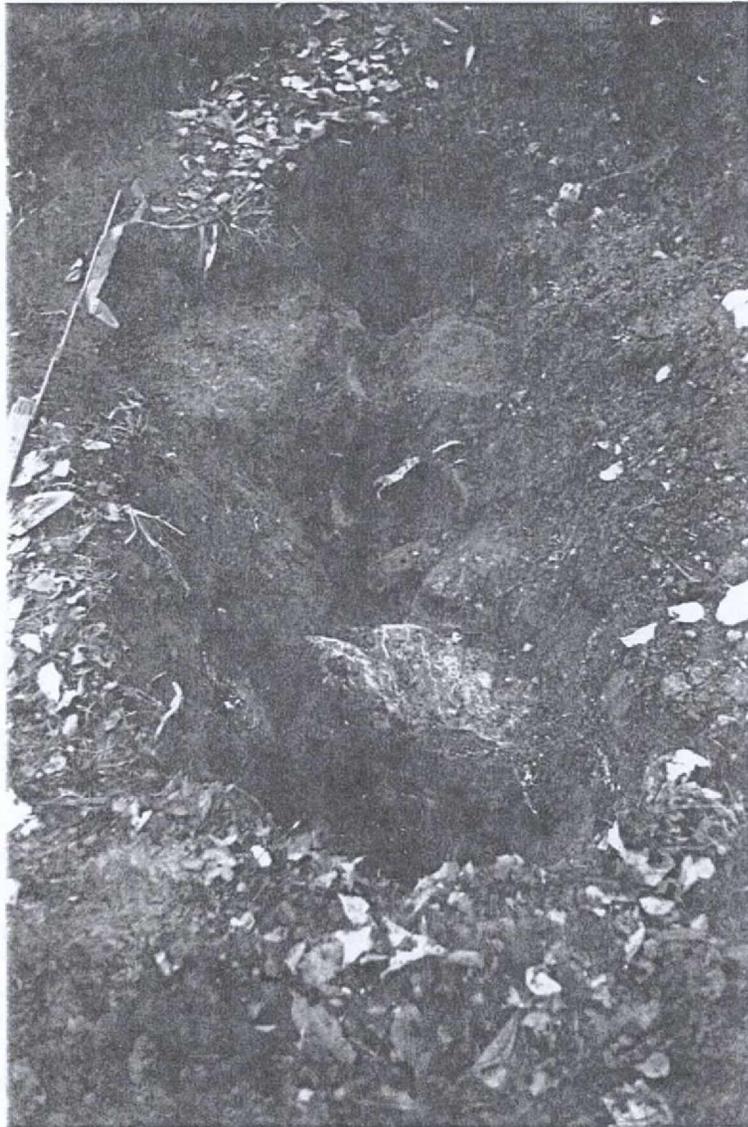
Plate 6
Stone Wall of Outbuilding #1 (Detail)
View West

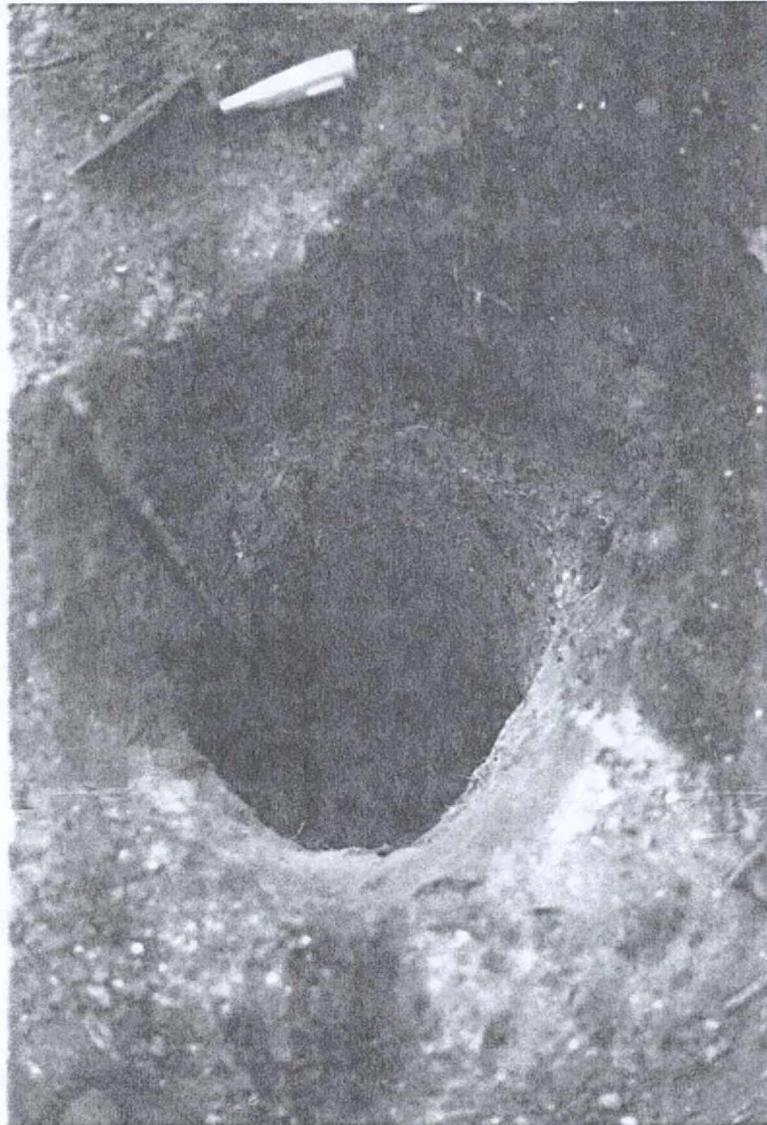
Plate 7
Shovel Test 32
Showing Upper Portion of Cinder Deposit and Overlying Fill
View Southeast

The preponderance of wire nails among those recovered from the cinder and ash deposit in S.T. 32 suggest deposition toward the end of the 19th century or later.
