PHASE1B ARCHAEOLOGICAL TESTING

CROTON WATER
TREATMENT PLANT
MOSHOLU GOLF COURSE,
VAN CORTLANDT PARK
BRONX, NEW YORK
DEP/98DEP027X

December 2004

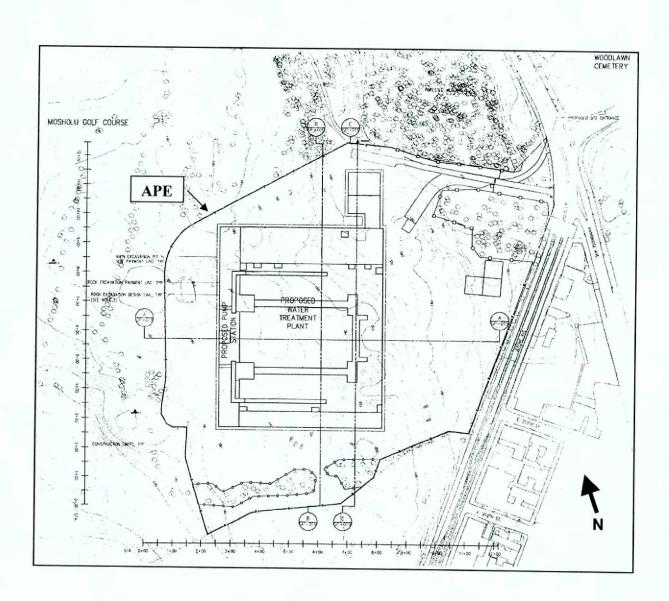
Figure 2: Proposed Mosholu Golf Course Water Treatment Plant Site.

The Croton WTP would be located at the Mosholu Golf Course and Driving Range. The site is located within the 1,146-acre Van Cortlandt Park in the Borough of the Bronx, New York (Figures 1, 2). This site is owned by New York City jurisdiction of the site was recently transferred to NYCDEP. The golf course and driving range is bound by the Mosholu Parkway and Major Deegan Expressway to the west and north, Jerome Avenue and the Interborough Rapid Transit (IRT) No. 4 elevated subway (the Woodlawn Station) to the east, and West Gun Hill Road to the south. The golf course and driving range comprise approximately 74 acres of the 1,146-acre park. Existing facilities at the Croton WTP site include a clubhouse, driving range, nine-hole course and a parking lot for approximately 75 cars. The proposed project would be situated under a portion of the 13-acre driving range. During construction the golf course would remain open with a temporary clubhouse, driving range, and parking facilities made available through the Shandler Recreation Area to the north, adjacent to the golf course and driving range. The temporary golf course would be a modification of the existing one, and would still have 9 holes open to the public during the construction period. Following construction, these facilities would be replaced with a new golf course clubhouse, maintenance facility, and new golf course parking lot.

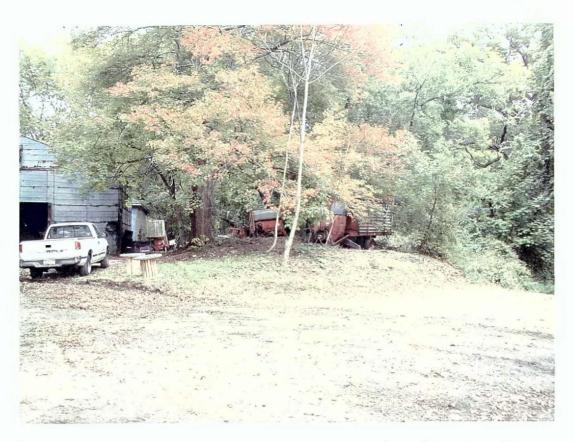
Photograph A: Disturbance around garages. Facing northeast from cart path.

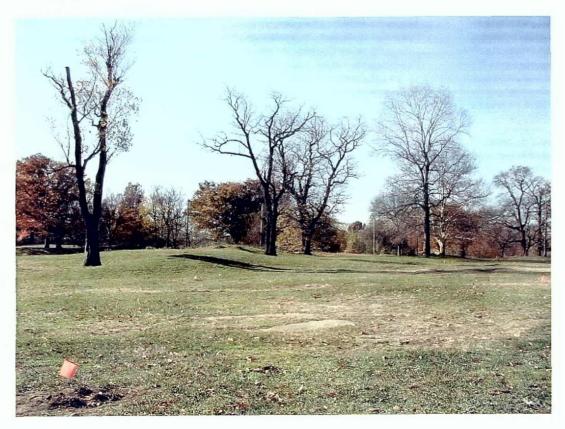
Photograph B: Scoured area in driving range with artificial mounds in background at left between and around trees. Facing southwest.

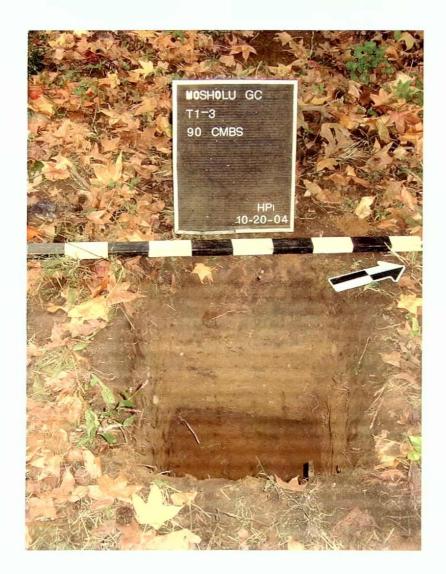
Photograph C: Shovel Test Pit T1-3. Buried "A" horizon encountered at about 40cm below surface.

Some of the units bore distinct evidence of prior disturbance (e.g., a buried pipe from the sprinkler system) or artificial deposition, such as the addition of an ash level or fill over a "Buried A" level (Photographs C-E; Appendix A). Others had pavement that was covered with topsoil when the layout of the golf course was modified (Appendix A). Overall, the upper levels of all STPs contained modern 20th century material which was introduced when the golf course was originally created and subsequently re-landscaped (e.g., an 1880-1913 nickel found together with plastic in the "A" horizon of T16-5). Virtually all upper levels bore similar evidence of relatively modern disturbance (Appendix B).

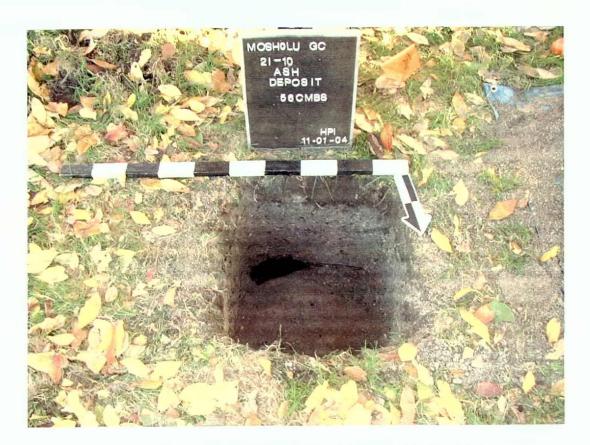
Photograph D: Ash lens in Shovel Test Pit T21-10, located in the driving range.

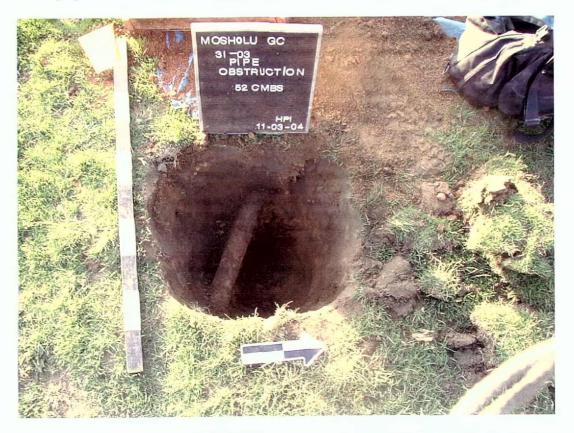
Photograph E: Irrigation pipe encountered in Shovel Test Pit T31-3, located in the driving range.

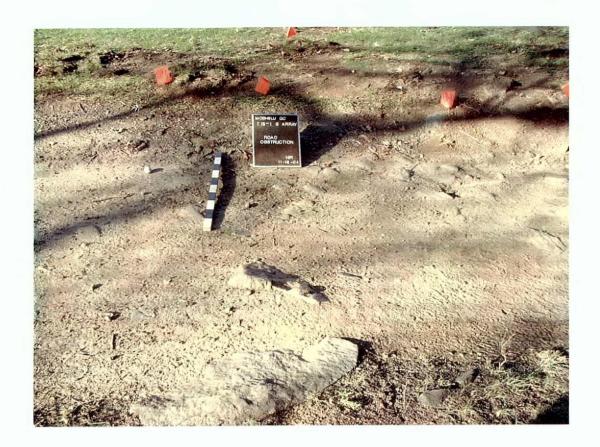
Photograph F: Array around positive Shovel Test Pit T15-1, facing north. Note that the South 1 unit was not completed due to obstruction caused by compaction in the roadway and an extensive deposition of rock.

A total of seven STPs contained one chert or one quartz flake or piece of shatter in the "B" horizon (Appendix B; Figure 5). In addition, one STP contained a precontact ceramic sherd in the "A" horizon, but in this single unit the "A" did not appear to be disturbed by the creation of the golf course. This unit was located directly between tree roots of a massive old tree, and may have escaped disturbance during the landscaping process. Therefore, test arrays were completed around these eight positive STPs. All but one array consisted of eight additional STPs placed at one and two meters north, south, east, and west of the original positive STP (Figures 4, 5). The eighth array contained only seven STPs because the eighth would have been within an excessively utilized golf cart path, which had exposed large cobbles and severely compacted soils (Photograph F).
