**NEW 120<sup>TH</sup> POLICE PRECINCT**  
BLOCK 556, LOT 100  
BOROUGH OF STATEN ISLAND  
PHASE IB ARCHAEOLOGICAL FIELD TESTING

Prepared for: Karlsberger Architecture, PC  
Prepared by: Celia J. Bergoffen, Ph.D., R.P.A.  
Date: December 22, 2006

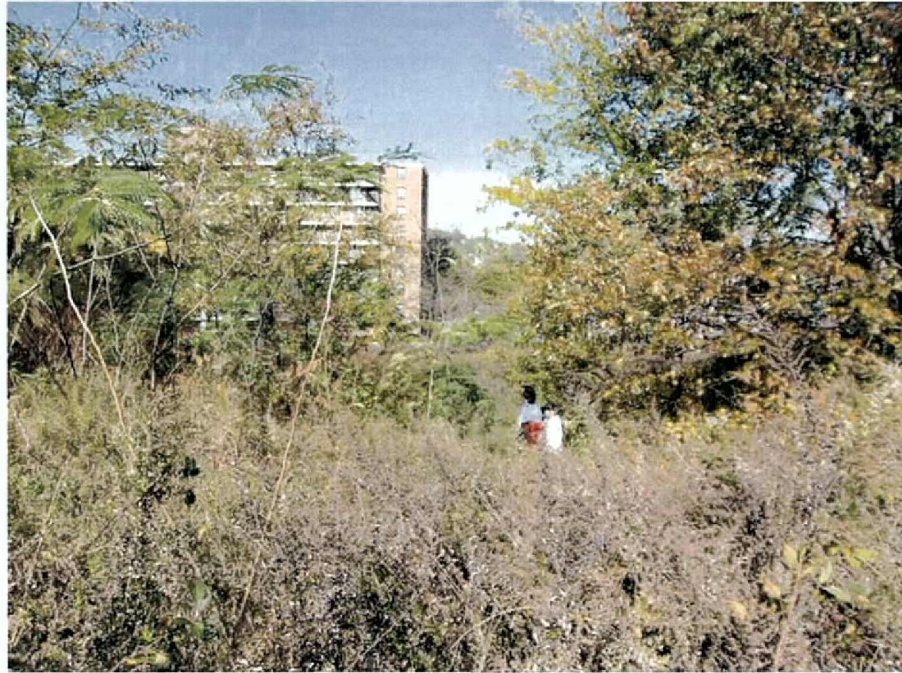
**Fig. 1. View of the project site before mowing, from the southeast looking north.**

The walkover, which was executed with six archaeologists, was intended to check whether any fragments of gravestones or other features could be seen on the surface of the project area that might indicate the presence of burials. Prior to the commencement of our investigations, the site was cleared of the chest-high grasses, weeds, saplings and brambles that would have made such a survey futile (Figs. 1 and 2). The walkover, however, only indicated that the project site had been liberally used as a dumping ground by the adjacent properties, and no fragments indicative of the presence of burials were noted.

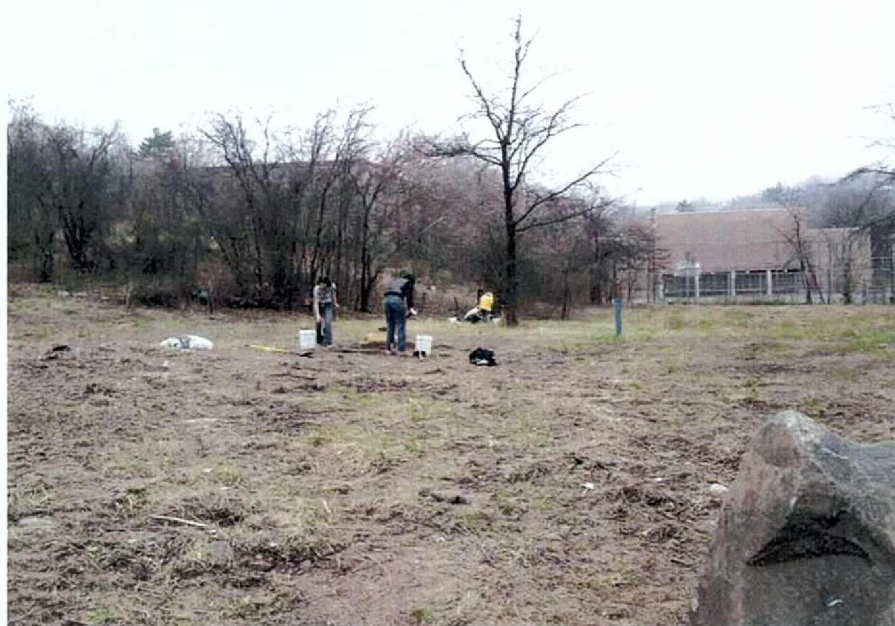
Fig. 4. View of the project site from near the northeast corner looking west towards the locations of test pits 1 and 2.

The northwest corner of this three by three foot test pit was located 70 ft. south of the north fence line and 104.8 ft. west of the east fence line. It was excavated on November 29th (Figs. 4, 5 and 6).

75.25 ft. southwest of the northwest corner of test pit 1. It was excavated on November 29th and 30th (Figs. 4, 7 and 8).

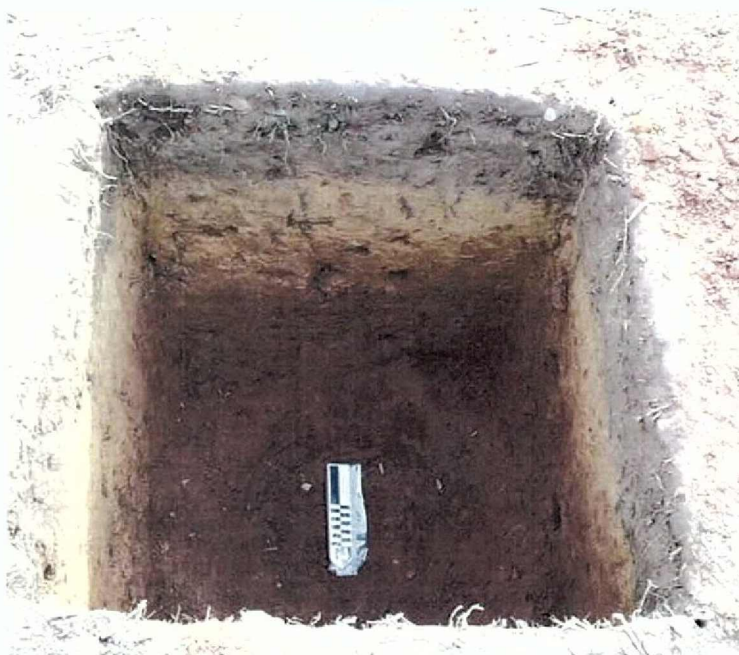
Fig. 5. View of test pit 1 at the end of excavation.

Layer 1 - topsoil - dark gray to dark brown fine, silty soil with many small and medium-sized stones, small cobbles, fragments of brick and glass. This layer continued to 0.8 ft. below grade in the northwest corner; 0.9 ft. in the northeast corner; 0.7 ft. in the southeast corner and 0.7 ft. in the southwest corner.

Layer 2 - brownish-yellow clayey soil, many stones, and small amount of ceramic fragments, glass, and brick fragments. The closing depth of this layer was 2.2 ft. below surface except in the southwest corner where it was 2.3 ft. below surface.

Layer 3 - brownish-red soil, sandy, hard and compact, some fractured slate and many small pebbles, no cultural remains. The quantity of stones increased until it became very difficult to excavate. The matrix was composed of small round cobbles, decomposed sandstone, chips of a micaceous, gneiss-like rock. The closing depth of this level was 3.6 ft. below surface.

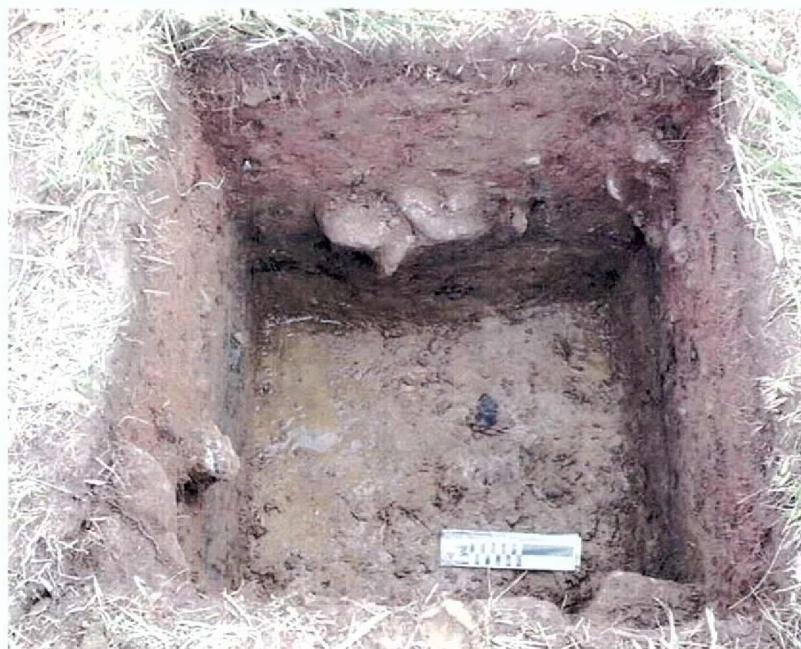
**Fig. 8. View of test pit 2 at the end of excavation**

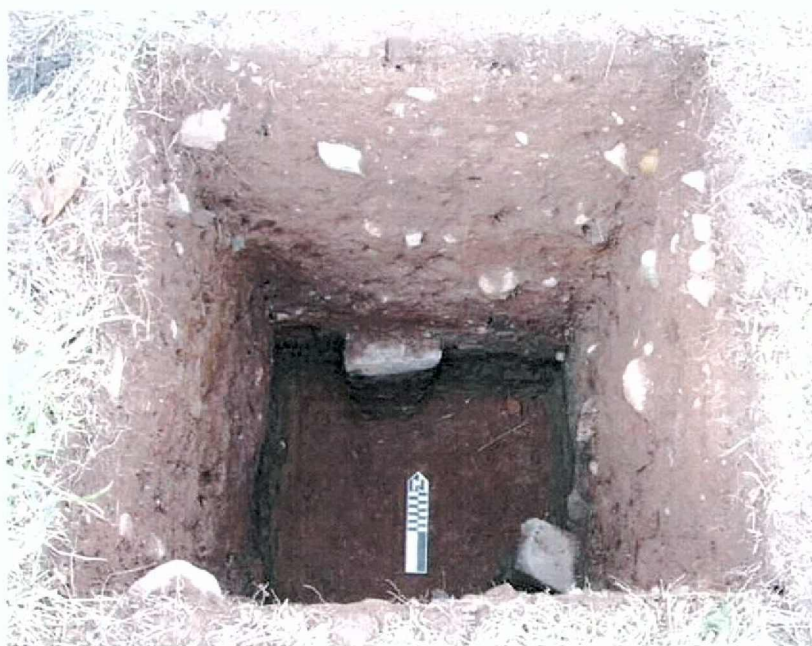
**Fig. 9. View of test pit 3 at the end of excavation.**

The northwest corner of this three by three foot test pit was located 26 ft. south of the north fence line and 80.5 ft. east of the west fence line (inner fence). It was excavated on November 30th and December 1st and 2nd (Figs. 9 and 10).

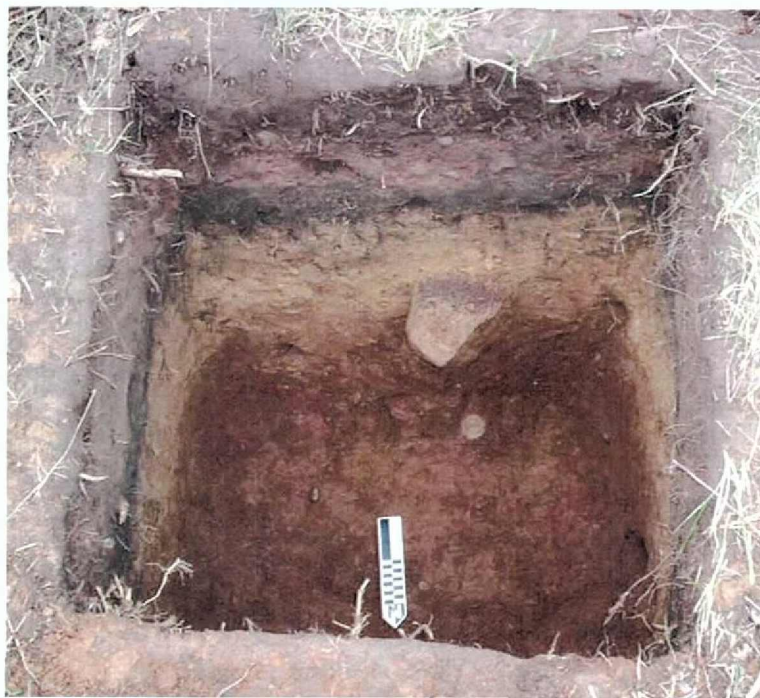
Fig. 12. View of test pit 4 at the end of excavation.

The northwest corner of this three by three foot test pit was located 140 ft. south of the north fence line and 61 ft. east of the west fence line (outer fence). It was excavated on November 30th and December 1st (Figs. 11 and 12).

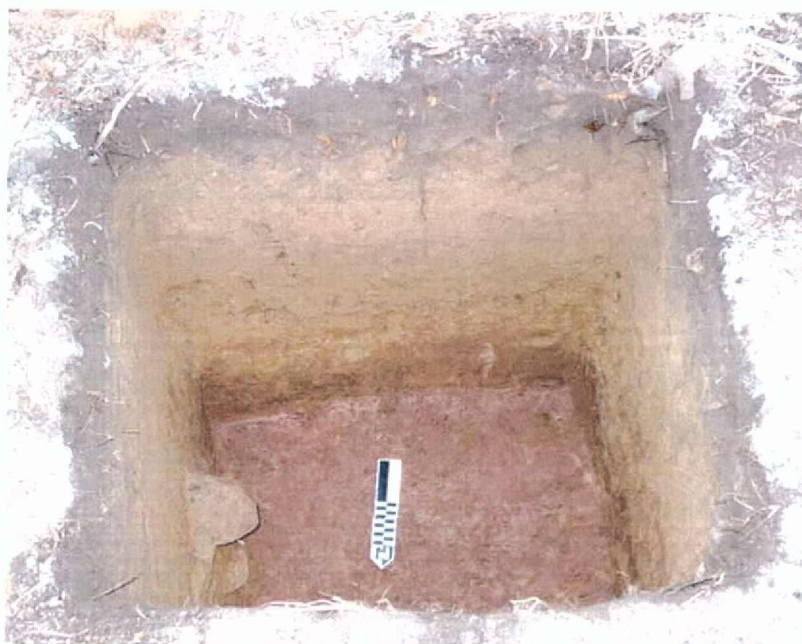
Fig. 13. View of test pit 5 at the end of excavation.

This test pit was excavated on December 2nd and 5th. It was located 175 ft. south of the north fence line and 132 ft. east of the west fence line (Figs. 13 and 14).

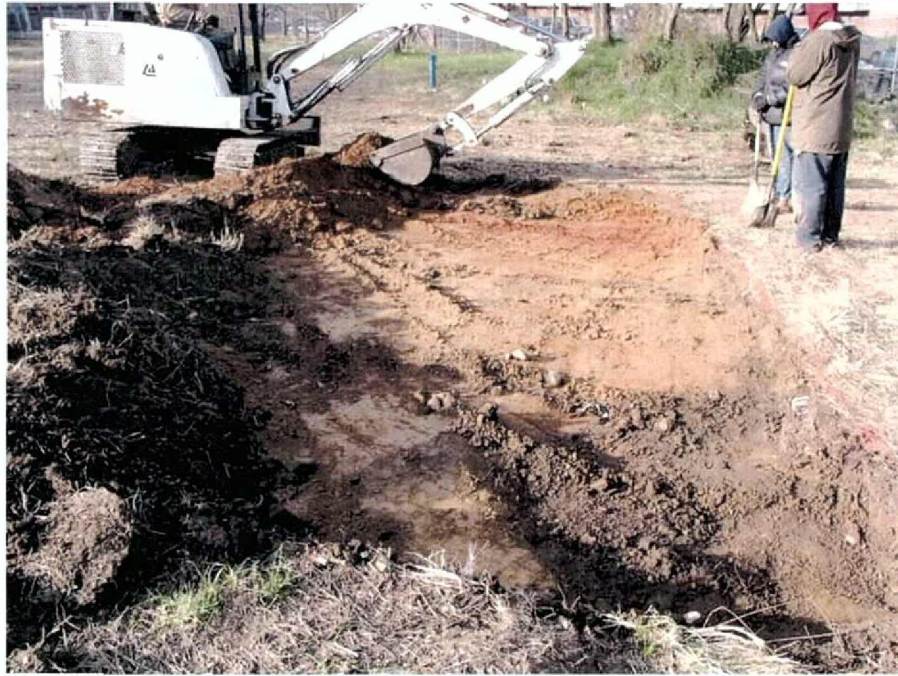
Fig. 17. View of backhoe trench A from its eastern end looking west during excavation and showing the location of the pit in the northeast corner of the trench.

The northwest corner of this 100-foot long trench was located 15 ft. south of the north fence line and 115 ft. west of the east fence line. The southwest corner of this trench was located 50.75 ft. south of the north fence line and 23 ft. west of the east fence line. This trench was excavated on December 6th and 7th (Figs. 17 and 18).

Beginning in the east, the yellow soil layer was encountered immediately below the topsoil, the humus layer being virtually absent. In the northeast corner of the trench we encountered a large pit filled with black, greasy soil that smelled like sewage and contained rags and other debris. Approximately 15 to 25 ft further northwest, the red sandy layer was intermixed with the yellow layer, and there were many chunks of broken

concrete, small fragments of brick, part of a white-painted, steam riser pipe (identified as such by Philip Heller, Project Manager of Karlsberger Architects P.C., who was visiting the site that morning). In the line of the entranceway from the gate, the ground surface dips down. There was a great of broken concrete here and mottled soil, without a clear yellow soil layer. It seems likely that this layer was dug out perhaps as part of an operation connected with the entrance. Immediately west of the gate area, the yellow soil layer reappeared but the roots of several trees standing on the north side of the trench churned up a thicker "A" layer intermixed with this yellow soil layer. No cultural debris at all was encountered in this area except for one brick fragment approximately 70 ft northwest of the northeast corner of the trench. Approximately 80 ft. northwest of the northeast corner of the trench we began again encountering large pieces of garbage including plastic bags, sections of thick rubber hose, and half a brick. This section was dug down approximately 1.6 ft. to clear the tree roots. Closing levels for the rest of the trench were approximately 0.6-0.8 ft. in the eastern half and ca. 0.8 from 50 to 80 ft. northwest of the northeast corner of the trench.

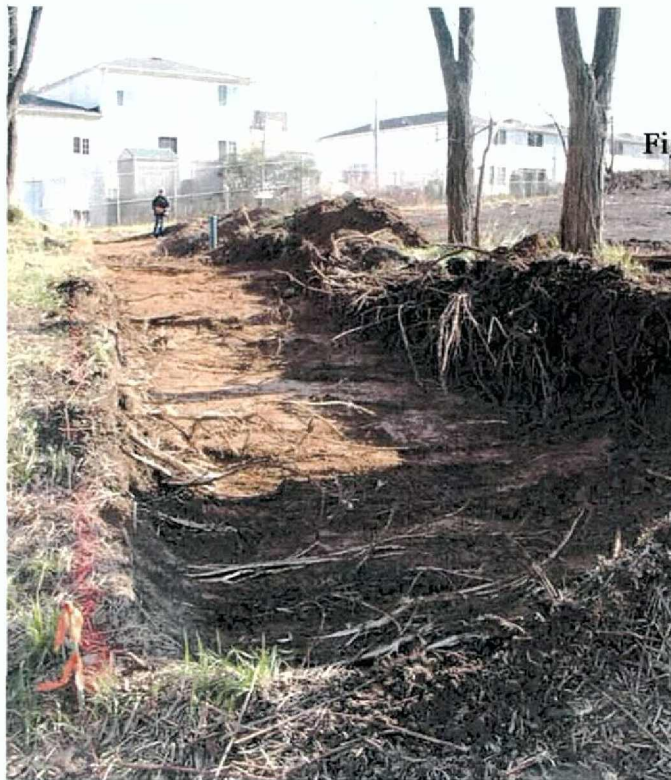
Fig. 18. View of backhoe trench A from its western end looking east at the end of excavation.

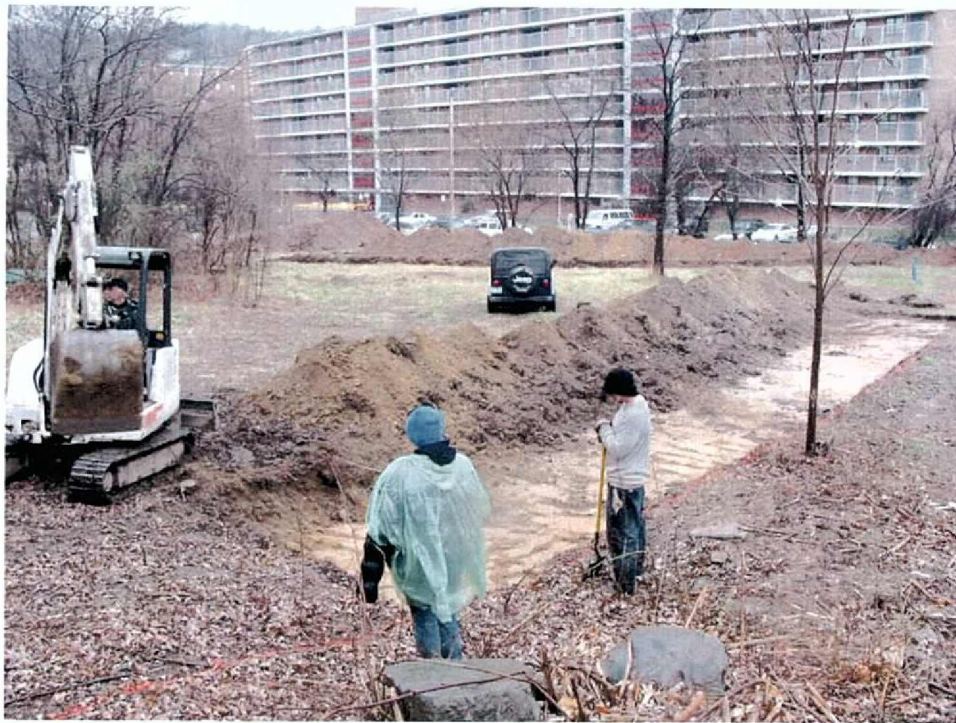
Fig. 19. View of backhoe trench C from the southeast looking northwest during excavation.

The northeast corner of this 100-foot long trench is 108 ft. west of the east fence line and 87.5 ft. south of the north fence line. The southeast corner is 178.5 ft. south of the north fence line and 89 ft. west of the east fence line. This was the fourth trench excavated, on December 13th (Figs. 19 and 20).

This trench was quickly excavated as, for most of its length, the clean, brownish-yellow layer began almost immediately below the topsoil and there were few artifacts or debris, except in what was clearly the topsoil. The trench was excavated from north to south and dug to a greater depth at its southern end, where the ground rose in between a hillock on the east and a large tree on the west. This section was disturbed by the tree roots and had a thicker humus ("A") layer and a very shallow, redeposited red soil layer above it that may have slid down from higher up the slope and was poor in cultural debris.

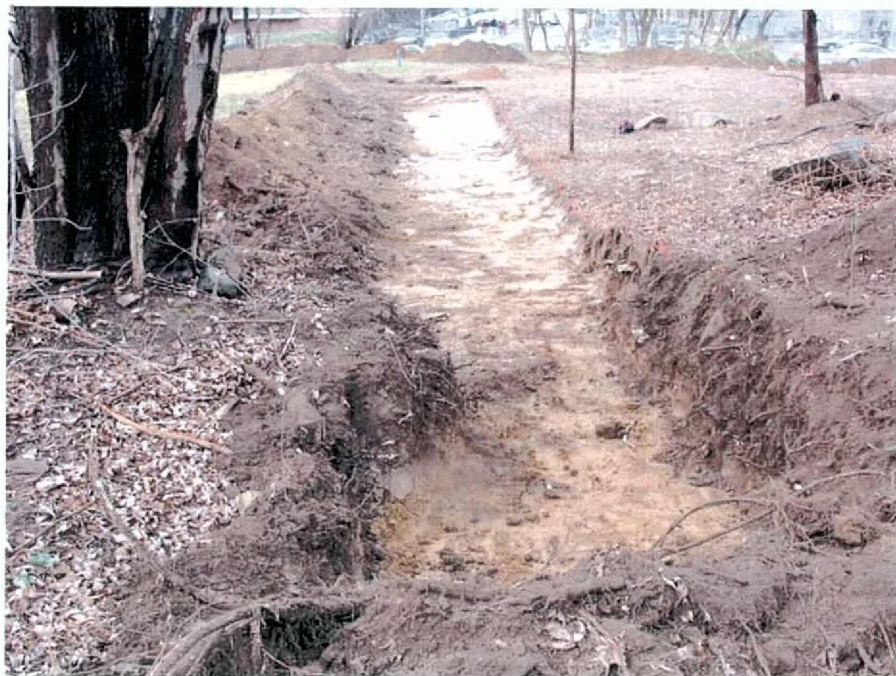
Fig. 20. View of backhoe trench C from its south end looking north at the end of excavation.

The closing depths of this trench below surface were, from north to south: north end - 0.6 ft.; 25 ft. - 0.75 ft.; 50 ft. - 0.8 ft.; 75 ft. - 1.95 ft.; south end - 3.1 ft.

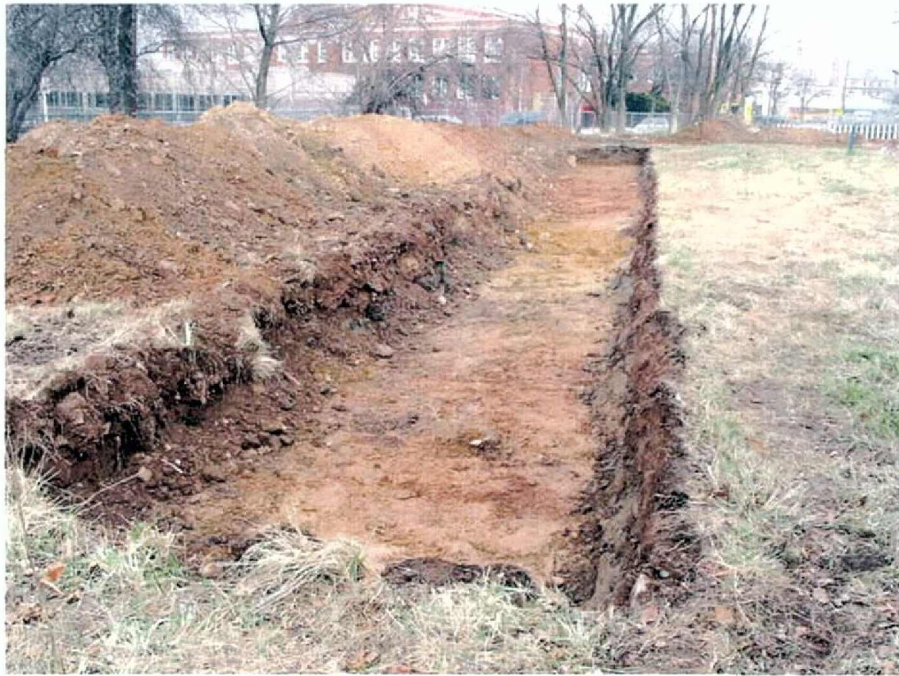
Fig. 21. View of backhoe trench D from its western end looking east at the end of excavation.

The southeast corner of this 95-foot long trench is 42 feet south of the north fence line and 135 feet west of the east fence line. The northwest corner is 77 ft. east of the west fence line (inner fence) and 75 feet south of the north fence line. This was the second trench excavated, on December 7th and 8th (figs. 21 and 22).

Beginning on the east side of the trench, we encountered two brick fragments and, just below the surface (two or three inches), a large area approximately three-feet square of a thin, flat layer of concrete. Nearby, the soil was mottled yellow with charcoal fragments. The concrete layer did not continue and we were not able to determine its purpose. There were also glass fragments in the topsoil. We dug a small probe at the east end of this trench to a depth of 3.3 ft. in order to verify the stratigraphy. Immediately below the topsoil we encountered the red soil layer of redeposited material (layer 2). This was followed by a mottled layer composed of dark greyish-yellow to brown silty soil (layer 3). Below this was a cleaner, brownish-yellow sandy silt layer (layer 4), and, at the bottom of the trench, the red silty sand layer (layer 5).

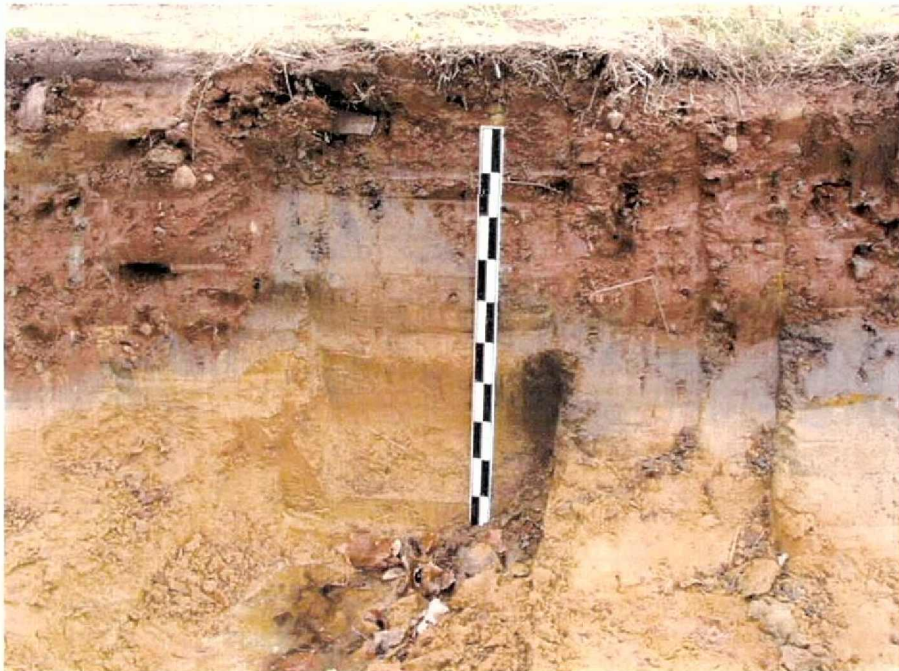
Fig. 22. View of the middle of the south baulk of backhoe trench D at the end of excavation.

piece of ceramic, and wood fragments in layer 2, among other cultural debris. Layer two got gradually thicker towards the western end of the trench. Further fragments of concrete, glass, another battery, wood planks and tile were encountered on December 8th, when we excavated the western half of the trench. We noted that the layers sloped down towards the west and that the greyish green layer 3 became thicker, blacker and denser. The yellow layer below this, layer 4, had dark patches on the top and we therefore excavated deeper here, to reach a clean level of natural deposit. It was determined that layer 3 was also probably a natural deposit, however, that had become infiltrated by organic material as a result of the fact that rainwater pools in this part of the site. At approximately 80 ft. west of the east end of the trench, the yellow layer, 4, became very thin and difficult to distinguish from the red layer immediately below it.

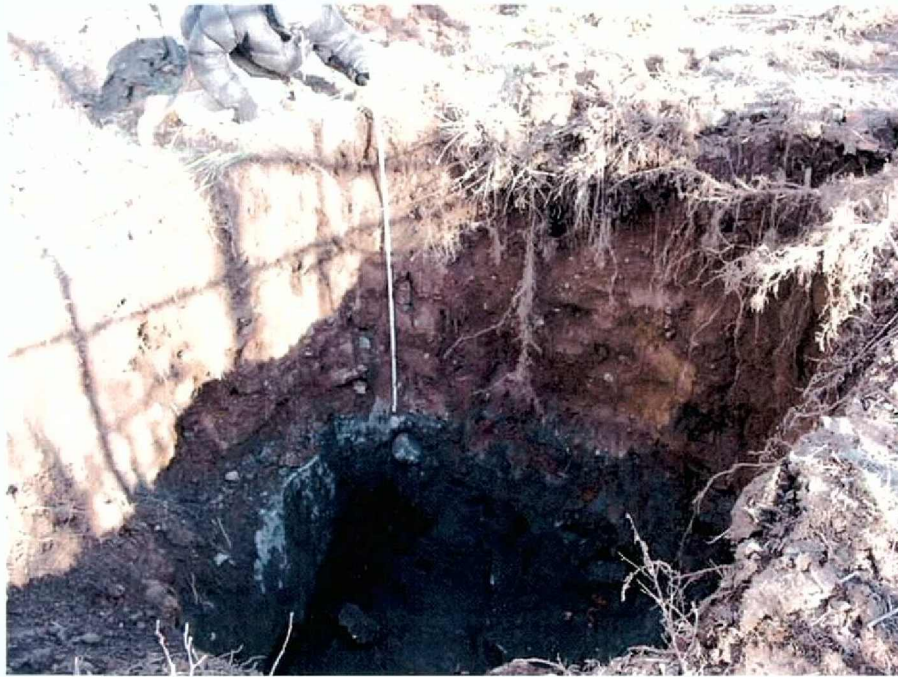
Fig. 23. View of the deep pit at the northern end of backhoe trench E.

This trench was begun at its northern end at the edge of the steep dip towards the street. The red, redeposited soil layer beginning immediately below the topsoil, was found to be very thick here and filled with building debris. But more surprisingly, it was followed by a layer of black soil filled with wooden planks up to 2.5 ft. long and both red and yellow bricks. There was also plastic and a bicycle inner tube, so clearly, modern fill

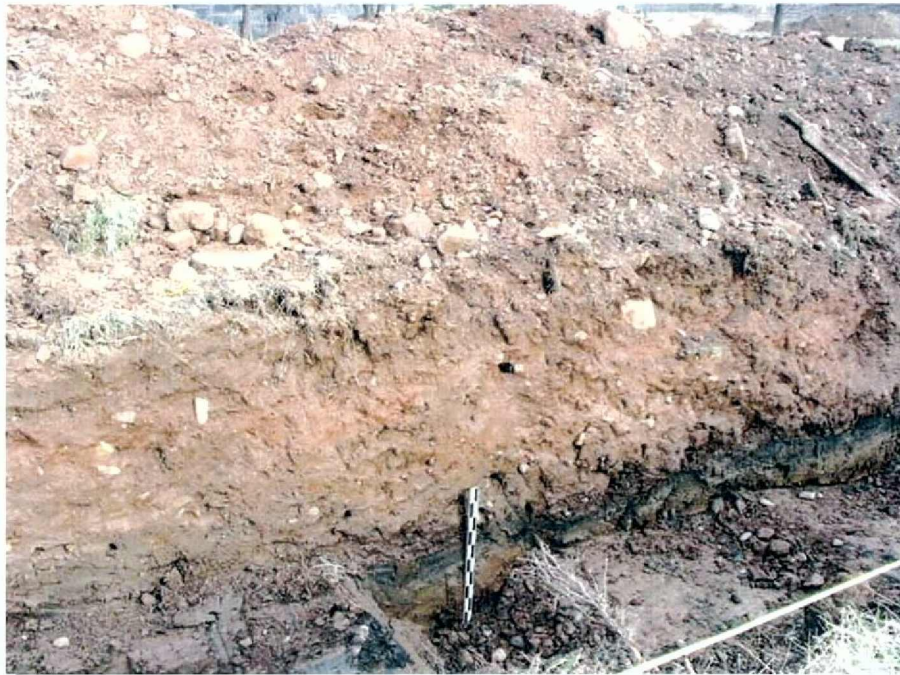
Fig. 25. View of the middle of the east baulk of backhoe trench E at the end of excavation.

The northeast corner of this trench is 15 ft. south of the north fence line and 12 ft. east of the west fence line (inner); the trench is 87 ft. in length. The south east corner of the trench is 66.5 ft. south of the north fence line. This very deep trench was third excavated, on December 8th, 12th and 13th (Figs. 24, 25, 26, 27, and 28).

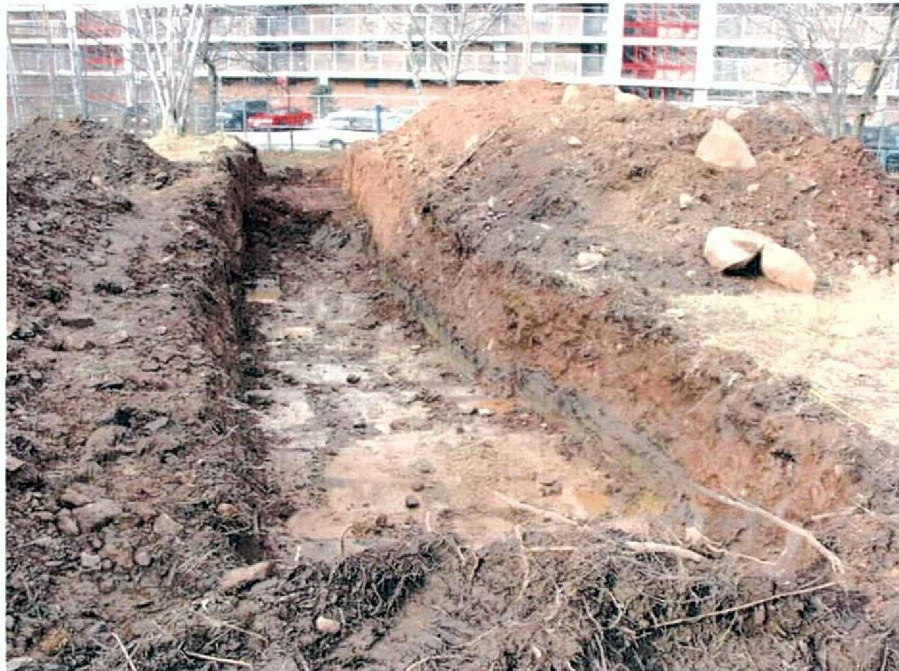
Fig. 26. View of backhoe trench E from its southern end looking north at the end of excavation.

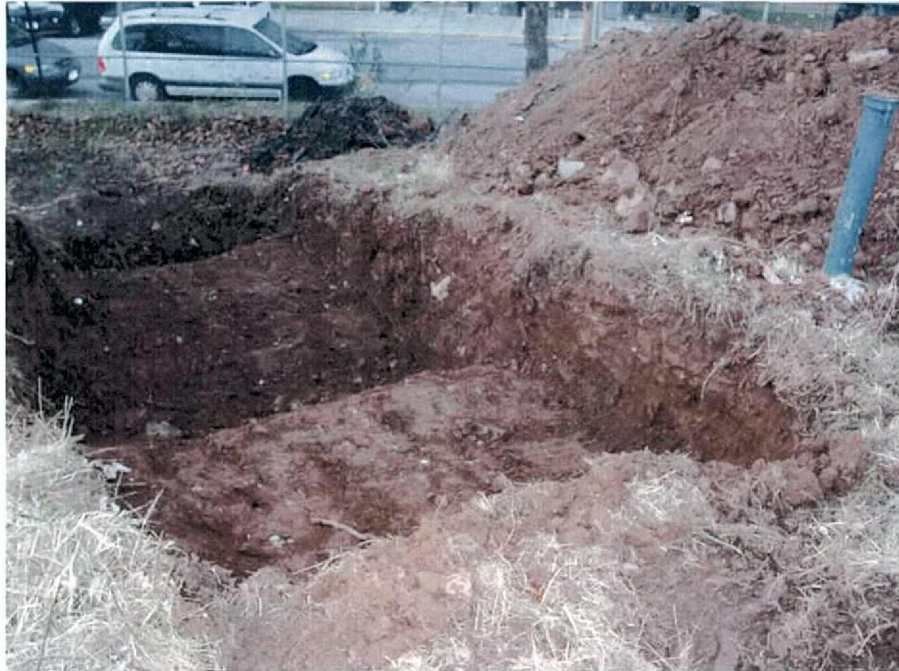
Fig. 27. View of the northern end of backhoe trench E looking north towards Hill Street.

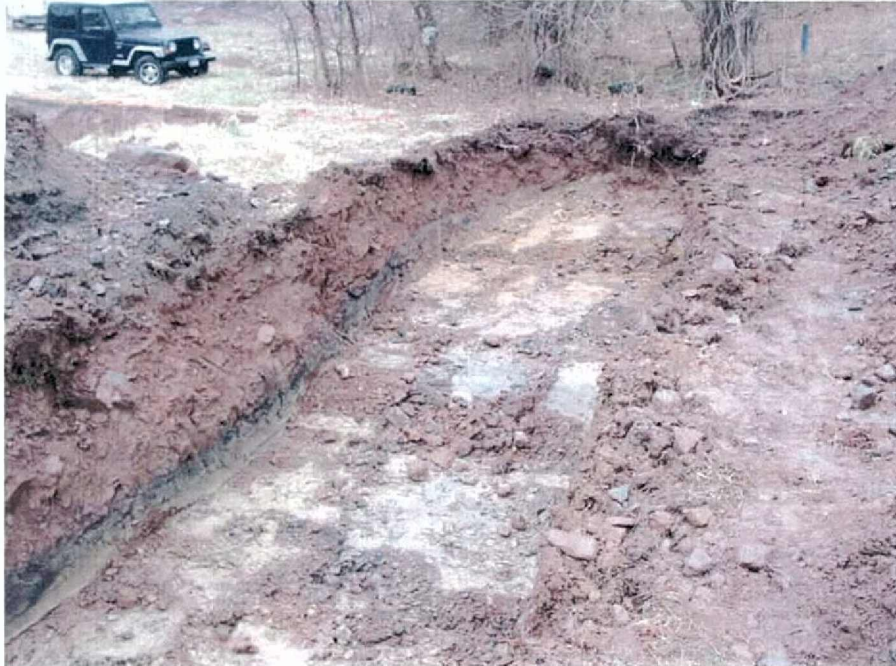
Fig. 28. View of the southern end of backhoe trench E looking south.

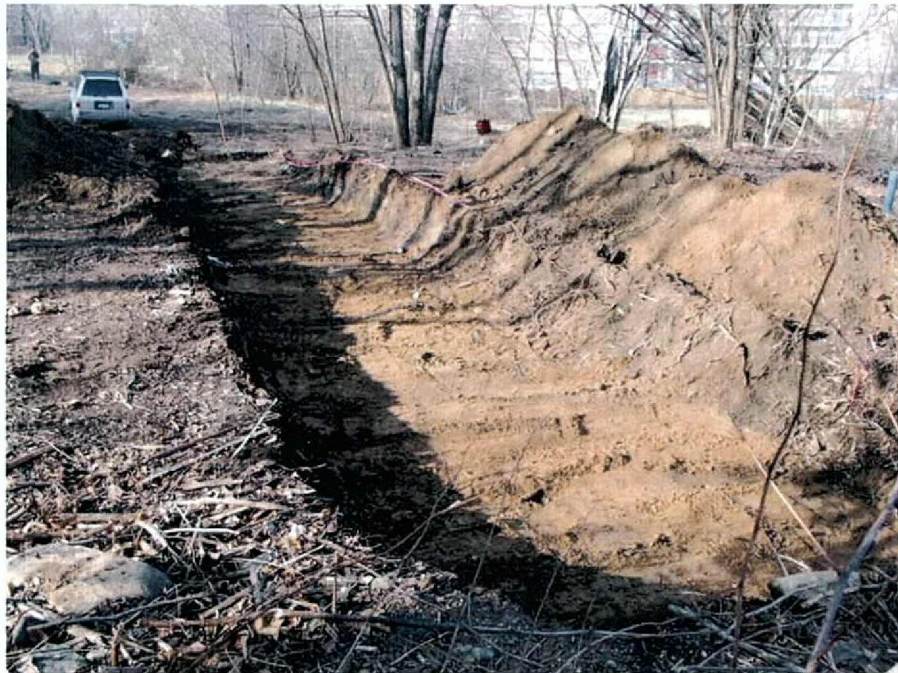
Fig. 29. View of backhoe trench F from its eastern end looking west at the end of excavation.

This trench is 71 feet long. Its northeast corner is 113 ft. northwest of the east fence line from a point 33 ft. north of the south fence line and 122 feet west of a point 87.5 feet north of the south fence line. This trench was the fifth excavated, on December 14th and 15th (Figs. 29 and 30).

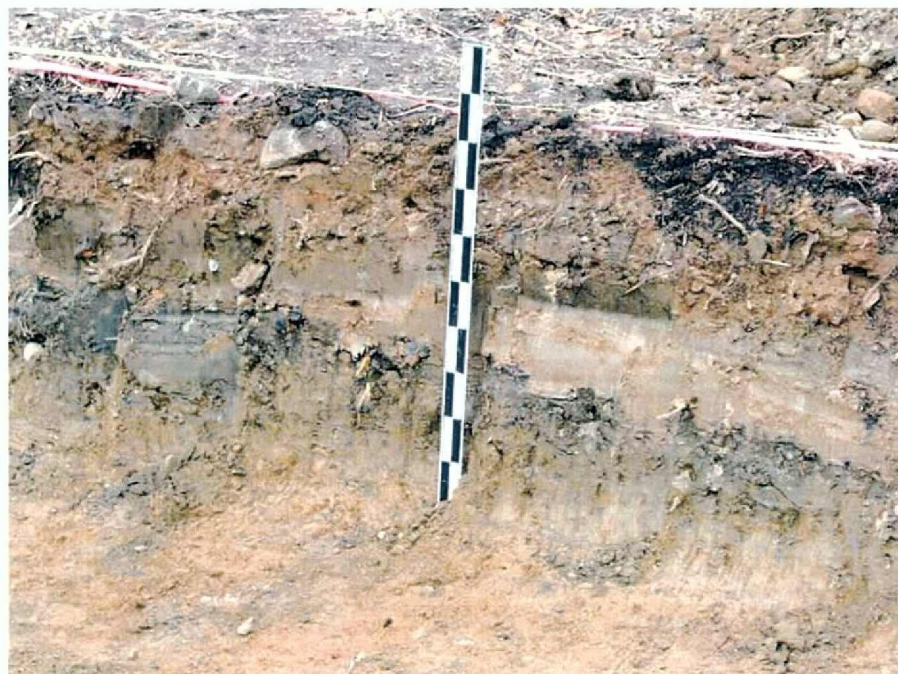
Fig. 30. View of the middle of the north baulk of backhoe trench F at the end of excavation.

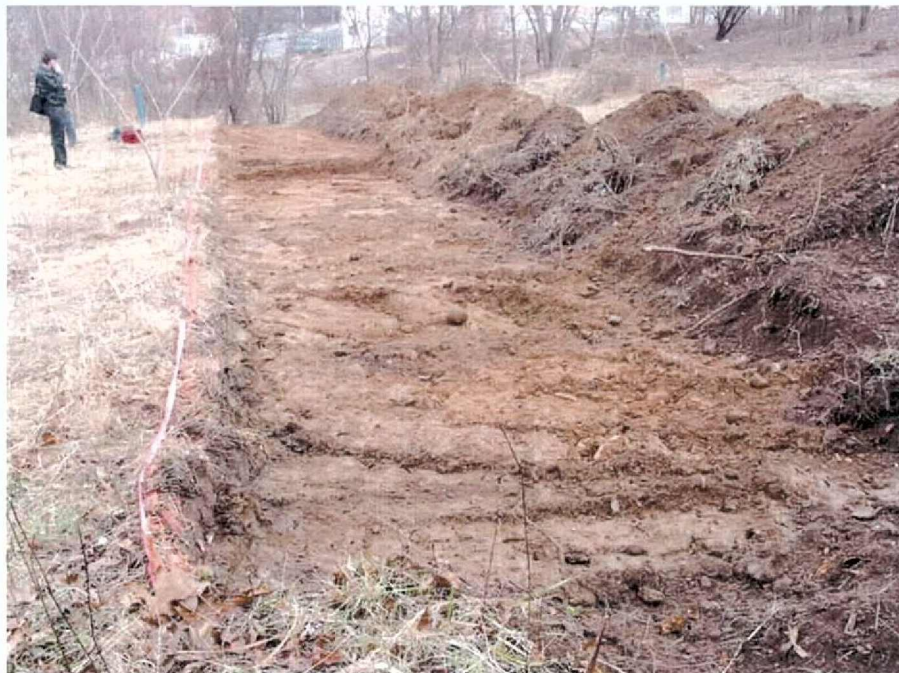
Fig. 31. View of backhoe trench G from the western end of the trench looking east at the end of excavation.

This trench is 100 ft. long. Its northwest corner is 105 feet east of the west fence line (outer) and 175 ft. south of the north fence line. The southwest corner is 143 ft. southwest of the northwest corner and 47 ft. northeast from a point on the west fence line (outer) 273 ft. south of the north fence line. This was the last trench excavated, on December 15th (Figs. 31 and 32).

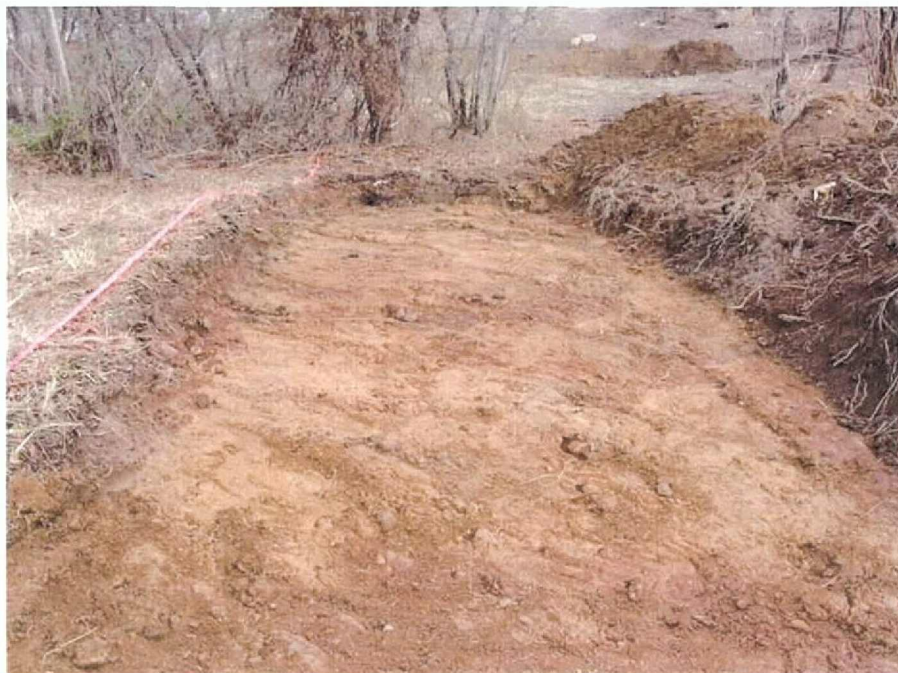
Fig. 32. View of the eastern end of backhoe trench G looking east at the end of excavation.
