REPORT ON
ARCHAEOLOGICAL TESTING AND
MONITORING OF SEVEN LOCATIONS OF
PLANNED ELECTRICAL POLES
FOR A WATERFALL ART INSTALLATION
ON GOVERNORS ISLAND
NEW YORK, NEW YORK

Prepared for: NYC Waterfalls LLC 1 East 53rd Street New York, New York 10022

Submitted by: Linda Stone, MA, RPA 249 East 48th Street, #12B New York, New York 10017

July 3, 2007

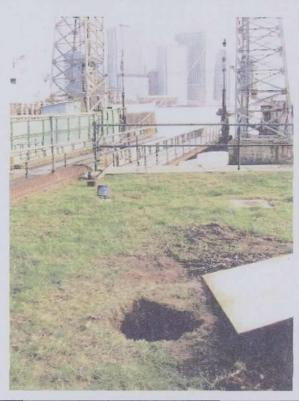
Location of completed hole for Electrical Pole 3 facing north in relationship to the ferry dock with the tip of Manhattan in the background.

EP 3 was the ten-foot deep hole located in the grassy area east of the ferry landing, behind Building 140. This area is at an elevation of about 1.8 feet (55 cm) above the ferry landing. There is a retaining wall along the edge of the landing. The hole location is about twenty feet (6 m) south of the seawall. Two attempts were made for EP 3 excavation. The first resulted in exposing a buried PVC pipe at 3 feet (91 cm) bgs. The hole was relocated to the south to avoid the pipe. The sod was underlain with loam to 1.3 feet (40 cm) bgs. This deposit contained ceramic and glass sherds, as well as bone, shell, coal, brick fragments and corroded nails. The loam was underlain with yellowish brown gravelly coarse sand. Several arbitrary levels were established for artifact provenience; Strata 3 -6. These strata contained more artifacts than the same soil in other EP locations. Diagnostic artifacts recovered from the yellowish brown sand include ceramic and glass sherds and smoking pipe stems. The tpq of the deposit is the late-nineteenth century, based on a bottle base recovered from Stratum 4 (see Photo 4). The initial location of the hole was later called EP 3B and the new and final location EP 3. This distinction was kept for maintaining artifact provenience and applies only to Stratum 3, the level directly above the PVC pipe, although the complete stratigraphy for both locations in detailed in Appendix B.

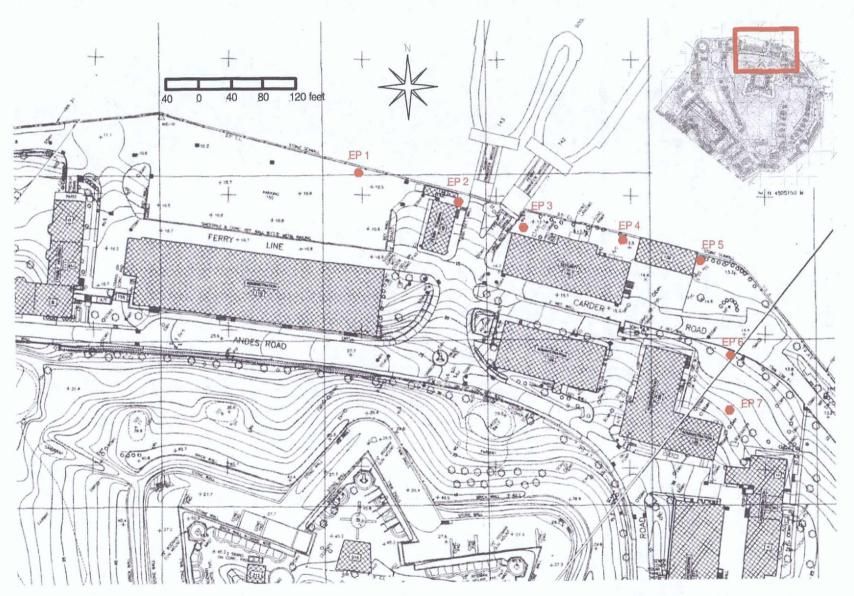
Figure 1 Location of the seven archaeological tests for the planned waterfall electric poles shown on a section of the Governors Island topographic survey.

The following is a discussion of the excavation at each pole location, including the artifacts found and the stratigraphy within each hole. It is followed by an analysis of the stratigraphy throughout all seven locations and an interpretation of the findings. Appendix B contains the stratigraphic records for each hole location. Appendix C is the artifact inventory. Figure 2 depicts the actual hole locations on the topographic survey (c. 1960) and Figure 3 shows the locations on the aerial photograph.

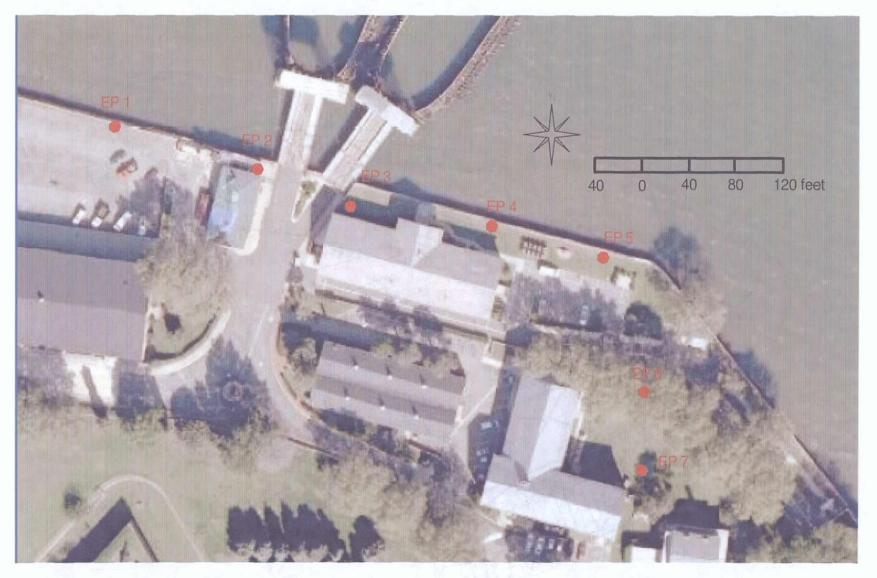
Figure 2 Location of the seven archaeological tests for the planned waterfall electric poles shown on the Governors Island aerial photograph.

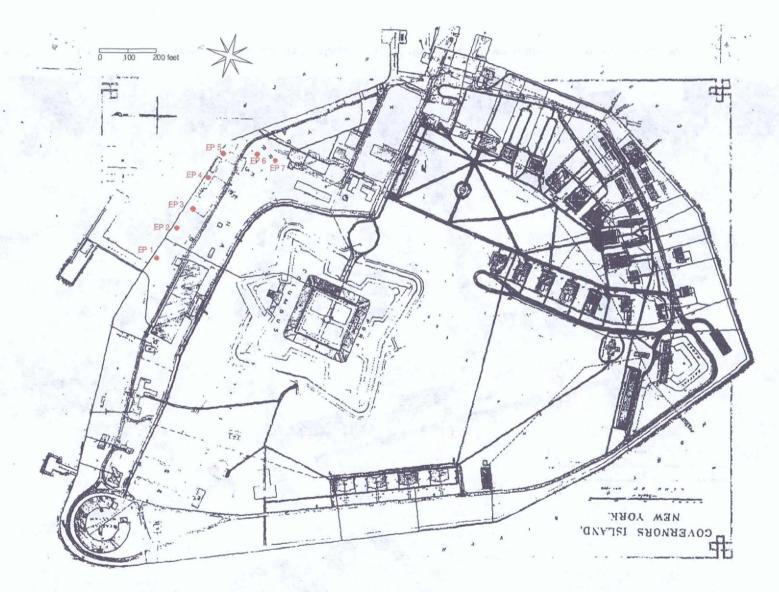
Figure 3 Kinsey's 1903 Blueprint of Governors Island with the location of the seven archaeological tests for the planned waterfall electric poles.

The southern part of the Island was created between 1901 and 1912 with the addition of fill from the construction of the subway system in New York City. Although the records of that work have not been reviewed during the preparation of this report, it seems quite plausible that as a scawall was created to hold fill on the south side of the Island during that time, the seawall on the north side of the island may have been upgraded to be incorporated into and blend with the then new seawall. This theory dovetails with the findings of artifacts in the electrical pole location's fill dating from the time period of expansion of Governors Island. The theory is enforced by the examination of the 1903 Kinsey Blueprint of Governors Island (see Figure 4). This map clearly depicts the change in the seawall in the area to the west of the ferry dock, in the vicinity of where EP 1 and EP 2 were placed.

Stratigraphy was documented providing a certain amount of knowledge about the historic shoreline. The results of this work indicate the majority of the fill was deposited around the turn of the twentieth century. It was hypothesized the fill could have been related to an upgrade in the seawall in the area of the planned electrical poles around the same time as the southern part of the Island was created by landfill from the New York City subway beginning in 1901. A 1903 map shows the area had been filled by then.

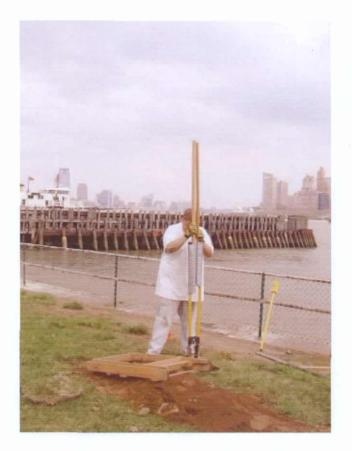
Photo 1 EP 5 in progress, facing northwest.

The sod and loam extended to a depth of 0.4 feet (12 cm) bgs in EP 5. The brown silty sand stratum extended to the base of excavation in this location; six feet. It was excavated in four arbitrary levels for tighter provenience control. A dense concentration of late-nineteenth/early-twentieth century red brick fragments was documented within Stratum 2 at 1.1 - 1.4 feet (34 - 43 cm) bgs. These included pieces of Reilly & Rose and DeNoyelles Company marked bricks. These companies were in the business of making these types of bricks from the late-nineteenth century through the early- to mid-twentieth century. Stratum 2 also contained milk glass which was first manufactured in the late-nineteenth century (see Photo 3).

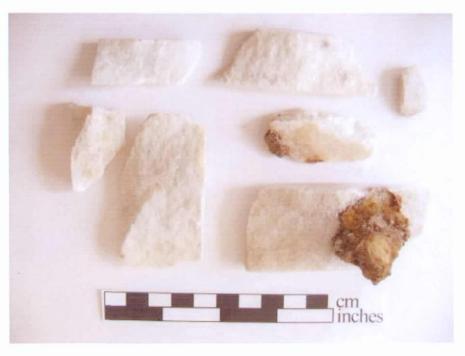
Photo 2 Quartz recovered from EP 1.6 (6 pieces on left) and EP 2.4 (1 piece on upper right).

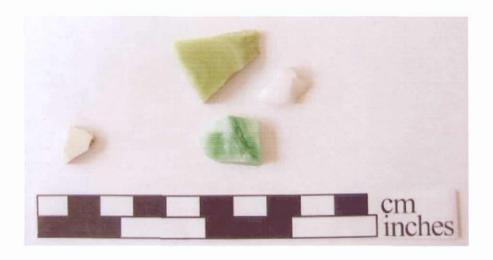
Photo 3 Whiteware sherd recovered from EP 1.6 on left and three pieces of milk glass recovered from EP 5.2 on the right.

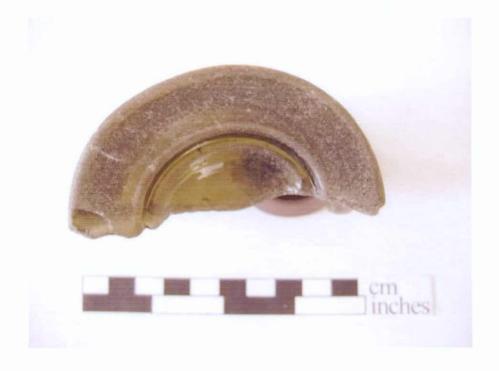
Photo 4 Bottle base recovered from EP 3.4.

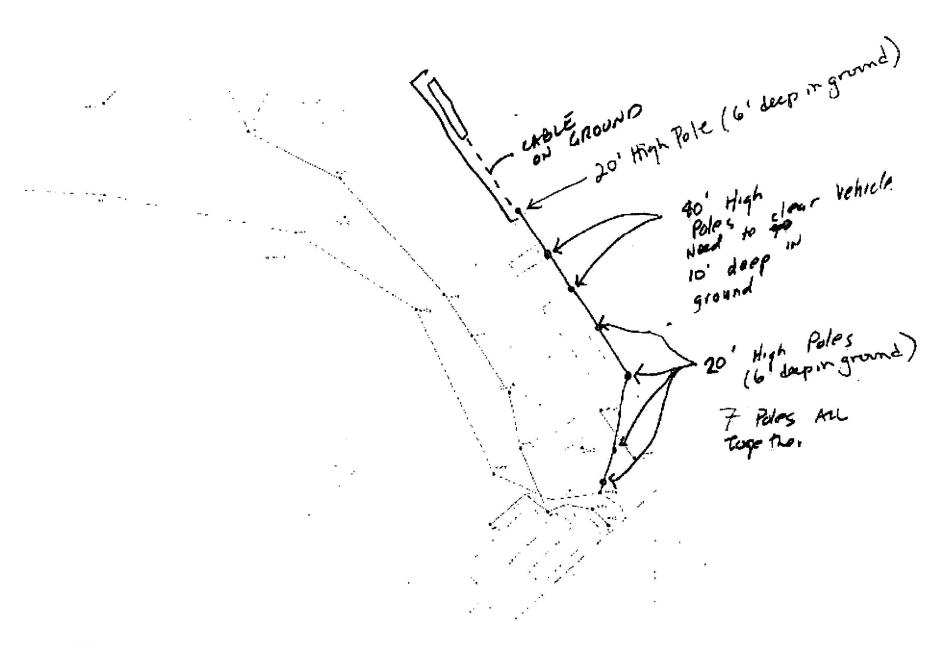
Figure 2 Copy of the Waterfall project plan for Governors Island showing the locations of seven utility poles.

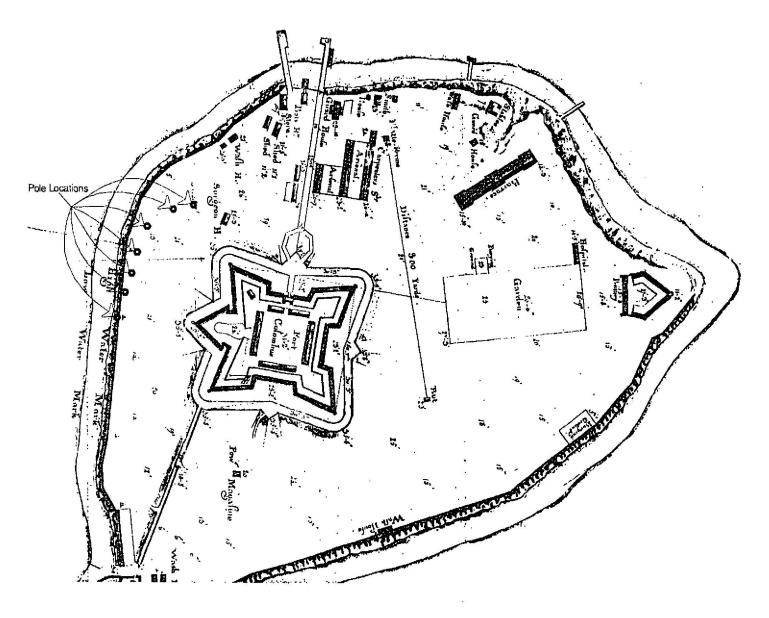
Figure 3 The 1813 Mangin Map of Governors Island showing the locations of the seven utility poles.

The initial research demonstrates there were no structures located within the footprint of the planned holes as of 1813. However, by 1879 several buildings had been built in and around some of the pole locations. In addition to Building 140, there was a stable at the point where the line of the poles turns southeastward. It is labelled on Figure 4 of Appendix A as Building 41. That figure also depicts two unnumbered buildings to the north of Building 41, perhaps in the footprint of the planned holes.

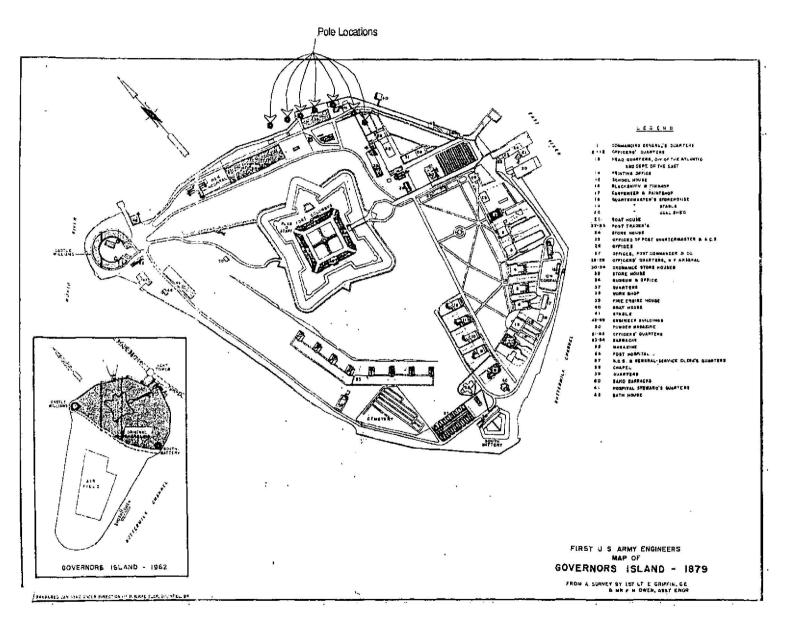
Figure 4 The Army Lingineers 1879 Map of Governors Island showing the locations of the seven utility poles.

As part of the background research on the planned waterfall location, two of the historic maps of Governors Island were overlaid with the pole plan to determine what may have once existed there (see Figures 3 and 4 in Appendix A). The 1813 map shows the five holes along the shoreline formerly at or above the high water line. However the 1879 map depicts the two western pole locations within the water (after the seawall was built). The only logical explanation for this is that the earlier seawall was built to the south of the original shoreline and has been expanded to the north since 1879. This explanation can be reinforced by examining the current shoreline on the north side of the island (see Figure 2) and comparing it to the 1879 shoreline. The more recent map shows the shore as a straight line from the near the western end of Building 110 (formerly Building 34) eastward to east of where EP 5 is depicted on Figure 2. This is contrasted with the more jagged seawall depicted on Figure 4 of Appendix A.

EP 1 and EP 2 are located in fill that was added since the locations were mapped in the water on the 1879 Map of Governors Island (Figure 4 – Appendix A). The brown silty sand that extended to about six feet (1.8 m) bgs in these locations contained a variety of diagnostic artifacts. The presence of a whiteware ceramic sherd in EP 1.6 puts the date of deposition of the fill no earlier than the early-19th century. Although EP 1 and EP 2 were in locations formerly under water and therefore certainly now covered with fill, EPs 3 – 5 were directly on the shore where landfill would have also been deposited. Those tests contained diagnostic artifacts in the same soil types dating from the late-19th century. EP 3.4 contained a bottle base dating from no earlier than the late-19th century and EP 5.2 contained two milk glass sherds dating not earlier than 1890. The combined information on the possible date of deposition of this ubiquitous soil type would place it toward the end of the nineteenth century or early-twentieth century.
