1 25593_m 109-6970 PUID 25593 211109 1 209 109 Waverly Place

Backyard Cistern Greenwich Village, New York

Memo Report

ARCHAEOLOGICAL MEMO REPORT

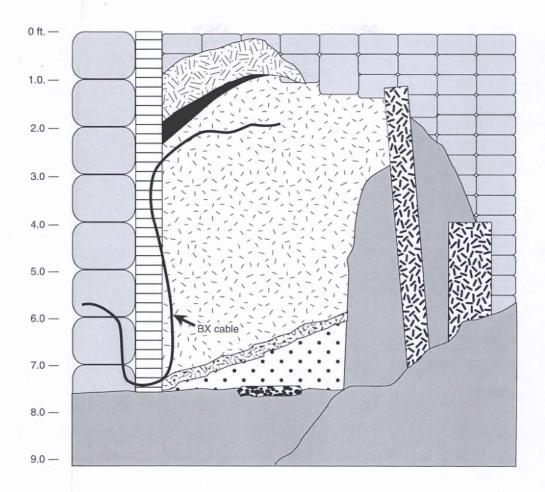
9 Exposed cistern deposit, a rubble-filled sand separated from a cleaner sand by a diagonal band of pink sand (arrow) that indicates two fill episodes, both devoid of significant cultural material. (Geismar 12/8/08; also see profile, Figure 10)
