**Summary Report of Archaeological Monitoring**

**City of New York Department of Parks and Recreation  
Sylvan Grove Cemetery (Independence Park)  
Victory Boulevard and Glen Street  
Block 2767, Lots 9 and 22  
Staten Island, Richmond County, New York**

May 2011

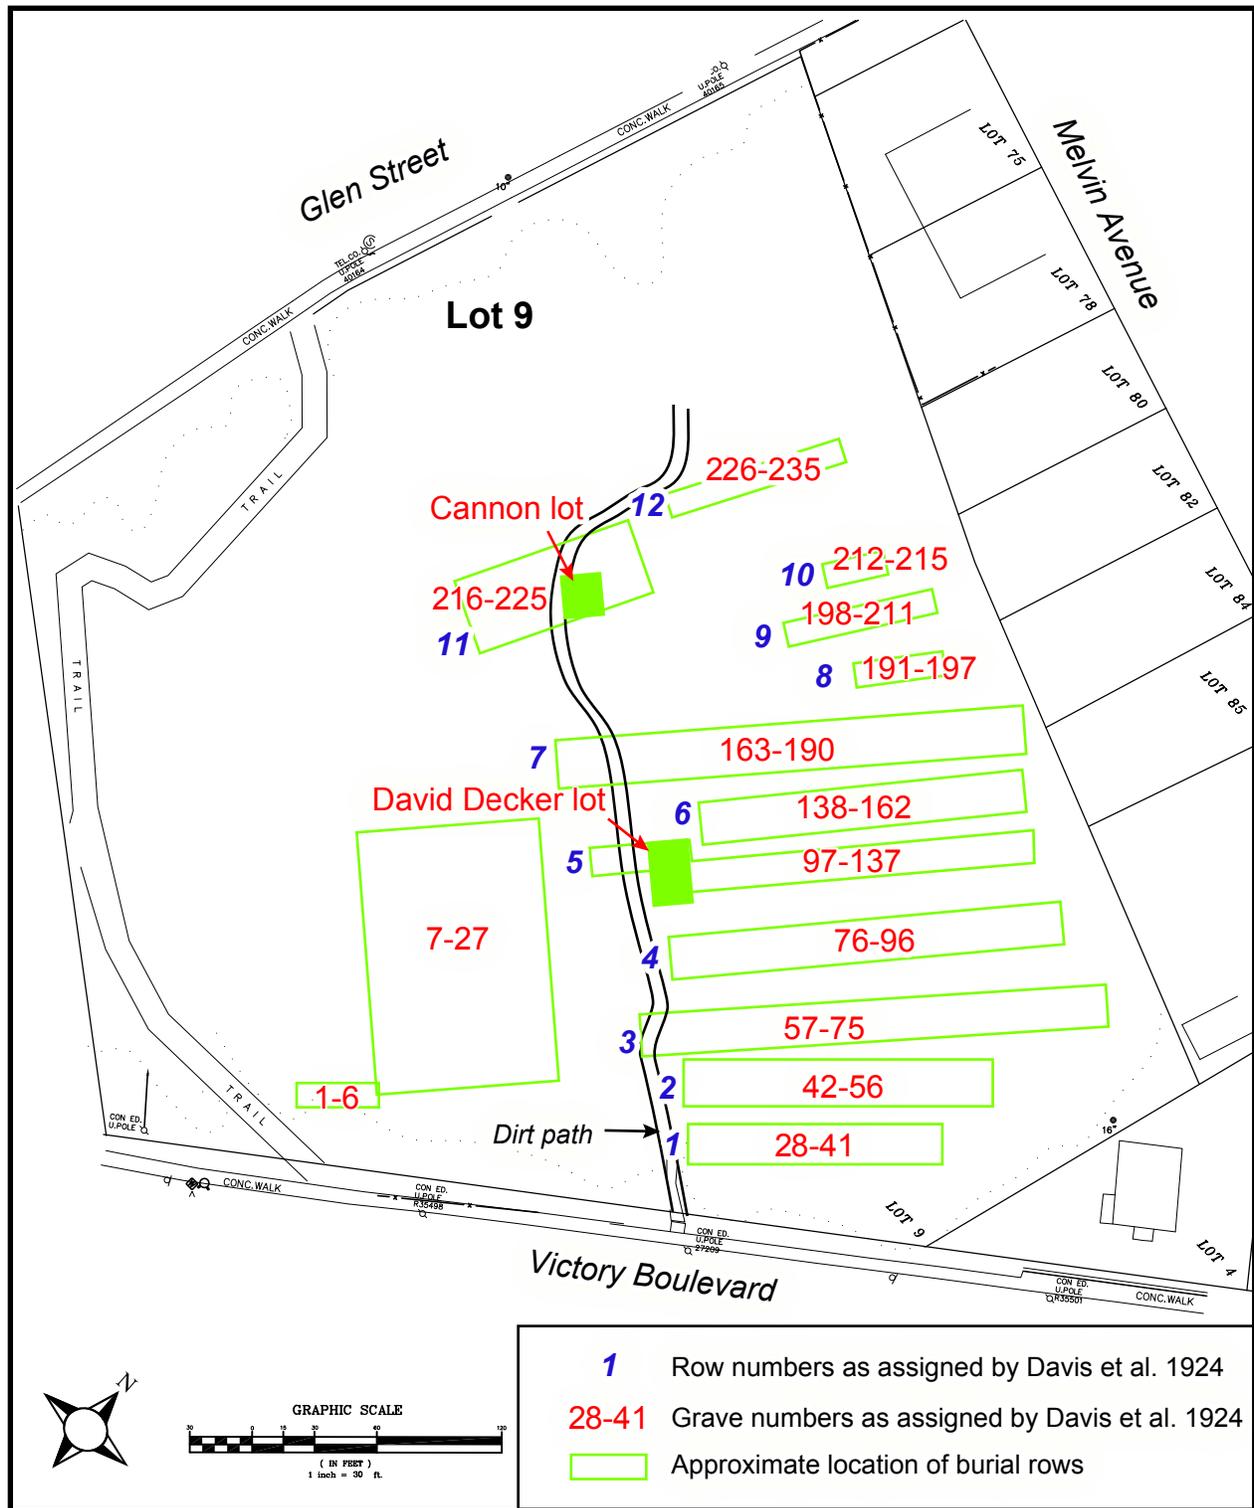
**FIGURE 8: Schematic of Burials at Sylvan Grove Cemetery.**

Some gravestones had been completely removed from their original placement in the ground (Photograph 36). In these cases, the document entitled *Staten Island Gravestone Inscriptions From The Sylvan Grove, Merrell and Hillside Cemeteries in the former town of Northfield...* (Davis, Leng, and Vosburgh 1924) proved enormously helpful in finding the correct location for the gravestones. While the map of the cemetery that was apparently originally attached to the document is no longer available, the descriptions of the monuments were arranged by rows. Although some of the original 12 rows were difficult to discern because of missing and damaged monuments, as well as heavy overgrowth, the verbatim epitaph transcriptions meant that even a small fragment could be identified, and matched to a specific plot or at least a general location. As a result, broken portions of stones that were far from their original location were able to be reunited with the rest of the monument. A number of footstones had also been pulled out of their original locations, and probably because of their smaller size, were often found far from the matching headstone. Luckily many of the footstones had engraved initials, and were able to be returned to their correct location. During the course of monitoring, the 1924 gravestone list was annotated to note the existence and condition of the remaining monuments (Appendix C). A map identifying the location of the rows was also created (Figure 8).

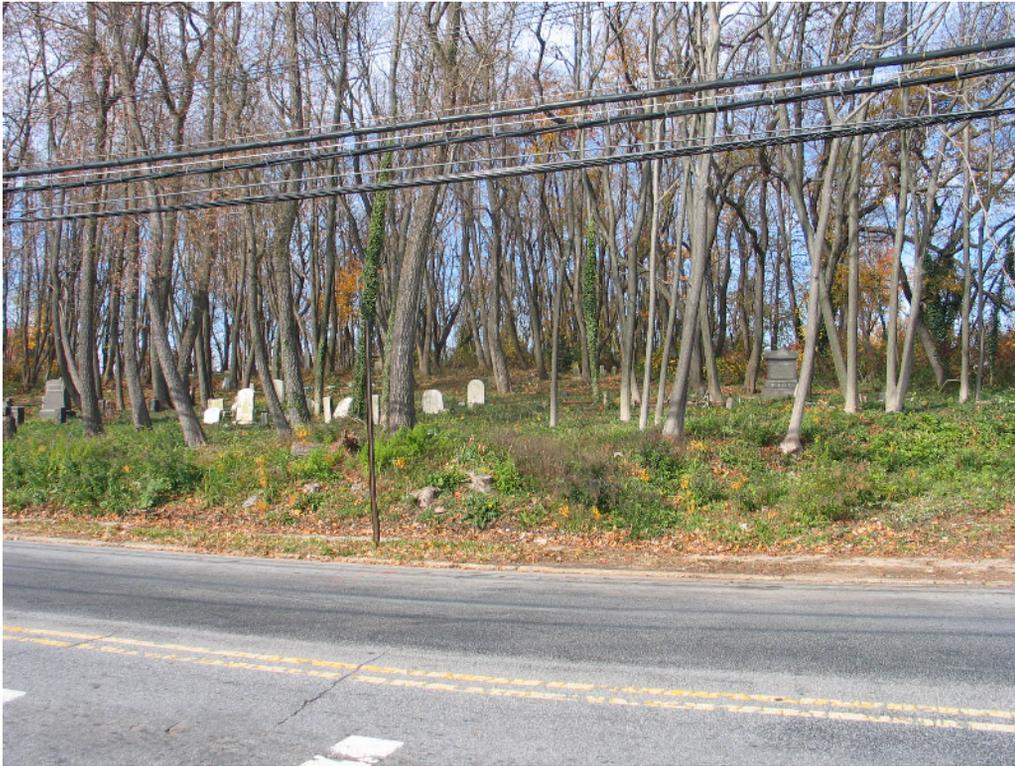
Photograph 1: Lot 9, the main cemetery property, showing gravestones on the slope of the hill. View looking northwest from Victory Boulevard.

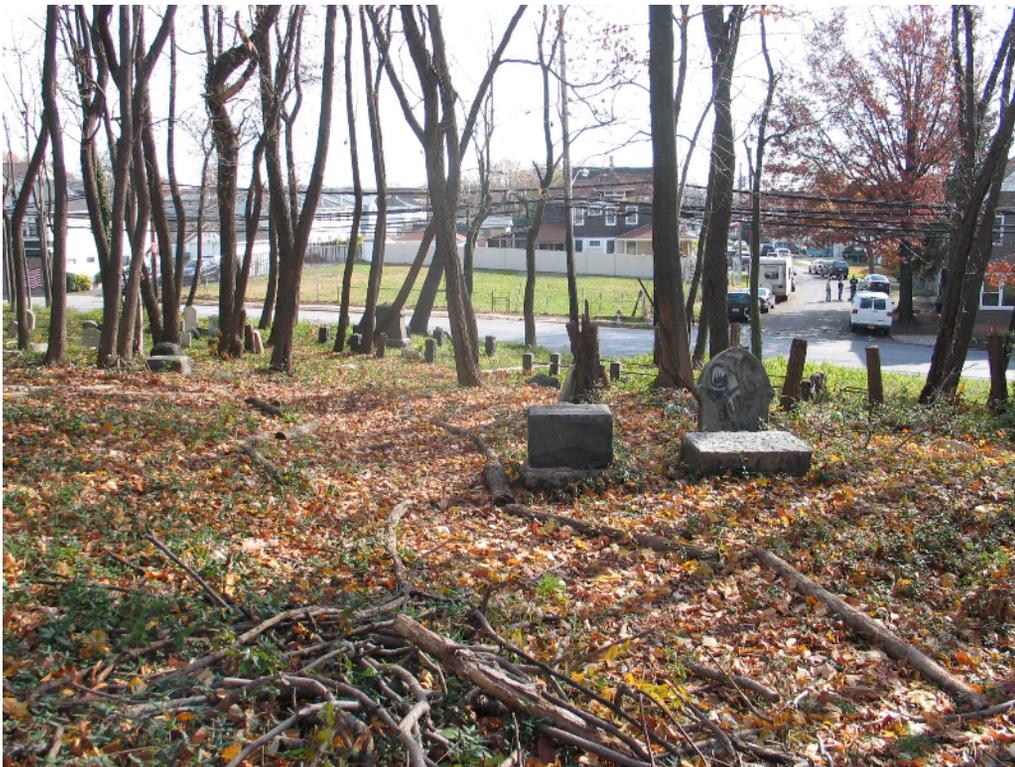
Photograph 2: Lot 9, the main cemetery property, at the top of the hill, with Victory Boulevard in the background. View looking southeast from interior of property.

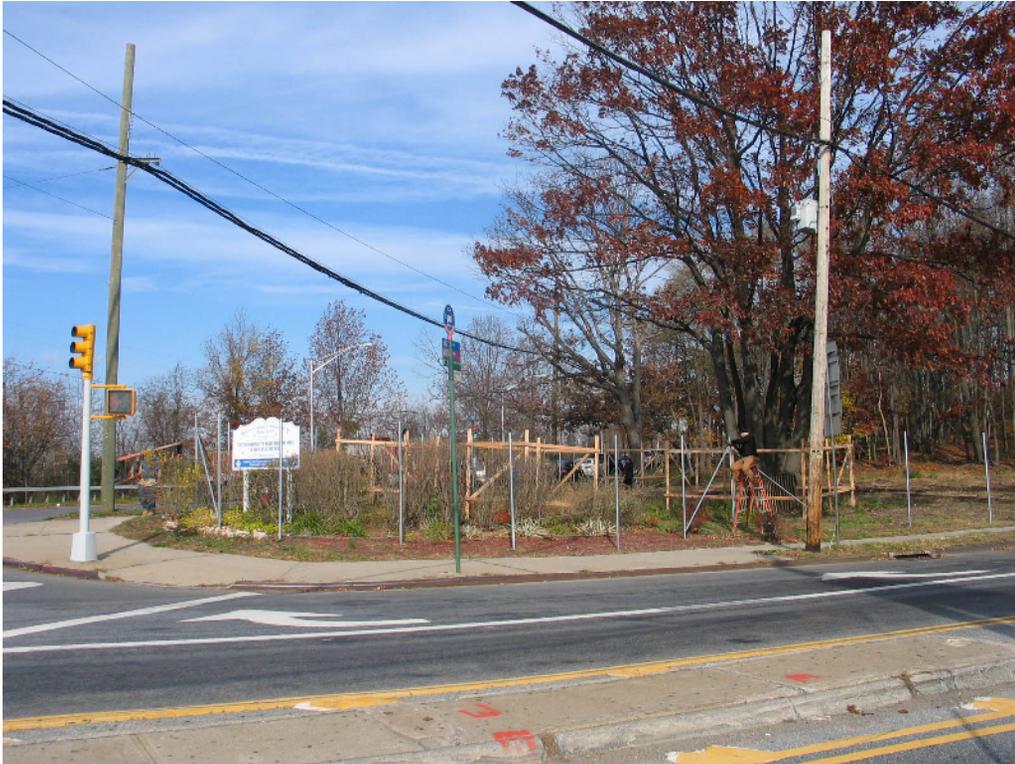
Photograph 3: Lot 22 showing the small landscaped area at the extreme tip of the lot, Independence Park, and a sign indicating the use of the property as a cemetery. View looking north from Victory Boulevard.

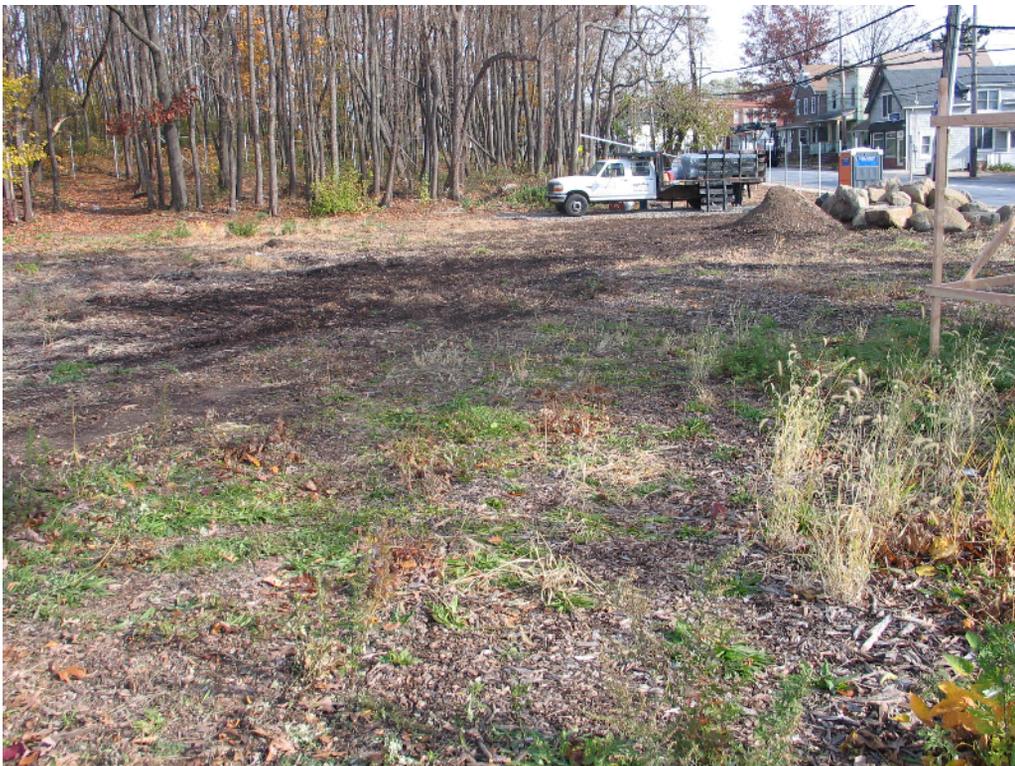
Photograph 4: Lot 22 prior to renovations, being used as a DPR construction staging area. View looking east from Glen Street.

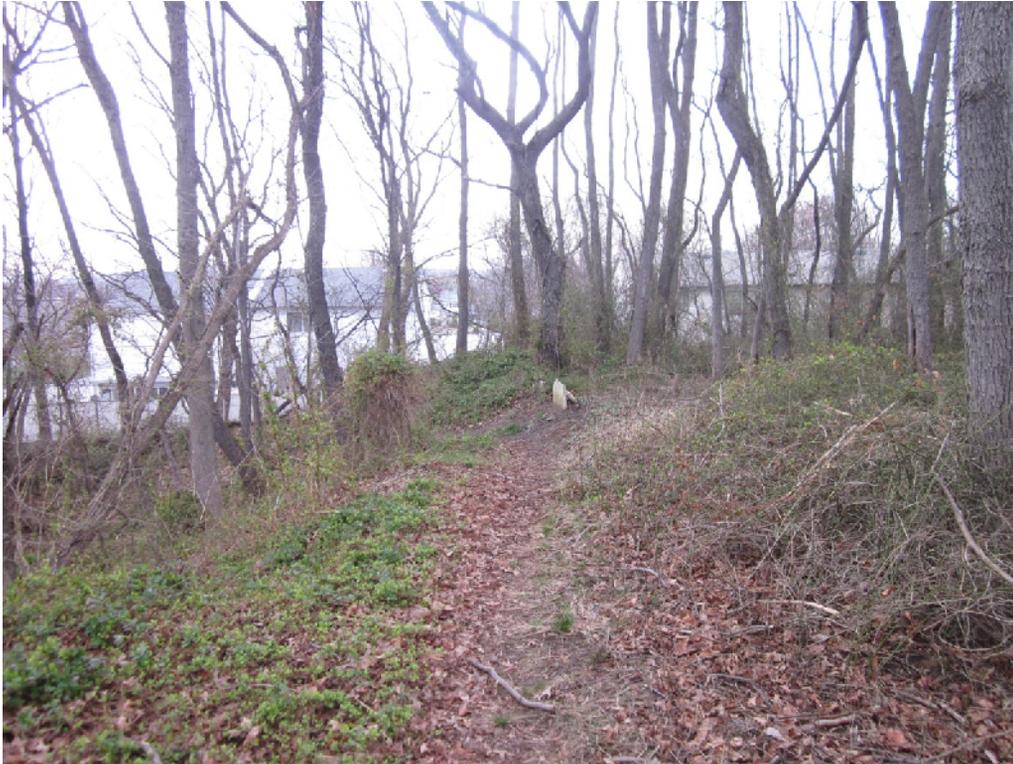
Photograph 7: Highest point of Lot 9, with quarried ridge at left, and westernmost extant gravestones in center of photo. Looking north-northwest.

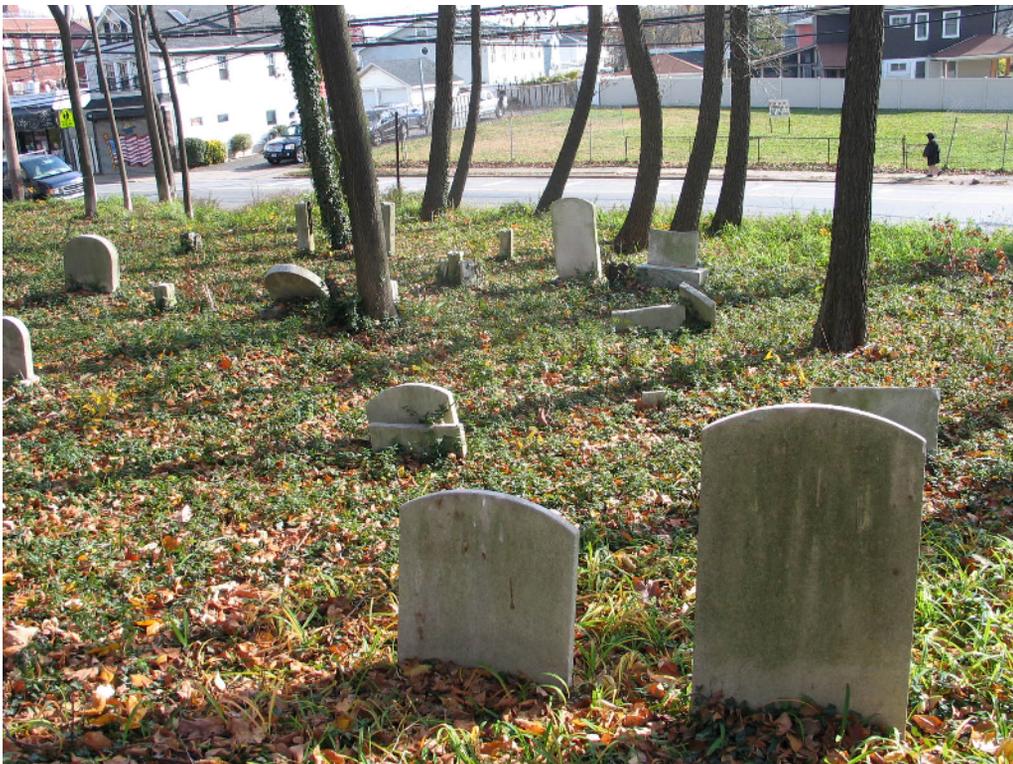
Photograph 8: Orientation of gravestones facing Victory Boulevard, with backs of gravestones shown. View looking southeast from interior of property.

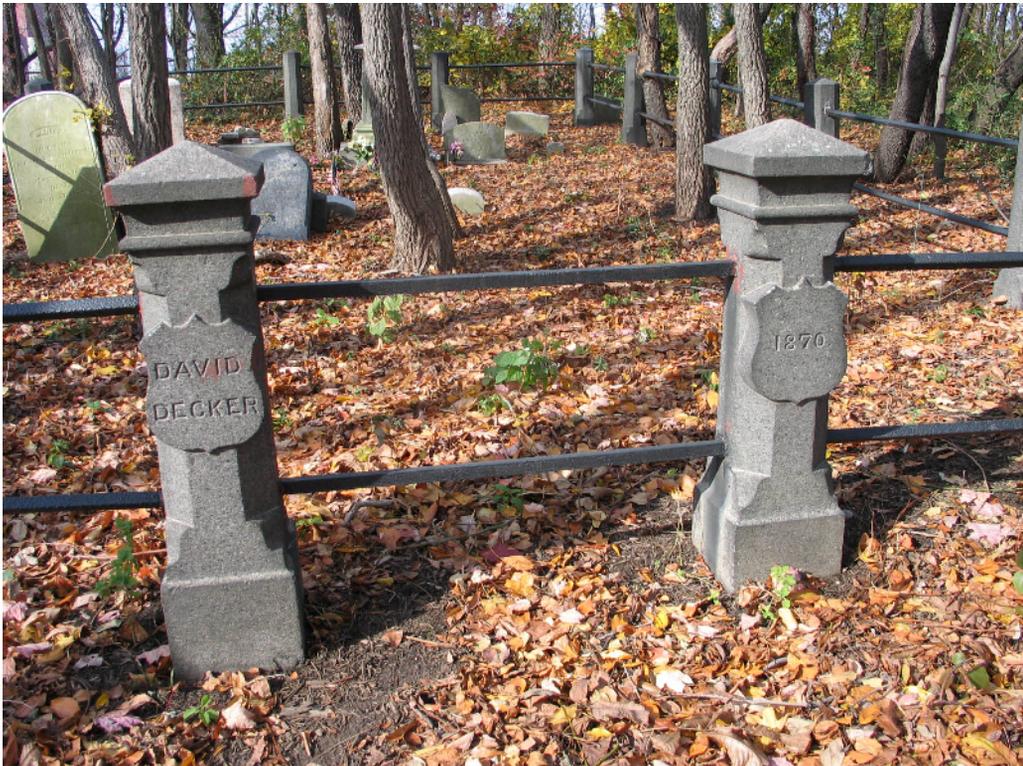
Photograph 10: David Decker family plot from 1870. View looking northwest from interior of property.

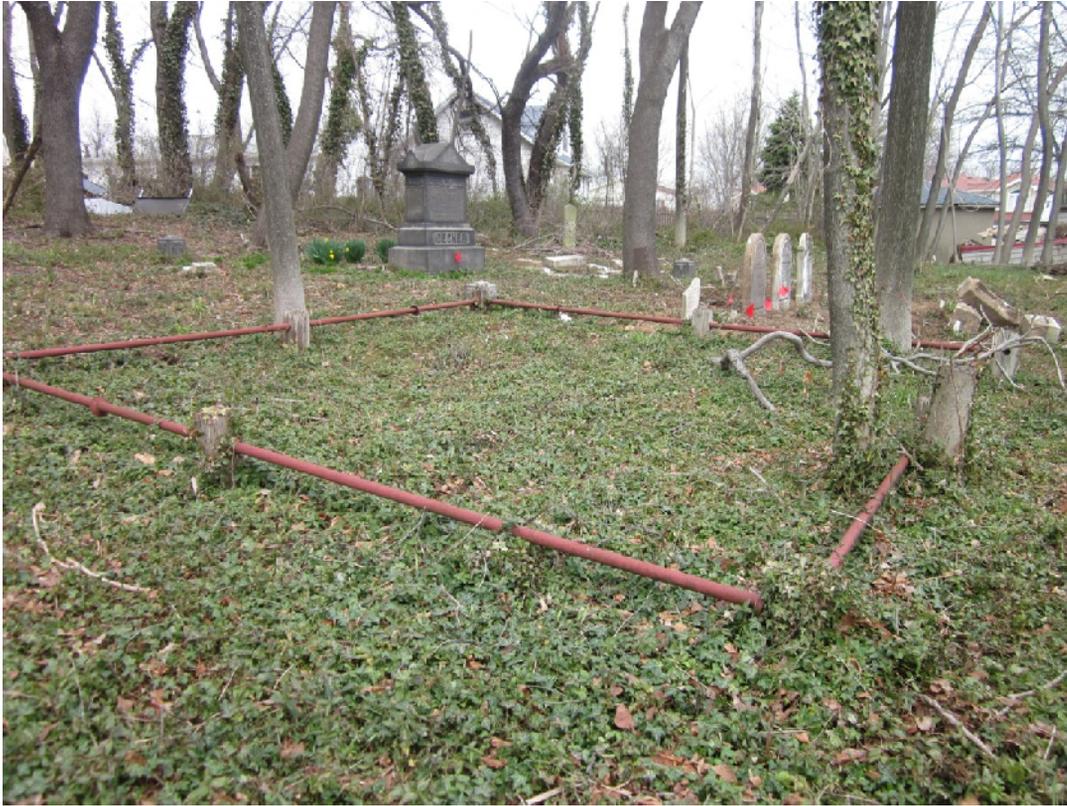
Photograph 11: Northeastern area of cemetery, showing empty plot with Sylvanus Decker family burials in rear, looking north-northeast.

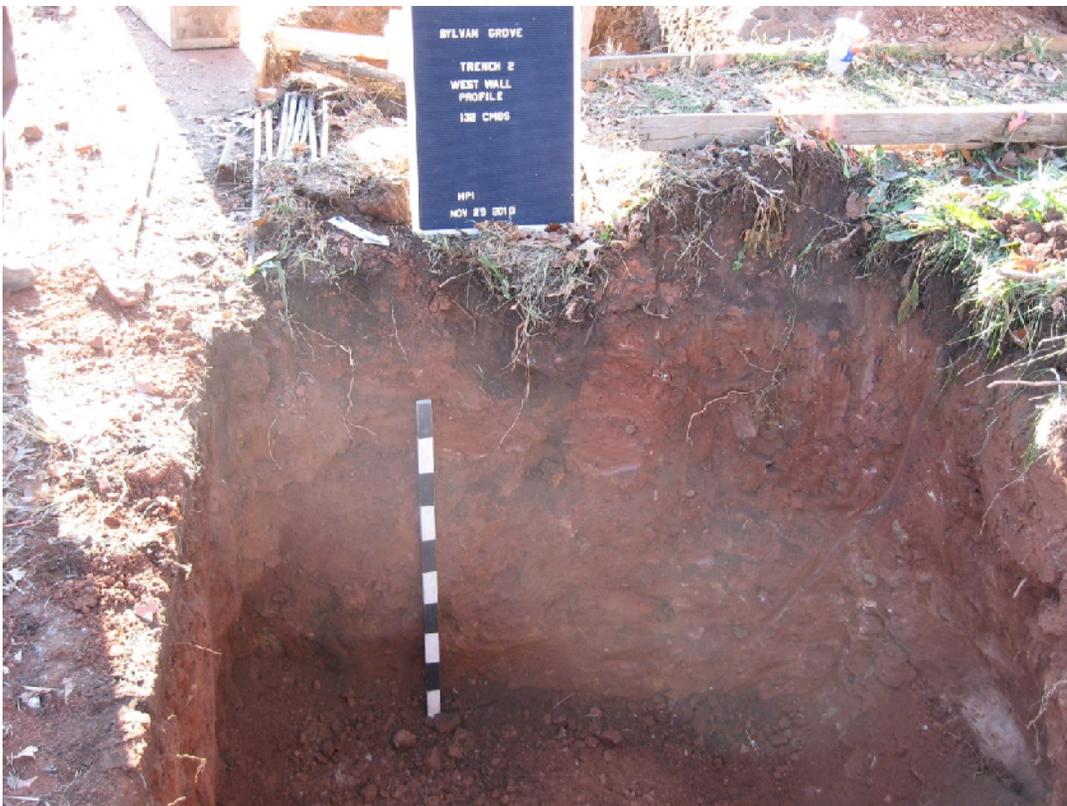
Photograph 12: Trench 2, in Lot 9 along Victory Boulevard, west wall profile.

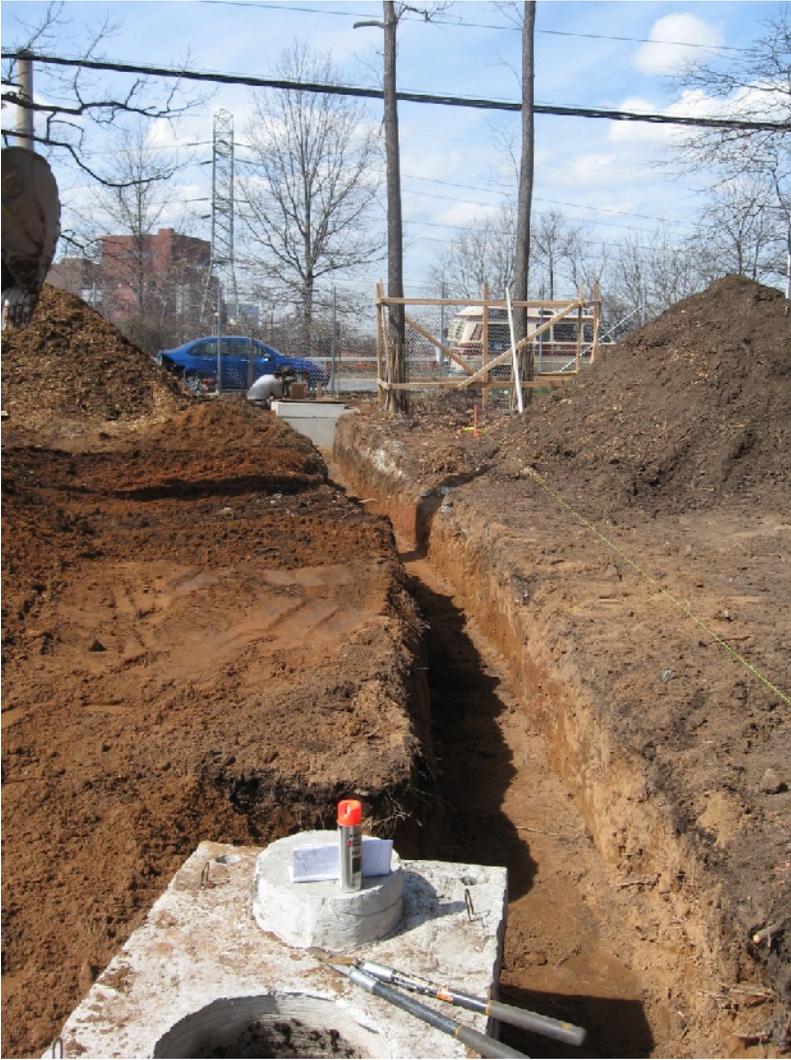
Photograph 15: Trench 5, looking west from Trench 6 to Trench 4 in Independence Park (Trenches 4 and 6 have concrete utility boxes in place).

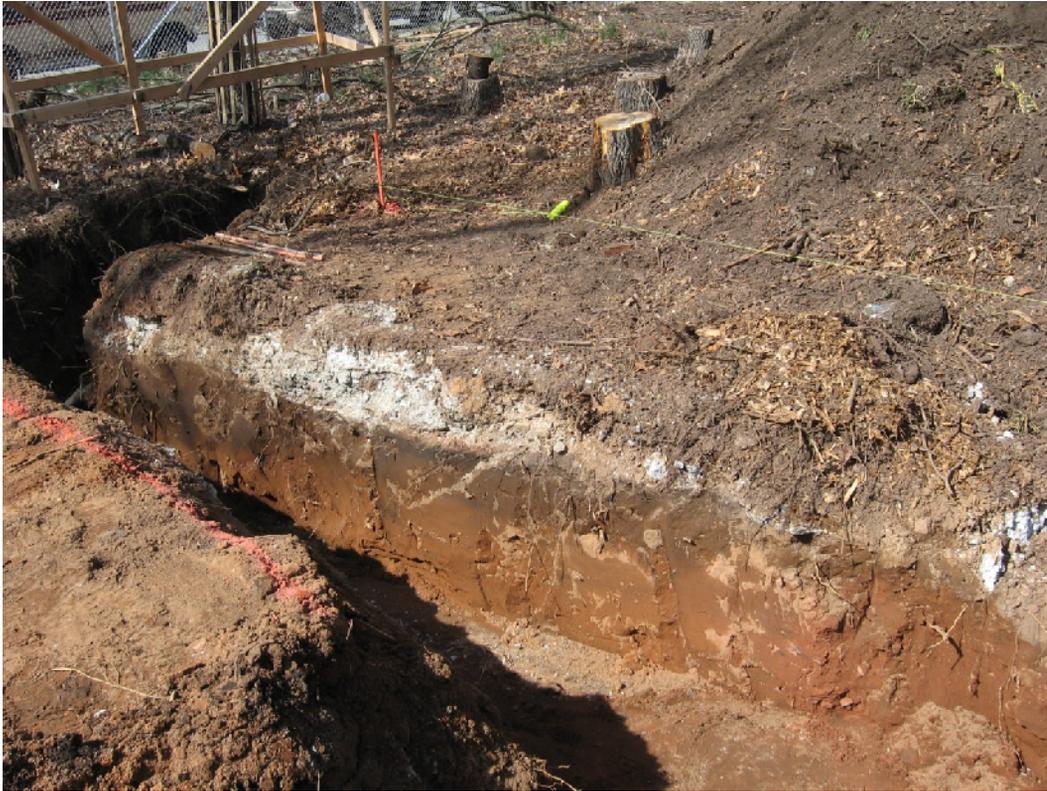
Photograph 17: North wall of Trench 5, looking northwest from Trench 9. Trench 8 is at left.

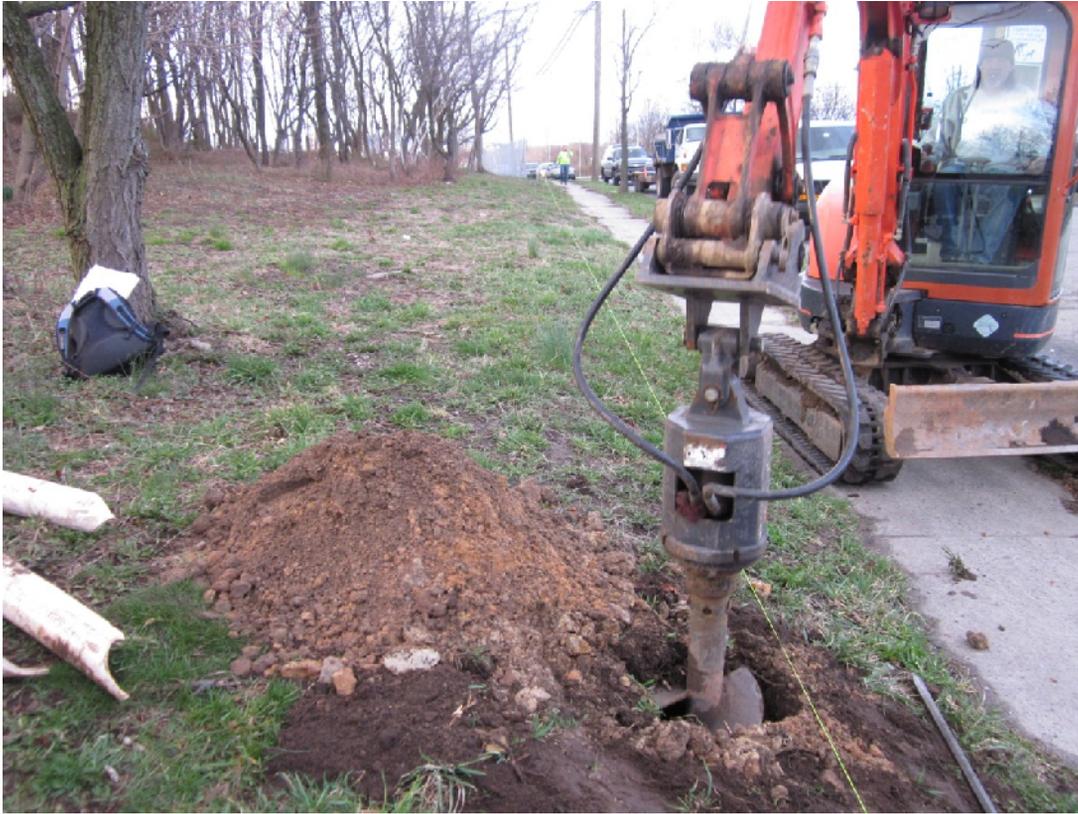
The installation of a wooden perimeter fence required posthole excavations at eight-foot (244 cm) intervals (Figure 4). These were mostly excavated by an auger attached to a small trackhoe (Photograph 19), with additional hand-finishing, but some fence postholes along Victory Boulevard were completely hand excavated because of the proximity to buried electrical utilities. The postholes were 40-50 cm (16-20 inches) in diameter, and ranged from 90-140 cm (35-55 inches) deep (Photographs 20 and 21). Excavation began along Glen Street, at the northernmost point of the project site, and proceeded south, and then proceeded east along Victory Boulevard. The fence line then turned north along the property line between Lot 9 (the cemetery), and Lot 4, a private residence, and once the location of the Long Neck Church and later a school (HPI 2010). There were 82 postholes excavated.

Photograph 19: Start of fence construction (Posthole 1) along Glen Street on Lot 9, looking south.

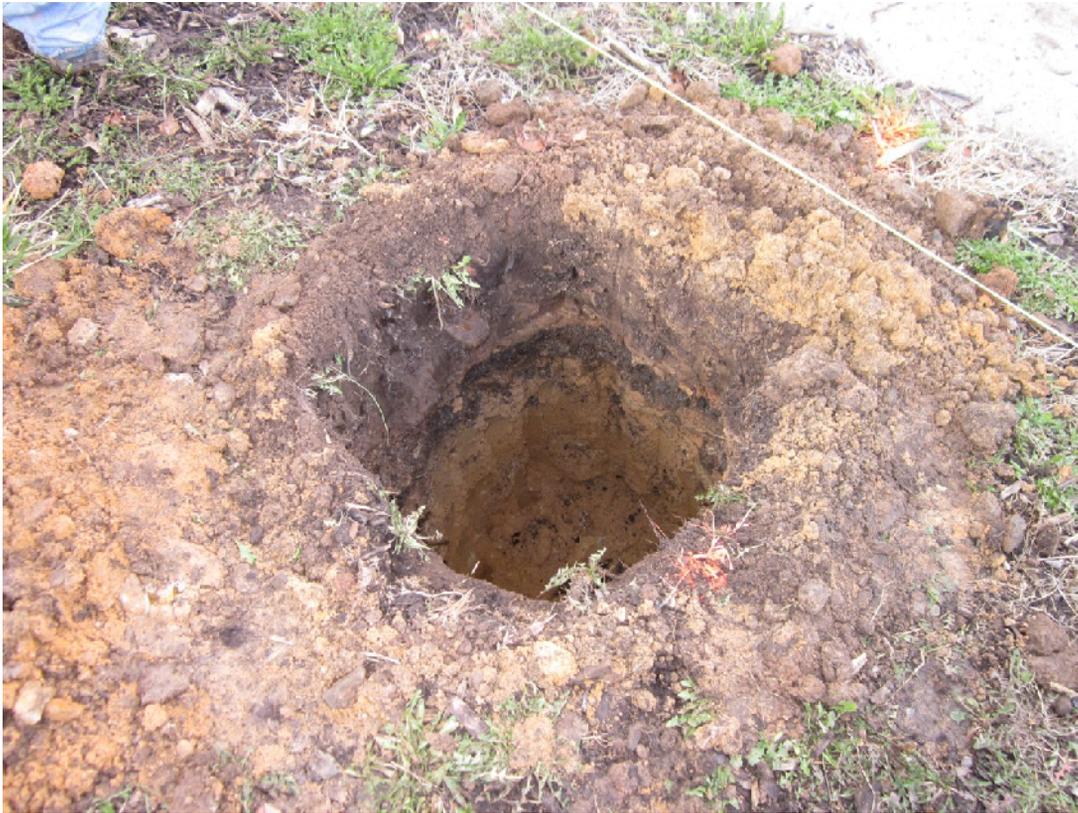
Photograph 20: Posthole 3, looking southwest.

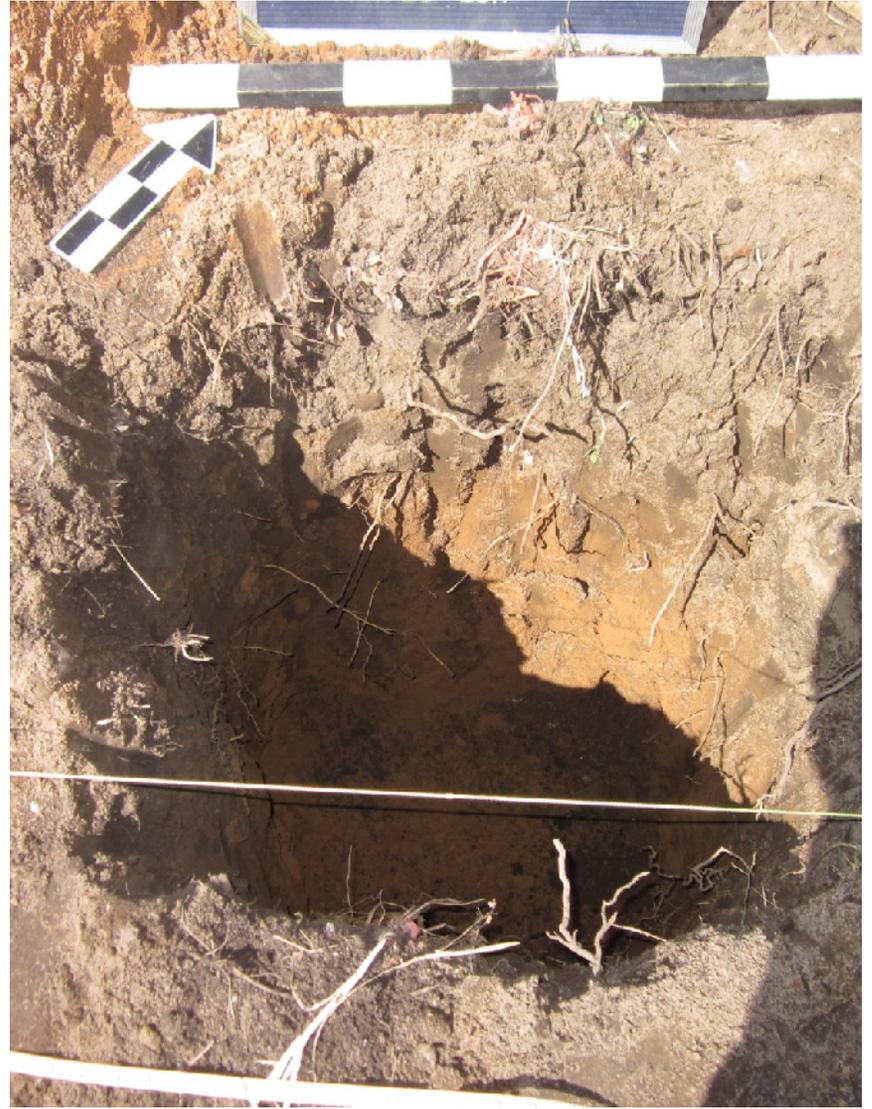
Posthole 50 was located at the approximate border between Lots 9 and 22 (Figure 4). The postholes in this area were all hand excavated because of a concern for encountering subsurface electrical conduits. Postholes 52 and 54 were relatively close to a group of graves in the southeast corner of the cemetery, and were hand excavated and screened. Posthole 52 had a topmost layer of black (10YR 2/1) silty sand to a depth of 50 cmbs (20 inches), then a layer of brown (10YR 3/6) sandy fill from 50-70 cmbs (20-28 inches), with some mottling from the upper layer, and finally a layer of dark yellowish brown (10YR 4/6) sand from 70-97 cmbs (28-38 inches) (Photograph 24). Posthole 54 had the same stratigraphy at similar depths. Both postholes contained modern artifacts, including bottle glass, plastic, and foil. The remaining postholes were again excavated by auger. Postholes 56 and 57 contained chunks of dark red (2.5YR 3/6) clay and silty clay in Level 2 as seen in the postholes along Glen Street.

Photograph 24: Posthole 52, along Victory Boulevard, Lot 9, looking northwest.

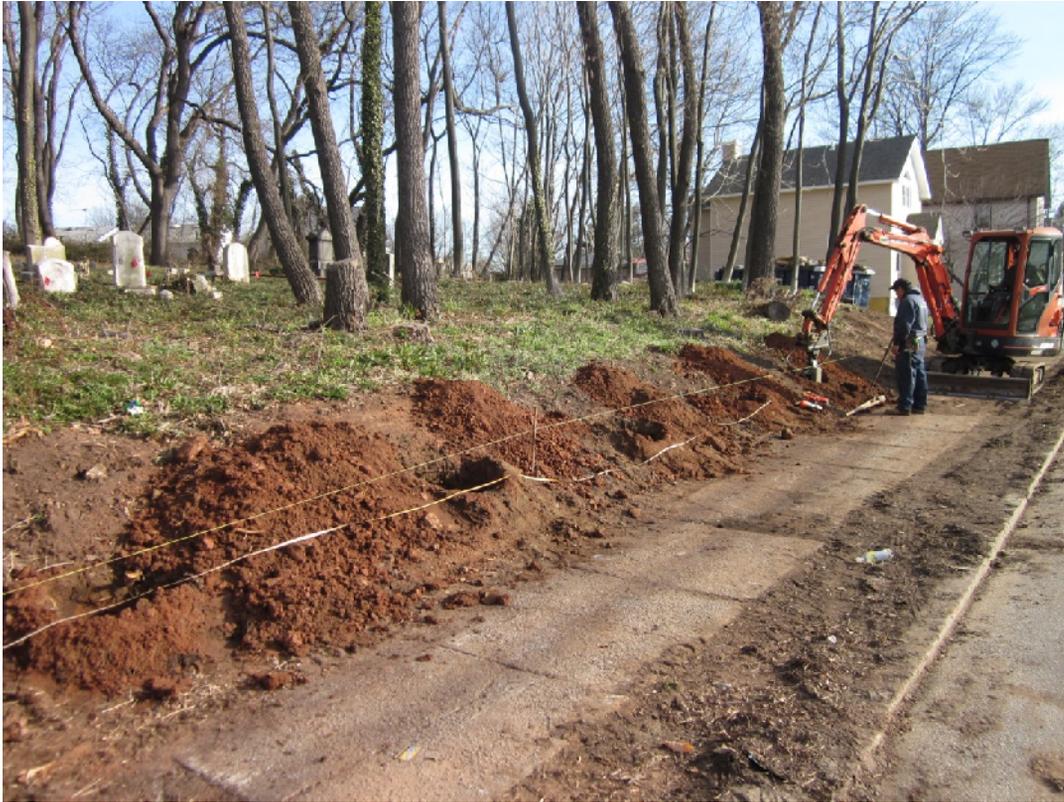
Photograph 25: Fence construction along Victory Boulevard, Lot 9, looking northeast. Building on left behind trackhoe is on Lot 4.

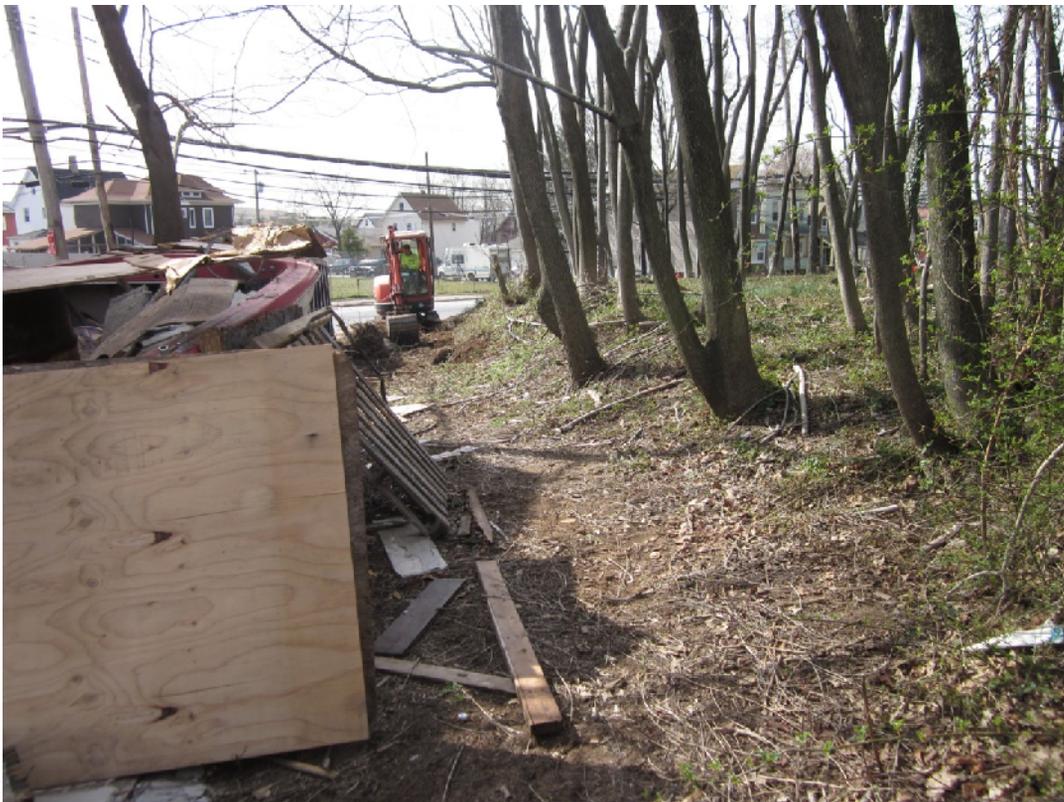
Posthole 73 was the easternmost posthole on Victory Boulevard. The fence line then turned north and continued along the border of the cemetery and the adjacent residential property next door (Photograph 26). An active driveway, used by the residents of Lot 4, actually falls partially within the borders of Lot 9, as does part of what appears to be the rear yard of this house (Figure 4, Photograph 27). Because of the long history of the property on Lot 4, dating to the early 1840s, the unusual triangular shape of the lot, and the very narrow rear yard of this property, the postholes in this area were very carefully observed for any potential historical subsurface shaft features such as wells, privies, or cisterns. The soil from Posthole 82, located adjacent to the rear yard of Lot 4, was hand excavated and screened. The top layer contained a dark brown (7.5YR 3/3) sandy silt from 0-20 cmbs (0-8 inches), then a layer of strong brown (7.5YR 5/6) sand was present from 20-78 cmbs (8-31 inches), and finally a layer of red (7.5YR 4/6) sandy clay mixed with sand was present from 78-97 cmbs (31-38 inches). After hand excavation, the auger was used to deepen the hole, and brought up a pink (7.5YR 7/3) compact sandy clay, believed to be the natural subsoil. Glimpses of this pink clay were seen in the auger in a few previous postholes. The first two levels contained window glass and coal, but no other artifacts, and nothing was found in the third level. The remaining postholes along the driveway contained similar soil profiles (Photograph 28). No evidence of subsurface features was observed, nor was there any concentration of artifacts possibly representing yard scatter. It is possible that grading of the driveway at some point in the past removed any evidence of past land use.

Photograph 26: Border between cemetery on Lot 9 to right, and Lot 4, to left, looking south. Boat and plywood on left are actually on Lot 9. .

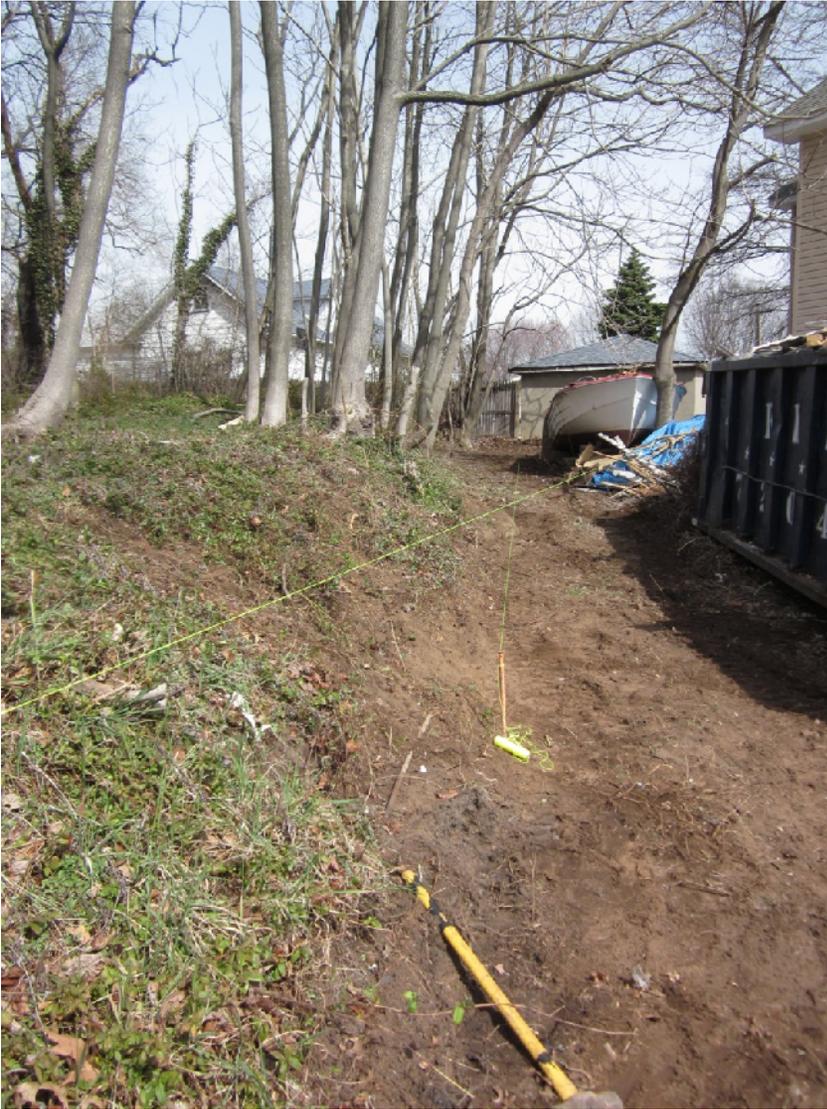
Photograph 27: Border between cemetery on Lot 9 at top left, and Lot 4, bottom right, looking north. Taut string line represents property line. Shed in rear belongs to house on Melvin Avenue.

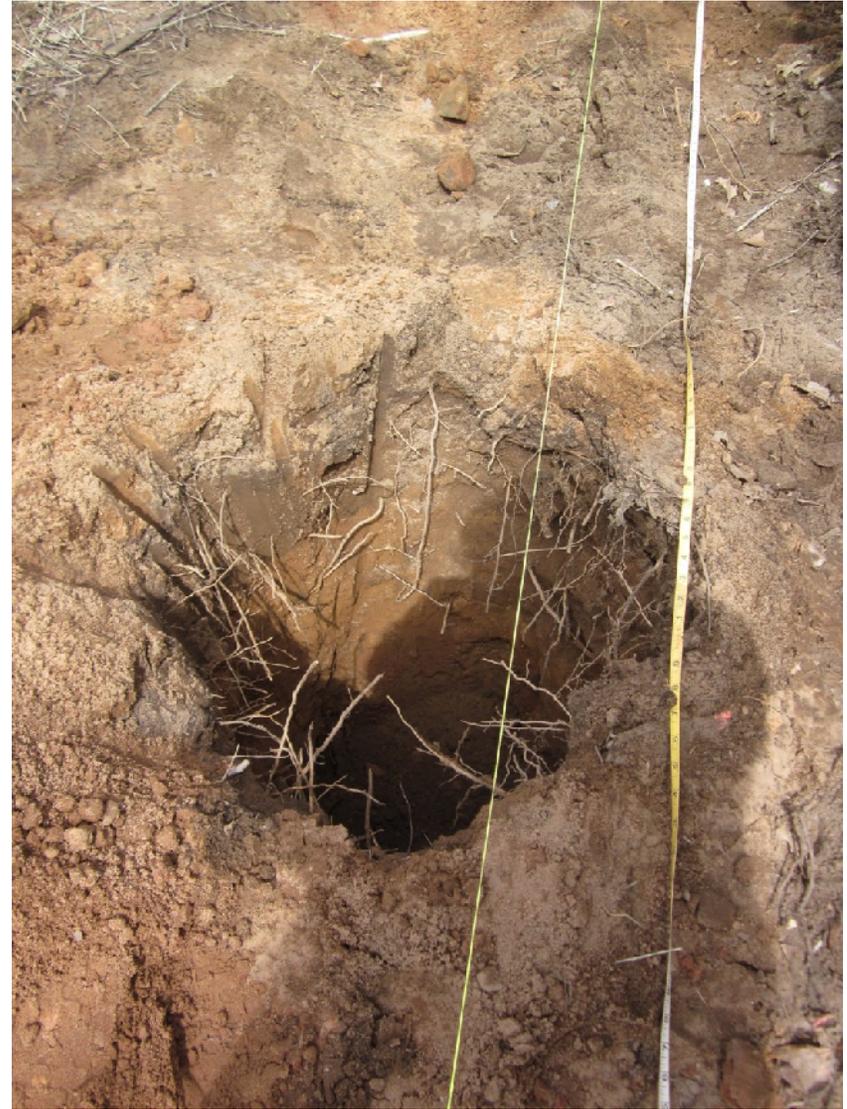
Photograph 28: Posthole 78, Lot 9 adjacent to Lot 4, looking south.

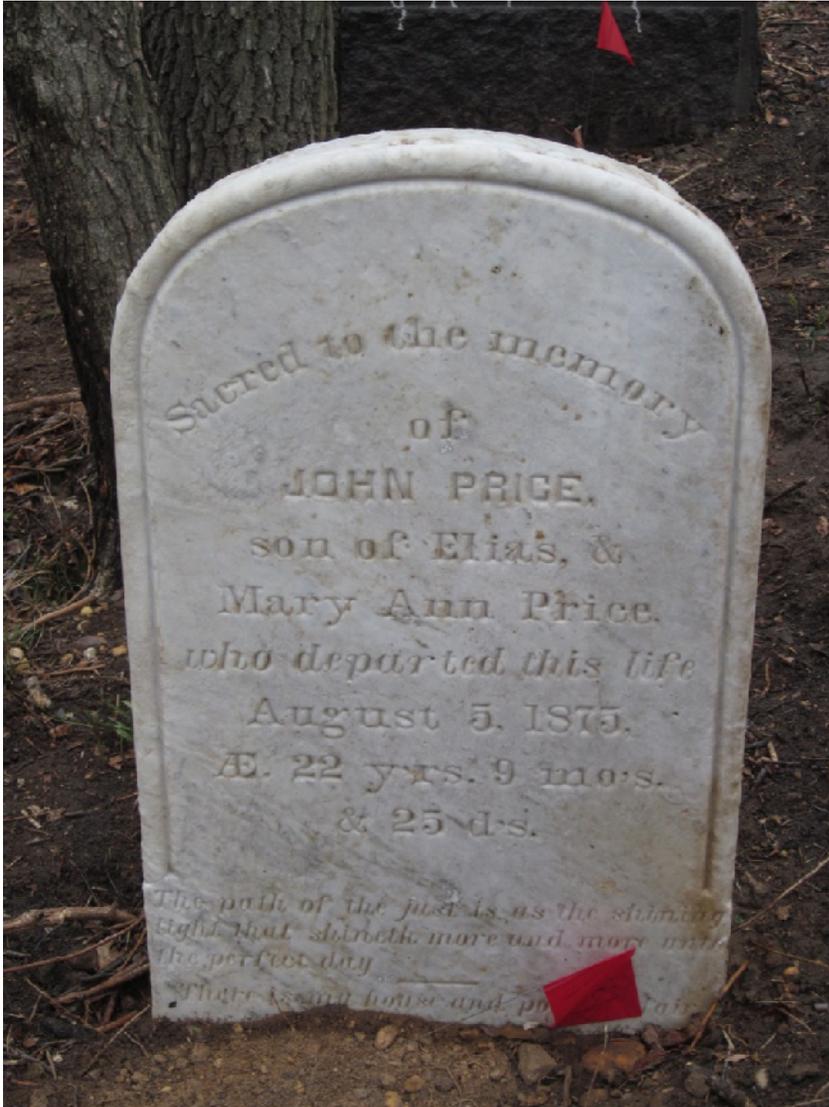
Photograph 33: Reset gravestone.

Second were those gravestones that were single slabs installed directly into the ground, which had been broken off at some part above the ground. Some stones were too badly broken to be repaired and were left *in situ* (Photograph 32). If the stone had been broken off at the bottom, a new rectangular cavity was excavated directly in front of the original location, usually to a depth of about 20 cmbs (8 inches). Then a concrete base was poured, into which the headstone was set (Photograph 33). If the gravestone had been broken midway, then a new base would be constructed adjacent to the original location, and the top part of the stone installed facing out (Photograph 34).
