Removal of Intrusions from the Burial Ground of the Flushing Meeting House of the Religious Society of Friends, 137-16 Northern Boulevard (Block 4977, Lot 26), Flushing, Queens

May 28, 2013

- To: Brian Doherty, as the Representative of the Flushing Meeting House of the Religious Society of Friends
- From: Joan H. Geismar, Ph.D., LLC
- Date: May 28, 2013
- *Re*: Removal of Intrusions from the Burial Ground of the Flushing Meeting House of the Religious Society of Friends: End of Field Memo Report

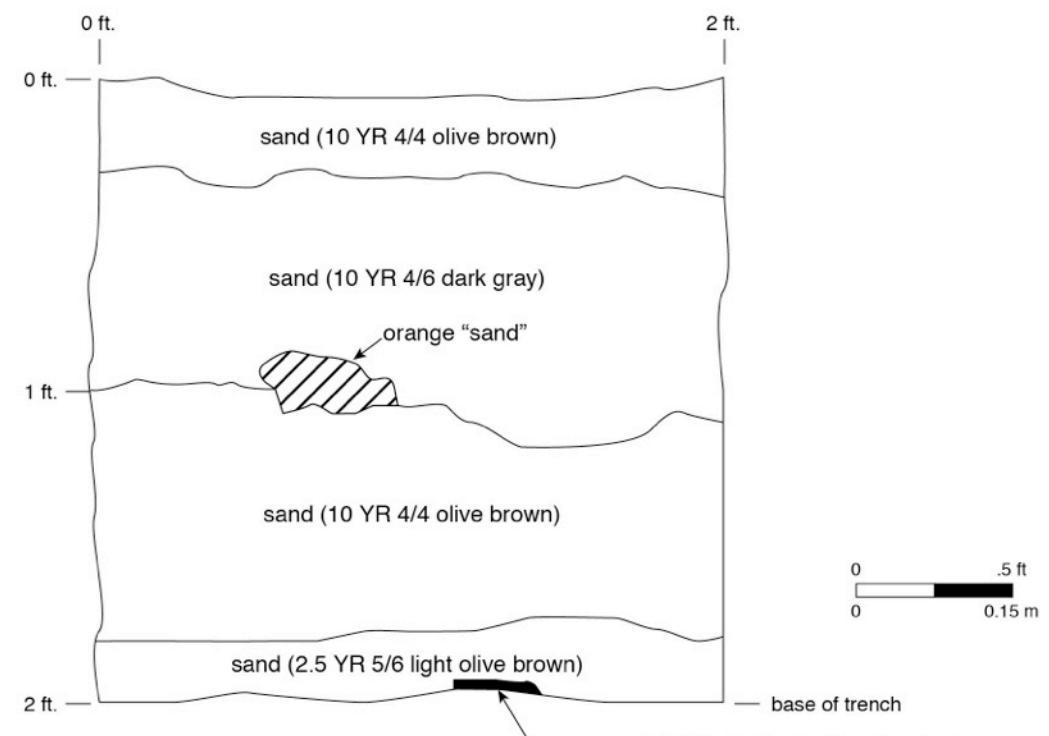
fragment of old black plastic sheeting in situ

Approximate location of 2- x 2-foot (0.61 x 0.61 m) section of the north "wall" profiled near the eastern end of the trench. Note the patch of orange (corrosion?) sand (upper arrow) and a fragment of old black plastic sheeting (bottom arrow) in the trench wall. Both indicate fill. (Geismar 5/16/13)
