Re: Letter Report, Unanticipated Discovery, 1763 86th Street, Brooklyn Borough, Kings County, New York (PO Number: 4500371572)

Archaeological Documentation, December 2, 2024

Letter Report, Archaeological Documentation
1763 86th Street, Brooklyn
December 13, 2024
Page 5

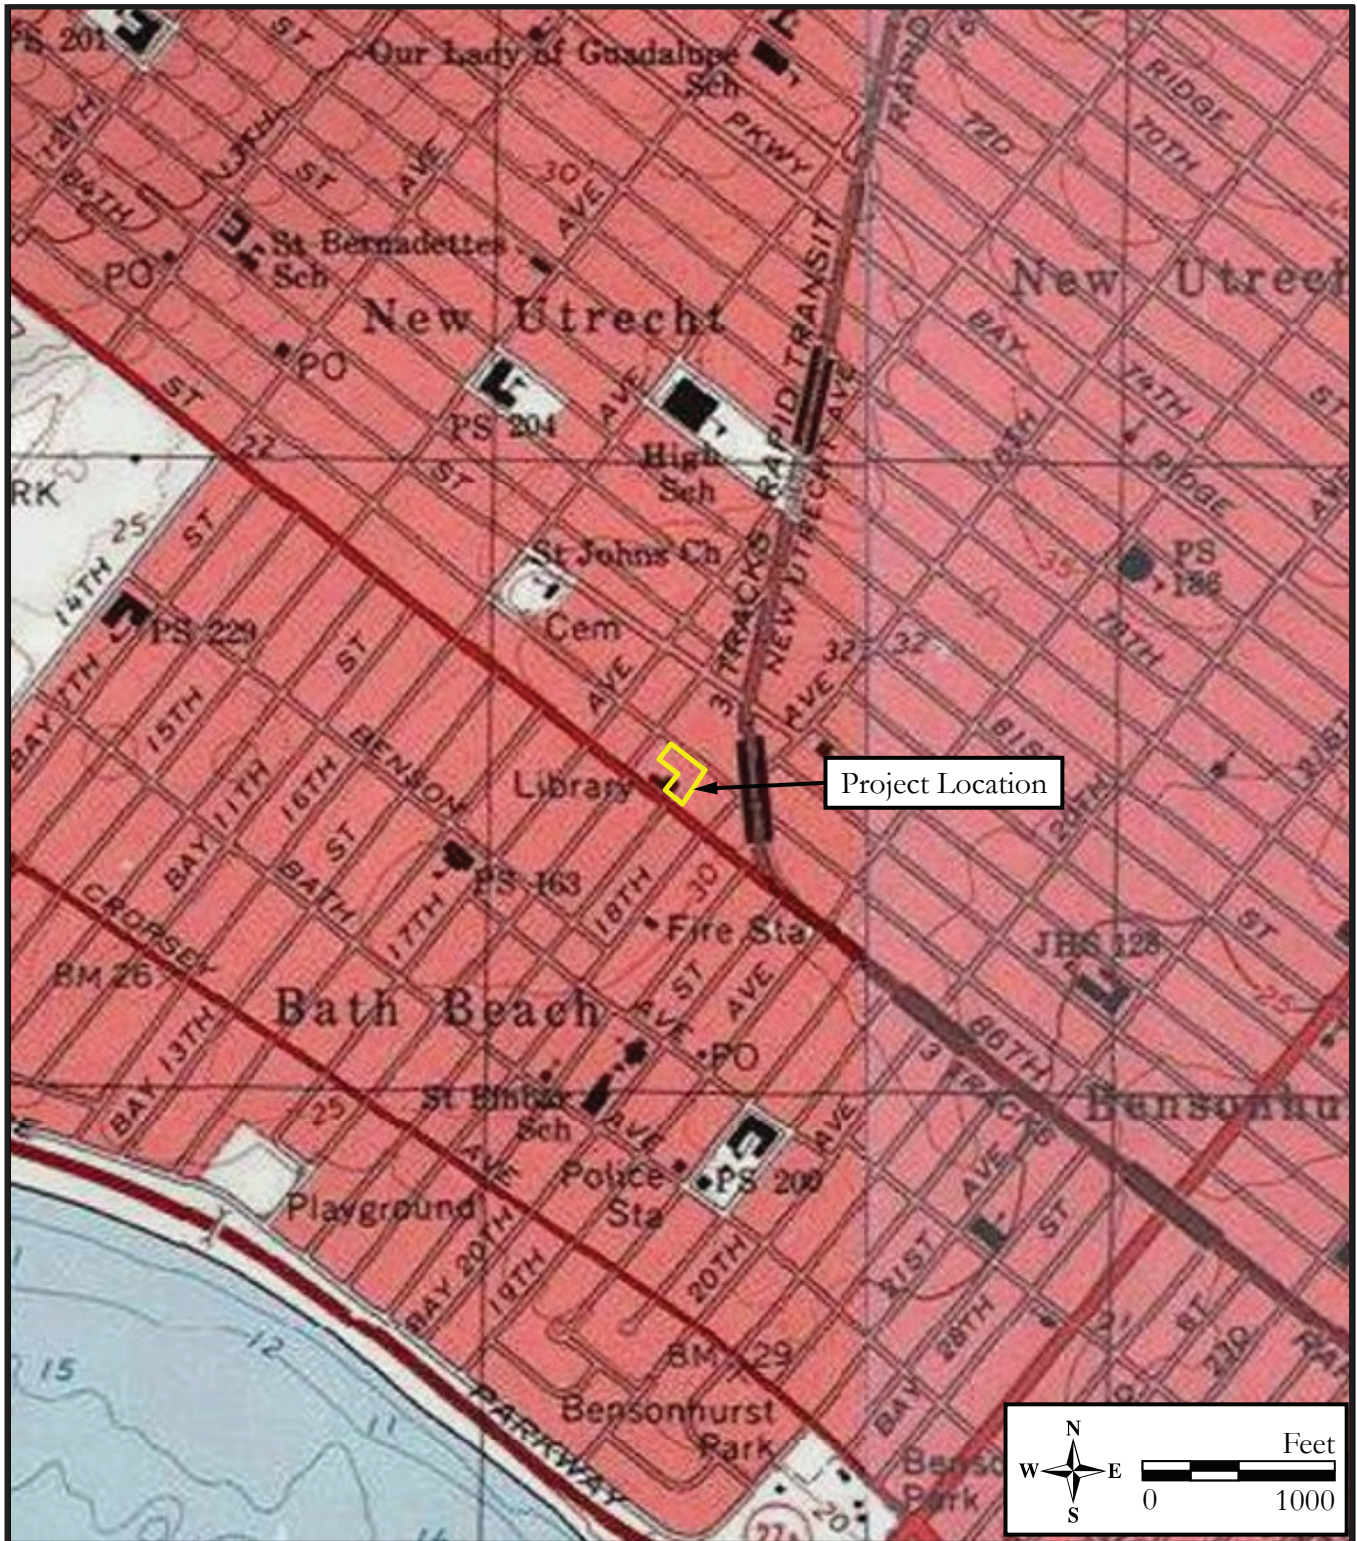
In Field Plan and Profile Drawings

The brick wall was located within the western trench wall directly below the asphalt laid for the existing parking lot. The brick portion of the wall was a little over two feet at its deepest point and was abutted by concrete directly below it. The concrete underlying the brick wall was just under a foot thick. The brick portion was not a perfectly square section and had sharp, clear boundaries. At least six courses of brick was documented. Disturbance was observed south of the brick wall. Soil was observed beneath the asphalt in locations where the brick wall had been removed. The soil consisted of a brown (10YR 4/3) sandy to silt loam that was mixed with cobbles and rubble. Some cobbles of various sizes were observed. A brick wall traversed the trench (perpendicular) and could represent the remnants of a former partition wall. The brick wall extends beyond the trench for an unknown distance further east toward the library.

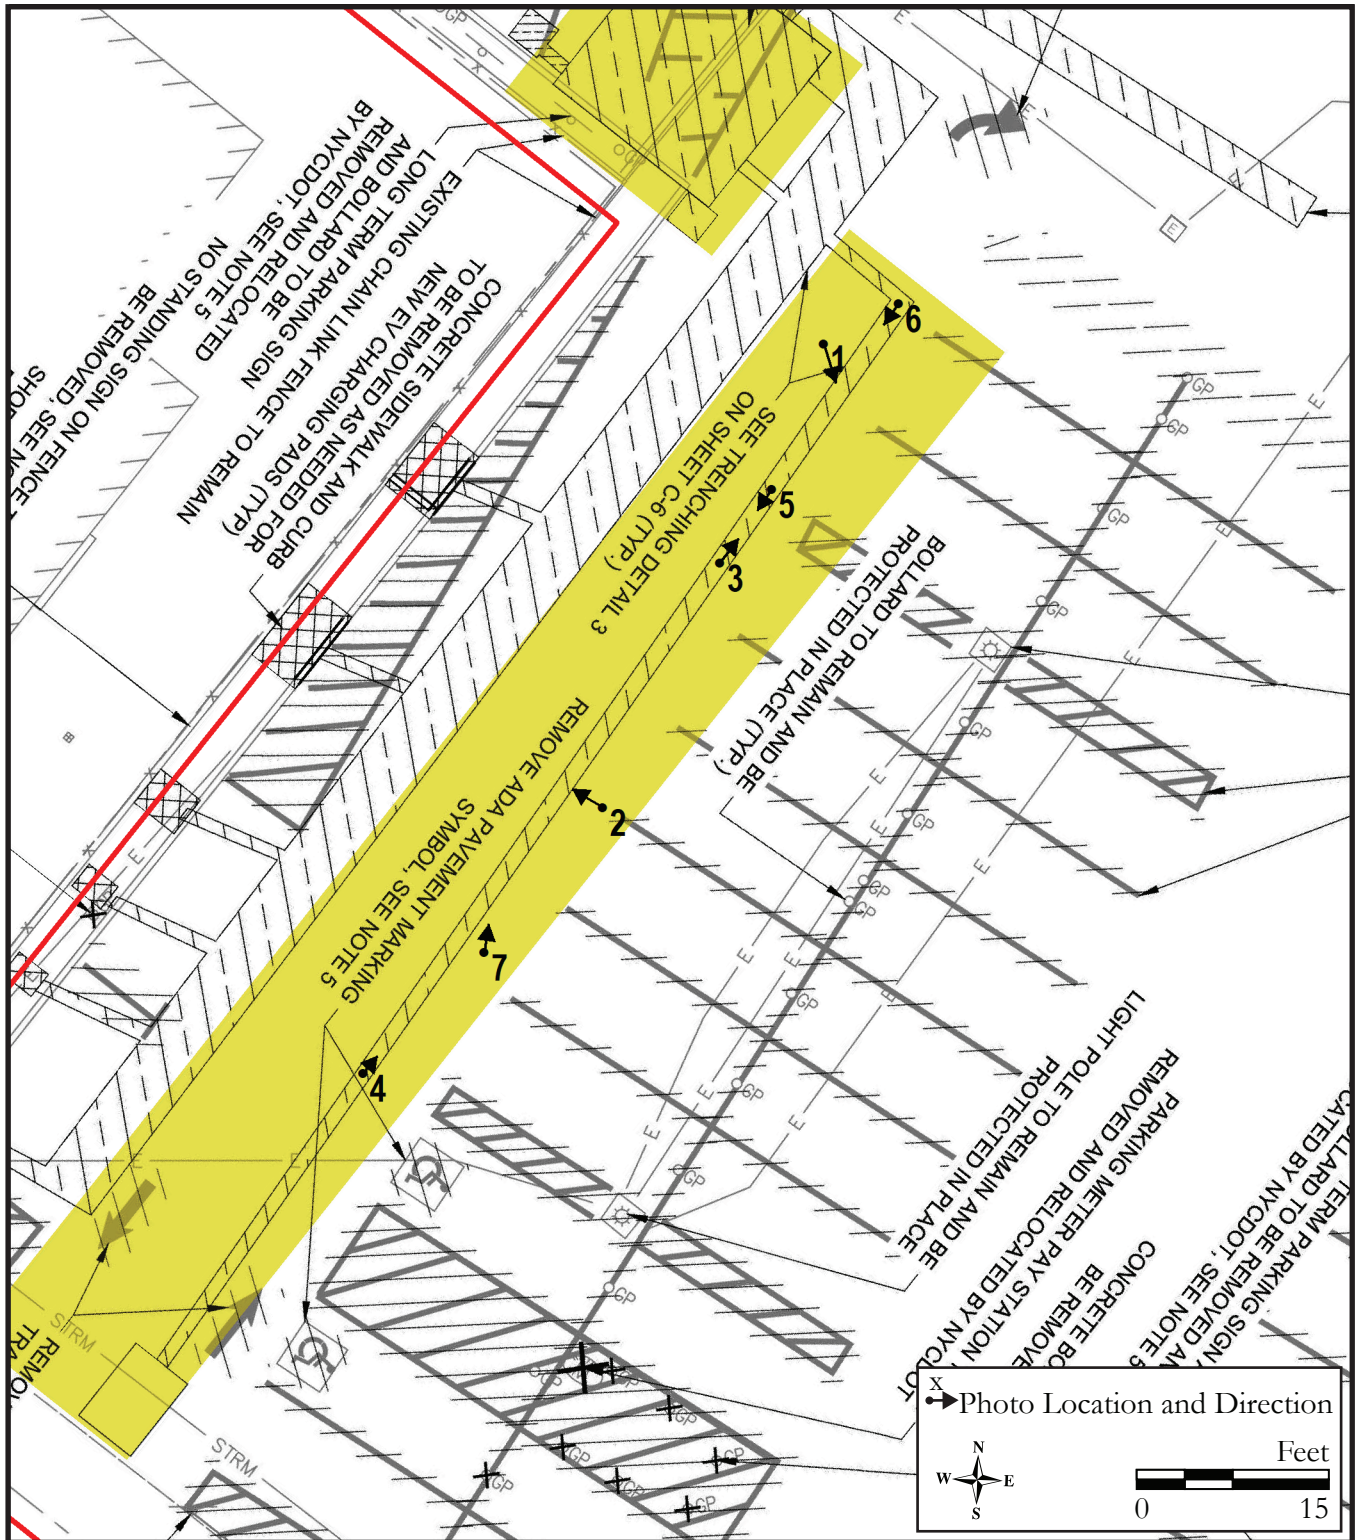
Figure 2: Construction Plan showing photograph locations.

On Monday, December 2, 2024, archaeologists Olivier Vansassenbrouck, MA, MSc., RPA and Edward McFadden were on site to complete archaeological documentation (Figure 2; Plates 1 to 7). The goal of this work was to document the unanticipated finds in a roughly 65-foot by 3-foot trench that was excavated within a parking lot to the southeast of the New Utrecht Branch of the Brooklyn Public Library. GPS points were taken of the trench corners and extent of the brick wall with a Trimble unit (Figure 3). The trench was oriented roughly north/south and had three metal pipes and a brick footing in the first 19-foot section that was documented. The three pipes ran east-west in the trench and nearly stretched from trench wall to trench wall. Some of the metal pipes appear to have been partially displaced. Rubble that caved in from the excavation of the area made it difficult to see the pipes in full. The pipes were surrounded by brick and concrete within the trench walls. No historic or otherwise cultural material besides modern paper and plastics were observed within the trench. A brick footing was documented about 6 feet from the end of the last metal pipe. This brick footing ran east-west along the floor of the trench and took a sharp turn upwards in both walls creating a clear break from what on the inside of this section to the rest of the trench to the south. There was another metal pipe directly against the brick footing that ran parallel with the wall along the excavation floor. An approximately 14-foot section with of the west wall of the trench contained an intact brick wall. The trench extended to a depth of 4-feet below grade. A sketch plan was drawn as well as a profile drawing of the brick wall. Documentation also included digital photography. Field notes are on file at RGA in Cranbury, New Jersey. Rough archaeological sketches are provided.
