Joan H. Geismar, Ph.D. Archaeologist

February 20, 2002

Re: Block 1770, Lot 49 (160 East 122 Street), Manhattan: Letter Report on Field Findings

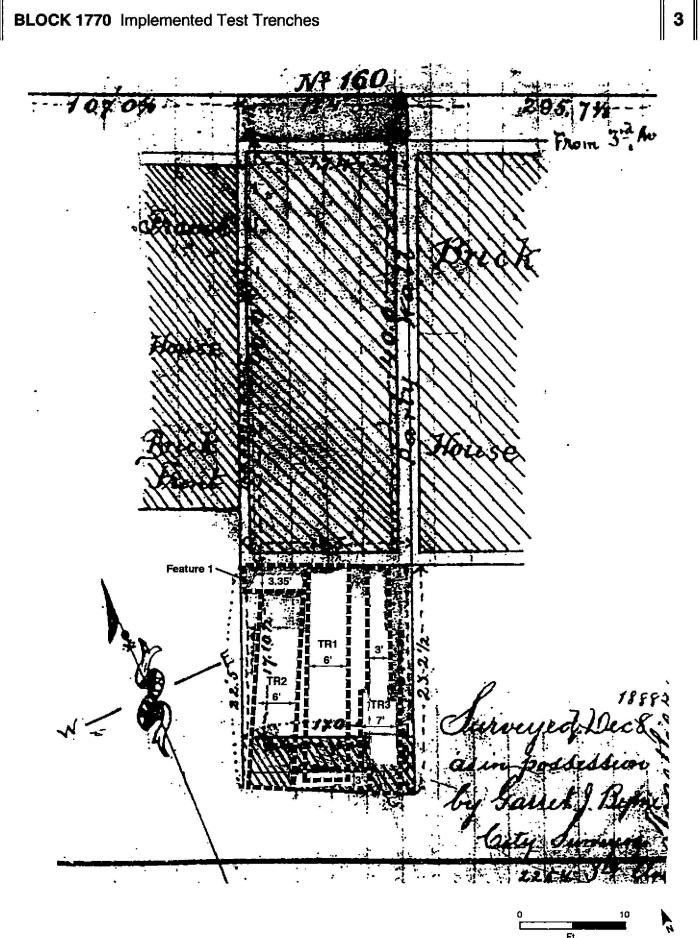
Using a rubber-tired CAT backhoe with a 24-inch bucket, three trenches were opened that ultimately tested almost the entire 23 by 17-foot backyard (Figure 3). The developer also provided the services of two laborers to expedite testing, and all trenching was under my direction assisted by Shelly Spritzer.
