RECONNAISSANCE OF MARINE CULTURAL RESOURCES
AT THE NEWARK BAY SITE
STATEN ISLAND, NEW YORK

NEW YORK CITY LONG RANGE SLUDGE MANAGEMENT
GEIS III/NEW YORK CITY DEPARTMENT OF ENVIRONMENTAL PROTECTION

April 10, 1992

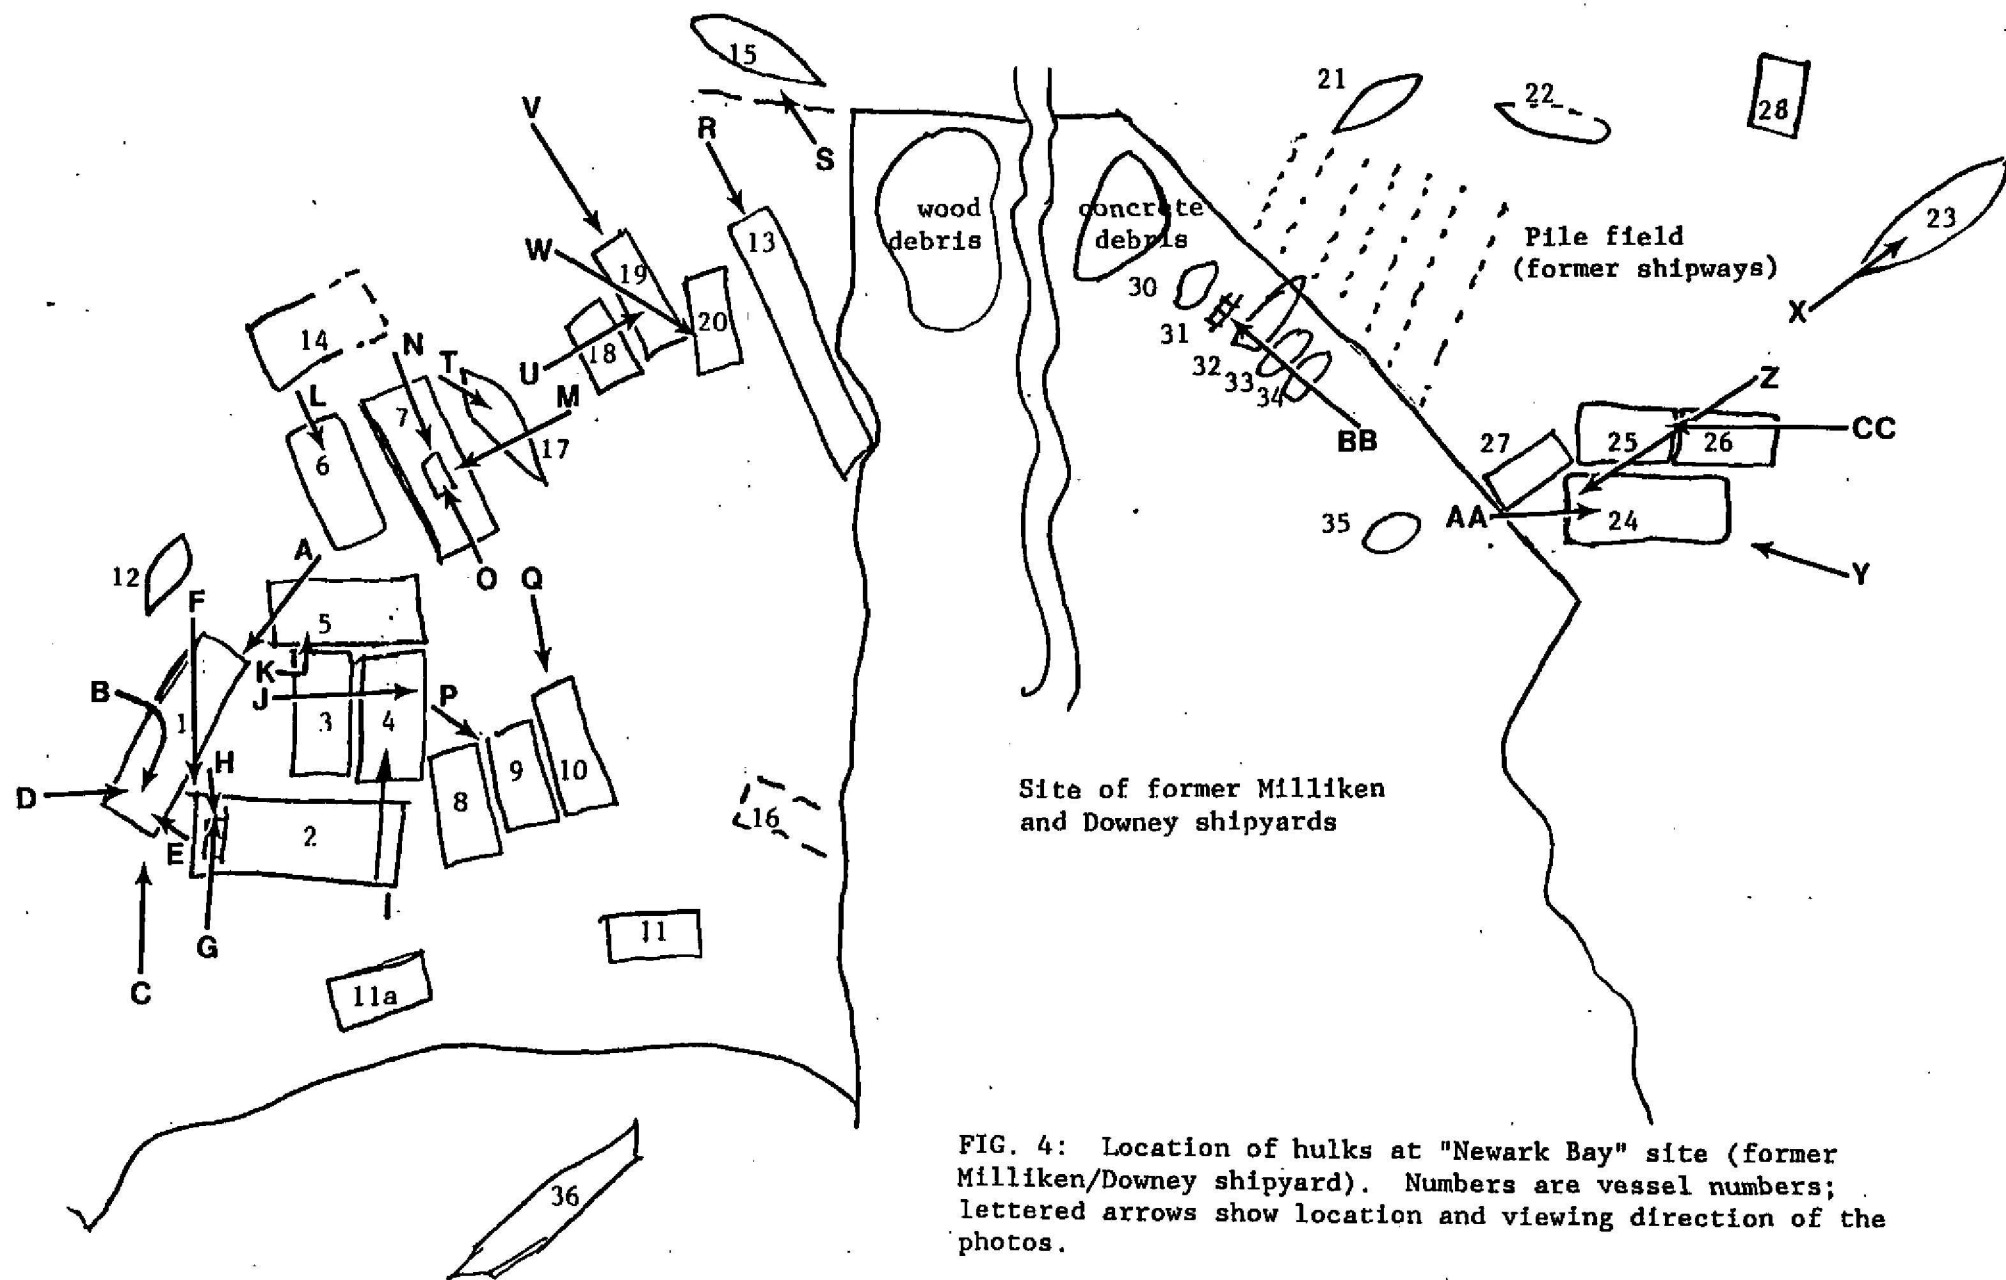
The present reconnaissance found two main types of hulks. Those we call the "powered" type are characterized by "lines", that is pointed bows, rounded sterns, shaped ribs, and the other traditional curves of wooden hull construction. Features of these hulls suggested that all had been powered vessels. One fragment may have come from a sailing lighter; the rest were powered by engines of some sort. The vessels of this type (located on Fig. 4) are 12, 15, 17, 21, 22, 23, and 30-34.

The other, "unpowered", type of vessel also possessed a wooden hull but is characterized by the square ends, flat sides, and generally boxy construction typical of unpowered scows and lighters used within a port. All other craft shown on Fig. 4 were of this type.

FIG. 4: Location of hulks at "Newark Bay" site (former Milliken/Downey shipyard). Numbers are vessel numbers; lettered arrows show location and viewing direction of the photos.

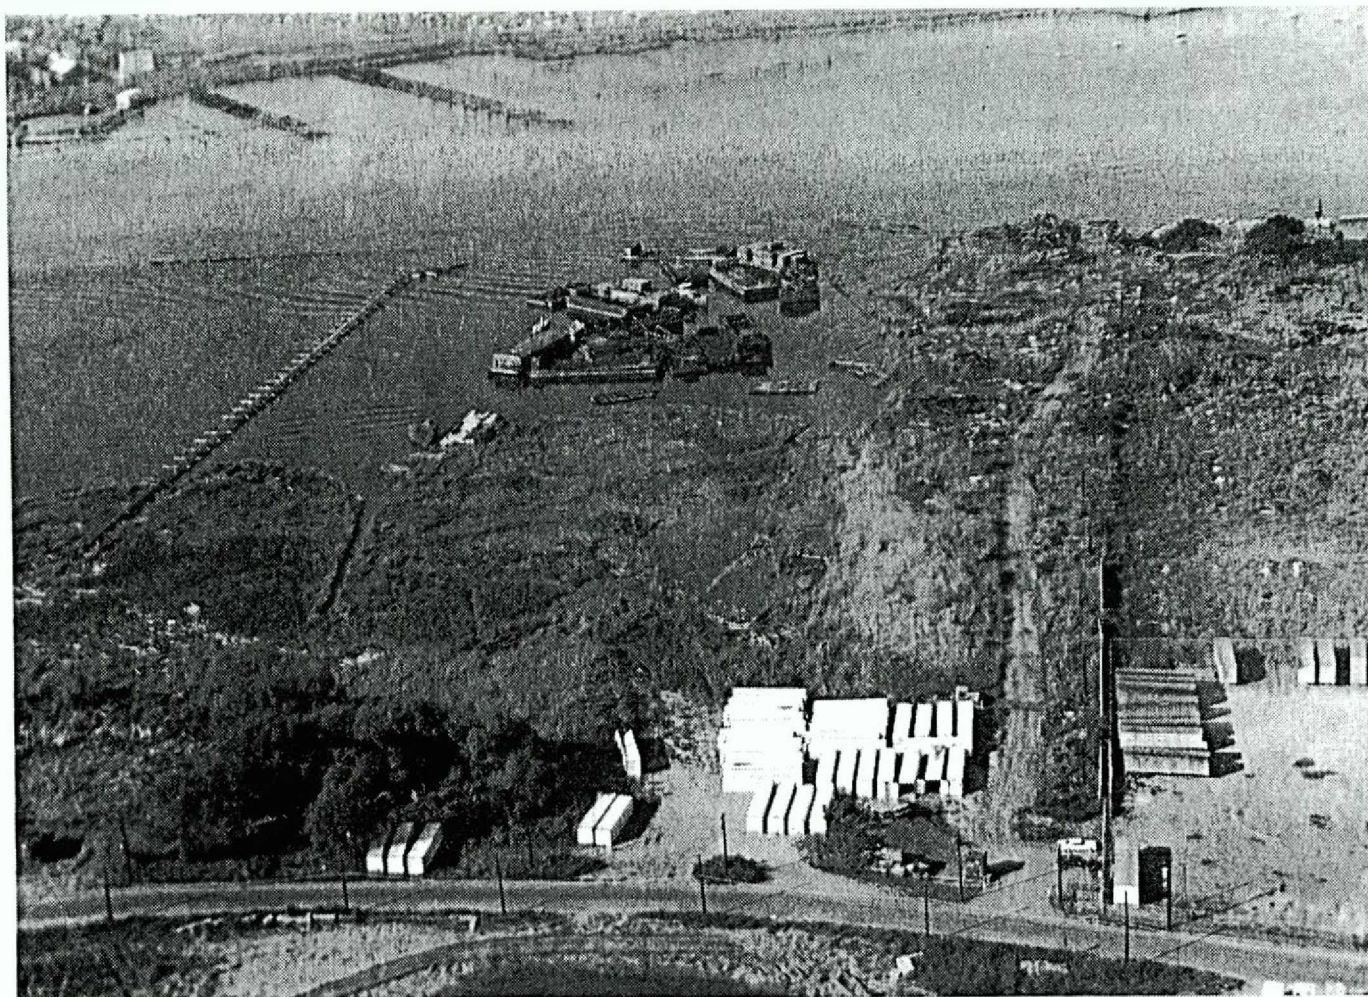
The condition of these vessels is such that their individual histories are unlikely to be recovered. The circa 1969/1972 photographs (Figs. 4 and 5) are not detailed enough to identify the markings on any of them. All of these vessels lack individual identification at present. Their historical significance lies rather in the information about barge construction that can be obtained from them.

FIG. 5: Oblique aerial view of the site circa October 1969,
courtesy of the South Street Seaport Museum library.

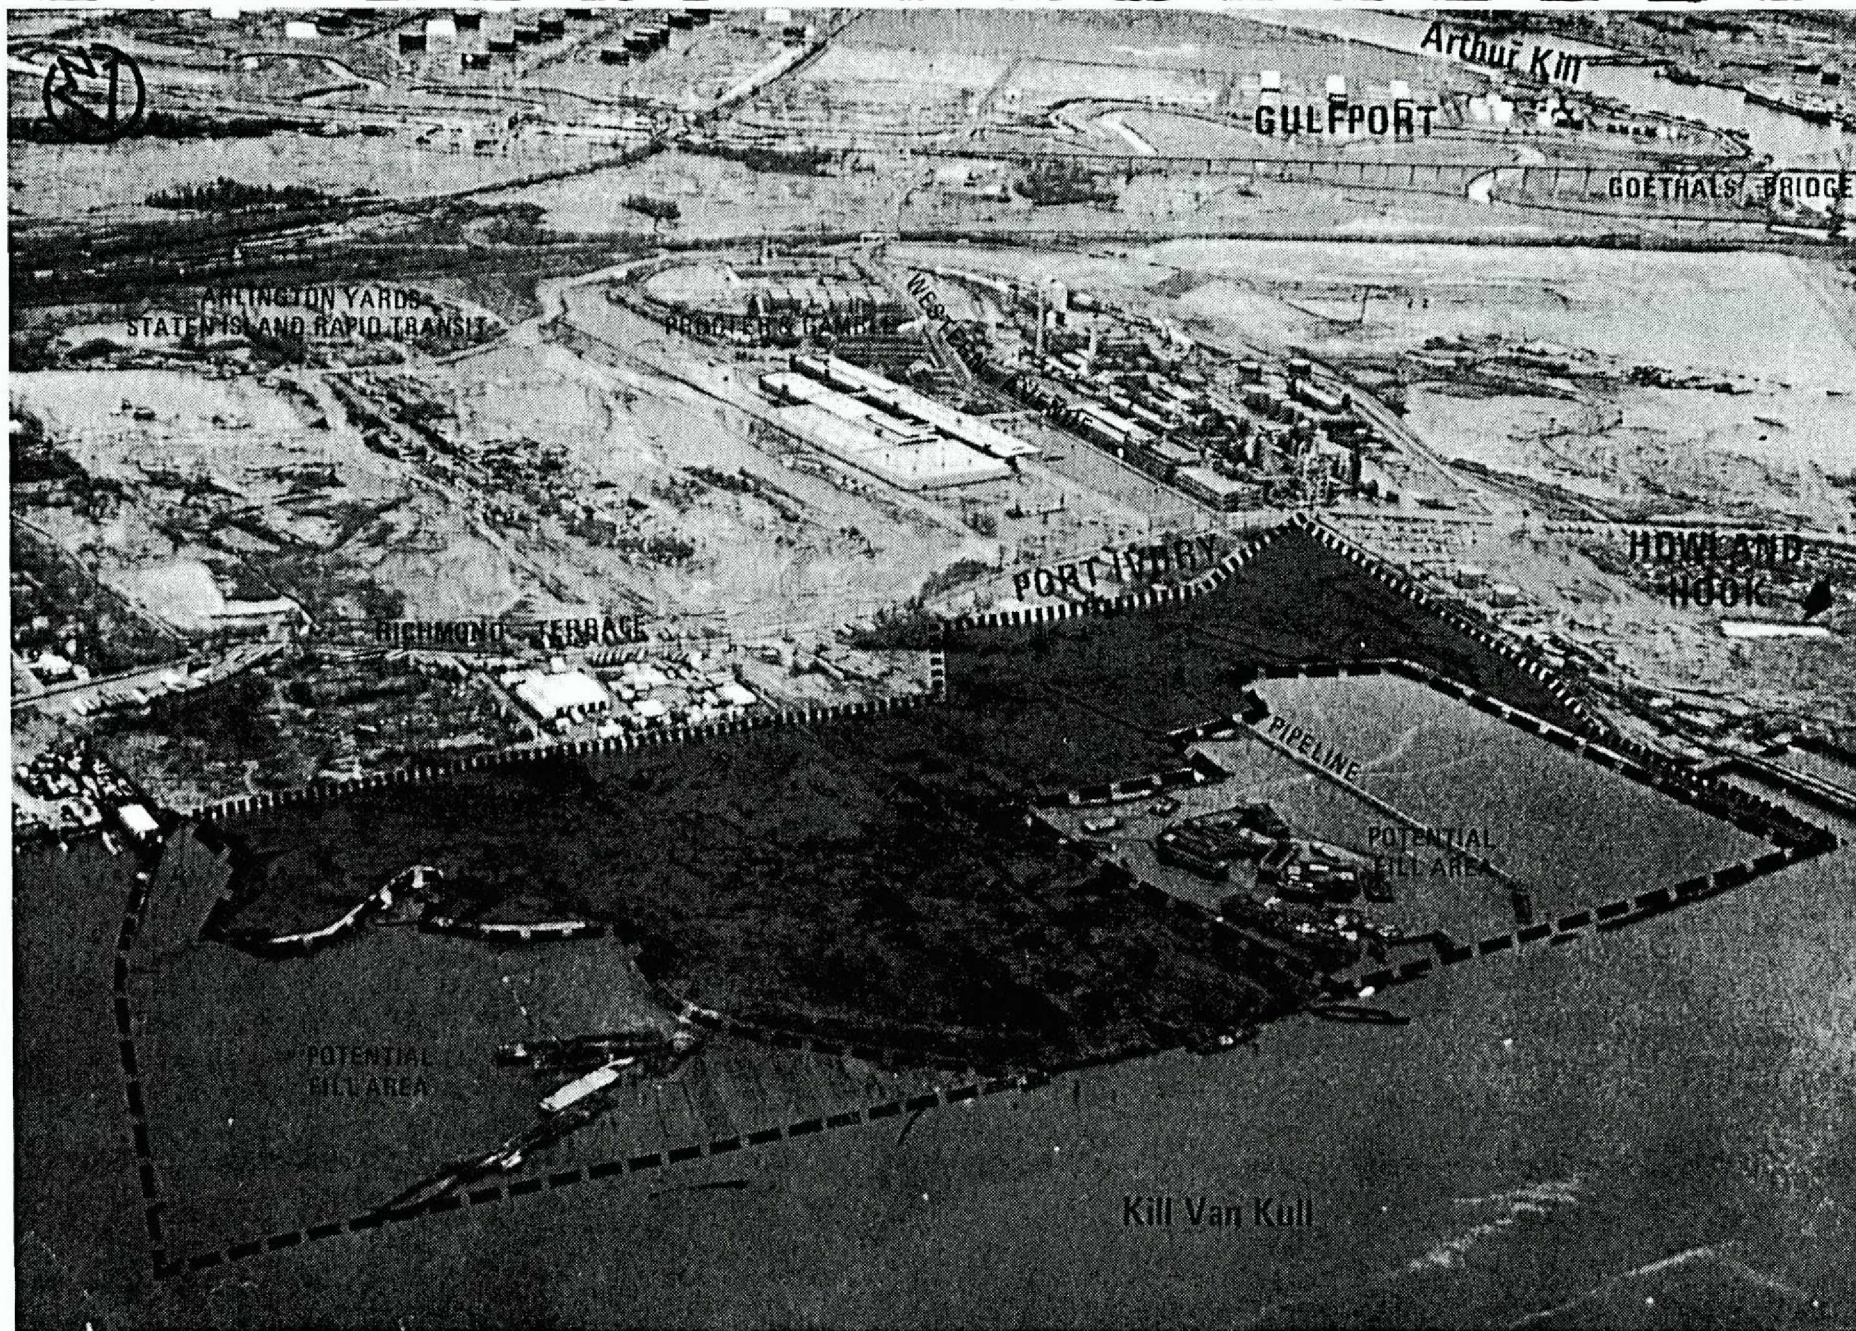
FIG. 6: Oblique aerial view of the site circa 1970-1971, from Port of New York Authority, 1971, p. 14.
