# **ARCHAEOLOGICAL FIELD MONITORING**

**IKEA RETAIL SITE  
RED HOOK, BROOKLYN,  
NEW YORK**

**GRAVING DOCK No. 2**

April 2008

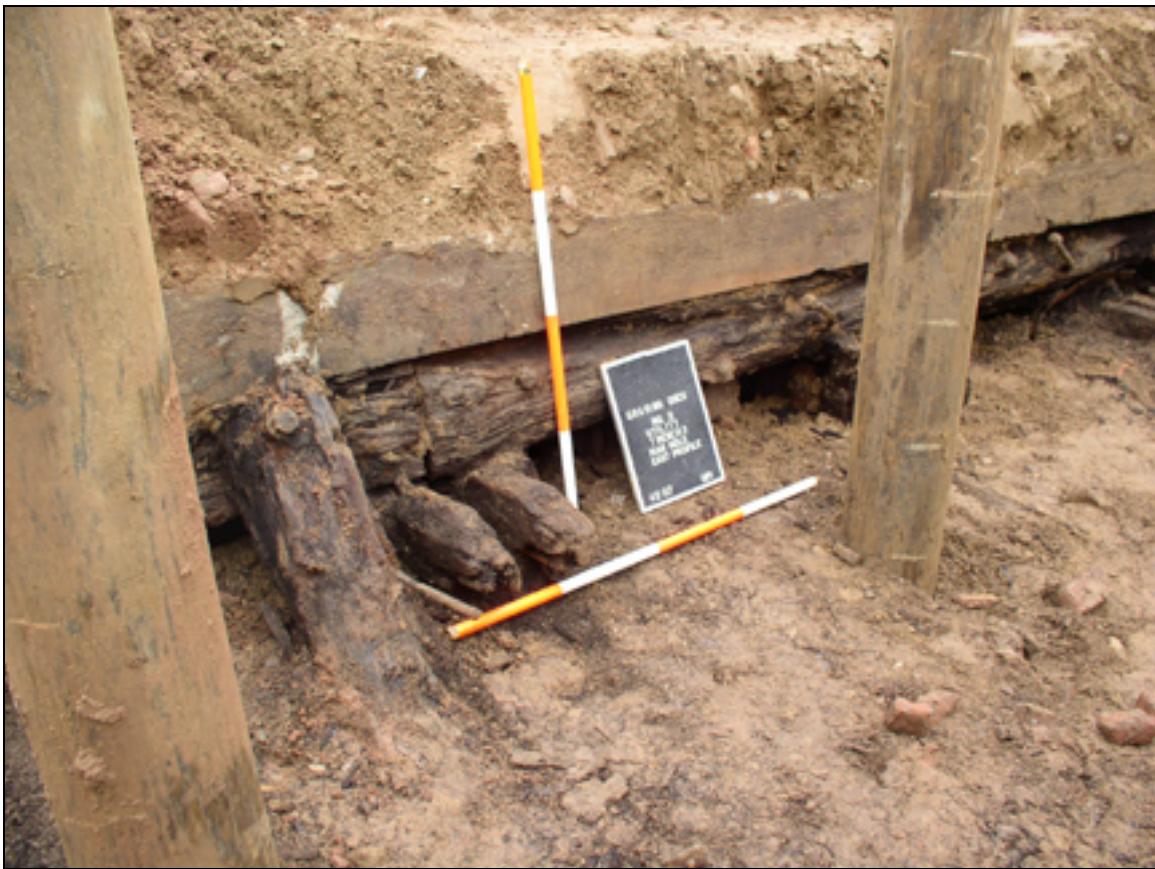
**Photo 3.29.** Close up of portion of Manhole Box, East Profile of Utility Trench 3, showing exposed wooden elements of East Wall of Graving Dock No. 2.

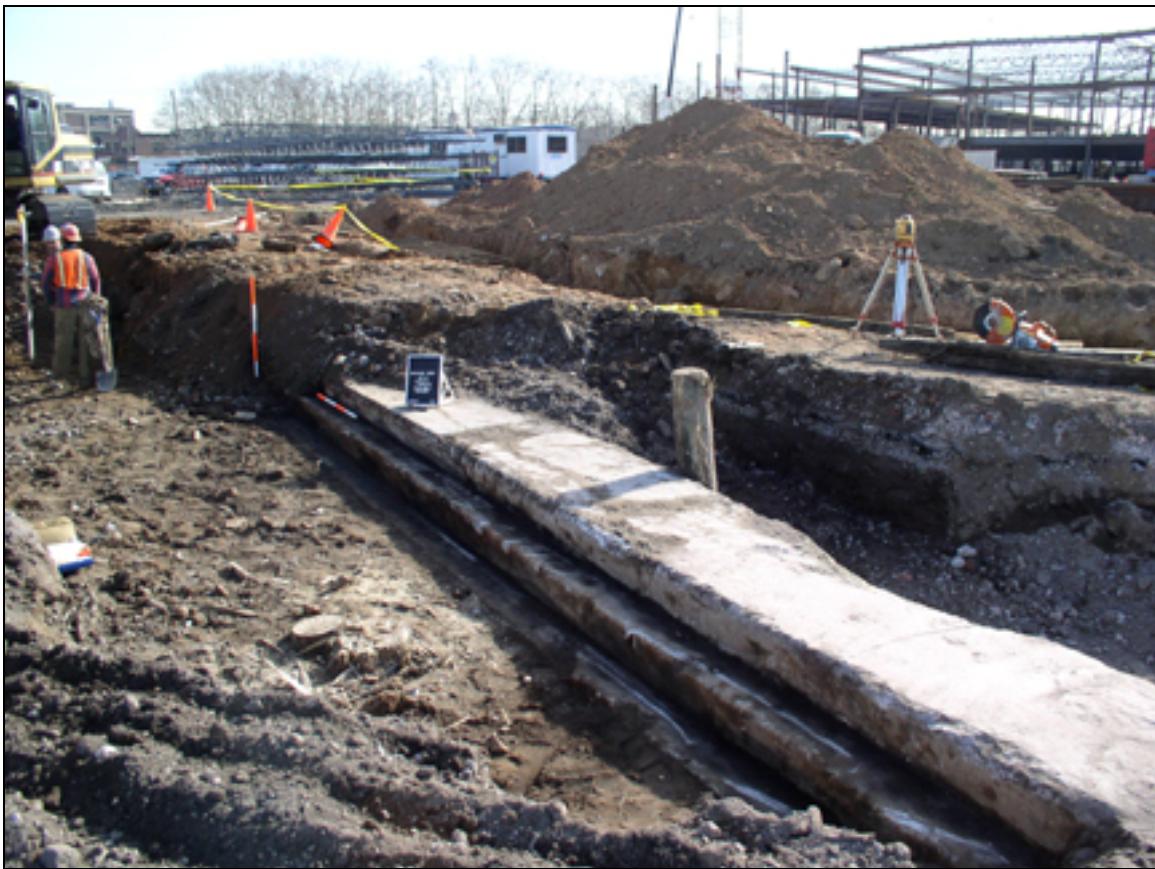
**Photo 3.30.** Close up of northernmost portion of Manhole Box, East Profile of Utility Trench 3, showing exposed wooden elements of East Wall of Graving Dock No. 2.

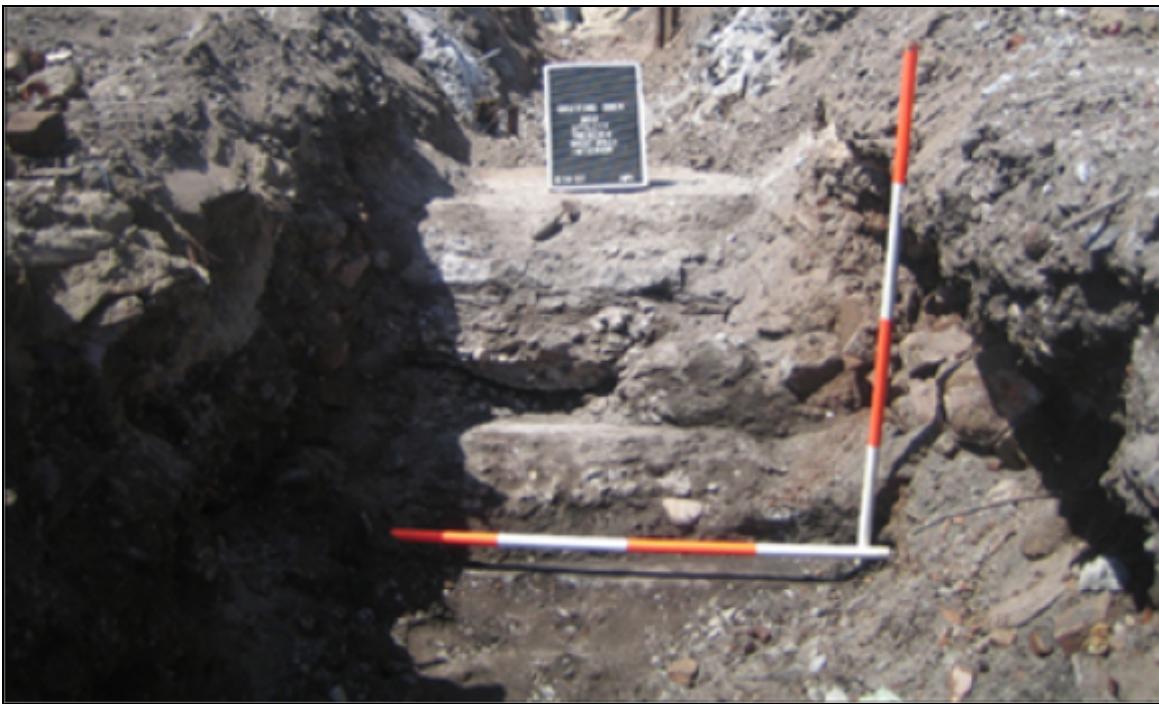
The wall contained two stepped altars below the top of the dock (cap) on its interior or eastern face. Each of the stepped altars were approximately seven inches wide and seven inches deep (Photograph 3.31-3.32). The concrete-encased electrical conduit paralleled the east wall, running along its east side, separated by approximately two feet of fill that contained a five-inch iron pipe. The pipe appeared to be parallel with both the east wall and the electrical conduit. Unfortunately, the relationship between the pipe, graving dock and electrical conduit is unclear (Photograph 3.32) due to the limited exposure within the excavation cut for Utility Trench 3.

**Photo 3.32.** West Profile/Exterior of Graving Dock No. 2 within Utility Trench 3, Southern Exposure, looking north.
