# Memorandum

Subject: **End of Field Summary, Phase 1B Archaeological Testing, Atlantic Yards Arena and Redevelopment Project, Blocks 1127, Lots 48 and 50, Brooklyn, New York**  
**05PR04690**  
**ESD/SEQRA-K**

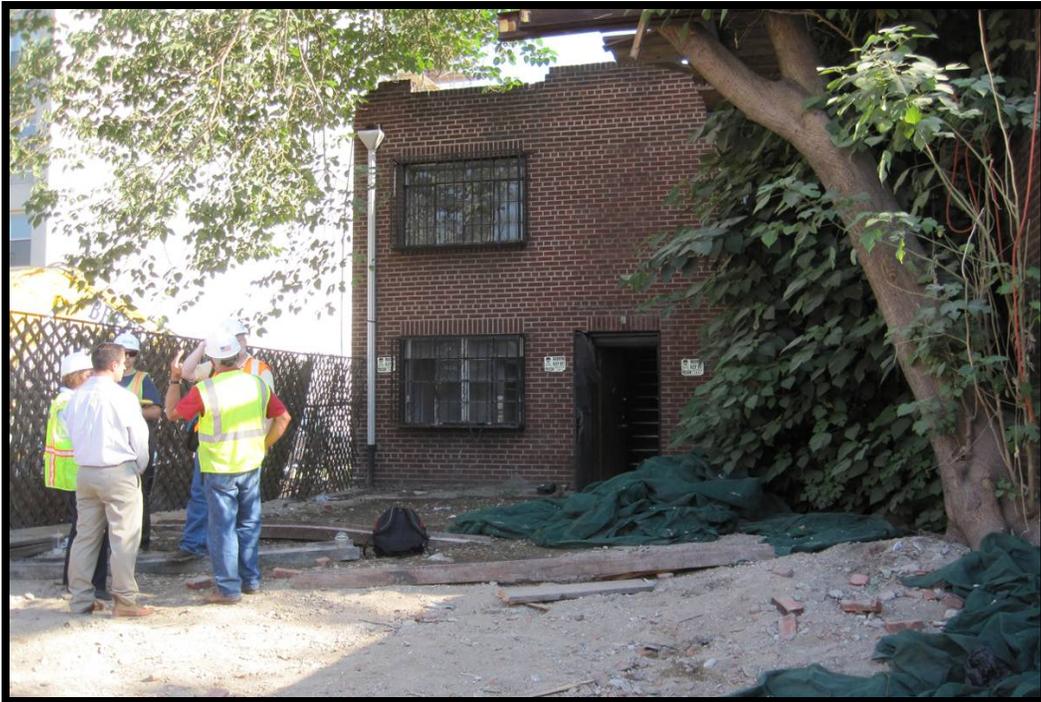
Photograph 1 Block 1127, Lot 50, prior to demolition.

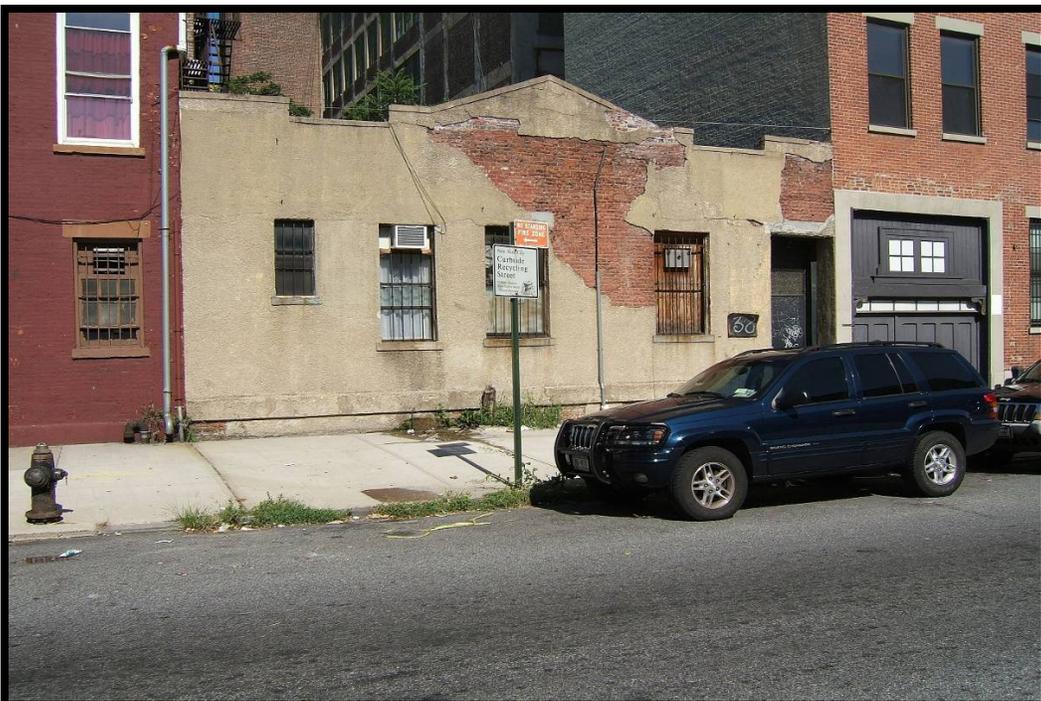
The second area recommended for testing as part of Lot 48 was a 30-x-15-foot area, designated Area C, located along 6<sup>th</sup> Avenue and is referred to as the 6<sup>th</sup> Avenue Out Parcel (see Figure 3). This lot is identified as Lot 43 on several historic maps, however, for the purposes of this investigation it is being referred to its modern designation as Lot 48. Formerly, a one-story stuccoed brick structure stood on this parcel (see Photograph 2).

Photograph 2 Block 1127, Lot 48, prior to demolition. Looking northeast along 6<sup>th</sup> Avenue.

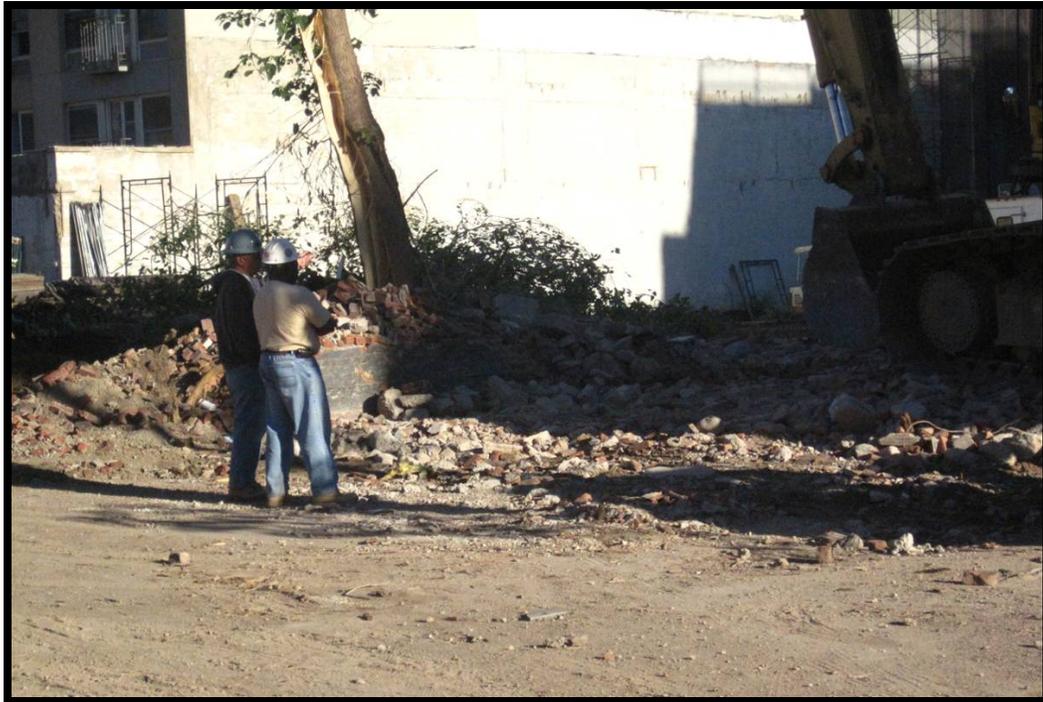
Photograph 3 Block 1127, Lots 48 and 50, post-demolition.

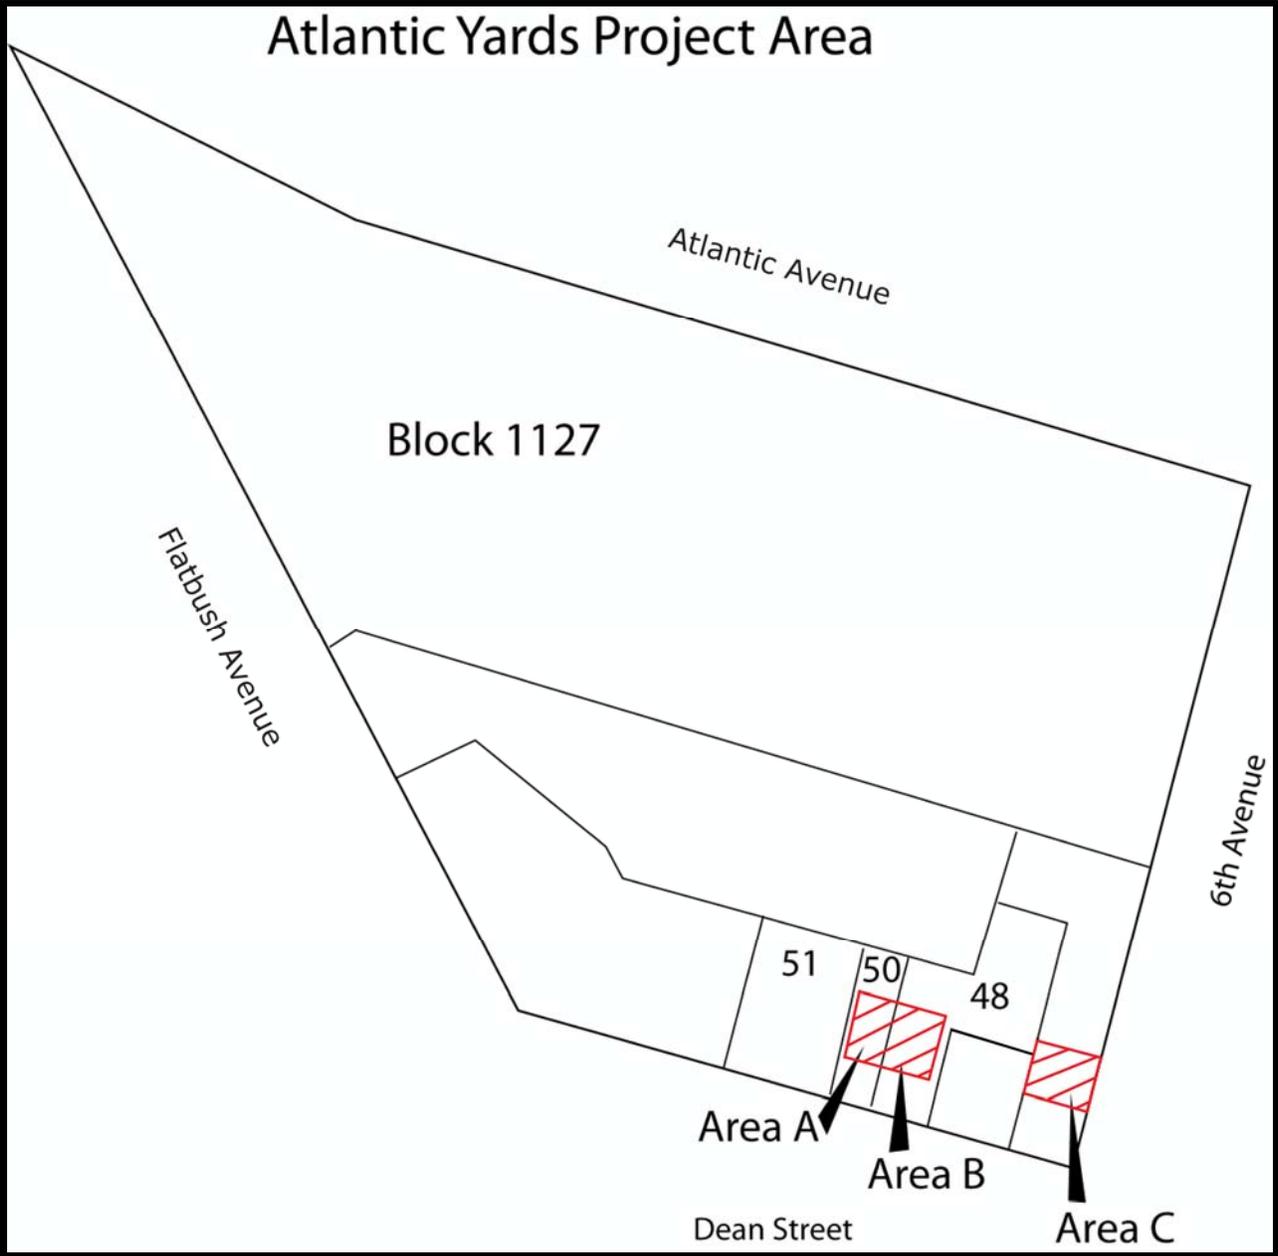
Figure 3 Atlantic Yards test area locations.

The Phase IA study recommended two areas for testing in Lot 48 (HPI 2001). The first was a 25-x-15-foot area, designated Area B, located adjacent to the area to be tested in Lot 50 (Figure 3). The area was covered in concrete and an enclosed fire escape was attached to the recently demolished brick building. Originally, eight shovel test pits (STPs) had been laid out, but the impassable nature of the soils in the northern half of the test area required shifting the testing methodology to backhoe trenching. Testing consisted of a series of five STPs and machine excavation (Figure 4).

The area recommended for testing within Lot 50 measured 25 x 25 feet and was designated Area A (see Figure 3). This area was located between the former three-story dwelling at the front of the lot and a two-story building that stood at the rear of the lot. The area had been used as a garden/yard area that consisted of stone slab sidewalks, and concrete bordered, raised flowerbeds. Subsurface investigations consisted of five STPs and three machine-excavated trenches.

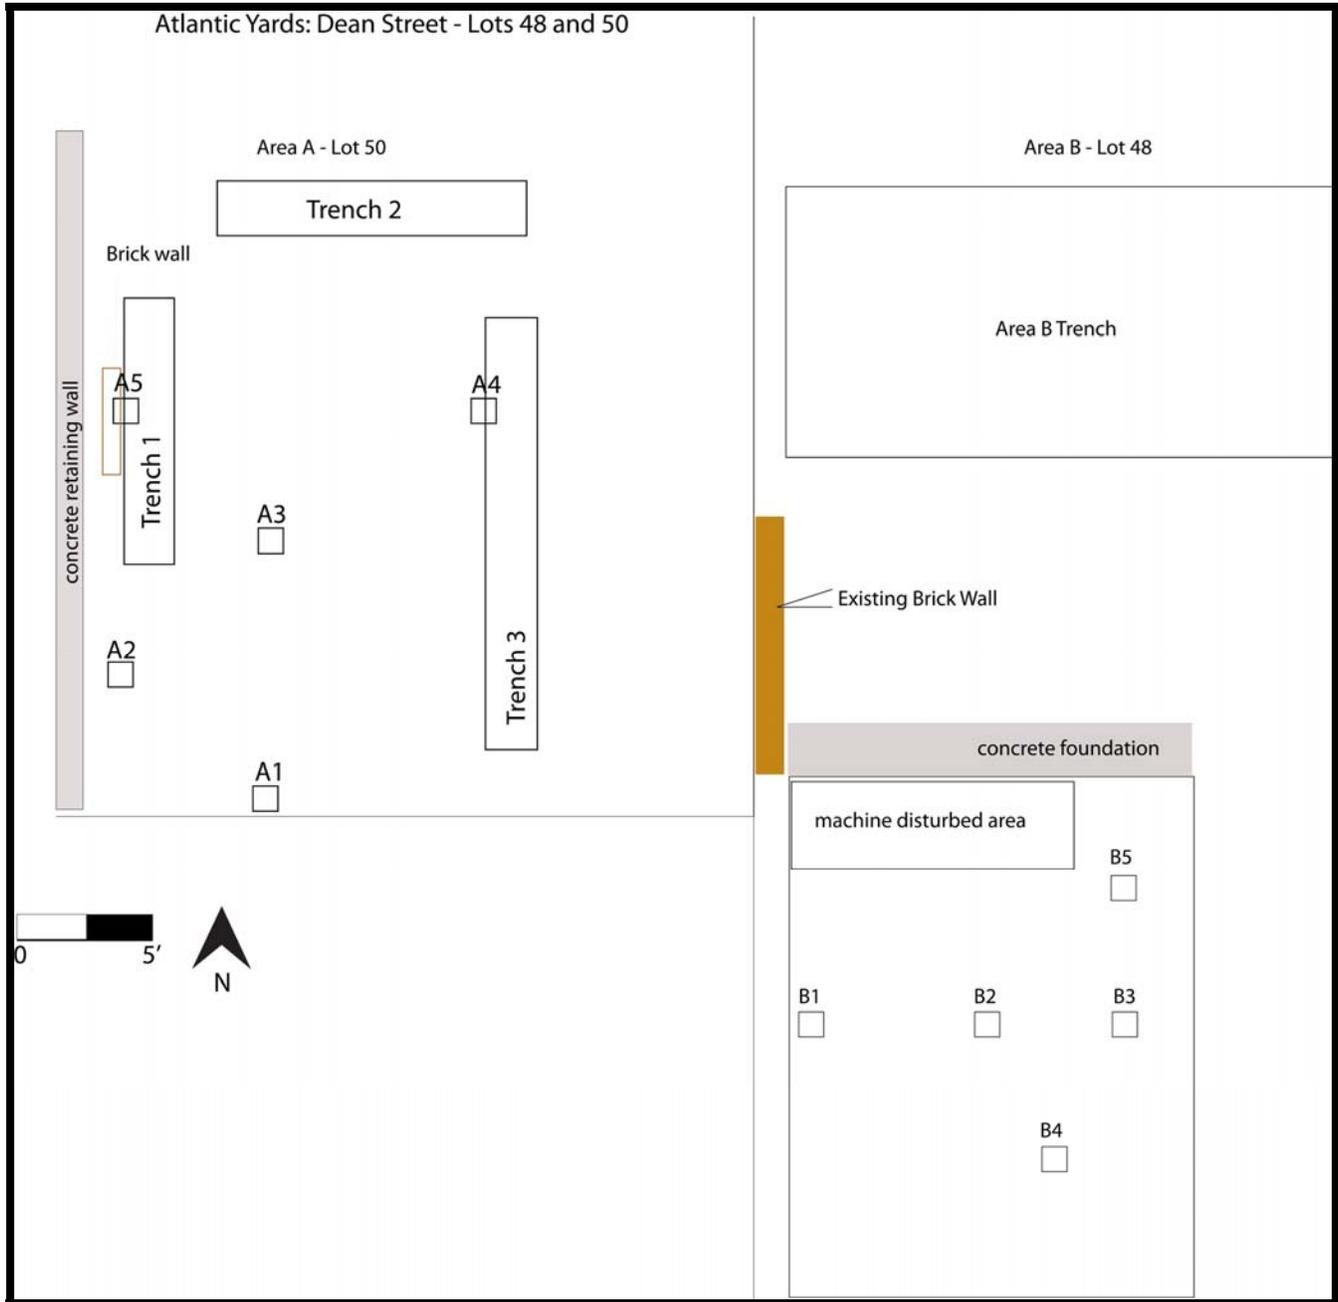
The backhoe test trench was positioned in the northern half of the test area in the vicinity of the former stair (see Figure 4). This trench measured 9 x 26 feet and was excavated to a depth of 5 feet. In this area, a 2-foot-thick concrete foundation was uncovered, extending beyond the 5-foot excavation depth (Photograph 5). The area north of the foundation wall was filled with brick and concrete building rubble and metal pipes. The area south of the foundation wall also contained a significant degree of rubble, as well as some disassociated large cobbles.

The scope of work called for two parallel transects, 10 feet apart, to be tested at 5-foot intervals. Based on site conditions, which included a range of demolition debris and the potential to locate an underground storage tank (location and depth unknown), a checkerboard pattern of STPs was laid out along with three trench locations (see Figure 4).

Three backhoe test trenches were positioned to expose the length and depth of the brick wall uncovered in STP A5 and to traverse the area both east to west and north to south to ascertain a broader stratigraphic profile (see Figure 4). The trenches were excavated to approximately 4.5–5 feet below surface.

Figure 4 Areas A and B, shovel test pit and test trench locations.

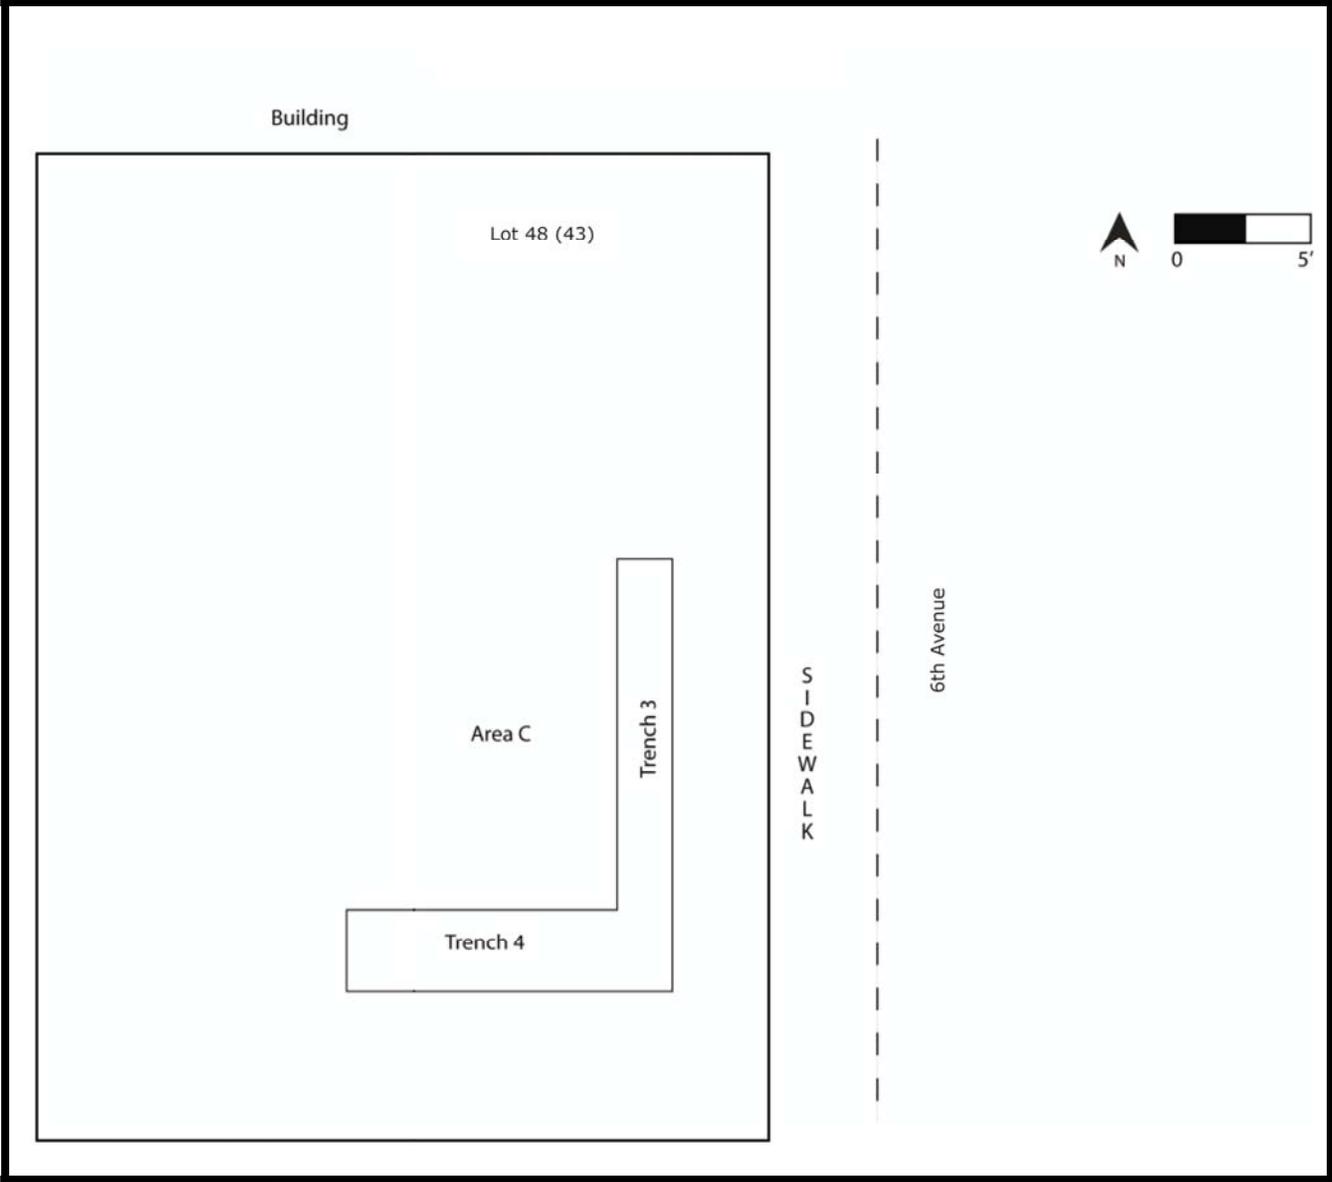
Subsurface investigations consisted of two machine-excavated trenches—measuring 2 x 16 feet and oriented north-south, and 3 x 10 feet and oriented east-west (Figure 5). Both trenches consisted of redeposited fill materials composed of rubble and recycled concrete aggregate (RCA) (Photograph 6). The brick within the

Figure 5 Area C, 6<sup>th</sup> Avenue Out Parcel, test trench locations.
