Fort Greene Park, Brooklyn Dry Well Locations Near Willoughby Gate Archaeological Testing Memo Report

Project No. B032 - 110M

Prepared for the New York City Department of Parks & Recreation
through Nancy Owens Studio, LLC
by Joan H. Geismar, Ph.D., LLC
May 19, 2014

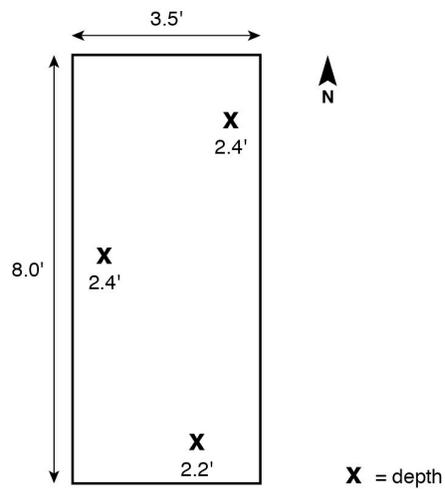
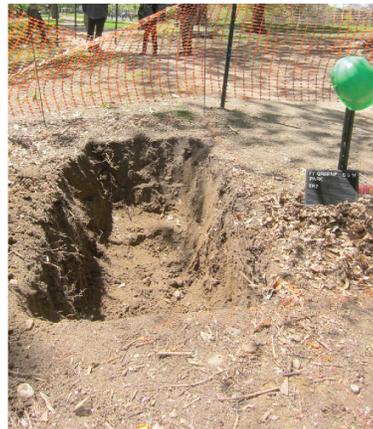
3b TR2

TR2, located upslope from TR1, and therefore higher above street level, contained the same mottled soil found in TR1 to a depth of ca. 7.5 feet (2.3 m) where it became siltier and darker with depth but with inclusions of small ceramic fragments, clinkers, and decomposed oyster shell to the bottom of the trench (9.2 feet [2.8 m] below grade; see Photo 3 for examples of the cultural material). Given the nature of the soil, only the east side of TR2 was taken to a depth of 9.2 feet (2.8 m); excavation on the west side of the trench was halted at 3 feet (0.91 m) below grade. Again, after a plan and schematic profile were drawn and photographs taken (Figure 5), the trench was backfilled.

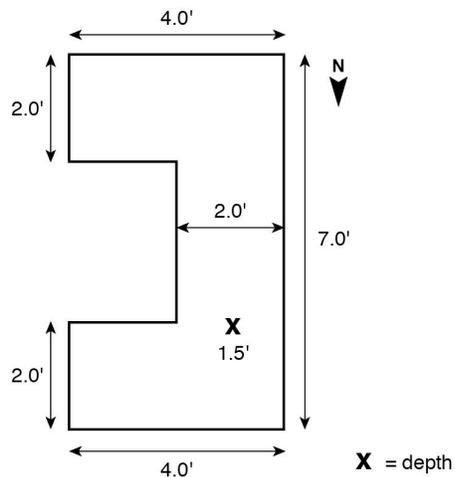
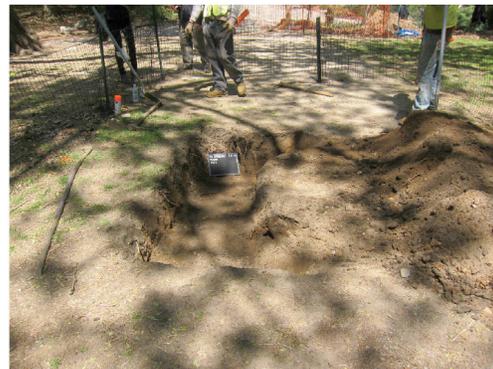
3c TP1

TP1 ultimately was also tested. Since it was backhoe excavated, it became a small trench rather than a true pit. Considerably more debris was found at this location (a broken but worked building stone was found below the surface, as was a sizeable concrete fragment at 3 feet [0.92 m], a piece of wire at 7 feet [2.1 m], and a small ceramic fragment at 8 feet [2.4 m]). What appeared to be a brick concentration at 7 feet (2.1 m) was explored by widening the pit slightly, but it proved to be debris. A broken, earth-filled but perhaps *in situ* terra-cotta drainpipe was encountered 7 feet (2.1 m) below grade in the southern part of the pit and window glass fragments were found at 9.6 feet (2.9 m). The excavation was taken to a depth of 10.3 feet (3.1 m) in the southern portion of the pit/trench (a straight pin (?) was found in the backdirt at approximately this depth; see Photo 4 for an example of the cultural material from TP1). Again, measurements and photographs were taken and a schematic profile drawn (Figure 7) before the pit was backfilled. The archaeologists then left the site with the assurance of the backhoe contractor that all would be restored to its pre-testing condition. A site visit on May 12, 2014, indicated that this was, indeed, the case (Photo 5).

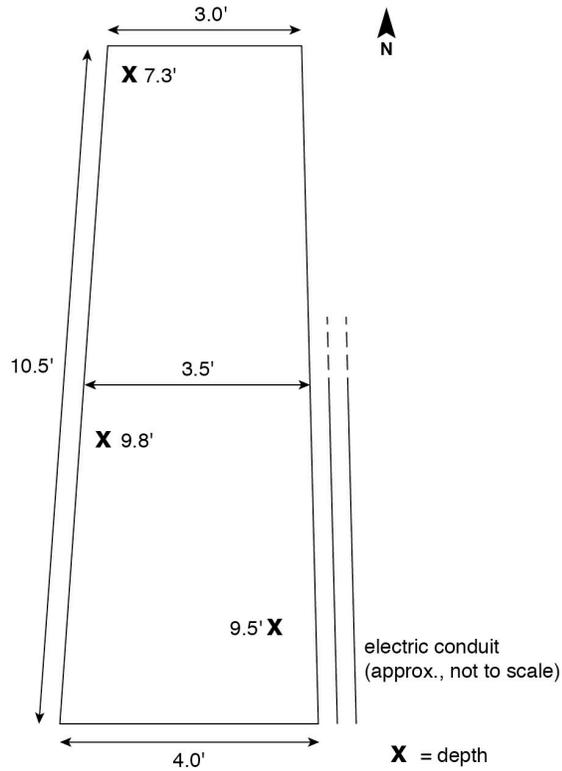
4a Schematic Plan

TR1, situated at the lowest point of excavation but still well above street level, was taken to 9.8 feet (3.0 m) in the center of the trench with relatively clean fill indicated throughout (roots from a Redbud tree scheduled for removal were present on the east side of the trench [see Figure 4b]. Metal tubing and oyster shells found at 6.0 feet (1.8 m) below grade and oyster shell noted at 8 feet (2.4 m) determined that the soil comprised fill. Perhaps most telling was the mottled soil, devoid of strata, that was found throughout. An electric conduit pipe was noted just beyond the southeast corner of the trench, and park drawings indicate there were water pipes and other electric lines nearby. TR1 was measured, a schematic profile was drawn, and it was photographed (Figure 4) and backfilled.
