# Saratoga Square Urban Renewal Area, Brooklyn, New York Field Testing June 1994

CEQR No. 89-232K

Prepared for the City of New York Department of Housing Preservation and Development

Prepared by Joan H. Geismar, Ph.D. August 1994

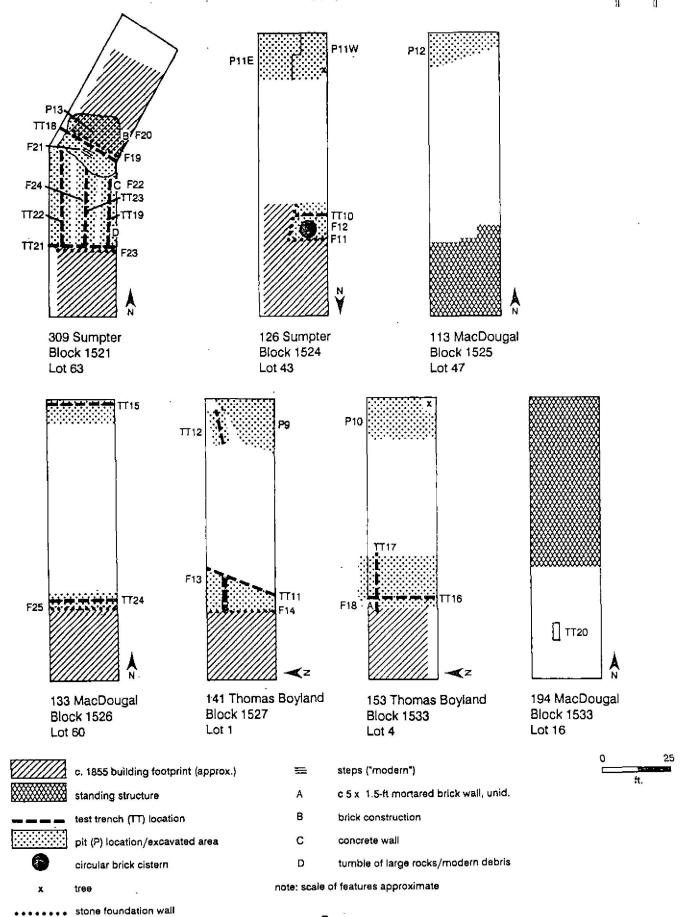
**3** Pit (P) 11 partially excavated, looking south. A cement floor, the remnant of a shed, was removed to access this part of the yard at 126 Sumpter St., but no evidence of a privy pit was found although the excavation extended into sterile yellow soil (arrow). (photo Geismar 6/7/94)
